Todd Energy Aquatic Centre
Monitoring Programme
Annual Report
2016-2017

Technical Report 2017-33

August 2017

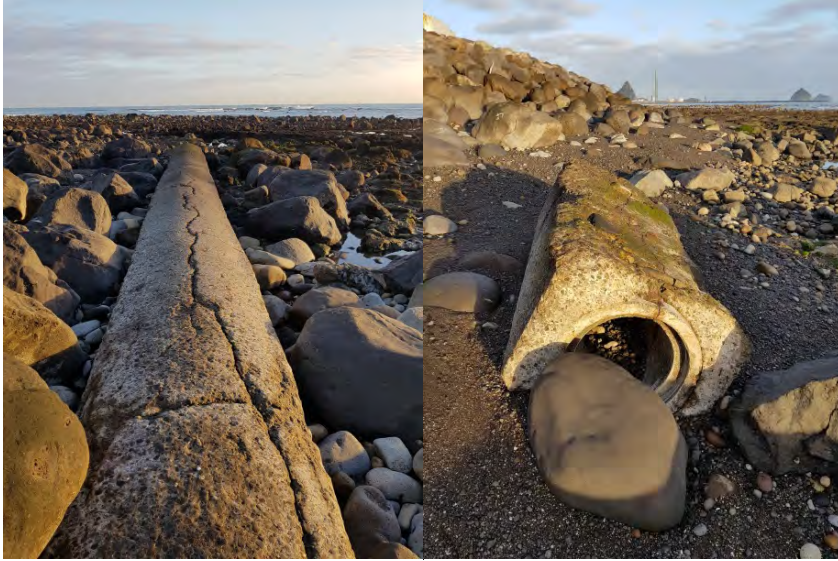
The marine outfall pipe was also inspected. Cracks were visible on the surface of the cement casing, and the dislodged end of the pipe was situated to the east of the main structure, on the Kawaroa Reef (Photo 2).

Photo 2 Cracks visible on the surface of the marine outfall structure (left), and the 2.4 m length of pipe dislodged from the end of the pipe at the Aquatic Centre (right)

The integrity of the outfall structure was also investigated during the year under review. Observations of cracks along the surface of the structure and the 2.4 m length of pipe that had dislodged from the end of the pipe were addressed with the Aquatic Centre, in relation to condition 2 of consent 4588-3.0 (Photo 2). The Aquatic Centre responded promptly on Monday 22 May with a report stating that the pipe was considered by NPDC to be in safe and sound condition (Appendix IV). Ongoing monitoring of the pipe, including taking photographs for comparison, will continue to shed light on the performance and integrity of the structure.

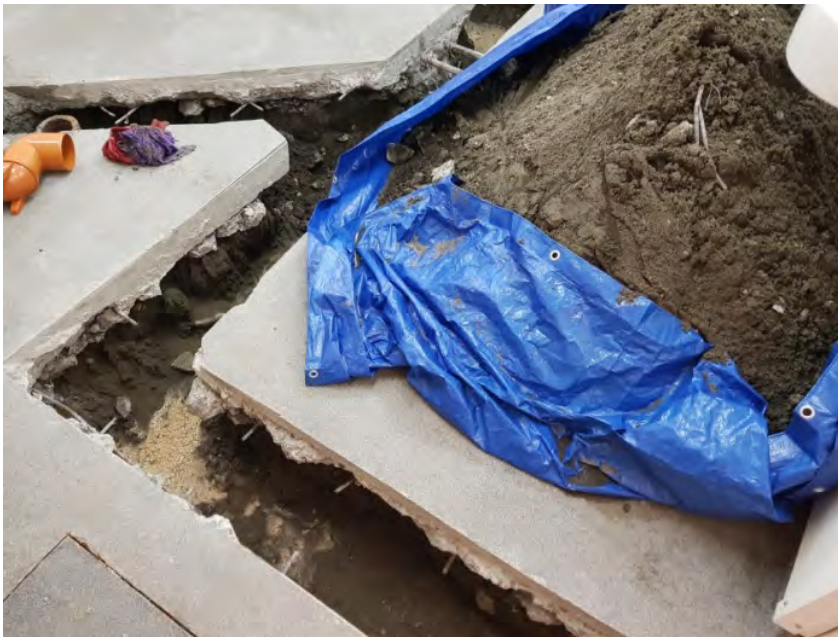
Photo 3 Extensive works being undertaken by NPDC to divert greywater from the women's showers to the sewerage system

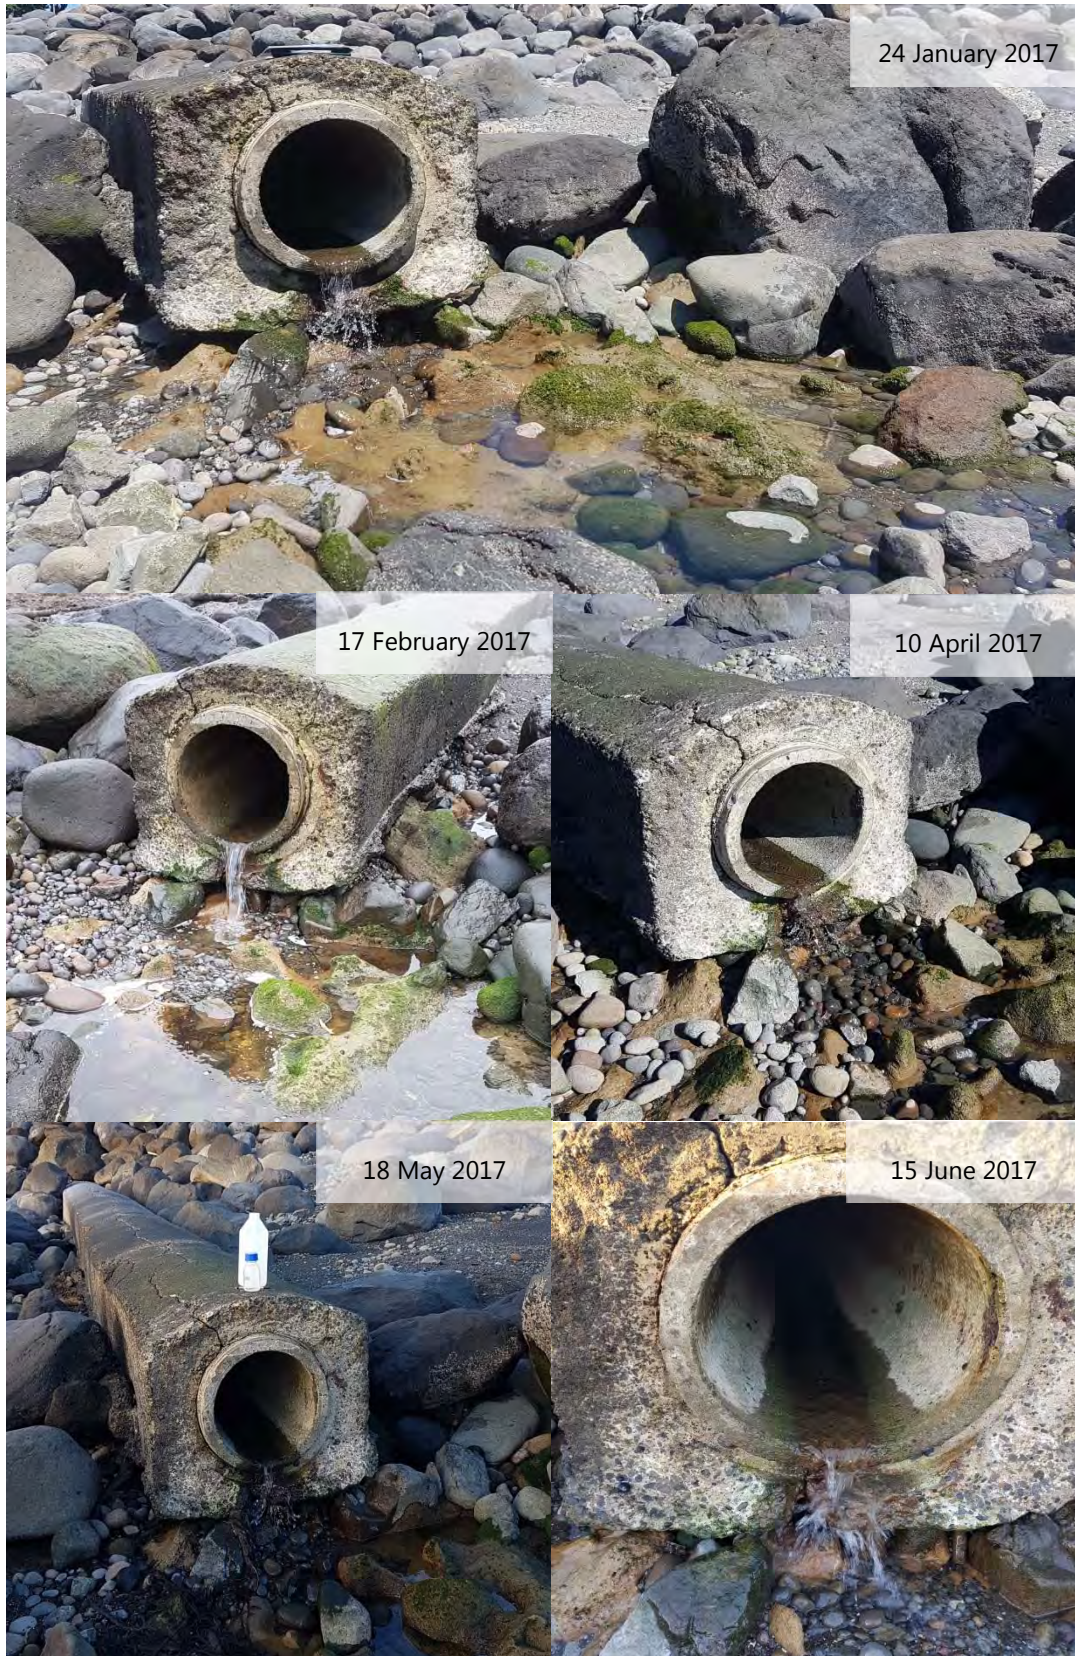
The reef inspection was carried out at the next practicable low tide (09:39 on 19 May 2017 at 1.1m). Upon arrival at the reef at 08:00, a medium residual flow which generated a small quantity of foam was found discharging from the outfall (Figures 2 & 3).

Figure 2 Water discharges observed occurring from the marine outfall pipe on the Kawaroa Reef during the 2016-2017 monitoring year

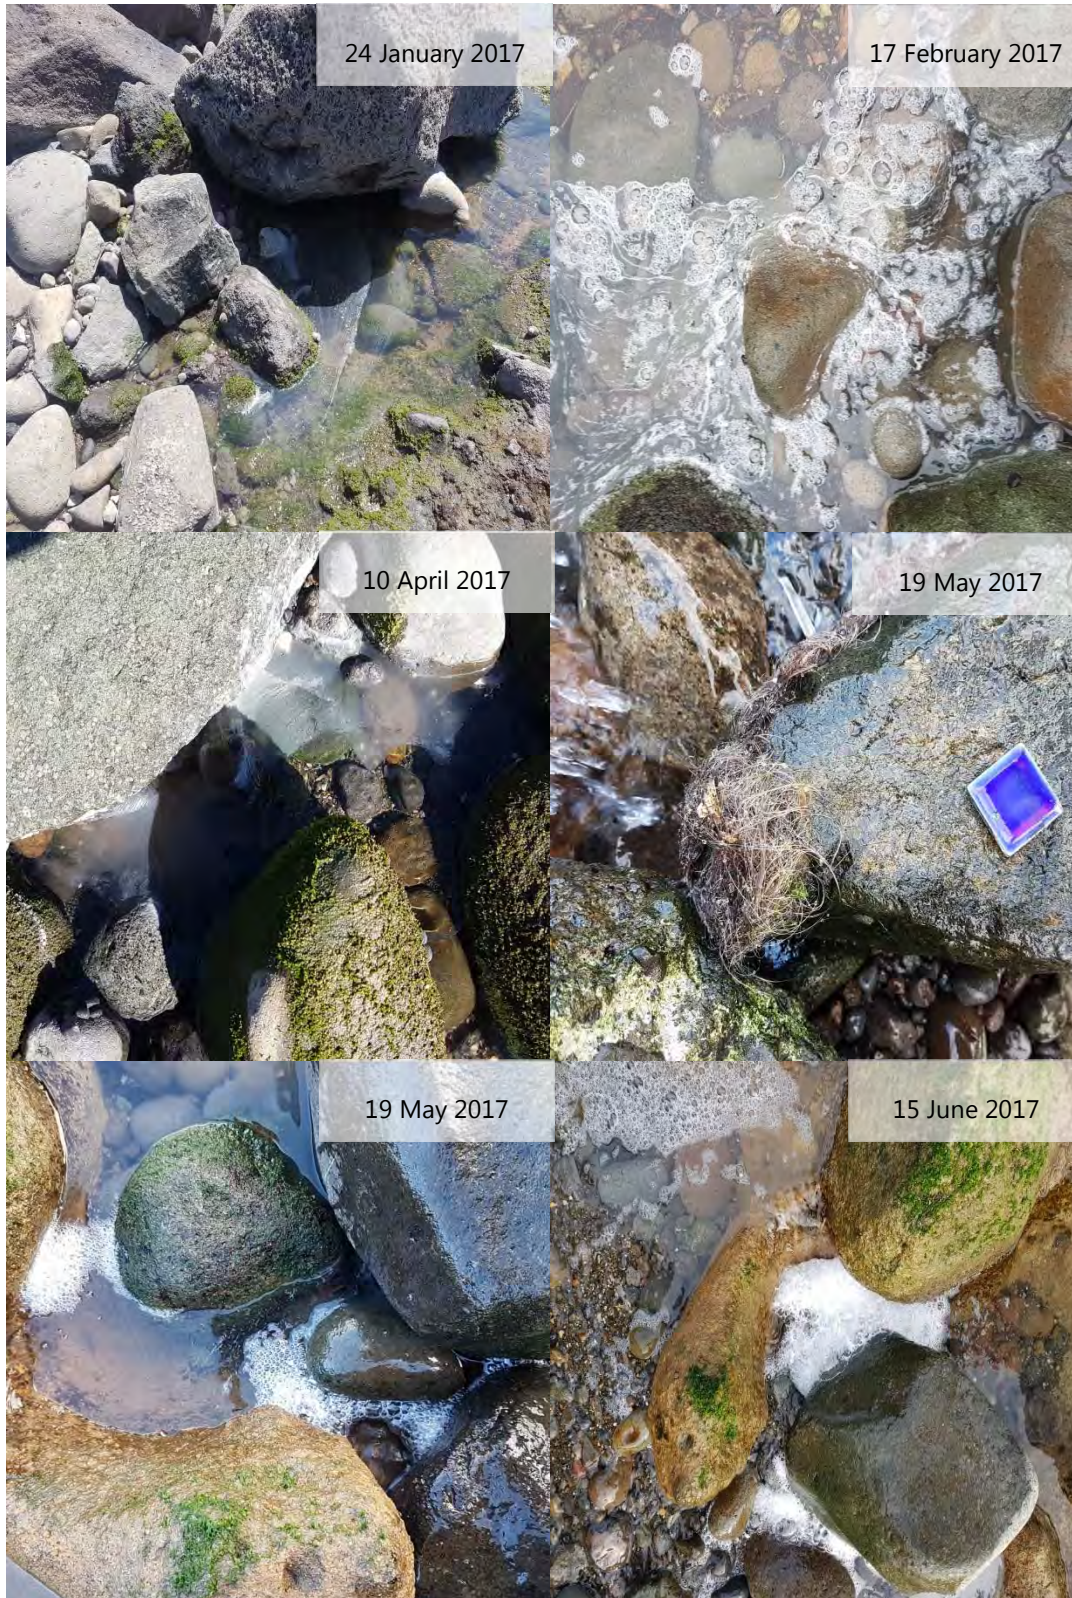
The inspection commenced at 08:00, in the vicinity of the outfall discharge. The weather was fine, sunny and dry at the time of inspection. Low tide that day (0.9m) occurred at 07:24. At the time of the inspection, water with a noticeable drain odour was discharging at a constant rate through the outfall onto the reef (Figure 2). Soapy foam and clumps of human hair were clearly visible in the pooled discharge close to the end of the outfall pipe (Figure 3).

Figure 3 Soapy discharges and shower debris observed in the vicinity of the marine outfall pipe on the Kawaroa Reef during the 2016-2017 monitoring year

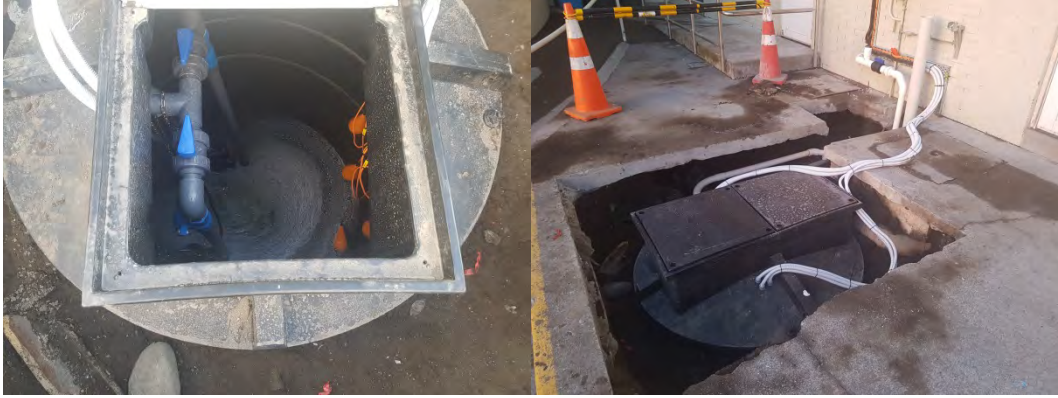
Photo 4 Commissioned works undertaken at the Aquatic Centre to divert greywater from the women's showers to the sewerage system (photo courtesy of NPDC, 27 June 2017)

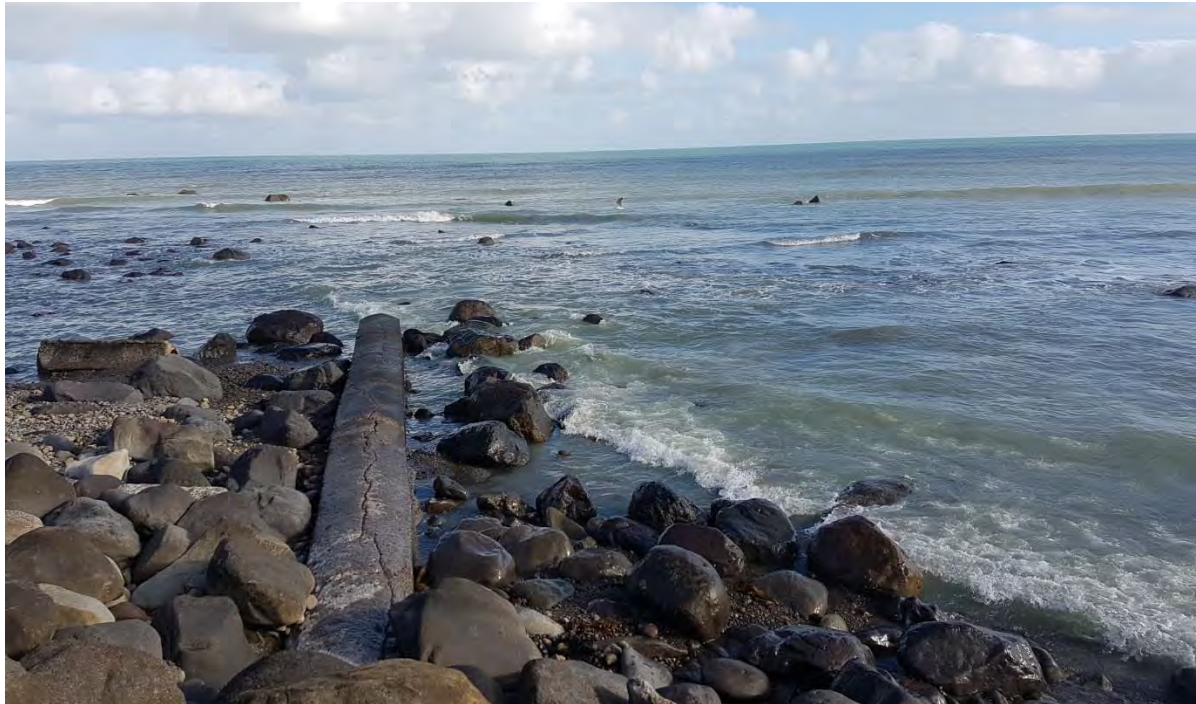
The sea, which was calm with little swell, did not appear discoloured or otherwise adversely affected by the discharge at the time the samples were taken (Photos 1). The inshore waters appeared turbid grey / brown up and down the coast, indicative of the recent rainfall and turbulent conditions.

Photo 1 Outfall pipe at time of shoreline water sampling

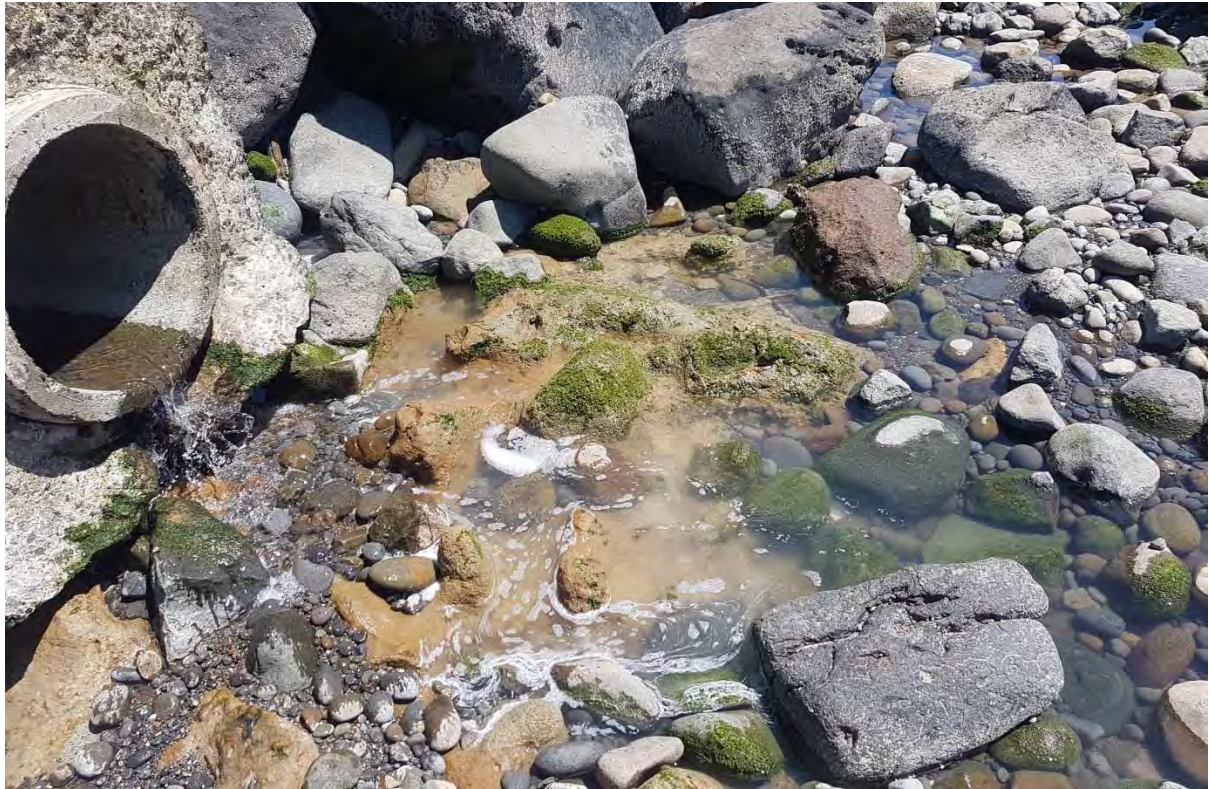
The reef inspection was carried out at the next low tide (14:33 on 24 January 2017 at 1.1m). Upon arrival at the reef at 14:30, a residual flow was found discharging from the outfall (approximately 0.1 - 0.2 L/s). As had previously been discussed with TEAC staff, the origin of this discharge may have been the site stormwater system, which aside from rain routinely collects water from swimmers and taps / hoses. However, the discharge started to generate a small quantity of foam; suggesting some of the water that is reaching the outfall may potentially carry soaps, detergents or other contaminants. The discharge persisted for the duration of the inspection (approximately 30 minutes). There were no odours detected at the discharge point; chlorine or otherwise. Patches of surface scum were found on tidal pools in the vicinity of the outfall. Most of these patches were found along the flow path of the outfall discharge. Most patches were found within 5 m from the discharge point, although some were found approximately 5 to 10 m away. A high proportion of the gastropods found along the flow path of the discharge were clustered above water level. Contrary to previous inspections, no brown microbial mats were found on the reef. However, the cover of algae (thought to be *Ulva intestinalis*) surrounding the outfall was very high. Unidentified grey mats (likely to be either a colonial ascidian or sponge) were observed in the vicinity of the outfall, as in previous inspections.

Photo 2 Foam discharging from outfall

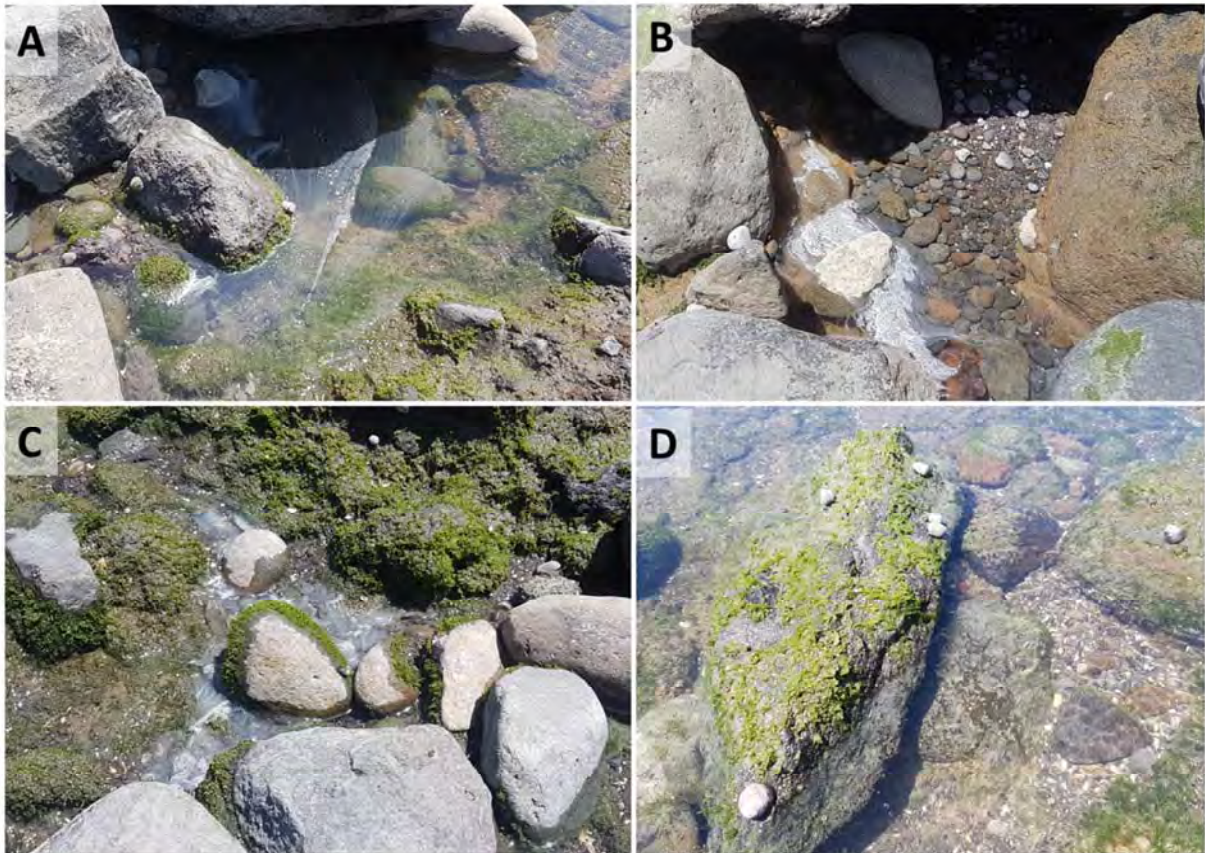
Photo 3 a,b,c) surface scum, d) gastropods above water

The discovery of the outfall's steady residual flow and its production of foam and surface scum raise concerns around sources of water draining to the outfall. This persistent flow is indicative of a water source additional to the intermittent contributions from swimmers, taps and hoses. Furthermore, the production of foam also raises the question of its origin. It is evident from the results of this reef inspection, that these discharges can have adverse effects on the reef. Such adverse effects were demonstrated by the presence of foam and surface scum, and also the movement of gastropods to positions out of the water.

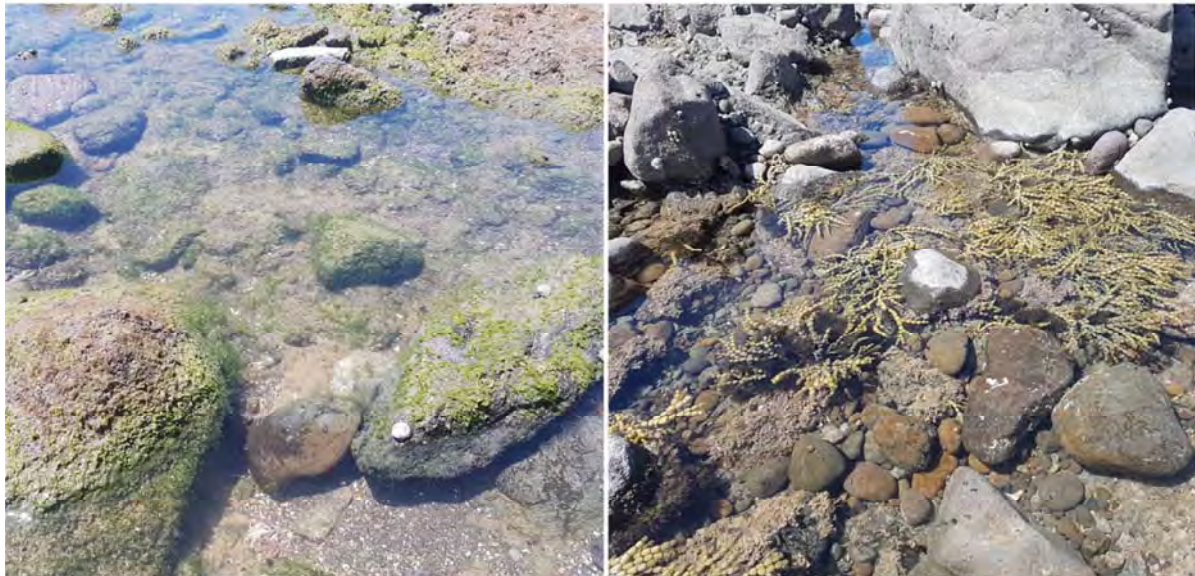
In comparison with the intertidal community further down the shore, the area surrounding the pipe supported very little biomass and diversity (Photo 4). However, this assemblage was similar to that found on previous inspections, and up shore intertidal reef environments generally support less biomass and diversity than down shore environments. The assemblage of species found down shore from the outfall was similar to what would be expected at this elevation on the shore and was comparable with previous inspections (Photo 4).

Photo 4 up shore (left) and down shore (right) intertidal reef communities

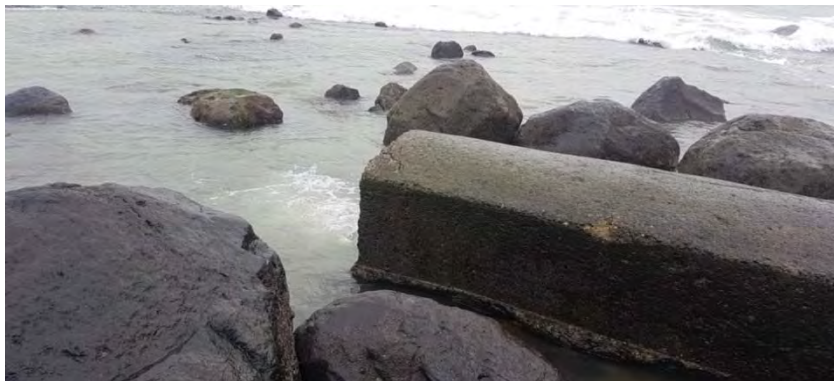
Photo 1 Discharge from the outfall pipe shortly after shoreline seawater sampling adjacent to the discharge pipe, 18 May 2017

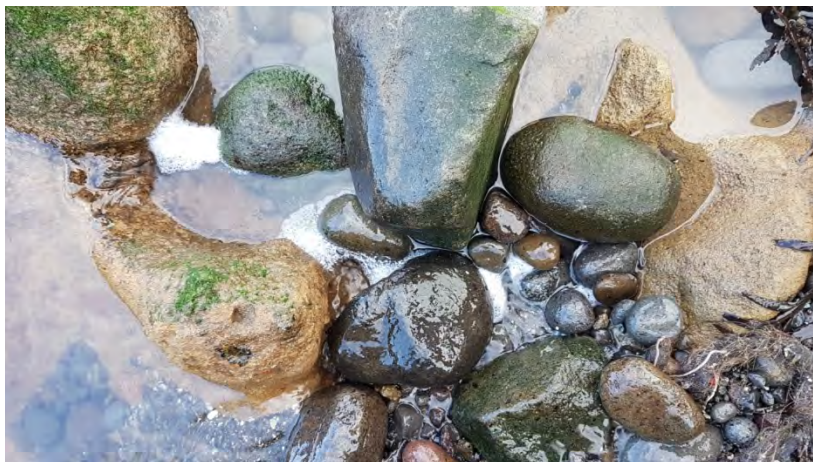
Photo 2 White foam in turbid water found in the pool adjacent to the outfall at approximately 09:00 on 19 May 2017

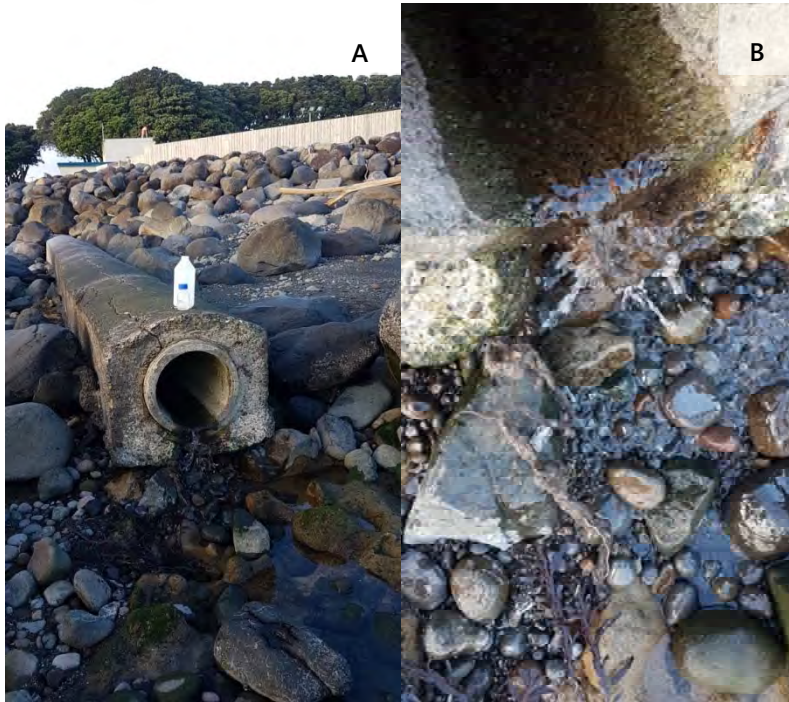
The next practicable low tide during which a reef inspection could be carried out was at 09:39 on 19 May 2017 (1.1m). A medium flow was discharging from the marine outfall (Photo 3) upon arrival at the reef (at approximately 08:15). The origin of the outfall discharge was unlikely to have been from the outdoor pool as the pool had only been partly emptied since the previous day. A sample of the discharge was taken at approximately 09:05. Foam and shower debris, including a shower tile, human hair, a hair clip and an entry wristband, were observed in the vicinity of the outfall (Photos 2 & 4). A TEAC membership card was also found at the outfall on the previous day. The reef inspection found no detectable chlorine odour.

Photo 3 (A) Medium flow discharging from the outfall on 19 May 2017;
(B) Close-up of water discharging from the outfall, with human hair visible in the vicinity of the outfall

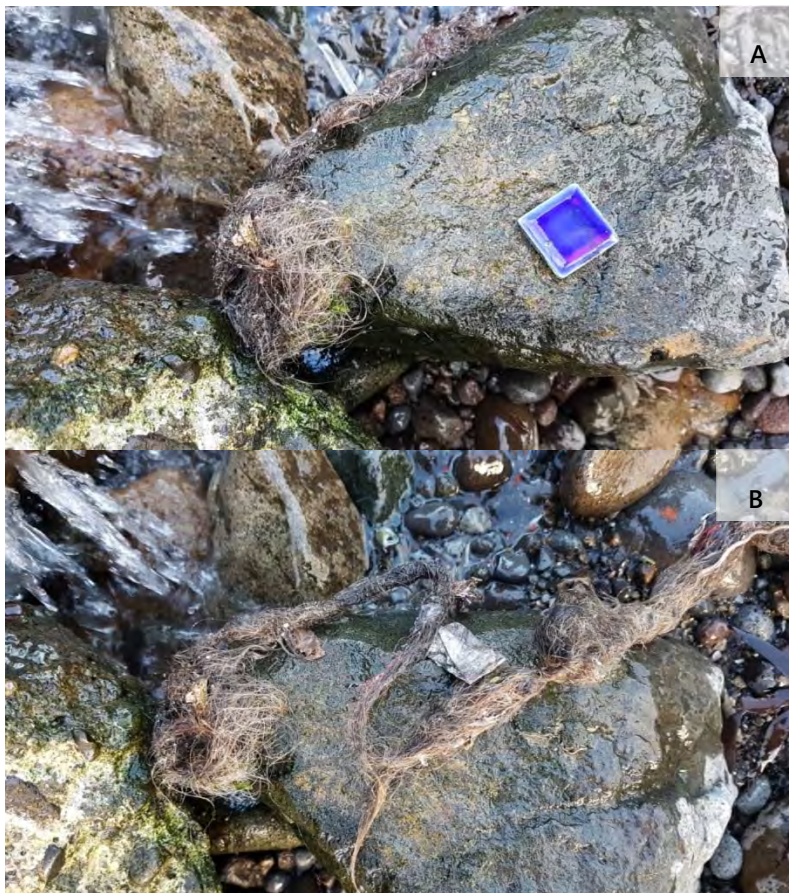
Photo 4 (A) Clumps of human hair and a shower tile found in the vicinity of the outfall on 19 May 2017, with water discharge from the outfall visible to the left;
(B) Human hair and a TEAC wristband, also found at the outfall

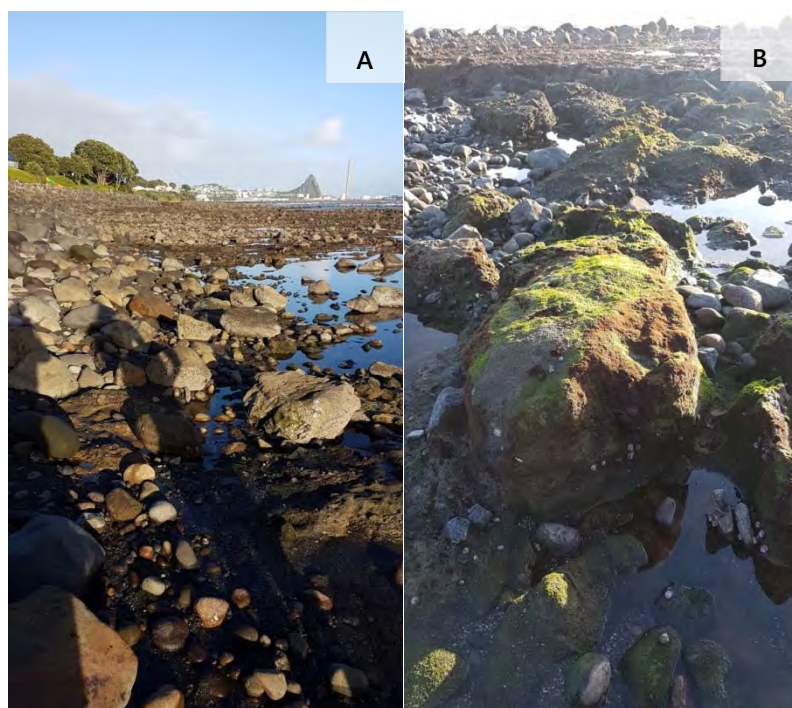
Photo 5 (A) Some *Ulva* sp. cover and limited biodiversity at the high tide mark, west of the outfall;
 (B) Extensive and prolific *Ulva* sp. cover 0-15 m from the outfall

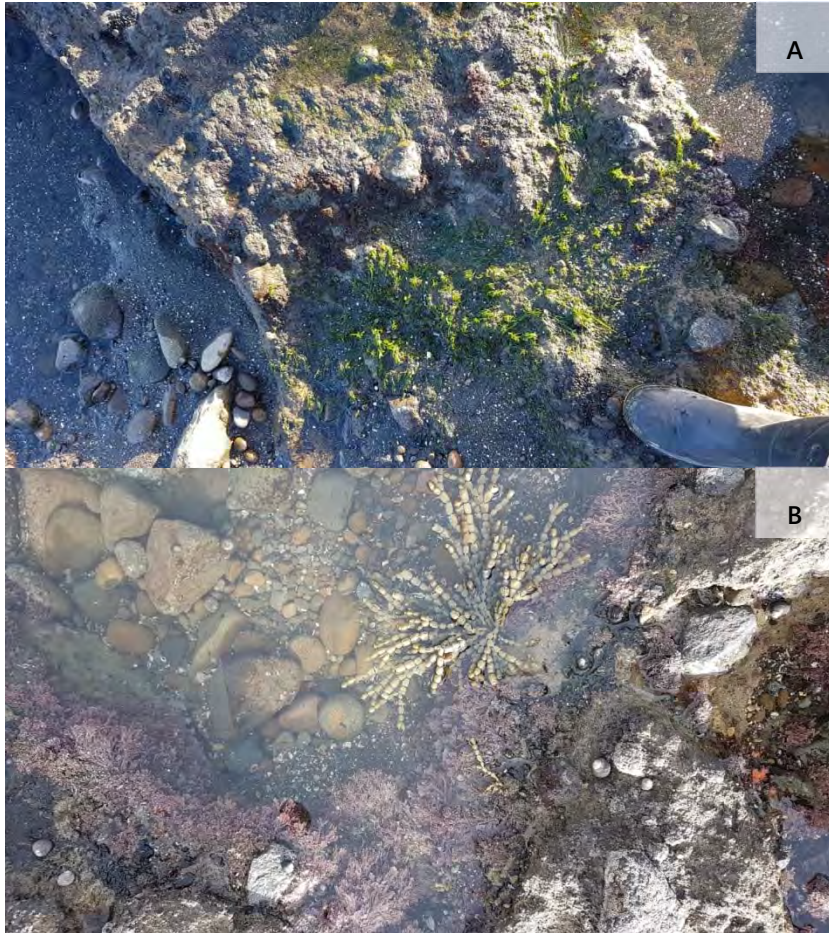
Photo 6 (A) Limited biodiversity, and greater *Chaetomorpha* coverage, within 5 m of the outfall;
(B) Greater biodiversity in a rockpool approximately 15 m away from the outfall

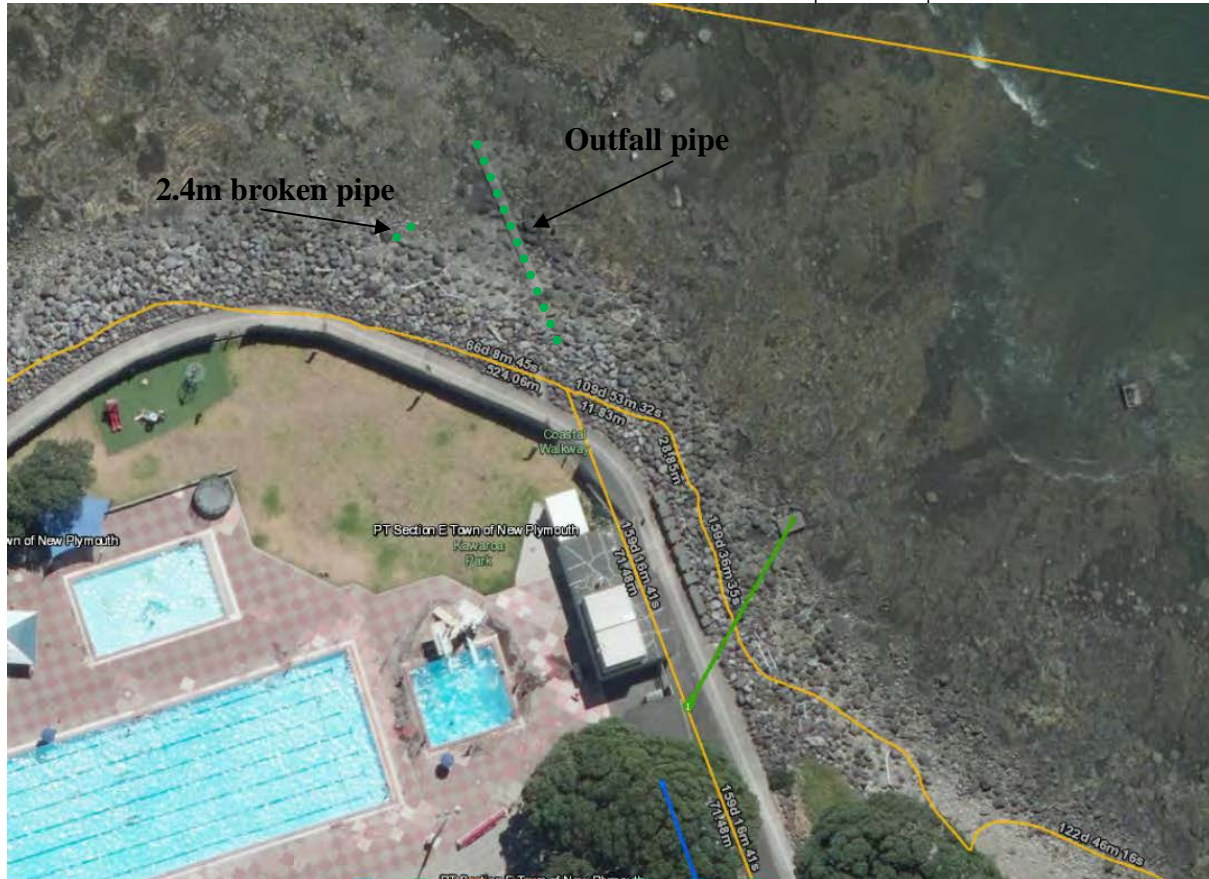
- An onsite inspection was undertaken on 19 May 2017 with NPDC staff to check the integrity of the pipeline.
- A 2.4m length of pipe has become dislodged off the end of the pipe.
- City Care Ltd was engaged to CCTV the internal pipe from the end of the outfall pipe to the shore line.
- The current distance off the high tide mark is 29.7m.
- The old distance of the high tide mark was 32.1m.

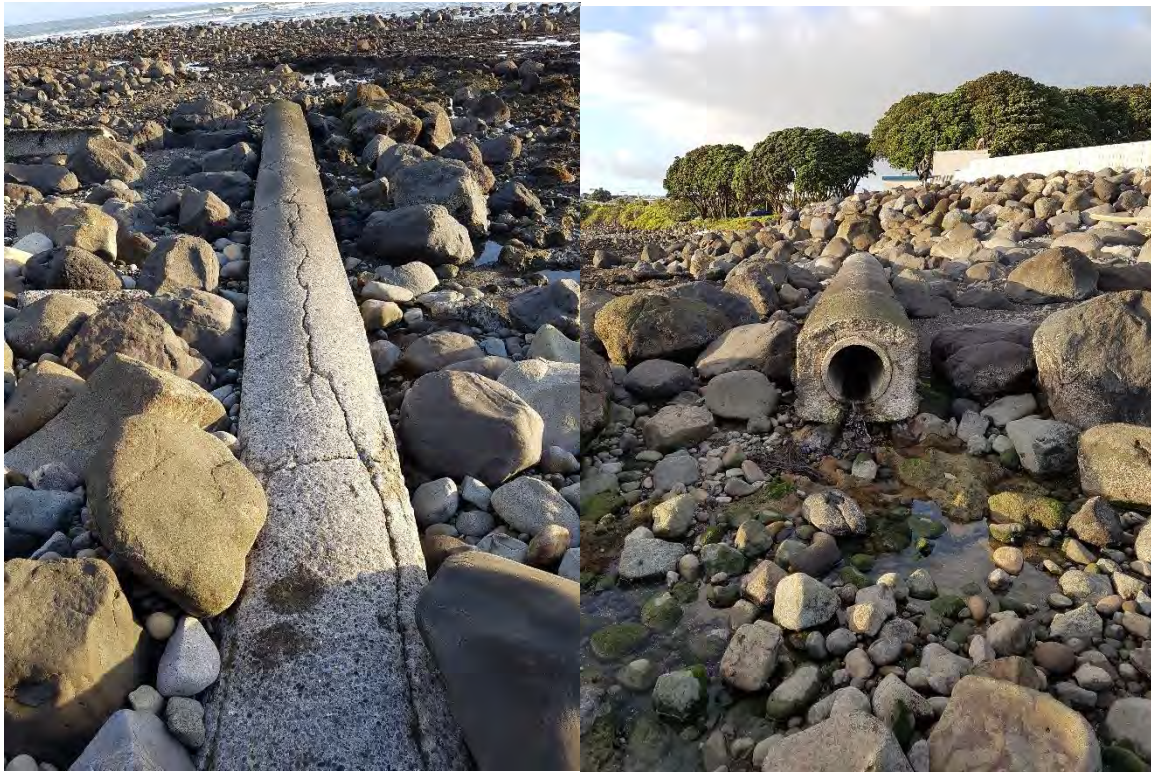
- The CCTV confirmed that the internal structure of the pipe is in good condition.
 - The length of the outfall has only been shortened by 2.4m from the high tide mark.
 - The current pipe to seabed foundation is in good condition.
 - The crack along the top external pipe/concrete casing is superficial.
-

- The overall outfall length has been shortened by 2.4m.
- The pipe is considered to be in a safe and sound condition and will continue to function effectively as an outlet structure, in accordance with special condition 2.
