Stratford District Council
Municipal oxidation ponds system
Monitoring Programme
Annual Report
2014-2015

Technical Report 2015-07

September 2015

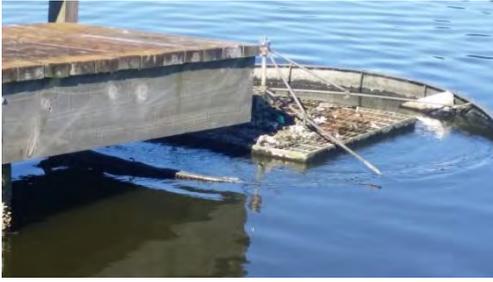
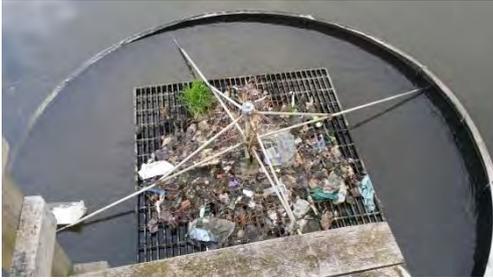
The primary pond varied from turbid pale green-brown to turbid, dark green-brown while the final cell of the secondary pond system varied from relatively clear, pale green to slightly turbid, dark green to turbid, dark green in appearance on inspection occasions. No surface accumulations of floating scum were noted in the corners or at the edges of the primary pond on any inspection occasions coincident with the continual operation of the mechanical aerators which maintained noticeable circulation through this pond. However, debris accumulation was noted on three occasions on the outlet structure which also required maintenance due to partial collapse (Photos 1 and 2).

Photo 1 & 2 Primary pond outlet, December 2014 and June 2015

New access jetties to the outlet grids had been constructed by the consent holder relatively recently for cleaning and maintenance purposes. However, maintenance of the primary pond outlet grid was inadequate at times during the period.

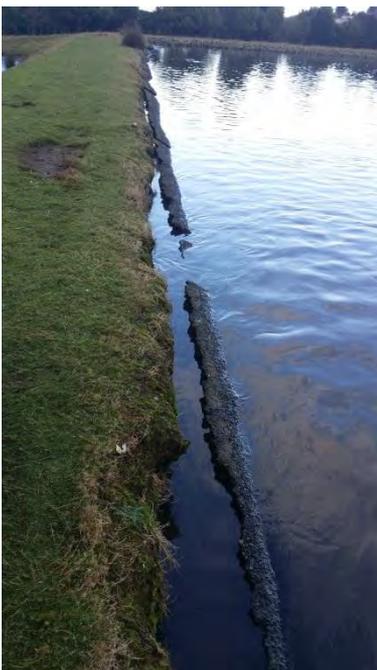
Photo 3 Waveband erosion June 2015

The ponds' surrounds were generally tidy due to grazing throughout the monitoring period. The waveband repairs of the mid 1990s which used gabion baskets, continue to be monitored by the consent holder with respect to weed growth, debris entrapment and/or odour problems. Further waveband replacement and repairs had been undertaken by the consent holder as a component of the consented upgrade. Some localised subsidence behind the original waveband repairs had previously required remedial backfilling (TRC, 2004). The secondary pond cells' walls were re-contoured and sealed early in the 2011-2012 monitoring period. There was some evidence of waveband scouring noted late in the monitoring period and there was consideration given to switching the aeration system off under extremely high pond level conditions (late June 2015) to prevent further undermining of the wavebands.
