Patea Freezing Works Detailed Site Investigation Report

Document No: 451931

Taranaki Regional Council
Private Bag 713
STRATFORD 4352

May 2008

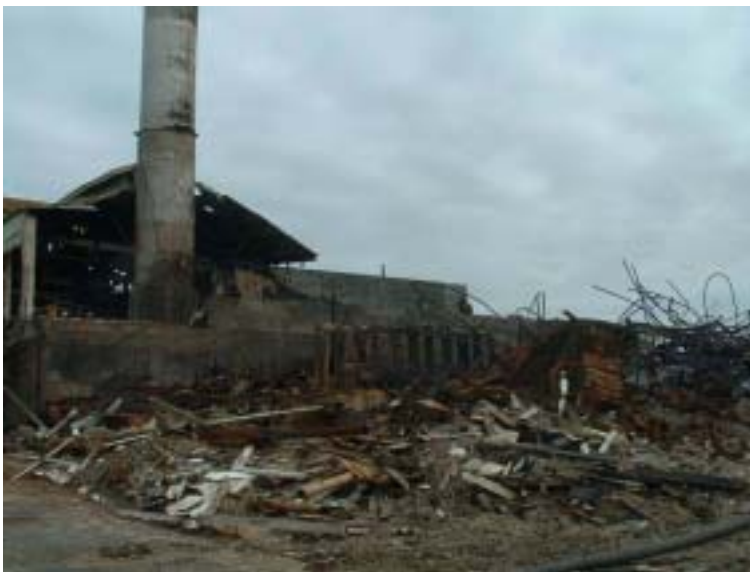
Progress on the investigation was significantly delayed by a fire which broke out in the early hours of Waitangi Day, 6 February 2008. The fire raged through most of the main body of buildings on the site. The Freezing and Cold Storage Buildings (predominantly timber) in the centre of the site were completely destroyed, the Slaughter House to the east was significantly damaged and a number of buildings west of the Boiler House were also completely destroyed.

Photograph 1 Remains of the Freezing and Cold Storage Buildings

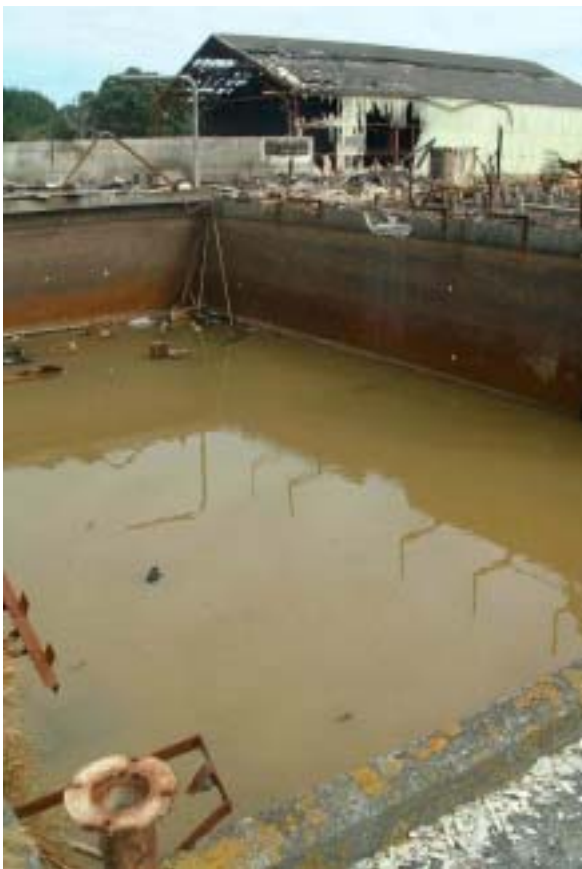
Photograph 2 Main Reservoir and Storage building
(prior to preparation as containment facility)

Based on its observed water retention, the Council believes the reservoir to be impervious and structurally sound, and therefore a suitable secure long-term containment facility.

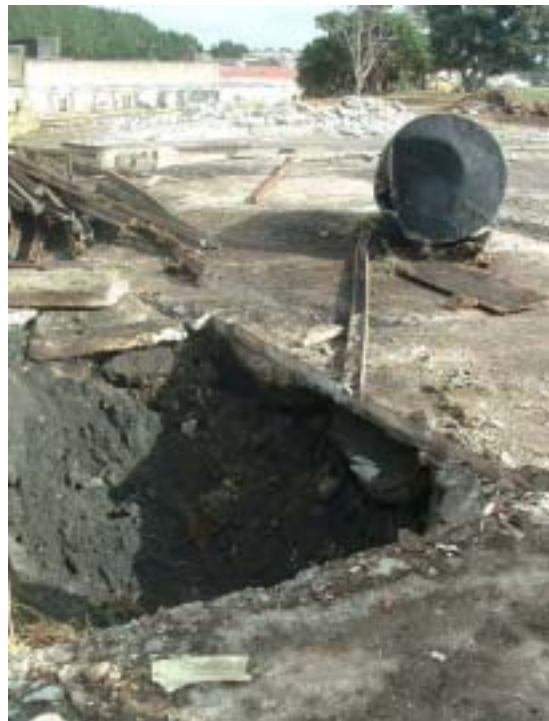
There was a minimal amount of product in the tank and no sign of obvious contamination in the pit (photograph 3). The tank appeared to be intact/unholed and was crushed on site and removed as scrap metal. Approximately 1-2 m³ of potentially contaminated bedding material was removed from the tank pit under the instruction of PDP.

Photograph 3 Covered Unloading Platform tank and pit

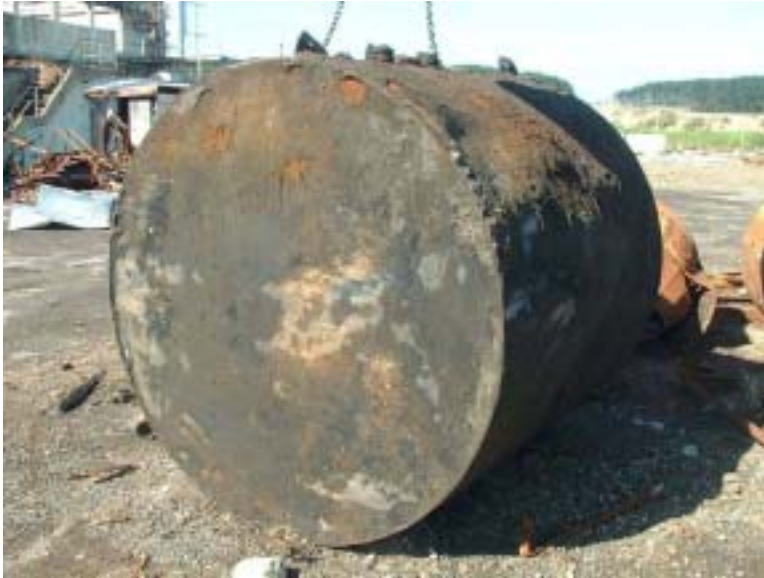
A 5,000 litre tank was removed from immediately inside the entrance gates on the northern side of the road (photograph 4). The tank appeared intact/unholed, and when lifted some rusty water drained from the tank onto the ground. There was no visible hydrocarbon sheen or odour associated with the water. The tank will be crushed and removed from site as scrap metal. Approximately 1-2 m³ of potentially contaminated bedding material was removed from the tank pit under the instruction of PDP. The pit was backfilled with clean soil.

Photograph 4 Gatehouse tank

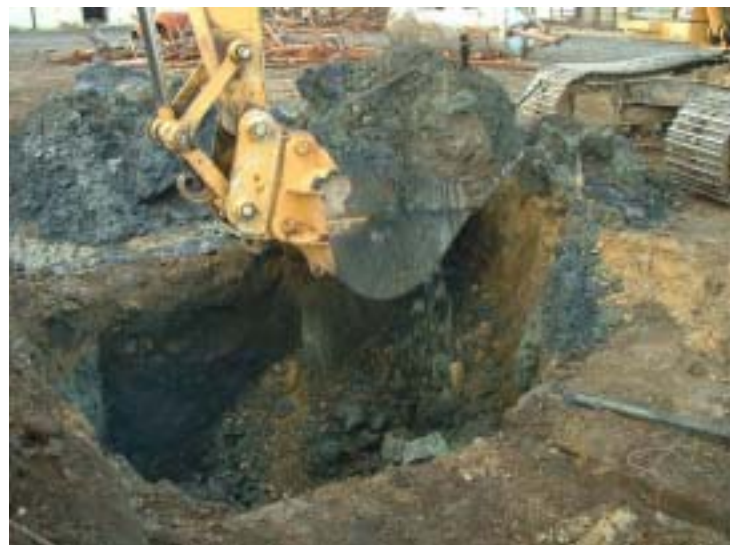
No tank was found at this site, although concrete slabs, pipework and tank straps indicated the location and purported site usage was correct. Excavation soon revealed what appeared to be extensive petrol residues (visual and odour observations), and approximately 100 m³ of soil was removed under the instruction of PDP (photograph 5). This was stockpiled on site along with the contaminated bedding material from the other two tank pits. It was regularly turned by excavator to aid in degradation of the hydrocarbons. Almost three weeks later, approximately 20 samples were collected from the surface of the stockpiled soil and composited for analysis. The results showed that hydrocarbon concentrations had reduced to below detection limits. The stockpile will be placed in the Main Reservoir.

Photograph 5 Excavation of contaminated soil

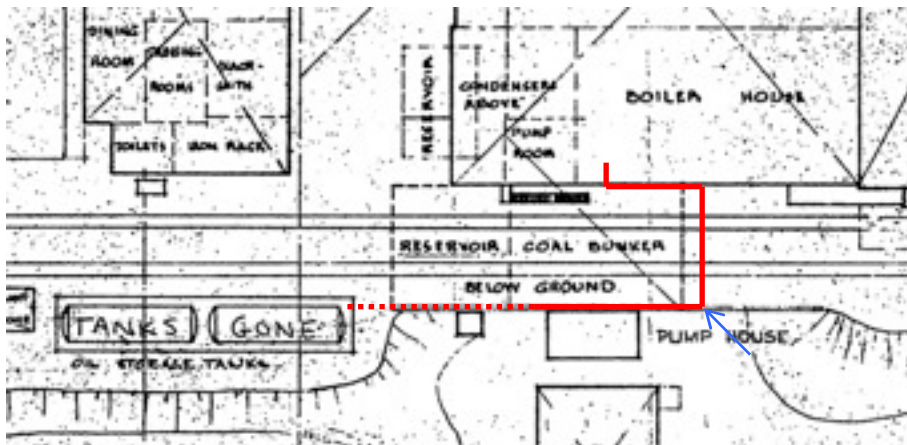
It was subsequently discovered that oil was leaking from a pipe further east next to the Pump House. This was in fact one of the pipes from the bund to the Boiler House. The following figure (figure 1) shows the pipework configuration, the dashed section of pipe is missing and the arrow indicates where an elbow on one of the lines had rusted through.

Figure 1 Fuel oil line to Boiler House

soil sampling. A decision was made to cut the second line at the intact elbow and chock up the western end of the pipes on the Pump House wall, allowing any oil remaining to drain into a container for disposal.

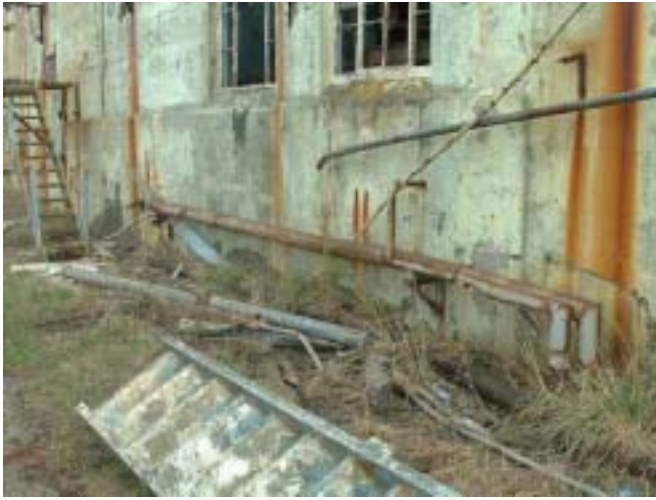
Photograph 6 Fuel oil pipework into the Boiler House

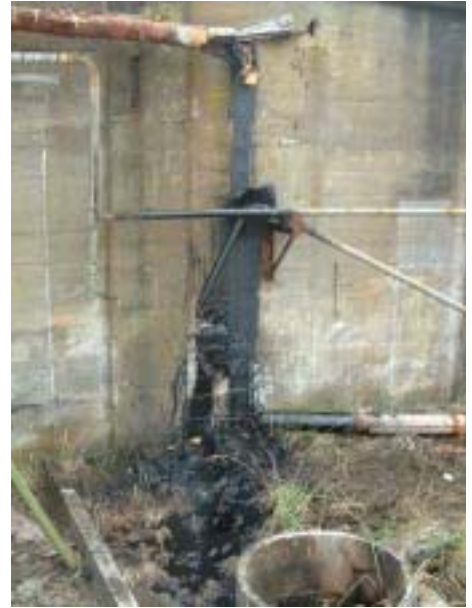
There was a large pool of oil on the concrete pad below the Boiler House (photograph 7). Oil was dripping into a drain pipe (through rust holes) and a small amount had entered a sump which discharges to the estuary. The drain pipe was removed to prevent further oil entering the sump. Stained soil on the concrete pad indicated that oil may have previously been leaking into a tile drain. Bedding material from the Gatehouse tank pit, excavated the previous day, was piled onto the pool of oil to absorb it. This soil was later added to the stockpile of contaminated soil which had been removed from the Fire Station tank pit and held on site for disposal.

Photograph 7 Leaking fuel oil

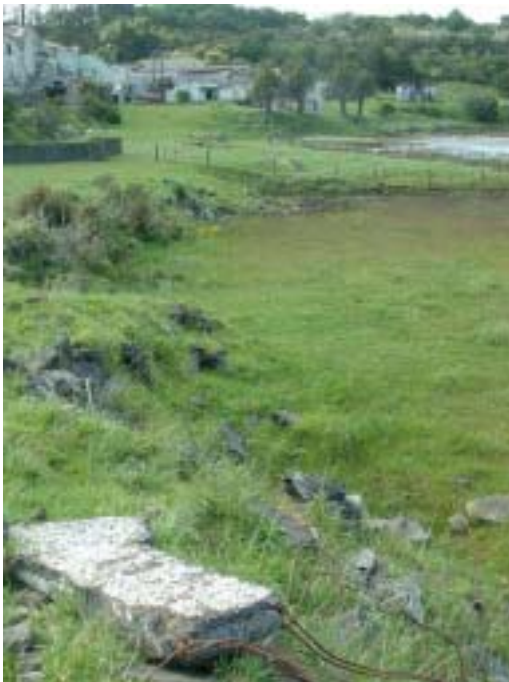
The entire embankment area between the factory and estuary had been used for the disposal of waste materials from the site. Of particular interest was the dumping of ash and clinker from the early period when the boilers were coal fired, prior to fuel oil and then gas. The following photographs give some indication of the extent of this practice.

Photograph 8 Looking west across fill

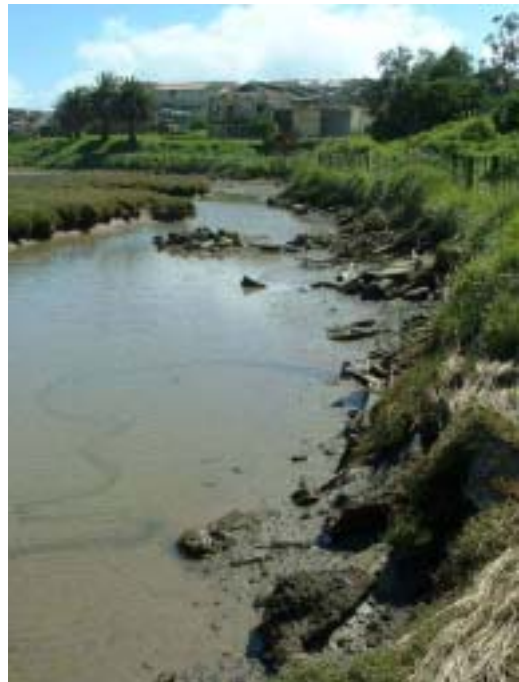
Photograph 9 Fill in estuary

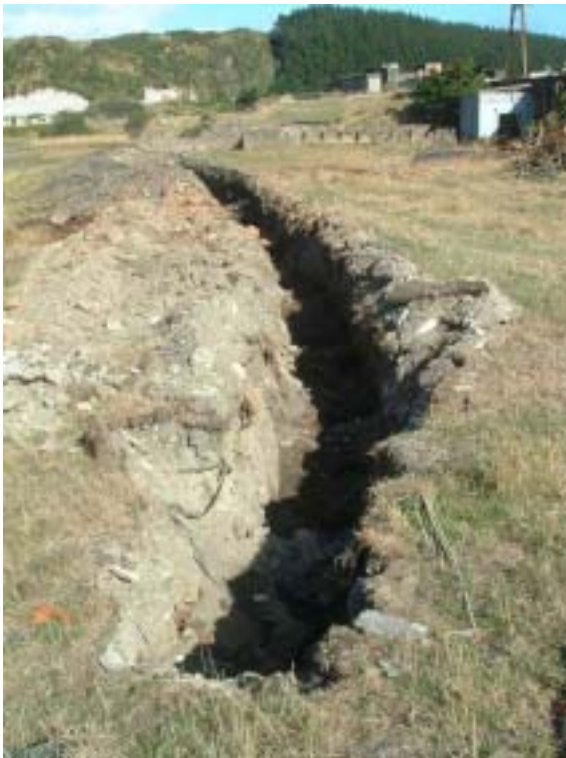
A trench approximately 1 m wide, 1.5 m deep and 85 m long was excavated parallel to the estuary to capture water run off from fighting the fire (photograph 10). This provided a great opportunity to inspect spoil from the trench and the soil/fill profile, and to collect samples from areas of interest.

Photograph 10 Trench looking west

Inspection of the trench spoil revealed that extensive dumping of building rubble had occurred in this area. A band of dark material approximately 100 mm thick was present at a depth of around 1 m, along almost the entire length of the trench. Samples of this material were collected at 10 m intervals and clinker was present in most, upon visual inspection.

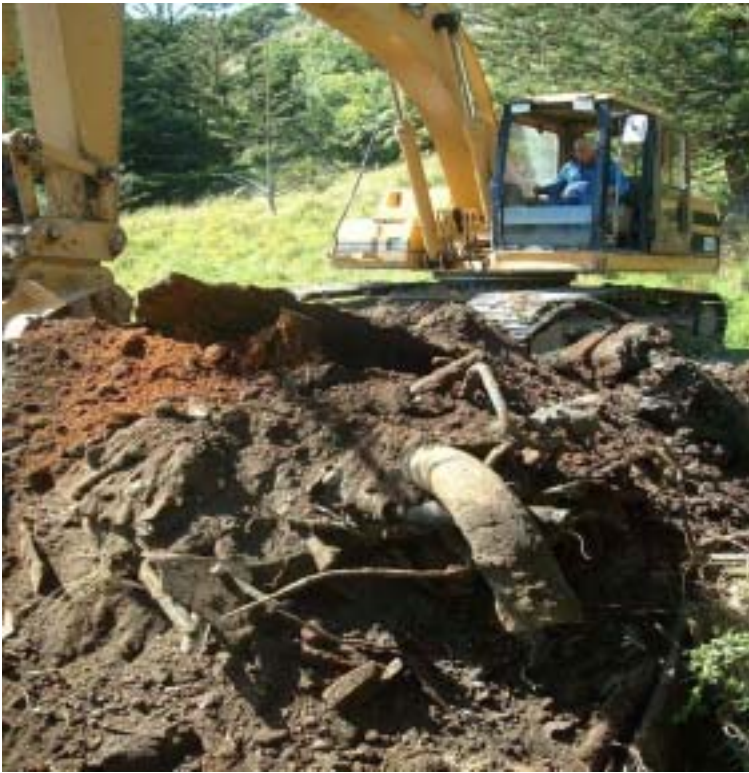
Photograph 11 Test pit spoil

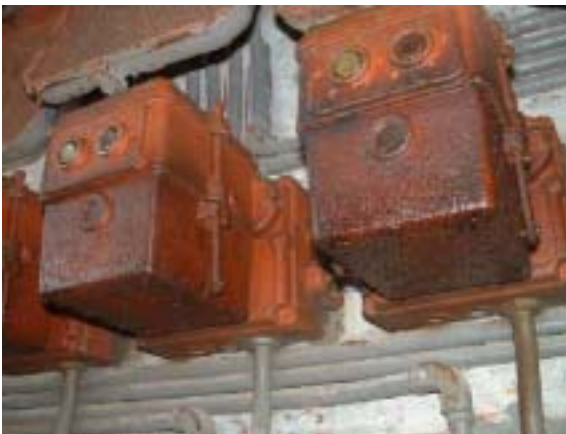
At a public meeting following the fire, a member of the public advised that electrical equipment containing PCBs, were located in the vicinity of the Boiler House and Engine Room. Council Officers located and removed one drum’s volume (294 kg gross) of PCB containing equipment, which was subsequently disposed of by Transpacific Technical Services. It was confirmed with the member of the public concerned that there were the PCBs that had been referenced. Some PCB equipment could not be safely removed for disposal (photograph 13 and Figure 2), including numerous small wall-mounted units present in some of the buildings, fire damaged equipment, and areas that were too dangerous to enter. The quantity remaining would be similar to or less than that removed.

Photograph 13 Electrical equipment containing PCBs remaining on site

Some electrical equipment containing PCBs remain on the site, as they could not be safely removed for disposal. This includes numerous small wall-mounted units present in some of the buildings, fire damaged equipment, and areas that were too dangerous to enter.

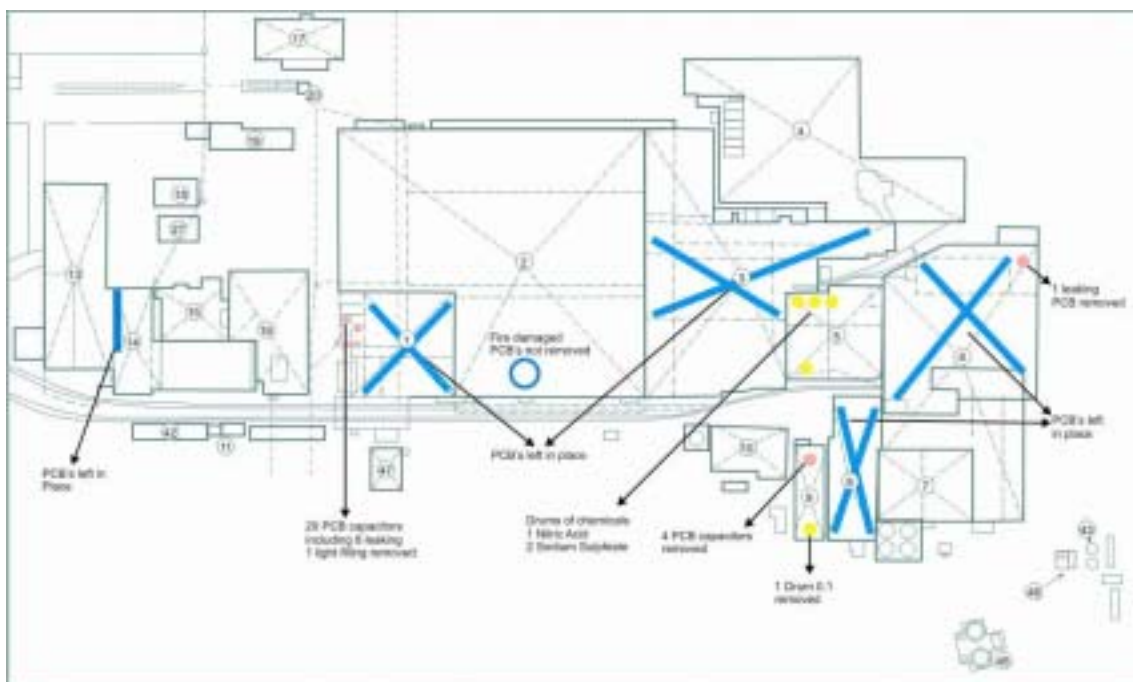
During close inspection of the buildings by Fire Service and Council personnel following the fire, several drums of materials were found, identified, and considered for treatment and disposal options. Subsequently the Fire Service removed three drums containing a small amount of oil from buildings on the site. Two drums containing sodium nitrate were moved outside of buildings and filled with water to dissolve the chemical. One severely corroded drum of nitric acid was punctured, allowing the acid to neutralise by reacting with the concrete floor. It was then diluted with approximately 2,000 litres of water. These activities were conducted in a manner which did not result in any adverse environmental effects. It is considered that no further action is required in respect of these drums.

Figure 2 Location of PCB equipment and chemical drums
