## File note

Document: 385580

### Patea Freezing Works – Investigation of existing bores

# **Patea Freezing Works Site**

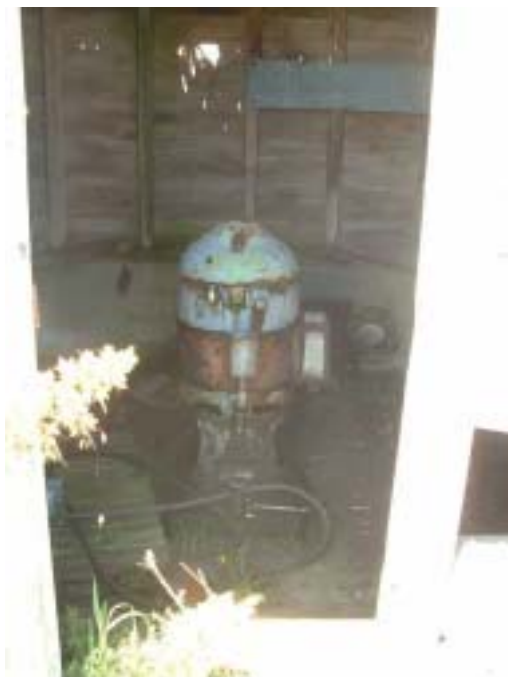
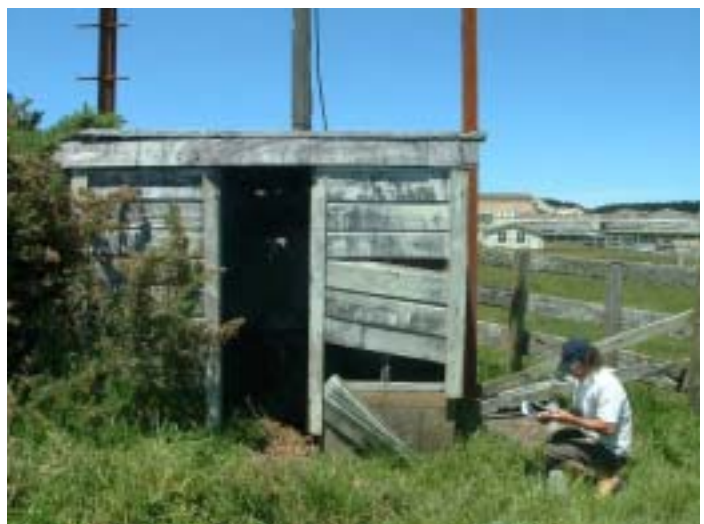
**No.1 well**                      2637606E-6159608N

Approx 100 m north of the site, on the eastern side of the paddocks.

No. 1 well pump

No.1 well pumpshed, with factory to south

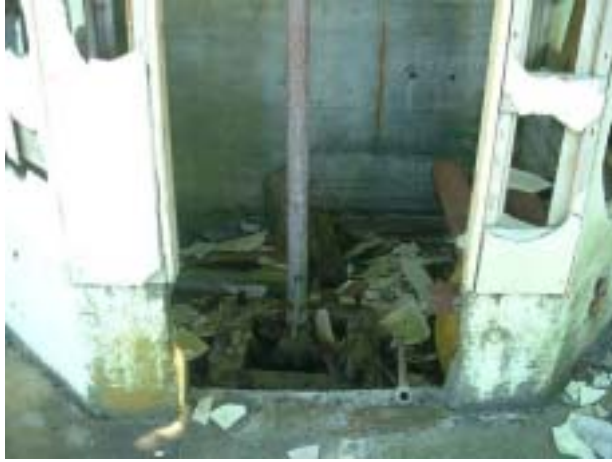
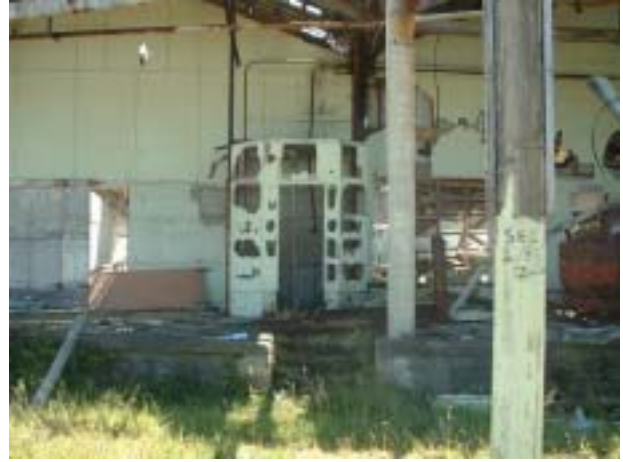
**No. 2 well** 2637358E-6159402N

Under the covered loading platform in the south west corner of the site. Pipework present, requires blanking to secure, there was oil in the surface mounting box. What appeared to be a sample pipe was removed allowing the probe to be dropped, the well is over 30m deep and oil was present.

No. 2 well

No. 2 well location

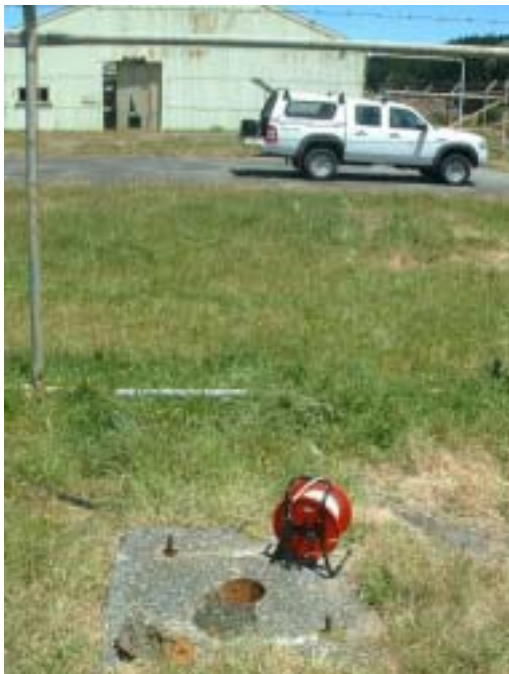
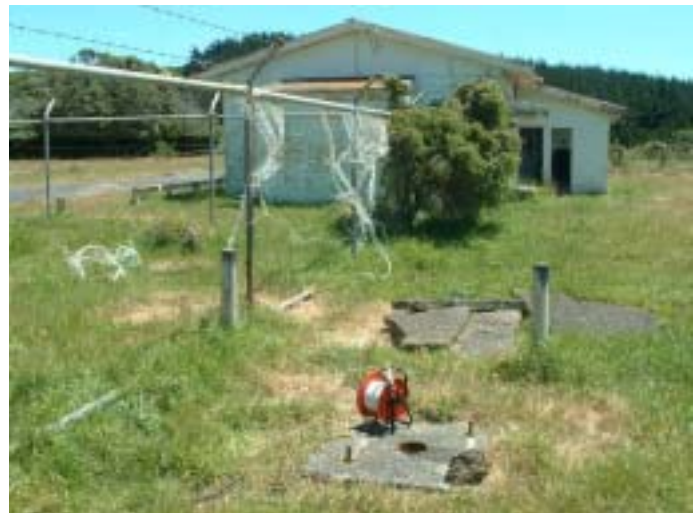
**No. 3 artesian well** 2637391E-6159499N

Approx 15 m east of the butchers shop, open - requires capping, water level 0.17 m, blockage at 5.6 m deep, suspect this is deeper.

No. 3 artesian well

No. 3 artesian well & butchers shop to west

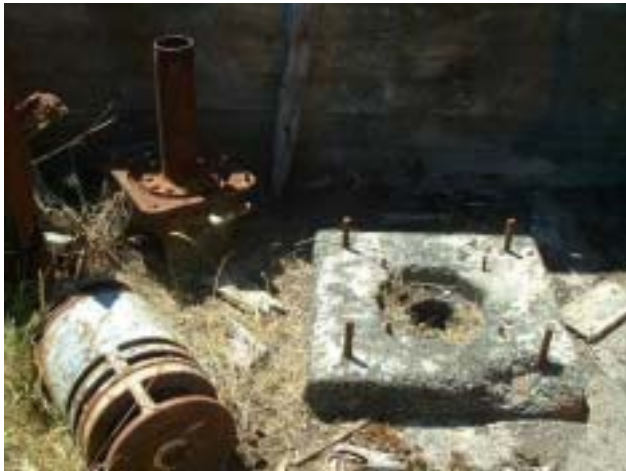
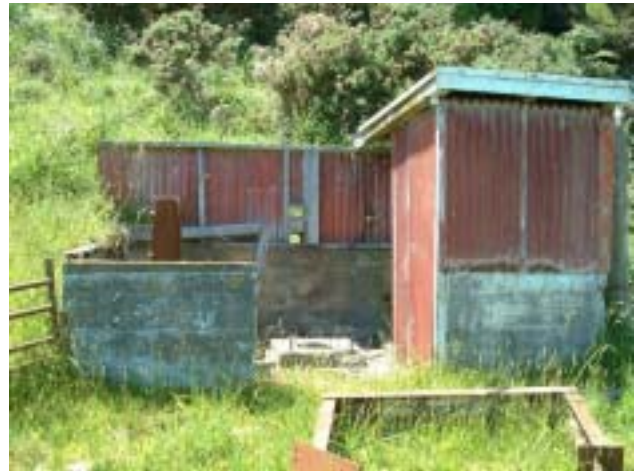
**No. 4 artesian well** 2637654E-6159417N

East of the stockyards, at the base of the cliffs, open - requires capping, water level 4.2 m, over 30 m deep.

No. 4 artesian well

No. 4 artesian well pumped

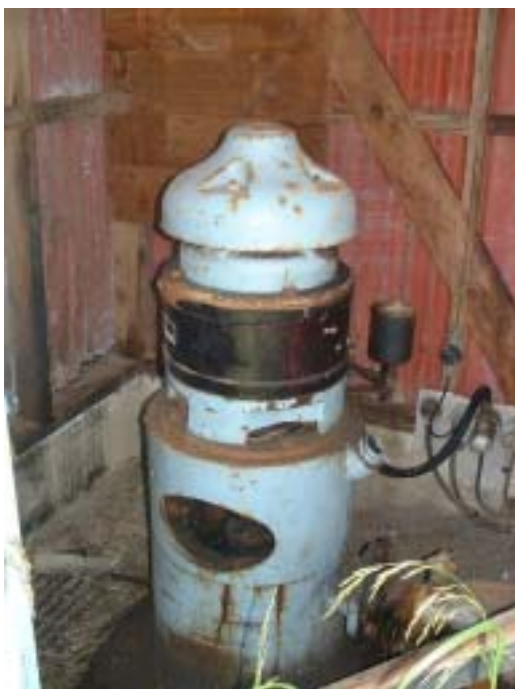
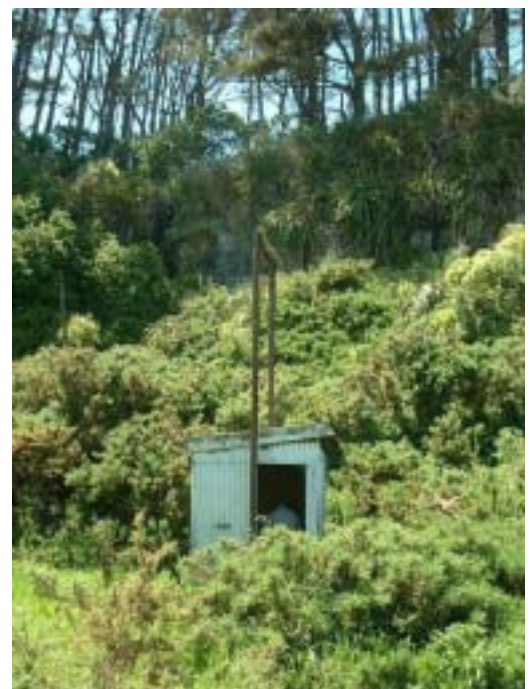
**No. 5 artesian well** 2637666E-6159371N

East of the fellmongery, at the base of the cliffs. There was a good flow (approx 5 l/s) of water between these wells from the cliffs.

No. 5 artesian well pump

No. 5 artesian well pumped

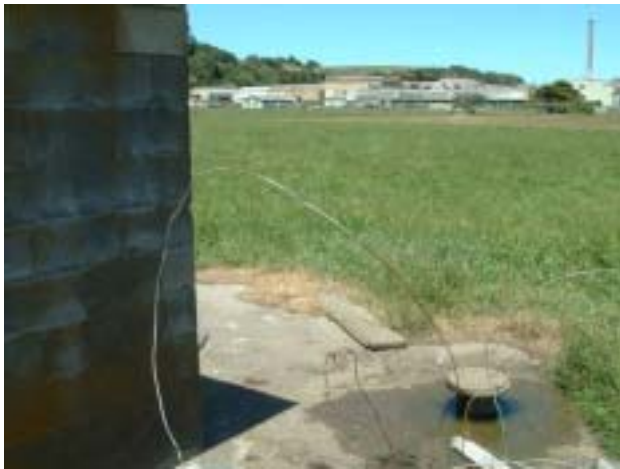
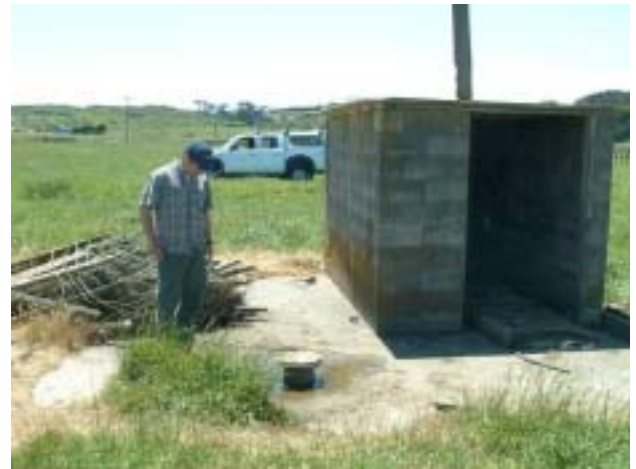
**No. 6 well**                    2637456E-6159699N

On the western side of the paddocks, approx 140 m north of the site, capped - appears to be artesian as water is leaking out from the cap.

No. 6 well and factory to south

No. 6 well and pumpshed

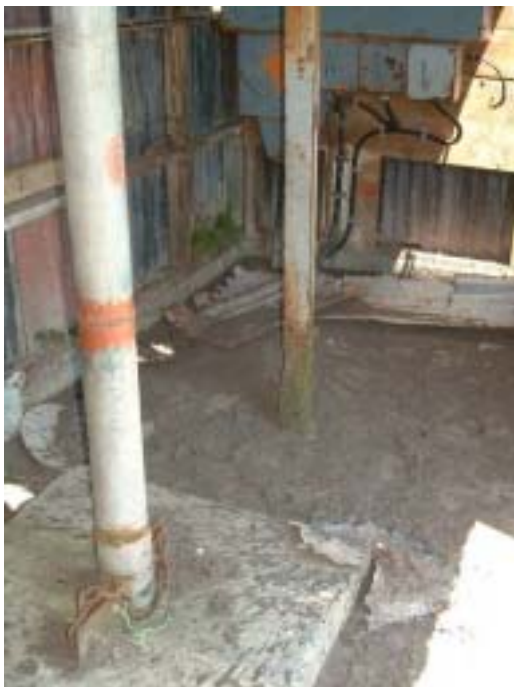
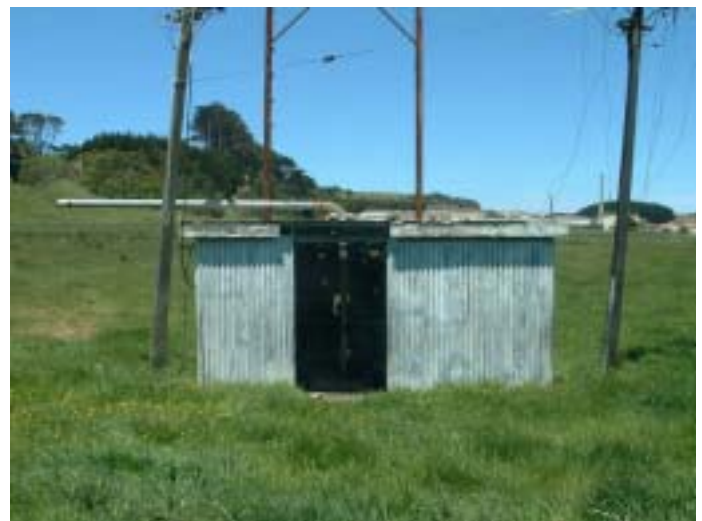
**No. 7 well**                    2637539E-6159917N

On the western side of the paddocks approx 350 m north of the factory.

No. 7 well

No. 7 well pumpshed and factory to south

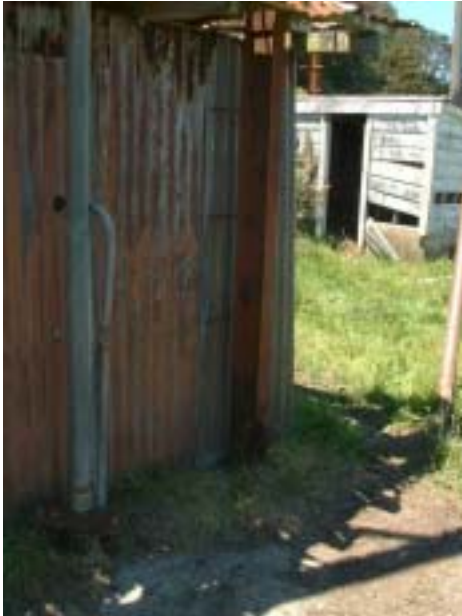
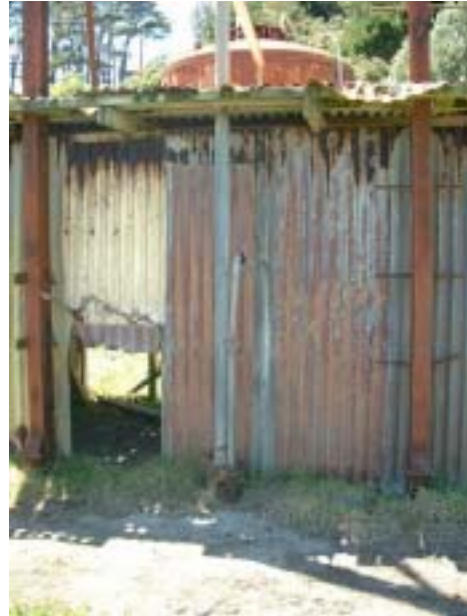
**No. 8 well**                    2637604E-6159616  
Approx 10 m north of No. 1 well.

No. 8 well with No.1 well in background

No. 8 well pumpshed

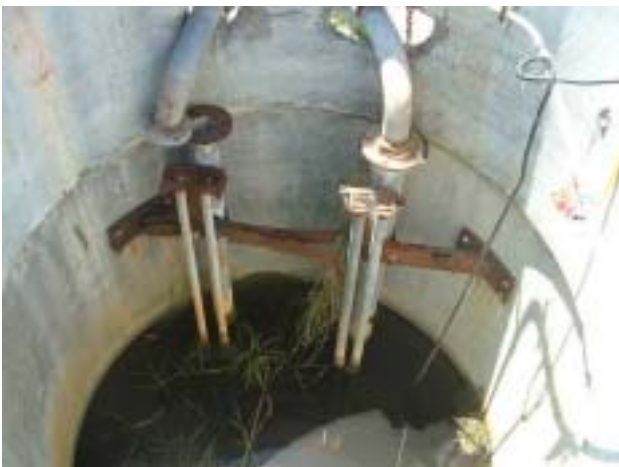
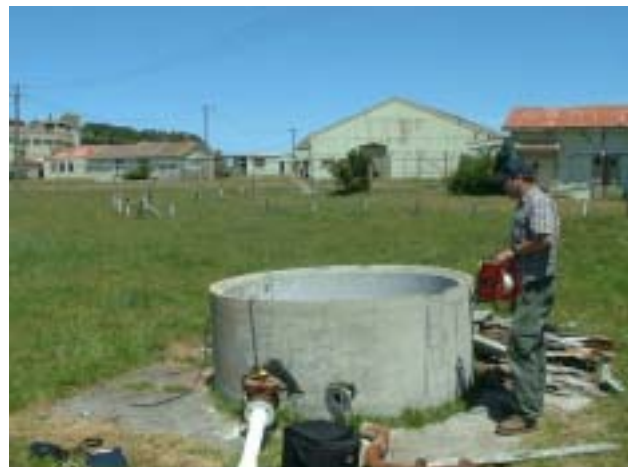
**Gallery**                    2637373E-6159531N  
Just south of the main gates, appears to be unused as there is no power connected and the pvc pipe on the northern side has a large crack in the joint. Water level 1.45 m, 4.5 m deep.

Gallery

Gallery and factory to south
