Page, M.J.; Rosser, B.J.; Townsend, D.B.; Carey, J.M.; Ries, W.F. 2015. Reconnaissance report on landsliding caused by the 19-20 June 2015 rainstorm in the Taranaki-Wanganui-Manawatu region, *GNS Science Consultancy Report 2015/172*. 50 p. + Appendices

## ABSTRACT

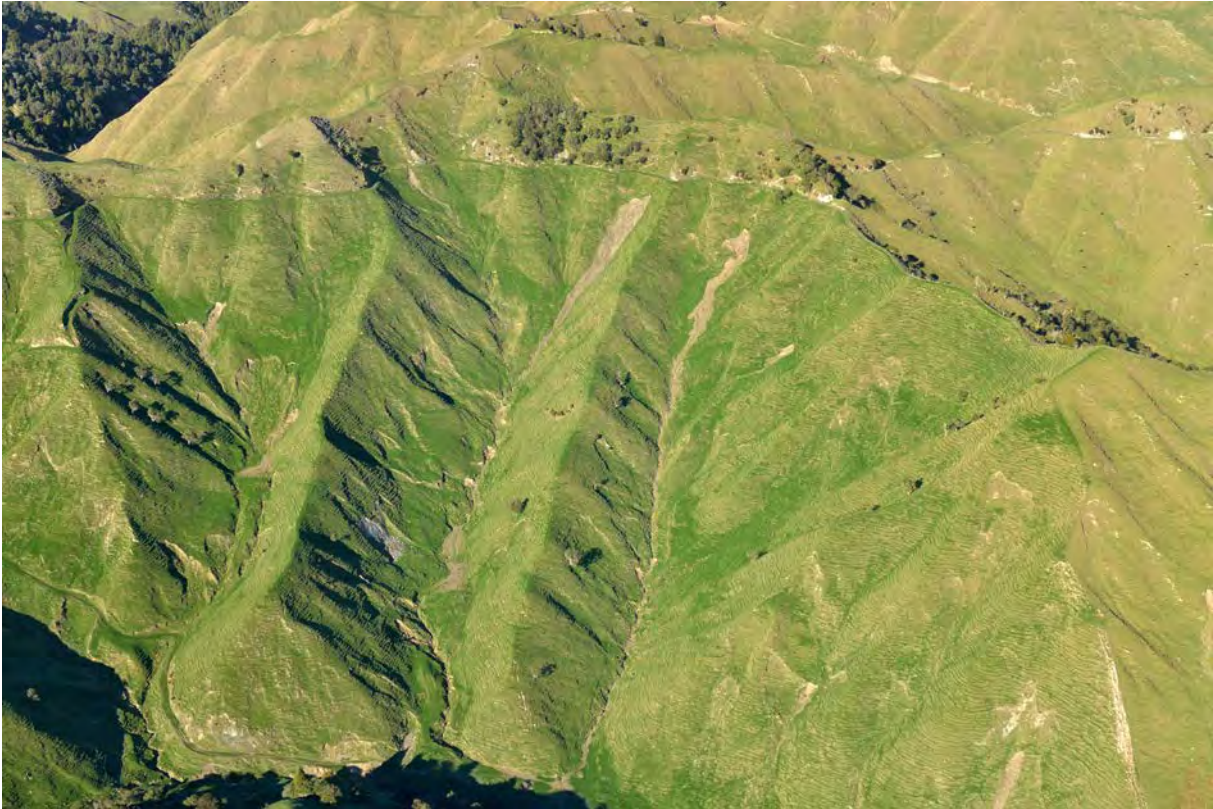
**Figure 3** Slight landsliding on mudstone/siltstone between Papanui Junction and Kakatahi, Whangaehu catchment. (GNS Photo: D02\_1181)

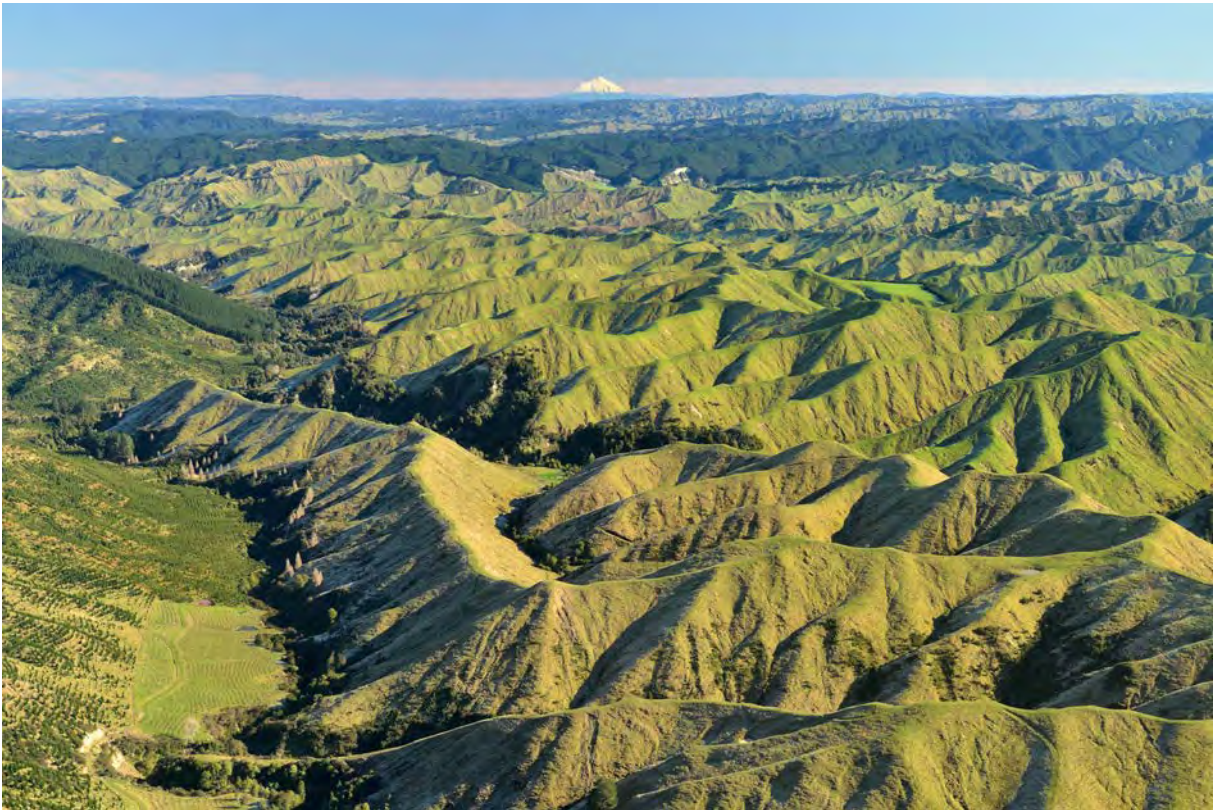
**Figure 4** Looking west near Poukiore, Turakina catchment. Slight landsliding in foreground on sandstone/siltstone, and moderate landsliding in background. (GNS Photo: D02\_1158)

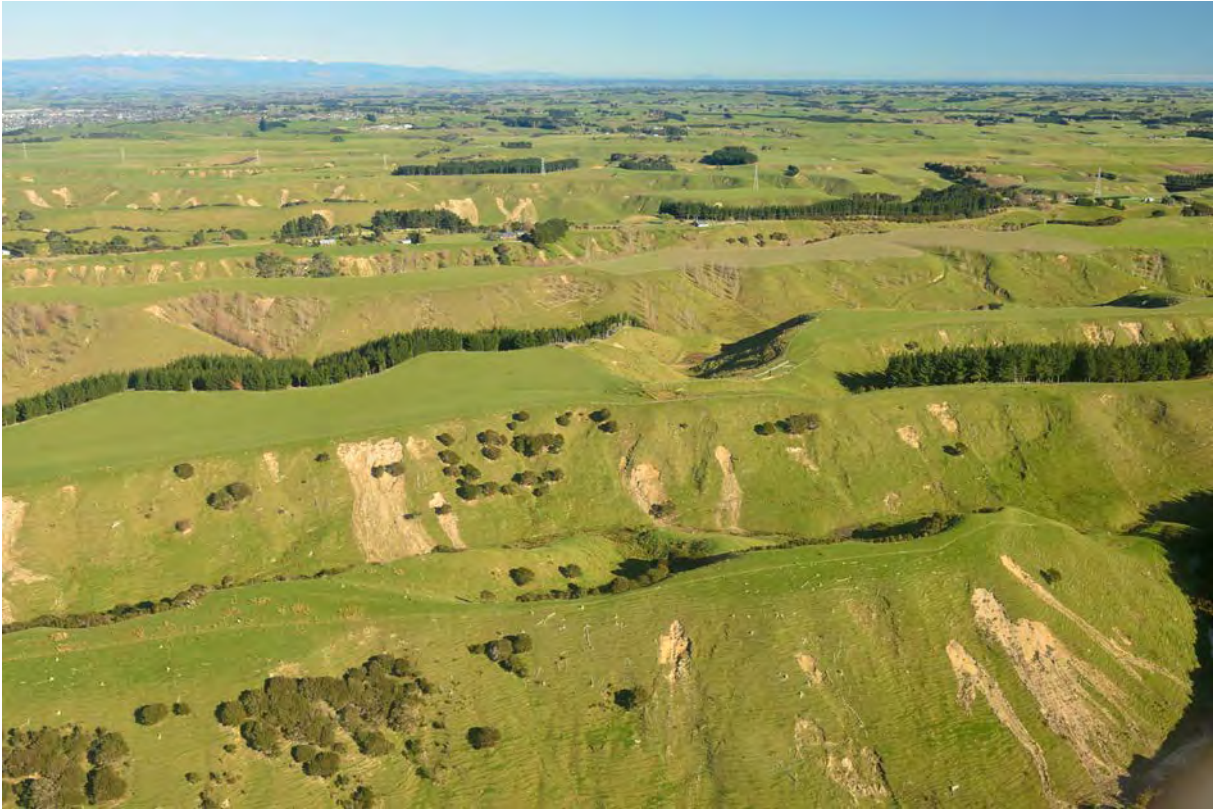
**Figure 5** Moderate landsliding on Shakespeare Group (Quaternary) marine sediments, 6 km east of Halcombe (north-facing slopes). (GNS Photo: D02\_1840)

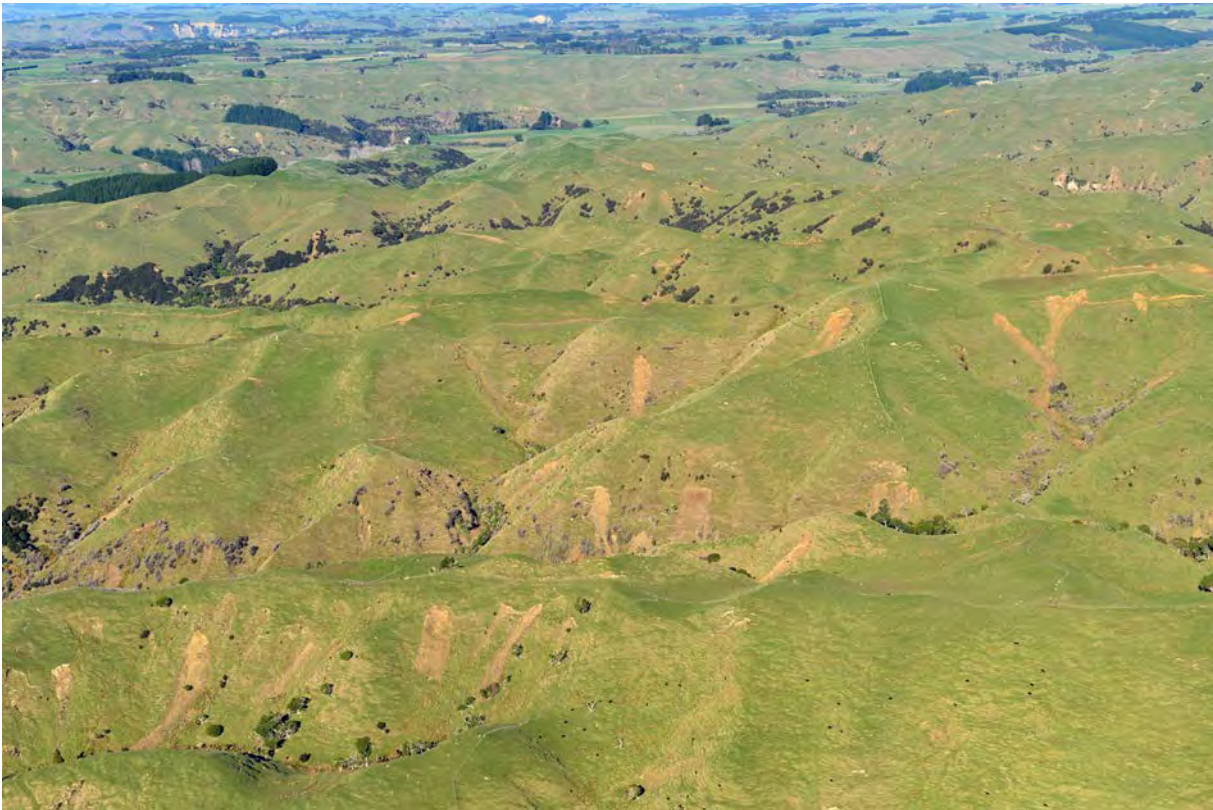
**Figure 6** Moderate landsliding in Kiwitea Stream area, in Okehu Group Quaternary sandstone. (GNS Photo: D02\_1132)

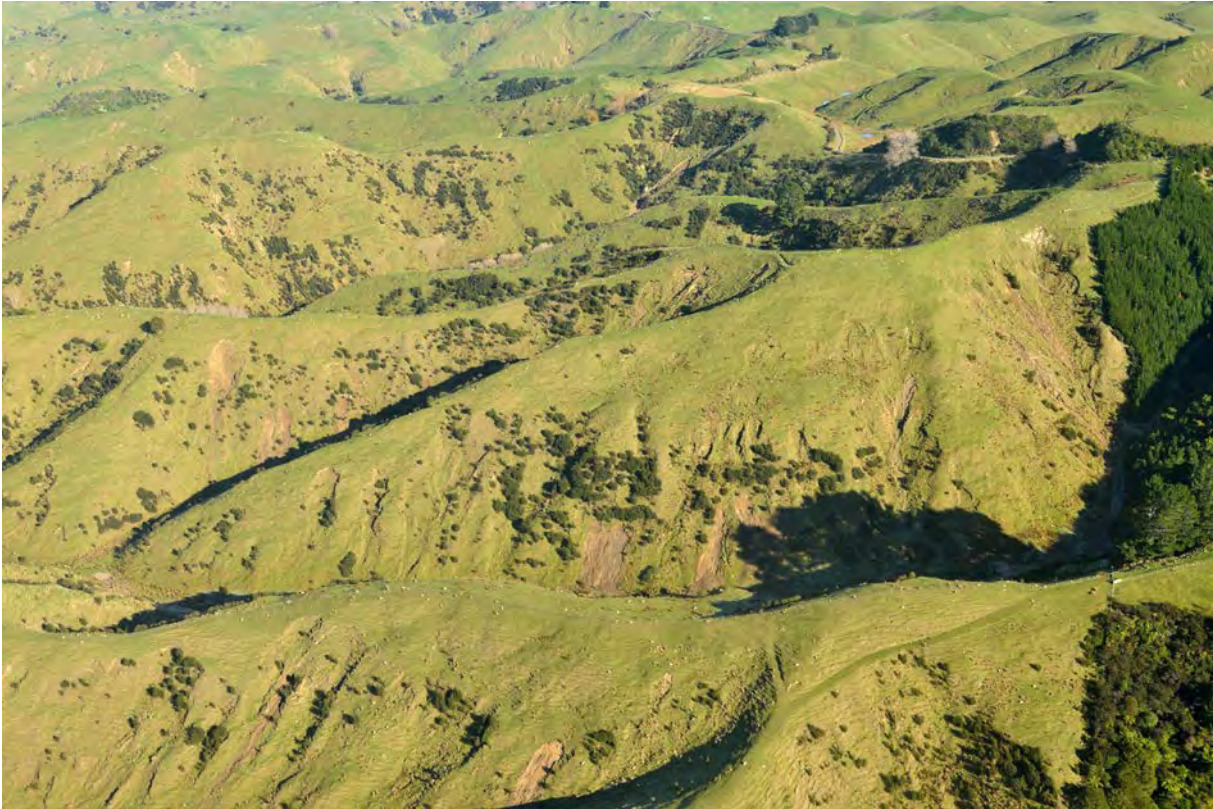
**Figure 7** Moderate landsliding in foreground, in Quaternary sandstone. Upper Beehive Creek, Pohangina catchment. (GNS Photo: D02\_1119)

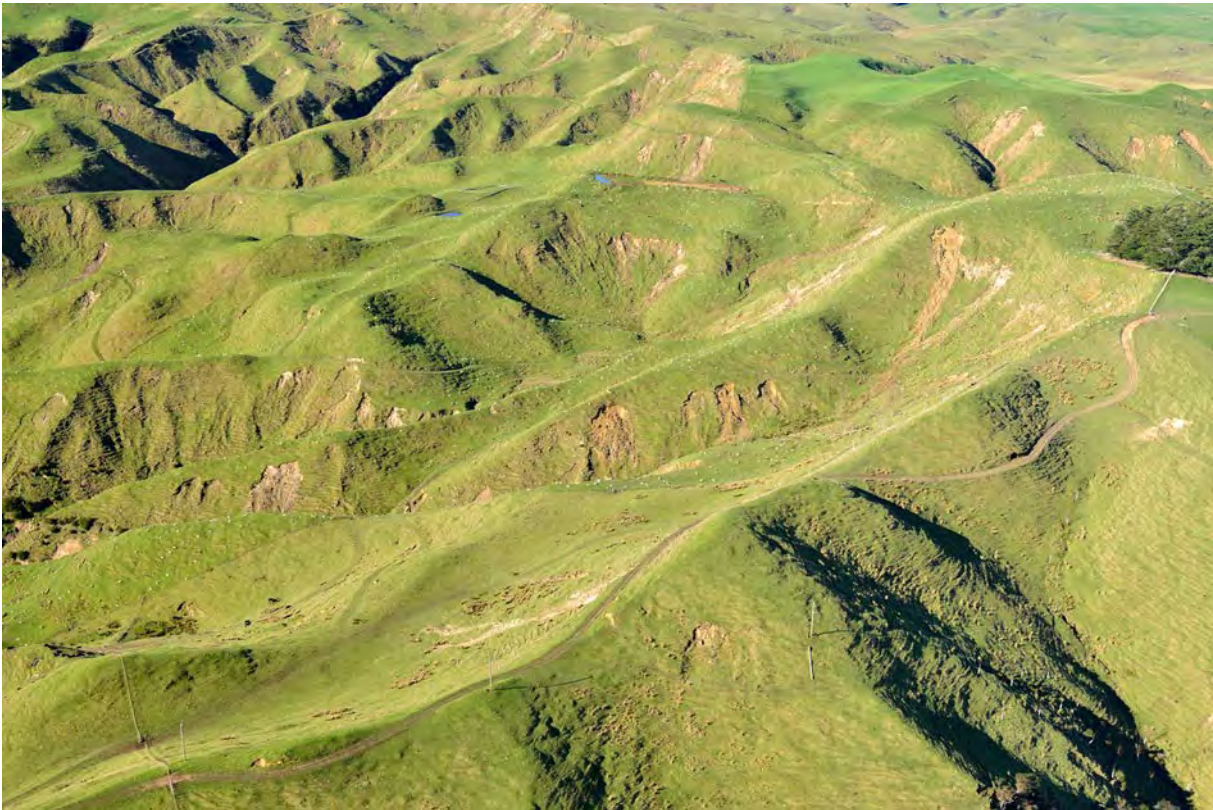
**Figure 8** Moderate landsliding on Quaternary sediments, Rangitikei Valley, 4 km northwest of Waituna West. (GNS Photo: D02\_1800)

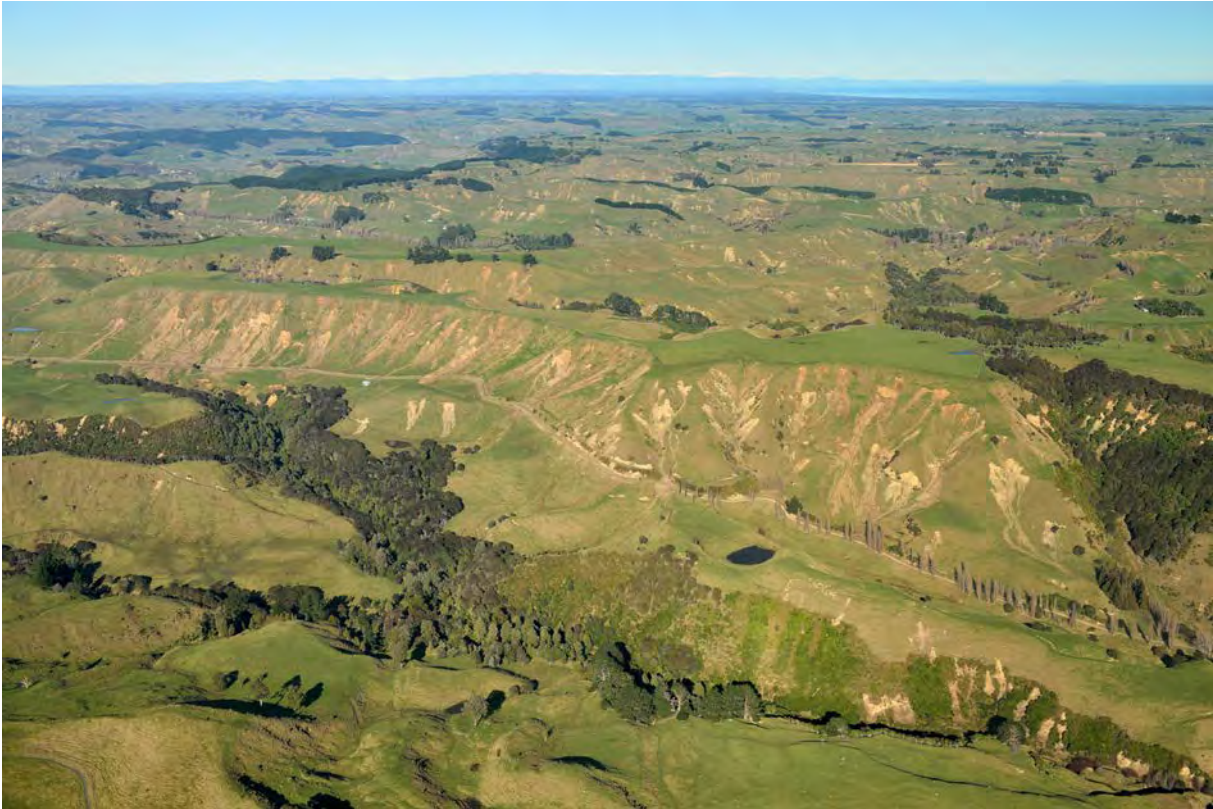
**Figure 9** Severe landsliding, Makirikiri Valley. (GNS Photo: D02\_1510)

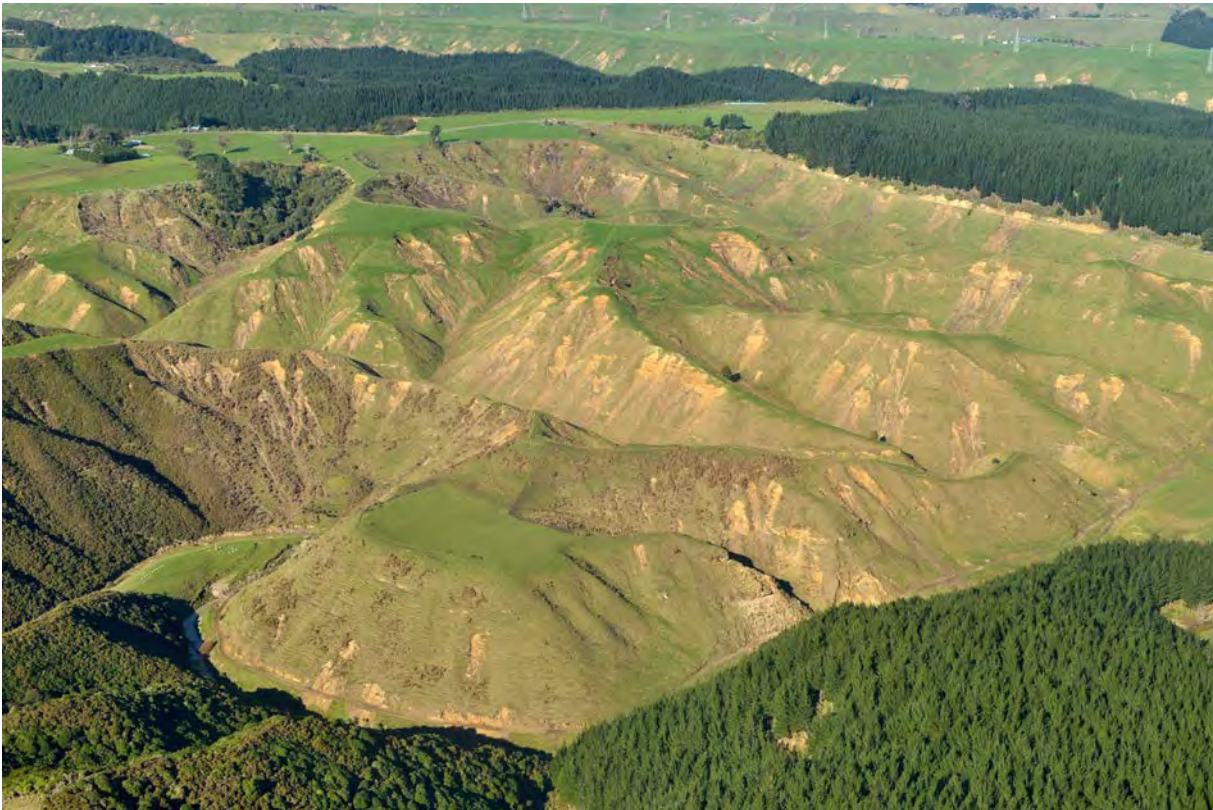
**Figure 10** Severe landsliding, Kai-lwi catchment, Brunswick Rd in distance. Maxwell and Nukumar Group sandstone/siltstone. (GNS Photo: D02\_1458)

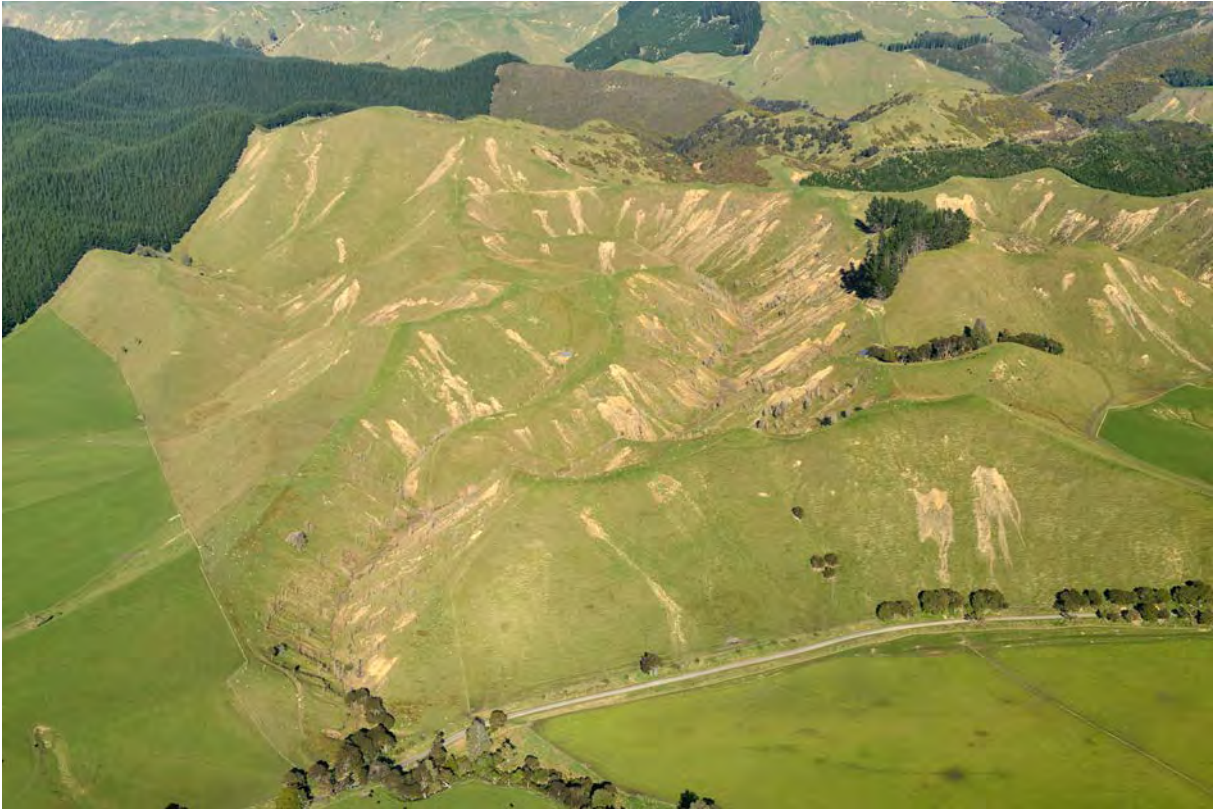
**Figure 13** Severe landsliding (centre of photo) within area where landsliding has been classified as moderate. Turakina Valley near Lakes Ngaruru and Namunamu. (GNS Photo: D02\_1708)

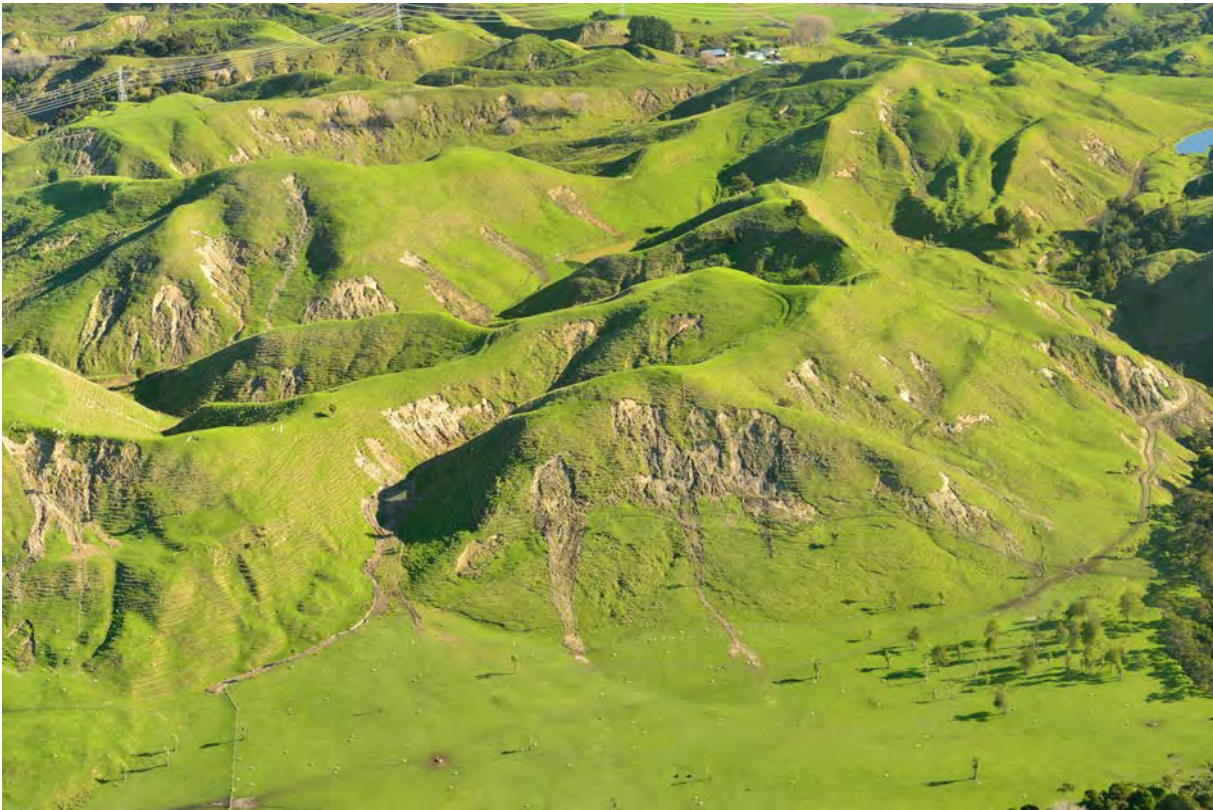
**Figure 14** Small area of severe landsliding on Kai-lwi Group (Quaternary) sediments, Turakina Valley near Makuhou Rd. (GNS Photo: D02\_1734)

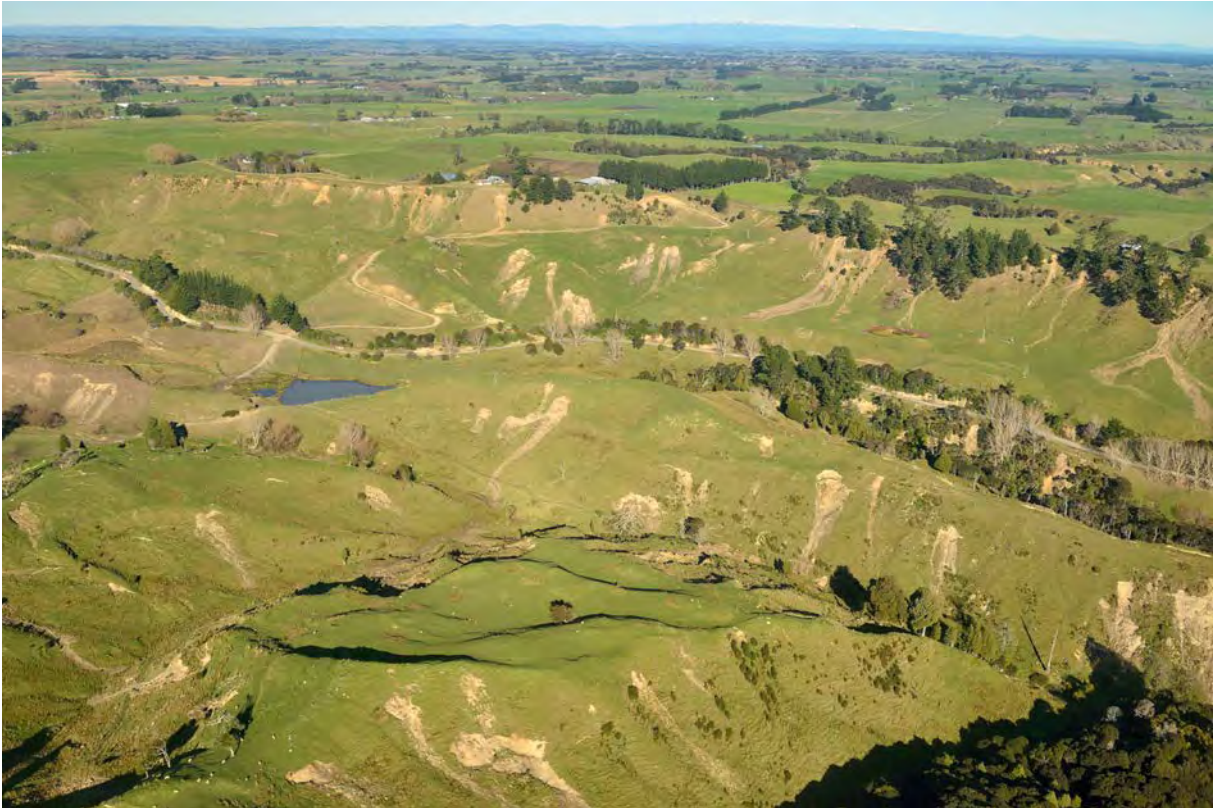
**Figure 15** Moderate landsliding on Kai-Iwi Group sandstone/siltstone with loess cover deposits, Makuhou Rd, near Marton Reservoirs. (GNS Photo: D02\_1764)

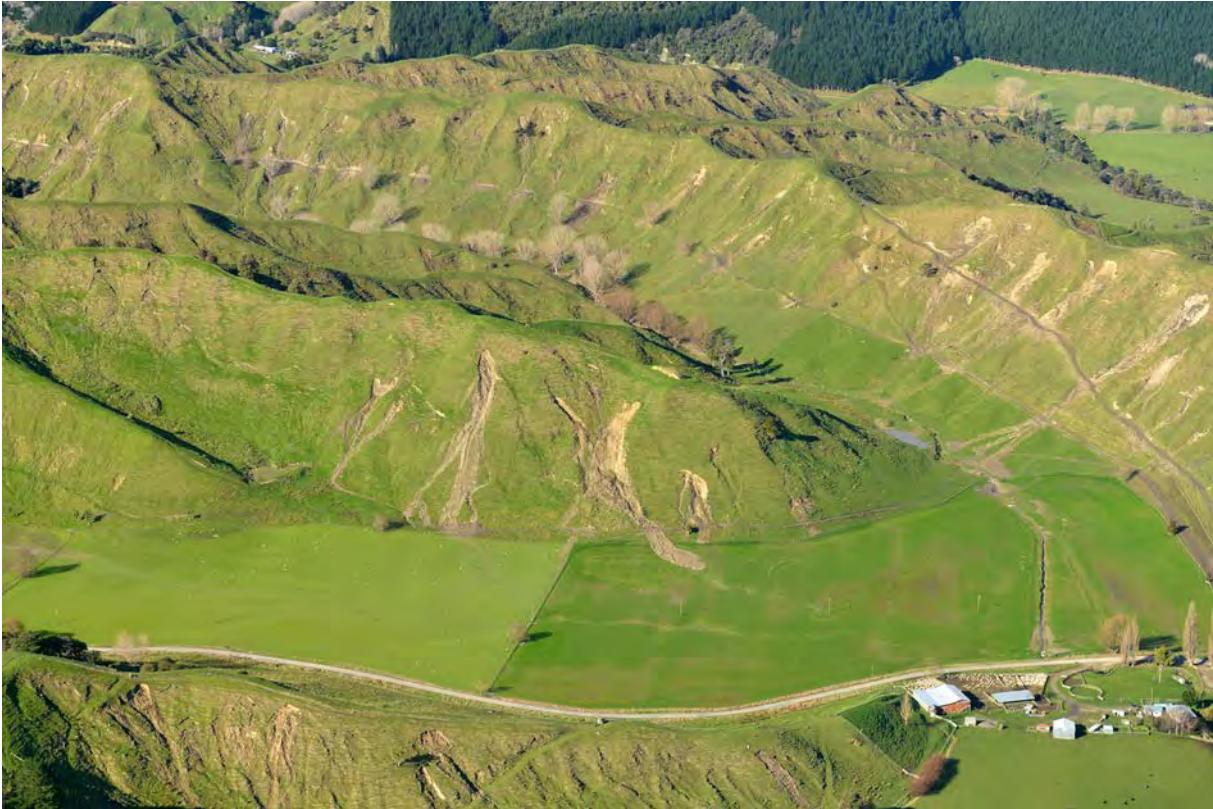
**Figure 16** Moderate landsliding on Pliocene sandstone, Whangaehu Valley, near Mangamahu. (GNS Photo: D02\_1649)

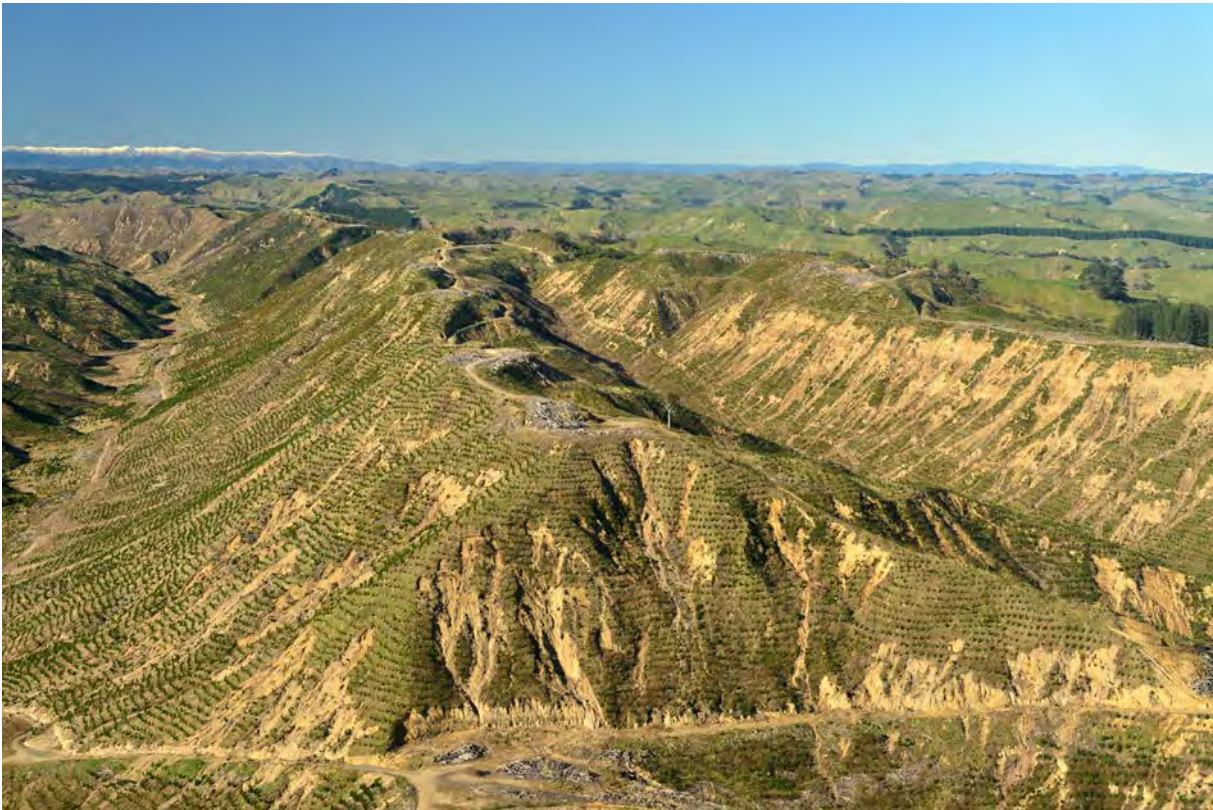
**Figure 17** Severe landsliding in areas of new plantings on Maxwell Group sandstone, Matariki Forest, Whangaehu Valley. (GNS Photo: D02\_1596)

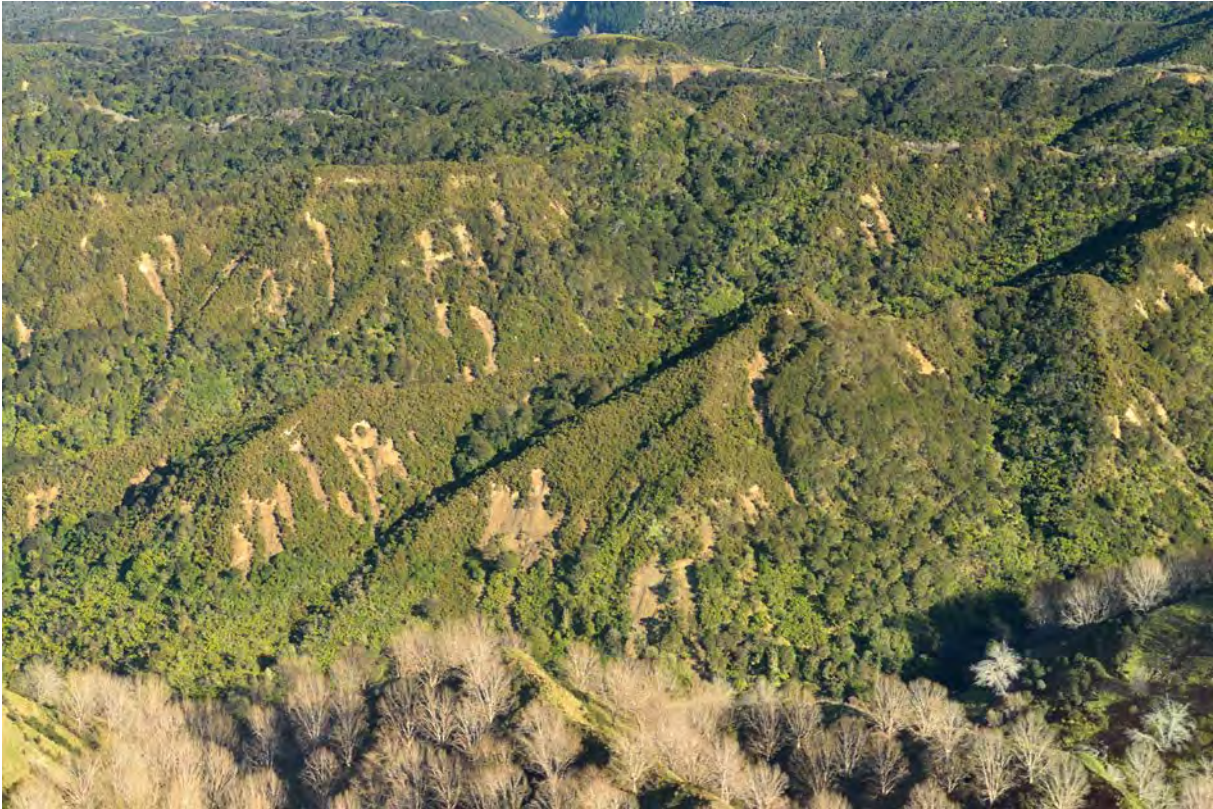
**Figure 18** Moderate landsliding in scrub underlain by Pliocene sandstone, 5 km north of Parikino, on western side of the Whanganui River. (GNS Photo: D02\_1211)

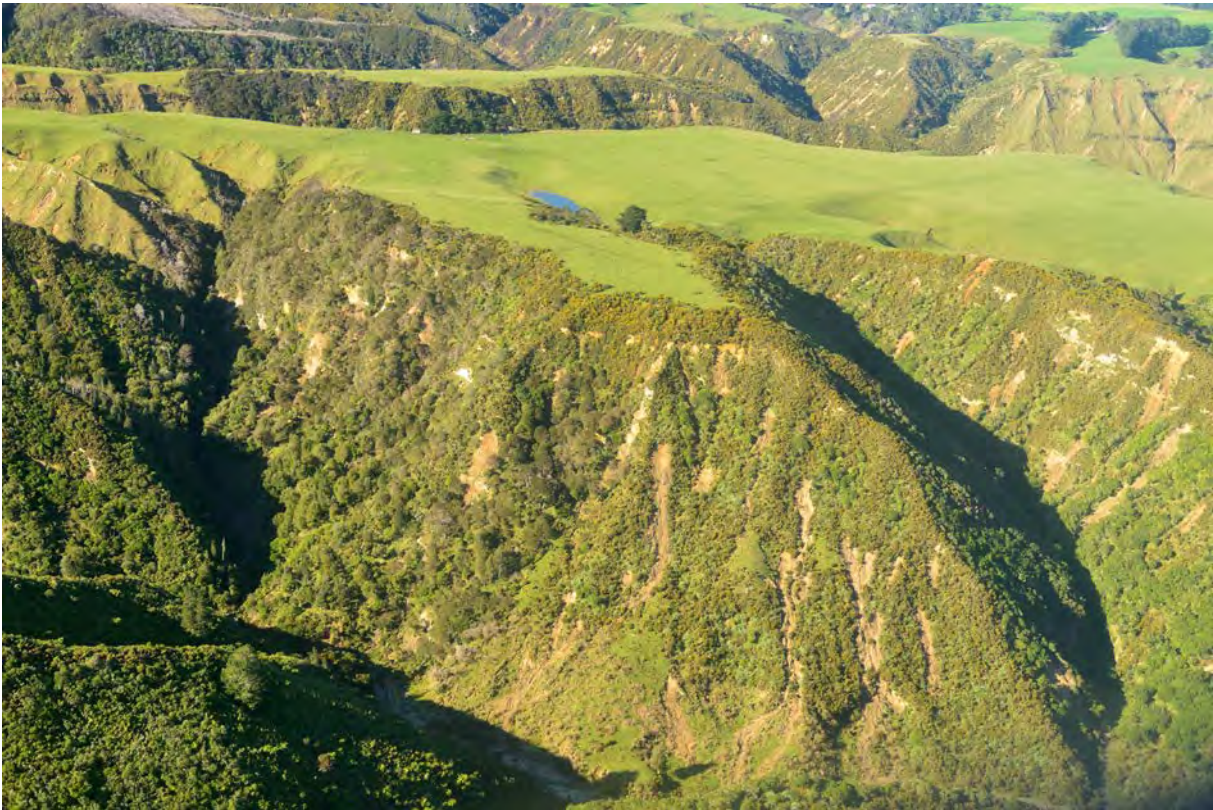
**Figure 19** Moderate landsliding in scrub on Whenuakura Group sandstone, near Ridge Rd north of Ngutuwera, Waitotara catchment. (GNS Photo: D02\_1370)

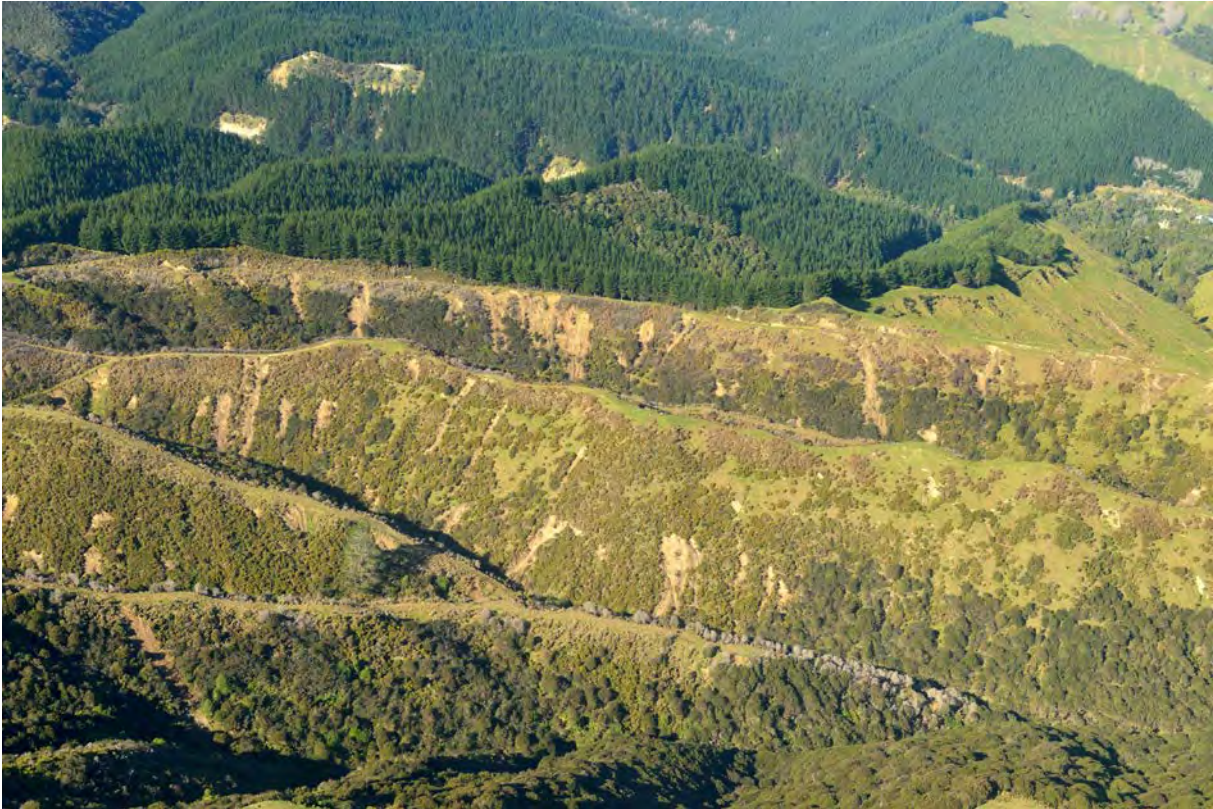
**Figure 20** Moderate landsliding on scrub, Whangaehu Valley, 3.5 km north of Mangamahu. Note lack of landslides in exotic forest (background). (GNS Photo: D02\_1659)

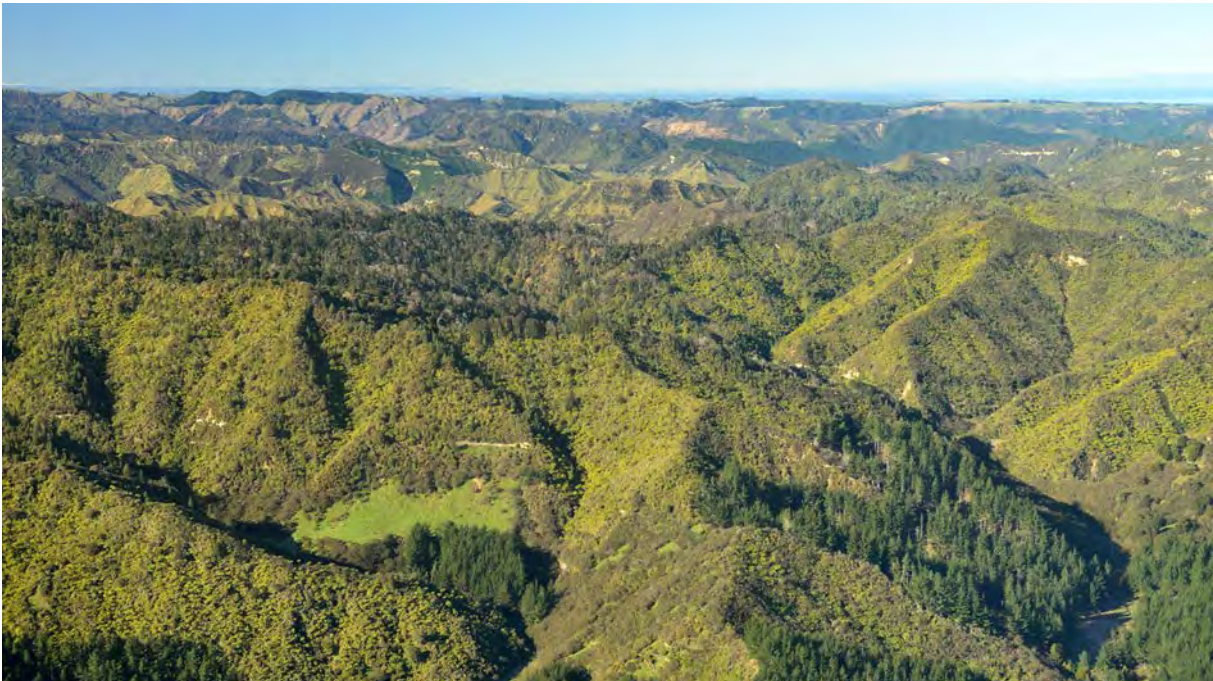
**Figure 21** Indigenous forest and scrub on Whenuakura Group sandstone, near Mangawhio, Weraweraonga catchment. Note there are very few landslides. (GNS Photo: D02\_1382)

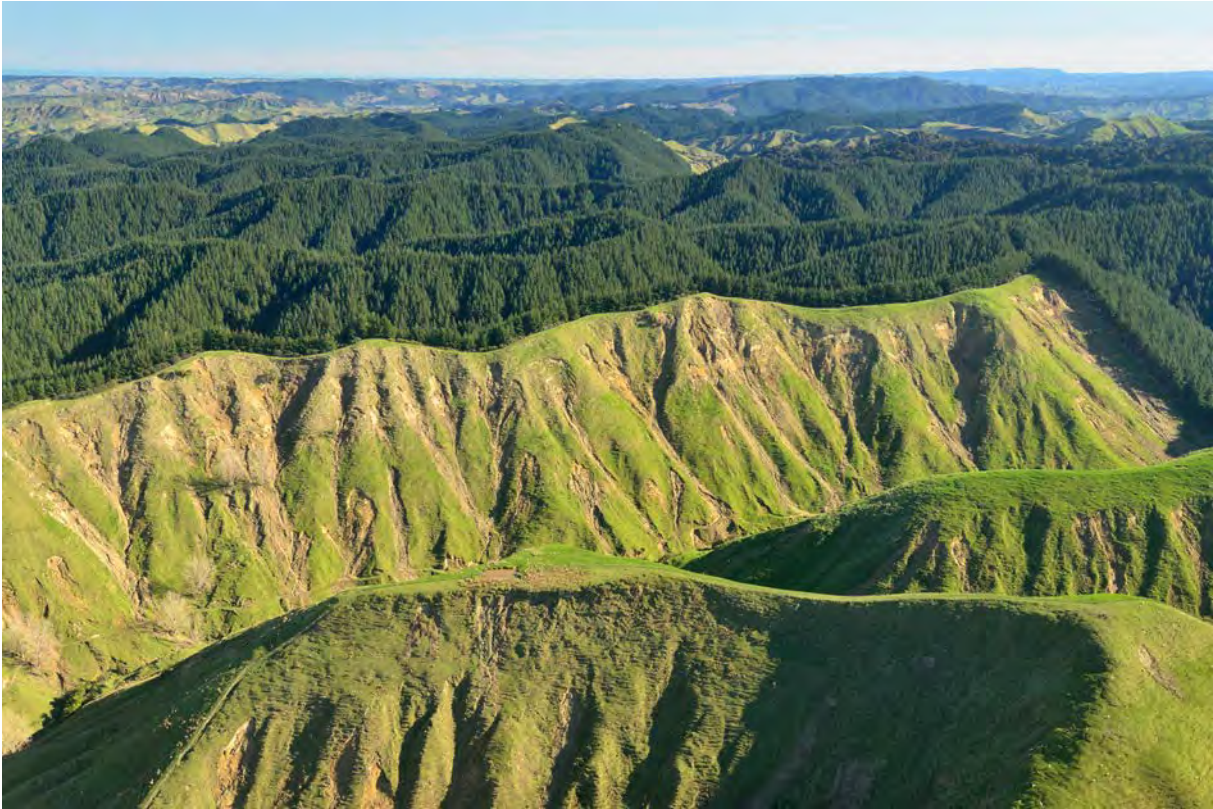
**Figure 22** Localised severe landsliding at Otairi, Turakina Valley. Note lack of landslides in exotic forest. (GNS Photo: D02\_1697)

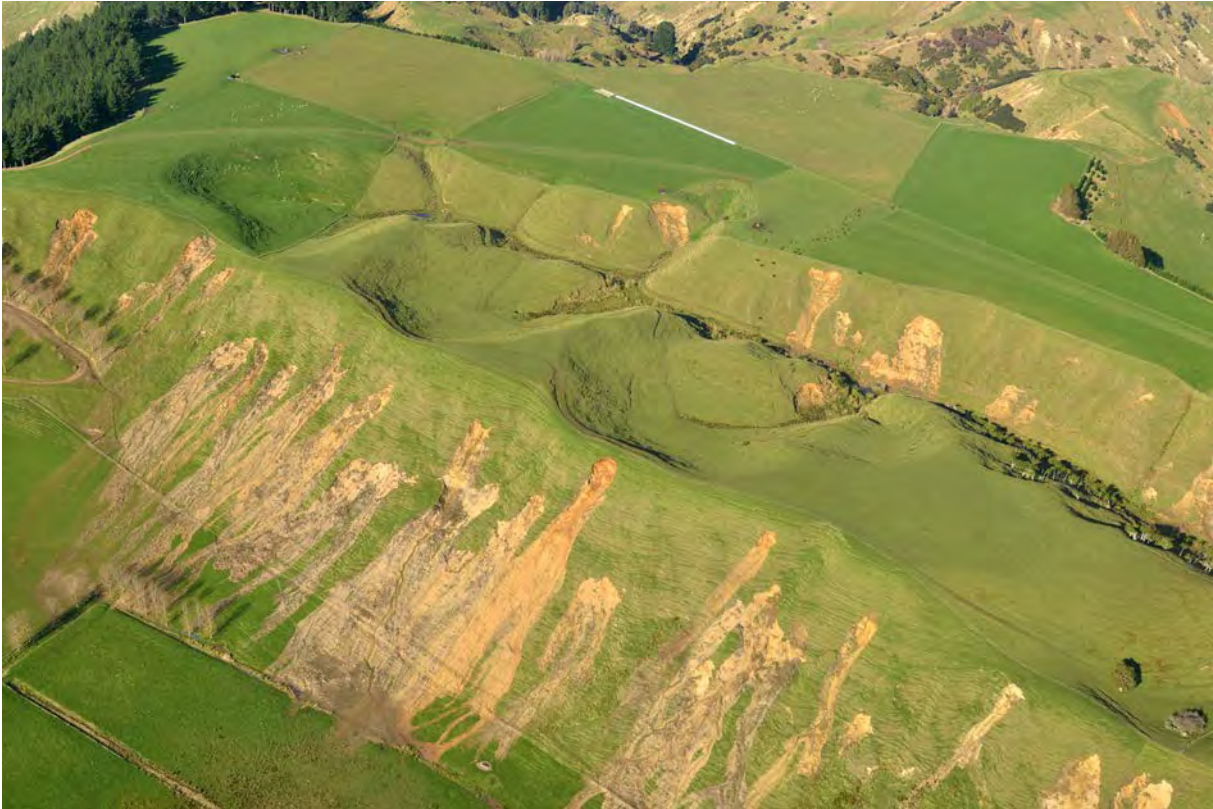
**Figure 23** Severe landsliding in Kai-lwi Group (eQk) early Quaternary sandstone/siltstone terrace scarps. Note brown colour of landslides near ridge line, indicating presence of weathered tephra/tephric loess cover deposits. Head of Makirikiri Valley, lower Whanganui catchment. (GNS Photo: D02\_1504)

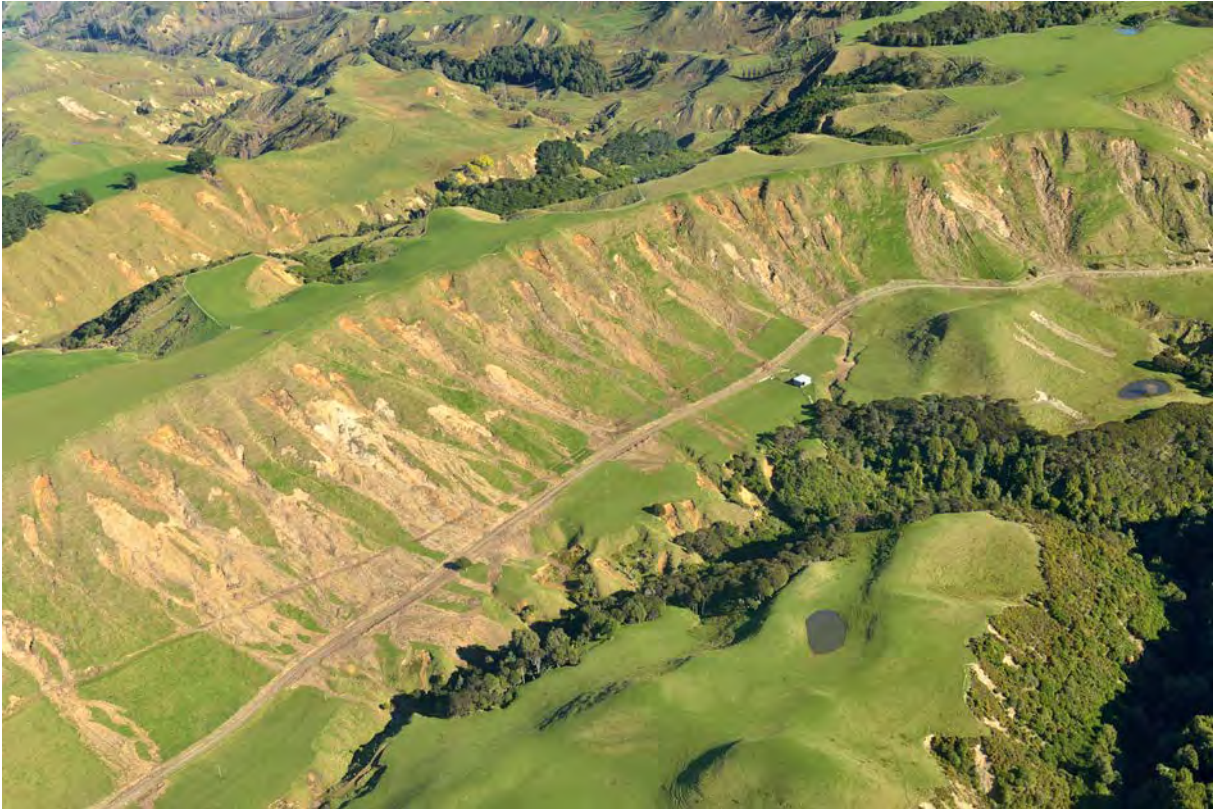
**Figure 24** Severe landsliding on scarps of Kai-lwi Group marine terraces, Makirikiri Valley. (GNS Photo: D02\_1505)

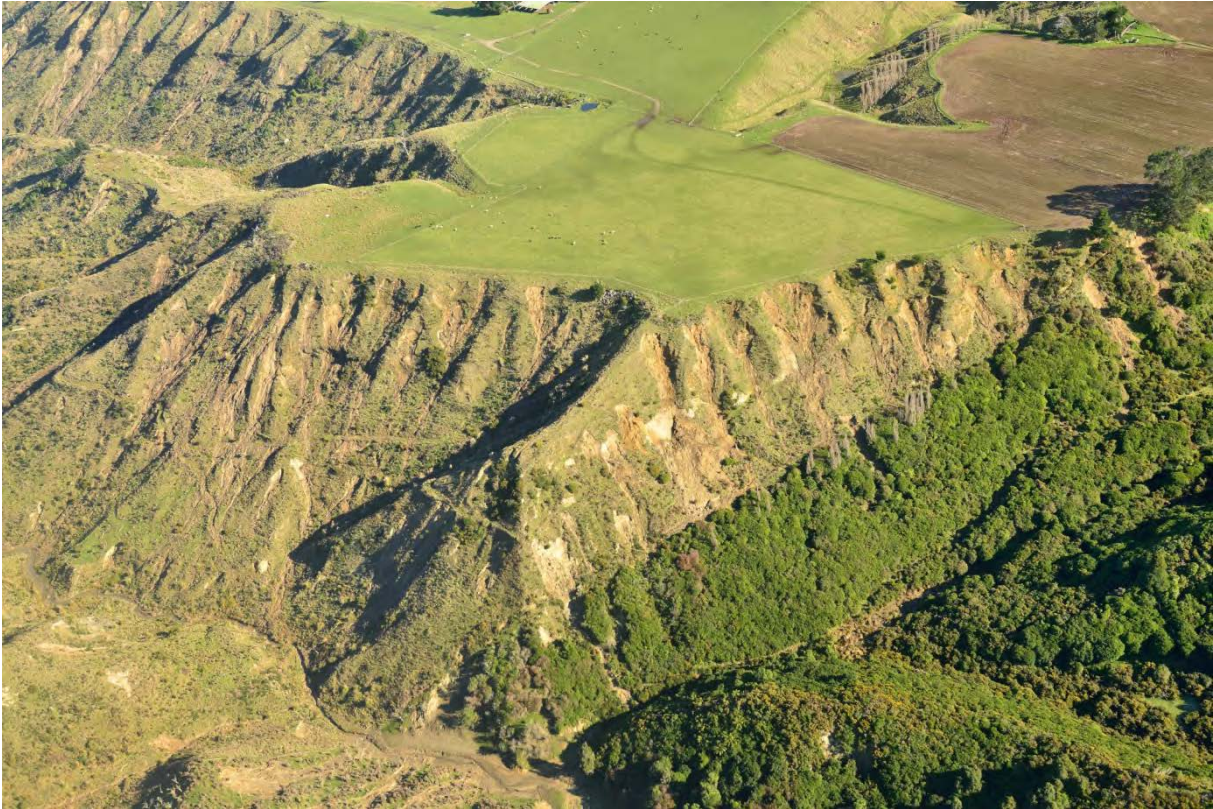
**Figure 25** Severe landsliding in head of Matarawa Stream, north of Fordell. Note location of landslide initiation at terrace-scarp boundary. (GNS Photo: D02\_1496)

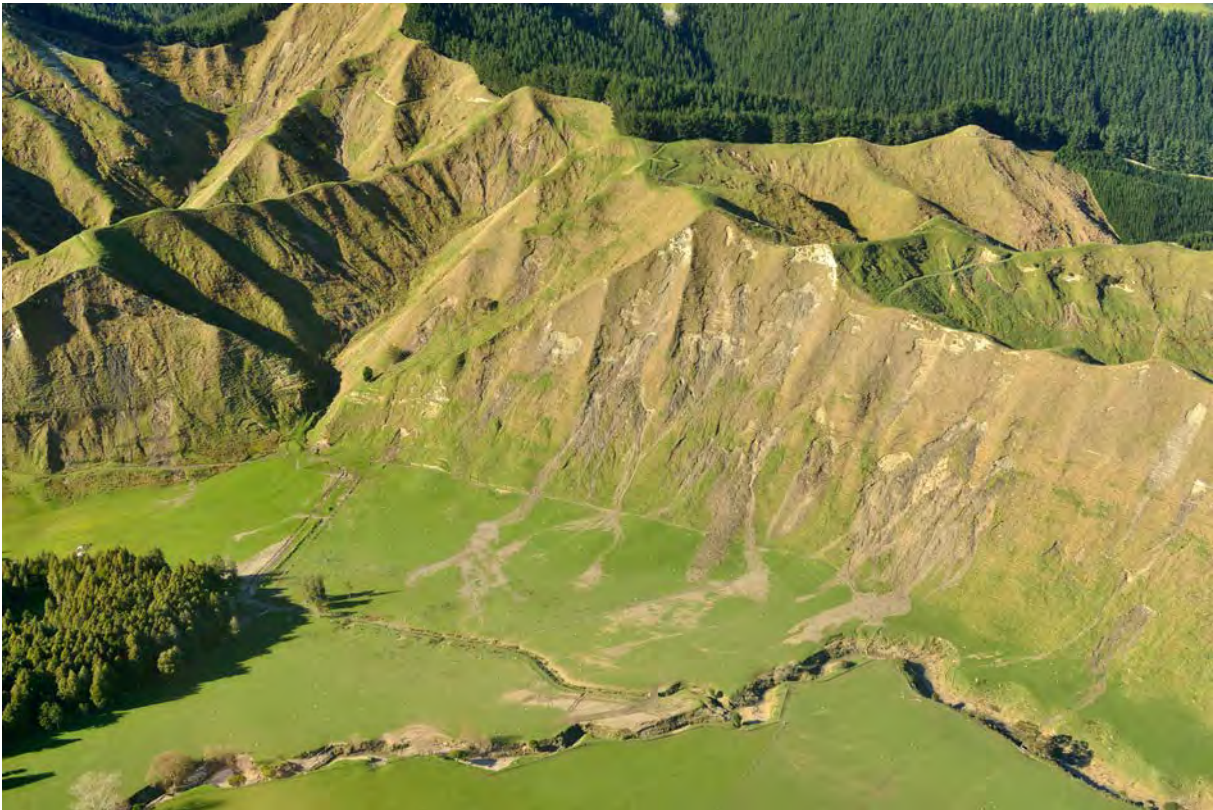
**Figure 26** Moderate landsliding with area of severe landsliding in centre. Pliocene sandstone, Parikino, Whanganui River. Note presence of old debris fans (in pasture) at foot of slope. (GNS Photo: D02\_1218)
