Page, M.J.; Rosser, B.J.; Townsend, D.B.; Carey, J.M.; Ries, W.F. 2015. Reconnaissance report on landsliding caused by the 19-20 June 2015 rainstorm in the Taranaki-Wanganui-Manawatu region, *GNS Science Consultancy Report 2015/172*. 50 p. + Appendices

## ABSTRACT

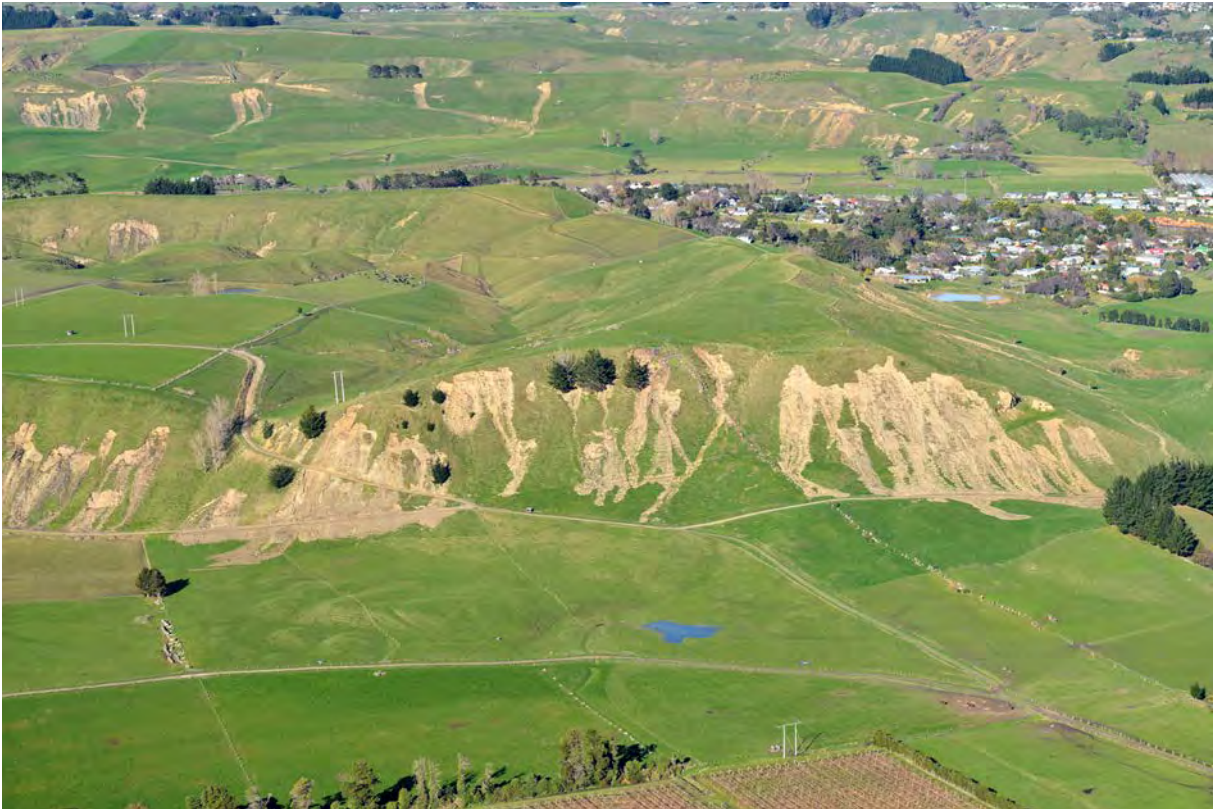
**Figure 27** Severe landsliding on north facing scarp of Kai-lwi marine terrace. Outskirts of Whanganui East in right background. Note coalescing of adjacent landslide scars and debris tails. (GNS Photo: D02\_1247)

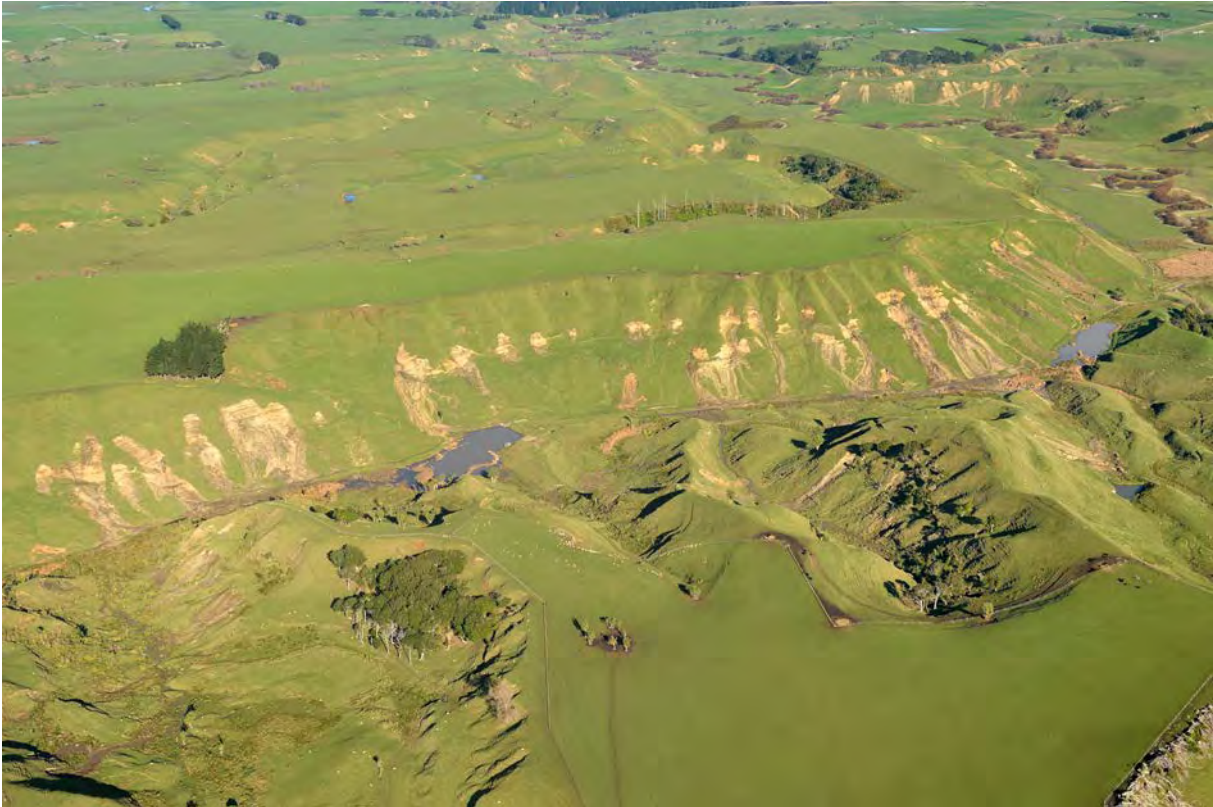
**Figure 28** Severe landsliding on north facing terrace scarps, Okehu catchment, between Kai Iwi and Maxwell. Late Pliocene to early Quaternary sandstone/siltstone. (GNS Photo: D02\_1282)

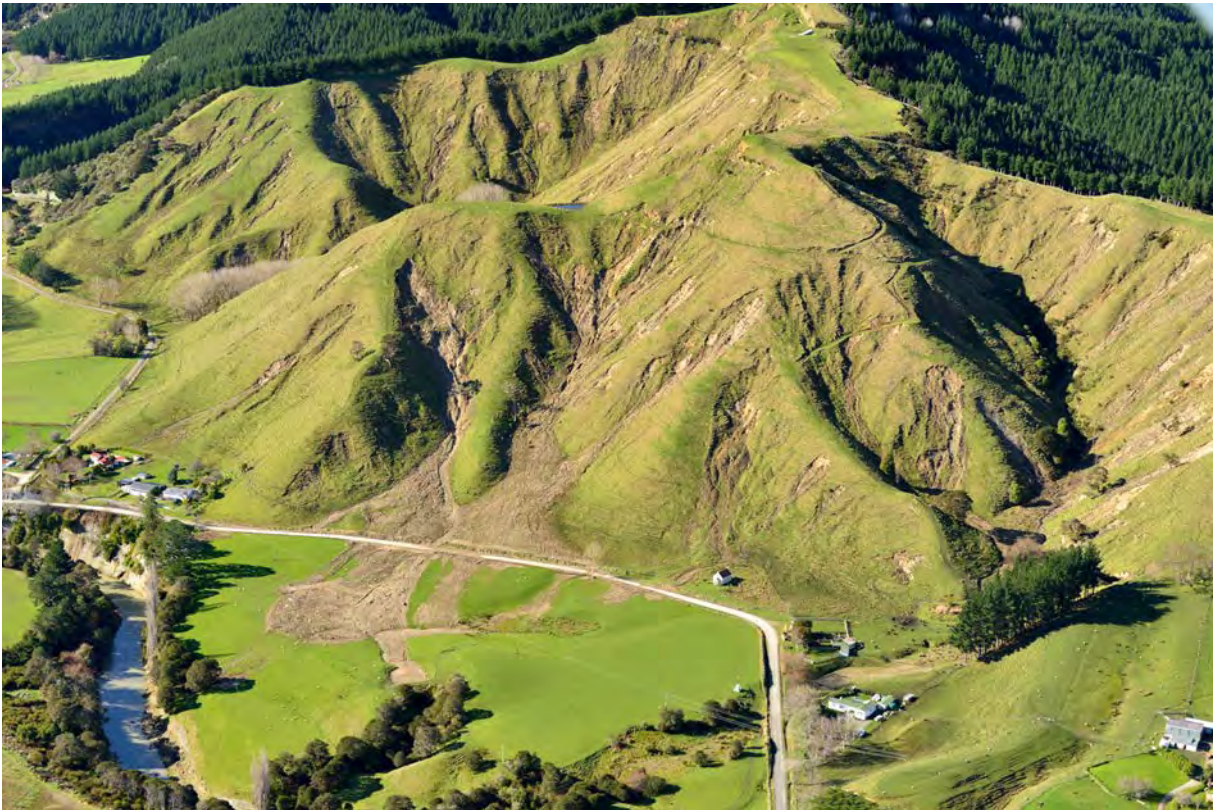
**Figure 29** Severe landsliding at Mangamahu, on Pliocene sandstone. Coalescing of landslide debris tails has increased run-out distance. (GNS Photo: D02\_1653)

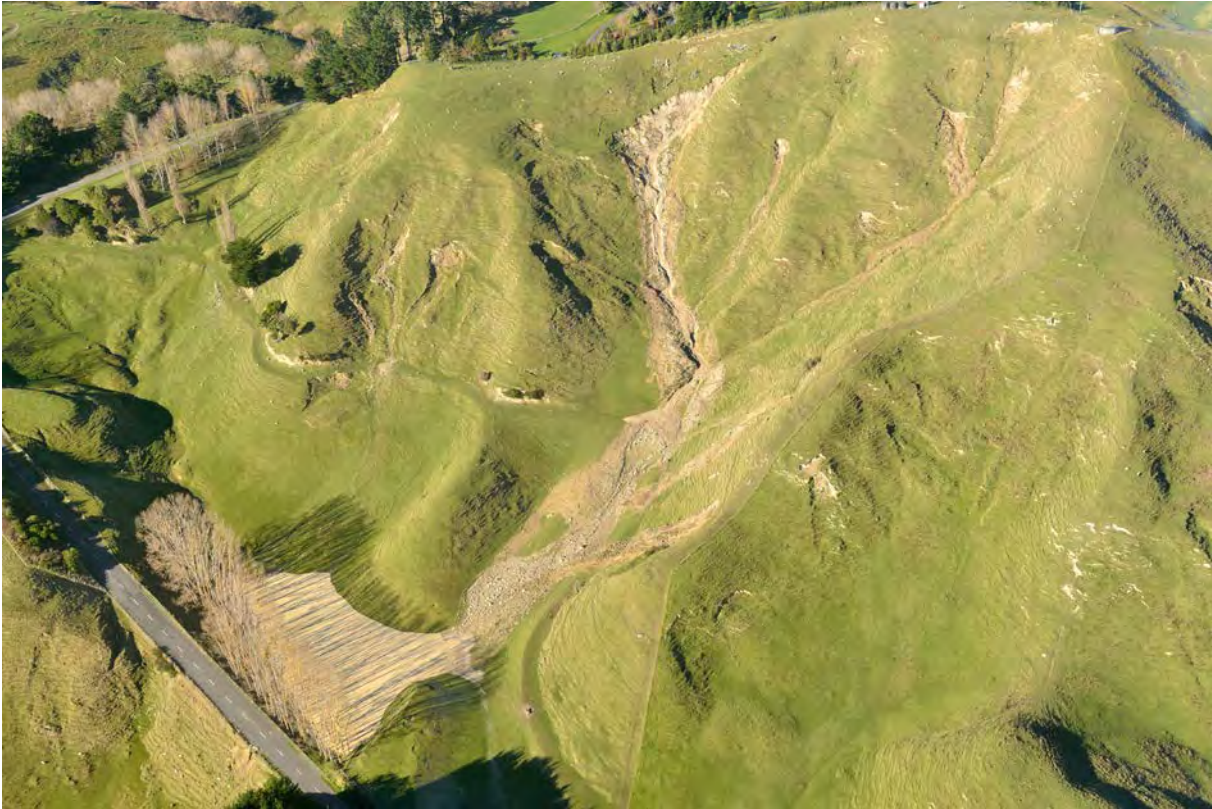
**Figure 30** Rangatira Rd east of Hunterville. Note gulying along debris tail path, and resulting deposition of bedrock material on lower slopes, and ponding of sediment-laden water beside road. (*GNS Photo: D02\_1145*)

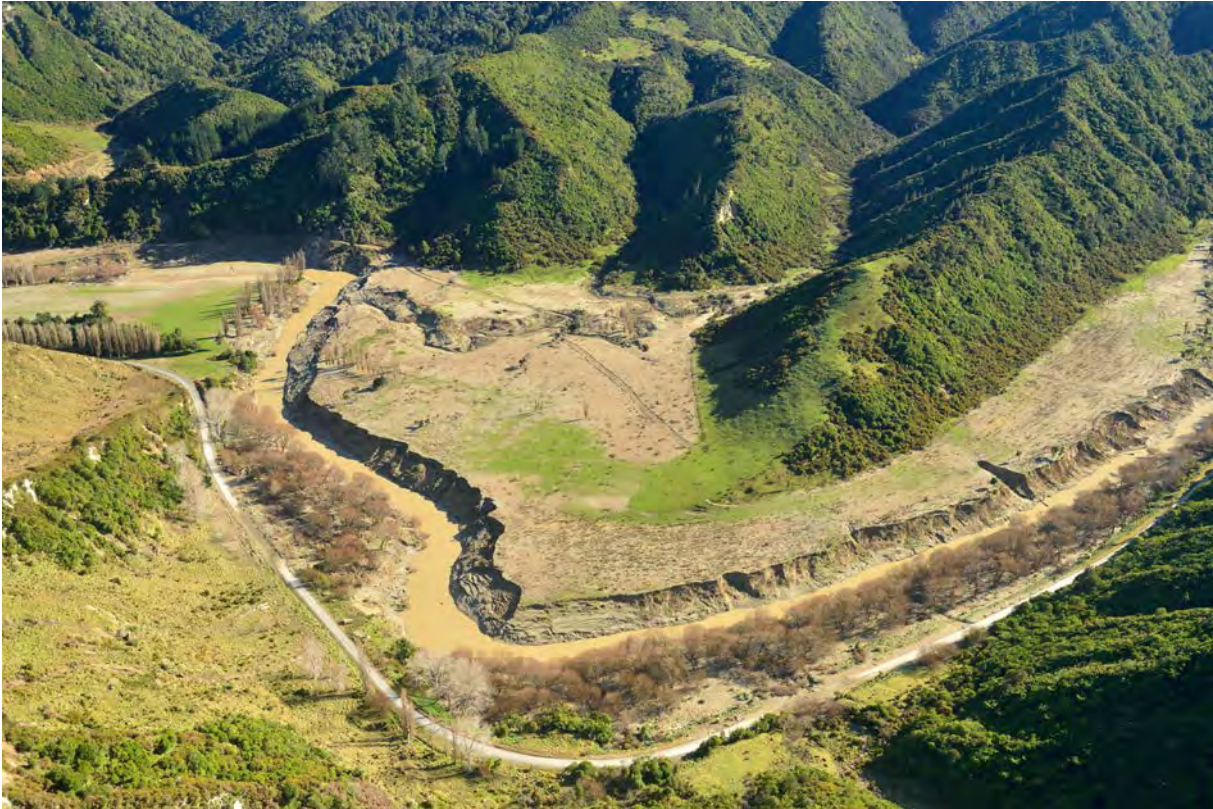
**Figure 31** Example of streambank erosion and sediment deposition in the Waitotara Valley, just north of Rangitatau. Note fresh bank failures (exposed brown sediment) at right, and incision (gully) of channelized flow into streambank. (GNS Photo: D02\_1318)

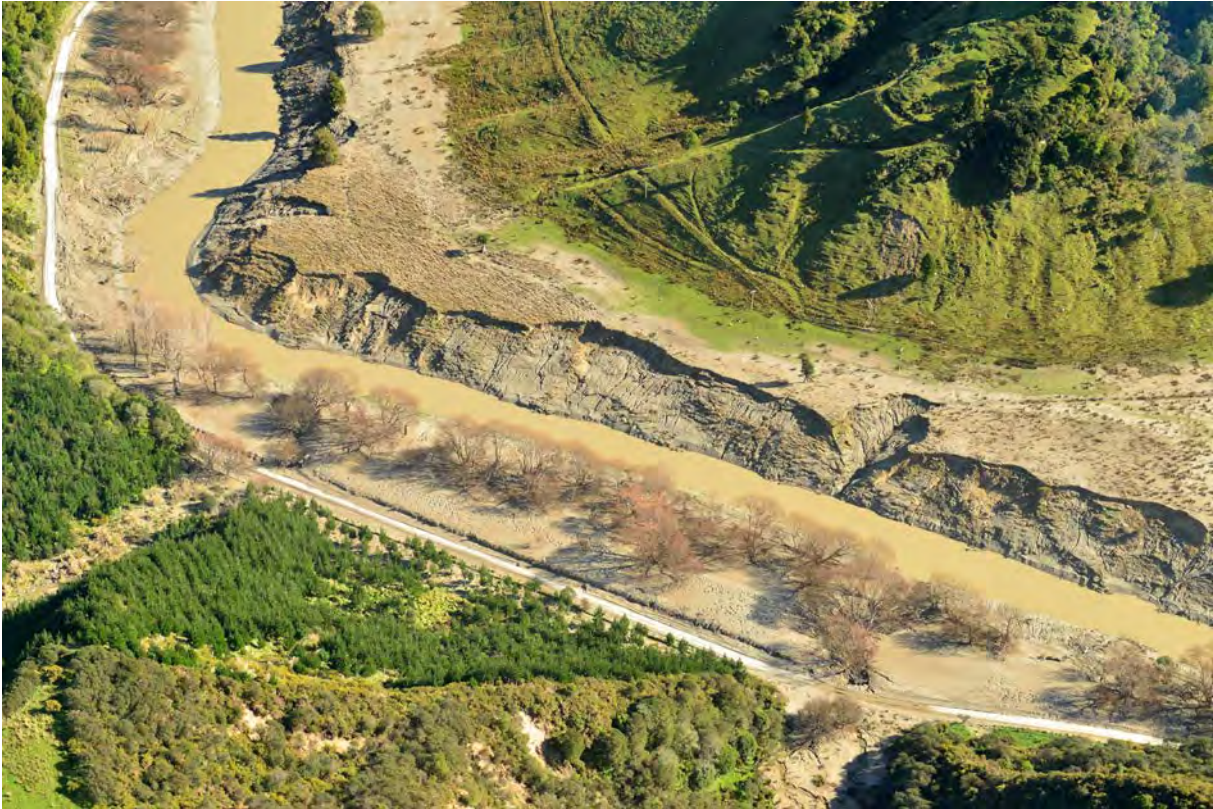
**Figure 32** Streambank erosion in the Waitotara Valley, just north of Puao. Note drape of fresh grey silt deposited on banks. (GNS Photo: D02\_1333)

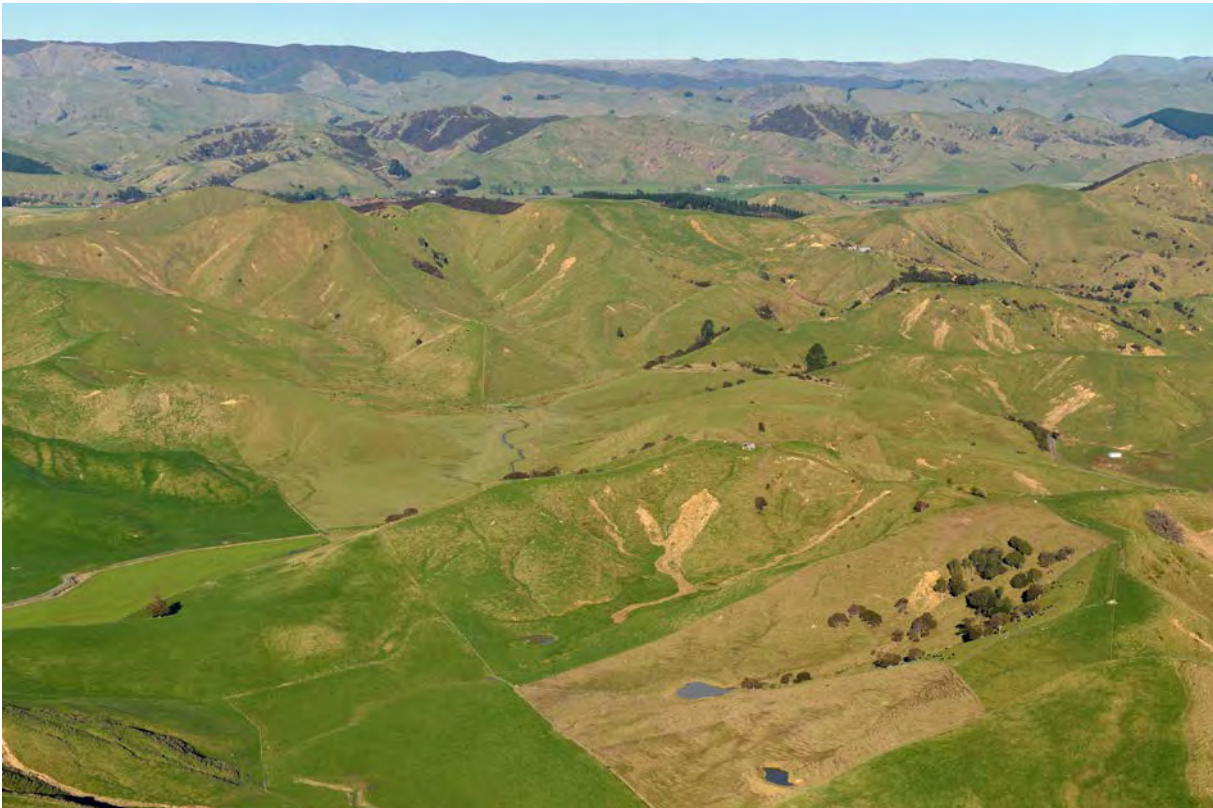
**Figure 33** Slight landsliding east of Woodville. (GNS Photo: D02\_1888)

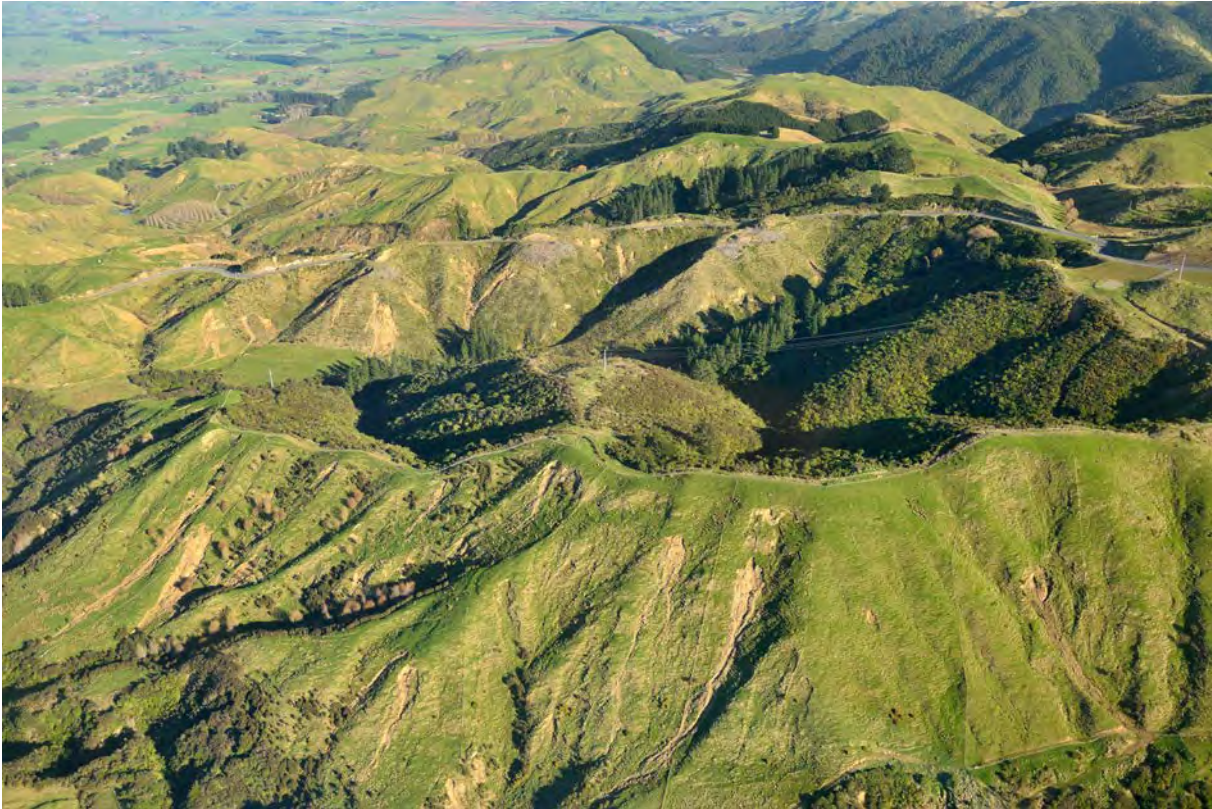
**Figure 34** Moderate landsliding on mudstone near Saddle Rd, north of Manawatu Gorge. (GNS Photo: D02\_1872)

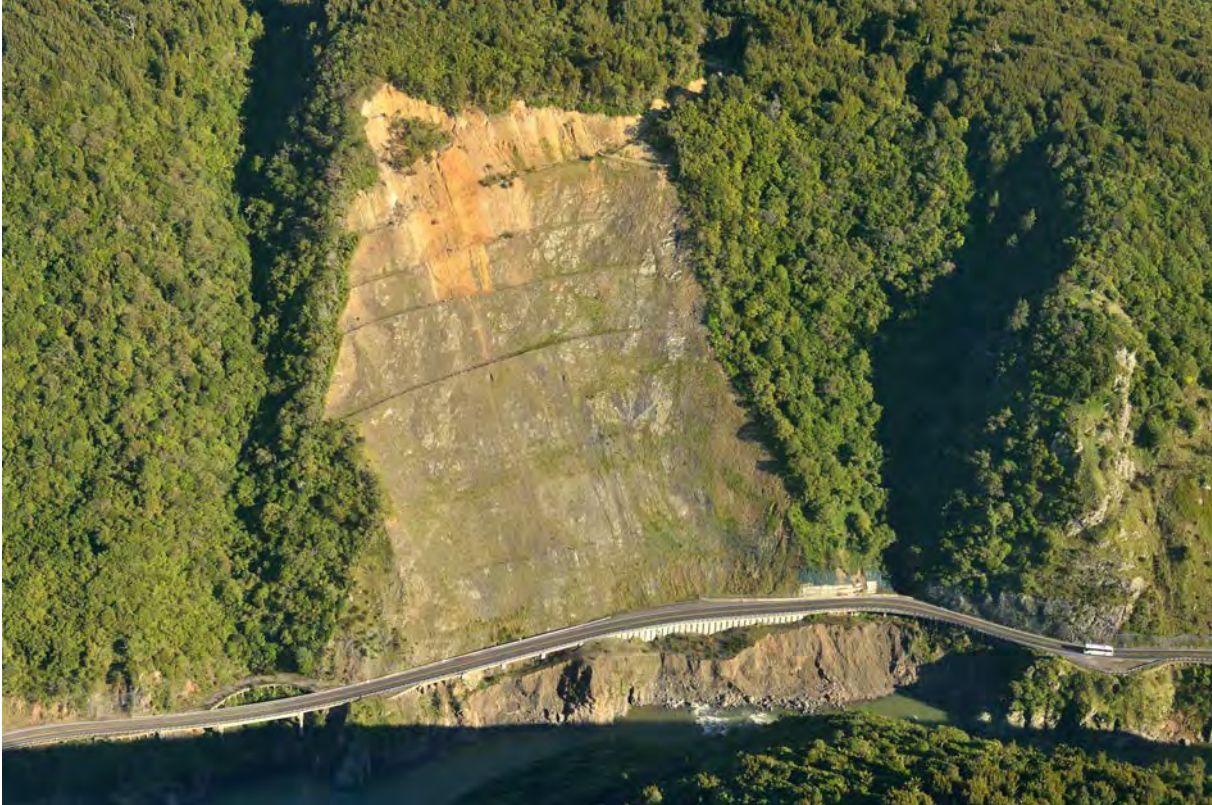
15. There are a number of large landslides in the Manawatu Gorge that periodically reactivate, at times blocking the highway for several weeks to several months. Almost all are failures associated with road cuttings. Following failures in 2004 and 2011, the largest of these landslides was cleared of surficial material, the slope benched, and drainage pipes installed in the rock face. During the June 2015 storm an area of the cleared head scarp of the landslide failed, and the resulting debris accumulated on three of the benches below (Figure 35).

**Figure 35** Head scarp failure of pre-existing landslide in Manawatu Gorge. The landslide had been benched and drainage installed following major failures in 2004 and 2011. (GNS Photo: D02\_1859)

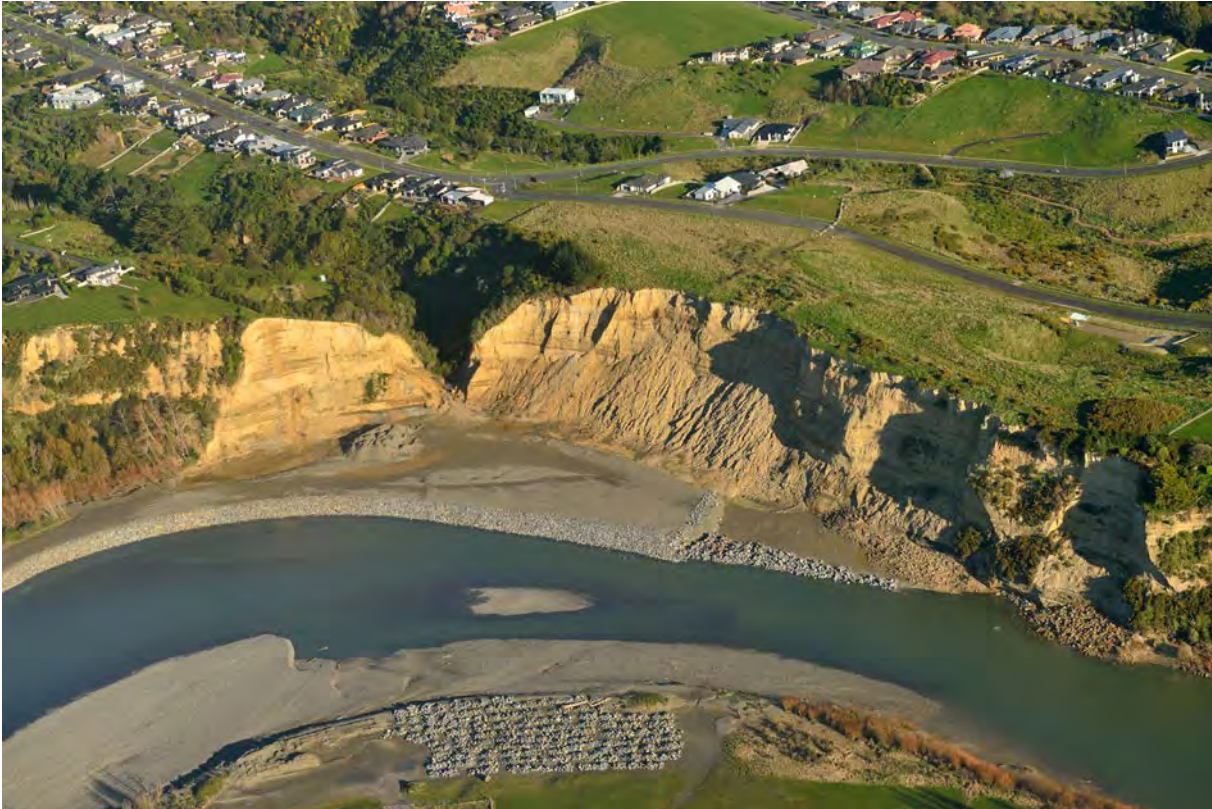
**Figure 36** Cliff failure along the Manawatu River at Anzac Park, Palmerston North. (GNS Photo: D02\_2080)

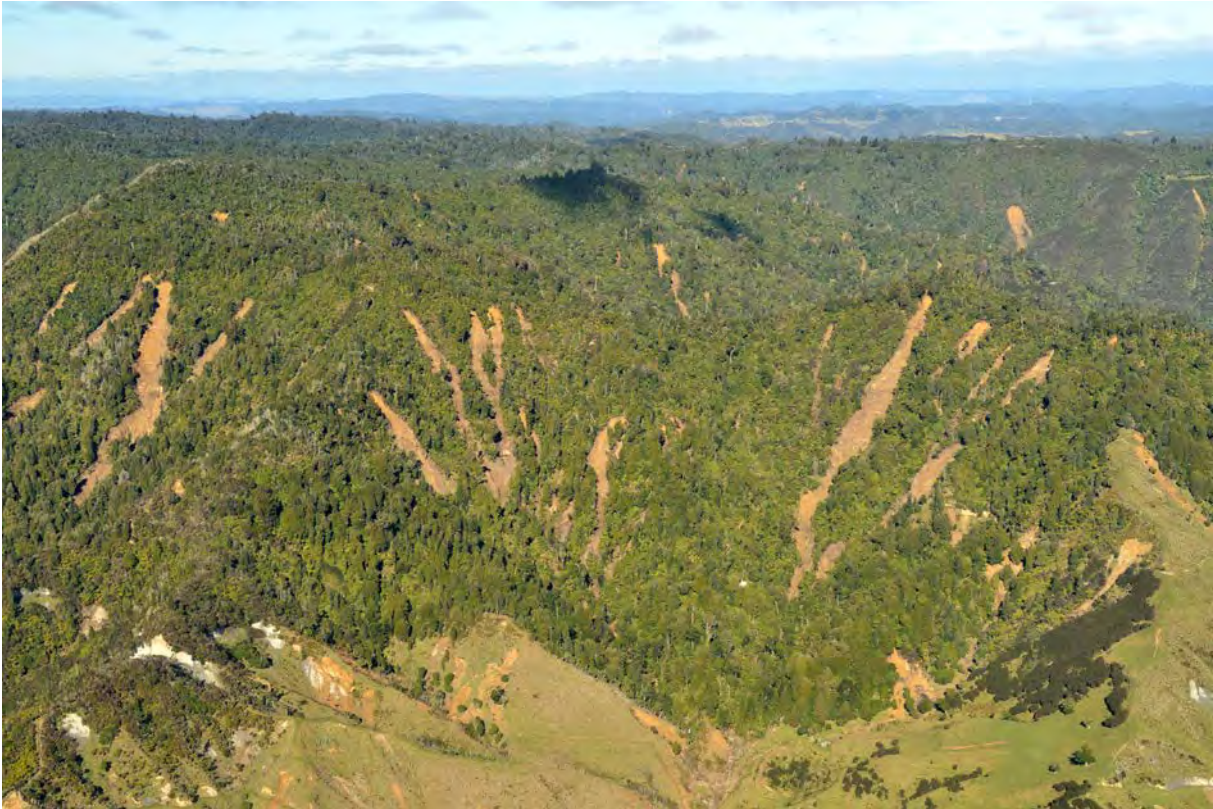
**Figure 37** Landslides on mature indigenous forest covered slopes in the Puniwhakau Stream catchment, a tributary to the Mangaehu Stream, Matemateaonga Range near Tututawa. Whangamomona Group sandstone. (GNS Photo: D02\_2767)

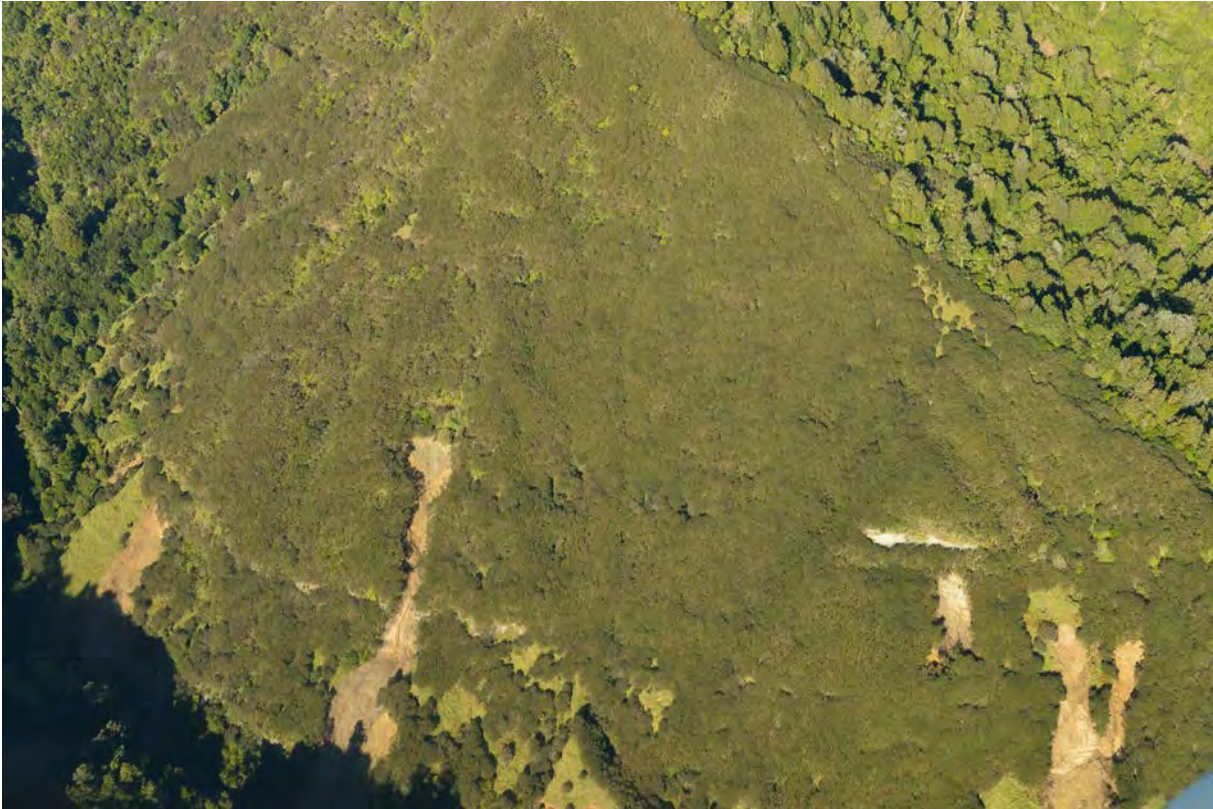
**Figure 38** Moderate landsliding on scrub covered slopes on Whangamomona Group sandstone on the Matemateaonga Range near Makahu. (GNS Photo: D02\_2788)

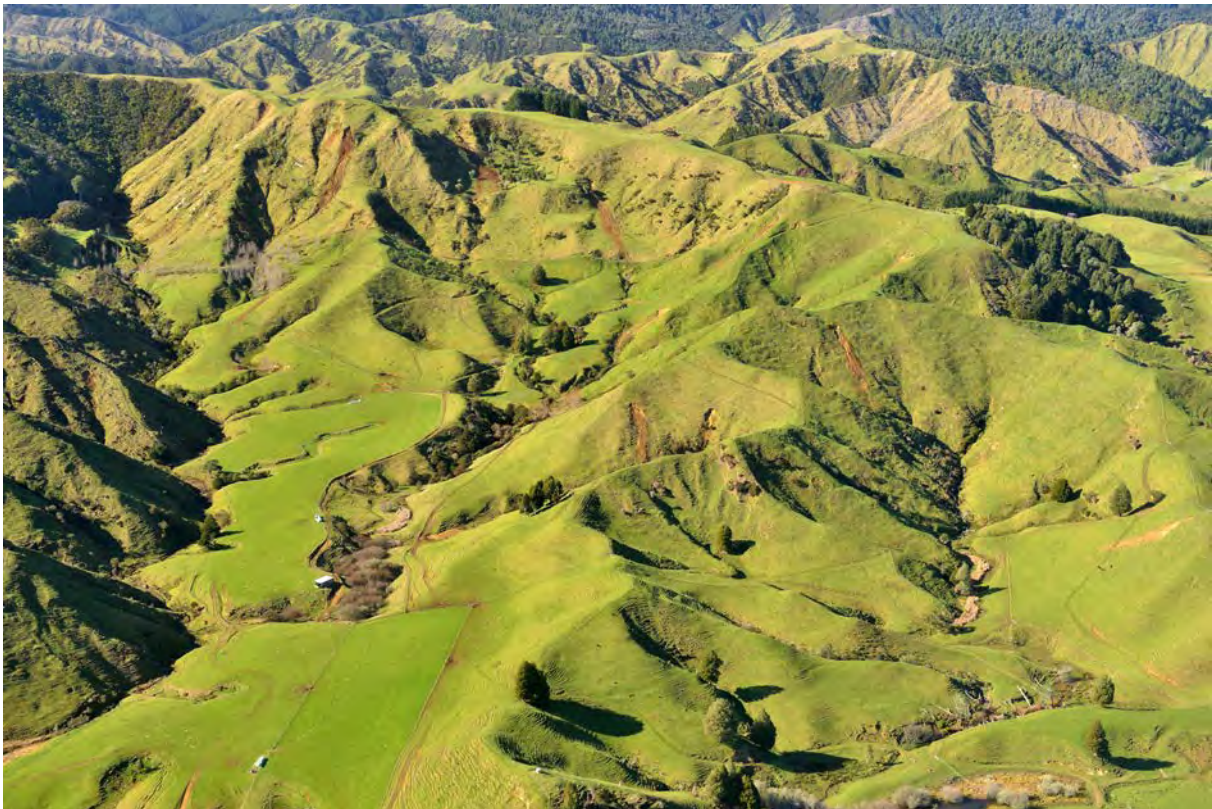
**Figure 39** Moderate landsliding near Makahu. Kiore Formation sandstone, Whangamomona Group. (GNS Photo: D02\_2486)

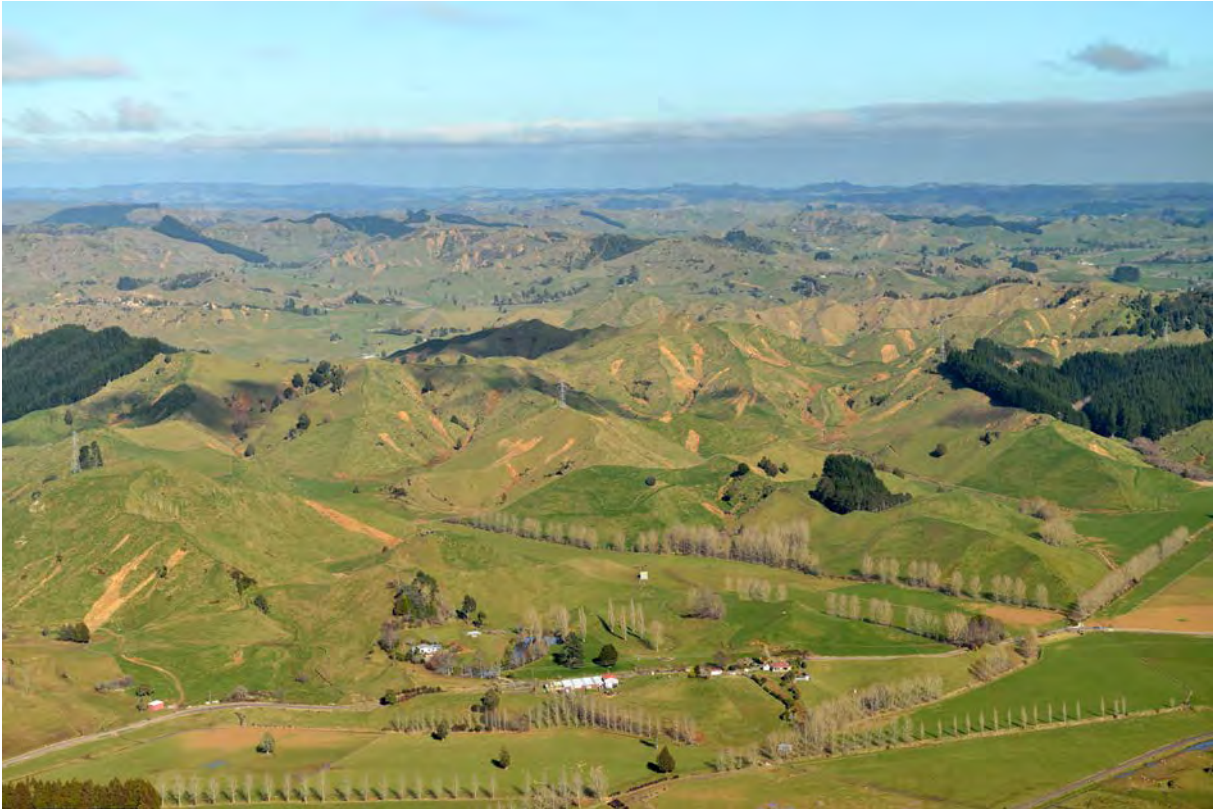
**Figure 40** Moderate landsliding on Miocene age Whangamomona Group Sandstone in the Mohakau Stream catchment near Huiroa (inland from Stratford). (GNS Photo: D02\_2721)

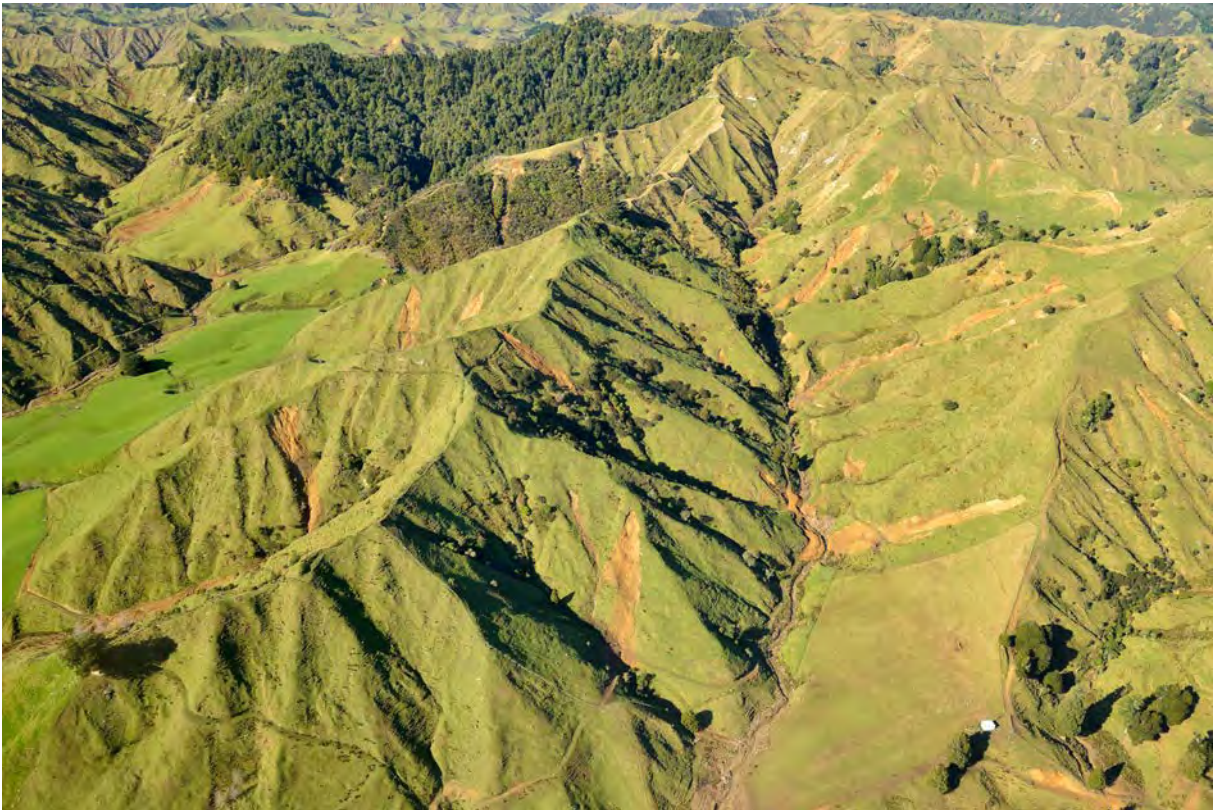
**Figure 41** Moderate landsliding on Miocene age Whangamomona Group Sandstone in the Mangaotuku Stream catchment, near Strathmore. (GNS Photo: D02\_2741)

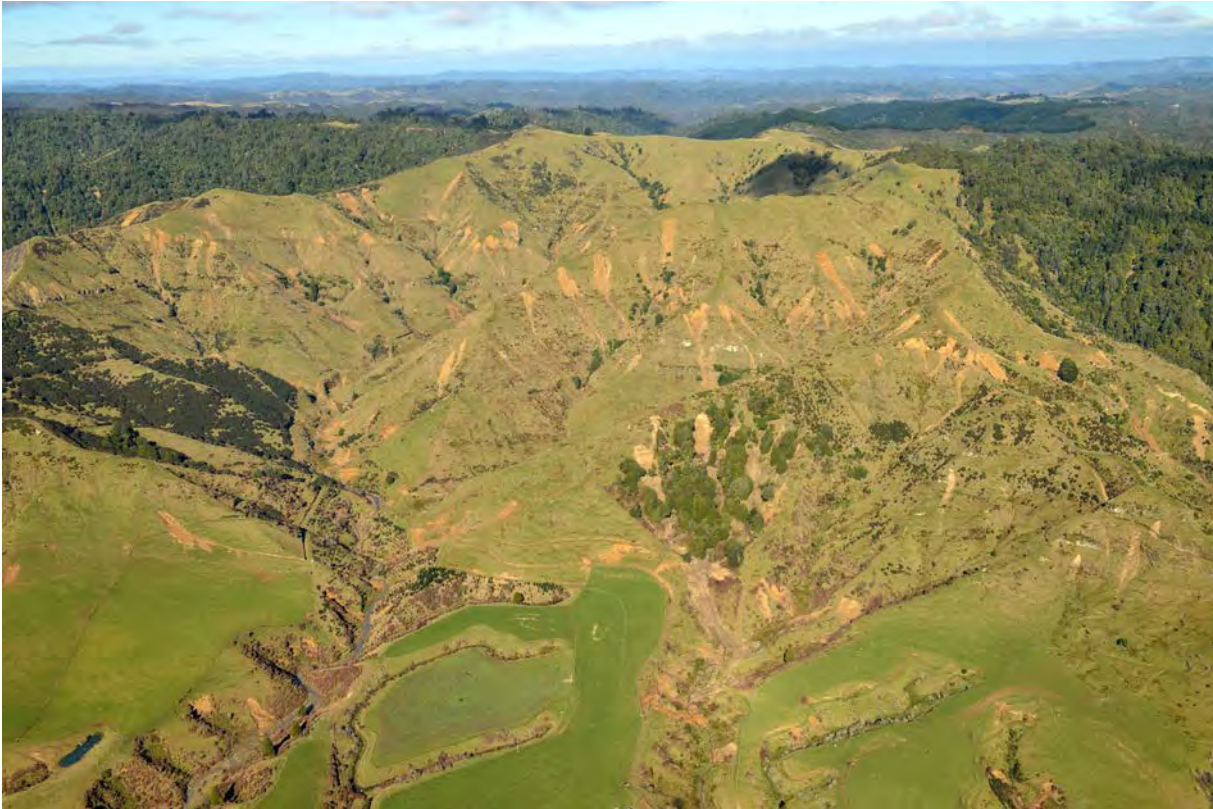
**Figure 42** Moderate landsliding in the Mangaehu Stream catchment on Miocene age Whangamomona Group Sandstone. (GNS Photo: D02\_2758)

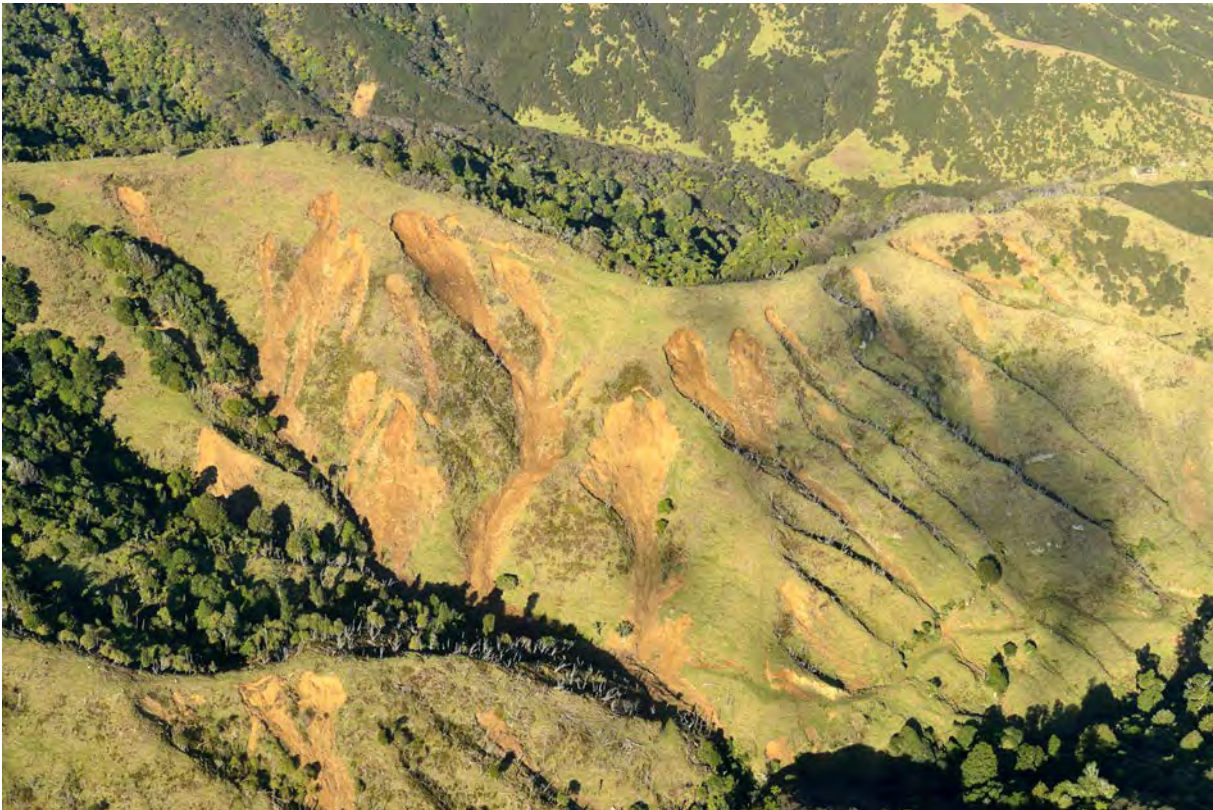
**Figure 43** Localised severe landsliding on Miocene age Whangamomona Group Sandstone in the Mangaehu Stream catchment near Tututawa. (GNS Photo: D02\_2796)

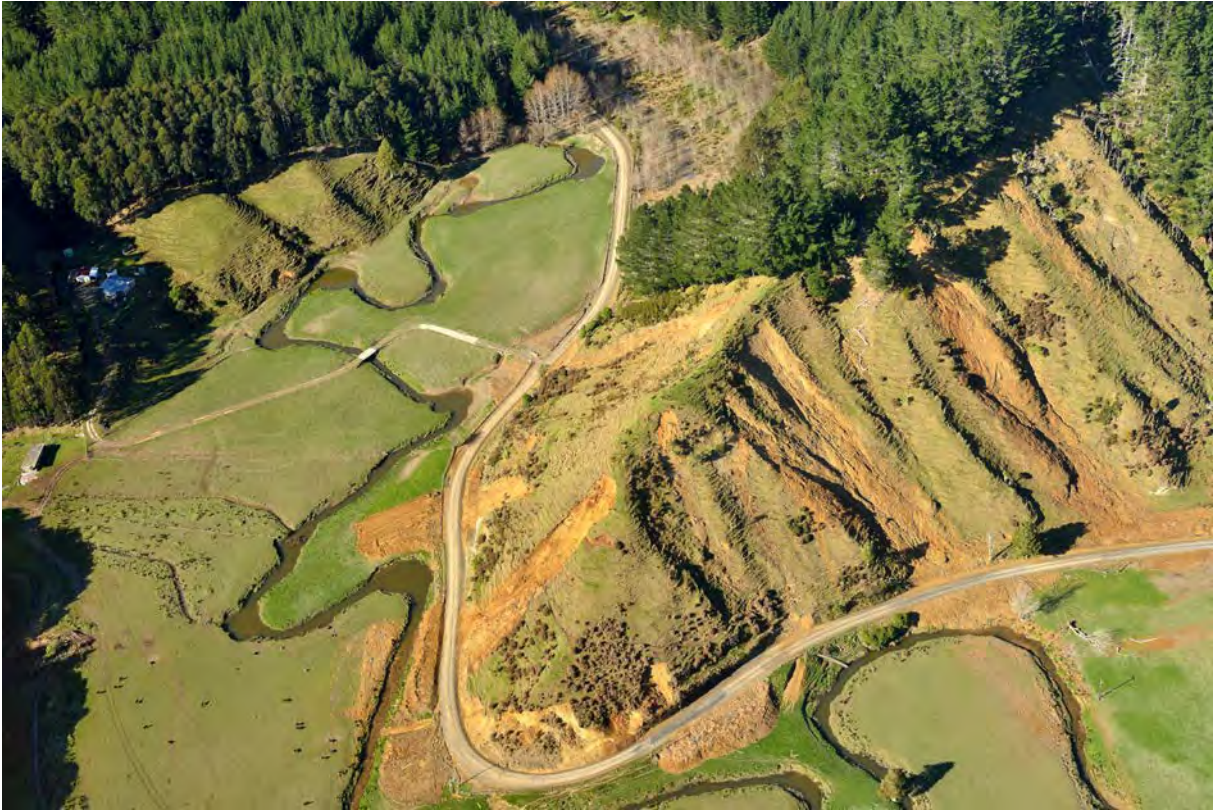
**Figure 44** Localised severe landsliding near Uruti, on Miocene age Mt Messenger Formation sandstone, Whangamomona Group. (GNS Photo D02\_2579)

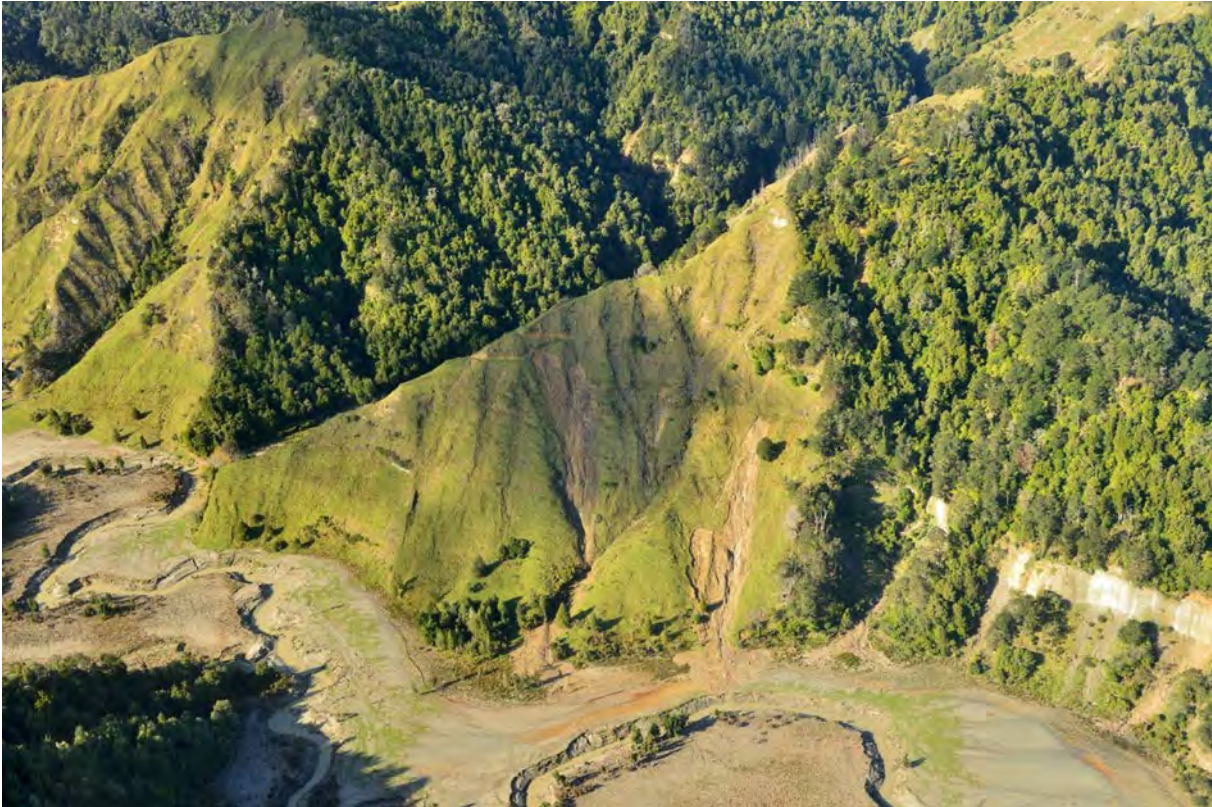
**Figure 45** Landsliding on steep hillsides adjacent to the Pokeka Stream, tributary of the Waitotara River. The landslides are formed on Whangamomona Group sandstone. (GNS Photo D02\_3095)

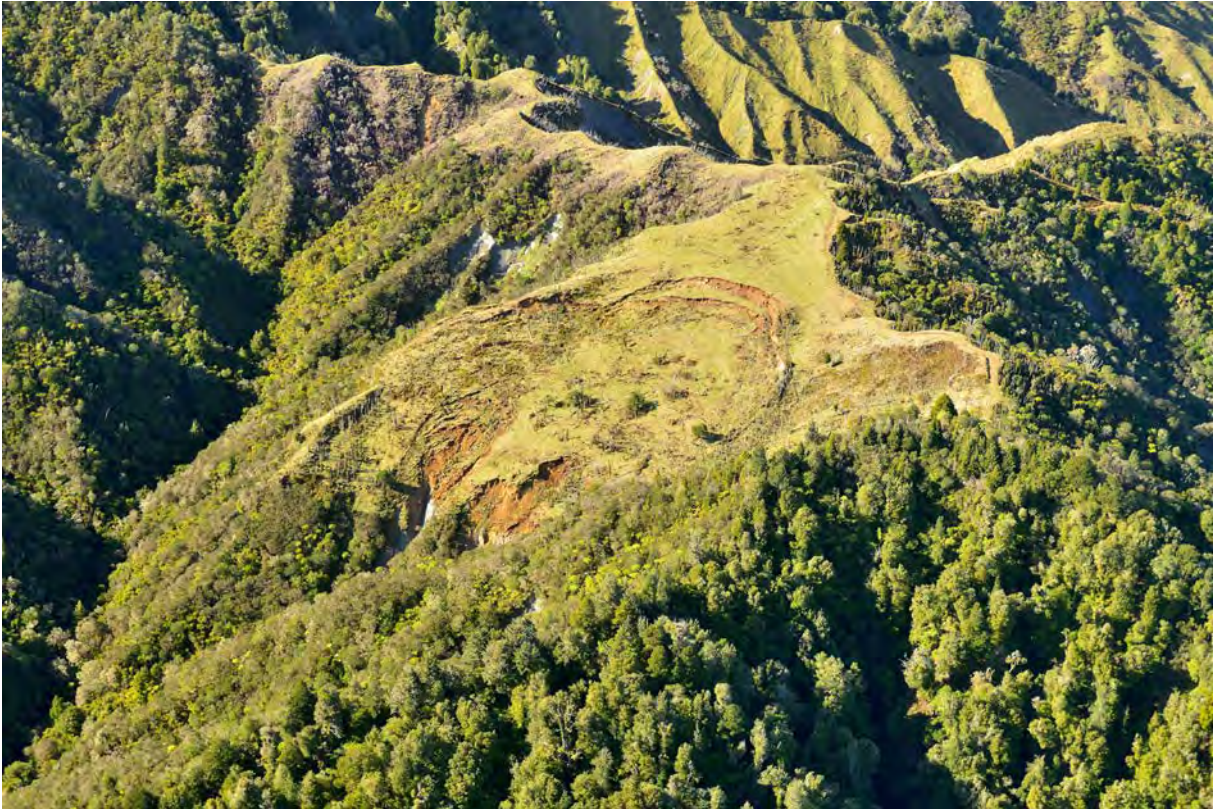
**Figure 46** Large, deep-seated landslide near Whangamomona, in Whangamomona Group, siltstone. (GNS Photo: D02\_2516)

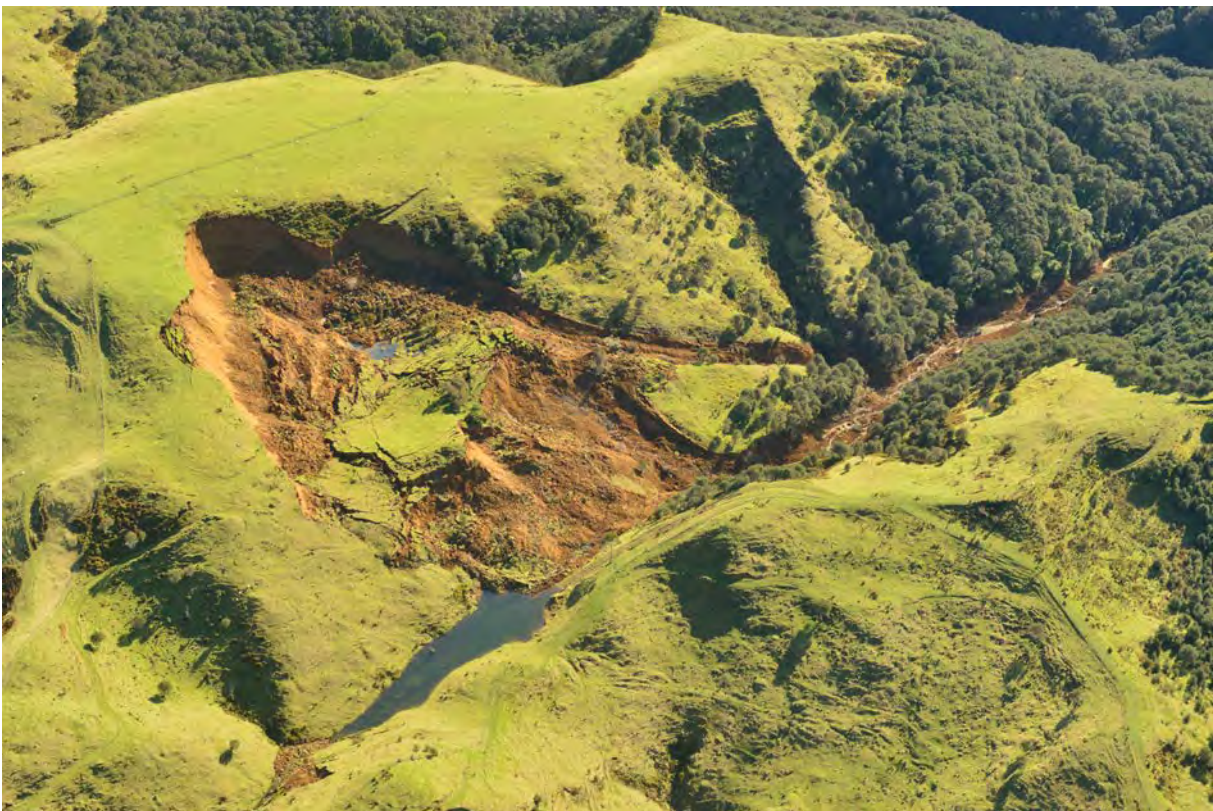
**Figure 47** Deep-seated landslide near Pohokura saddle, Waitara River, on Miocene age Whangamomona Group sandstone (Kiore Formation). Note the small lake formed upstream of the landslide debris. (GNS Photo: D02\_2620)

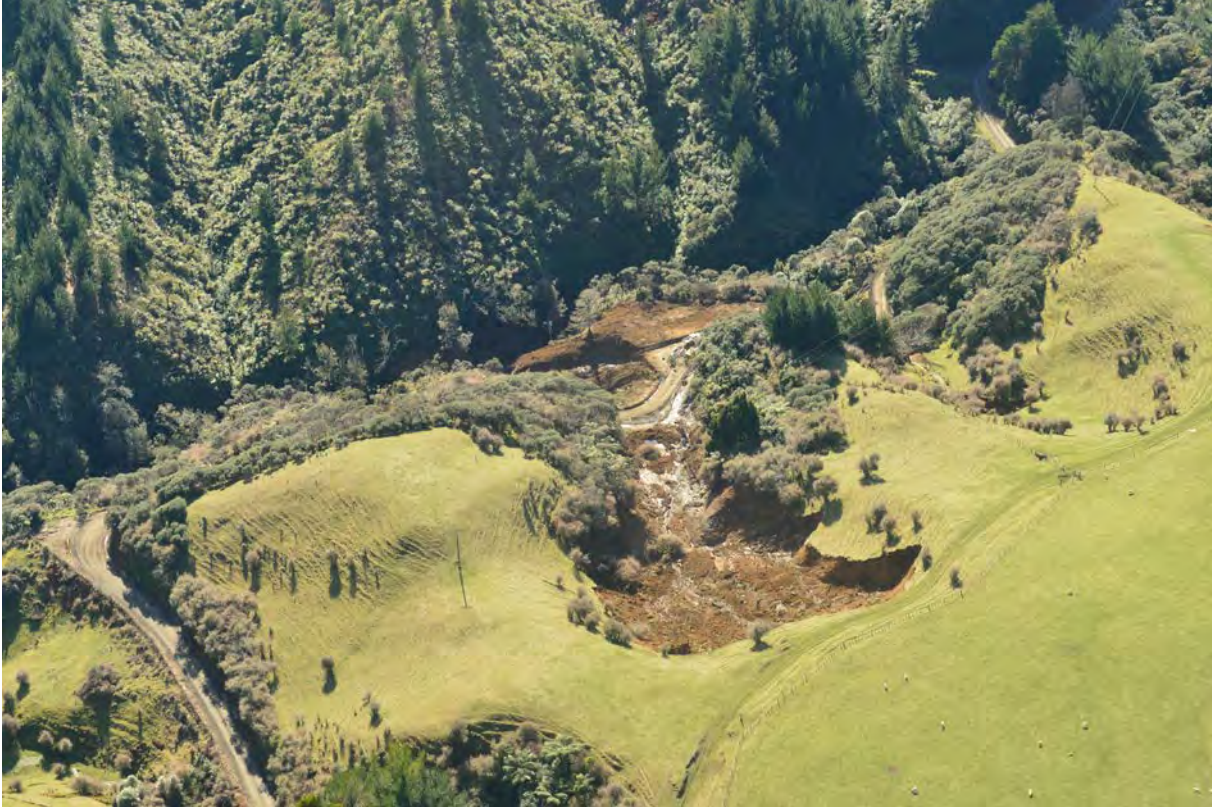
**Figure 48** Moderate deep-seated landslide near Huiroa (inland from Stratford) that blocked the channel of the stream below. The landslide is in Miocene age Whangamomona Group Sandstone. (*GNS Photo: D02\_2713*)
