Page, M.J.; Rosser, B.J.; Townsend, D.B.; Carey, J.M.; Ries, W.F. 2015. Reconnaissance report on landsliding caused by the 19-20 June 2015 rainstorm in the Taranaki-Wanganui-Manawatu region, *GNS Science Consultancy Report 2015/172*. 50 p. + Appendices

## ABSTRACT

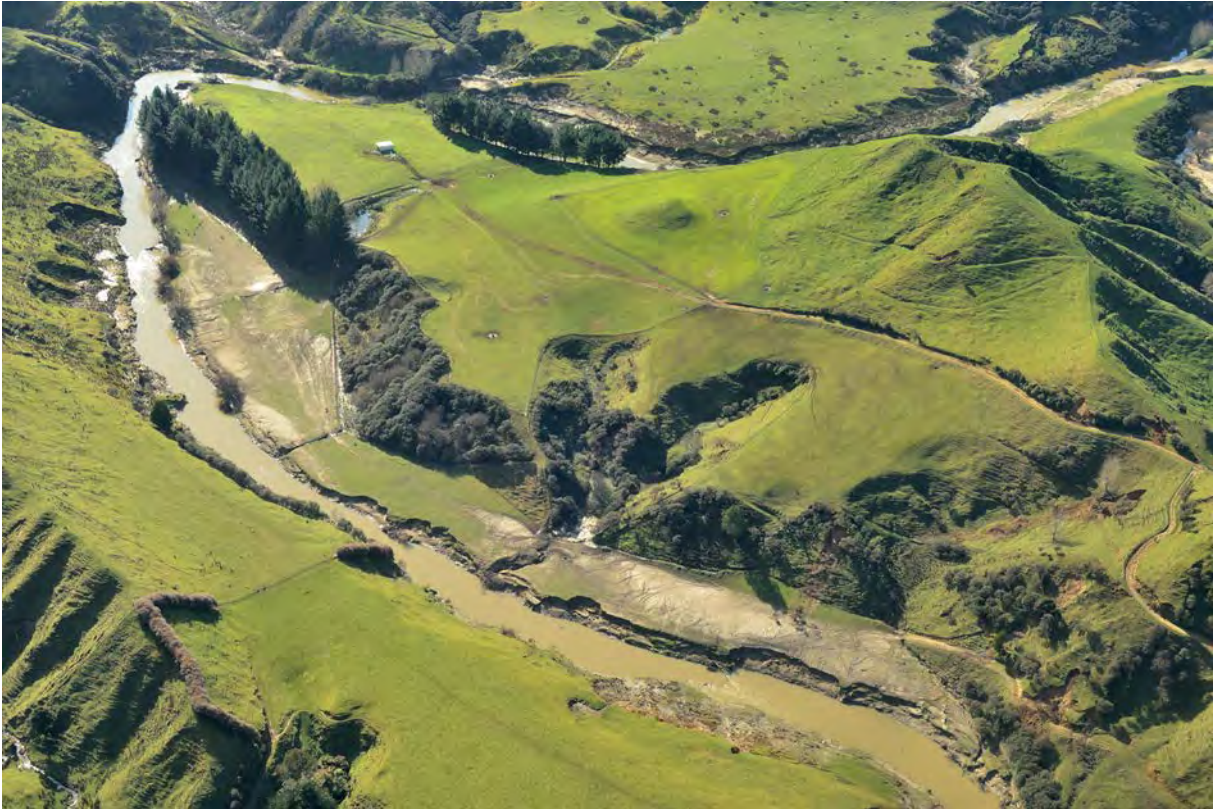
**Figure 49** Severe streambank erosion along the Mangaehu Stream, tributary to the Patea River. (GNS Photo: D02\_2802).

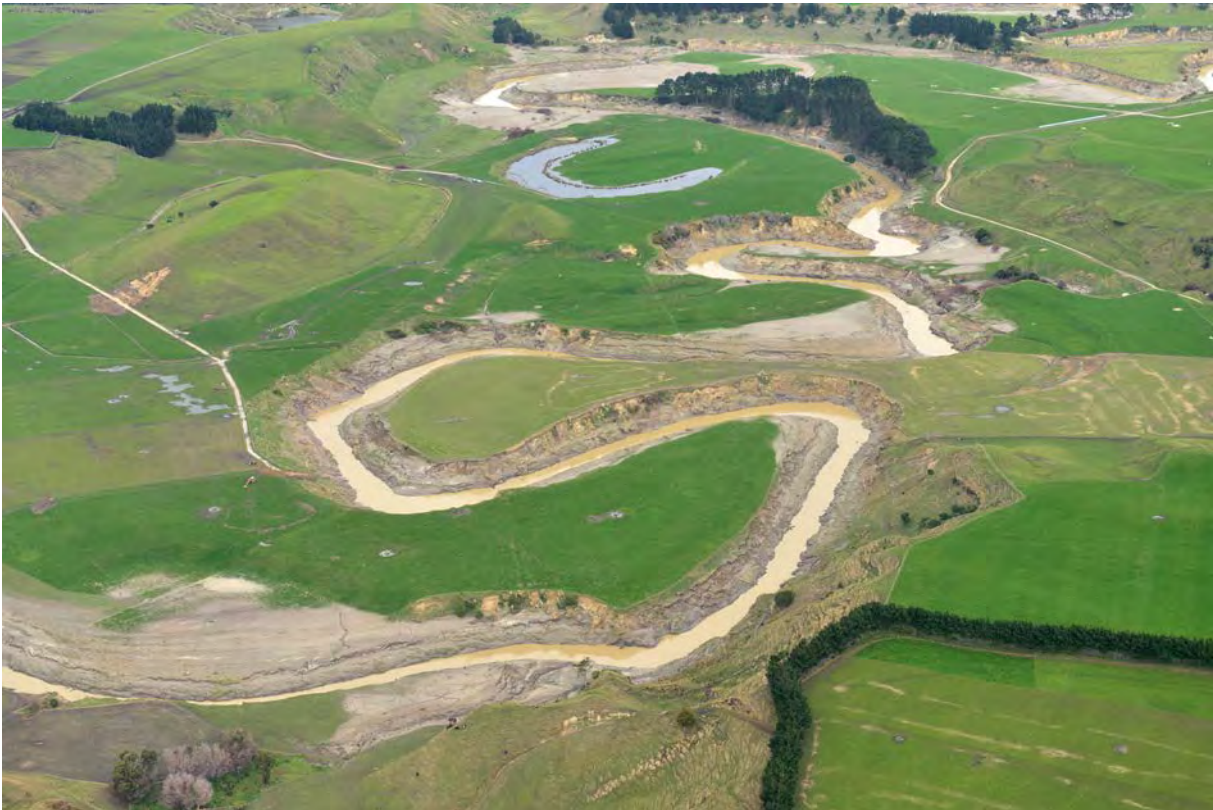
**Figure 50** Severe streambank erosion along the lower reaches Whenuakura River, near Patea. (GNS Photo: D02\_2920)

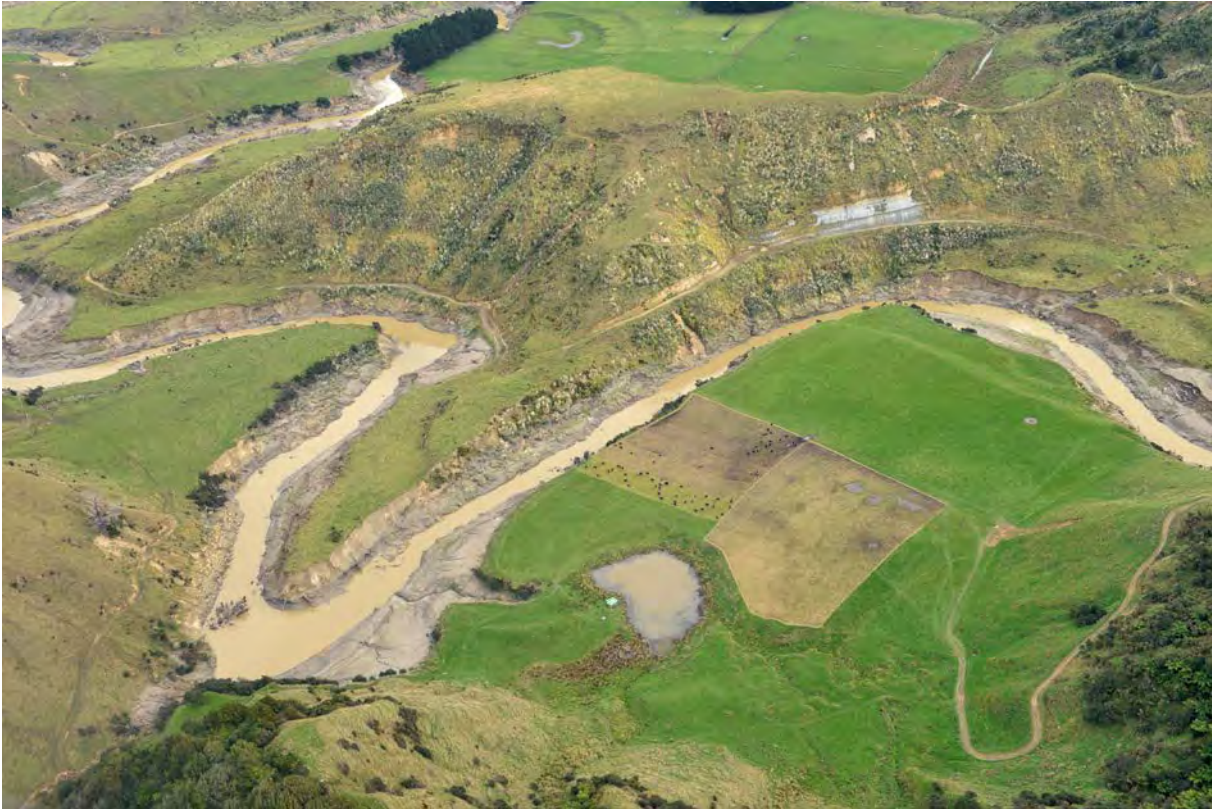
**Figure 51** Severe streambank erosion along the lower reaches Whenuakura River, near Patea. (GNS Photo: D02\_2930)

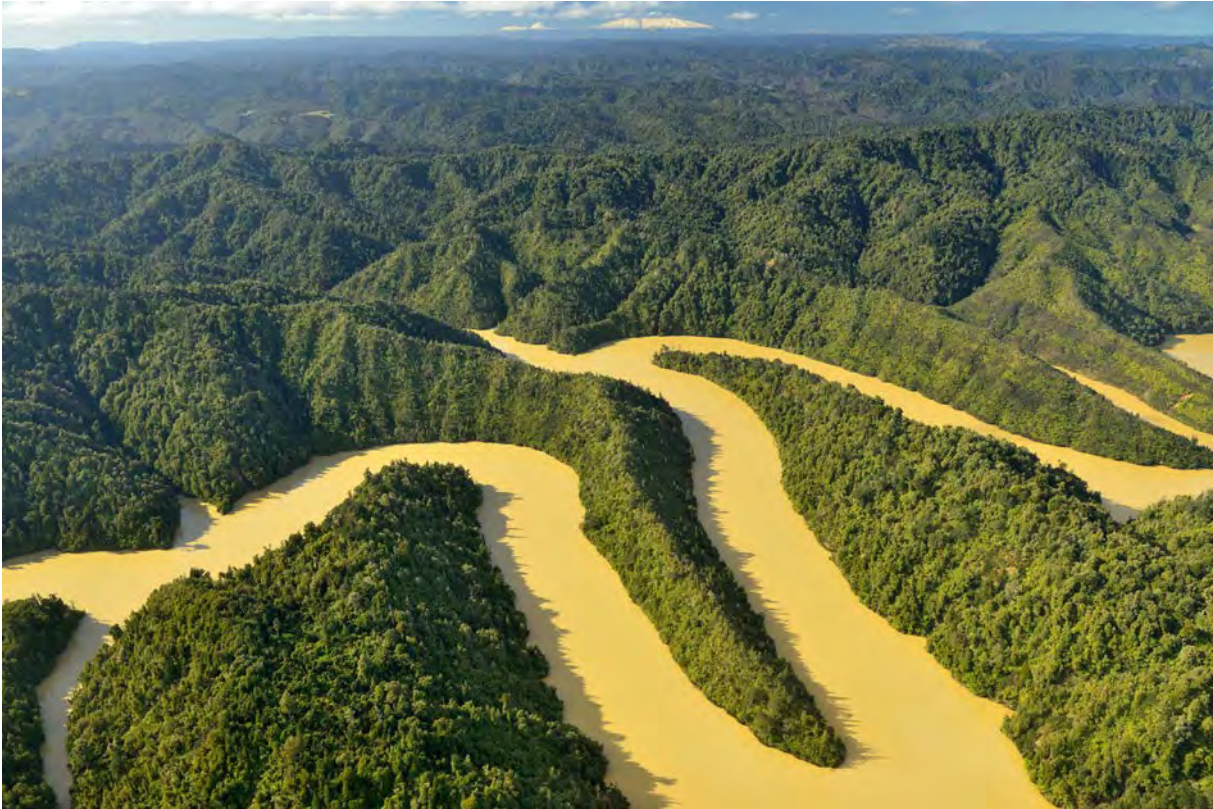
17. There was less streambank erosion along reaches of streams and rivers planted with willows.
18. Lake Rotorangi on the Patea River was highly discoloured by sediment (Figure 52). Adjacent to the Patea Dam there is an ancient deep-seated landslide, on which there are pre-existing cracks that indicate landslide movement (Figure 53). It was not possible to determine if there had been any movement caused by the June 2015 rainstorm event. TransPower has installed equipment to monitor movement of the landslide, and analysis of these data could determine whether the rainstorm has had any effect on movement of the landslide.

**Figure 52** Lake Rotorangi on the Patea River, upstream of the Patea Dam, discoloured by sediment. (GNS Photo: D02\_2845).

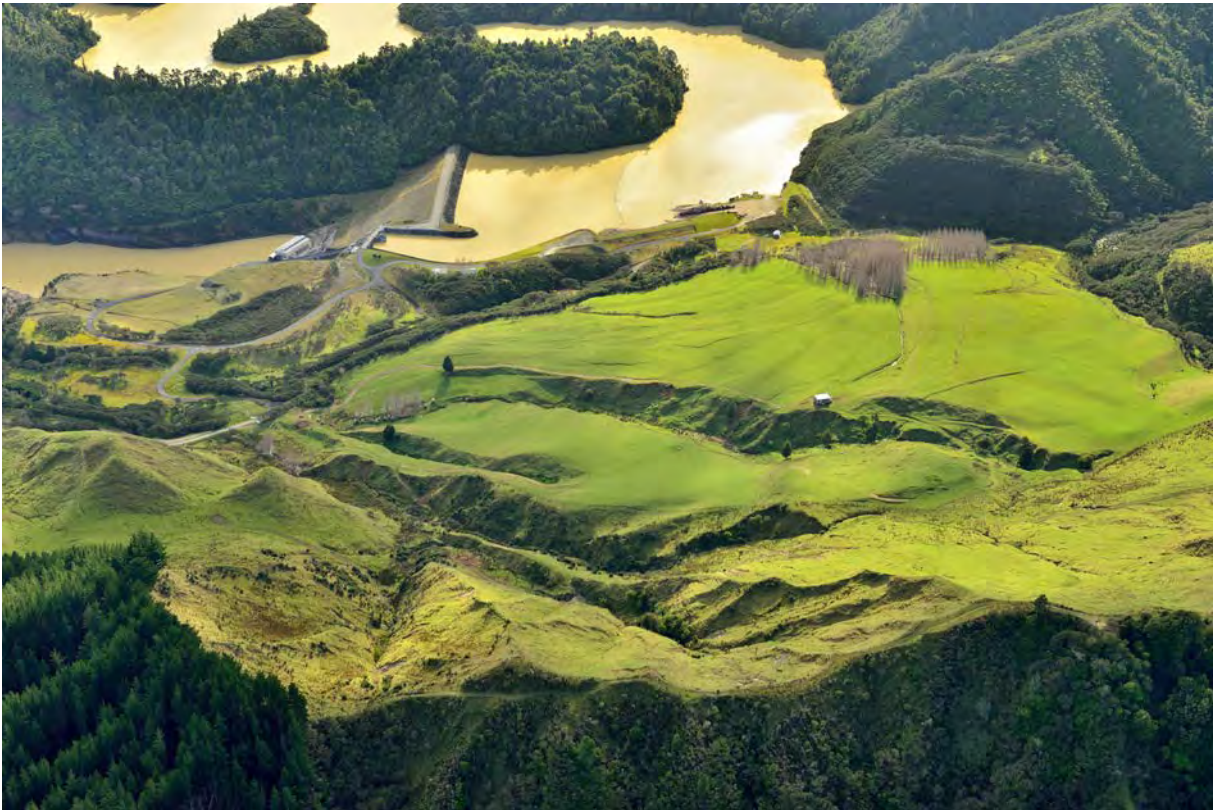
**Figure 53** The Patea Dam, and an ancient deep seated landslide to the centre right. Note pre-existing signs of movement on the landslide (cracks). However, it was not possible to determine whether the rainstorm had caused movement of the landslide. (GNS Photo: D02\_2856)

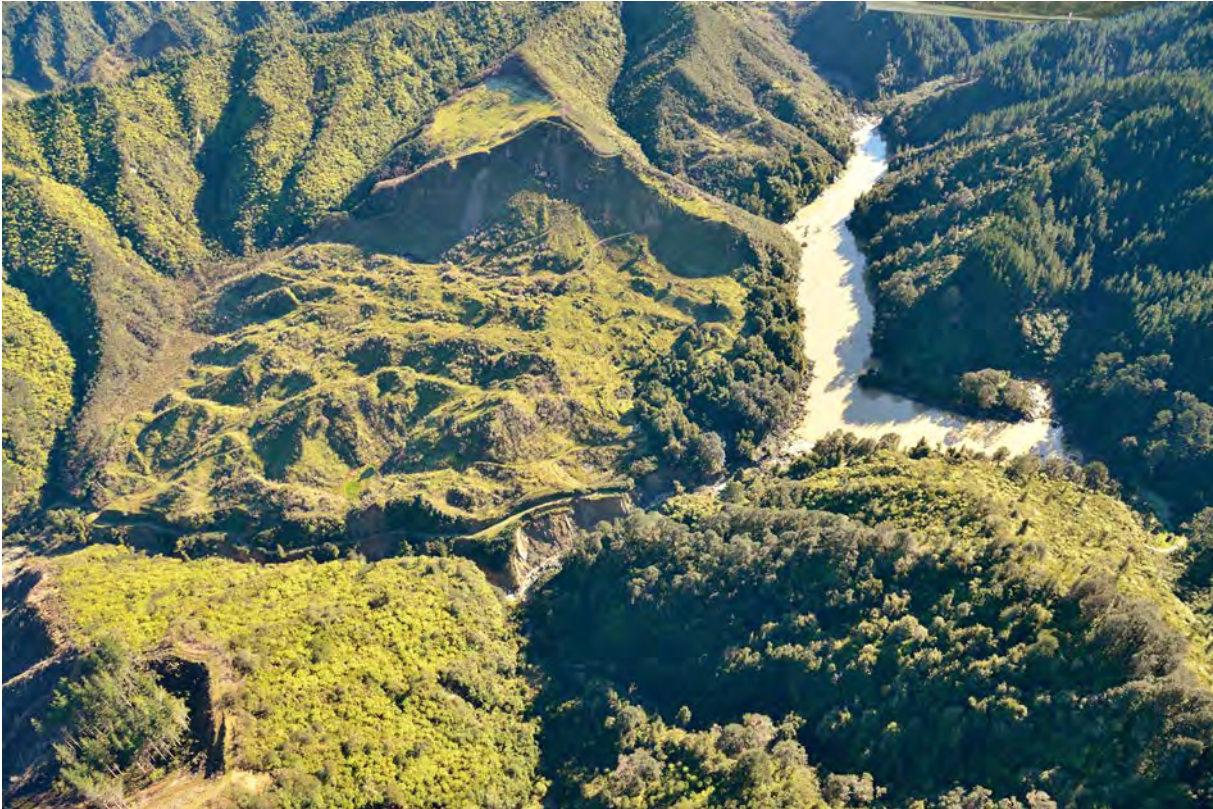
**Figure 54** Lake Mangawhio, a prehistoric landslide-dammed lake on a tributary of the Weraweraonga Stream, Waitotara catchment. Incision of the outlet channel can be seen (centre). (GNS Photo: D02\_1422)

Once access is restored to these sites, GNS Science recommends that field visits be made to investigate the circumstances leading to the drop in lake levels, the consequences of a rapid release of water on flood levels downstream, assess the future stability of the channels, and potentially collect organic material from the exposed landslide debris and lake sediments for radio-carbon dating.

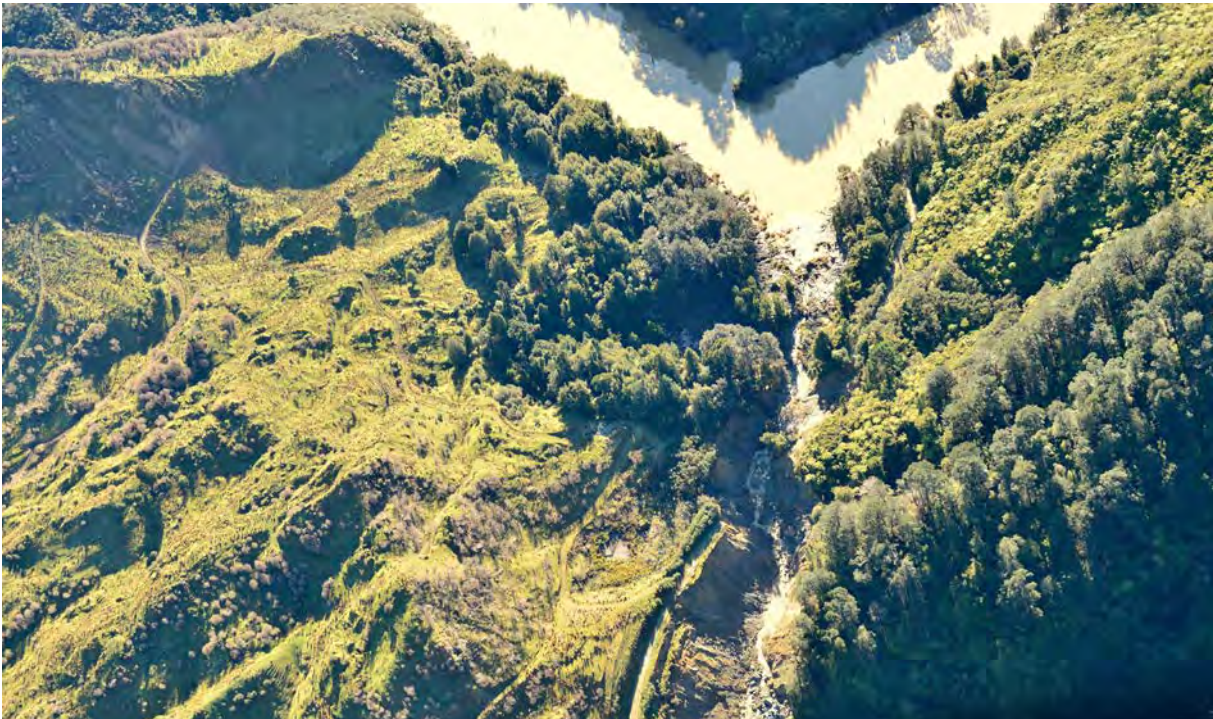
**Figure 55** Outlet channel of Lake Mangawhio showing incision that occurred during June 2015 storm. Note location of the county road, and the point where it crossed the outlet channel. (GNS Photo: D02\_1420)

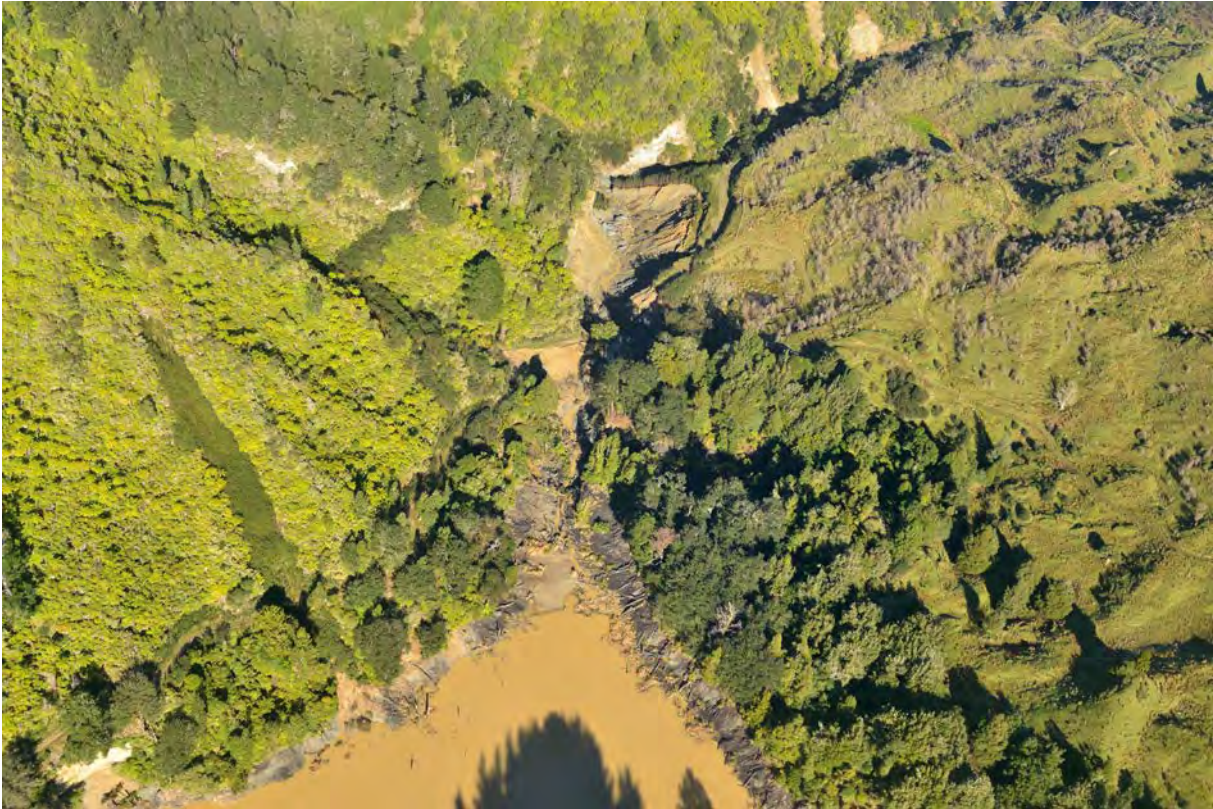
**Figure 56** Outlet of Lake Mangawhio, showing drop in lake level and exposed lake margin. (GNS Photo: D02\_1393)

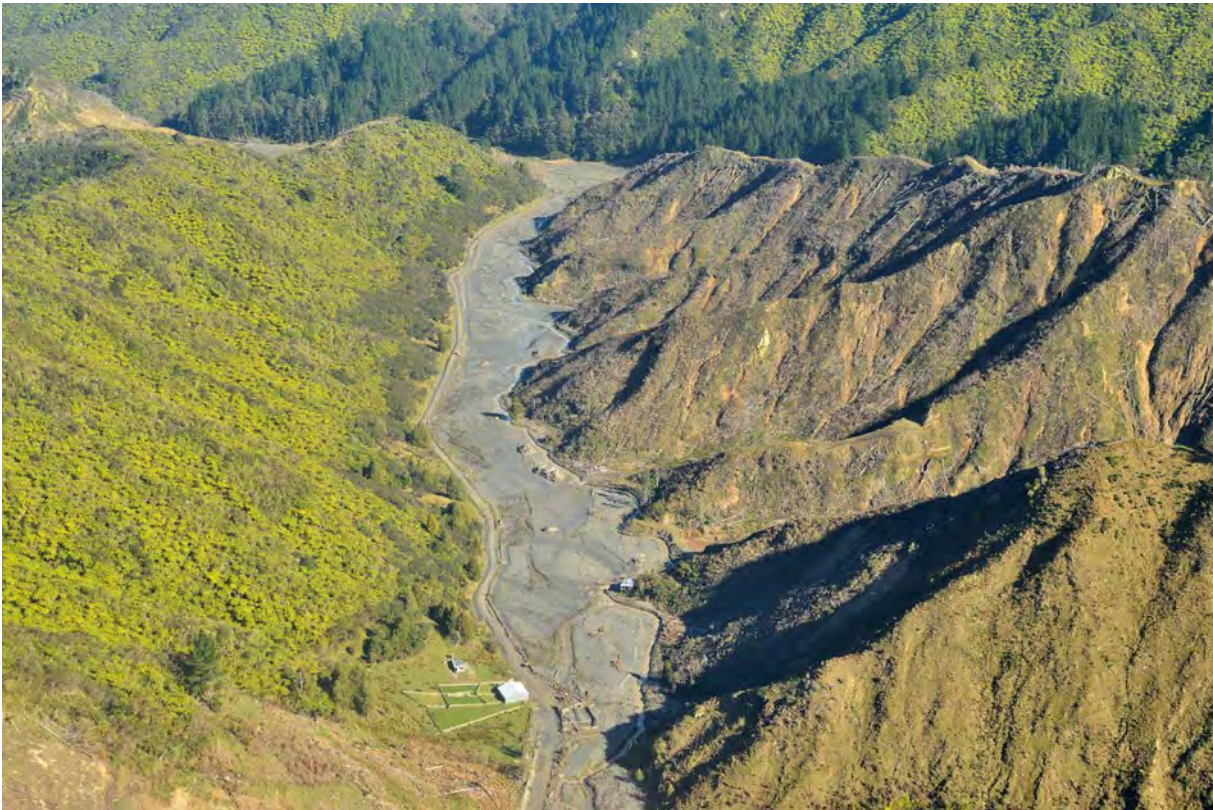
**Figure 57** Sediment covering the valley floor downstream of Lake Mangawhio. (GNS Photo: D02\_1388)

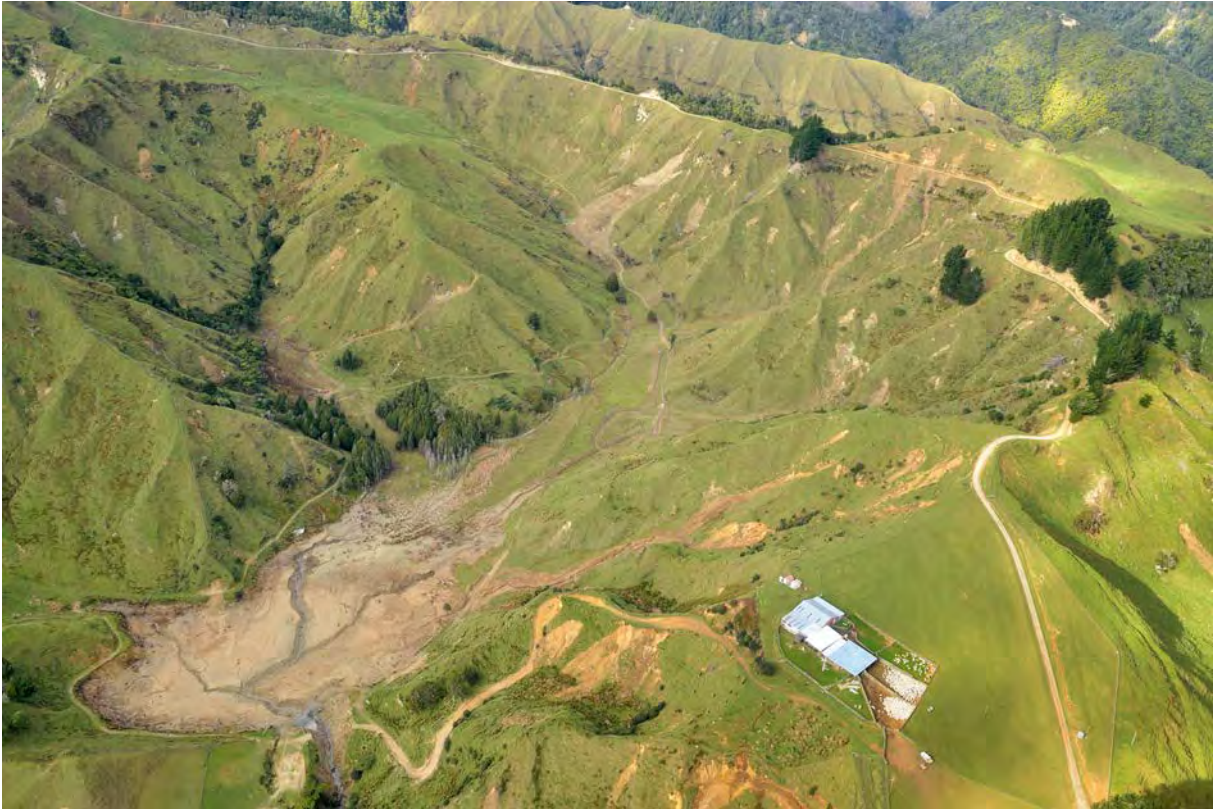
**Figure 58** Small, unnamed lake near Karahaki, Whenuakura catchment. The lake drained following incision of the outlet channel in the June 2015 storm. Note incision of outlet channel, farm track across outlet and gully within the lake-bed sediments. (GNS Photo: D02\_2946)
