Origin Energy NZ Ltd

Rimu Pipeline Leak, October 2010: Cause, Remediation and Learning Points

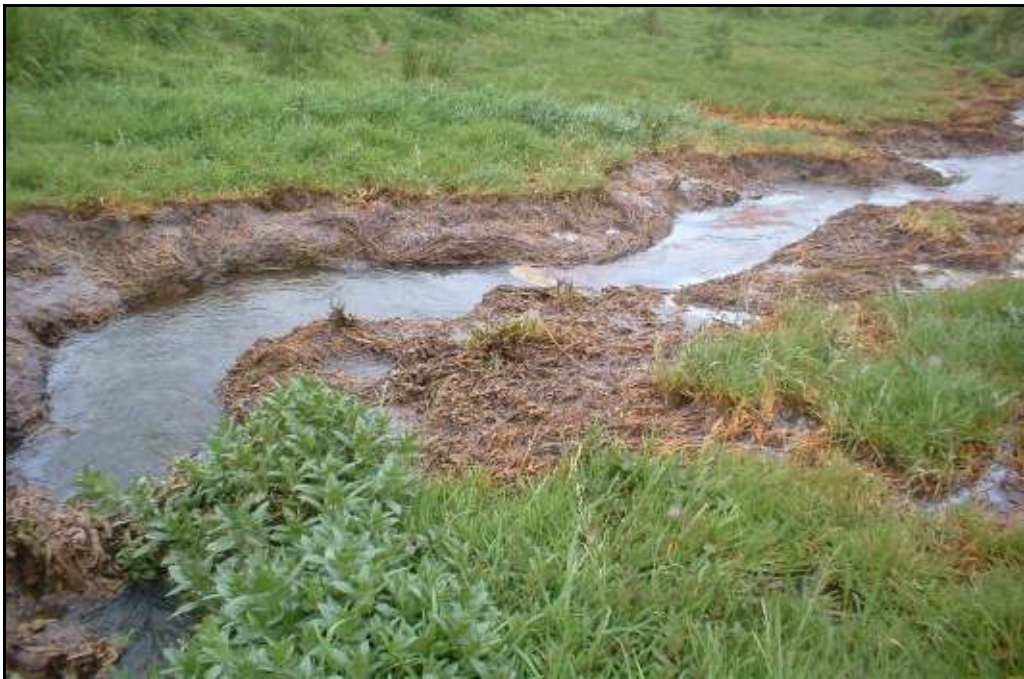
Photograph 1 – Affected area of the unnamed tributary - 8 October 2010

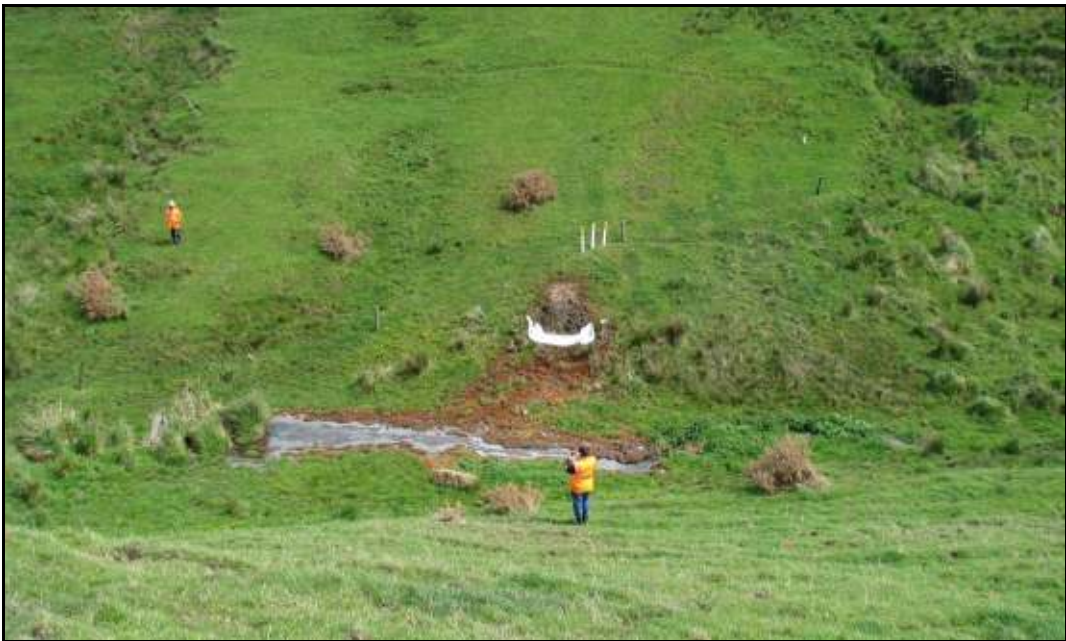
Photograph 2 – Inspecting the affected area - 8 October 2010. Pipeline leakage point upslope of white sheet

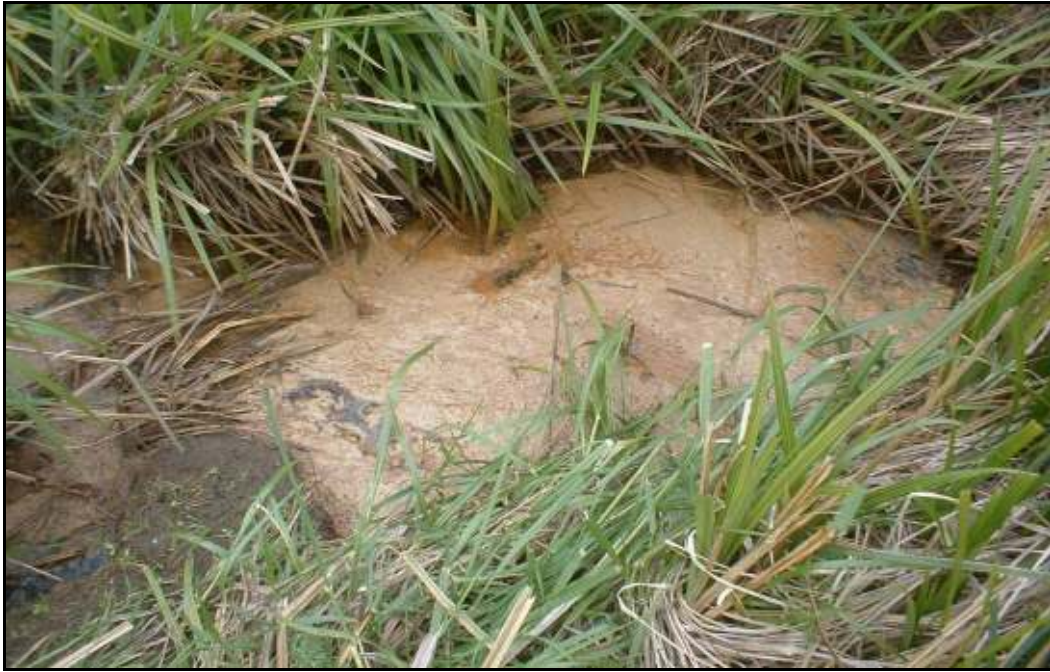
Photograph 3 – Discharge appearing in a wax like form - 8 October 2010

- 3.33 Mr Pope and Mr McLay advised that early observations had shown the discharge from the pipeline had solidified when it reached the ambient temperature in the environment. This caused it to settle on the bed of the stream, preventing the discharge from effecting more than 160m of stream down to the confluence with the Manawapou River.

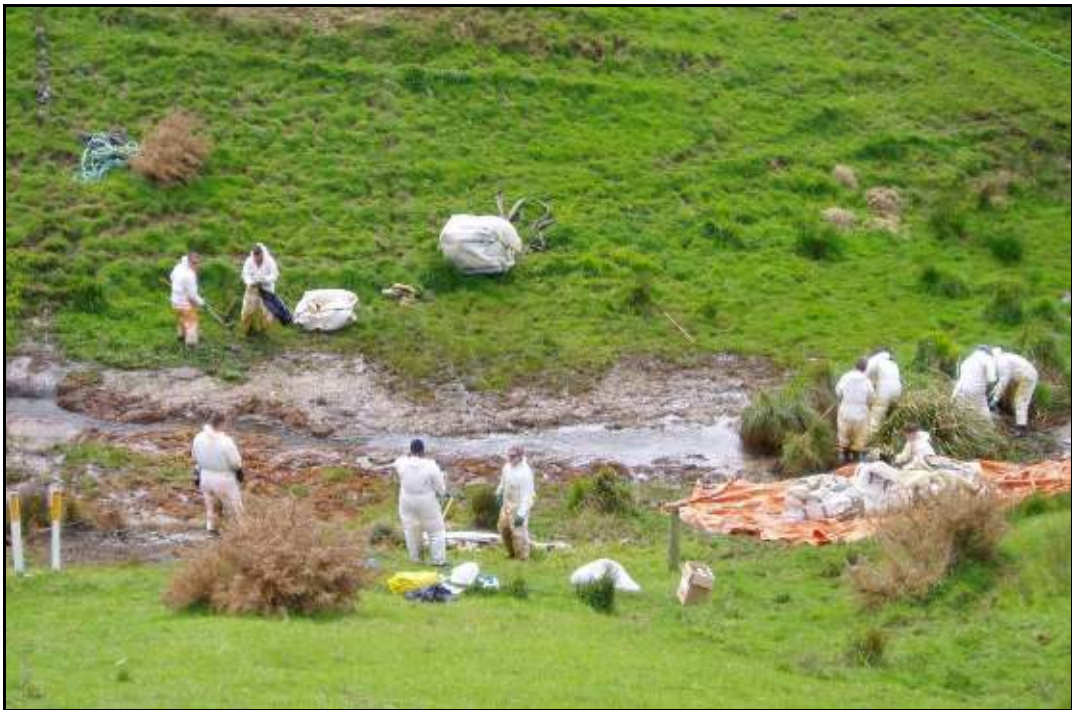
- 3.18 Mr Pope and Mr Payne observed the stream clean-up by OENZ staff shovelling crude oil into manure bags, and then inspected the lower reaches of the tributary and the Manawapou River.

Photograph 4 – Manual clean-up of oil spill - 9 October 2010

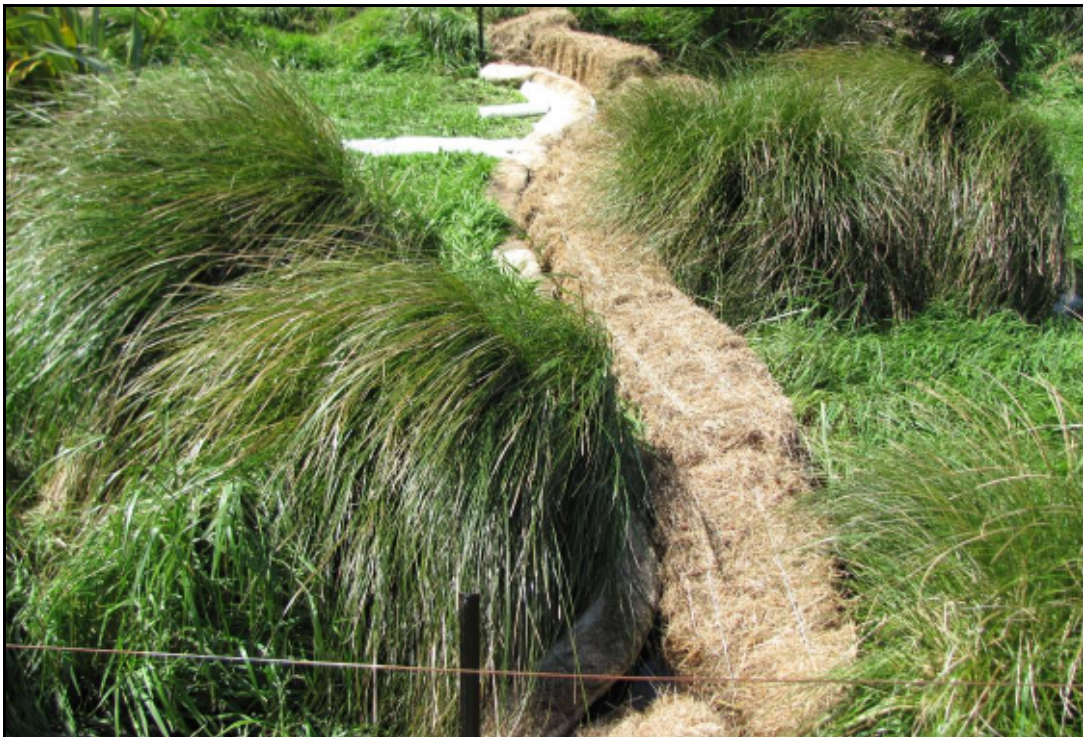
Photograph 5 – Hay bales and absorbent booms at one of the containment points (Figure 2) - 12 October 2010

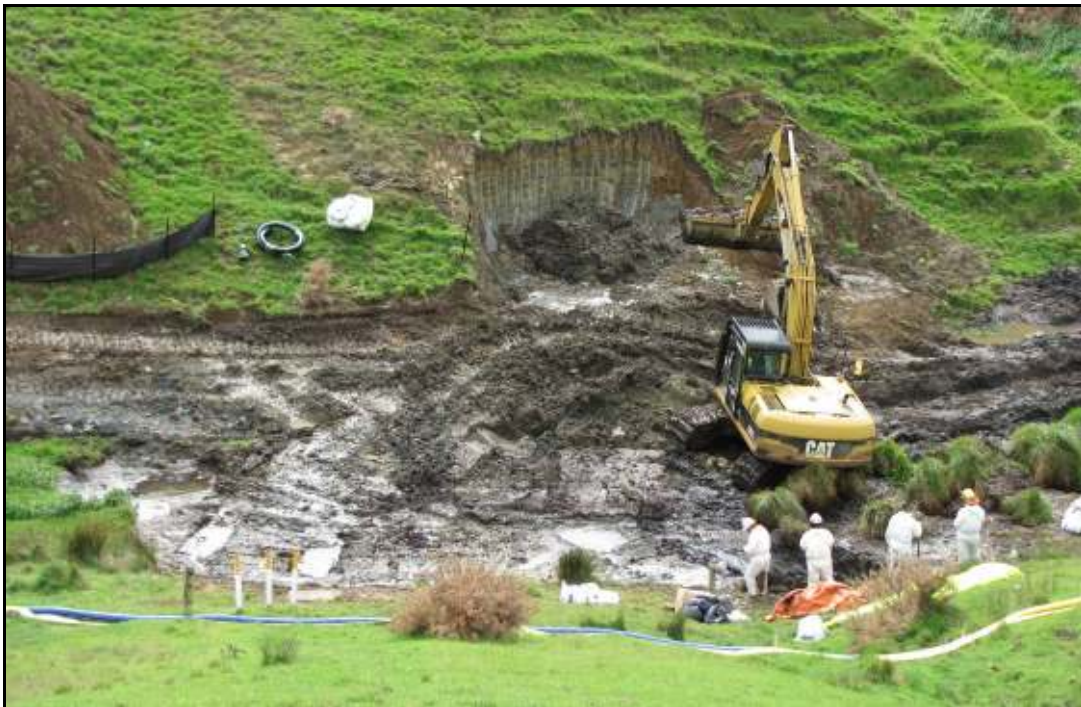
Photograph 6 – Removing the contaminated soil from the pipeline route– 18 October 2010

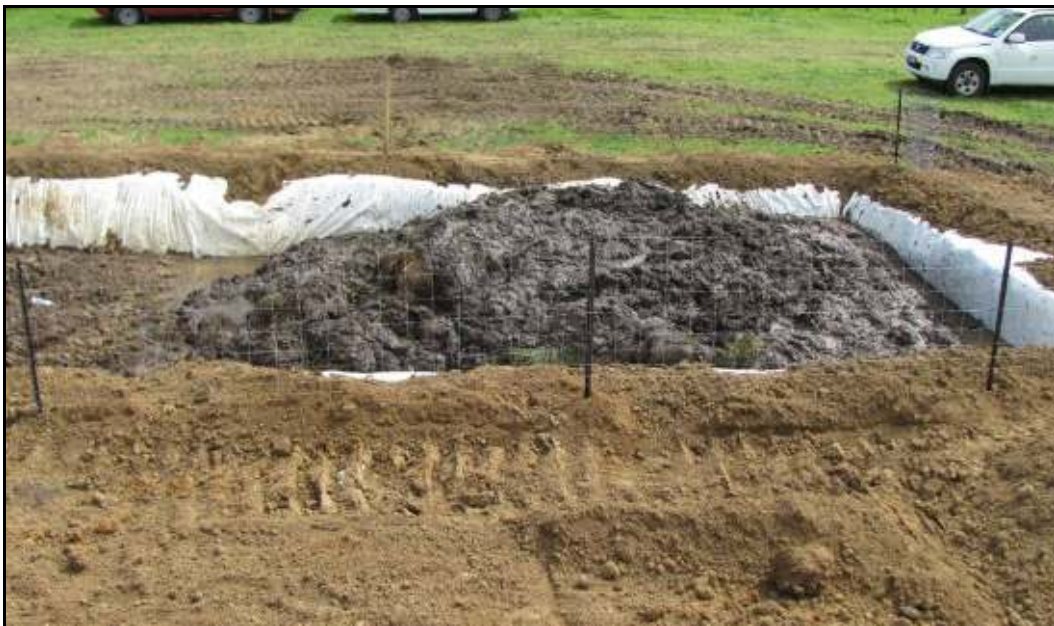
- 3.91 Mr Caskey inspected the contaminated soil pits and they were nearly full. OENZ staff had taken samples from the pits. OENZ staff said the pits were going to be emptied prior to the opening up of the site over the suspected pipeline fracture area.

Photograph 7 – Contaminated soil storage pit – 19 October 2010

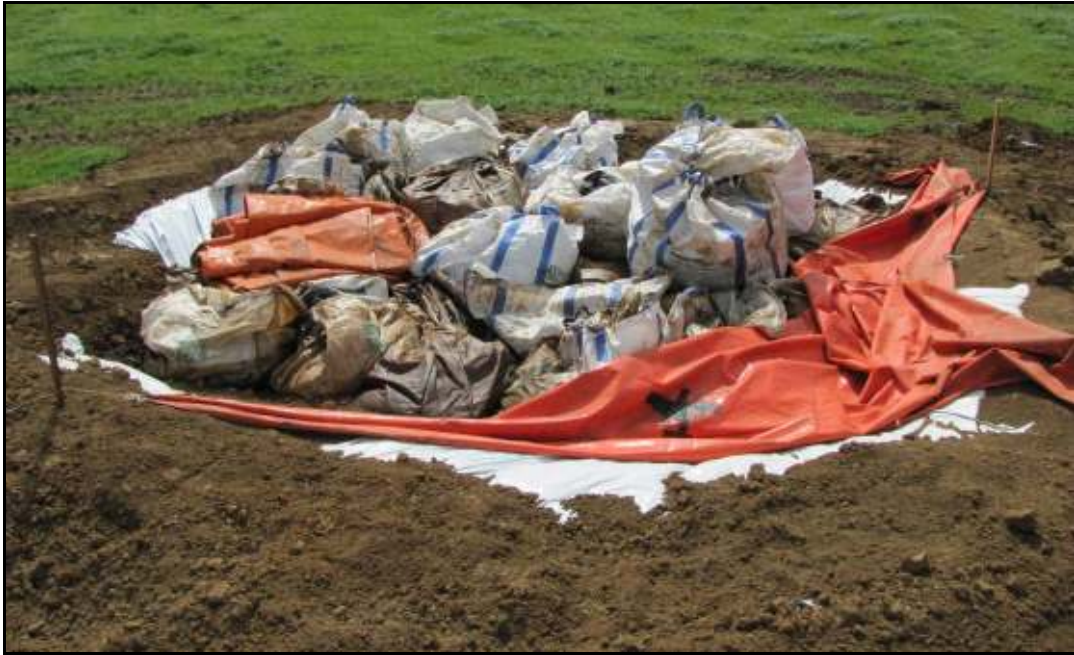
Photograph 8 – waste bags full of contaminated soil – 18 October 2010

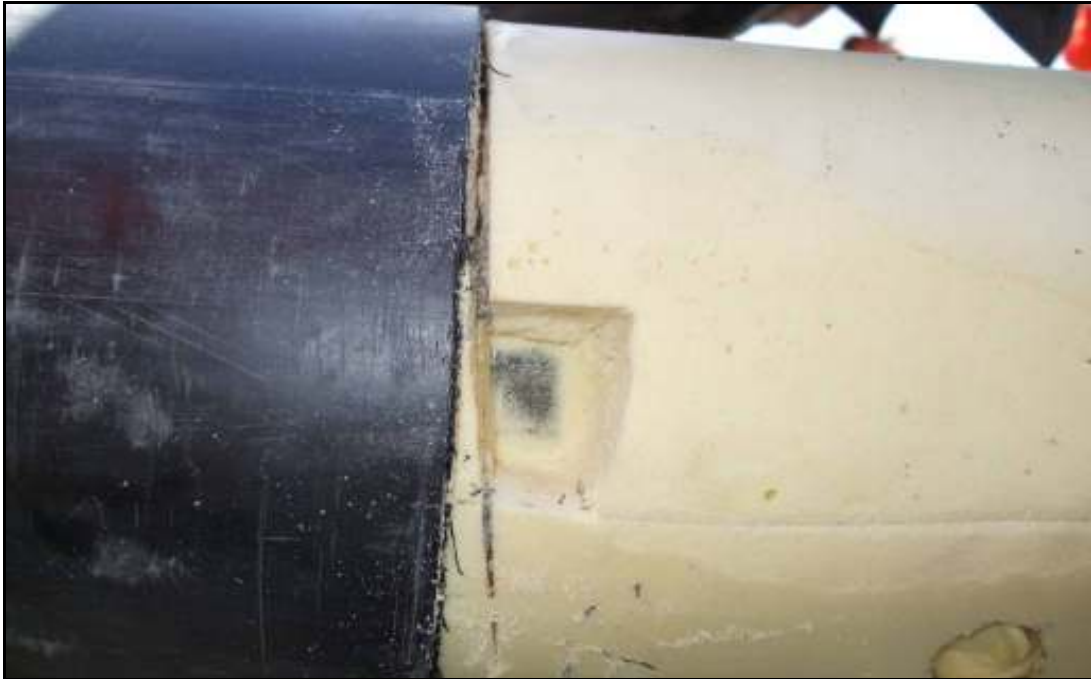
3.100 Manual clean-up in the stream continued and dirty tarpaulins were removed from the site for cleaning. Excavation continued from the downhill side of trench with the 4" pipe exposed and section of insulation removed. No indication of oil or water was present so the leak was not coming from up slope. The section was

rewrapped with industrial cling wrap to prevent any water entry into the Insapipe foam.

Photograph 9 – Exposed section of pipeline insulation – 22 October 2010

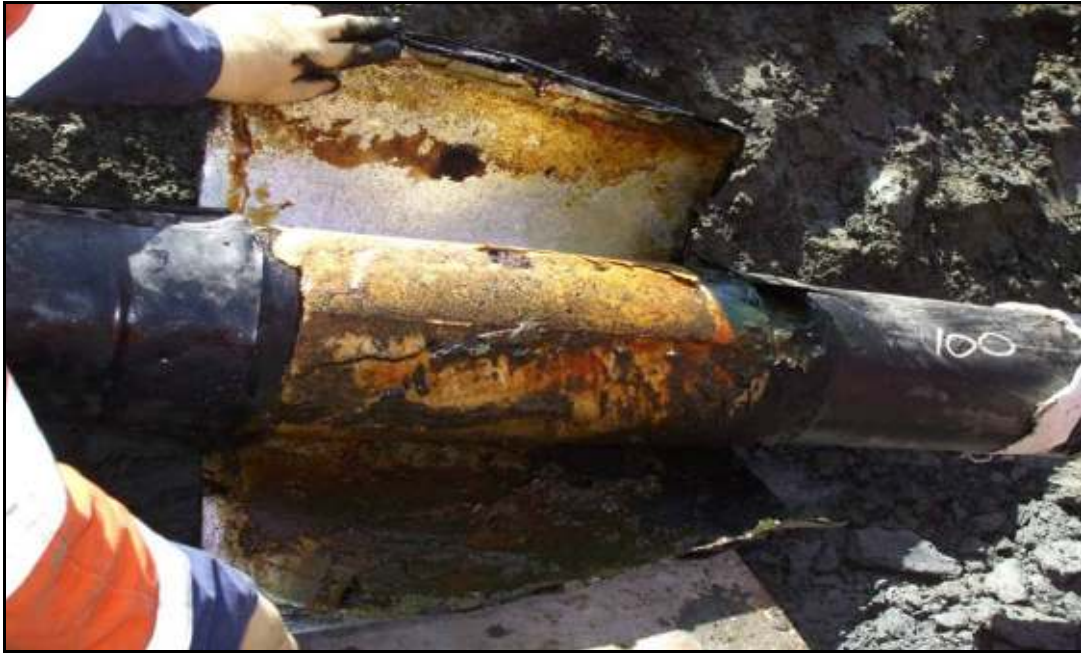
3.106. Insulation from the area of pipeline where the leak was presumed to be was removed to inspect for oil or water presence. An abundance of oil and water was found but there was no obvious evidence of the leak point in the pipeline.

Photograph 10 – Exposed insulation section after wrap removal – 26 October 2010

- 3.107. The weld and external wall of the pipeline showed no obvious sign of defects, but the heat tracing equipment channel was full of contamination indicating that the leak point was possibly elsewhere on the line but only exited from this location. The exposed section was rewrapped with industrial cling wrap.
- 3.108. Staff had not found the leak.

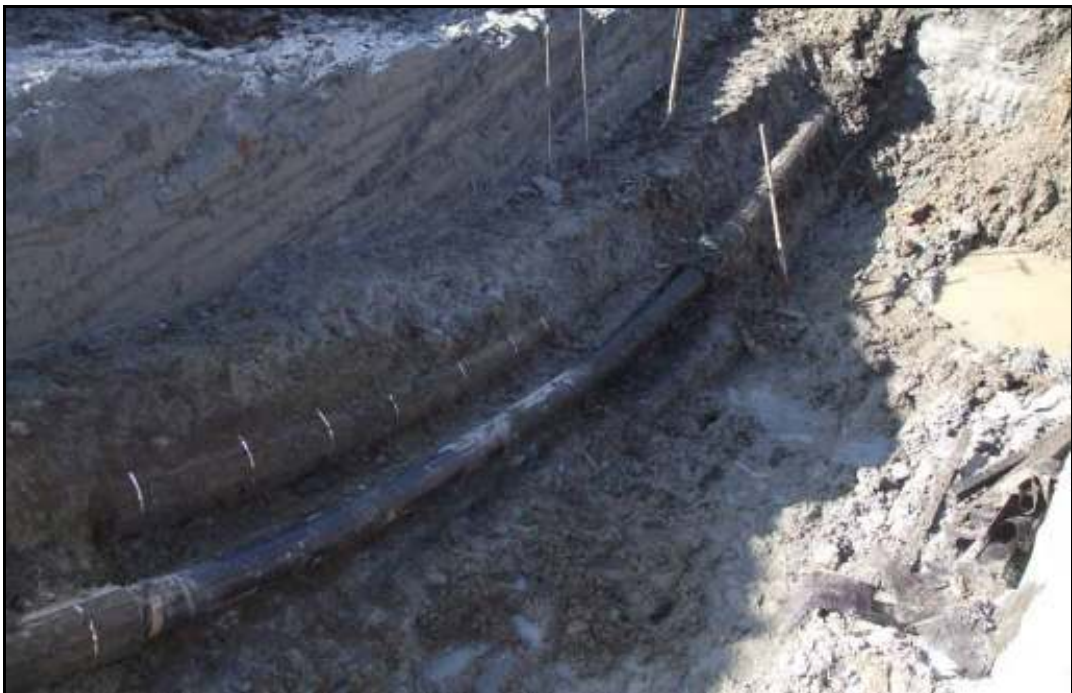
Photograph 11 – Excavation of the pipeline – 27 October 2010

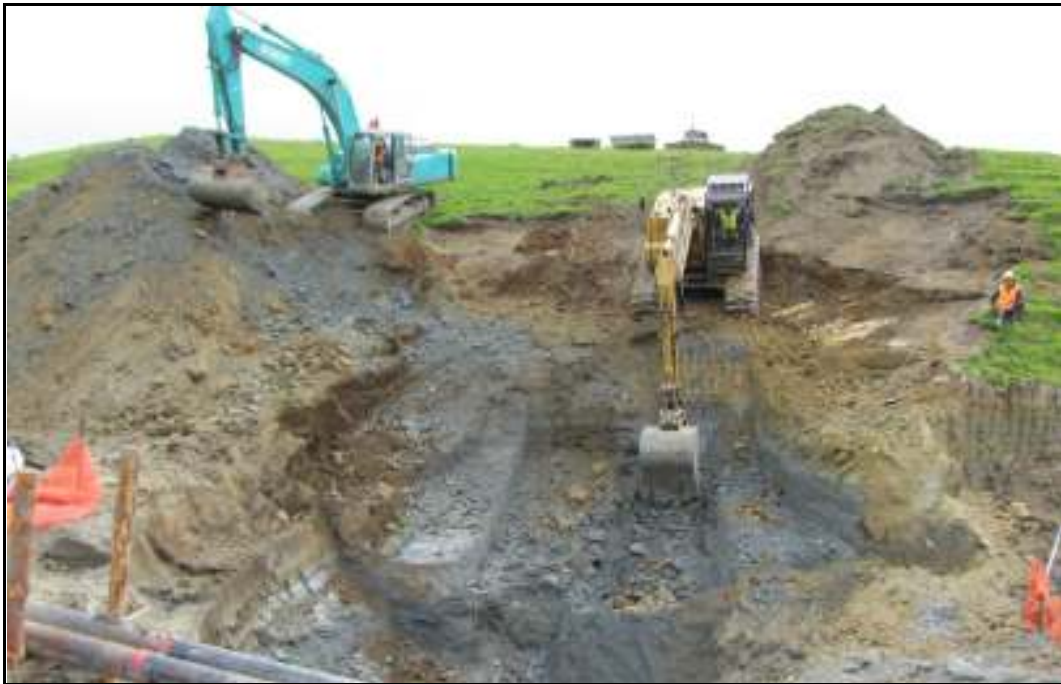
Photograph 12 – Diggers removing the soil – 2 November 2010

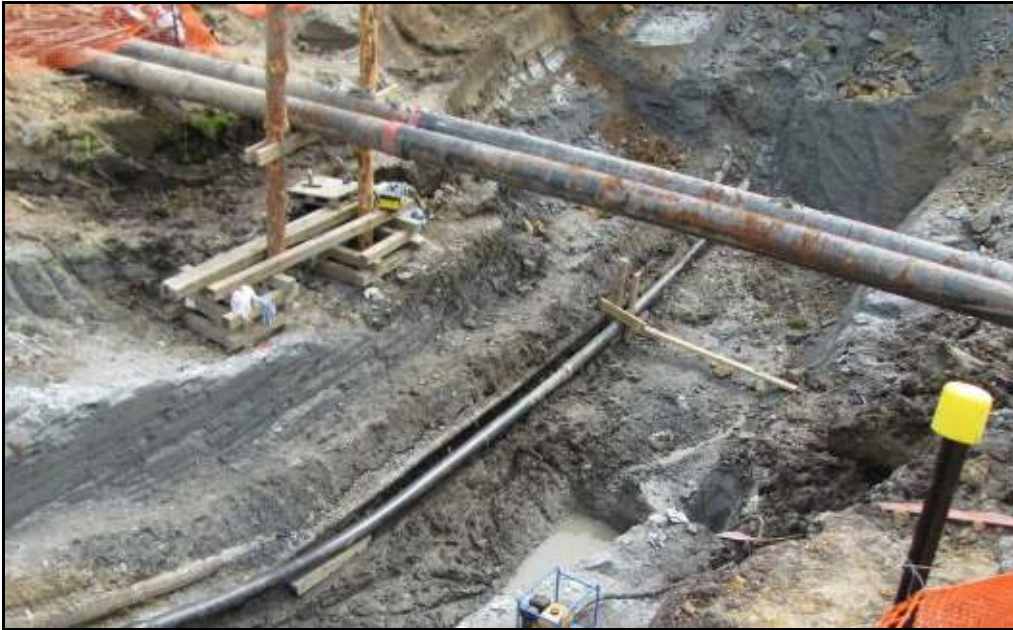
Photograph 13 – Tributary diversion above the oil pipe – 4 November 2010

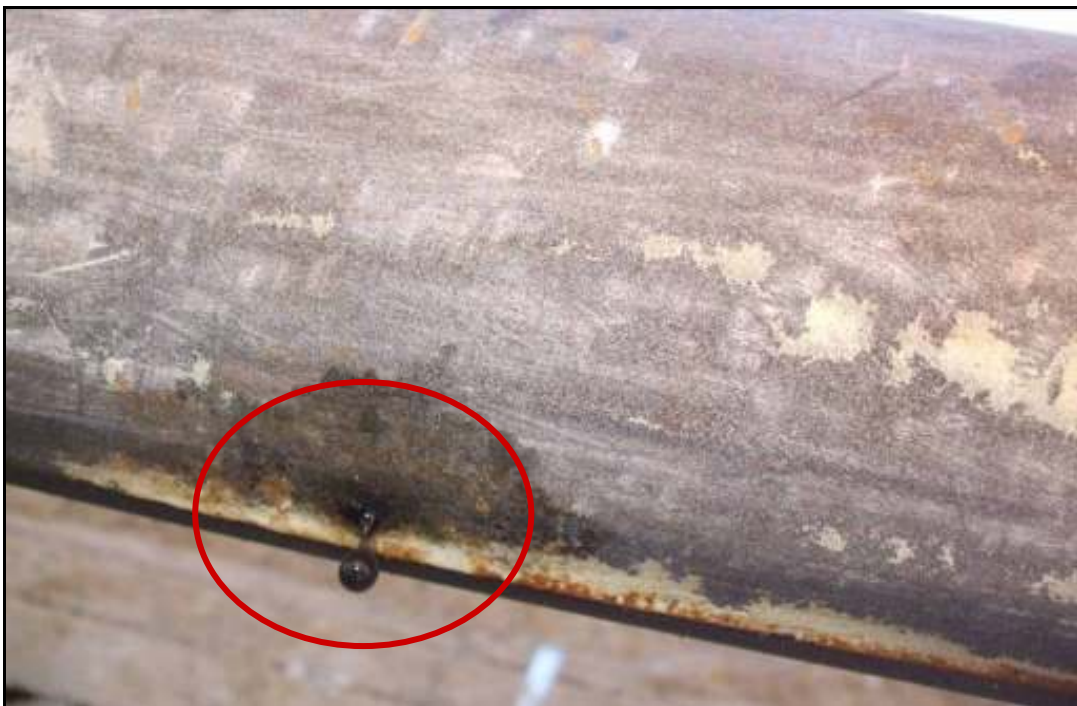
- 6.4. Wall thickness checks were conducted on site around the welds and at various points along the pipeline to test for internal corrosion. The first sign of wall loss was indicated on length 100 of the pipeline at the 6 o'clock position, being approximately 4.3 mm – 5.7 mm. Lengths 99, 101 and 102 were also discovered to have extensive internal wall loss spanning from the 4 – 8 o'clock position in the pipeline.

Photograph 14 - Location of the pipeline leak point - 8 November 2010

- 6.5. The leak point was discovered on Monday 8 November where a 4 mm x 1 mm slit was discovered at the 6 o'clock position in the pipeline (photographs 14 and 15). The section was cut from the pipeline and sent away for independent specialist

metallurgy testing on Thursday 11 November to assist in investigating the pipeline failure.

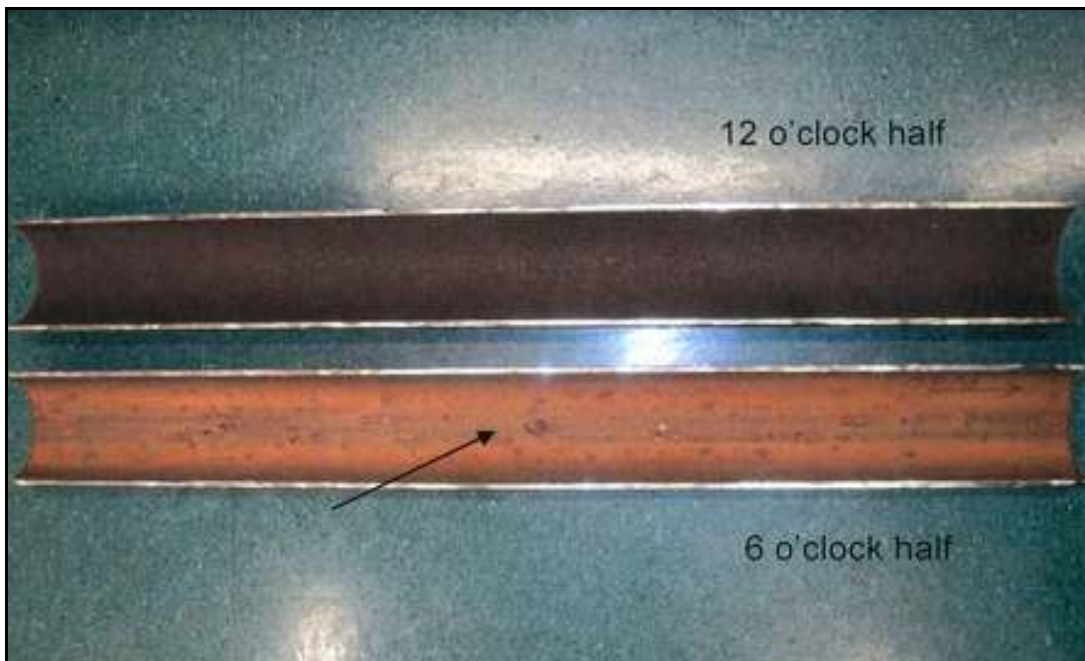
- 6.8. With the horizontal outline of the pipeline documented, final analysis of the pipe section indicated that the failure was located within the part of the pipe-work with lowest vertical position. At this specific location the pooling of well stream fluids would have occurred due to the irregular use of the pipe.

Photograph 15 – Location of pipeline failure located by arrow

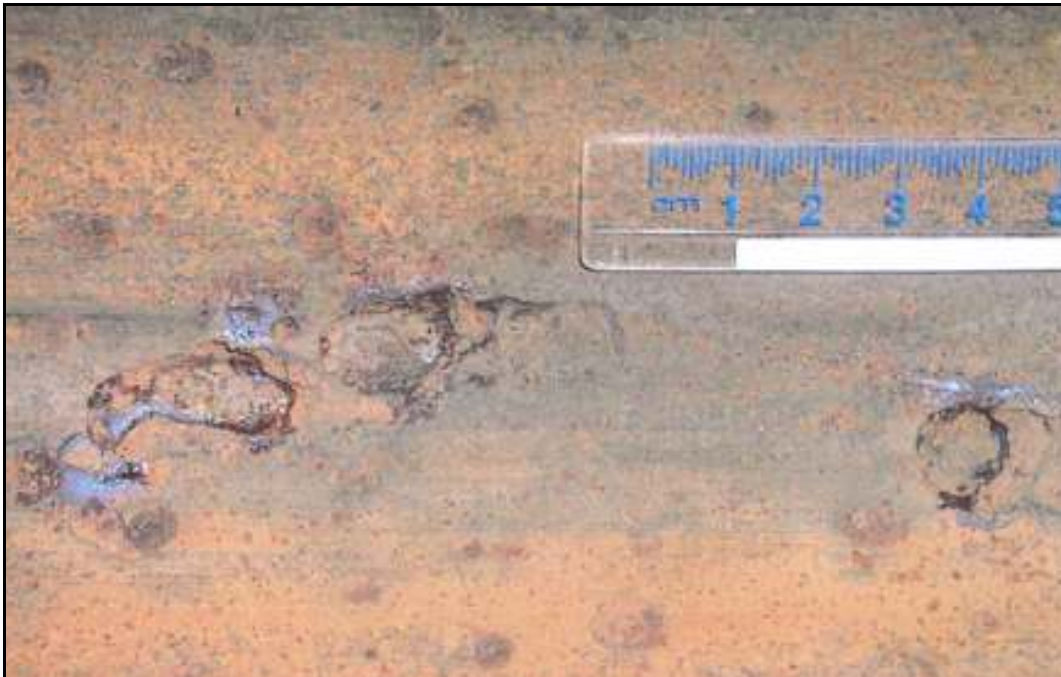
- 6.9. The pipeline fluid was found to be corrosive and contained solids as well as chloride ions. There is a high possibility that the pipeline bottom would have accumulated sediment which in turn eliminates the effect of the corrosion inhibitor programme.
- 6.10. Larger pits were found to have an oval shape with some displaying a comet like appearance which is often associated with flow assisted pipeline erosion/corrosion (Photograph 16).
- 6.11. Two sections of the 200 NB gas line, which is adjacent to the 100 NB line, were also inspected, one opposite to the leak point and the other at the low point of the pipeline. Non destructive testing indicated random pitting at a maximum of 1.8

mm on a nominal wall thickness of 8.2 – 8.4 mm. However, when the pipe section was removed for inspection minimal wall loss was evident.

Photograph 16 – Appearance of pipeline pits in the 6 o'clock position

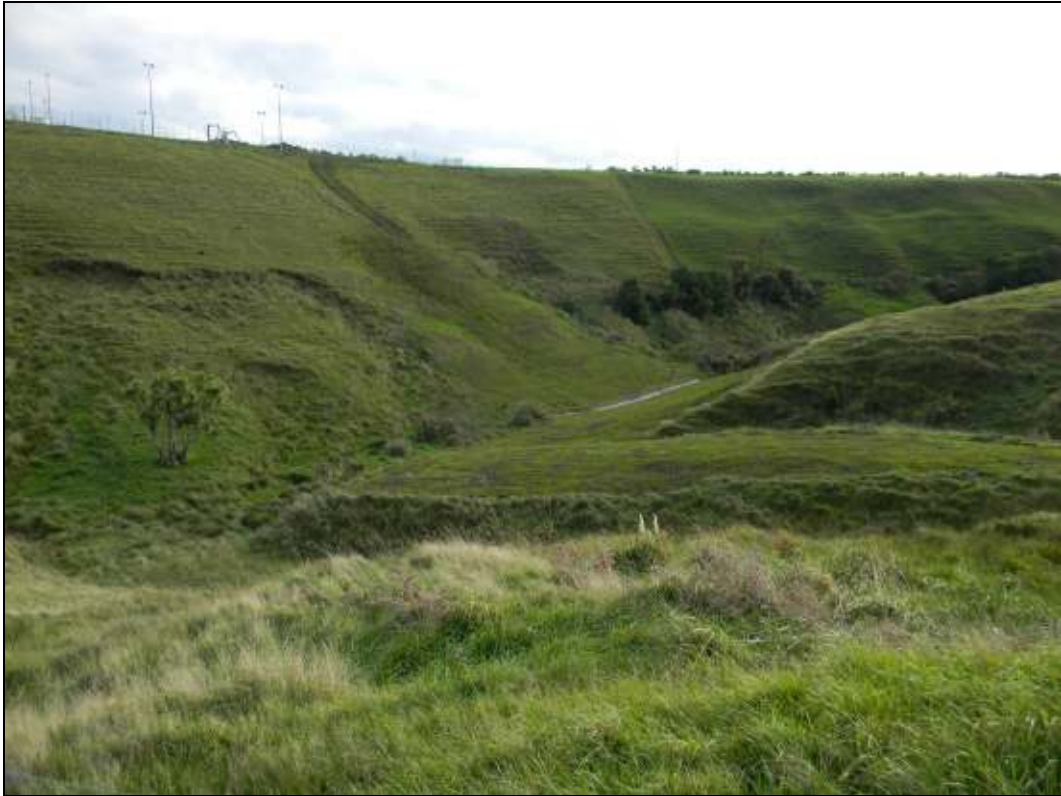
- 8.16. Photograph 17, taken seven months after the oil spill shows the pipeline excavation and stream area. The area has been recently re-grassed and the streambed area has had small cobbles added. A slight hydrocarbon odour was noticeable in the stream substrate at the site due to residual hydrocarbons and this is expected to shortly dissipate.

Photograph 17 - Reinstated pipeline excavation area and affected streambed (centre of photograph) on 24 May 2011. RPS perimeter fence on upper left side of the photograph.

- 4.4. The leaking pipe was repaired by Energyworks Ltd and completed by 15 April 2010. It was then inspected by M & I SGS for certification before use. The work area was reinstated shortly thereafter and the extent of re-grassing in May 2010 is shown in Photograph 17.
