STDC Coastal Structures

Monitoring Programme

Biennial Report

Technical Report 2023-37

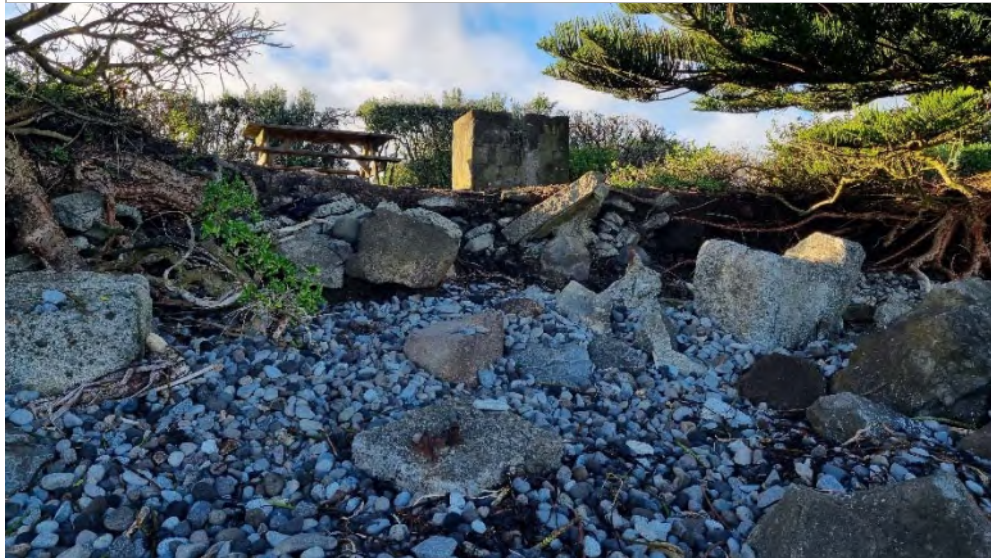
| 5512-2: Bayly Road seawall | | | |
|---|---|---|---|
| Inspection summary: This structure was inspected twice by Council in the 2021-2023 period. During the latest inspection, erosion was observed by the picnic table (Photo 7), extending to below the pine trees adjacent to the rip-rap. This section in its current state was assessed as being steep and hazardous, and needing to be repaired. Moreover, evidence was observed of unauthorized maintenance works likely carried out by members of the public in an attempt to fill the scouring sections with alternative materials (i.e., broken concrete, Photo 8). In multiple sections of the seawall, boulders appeared partially perched and in need of maintenance to reduce the risk of them falling. STDC also carried out an inspection of this structure during the year under review and identified the same issues. Their report was provided to Council on 30 June 2023. Following the discovery of the issues, STDC have installed fencing and warning signage near the picnic table while further remedial works are planned. | | | |

Photo 7 Section of Bayly Road seawall below picnic table and pine trees (13 June 2023)

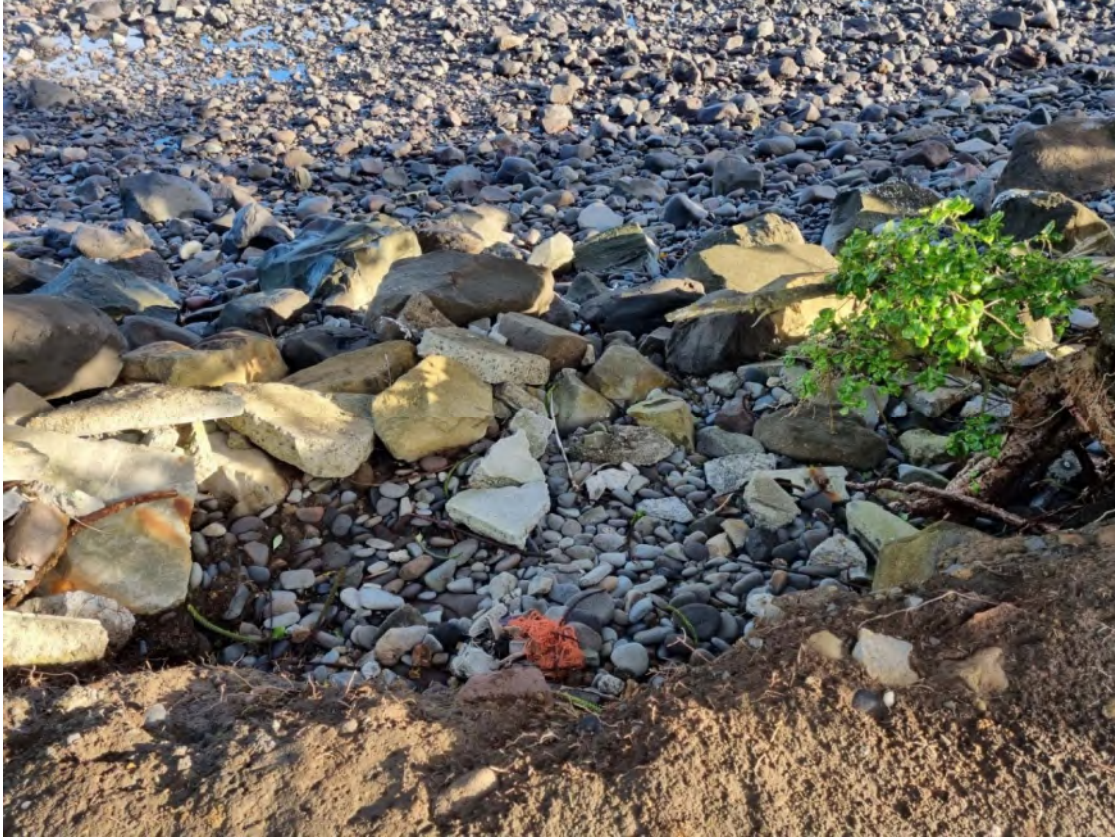
Photo 8 Unsuitable fill materials below picnic table and pine trees (13 June 2023)

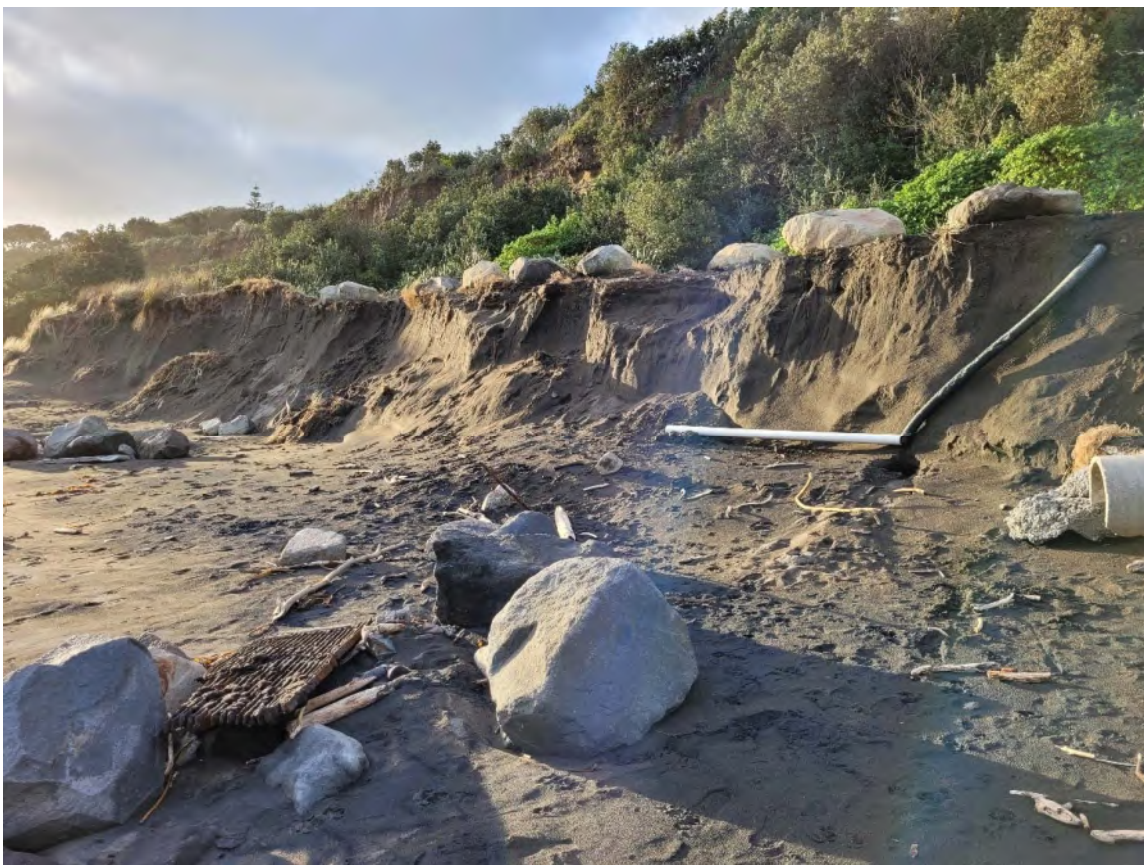
following the increased erosion. Warning signs were also installed advising the public to avoid the eroding sand dunes. Design work is also underway to repair some degraded sections of the seawall.

Photo 9 Increased erosion adjacent to Middleton Bay seawall showing hazardous boulders on the scarp (29 June 2021)

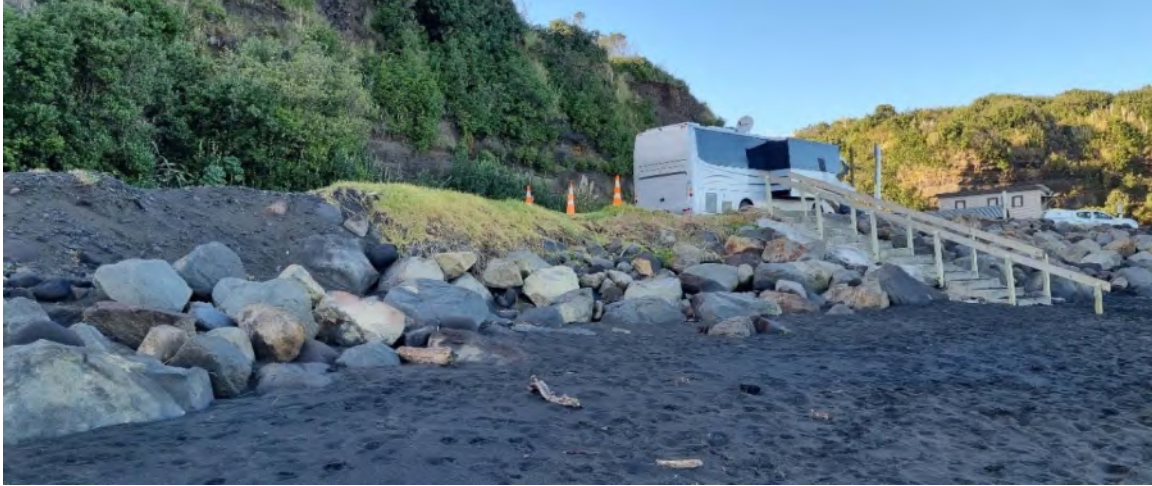
Photo 10 Northern end of Middleton Bay seawall (13 June 2023)

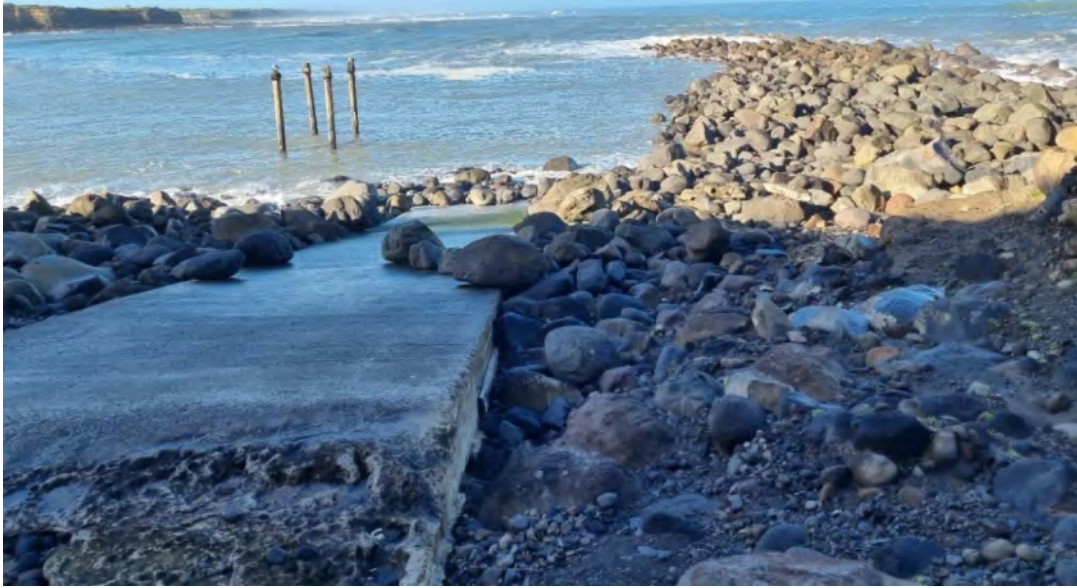
Photo 11 Ōpunake Bay boat ramp and rock groyne (13 June 2023).

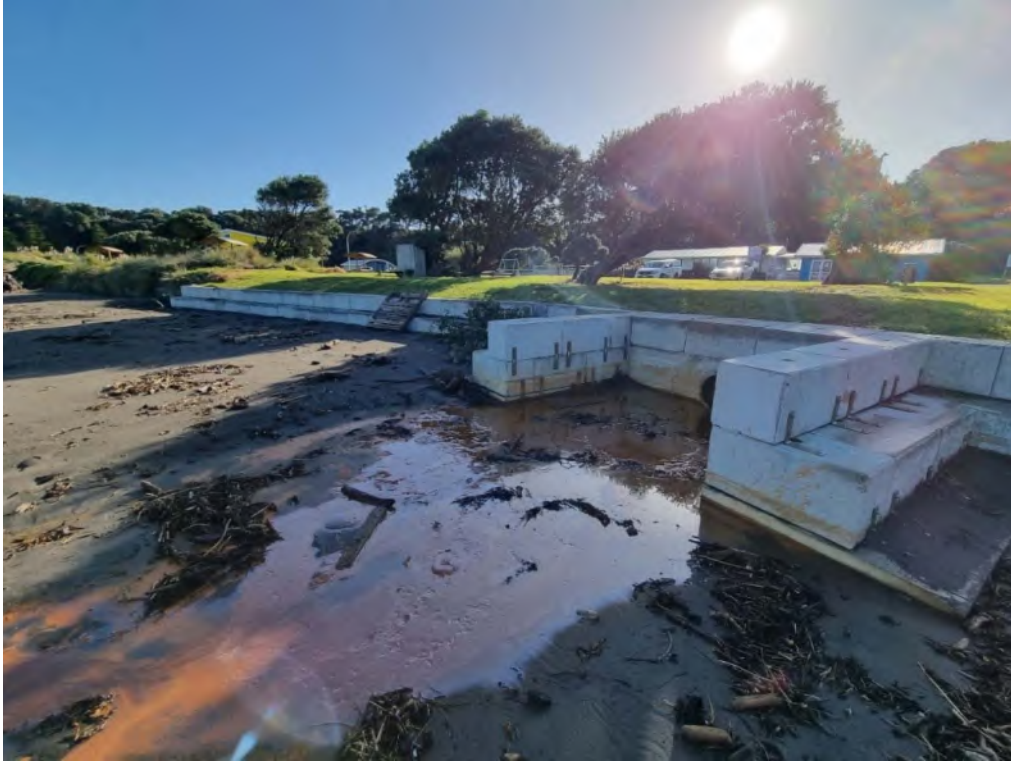
Photo 12 Opunake Beach replacement structure (13 June 2023)

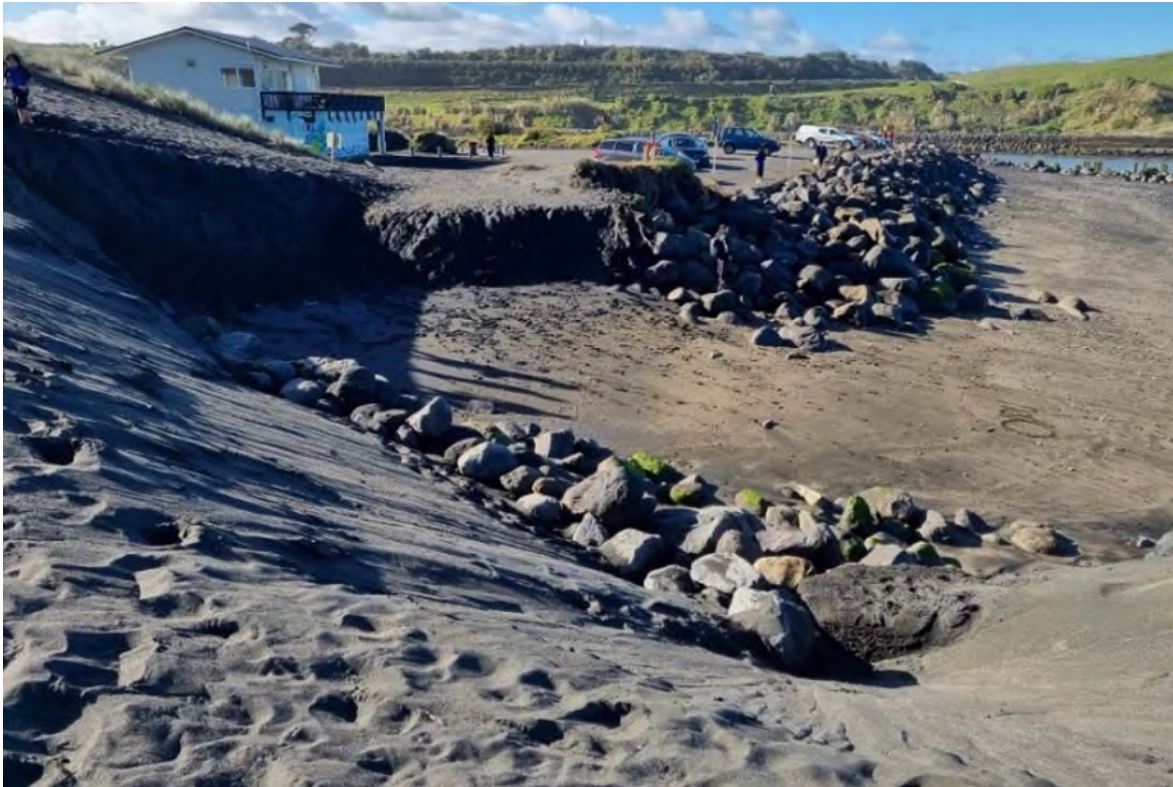
Photo 14 Eroded access from carpark to Pātea beach (13 June 2023)

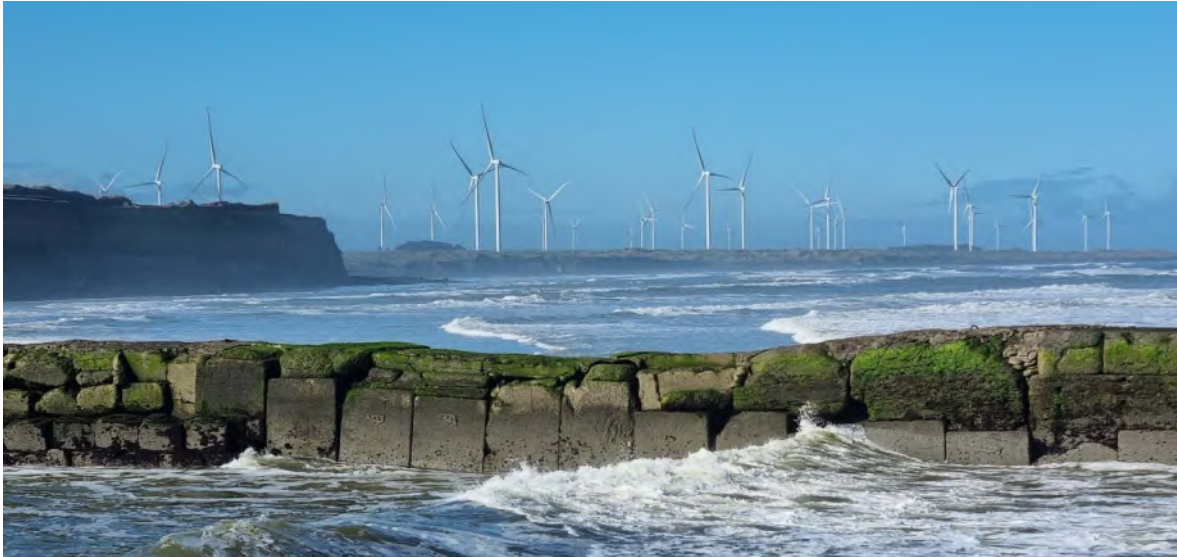
Photo 15 Southern mole slumping (13 June 2023)

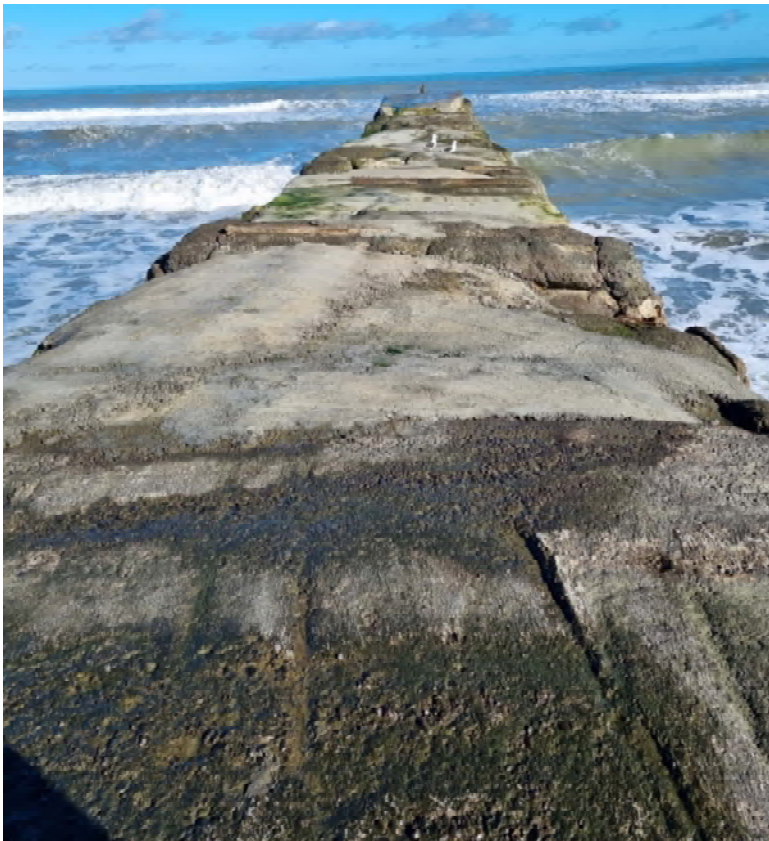
Photo 16 Recent concrete repair works on the northern mole (13 June 2023)

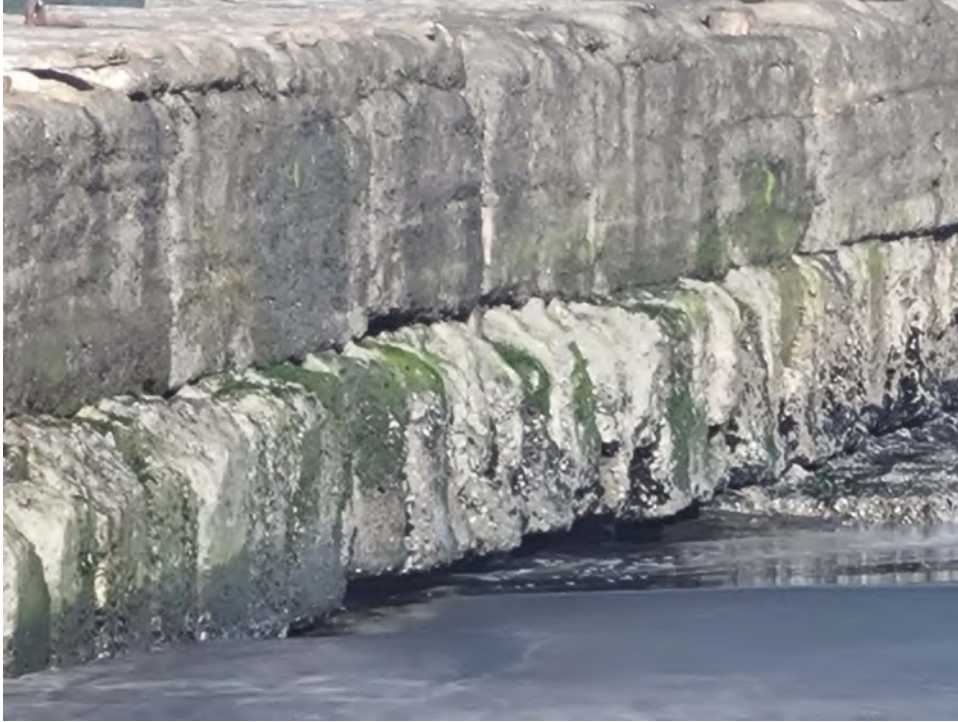
| 4573-2: Pātea River mouth structures | | | |
|---|---|---|---|
| <p>The structures were inspected by Council twice in the 2021–2023 period. During the 2022 inspection, the structures appeared to be in a degraded, but satisfactory condition. A few slumping sections were observed on the northern mole and towards the end of the southern mole (Photo 15), however the structures still appeared to be functioning as designed. There was a reduction in the beach volume, as was apparent due to the exposed shipwreck on the northern side of the river mouth. No eroding, hazardous or perched sections were observed at the Mana Bay rock wall, half-tide wall or wave guide wall. The latter was more exposed due to the reduction of sand.</p> <p>At the time of the most recent inspection (13 June 2023), accessibility from the carpark to the beach had reduced due to erosion of the dune (Photo 14). This was raised with STDC and they are now looking into causes and options to restore access. No major issues were identified with the Mana Bay seawall, half tide wall or the wave guide wall. However, some of the rockwork had shifted out of place and needed repositioning. The maintenance works carried out on the northern mole during April 2023 was observed and appeared to be in good condition (Photo 16). Scouring underneath the northern mole was also observed, which requires ongoing monitoring (Photo 17). STDC have advised Council that further</p> | | | |

Photo 17 Northern mole showing scouring underneath (13 June 2023)

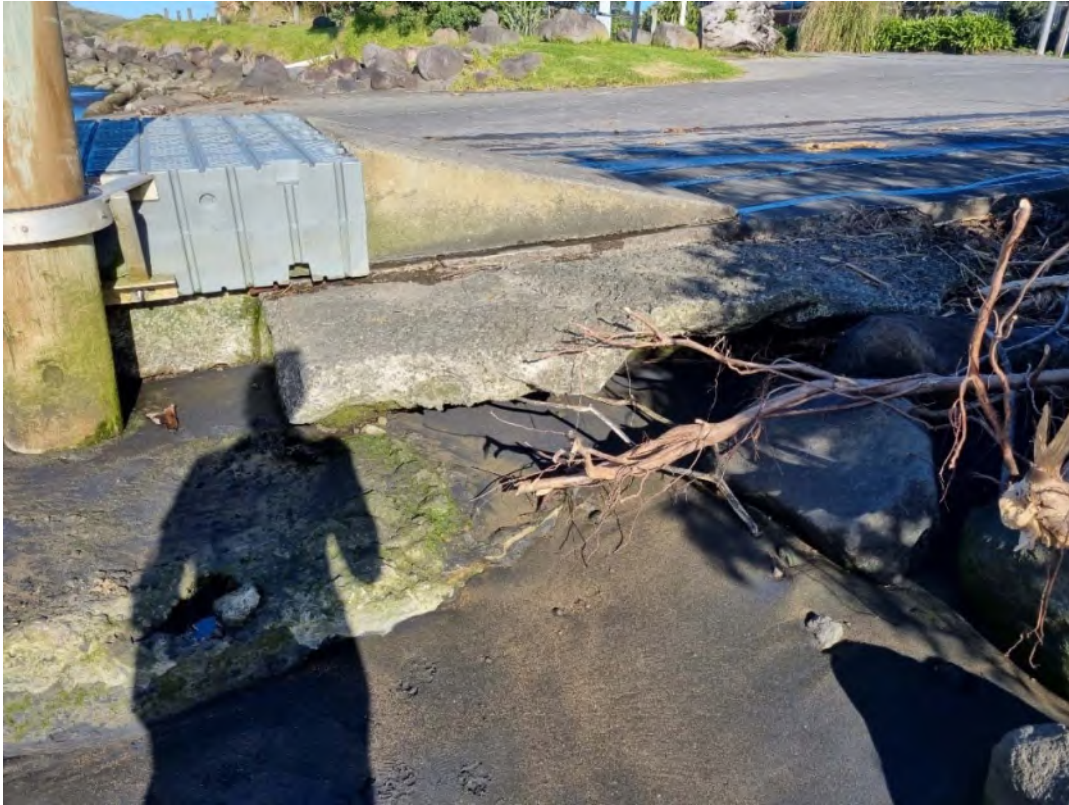
Photo 18 Pātea jetty showing scouring underneath (13 June 2023)

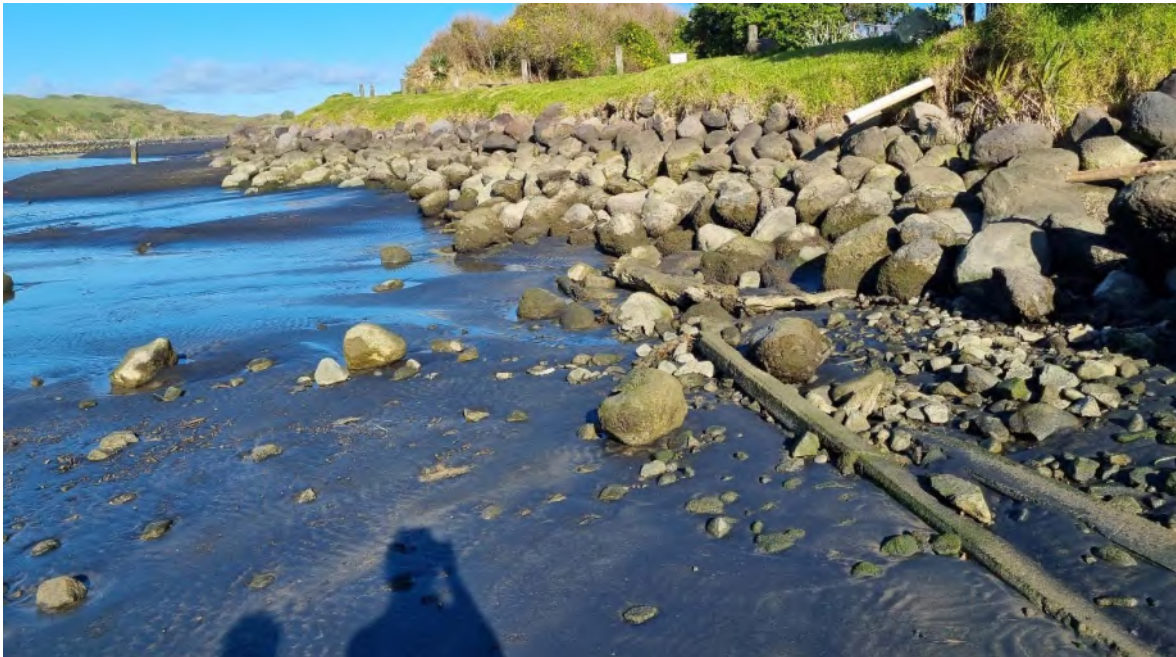
Photo 19 Rock wall downstream of boat ramp showing displaced rocks (13 June 2023)

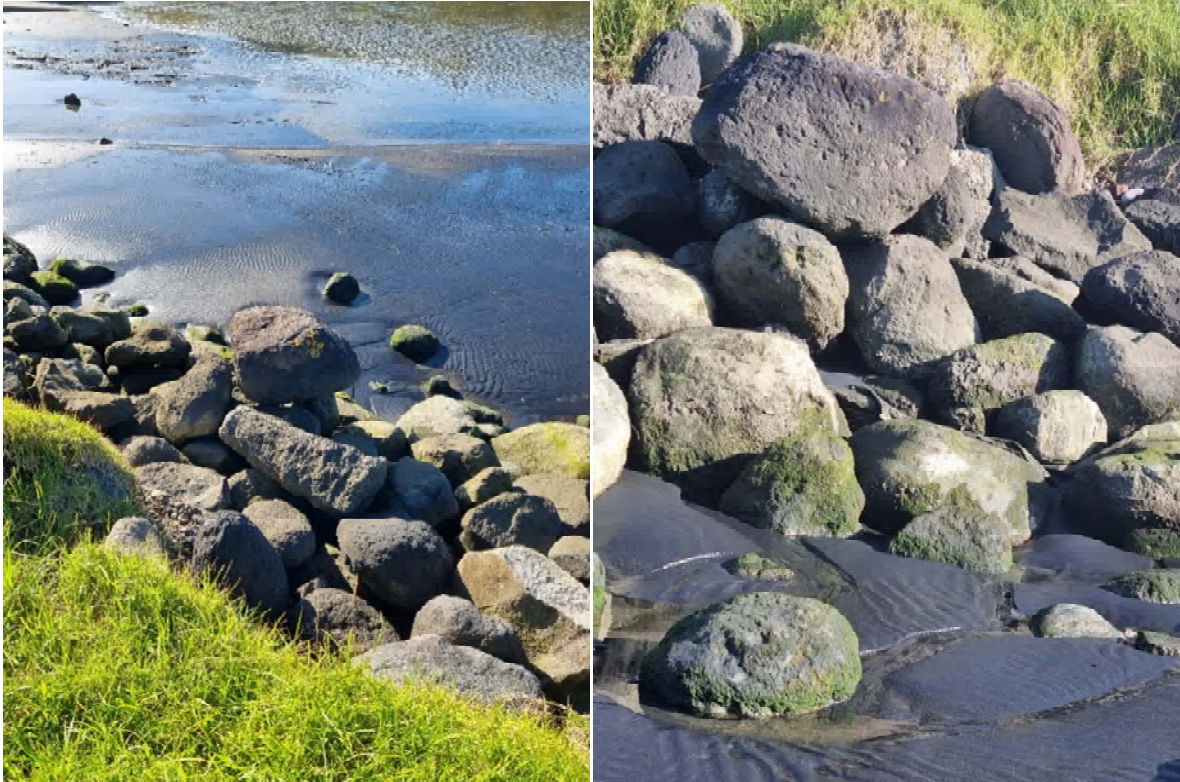
Photo 20 Perched rocks on rock wall downstream of boat ramp (13 June 2023)

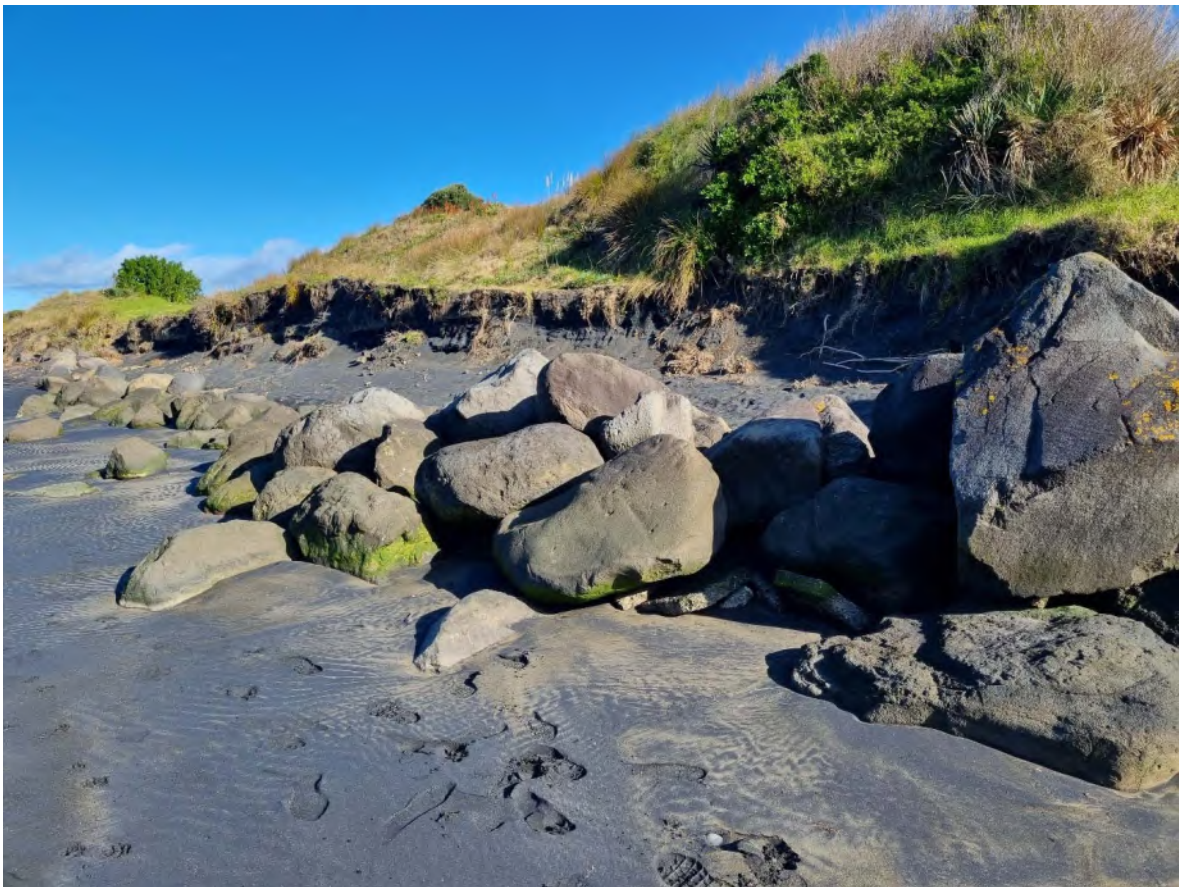
Photo 21 Erosion behind rock wall downstream of boat ramp (13 June 2023)

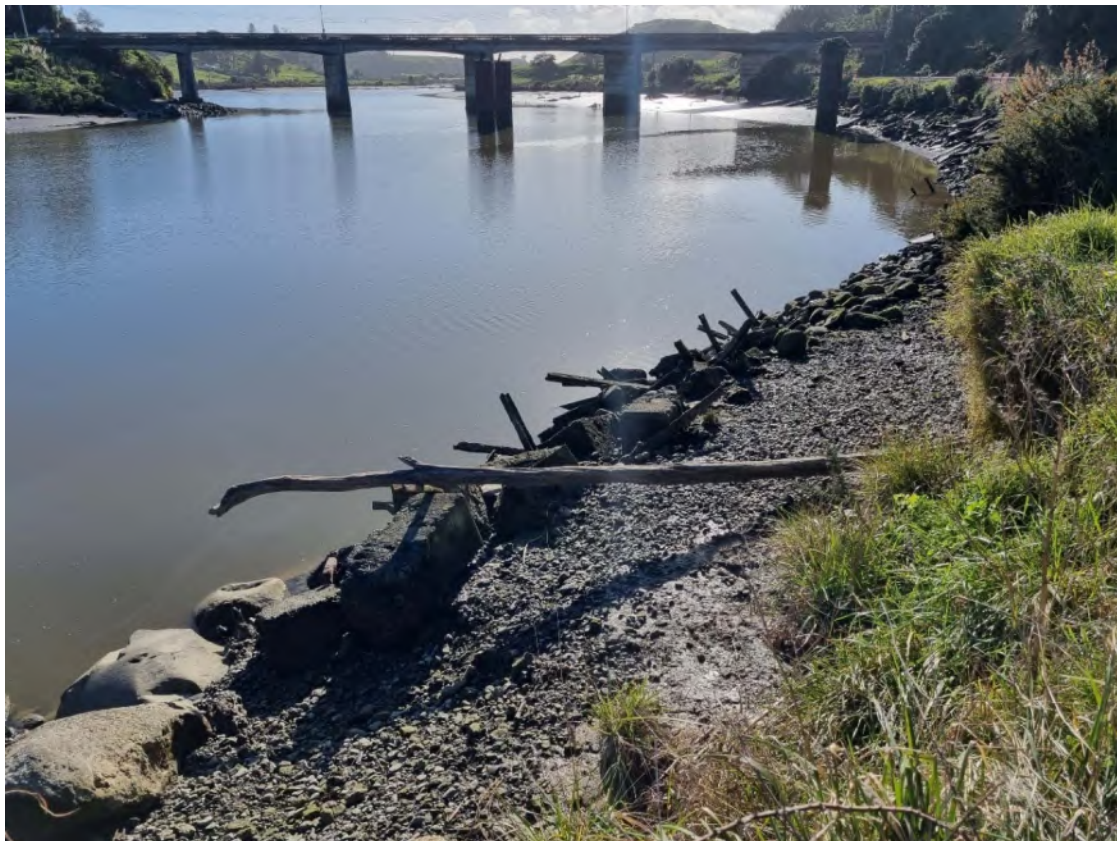
Photo 22 Posts protruding from rip-rap upstream of wharf (13 June 2023)

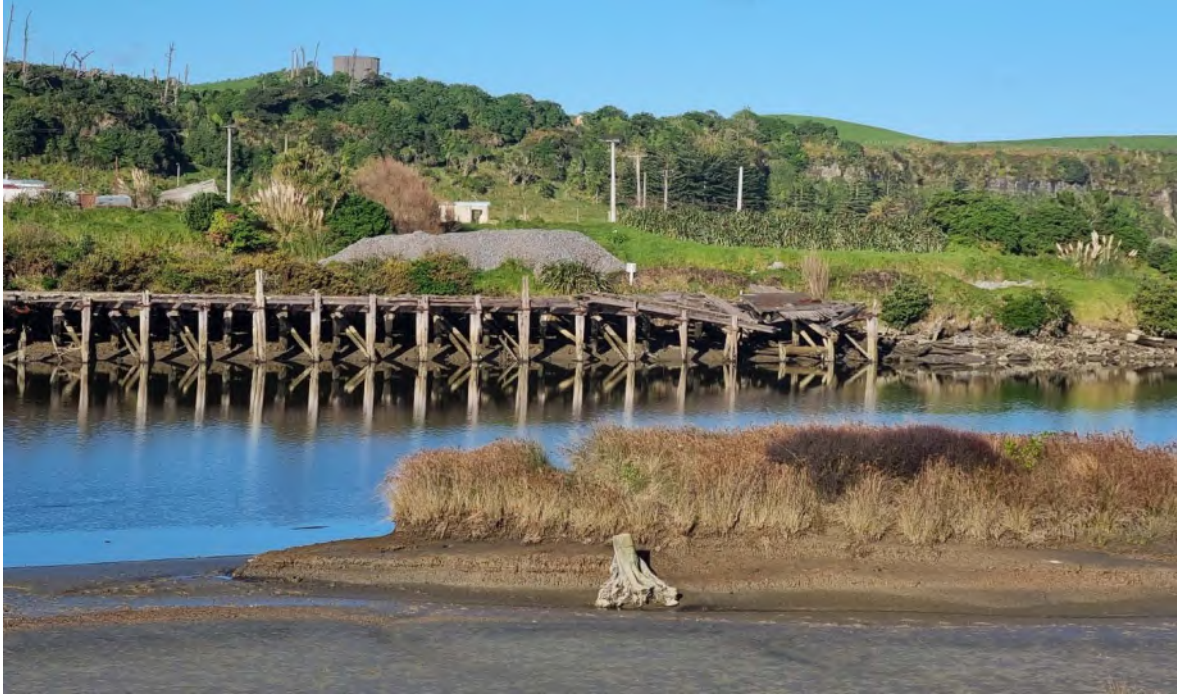
Photo 23 Collapsing section of Pātea wharf (13 June 2023)

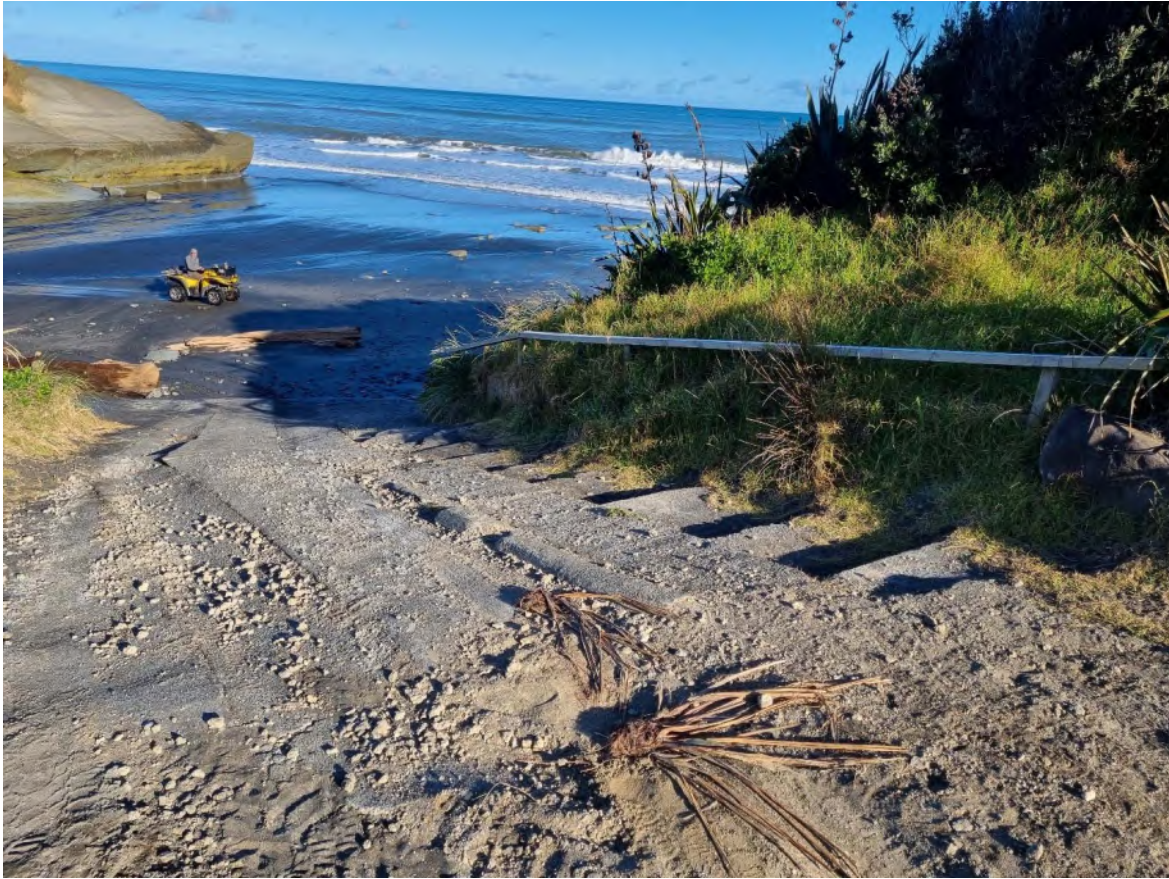
| 4579-2: Caves Beach access ramp | | | |
|---|---|---|---|
| Inspection summary: At the time of the inspection, no obvious changes from the previous year were observed. The structure is in a slightly degraded state but still appears to be providing safe access to the beach (Photo 24). STDC also carried out an inspection of this structure during the year under review. Their report was provided to Council on 30 June 2023. | | | |

Photo 24 Caves Beach access ramp (13 June 2023)
