Remediation New Zealand Ltd

Uruti composting facility

Monitoring Programme

2021-2022

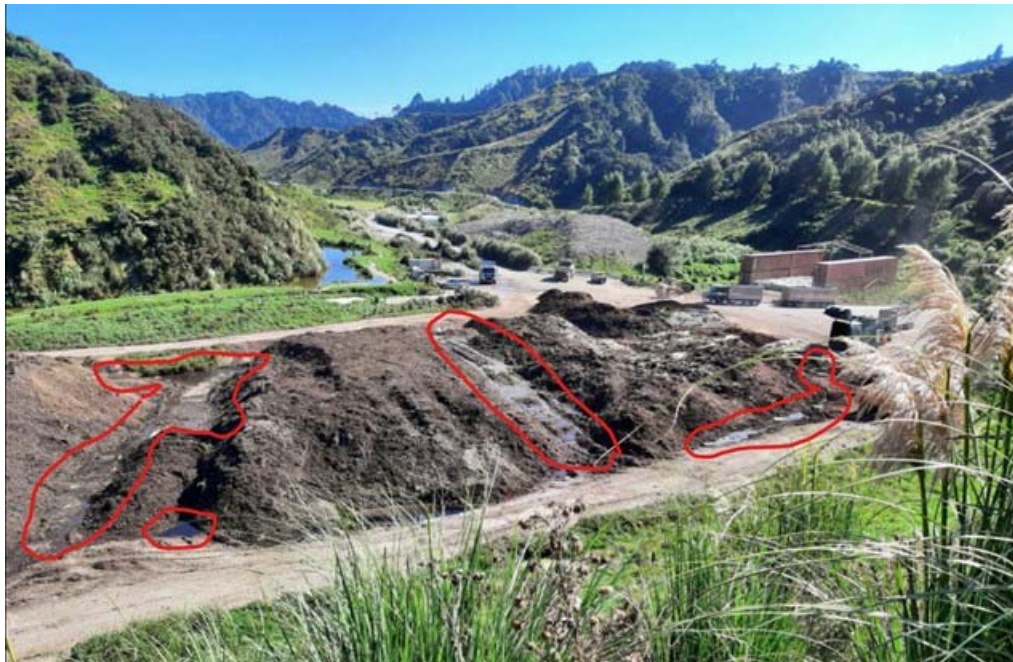
A Council officer noted that the windrows were excessively bulky (well in excess of the guidance given in NZS4454, the national guide for composting) and that they were quite odorous. Over-sized compost piles do not allow good penetration of air and thus become anaerobic, releasing unpleasant odours. Further, the drains around the piles contained stagnant water, and the initial piles had not been covered with odour-

absorbing material such as bark, soil, or mature compost, as had been previously advised by RNZ's consultant.

Photo 1 Windrows on Pad 1. Note the height is greater (4 to 5 m) than the maximum recommended by NZS4454 (~2 m) and stagnant wastewater is present in the proximity of the piles (encircled in red). Photograph taken 01/03/2022

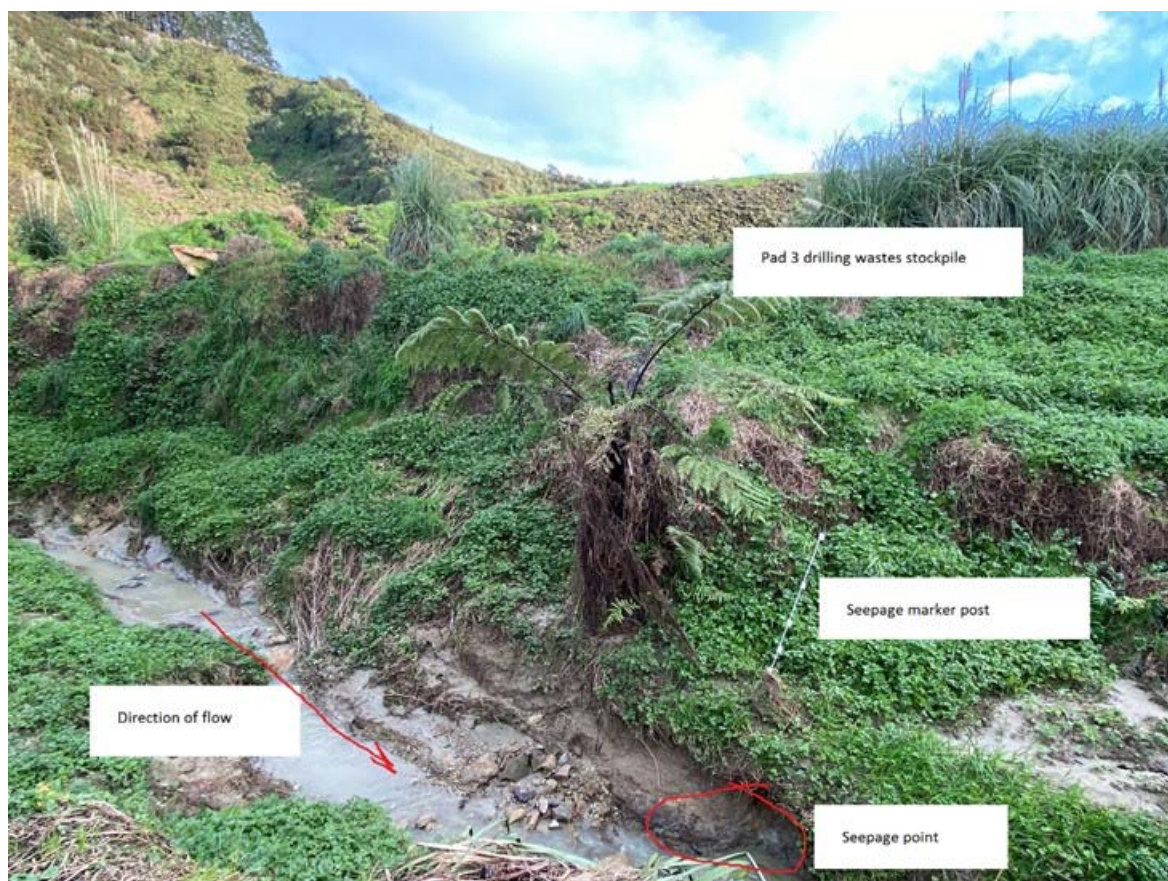
The laboratory analysis of the sample collected at site HHG000106 on 11 March 2022 also detected an extremely high chloride concentration, which is a typical marker for drilling wastes. While LOSPs are also present in the sawdust stockpile on Pad 1, there is no basis to assign the origin of the extremely high chloride leakage to the sawdust or to the materials composting on Pad 1. Therefore, it is reasonable to assume that the source of the contamination found to be leaking into the tributary is associated more particularly with the drilling wastes. This is likely to be from the stockpile, the holding pond previously used to receive wastes destined for Pad 3, and/or the truck-wash and irrigation ponds, as these have received run-off and leachate from Pad 3 and its dumping pond.

The point of seepage is to the east of the drilling wastes stockpile and several metres below it downslope. The various ponds are further away, beyond Pad 3. The point of seepage is shown below in photo 2, by the white plastic standard.

Photo 2 Location of seepage into tributary, 20 June 2022

Given the fine weather on the day of this sampling survey, and the day preceding it, this result is regarded as clear evidence of a plume of contaminated groundwater emerging as a discharge into the unnamed tributary at some point or points, rather than being due to uncontrolled surface stormwater runoff or pond overflow.

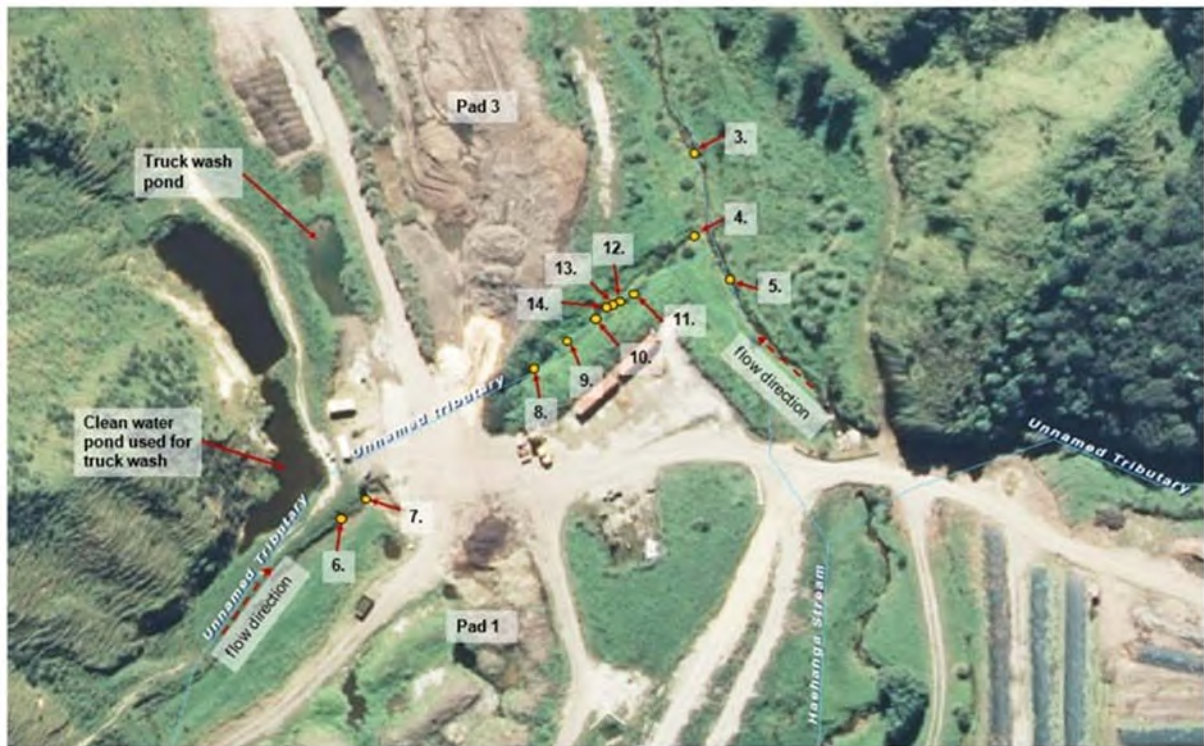
Figure 4 Sites used for intensive conductivity-based survey on 30 March 2022, and results. Sites 1 and 2 were either side of the ‘twin culverts’ road access crossing of the Haehanga Stream, beyond the top (north) of the photograph.

Haehanga Stream		
Site	Distance from Site 4 (metres)	Condy mS/m
1	845 downstream	44.2
2	835 downstream	44.1
3	21 downstream	31.7
5	12 upstream	27.2

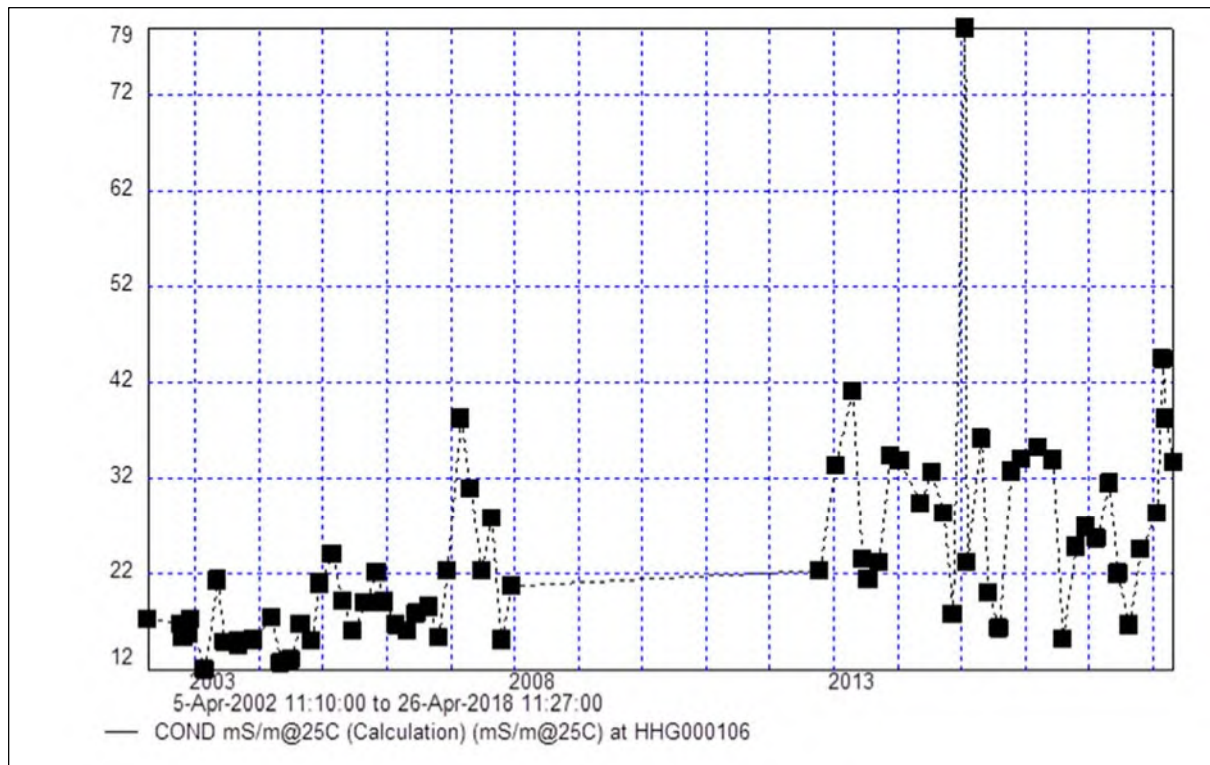
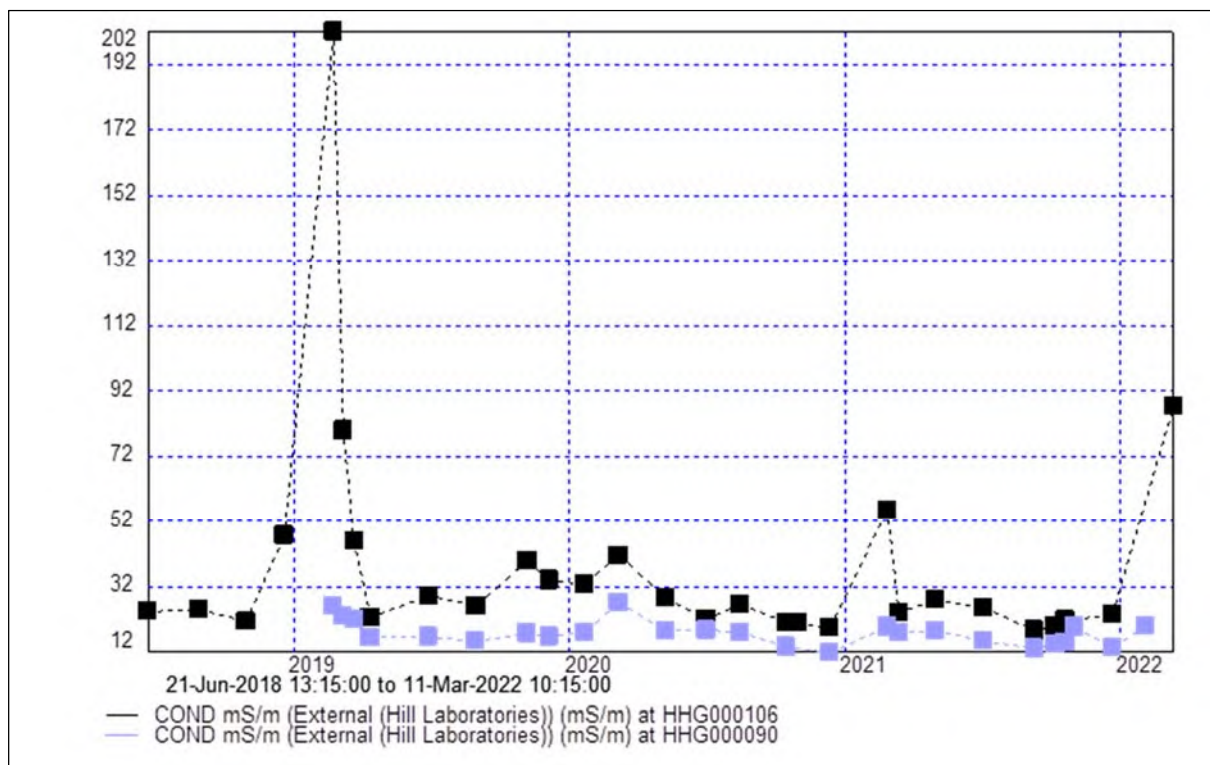
Figure 5 Conductivity measured at Site HHG000106, April 2002 to April 2018

Figure 6 Conductivity measured at Site HHG000106, June 2018 to March 2022

Figure 5 and Figure 6 display the conductivity measured at Site HHG000106 since 2002. The monitoring site is at the bottom of the tributary. There is clear evidence that the leakage of contaminated wastewater into the tributary has been a recurring issue over this entire period. There seems to be a pattern that it is most evident in summer surveys. In addition, by observation there appears to be a pattern of an overall increase in conductivity recorded at the monitoring site over the years (Figure 5), while conductivity in the tributary is consistently elevated above background levels upstream in the Haehanga Stream itself. Conductivity has not been measured previously upstream in the tributary itself.

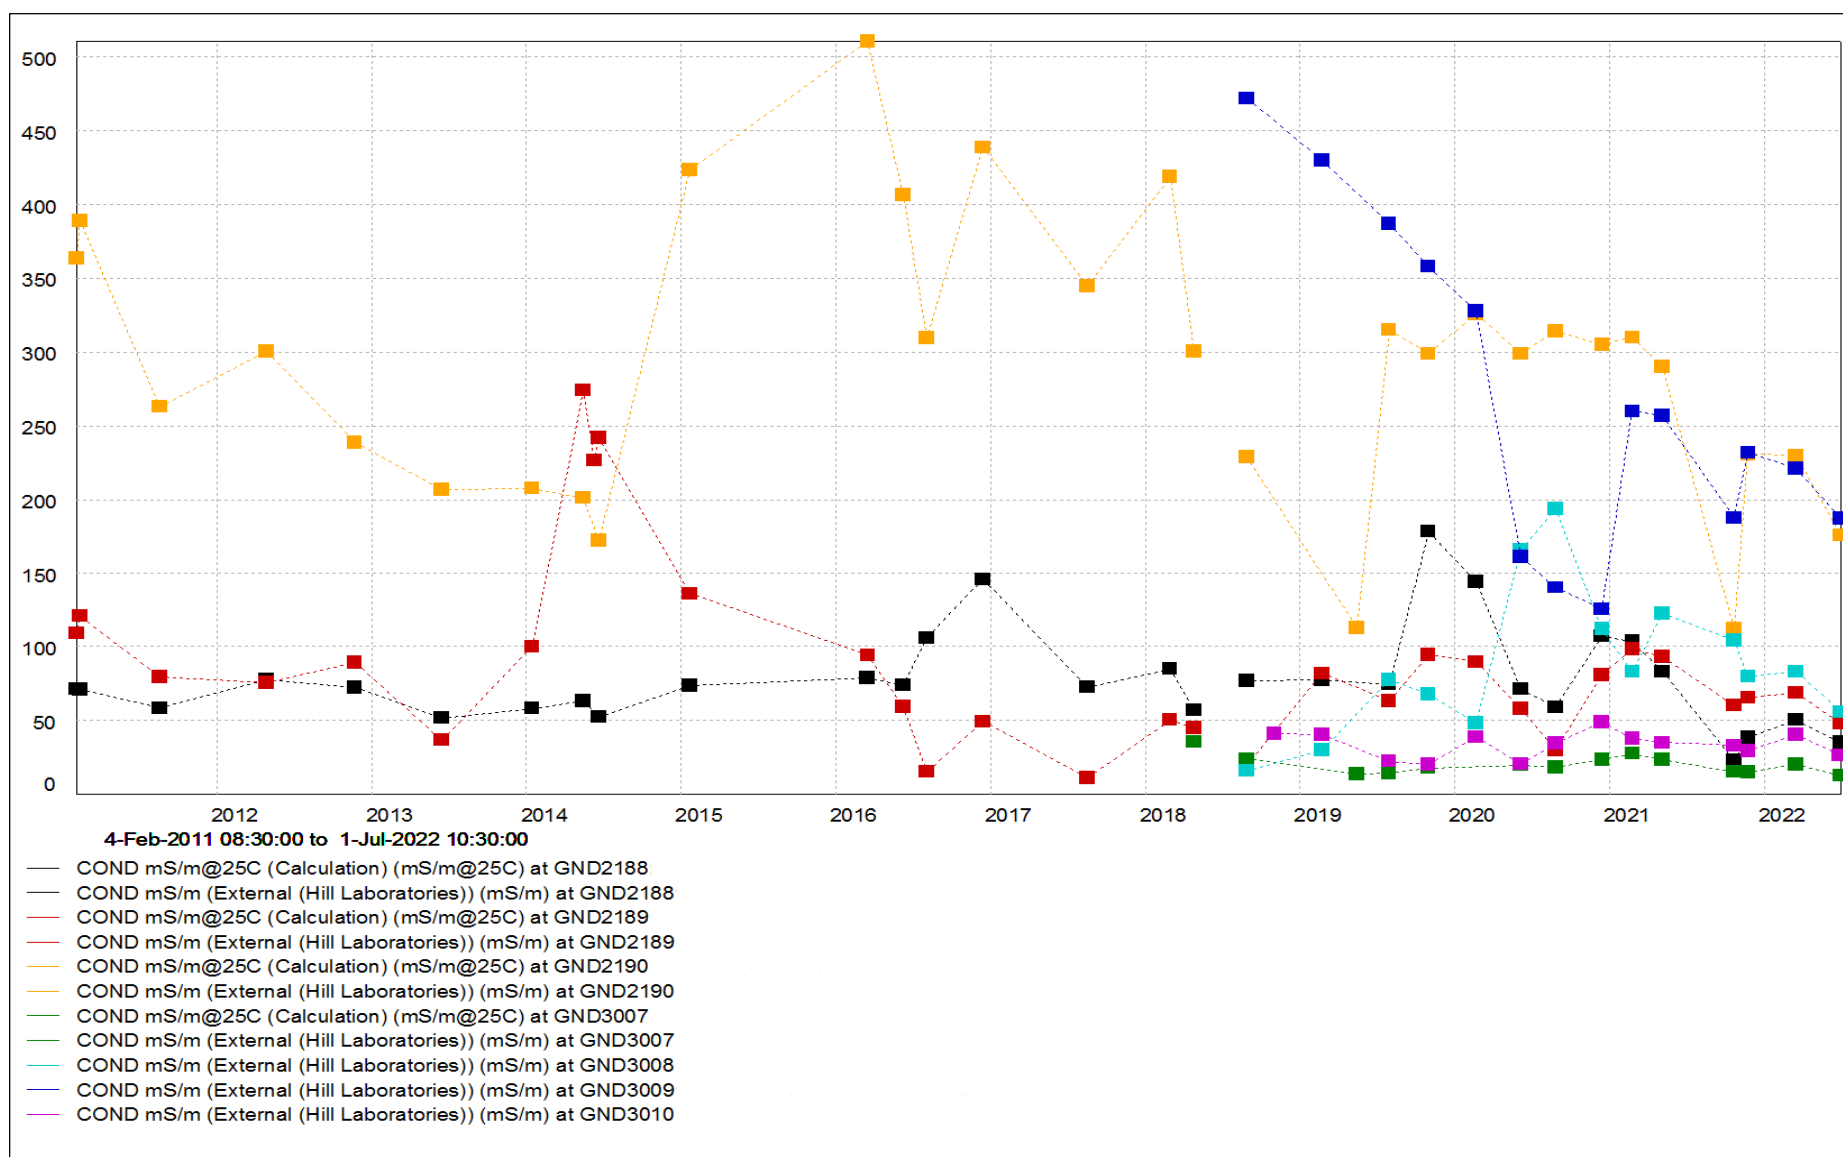
Figure 12 Total conductivity concentrations in groundwater 2011–2022

The conductivity graph is displaying an overall general decrease in concentration across all bores from 2011–2022. Bores GND3008 and GND3009 appeared to increase slightly during 2020 to late 2021, but are decreasing once again.

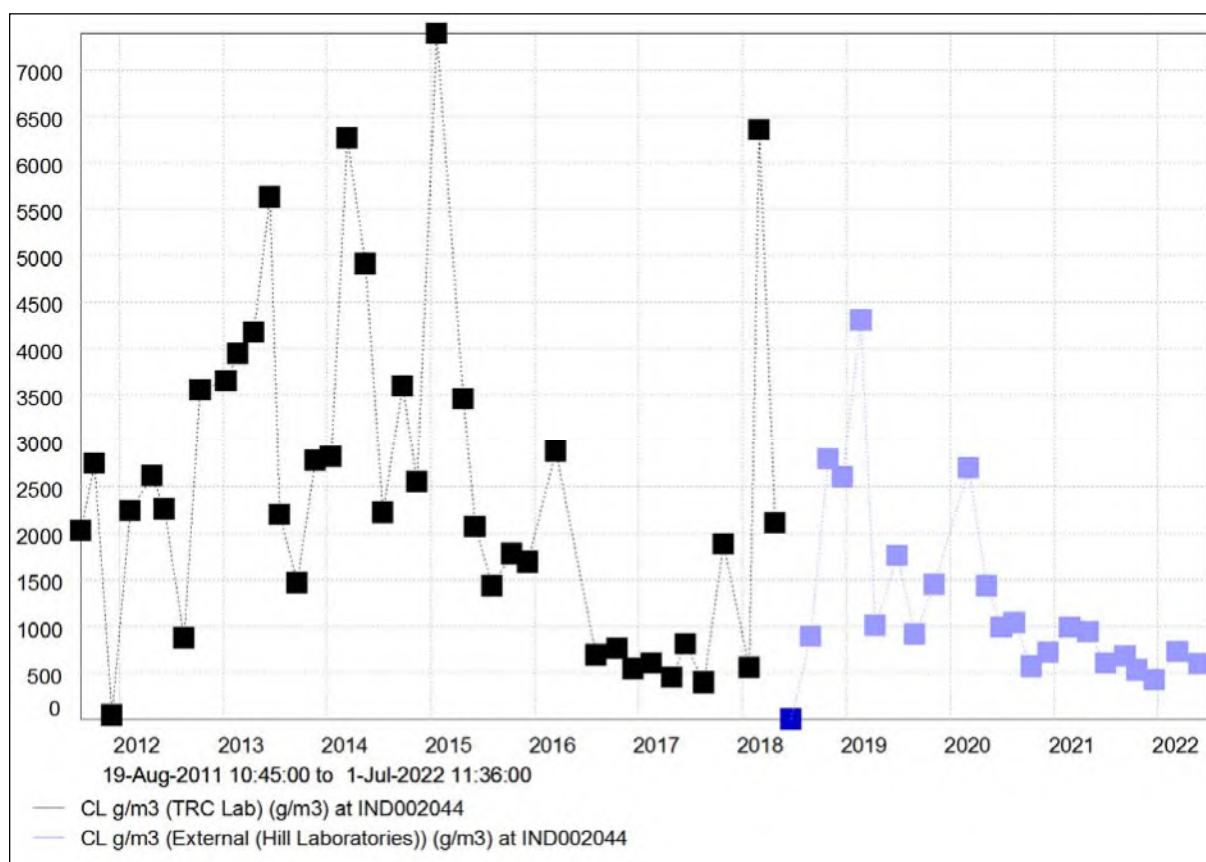
Figure 13 Chloride levels in the irrigation retention pond 2011-2022

LOSP pesticides were routinely detected in the irrigation pond wastewaters on most occasions, indicating their ongoing leaching from the drilling wastes stockpile into the wider environment. Likewise, barium continues to be mobilised. Barium is a marker for drilling wastes due to its use as a weighting mud.

Figure 13 above shows the trends in the concentration of chloride in the irrigation pond since 2011. RNZ committed to ending the acceptance of drilling wastes in or about December 2020. The data shows a substantial reduction in the concentration of chloride entering the irrigation holding pond since that date, while noting a pattern of overall reducing chloride leachate prior to that decision, particularly in 2017.

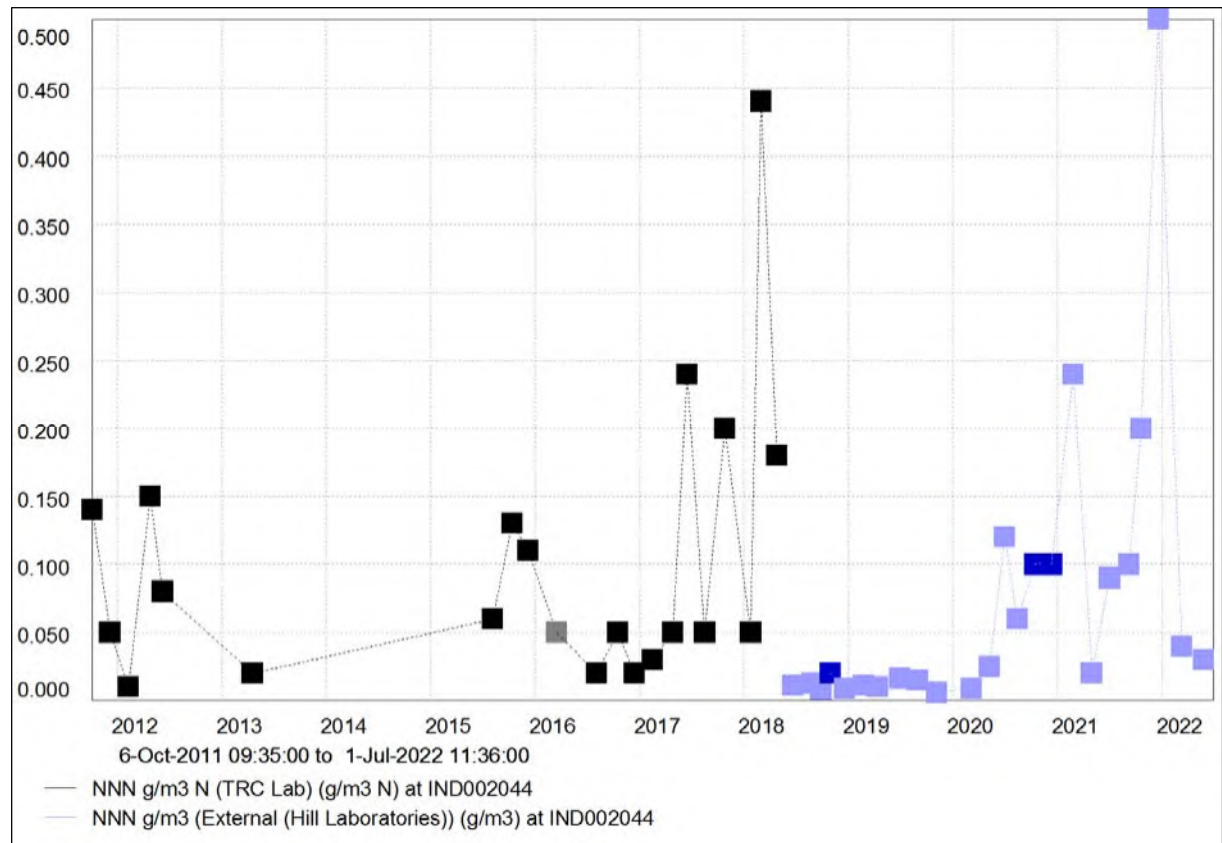
Figure 14 Oxidized nitrogen (nitrate+nitrite) concentrations in the irrigation retention pond 2011-2022

Figure 14 above shows the trends in the concentration of nitrate-nitrogen in the irrigation pond since 2011. The data show considerable variation in the concentration of nitrate within the irrigation holding pond over that period, with peaks in 2018 and again in December 2022. The December 2022 value was the highest recording value to date at 13.8 g/m³. The data suggests that at times, the composting process is creating highly stable compost (shown by peaks in oxidised nitrogen), while at other times ammonia rather than nitrate is being leached from Pad 1 (see Figure 15 below).

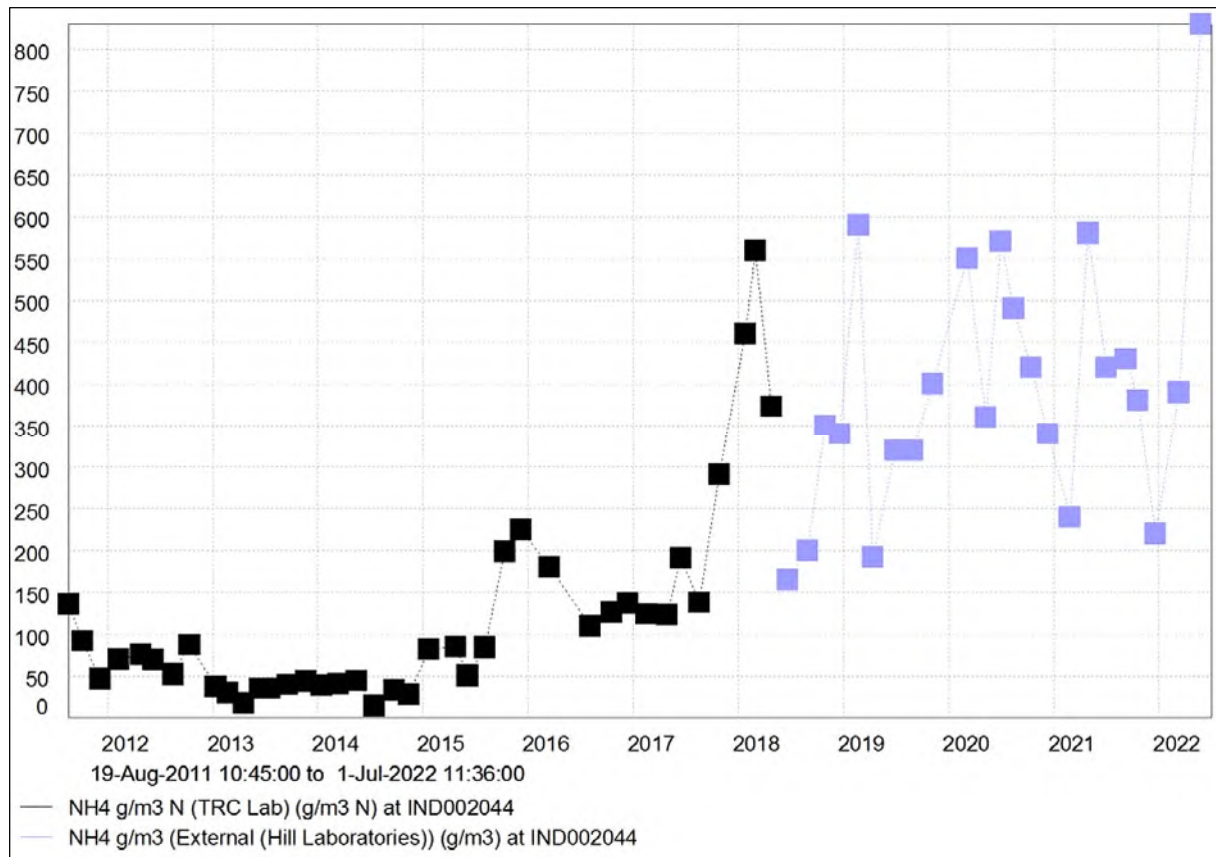
Figure 15 Total ammoniacal nitrogen concentrations in the irrigation retention pond 2011-2022

Figure 15 above shows the trends in the concentration of ammoniacal nitrogen in the irrigation pond since 2011. The data show a substantial overall increase in the concentration of ammonia entering the irrigation holding pond since around 2018, and a sharp and high peak in May 2022 that was more than a third higher than any previous result (and is the most recent sampling run reported). The significance of the recent increased ammoniacal nitrogen for the nitrogen loading on the pasture in the irrigation fields is discussed in Section 3.1.

The pattern of much higher leaching of ammonia in recent years is suggestive of much greater volumes of organic wastes being processed, and/or poorer covering of the materials during the composting process, leading to greater leaching and loss rates of soluble nutrients.

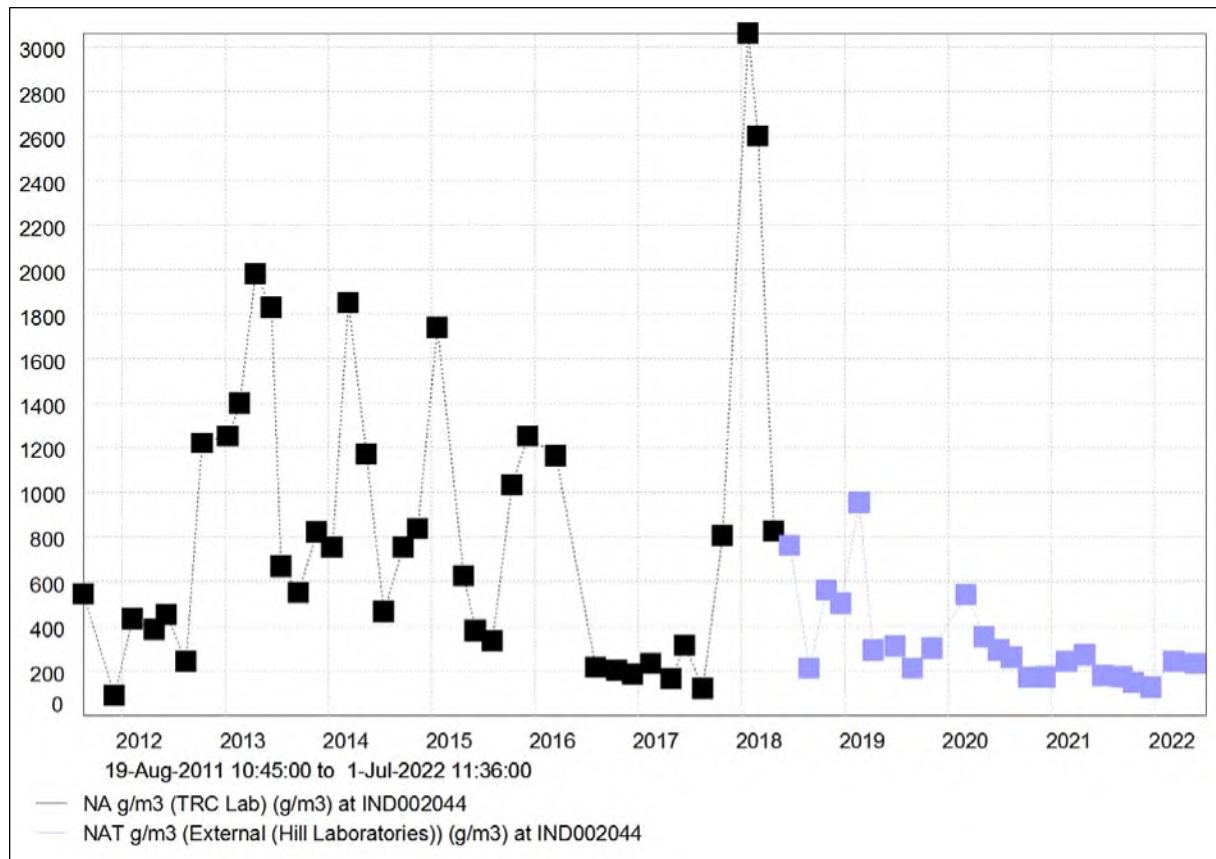
Figure 16 Ionised sodium concentrations in the irrigation retention pond 2011-2022

Figure 16 above presents the data for the concentration of sodium in the irrigation wastewaters since 2011. The application of excessive quantities of ionic sodium to soil causes degradation of soil structure, leading to loss of productivity and increased erosion. The pattern of reducing sodium concentrations is encouraging. It is noted that RNZ committed to eliminating the reception of drilling wastes from December 2020, and this appears to have had clear benefits, while noting that sodium concentrations were overall reducing prior to this time in any case (but with considerable variability and wide ranges in results).

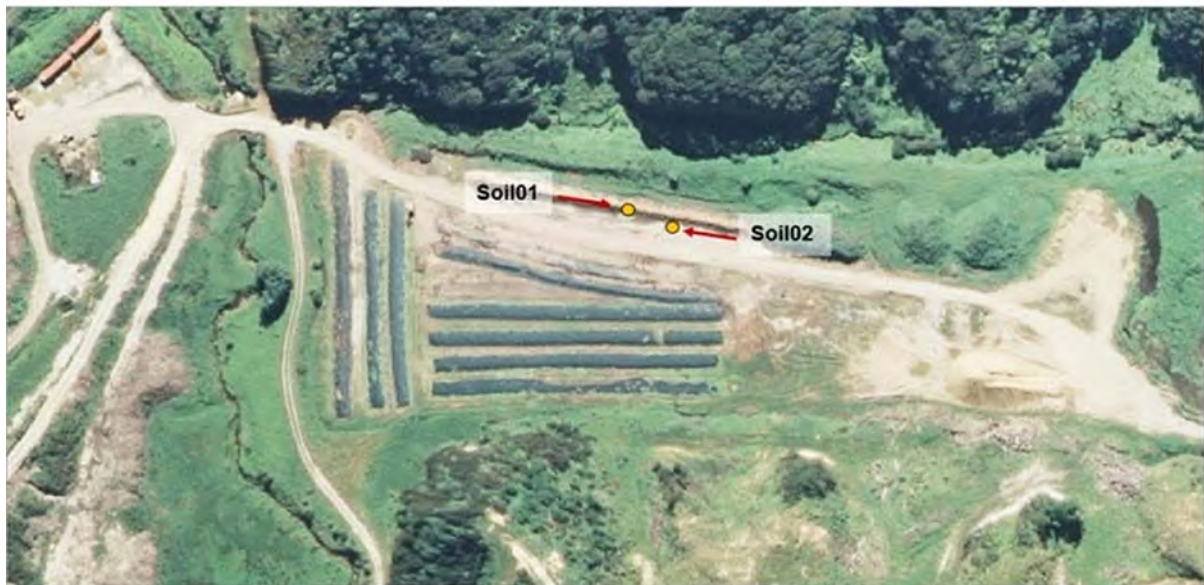
On 30 March 2022, a Council officer collected two samples of the solid material from the heap by the Council. The location of the heap and the sampling locations are shown in Figure 18. Subsequent analysis of the two samples found total recoverable barium (a definitive marker for drilling muds) at concentrations of 4,500 mg/kg and 5,000 mg/kg, respectively. These concentrations are at the higher end of those found in the stockpile of drilling wastes present on Pad 3, and far beyond background soil concentrations. A Council officer informed the on-site management staff of RNZ of the analytical results,, and instructed the RNZ staff that the stockpile was not to be disturbed, removed, or added to in the interim. This instruction was issued to avoid the possibility of exposed material falling or being washed into the adjacent tributary of the Haehanga Stream. Further testing of the soil found the fungicides and tanalising chemicals that the Council has previously detected in the sawdust stockpiles on the site and in the drilling wastes stockpile.

Figure 18 Location of sampling points in stockpiled waste heaps near paunch pad and vermiculture beds.
The tributary flows right to left, between the stockpiles and the bush

Following the end of the period under review, RNZ have committed to undertaking site investigations, to determine the location and significance of contamination across the property, and to ascertaining options for site rehabilitation. With the various stages required, these investigative works are to be completed by April 2023, and if an on-site disposal option is selected, a suitable location is to be identified by February 2024.
