**Dow Final Preliminary Site Investigation Review**

- Preliminary Site Investigation, Paritūtū, New Plymouth prepared for Dow Chemical (NZ) Limited by Tonkin & Taylor Limited (T+T); Final Version 007 dated 11 July 2024 (the final PSI report).

0021795.0200 v007

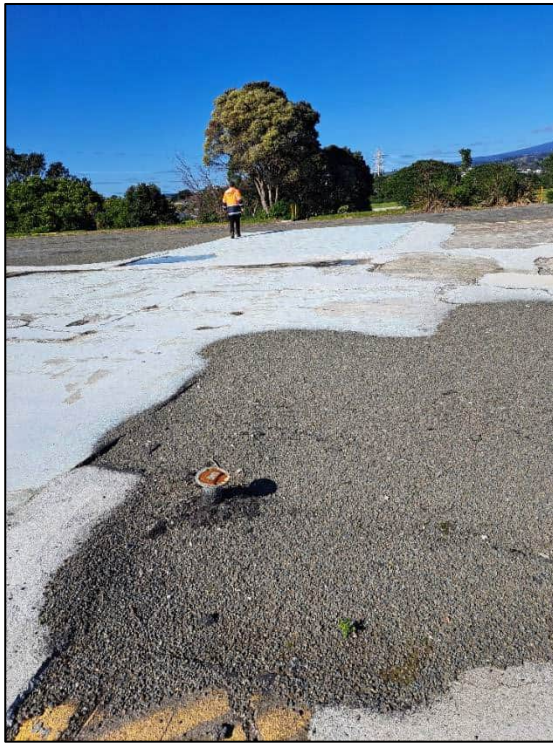
Photograph 1: Welded fill point for process water piping adjacent to Building 15.

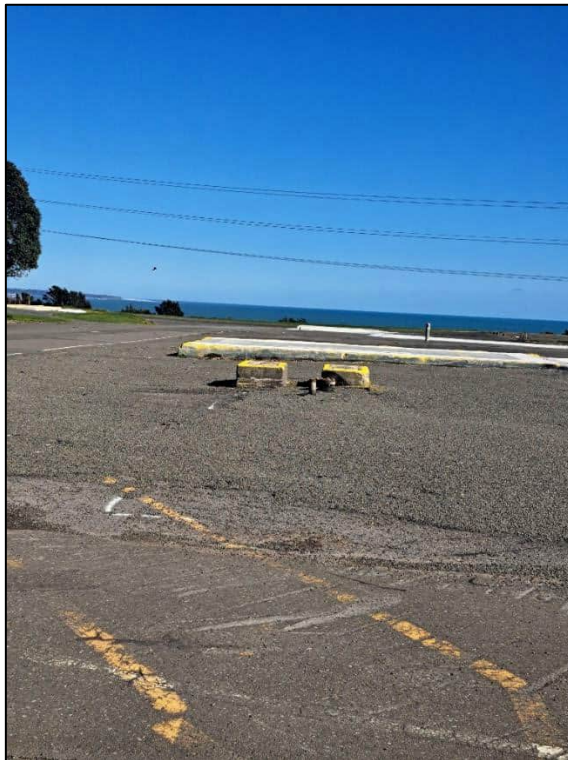
Photograph 2: Welded fill point for process water piping adjacent to Building 09.

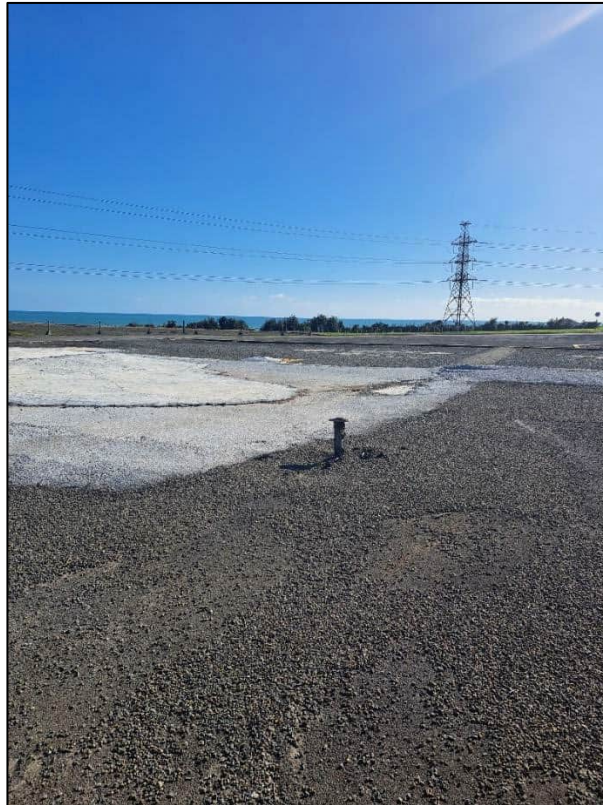
Photograph 3: Welded fill point for town mains water adjacent to Building 30.

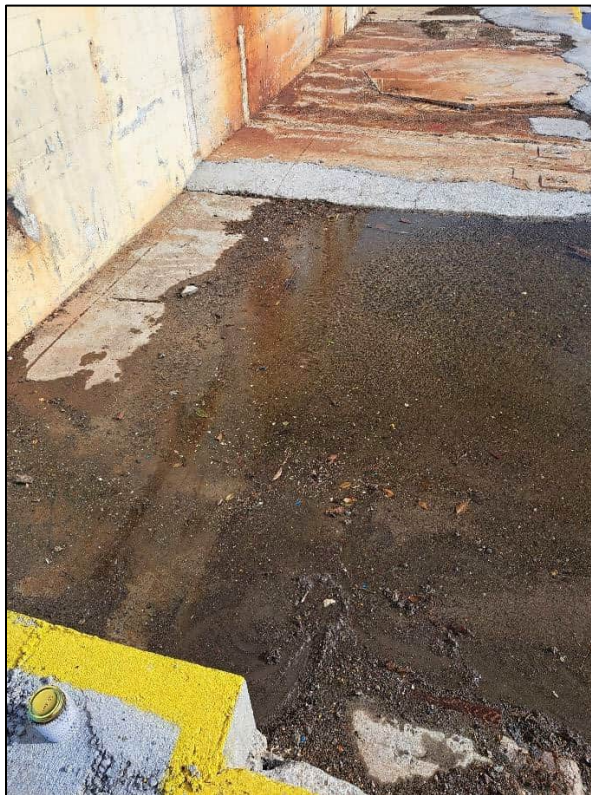
Photograph 4: Demolition debris/sediment adjacent to Building 03.

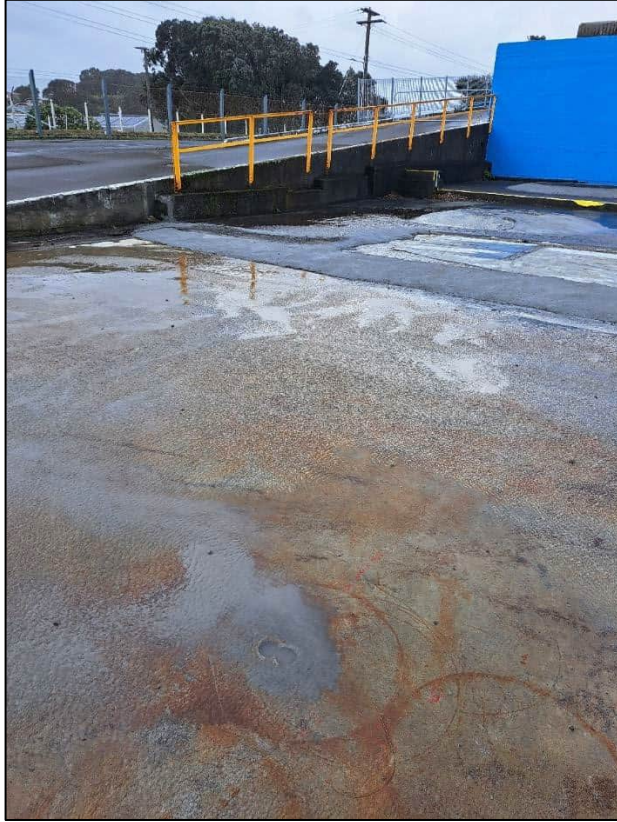
Photograph 5: Former storage of round drums on the concrete adjacent to Building 03.

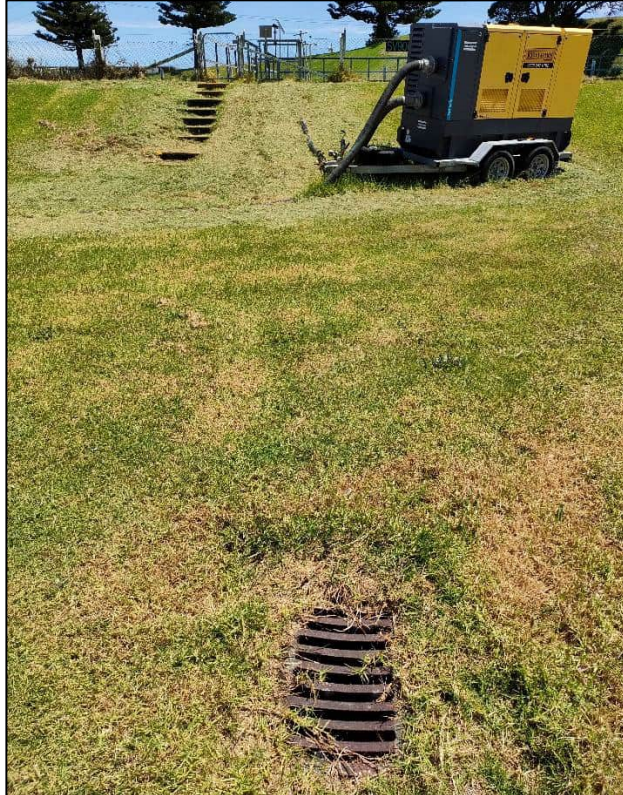
Photograph 6: Pumps servicing the stormwater ponds SV9000/9100.

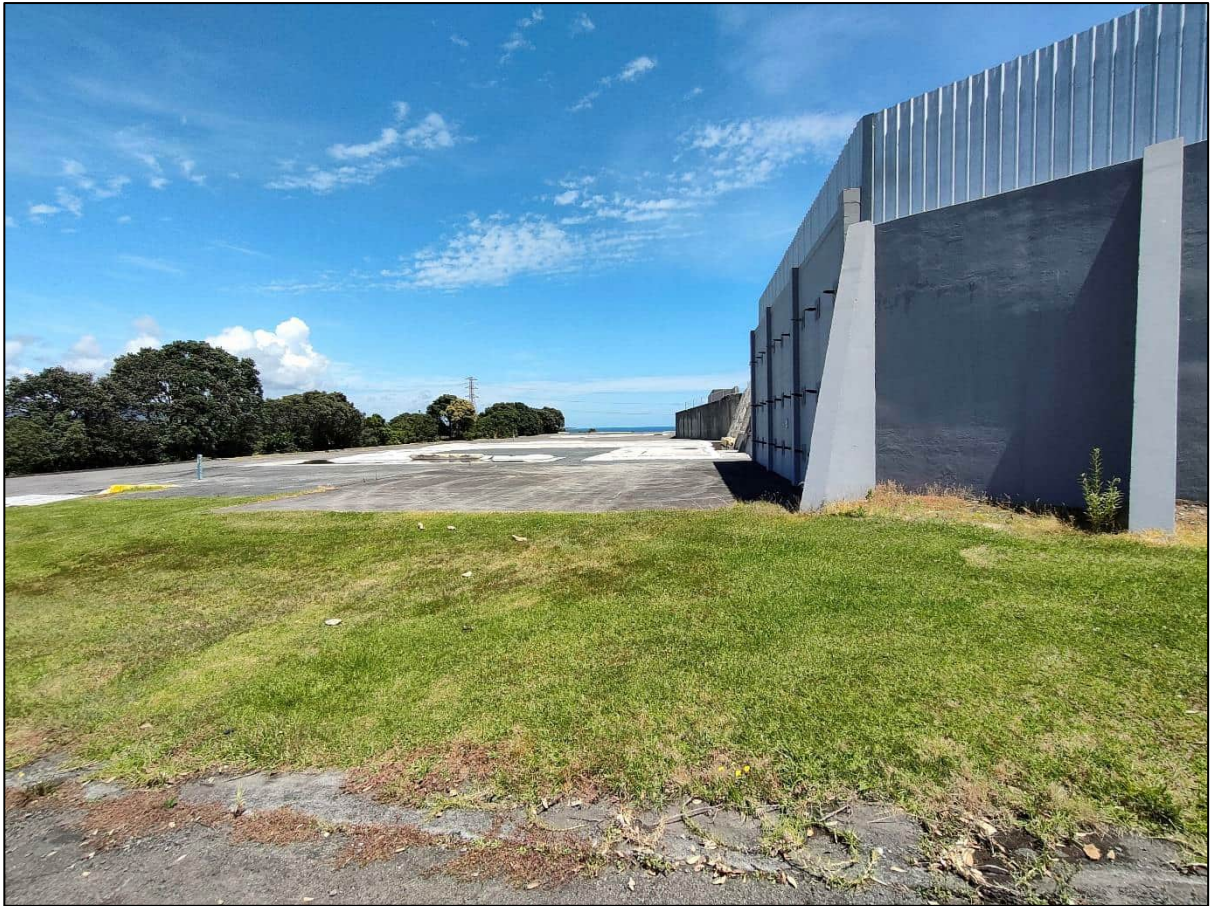
Photograph 7: View looking west showing the former footprint of Building 13, the retaining wall to the top yard behind Building 3.
