NPDC Colson Road Landfill  
Monitoring Programme  
Annual Report  
2018-2019

Technical Report 2019-45

Taranaki Regional Council  
Private Bag 713  
STRATFORD  
February 2020

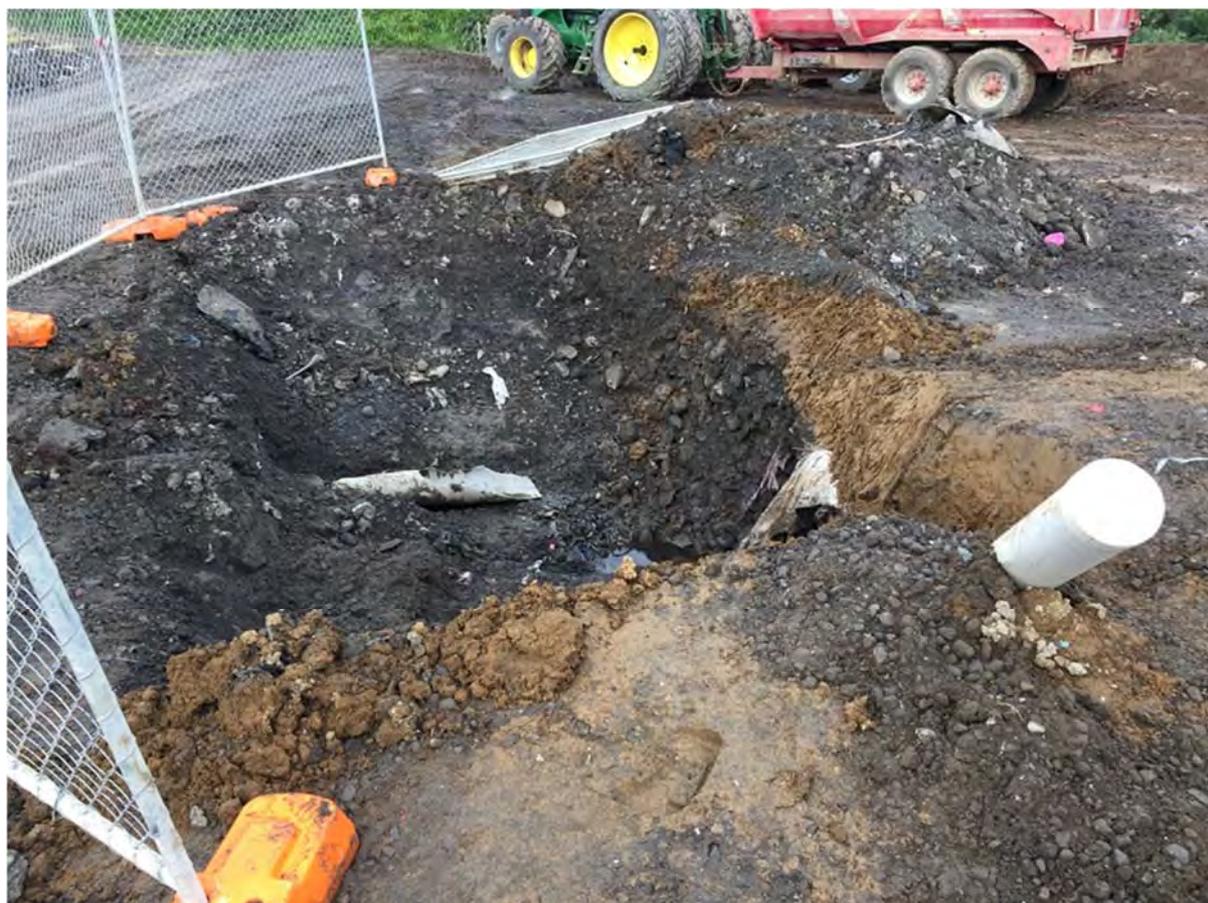
There were mild landfill gas odours present at the white stand pipe at the edge of the tip access track. An underground pipe had been damaged below the white stand pipe. It was noted that this pipe was part of the leachate collection system that transfers potentially contaminated stormwater from one side of the road to the other.

Photo 8 Broken leachate pipe, July 2018

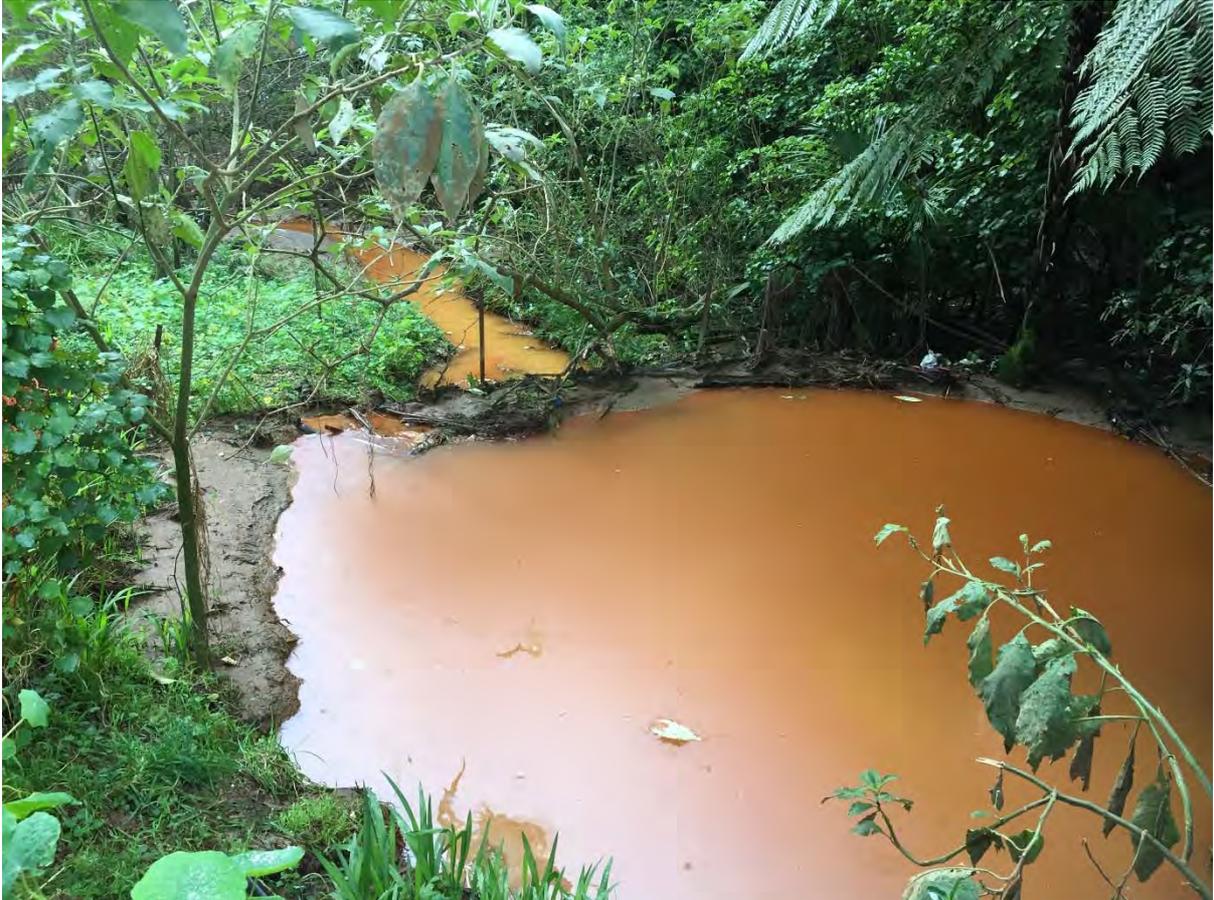
No odours or litter were observed around the stormwater and silt ponds. The small silt ponds were a very bright orange/brown colour, although water flowing into the small western pond at the time of inspection was clear. The small eastern pond contained a lot of silt. It was noted that this has been recently de-silted, but that it had already filled with silt again (Photo 9). The inspecting officer noted that a contractor had been engaged to replace the silt fence and hay bales at the front of the pond. The Puremu Stream outlet grate was clear of obstructions.

Photo 9 Small eastern slit pond, July 2018

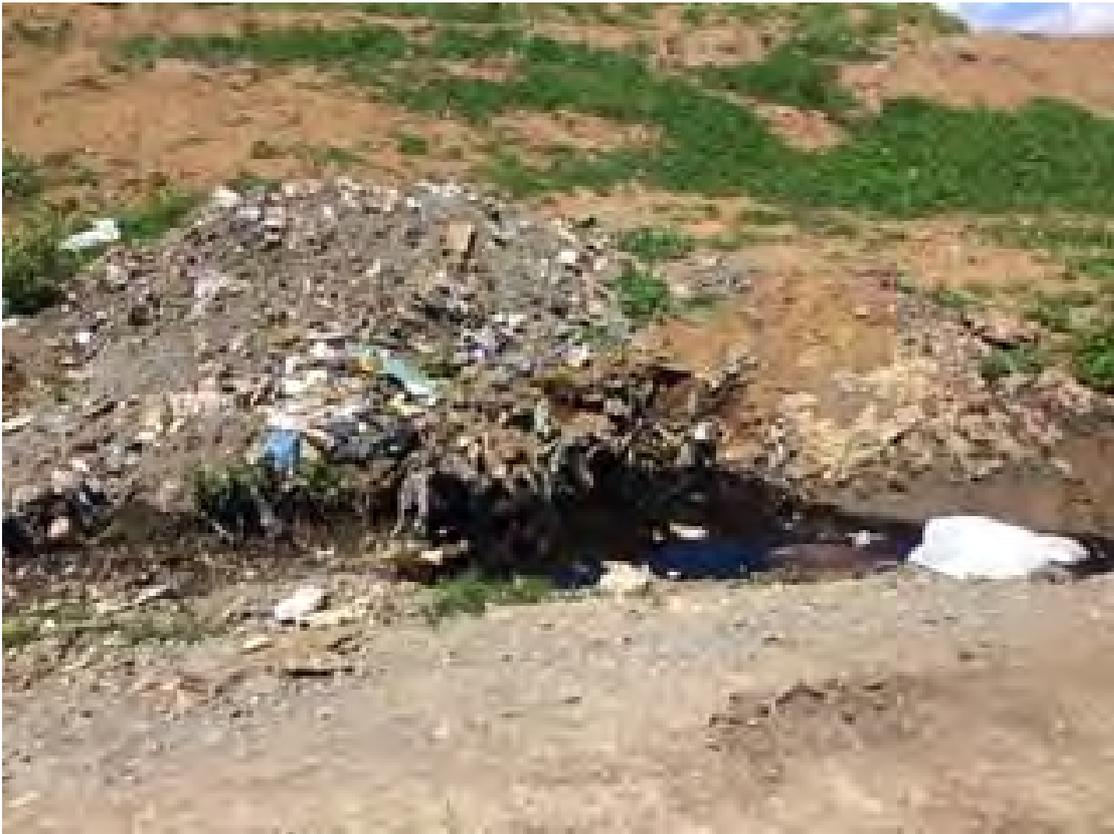
There were mild odours present around the white stand pipe at the edge of the tip access track. Refuse in the special waste pit was not covered with soil, but there was a digger parked next to the pit. NPDC were asked to continue to ensure that the special waste pit is covered as per management plan requirements. Across the road from the white stand pipe there was a large pile of soil and rubbish that had been dug out leaving a large pond of leachate (Photo 10). This is an area on the up gradient side of a leachate pipe that crosses beneath the road **before passing** into the gravel around the leachate cleaning line (white pipe) and ultimately into the leachate collection system. Given the ponded leachate it is likely this pipe is not conveying the leachate across under the road. Due to the contour of the ground around this location it was likely that any overflow during rain would run back towards the access road and stormwater drains.

Photo 10 Poned leachate, 14 November 2018

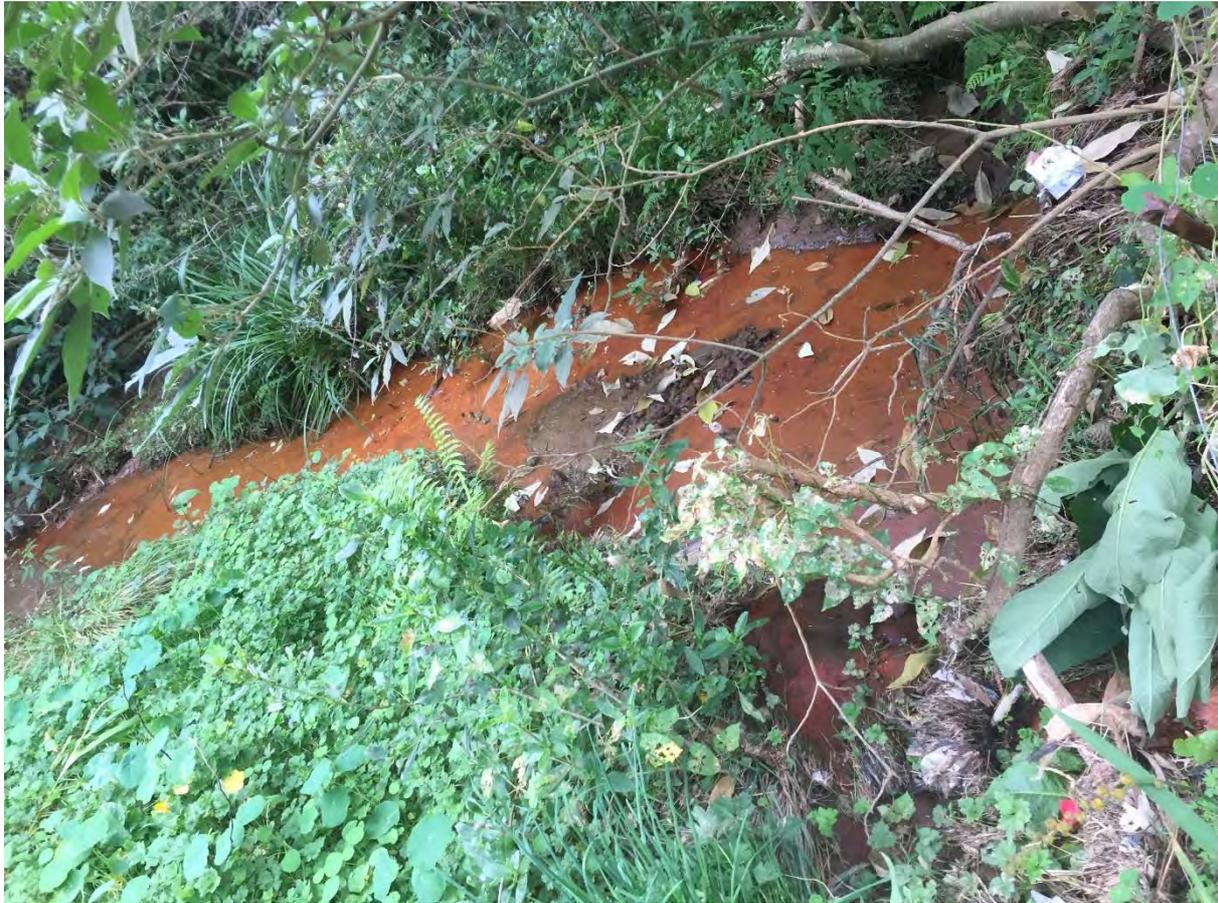
the potential for impoundment occurring within the tributary. The Puremu Stream was running clear above the confluence with the small silt pond discharges and the outlet grate was clear of obstructions.

Photo 11 Silt bank in the tributary below the eastern small silt pond, March 2019

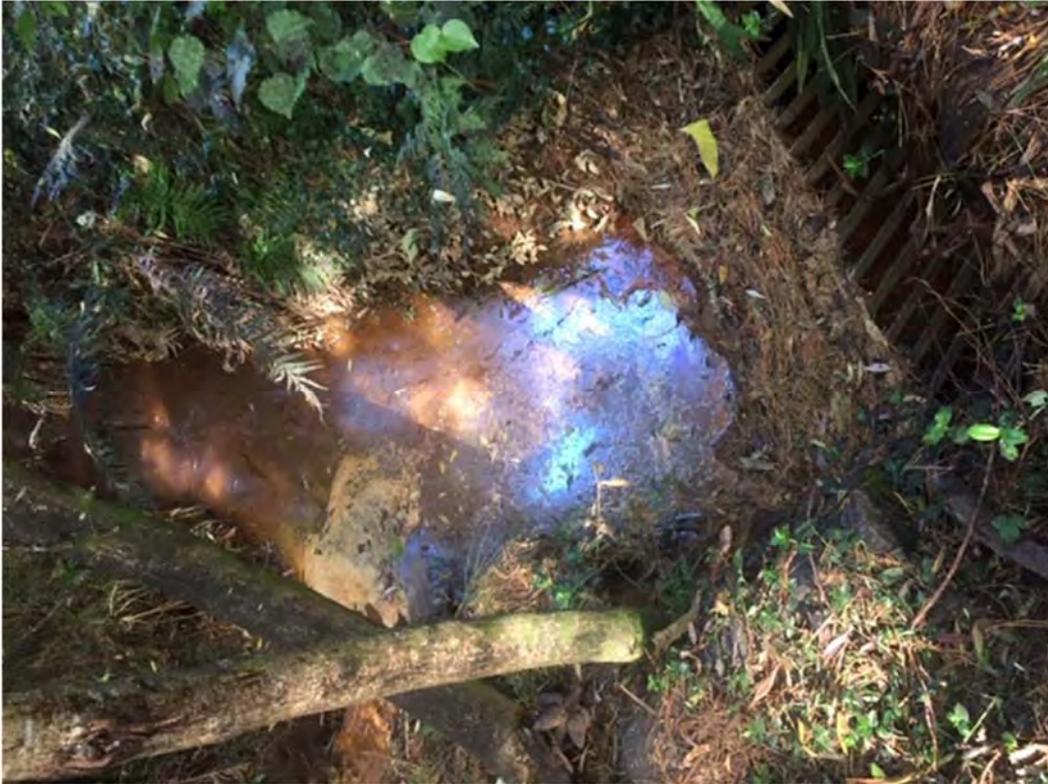
The main branch of the Puremu Stream was very orange and appeared almost stagnant with films and scums on the stream surface as the culvert grate was still blocked with debris despite the request for it to be cleared following the previous inspection (Photo 12). Only a small amount of water was running out from underneath and into the culvert. No heterotrophic growths were observed. As the NPDC had not addressed this issue in the preceding month, the inspecting officer attempted to kick away some of the debris and clear the bottom of the grate. There was still some debris at the top of the grate, however normal flow was mostly resumed and the scums/films washed downstream.

Photo 12 Obstructed SPCA driveway culvert inlet, April 2019

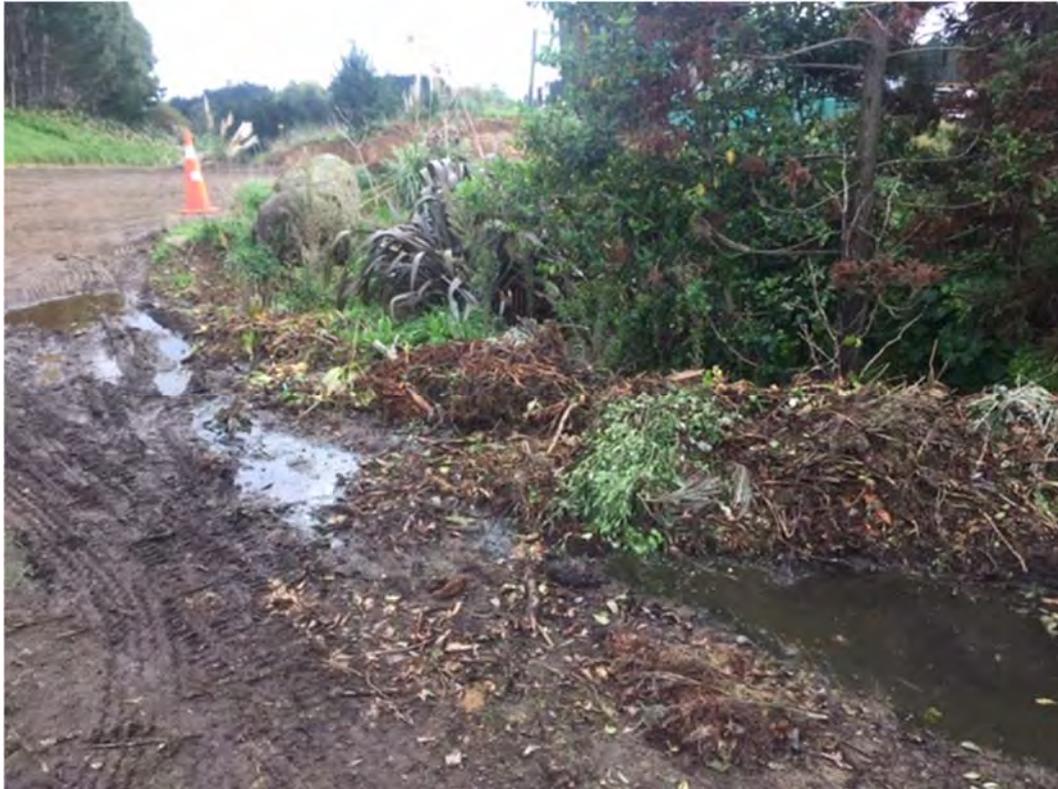
The current composting area contained mainly aged product, along with some piles of fresher material. The area was almost full to capacity. A digger was active in the area loading trucks with finished product. Mild composting odours were noted, nothing unpleasant and no airborne dust. The ground was a bit muddy and there was a small amount of ponded water around the entrance to the area. Some fresh material had been placed on top of the drains to the ponds (Photo 13). This was not causing an issue at the time of the inspection due to the lack of flow, however the material would block the discharge of any runoff from the pad if not moved before the next rain. The ponds all contained some water, which was a dark black/brown colour. The ponds were not discharging to the eastern drain.

Photo 13 Green waste placed in compost area stormwater drain to treatment ponds, May 2019

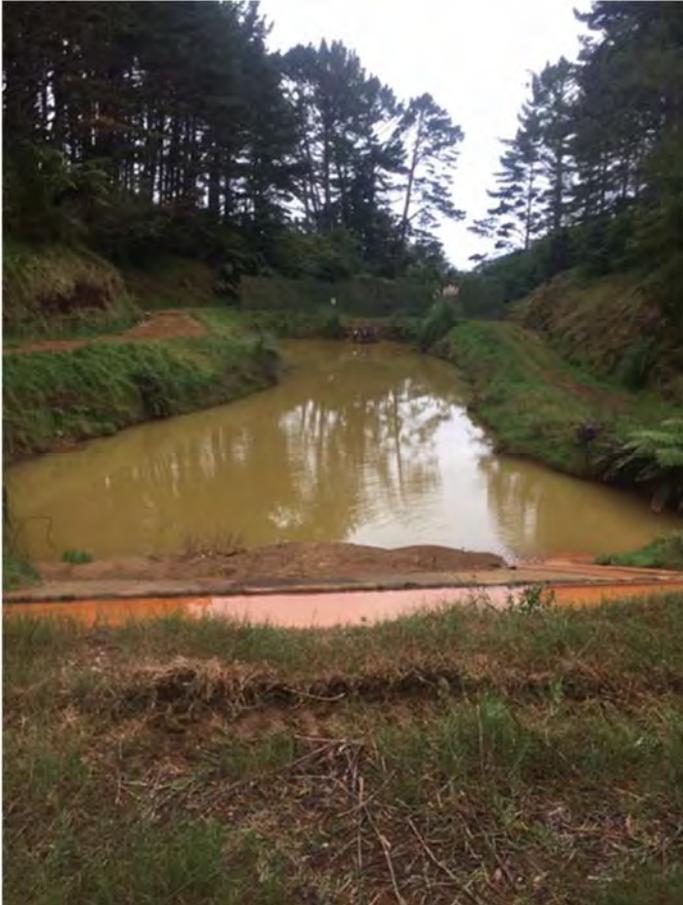
The large silt pond was at a moderate level and brown-orange in colour. There was an area of surface sheens down the northern/outflow end. At the time of inspection it was not determined whether this was due to hydrocarbons or bacteria. The photos shared with NPDC also showed a silt bank below the weir in the large silt pond.

Photo 14 Silt bank below weir of large silt pond, May 2019

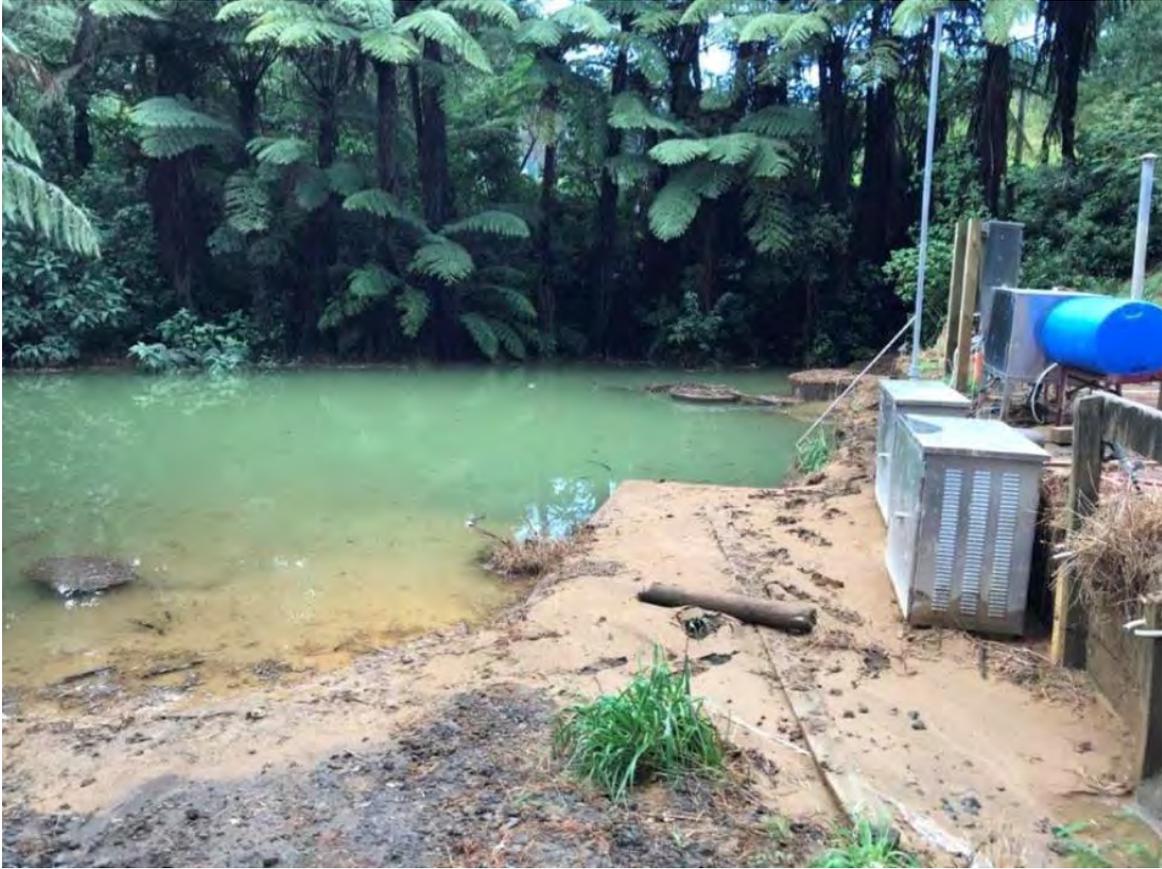
Photo 15 Leachate pond 23 April 2019, from NPDC investigation report

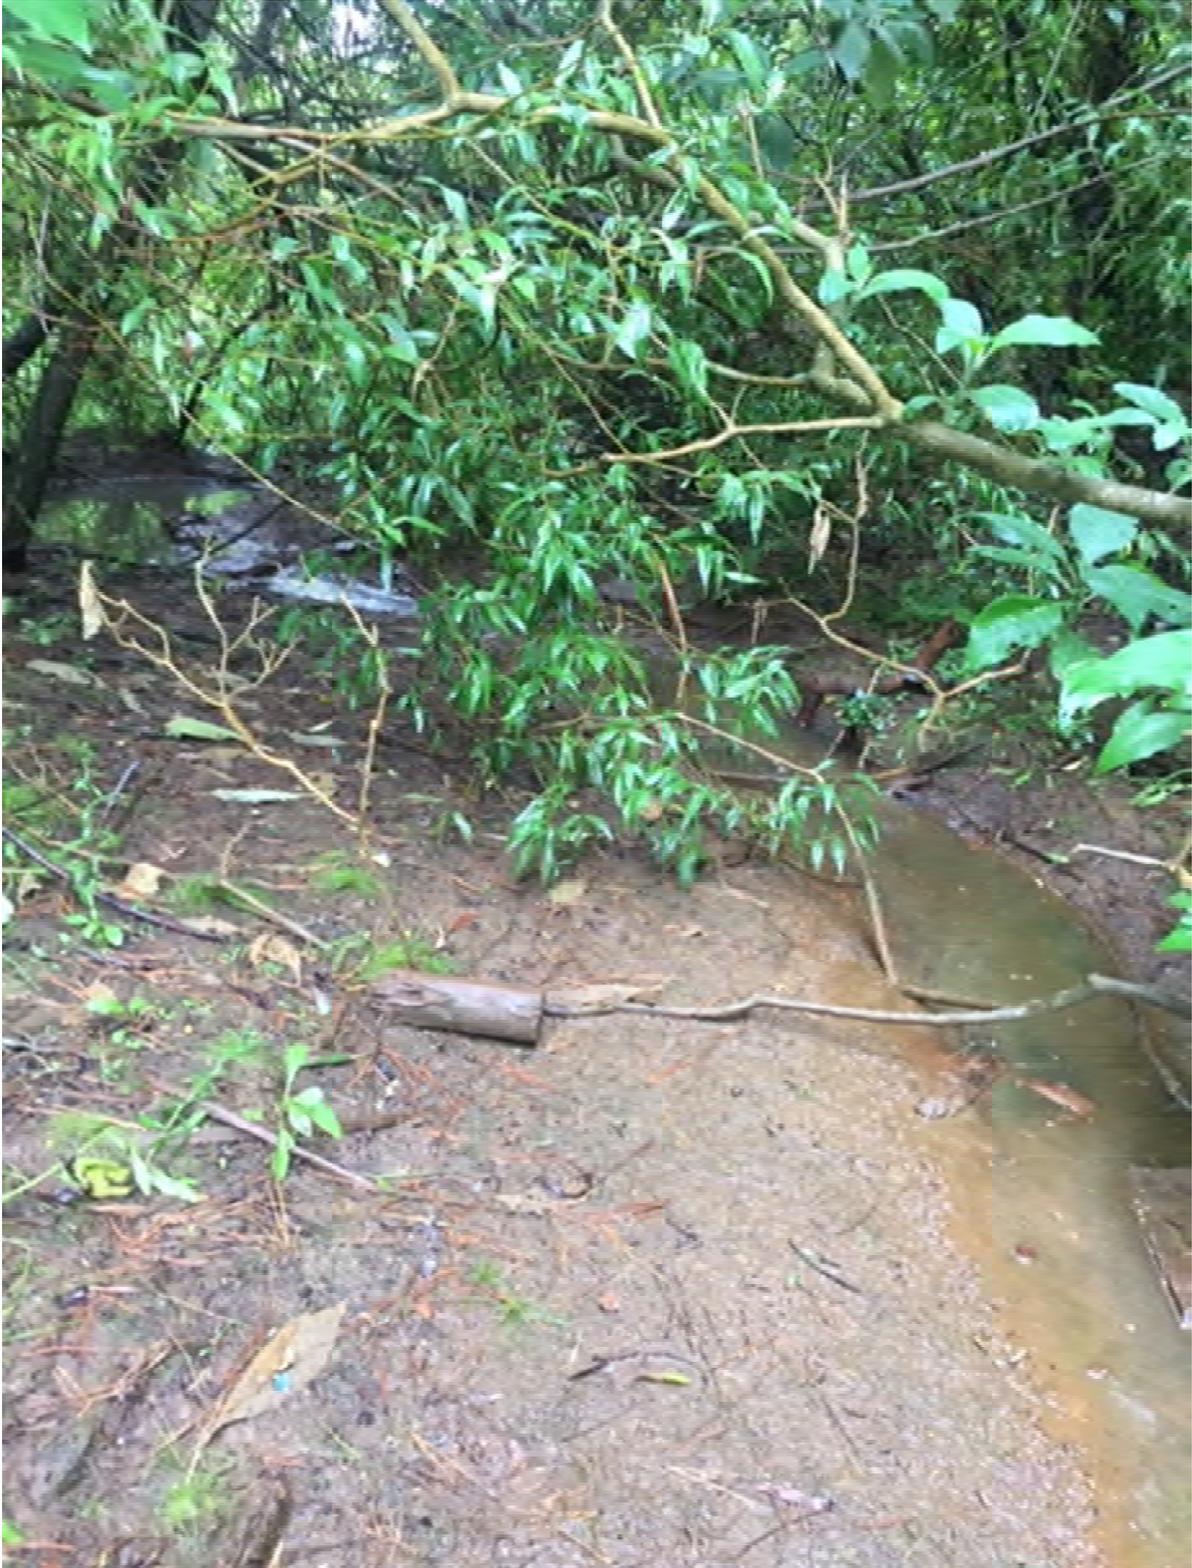
Photo 16 Silt in the western tributary below the small eastern silt pond, February 2019

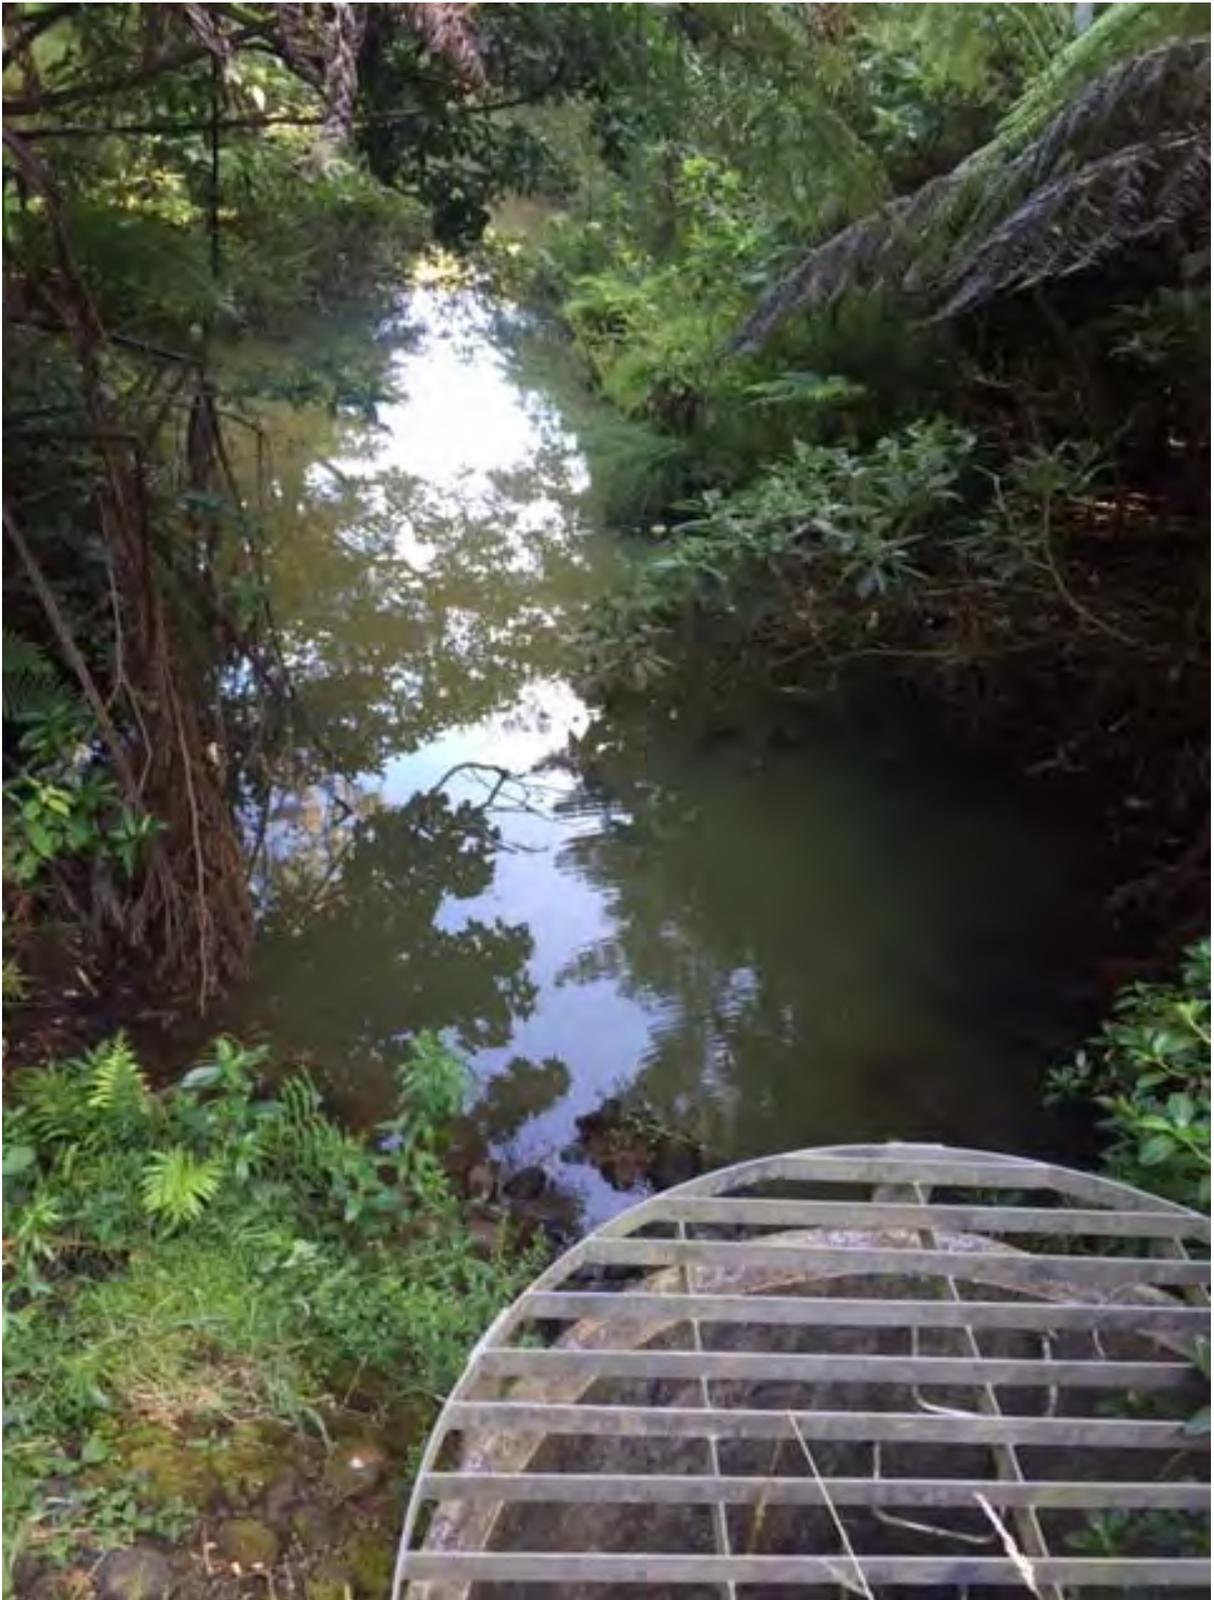
Photo 17 Widening of eastern tributary above wetland polishing area, Jan 2019

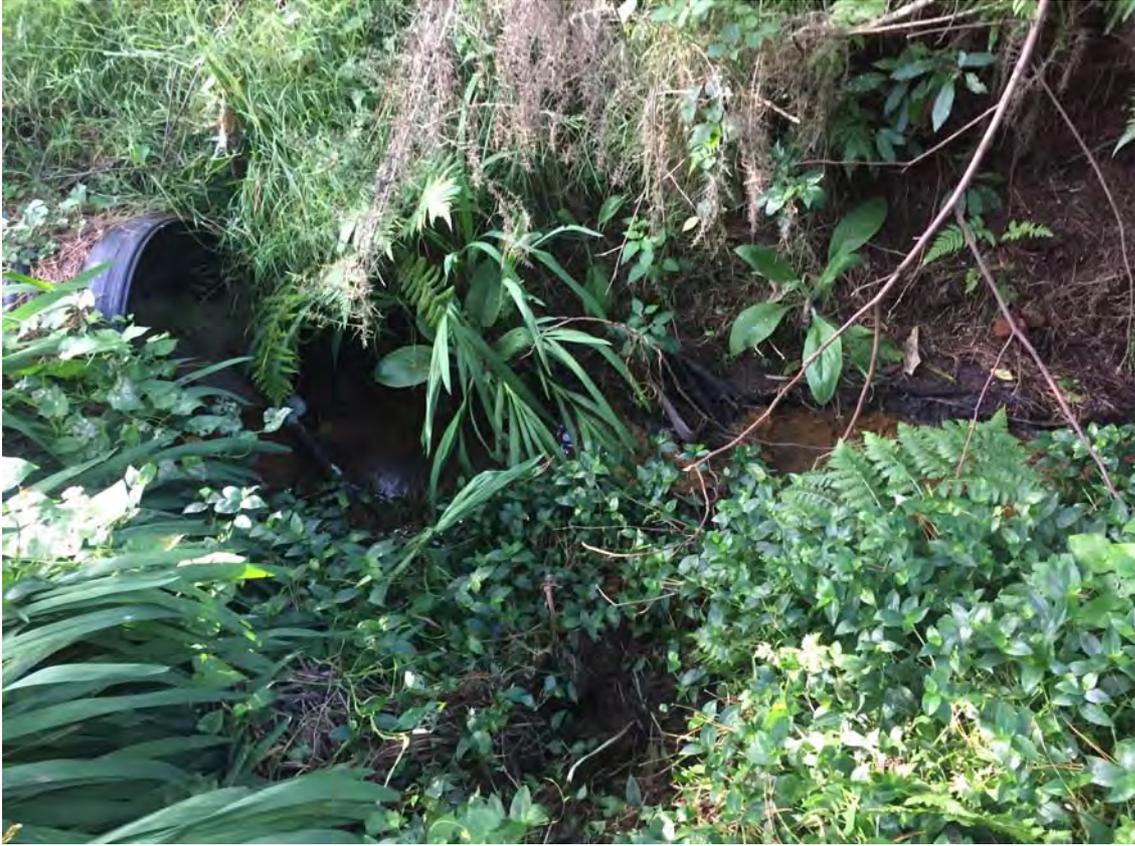
Photo 18 Flow in eastern tributary below wetland polishing area, Jan 2019

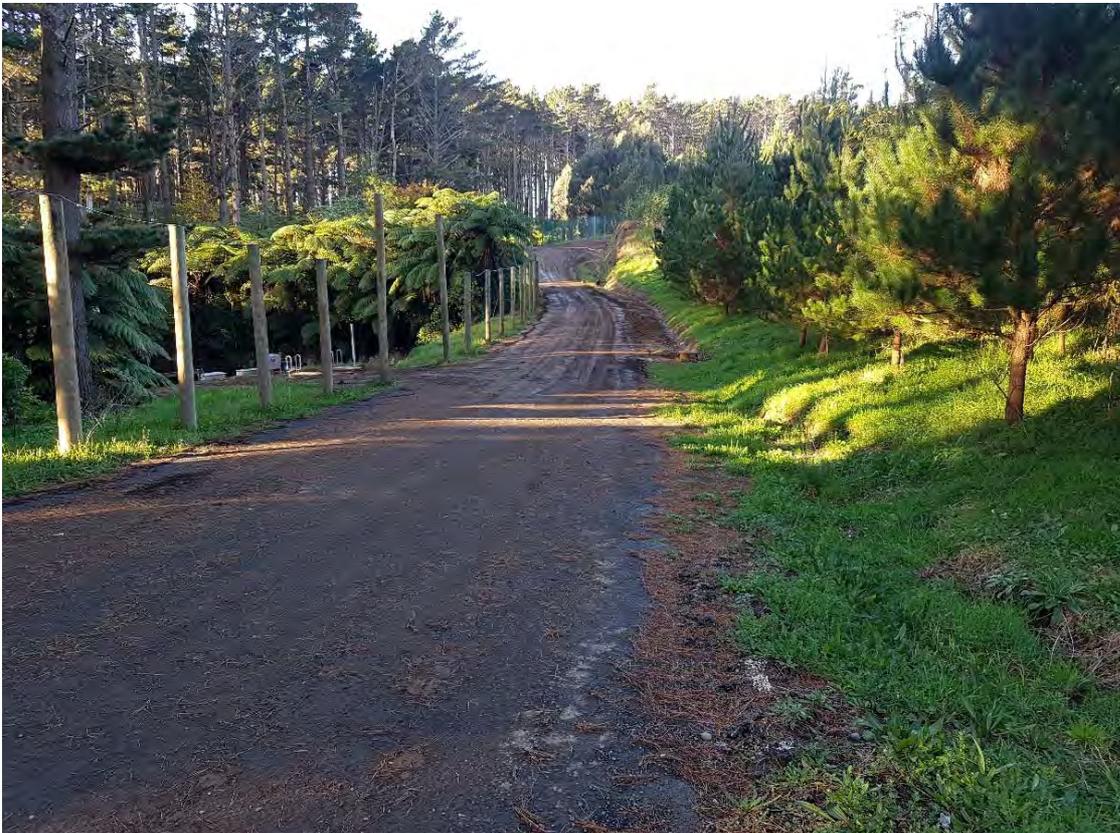
Photo 19 Silt on access road, 5 July 2017
