Stratford District Council  
Municipal oxidation ponds system  
Monitoring Programme  
Annual Report  
2013-2014

Technical Report 2014-14

July 2014

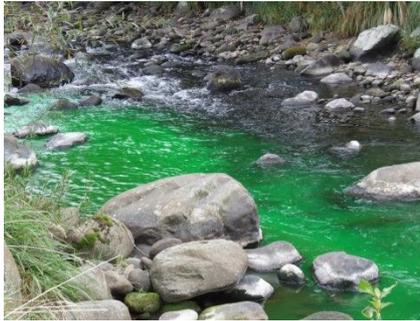
**Photo 2** Dye-tracing from the WWTP outfall into the Patea River, March 2014

The adequacy of the mixing characteristics within the consented 100 metres mixing zone of the river was confirmed by a fluorescein dye-tracing exercise undertaken on 28 March 2014 under relatively low river flow conditions (Skinner Road recorder flow: 0.495 m<sup>3</sup>/s). The dye tracer (Photo 1) indicated complete mixing

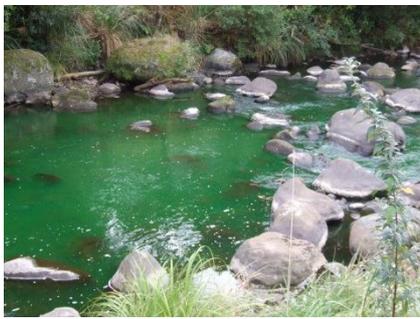
**Photo 2** Dye tracing in the Patea River at the boundary of the mixing zone, March 2014

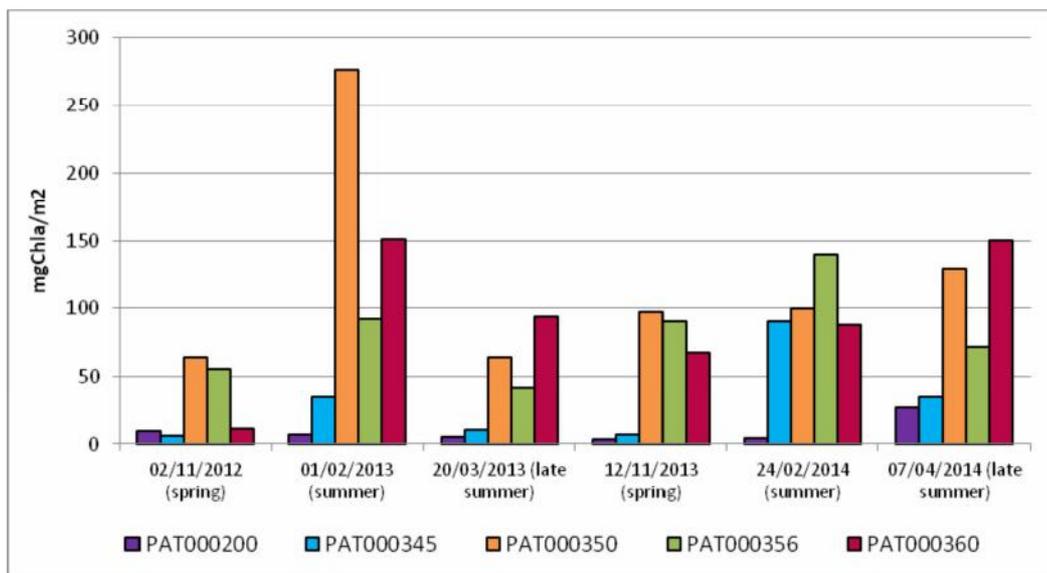
This illustrates (Figure 3) the impact of the WWTP discharge (between sites PAT000345 and PAT000350) upon the streambed periphyton cover in the mid reaches of the Patea River in each of the two periods.

**Figure 2** Chlorophyll-a concentrations in the Patea River for the spring 2012 to late summer 2013 and spring 2013 to autumn 2014 periods
