6 May 2008

Document: 452953

Patea Freezing Works – Inspection of tanks and vessels

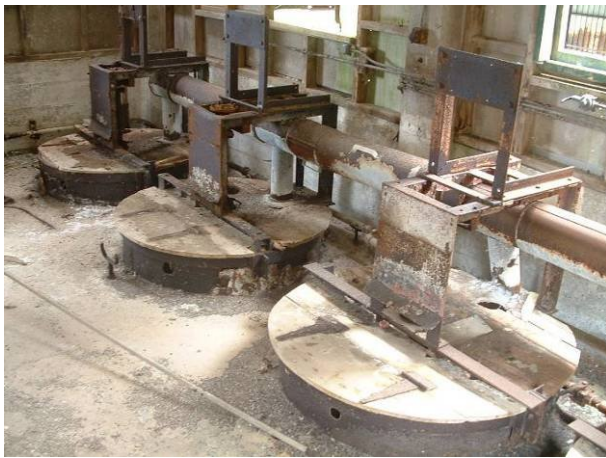
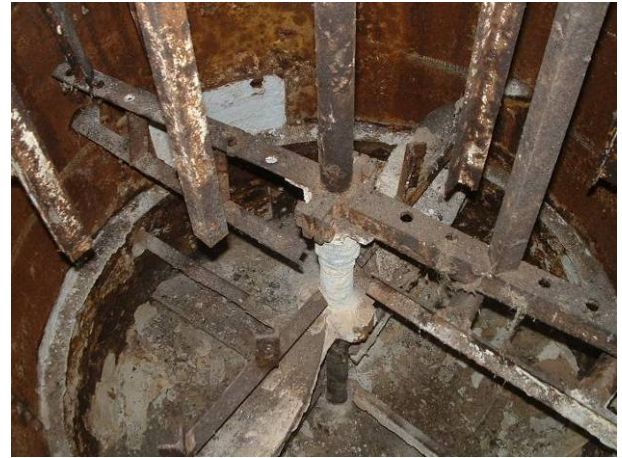
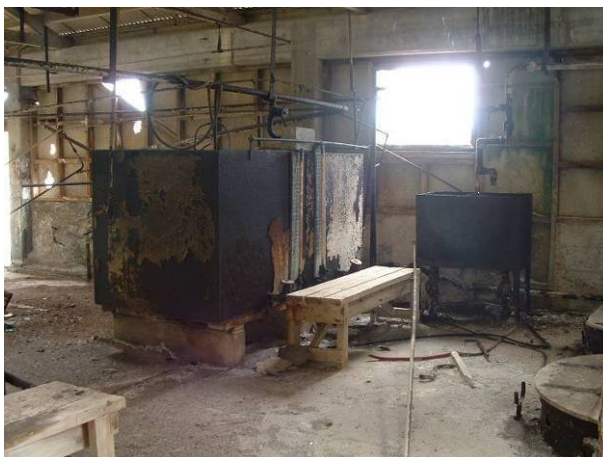
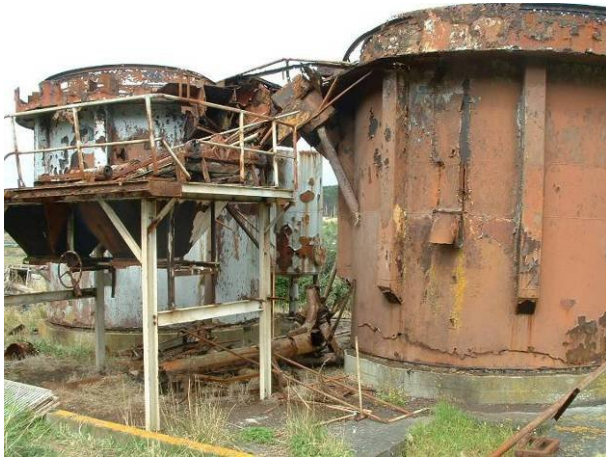
Fellmongery - Paint Mix Room, 2 x 4 tanks, all empty but contain some residues of white powder/rust.

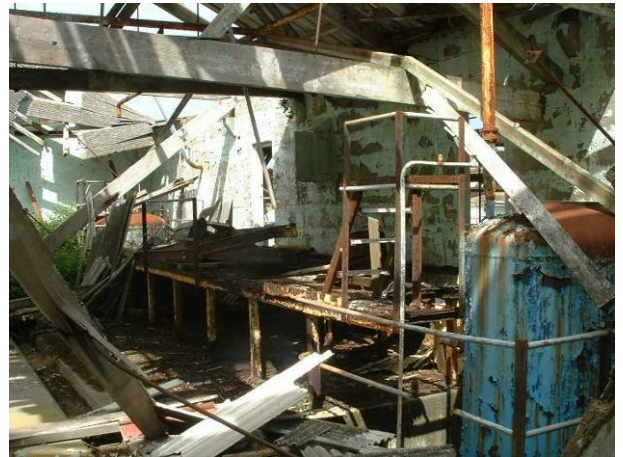
Effluent Treatment Plant

3 vessels, completely rusted through at the base, empty.

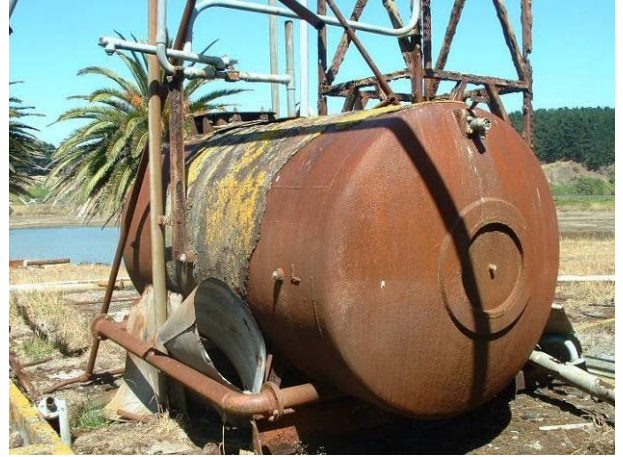
Slaughter House

No safe access.

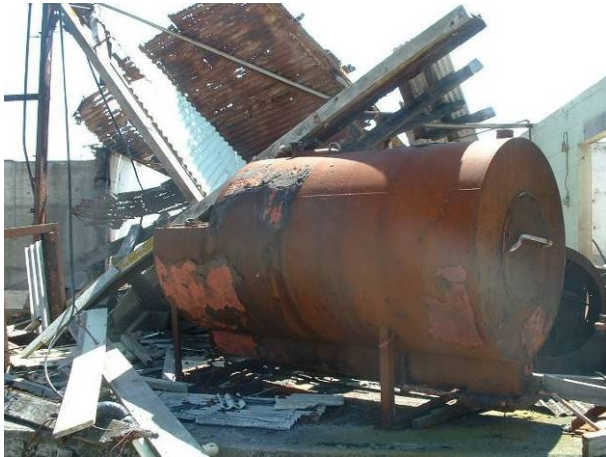
Boning Floor

At the base of stairs leading to Boning Floor, possibly a water heater, empty.
