**UNDER** the Resource Mangement Act 1991 ("RMA")  
**IN THE MATTER** of a resource consent application to the Taranaki Regional Council for the application by Remediation (NZ) Limited

**STATEMENT OF EVIDENCE OF HAYDEN RUSSELL EASTON ON BEHALF  
OF REMEDIATION NEW ZEALAND LIMITED**

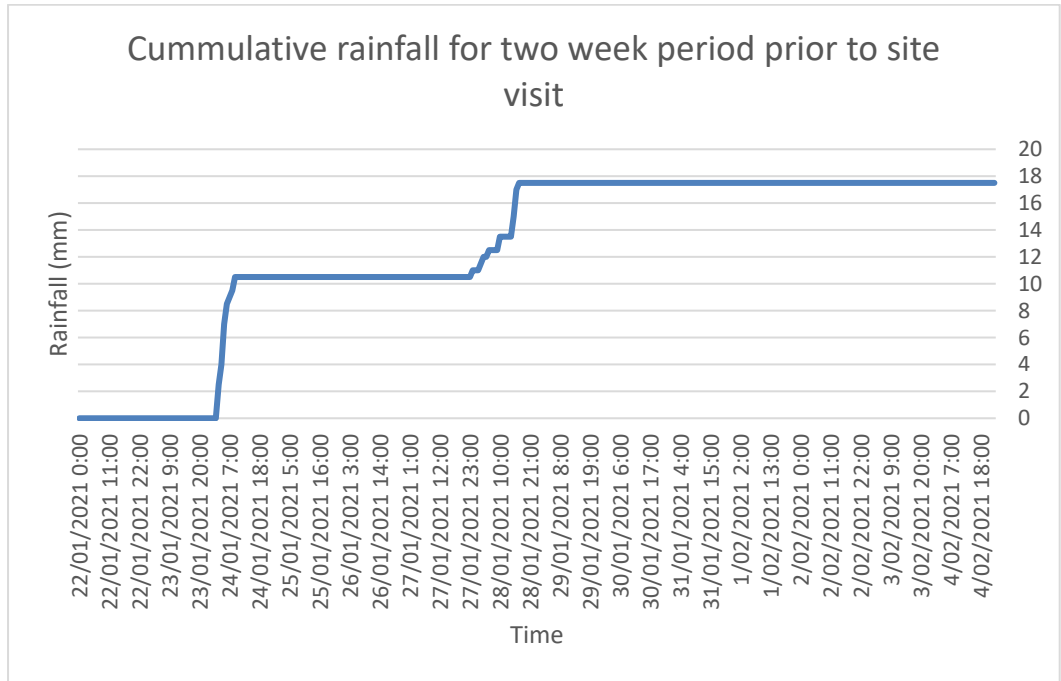
**Figure 1: Cummulative rainfall recorded at the Taranaki Regional Council operated rainfall station (Uruti @ Kaka Road) two weeks prior to my site visit conducted on 4 February 2021.**

4.4 As Figure 1 suggests, 17.5 mm of rainfall was measured at the Uruti @ Kaka Road rainfall monitoring site in the two weeks prior to my site visit. Specifically, no rainfall had occurred for six days prior to the site visit.

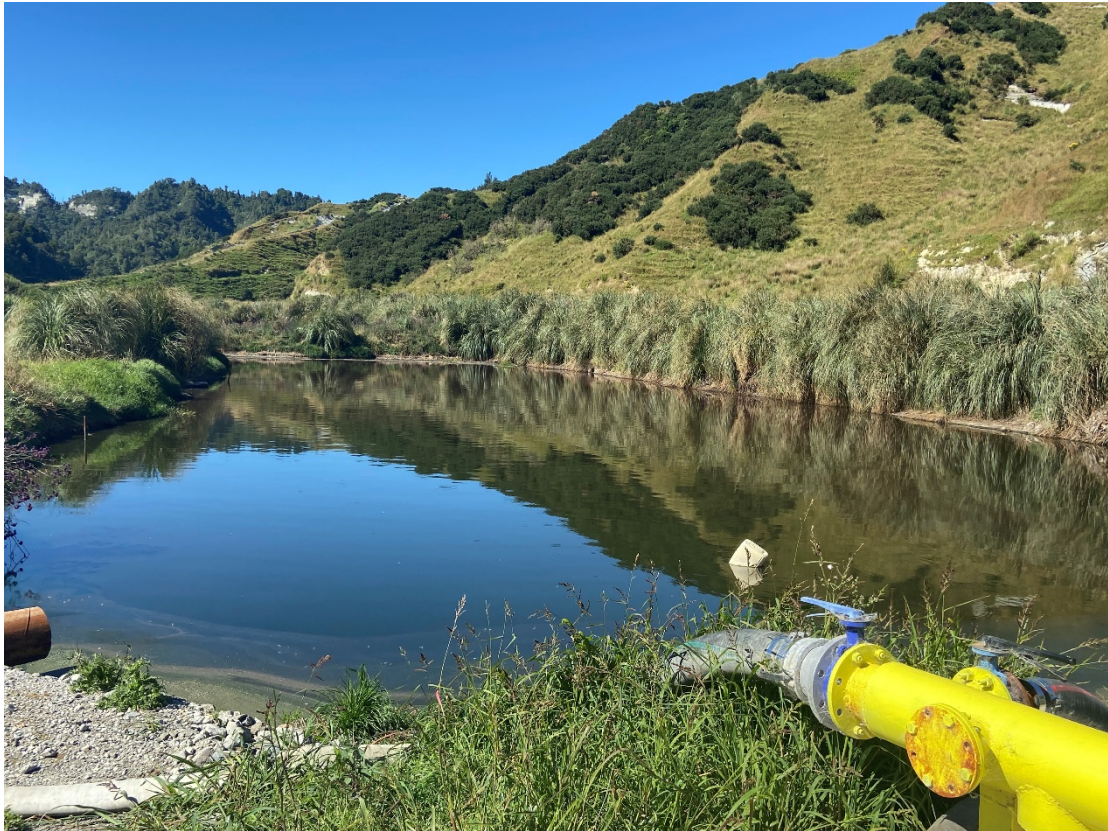
All ponds at the time of inspection were full of water. Antecedent rainfall conditions prior to the visit have been dry for many days. Based on data from the Uruti@Kaka Road rainfall monitoring station, operated by the Taranaki Regional Council (TRC), the last rainfall that occurred at the facility was on 28 January 2021 (a daily total of 7 mm). Only a total of 17.5 mm had fallen in the two weeks prior to the site visit.

BTW Company (2015) assessed the groundwater levels within the Haehanga catchment. The report in summary suggests that groundwater levels are approximately 0.81 metres below ground level. The report also comments that groundwater ingress into the ponds is a possibility. This groundwater ingress could be a possible explanation as to why pond levels were full when observed on site.

**Photograph 1: Irrigation Pond**

To ascertain the integrity of the liner, it is recommended that a permeability test be conducted. Engineering New Zealand guidelines (IPENZ, 2017) recommend that a clay liner should have a permeability no greater than  $1 \times 10^{-9}$  m/s. Should it be found that a liner has a permeability greater than  $1 \times 10^{-9}$  m/s, RNZ should install a new liner.

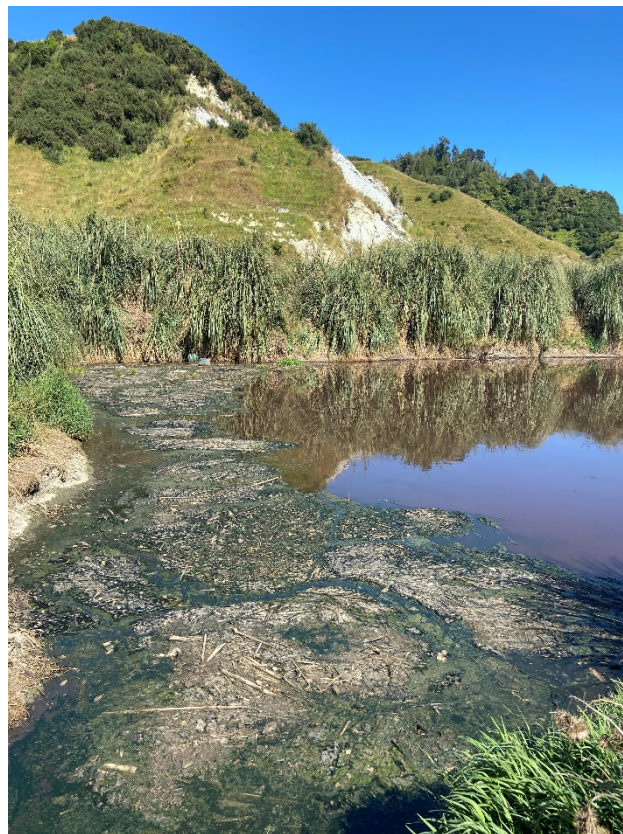
All four ponds were observed to have elevated algae populations on the date of inspection. The southernmost pond was also observed to have a large volume of sediment build up. Water in all ponds was very dark to black in colour and in areas was seen to be gassing. These observations are indicators that the ponds are likely to be in an anaerobic state.

**Photograph 2: Stormwater Treatment Pond with accumulated sediment**

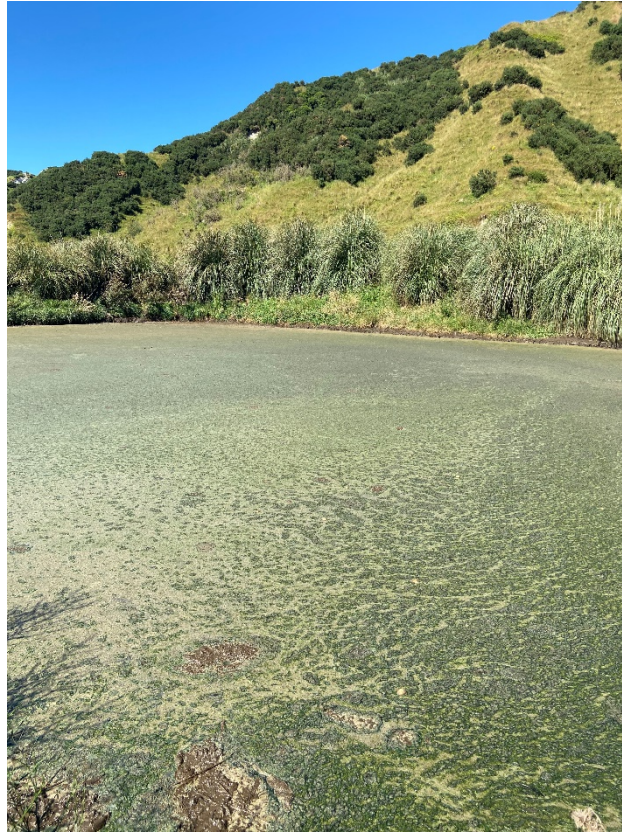
**Photograph 3: Stormwater Treatment pond with elevated algal population**

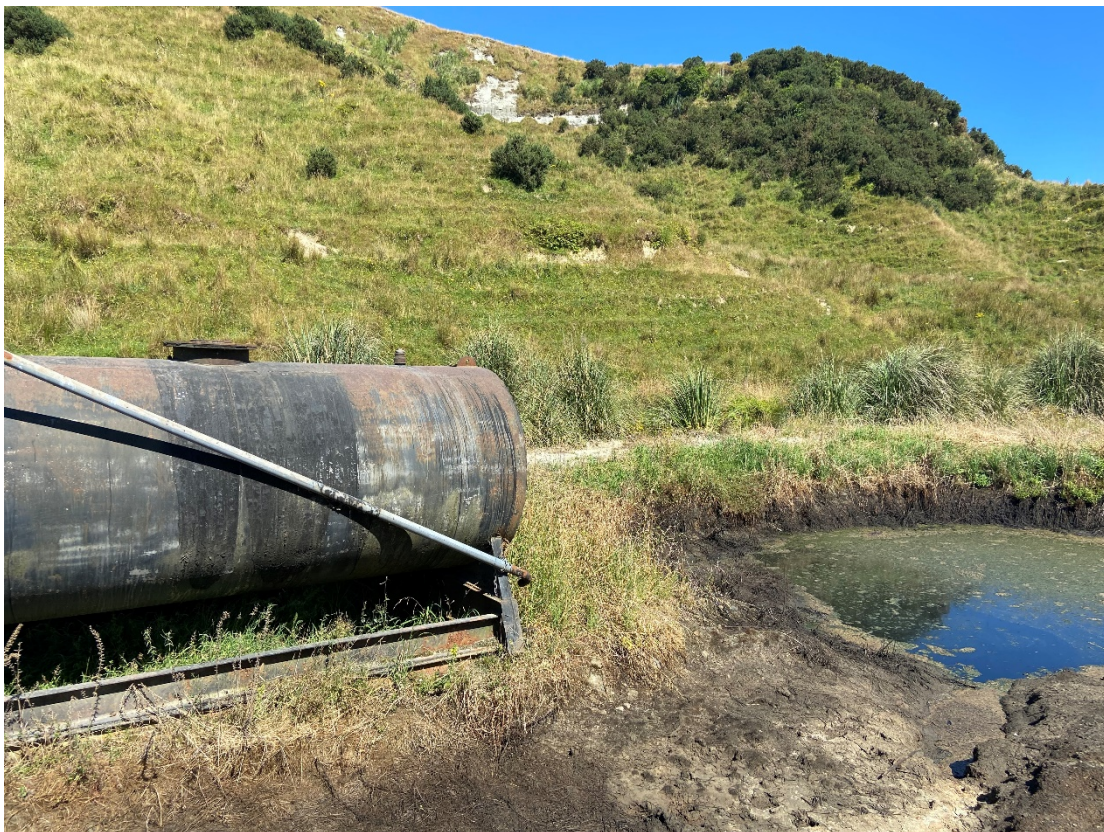
Directly adjacent to the first diesel tank, a ponding area/ditch had been dug. The ditch is connected to the southernmost pond (discussed above) via a pipe. Water was present within pond/ditch, most likely because it was hydraulically connected to the southern pond. Soils surrounding the ditch and leading back to the diesel tank were visually observed to be contaminated with hydrocarbons. PDP understands that Remediation NZ will rehabilitate the above described soils once the diesel tank is removed from facility.

**Photograph 4: Above Ground Diesel Storage Tank which will be removed from site**

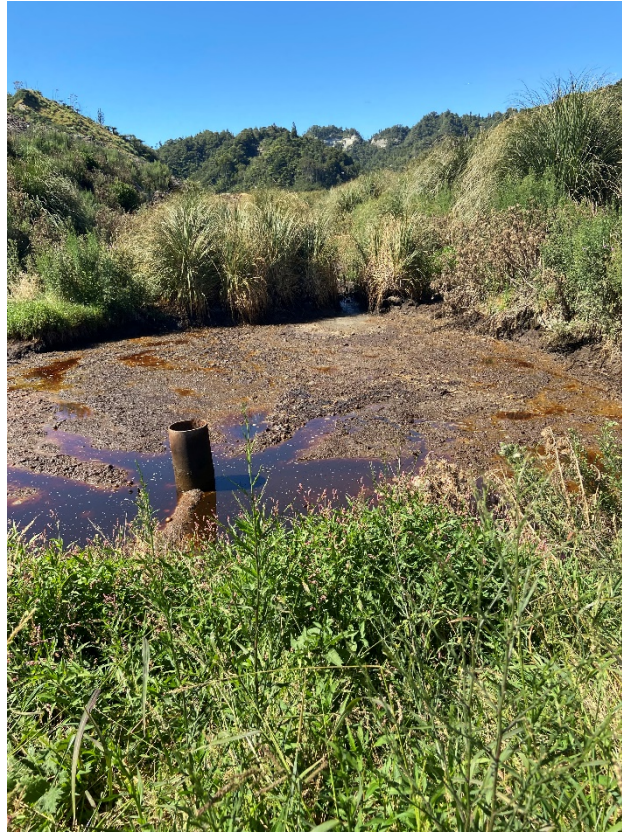
As discussed in section 2.1, hydrocarbons were observed within the southernmost pond at the time of inspection. Hydrocarbons were not seen in any downgradient pond. This is likely due to the configuration of the decanting outlet.

**Photograph 5: Stormwater Treatment Pond with accumulated hydrocarbon product**

- (d) Installation of an appropriate spill response kit at the used above ground diesel storage tank.
  - (e) Removal of accumulated hydrocarbon product within the stormwater treatment ponds.

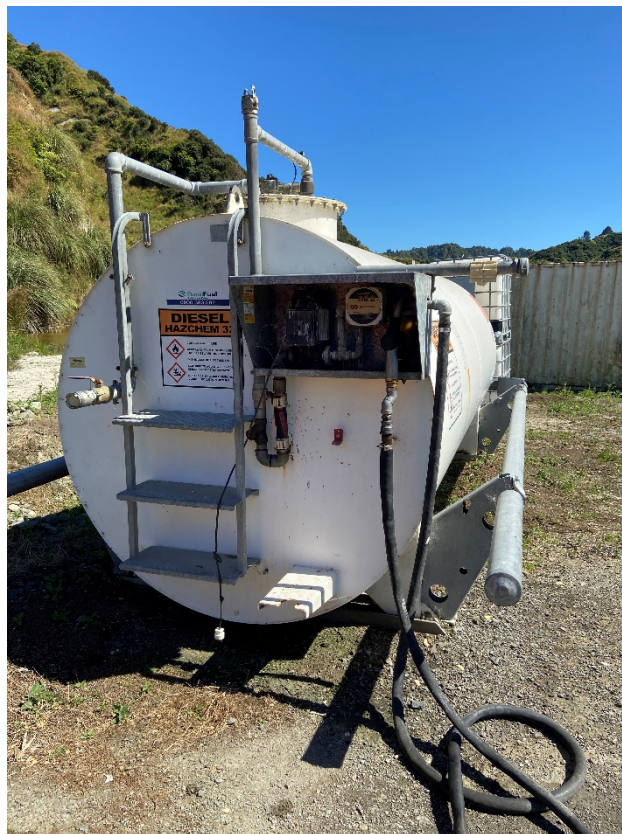
It was noted that there was not a spill kit present in close proximity to the second diesel tank at the time of inspection.

**Photograph 6: Above Ground Diesel Storage Tank which will remain onsite**

PDP understands from Remediation NZ that the direct area surrounding the second diesel tank (located west of the composting pad), is contoured to a drainage channel which then connects to the four ponds. Based on visual observation, the area is flat, but does have a slight gradient in a westerly directly, thereby confirming the comment made by Remediation NZ. In addition, it is understood that any mechanical repairs to vehicles/machinery is undertaken (where possible) adjacent to this diesel tank. As such, any spills that may occur during repairs, is contained within the ponds. It is strongly recommended however, that a spill response kit (with appropriate contents and size) is provided in the direct vicinity to this tank.

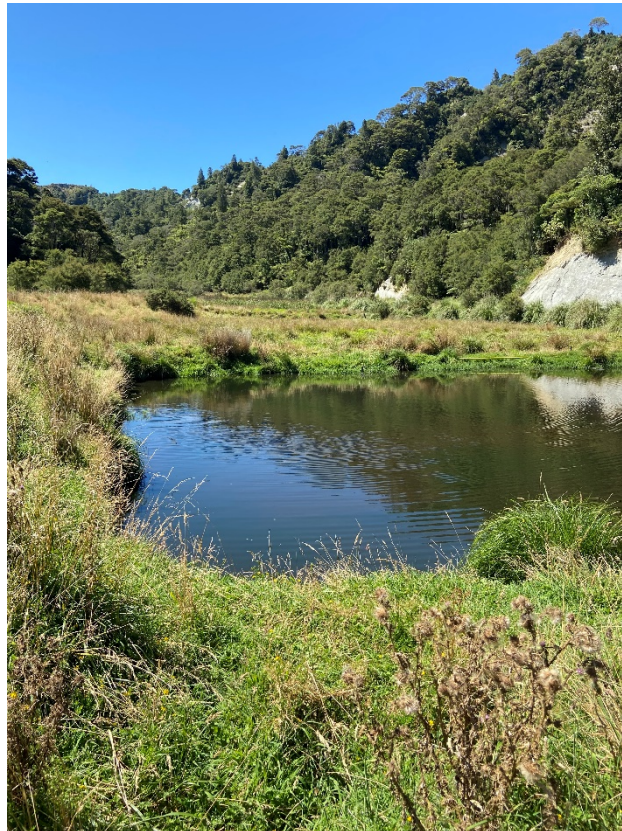
**Photograph 8: Paunch Pond**

The pond (which runoff from the paunch pad drains to) had visual sediment accumulation at the eastern banks. Oesophageal tube clips were also observed to be present within this pond.

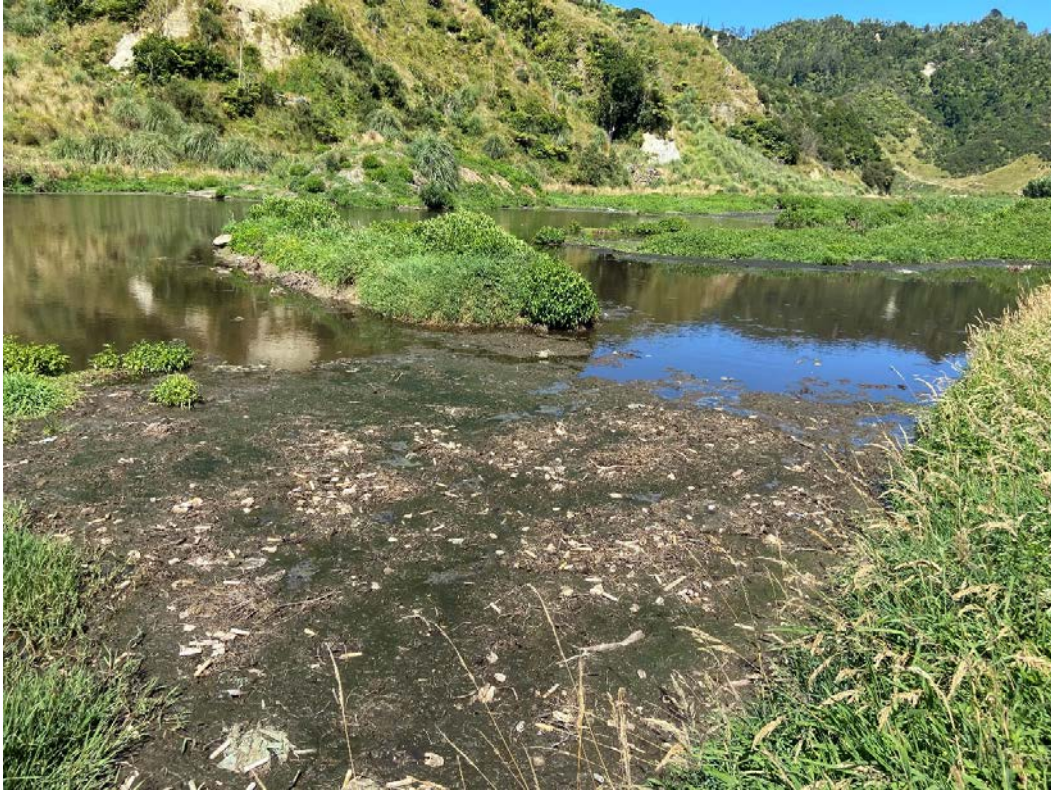
The paunch pond is currently subjected to accumulated sediment and gross pollutants (oesophageal tube clips). PDP suggest that as part of Remediation NZ's routine monitoring programme, that observations be conducted of the paunch pond to identify the future presence of oesophageal tube clips. If found to be present, oesophageal tube clips are to be collected and disposed of appropriately.

**Photograph 9: Paunch Pond with accumulated sediment and oesophageal tubes**

PDP also recommend the dredging of the paunch pond to remove accumulated sediments.

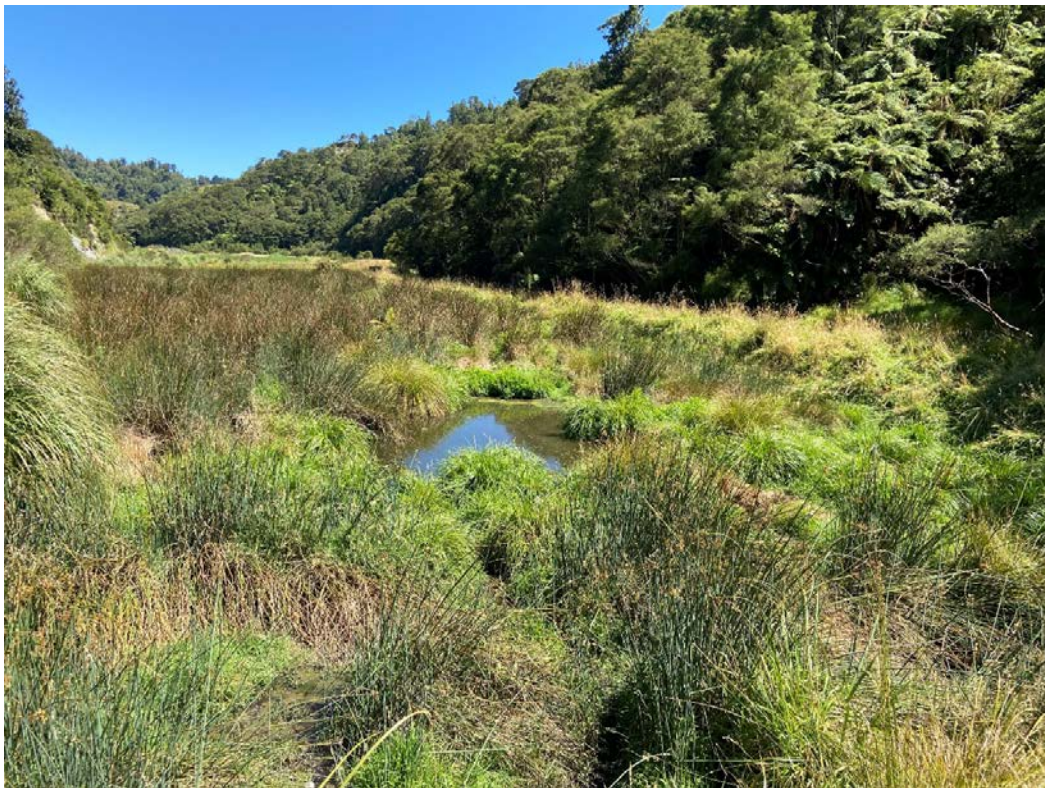
**Photograph 10: Wetland looking west (Baumea species)**

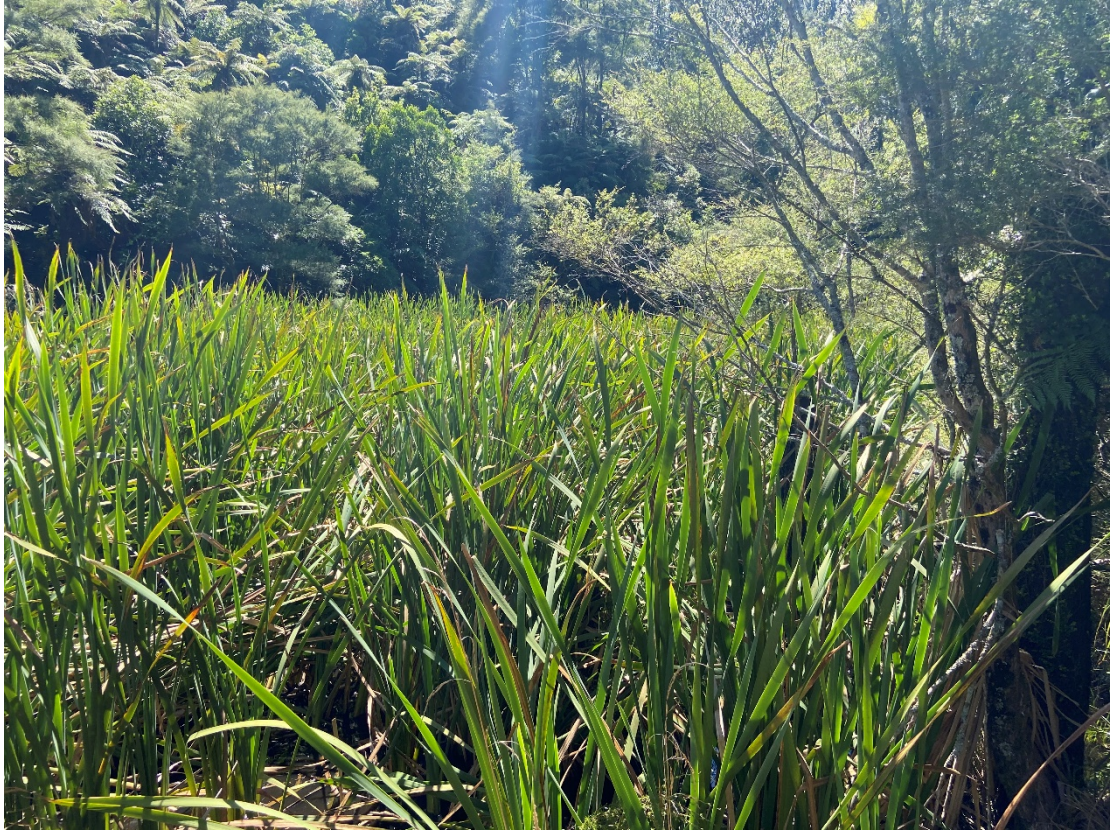
**Photograph 11: Wetland looking east (Raupo)**
