Hydraulic and Geotechnical
Assessment – Riley Consultants
Limited

MOTUKAWA RACE HYDRAULIC AND GEOTECHNICAL ASSESSMENT MOTUKAWA HYDRO-ELECTRIC POWER SCHEME

Report prepared for: Trustpower Limited

Report reference: 18MTK-ENH-C

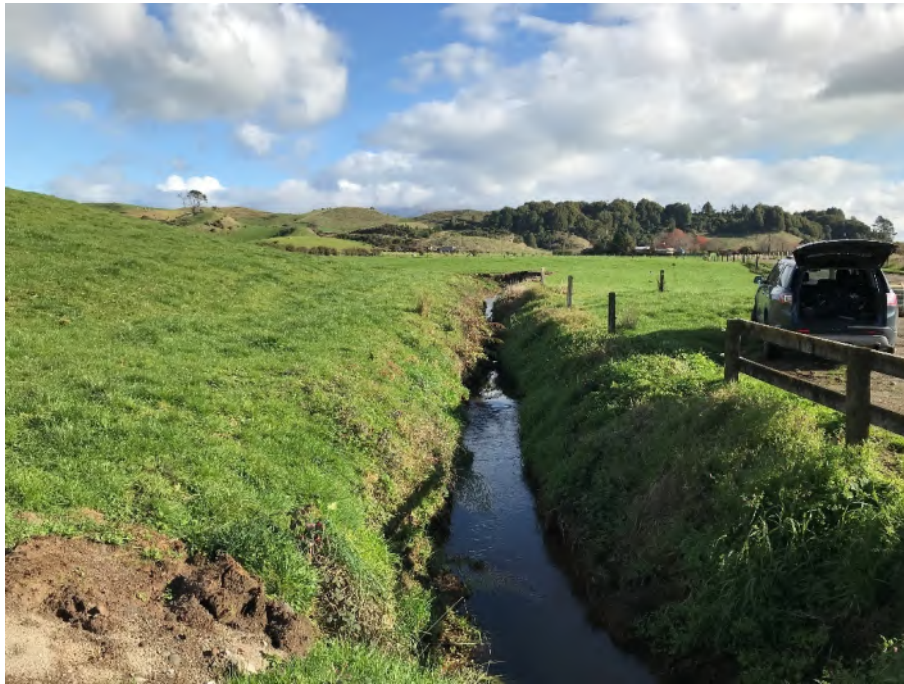
Photo 1: CH 1300m Tributary as viewed from just upstream of the confluence with the Race (June 2020).

The two largest tributaries that feed directly into the Race are at chainage (CH) 1300m (refer to Photo 1, 1.3km from the intake, Salisbury Drain immediately upstream of the Salisbury Road Culvert) and at CH 3400m (refer to Photo 2, 3.4km from the intake, unnamed drain upstream of Tunnel 2). Prior to the Race construction and modifications to the drainage system for farming purposes, these two tributaries were likely to have discharged to the Manganui River and the Mangaotea Stream, respectively.

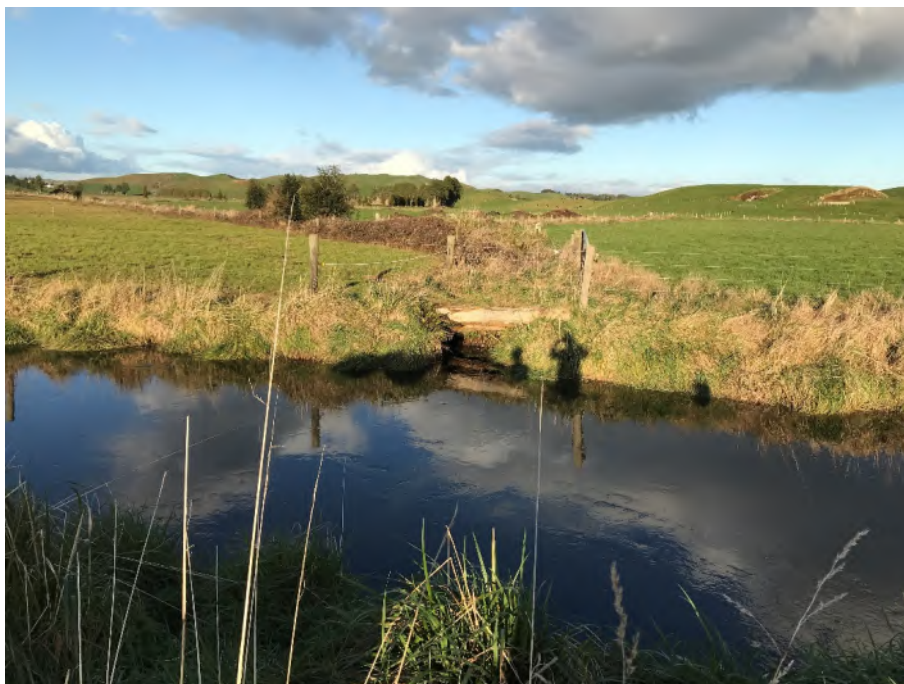
Photo 2: CH 3400m Tributary as viewed from left bank of the Race across to the right bank (June 2020).

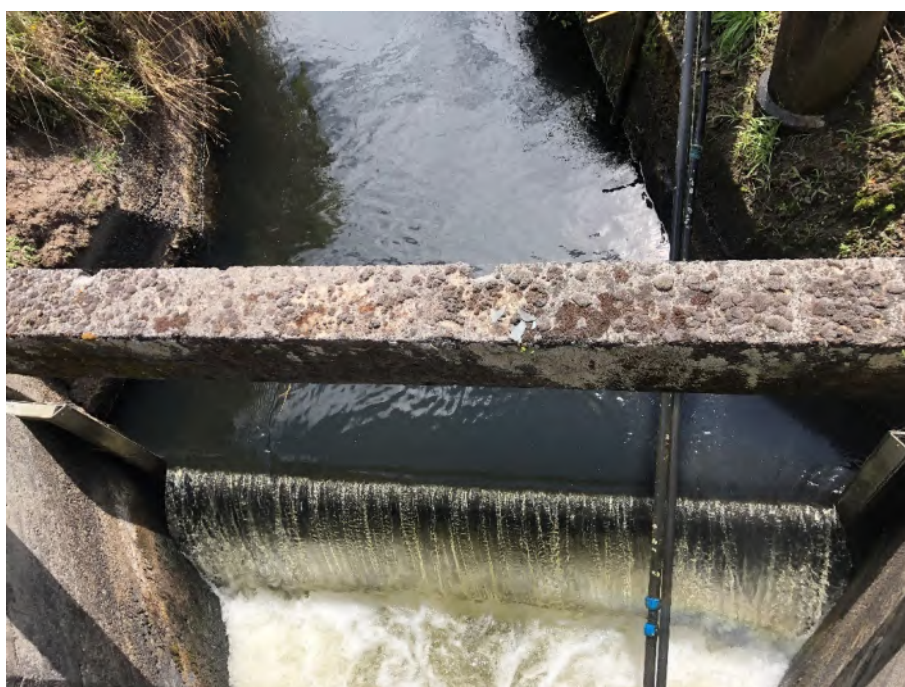
Photo 3: Flow over Tariki Weir (February 2019).

Observations on-site indicate that the Tariki Weir has a backwater effect well upstream of the weir. The weir currently acts as a flow control device to assist with upstream flow gauging. Removal of the weir would lower the water level upstream at a given flow. The weir has been removed previously on a temporary basis to lower the water level within the Sediment Pond (also known as Ayling’s Pond, located upstream of the weir) during maintenance works. We understand the weir consists of a steel plate and can be lifted out with a Hiab (a crane truck). Photo 3 shows the water level drop over the weir.

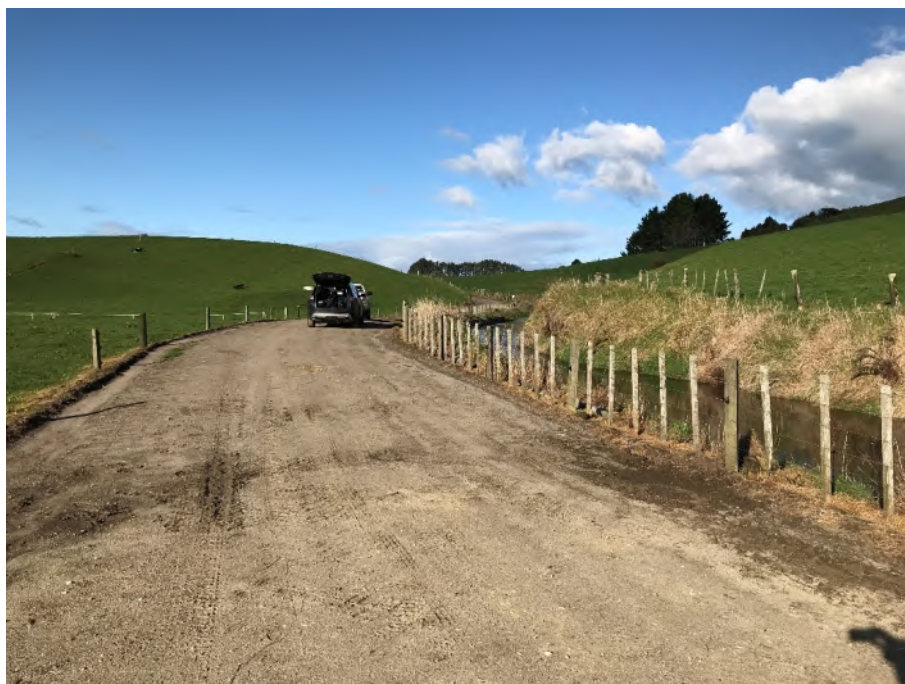
Photo 4: View downstream from CH 1830m (June 2020). The freeboard at the time of the inspection was estimated to be 400mm on the true left bank. The paddock to the left of the farm track is lower than the track. The low point in the track is evident in the lower to centre part of the photo. The vehicles are parked at the high point on the track.

Chainage (m)	Comment
1800 – 1850	Within reach upstream of Tunnel 1. June 2020 inspection indicated that existing freeboard is in the order of 400mm at a low point on the true left bank, over a length of approximately 50m (refer to Photo 4). This low point is also evident from the LiDAR. The paddock beyond the bank is lower than the bank and therefore, consideration will need to be given to farm drainage if the Race bank is raised at this location.
2570 – 2740	Within reach upstream of Mangaotea Road culvert. June 2020 inspection indicated that race bank stability works have been undertaken in the time since the LiDAR (used in the hydraulic modelling) was undertaken. These stability works have modified some of the ground levels adjacent to the Race and improved freeboard to typically 900mm (refer Photo 5). Some further filling behind the new timber wall may be required to improve security of freeboard.

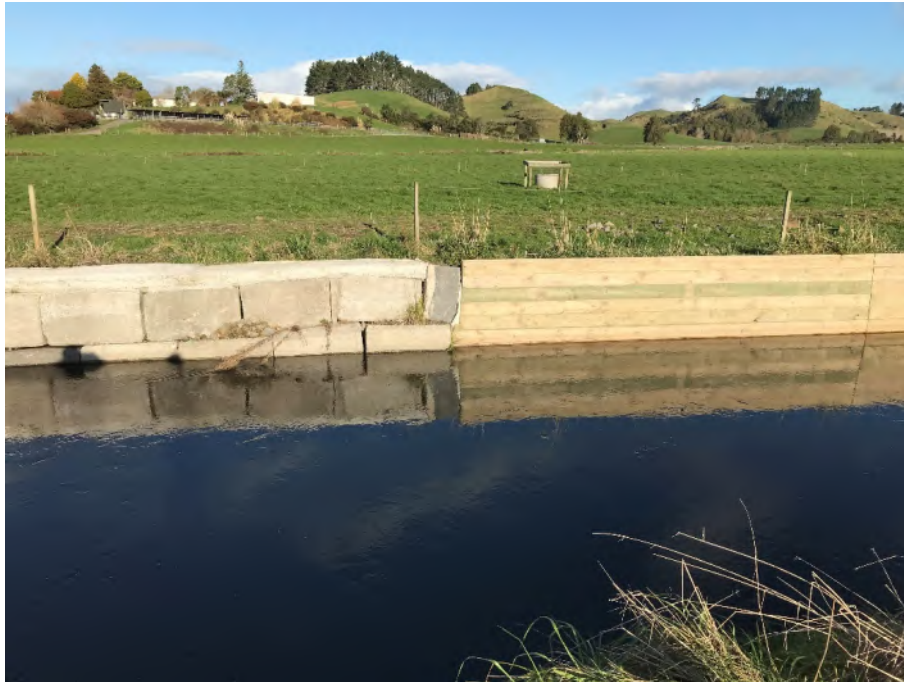
Photo 5: 900mm freeboard at CH 2660m on true left bank (June 2020). Note that the timber wall appears to extend above ground levels behind. Timber board are 150mm deep and the concrete blocks in the order of 600mm high.

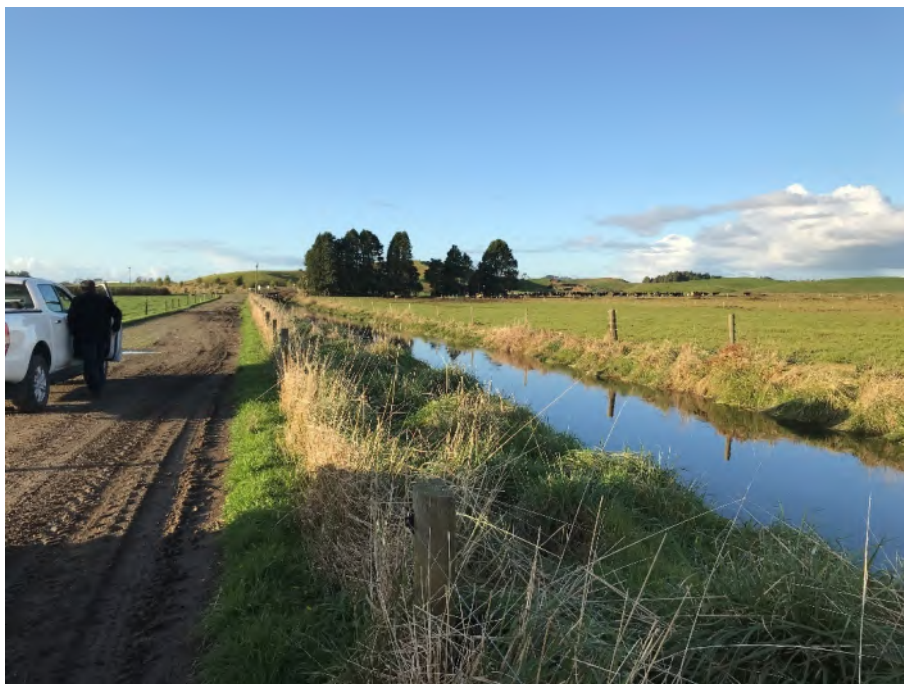
Photo 6: View downstream from CH 3400m (June 2020). The Race freeboard at the time of the inspection was estimated to be as low as 600mm on the true right bank. The ground levels in the paddocks beyond the right bank rise slowly. The true left bank (farm track) is significantly higher.

3040 – 3400	Within reach upstream of Tunnel 2 on true right side. June 2020 inspection confirmed that the true right side appeared to have a freeboard of as low as 600mm to the top of the bank at the time of the inspection (refer to Photo 6). We note that the lake level was approximately RL 198.4m at the time (300mm below maximum normal operating level), and that the proposed 7.5m ³ /s flow take will increase water levels in the order of 300mm. Ground levels do rise slightly further into the paddock, so any overtopping issues are likely to be localised to the edges of the Race/paddock.

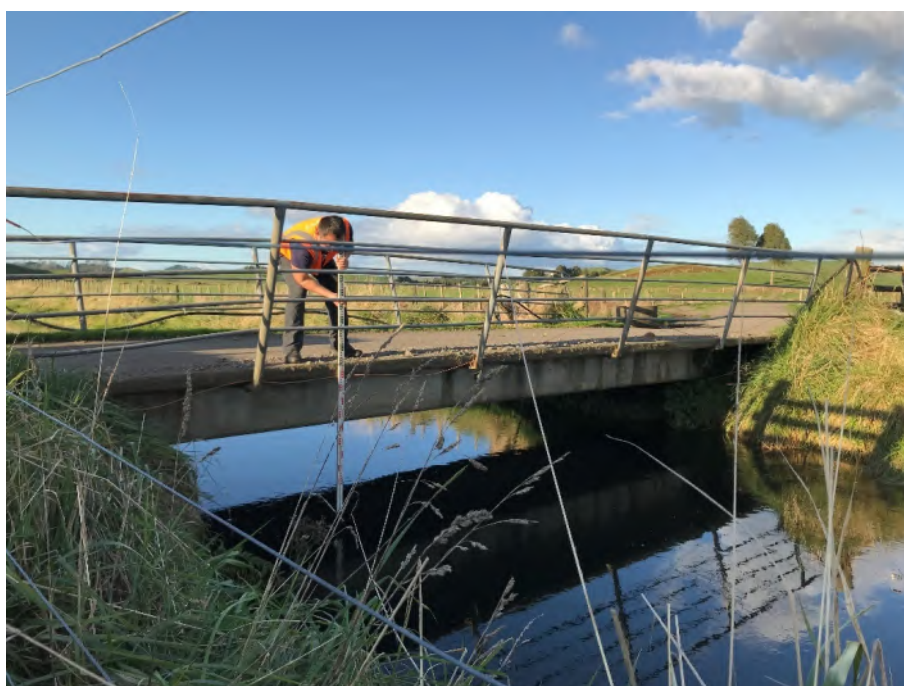
Photo 7: Lower Mangaotea Bridge with freeboard of 700mm (June 2020, lake level RL 198.4m).

The one exception is at the Lower Mangaotea Bridge, where the modelled freeboard is approximately 290mm for the lower race losses scenario (refer to Photo 7). This is slightly less than the adopted performance criteria of not less than 300mm but is well within modelling tolerances. We note that, during the June 2020 inspection, a freeboard of 700mm was measured with the lake level at RL 198.4m. These site observations align with the increased flow model results and a lake level at RL 198.7m.

If race losses were closer to the high end ($n = 0.025$) the results indicate some work is likely to be required in the vicinity of the Lower Mangaotea Bridge if a flow of 7.5m³/s is to be achieved.

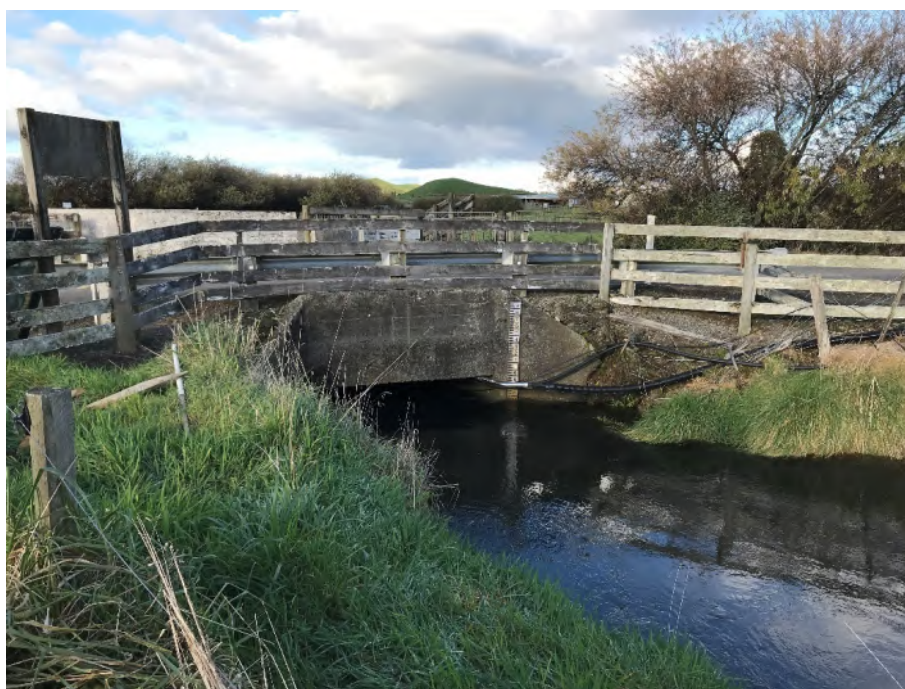
Photo 8: Mangaotea Road Culvert entrance (June 2020).

The model results presented within Table 11 indicate that, for the low losses scenario, the Mangaotea Road culvert will come close to being surcharged with a maximum abstraction flow of 7.5m³/s (and a lake level of RL 198.7m). The other two culverts along the Race meet performance criteria. During the June 2020 inspection (refer Photo 8), we observed a freeboard of 350mm to the culvert obvert² (lake level RL 198.4m). At full supply lake level of RL 198.7m (i.e., 300mm higher), site observations confirm that the culvert is likely to become surcharged with any increase in flow above the existing maximum of 5.2m³/s.

For the higher race loss scenario, the Mangaotea Road Culvert can expect to become surcharged if no works are undertaken to improve hydraulic performance.

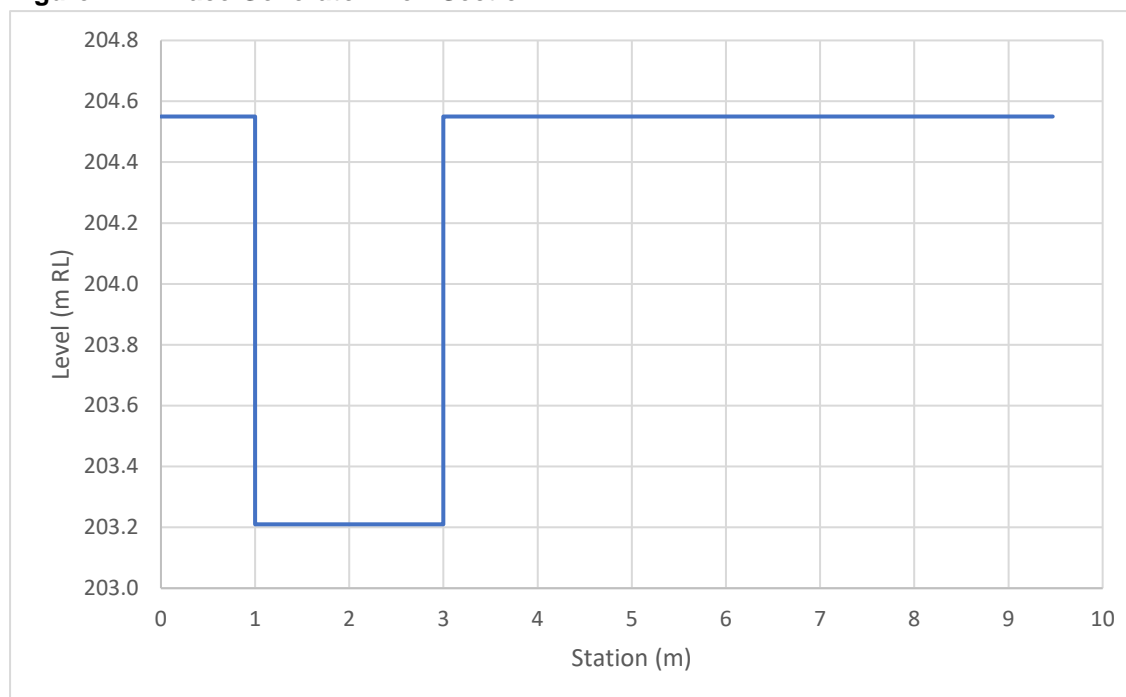
Figure 2: In Race Generator Weir Section

We have not been able to confirm the design upstream water level at the In Race Generator, while in generation. We have therefore, assumed that the weir controls the water level at the In Race Generator. We recommend that the influence of the In Race Generator is further investigated during future assessments.

We note that the race water levels downstream of the In Race Generator are affected by Lake Rataipiko water levels.

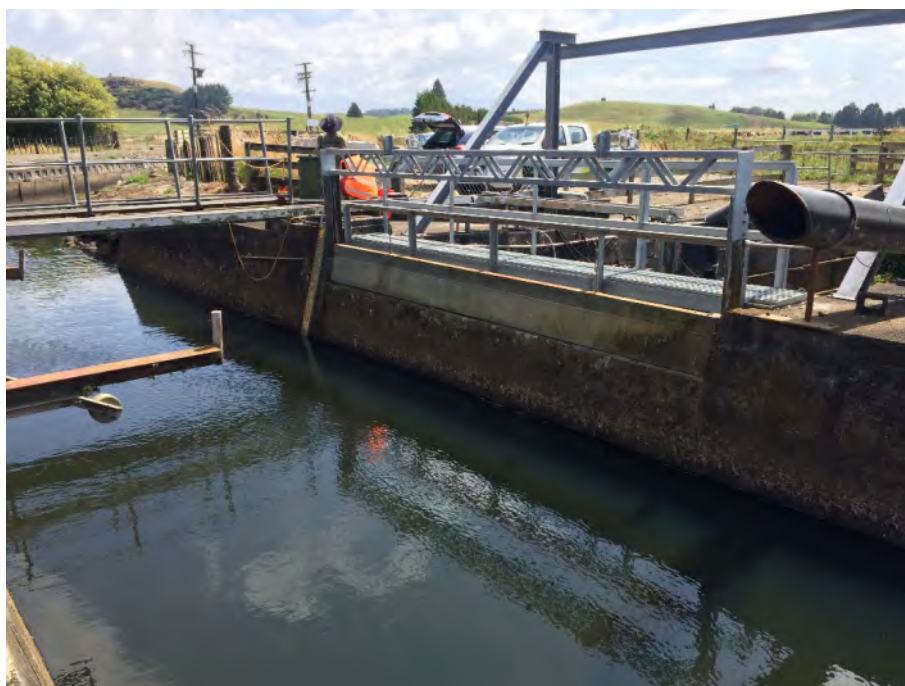
Photo 1: Mangaotea Aqueduct and Spillway Gate (February 2019)

We have modelled the Mangaotea Aqueduct bypass as an internal connection. The input parameters are presented with Table 8. The bypass consists of four separate box channels, separated by concrete walls. The size of each box channel was measured during the site inspection as 1250mm wide by 630mm high. For the purpose of this assessment, we have modelled the bypass as a single box culvert with a width of 5.00m. Within some model simulations we have assumed some blockages of the bypass by reducing the culvert width.

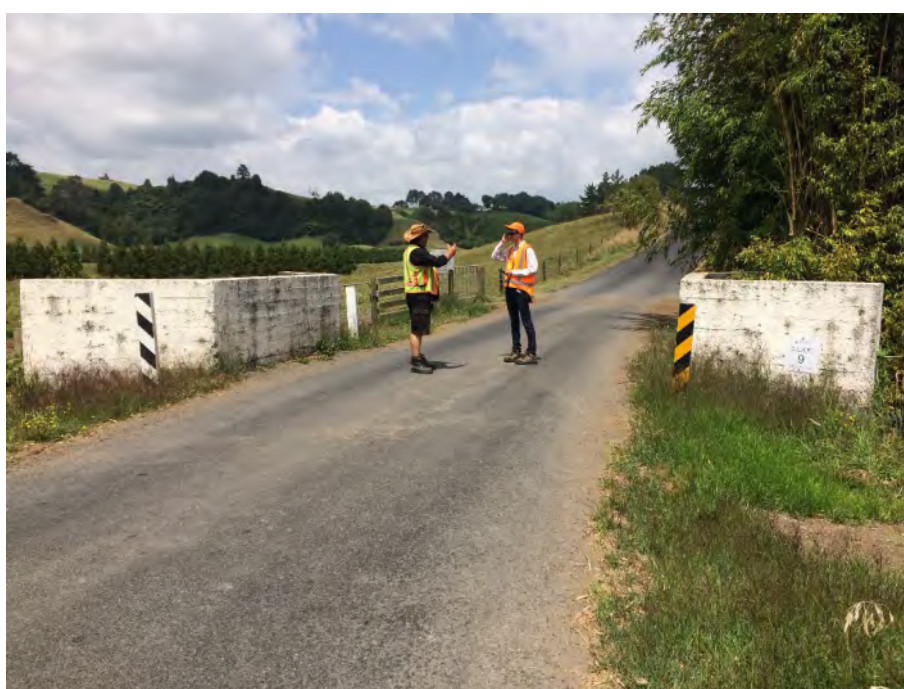
Photo 2: Salisbury Road Culvert. View towards the south along Salisbury Road

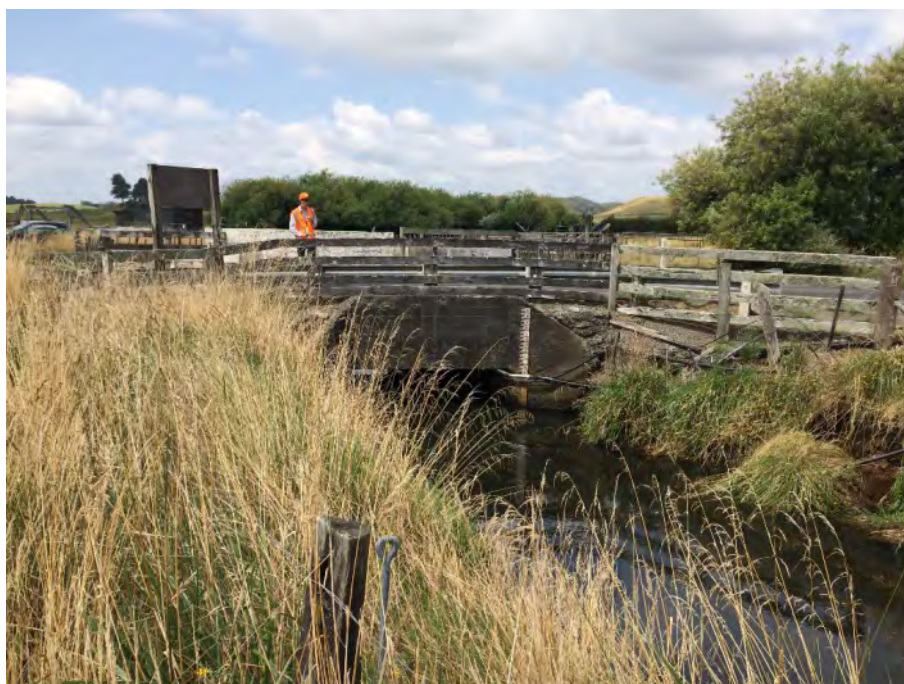
Photo 3: View downstream towards Mangaotea Road Culvert

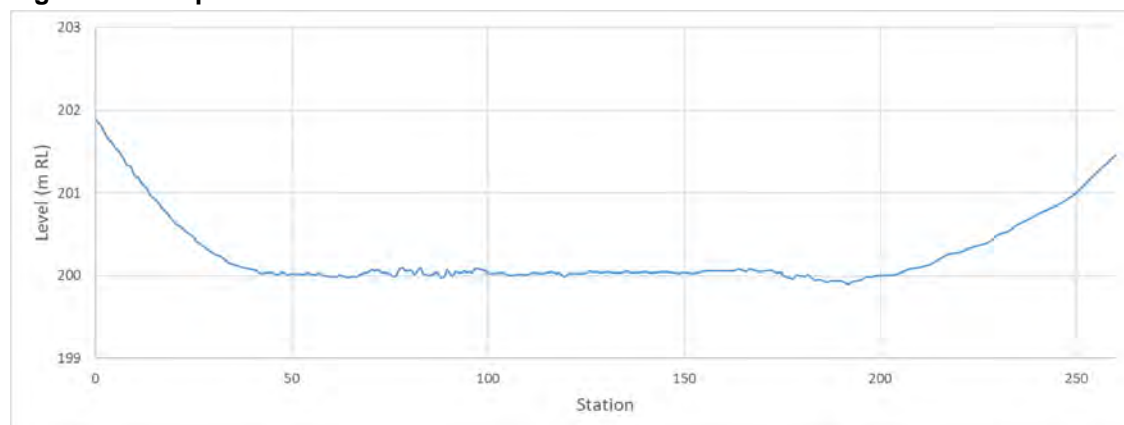
Figure 3: Ratapiko Road Weir Profile

We note that the 2018 LiDAR indicates that there is head loss of approximately 100mm across the Ratapiko Road culverts during normal operating conditions. We also note that potential blockage of the culverts has not been considered.

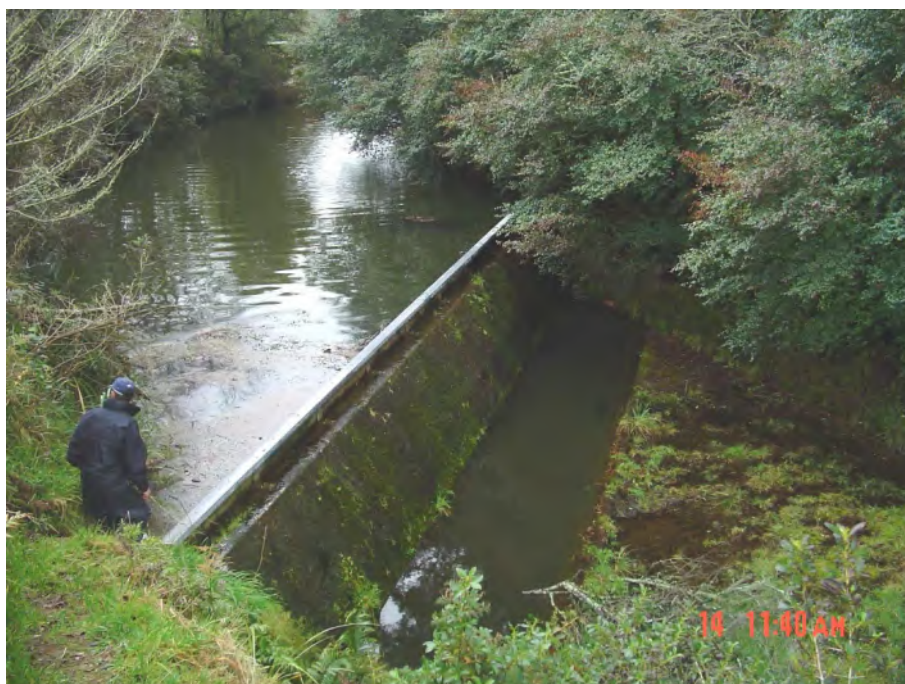
Photo 4: Service Spillway Flashboards (Photograph taken in 2004)

More recently, five tipping flashboards, each 3.9m long and 300mm high, were installed on top of the weir in 2014. A completion report for the installation of the flashboards was prepared by Pattle Delamore Partners Ltd in 2014. The report made recommendations regarding the testing of the flashboards. It is not clear if these recommendations have been undertaken. We recommend that testing of the flashboards is undertaken and documented if it has not been done already. It is also not clear from the report what the effective weir crest elevation is when the flashboards have tipped (i.e., the flashboard will lie across the concrete crest). We have assumed that the effective weir height when tipped is RL 198.47m (i.e., 100mm above the concrete crest), unless otherwise stated.

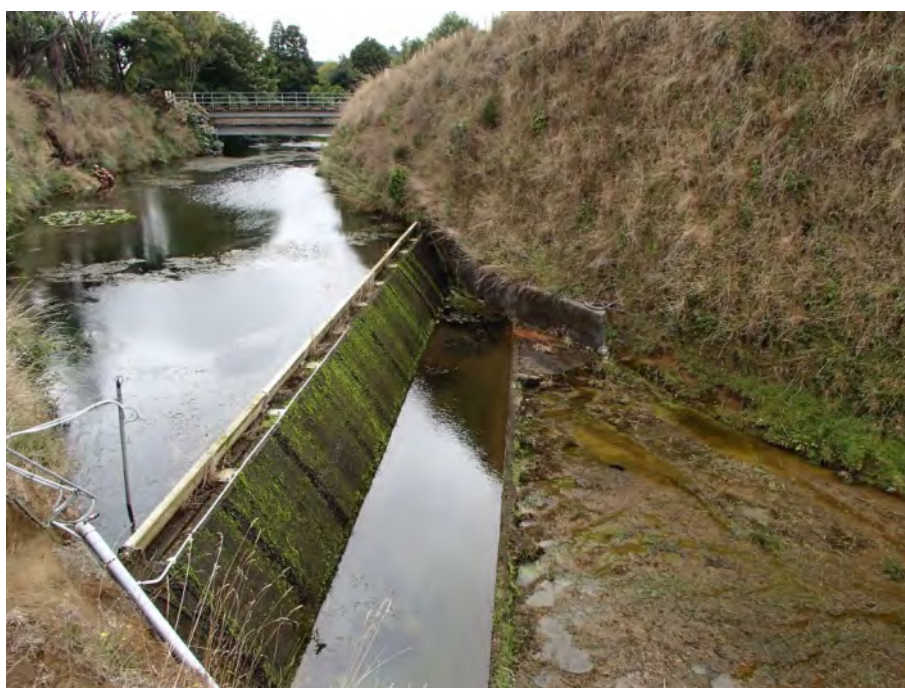
Photo 5: Service Spillway Flashboards (Photograph taken in 2016)

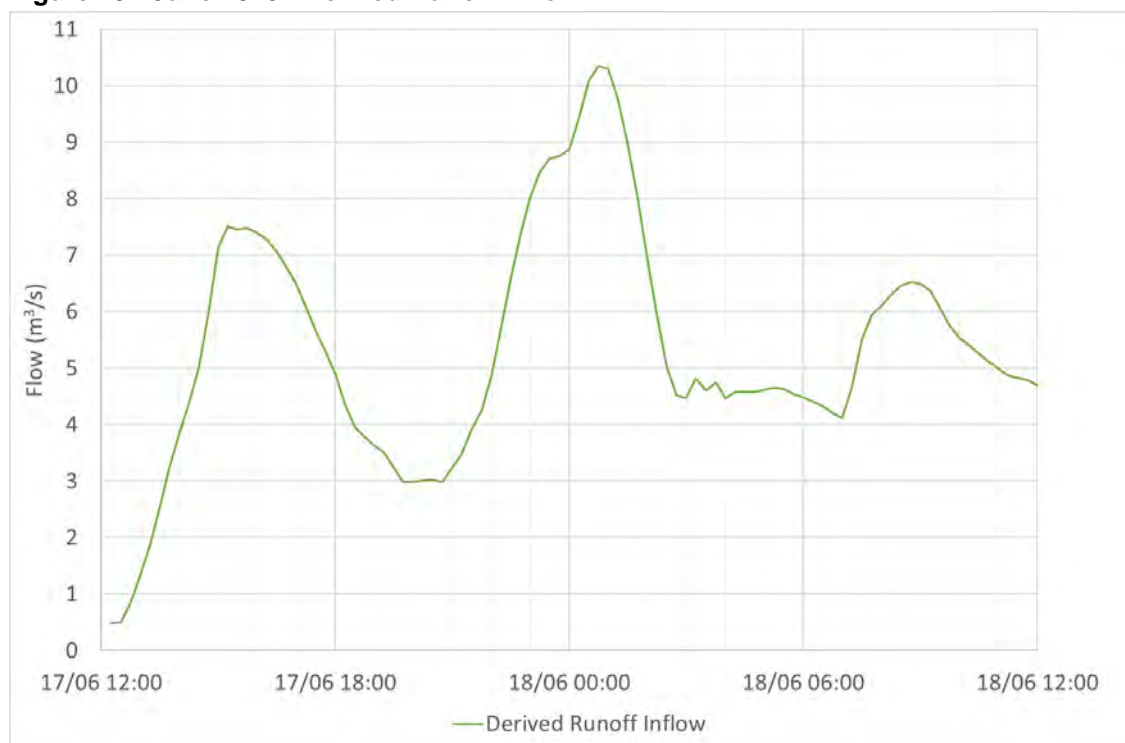
Figure 20: June 2013 - Derived Runoff Volume

Figure 20 presents the derived volumes.

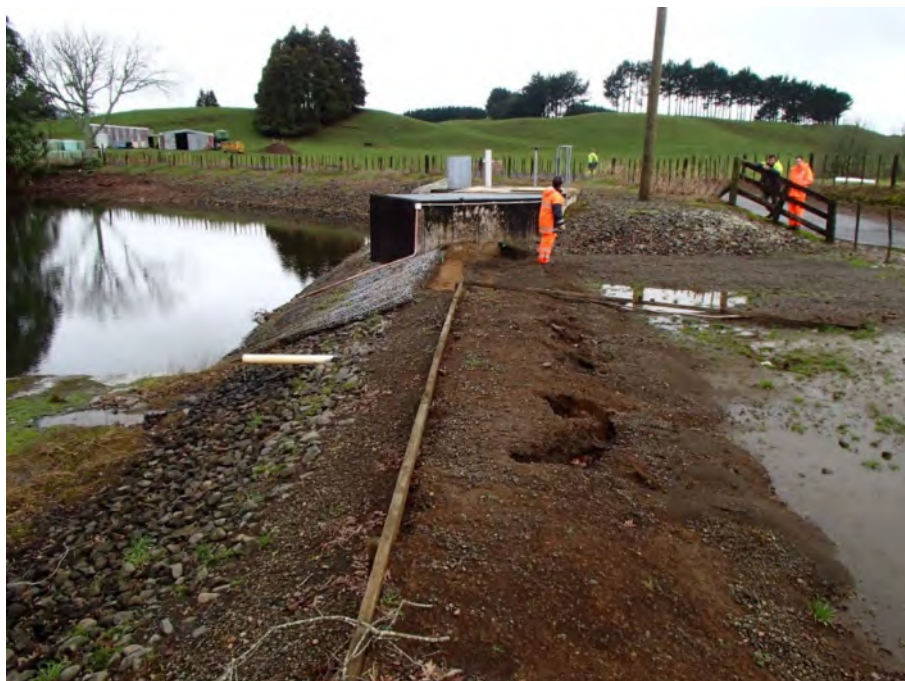
Vaughan Martin (RILEY) inspected the site on 7 July 2015. The fuse plug was observed to have only fused on the true left, although it was evident that the fuse plug had been overtopped along its entire length (rilling erosion was noted on the downstream side of the plug).

Photo 2: Photograph taken on 7 July 2015 (after June 2015 flood event)
Note: Only the true left-hand-side of the fuse plug has fused, although scour is evident on the downstream face of the unfused plug. Lake level instrument MTK_H13LT_007 is located on the face of the gabion mattress.

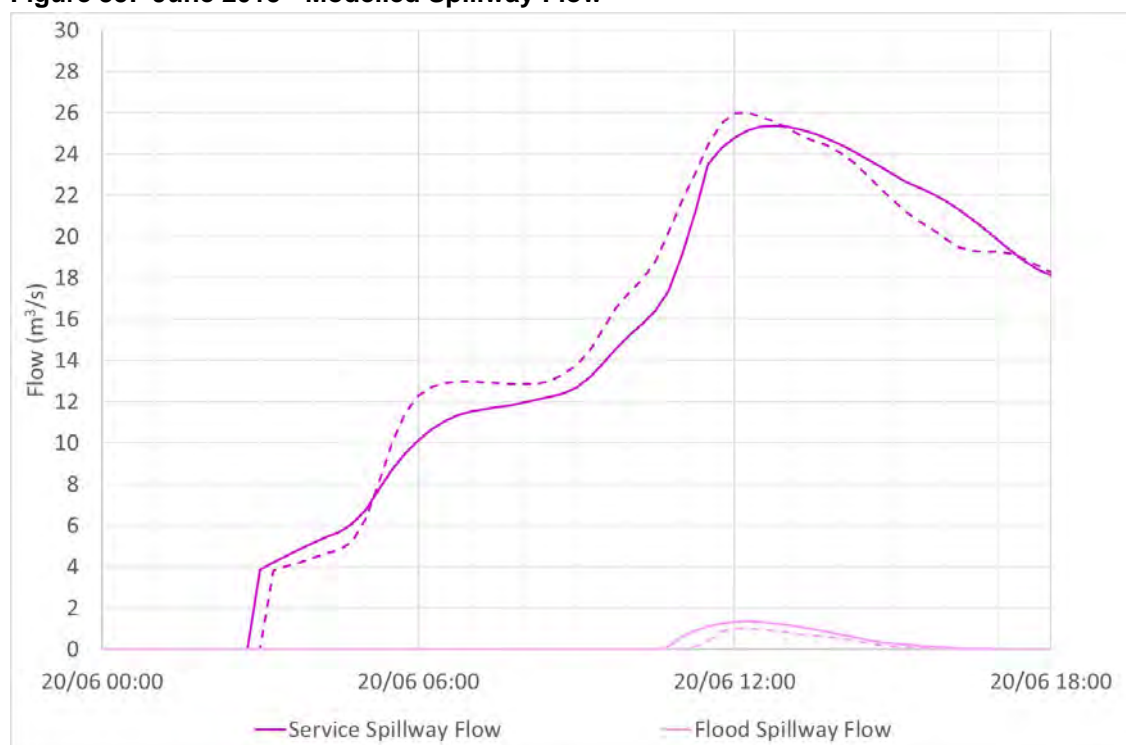
Figure 35: June 2015 - Modelled Spillway Flow

Note: Modelled results are dashed.

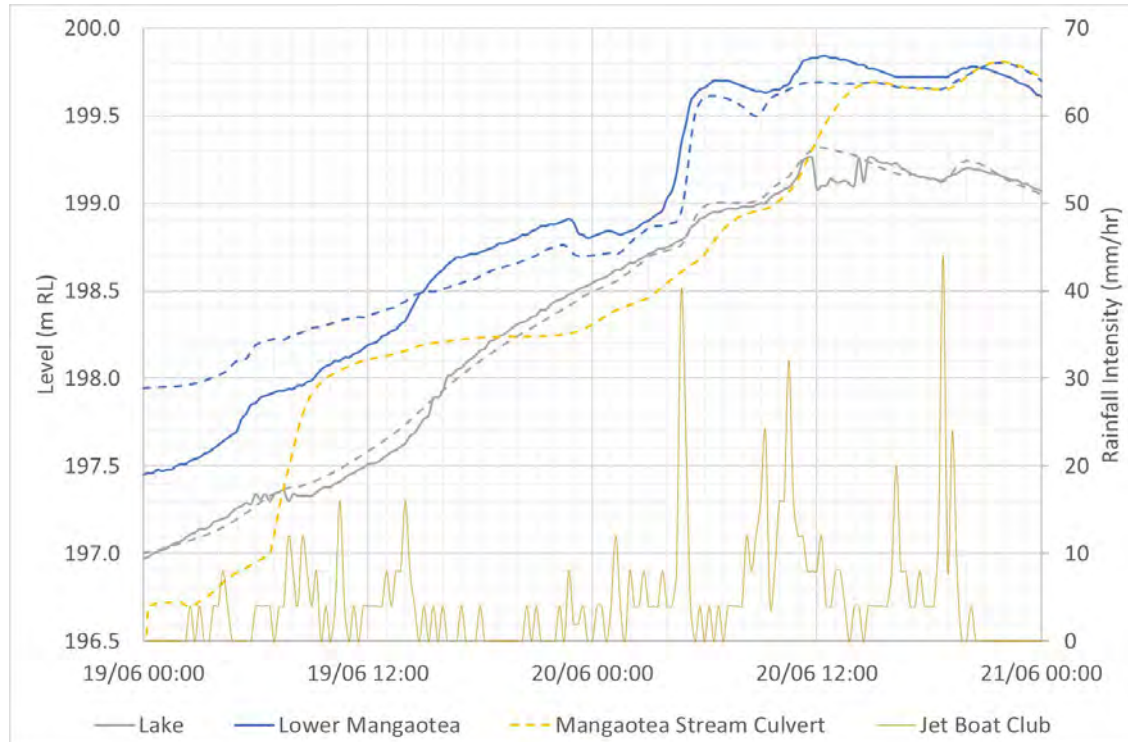
Figure 36: June 2015 – Lower Mangaotea Canal Levels

Note: Modelled results are dashed.

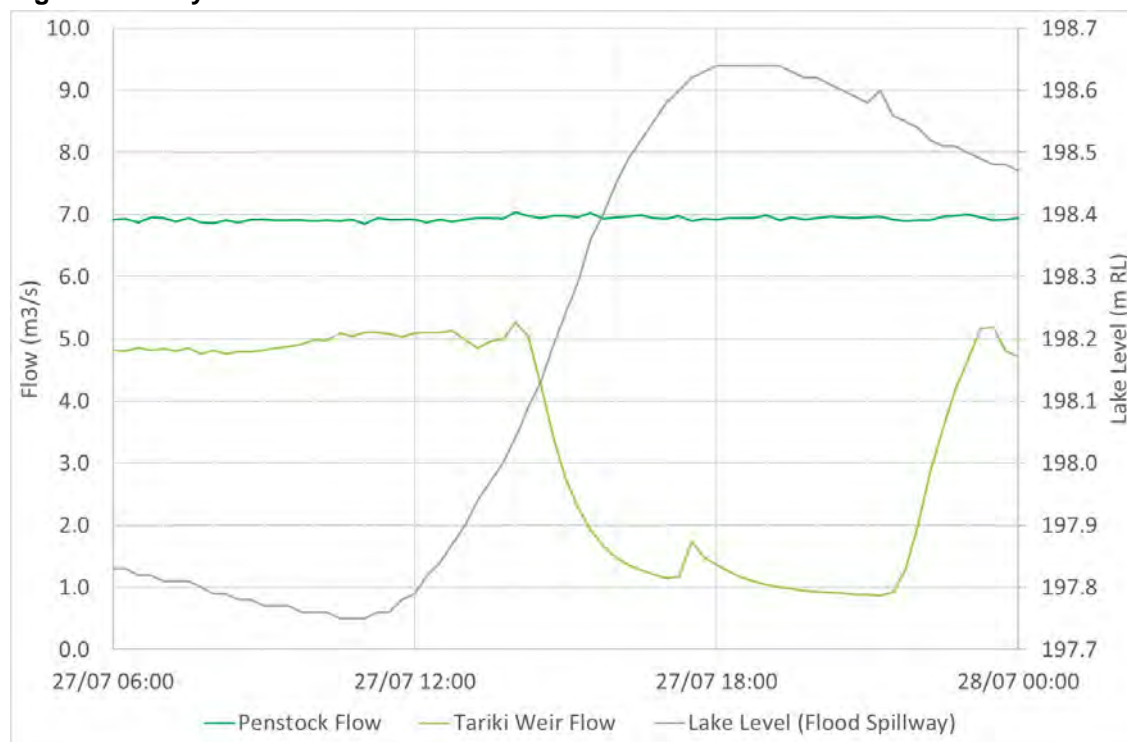
Figure 45: July 2017 - Recorded Flow

The recorded flow hydrographs are presented within Figure 45.

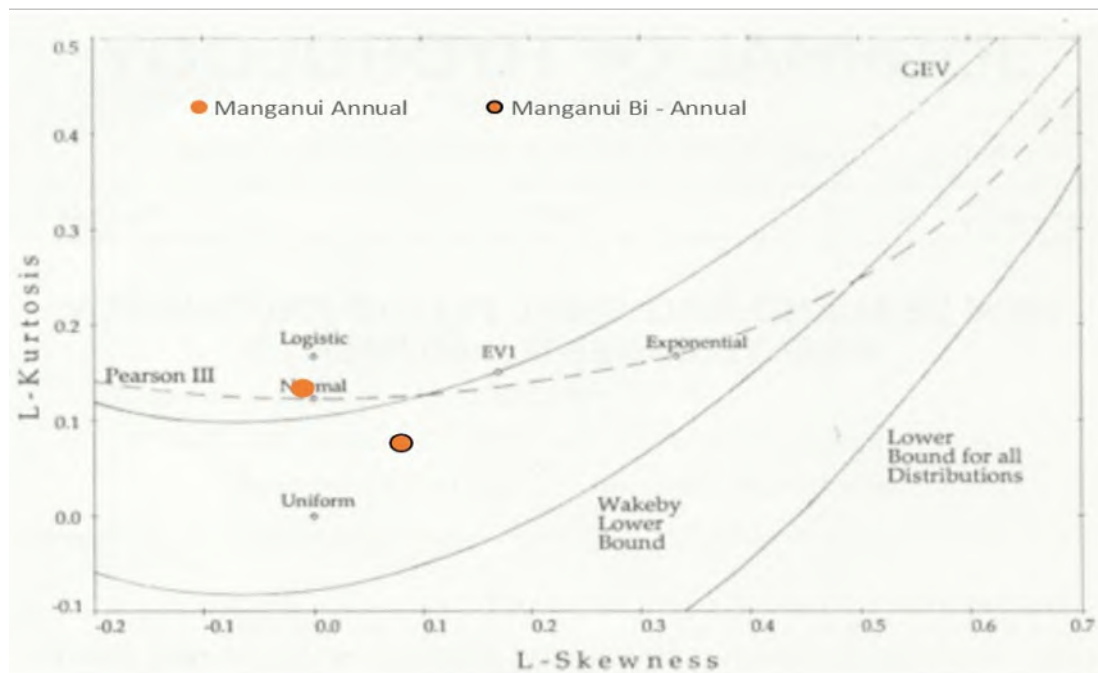
Figure 1: L-moments Analysis

This analysis suggests that the Pearson Type III distribution is likely to be most representative of the Manganui at SH3 annual maxima series. The EV1 distribution is potentially overconservative for the Manganui at SH3 record. The EV3 distribution is likely to be more representative than the EV1. A transformation was applied to the dataset, to consider the effects of a biennial maxima series. This was not found to significantly improve or deplete the fit of the EV1 distribution.

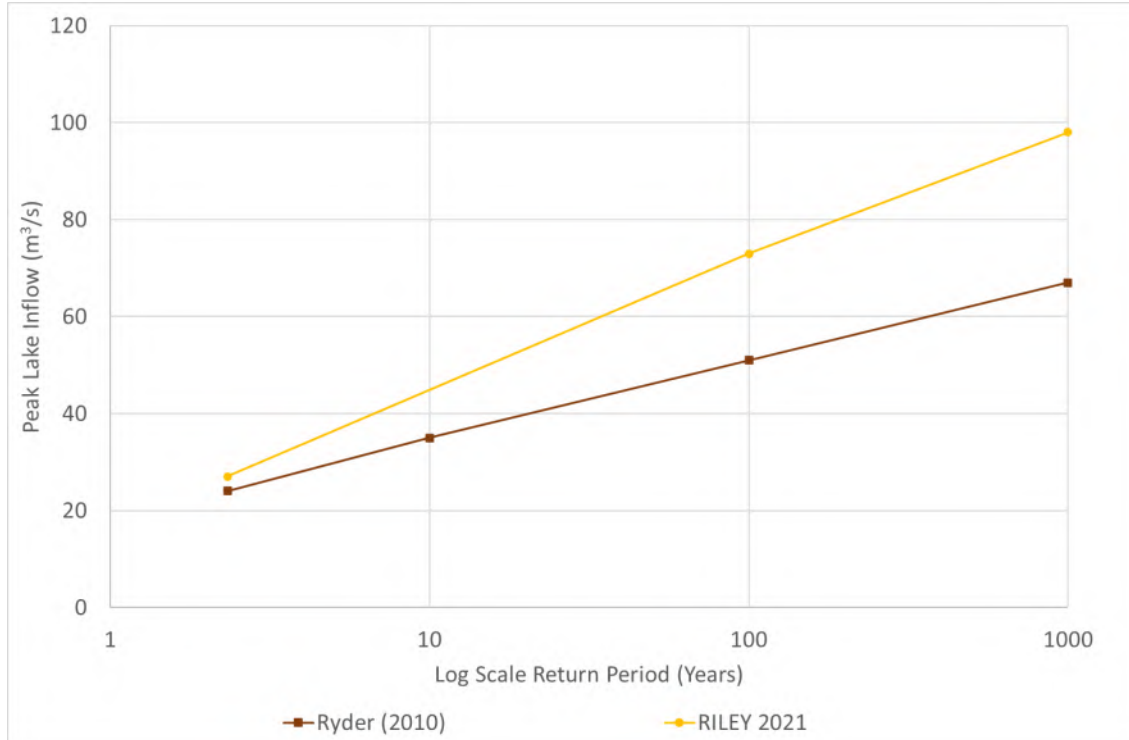
Figure 3: Lower Lake Peak Inflows - Design Flood Summary

We note that there is a large range of uncertainty when predicting extreme return period floods. Figure 3 presents a summary of the design floods compared to the previous Ryder assessment.

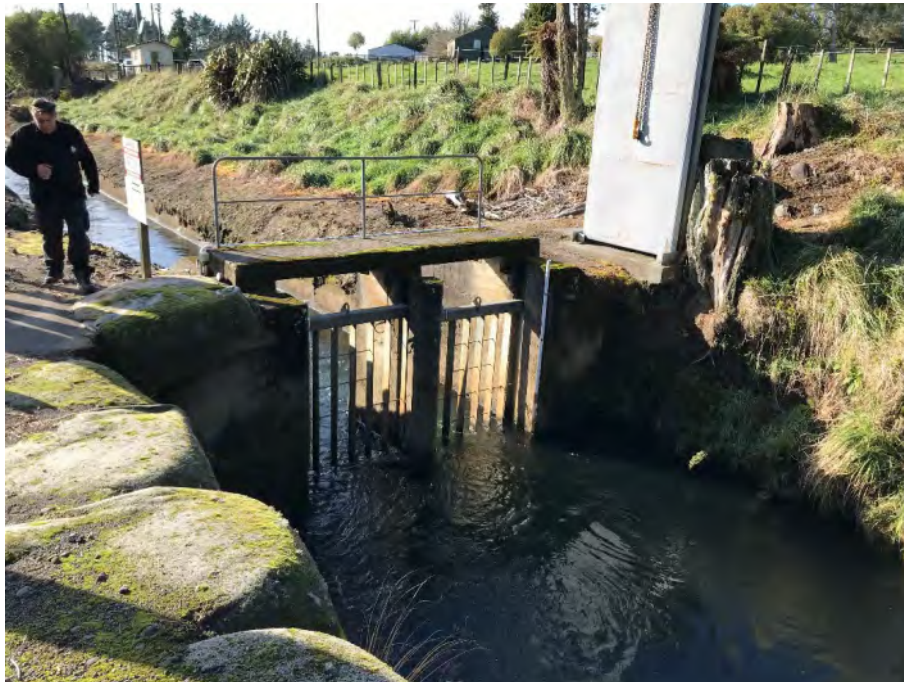
Photograph 1: Intake screens, with concrete lined Race downstream (June 2020).

Section 1 is approximately 725m long and extends from the Manganui River to Tariki Weir. The section is predominantly concrete lined (apart from one section shown in Photograph 1 and the Sediment Pond). We did not observe any significant existing erosion issues during the June 2020 inspection.

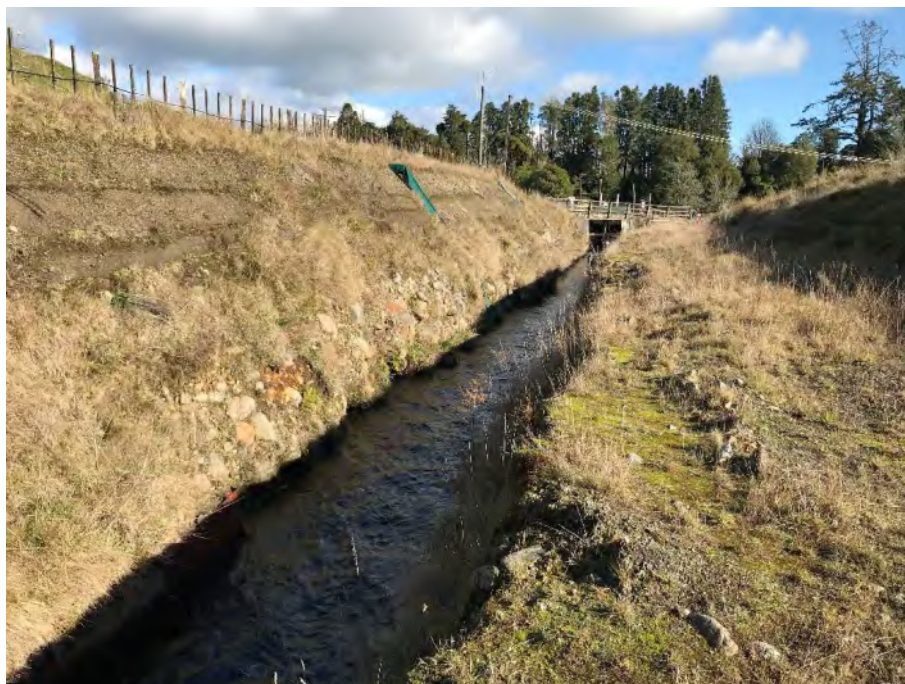
Photograph 2: View from CH150 upstream with the intake gates visible (June 2020).

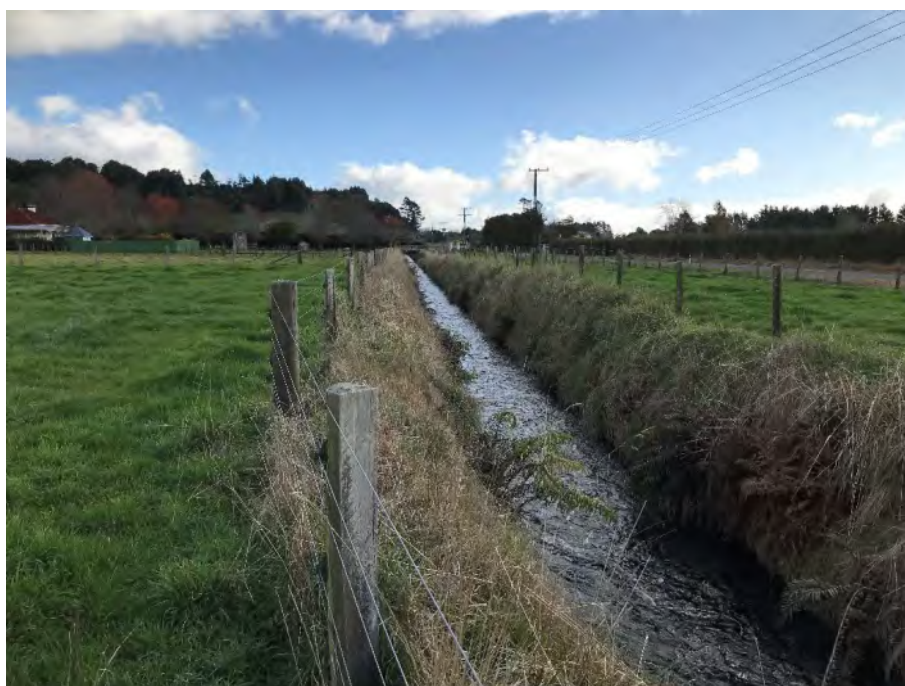
Photograph 3: View from CH 1075 upstream (June 2020).

Section 2 is approximately 350m long and extends from the Tariki Weir (Chainage (CH) 725) to the end of the concrete lining at CH 1075. The section appears to be concrete lined along its entire length. We did not observe any significant existing erosion issues during the June 2020 inspection.

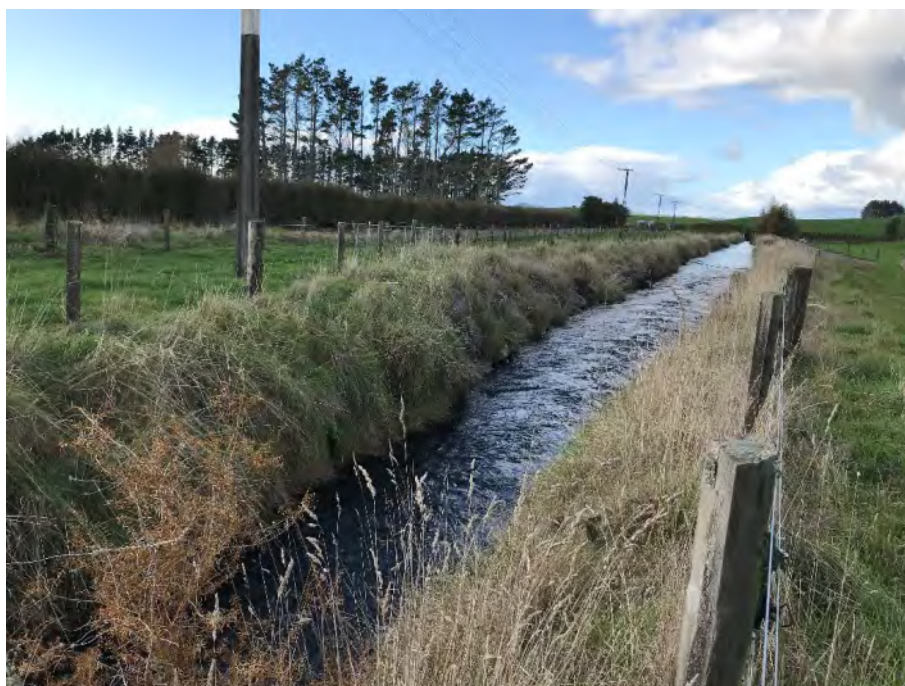
Section 3 is approximately 525m long and extends from the end of the concrete lining at CH 1075 to the end of the steep section at CH 1600. This section has a relatively steep longitudinal grade (including a drop structure) and has variable geometry, lining and flow conditions/velocities. During the June 2020 inspection no significant slumping or erosion was identified.

Photograph 4: View from CH 1075 (end of concrete lining) downstream (June 2020). Note the velocities reducing downstream.

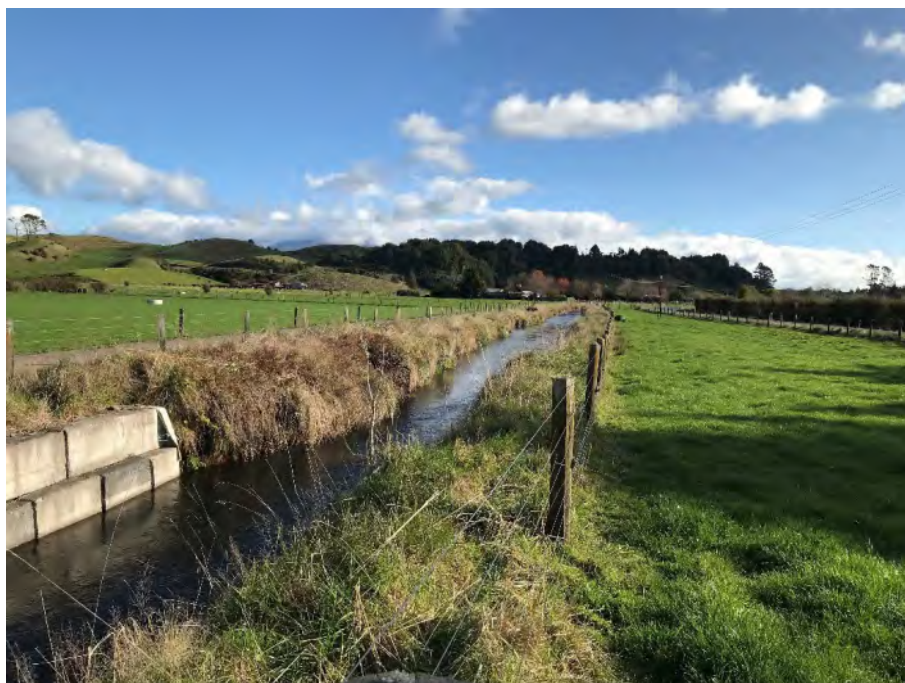
Photograph 5: View from CH 1225 upstream (June 2020). Note the low velocities and the mass concrete block repair.

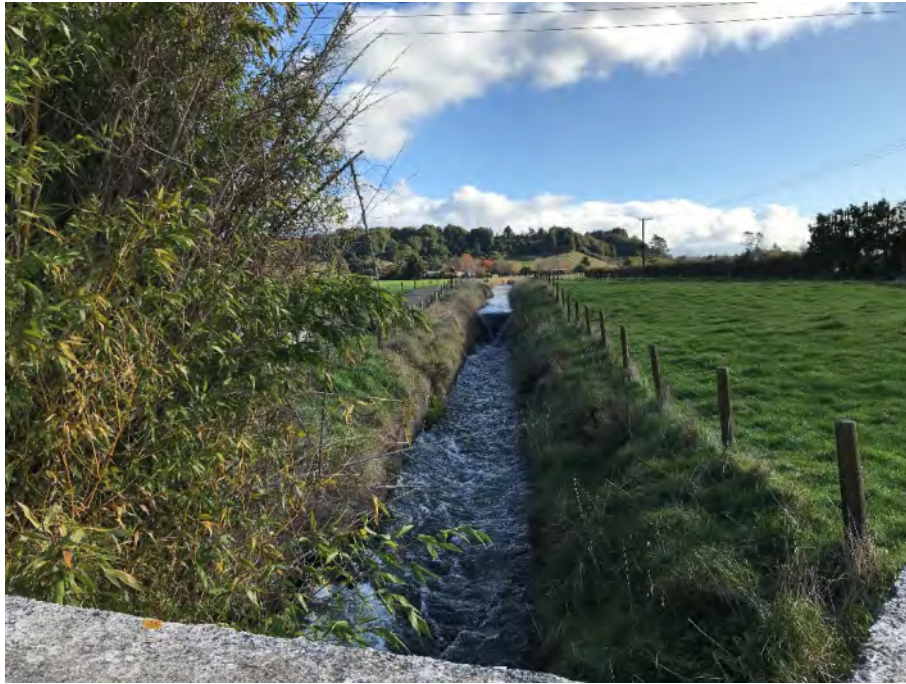
Photograph 6: View from Salisbury Road Culvert CH 1325 upstream (June 2020). Note the drop structure and the higher velocities downstream of this (concrete lined).

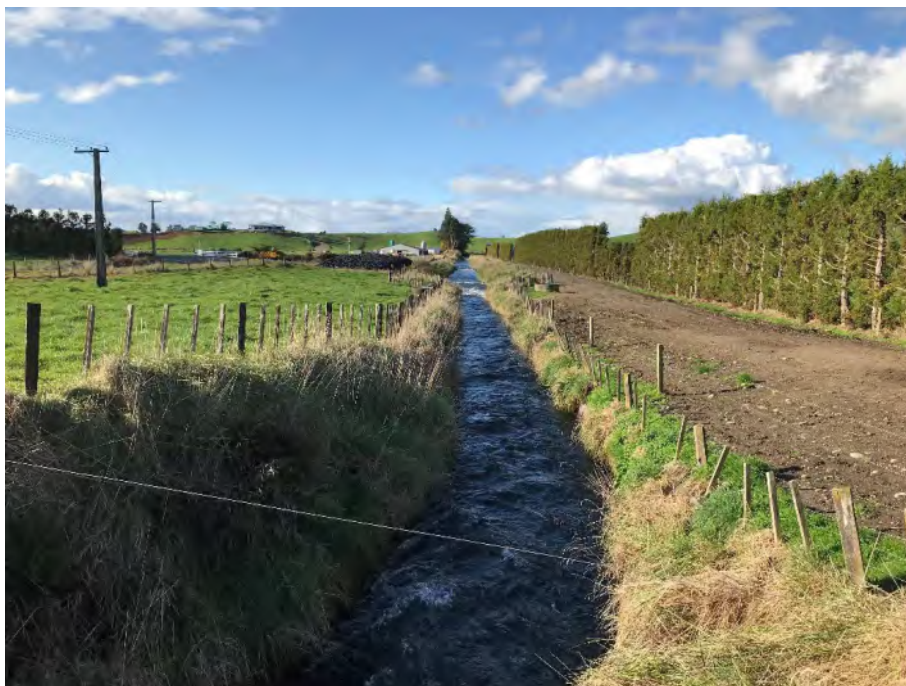
Photograph 7: View from Salisbury Road Culvert CH 1325 downstream (June 2020). Note the rapids further downstream (riprap lined).

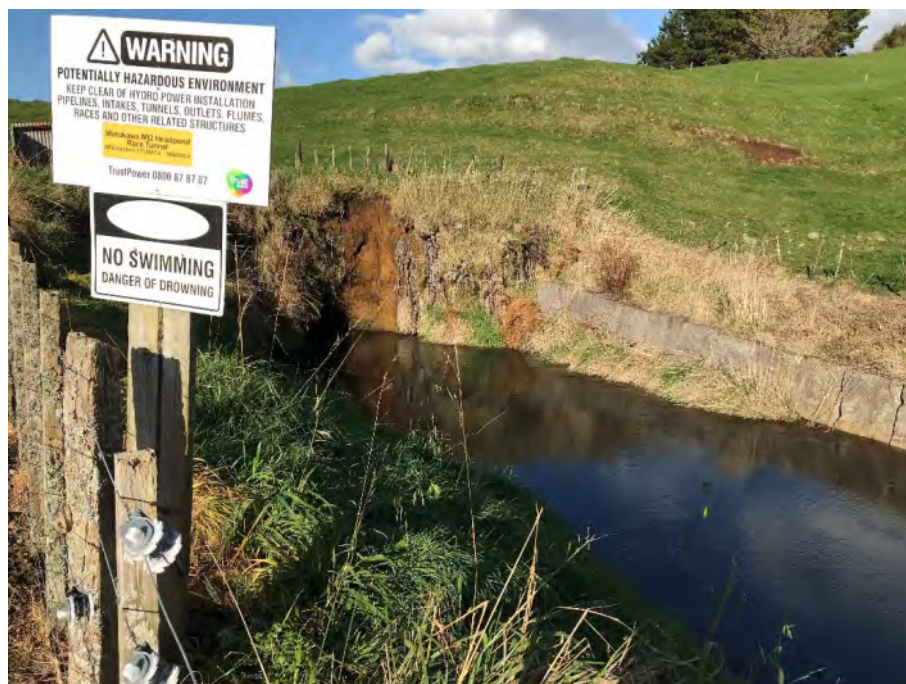
Photograph 8: Tunnel 1 Entrance. Note the low velocities and recent instability downstream of the mass concrete blocks.

Section 4 is approximately 625m long and extends from the end of the steep section at CH 1600 to the In-Race generator. Velocities are generally low.
