Hydraulic and Geotechnical
Assessment – Riley Consultants
Limited

MOTUKAWA RACE HYDRAULIC AND GEOTECHNICAL ASSESSMENT MOTUKAWA HYDRO-ELECTRIC POWER SCHEME

Report prepared for: Trustpower Limited

Report reference: 18MTK-ENH-C

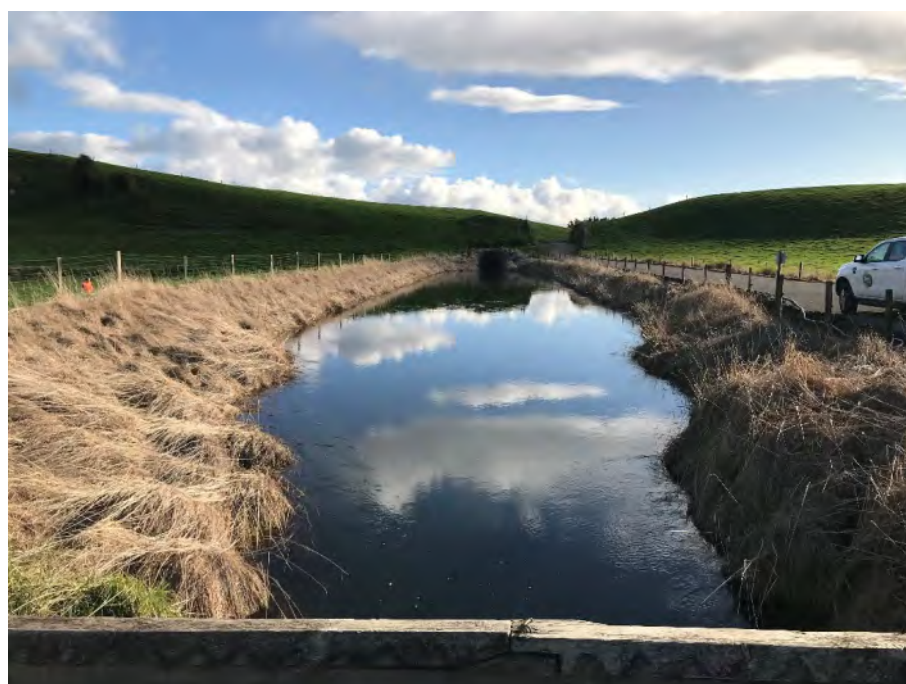
Photograph 9: View upstream from In-Race Generator. Note the low velocities.

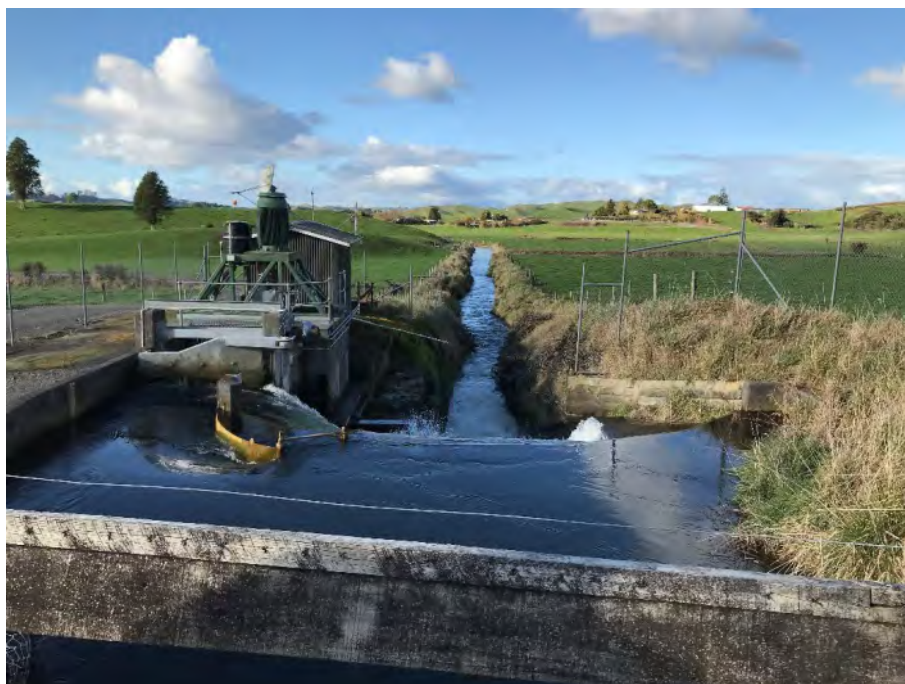
Photograph 10: View downstream from In-Race Generator (June 2020). Note the uneven appearance of the Race banks. The Upper Mangaotea Bridge is not visible (located around a left-hand bend).

Section 5 is approximately 325m long and extends from the In-Race Generator to the Upper Mangaotea Bridge. We did not observe any significant existing erosion issues during the June 2020 inspection, however the uneven appearance of the Race banks in the reach downstream of the In-Race Generator (refer Photograph 15) indicates that some historical erosion may have occurred through this reach. Some mass concrete block remedial works have also been undertaken in the past further downstream.

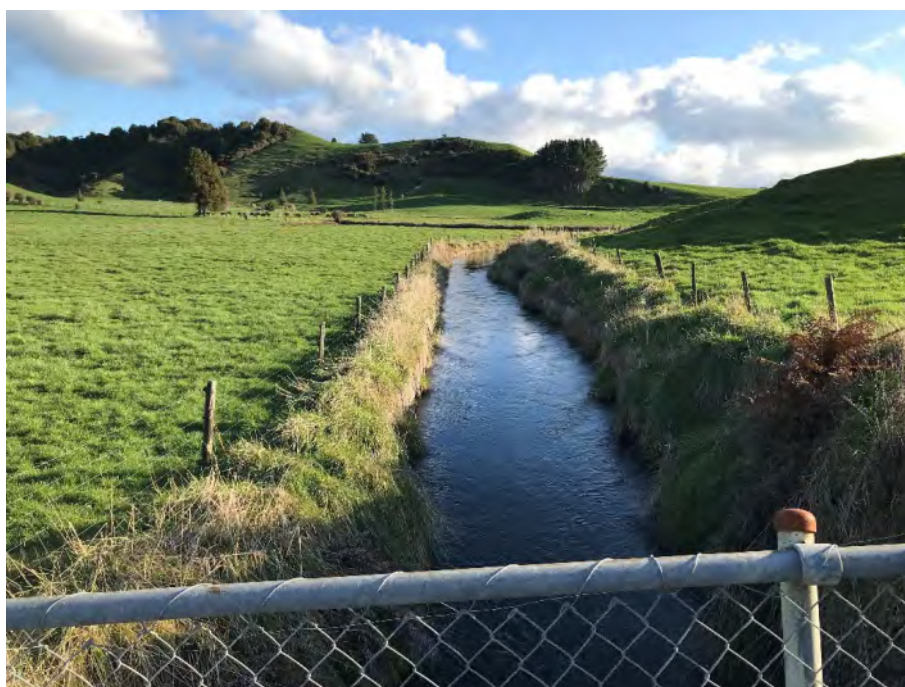
Photograph 11: View upstream from the Upper Mangaotea Bridge (June 2020). Velocities of up to 2.0 m/s were estimated during the inspection.

During the June 2020 inspection, we observed velocities of up to 2.0m/s immediately upstream of the bridge. Model results indicate velocities at this location could reach 2.1m/s for a maximum abstraction flow of 7.5m³/s. Overall, there appears to be a moderate risk of further erosion and slumping requiring periodic remedial repairs.

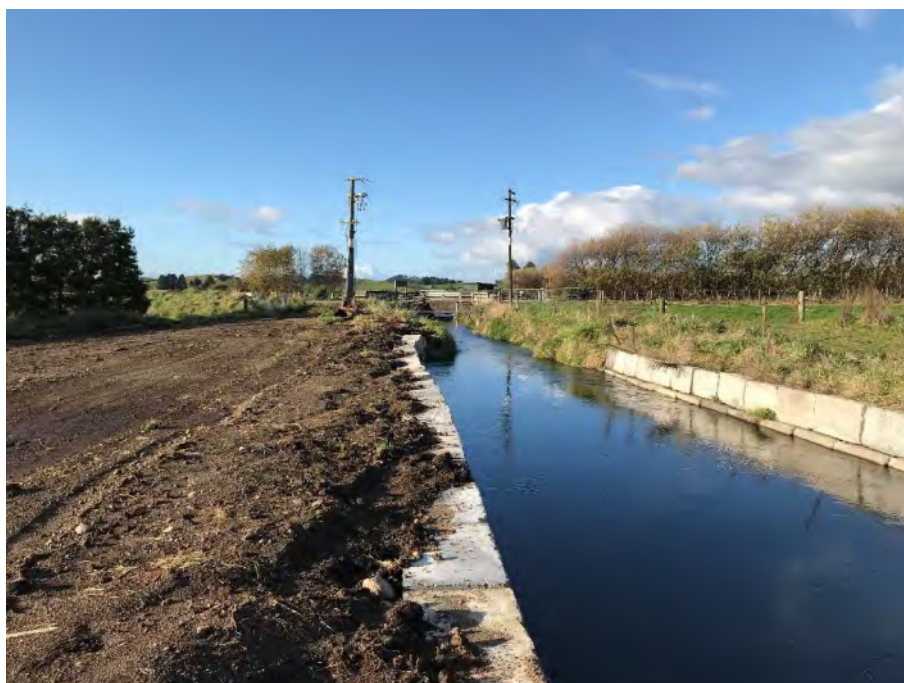
Through this section, extensive erosion remedial works have been undertaken over recent years. The repairs consist of mass concrete blocks and a timber retaining wall section. We understand the retaining wall was constructed instead of the mass concrete blocks due to settlement issues relating to the low strength of the organic founding material. To date, the remedial works appear to be performing adequately.

Photograph 12: Recent mass concrete block remedial works (June 2020). Note the relatively low velocities within the Race.

Through this section, extensive erosion remedial works have been undertaken over recent years. The repairs consist of mass concrete blocks and a timber retaining wall section. We understand the retaining wall was constructed instead of the mass concrete blocks due to settlement issues relating to the low strength of the organic founding material. To date, the remedial works appear to be performing adequately.

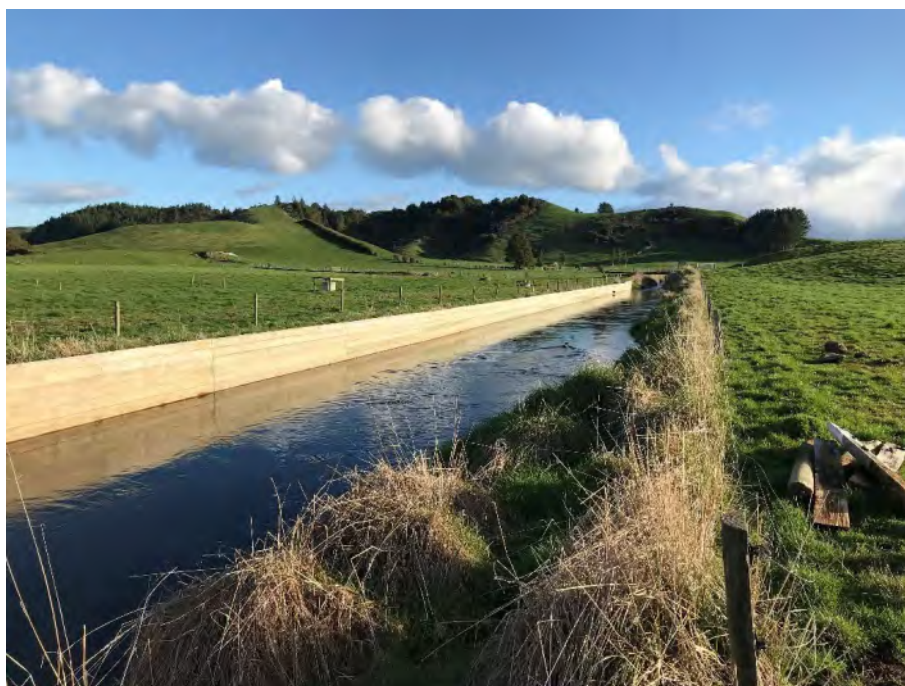
Photograph 13: Recent timber retaining wall remedial works (June 2020). Note the relatively low velocities within the Race and the low lying nature of the surrounding floodplain. Upper Mangaotea Bridge is beyond the upstream extent of the wall.

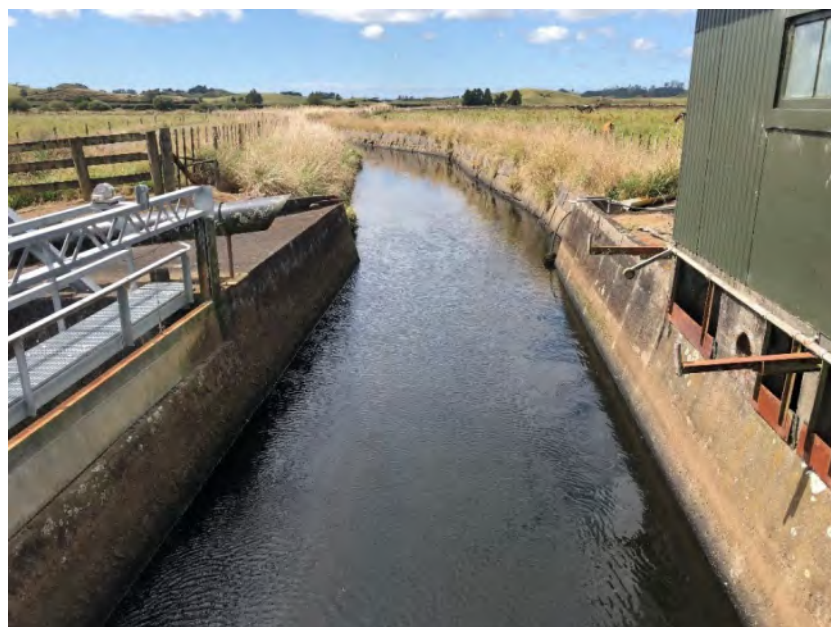
Photograph 14: View downstream from Mangaotea Aqueduct. Aqueduct is a concrete structure. Mass concrete blocks located on true right bank immediately downstream (February 2019 – low flows).

This section was not inspected during the June 2020 inspection; however, we understand from Trustpower Site Personnel that existing erosion remediation works consisting of mass concrete blocks are performing adequately.

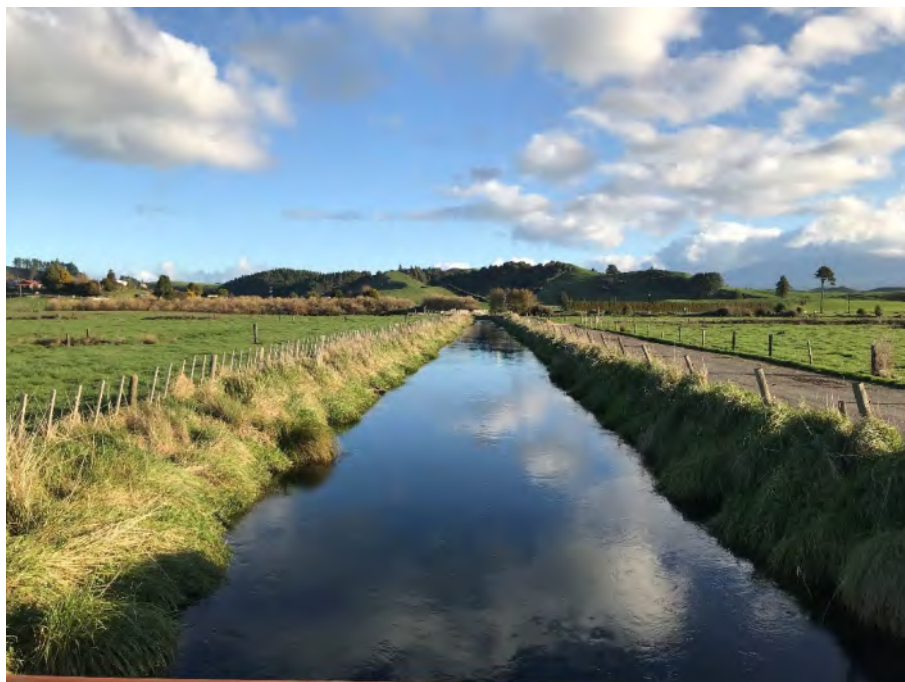
Photograph 15: View upstream from Lower Mangaotea Bridge (June 2020). Note the low velocities.

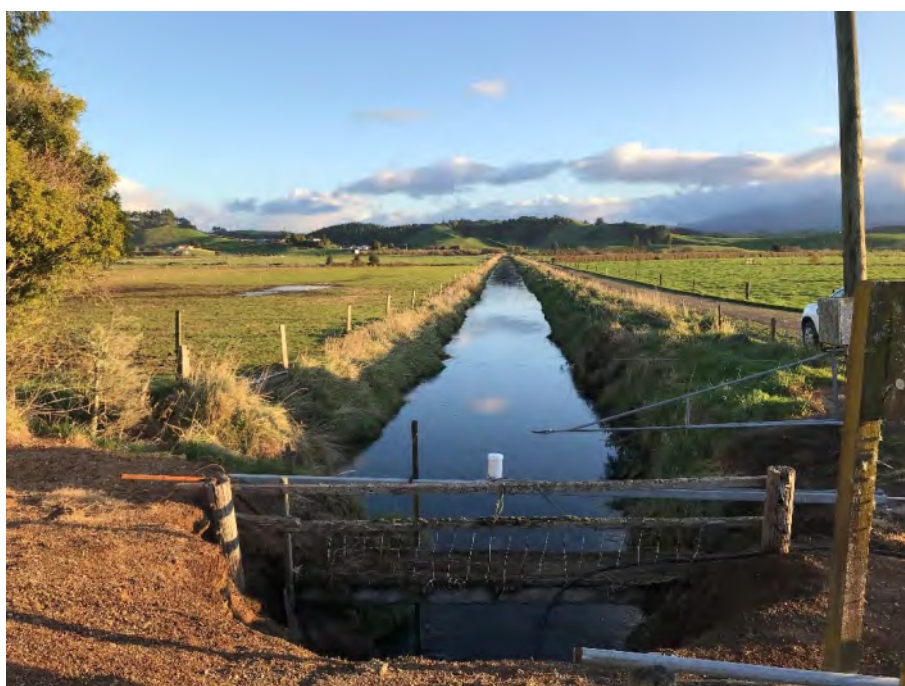
Photograph 16: View upstream from Tunnel 2 (June 2020). Note the low velocities and the well vegetated banks.

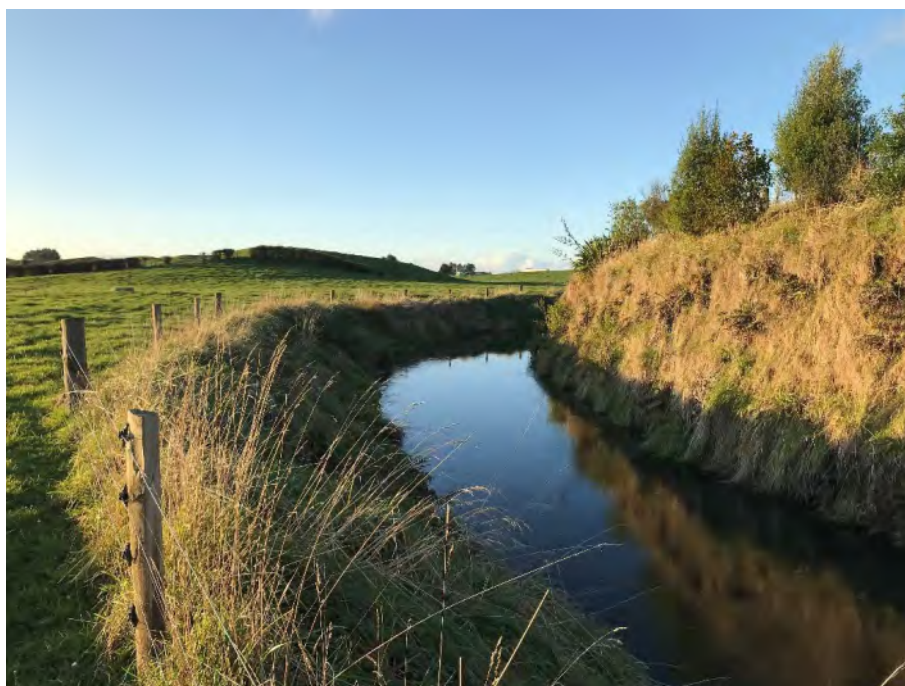
Photograph 17: View downstream from Tunnel 2 (June 2020).

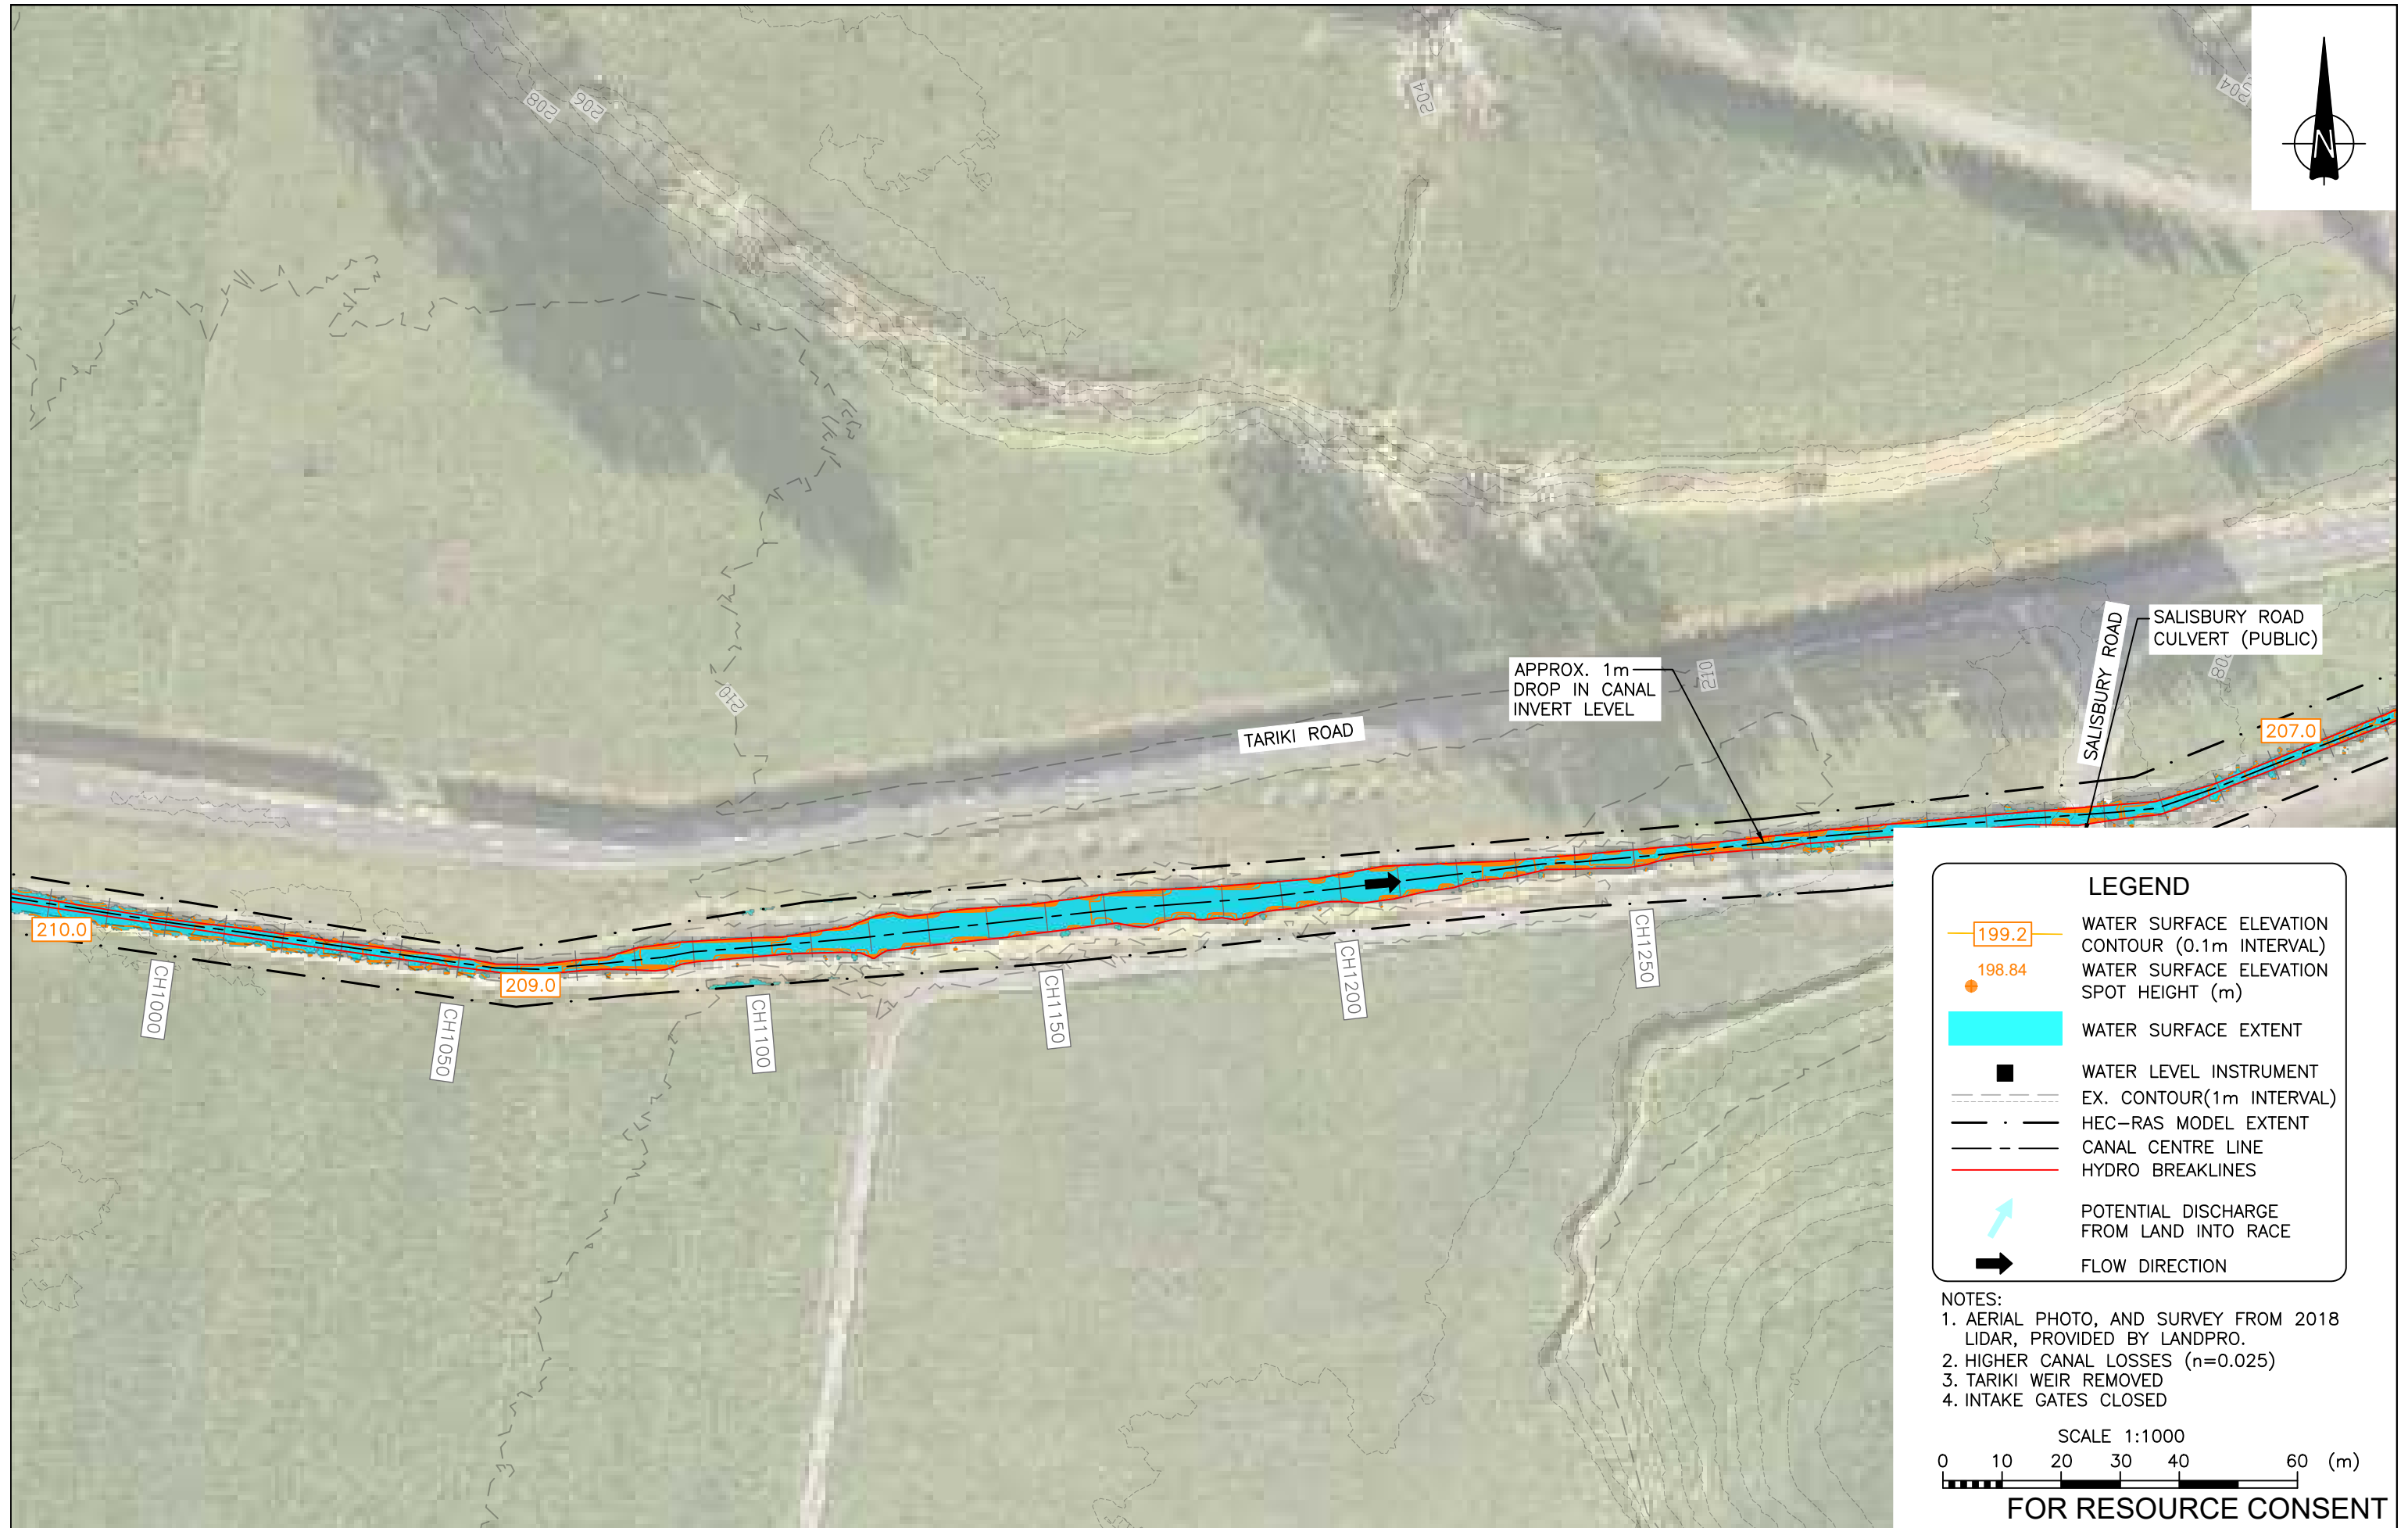
CLIENT: TRUSTPOWER LTD
 ADDRESS: MOTUKAWA HYDRO ELECTRIC POWER SCHEME
 PROJECT: RACE HYDRAULIC AND GEOTECHNICAL ASSESSMENT
 SHEET TITLE: MEAN ANNUAL FLOOD EVENT - LEVELS - PLAN 3

1. AERIAL PHOTO, AND SURVEY FROM 2018 LIDAR, PROVIDED BY LANDPRO.
2. HIGHER CANAL LOSSES (n=0.025)
3. TARIKI WEIR REMOVED
4. INTAKE GATES CLOSED

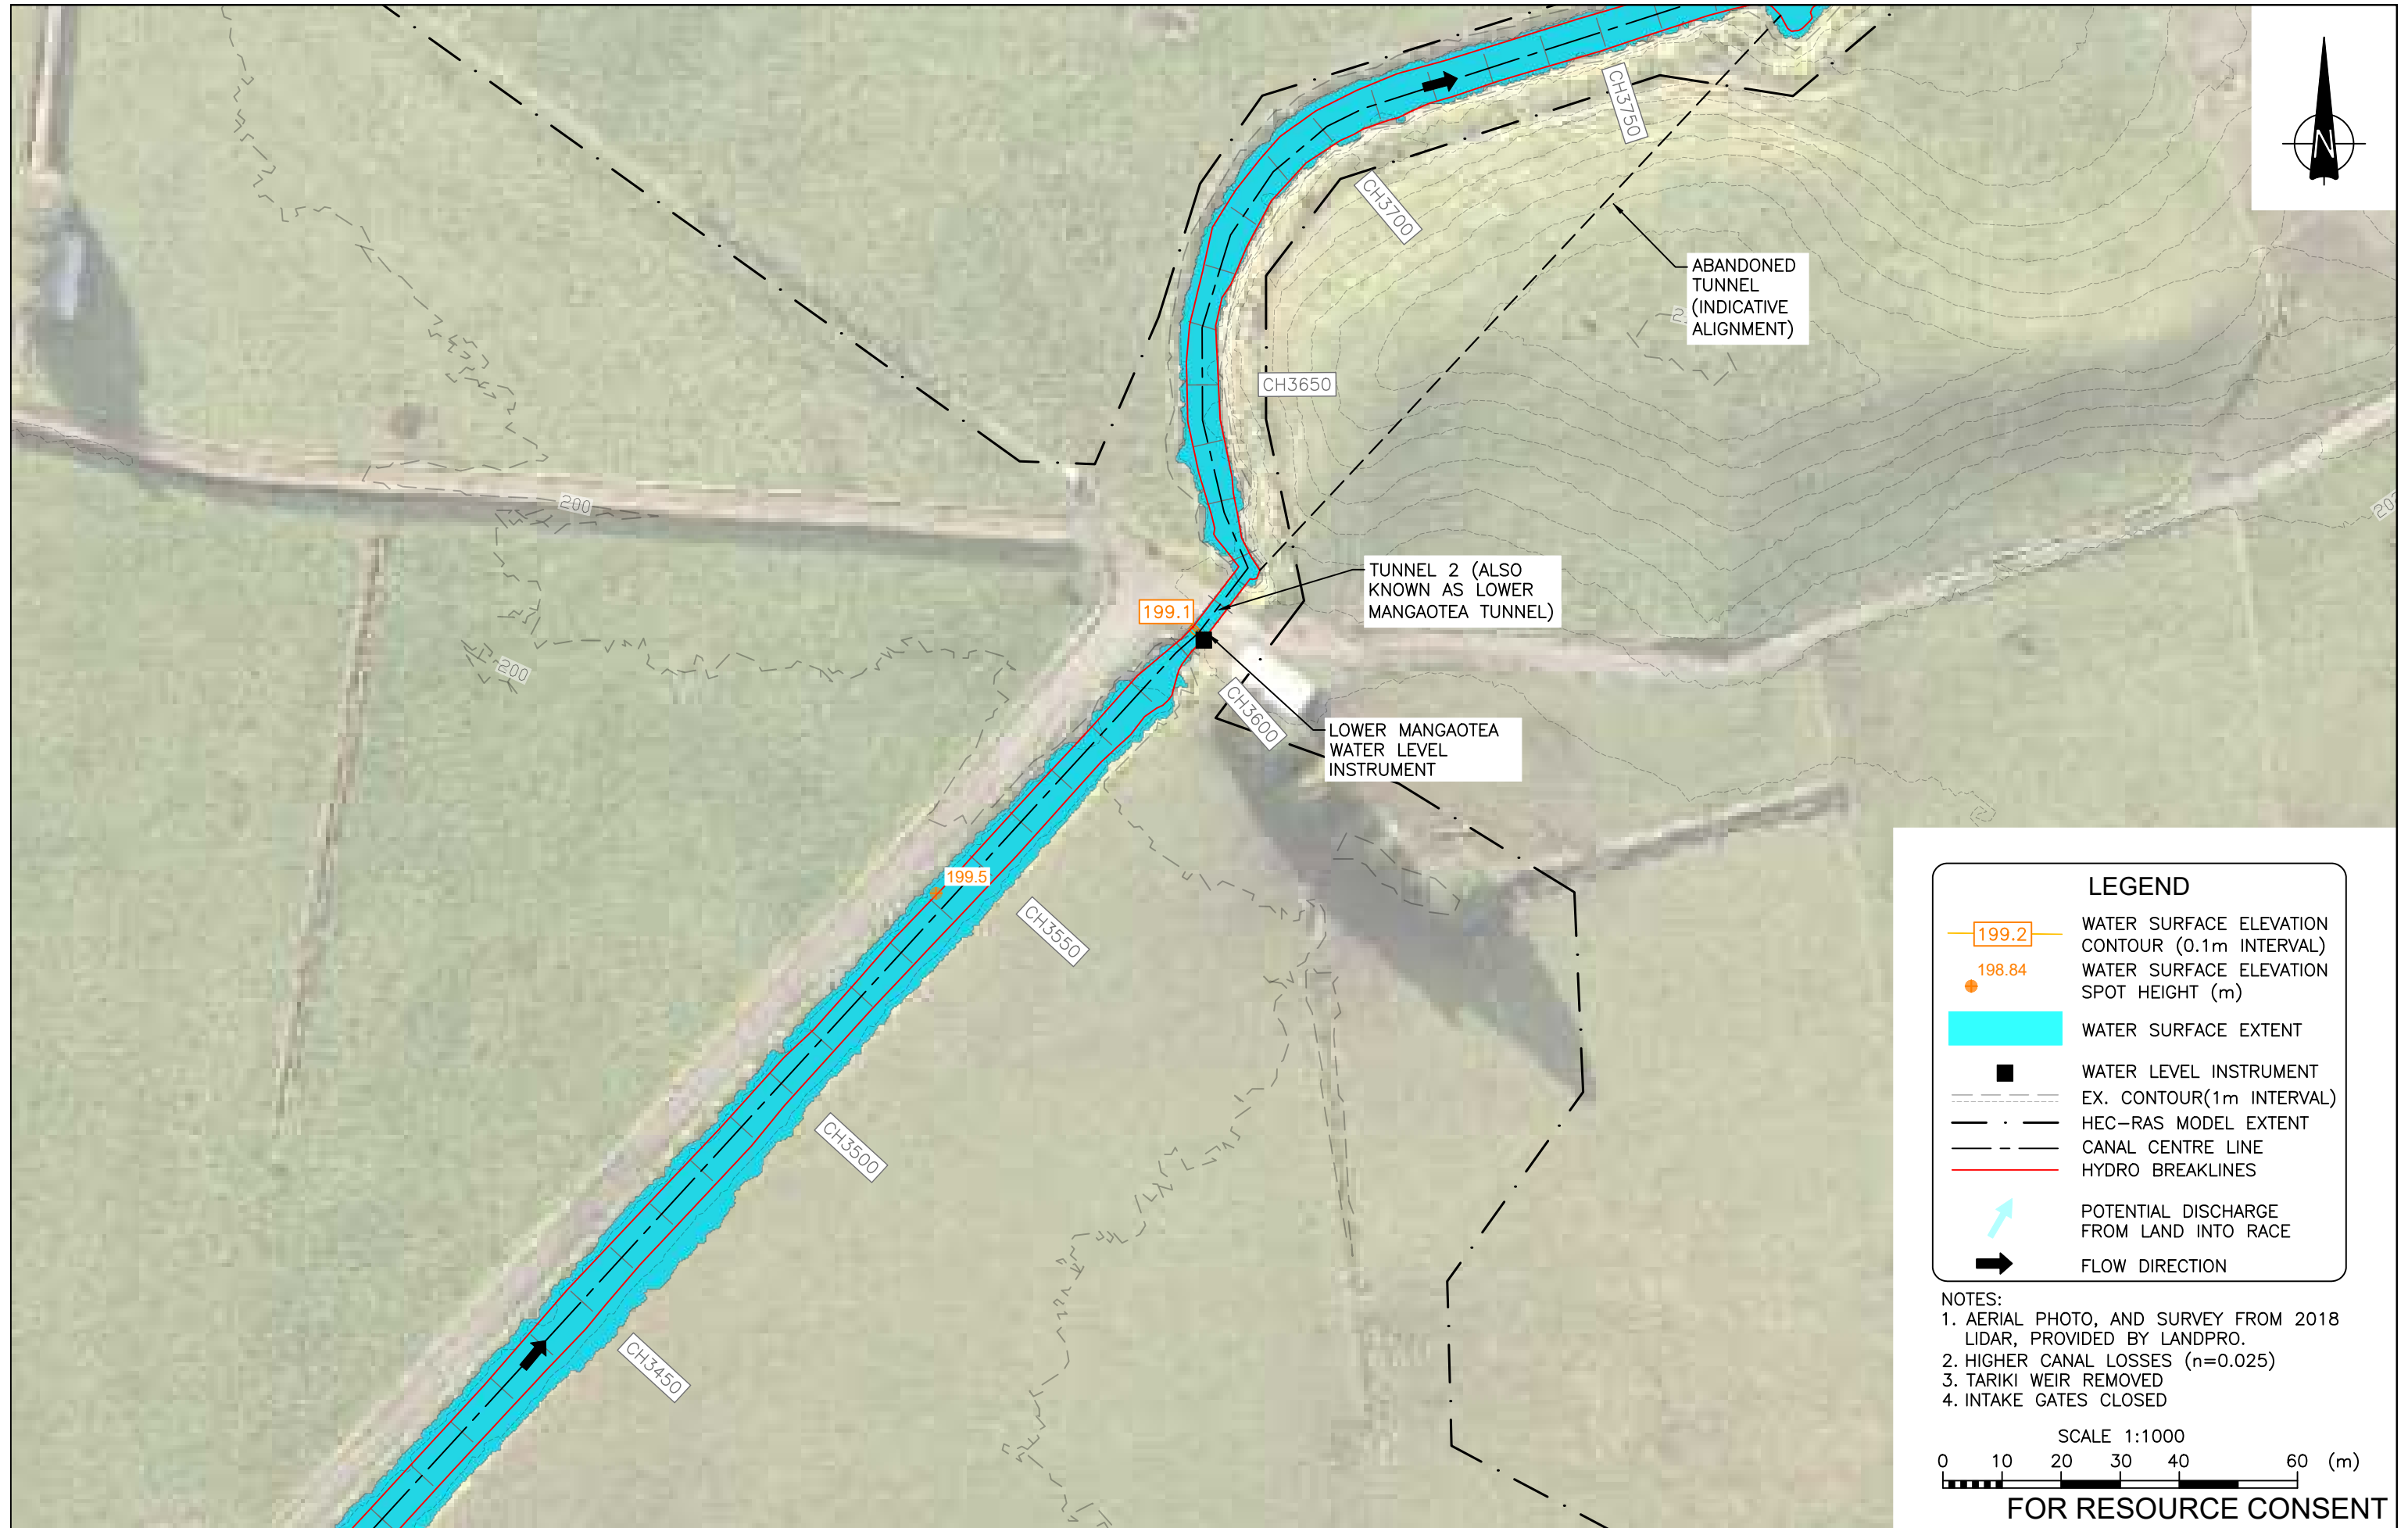
CADFILE: 18MTK_ENH-250to267.dwg
 SCALE (A3): 1:1000
 ORIG. SHEET SIZE: A3
 DRAWING No.: 18MTK_ENH-260
 REV.: 1

CLIENT: TRUSTPOWER LTD
 ADDRESS: MOTUKAWA HYDRO ELECTRIC POWER SCHEME
 PROJECT: RACE HYDRAULIC AND GEOTECHNICAL ASSESSMENT
 SHEET TITLE: MEAN ANNUAL FLOOD EVENT - LEVELS - PLAN 11

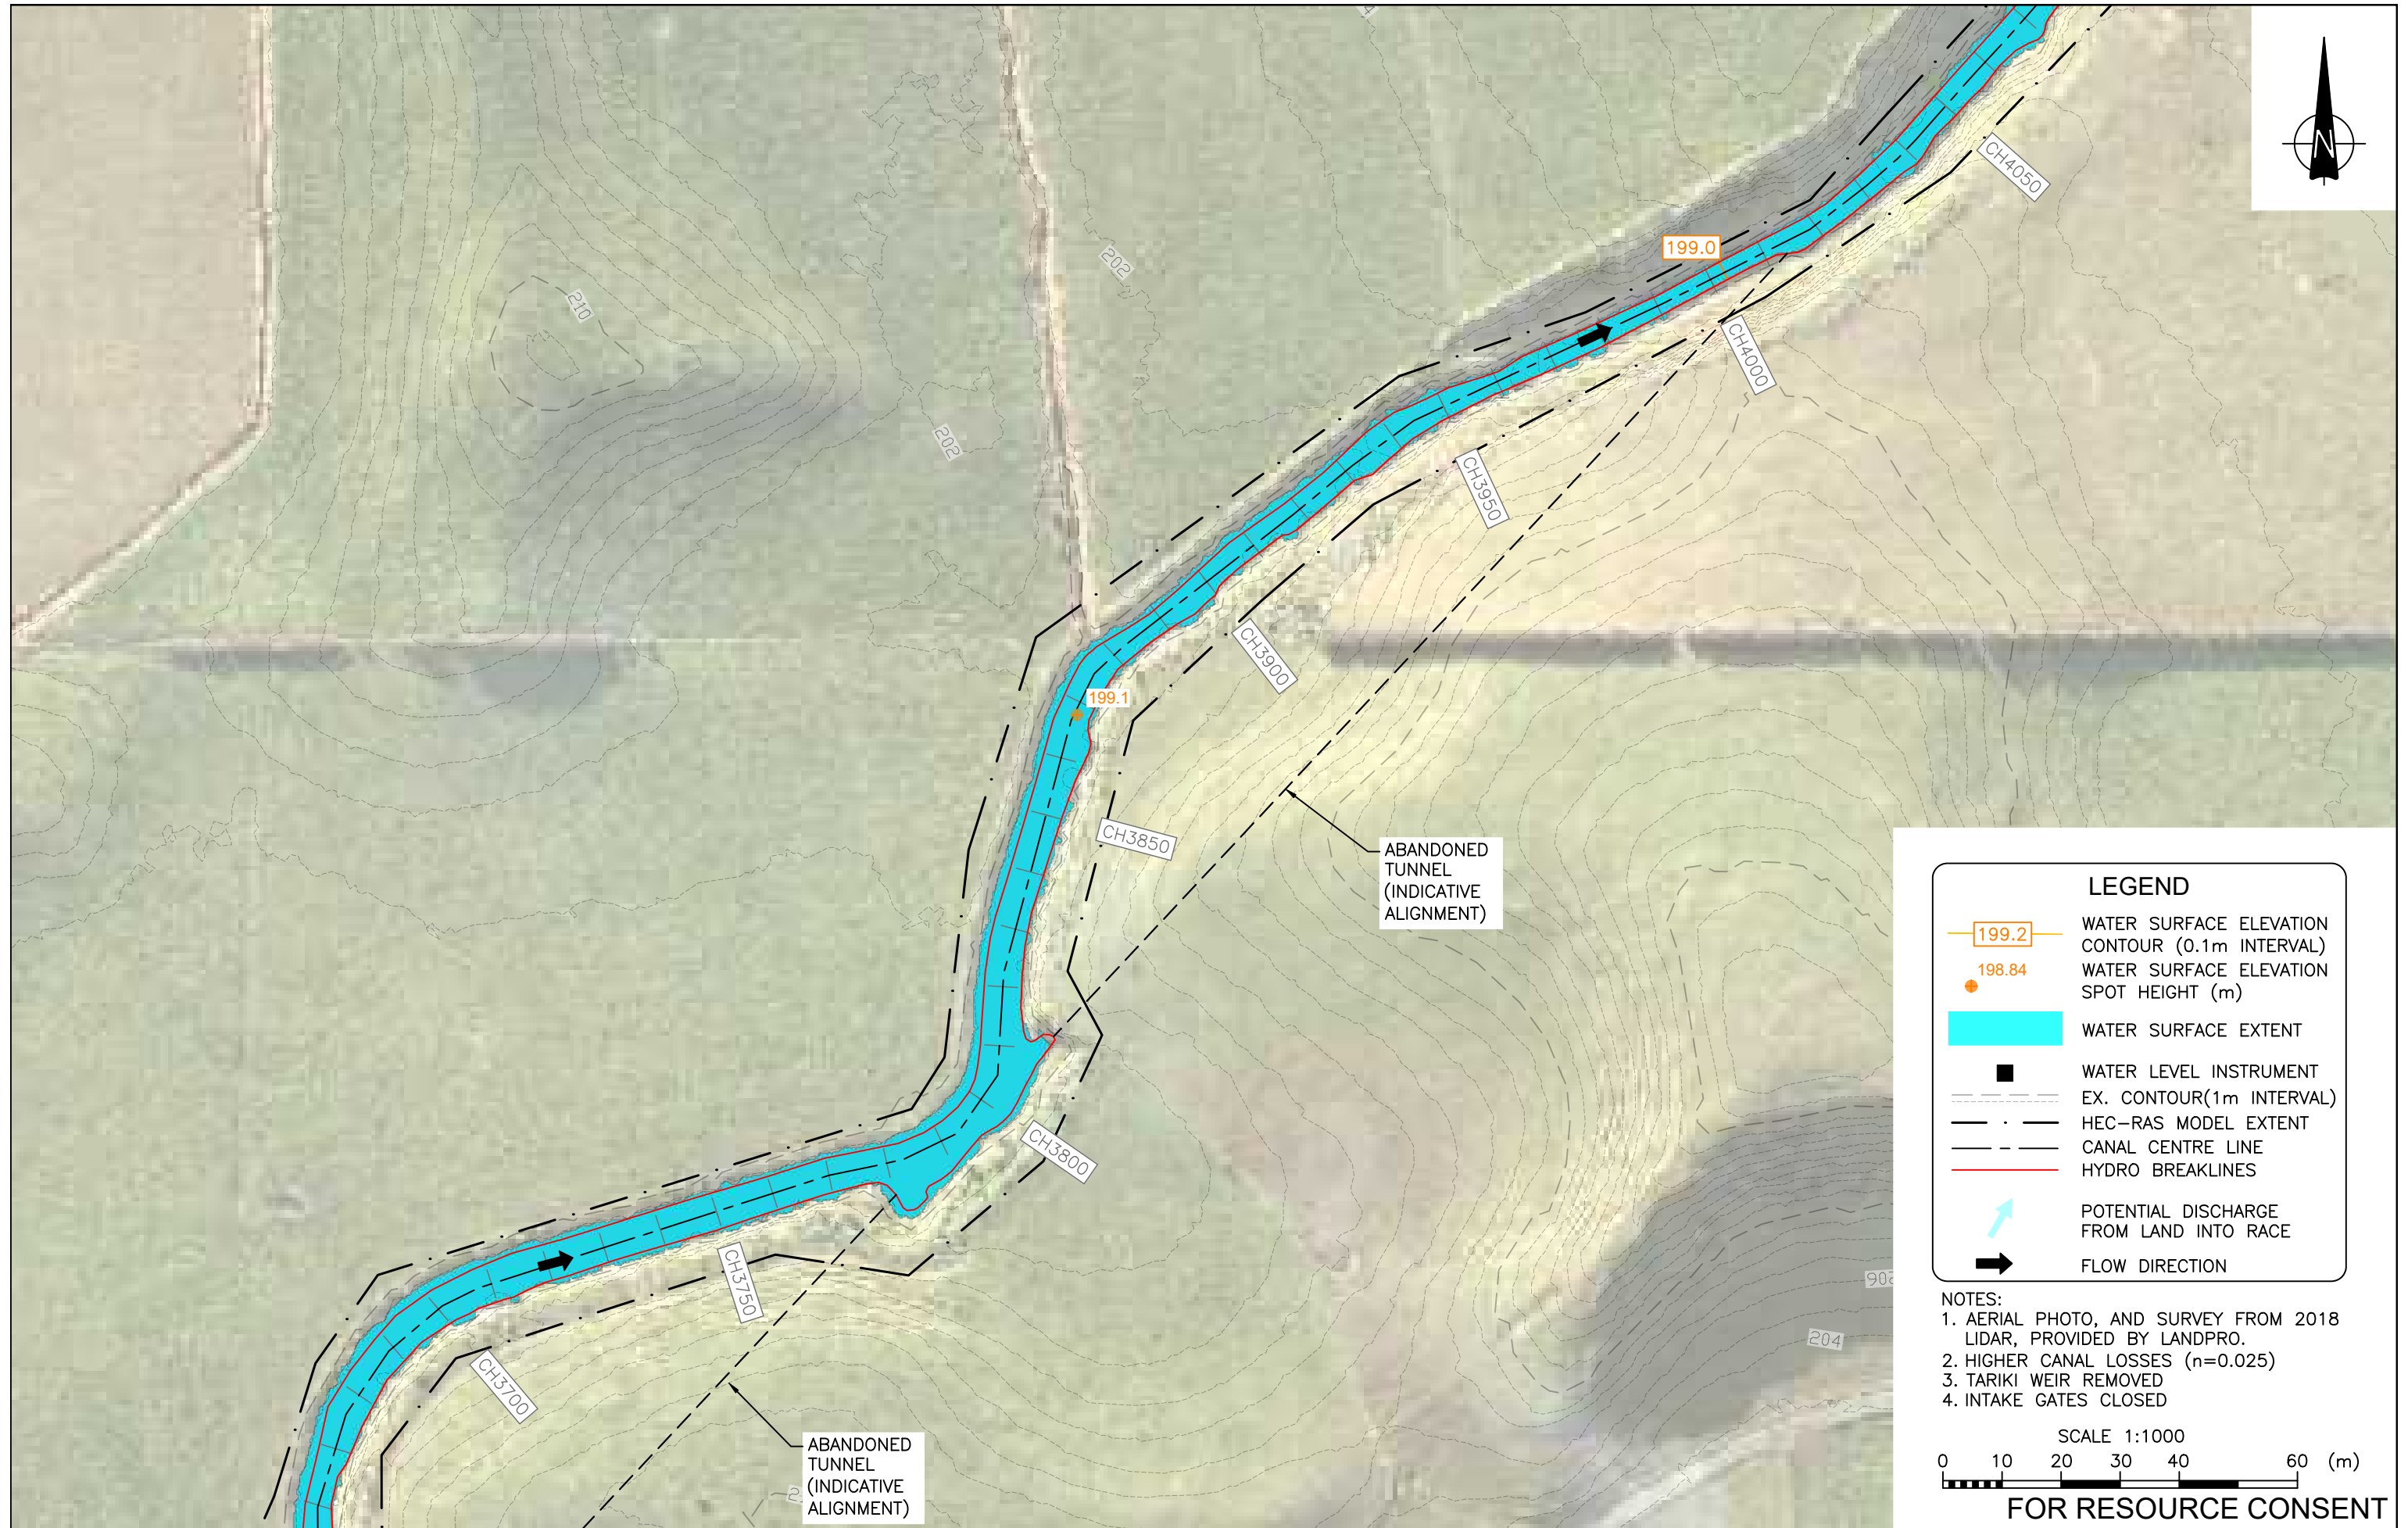
CADFILE: 18MTK_ENH-250to267.dwg
 SCALE (A3): 1:1000
 ORIG. SHEET SIZE: A3
 DRAWING No.: 18MTK_ENH-261
 REV.: 1

CLIENT: TRUSTPOWER LTD
 ADDRESS: MOTUKAWA HYDRO ELECTRIC POWER SCHEME
 PROJECT: RACE HYDRAULIC AND GEOTECHNICAL ASSESSMENT
 SHEET TITLE: MEAN ANNUAL FLOOD EVENT - LEVELS - PLAN 12

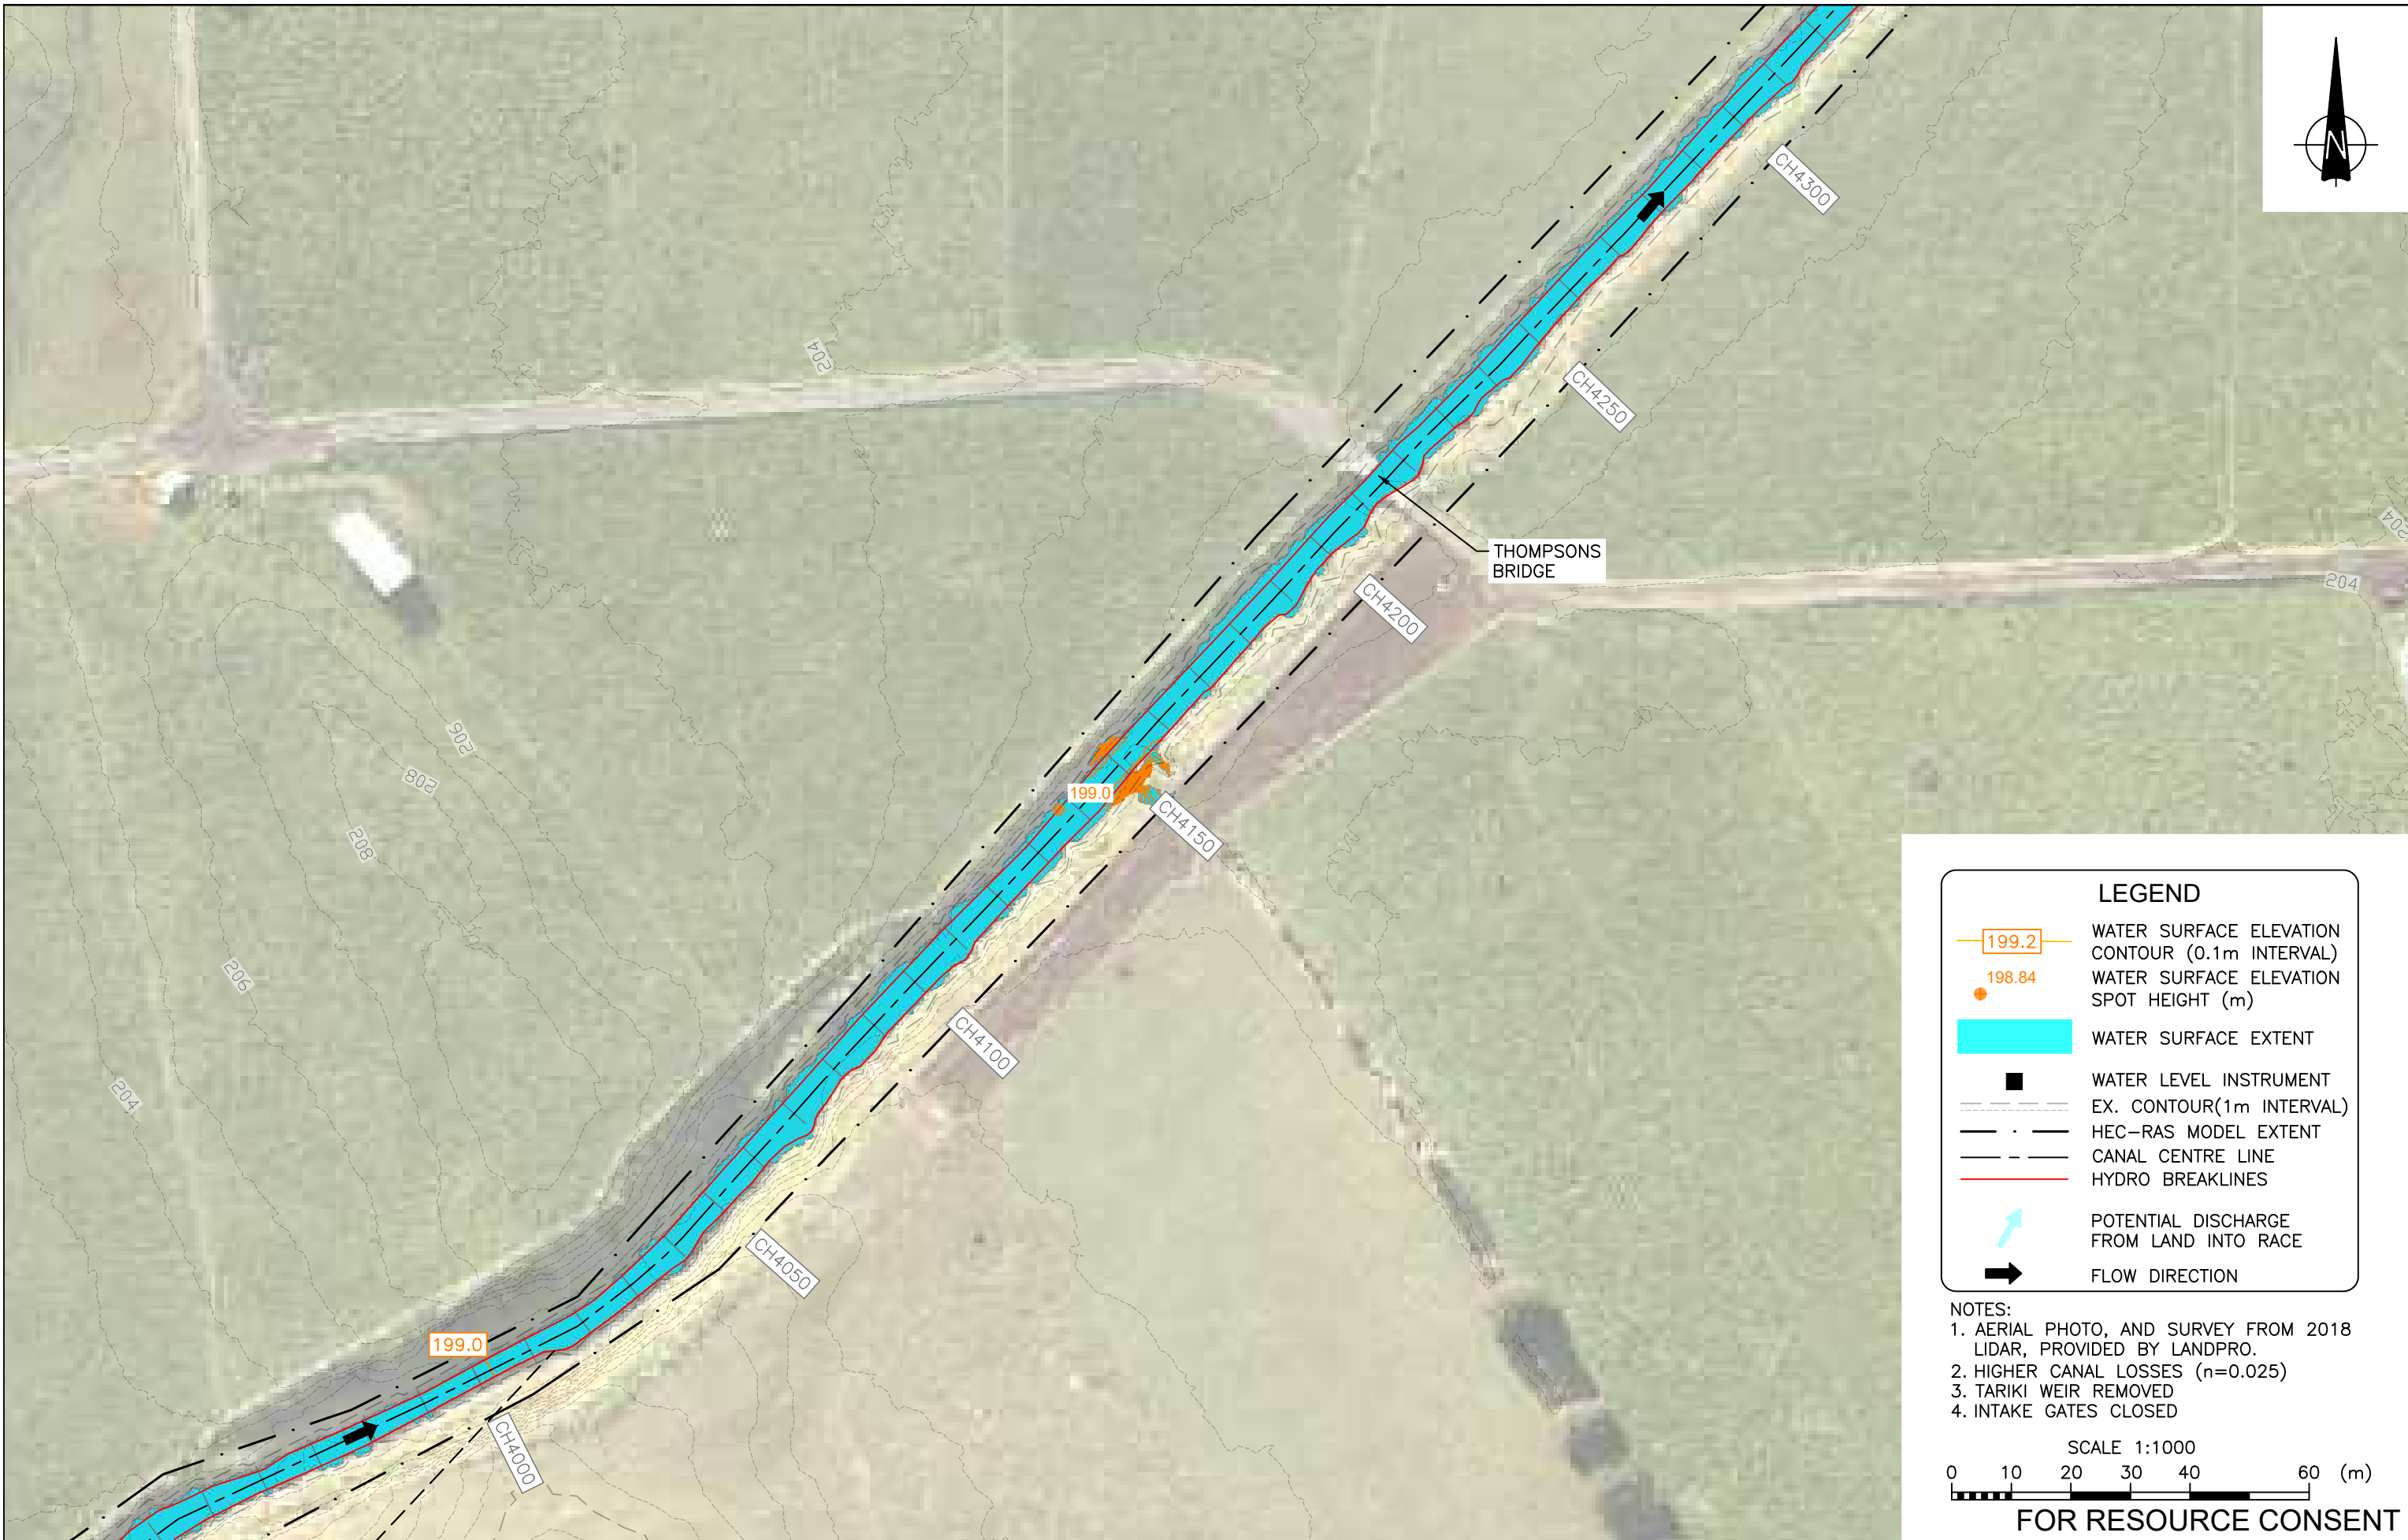
CADFILE	
18MTK_ENH-250to267.dwg	
SCALE (A3)	ORIG. SHEET SIZE
1:1000	A3
DRAWING No.	REV.
18MTK_ENH-262	1

CLIENT	TRUSTPOWER LTD
ADDRESS	MOTUKAWA HYDRO ELECTRIC POWER SCHEME
PROJECT	RACE HYDRAULIC AND GEOTECHNICAL ASSESSMENT
SHEET TITLE	MEAN ANNUAL FLOOD EVENT - LEVELS - PLAN 13
