Hydraulic and Geotechnical
Assessment – Riley Consultants
Limited

MOTUKAWA RACE HYDRAULIC AND GEOTECHNICAL ASSESSMENT MOTUKAWA HYDRO-ELECTRIC POWER SCHEME

Report prepared for: Trustpower Limited

Report reference: 18MTK-ENH-C

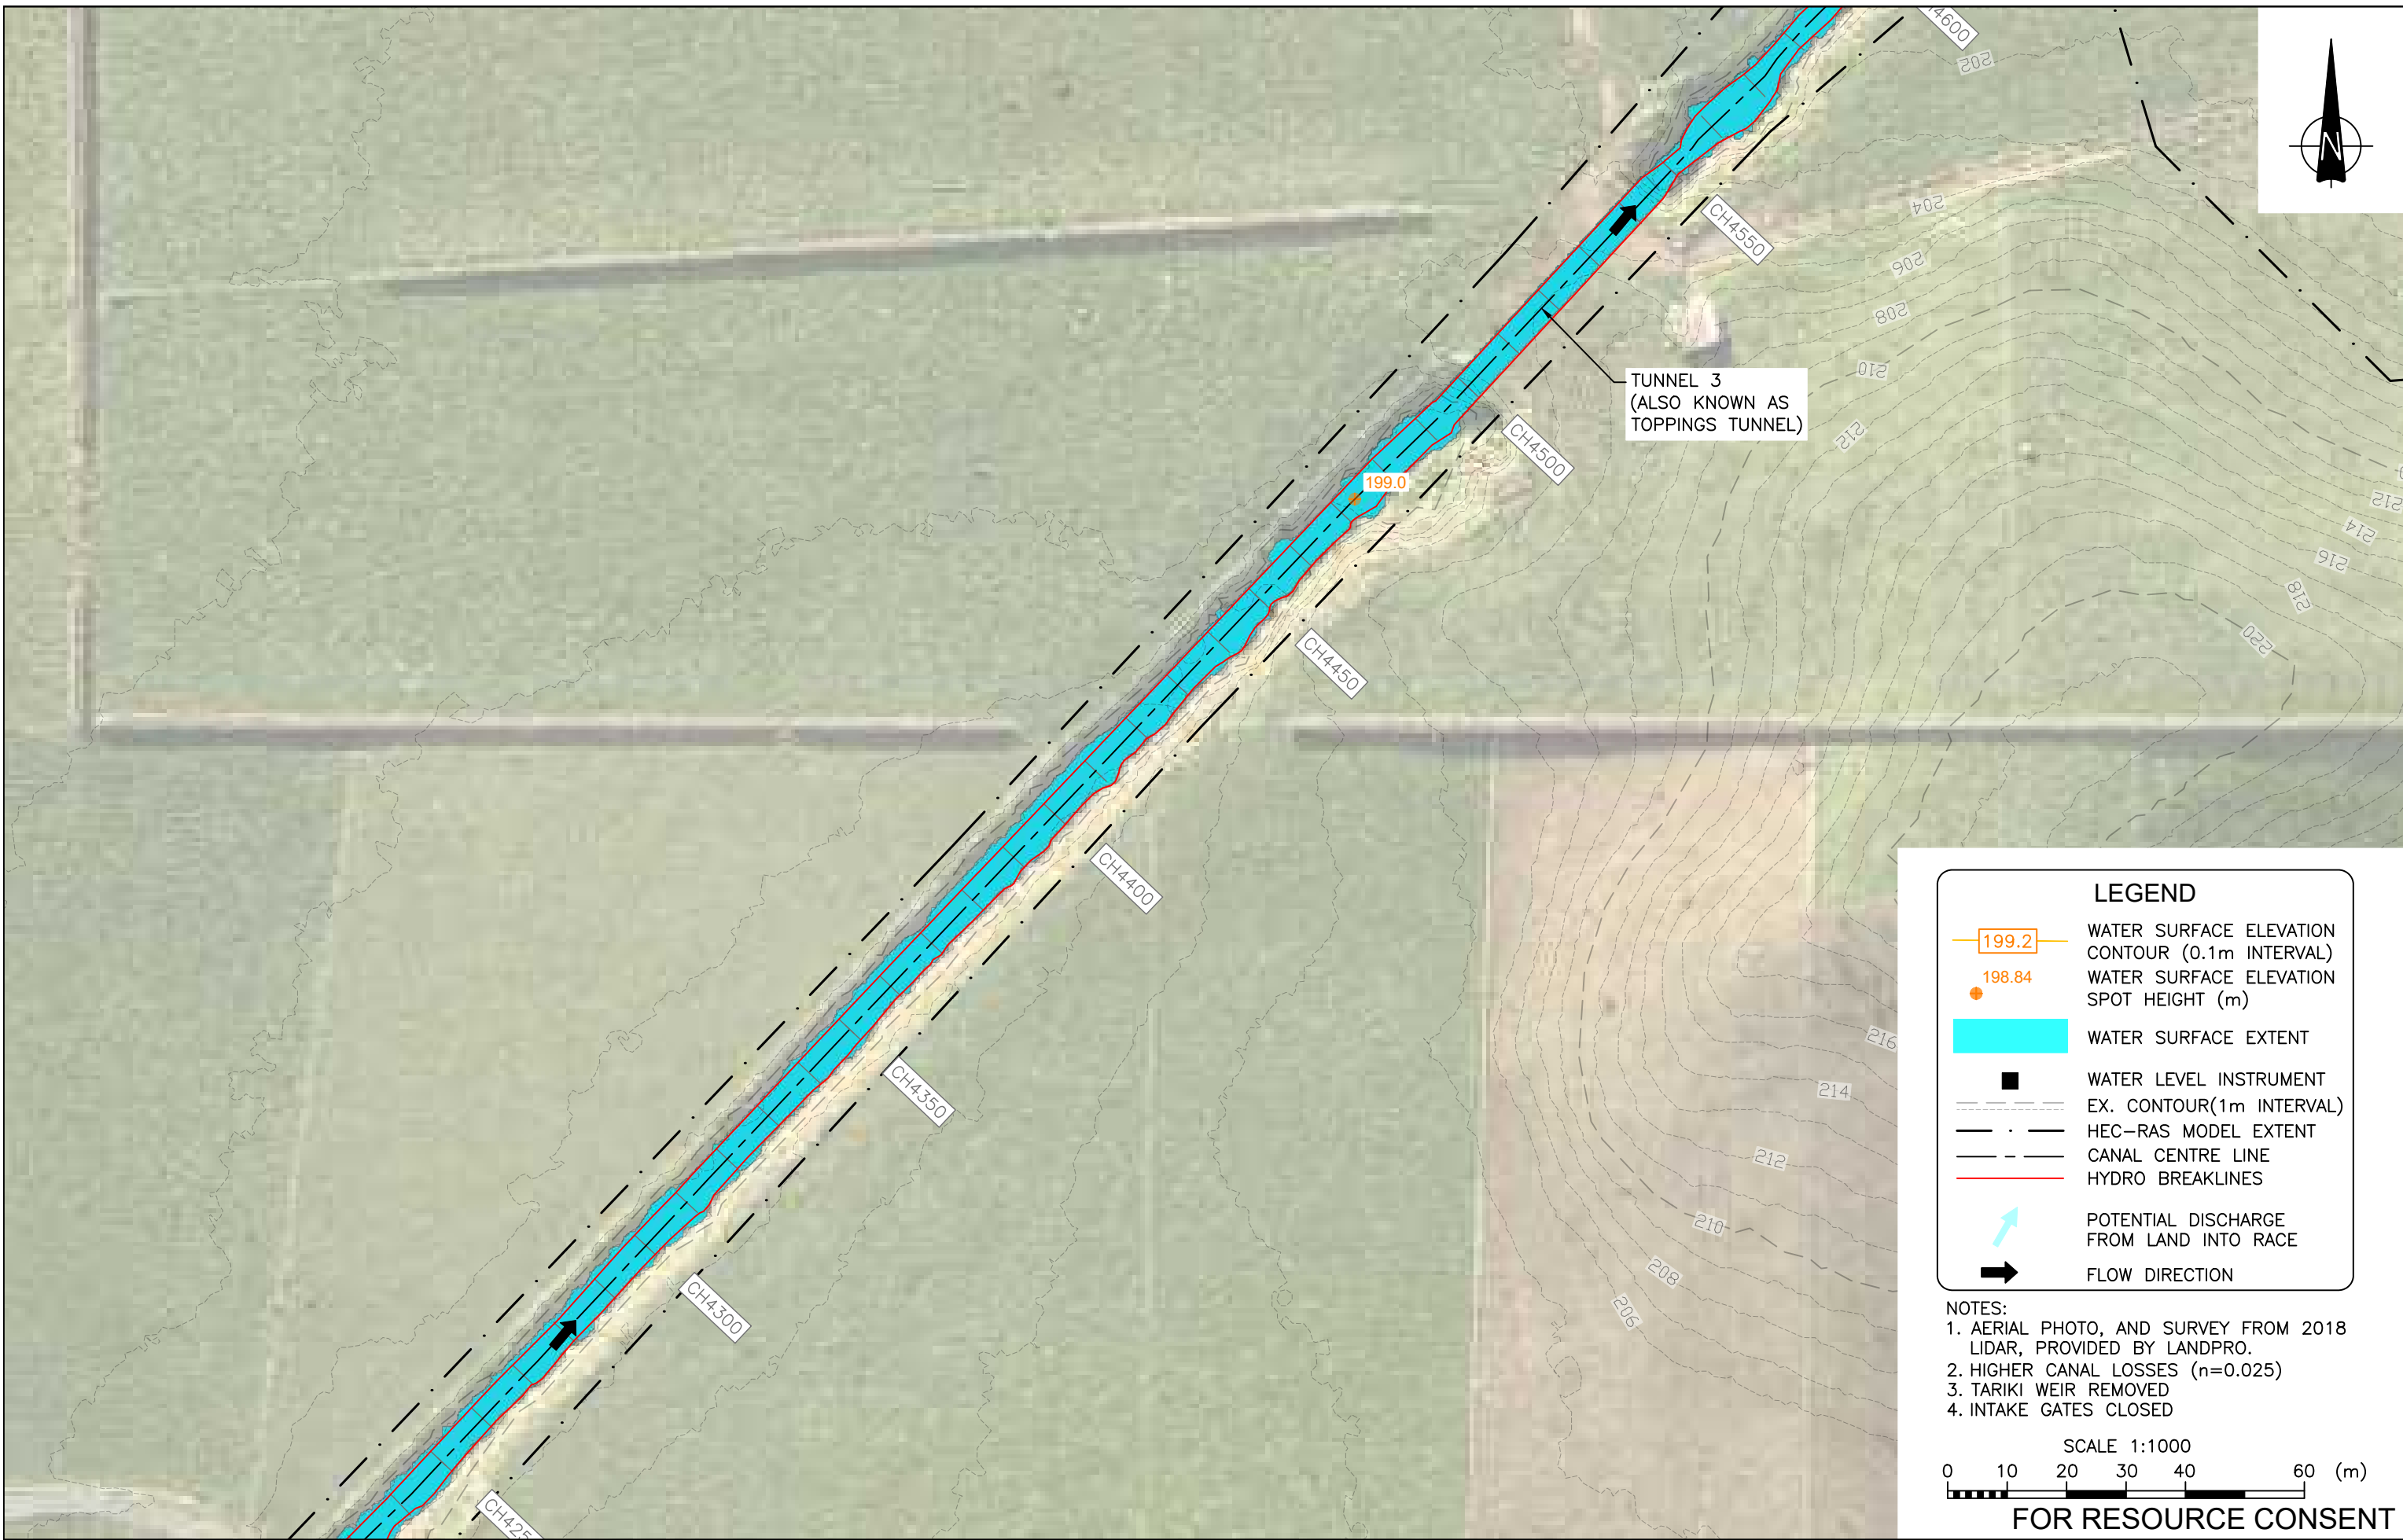
CADFILE	
18MTK_ENH-250to267.dwg	
SCALE (A3)	ORIG. SHEET SIZE
1:1000	A3
DRAWING No.	REV.
18MTK_ENH-263	1

CLIENT	TRUSTPOWER LTD
ADDRESS	MOTUKAWA HYDRO ELECTRIC POWER SCHEME
PROJECT	RACE HYDRAULIC AND GEOTECHNICAL ASSESSMENT
SHEET TITLE	MEAN ANNUAL FLOOD EVENT - LEVELS - PLAN 14

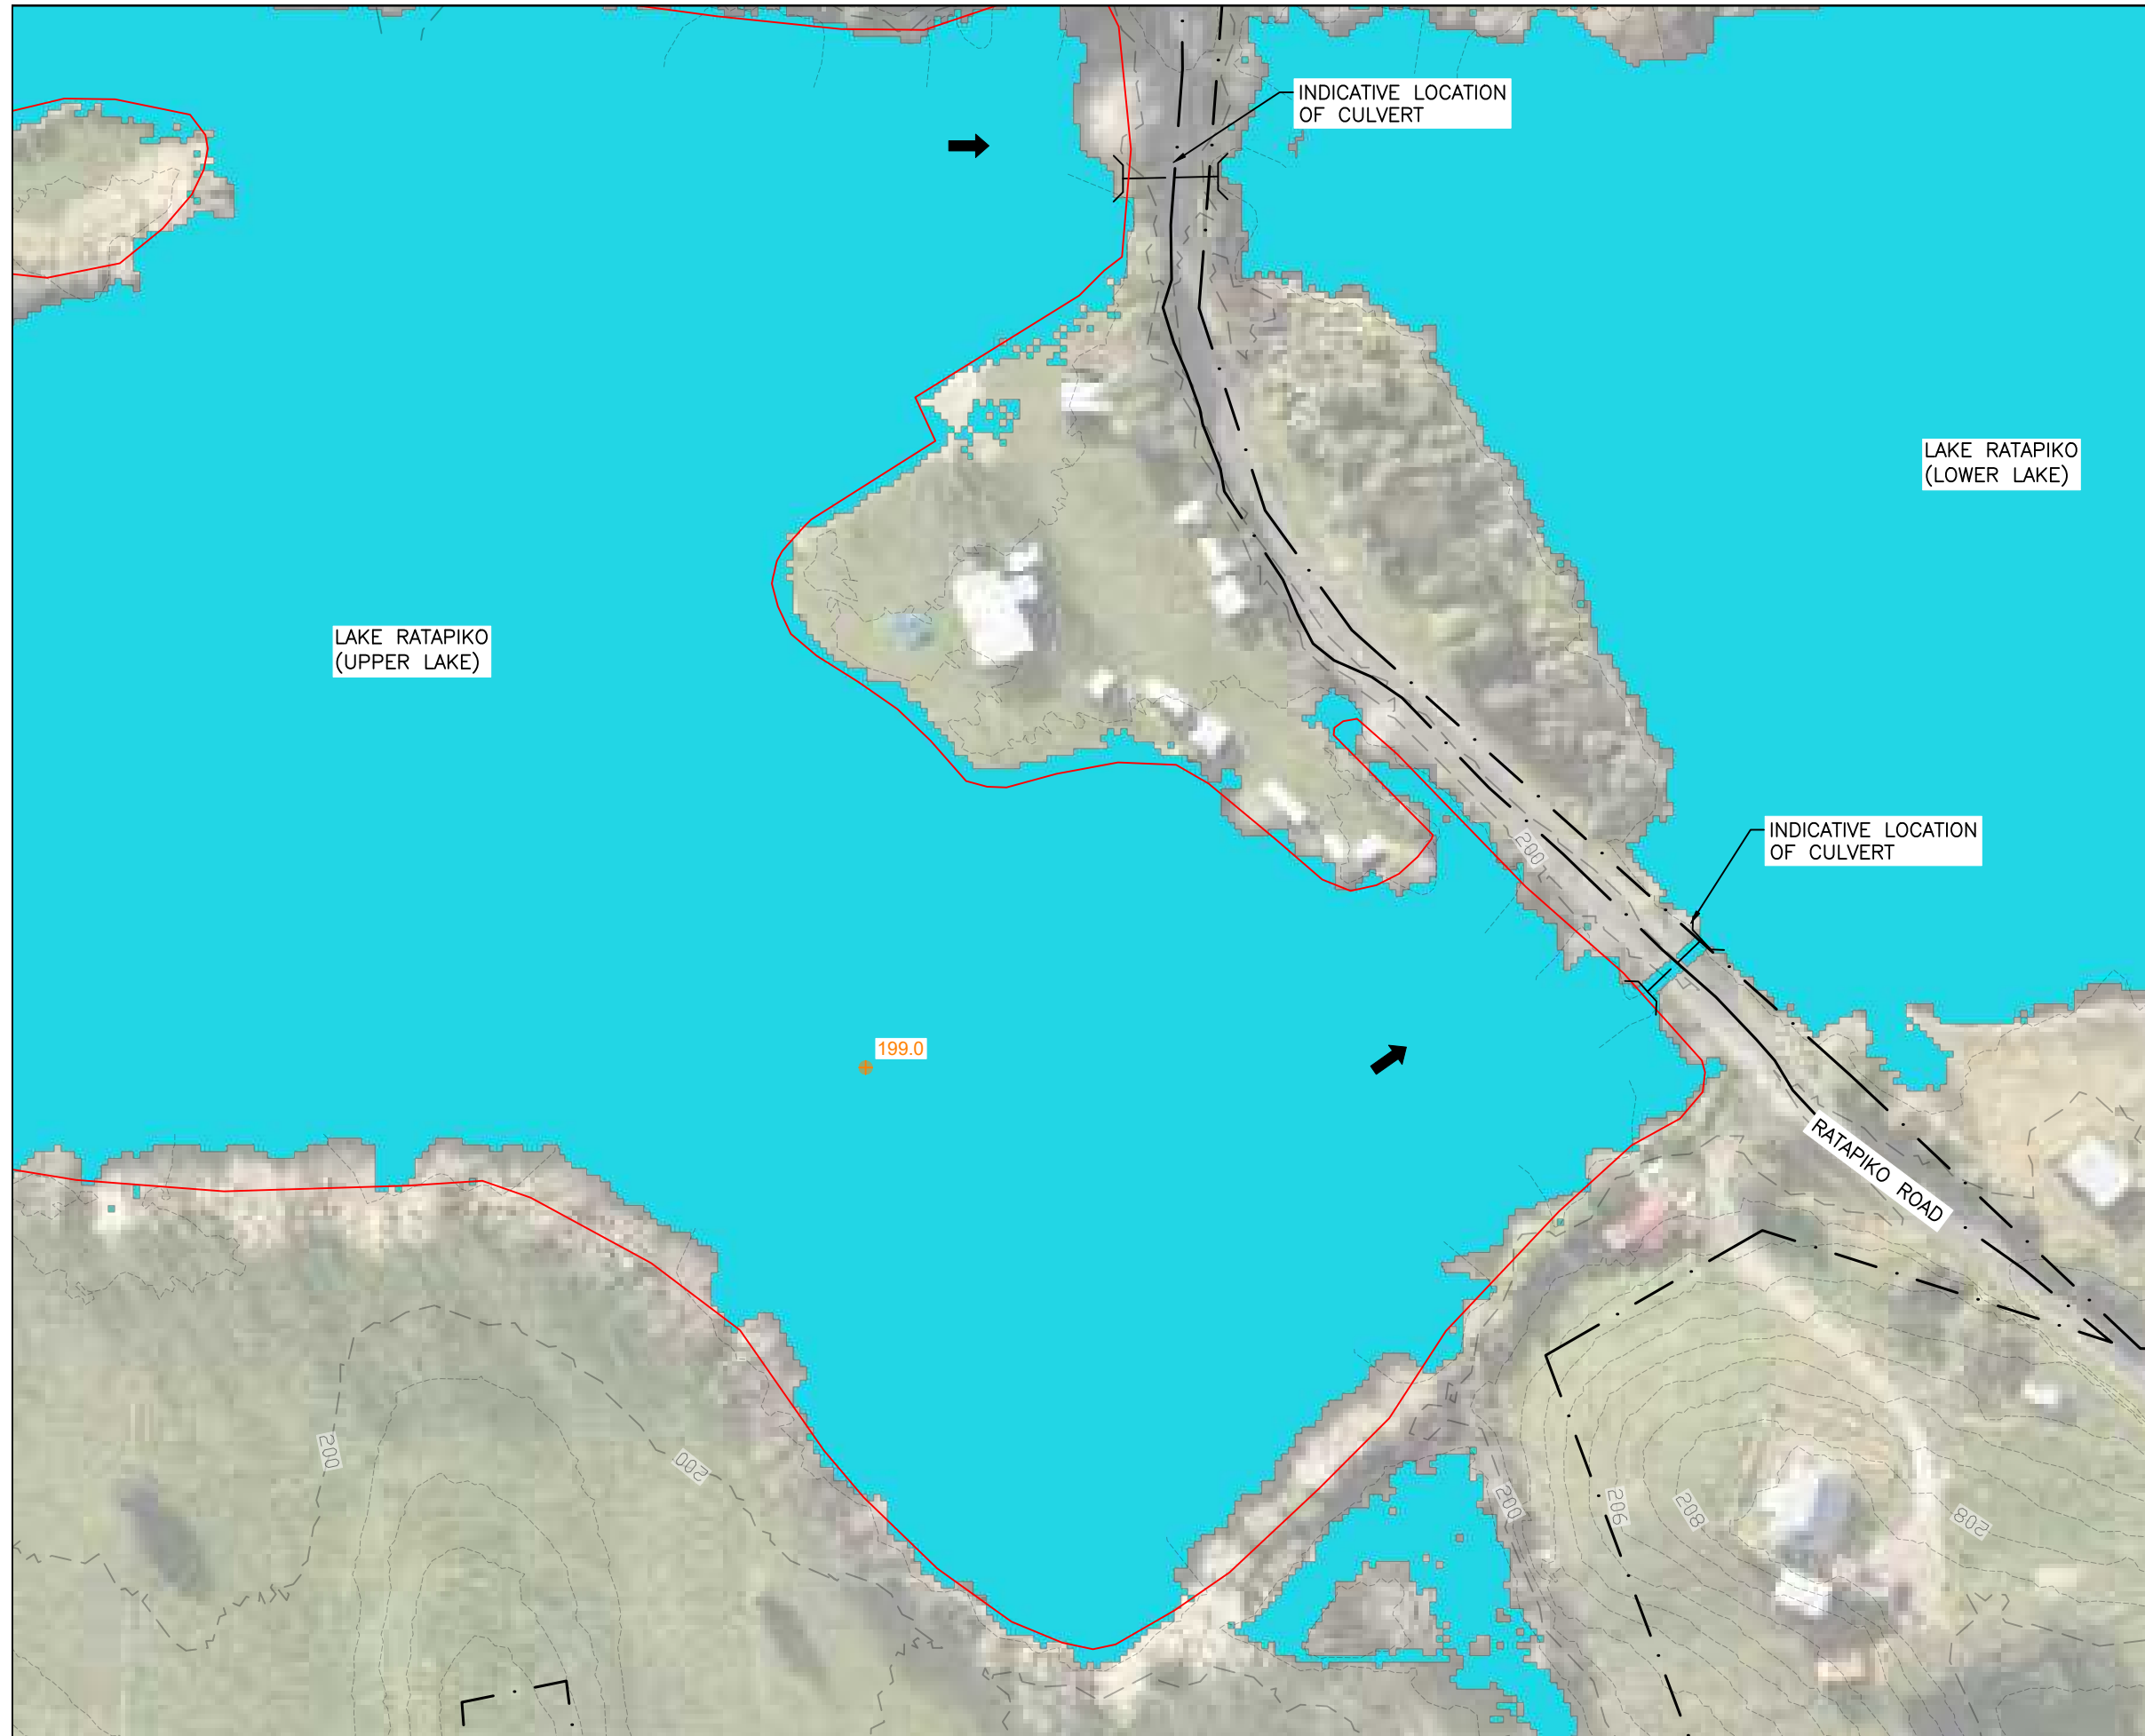
CADFILE
18MTK_ENH-250to267.dwg
SCALE (A3) 1:1000
ORIG. SHEET SIZE A3
DRAWING No. 18MTK_ENH-266
REV. 1

CLIENT	TRUSTPOWER LTD
ADDRESS	MOTUKAWA HYDRO ELECTRIC POWER SCHEME
PROJECT	RACE HYDRAULIC AND GEOTECHNICAL ASSESSMENT
SHEET TITLE	MEAN ANNUAL FLOOD EVENT - LEVELS - PLAN 17

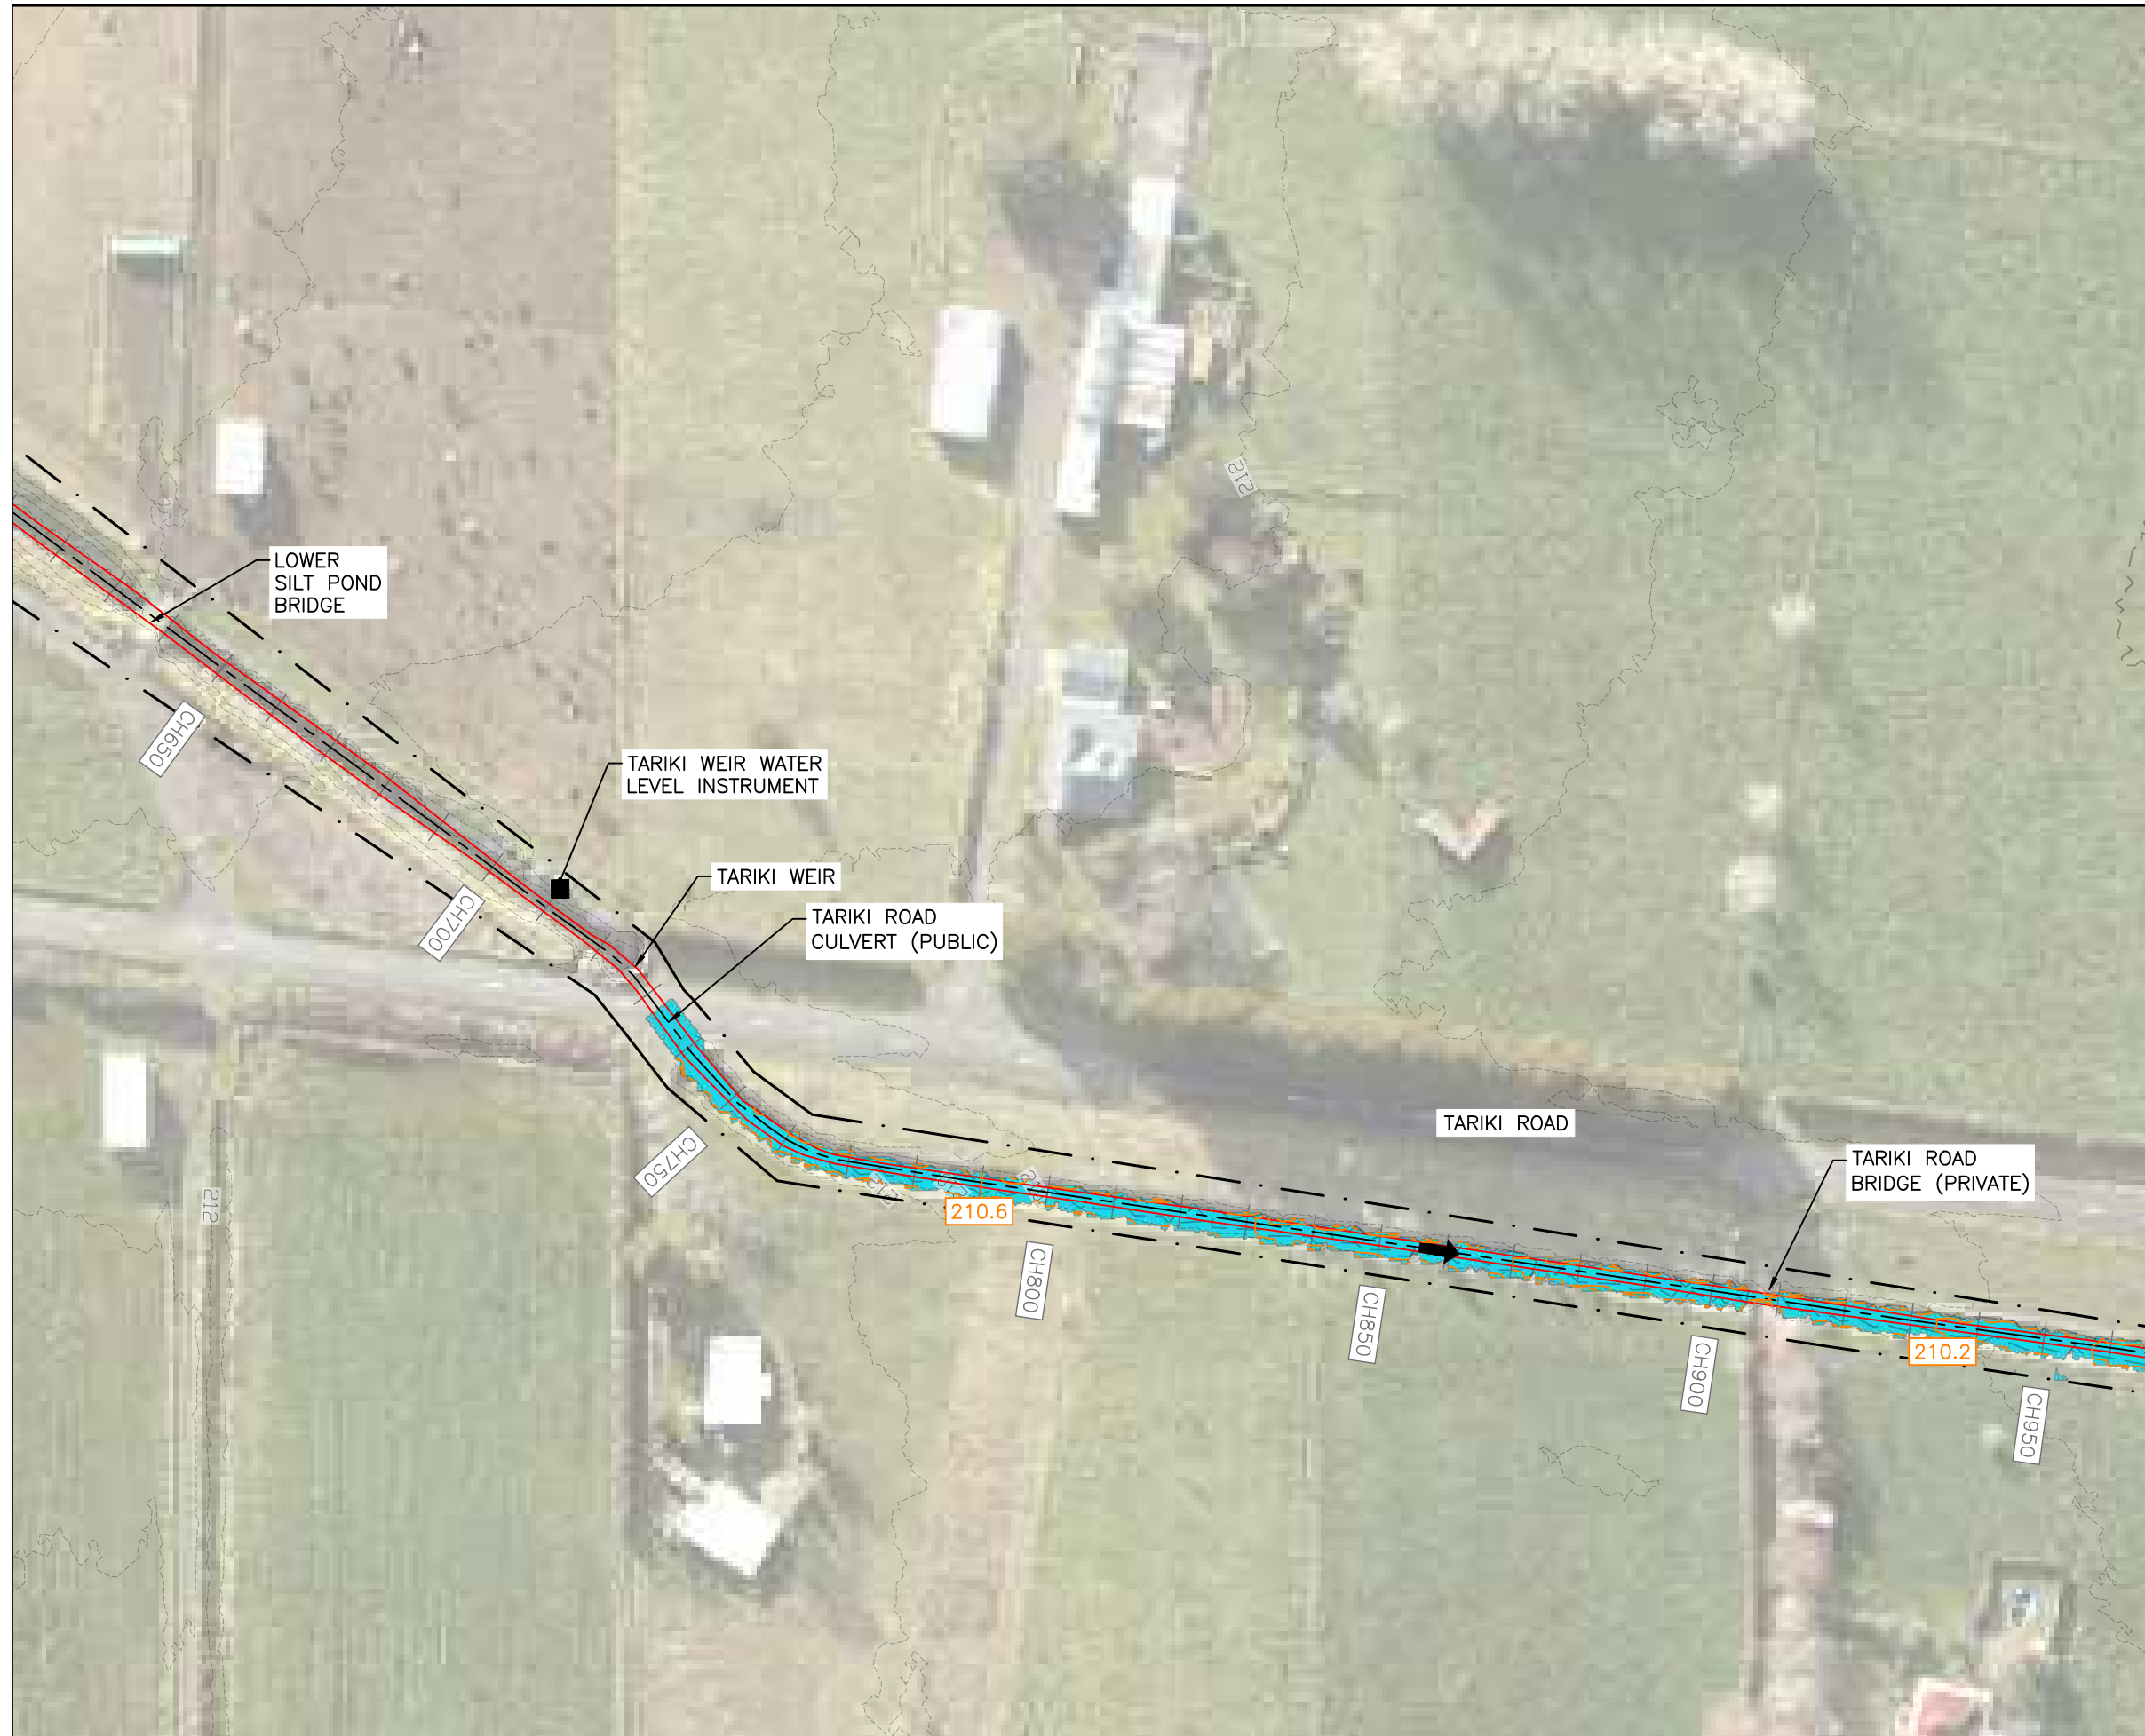
CADFILE: 18MTK_ENH-250to267.dwg
 SCALE (A3): 1:1000
 ORIG. SHEET SIZE: A3
 DRAWING No.: 18MTK_ENH-267
 REV.: 1

CLIENT: TRUSTPOWER LTD
 ADDRESS: MOTUKAWA HYDRO ELECTRIC POWER SCHEME
 PROJECT: RACE HYDRAULIC AND GEOTECHNICAL ASSESSMENT
 SHEET TITLE: MEAN ANNUAL FLOOD EVENT - LEVELS - PLAN 18

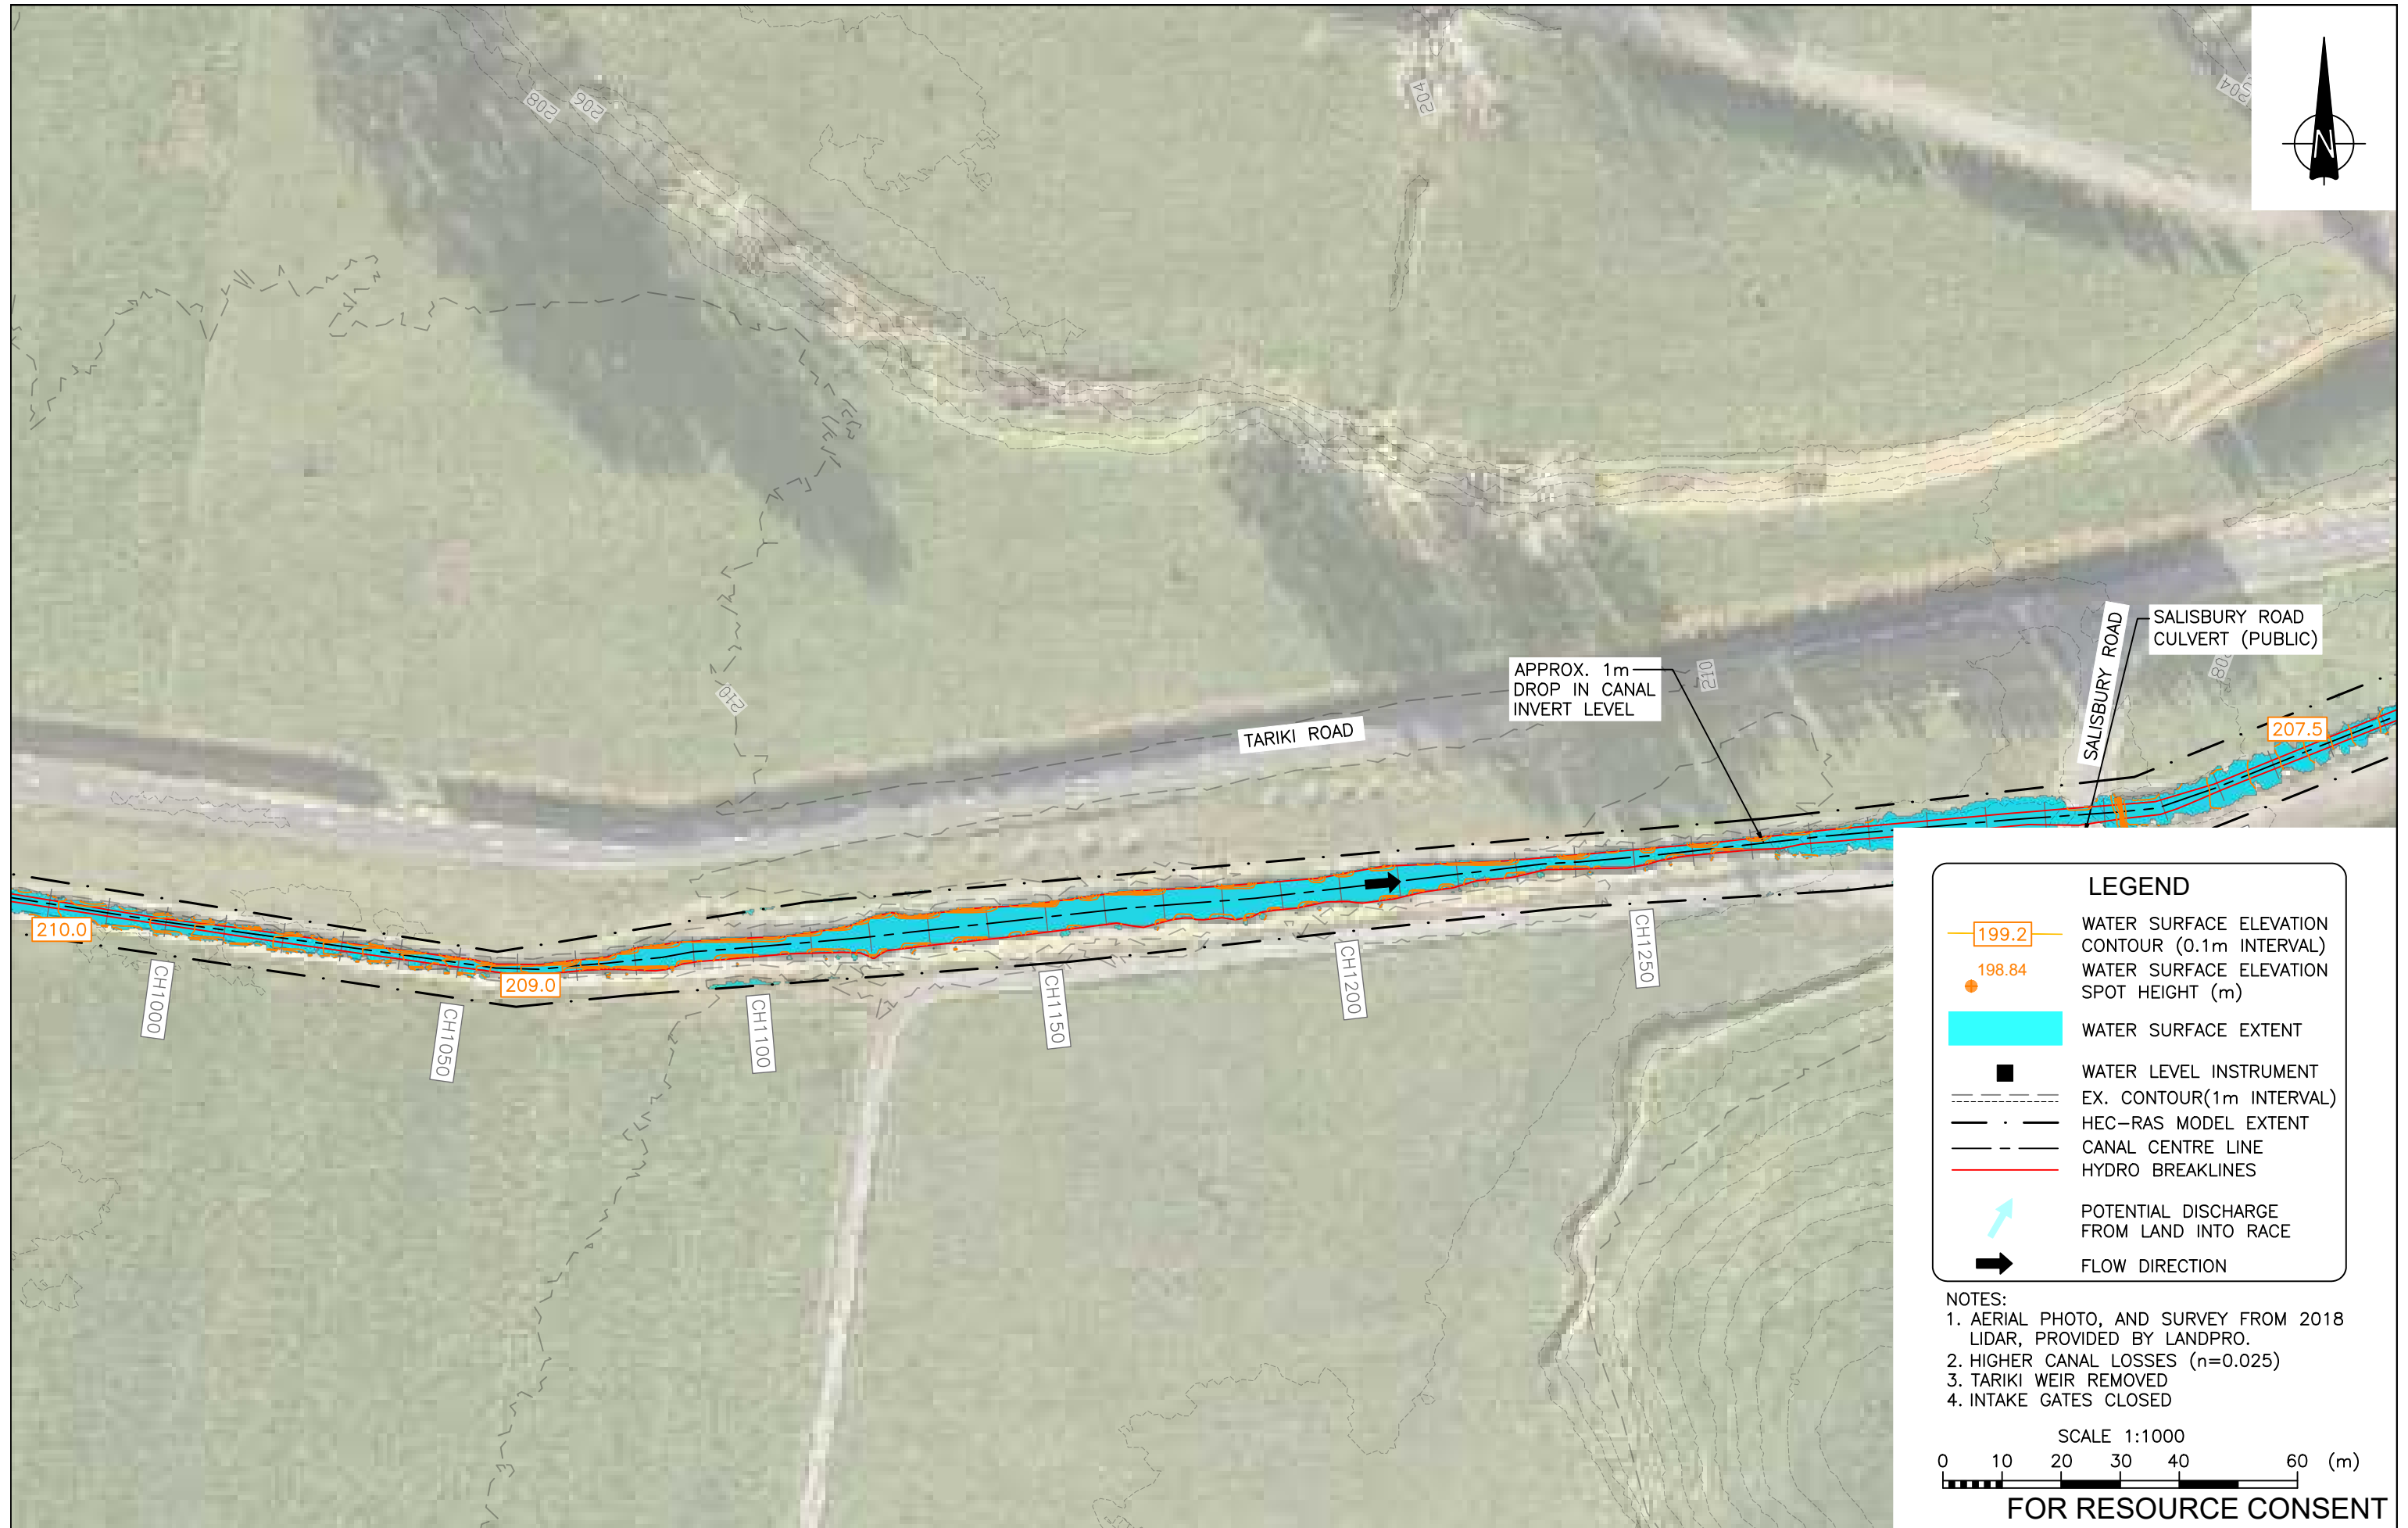
CADFILE	
18MTK_ENH-270to287.dwg	
SCALE (A3)	ORIG. SHEET SIZE
1:1000	A3
DRAWING No.	REV.
18MTK_ENH-272	1

CLIENT	TRUSTPOWER LTD
ADDRESS	MOTUKAWA HYDRO ELECTRIC POWER SCHEME
PROJECT	RACE HYDRAULIC AND GEOTECHNICAL ASSESSMENT
SHEET TITLE	100 YEAR FLOOD EVENT - LEVELS - PLAN 3

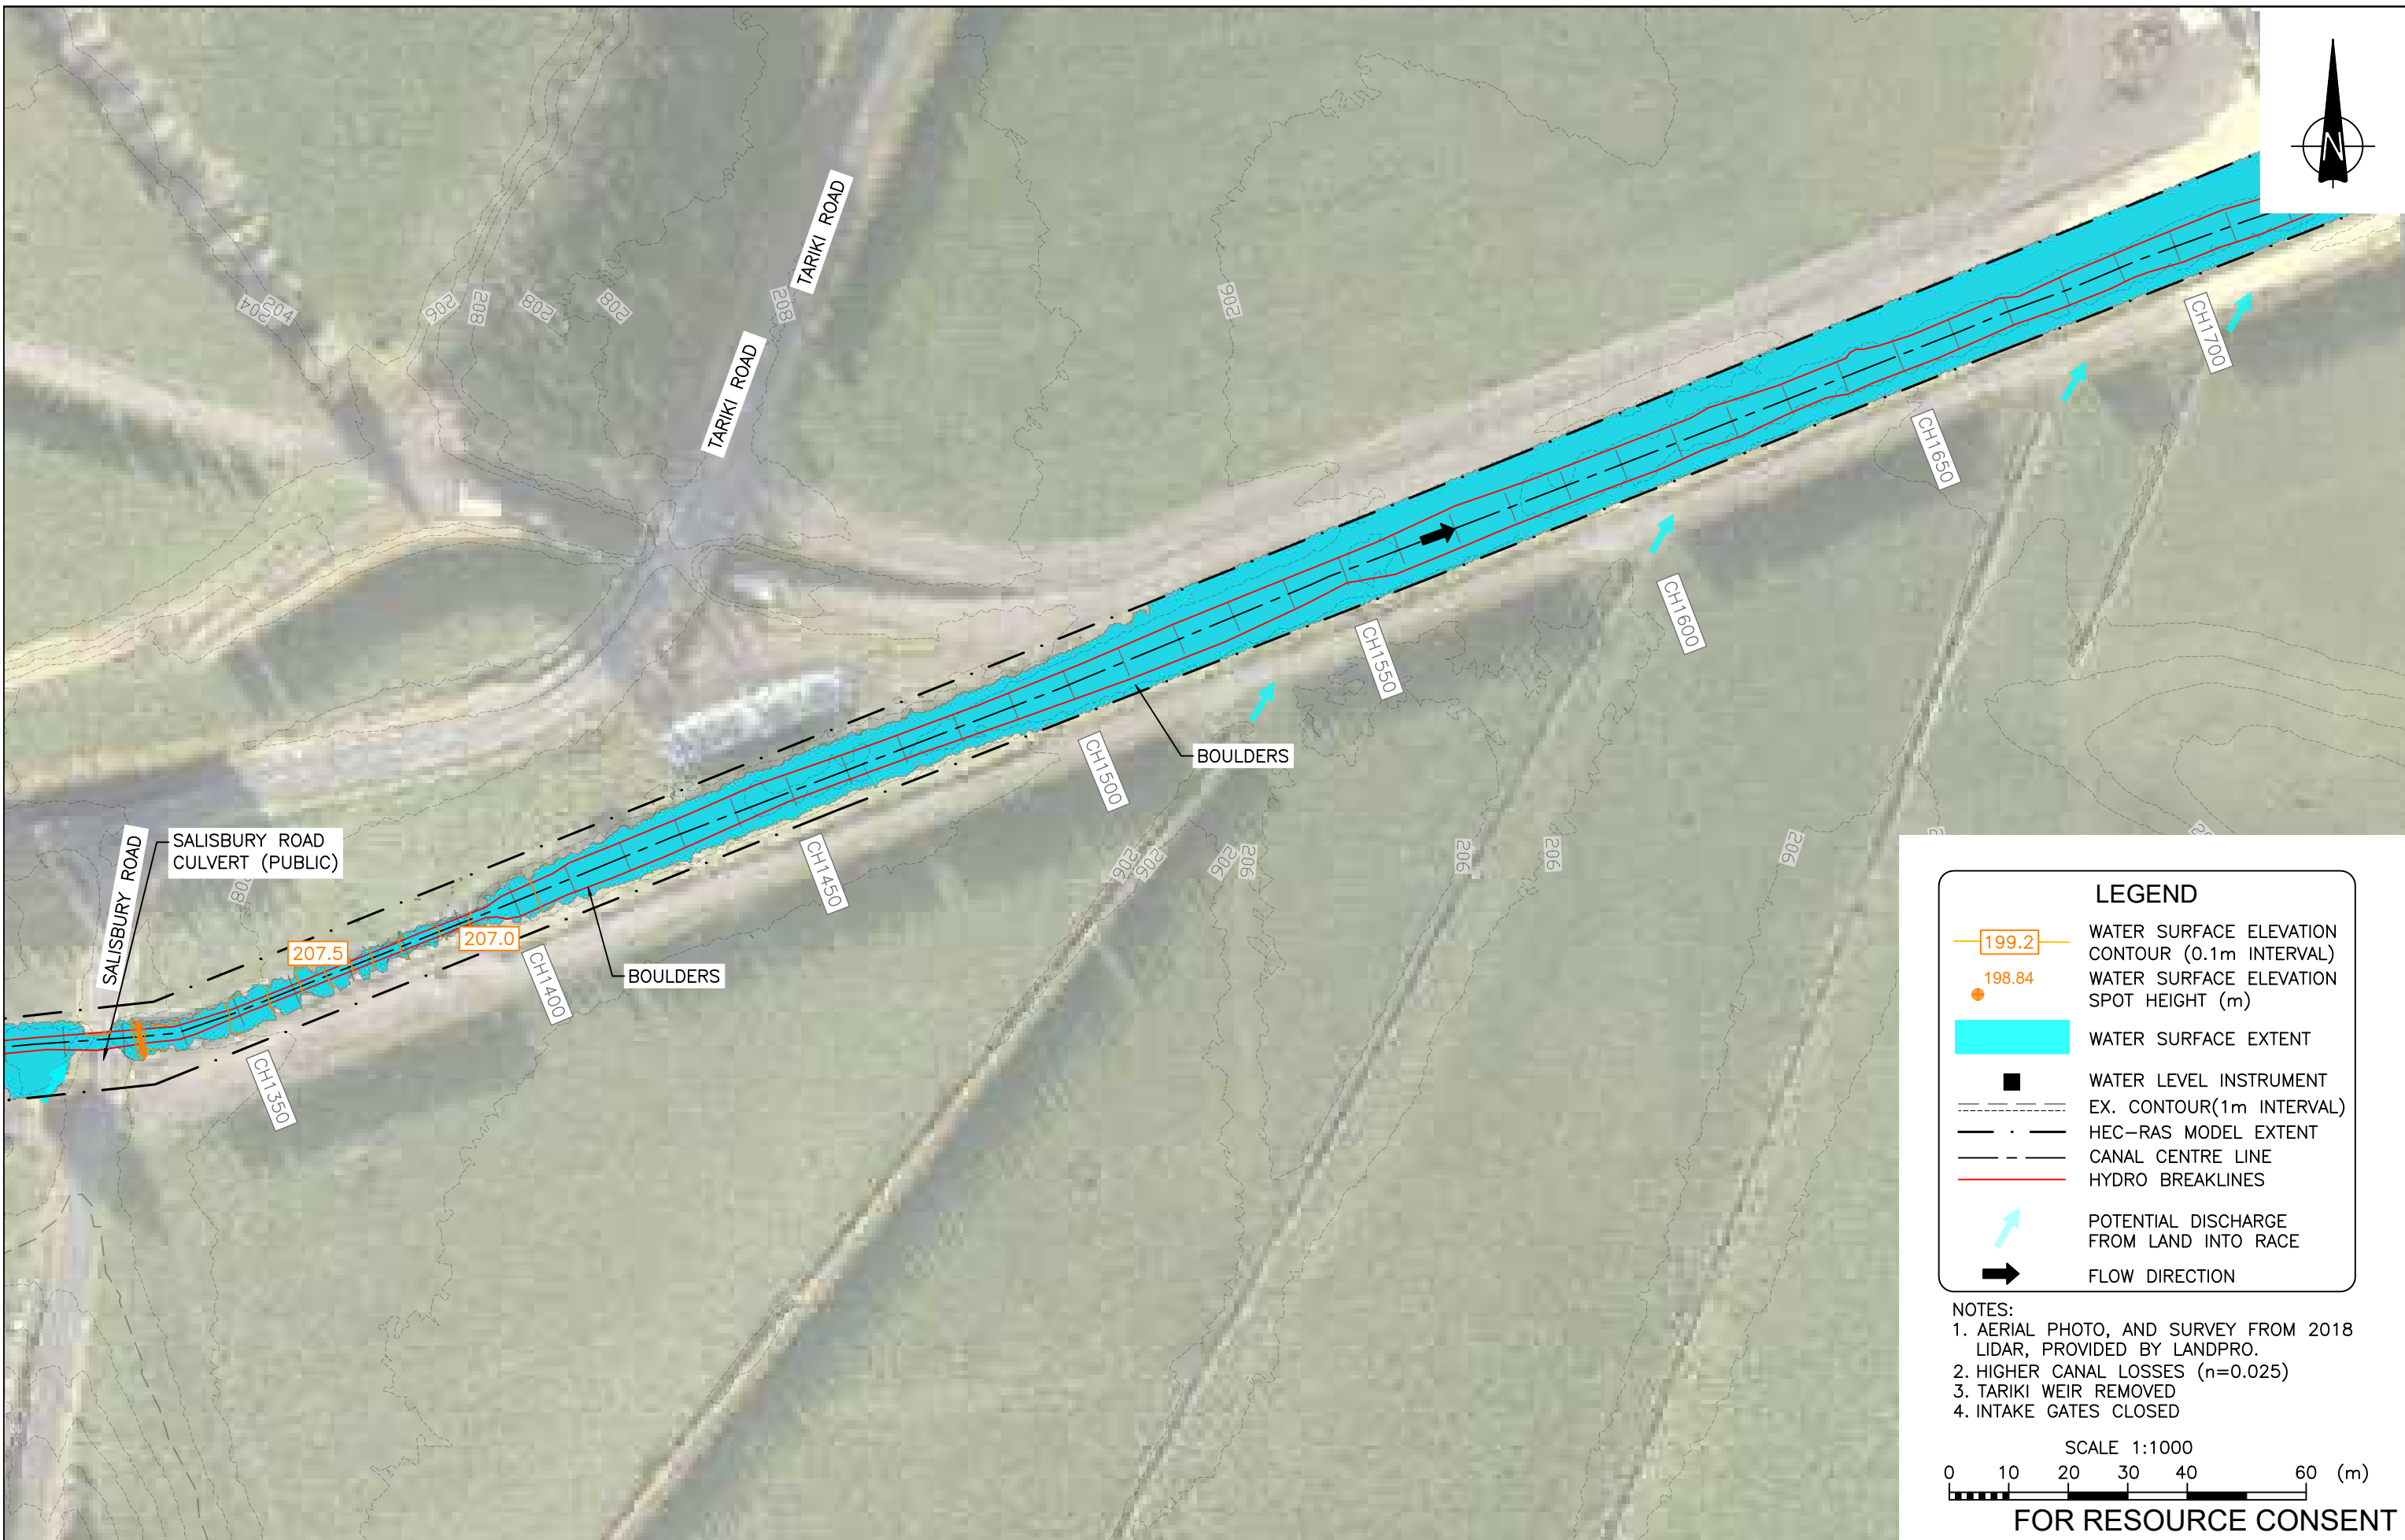
CADFILE	18MTK_ENH-270to287.dwg
SCALE (A3)	1:1000
ORIG. SHEET SIZE	A3
DRAWING No.	18MTK_ENH-273
REV.	1

CLIENT	TRUSTPOWER LTD
ADDRESS	MOTUKAWA HYDRO ELECTRIC POWER SCHEME
PROJECT	RACE HYDRAULIC AND GEOTECHNICAL ASSESSMENT
SHEET TITLE	100 YEAR FLOOD EVENT - LEVELS - PLAN 4

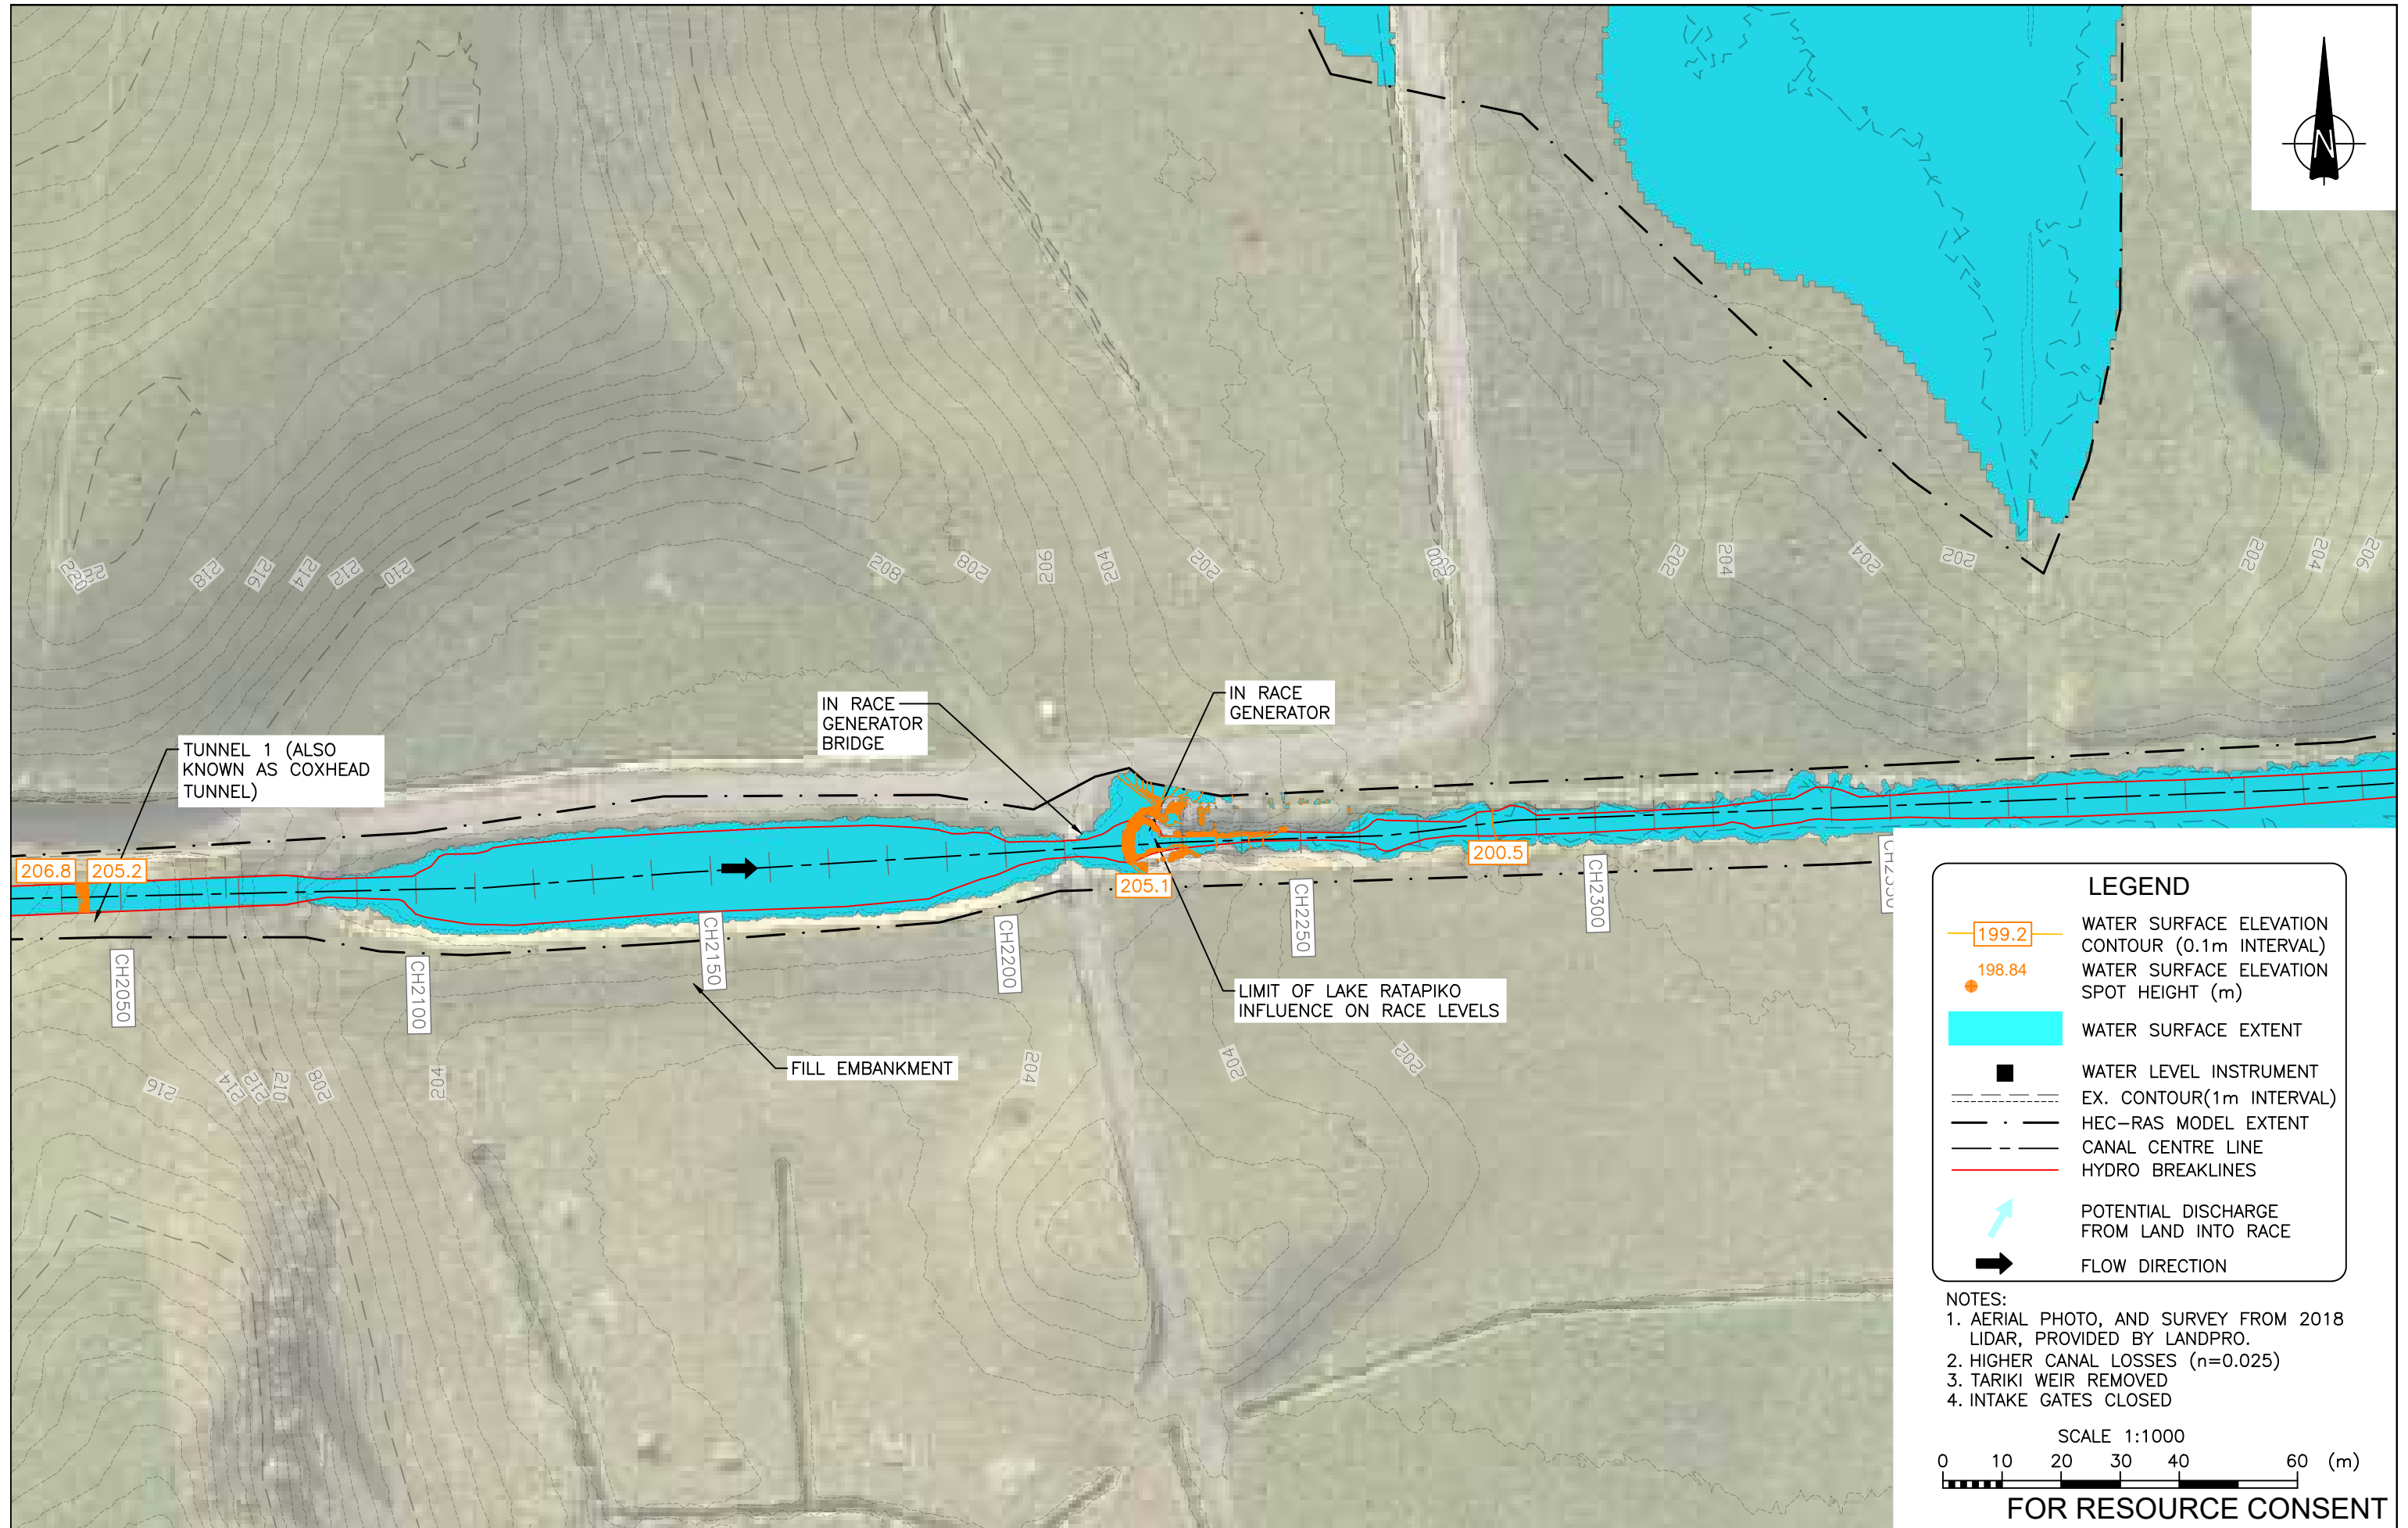
CADFILE: 18MTK_ENH-270to287.dwg
 SCALE (A3): 1:1000
 ORIG. SHEET SIZE: A3
 DRAWING No.: 18MTK_ENH-275
 REV.: 1

CLIENT: TRUSTPOWER LTD
 ADDRESS: MOTUKAWA HYDRO ELECTRIC POWER SCHEME
 PROJECT: RACE HYDRAULIC AND GEOTECHNICAL ASSESSMENT
 SHEET TITLE: 100 YEAR FLOOD EVENT - LEVELS - PLAN 6
