Hydraulic and Geotechnical
Assessment – Riley Consultants
Limited

MOTUKAWA RACE HYDRAULIC AND GEOTECHNICAL ASSESSMENT MOTUKAWA HYDRO-ELECTRIC POWER SCHEME

Report prepared for: Trustpower Limited

Report reference: 18MTK-ENH-C

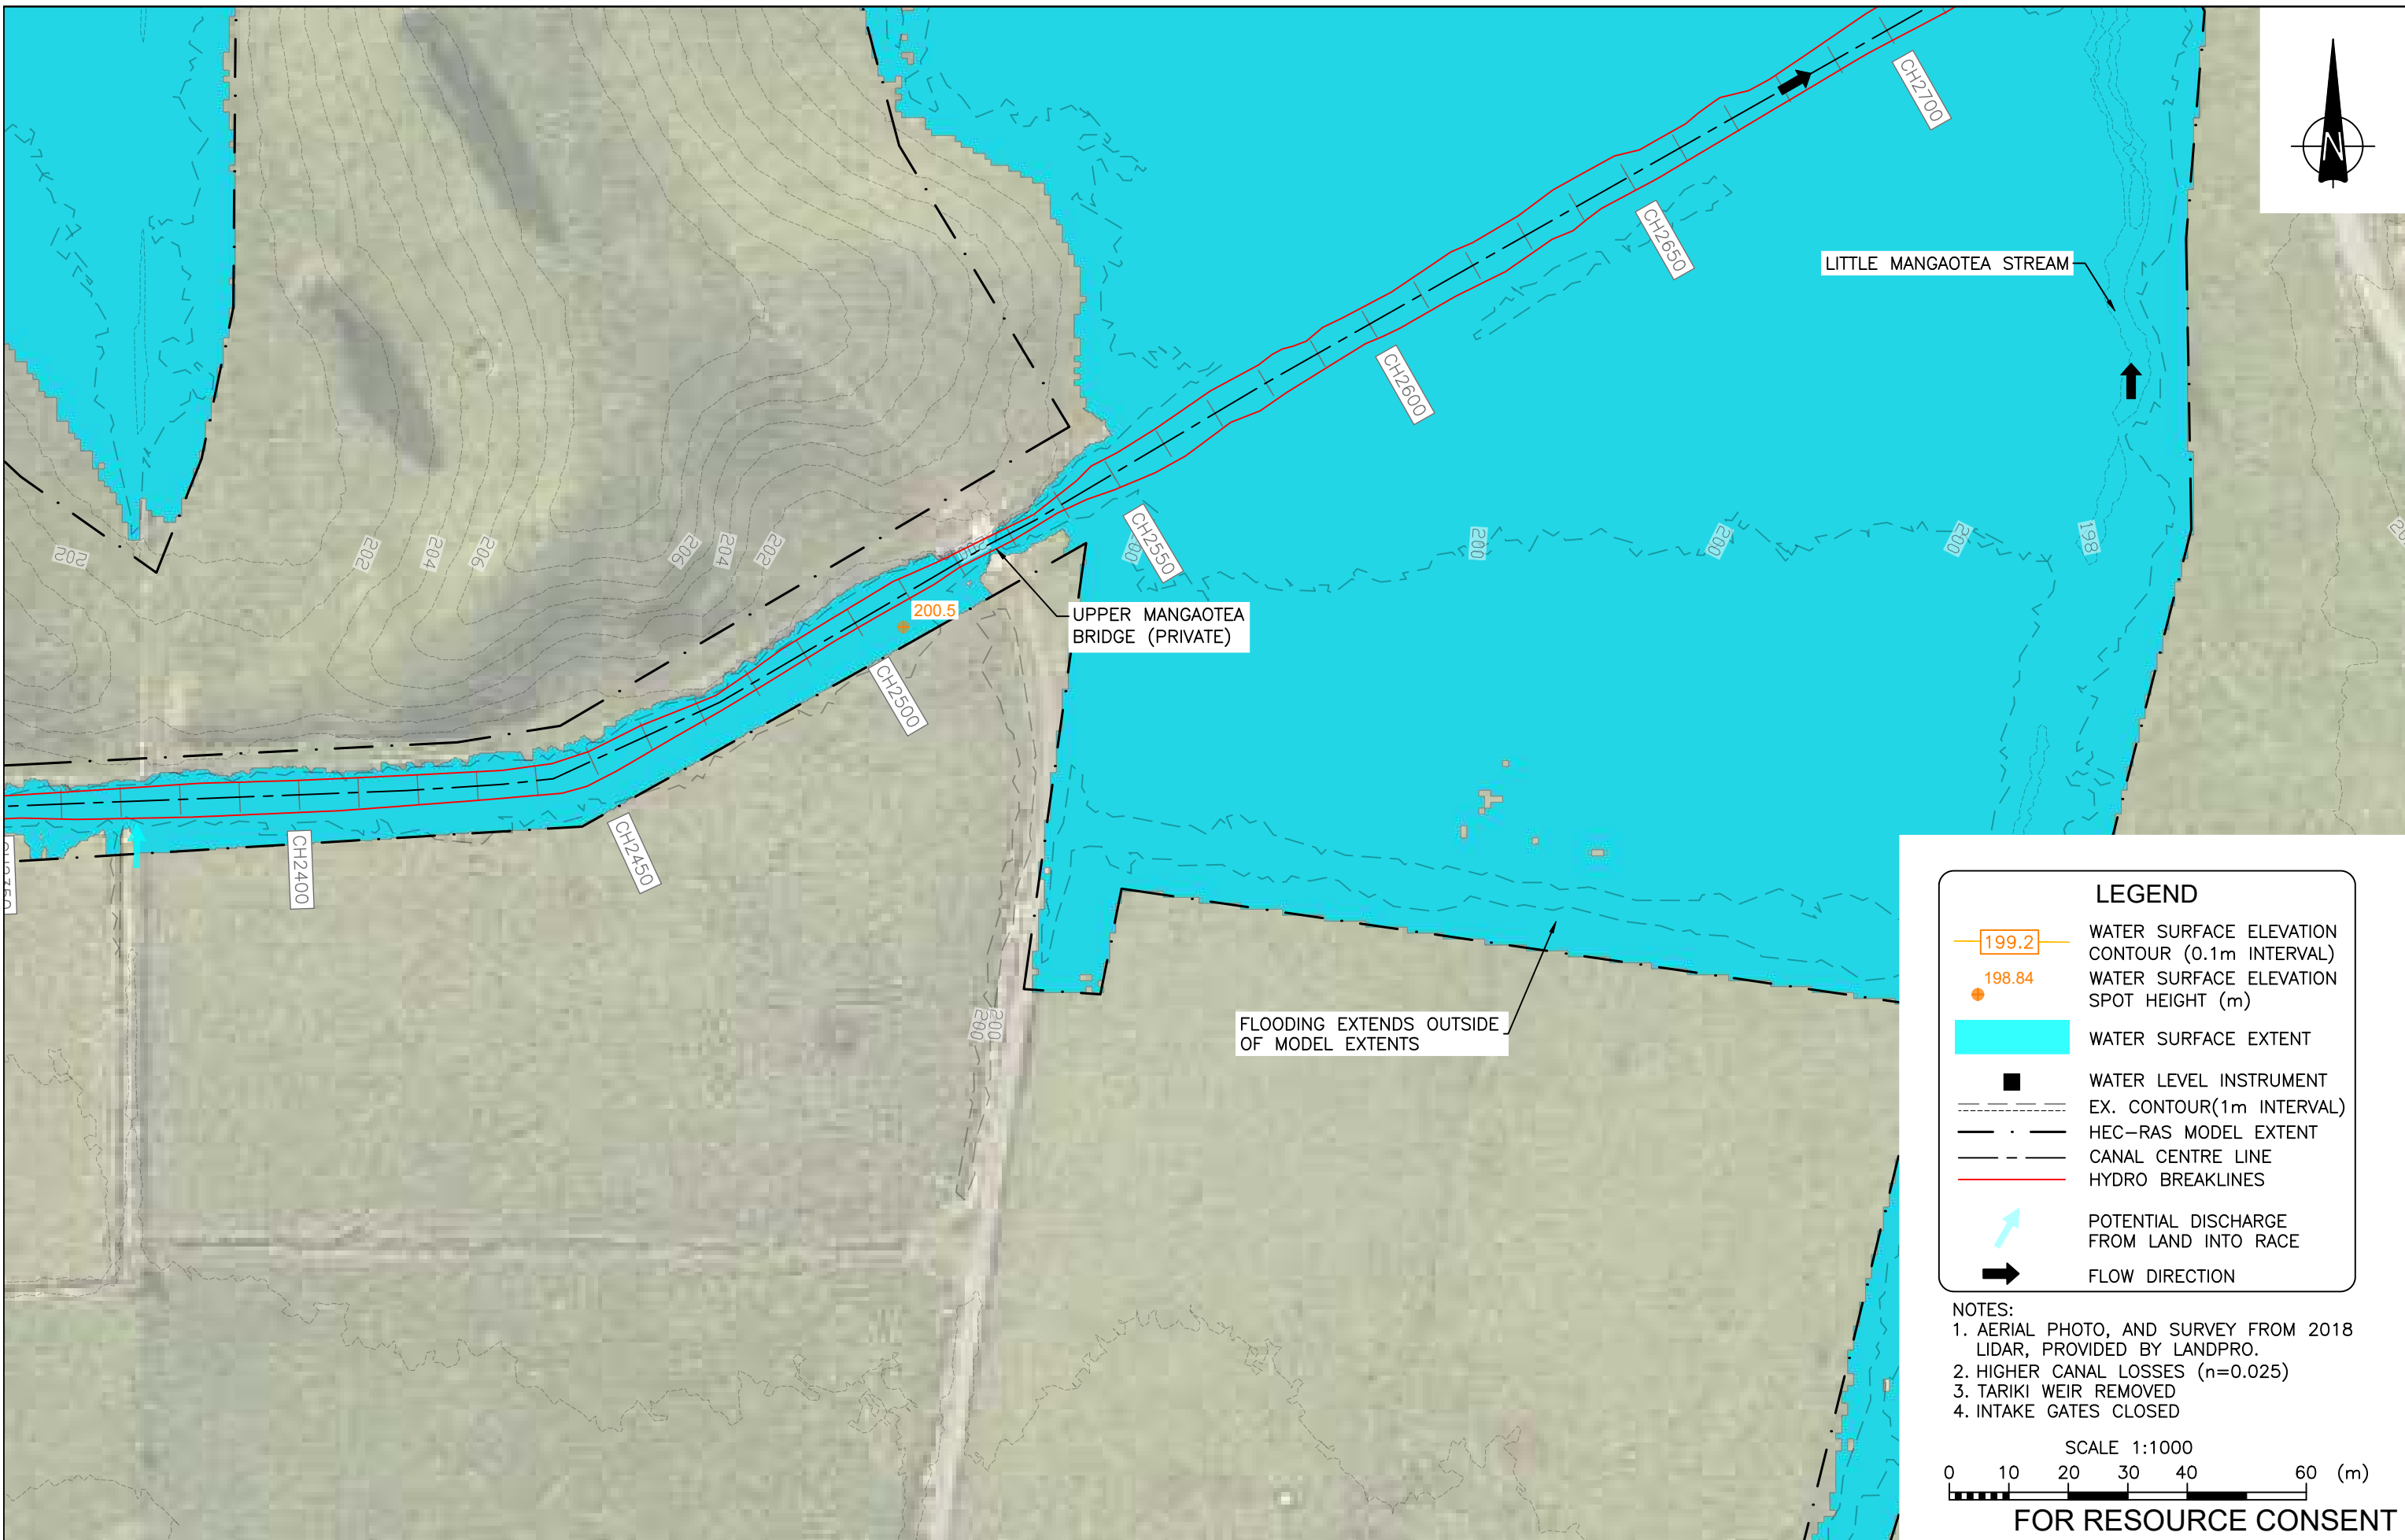
CADFILE	18MTK_ENH-270to287.dwg
SCALE (A3)	1:1000
ORIG. SHEET SIZE	A3
DRAWING No.	18MTK_ENH-276
REV.	1

CLIENT	TRUSTPOWER LTD
ADDRESS	MOTUKAWA HYDRO ELECTRIC POWER SCHEME
PROJECT	RACE HYDRAULIC AND GEOTECHNICAL ASSESSMENT
SHEET TITLE	100 YEAR FLOOD EVENT - LEVELS - PLAN 7

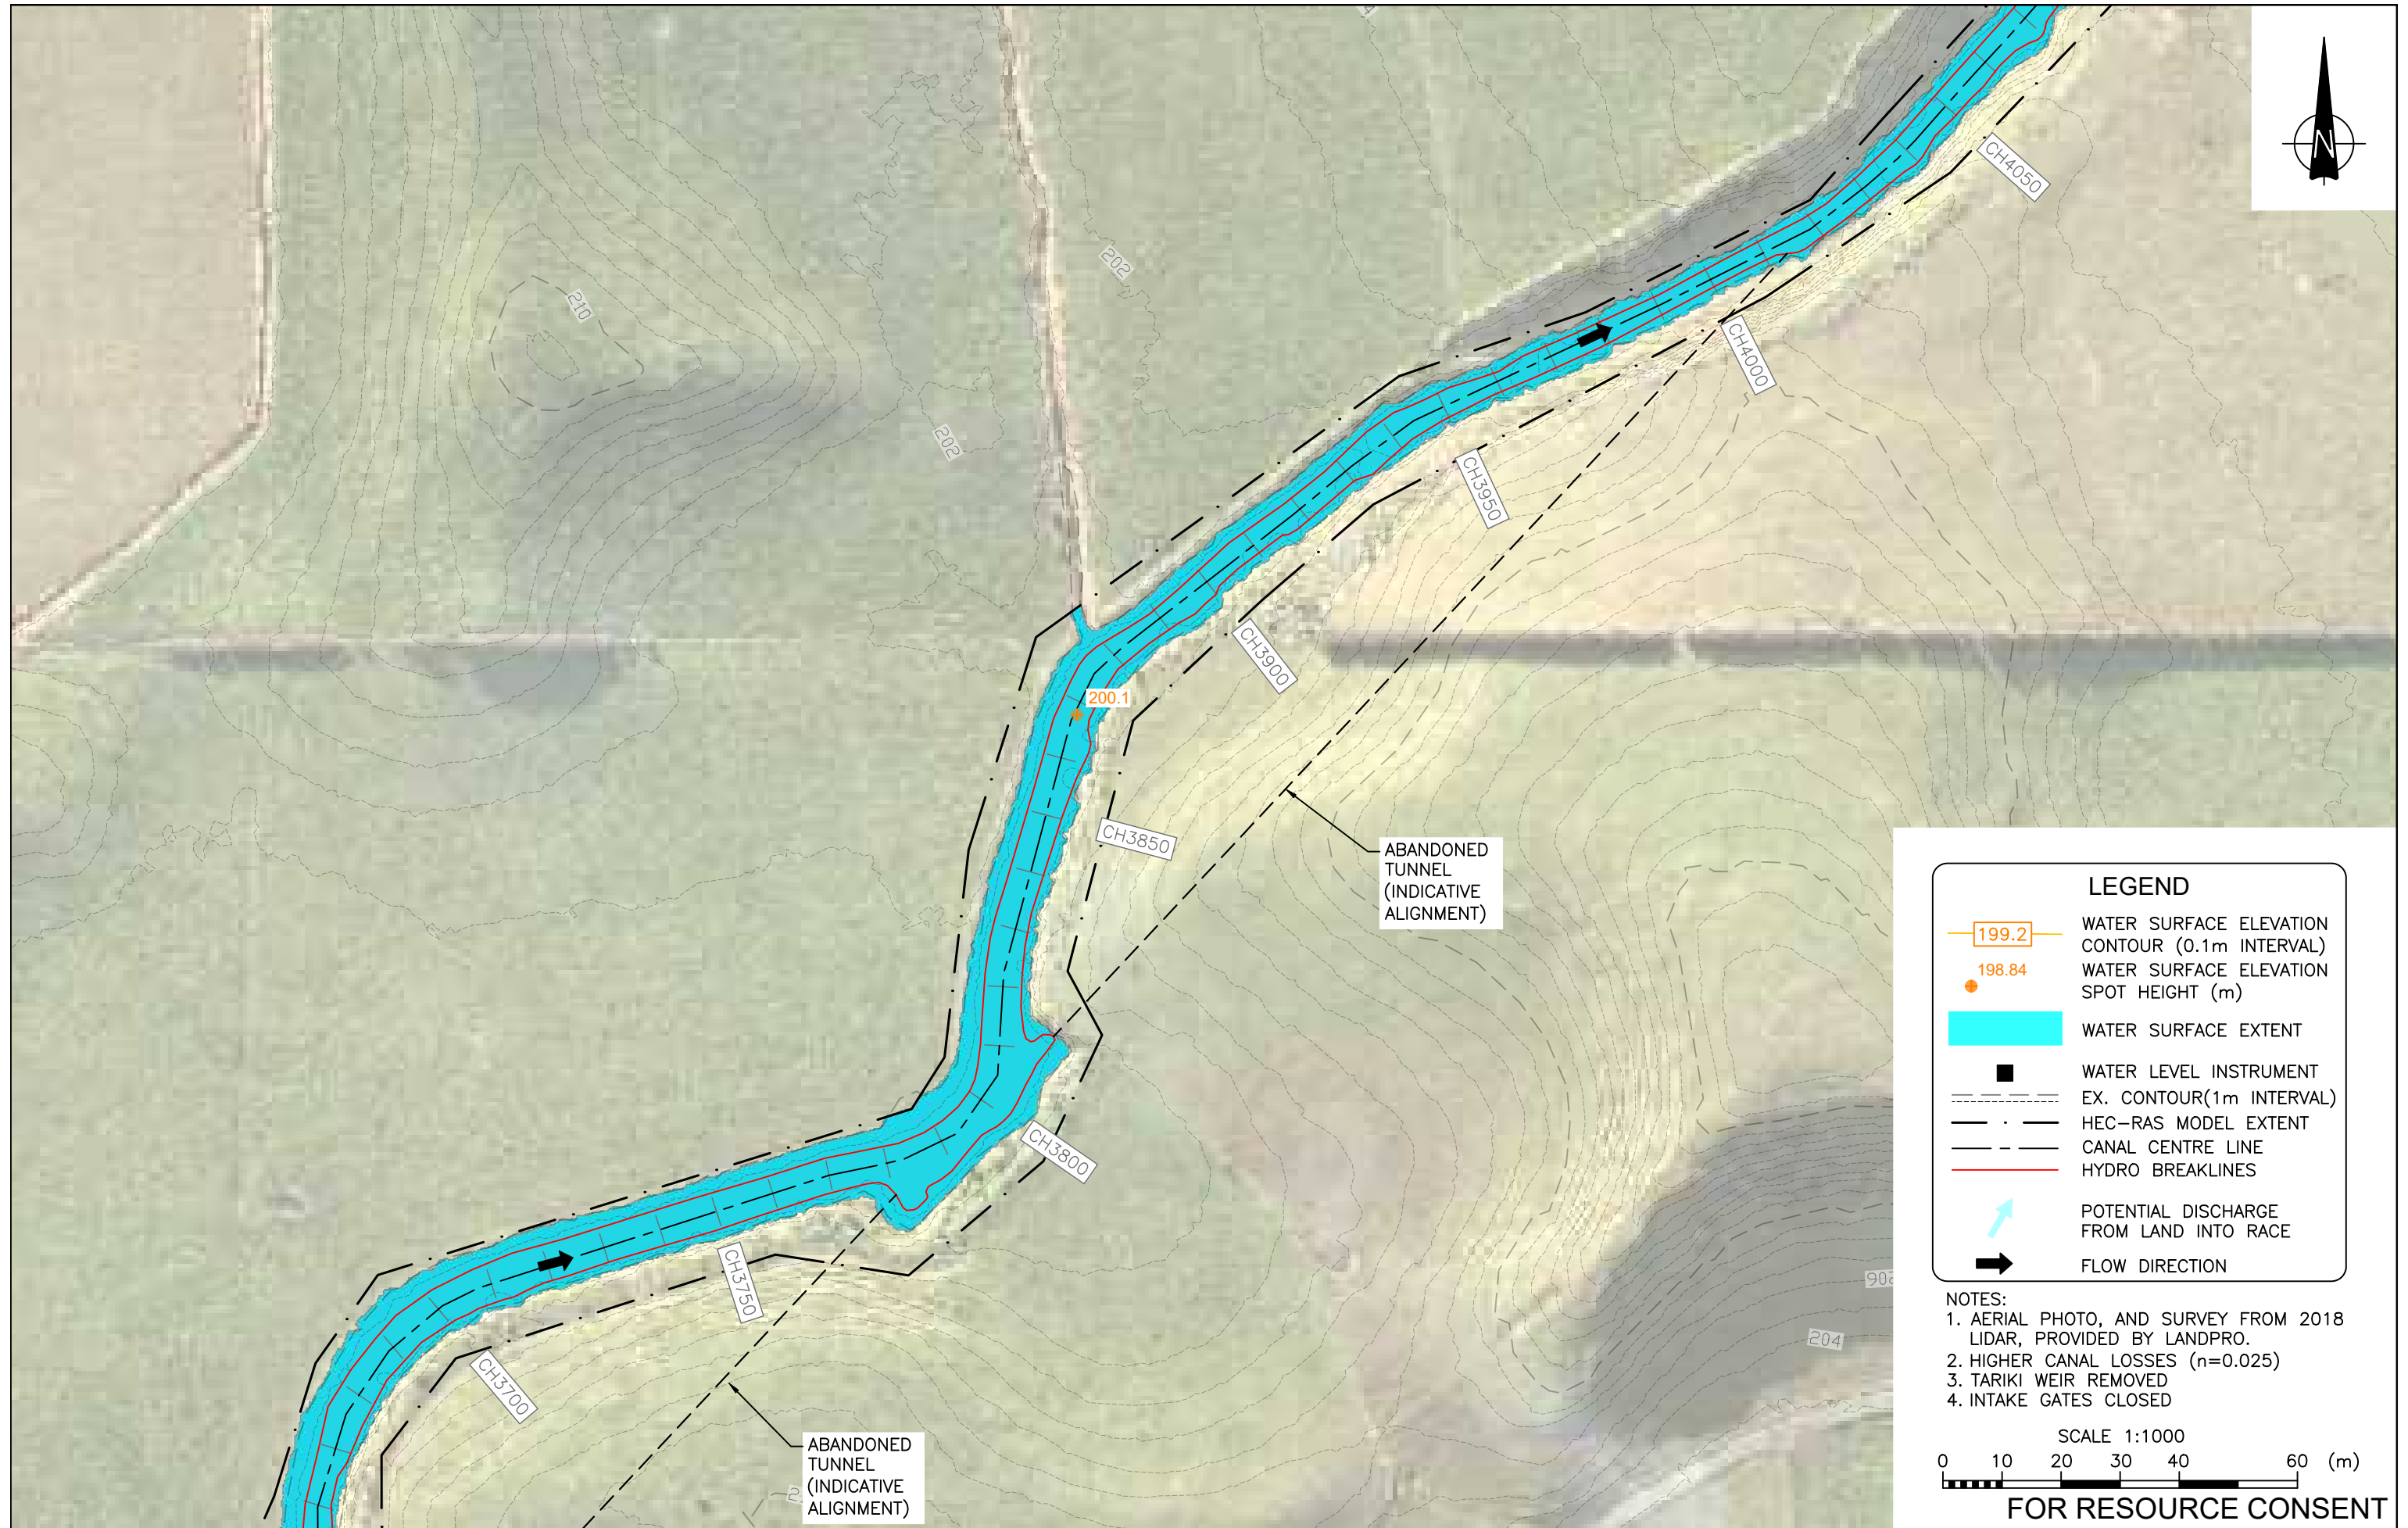
CADFILE	18MTK_ENH-270to287.dwg
SCALE (A3)	1:1000
ORIG. SHEET SIZE	A3
DRAWING No.	18MTK_ENH-281
REV.	1

CLIENT	TRUSTPOWER LTD
ADDRESS	MOTUKAWA HYDRO ELECTRIC POWER SCHEME
PROJECT	RACE HYDRAULIC AND GEOTECHNICAL ASSESSMENT
SHEET TITLE	100 YEAR FLOOD EVENT - LEVELS - PLAN 12

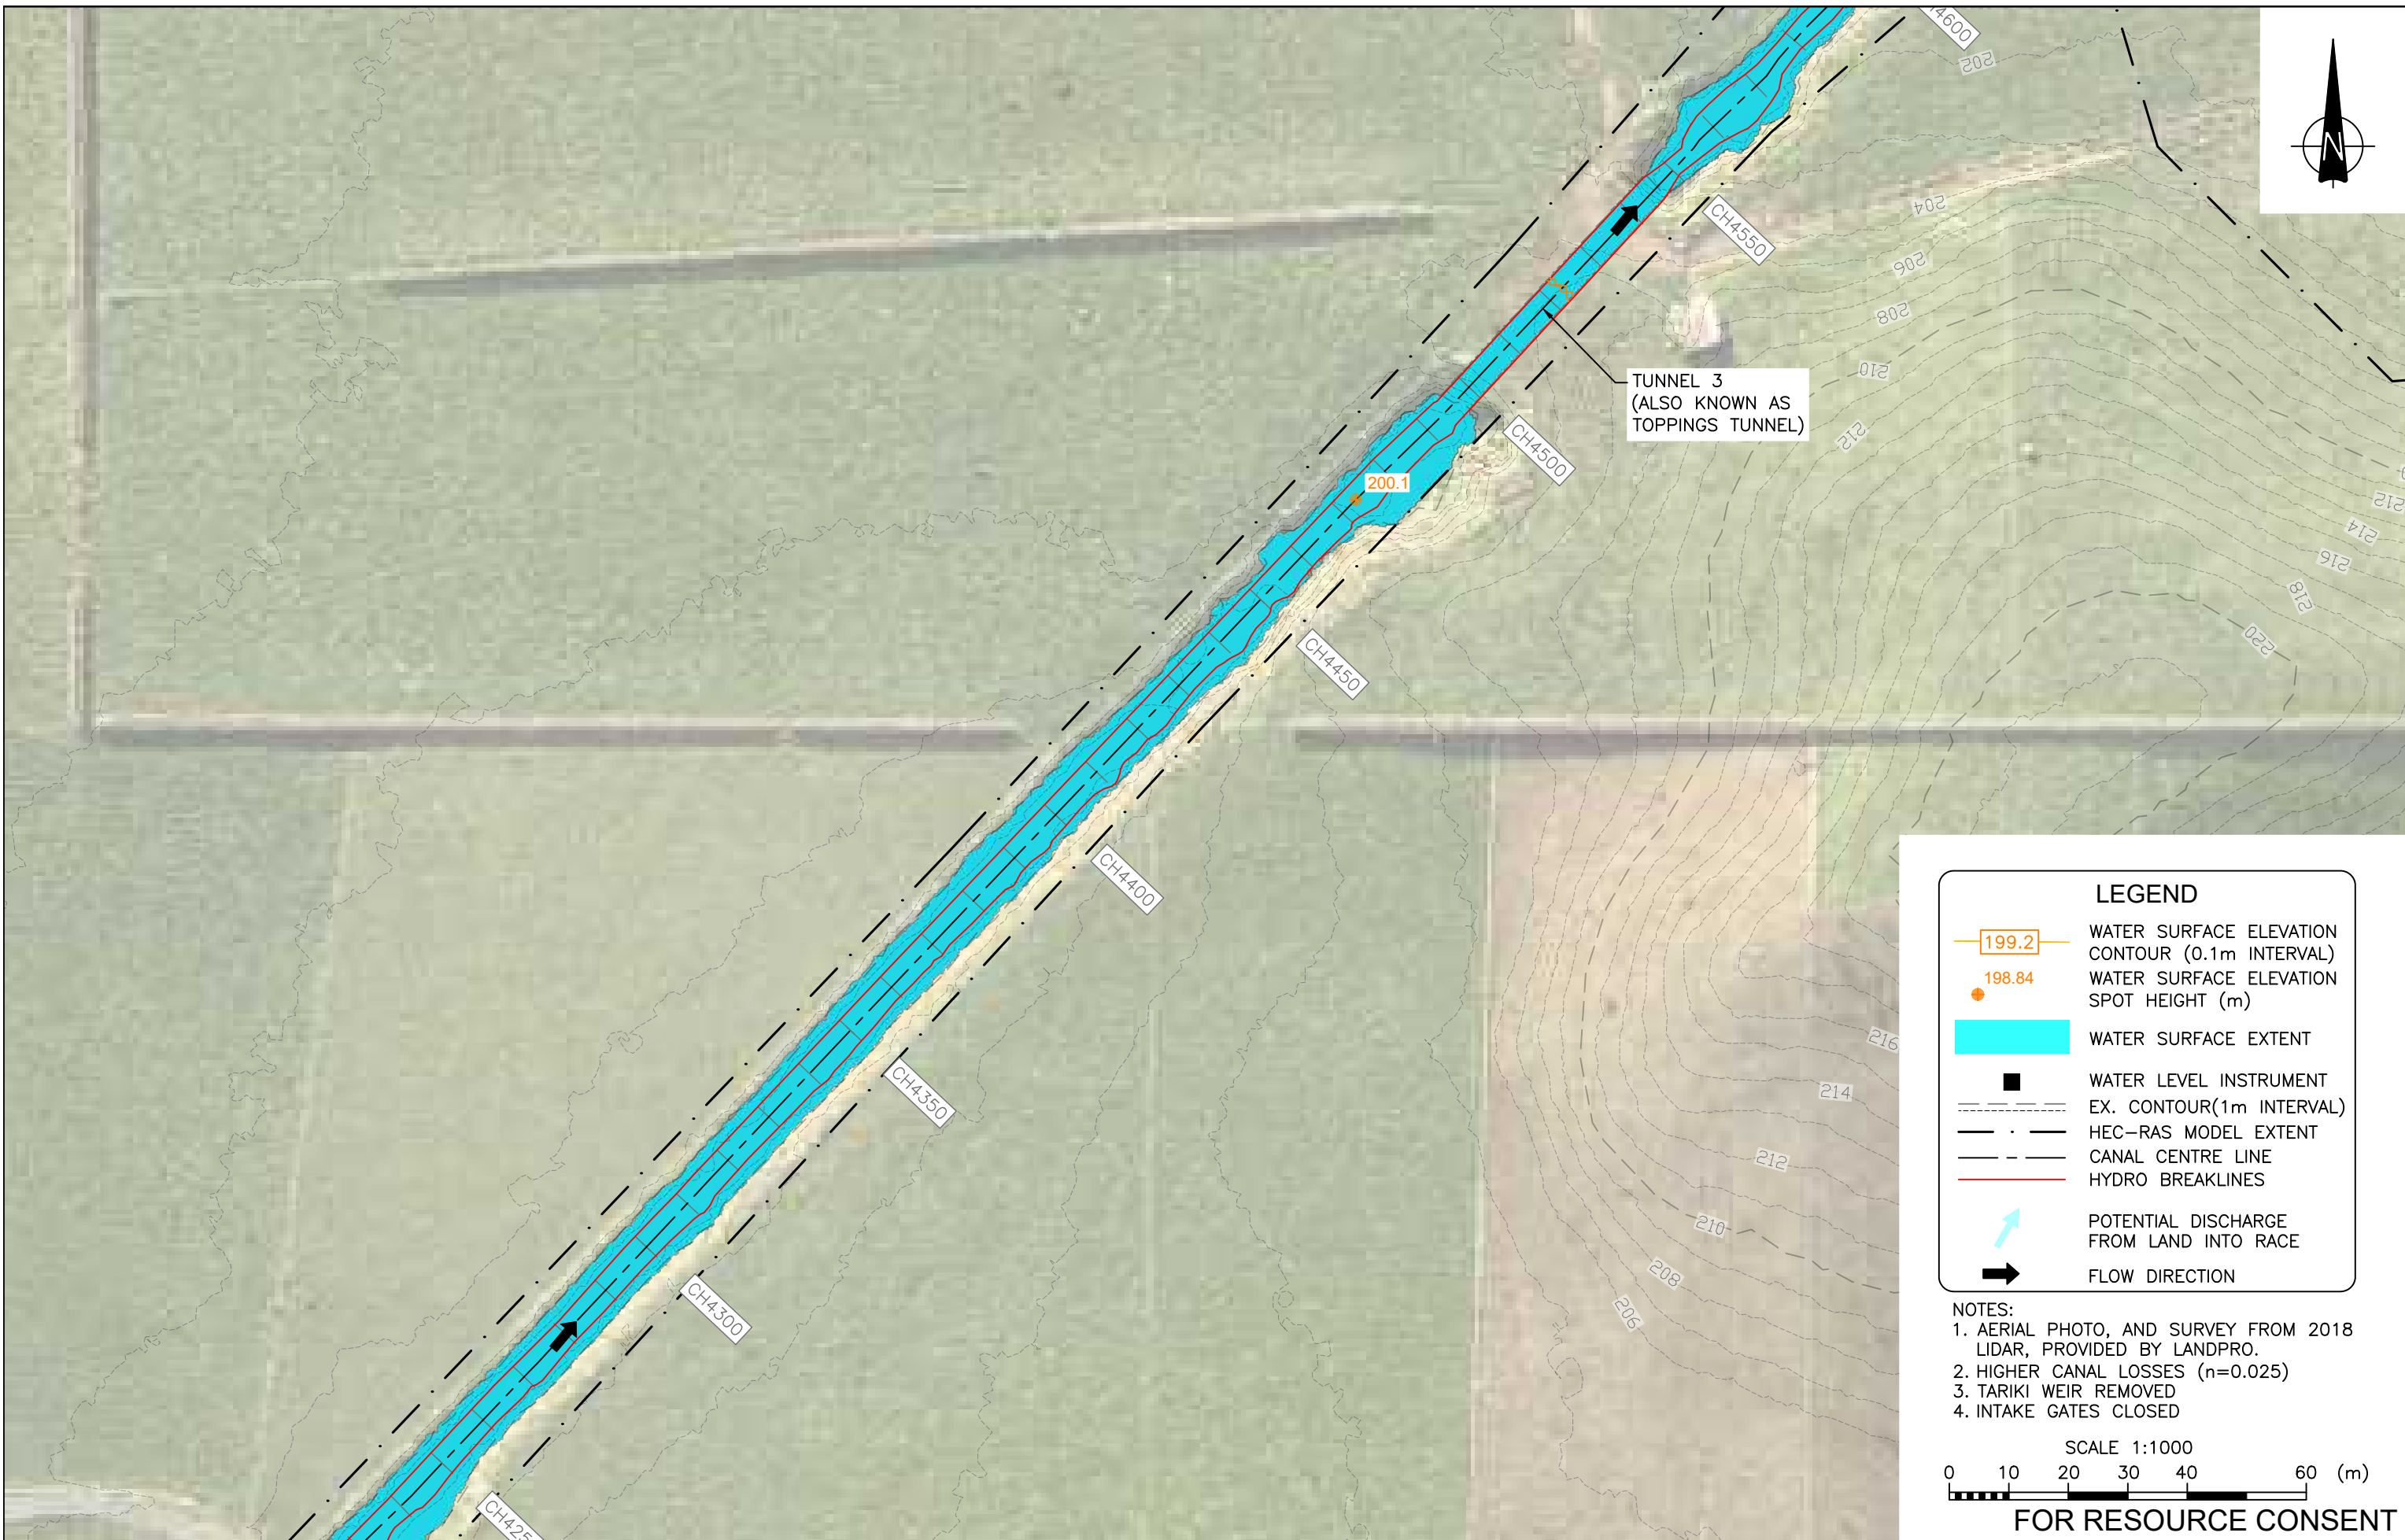
CADFILE
18MTK_ENH-270to287.dwg
SCALE (A3) 1:1000 ORIG. SHEET SIZE A3
DRAWING No. 18MTK_ENH-283 REV. 1

CLIENT	TRUSTPOWER LTD
ADDRESS	MOTUKAWA HYDRO ELECTRIC POWER SCHEME
PROJECT	RACE HYDRAULIC AND GEOTECHNICAL ASSESSMENT
SHEET TITLE	100 YEAR FLOOD EVENT - LEVELS - PLAN 14
