STDC Coastal Structures  
Monitoring Programme  
Annual Report  
2014-2015

Technical Report 2015-94

March 2016

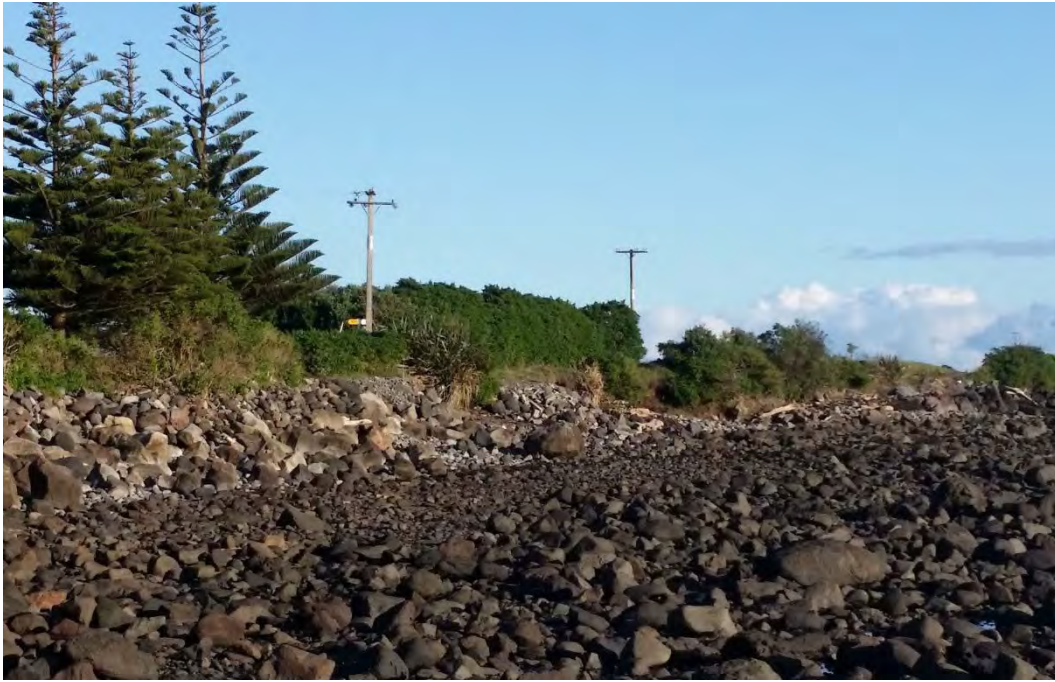
**Photo 1** Bayly Road seawall (May, 2015)

As a result of the works, the boulder protection now extends from the boat ramp in the north to the pre-existing 40 m of boulder protection south of Bayly Road, with a total length of approximately 290 m (Photo 1).

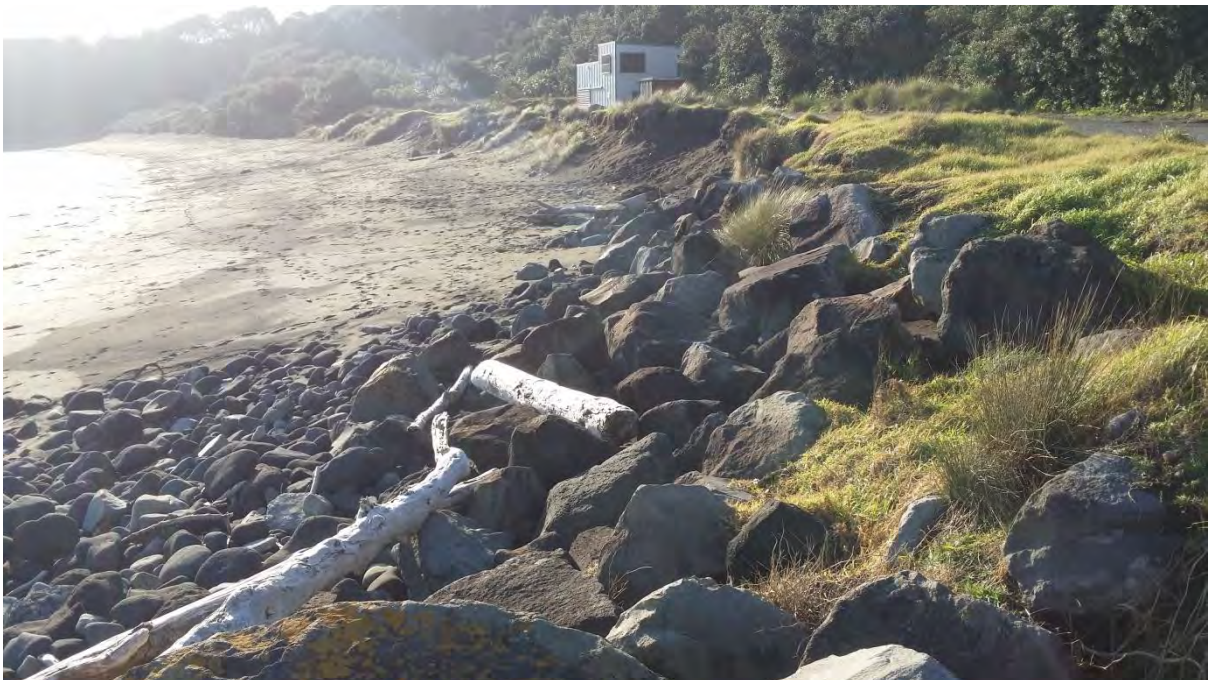
**Photo 2** Rip rap seawall, Middleton Bay (May, 2015)

Due to Middleton Bay being a pocket sand beach, and the location of the revetment being well forward towards the surf zone, there is a high potential for adverse effects to the soft shoreline at the north-western end and in front of the structure. Within a year of the structure being constructed, there was erosion of the foredune at the north-western end of the revetment, which may have been as a result of 'end effects' from the structure (Tonkin & Taylor, 2001).

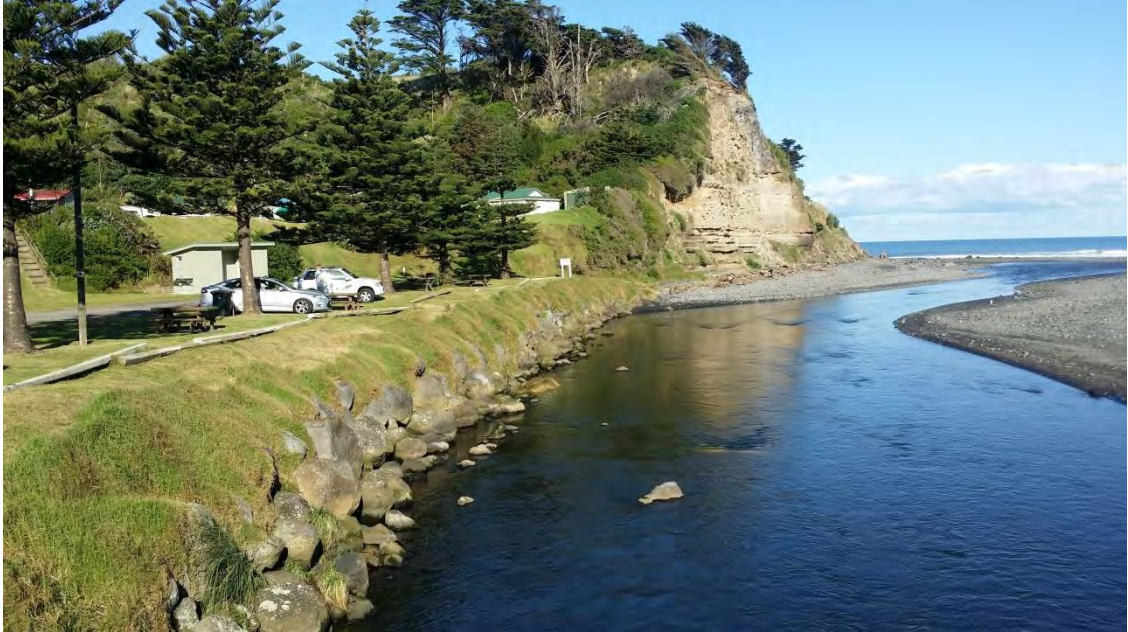
**Photo 3** Looking upstream along rock protection works in the Kaupokonui Stream (May 2015)

Following receipt of a complaint regarding works in the Kaupokonui Stream in 2002, investigation by Council officers discovered that substantial boulder rock rip rap had been placed on the true left bank of the Kaupokonui Stream (Photo 3).

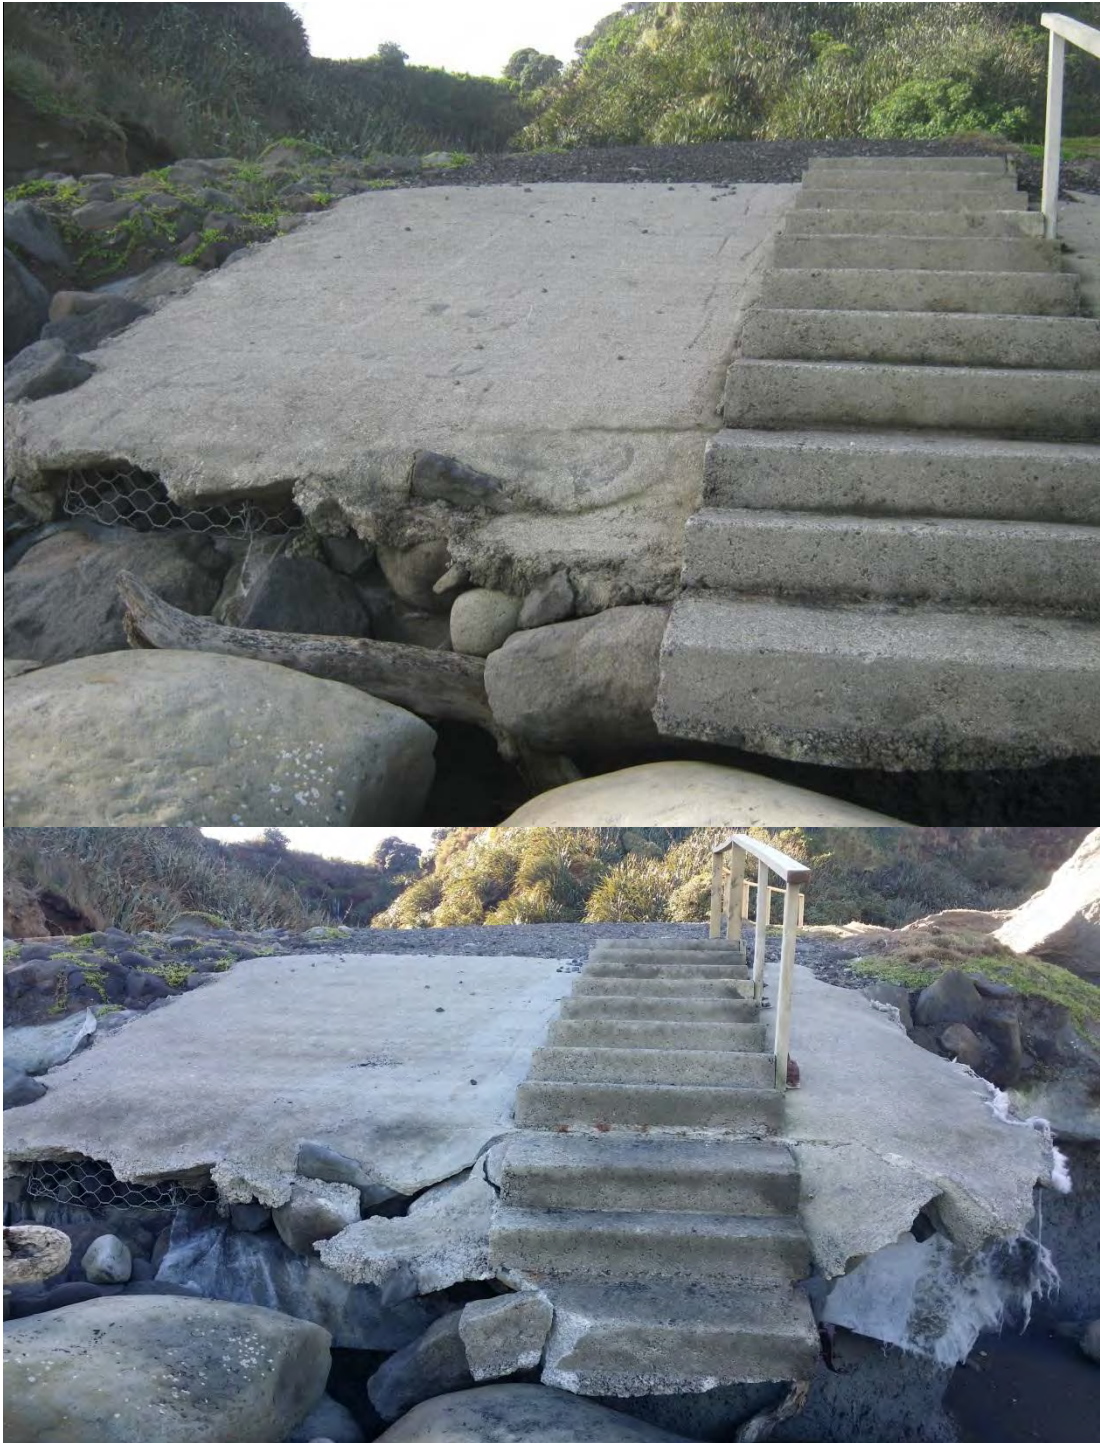
**Photo 4** Access way to Waihi Beach, Hawera (above May 2014, below May 2015)

In Hawera, locals access Waihi Beach via the track at the end of Denby Road. The track down to the beach is cut through the cliffs from the carpark at the end of Denby Road. Over time the access to the beach has become difficult, due to storms and erosion, with large sections of the track eroding away.

STDC installed a gabion mattress at the bottom of the access track with the intention of improving access to the beach and helping control the erosion problems. This structure is authorised by coastal permit 6736. The gabion mattress measured 6 m x 2 m x 0.23 m in size and was placed on existing rocks. Surrounding the rocks a geo textile fabric was used to prevent the scouring of sand and to increase the longevity of the structure. Once completed, the structure was covered in concrete to further aid pedestrian access. The structure is authorised by coastal permit 6736.

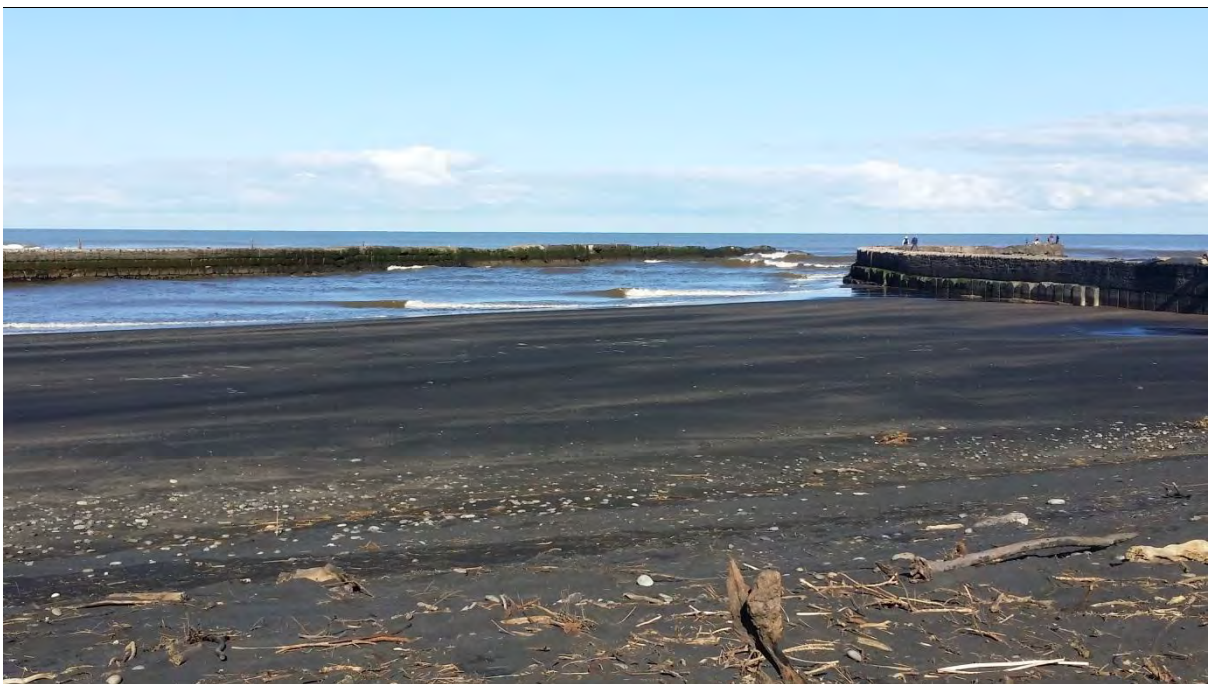
**Photo 5** Patea groynes (May 2015)

Significant levels of erosion have occurred along this coastline during the past 50 years which has led to the river moles becoming seriously degraded. Studies undertaken by consultants (Duffill Watts & King, 2006) have shown that with the current condition of the moles and rate of shoreline change, the river moles could decay, threatening the overall stability of the river entrance. If the stability of the river entrance was changed, this could result in the passage between the river and sea becoming no longer navigable. From the studies undertaken by Duffill Watts & King (2006), it was found that without some intervention process the Patea River will break through behind the southeast mole within 20 to 25 years which would prevent navigable access to the sea. It was proposed that the most effective method to maintain a navigable river entrance for small seagoing craft was to reconstruct the southeast seawall. Consent **6839** was granted by the Council authorising the works, which aimed to constrain the river channel to its existing alignment and prevent it from breaking through behind the left mole (Photo 5).

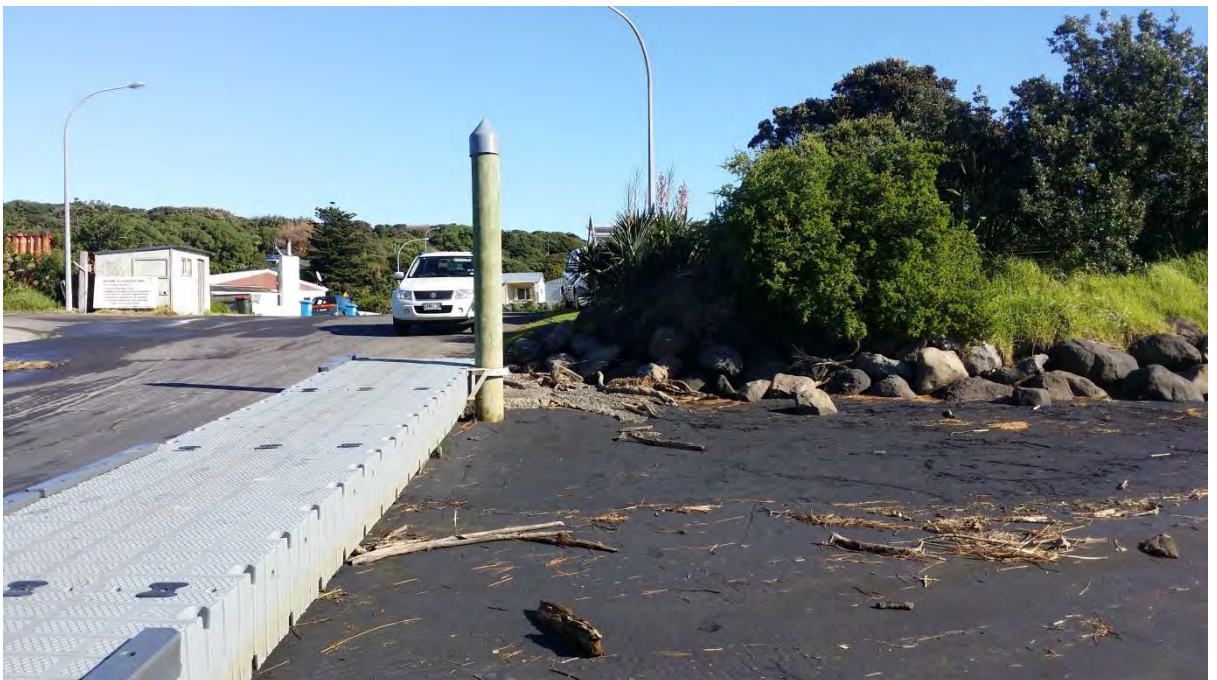
**Photo 6** Patea boat ramp (May 2015)

The boat ramp at Patea has been in existence for many years, providing one of the few effective and safe boat launching facilities on the South Taranaki coast (Photo 6). The facilities are used extensively and are considered to be one of Patea's more important recreational facilities.

The launching ramp was an undular concrete pad which extended from the end of the formed roadway of Turi Street, down to approximately the low tide level of the river. Upon granting of coastal permit **4566**, the STDC strengthened the existing boat launching ramp by placing a concrete strengthening overlay over the existing ramp. The overlay is 7 m wide and extends a further 3 m down into the river than the previous ramp, improving the launching facility.

The overlay was contoured so it is more consistent with natural beach profiles than the previous ramp and is therefore expected to have less effect on riverbed/beach processes than the previous ramp. In association with expanding and strengthening the ramp, the STDC reinstated and rock protected the eroding riverbank both immediately upstream and downstream of the ramp. The bank protection was wrapped smoothly into the existing bank and aligned in a manner which is compatible with wave refraction/diffraction patterns and which will not adversely affect natural river processes.

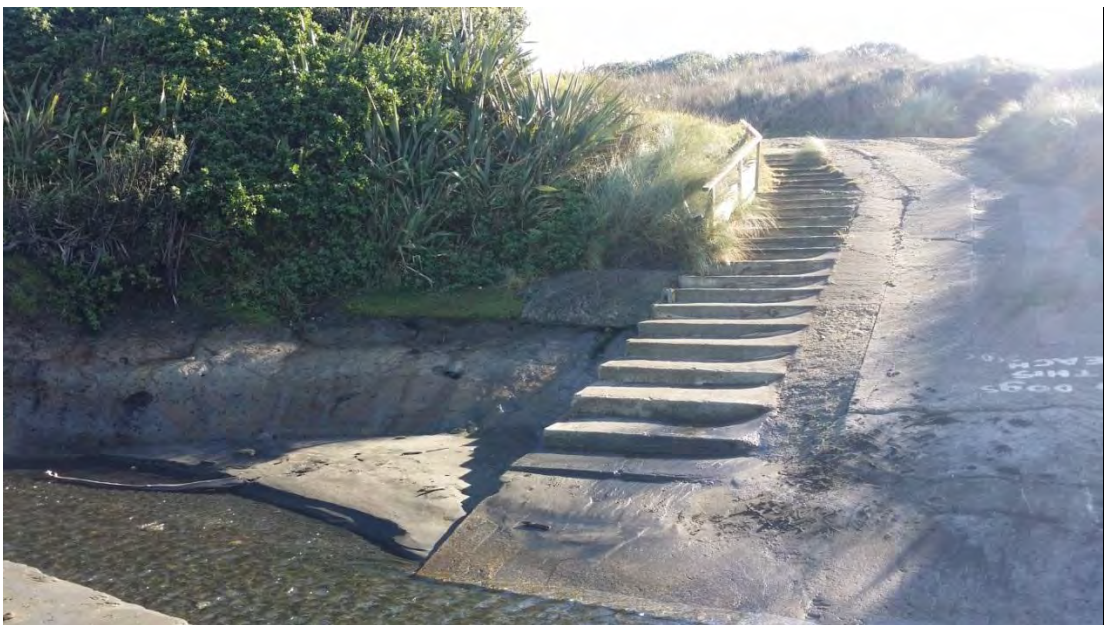
**Photo 7** Access to Waverley Beach (May 2015)

The structure covered by consent **4579** consists of a concrete public access ramp way, 20 m in length and 3 m in width with an associated 2 m wide by 16 m long concrete step-way down the western edge of the ramp (Photo 7). The ramp extends down to the beach sands from the upper ground level of the mudstone coastal bluffs, providing access to Caves Beach, again reducing pedestrian damage of the fragile sand dunes.

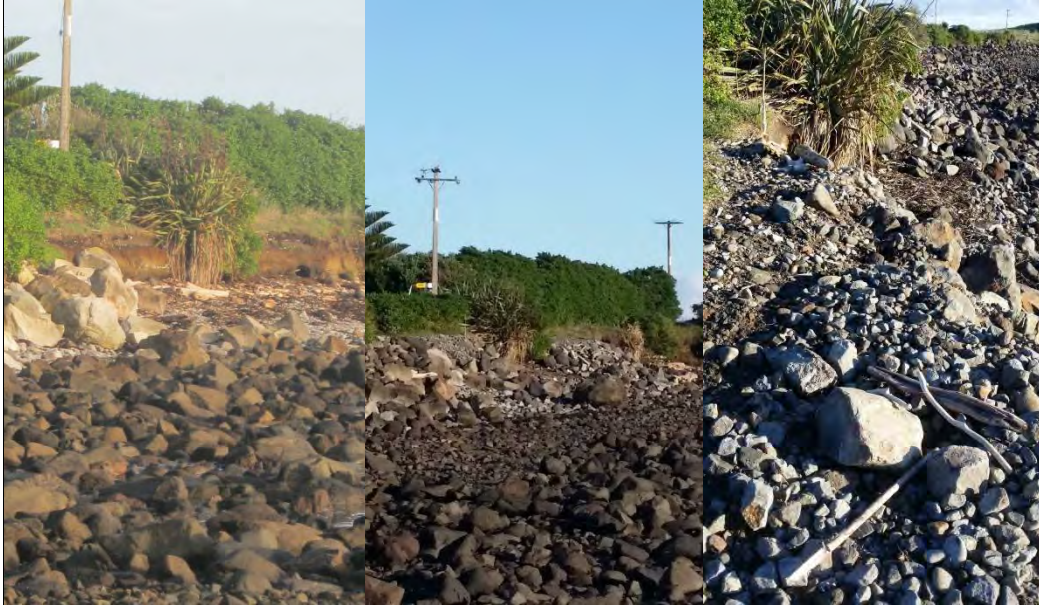
An inspection of the Bayly Road seawall was undertaken on 29 May 2015. The rip rap appeared satisfactory and areas of previous erosion at the south end had been filled with rubble (Photo 8).

**Photo 8** Left, erosion on the south side of the Bayly Road seawall May 2014, centre and right rubble used to prevent further erosion May 2015

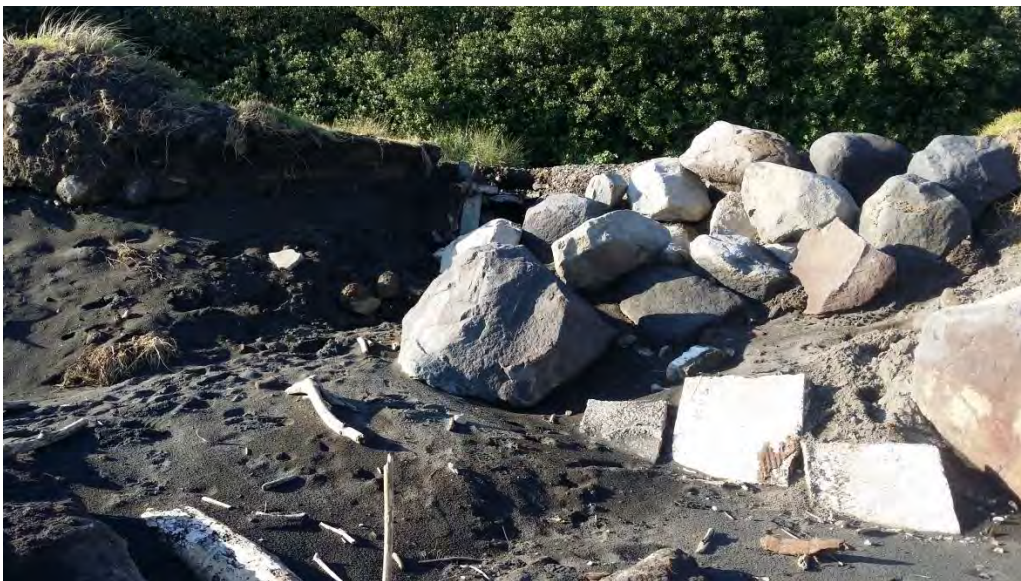
An inspection of the Middleton Bay seawall was undertaken on 29 May 2015. The seawall itself was in good condition. Erosion was evident off the north-west end of the seawall where an area of the bank was being used as an access track to the beach (Photo 9). Use of this track appeared to be accelerating erosion of the bank.

**Photo 9** Erosion at the north-west end of the Middleton Bay seawall (May 2015)

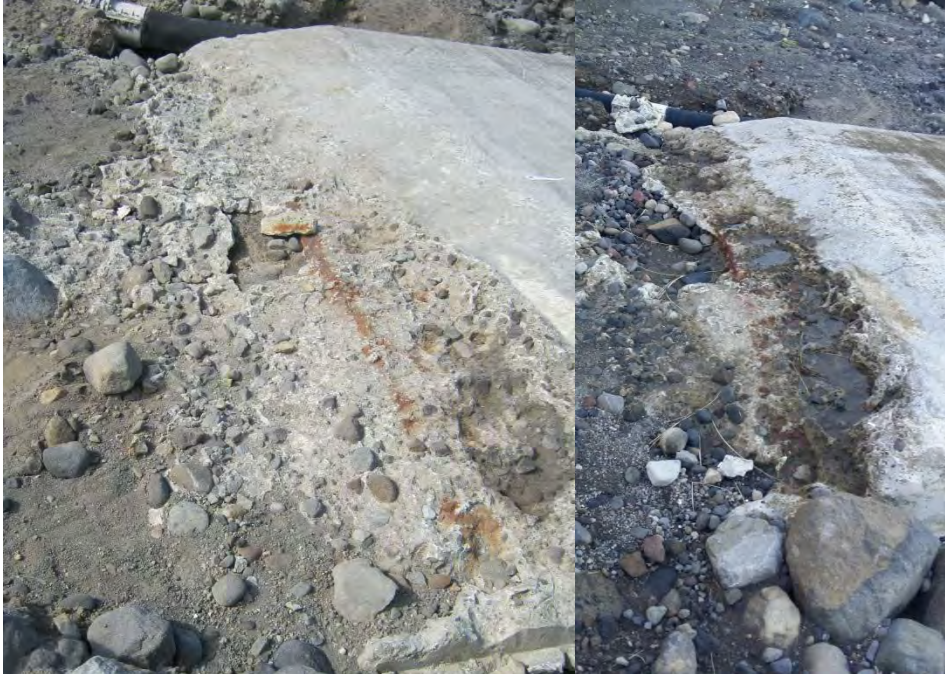
An inspection of the Opunake Bay boat ramp was undertaken on 29 May 2014. The structure appeared to be in satisfactory condition. There was some erosion above the top end of the boat ramp which could potentially cause access difficulty for some vehicles (Photo 10).

**Photo 10** Top section of the Opunake Beach boat ramp (left March 2012, right May 2015)

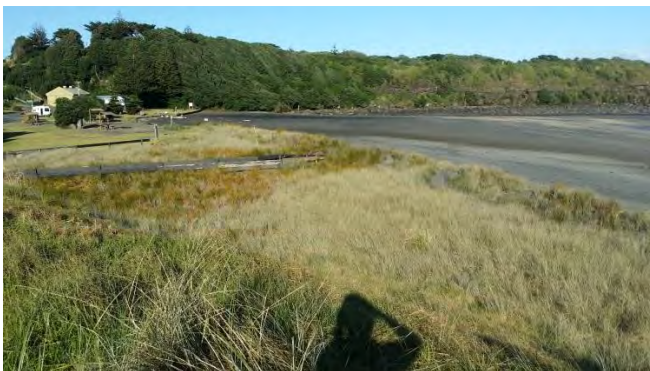
The retaining wall at Opunake Beach appeared to be sound when inspected on 29 May 2015. The dune planting in front of the Surf Life Saving Club, carried out early in 2011, appeared to have been effective as there was no obvious erosion of the dunes at the time of inspection (Photo 11).

During the 2013-2014 period STDC had undertaken works to remove the build-up of sand from the top of the retaining wall. No additional work was required over the period under review (2014-2015).

**Photo 11** Dune planting at Opunake Beach (May 2015)

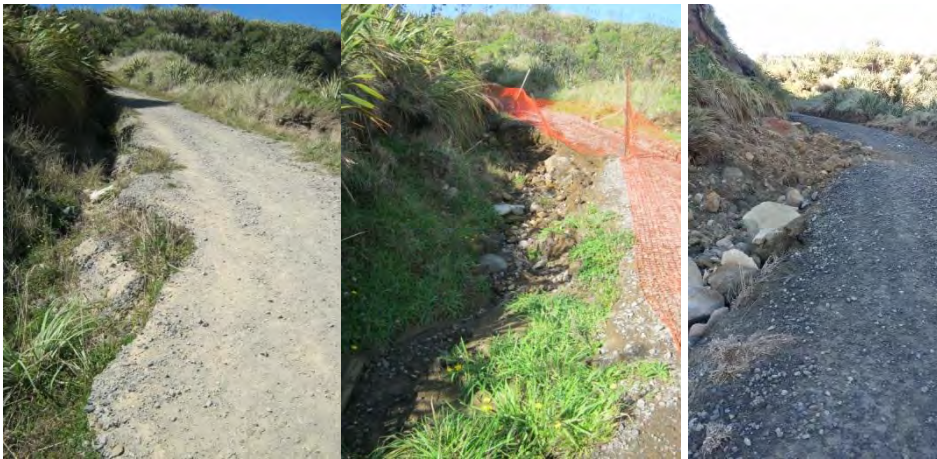
The structure was inspected on 29 May 2015. Due to the soft substrate this track has been subject to constant erosion. During the previous inspection in May 2014, erosion to the side of the track, approximately half way down, was clearly evident and had continued to worsen (Photo 12) making access difficult. This damage had been repaired by the May 2015 inspection (Photo 12). Wave and weather damage at the base of the structure appeared to have worsened over the 2014-2015 period (Photo 4). At the time of inspections it was questionable whether the ramp was fit for purpose (Consent 6736) i.e. to allow emergency access to the beach.

**Photo 12** Erosion of beach track at the end of Denby Road left March 2013, centre May 2014, right May 2015

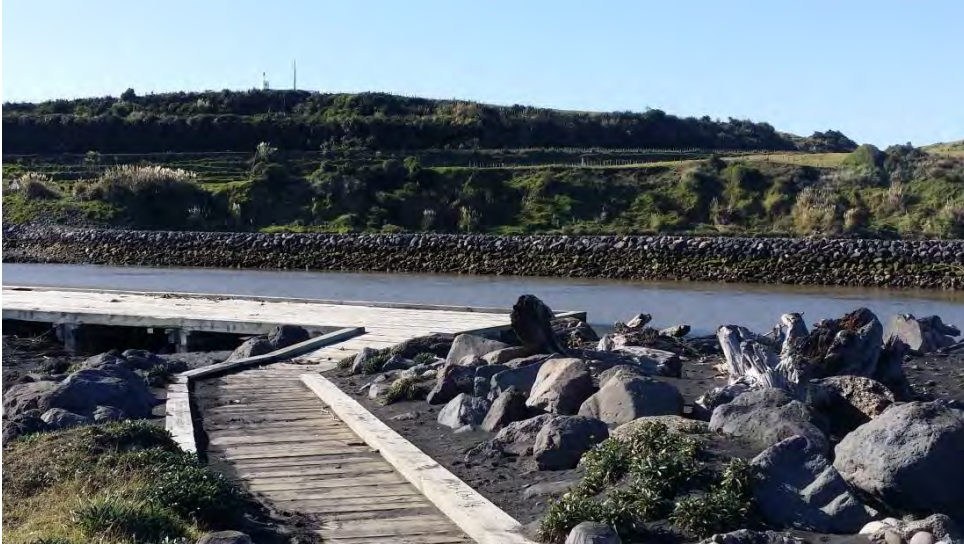
**Photo 13** Training wall at Patea (May, 2015)

The boat ramp was inspected on 29 May 2015. No problems were observed.

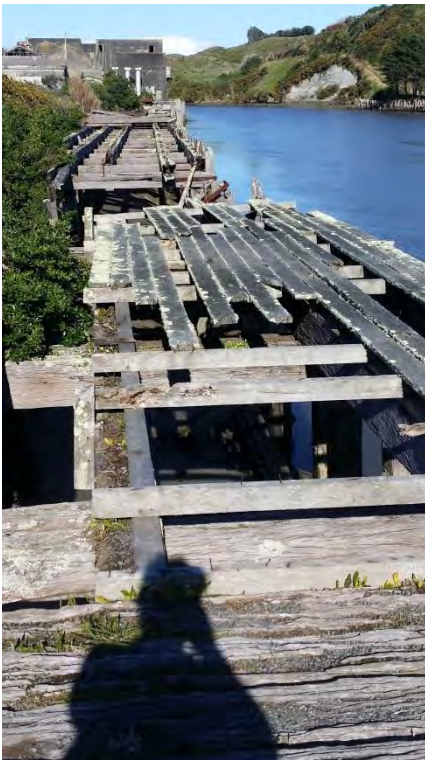
As noted in previous inspections, the wharf was in a dilapidated state and had been so for some time. No improvements were noted during the inspections carried out on 29 May 2015 (Photo 14).

The consent for this structure was renewed on 23 June 2010 with reduced maintenance requirements. This allows STDC to continue to occupy the space provided the derelict wharf does not pose a navigational hazard. No warning signs had been erected to warn the public of the unsafe structure.

**Photo 14** Old Patea wharf (May 2015)

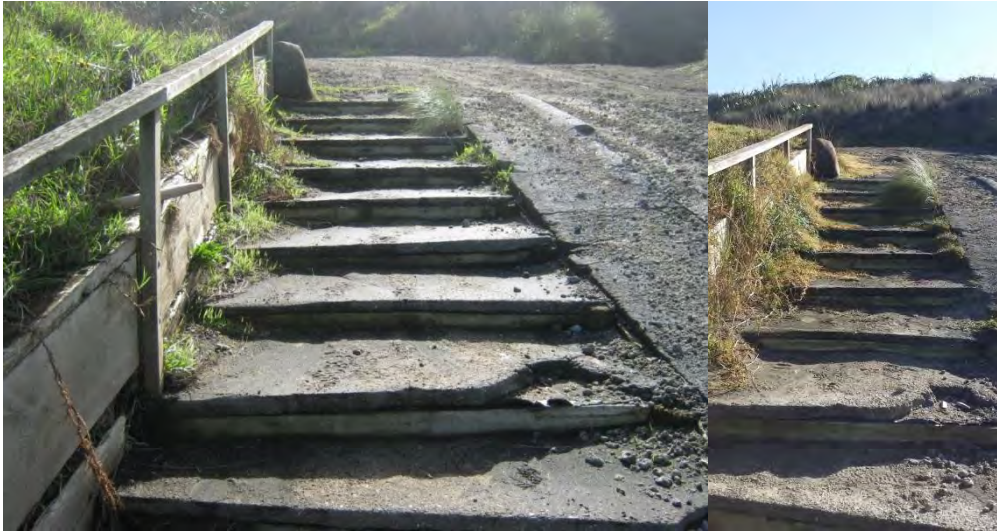
Waverley Beach was visited on 29 May 2015. In general, the access ramp down to Waverley Beach was in a satisfactory condition. The access to Caves Beach had sections of concrete missing from the middle steps (Photo 15). This area of damage showed no significant deterioration since the previous inspection in May 2015. During the March 2013 inspection the top steps were overgrown with vegetation. This had been cleared by the May 2014 inspection. During the 2015 inspection, although there was some grass growing onto the steps, this did not impinge access to the beach.

**Photo 15** Access to Caves Beach, Waverley (right May 2014, left May 2015)
