STDC Coastal Structures
Monitoring Programme
Annual Report
2016-2017

Technical Report 2017-85

October 2017

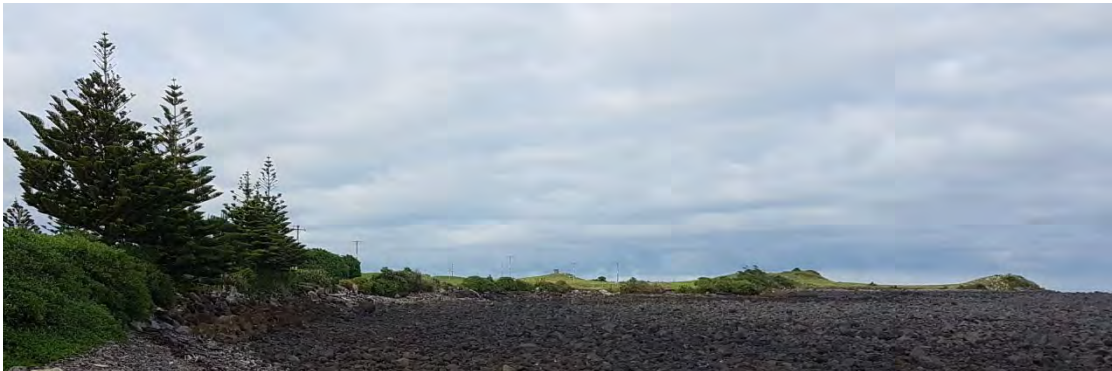
Photo 1 Bayly Road seawall (April 2017)

As a result of the works, the boulder protection now extends from the boat ramp in the north to the pre-existing 40 m of boulder protection south of Bayly Road, with a total length of approximately 290 m (Photo 1).

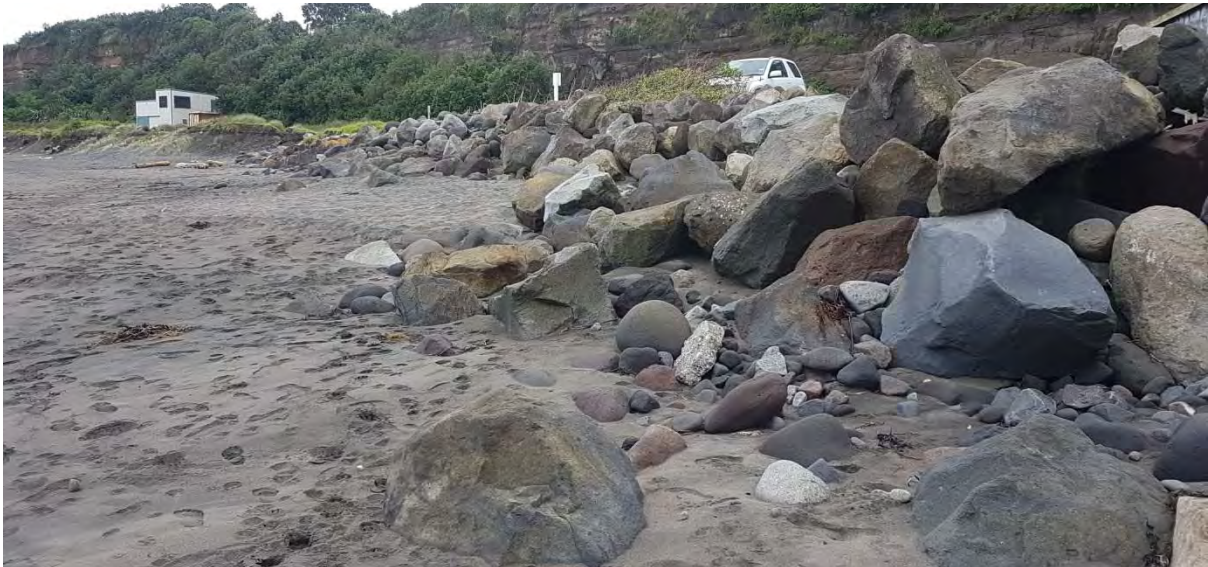
Photo 2 Rip rap seawall, Middleton Bay (April 2017)

Due to Middleton Bay being a pocket sand beach, and the location of the revetment being well forward towards the surf zone, there is a high potential for adverse effects to the soft shoreline at the north-western end and in front of the structure. Within a year of the structure being constructed, there was erosion of the foredune at the north-western end of the revetment, which may have been as a result of 'end effects' from the structure (Tonkin & Taylor, 2001).

An inspection of the Middleton Bay seawall was undertaken on 19 April 2017. The seawall itself was in good condition (Photo 2). The area to the north west of the wall was checked for potential end effects. Erosion was evident off the north-west end of the seawall where an area of the bank was being used as an access track to the beach (Photo 9). Use of this track appeared to be accelerating erosion of the bank.

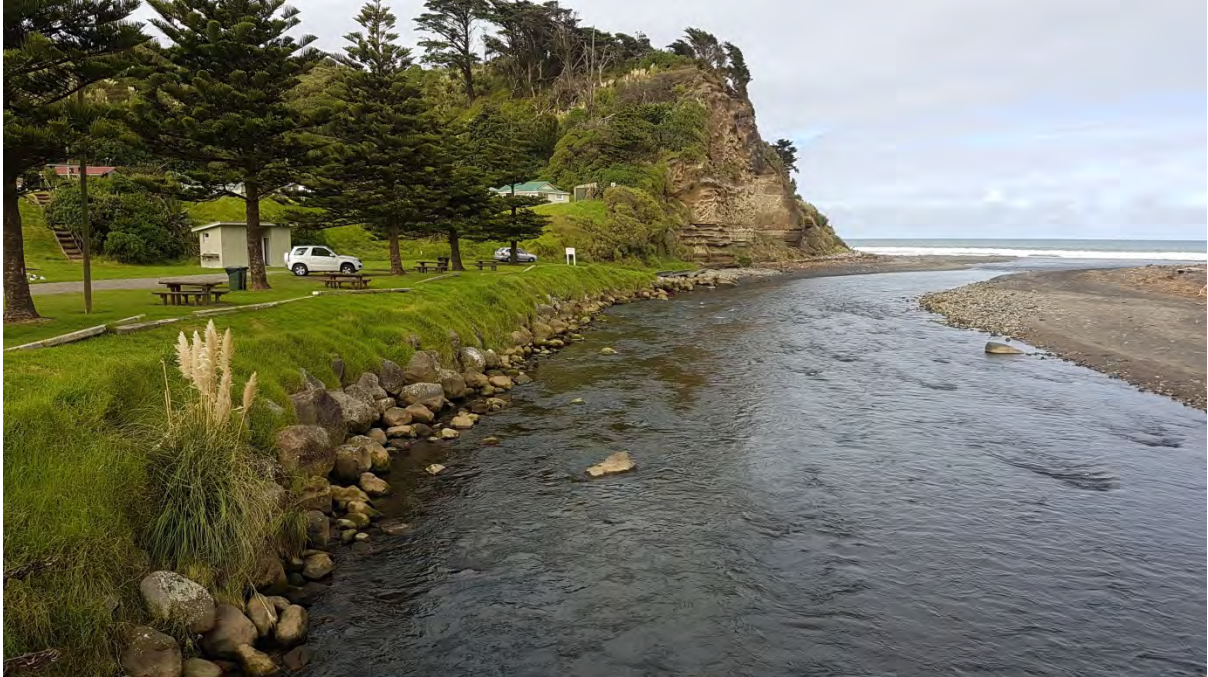
Photo 3 Looking upstream along rock protection works in the Kaupokonui Stream (April 2017)

Following receipt of a complaint regarding works in the Kaupokonui Stream in 2002, investigation by Council officers discovered that substantial boulder rock rip rap had been placed on the true left bank of the Kaupokonui Stream (Photo 3).

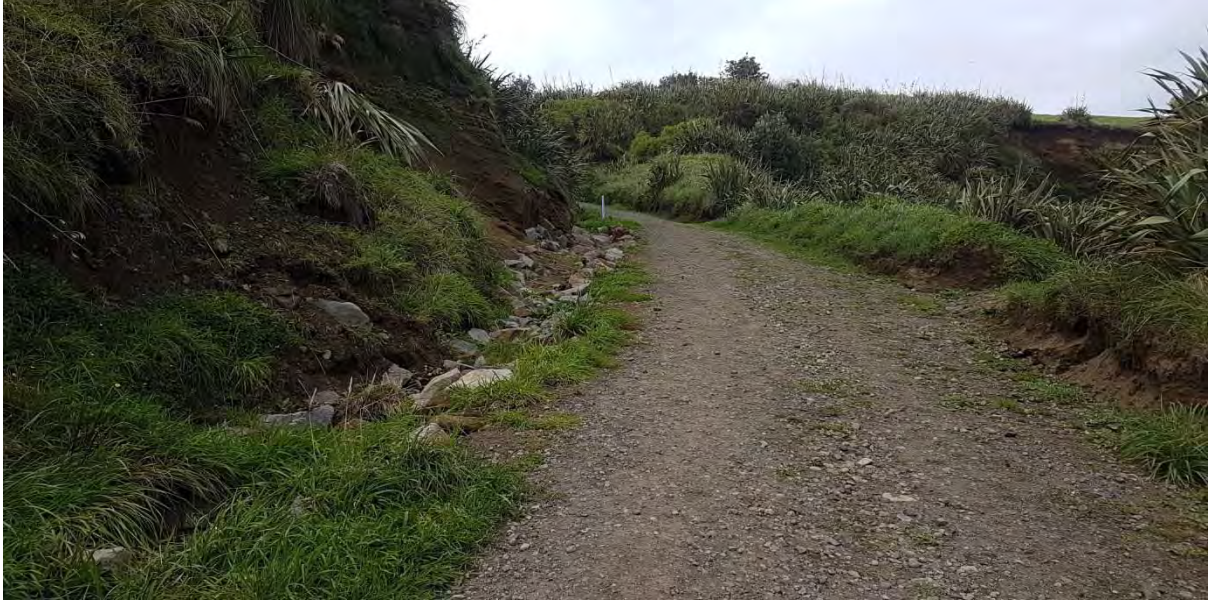
Photo 4 Beach track at the end of Denby Road leading to the gabion mattress consented under 6736 (April 2017)

STDC installed a gabion mattress at the bottom of the access track with the intention of improving access to the beach and helping control the erosion problems. This structure is authorised by coastal permit **6736**. The gabion mattress measured 6 m x 2 m x 0.23 m in size and was placed on existing rocks. Surrounding the rocks a geo textile fabric was used to prevent the scouring of sand and to increase the longevity of the structure. Once completed, the structure was covered in concrete to further aid pedestrian access. The structure is authorised by coastal permit 6736.

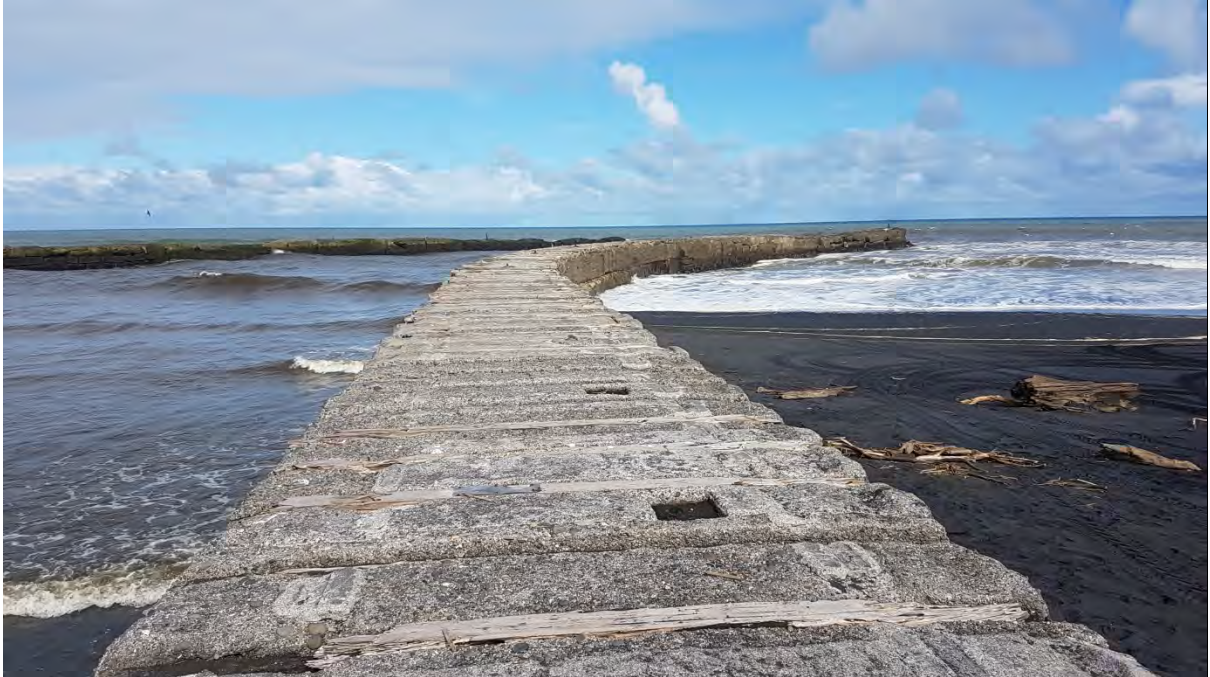
Photo 5 Patea groynes (April 2017)

Significant levels of erosion have occurred along this coastline during the past 50 years which has led to the river moles becoming seriously degraded. Studies undertaken by consultants (Duffill Watts & King, 2006) have shown that with the current condition of the moles and rate of shoreline change, the river moles could decay, threatening the overall stability of the river entrance. If the stability of the river entrance was changed, this could result in the passage between the river and sea becoming no longer navigable. From the studies undertaken by Duffill, Watts & King (2006), it was found that without some intervention process the Patea River will break through behind the southeast mole within 20 to 25 years which would prevent navigable access to the sea. It was proposed that the most effective method to maintain a navigable river entrance for small seagoing craft was to reconstruct the southeast seawall. Consent **6839** was granted by the Council authorising the works, which aimed to constrain the river channel to its existing alignment and prevent it from breaking through behind the left mole (Photo 5).

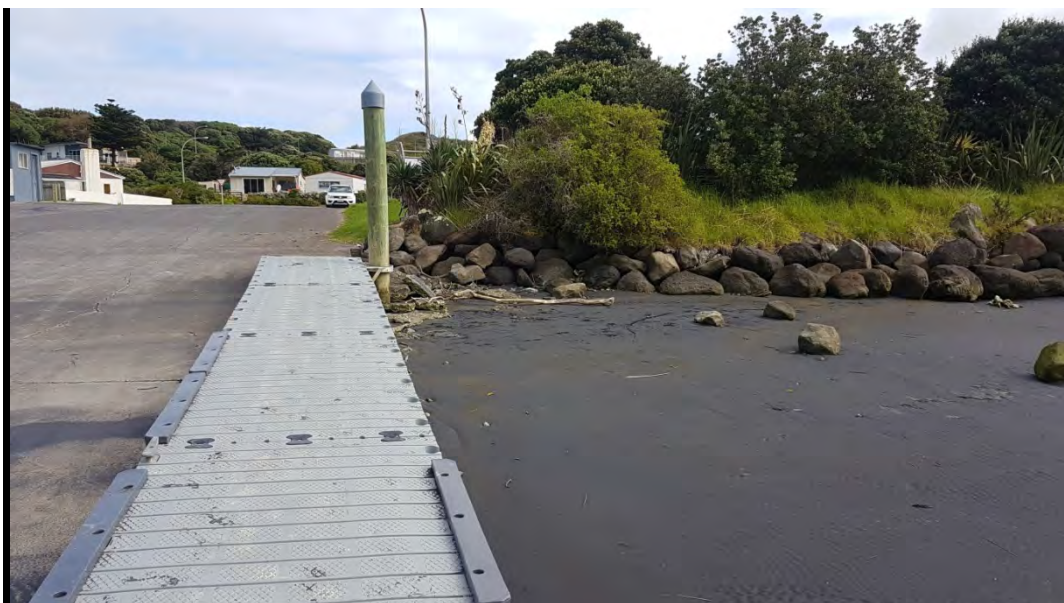
Photo 6 Patea boat ramp (April 2017)

The boat ramp at Patea has been in existence for many years, providing one of the few effective and safe boat launching facilities on the South Taranaki coast (Photo 6). The facilities are used extensively and are considered to be one of Patea's more important recreational facilities.

The launching ramp was an undular concrete pad which extended from the end of the formed roadway of Turi Street, down to approximately the low tide level of the river. Upon granting of coastal permit **4566**, the STDC strengthened the existing boat launching ramp by placing a concrete strengthening overlay over the existing ramp. The overlay is 7 m wide and extends a further 3 m down into the river than the previous ramp, improving the launching facility.

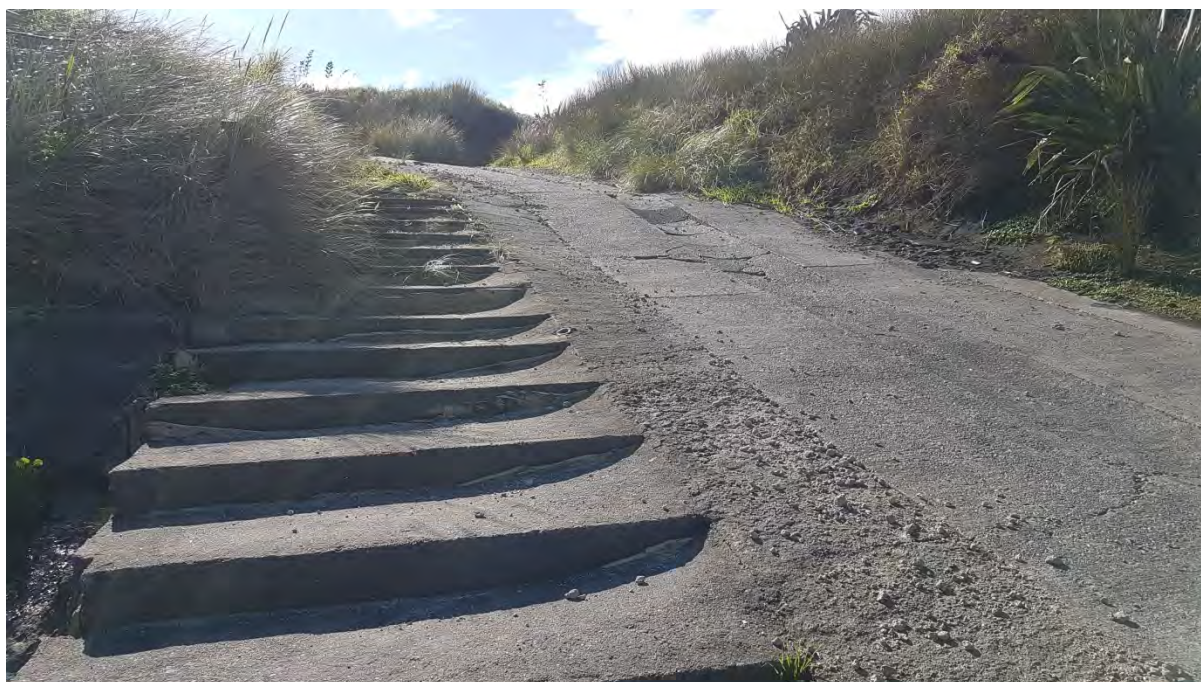
Photo 7 Access to Waverley Beach (April 2017)

The structure covered by consent **4579** consists of a concrete public access ramp way, 20 m in length and 3 m in width with an associated 2 m wide by 16 m long concrete step-way down the western edge of the ramp (Photo 7). The ramp extends down to the beach sands from the upper ground level of the mudstone coastal bluffs, providing access to Caves Beach, again reducing pedestrian damage of the fragile sand dunes.

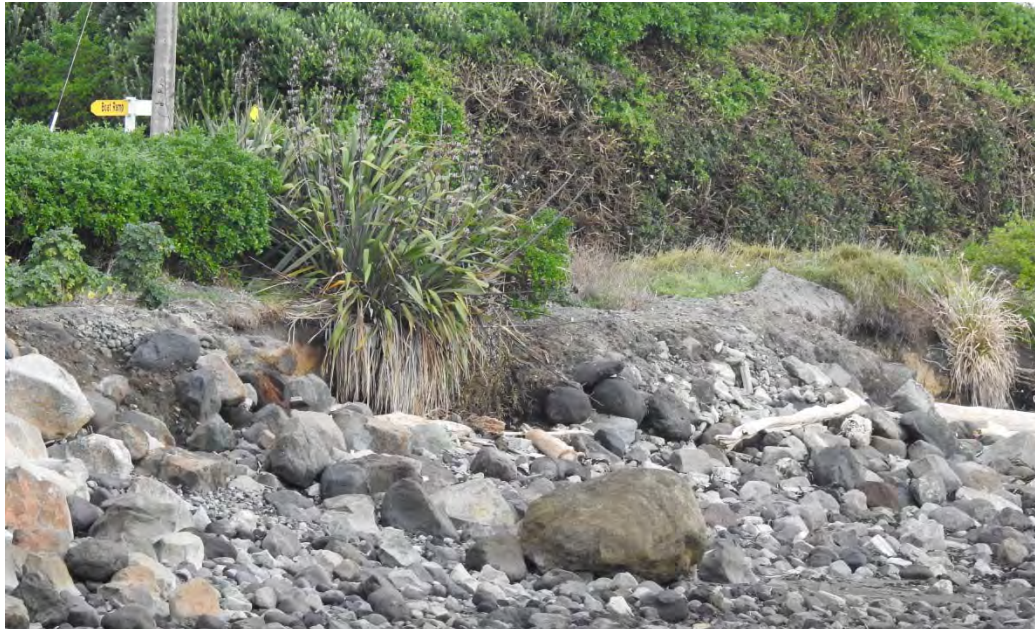
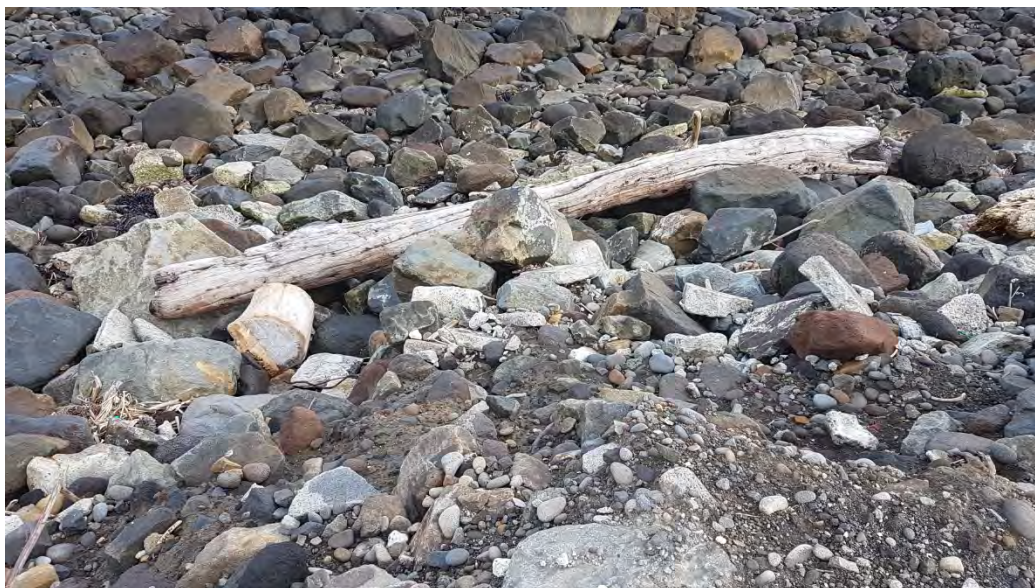
Photo 8 Bayly Road seawall (top rubble used to prevent further erosion May 2016, bottom rubble remaining in place April 2017)

An inspection of the Bayly Road seawall was undertaken on 19 April 2017. The rip rap appeared satisfactory and areas of previous erosion at the south remained filled in with rubble (Photo 8).

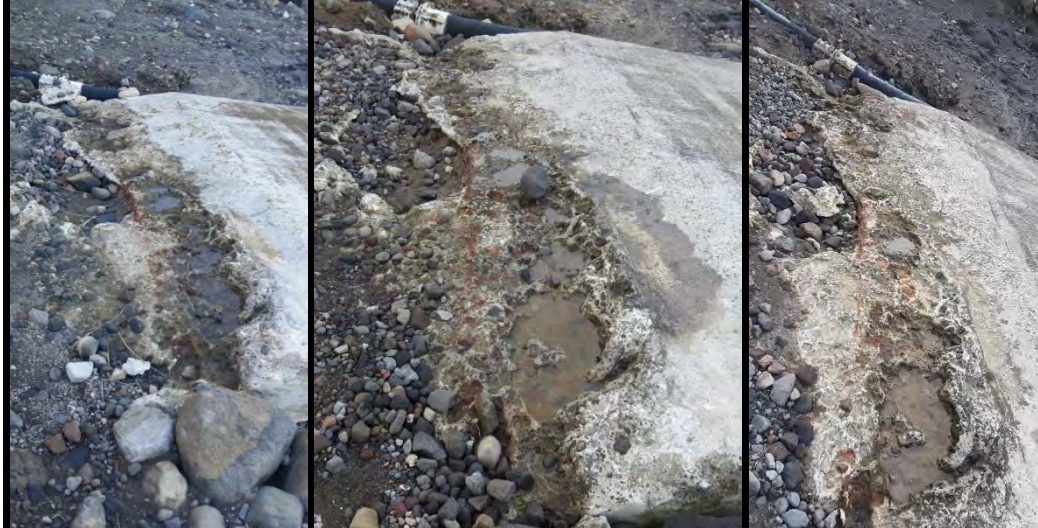
Photo 10 Top section of the Opunake Beach boat ramp (left May 2015, right May 2016, April 2017)

An inspection of the Opunake Bay boat ramp was undertaken on 19 April 2017. The structure appeared to be in satisfactory condition. There was some erosion above the top end of the boat ramp which could potentially cause access difficulty for some vehicles. Erosion immediately above the ramp had not worsened over the last few years (Photo 10). The access track leading down to the consented structure looked more eroded than previous years as a result of recent heavy rainfall.

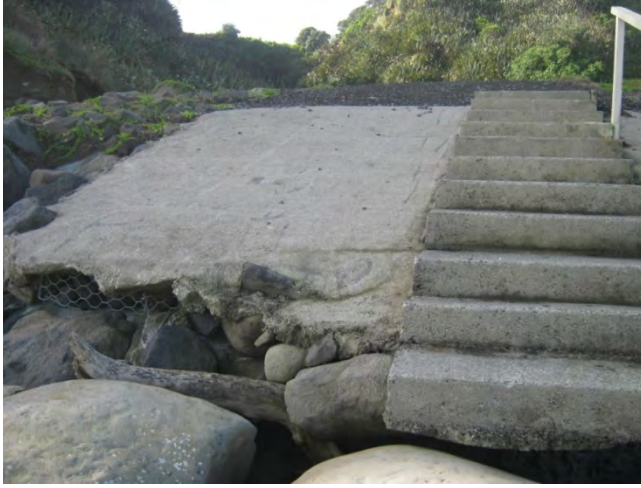
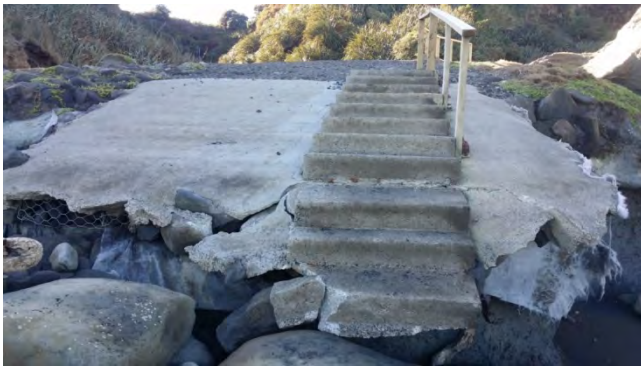
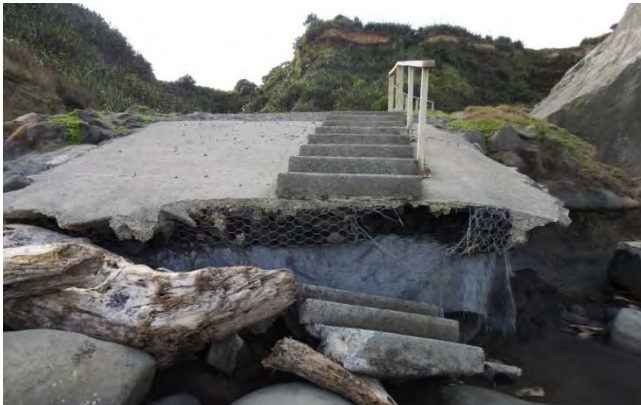
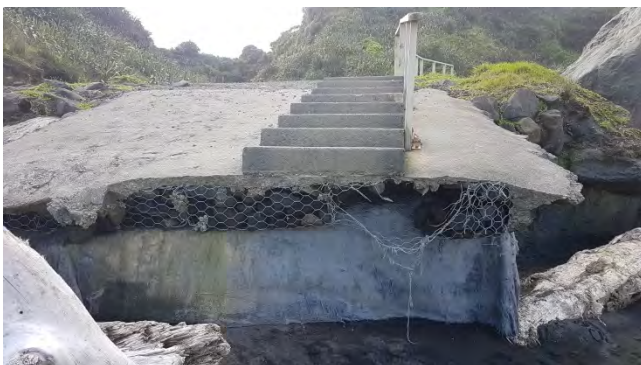
Photo 12 Access way to Waihi Beach, Hawera (top May 2014, middle above May 2015, middle below May 2016, bottom April 2017)

Wave and weather damage at the base of the structure appeared to have worsened over the 2016-2017 period (Photo 12). At the time of inspections it was questionable whether the ramp was fit for purpose (Consent 6736) i.e. to allow emergency access to the beach.

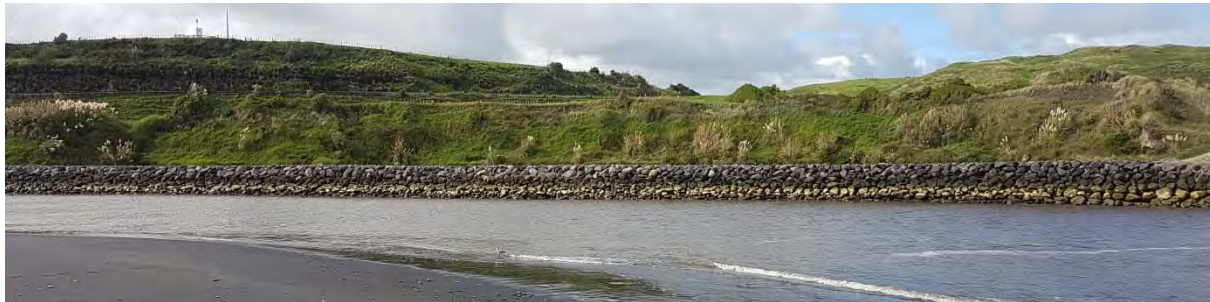
Photo 13 Training wall at Patea shown on the far side of the river (April 2017)

Visible sections of the Patea River training wall and groynes were inspected on 19 April 2017 and were found to be in satisfactory condition. It must be noted that large sections of the groynes are below sea level (Photo 5) and are not possible to inspect without divers. Areas of damage on the training wall noted in previous inspections had been repaired and have not been evident since March 2013 (Photo 13). Mana Bay seawall and Carlyle Beach rock protections were also inspected and photographs are available on request.

STDC have been undertaking significant repairs in this area, since works began in 2006. STDC continued repair works to the Patea groynes and training walls over the 2013-2014 period with an expenditure of approximately \$40,000 associated with repairs to the eastern training wall in 2013. No repairs or maintenance works were required during the 2016-2017 monitoring year.

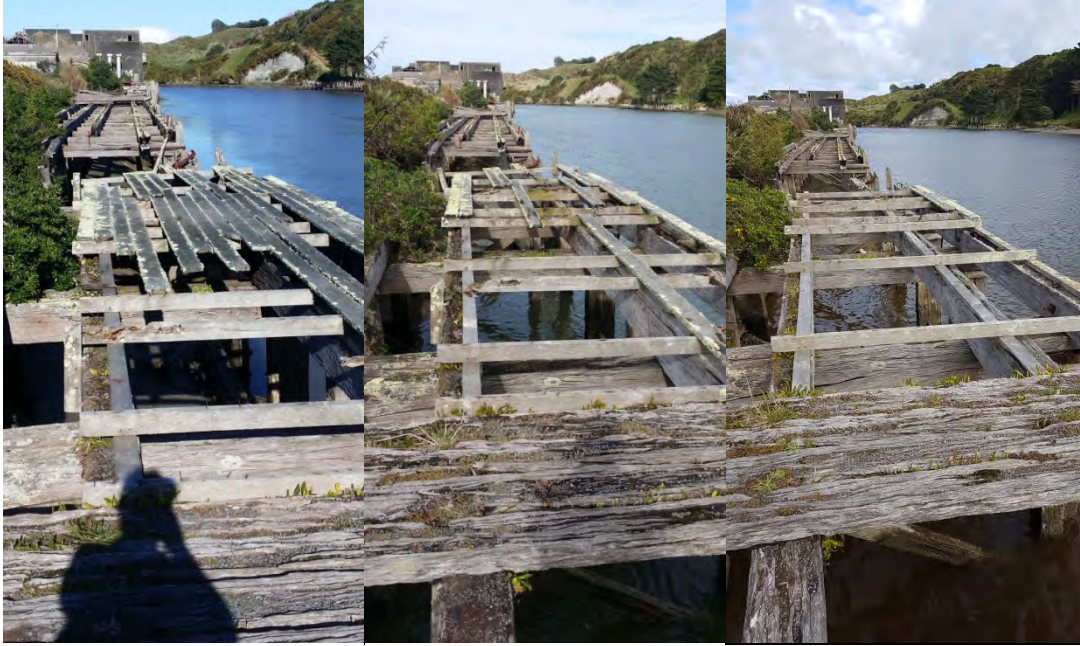
Photo 14 Old Patea wharf (left May 2015, middle May 2016, right April 2017)

As noted in previous inspections, the wharf was in a dilapidated state and had been so for some time. The condition of the wharf had deteriorated over the last three inspections (Photo 14). In the inspection on 17 April 2017 access to the wharf was dangerous. No warning signs had been erected to warn the public of the unsafe structure.

The consent for this structure was renewed on 23 June 2010 with reduced maintenance requirements. This allows STDC to continue to occupy the space provided the derelict wharf does not pose a navigational hazard.

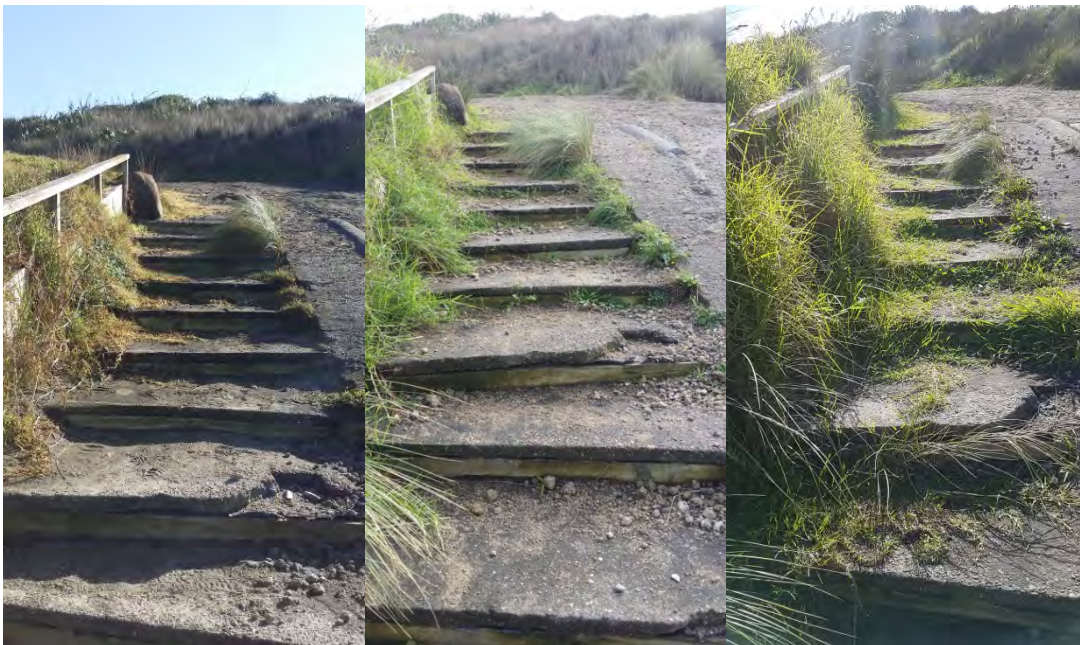
Photo 15 Access to Caves Beach, Waverley (left May 2015, middle May 2016, right April 2017)

Waverley Beach was visited on 19 April 2017. In general, the access ramp down to Waverley Beach was in a satisfactory condition. The access to Caves Beach had sections of concrete missing from the middle steps (Photo 15). This area of damage showed no significant deterioration since the previous inspection in May 2016. During the April 2017 inspection the top steps were overgrown with vegetation compared to previous years.
