STDC Coastal Structures
Monitoring Programme
Annual Report
2017-2018

Technical Report 2018-10

Taranaki Regional Council
Private Bag 713
STRATFORD
August 2018

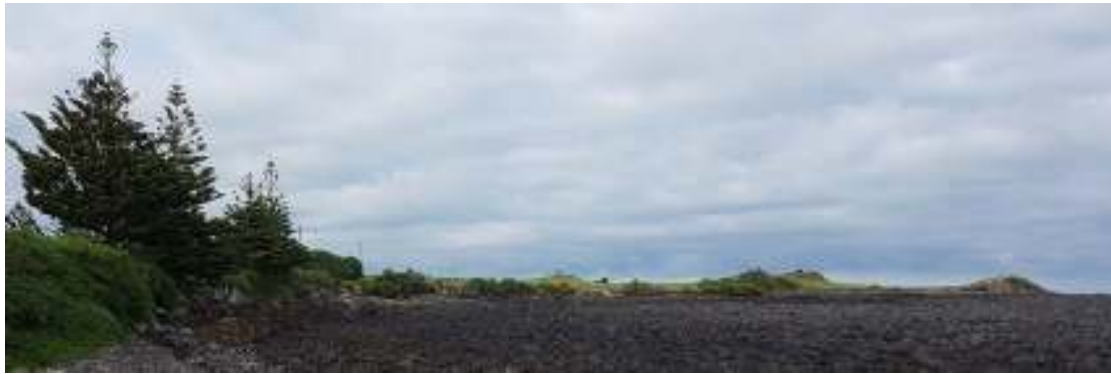
Photo 1 Bayly Road seawall (April 2017)

As a result of the works, the boulder protection now extends from the boat ramp in the north to the pre-existing 40 m of boulder protection south of Bayly Road, with a total length of approximately 290 m (Photo 1).

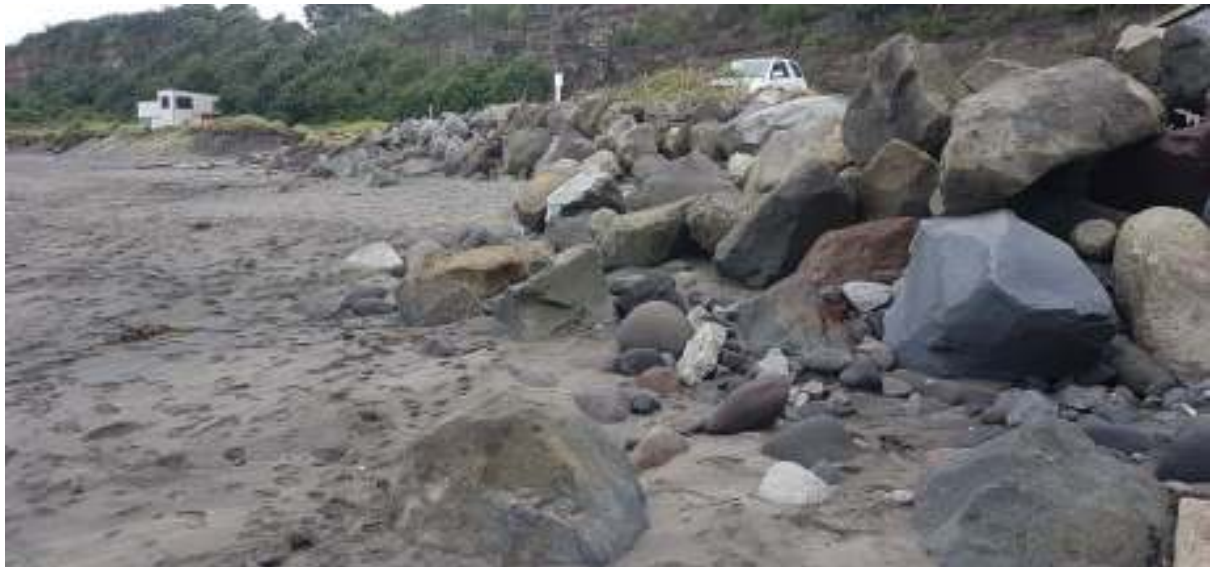
Photo 2 Rip rap seawall, Middleton Bay (April 2017)

Due to Middleton Bay being a pocket sand beach, and the location of the revetment being well forward towards the surf zone, there is a high potential for adverse effects to the soft shoreline at the north-western end and in front of the structure. Within a year of the structure being constructed, there was erosion of the foredune at the north-western end of the revetment, which may have been as a result of 'end effects' from the structure (Tonkin & Taylor, 2001).

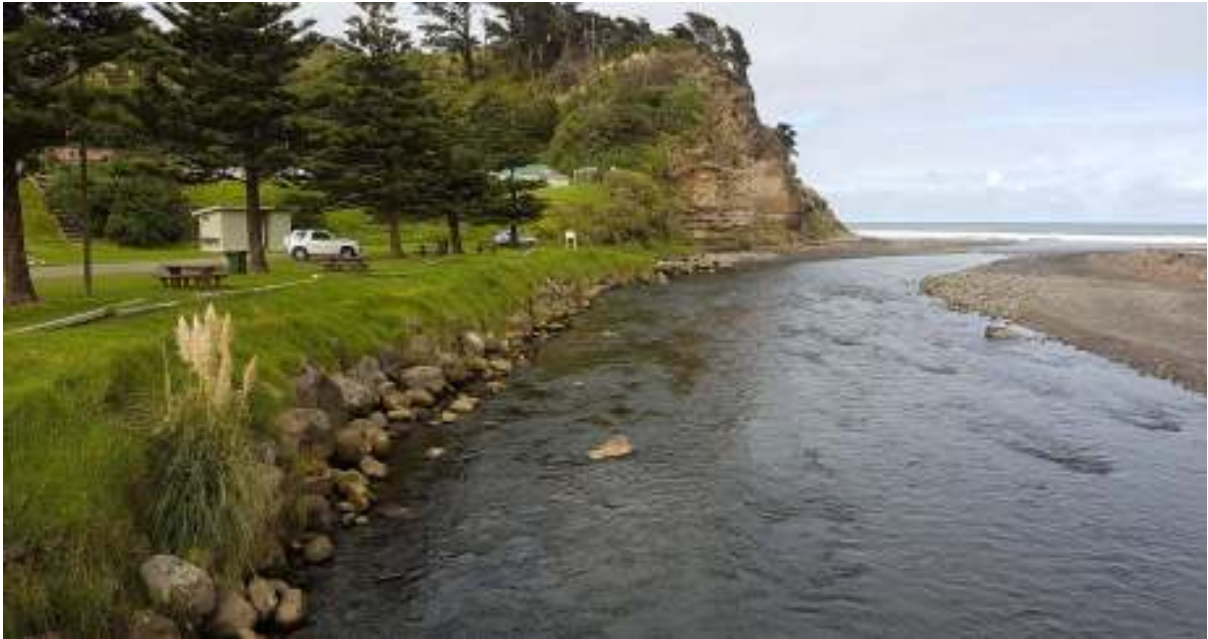
Photo 3 Looking downstream along rock protection works in the Kaipokonui Stream (April 2017)

Following receipt of a complaint regarding works in the Kaupokonui Stream in 2002, investigation by Council officers discovered that substantial boulder rock rip rap had been placed on the true left bank of the Kaupokonui Stream (Photo 3).

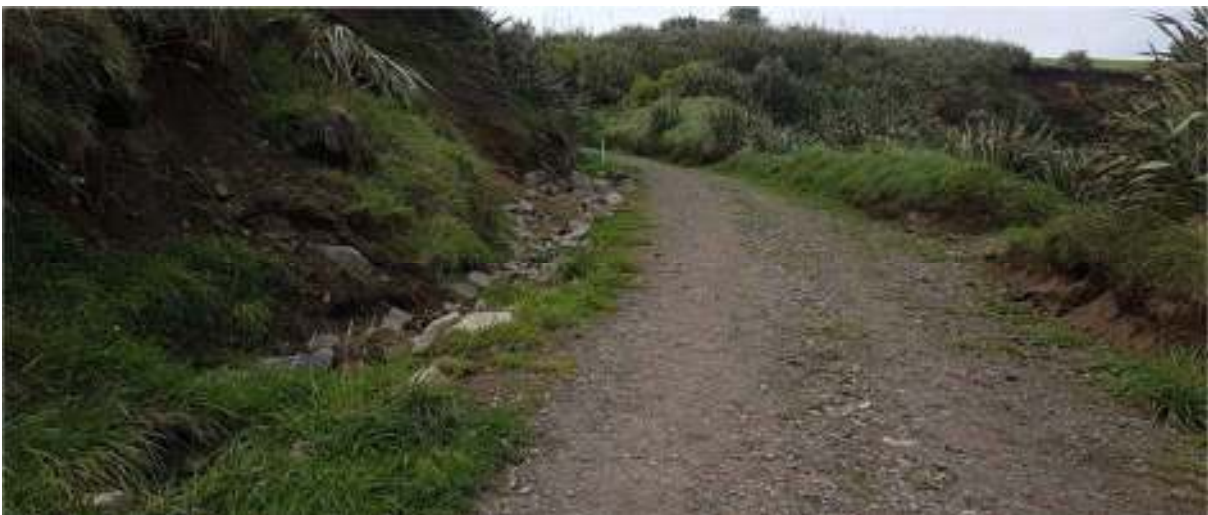
Photo 4 Beach track at the end of Denby Road leading to the gabion mattress consented under 6736 (April 2017)

In Hawera, locals access Waihi Beach via the track at the end of Denby Road (Photo 4). The track down to the beach is cut through the cliffs from the carpark at the end of Denby Road. Over time the access to the beach has become difficult, due to storms and erosion, with large sections of the track eroding away.

STDC installed a gabion mattress at the bottom of the access track with the intention of improving access to the beach and helping control the erosion problems. The mattress measured 6 m x 2 m x 0.23 m in size and was placed on existing rocks. Surrounding the rocks a geo textile fabric was used to prevent the scouring of sand and to increase the longevity of the structure. Once completed, the structure was covered in concrete to further aid pedestrian access. The structure is authorised by coastal permit **6736**.

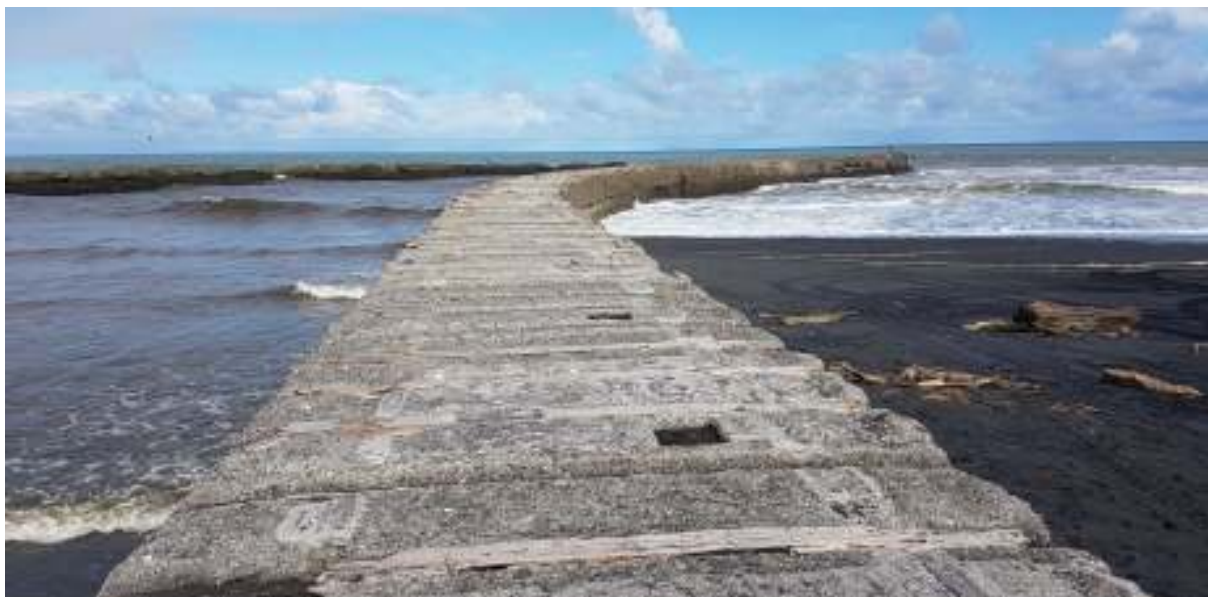
Photo 5 Patea groynes (April 2017)

Significant levels of erosion occurred along this coastline during the past 50 years which led to the river moles becoming seriously degraded. Studies undertaken by consultants (Duffill Watts & King, 2006) showed that with the condition of the moles and rate of shoreline change, the river moles could decay, threatening the overall stability of the river entrance. If the stability of the river entrance changed, this could result in the passage between the river and sea becoming no longer navigable. From the studies undertaken by Duffill, Watts & King (2006), it was found that without some intervention process the Patea River would break through behind the southeast mole within 20 to 25 years and prevent navigable access to the sea. It was proposed that the most effective method to maintain a navigable river entrance for small seagoing craft was to reconstruct the southeast seawall. Consent **6839** was granted by the Council authorising the works, which aimed to constrain the river channel to its existing alignment and prevent it from breaking through behind the left mole (Photo 5).

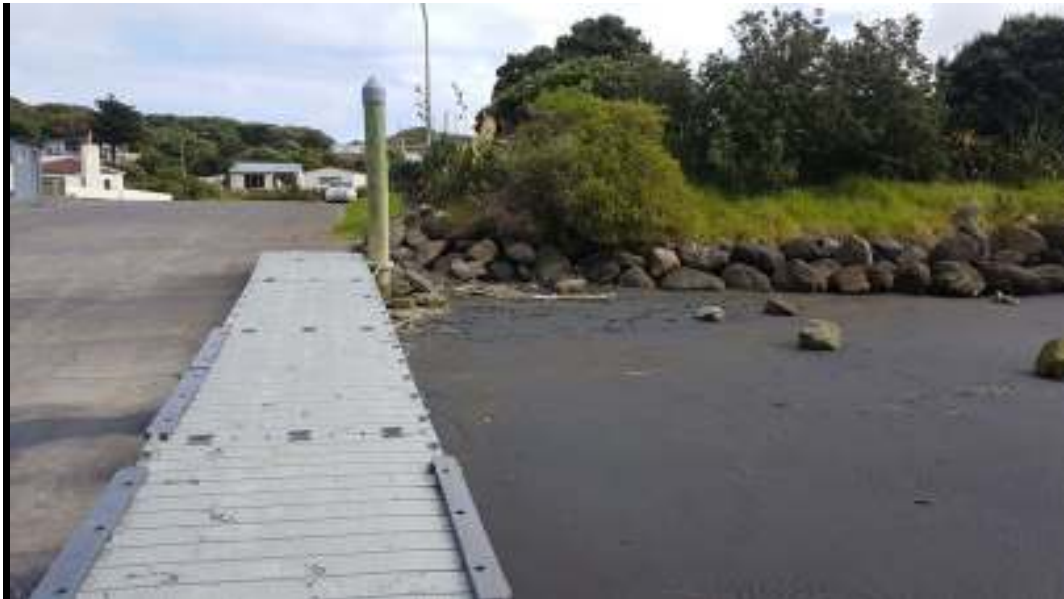
Photo 6 Patea boat ramp (April 2017)

The boat ramp at Patea has been in existence for many years, providing one of the few effective and safe boat launching facilities on the South Taranaki coast (Photo 6). The facilities are used extensively and are considered to be one of Patea's more important recreational facilities.

The launching ramp was an undular concrete pad which extended from the end of the formed roadway of Turi Street, down to approximately the low tide level of the river. Upon granting of coastal permit **4566**, the STDC strengthened the existing boat launching ramp by placing a concrete strengthening overlay over the existing ramp. The overlay is 7 m wide and extends a further 3 m down into the river than the previous ramp, improving the launching facility.

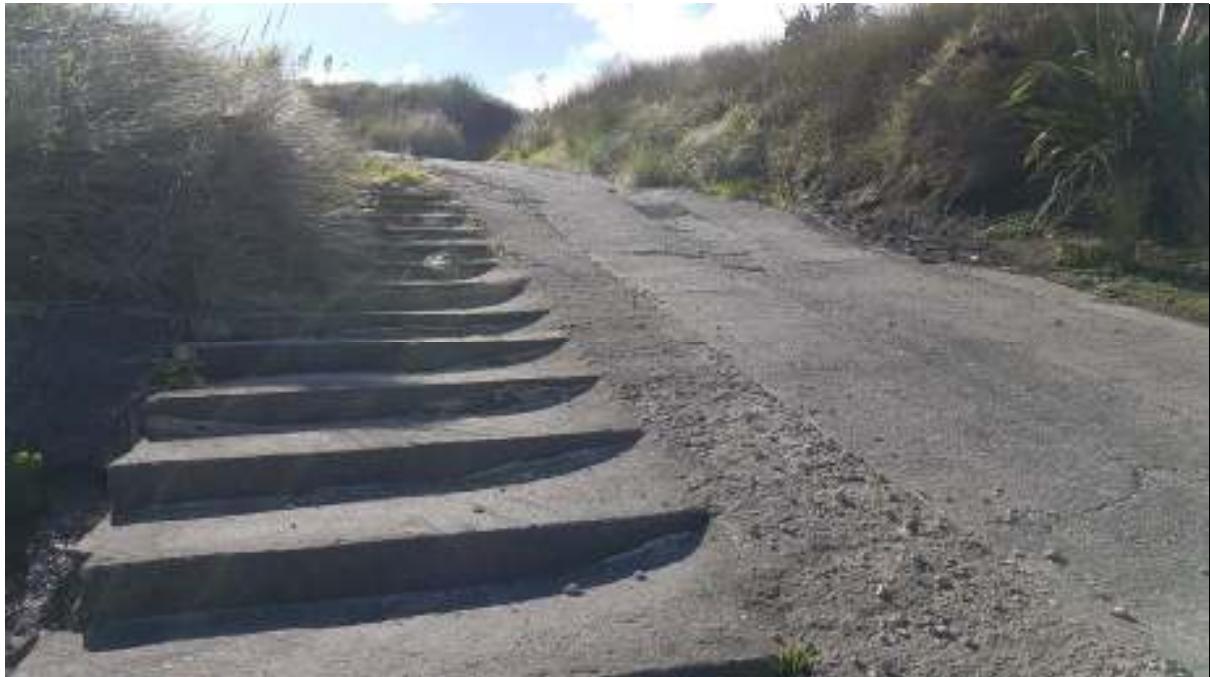
Photo 7 Access to Waverley Beach (April 2017)

The structure covered by consent **4579** consists of a concrete public access ramp way, 20 m in length and 3 m in width with an associated 2 m wide by 16 m long concrete step-way down the western edge of the ramp (Photo 7). The ramp extends down to the beach sands from the upper ground level of the mudstone coastal bluffs, providing access to Caves Beach, again reducing pedestrian damage of the fragile sand dunes.

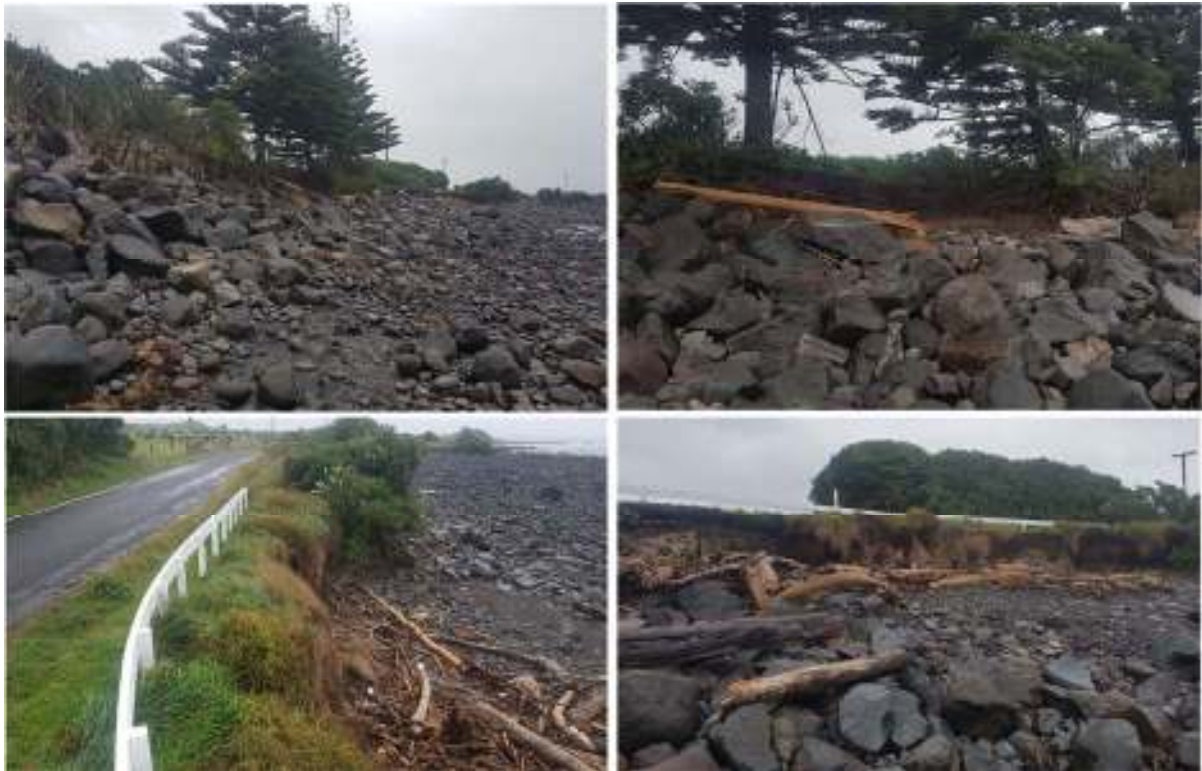
Photo 8 Bayly Road seawall, 11 May 2018

An inspection of the Bayly Road seawall was undertaken on 11 May 2018. There were a number of sections along the scarp where scour and erosion were evident (Photo 8). This appeared to be a result of decreased wave protection due to slumping and/or loss of material from the seawall. Significant erosion had occurred at the intersection between Bayly and Coast Roads. No wider environmental effects were apparent. Repair works were being undertaken at the time of writing this report.

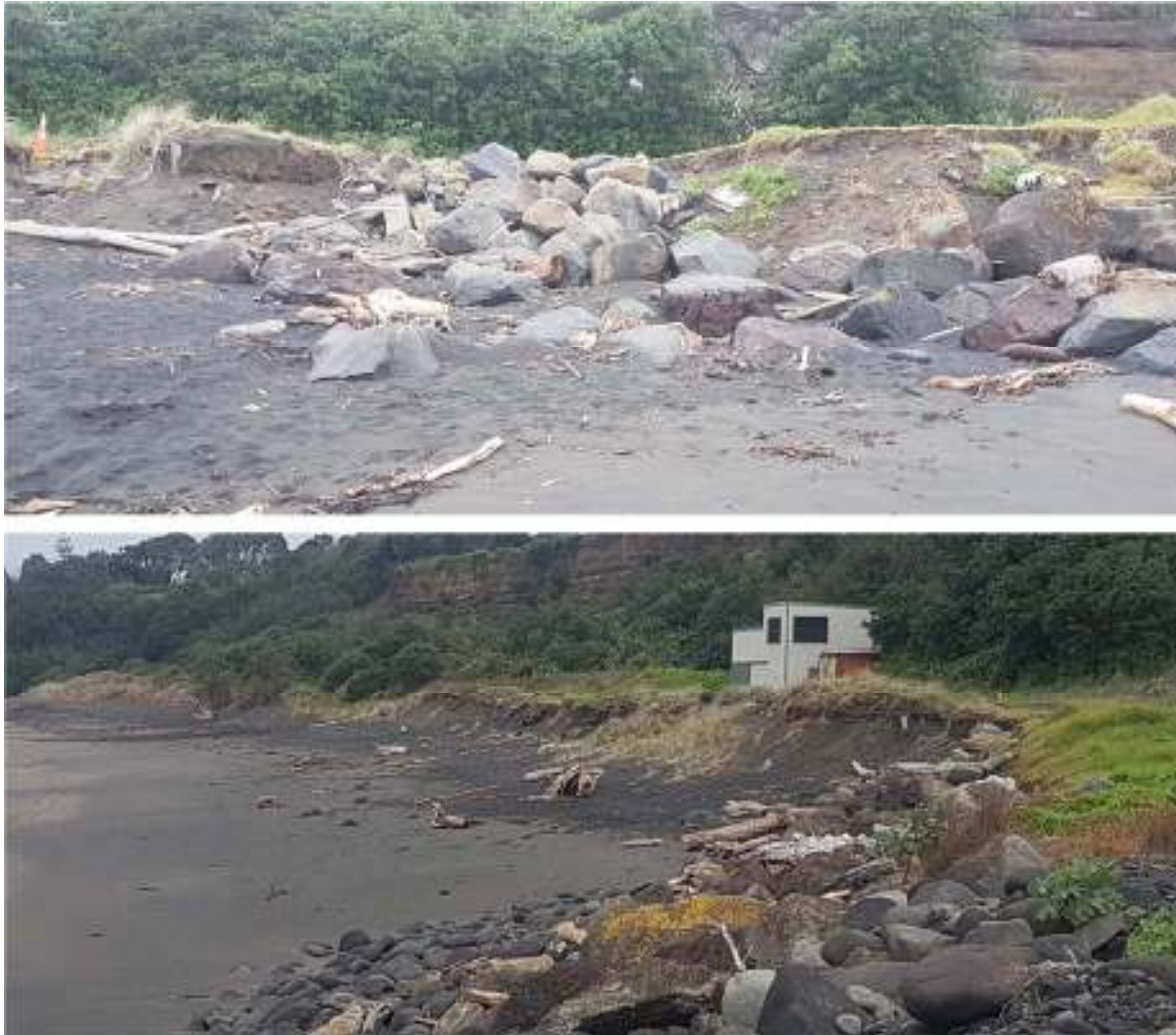
Photo 9 Middleton Bay seawall and dunes, 11 May 2018

An inspection of the Middleton Bay seawall was undertaken on 11 May 2018. Most of the seawall structure was in good condition, though it appeared to have lost cohesion at its northern end. End effects from the wall may be contributing to erosion at the northern end, though it is likely accelerated through pedestrian beach access (Photo 9). Further around the bay, the dunes appear to have lost volume through scour and erosion (Photo 9).

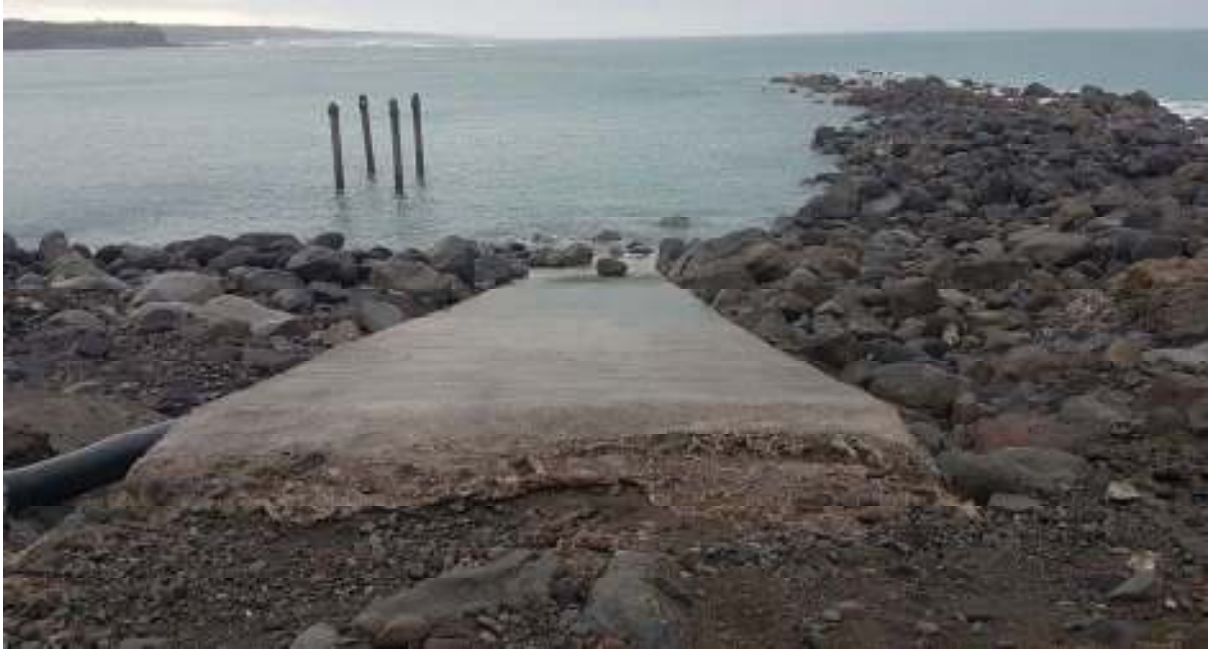
Photo 10 Opunake Bay northern headland boat ramp, 11 May 2018

An inspection of the Opunake Bay boat ramp was undertaken on 11 May 2018. There was some erosion above the top end of the boat ramp which could potentially cause access difficulty for some vehicles, though it did not appear to have worsened over the last few years. Boulders from the adjacent breakwater were found scattered across the end of the boat ramp (Photo 10). In the current state, launching vessels on this boat ramp would be problematic if not impossible. Although this does not breach any consent conditions, it remains counterintuitive to the underlying purpose of the coastal permit i.e. to provide boat access to Opunake Bay. However, since the artificial surf reef project was abandoned, it remains unclear as to whether the ramp is still used for launching boats.

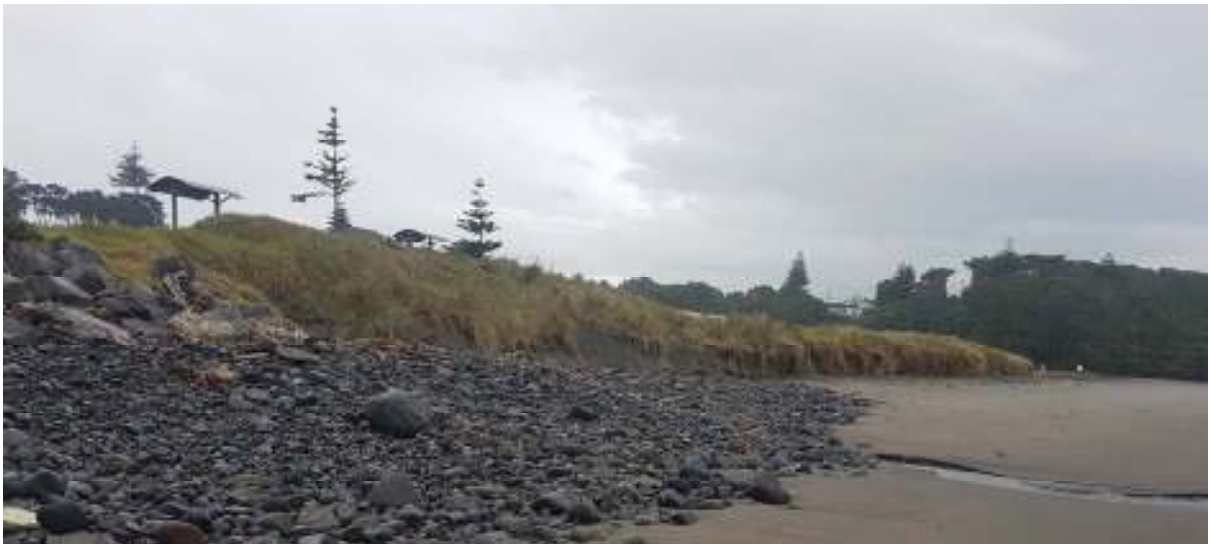
There did not appear to be any structural issues with the seawall at the northern end of Opunake Beach when inspected on 11 May 2018. A considerable length of retaining wall in front of the surf club is now buried under the dunes therefore it was not possible to assess the integrity of this structure. The associated access ramps appeared to be in good condition. The dunes appeared to have recently lost a lot of volume through scour and erosion, similar to what was seen at Middleton Bay (Photo 11, 12). It is difficult to determine whether any of the erosion has occurred in part as an end effect from the northern seawall. Pedestrian access tracks were found at various points in the dunes, likely contributing to the erosion. Further south along the beach, the exposed sections of retaining wall showed minor signs of deterioration.

Photo 11 Dune scour at Opunake Beach

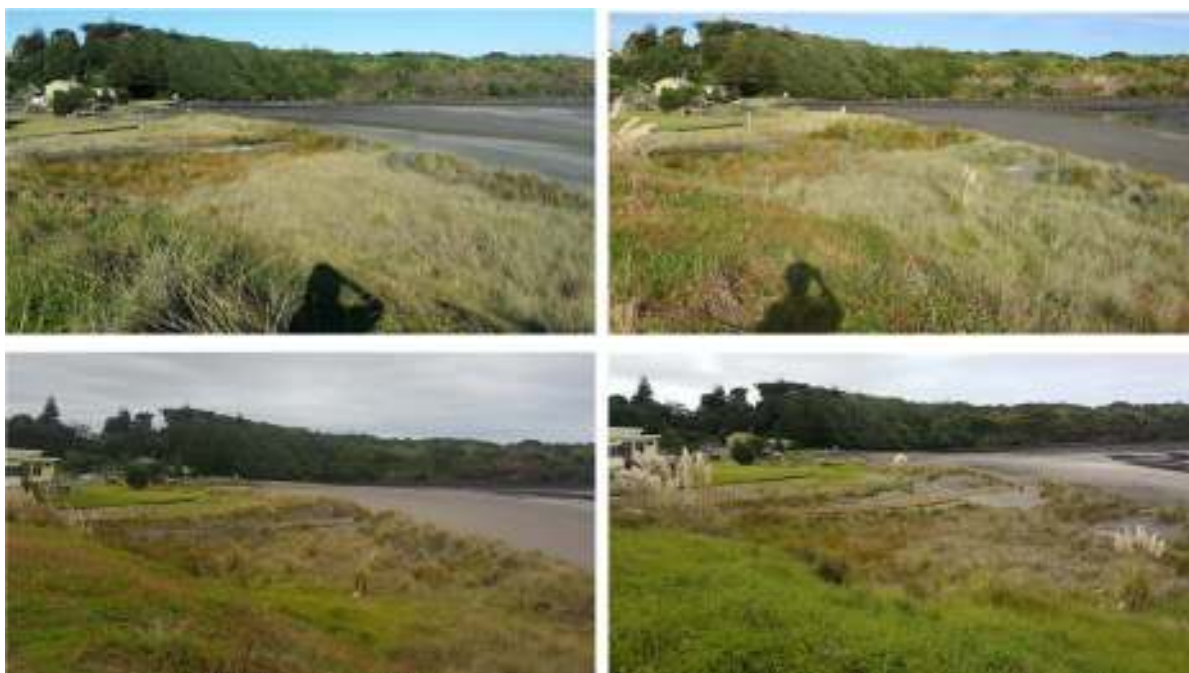
Photo 12 Dune planting at Opunake Beach (clockwise from top left: May 2015, May 2016, April 2017, May 2018)

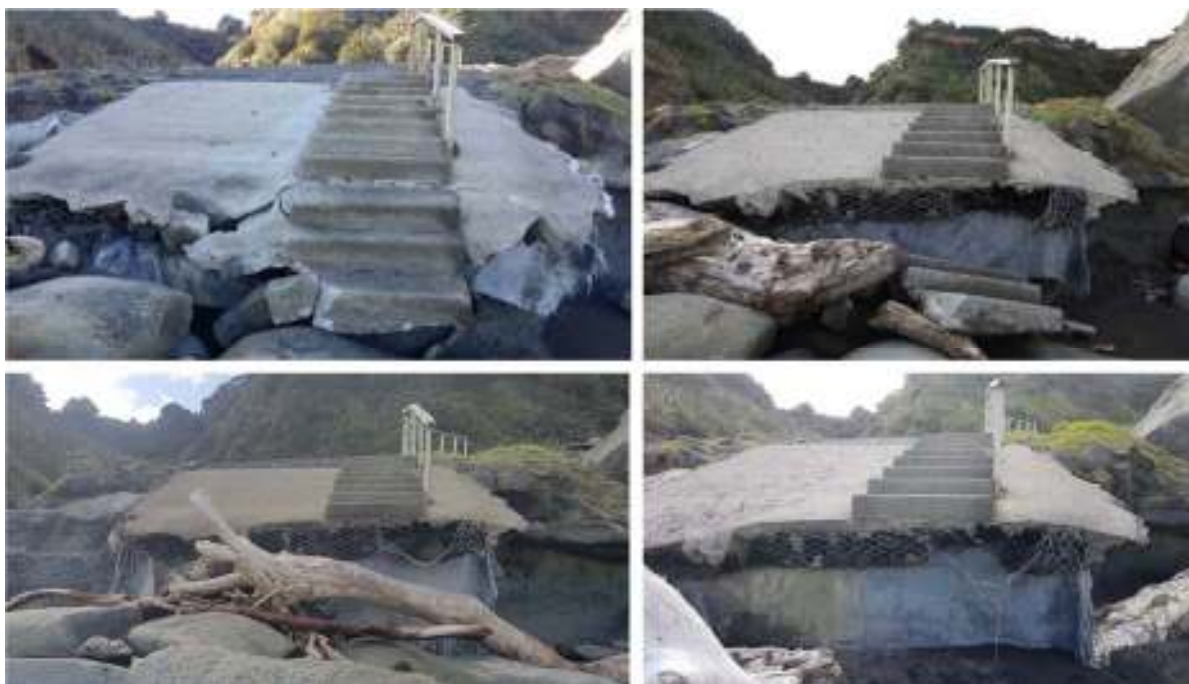
Photo 13 Waihi Beach access (clockwise from top left: May 2015, May 2016, April 2017 and May 2018)

The Waihi Beach access ramp was inspected on 22 May 2018. The structure and adjacent land has continued to erode since the last inspection, though the rate of erosion appears to have slowed (Photo 13).

In the 2017-2018 monitoring period, the only structure that was not fulfilling its consented purpose, was the Denby Road access way. The structure has continued to deteriorate to the point where it no longer provides emergency access to the beach. STDC have acknowledged that the structure is not fit for purpose and are currently working through alternative options for providing beach access.

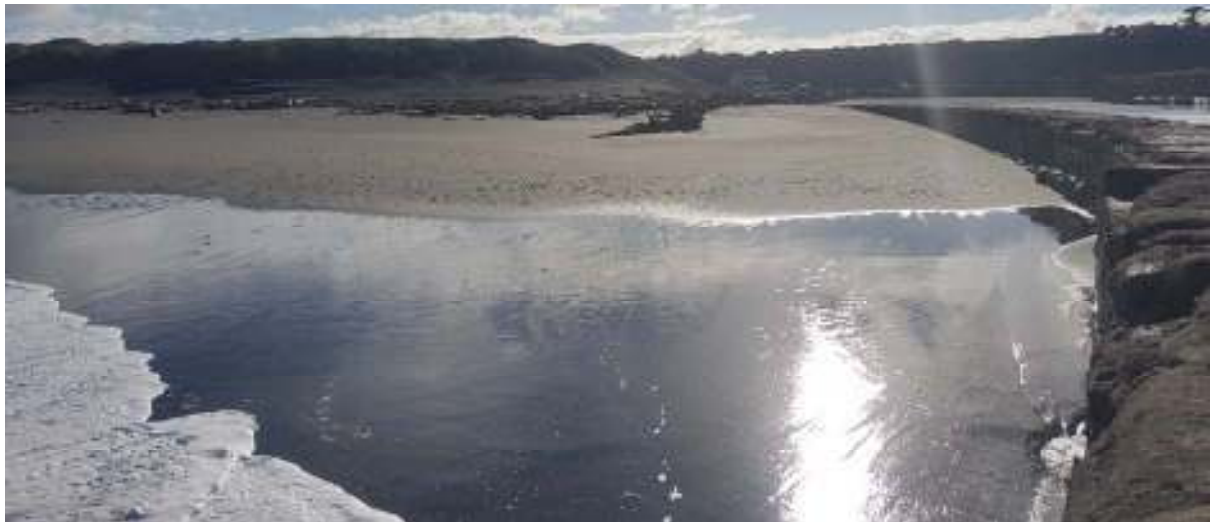
The seaward end of the eastern mole appeared to be in a more degraded state than the western mole. Also serving its function as a groyne, a large beach has formed on the outside of the western mole (Photo 14). Overall, no significant issues were noted for the east and west moles.

The half tide training wall, wave guide wall and Mana Bay seawall all appeared to be in good condition, having no notable adverse effects. The Carlyle Beach rock protections were not immediately obvious during the inspection and it is suspected that they have been buried by the large volume of sand that has built up inside the river mouth.

Photo 14 Sand build up outside the western mole at the Patea River mouth, 22 May 2018

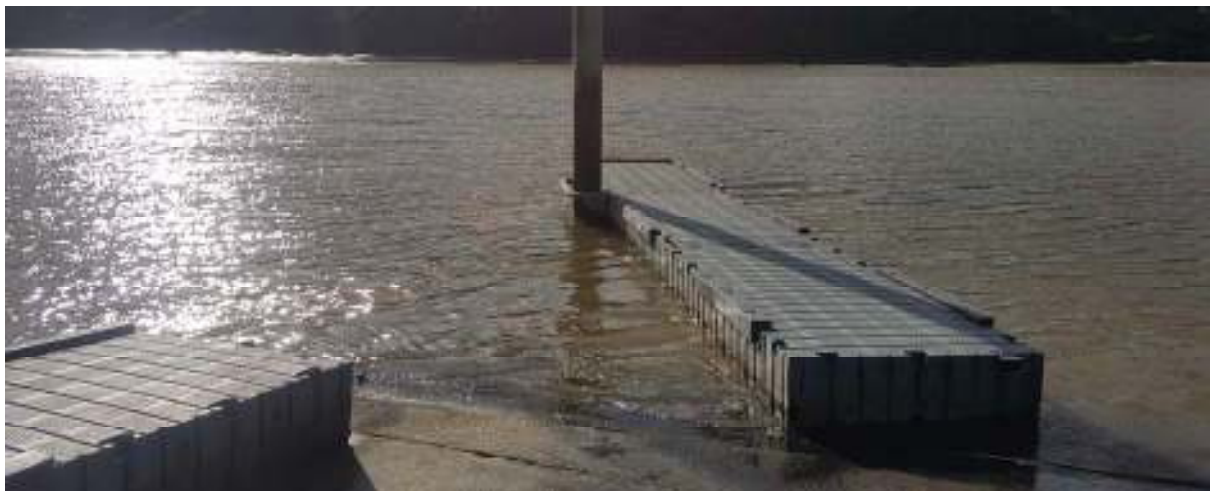
Photo 15 Damaged jetty at the Patea boat ramp, 22 May 2018

The boat ramp was inspected on 22 May 2018. At the time of the inspection, the jetty appeared to have recently been damaged, potentially by debris being brought down the river during high flows (Photo 15). The bottom section of the jetty had broken at the joint and had been pushed around across the ramp by the flow of the river. No other issues or end effects were found. The jetty was subsequently secured and repaired.

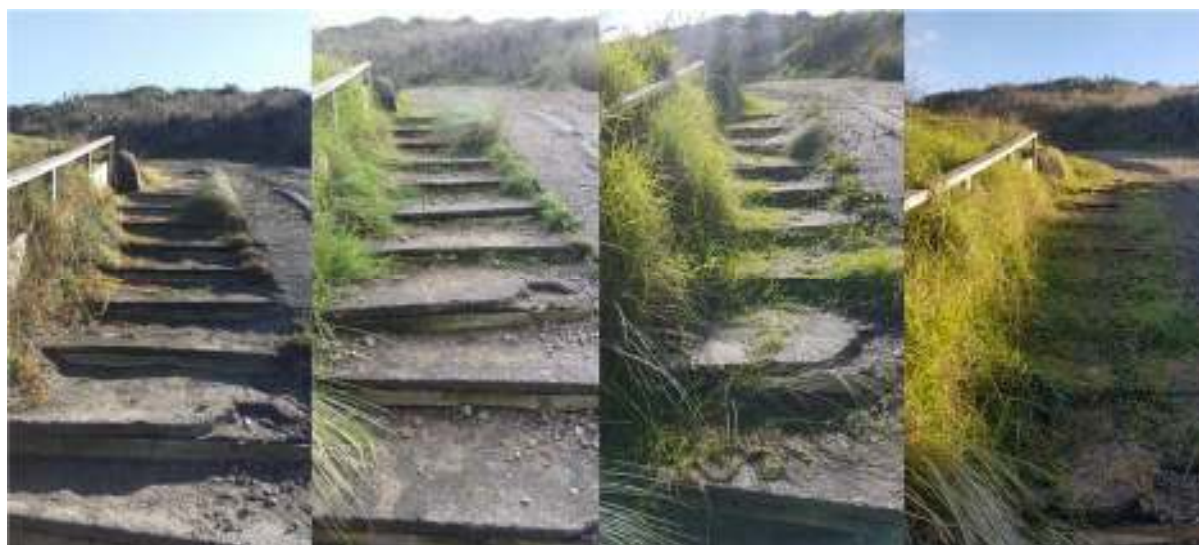
Caves Beach was visited on 22 May 2018. The condition of the steps had continued to deteriorate and were now covered with grass and sand (Photo 16). The bank at the base of the structure showed signs of scouring; a process that is potentially aggravated by the stream that runs across the beach at the base of the ramp. Overall, the access ramp down to Caves Beach still provided beach access and did not appear to be adversely affecting the surrounding environment.

Photo 16 Deterioration of the Caves Beach access ramp (from left to right: May 2015, May 2016, April 2017 and May 2018)

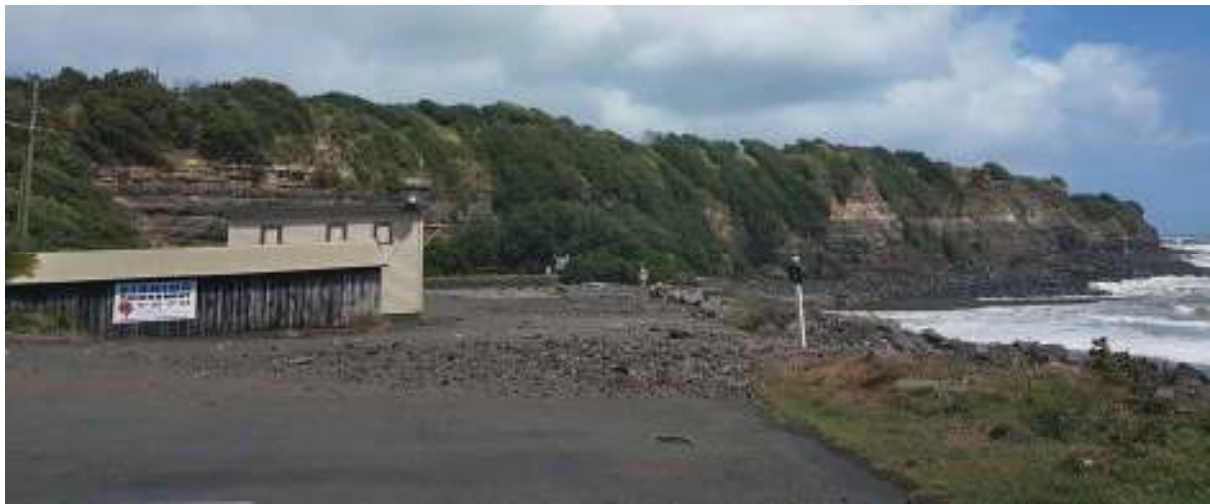
As is often the case, Taranaki's coastal environment received intermittent bouts of high energy, stormy conditions in the monitoring period under review. However, the beginning of February was marked by an extraordinary meteorological event. Coinciding with a king tide, Ex-Cyclone Fehi brought winds and storm surges that battered the Taranaki coastline beyond its typical threshold. In North Taranaki, a large amount of work was required to repair a number of hard protection structures and dunes systems which were damaged as a result of this event. South Taranaki was also impacted by this event, and subsequent storm surges later in the year (Photo 17).

Photo 17 Rocks and gravel washed onto Middleton Bay car park by Ex-Cyclone Fehi.
