Taranaki By-Products Ltd
Monitoring Programme
Annual Report
2018-2019

Technical Report 2019-78

This report for the period July 2018 to June 2019 describes the monitoring programme implemented by the Taranaki Regional Council (the Council) to assess TBP's environmental and consent compliance performance during the period under review. The report also details the results of the monitoring undertaken and assesses the environmental effects of TBP's activities.

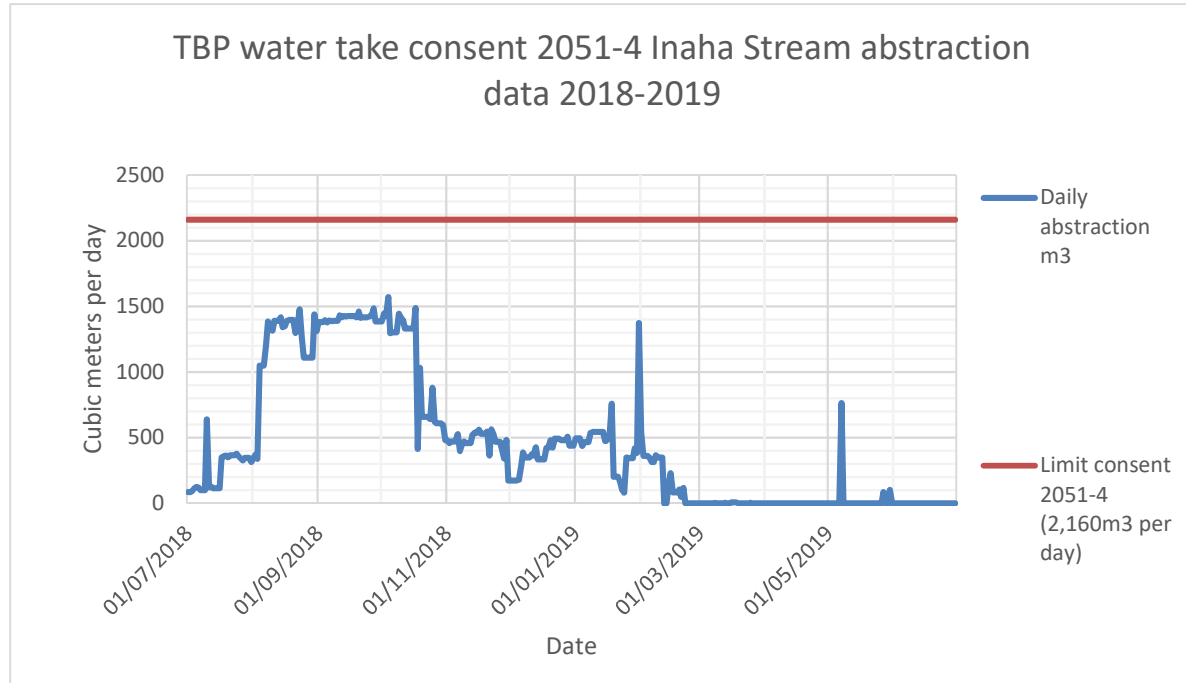
Figure 4 Consent 2051-4 abstraction data 2018-2019

The records provided by the Company (Figure 4) indicated that the consented abstraction daily maximum of 2,160 m³ was complied with for the entirety of the 2018-2019 monitoring period. This is an improvement from the 2017-2018 monitoring period where an exceedance was observed on one occasion.

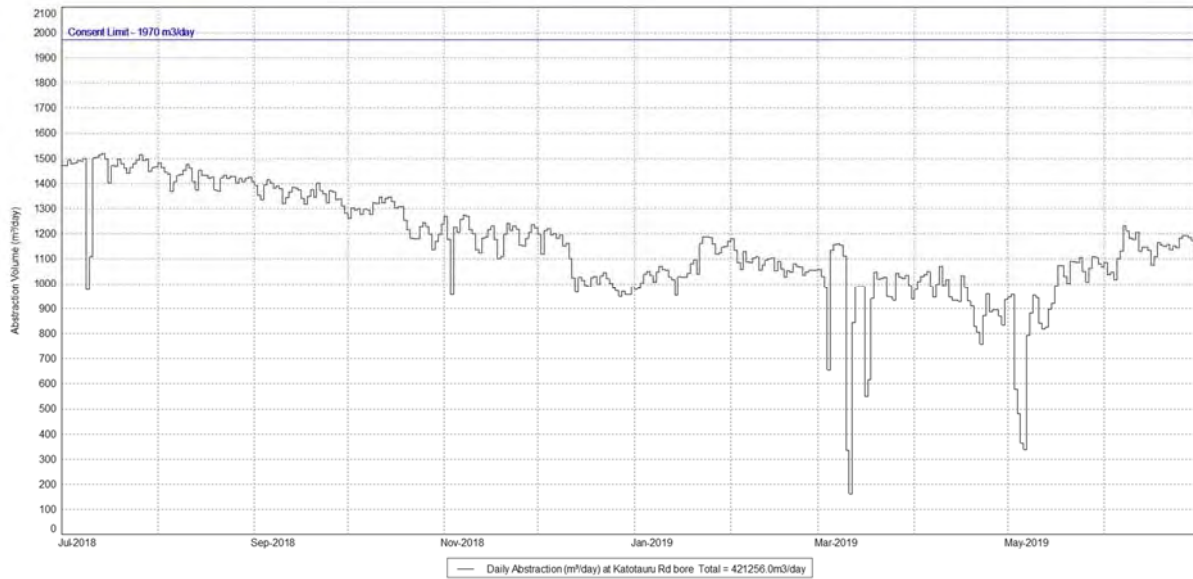
Figure 5 Daily groundwater abstraction volumes consent 9756-1 2018-2019

The analysis provided in Figure 5 indicated that the daily maximum limit of 1,970 m³ was not exceeded for the whole of the monitoring period.

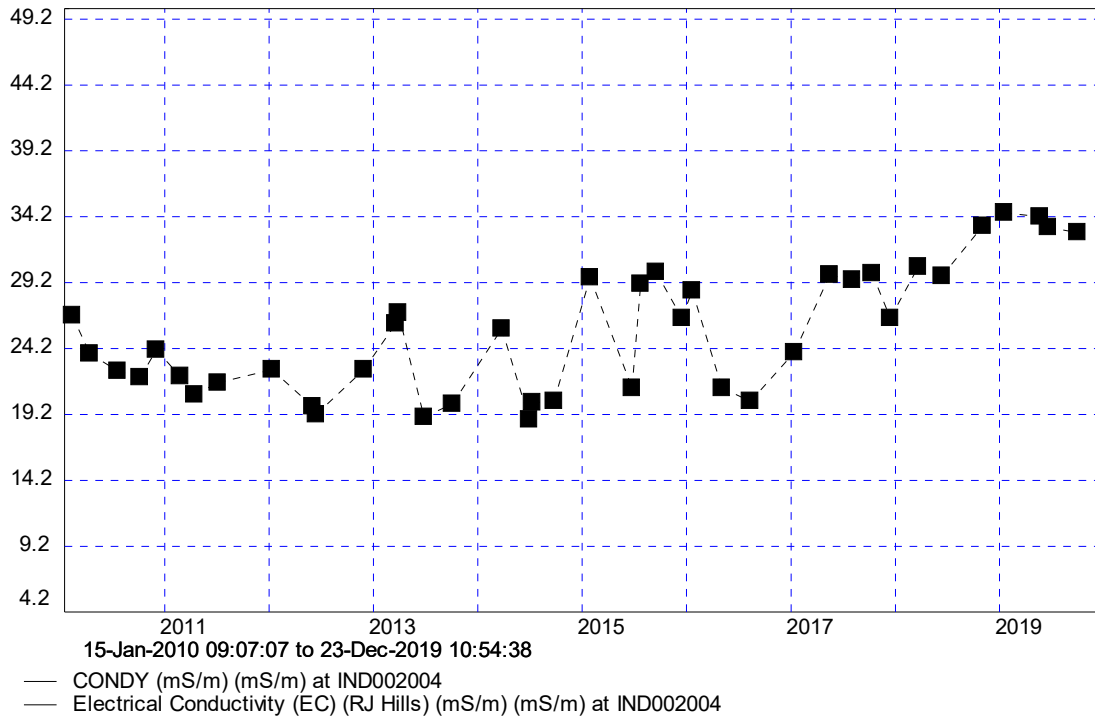
Figure 6 Long term conductivity measurements of IND002004 January 2010-December 2019

- These values do denote a slight increase in conductivity values over time, when compared to the long term analysis of this parameter (Figure 6). Condition 2 of consent 2050 requires that the discharge shall not contain concentrations of any chemical, biological or physical contaminant (other than heat or suspended solids) greater than those found in the water abstracted from the Inaha Stream.

- Surface water monitoring location INH000400, which is above the surface water intake, generally ranged (in term of conductivity) around 25 mS/m at 25°C, whereas the values reported ranged around 33.5 mS/m at 25°C. The likely cause of this slight elevation in conductivity may be related to the cooling water boiling as a process of its use as a cooling agent, however it may also indicate some enrichment of cooling water.

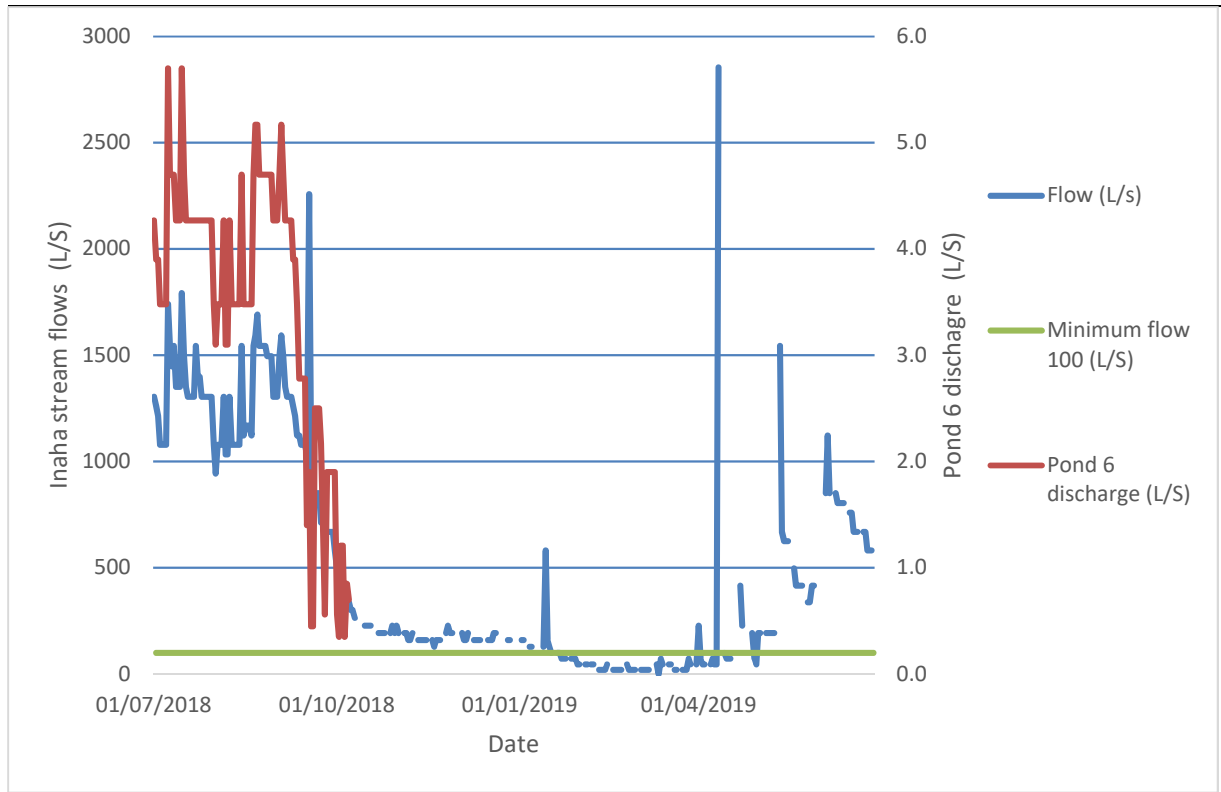
Figure 8 Hydrograph of Inaha stream and pond 6 discharge 2018-2019

The results from the monitoring of wastewater and receiving water discharge rates by TBP show that the limit on the minimum dilution rate of 300:1 fold was achieved for the whole of the 2018-2019 period. The discharge ceased on the 11 October 2018, and no discharge to the Inaha Stream occurred till the following monitoring period 4 July 2019.

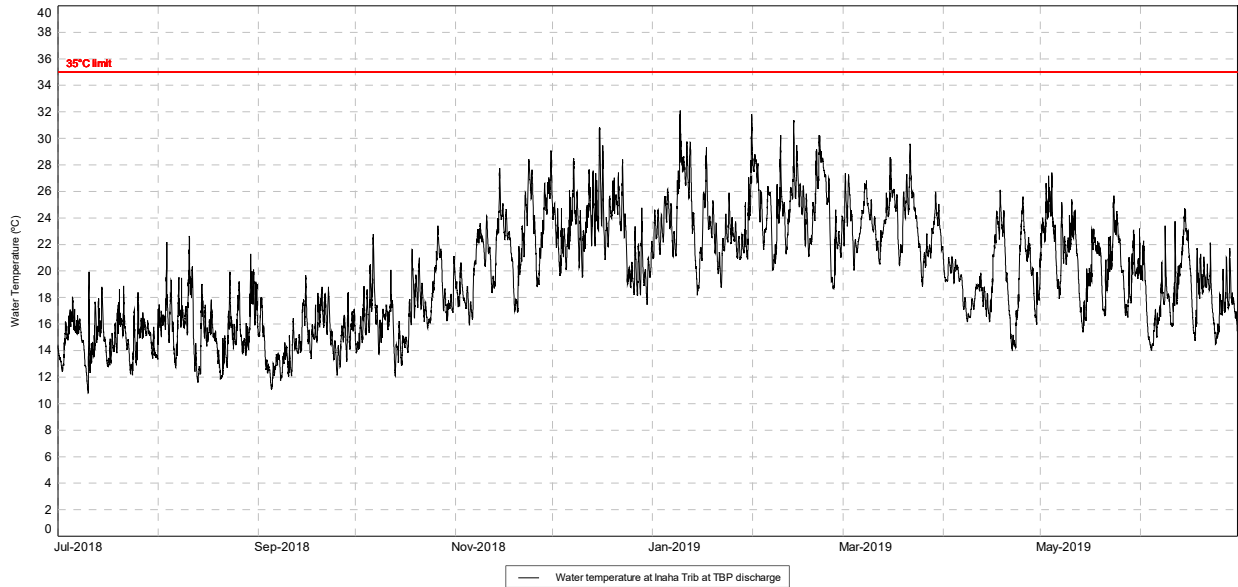
Figure 9 Cooling water temperature Inaha tributary 2018-2019

For background, special condition 3 on consent 2050 requires that the temperature of the cooling water discharge must not exceed 35°C . In this monitoring period (Figure 9) the limit was not exceeded, marking the sixth year TBP has been in compliance with this cooling water temperature condition.

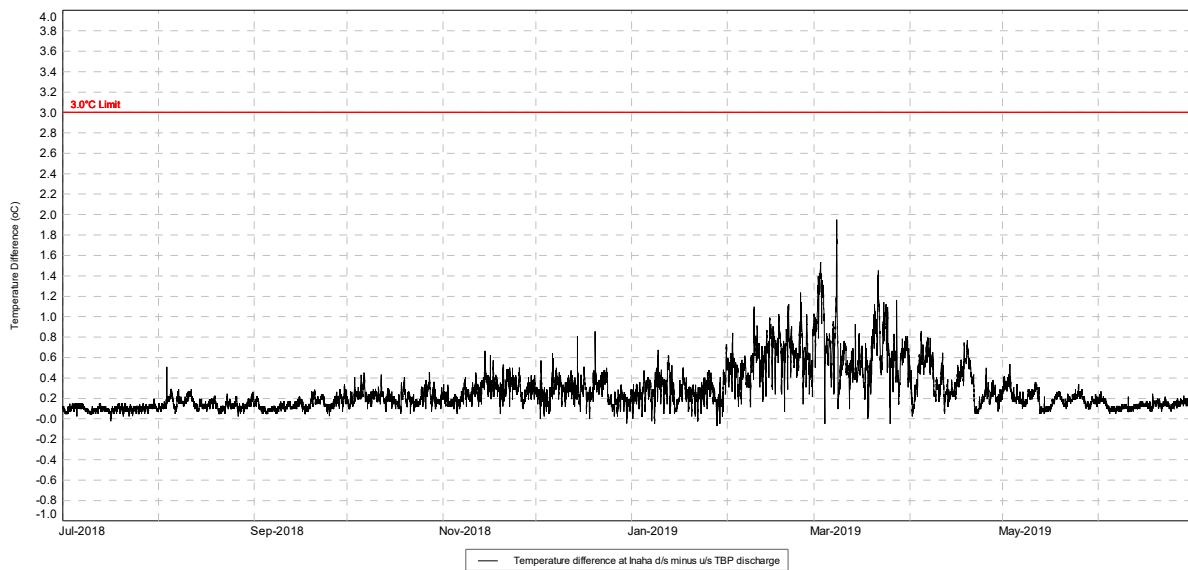
Figure 10 Inaha stream temperature increase post discharge 2018-2019

Special condition 9 (c) on consent 2049 and special condition 5 (g) on consent 2050 require that there be no more than a 3.0°C temperature differential in the receiving waters below the mixing zone as a result of the wastewater and cooling water discharges, respectively. Results presented in Figure 10 indicate compliance with this condition.

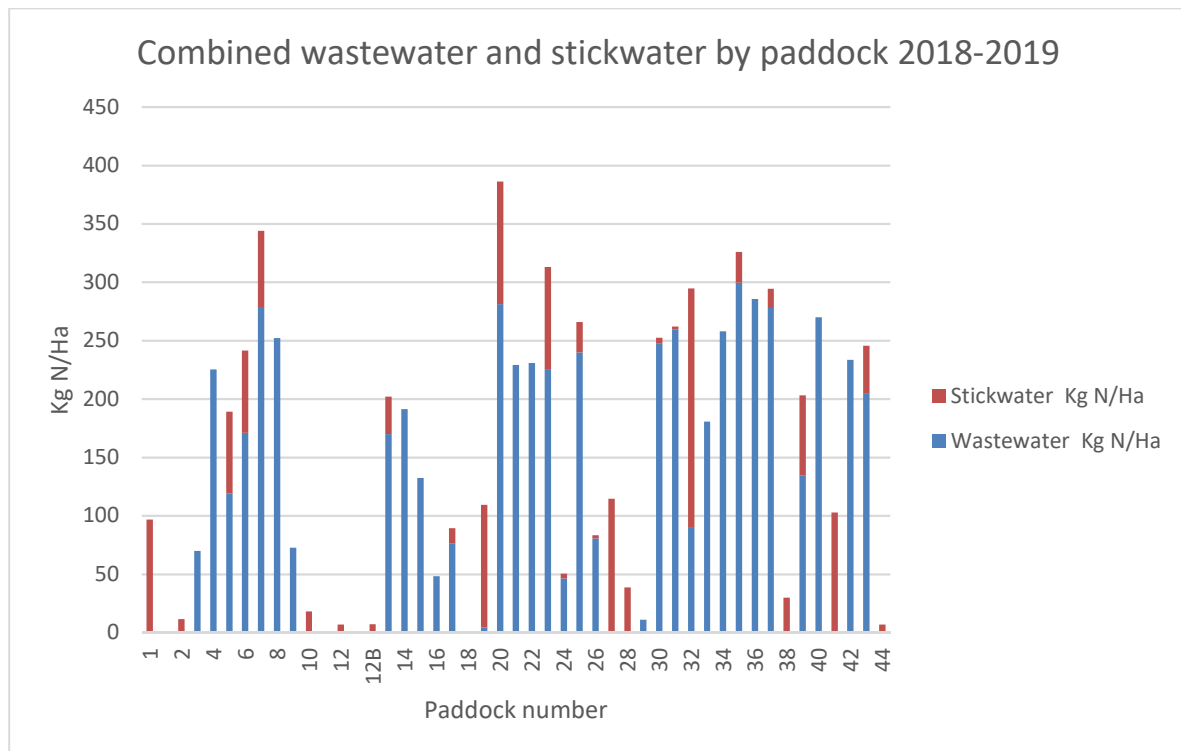
Figure 11 Combined water and stickwater loading by paddock 2018-2019

No paddock received an application of wastewater which exceeded 300 Kg/N/ha, which is the limit of the consent.

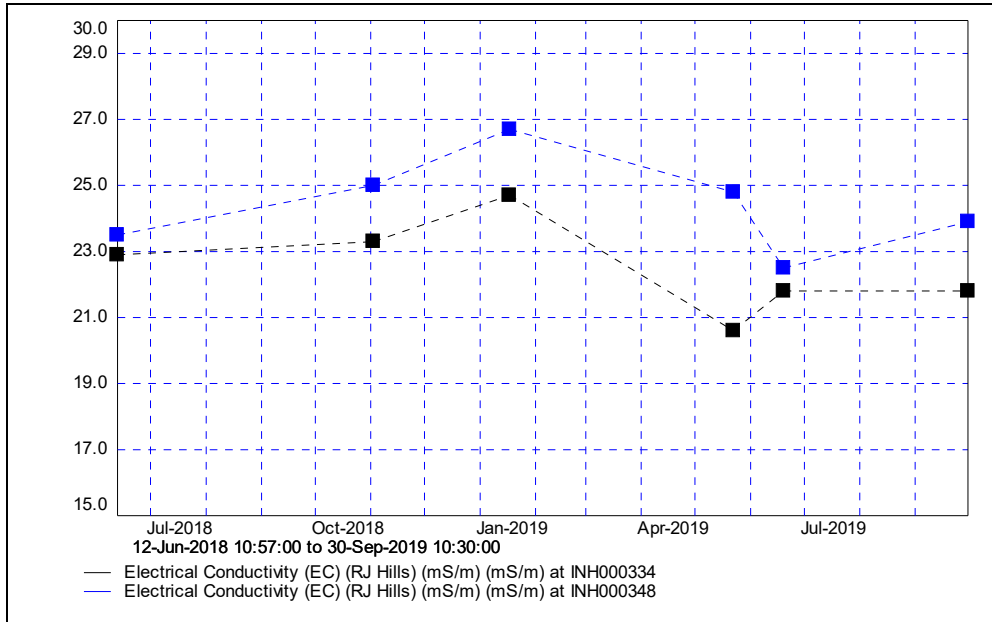
Figure 23 EC monitoring Inaha Stream INH000334 and INH000348 2018-2019

Of note was a slight increase in EC values between the two sites of INH000334 and INH000348 (Figure 23) as well NNN concentration (Figure 24). However there is considerable distance between these two monitoring locations and the Company do irrigate to land further up the catchment, on both sides of the stream, thus the slight increases may not be solely an effect of the waste burial consent.

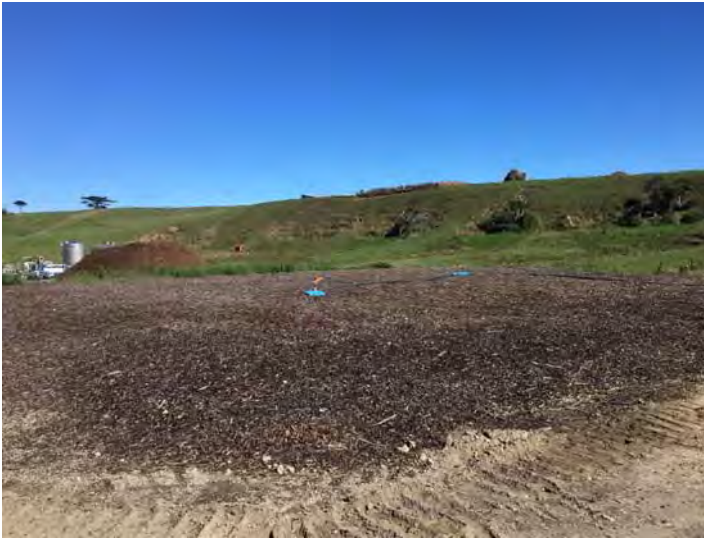
loading to the bed. As such the bottom layer of the bed was very wet, compacted and broken down. This needs replacement with similar bark to the new 500 mm top layer of the bed. When additional cooling is installed at the 2-stage scrubber and this bed is remediated then approximately twice the current concentrated source flow rate could be effectively treated.

Figure 1: Photograph of the TBL concentrated source biofilter (April 2019).

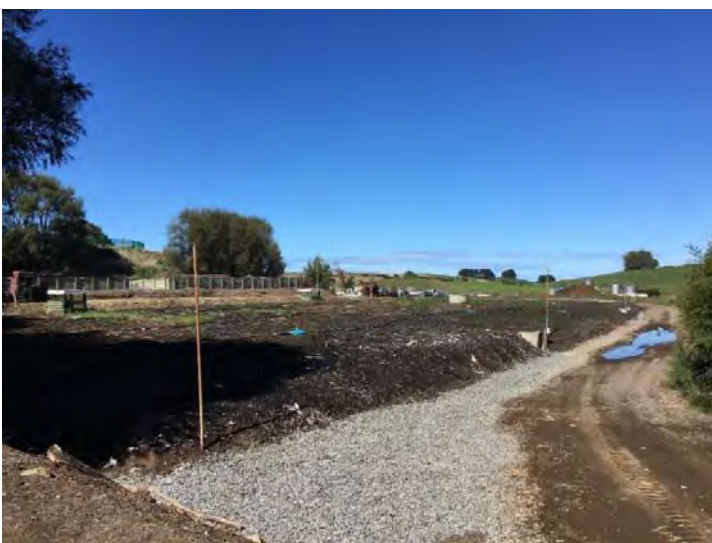
The inlet duct pressure was measured at 2.7 kPa (unchanged from 2017) and is very high given the moderate bed air loading rate of $20 \text{ m}^3_{\text{air}}/\text{hr}/\text{m}^3_{\text{media}}$. The bed has a Magnehelic pressure gauge connected the end of the lateral within the bed and this showed a media pressure of 0.7 kPa. The media is in reasonable condition and is not excessively wet, which is in line with the lateral pressure. This suggests that the inlet duct pressure of 2.7 kPa could be due to water logging within the air inlet manifold system or the laterals. This aside, the bed is effectively removing odour from TBL rendering building air at $86,000 \text{ m}^3/\text{hr}$.

Figure 2: Photograph of the TBL Factory Air #1 biofilter (April 2019).

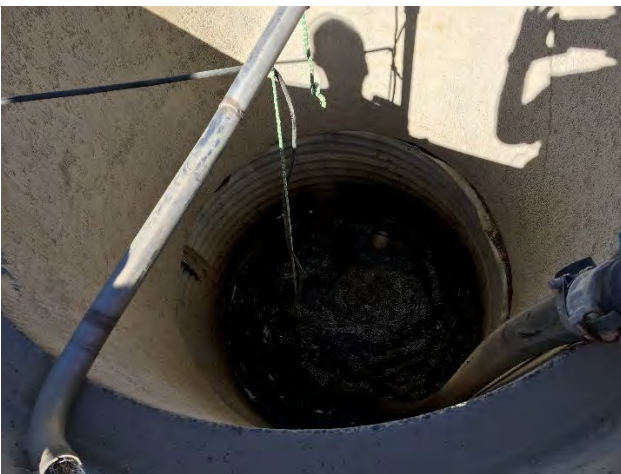
TBE Concentrated Sources: The TBE concentrated sources biofilter also contains sections of old broken-down media, which needs discarding and replacement with new bark. The sections of media that are relatively new and in good state, are not overly wet as is the case for the Duskie biofilter bed. The inlet pressure of 0.3 kPa is low and a result of the low bed air loading rate of 17 m³_{air}/hr/m³_{media} as well as maintaining an appropriate moisture content within the bed media. Addition of the cyclonic air flows (removed from the inlet to the Duskie exhaust) can be readily accommodated by this bed.

Figure 3: Leachate sump for TBE concentrated source biofilters showing large inlet flow.

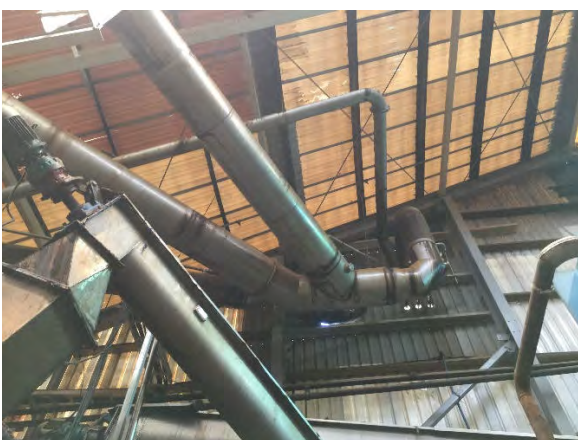
Regarding the ventilation of the bovine meal dryer exhaust streams, it was noted during the audit that the common duct for Dryer 1 and 2 exhaust involved a section a reduced diameter that could exacerbate the loss of fugitive exhaust emissions. This is shown in Figure 4 below, where following the joining the two separate dryer exhaust ducts, there is a significant reduction in diameter, where in practice this should increase.

Figure 4: Bovine dryer 1 and 2 common exhaust duct.
