Todd Energy Aquatic Centre
Monitoring Programme
Annual Report
2019-2020

Technical Report 2020-18

Taranaki Regional Council
Private Bag 713
STRATFORD
September 2020

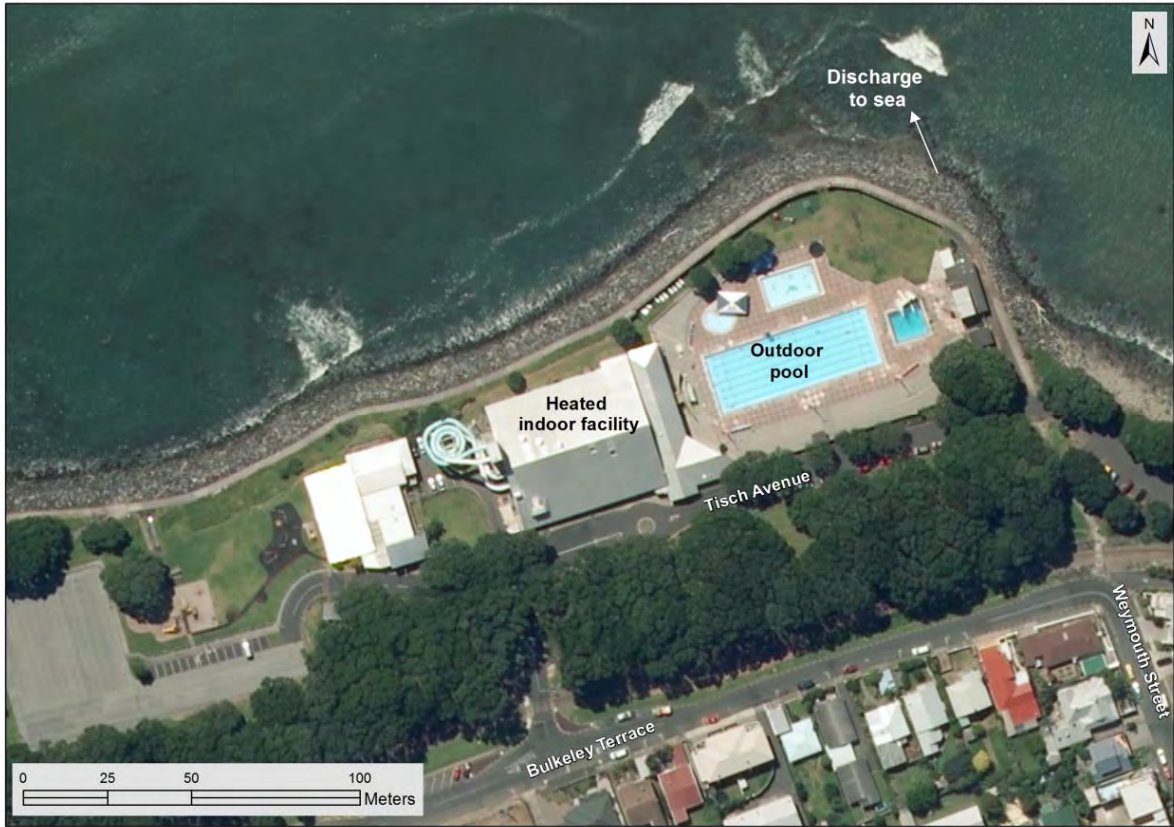
Figure 1 Location of the Aquatic Centre

The Aquatic Centre is sited on the foreshore at Tisch Avenue, New Plymouth. The facility consists of outdoor pools (including a main pool, diving pool and children's pools) and an indoor pool complex (Figure 1).

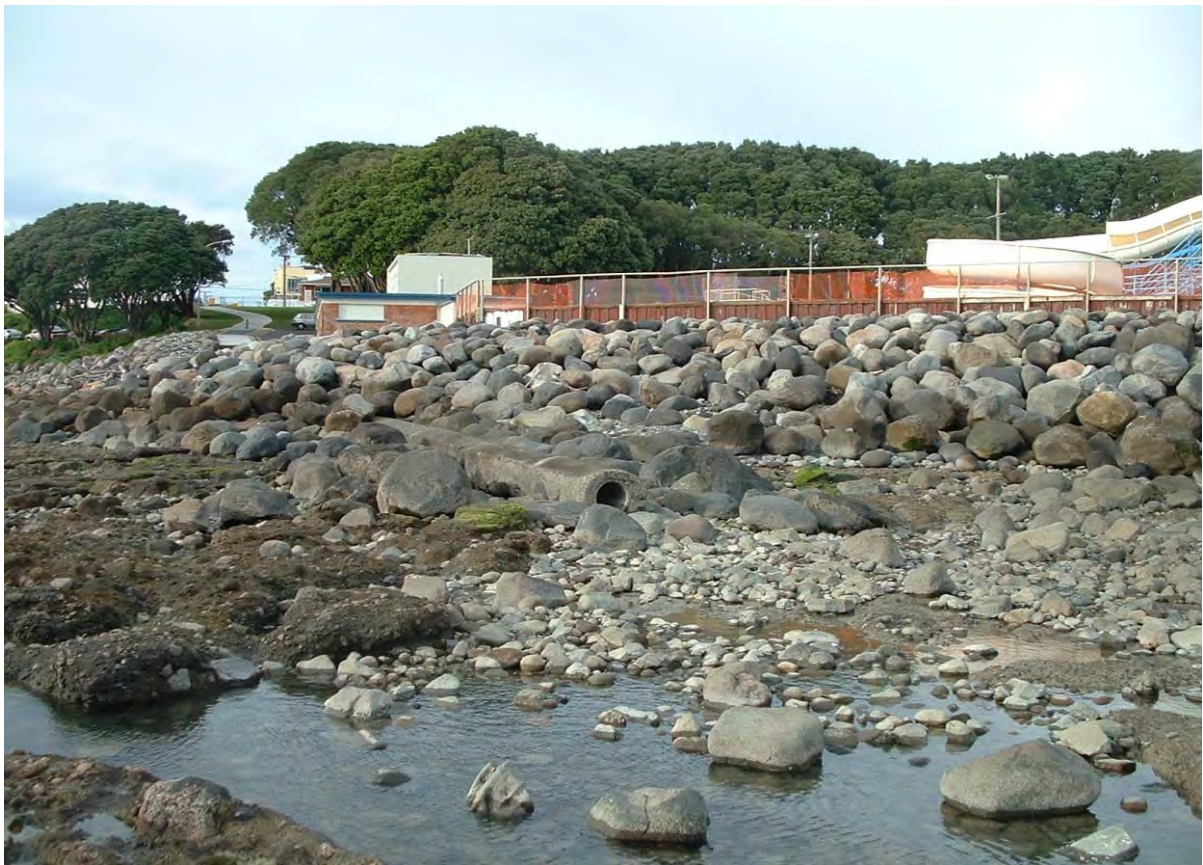
Photo 1 Aquatic Centre ocean outfall

The ocean outfall consists of a 300 mm diameter encased concrete pipe that discharges at approximately mid-tide level. This structure was constructed in 1962 and has been in use ever since for the purpose of backwashing the outdoor pool filters.

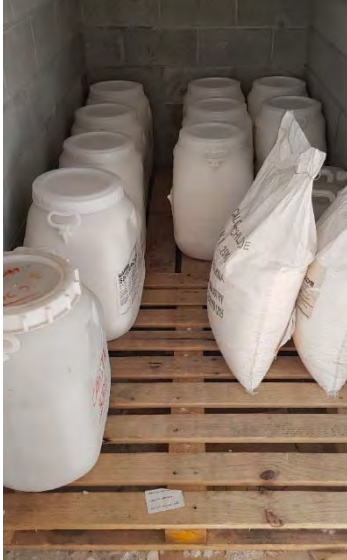
Figure 2 Maintenance shed, showing chemicals stored on pallets

An inspection of the maintenance shed was conducted on 5 May 2020. The shed was found to be mostly tidy, with all chemical sacks stored on pallets away from the door (Figure 2).

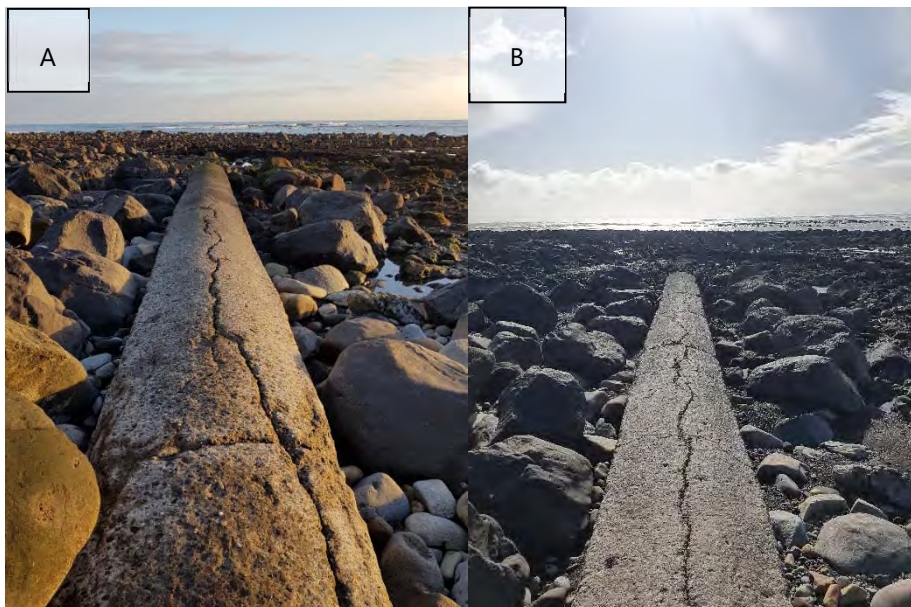
Figure 3 Surface cracks along ocean outfall, on A) 15 June 2017 and B) 5 May 2020, indicating little change in structural integrity.

The ocean outfall was also inspected during the site visit and found to be compliant with consent conditions. Although the structural integrity of the ocean outfall has declined in recent years, the inspection indicated little change since a 2.4 m length of the structure dislodged in the 2016-2017 year (Figure 3).

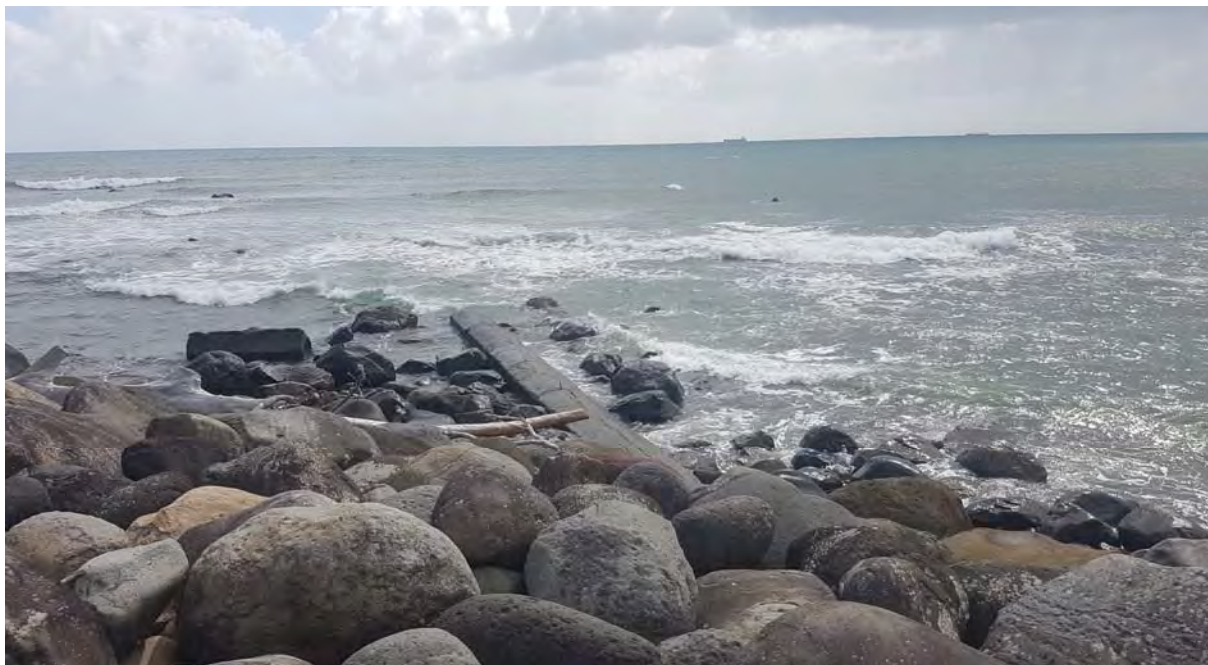
Pool water testing found that the concentration of total chlorine was compliant with the limit set out in condition 4 of resource consent 2339-4 (< 0.5 g/m³, Table 1). Aquatic Centre staff were advised of this, and that they could begin emptying the pool within two hours of the next high tide (providing compliance with condition 8). High tide was at 10:54 (NZDT) on the day of the inspection. Samples were collected from the outdoor pool at 11:15 and from the Tasman Sea at 12:15 (Photo 1). Samples were collected from the Tasman Sea on this day given the outdoor kids pools were discharging. Aquatic Centre staff advised the Council that the 50 m pool would be emptied in batches over the next three daylight high tide windows.

Photo 1 Shoreline seawater sampling adjacent to the marine outfall (24 March 2020)

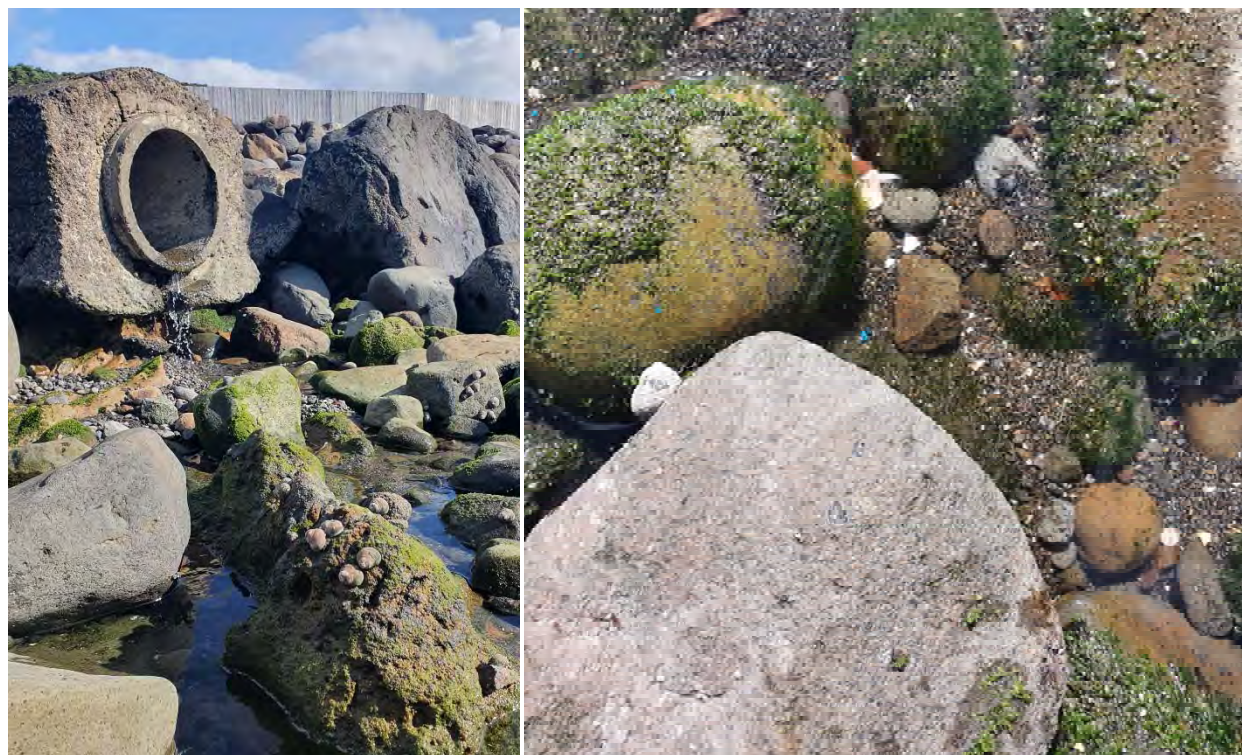
A reef inspection was carried out on Wednesday 25 March 2020 during the next low tide after the 50 m pool began discharging, which was at 17:36 (0.2 m). Upon arrival at the reef at approximately 16:00, a low flow was found to be discharging from the marine outfall (Photo 2). There were no objectionable odours, or conspicuous films or scums, at the discharge point. As with previous inspections, blue paint chips were found in the immediate vicinity of the outfall (Photo 2). The outdoor pool had only been partly emptied since the morning inspection, indicating compliance with the consent condition of only discharging in batches within two hours either side of high tide. The reef inspection found no detectable chlorine odour or any visual issues outside of the discharge mixing zone.

Photo 2 (A) Low flow discharging from the outfall at 16:15 (25 March 2020);
(B) Close-up of paint chips

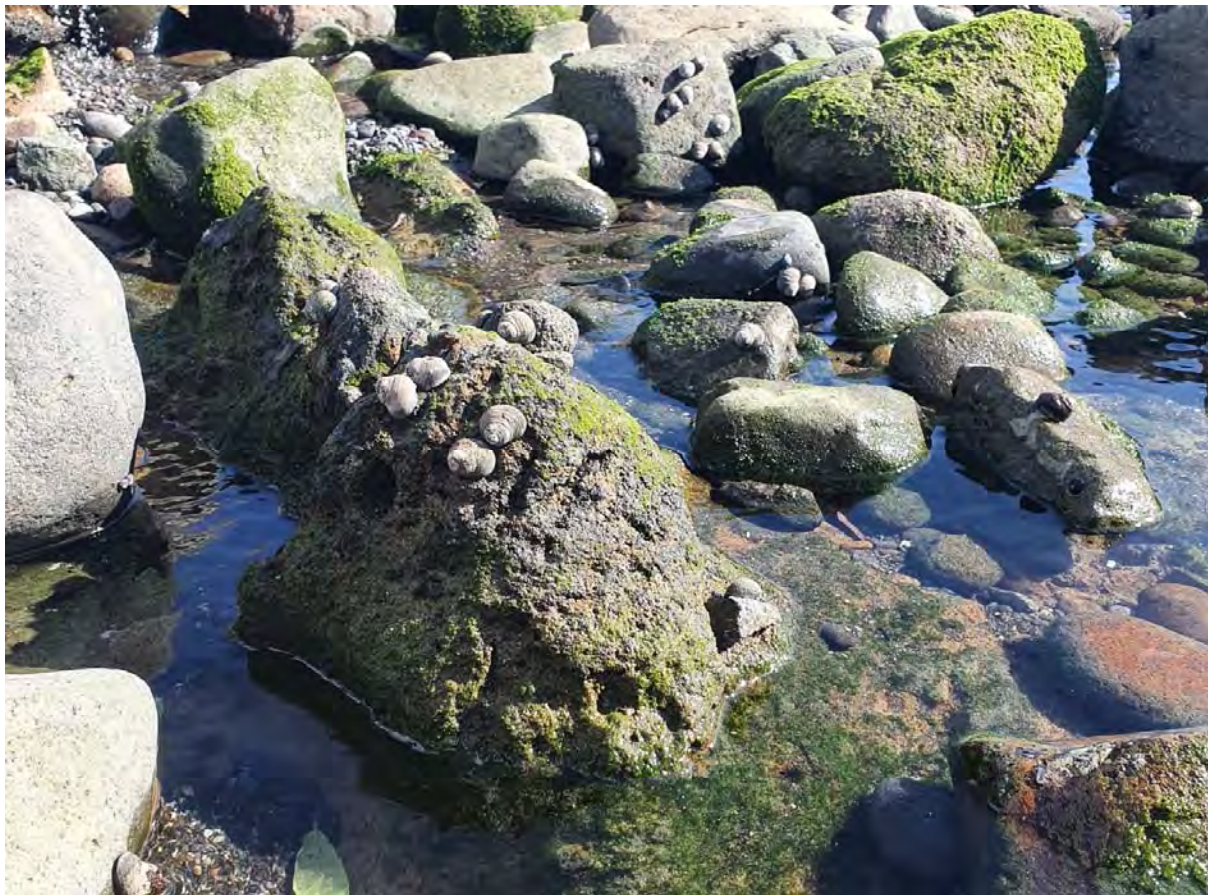
The cover of *Ulva* sp. appeared to track the flow path of discharge from the outfall and was similar to the extent of cover recorded during the May 2019 reef inspection. It was also noted that some gastropods (e.g. *Diloma aethiops*) found within 5 m of the marine outfall were all out of the water (Photo 3). This could be due to the water coming out of the outfall being fresh, not saline. However, these adverse effects were not detected outside of the 5 m mixing zone. In comparison with the intertidal community further down the shore, the area surrounding the pipe supported very little biomass and was less diverse (Photo 4). However, this assemblage was similar to that found on previous inspections in the vicinity of the pipe, and is typical for this height on the shore.

Photo 3 Gastropods found out of the water within the 5 m mixing zone east of the marine outfall

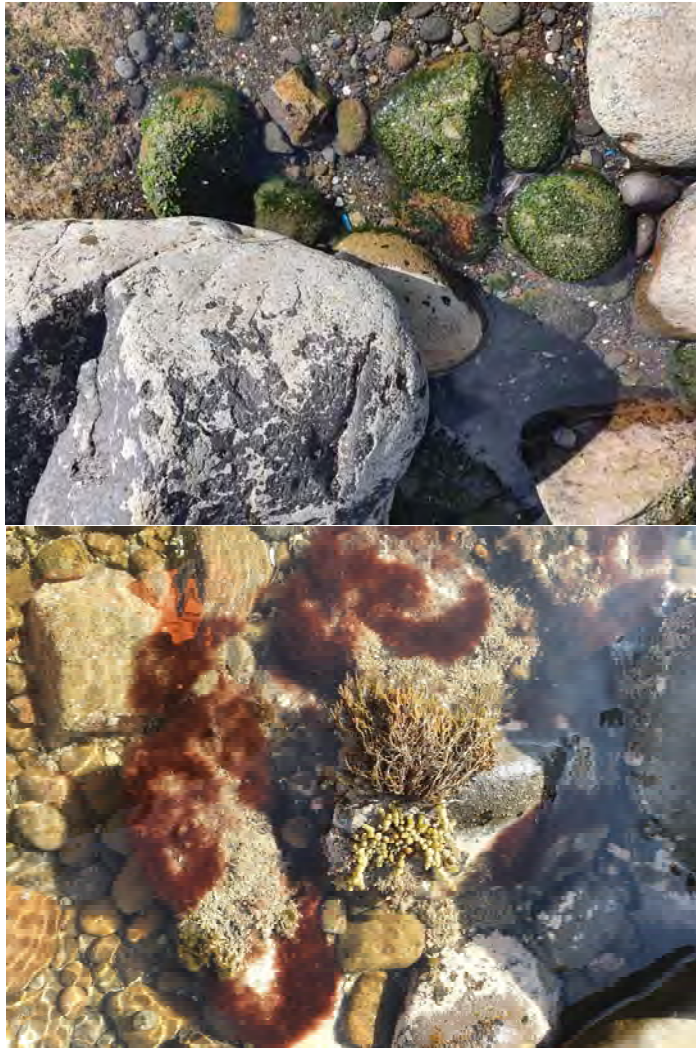
Further down the shore approximately 10 m from the outfall, still within the influence of the pipe discharge, the following species were identified: molluscs *Haustrum scobina*, *D. aethiops* (very abundant), *Zeacumantus subcarinatus* (very abundant), and *Lunella smaragdus*, the chitons *Sypharochiton pelliserpentis* and *Chiton glaucus*, limpets *C. radians*, *C. ornata*, *Scutus breviculus*, and *Notoacmea* sp., sea anemone *Isactinia olivacea*, mussel *Xenostrobus pulex*, and the polychaete worms *S. cariniferus* and *Spirorbis* sp.. A shrimp *Palaemon affinis*, and the crab *Petrolisthes elongatus* were also found. Red algae included *Corallina officinalis* and *Jania micrarthodia*. Brown algae included *Ralfsia* sp. (widespread), *Scytothamnus australis*, *Hormosira banksia* and its obligate epiphyte *Notheia anomala*, and the green algae *Chaetomorpha aerea* and *Ulva* sp. were also present. Overall, these species are similar to what would be expected at this elevation on the shore.

Photo 4 (A) Species characteristic of the exposed upper shore, within 5 m of the outfall;
(B) Greater abundance and biodiversity in a rockpool approximately 10 m away from the outfall

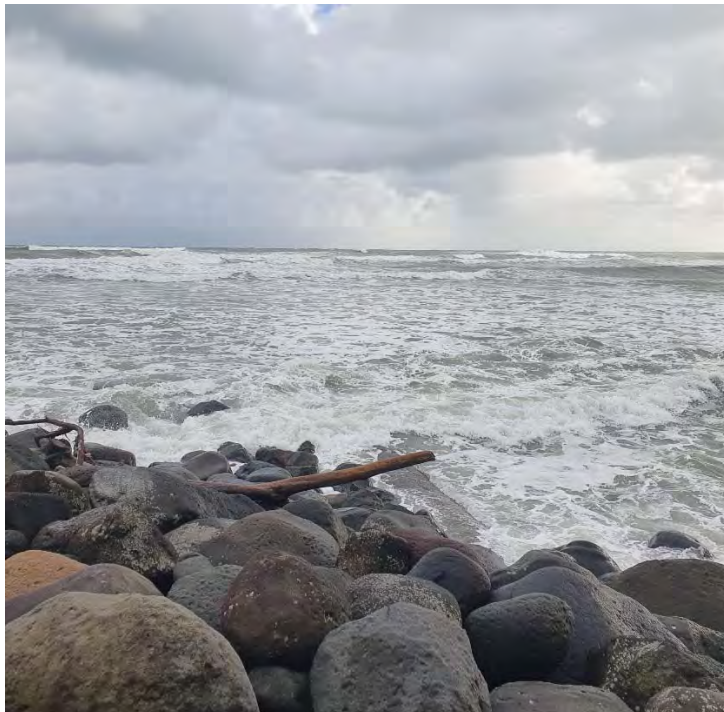
Pool water testing found that the concentration of total chlorine was compliant with the limit set out in condition 4 of resource consent 2339-4 (< 0.5 g/m³, Table 1). Aquatic Centre staff were advised of this, and that they could begin emptying the pool within two hours of the next high tide (providing compliance with condition 8). High tide was at 07:45 (NZDT) on the day of the inspection. Samples were collected from the indoor pool at 08:05 and from the Tasman Sea at 08:40 (Photo 1). Samples were collected from the Tasman Sea on this day approximately 15 minutes after beginning to empty the indoor pool.

Photo 1 Shoreline seawater sampling adjacent to the marine outfall (5 May 2020)

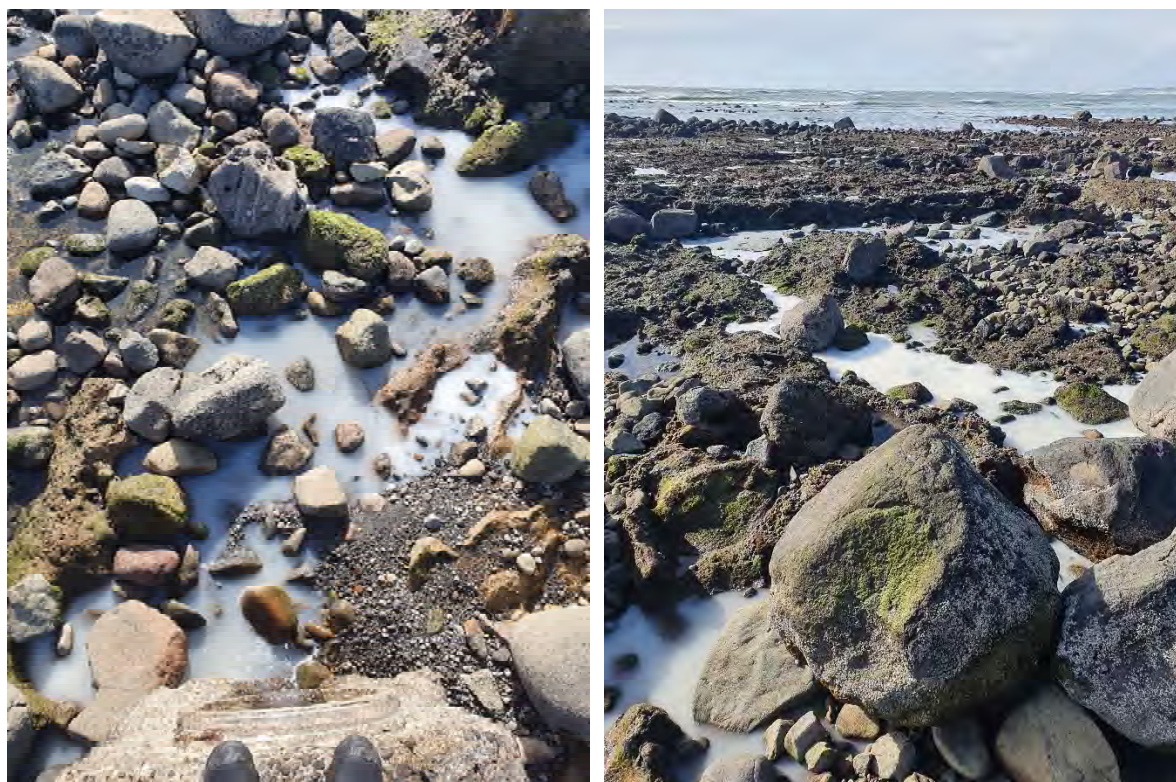
A reef inspection was carried out on Tuesday 5 May 2020 during the next low tide after the 25 m indoor pool began discharging, which was at 14:05 (0.2 m). Upon arrival at the reef at approximately 13:45, a low flow of white coloured water was found to be discharging from the marine outfall (Photo 2). There were no objectionable odours, or conspicuous films or scums, at the discharge point. The reef inspection found no detectable chlorine odour. Upon further inspection, the outfall discharge was found to have discoloured the tidal pools on the reef beyond the extent of the designated mixing zone (Photo 2).

Photo 2 (A) Low flow discharging from the outfall into the mixing zone at 13:50 (5 May 2020);
 (B) Looking from the outfall following the track of the discoloured water downshore

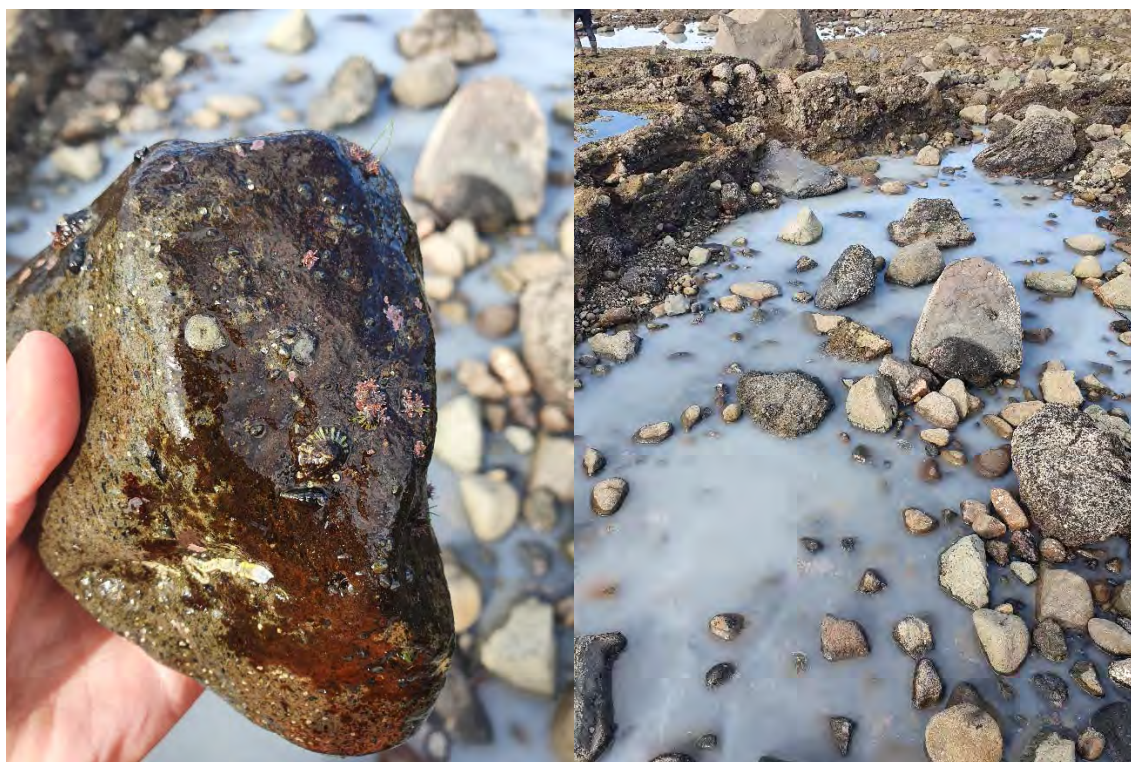
Further down the shore approximately 10 m from the outfall, still within the influence of the pipe discharge, the following species were identified: molluscs *Haustrum scobina*, *D. aethiops* (very abundant), *Zeacumantus subcarinatus* (very abundant), *Siphonaria australis*, *Cantharidella tessellata*, and *Lunella smaragdus*, the chitons *Chiton sinclairi*, and *Chiton glaucus*, limpets *C. radians*, and *Notoacmea* sp., sea anemone *Isactinia olivacea*, mussel *Xenostrobus pulex*, and the polychaete worms *S. cariniferus* and *Spirobis* sp.. The crab *Petrolisthes elongates*, an unidentified sponge, amphipods, and the sea star *Pateriella regularis* were also found. Red algae included *Corallina officinalis* and *Jania micrarthodia*. Brown algae included *Ralfsia* sp. (widespread), *Hormosira banksia* and its obligate epiphyte *Notheia anomala*, and the green algae *Chaetomorpha aerea* was also present. Overall, these species are similar to what would be expected at this elevation on the shore at other rocky reef locations around Taranaki.

Photo 3 (A) Species characteristic of a rock pool approximately 10 m away from the outfall;
(B) White coloured water in a rock pool approximately 10 m away from the outfall.

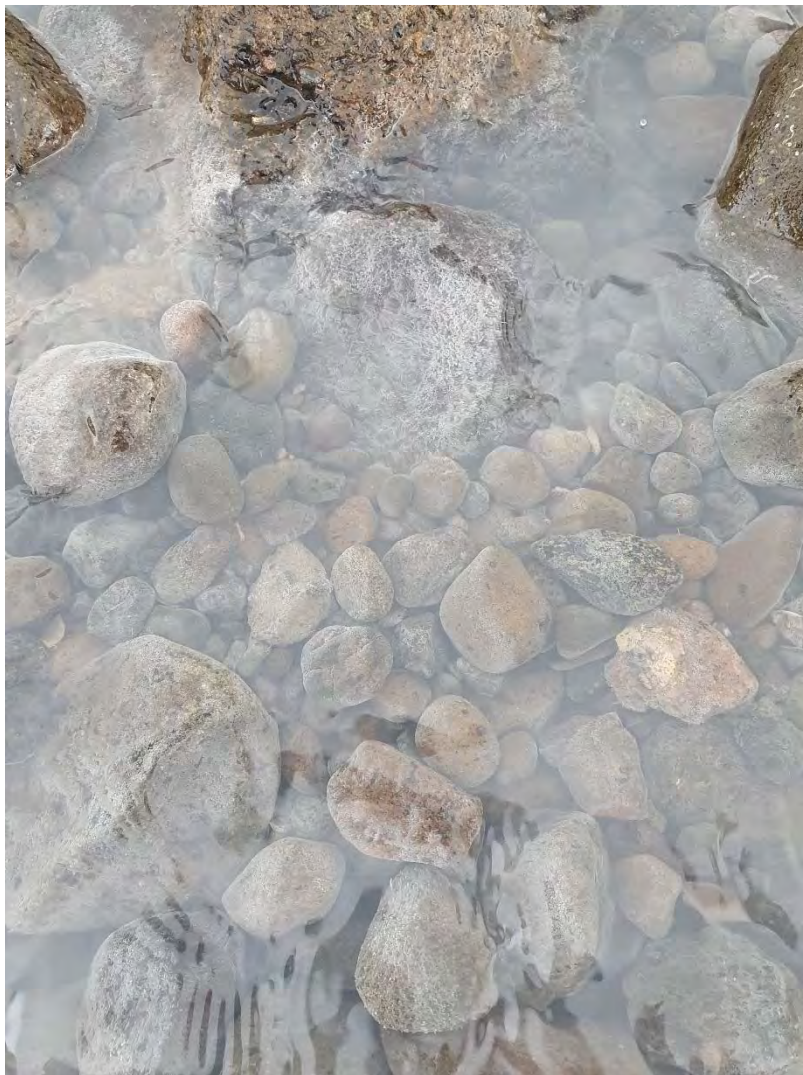
The white water discharging from the marine outfall tracked from the small rock pool directly by the outfall, through the rock pool approximately 10 m away from the outfall, into another rock pool approximately 30 m away from the outfall where it mixed with the existing water in the rock pool and dissipated. The discharging water from the outfall was white when the reef inspection began at 13:45 and by approximately 14:15 the discharge from the outfall was a brown colour. By the end of the reef inspection at approximately 15:10, the white coloured water had settled out and white residue was left on the flow path of discharge from the outfall (Photo 4).

Photo 4 White residue found on rocks outside of the 5 m mixing zone east of the marine outfall

A follow-up marine ecological inspection on the next day's low tide was also conducted. It found that the range and health of intertidal species identified was considered normal for that environment, and no traces of the unauthorised discharge were apparent. The manager was spoken to who advised the cleaning, which is usually undertaken by a contractor was being undertaken by staff due to Covid-19 restrictions. The process was changed to prevent further discharge.

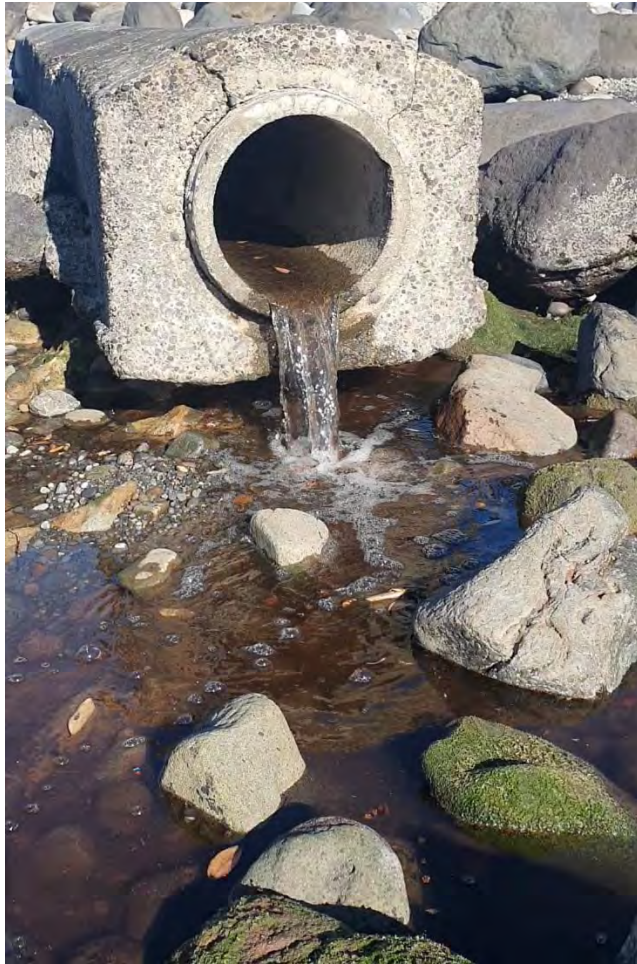
The reef was re-inspected on 6 May 2020, using the same rapid assessment method. The inspection commenced at 14:15, with low tide occurring at 14:53 (0.2 m). Upon arrival at the reef, brown coloured water with leaf litter was found to be discharging through the outfall at approximately 0.5 L/s. The water was found to be coming from a worker washing away leaf litter near a drain by the chemical storage sheds. The discoloured water did not extend beyond the 5 m mixing zone of the outfall. The composition of intertidal species identified during the inspection was found to be similar to the previous day and the white water

discharge did not appear to have caused any significant effects on the local intertidal community. There was no lasting white colouration of the tidal pools or any white residue left on the rocks.

Photo 5 Discharge from outfall (6 May 2020)
