**Mangati Catchment**  
Joint Monitoring Programme  
Annual Report  
2020-2021

Technical Report 2021-74

This report is the Annual Report for the period July 2020 to June 2021 by the Taranaki Regional Council (the Council) describing the monitoring programme associated with 13 industries within the catchment of the Mangati Stream, Bell Block.

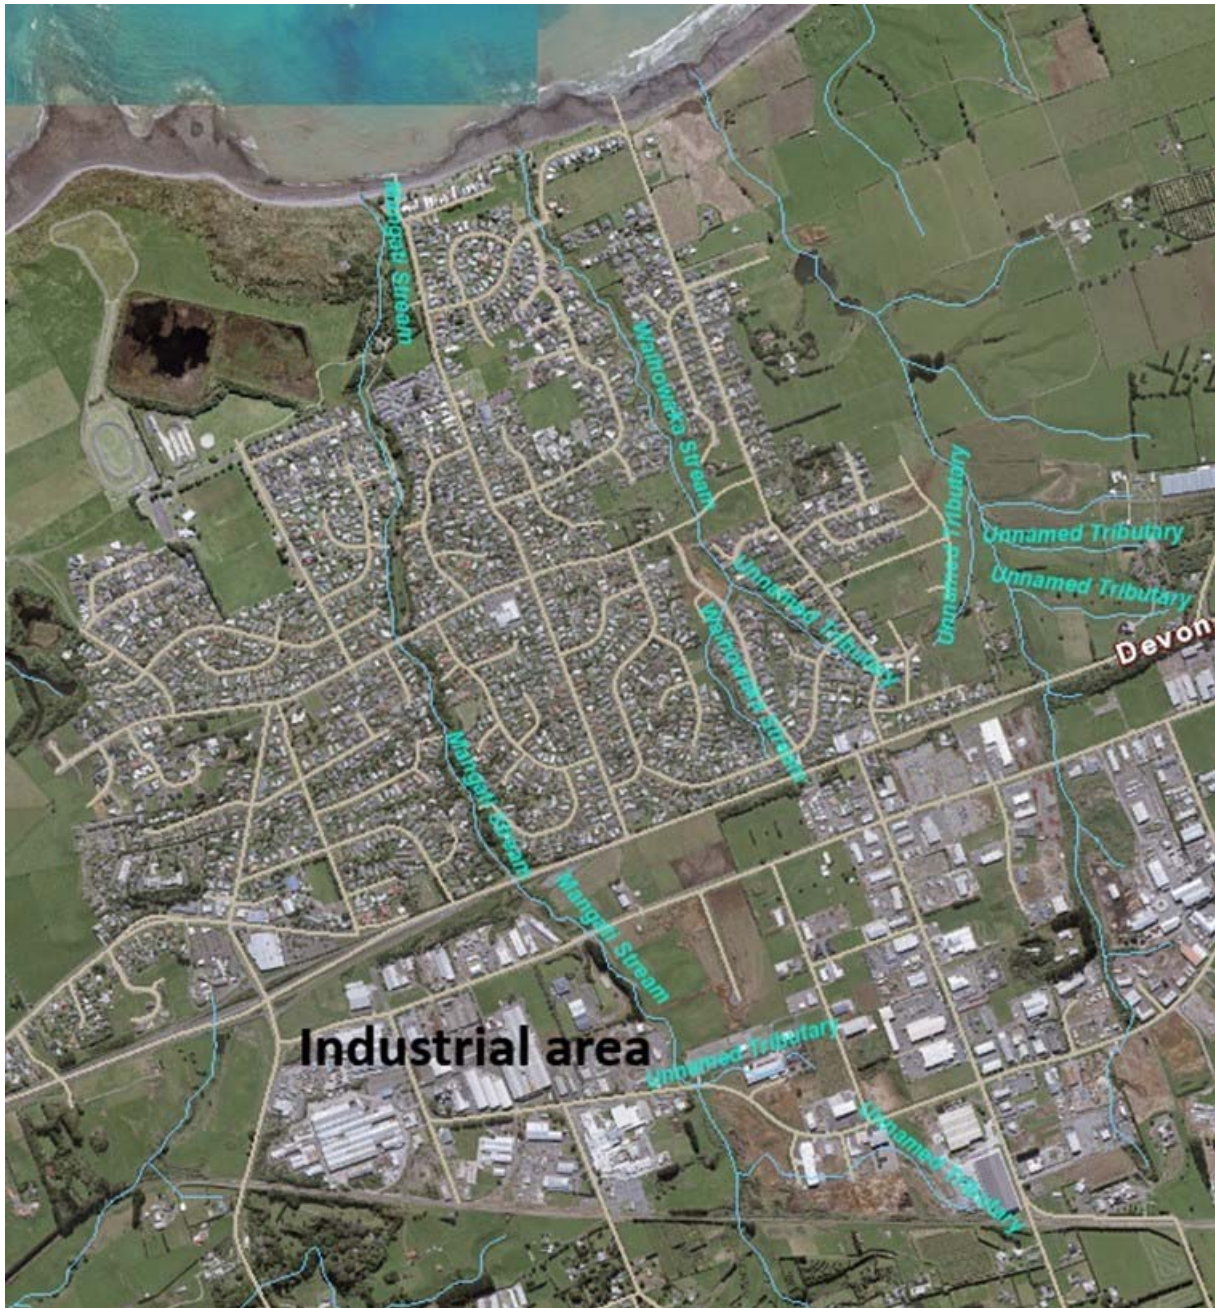
Figure 1 Mangati Catchment

The industrial area at Bell Block is situated mid-catchment (Figure 1). Historically, the industrial areas were located predominantly on the western side of the stream however ongoing development since 2016 has resulted in more sites on the eastern side. These sites fall under permitted activity rules and are not covered by this monitoring report. Upstream, land use is pastoral and horticultural. Downstream, the Mangati flows through the residential area of Bell Block. The Mangati Reserve (Photo 1), with its popular well maintained walkway, borders the stream immediately below the industrial area. The beach at the mouth of the stream is also a popular recreational area (Photo 2).

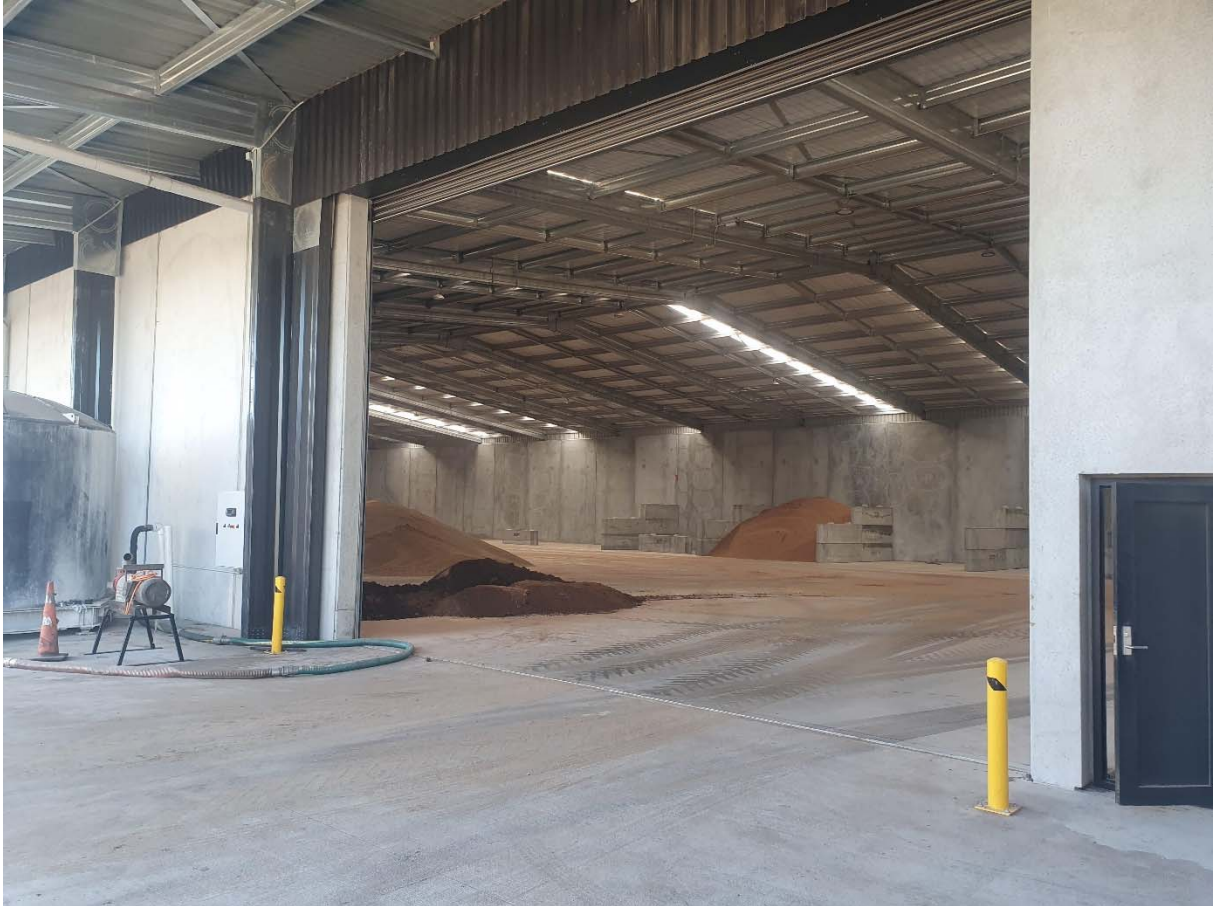
Photo 3 New storage shed at Barton site, June 2021

Barton Holdings Ltd (Barton) supplies liquid and dry stock feed from a 0.46 ha storage site at 21 Paraita Road, in the industrial area of Bell Block (Photo 3). GrainCorp Feeds Ltd originally operated this site, however during the 2017-2018 monitoring period, the consent was transferred to Barton.

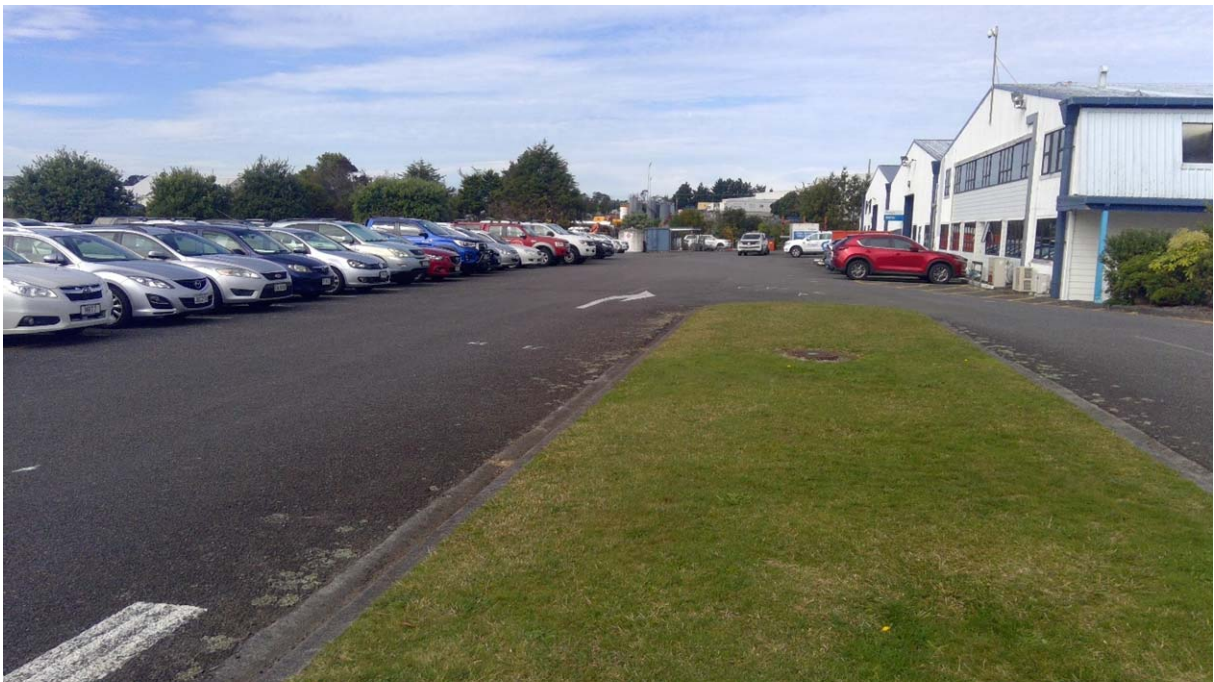
Photo 5 View of stormwater catchment at First Gas site

The area of the site is approximately 4 ha. The operation building and maintenance building along with sealed car parking area and access make up approximately 60 percent of the area (Photo 5). The remaining 40 percent is covered in grass. The maintenance shed is enclosed, and any wash water from inside the shed is directed to a holding system which is emptied by a licensed wastewater collector.

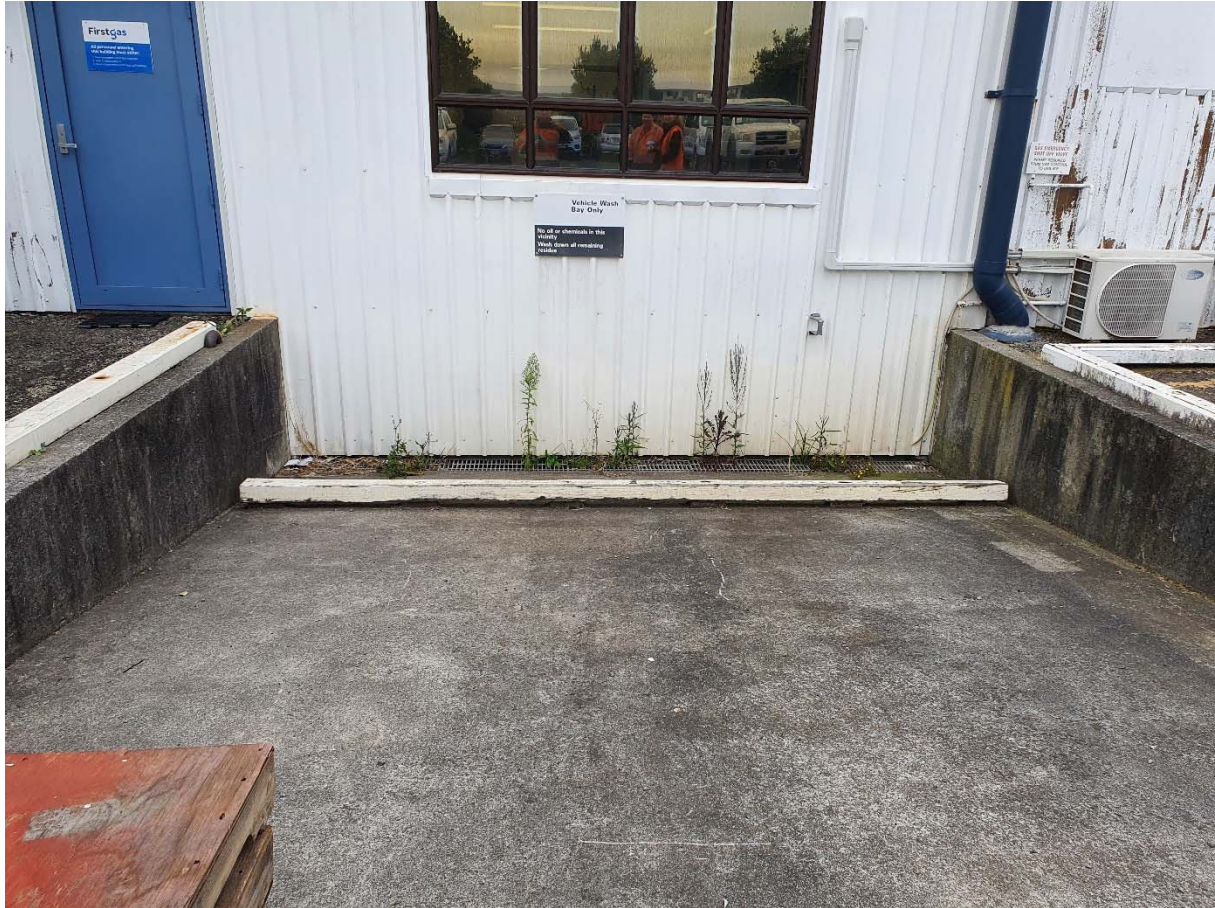
Photo 6 Decommissioned wash bay, August 2020

The site is considered to pose only a very low environmental risk and is therefore only scheduled for two inspections per year, however additional inspections are carried out on occasions when the inspecting officer is in the area. The onsite vehicle wash bay is currently decommissioned and no longer discharges to the stormwater system (Photo 6).

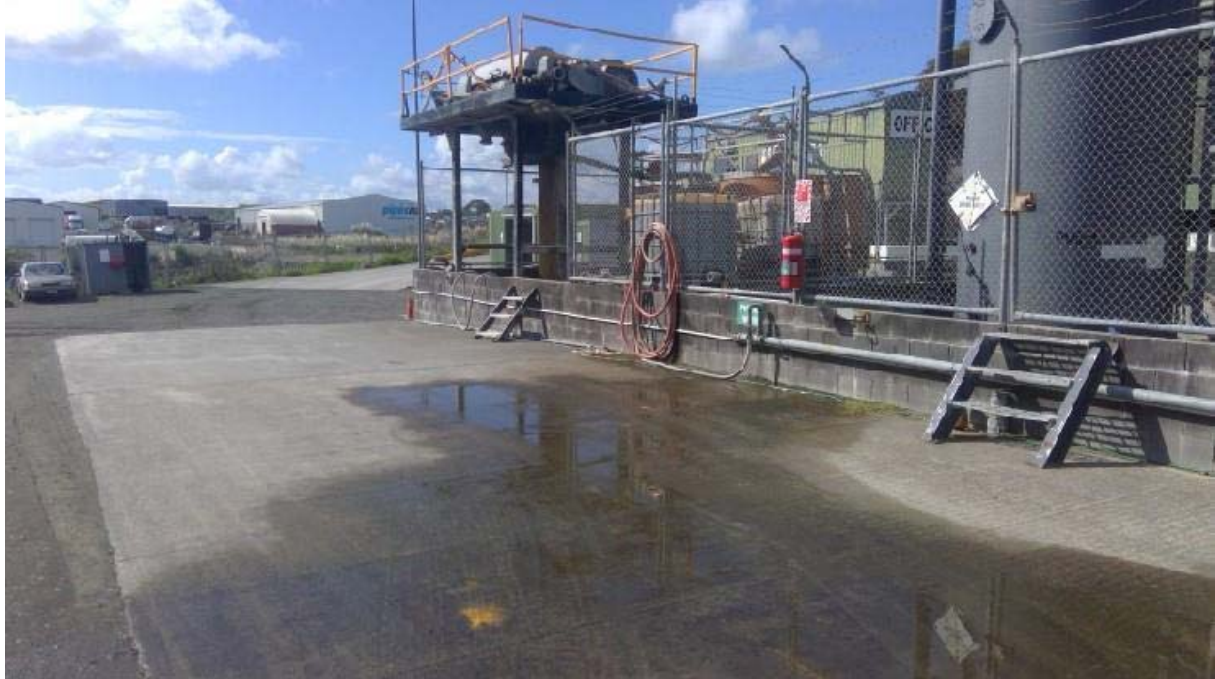
Photo 7 Storage areas and bunding on GPL site, September 2020

Greymouth Petroleum Acquisitions Company Ltd's (GPL) pipe yard on De Havilland Drive, formerly operated by Fletcher Challenge Energy Taranaki Ltd (FCET), was established in 1986 as a storage area for well casing, drill pipe and other drilling and testing equipment used in the oil industry. The yard has been used for cleaning and preservation of casing and drill pipe (Photo 7).

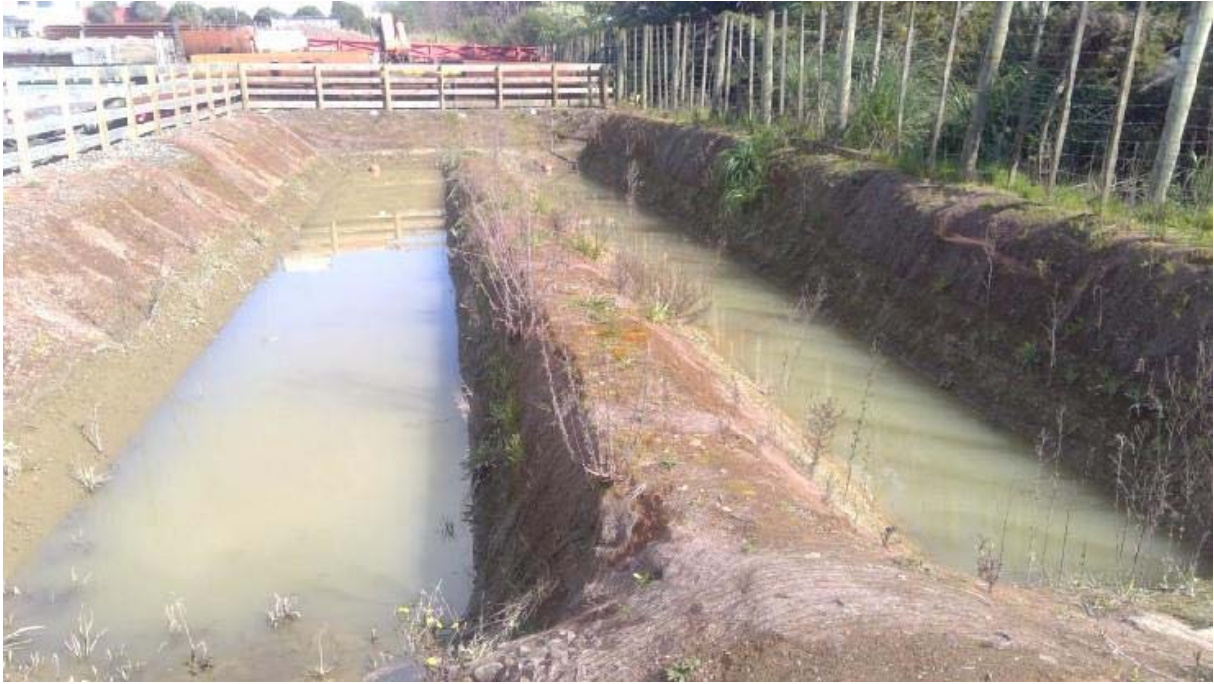
Photo 8 New sediment retention pond, September 2020

In the 2020-2021 period, a separate sediment retention pond was installed in the stormwater system below the interceptor but above the final holding pond (Photo 8). Originally the discharge from the holding pond entered a small open drain where it mixed with discharges from Tasman Oil Tools and First Gas prior to being discharged to the Mangati Stream. Works undertaken in the 2016-2017 monitoring period resulted in the discharges from First Gas and Tasman Tools being piped along the bottom of the dry stream bed and GPL stormwater discharging to a gravel filter bed laid over the top of the pipework (Photo 9). These works were undertaken to improve the quality of the discharges from the GPL site.

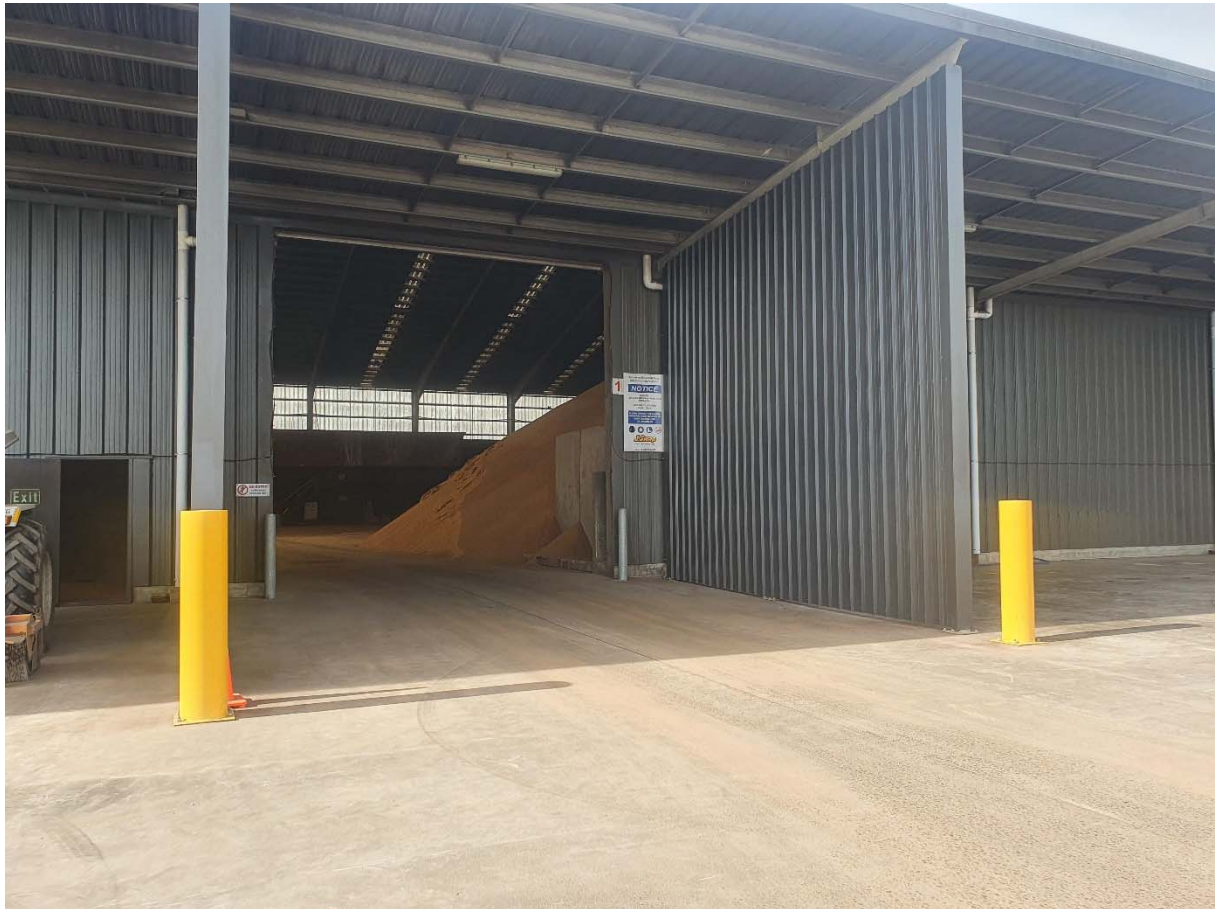
Photo 10 View of PK stockpiled inside J Swap storage shed, July 2020

The site is predominantly used for the storage and dispatch of palm kernel expeller cattle feed (PK). There are two feed stores on the site in which PK is stored, screened and then loaded on to trucks for delivery (Photo 10). A small section of one of the buildings is occupied by Ballance Agri-Nutrients where fertilisers are stored and transferred.

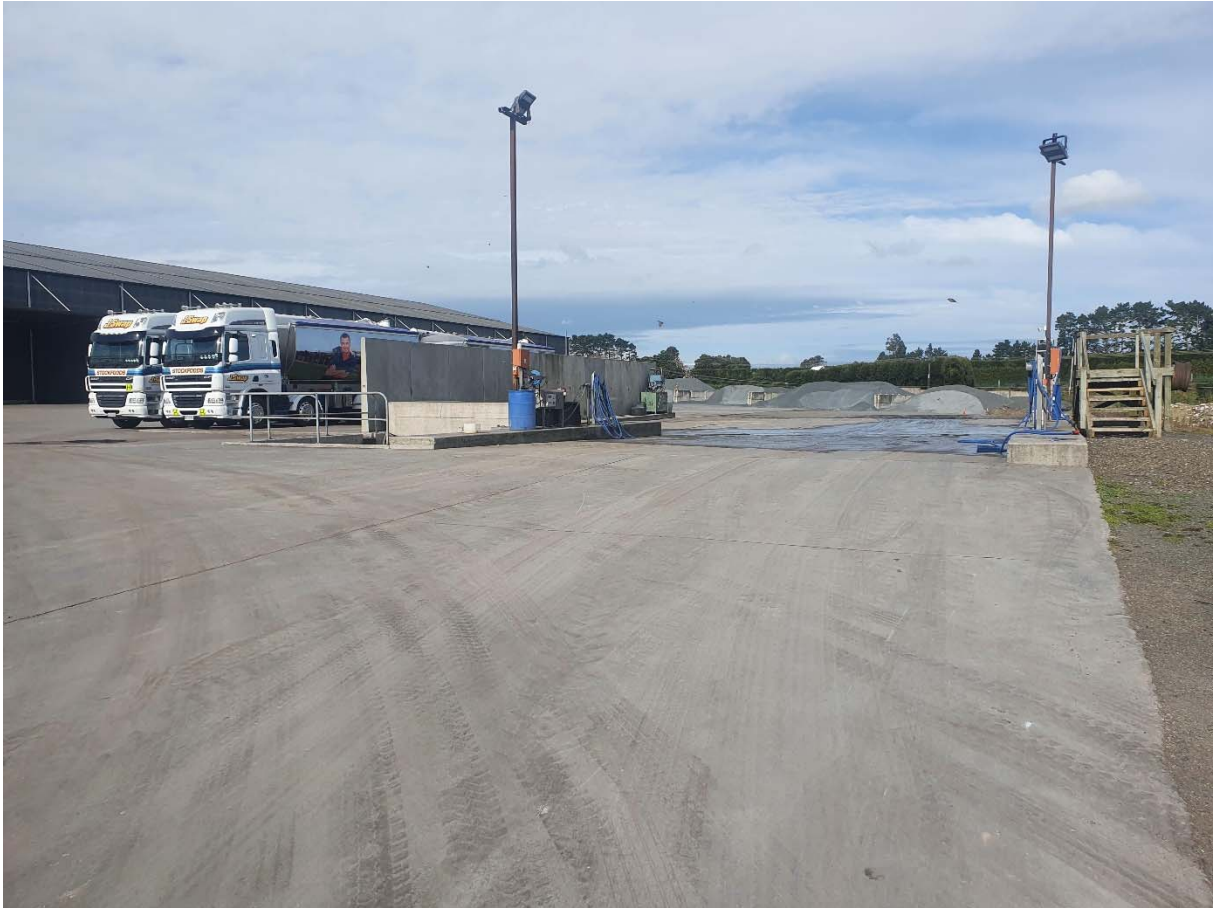
Photo 11 Truck wash on J Swap yard, July 2020

J Swap operate a truck wash onsite which sends wash water to trade waste (Photo 11). After 60 minutes of rain (with no washing activity) it then diverts stormwater from the wash pad to mix with roof water for discharges to an unnamed tributary of the Mangati Stream. This is done to minimise the entrainment of contaminants in the stormwater prior to discharge to the Mangati Stream. The site also contains a truck refuelling facility.

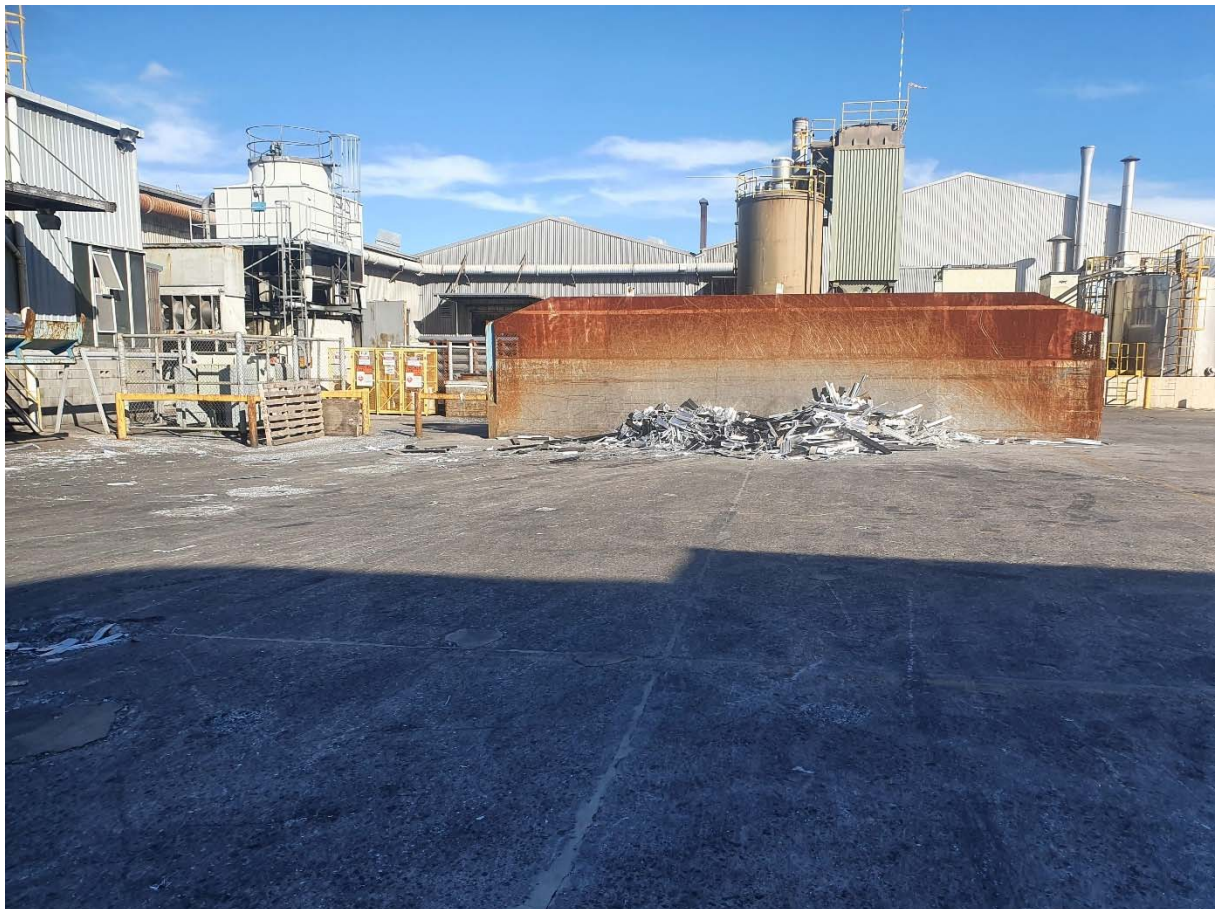
Photo 12 Scrap sorting yard at MCK site, May 2020

About 2.7 ha of the site is under roof, comprising the old brass and copper processing buildings and the aluminium foundries, extrusion and finishing mills, and administration and utilities buildings. In the rest of catchment there are bunded areas for storage of chemicals and oils, oil/water separators, wastewater holding tanks and an open aluminium scrap yard (Photo 12). The majority of the aluminium sorting and storage is now done under cover in the Mangaone Stream catchment. Wastewater is sent to sewer, after pH neutralisation.

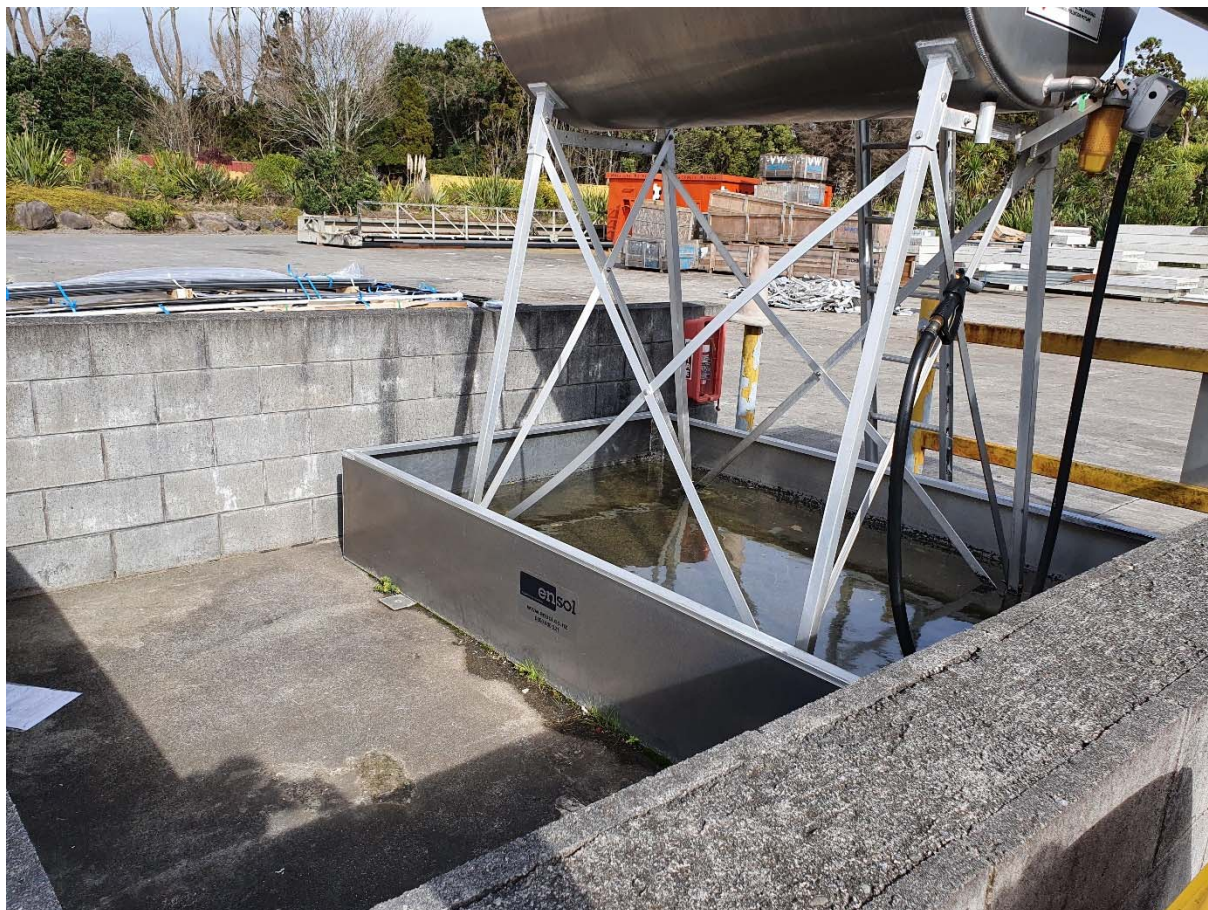
Photo 13 Hazardous chemical storage and bunding, July 2020

A suite of contingency plans are in place in case of spillage. MCK operates an Environmental Management System, and specific contingency plans are included as individual Works Procedures within the McKechnie Aluminium Solutions Ltd Management System-Environmental Manual. All new work procedures that have an environmental aspect are incorporated into the documented system. The strengths of this new integrated system are that responsibilities are clearly defined, and that the whole system is reviewed regularly.

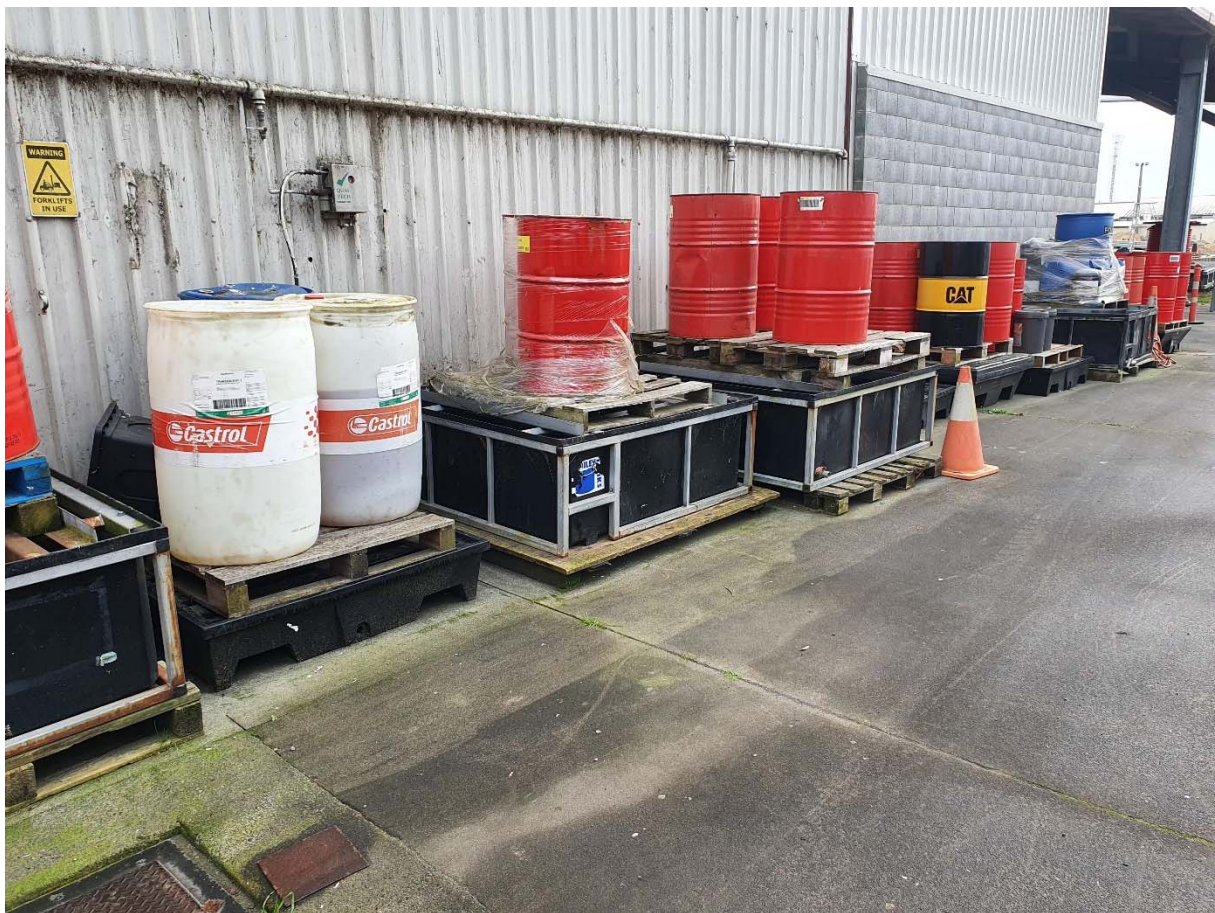
Photo 16 Bundling in place beside OMV wash facility, August 2018

Chemicals, of limited quantities and classes, are stored either under cover in the warehouse buildings, or in banded shipping containers in the yard, prior to dispatch (Photo 16).

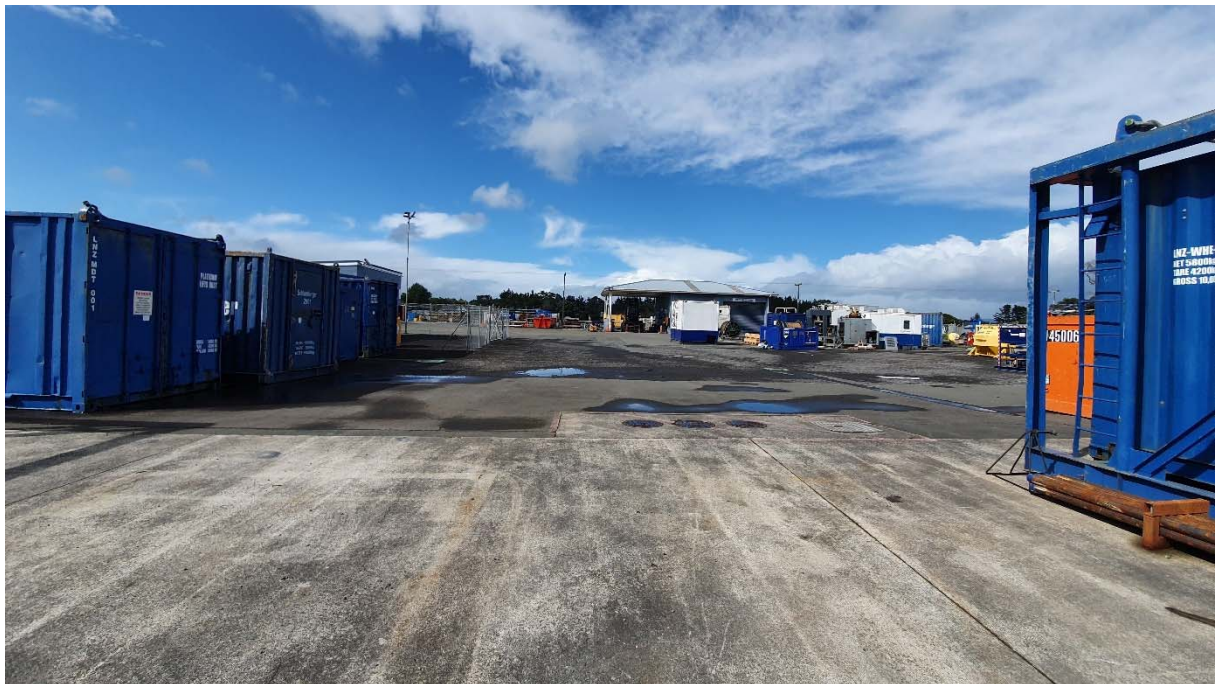
Photo 17 Schlumberger yard and lay dawn area, October 2019

Schlumberger New Zealand Ltd (Schlumberger) provides services to the oil production industry, and stores a range of hazardous substances in enclosed areas of the site (Photo 17). Washwater containing drilling mud and occasionally oil residue from down-hole tools occurs onsite, and this water is discharged to the stormwater system following treatment in an onsite interceptor.

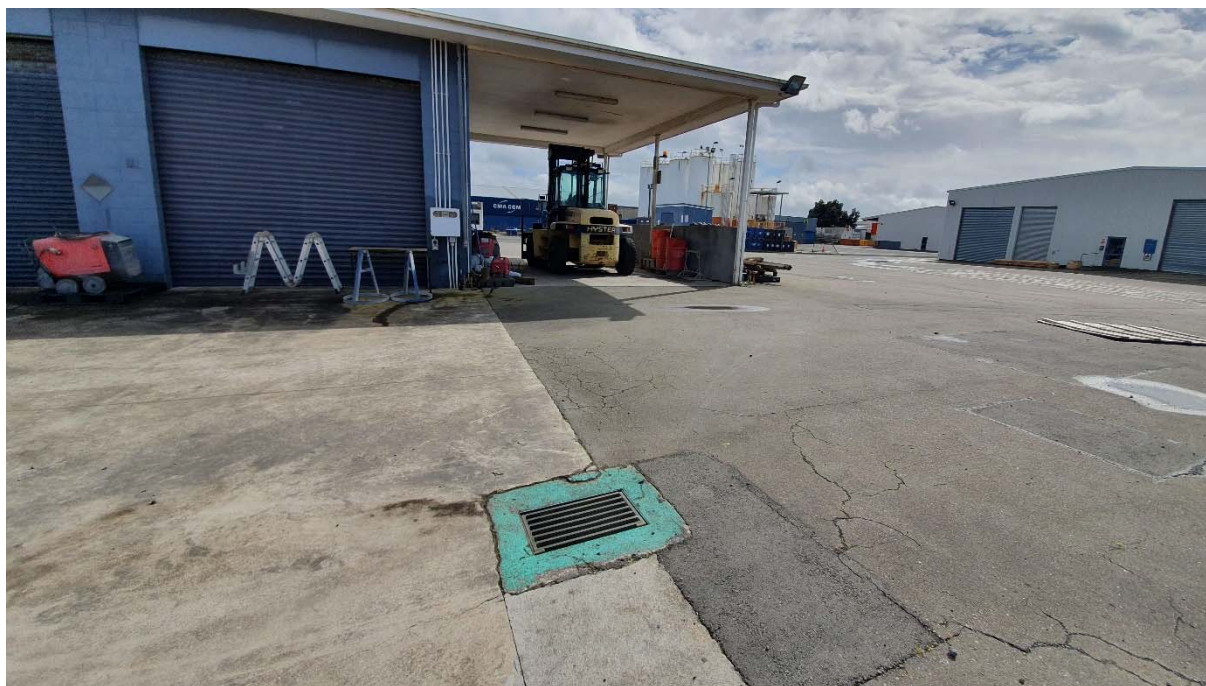
Photo 18 View of wash bay, October 2019

The wash area is housed within a building that also contains the paint, waste, oil, and chemical storage areas (Photo 18). The floors within this building all drain to a common 1.5 m<sup>3</sup> capacity sealed sump. The liquid collected in this sump can either be removed by a contractor for appropriate off-site disposal, or be pumped to the stormwater drainage system via an oil separator, which removes the oily waste and suspended solids from the effluent stream.

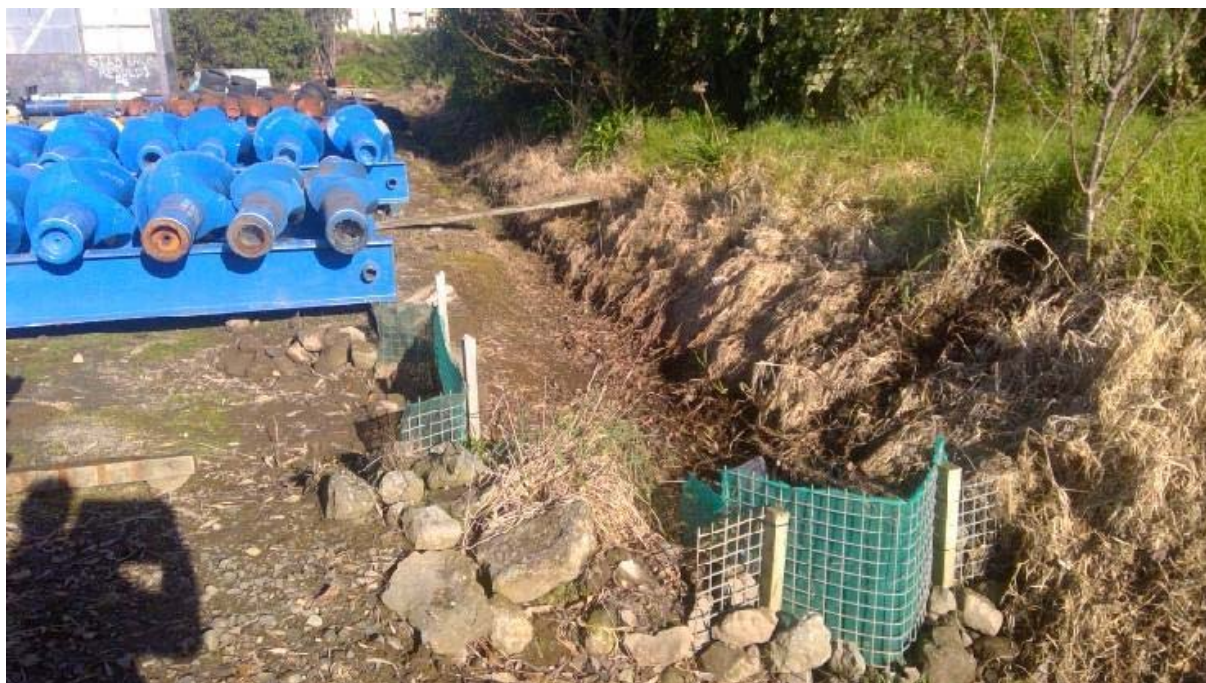
Photo 19 Sediment controls on Tasman Tools' perimeter drain, September 2020

Stormwater from the site is collected in open perimeter drains, treated in a three stage interceptor and settling pond, and then directed to the Mangati Stream (Photo 19).

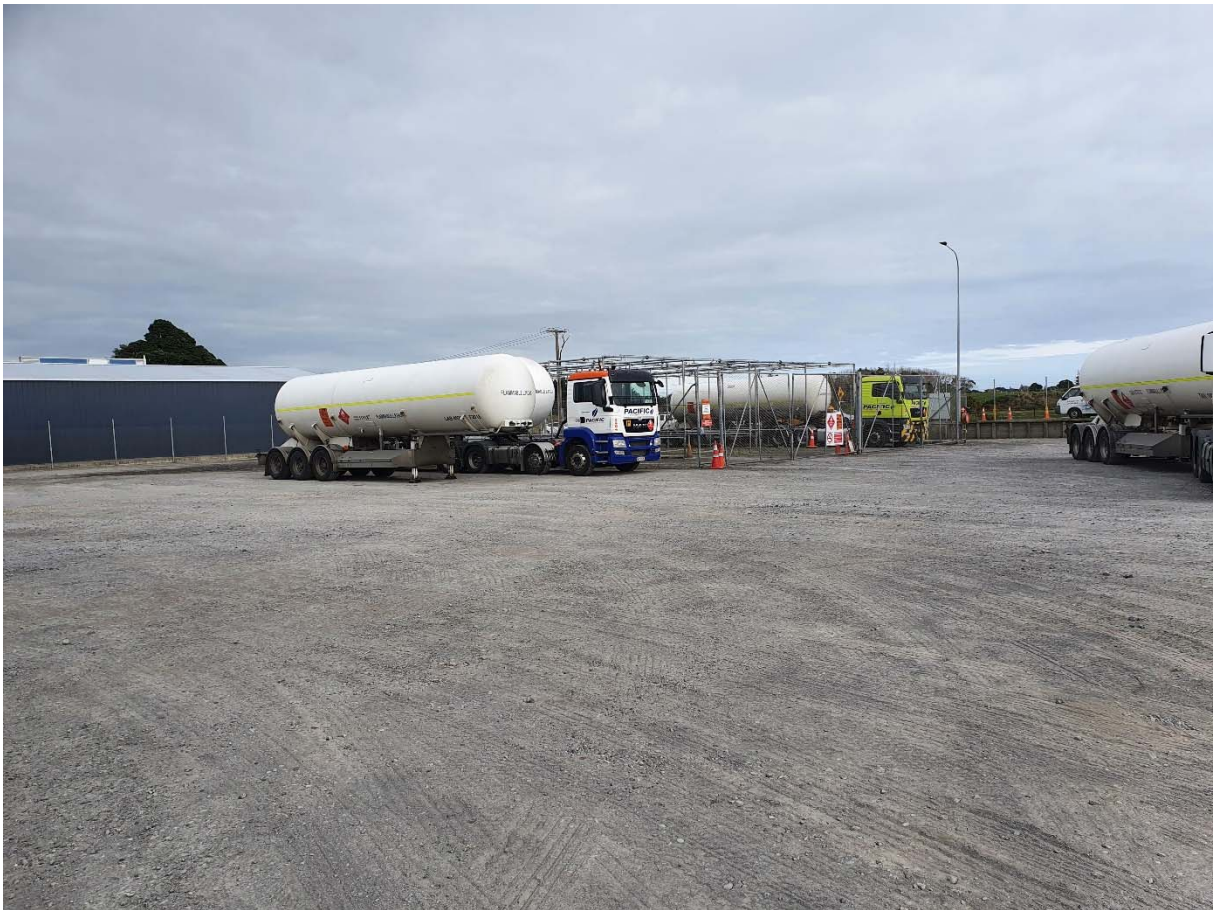
Photo 20 TIL truck parking area and hazardous storage lock up, July 2020

Activities in the Mangaone catchment include a container storage area, a truck parking area (Photo 20), a truck wash facility and Ross Graham Motors workshop.

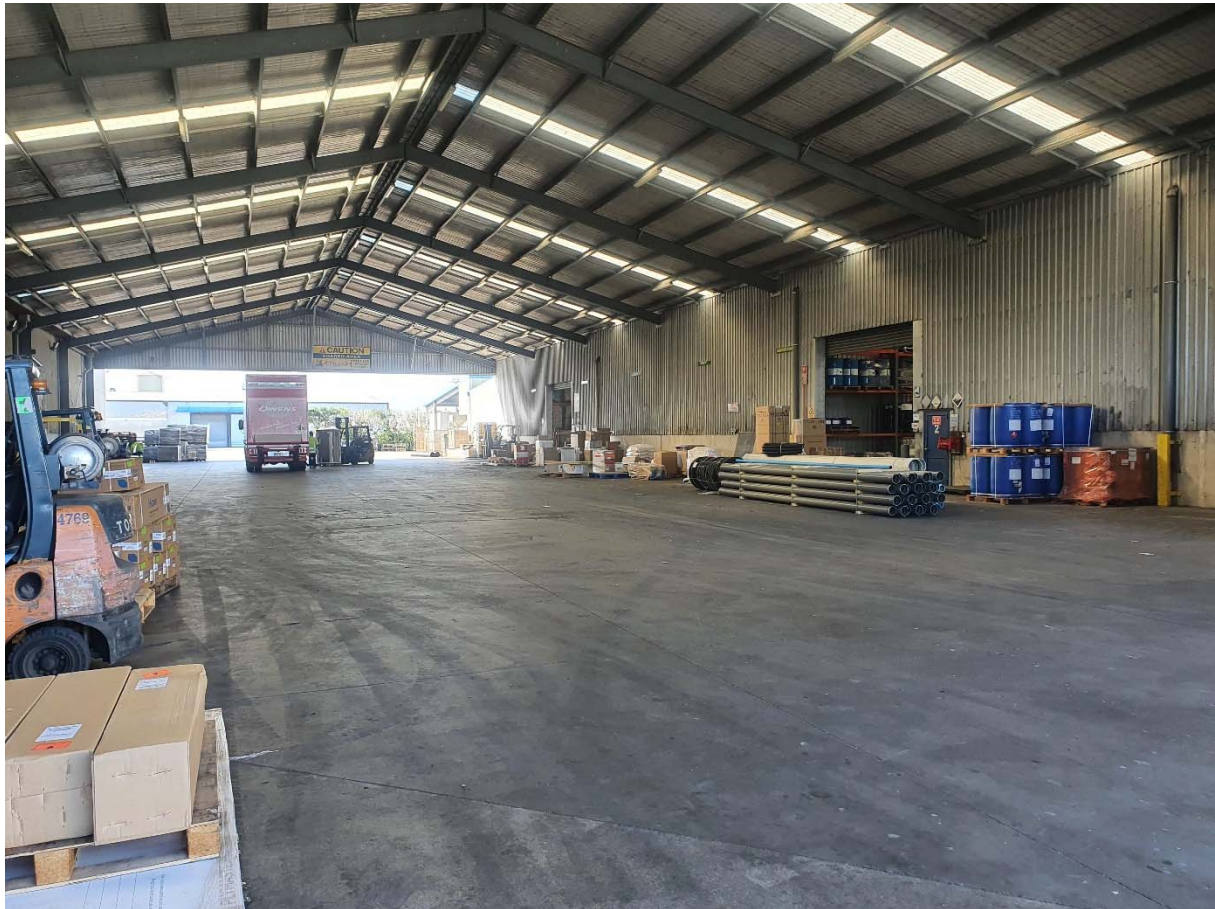
Photo 21 View inside TIL freight loading tunnel, May 2021

A large proportion of this area of the site is roofed (approximately 1.26 ha) (Photo 21) and the remainder is predominantly hard paved or metalled. Activities within the stormwater catchment include parking, loading, storage and heavy vehicle movements.

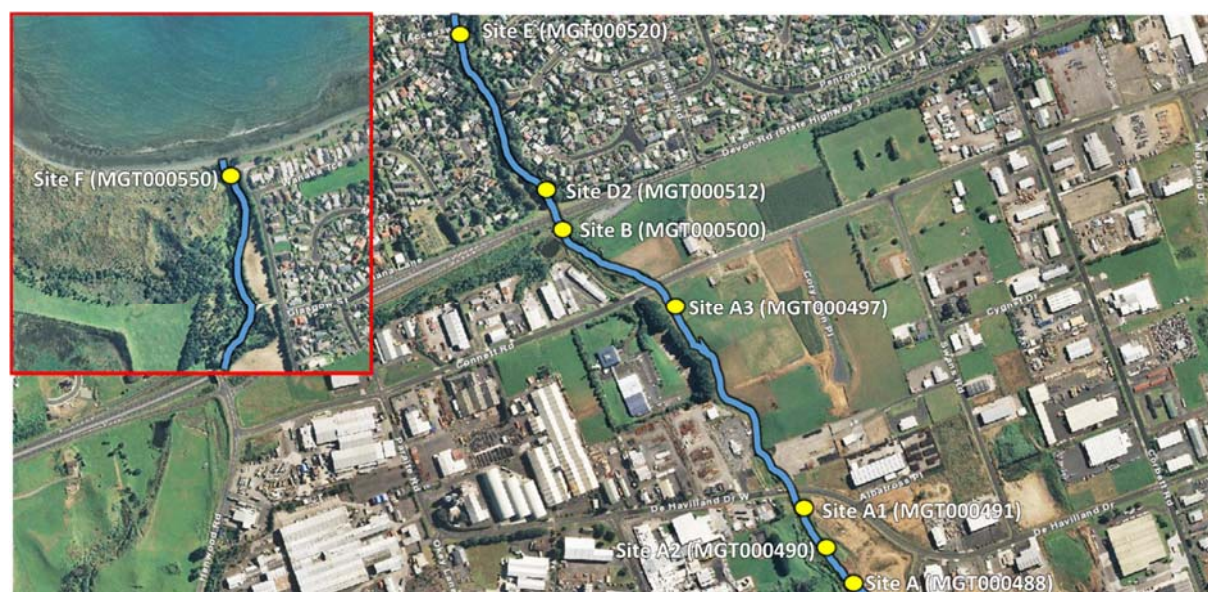
Figure 4 Macroinvertebrate sampling sites in the Mangati Stream

The surveys measure the “health” of the stream in terms of the presence and abundance of benthic macroinvertebrates (bottom dwelling life) and microflora. There are eight fixed sites, as described in Table 62 and Figure 4. The uppermost site is above the influence of any known industrial discharge. There are five sites above and four below the pond 3 discharge from the wetland.

Site No	Site code	Grid reference	Location
A	MGT000488	E1700095 N5678043	Mangati Stream, 20 m upstream of swampy tributary
A2	MGT000490	E1700062 N5678084	Mangati Stream, 100 m downstream of swampy tributary
A1	MGT000491	E1700018 N5678166	Mangati Stream, 50 m upstream of De Havilland Drive
A3	MGT000497	E1699775 N5678573	Mangati Stream, 10 m above Connett Road
B	MGT000500	E1699596 N5678691	Mangati Stream above the industrial tributary, below wetland
D2	MGT000512	E1699513 N5678787	Mangati Stream, 20 m downstream SH3
E	MGT000520	E1699385 N5679103	Mangati Stream, 400 m below Devon Road
F	MGT000550	E1699215 N5680409	Mangati Stream, 50 m above Bell Block beach

The sites that were trended were site A (above industrial catchment) and site E (below industrial catchment), and site locations are shown in Figure 4. A non-parametric statistical trend analysis of the MCI data using the Mann-Kendall test was then performed on 24 years of SEM results (1995-2019) and the most recent ten-years of results (2009-2019).
