Pacific Natural Gut String Company Limited
Monitoring Programme
Annual Report
2012-2013

Technical Report 2013-92

March 2014

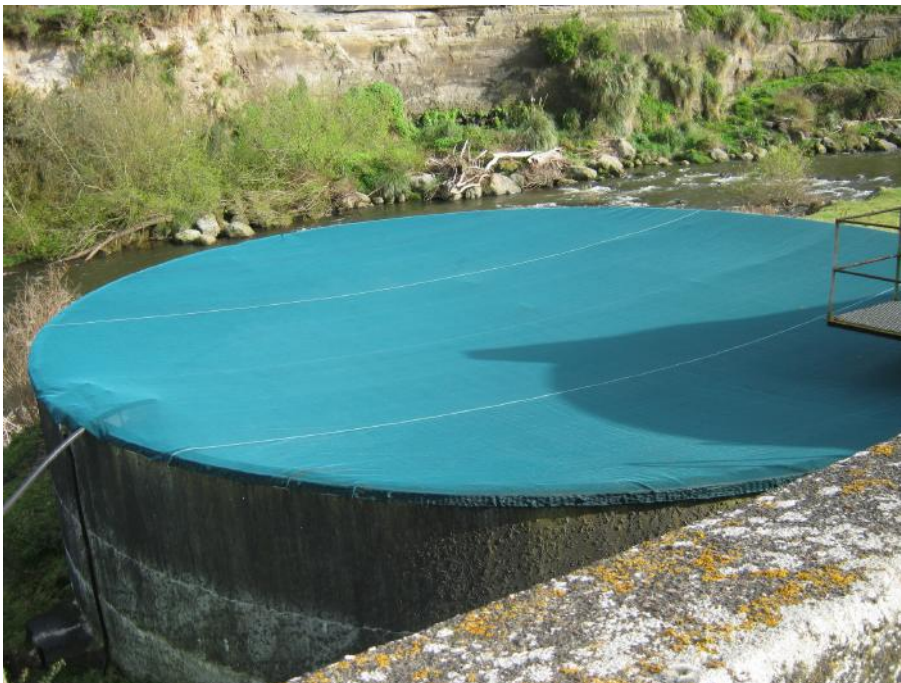
The factory was tidy at the time of the inspection. Raw materials on site included 9 empty drums of alcohol ethoxylate, 7 bags of EDTA, 13 bags of soda ash, and 2 bags of caustic soda. The chemicals were banded and the area was tidy. At the time of the inspection the roof on the outside chemical storage area was being fixed in order to prevent future leaks. The banded area contained 13 x 25kg carboys of hydrogen peroxide. The moss/algae previously growing within this bund had been removed and the integrity of the bund appeared fit for purpose. The holding tank was over half full and was about to be discharged at high tide. There was little foaming on the surface. A new cover had been fitted on the holding tank (fitted July 2012, Photograph 1), replacing the old ripped cover. The pump shed floor was dry and there were no leaks at the time of inspection. There was a small trickle of discharge from the outfall pipe at the time of inspection. Foam was clearly visible on the cliff below the outfall (Photograph 2) and at the base of the cliff. This foam was attributable to Ecoteric LA8N surfactant. The surfactant is biodegradable and therefore not expected to have an adverse biological effect on the receiving environment. The extent of foam is likely to have resulted from cleaning of the factory the day before combined with a strong persistent on-shore westerly wind. Access to a suitable location to inspect the end of the outfall pipe was difficult.

Photograph 1 New cover on the effluent holding tank

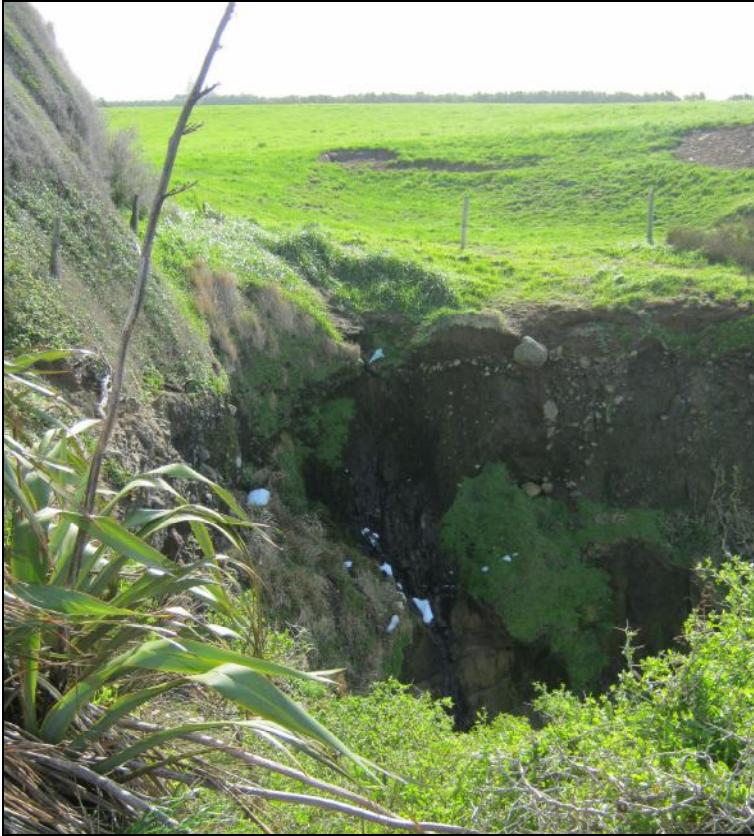
Photograph 2 Foam around point of discharge
