Mangati Catchment
Joint Monitoring Programme
Biennial Report
2012-2014
Technical Report 2014-127

October 2015

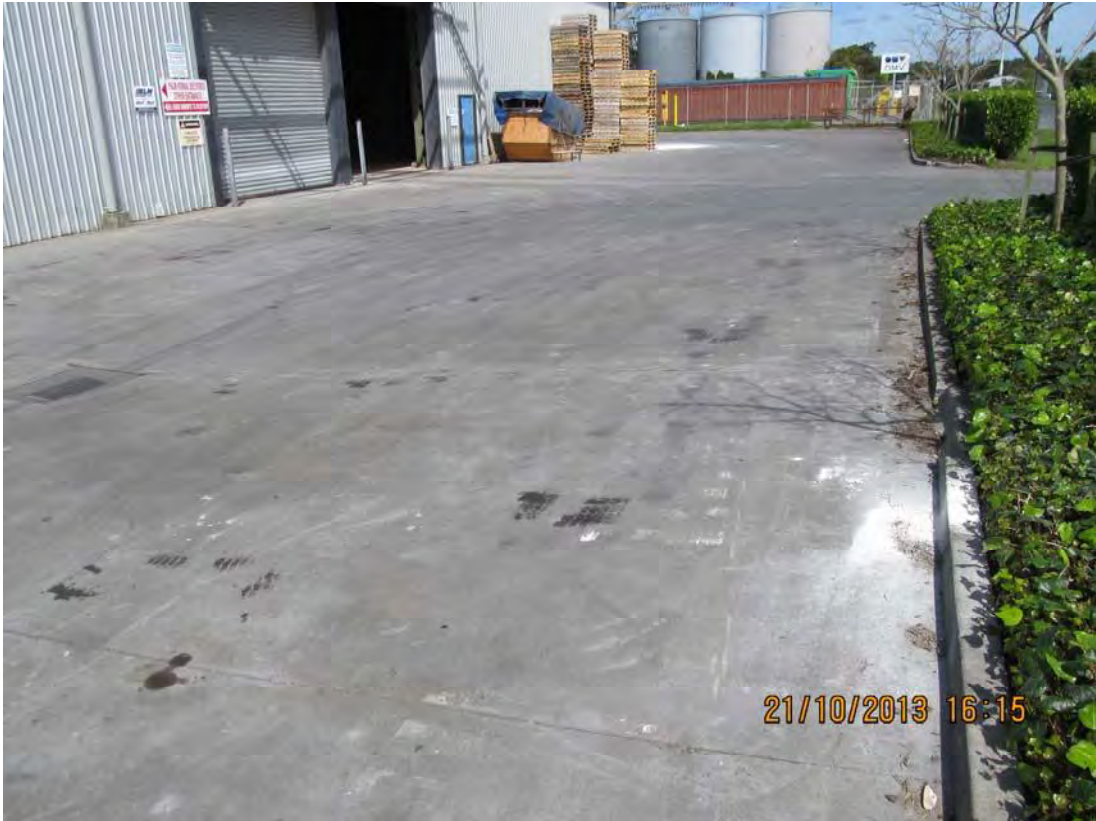
The site was, for the most part, clean and tidy. There were a few spills on site that were brought to the attention of staff. Two spills consisted of lime, while one was oil from a truck that had parked on site during the weekend. Staff advised that these spills would be cleaned up. The Council Officer was advised that staff tried to keep product from discharging onto the site where the stormwater drains were by having trucks exit onto the side of the shed that has drains discharging to sewer. It was evident that trucks had been exiting from the building on the side that has the stormwater drains present and some residual product was observed tracking from the shed (Photo 3). Staff said that the site was swept to reduce/minimise effects on the stormwater system. The drains were inspected and appeared to contain organic matter in the sumps (Photo 4).

Photo 3 BLM Feeds – tracking from storage shed, 21 October 2013

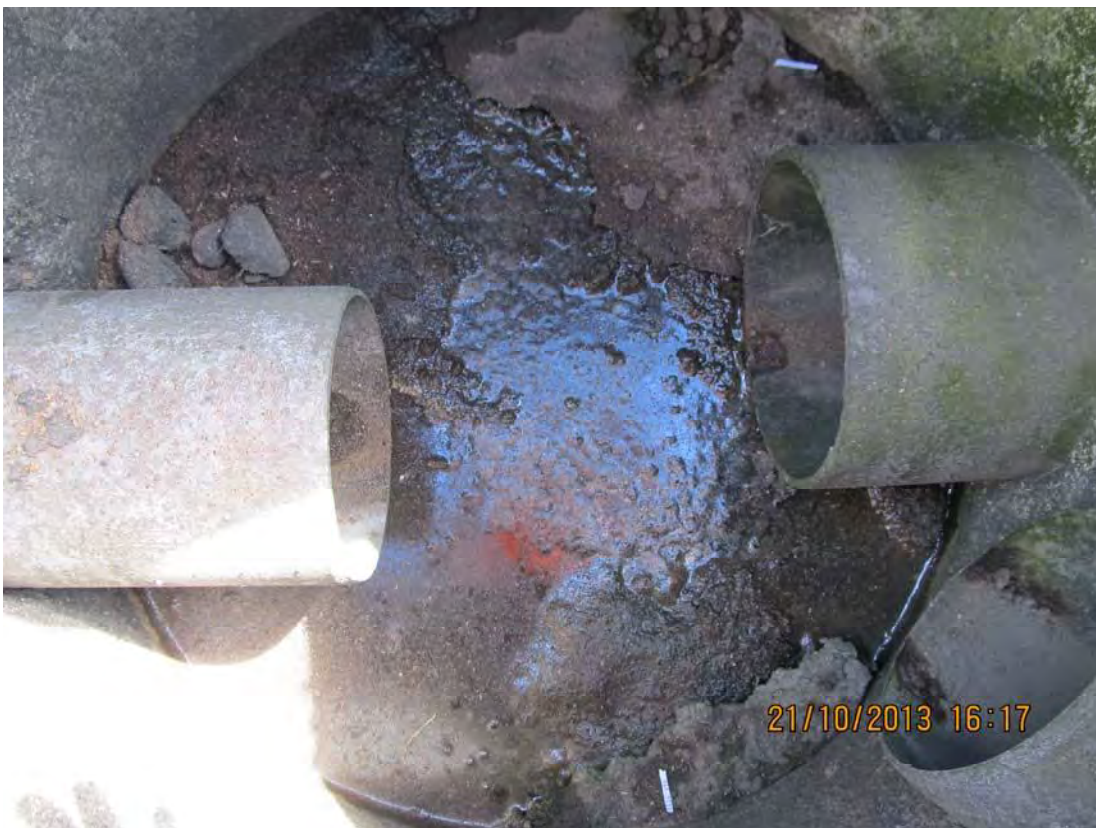
Photo 4 BLM Feeds – organic matter in stormwater sump, 21 October 2013

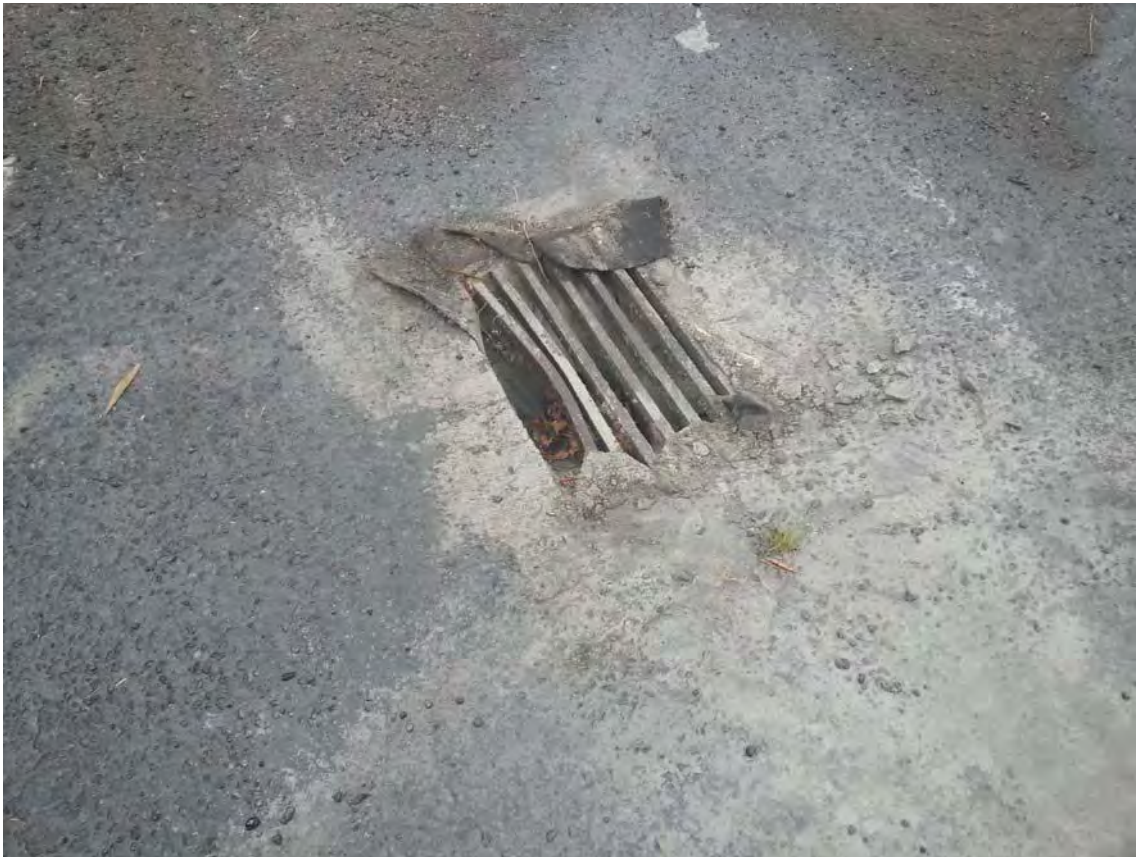
During the Mangati catchment wet weather run it was found that constituents in the discharge from Halliburton's lower yard were not within resource consent conditions on 6 November 2013. A water sample collected from the site discharge point from the lower yard contained a suspended solid concentration of 800 g/m³, which was higher than permitted by resource consent 2337-3. This was discussed with the consent holder at an inspection on 18 March 2014, when it was again found that the consent condition requiring that best practicable option to prevent and/or minimise adverse effects be adopted at the site, was not being complied with.

Photo 5 Halliburton stormwater drain 18 March 2014

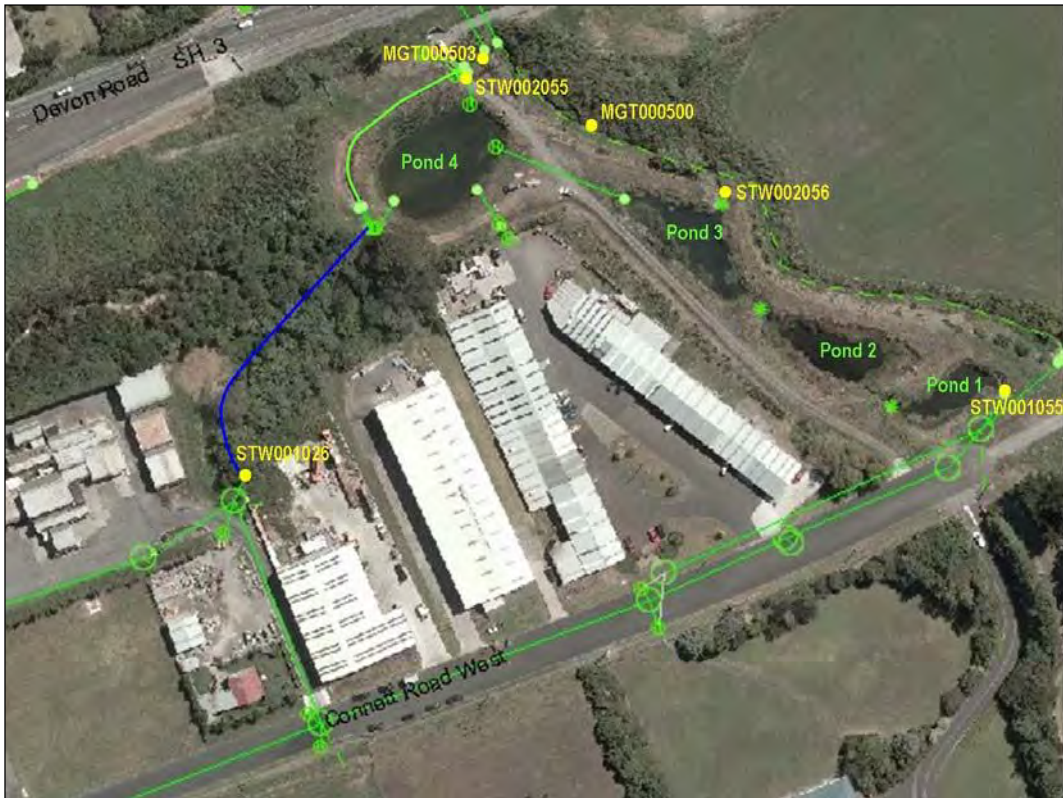
Figure 5 NPDC stormwater flow paths and sampling points

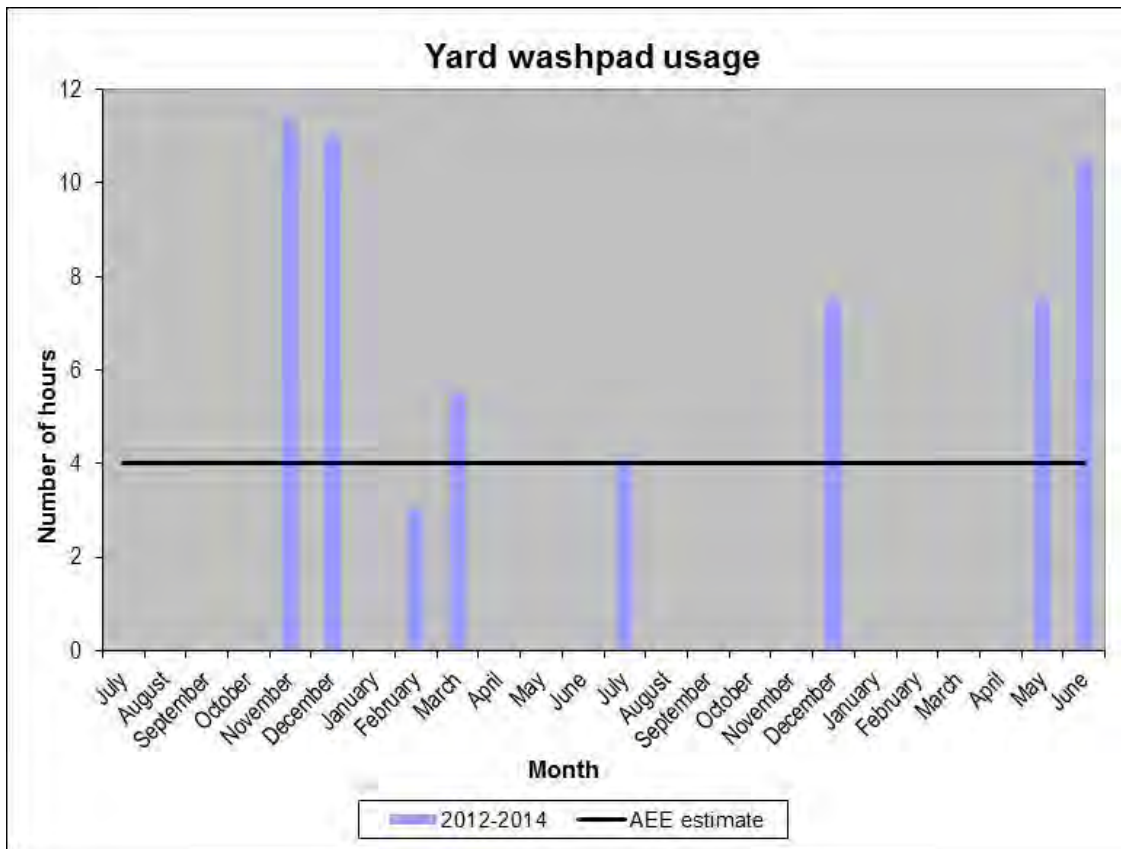
Tasman Oil forwarded the yard washdown usage logs for 2012-2014 to the Council upon request. The washpad usage reported is included as Appendix V and is summarised in Figure 6. The total washpad usage was relatively low for the 2012-2014 period (60.3 hours), however, it is noted that at times the intensity of wash pad use has been greater than anticipated at the time of the consent application.

Figure 6 Yard wash pad usage – drains to stormwater

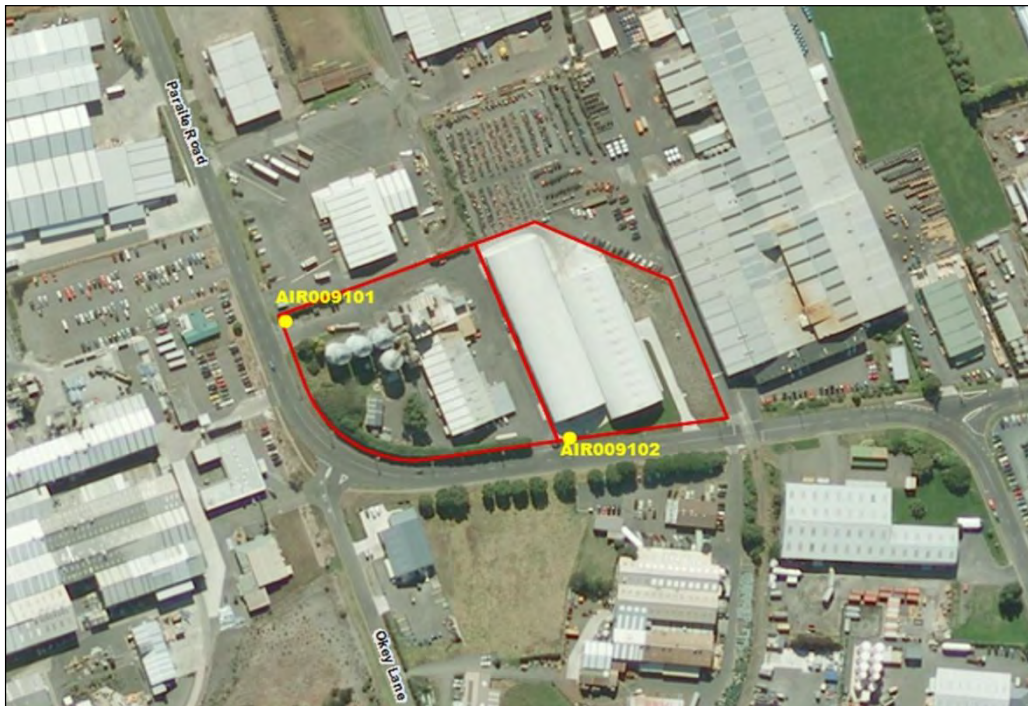
Figure 7 Location of Tegel's feed mill deposition gauges

Material from the gauges was analysed for solid particulates associated with pollution. The location of the gauges is shown in Figure 7, and the results are presented in Table 44 below.

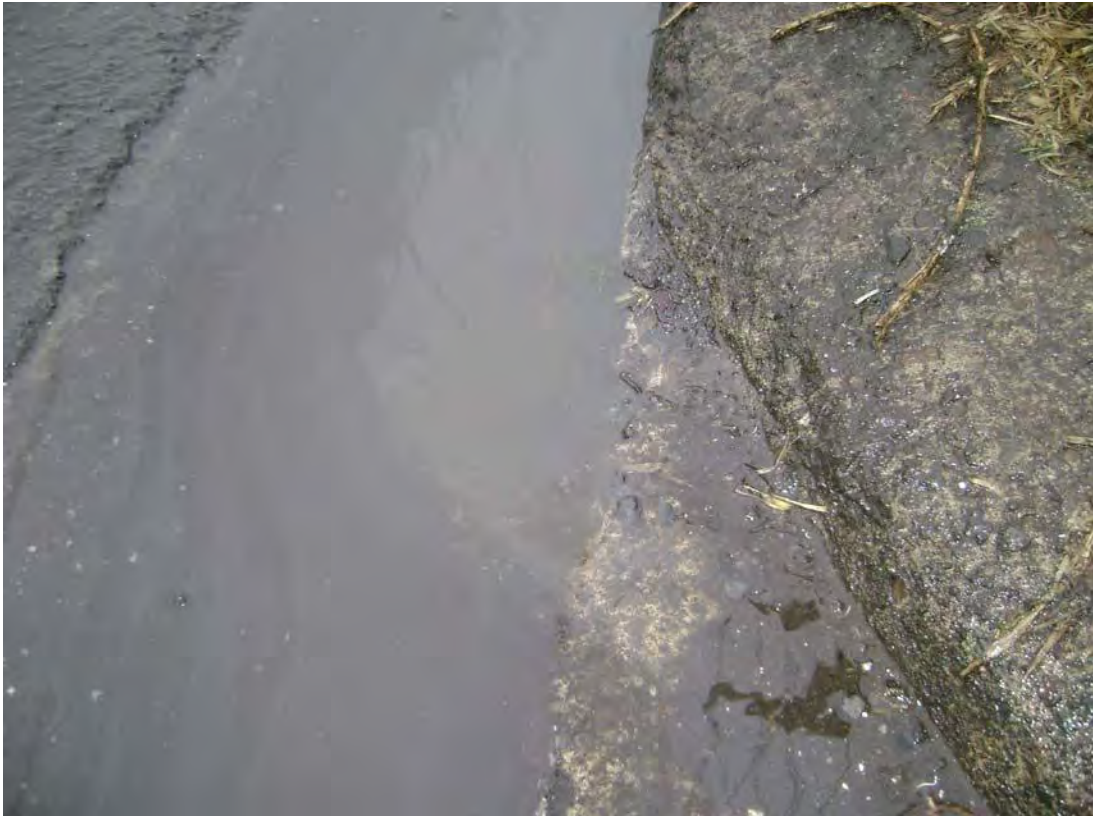
In addition, during the sampling survey undertaken on 3 July 2012 a further sample was collected from an overland flow in the gutter on the northern side of the western driveway. This sample was collected as there was a sheen observed on a discharge that was flowing from the site entrance (Photo 6) into a roadside drain that joins the reticulated stormwater network that flows to the NPDC ponds before entering the Mangati Stream. The sample was analysed for oil and grease only, and returned a result of 6.3 g/m^3 , which is well below the component concentration limit given in the consent for this parameter.

Photo 6 Tegel feed mill, sheen on overland flow discharge 3 July 2012

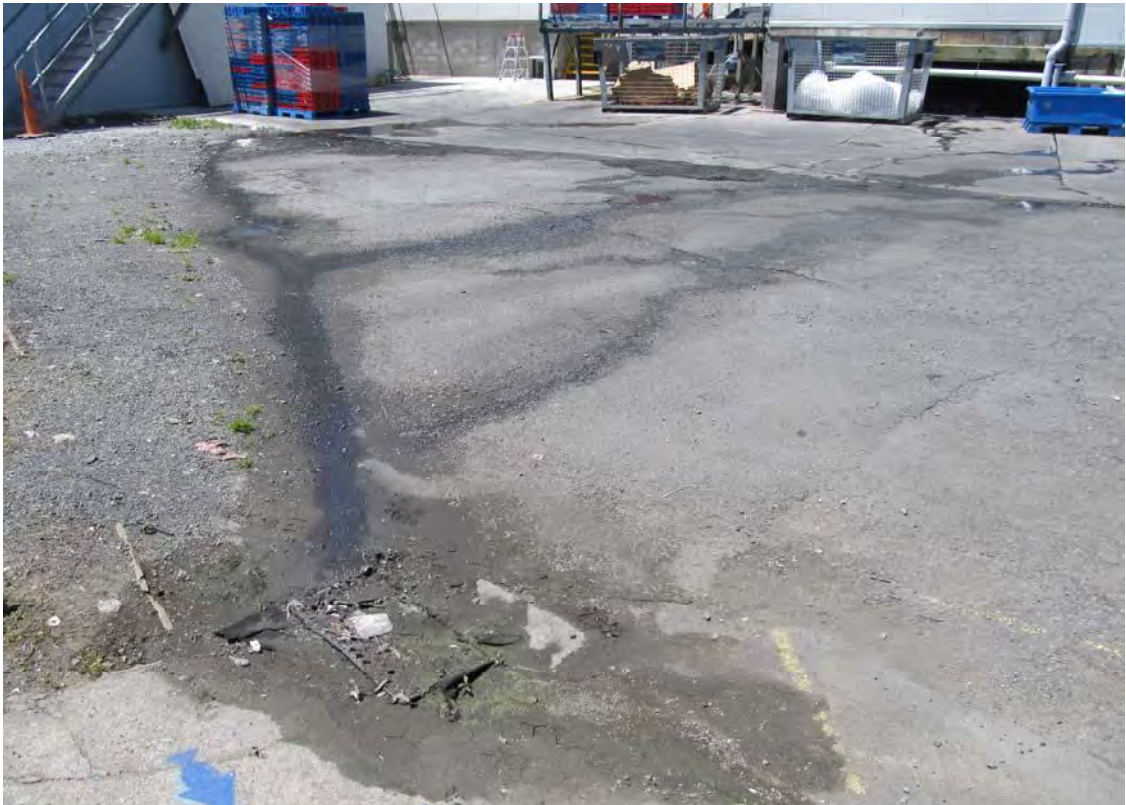
The site was inspected in fine weather conditions. It was found that, in general the site was tidy and clean. There were good processes in place regarding the bunding and storage of chemicals. The wastewater pond appeared to be approximately half full. The burial area looked satisfactory, with no slumping evident. It was considered that the wetland was working well, with a clear discharge from the exit point into the Mangati Stream. It was observed that washdown water from inside a building on the western side of the site was still discharging nutrient rich wastewater. This discharge was entering a stormwater drain at the time of inspection. HSE staff advised that since the last inspection, attempts had been made to stop the discharge. Photographs were taken at the time of inspection (Photo 7). Tegel was instructed that this discharge must stop, and it was likely that an abatement notice would be issued requiring further works to be undertaken. This matter was logged as a further unauthorised discharge on the Council's Incidents Register and is discussed further in section 16.2.4.1. It was noted that the issue raised during the last inspection, concerning waste material entering as stormwater drain near the crate storage area, had been addressed.

Photo 7 Tegel poultry processing plant leak from free flow building, 2 December 2013

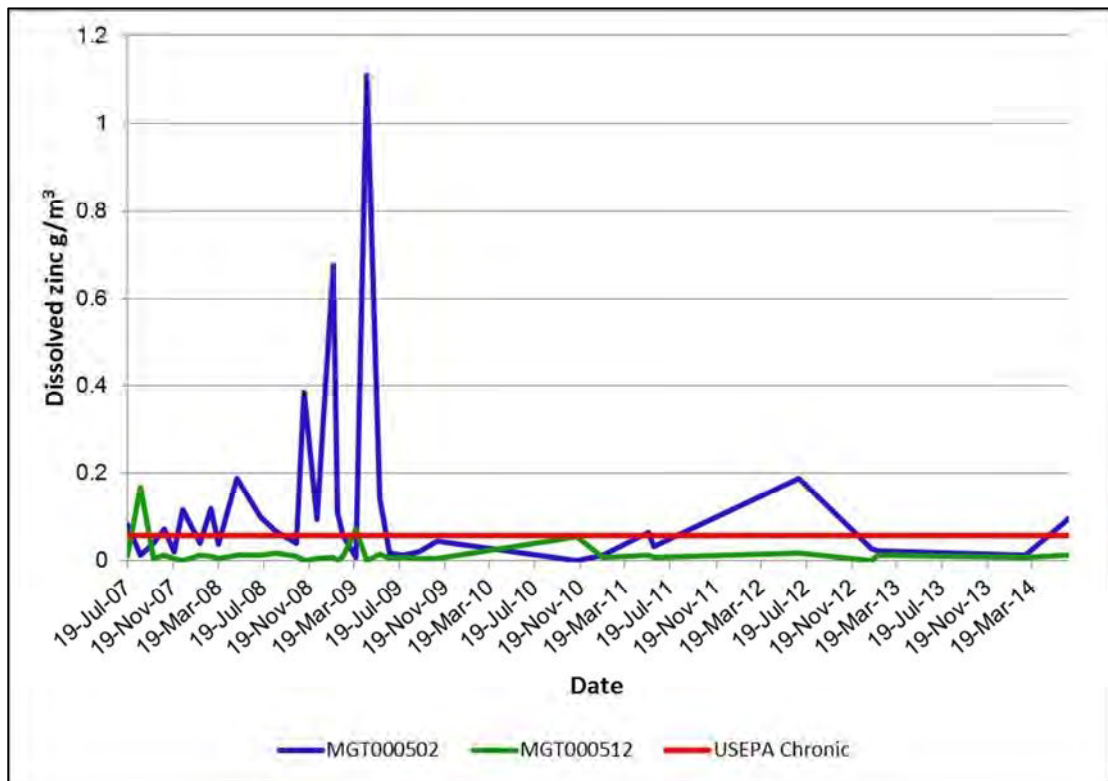
The dissolved zinc concentration recorded was in excess of the chronic and acute toxicity levels for the sample taken from the industrial drain upstream of the wetland in both samples collected in June 2014. However, the samples taken from the Mangati Stream below the discharge showed that the concentration remained lower than the chronic criteria in the stream itself throughout the years under review. Figure 8 shows the past seven years of dissolved zinc data from this aspect of the monitoring programme in relation to the chronic criteria of 0.058 g/m³.

Figure 8 Dissolved zinc monitoring data for dry weather Mangati Stream water July 2007 to June 2014

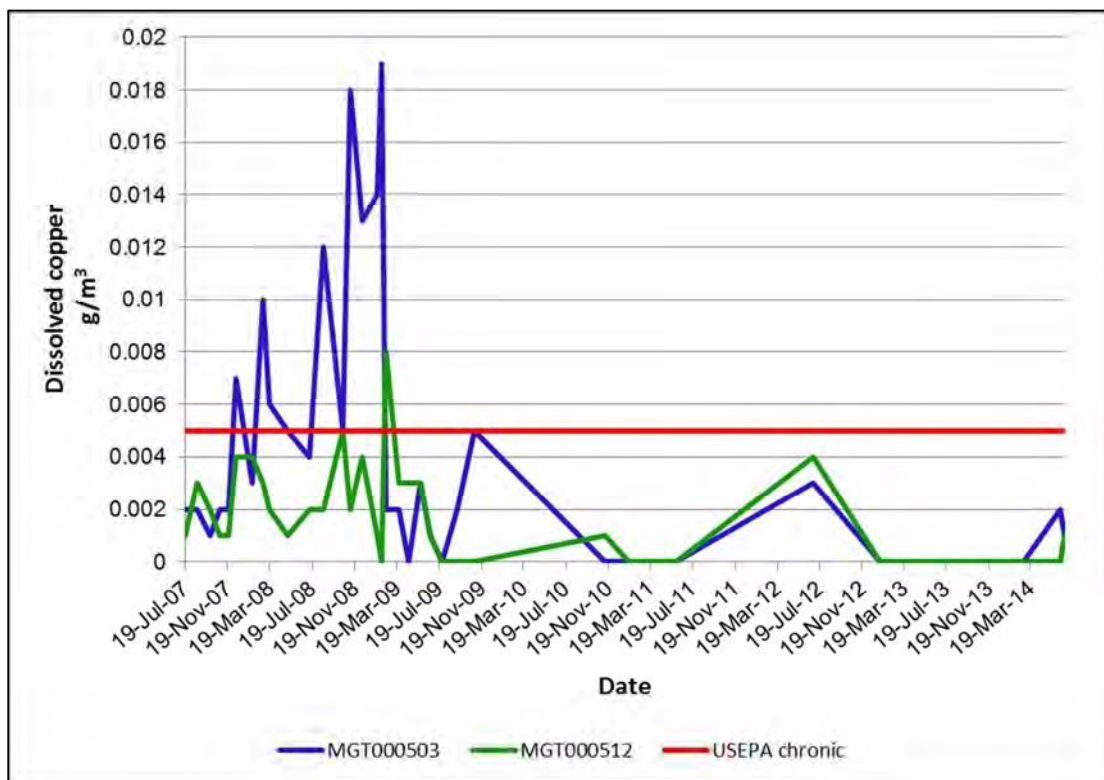
The dissolved copper concentration did not exceed the chronic criterion in either of the samples collected during the years under review, and was in fact found to be at, or below, the limit of detection in the stream on all monitoring occasions. Figure 9 shows the past seven years of dissolved copper data from this aspect of the monitoring programme in relation to the chronic criteria of 0.005 g/m³.

Figure 9 Dissolved copper monitoring data for dry weather Mangati Stream water July 2007 to June 2014

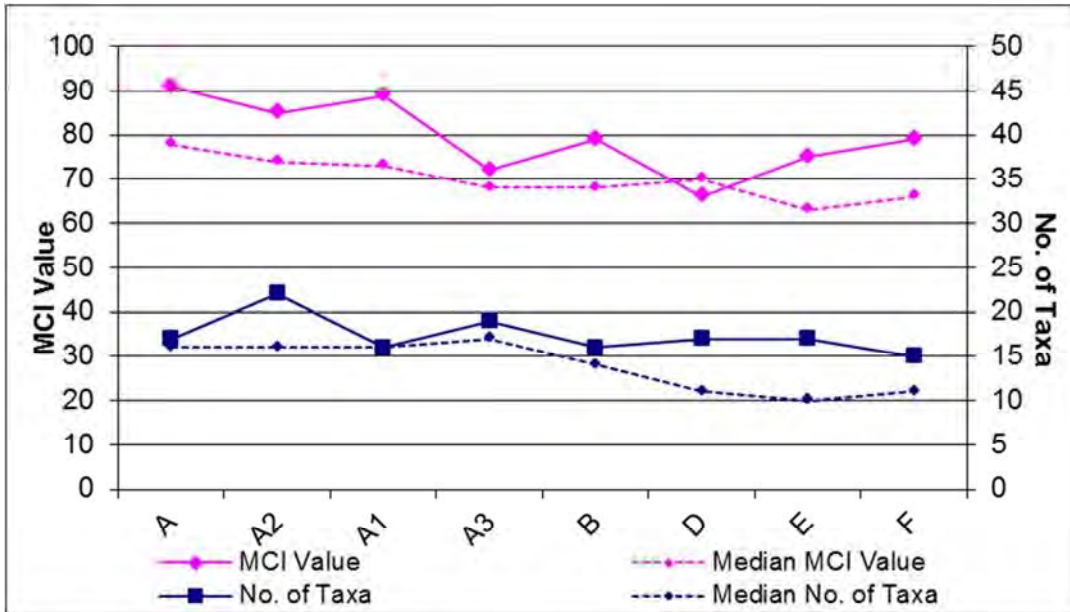
Upstream of Connett Road (and the wetland discharge), MCI scores were equal with or higher than their respective historical medians. Downstream of Connett Road, an improved pattern was noted in terms of MCI scores, with sites B, E, and F recording scores higher than their respective historical medians in all surveys. The exception was site D2 (immediately below the pond 4 and pond bypass drain discharges), which recorded a score less than the historical median in both of the late summer surveys (Figure 10 and Figure 11).

Figure 10 Numbers of taxa and MCI values recorded at sites in the Mangati Stream in the February 2013 survey

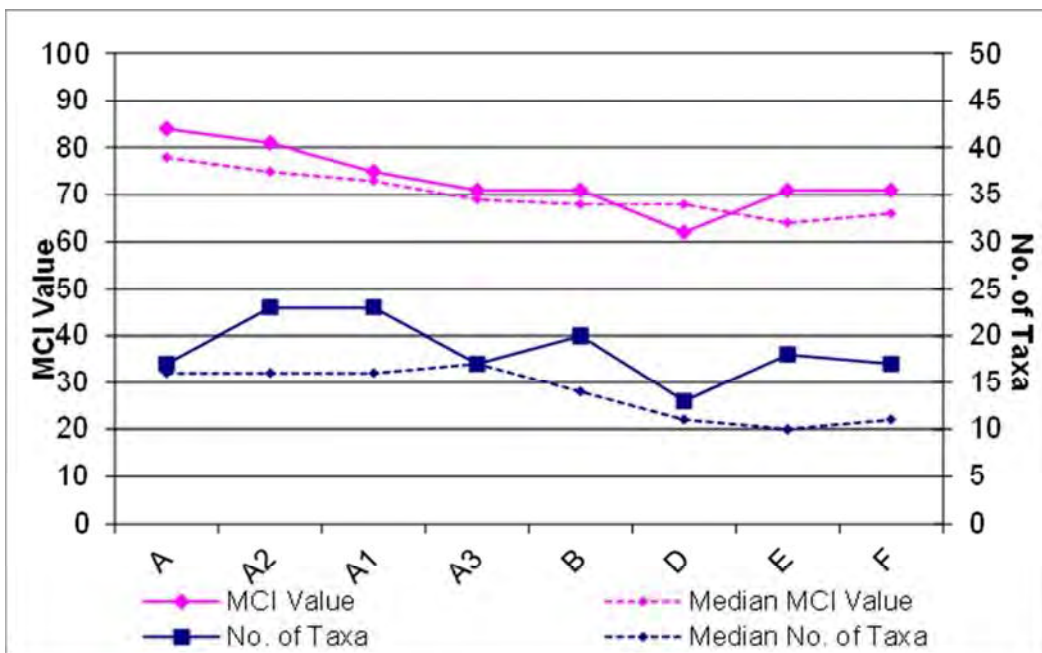
Figure 11 Numbers of taxa and MCI values recorded at sites in the Mangati Stream in the February 2014 survey

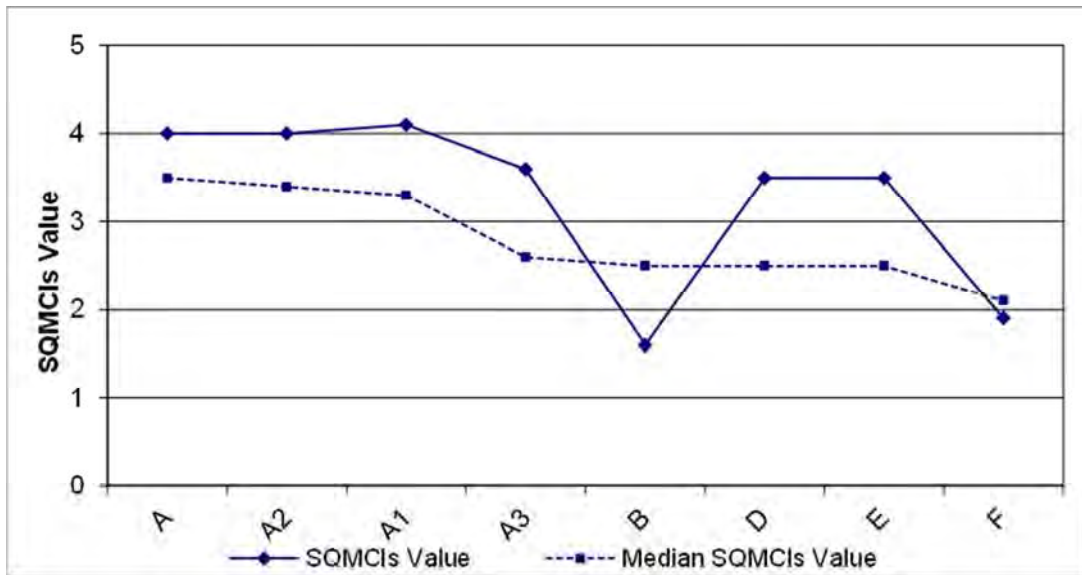
Figure 12 SQMCI_s values recorded at sites in the Mangati Stream in the October 2012 survey

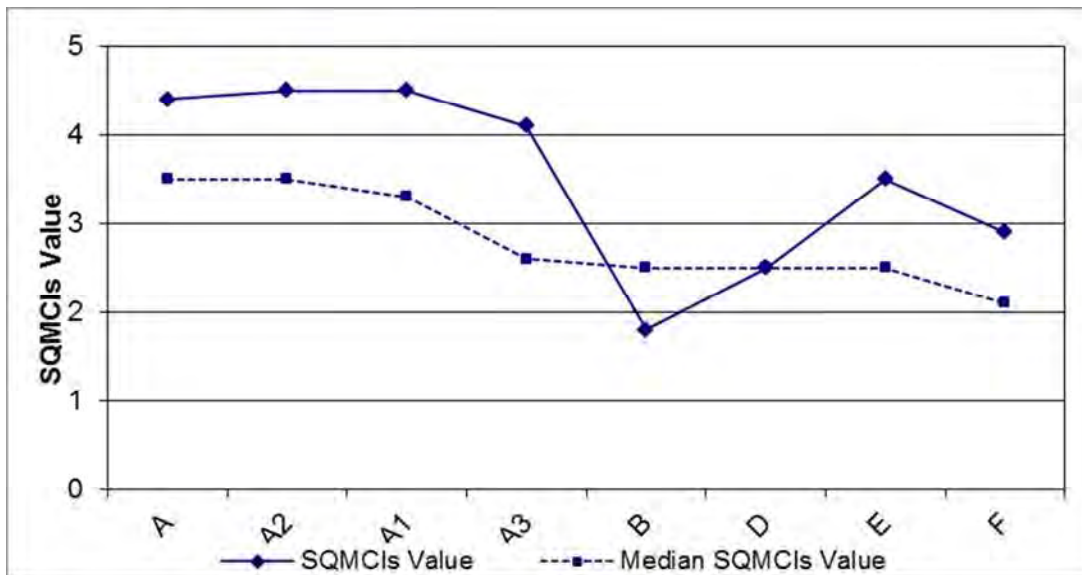
Figure 13 SQMCI_s values recorded at sites in the Mangati Stream in the February 2013 survey

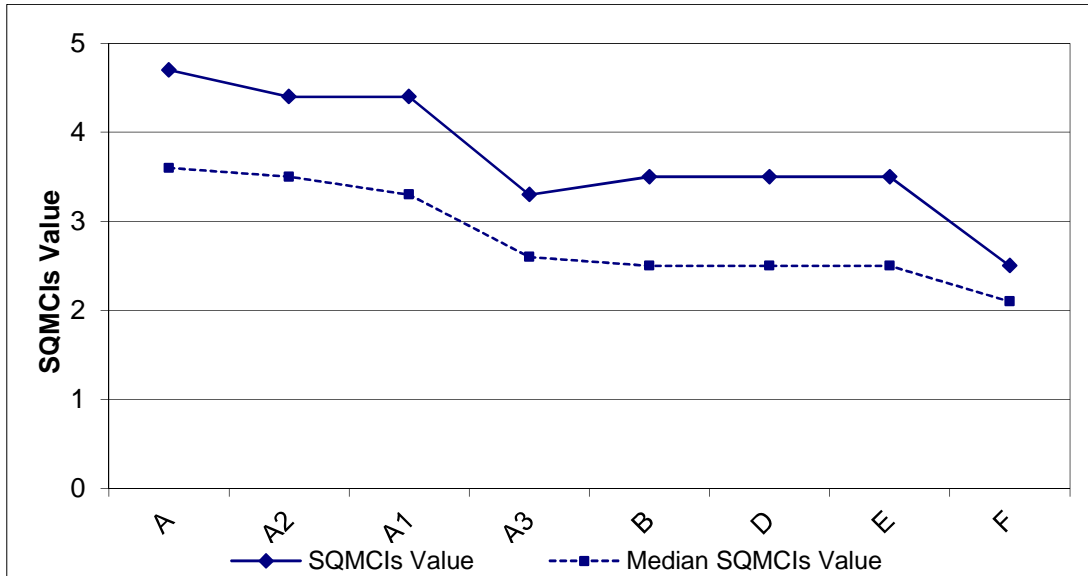
Upstream of Connett Road all sites exhibited SQMCI_s scores higher than their respective historical medians, many of which were close to previous maxima. Downstream of Connett Road, Site B recorded SQMCI_s scores significantly less than the median in both October 2012 (Figure 12) and February 2013 (Figure 13), which indicated a subtle impact of the wetland discharge from pond 3, a pattern that had occurred for a number of years. However, in the November 2013 (Figure 14) and February 2014 (Figure 15) surveys all sites recorded SQMCI_s scores above their respective historical medians, indicating further recovery compared with the results of the earlier surveys.

Figure 14 SQMCI_s values recorded at sites in the Mangati Stream in the November 2013 survey

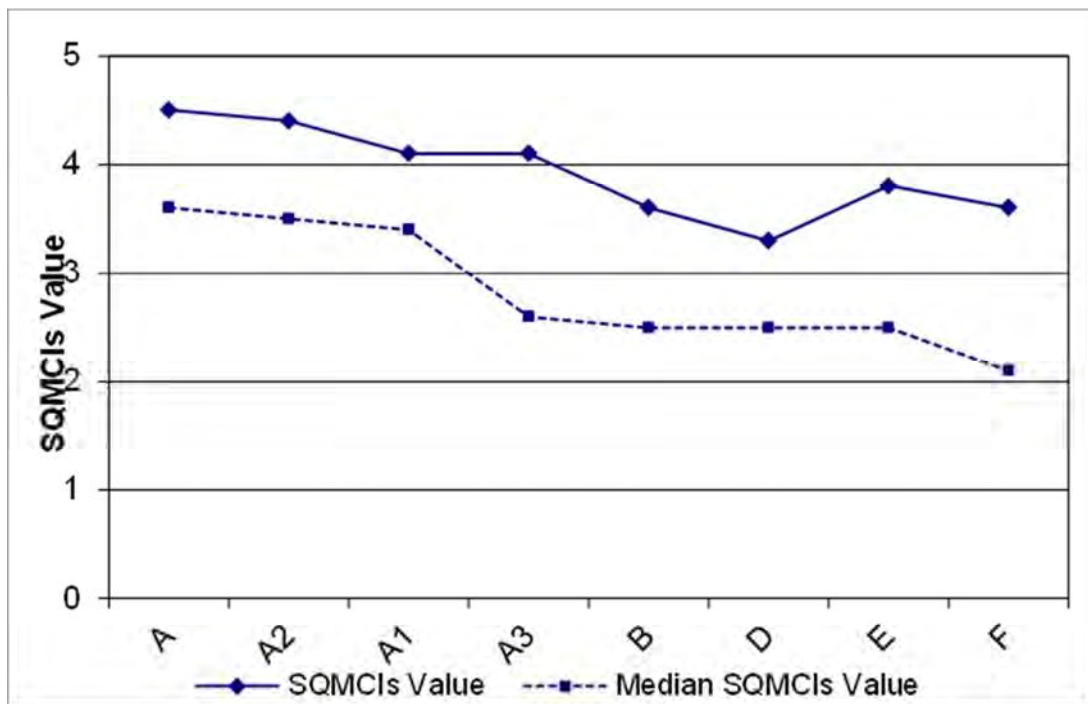
Figure 15 SQMCI_s values recorded at sites in the Mangati Stream in the February 2014 survey

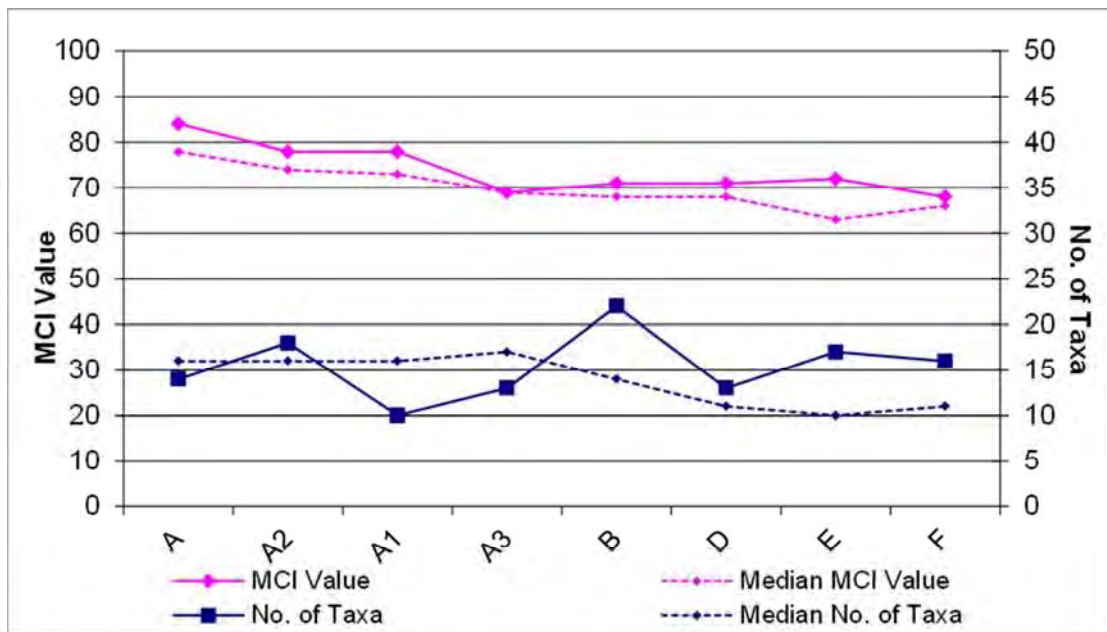
Overall, the generally minimal changes in community structure, number of taxa, and MCI scores throughout the upper to mid reaches of the Mangati Stream, indicated that there have been no significant adverse effects on macroinvertebrate communities resulting from discharges from Tegel Poultry, De Havilland Drive West, Tasman Oil or Greymouth Petroleum. However, the discharge from the wetland ponds, although not causing the same impact as that recorded in the spring 2010 survey, may still have been subtly impacting on the macroinvertebrate community of site B, immediately downstream of the pond 3 and/or the pond 4 and pond bypass drain discharge points during the October 2012, and February 2013 and 2014 surveys. No impact was noted in the November 2013 (Figure 16) survey and this may have been attributed to higher flow conditions.

Figure 16 Numbers of taxa and MCI values recorded at sites in the Mangati Stream in the November 2013 survey

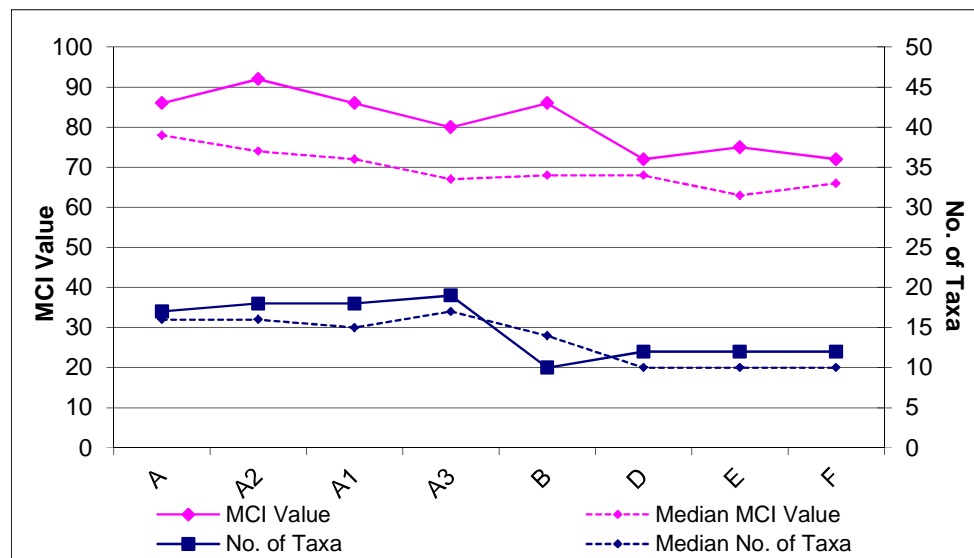
Numbers of taxa and MCI scores recorded by the current survey in the Mangati Stream are illustrated in Figure 2.

Figure 2 Numbers of taxa and MCI values recorded at sites in the Mangati Stream by the current survey

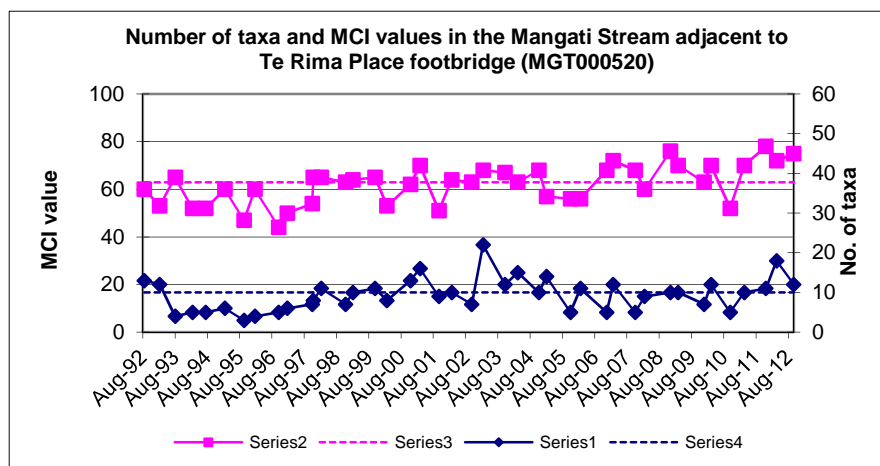
No change in taxa richness was observed at site E (12 taxa) in comparison with site D2. This was two taxa higher than the median for this site (Table 3, Figure 10) but six taxa fewer than found by the previous survey. This community was characterised by three 'tolerant' taxa [oligochaete worms, extremely abundant snail (*Potamopyrgus*), and orthoclad midges] similar to dominant taxa at most of the upstream sites. There were no significant differences in individual taxon abundances found between sites D2 and E resulting in no change in SQMCI_s scores (3.5 units) between sites.

Figure 10 Numbers of taxa and MCI values recorded at site E to date

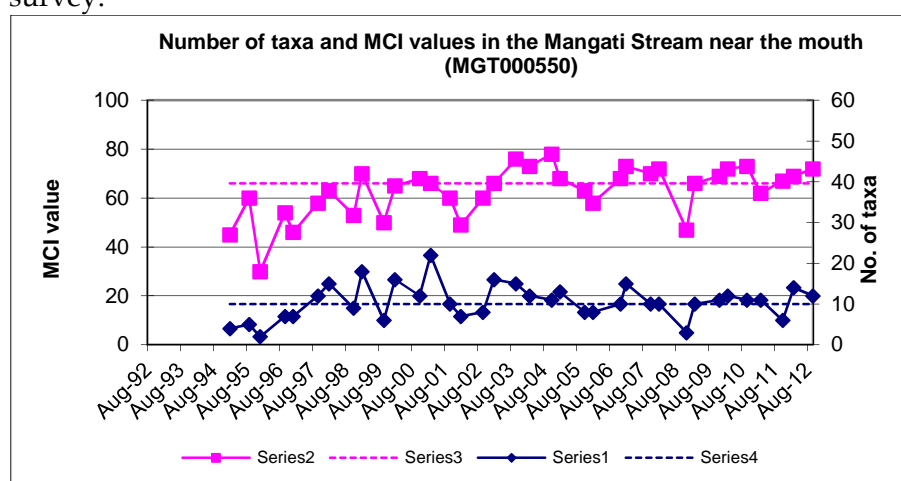
Taxa richness (12 taxa) was slightly lower than that recorded by the previous survey and was two taxa higher than the median richness (Figure 11, Table 3). This is considered to have indicated continued recovery from the significant habitat loss caused by erosion of the stream bed and banks by high flows and possibly high seas documented by the spring 2011 survey.

Figure 11 Numbers of taxa and MCI values recorded at site F to date

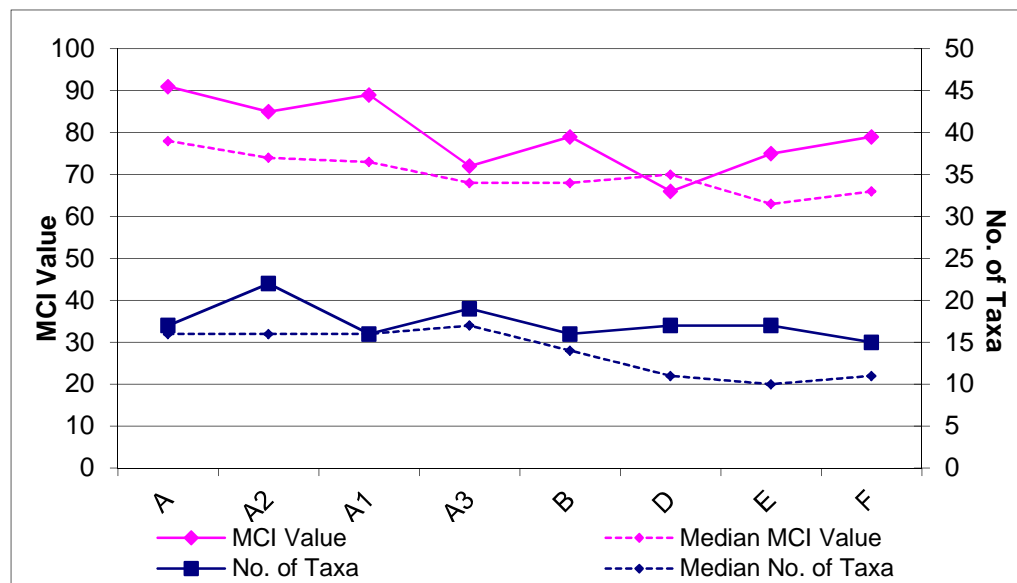
Numbers of taxa and MCI scores recorded by the current survey in the Mangati Stream are illustrated in Figure 2.

Figure 2 Numbers of taxa and MCI values recorded at sites in the Mangati Stream by the current survey

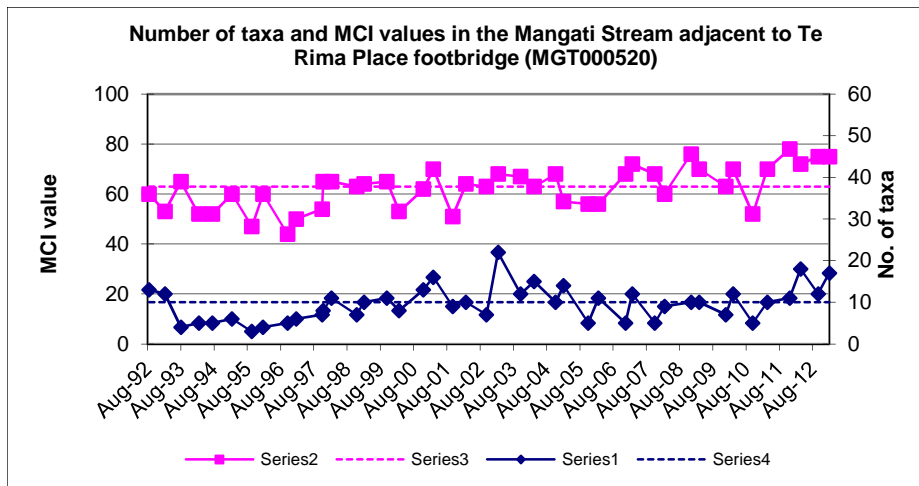
No downstream change in taxa richness was found at site E (17 taxa), which was seven taxa more than the median richness for this site (Table 3, Figure 10). This community was characterised by two ‘tolerant’ taxa [oligochaete worms and extremely abundant snail (*Potamopyrgus*)] and one ‘moderately sensitive’ taxon [vegetation-cased caddisfly (*Triplectides*)] which was relatively similar to those at the nearest upstream site. There was only one significant difference in individual taxon abundance found between sites D2 and E, with the ‘tolerant’ snail (*Physa*) reduced in abundance.

Figure 10 Numbers of taxa and MCI values recorded at site E to date
