Fonterra Kapuni
Air and Water
Monitoring Programme
Biennial Report
2013-2015
Technical Report 2015–111

May 2016

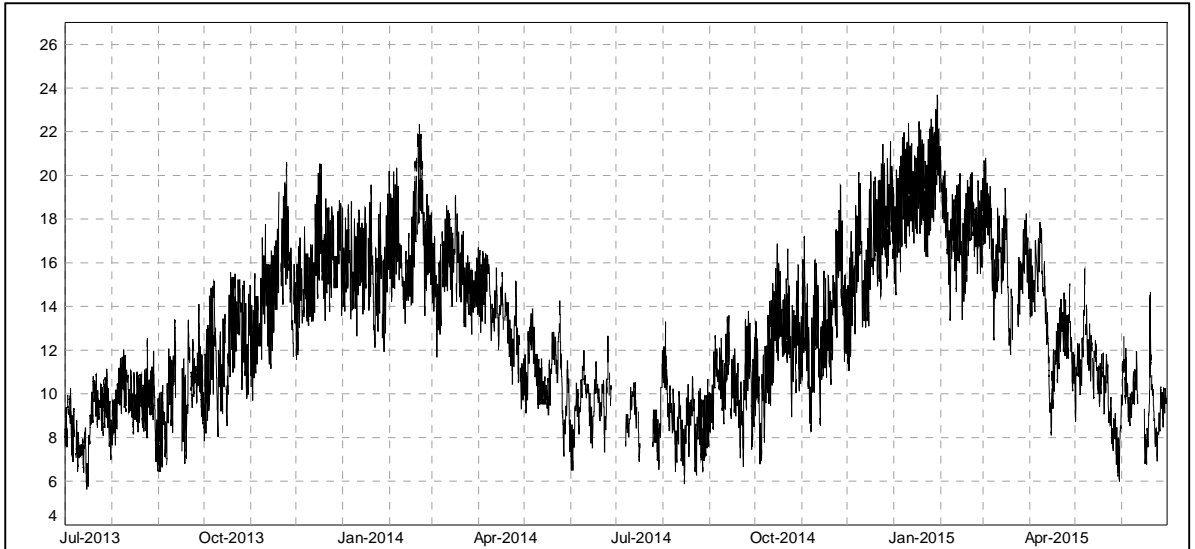
Figure 3 Water temperature (°C) records for the Kaipokonui Stream upstream of lactose plant during the period 1 July 2013 to 30 June 2015

The temperature record over the 2013-2015 reporting period for the Kaipokonui Stream upstream and downstream of the lactose plant discharge are presented in Figure 3 and Figure 4. The increase in temperature is given in Figure 5.

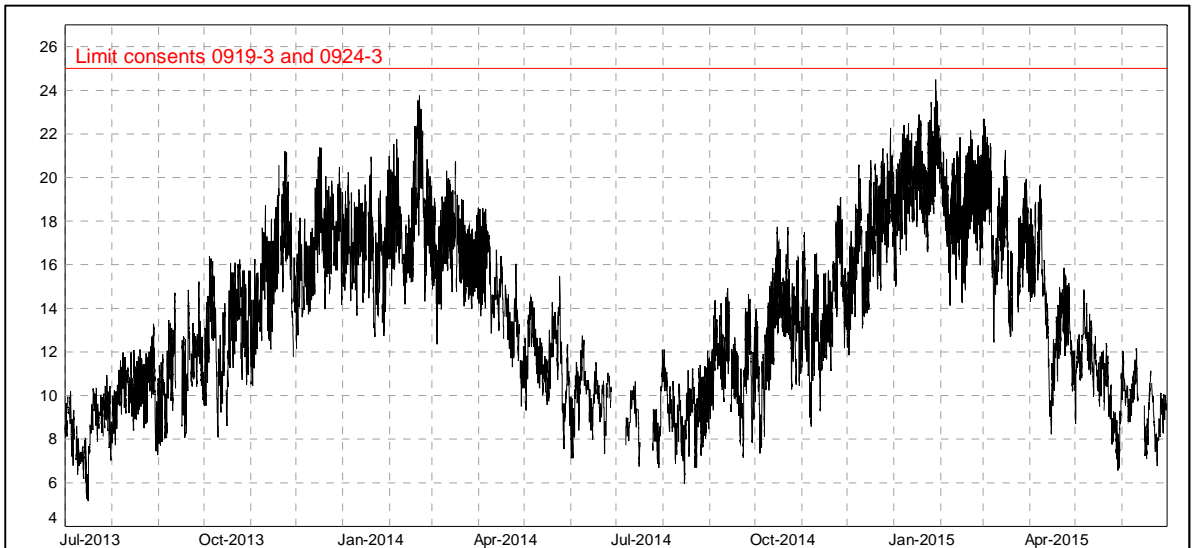
Figure 4 Water temperature (°C) records for the Kaipokonui Stream downstream of lactose plant during the period 1 July 2013 to 30 June 2015

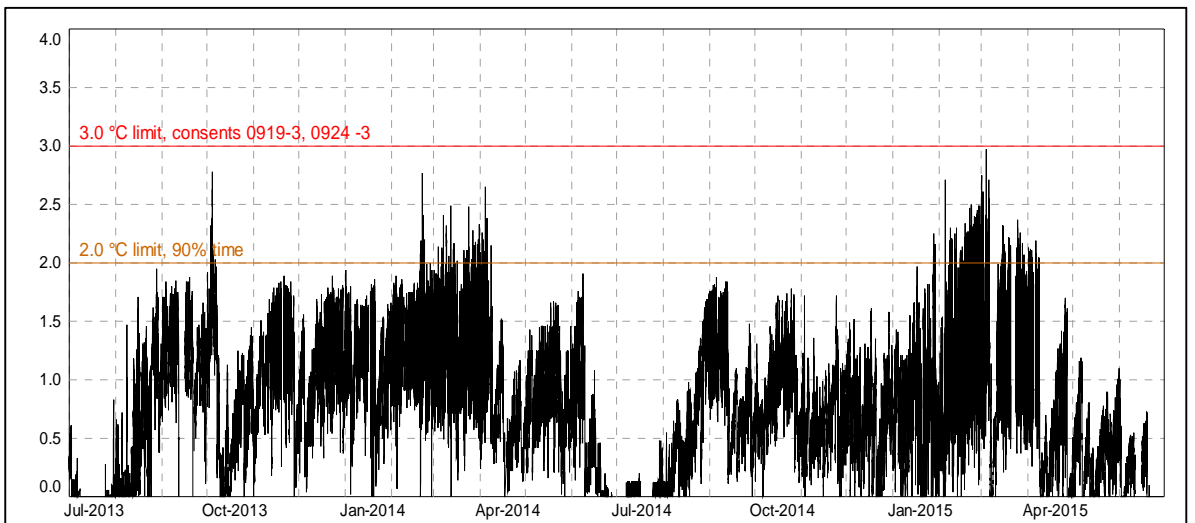
Figure 5 Kaupokonui Stream temperature increase below lactose plant for period 1 July 2013 to 30 June 2015

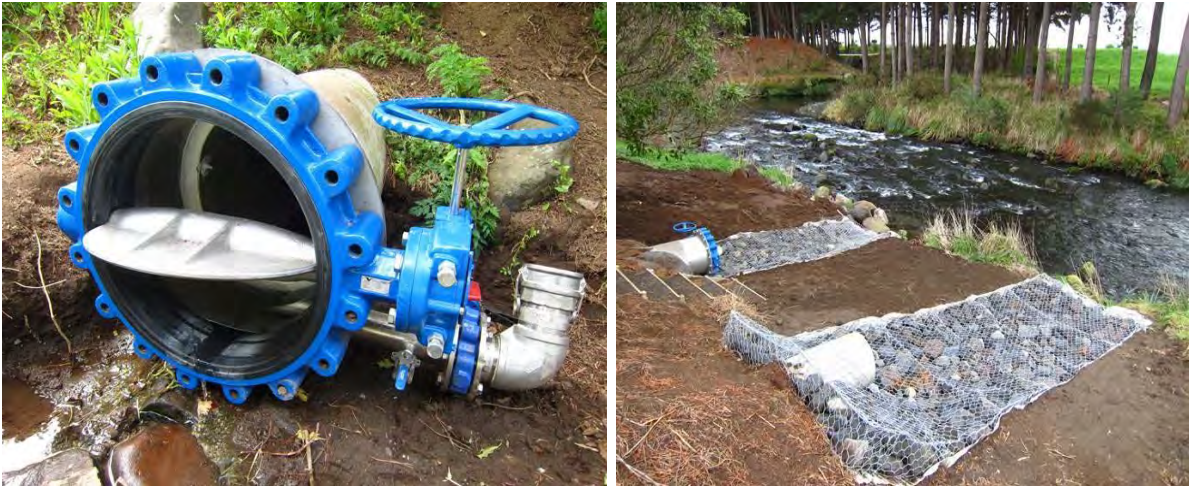
The stormwater outfalls, from the IGL plant installed upstream of the old rail bridge and the detention pond downstream of the cooling water sprayers, did not cause concern during the monitoring period, due to either very low discharge rates or limited contamination of the discharge.

Photo 1 Valve on northern storm drain, and Reno mattresses laid out below storm drains to Kaupokonui Stream

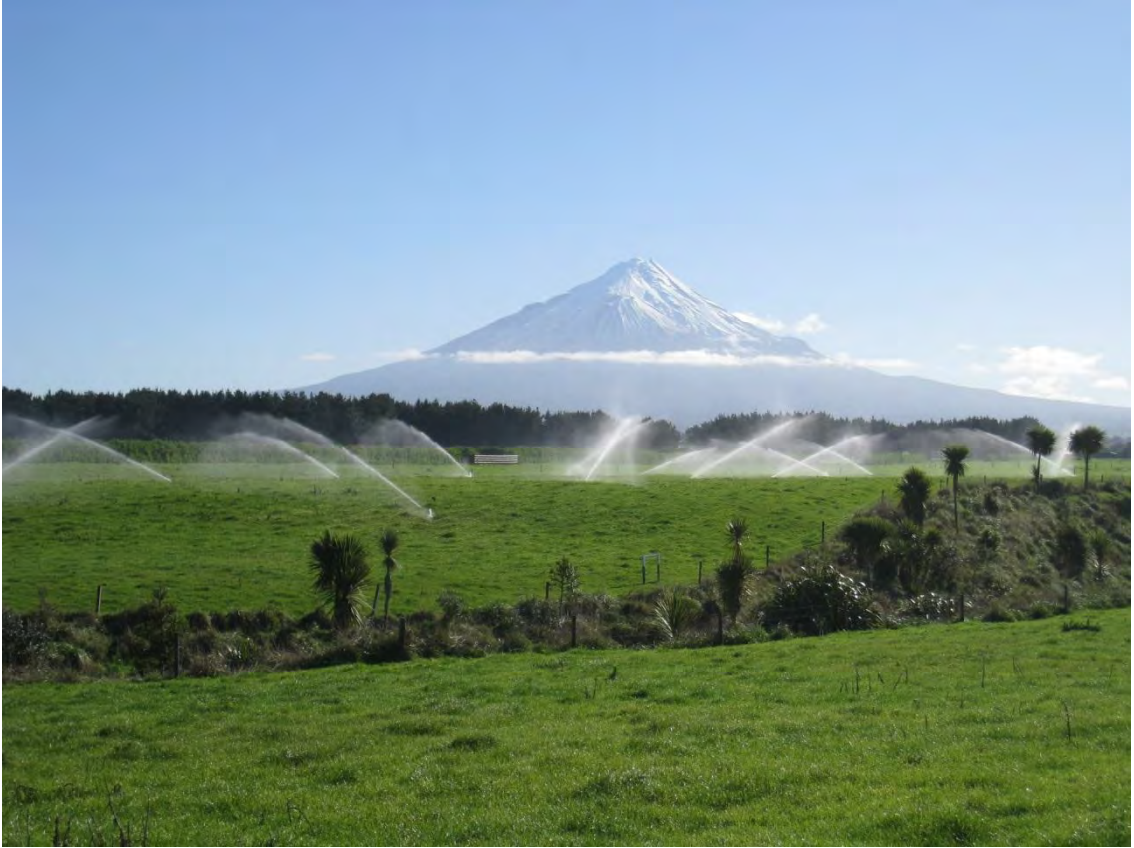
An example of riparian planting is given in Photo 2, along the Waiokura Stream on Farm 2, and about 1.1 km south of Skeet Road (Riparian Management Plan RMP1425). Groundwater monitoring bore GND2050 is situated down-gradient of the fixed-in-place irrigators and up-gradient of the riparian plantings.

Photo 2 Riparian plantings along Waiokura Stream, Farm 2 with fixed irrigators in operation

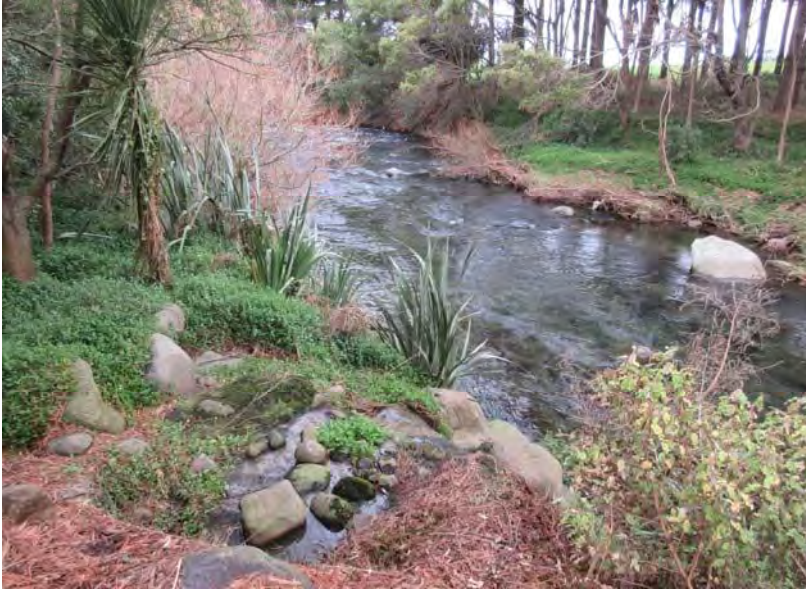
Samples were also collected from the outlet of the stormwater pond (Site STW002078, Table 14 and Photo 3) on six occasions during 2013-2015. The results of the grab samples collected are presented in Table 14. There had been no, or very little, recent rain prior to the collection of samples. The stormwater pond outlet valve was closed on all sampling occasions, suggesting groundwater seepage.

Photo 3 Outfall from stormwater pond to Kaipokonui Stream

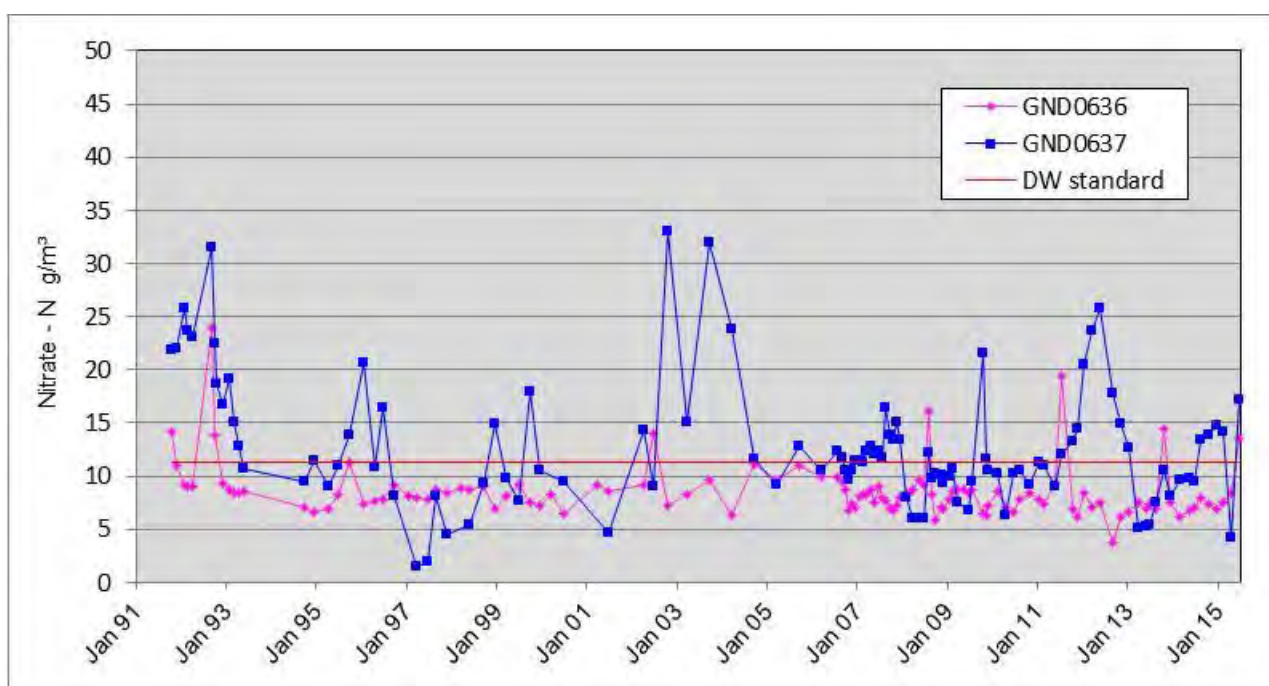
The water quality of the control bore GND0636 groundwater continued to be relatively stable in terms of nitrate. The median nitrate-N concentration of 7.5 g/m³ was lower than the historical median of 8.3 g/m³. Two peaks were recorded, of 14.4 g/m³ in July 2013 and 13.6 g/m³ in June 2015, both when groundwater level was high (this is consistent with the observation that heavy rainfall tends to flush more nitrate into groundwater). Water quality at the impact bore GND0637 showed a marked elevation in sodium (and chloride) and conductivity levels when compared with the control bore, consistent with the effect of leaching of wastewater from spray irrigation disposal to shallow groundwater. Sodium concentration appears to be reducing, overall (refer to Table 20). COD at the impact bore fluctuated, within previously recorded values, increasing when groundwater level fell.

Figure 8 Trends in groundwater Nitrate-N concentration at Farm 1

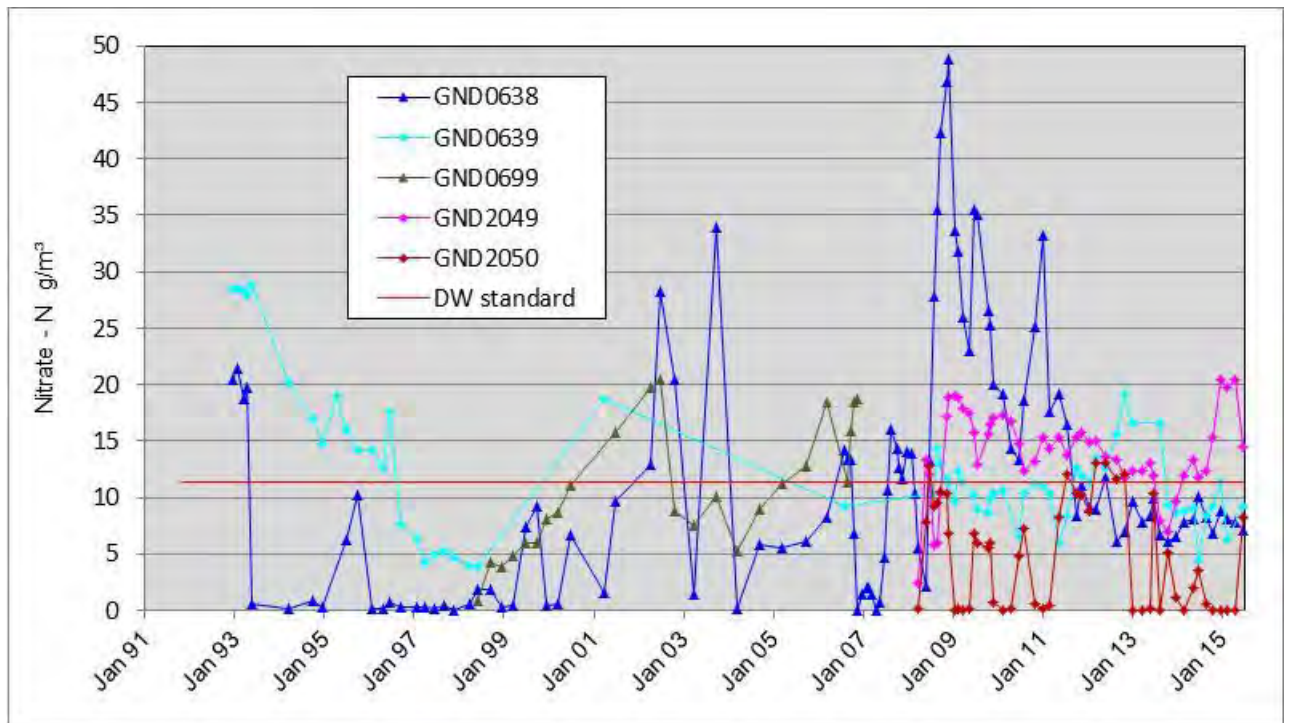
At the new impact bore beside the Waiokura Stream, GND2050, nitrate-N concentration appears to fluctuate with groundwater level, being in the range 3 to 13 g/m³ during winter and spring over the total record, and falling to <1 g/m³ in summer and autumn. Mineral levels were significantly higher than at the control bore.

Figure 9 Trends in groundwater Nitrate-N concentration at Farm 2

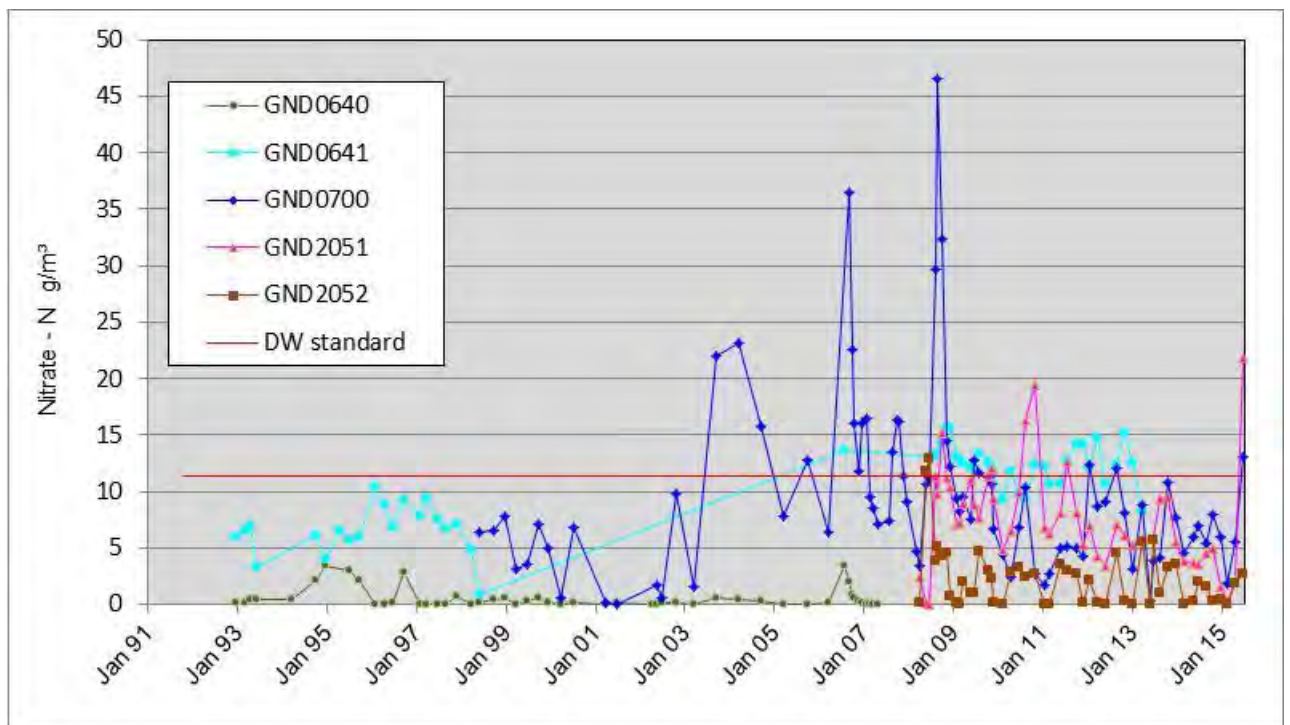
Figure 10 Trends in groundwater Nitrate-N concentration at Farm 3

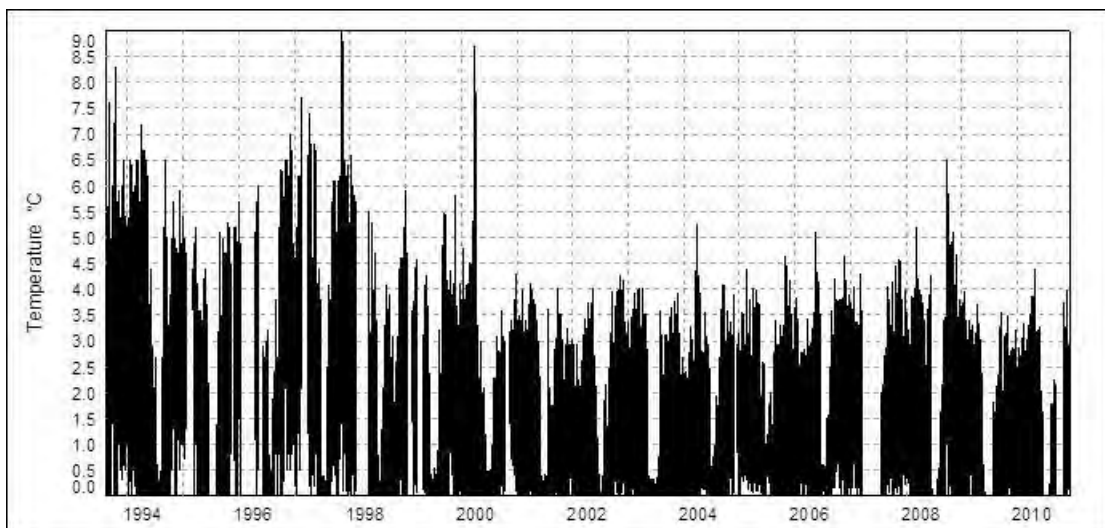
In January 2011, the Council stopped monitoring temperature differential across the width of the stream, after continuous monitoring (at 15-minute intervals with very occasional disruption) since August 1993. The record is depicted in Figure 11. The monitoring ceased for two reasons. First, there was an unacceptable risk to the safety of the personnel who climbed down the stream bank and waded to the monitoring sites. Secondly, while temperature measurement along the length of the mixing zone was continued by the Company, transverse monitoring was no longer considered necessary, as disruption to fish passage was not expected to occur because significant periods of cooler water conditions had been demonstrated towards the right bank of the stream and there was gradual mixing of the cooling water discharges with the receiving water.

Figure 11 Kaupokonui Stream water temperature differential (LB-RB) records at the periphery of the Fonterra Kapuni spray cooling water discharge zone, 1993-2010

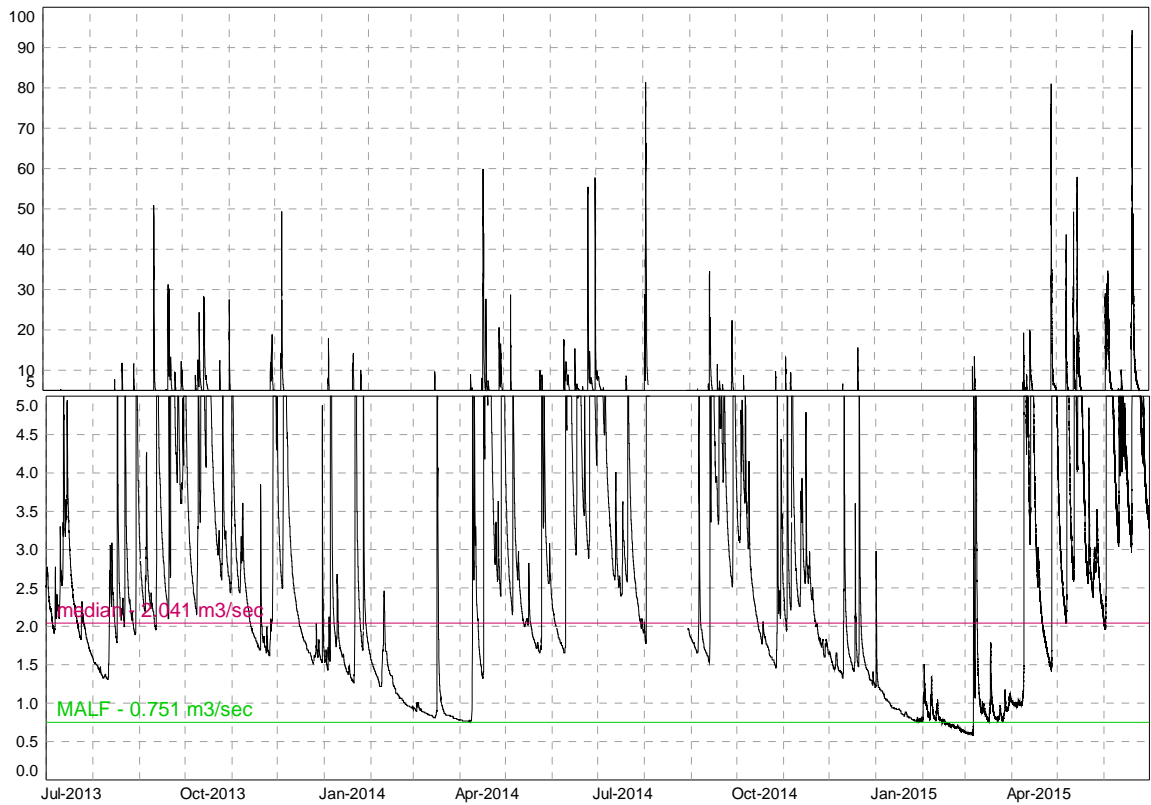
Figure 12 Kaupokonui Stream at Glenn Road flow record (m³/s) for period 1 July 2013 to 30 June 2015

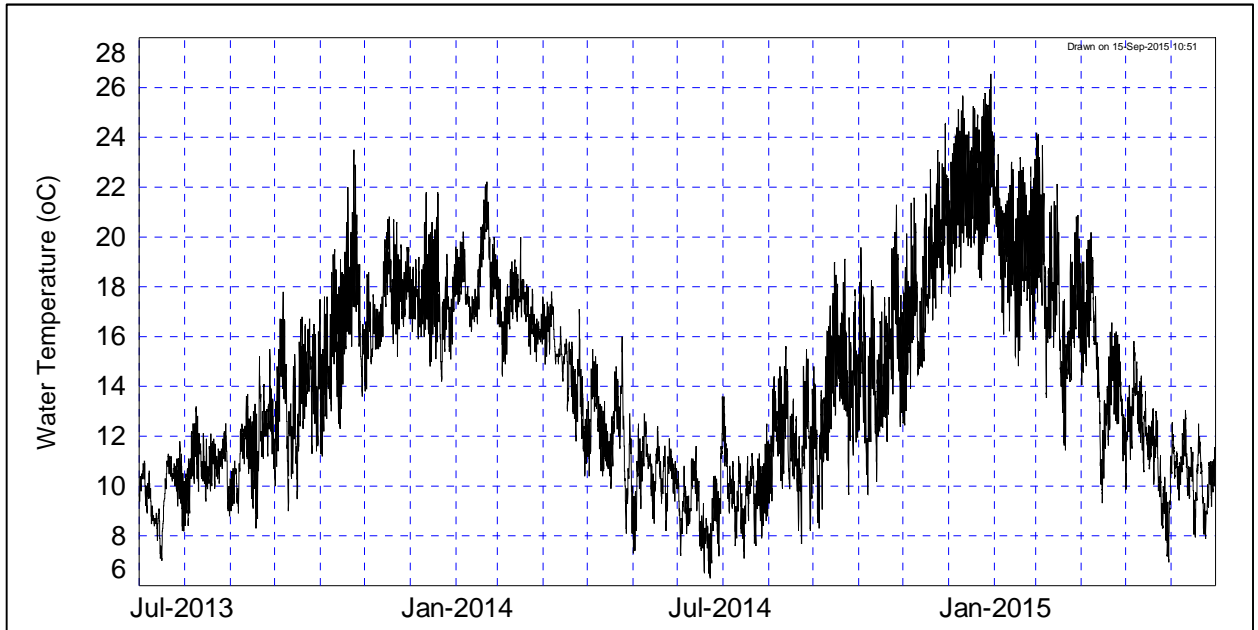
Figure 13 Water temperature (°C) records for the Kaupokonui Stream at Glenn Rd during the period 1 July 2013 to 30 June 2015

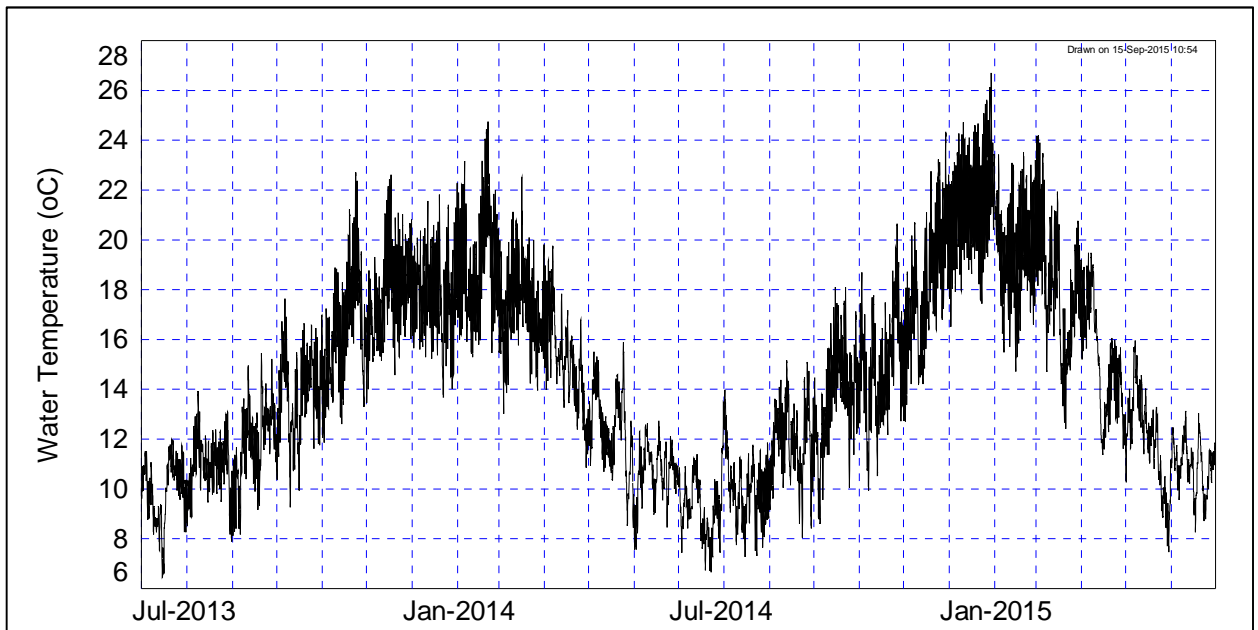
Figure 14 Water temperature (°C) records for the Kaupokonui Stream at beach during the period 1 July 2013 to 30 June 2015

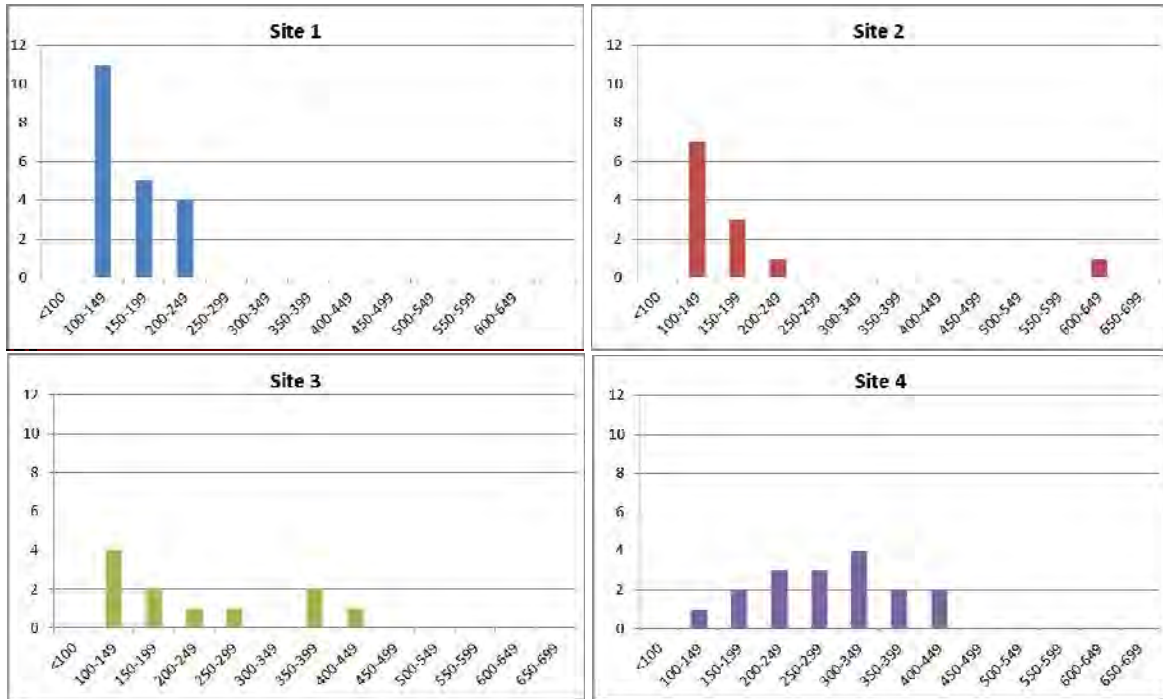
Figure 3 The size of range of eels recorded at each site

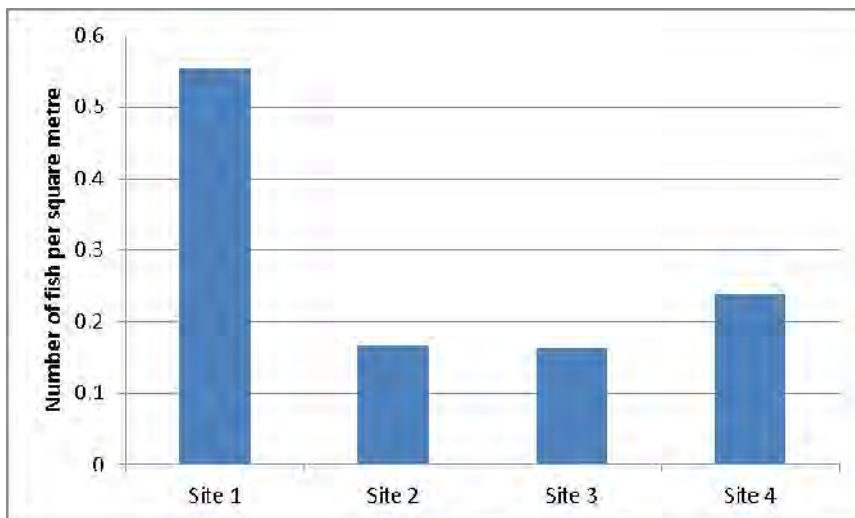
Only two species were recorded at sites 1 and 2, while site 3 recorded three species, and four species were recorded at site 4. Longfin eel and shortfin eel were recorded both upstream and downstream of the weir, while redfin bully were only recorded downstream of the weir, and in very low abundance. A juvenile rainbow trout was recorded at site 3, and freshwater crayfish were recorded at all sites, being most abundant at site 2. This low species abundance, and also low redfin bully abundance is an indication that the Glenn Road weir is still having a significant deleterious effect on upstream fish migration. Although only two species were recorded upstream of the Kapuni Lactose weir, there is no indication that this weir is posing a significant barrier to fish passage. There were good numbers of juvenile eels recorded upstream of the weir (Figure 3), and no evidence of fish accrual immediately downstream of the weir (Figure 4). This would have been evident by higher fish abundance per square metre at site 2 than any other site, especially site 1.

Figure 4 The average number of fish recorded per square metre sampled at each site

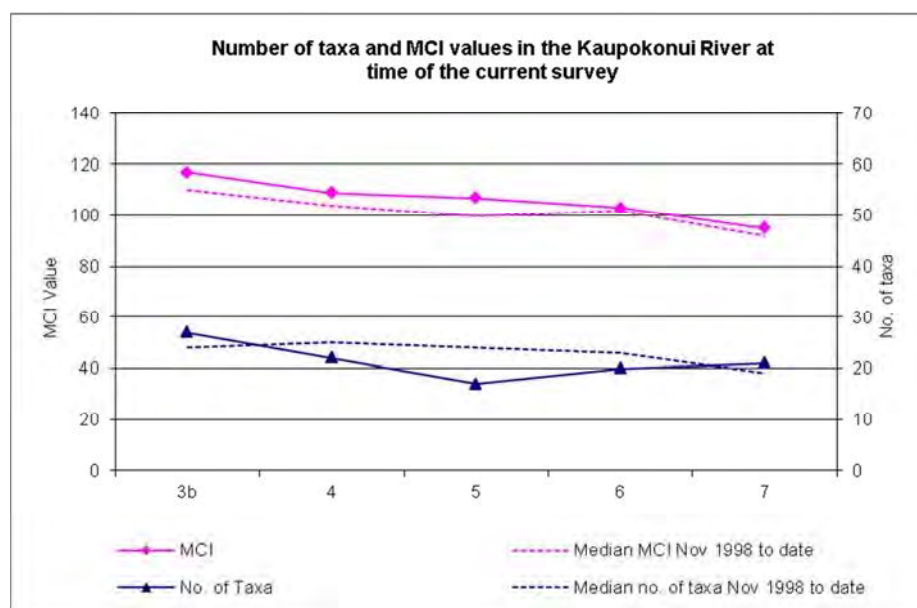
The 'fair' to 'good' MCI scores did not reflect the results of the microscopic scan for undesirable biological growths, which recorded such growths at sites 5 and 6. This indicates that although the cooling water discharge was facilitating the growth of sewage fungus, it either had not been occurring for very long, and/or was not causing sufficient deterioration in water quality that caused a reduction in macroinvertebrate community health. The last time such growths were noted in the Kaipokonui River was during the spring 2010 survey, which found dense growths of filamentous bacteria at two sites.

Figure 2 Numbers of taxa and MCI values recorded in the Kaipokonui River in this survey, together with median values from previous surveys (November 1998 to date)

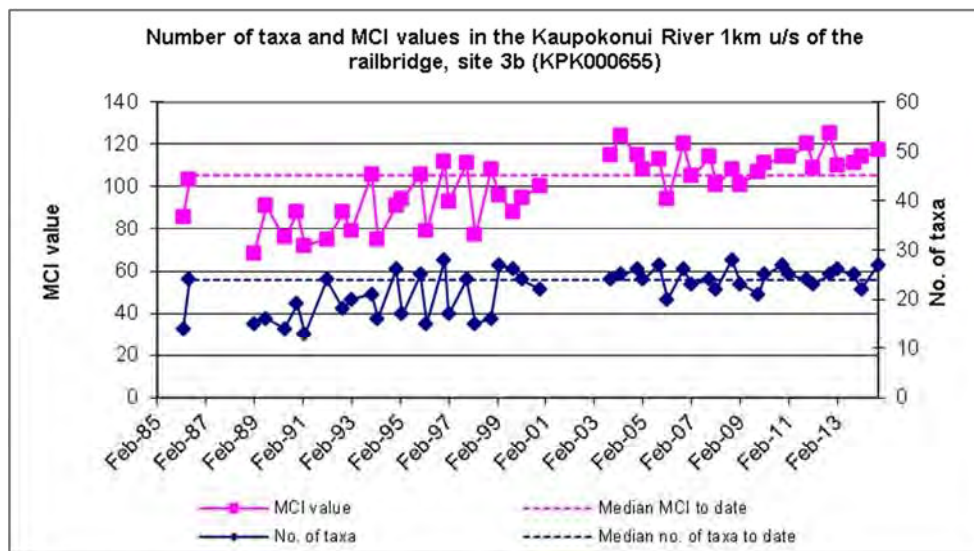
The moderate proportion of 'tolerant' taxa in the community (26% of taxa richness) was reflected in the MCI score (117) which was similar to the previous summer (2014) survey score and six units higher than the previous spring score at this site (Figure 3). The presence of eight 'highly sensitive' taxa indicated good preceding physicochemical water quality at this control site, above all Fonterra activities in the Kaupokonui River catchment.

Figure 3 Numbers of taxa and MCI values recorded at site 3b in the Kaupokonui River since 1985

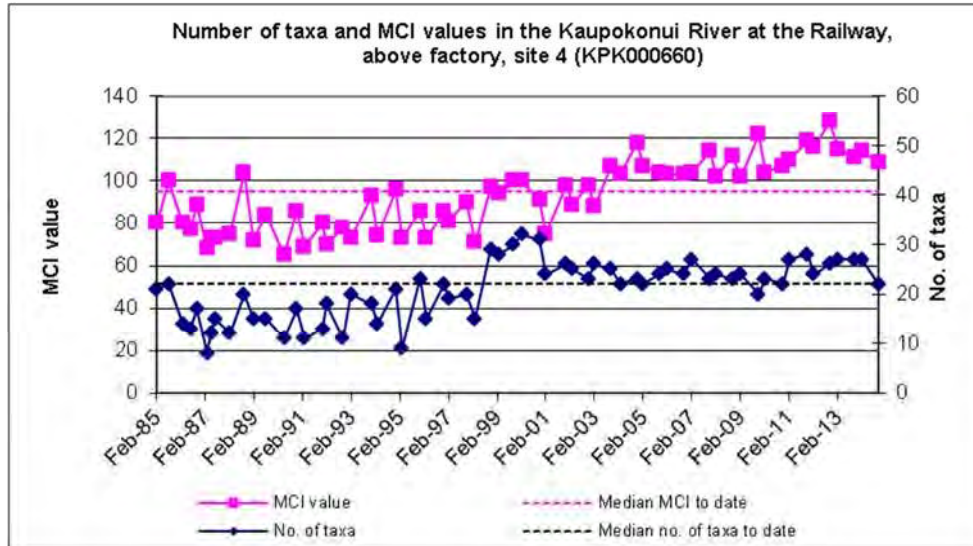
The community was characterised by one 'highly sensitive' taxon [mayfly (*Deleatidium*)]; five 'moderately sensitive' taxa [mayfly (*Coloburiscus*), elmid beetles, dobsonfly (*Archichauliodes*), free-living caddisflies (*Costachorema*), and crane fly (*Aphrophila*)]; and four 'tolerant' taxa [oligochaete worms, net-spinning caddisfly (*Aoteapsyche*), and midges (orthoclads and *Maoridiamesa*)]. Only three taxa showed a significant change in abundances between sites 3b and 4 (Table 3).

Figure 4 Numbers of taxa and MCI value recorded at site 4 in the Kaipokonui River since February 1985

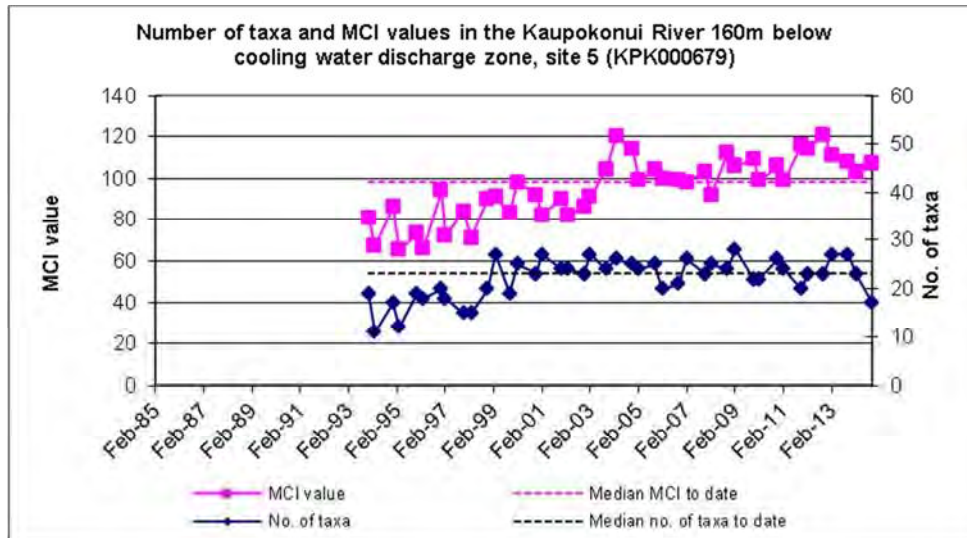
The community was characterised by one 'highly sensitive' taxon [mayfly (*Deleatidium*)]; one 'moderately sensitive' taxon [mayfly (*Coloburiscus*)]; and two 'tolerant' taxa [midges (*Maoridiamesa* and orthoclads)] (Table 3). This represents a reduction in the number of abundant taxa from that recorded in the previous (summer 2014) survey.

Figure 5 Numbers of taxa and MCI values recorded since December 1993 at site 5 in the Kaipokonui River

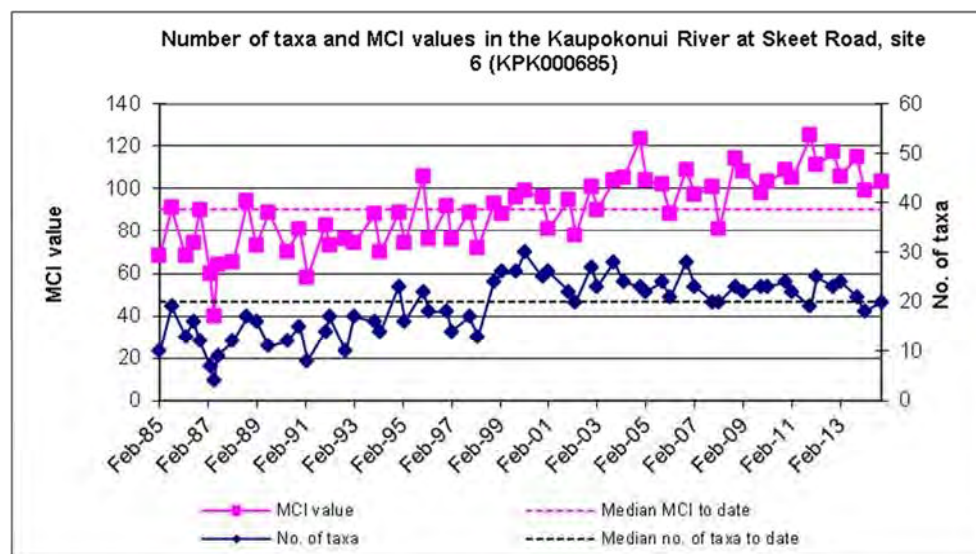
An increased richness of twenty taxa was recorded at site 6, at Skeet Road, a further 700 m below the cooling water discharges. This was three taxa fewer than the median number of taxa since 1998 for this site but equal to the historical median. It was however three taxa more than found at the nearest upstream site 5 (Table 2, Figure 2 and Figure 6).

Figure 6 Numbers of taxa and MCI values recorded at site 6 in the Kaipokonui River, at Skeet Road, since February 1985
