Lower Waiwhakaiho Catchment  
Monitoring Programme  
Annual Report  
2014-2015

Technical Report 2015-114

May 2016

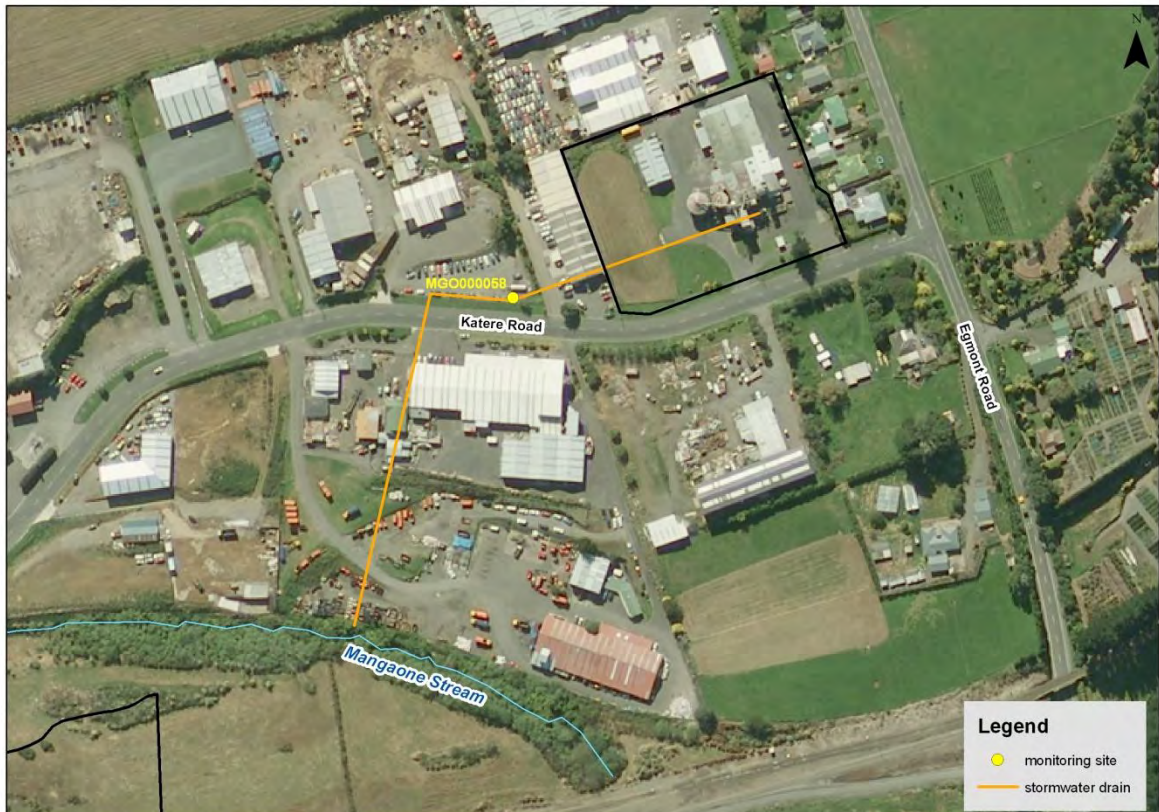
Figure 7 Viterra (NZ) Limited site and sampling point locations

The New Plymouth Feed Mill now owned by Farmlands Co-operative Society Limited (Farmlands) had been in operation on this 1.03 ha site at the eastern end of Katere Road, New Plymouth from 1966 to 2011. Raw grain and supplements were processed into feed for central North Island divisions of PCL Industries Limited and then Viterra (NZ) Limited.

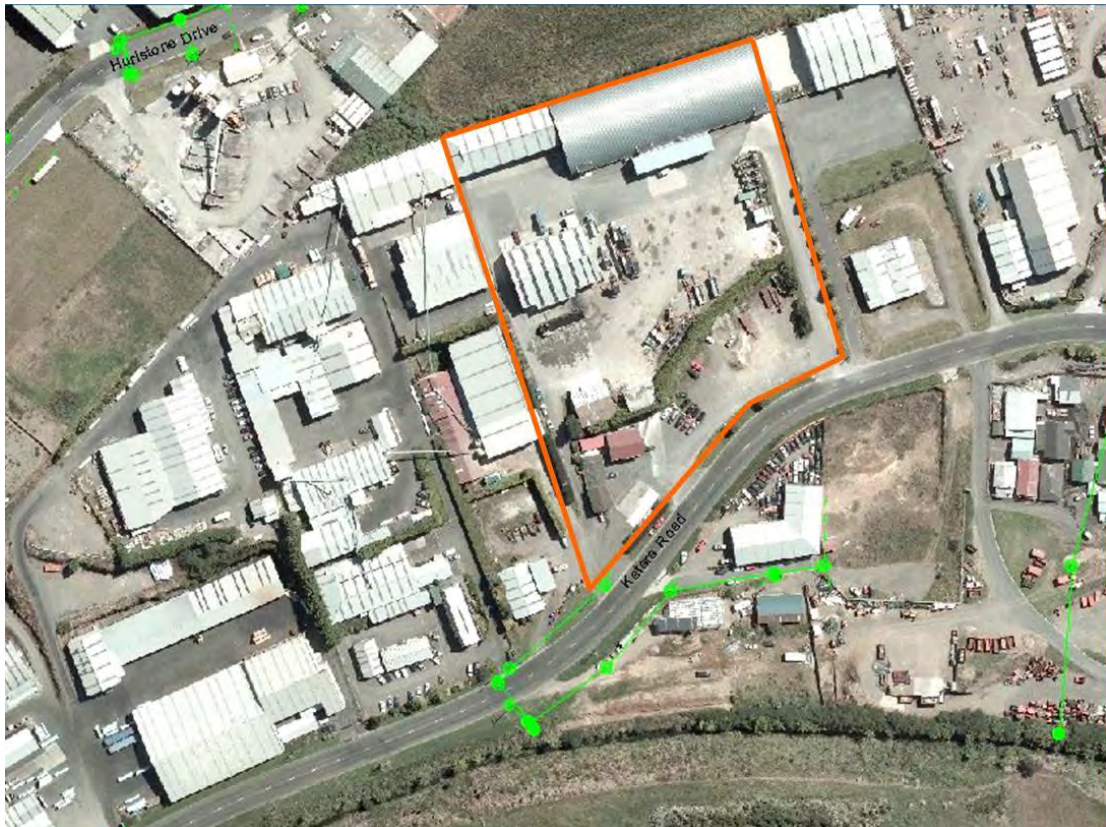
**Figure 11** Location of Freight and Bulk Transport Holdings site

Freight and Bulk Transport Holdings Limited (FBT) operate a truck depot that services the rural sector from this 1.77 ha site on Katere Road.

The Company stores, blends and distributes dry stock feeds such as crushed meal, palm kernel and grains. Lime, fertiliser and gravel used for farm races are also stored at the site. The lime, stock feeds and fertilisers are stored in the sheds at the northern end of the site; only the gravel is stored outside in the stormwater catchment. Trucks are washed at the site and the wash water is directed to soak holes.

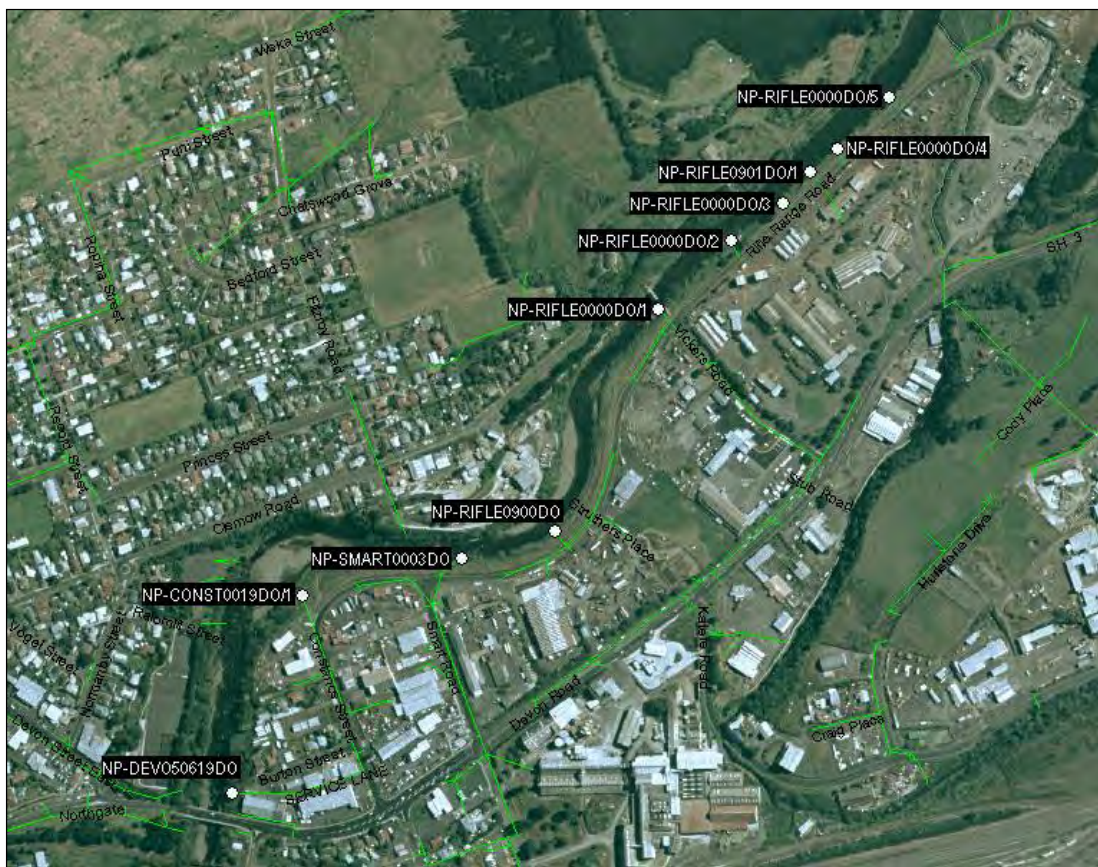
Figure 13 NPDC stormwater drainage and consented discharge points to the Waiwhakaiho River

New Plymouth District Council (NPDC) holds consents to discharge stormwater to the lower Waiwhakaiho River and Mangaone Stream, and to discharge rubbish dump leachate to groundwater and the Waiwhakaiho River from an industrial development off Bewley Road. The catchment areas and discharge points associated with the stormwater consents are shown in Figure 13 and Figure 14. The results for the stormwater and leachate discharge monitoring are reported on separately.

NPDC holds two resource consents in relation to discharges to the Lower Waiwhakaiho River below State Highway 3, and one consent in relation to discharges to the Mangaone Stream.

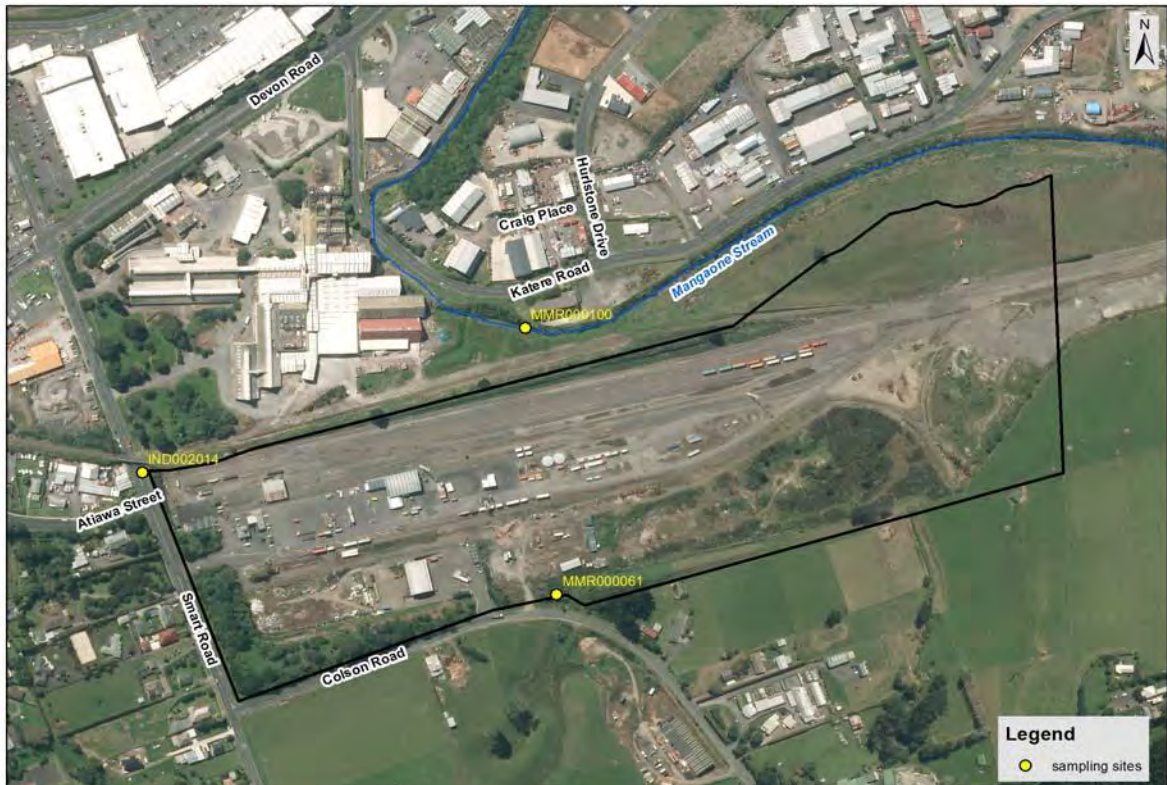
**Figure 16** New Zealand Railways Corporation's rail yard and sampling point locations

New Zealand Railways Corporation (NZRC) owns a rail terminal on a site off Smart Road. In addition to transportation of freight, the terminal is utilised as a maintenance depot. The freight receipt and dispatch area and the refuelling and maintenance depots are situated at the Smart Road end of the site. The various activities undertaken at the site are carried out by the subsidiaries: Ontrack, Kiwi Rail, United Group Rail, and Toll Tranzlink, and Transfield Services.

Drainage from the area to the west and north of the offices (i.e. the refuelling area and maintenance area) flows to the Waiwhakaiho River via McLeod's Drain, an underground pipe that also receives stormwater from Ravensdown's fertiliser depot, other industrial sites, a residential area, and a rural area. Wastewater from washing of wagons, containers and locomotives is treated in a three-stage oil separator before discharge to the river. Liquids from the repair depot and locomotive fuelling point are discharged to an underground holding tank that is emptied by a waste disposal company at two-monthly intervals. The holding tank is also connected to the oil separator via an automatic pump in case of overflowing.

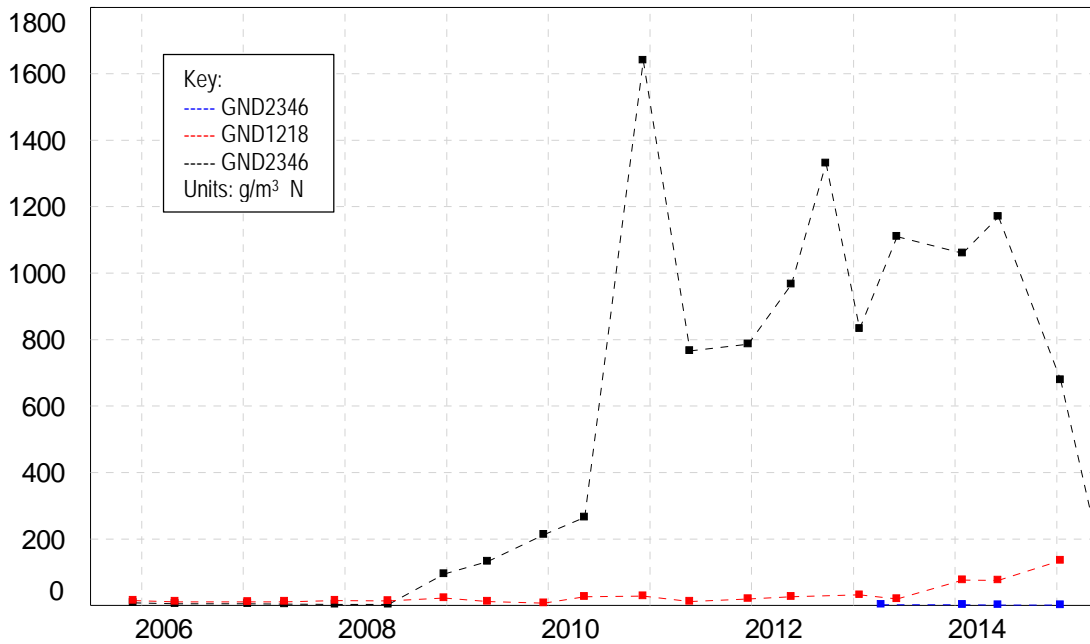
Samples taken from the new bore (GND2346) used in place of GND1342 returned results significantly lower than the range of results previously reported for GND1342.

**Figure 18** Ammoniacal nitrogen concentration at sites GND1218, GND1218 and GND2346 from June 2002 to June 2015

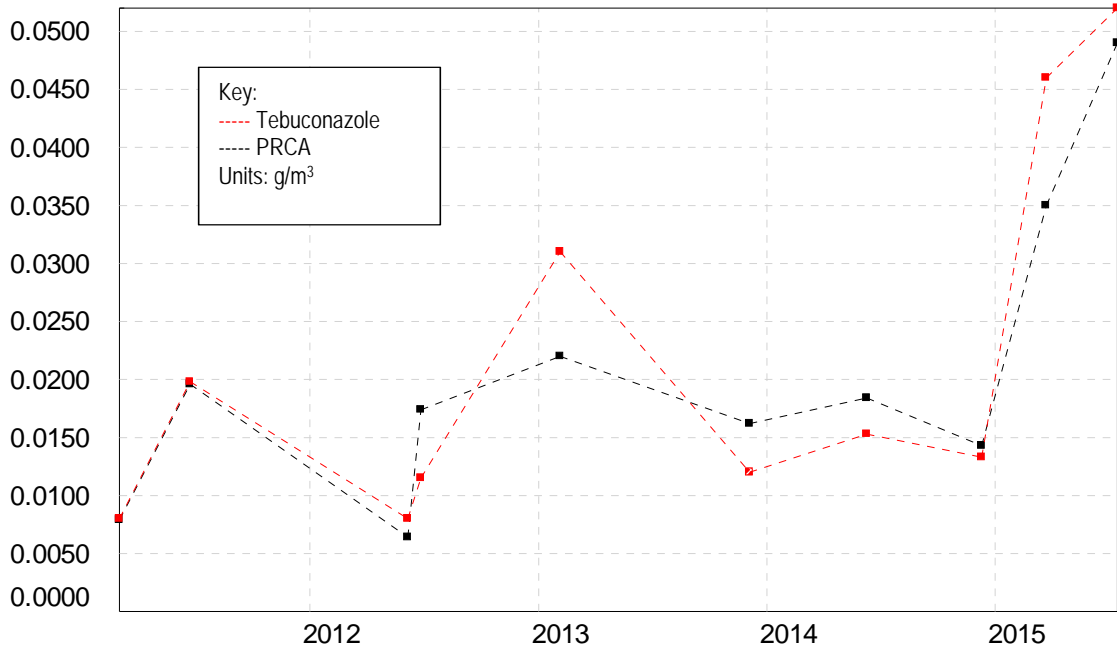
Figure 20 Tebuconazole and Propiconazole concentrations TSM's discharge-site IND001006

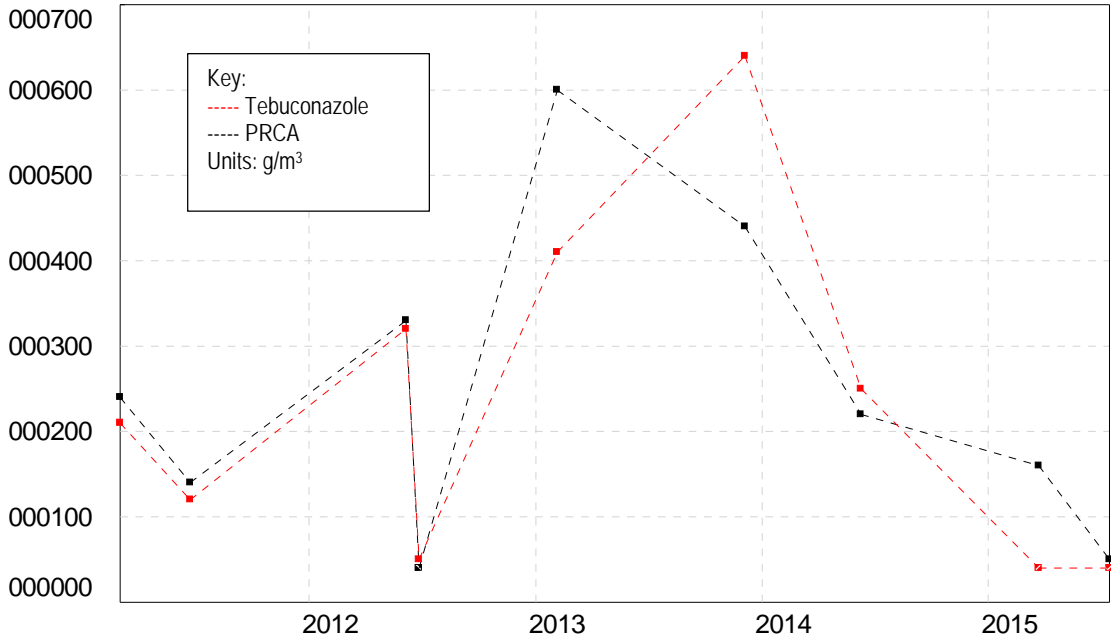
Figure 21 Tebuconazole and Propiconazole concentrations downstream of TSM's discharge

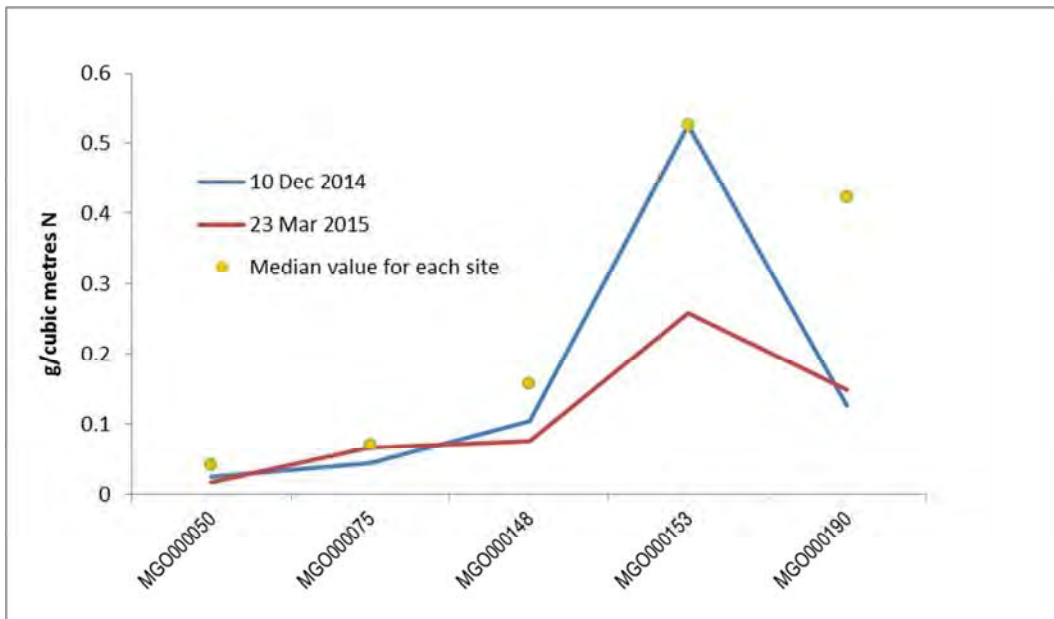
**Figure 23** Longitudinal profiles of NH<sub>4</sub>-N in the Mangaone Stream

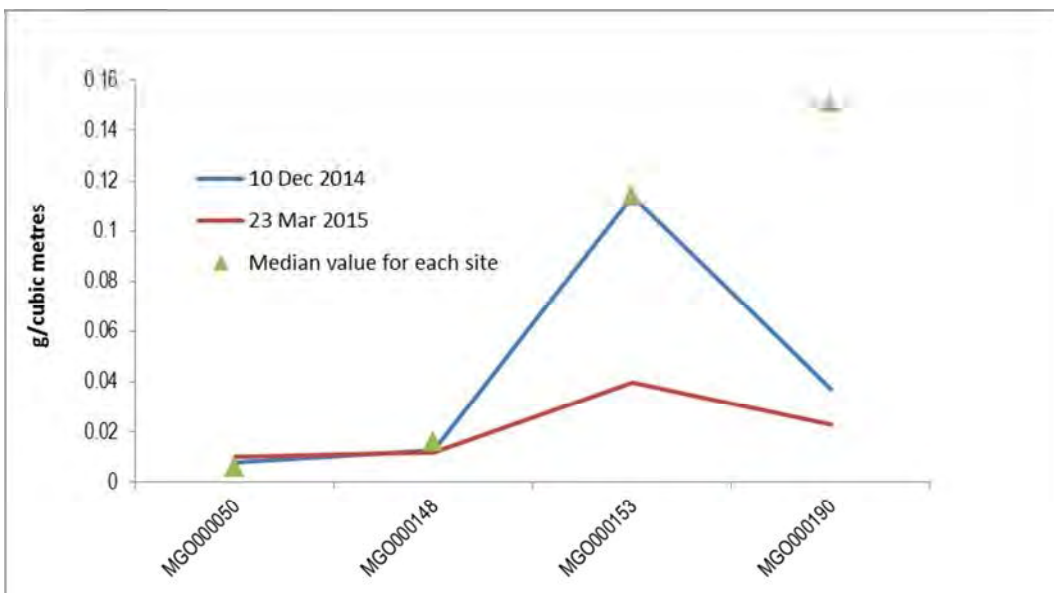
Ravensdown decommissioned and demolished the rock store. In the event that the site is completely demolished and remediated it is expected that phosphorus levels will improve.

**Figure 24** Longitudinal profiles of DRP in the Mangaone Stream

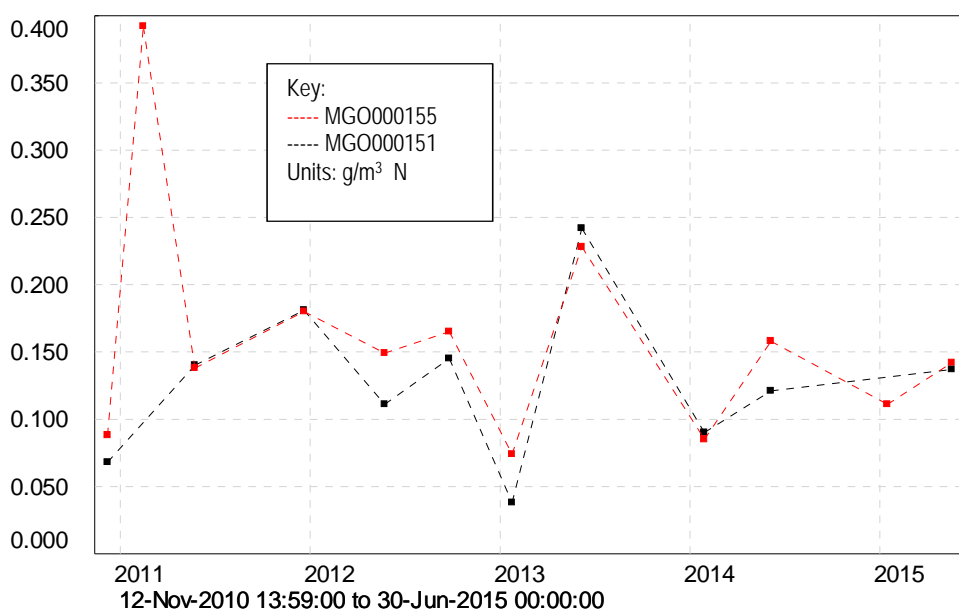
During the period under review dry weather monitoring was undertaken in the Mangaone Stream in conjunction with monitoring of the groundwater in the vicinity of the Ravensdown site (Section 12.3.3.3). The two sites monitored were MGO000151, approximately 20 m downstream of the Ravensdown rear drain, and MGO000155, approximately 15 m downstream of the Katere Road bridge. As this monitoring is predominantly carried out to assess potential effects from the Ravensdown store, the full results of these surveys are reported in Section 12.3.3.3, Table 49. Due to elevations in the ammoniacal nitrogen concentration observed in a Ravensdown bore on Katere Road, this is the parameter of primary interest here and **Error! Reference source not found.** shows the trends in ammoniacal nitrogen concentrations at the upstream and downstream sites.

**Figure 25** Mangaone Stream ammoniacal nitrogen concentrations in the vicinity of the Ravensdown site under dry weather conditions 2010-2015

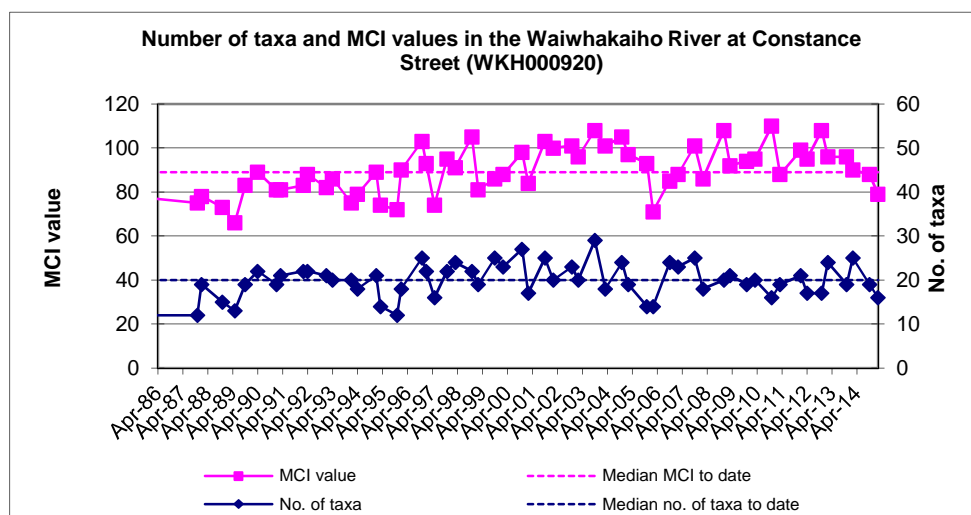
A moderate taxa richness (16 taxa) was found at this site, upstream of all discharges from the Fitzroy industrial area. This was four taxa less than the median richness for this site (Table 2 and Figure 2), but within the range of previous richnesses.

**Figure 2** Numbers of taxa and MCI values for Waiwhakaiho River at Constance Street since 1987

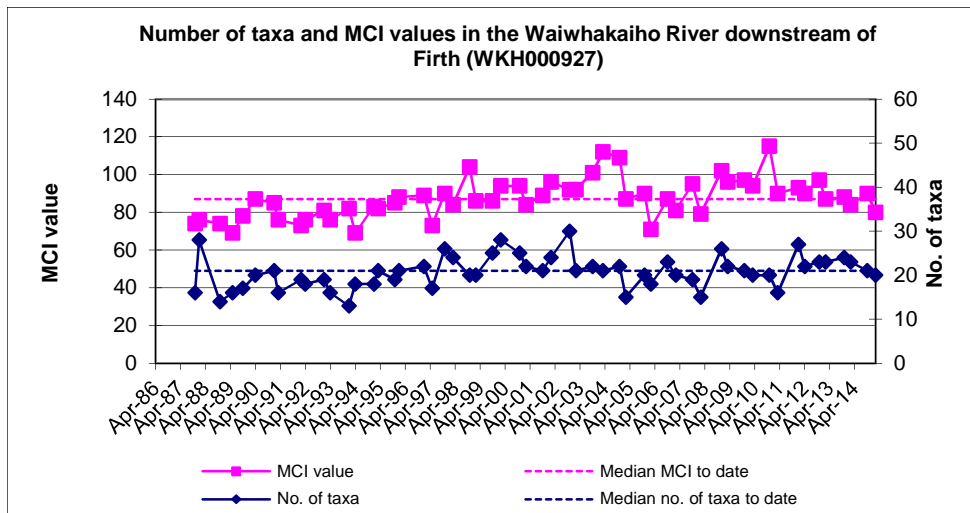
This site also had a moderate community richness (20 taxa), one taxon less than the historical median at this site (Table 2 and Figure 3).

**Figure 3** Numbers of taxa and MCI values for Waiwhakaiho River below Firth Industries (left bank) since 1987

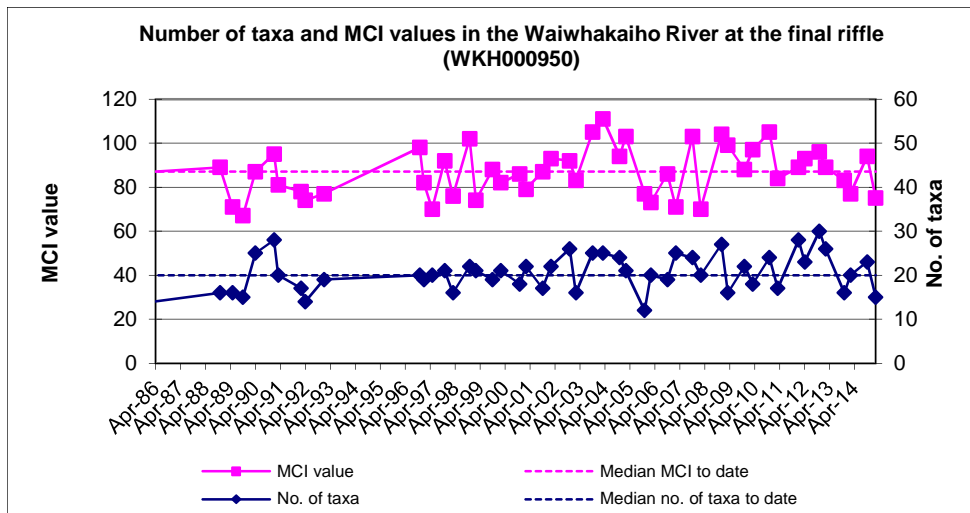
A moderate richness of 15 taxa was found at this site, situated downstream of all industrial discharges to the lower catchment, within a reach where high tides may slow river current speeds (and very occasionally increase salinity) near the river mouth. This richness was eight taxa less than that recorded by the previous spring survey and five taxa less than the historical median richness, but four taxa more than recorded at the site below Firth Industries (8) upstream (Table 2 and Figure 4).

**Figure 4** Numbers of taxa and MCI values for Waiwhakaiho River d/s of Lake Rotomanu since 1987

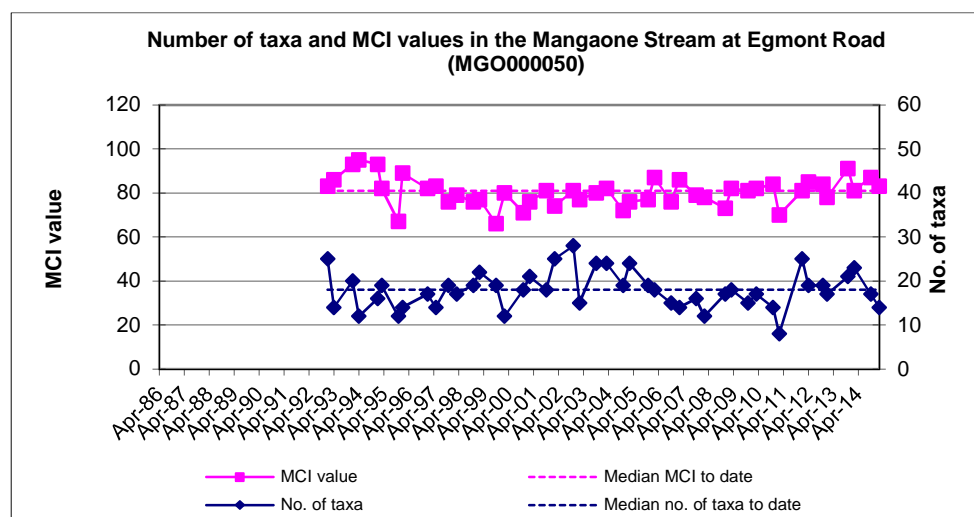
A moderate community richness (14 taxa) was found amongst the vegetation and the soft silt- bottomed habitat of this site. This was four taxa less than the median richness for this site and three taxa less than found by the previous spring (2014) survey (Table 2 and Figure 5). This may indicate a return to continually below median community richness, a trend recorded from 2006 to 2011 (Figure 5).

**Figure 5** Number of taxa and MCI values for Mangaone Stream at Egmont Road since 1992

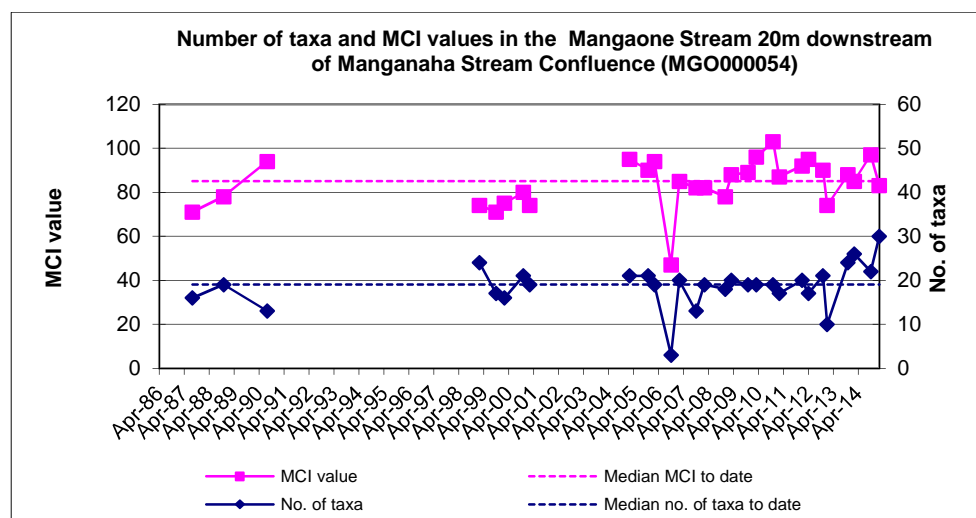
There were many significant changes in individual taxon abundances between adjacent sites 12 and 16 with the most significant including increased abundances of two 'tolerant' taxa [oligochaete worms and snail (*Potamopyrgus*)] a decrease in 'tolerant' dixid midges and an increase in 'sensitive' elm mid beetles. The changes recorded at this site (when compared with site 12) were coincident with an increase in periphyton substrate cover and decrease in aquatic vegetation, at the downstream site, increased hard-gravel substrate, and the resultant partial change in sampling technique.

**Figure 6** Numbers of taxa and MCI values for the Mangaone Stream downstream of the confluence with Manganaha Stream since 1987

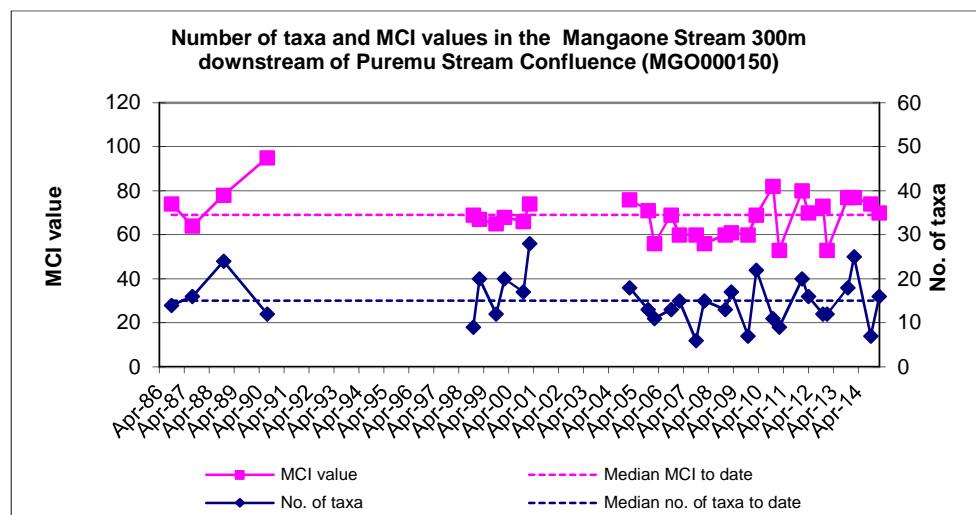
Earlier surveys had noted extensive filamentous algal growth at this site. Although not as apparent during several more recent surveys, such growth was patchy at the time of the current survey and aquatic vegetation was also present. This may indicate that the surveyed riffle has become more stabilised with reduced substrate turnover during high flows, allowing for greater periphyton establishment.

**Figure 7** Numbers of taxa and MCI values for Mangaone Stream downstream of the confluence with Puremu Stream since 1986

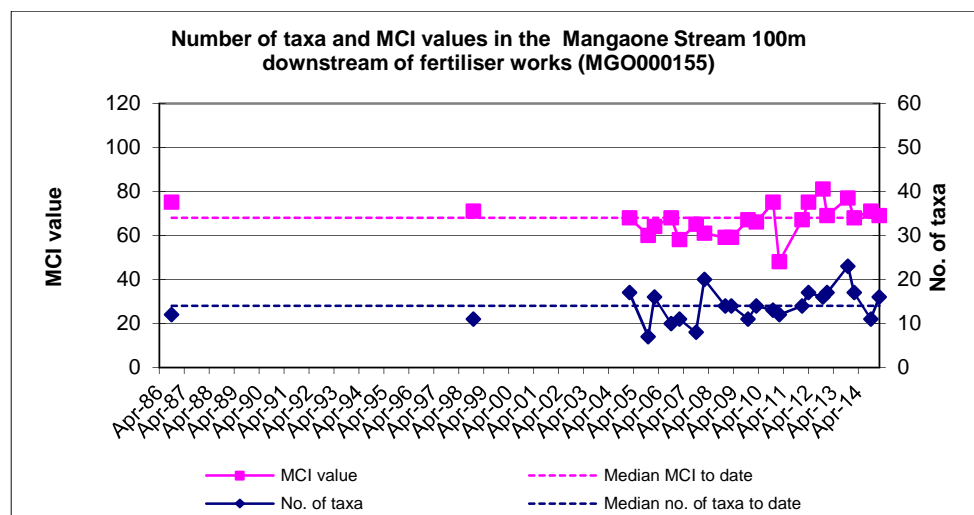
A moderate richness (16 taxa) was also recorded at this site, 100 m downstream of the discharges from the fertilizer depot. This richness was slightly above the median historical richness and slightly above that recorded by the previous spring survey (Table 2).

**Figure 8** Numbers of taxa and MCI values for Mangaone Stream 100 m downstream of the fertilizer works/depot since 1986

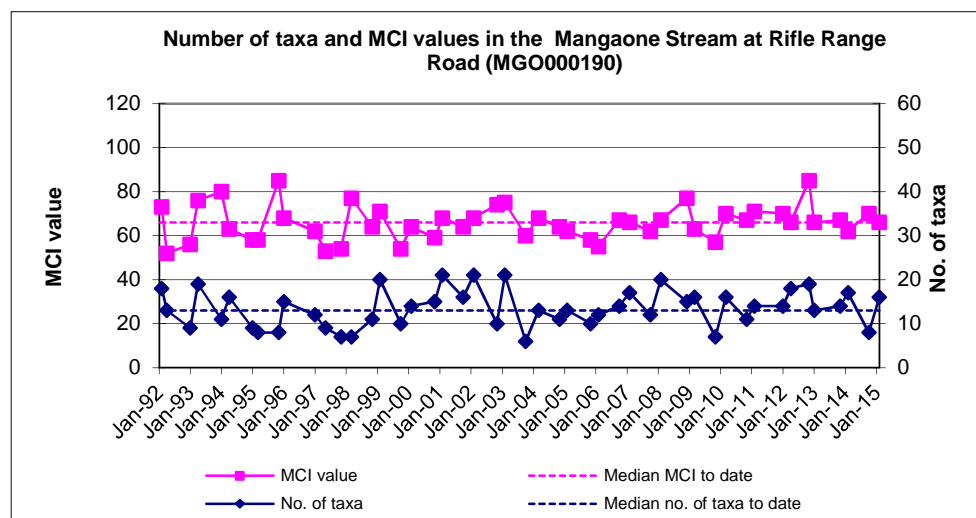
stony habitat taxa as the majority of the upstream habitat is softer-bottomed and weedy. Deterioration in physicochemical water quality between sites 12 and 11 may also have been a factor, as this reach, which runs through an industrial catchment, receives several stormwater discharges including localised run-off.

**Figure 9** Numbers of taxa and MCI values for Mangaone Stream at Rifle Range Road since 1992

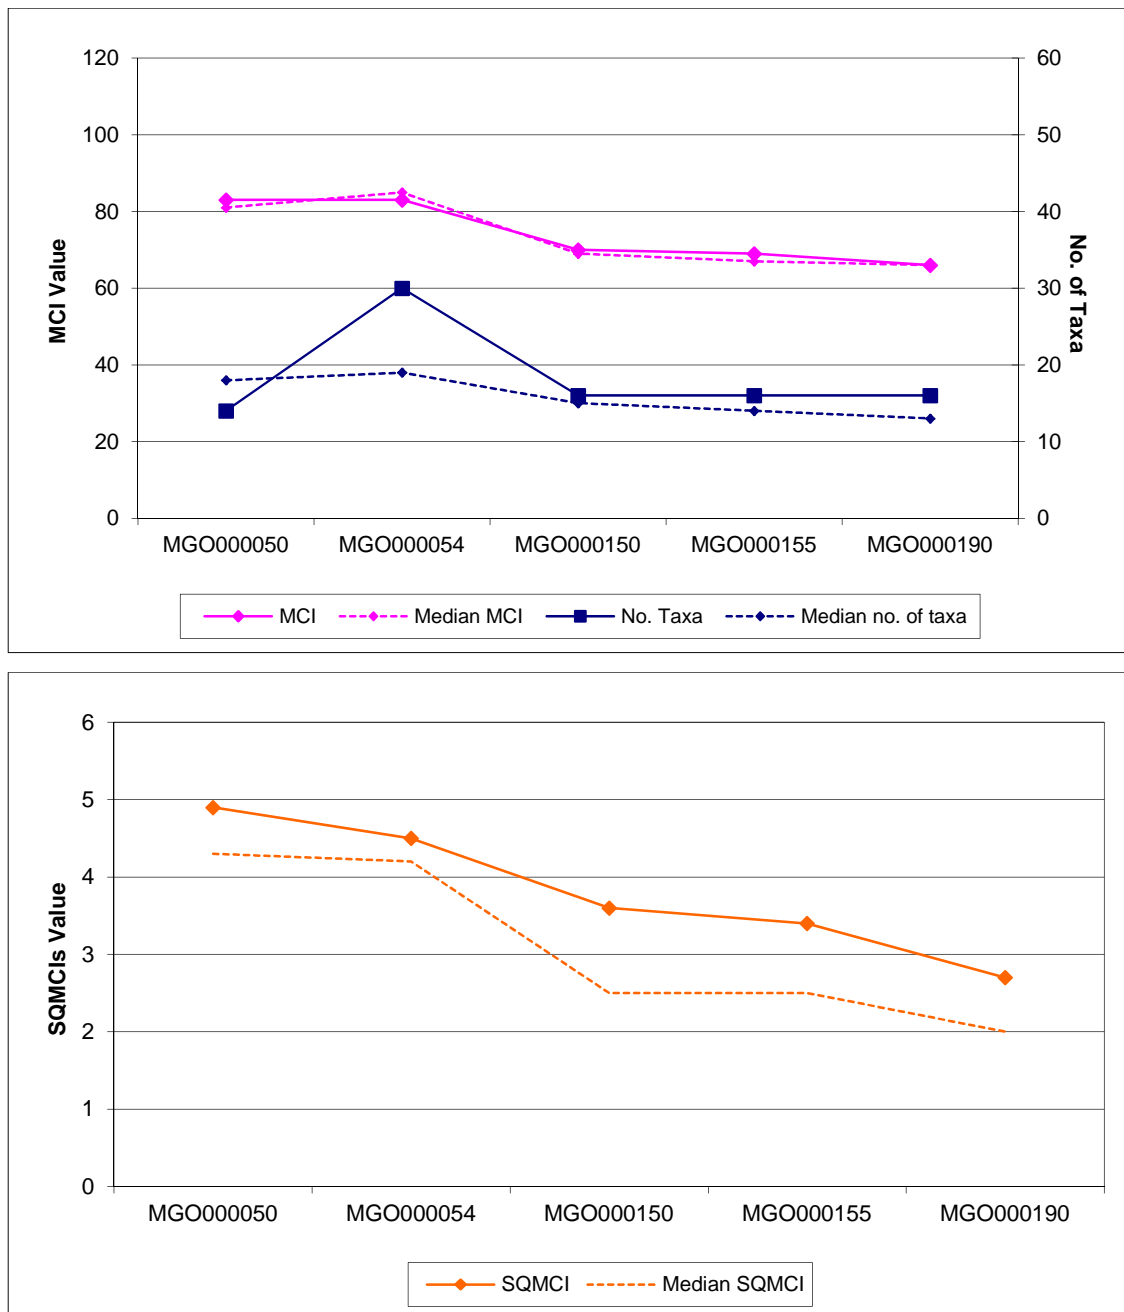
The longitudinal trends in the number of taxa, MCI and SQMCI<sub>s</sub> values along the reach of the Mangaone Stream surveyed in February 2015 are illustrated in Figure 10.

**Figure 10** Longitudinal trend in number of taxa, MCI and SQMCI<sub>s</sub> values in the Mangaone Stream for the survey of 12 February 2015

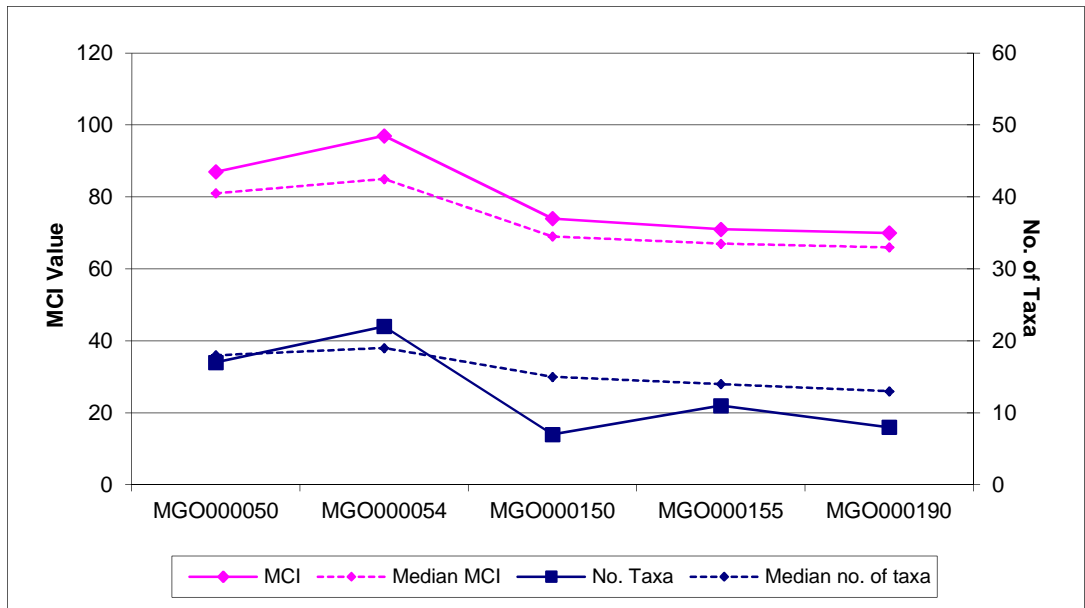
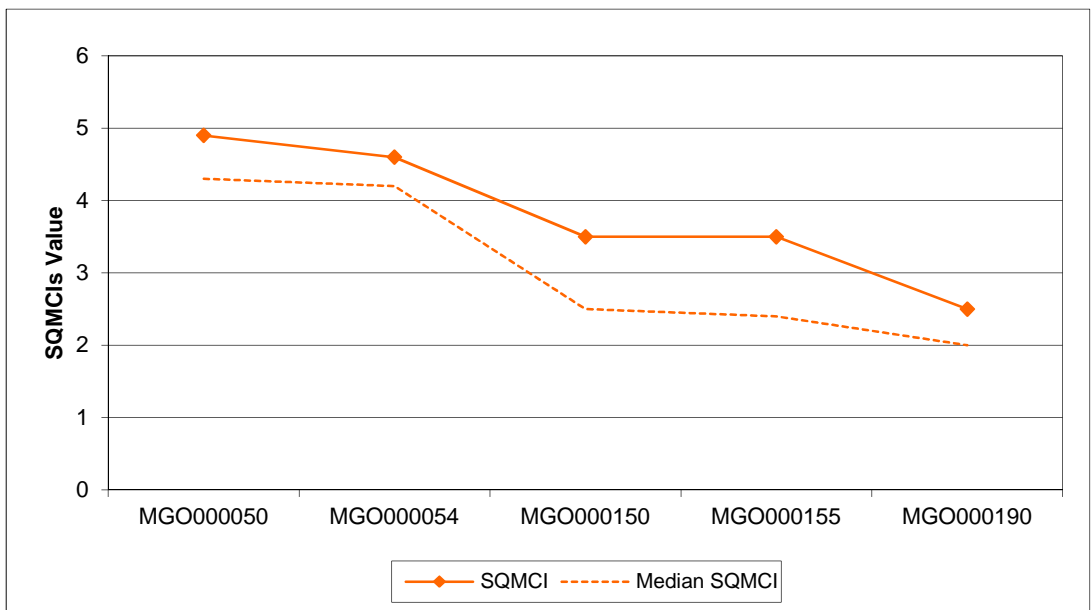
**Figure 9** Longitudinal trend in number of taxa, MCI and SQMCI<sub>s</sub> values in the Mangaone Stream for the survey of 16 October 2014
