Todd Energy Aquatic Centre
Monitoring Programme
Annual Report
2014-2015

Technical Report 2015-13

Taranaki Regional Council
Private Bag 713
STRATFORD
September 2015

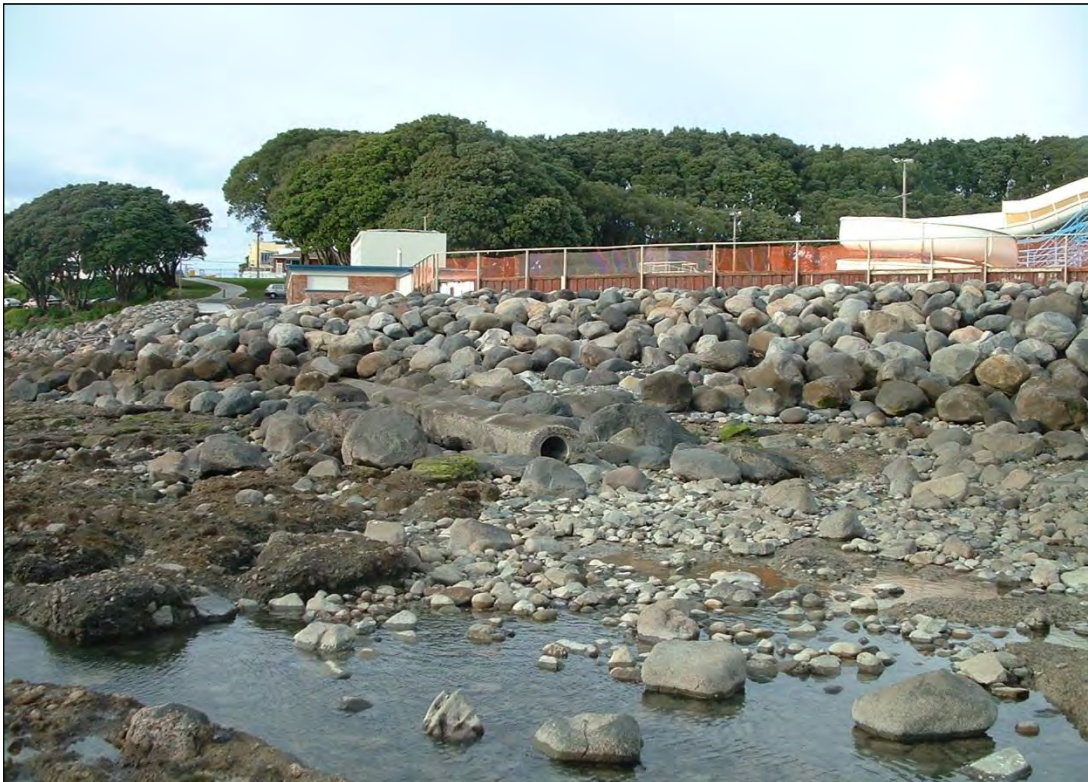
The discharge pipe consists of a 300 mm diameter encased concrete pipe and discharges at approximately mid-tide level. This structure was constructed in 1962 and has been in use ever since for the purpose of backwashing the outdoor pool filters.

Photograph 1 Todd Energy Aquatic Centre ocean outfall

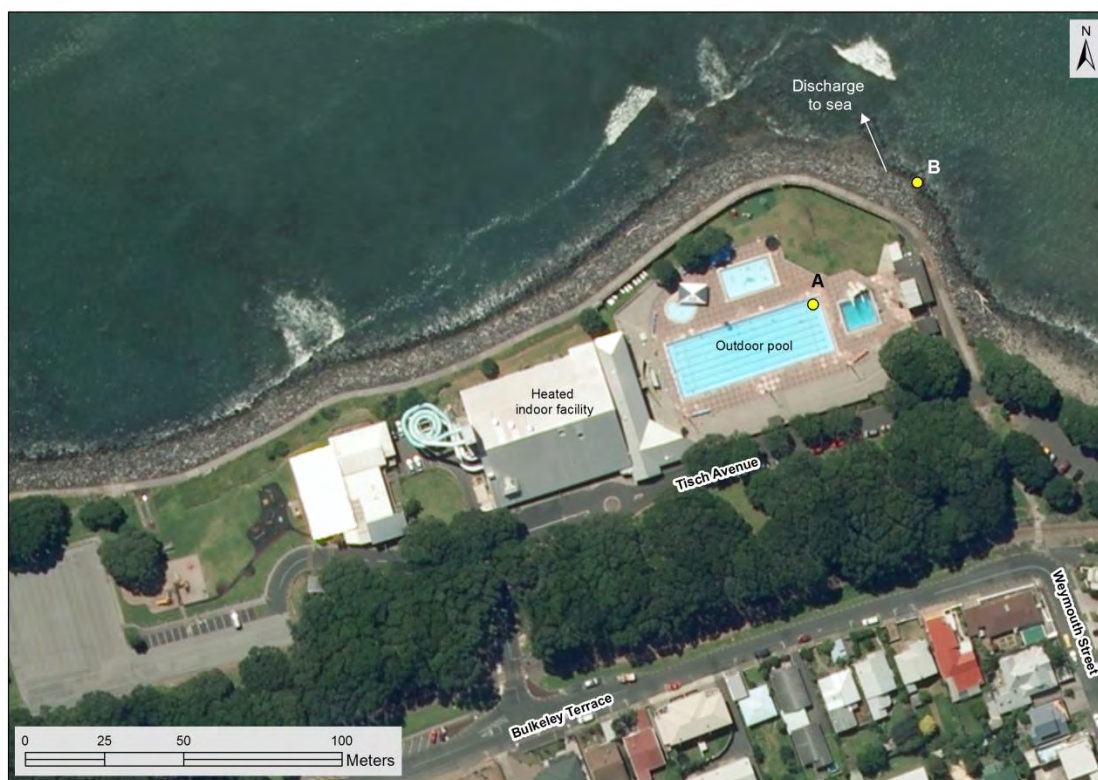
Figure 1 Location of Todd Energy Aquatic Centre with the swimming pool wastewater sampling site, (A), and the seawater sampling site, (B)

The Aquatic Centre is sited on the foreshore at Tisch Avenue, New Plymouth. The facility consists of outdoor pools, including a main pool, diving pool and children's pools, and an indoor pool complex (Figure 1).

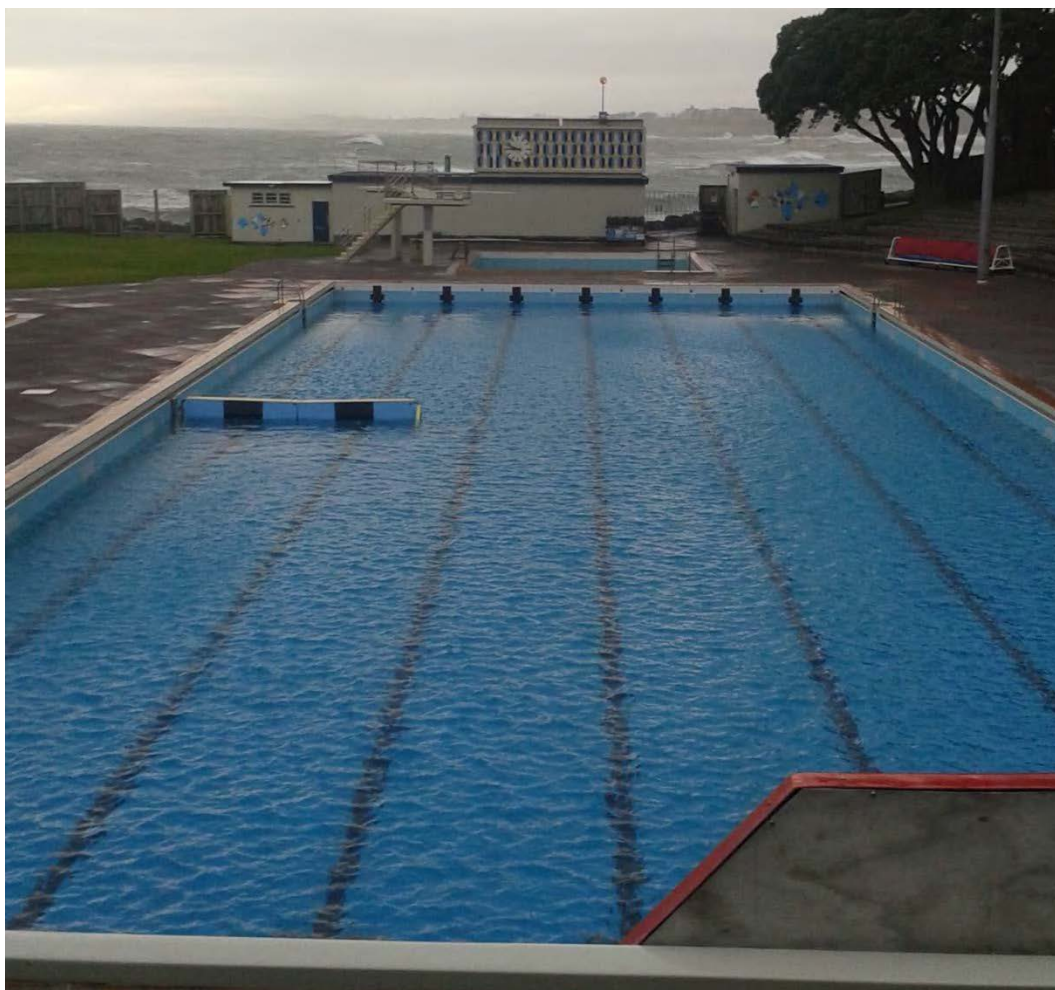
During the second inspection of the Aquatic Centre, on 2 June 2015, some chemical sacks were found on the ground of the chemical storage shed. It was asked that these be shifted and stored on pallets, as was the case with the remaining chemical sacks. Overall, however, the site was tidy and well managed. No other issues were noted during either inspection.

Photograph 2 Outdoor pool prior to emptying on 2 June 2015

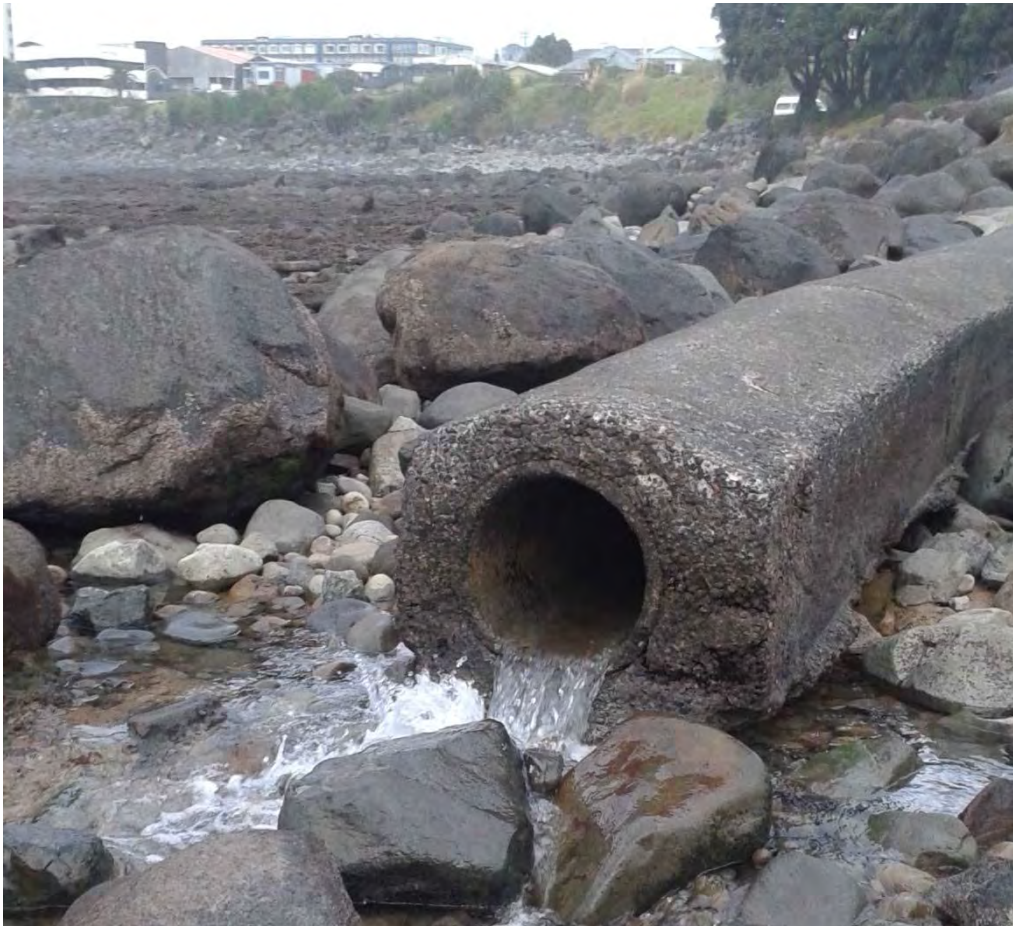
**Photograph 3** High flow rate discharging at approximately low tide

Upon arrival at the reef at approximately low tide there was still a high flow rate discharging from the pipe and the main outdoor pool was not yet empty. This discharge was occurring four hours outside of the permitted time frame. The ecological inspection identified what was considered to be a normal range and abundance of intertidal species for this type of environment. Although the discharge was occurring outside of the permitted time period, no adverse effects on local intertidal biological communities were observed.

On 2 June 2015 a pool wastewater discharge was found to be occurring four hours outside of the permitted timeframe. Consequently, a 14-day letter was issued requesting a formal response as to why this breach of consent occurred. NPDC staff responded by attributing the breach of consent to a communication breakdown between the Team Leader of Operations and the Aquatic Coordinator in charge for that day. NPDC staff have since made an effort to prevent further incidents by reiterating the importance of consent compliance at an operations meeting. The Council has subsequently decided not to take any further enforcement action.

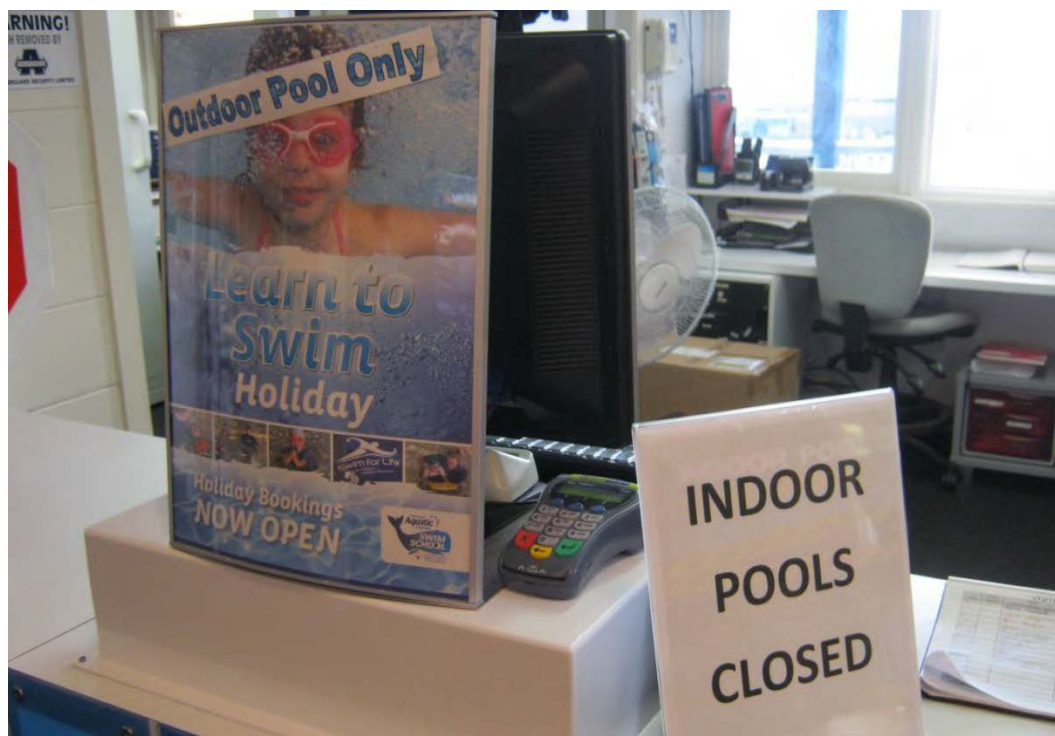
Photograph 1 Indoor pool closed for four months for maintenance purposes

¹ Due to maintenance requirements the indoor pool will be closed for approximately four months commencing mid January 2015 (Photograph 1).

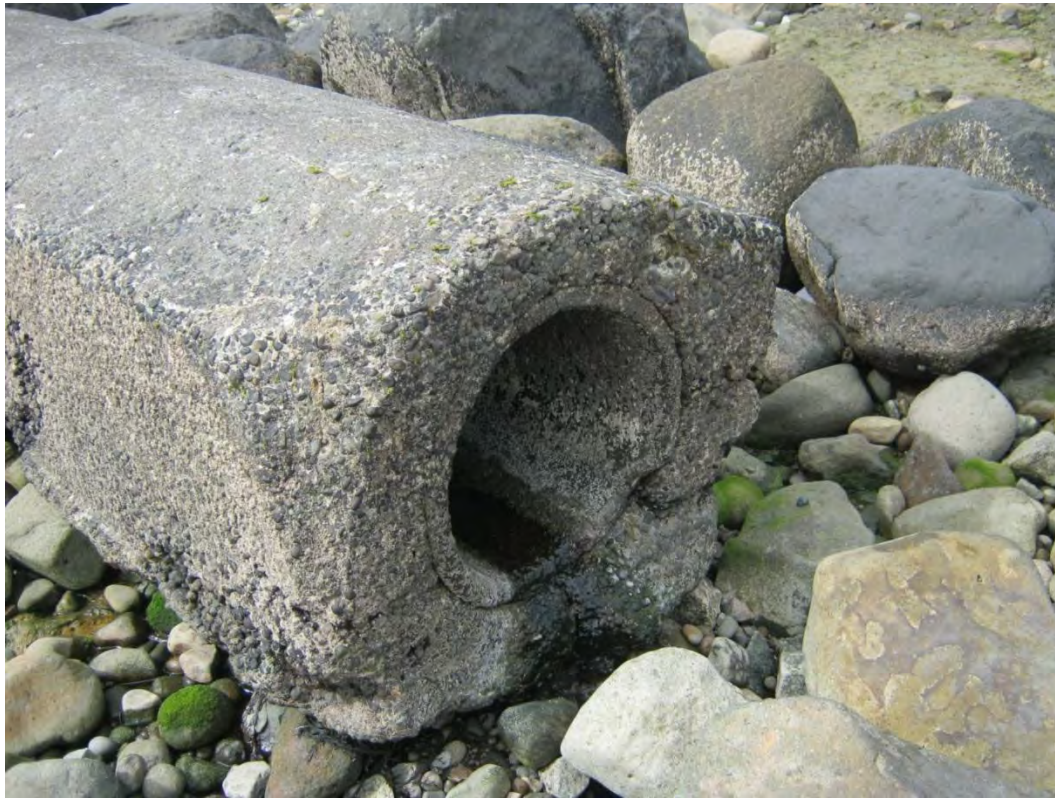
There was no detectable chlorine odour at the end of the pipe where the discharge entered the receiving environment (Photograph 2). A small amount of white foam, human hair and thread was present within 5 m of the end of the discharge pipe (Photograph 3).

Photograph 2 Todd Energy Aquatic Centre discharge pipe

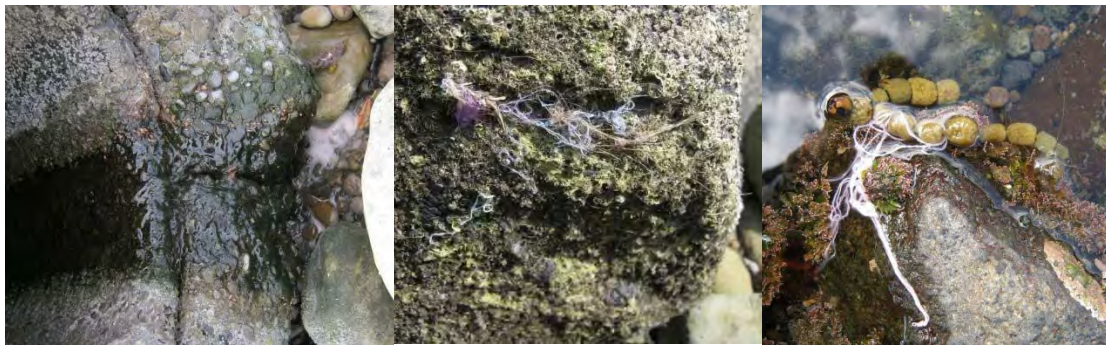
Photograph 3 Foam, hair and thread present within 5 m of the end of the discharge pipe

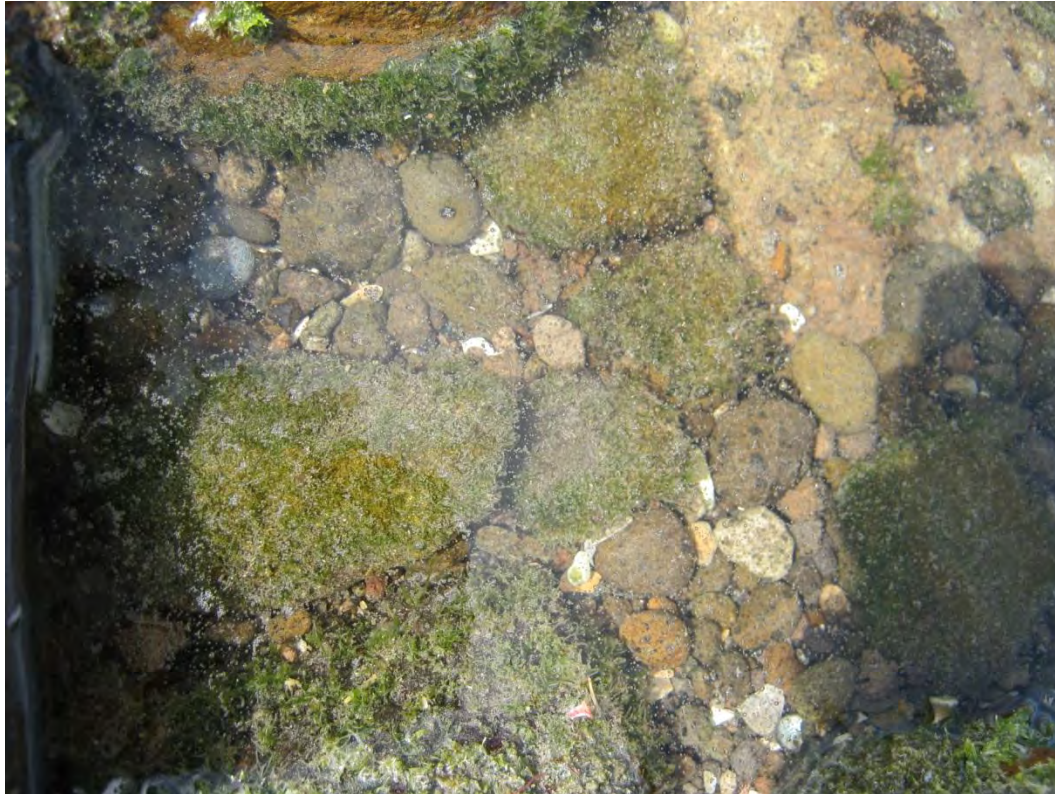
Photograph 4 Green macroalgae *Ulva intestinalis* (indicative of freshwater input) dominated pools in the near vicinity of the discharge pipe, but was not abundant further down the shore

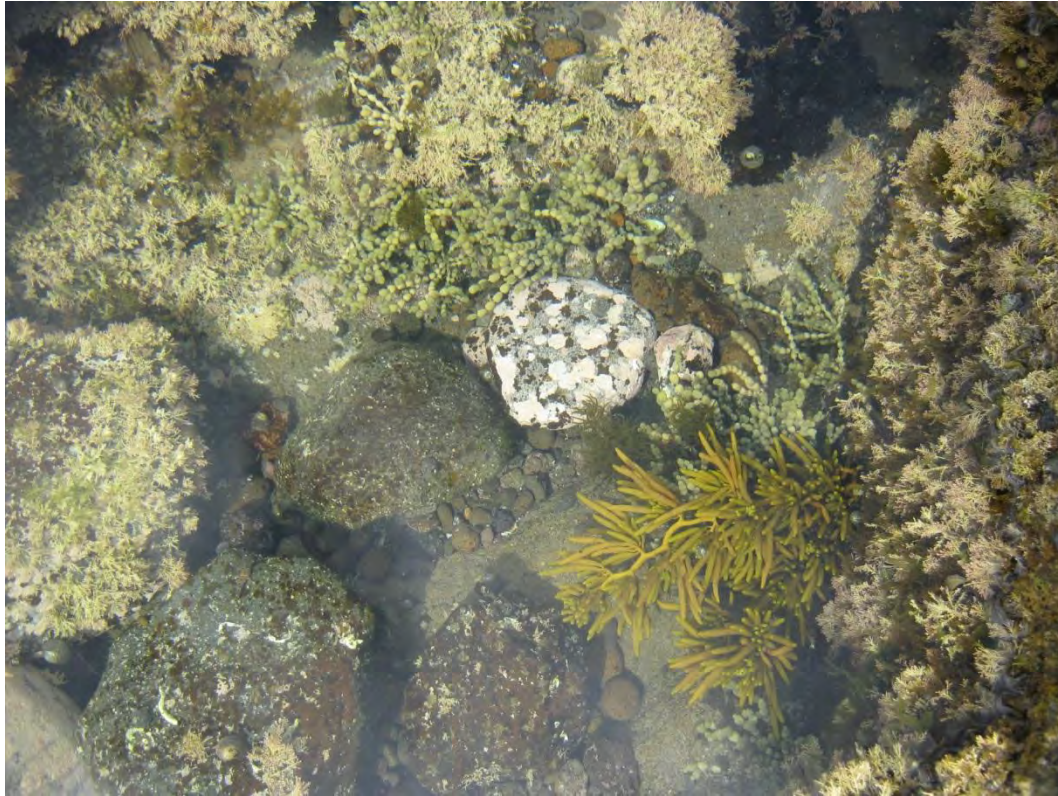
Lower down on the shore, still within the influence of the pipe discharge, the following species were identified: the molluscs *Haustorium scobina* (very abundant), *Melagraphia aethiops*, *Turbo smaragdus*, *Cominella maculosa*, *Cellana radians*, *Cellana ornata*, *Xenostrobus pulex* and *Sypharochiton pelliserpentis*, barnacle *Chamaesipho* sp., sea urchin *Evechinus chloroticus* and the polychaete worms *Spirobranchus cariniferus* and *Neosabellaria kaiparaensis*. Algae included coralline turf (abundant in pools), *Hormosira banksii* (very abundant), *Notheia anomala*, *Gelidium caulacanthum*, *Cystophora* sp. and *Ralfsia* sp. These species are similar to what would be expected at this elevation on the shore (Photograph 5).

Photograph 5 Macroalgae in low shore rock pools

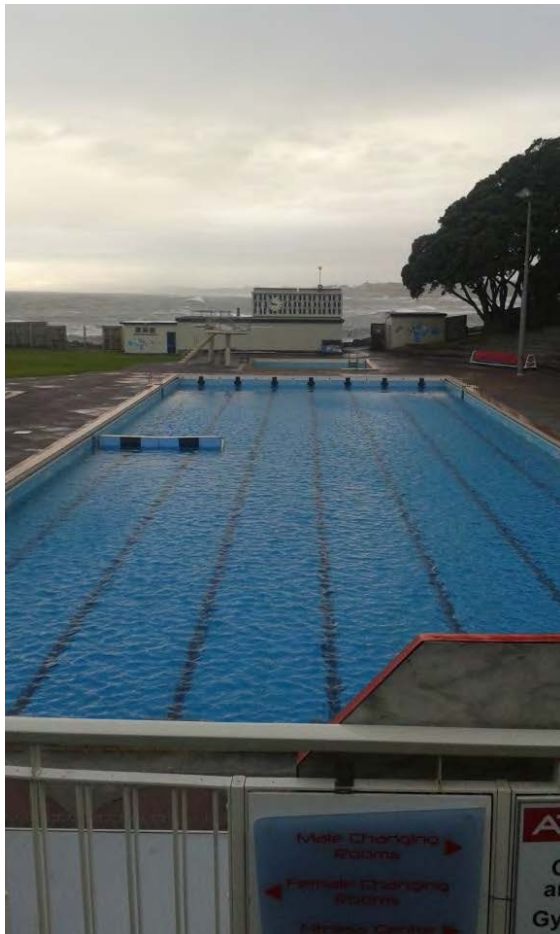
Photograph 1 Outdoor area on the morning of 2 June 2015

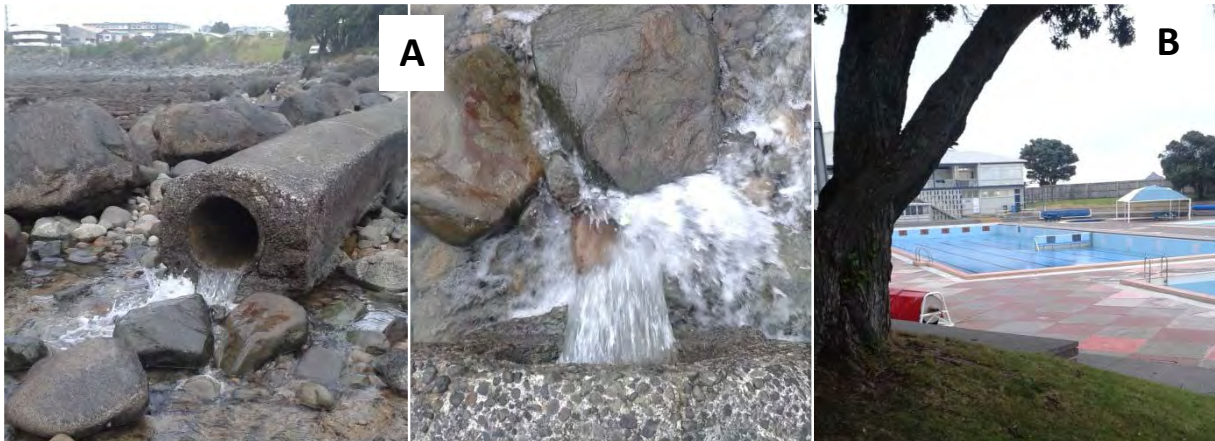
Upon arrival at the reef (at approximately 15:30 NZST), there was still a high flow rate discharging from the pipe and the main outdoor pool was not yet empty (see photograph 2). This was in breach of special condition 8, consent 2339-4.0: *Any discharge shall only occur two hours either side of high tide.*

Photograph 2 A Todd Energy Aquatic Centre discharge pipe discharging onto Kawaroa Reef at 15:45 (low tide at 15:55). B Low level of water remaining in outdoor pool at 15:50 (low tide at 15:55)

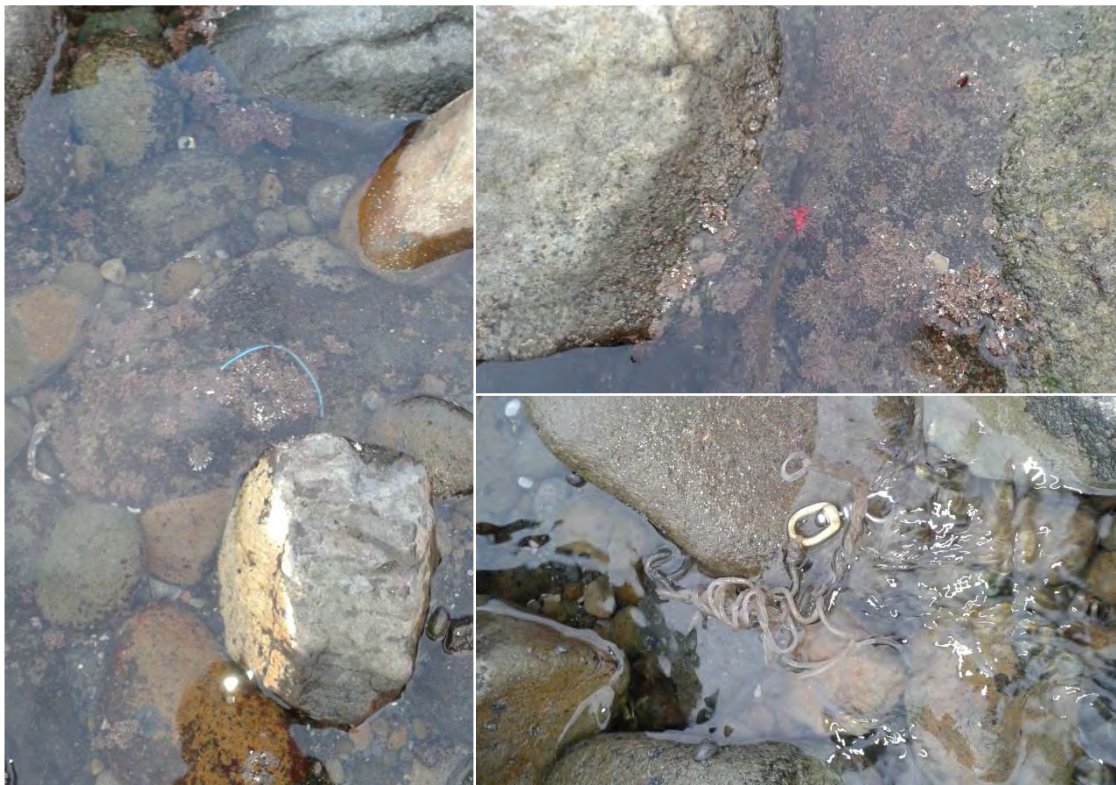
There was no detectable chlorine odour at the end of the pipe where the discharge entered the receiving environment. A small amount of rubbish, including hair ties and a plastic cord were found within 5 m of the end of the discharge pipe (see Photograph 3). A small accumulation of scum was discovered on the surface of a tidal pool approximately 10 m from the discharge pipe; outside of the designated 5 m mixing zone (see Photograph 4).

Photograph 3 Rubbish, including hair ties and plastic cord found within 5 m of the end of the discharge pipe

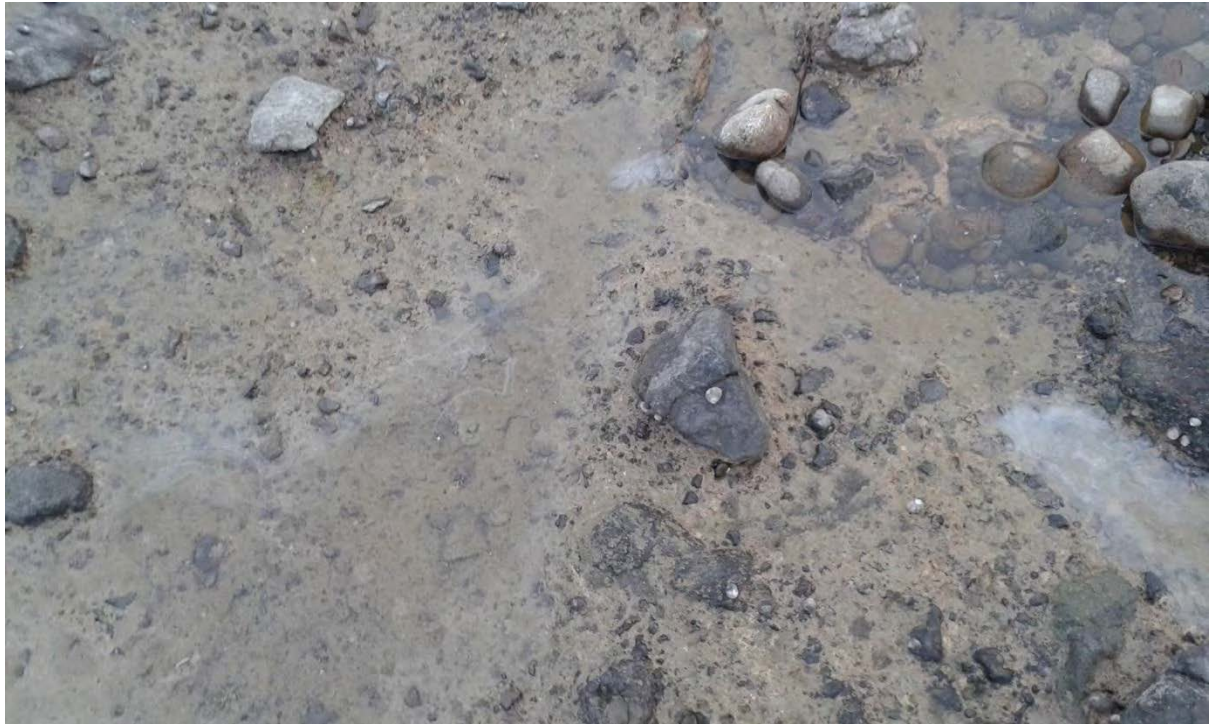
Photograph 4 Scum on the surface of intertidal pools approximately 10 m from the discharge pipe

Although the discharge was occurring outside of the authorised time period, there were no obvious signs of it adversely affecting the intertidal biota surrounding the pipe. Furthermore, the source of the scum that had accumulated outside of the 5 m mixing zone was ambiguous so could not definitely be attributed to the TEAC discharge.

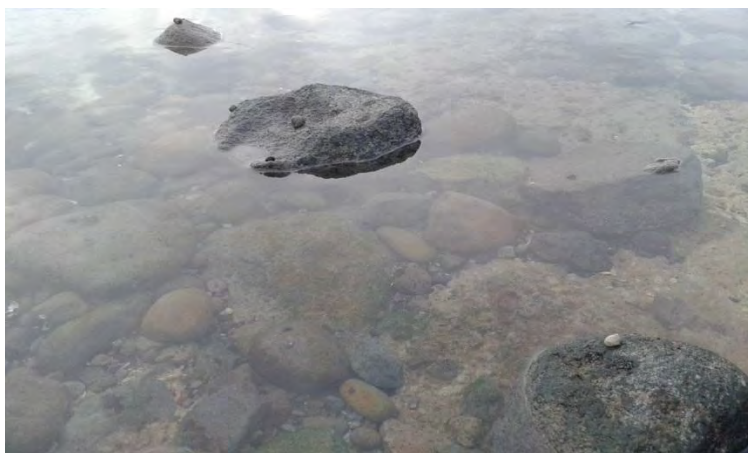
The following invertebrates were present on the upper shore in the vicinity of the pipe: molluscs *Melagraphia aethiops*, *Diloma* spp., *Turbo smaragdus*, *Haustrum scobina*, *Cellana radians* and *Cellana ornata*, barnacle *Chamaesipho* sp., and the polychaete worm *Spirobranchus cariniferus*. A species of green algae resembling *Ulva intestinalis* was present, although not as widespread as in the previous survey, where it covered rocks and pools around the pipe. The brown alga *Ralfsia* sp. and red alga *Gelidium caulacanthum* were also present. In comparison with the intertidal community further down the shore the area surrounding the pipe supported very little biomass and was less diverse (Photograph 5). However, this assemblage is similar to that found on previous inspections in the vicinity of the pipe, and is typical for this height on the shore.

Photograph 5 Relatively low biomass and diversity of the upshore community

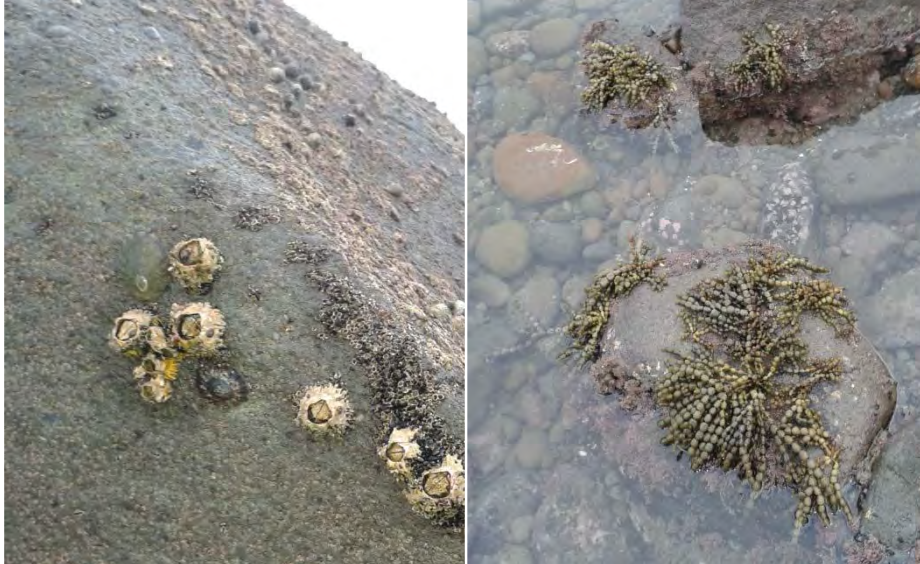
Further down on the shore, still within the influence of the pipe discharge, the following species were identified: the molluscs *Haustrum scobina* (very abundant), *Melagraphia aethiops*, *Turbo smaragdus*, *Cominella maculosa*, *Cellana radians*, *Cellana ornata*, *Xenostrobus pulex* and *Sypharochiton pelliserpentis*, barnacles *Chamaesipho* sp and *Epopella plicata*., and the polychaete worm *Spirobranchus cariniferus*. Algae included coralline turf (abundant in pools), *Hormosira banksii* (very abundant), *Notheia anomala*, *Gelidium caulacanthum*,. and *Ralfsia* sp. These species are similar to what would be expected at this elevation on the shore (Photograph 6).

Photograph 6 Higher diversity and biomass further downshore
