Remediation NZ Limited  
Monitoring Programme  
Annual Report  
2015-2016

Technical Report 2016-83

March 2017

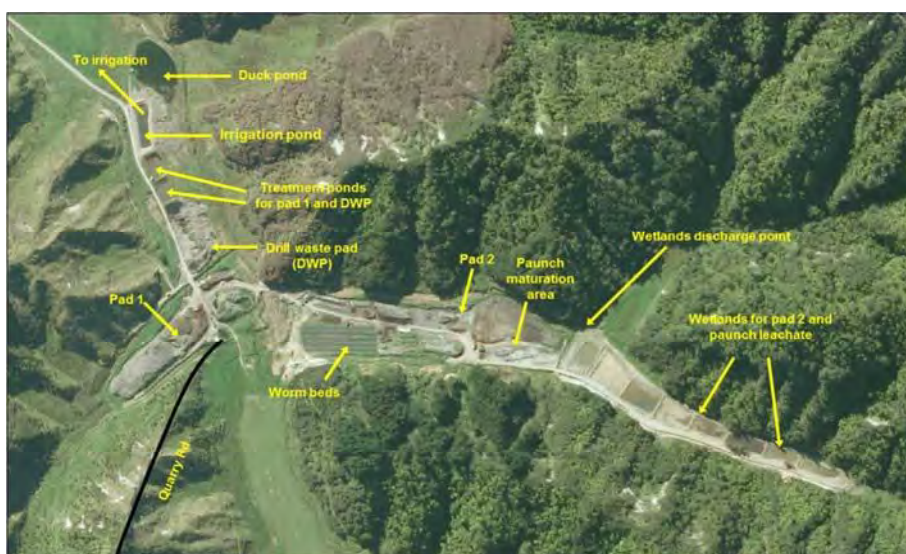
Figure 2 RNZ Uruti site

Runoff and leachate from composting pad 2 and a paunch grass maturation pad is pumped up to the top of a seven tier constructed wetland. Under dry conditions the water from the bottom pond of the wetland is reticulated back to the top tier of the wetland. Under high flow conditions the wetland discharges the treated stormwater/leachate to a tributary of the Haehanga Stream.

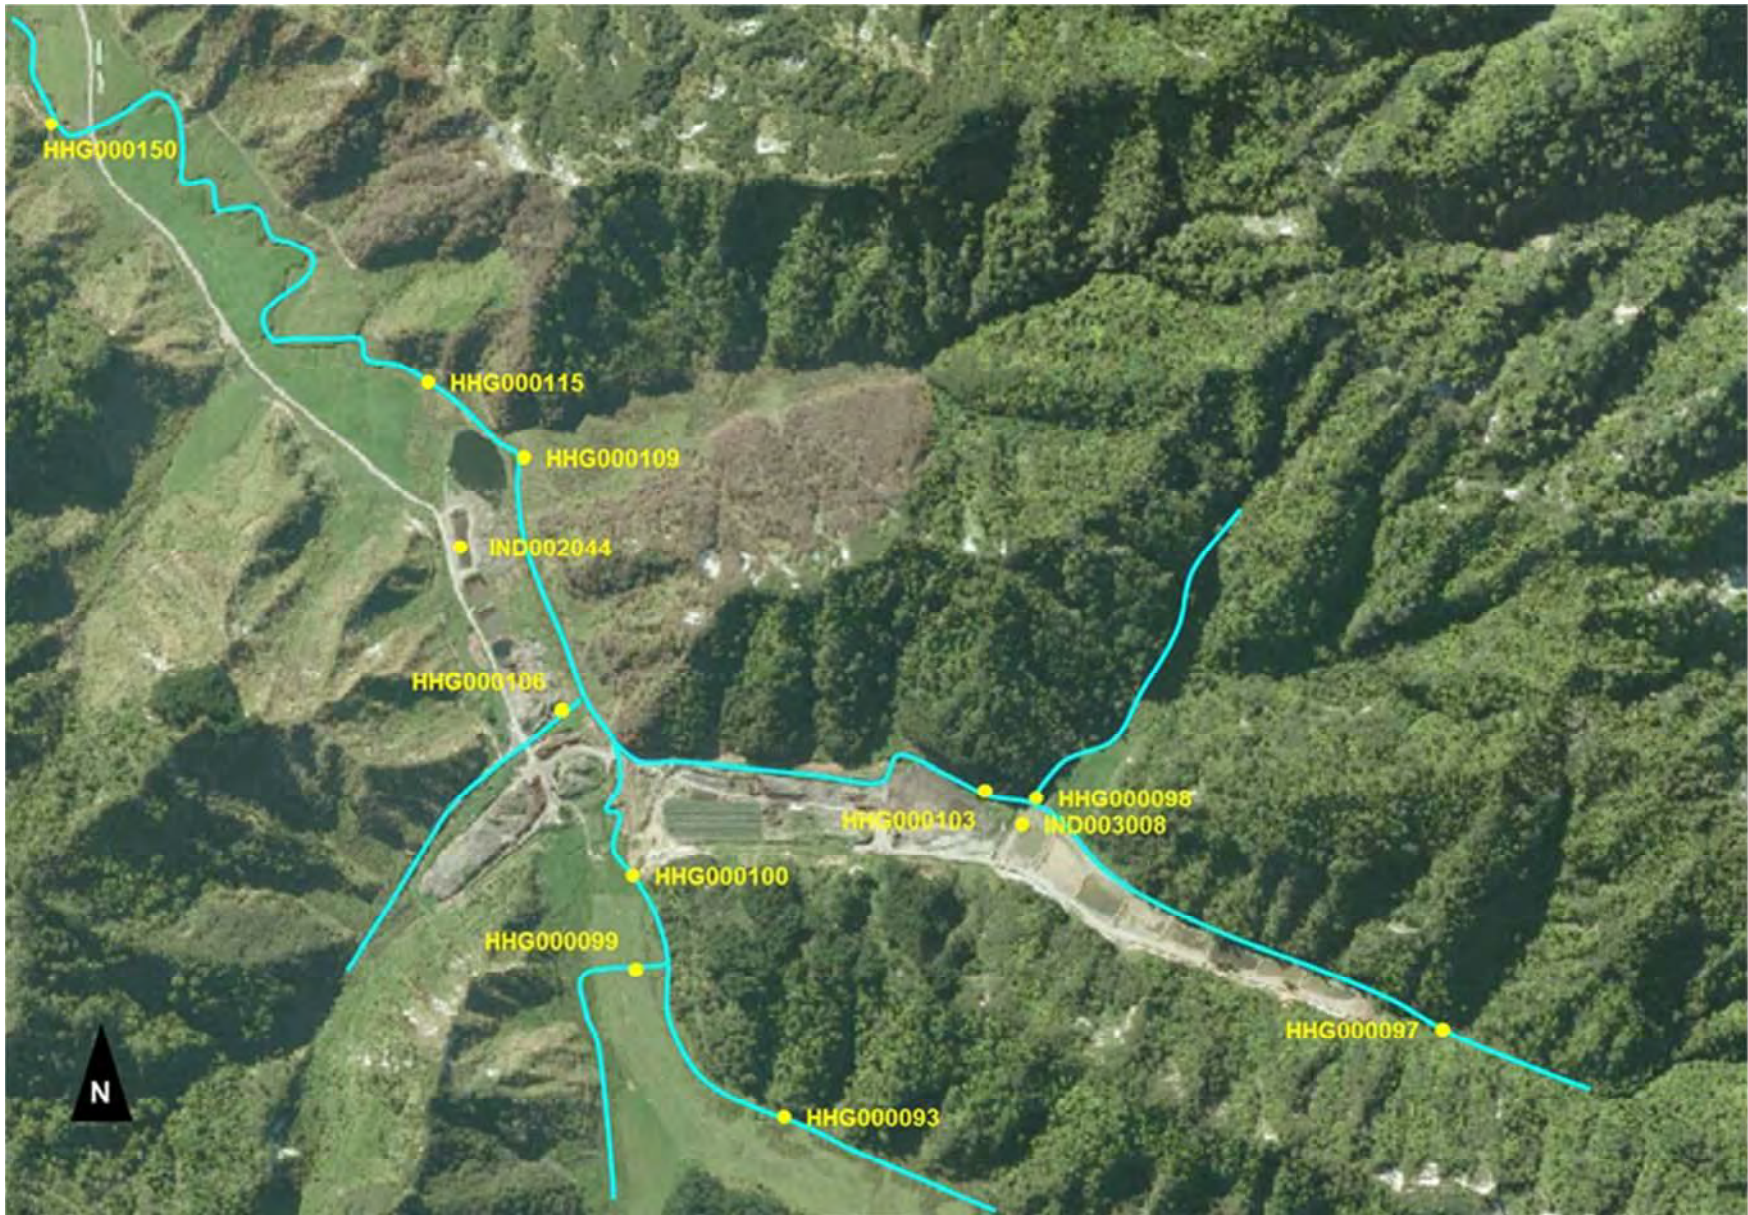
**Figure 3** Surface water sampling location RNZ Uruti

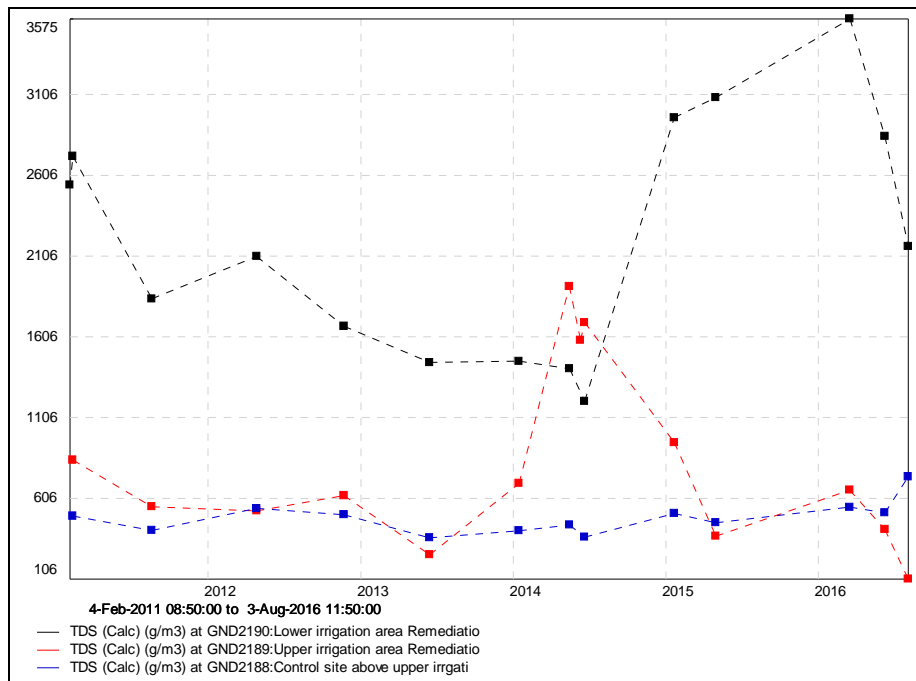
Long term TDS concentrations are provided in the following Figure 5.

**Figure 5** Long term TDS concentrations in groundwater RNZ Uruti

The monitoring showed that similar to the previous monitoring period, salinity trends in the groundwater were increasing in the specific irrigation areas. This is further supported by the increasing sodium absorption ratio found in the soil analyses of these specific areas this period. RNZ must enact their tiered approach as specified by their site specific management plan to mitigate these issues moving forward.

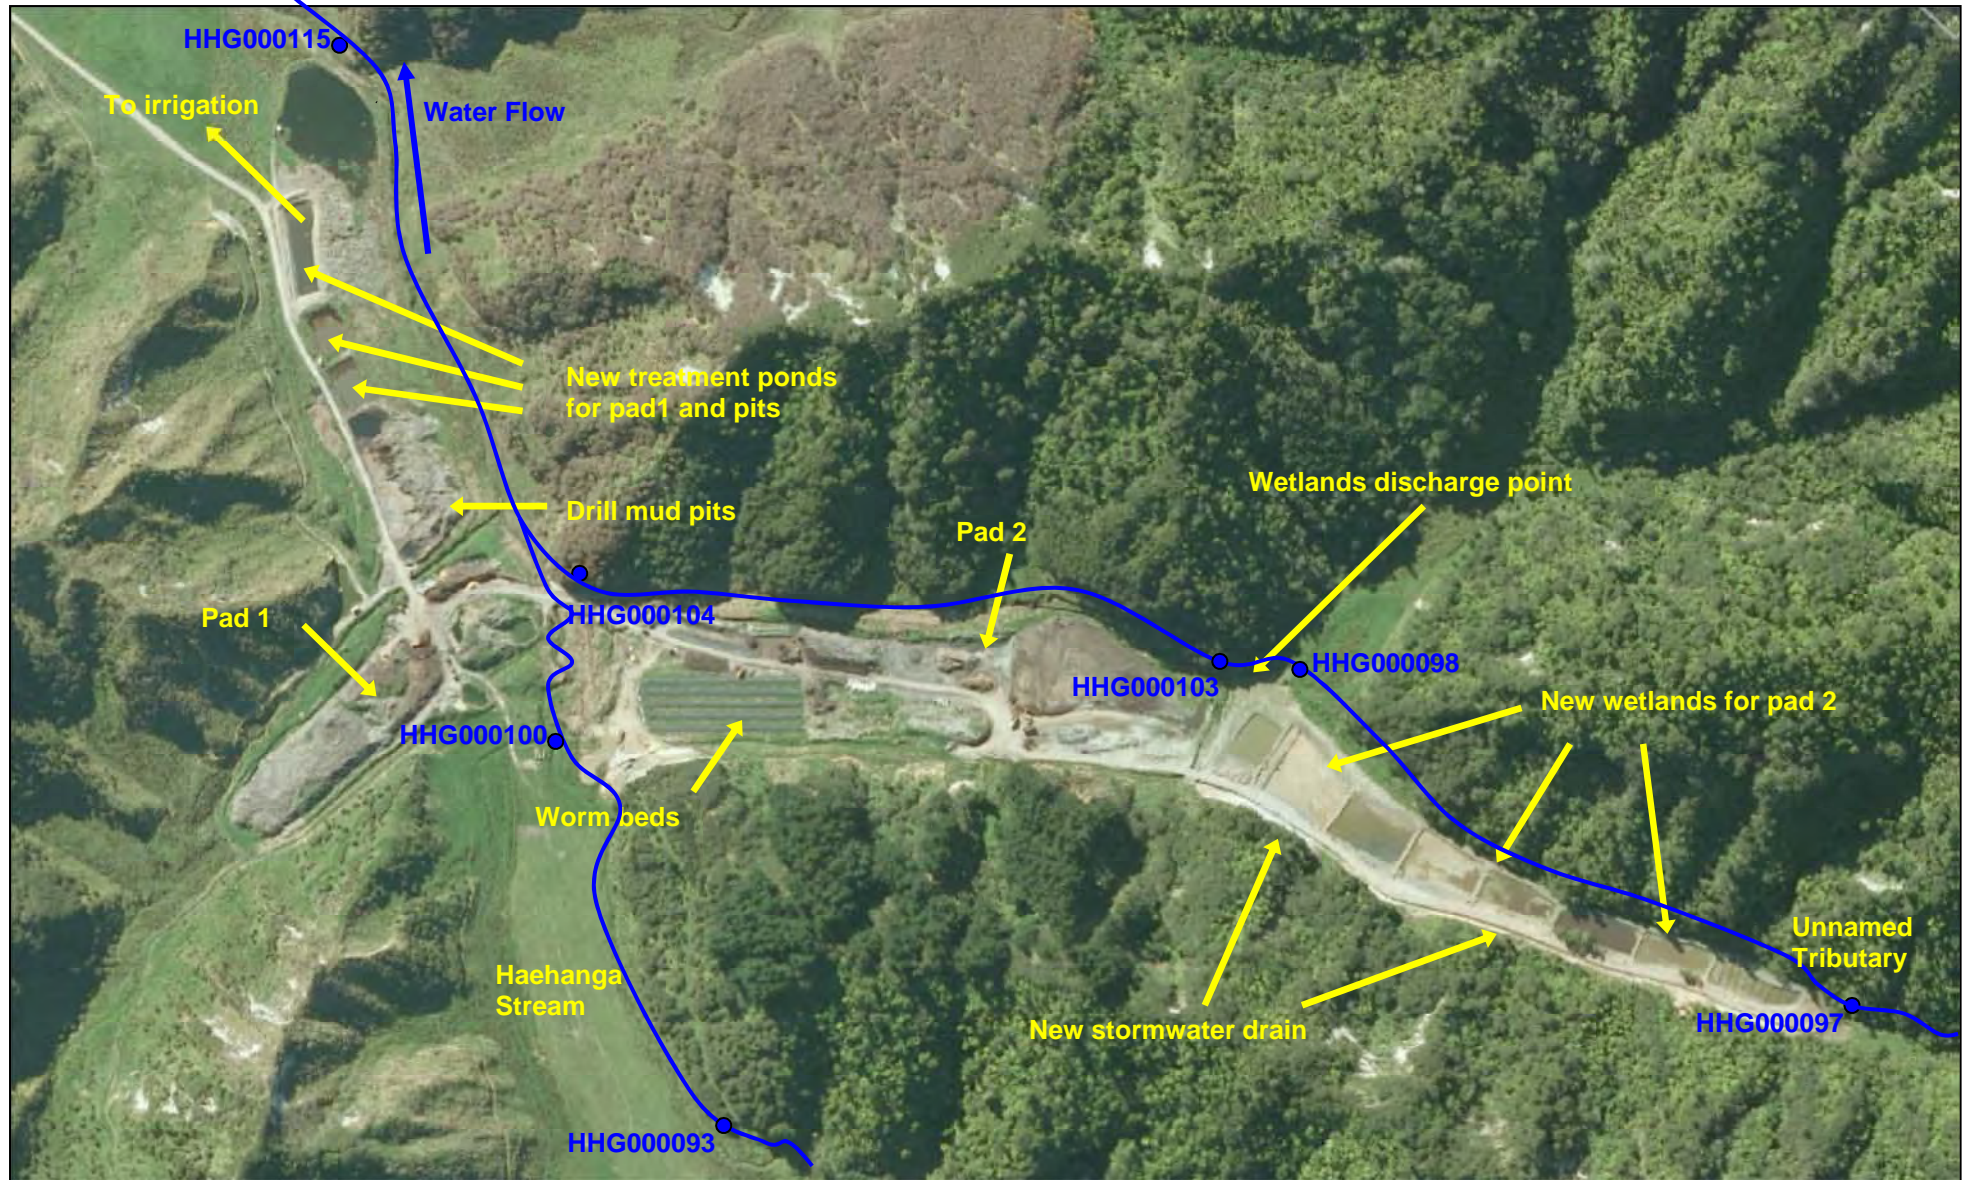
**Figure 1** Location of biomonitoring sites in the Haehanga Stream catchment

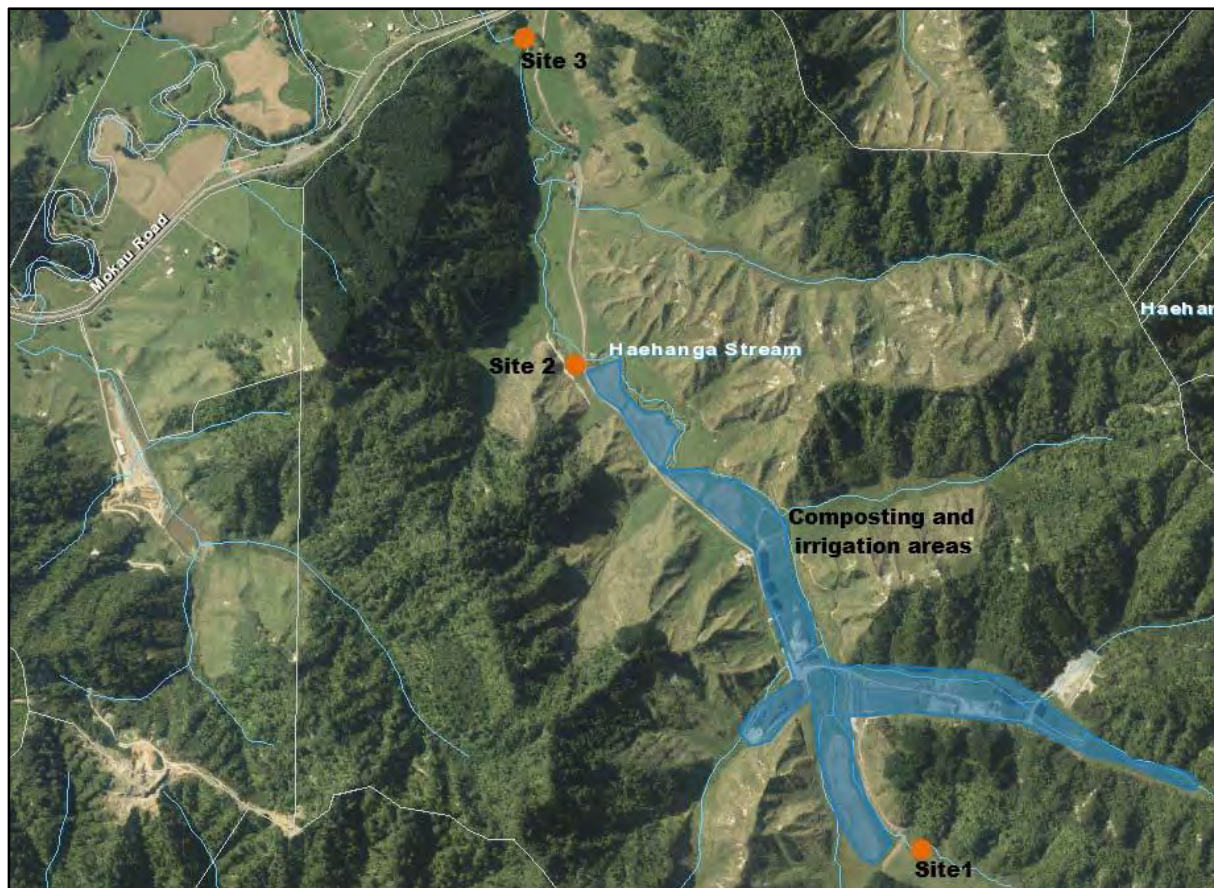
**Figure 1** Location of the three sampling sites in relation to composting and waste water irrigation areas.

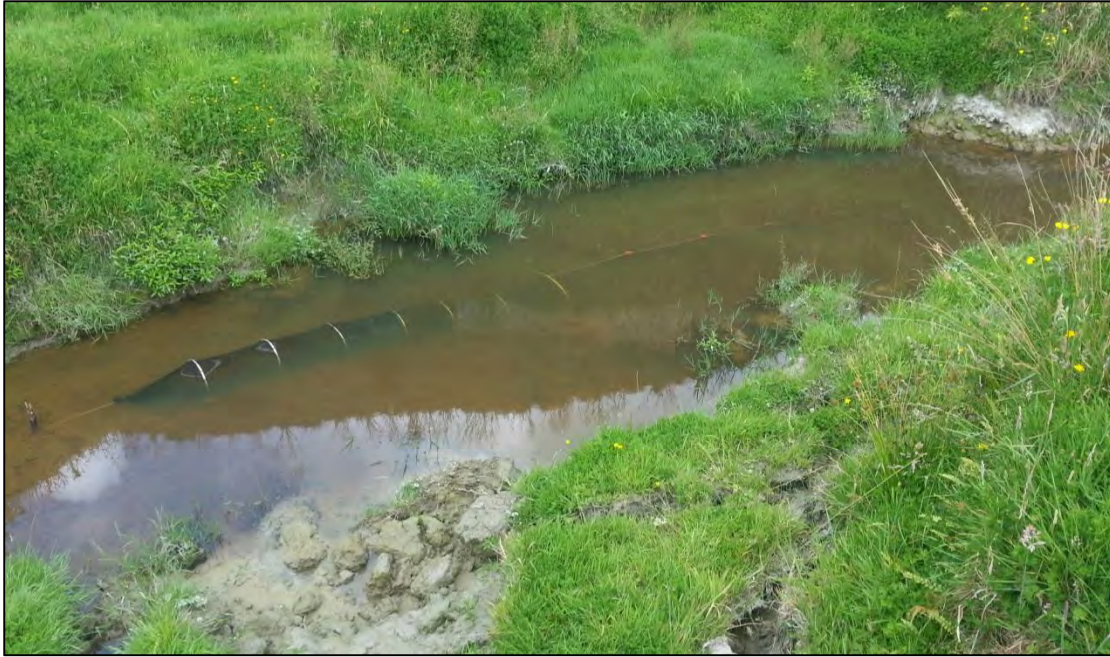
**Photo 1** A fyke net, set at site 2, Haehanga Stream.

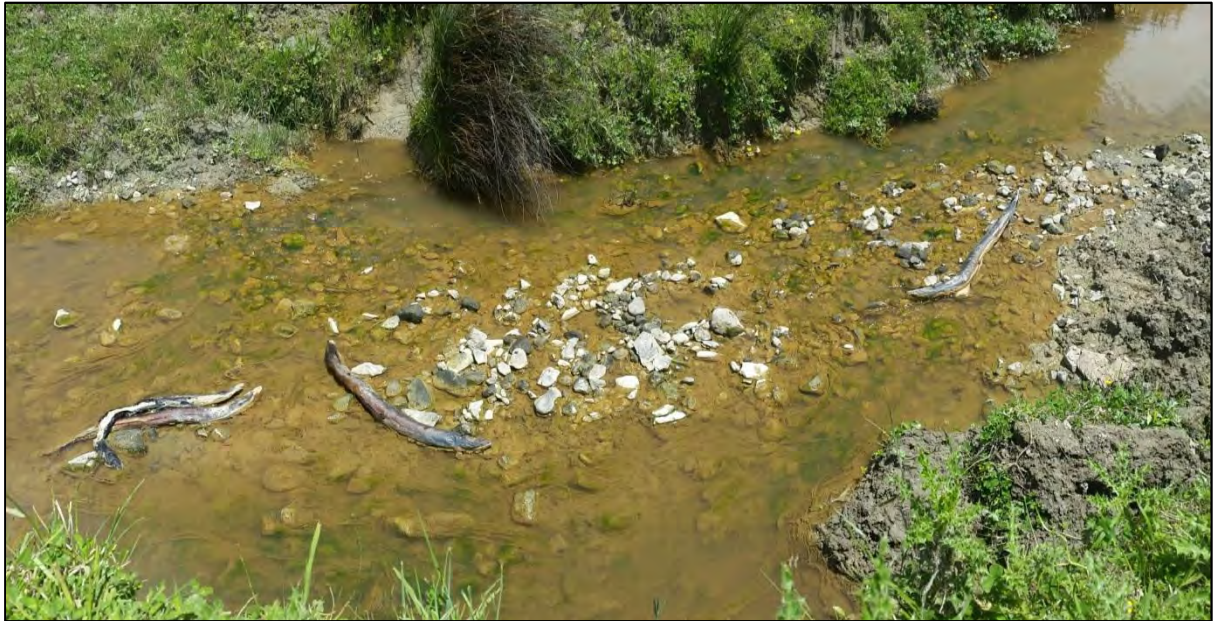
**Photo 2 (top)**

Dead eels observed immediately downstream of site 2.

These results indicate that the composting activities and/or irrigation of wastewater upstream has caused the death of a number of eels, and possibly contributed to a reduced abundance and species richness at this site. Furthermore, the access culvert is considered to present a severe restriction to fish passage, which limits the species abundance upstream, and also limits the recovery of upstream fish communities.

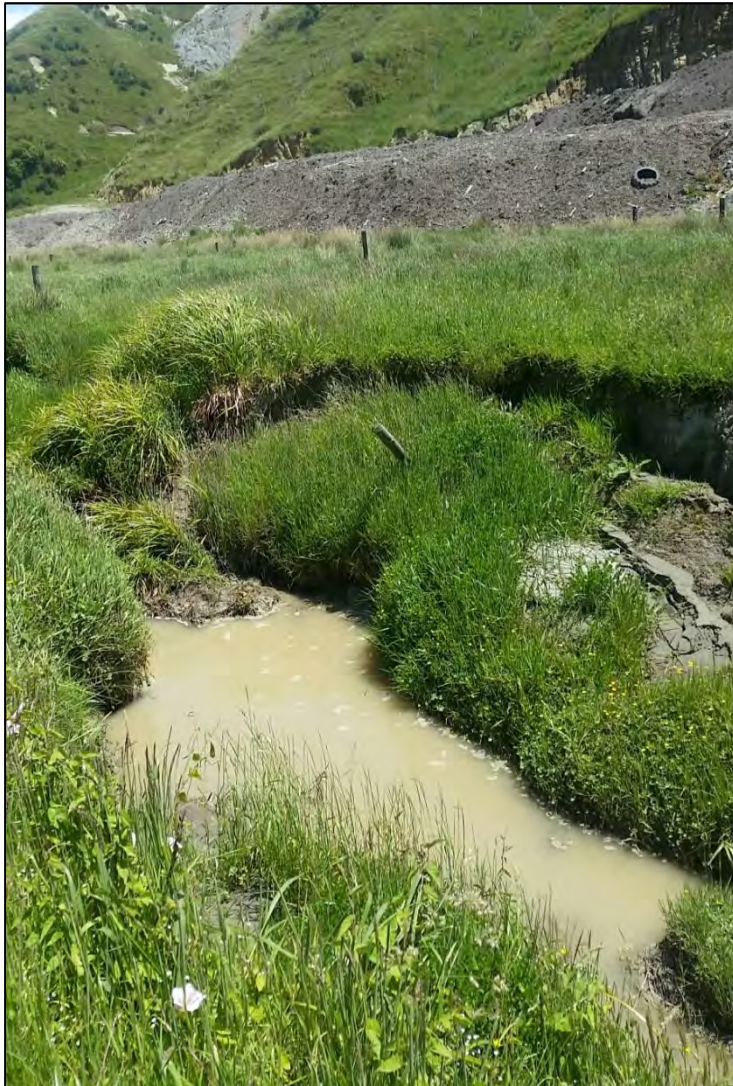
**Photo 3 (left)**

Discolouration noted between sites 1 and 2, caused by works in an unnamed tributary upstream. Note also the significant bank slumping at this site.

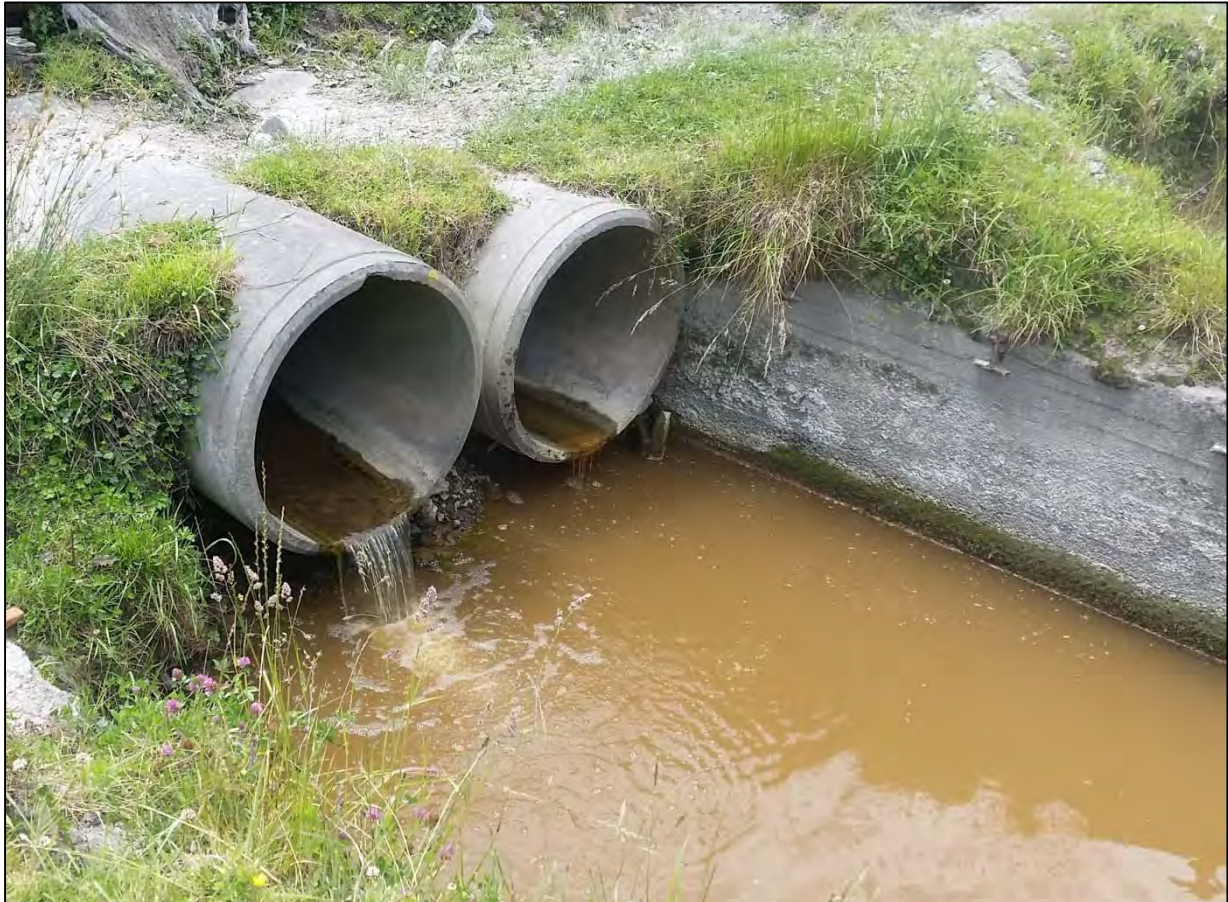
**Photo 4** The access culvert immediately upstream of site 2, 9 December 2016.

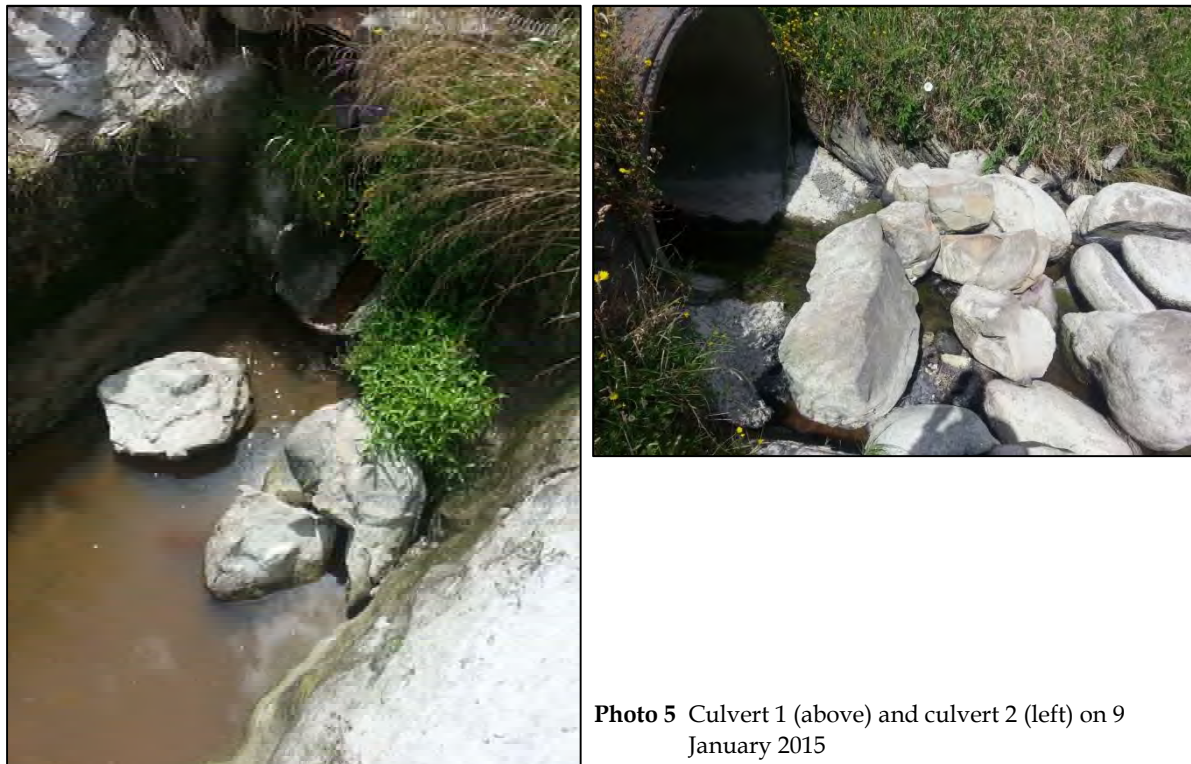
**Photo 5** Culvert 1 (above) and culvert 2 (left) on 9 January 2015

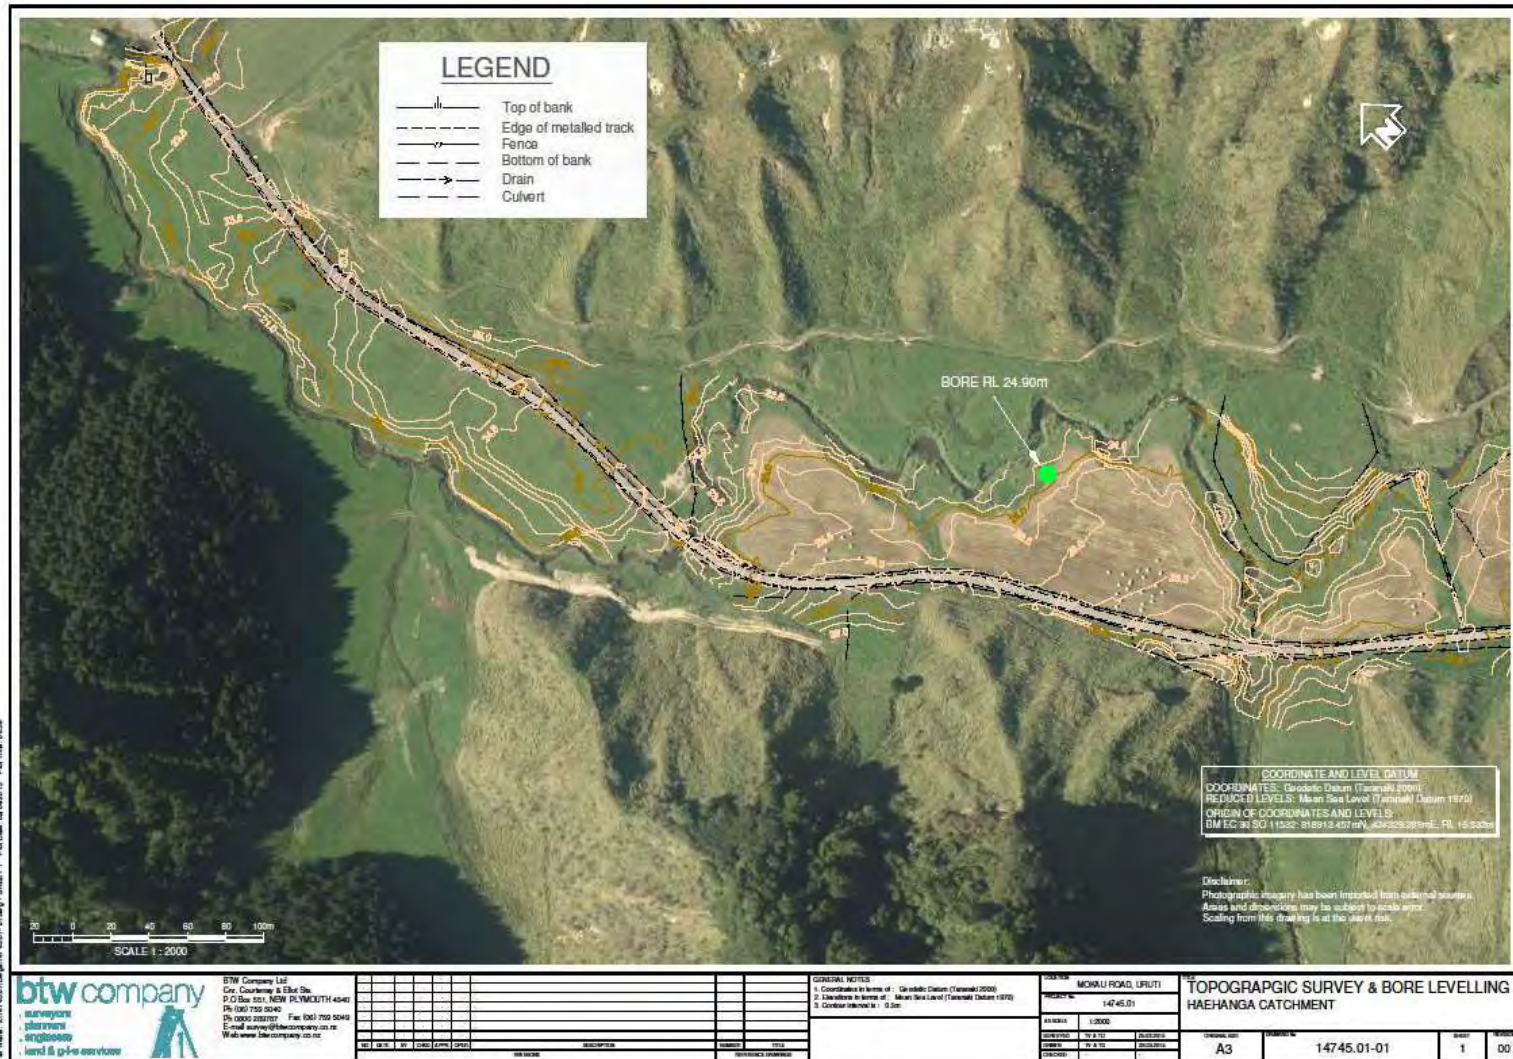
Figure 2.1:Uruti Composting Topography Survey-lower part of site. Green dot denotes GND 2190 and reduced level

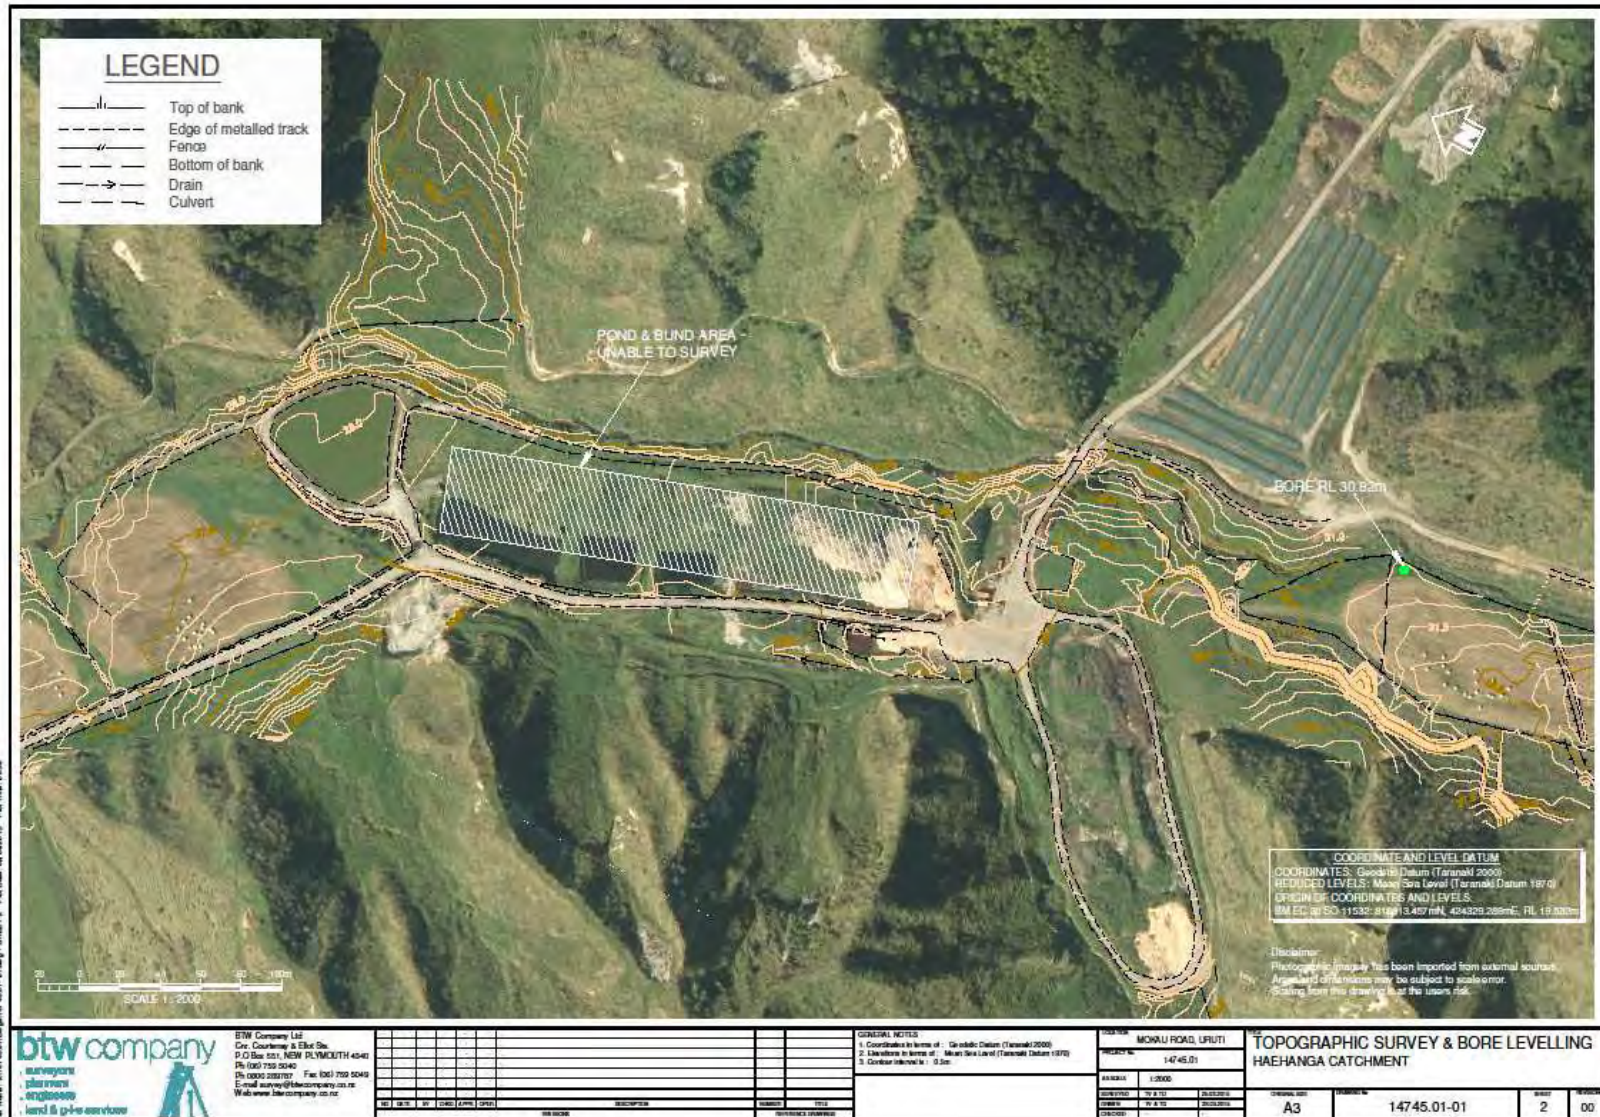
Figure 2.2:Uruti Composting Topography Survey-middle part of site. Green dot denotes GND 2189 and reduced level

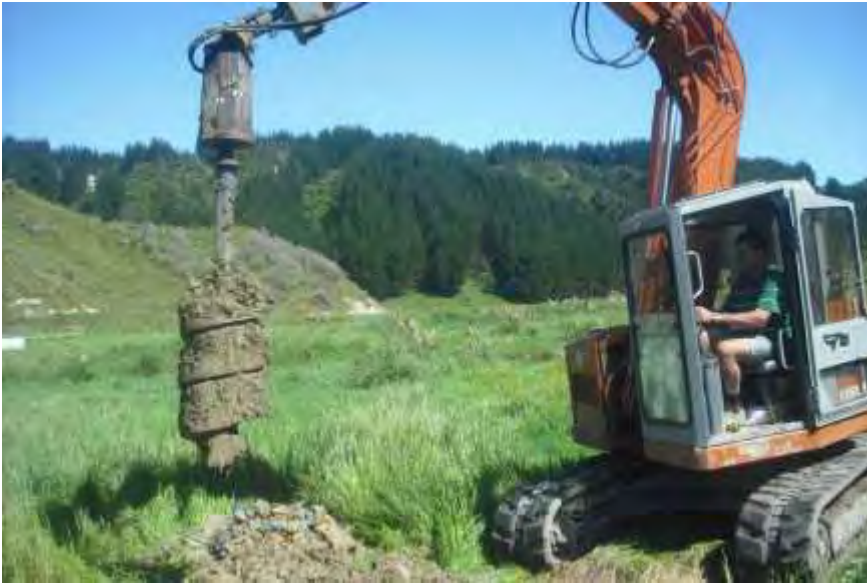
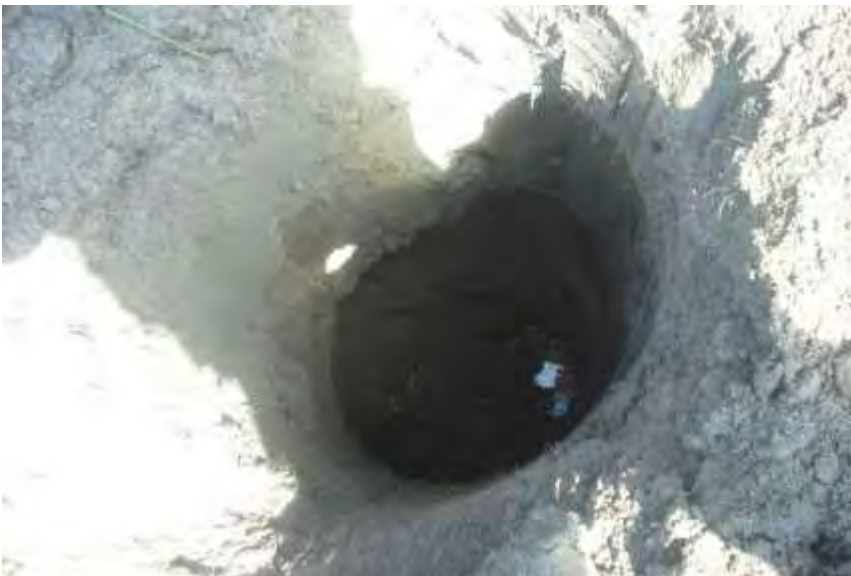
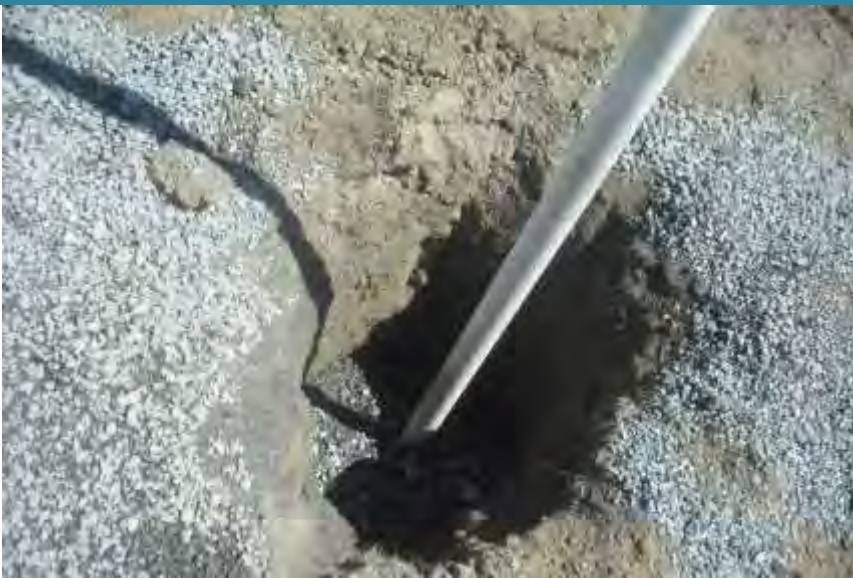
## APPENDIX B MONITORING BORE INSTALLATION

- Final depths should be measured and recorded
- The slotted portion of the pipe should start 0.2m below the ground level as per the schematic. This is not the case in all the bores.
- The top of the monitoring well should be capped to prevent contaminants entering the bore
- The top of the casing should be 300 mm above the ground and sealed so that potential contaminants or small animals cannot get in.
- A 2 meters perimeter fence should be erected around the monitoring well ( i.e, 0.5 x 0.5 x0.5 x 0.5)

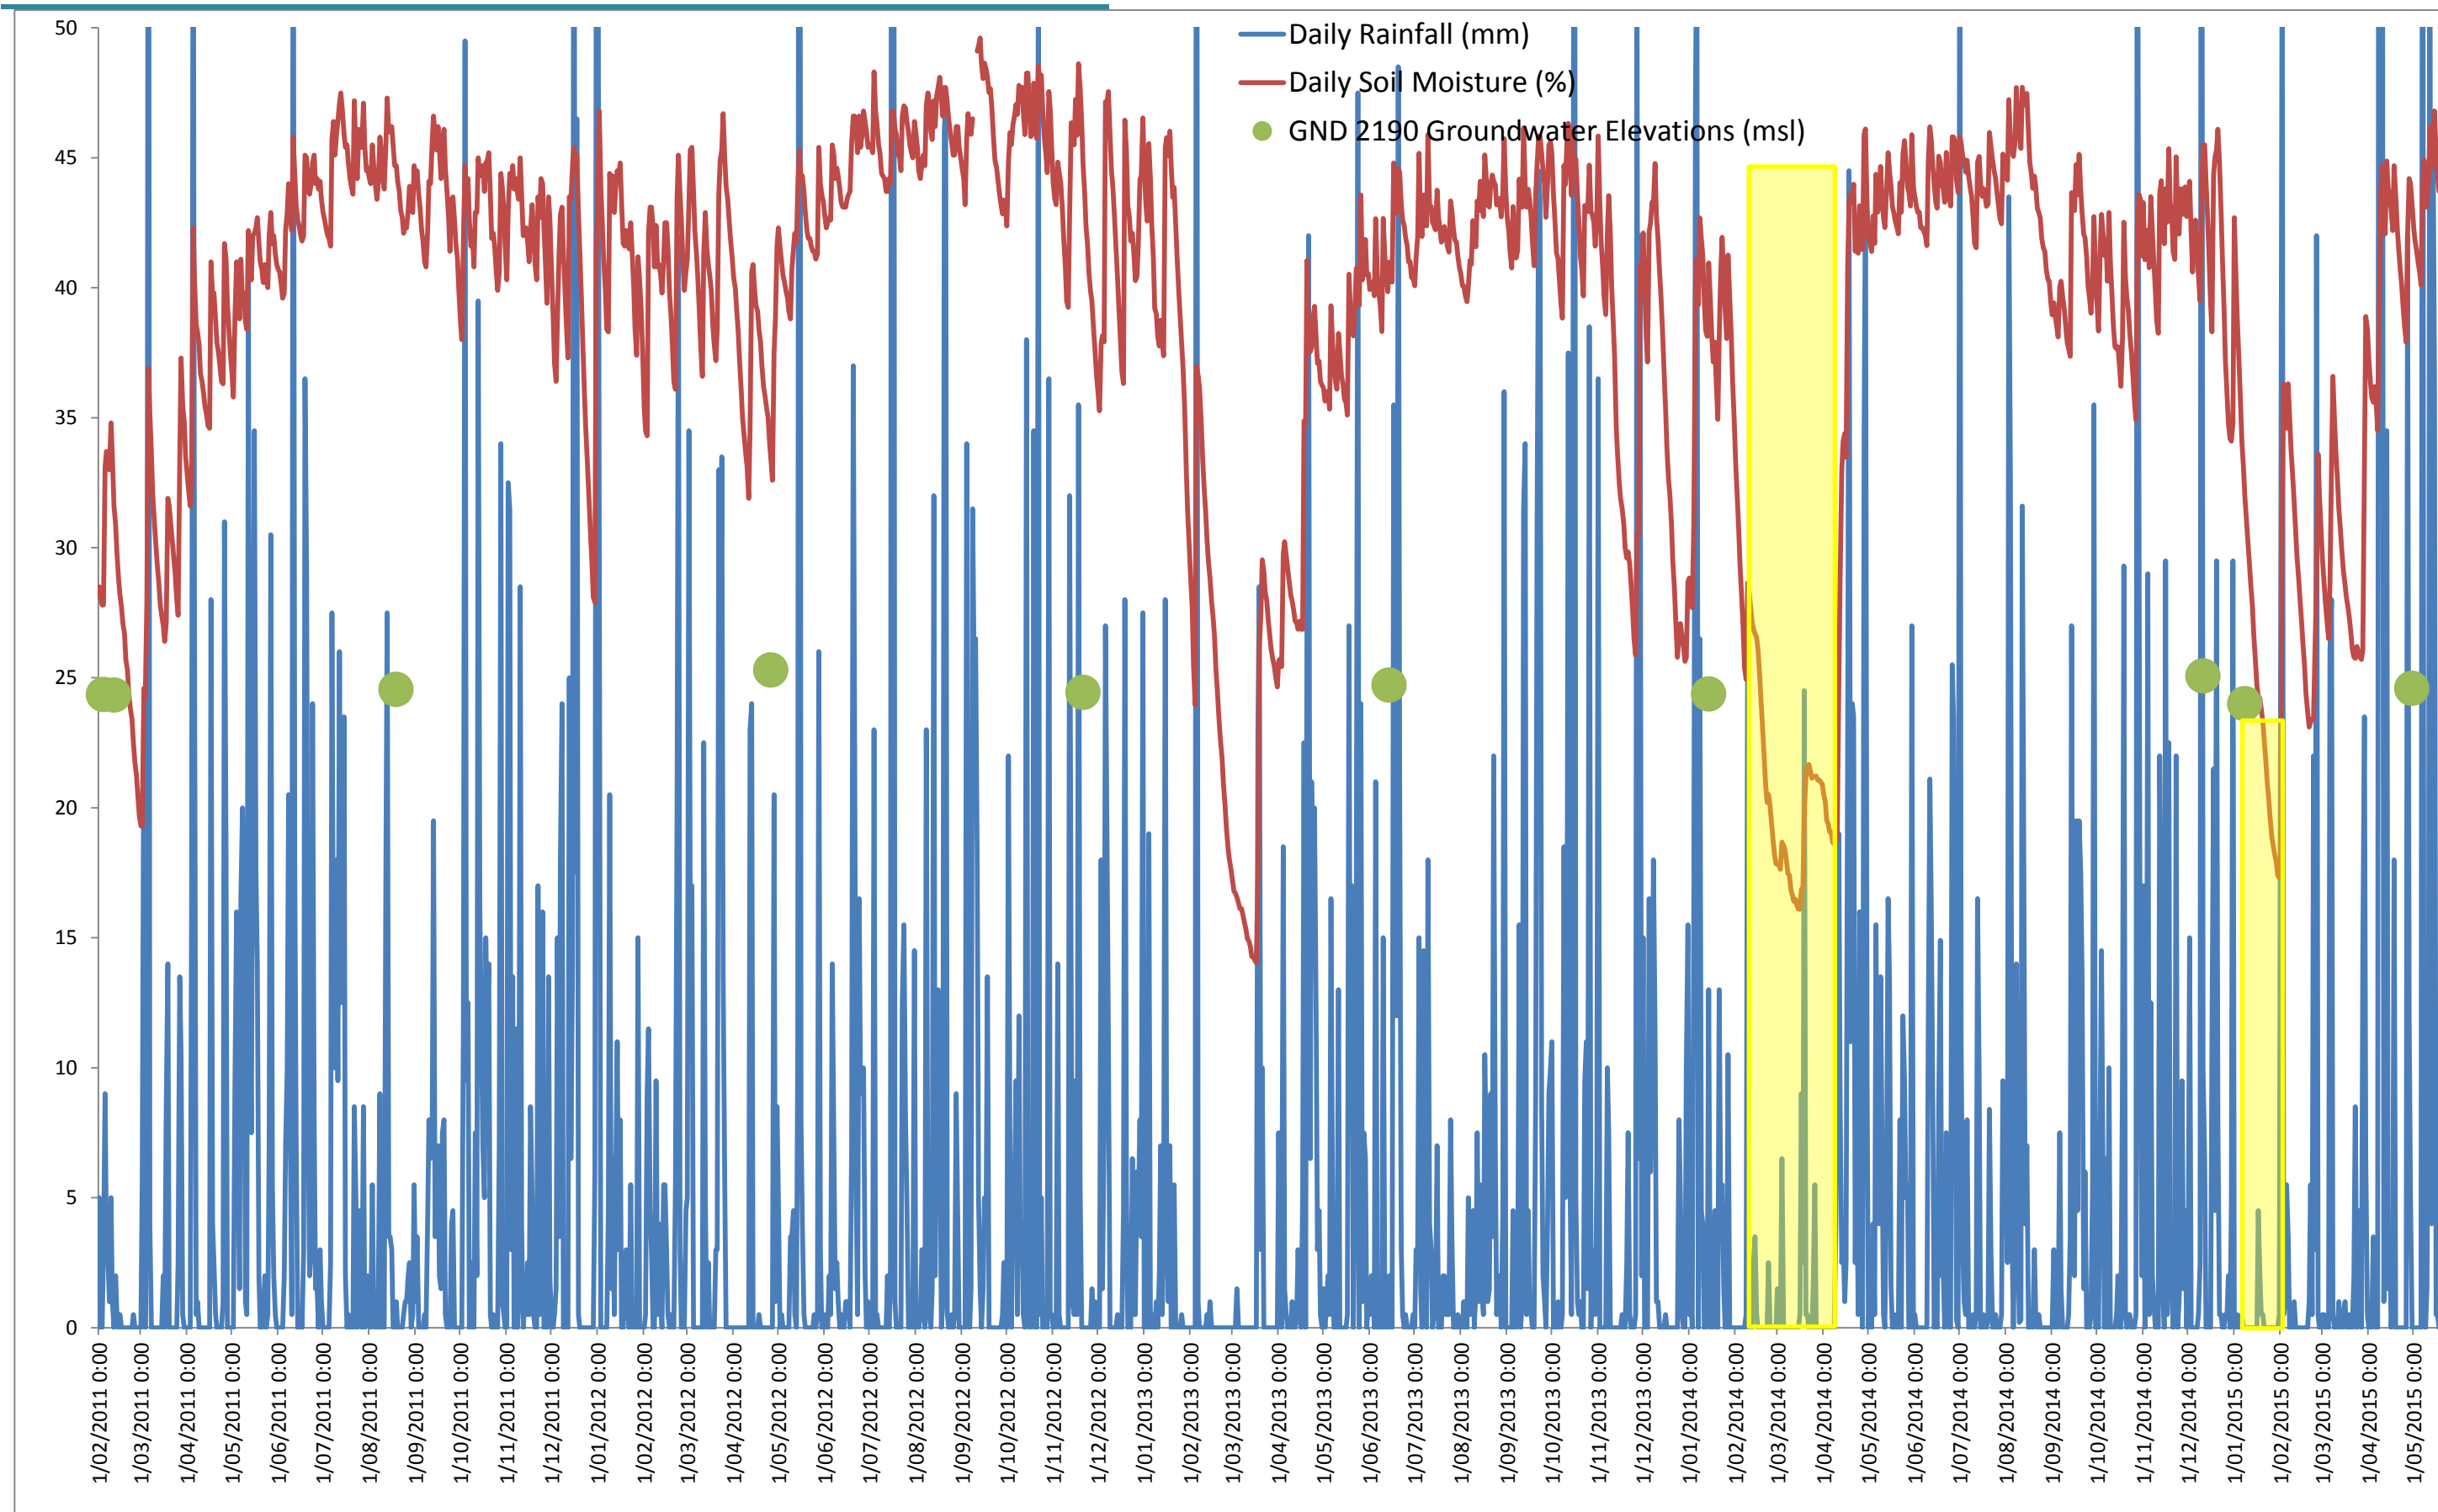
Uruti at Kaka Road Monthly Rainfall and Soil Moistures, yellow bars denote elevated Chloride concentrations in the Haehanga Stream and monitoring bore GND 2190

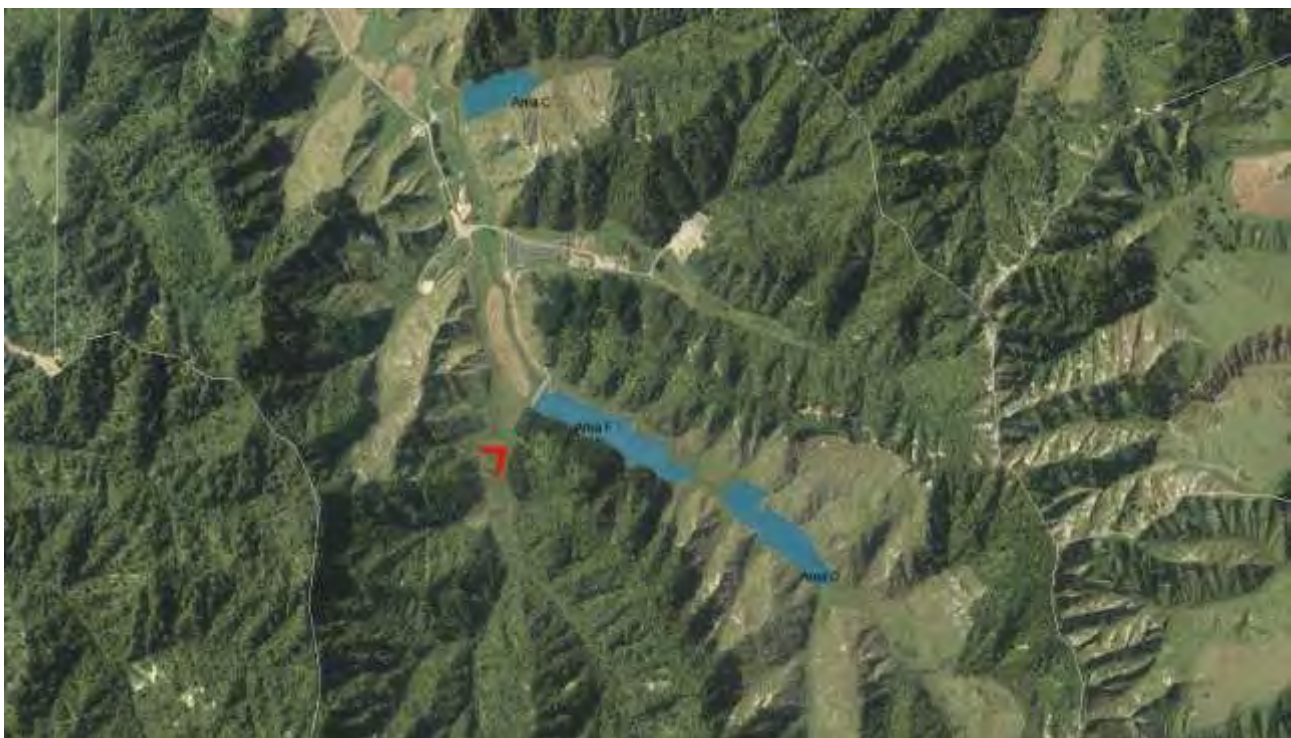
**Figure 4.1: Proposed Irrigation Areas C, D & F and Storage Dam in red**

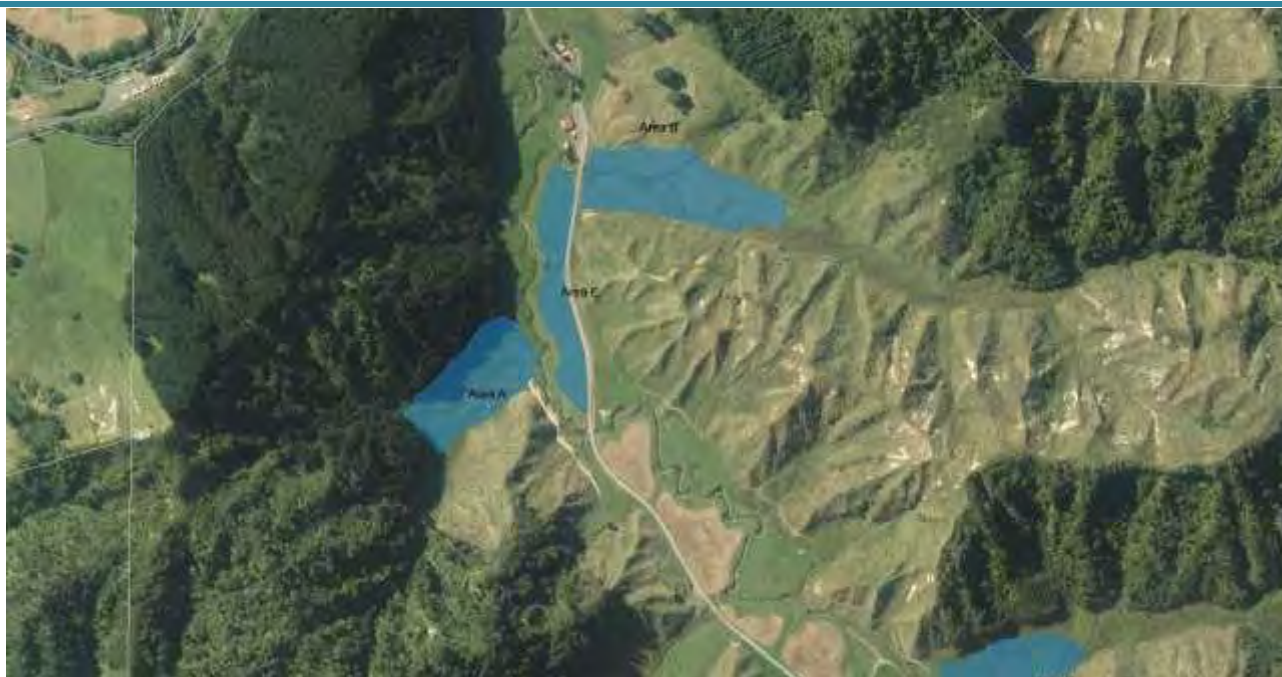
Figure 4.2: Proposed Irrigation Area A, B & E
