Fonterra Kapuni  
Air and Water  
Monitoring Programme  
Annual Report  
2016-2017

Technical Report 2017–92

Taranaki Regional Council

March 2018

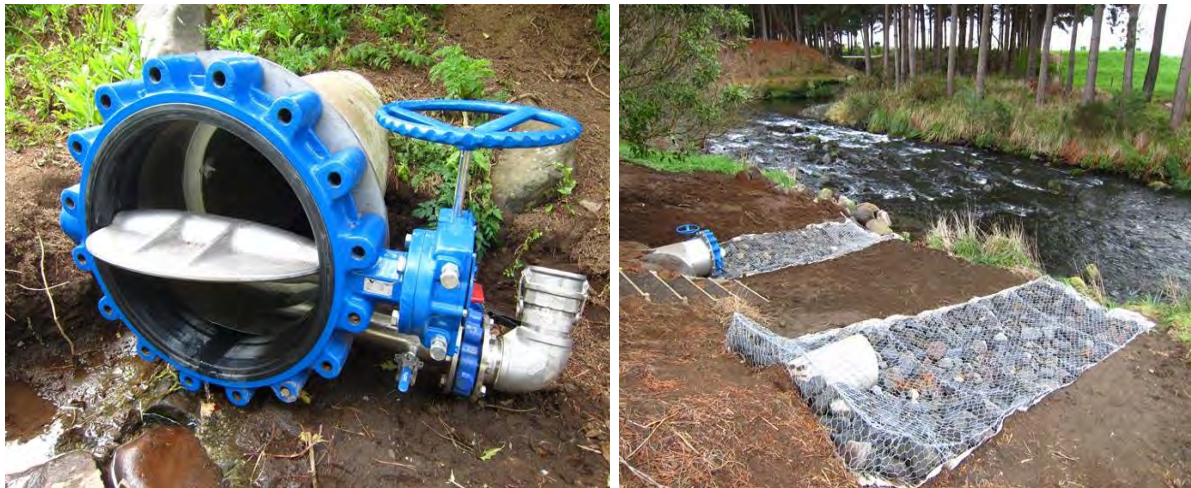
Photo 1 Valve on northern storm drain, and Reno mattresses laid out below storm drains to Kaupokonui Stream

The stormwater outfalls, from the IGL plant installed upstream of the old rail bridge and the detention pond downstream of the cooling water sprayers, did not cause concern during the monitoring period, due to either very low discharge rates or limited contamination of the discharge.

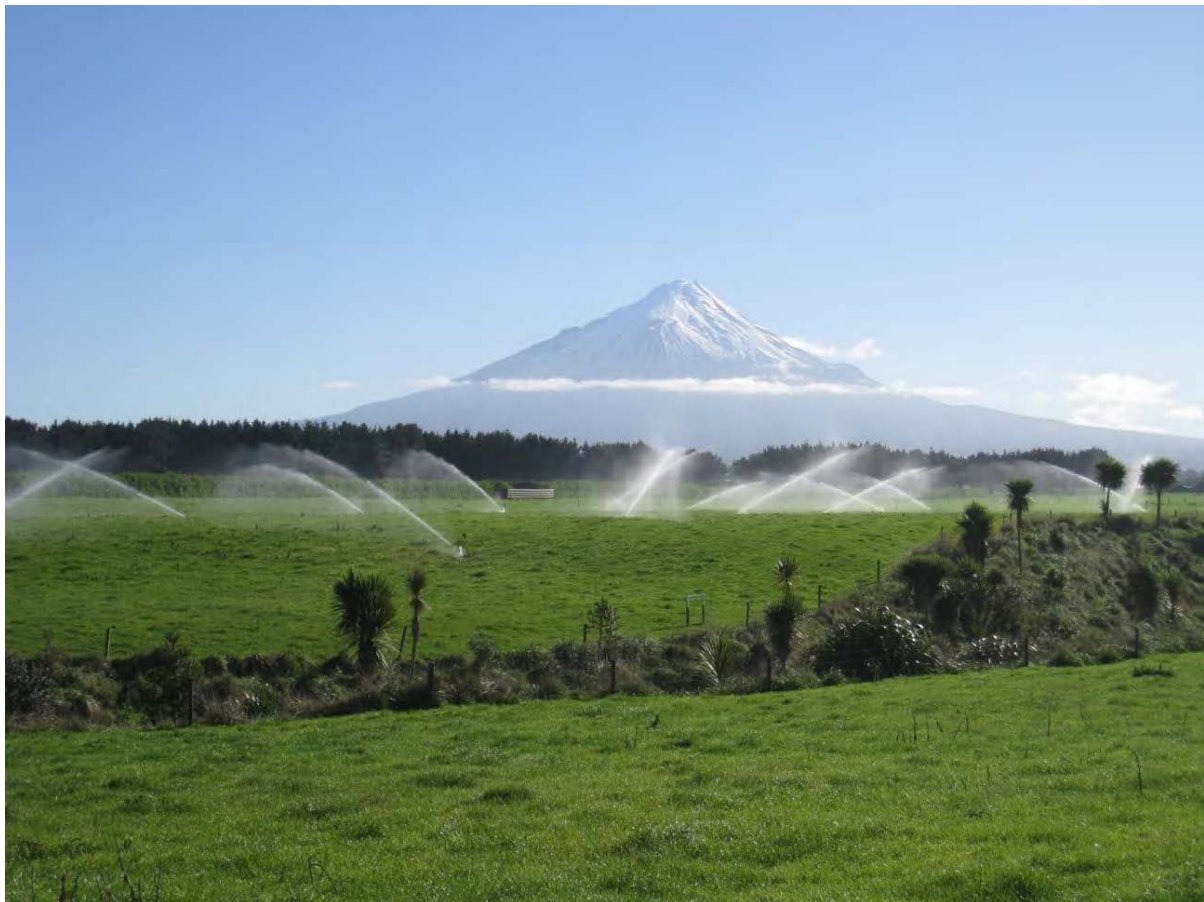
Photo 2 Riparian plantings along Waiokura Stream, Farm 2 with fixed irrigators in operation

An example of riparian planting is given in Photo 2, along the Waiokura Stream on Farm 2, and about 1.1 km south of Skeet Road (Riparian Management Plan RMP1425). Groundwater monitoring bore GND2050 is situated down gradient of the fixed-in-place irrigators and up-gradient of the riparian plantings.

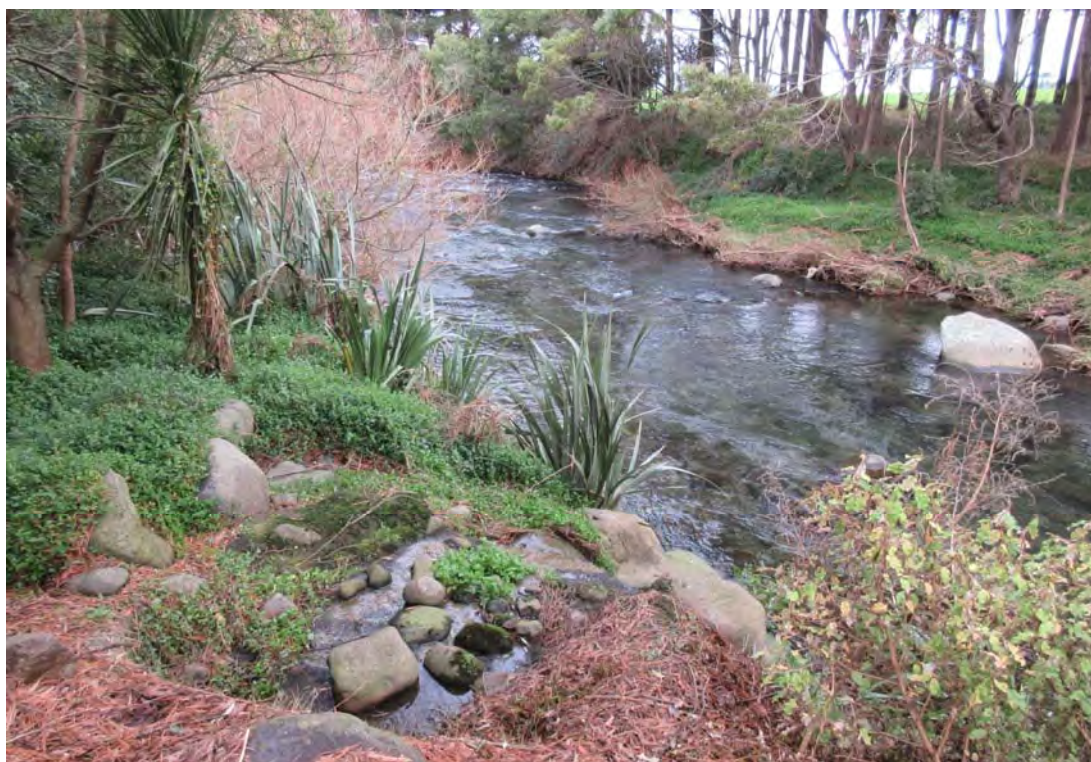
Photo 3 Outfall from stormwater pond to Kaipokonui Stream

Samples were also collected from the outlet of the stormwater pond (Site STW002078, Table 14 and Photo 3) on seven occasions during 2016-2017. The results of the grab samples collected are presented in Table 14. There had been a recent rainfall event prior to the collection of five of the seven samples, with the stormwater pond outlet valve reported to have been closed on two of these sampling occasions, suggesting groundwater seepage. On 28 July 2017, the stormwater pond contents were being discharged; there was an organic pipe odour, and on 18 May 2017 there was a pungent odour reported.

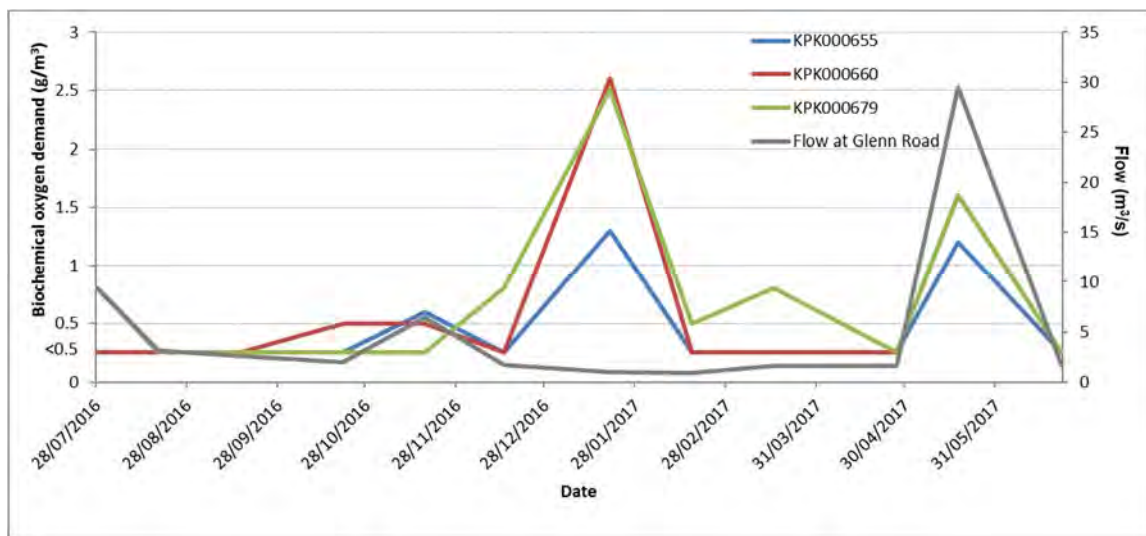
Figure 21 Downstream biochemical oxygen demand changes in the Kaipokonui Stream from the monthly stream surveys

The consent limit on maximum concentration of filtered BOD of  $2 \text{ g/m}^3$ , in the river at the mixing zone periphery, was complied with all but one of the twelve monitoring occasions. On 19 January, the BOD of the stream at the control site was already elevated at  $1.3 \text{ g/m}^3$  (filtered;  $0.7 \text{ g/m}^3$ ). The BOD of the sample collected at the stream site below the lactose plants stormwater discharges had increased by a further  $1.3 \text{ g/m}^3$  (filtered;  $1.4 \text{ g/m}^3$ ) to  $2.6 \text{ g/m}^3$  ( $2.4 \text{ g/m}^3$ ). The BOD was found to have changed little, if at all, at the monitoring site downstream of the cooling water discharges. With the changes in the total and filtered BODs being similar, this shows that the increase in BOD was due to dissolved organic contaminants. On this sampling occasion it was noted that there was dairy effluent discharging to the stream from the bridge crossing the stream immediately upstream of site KPK000655. It is possible that due to the discrete nature of grab sampling, both in terms of location with respect to the width of the stream, and in time, the effects of this discharge on BOD could have been more apparent further downstream. It is proposed that during the 2017-2018 year that the upstream control site for monitoring of the Fonterra site discharges is moved further downstream, to ensure that is downstream of the mixing zone of any potential discharges from the bridge or farm dairy shed on the true left bank above the lactose plant.

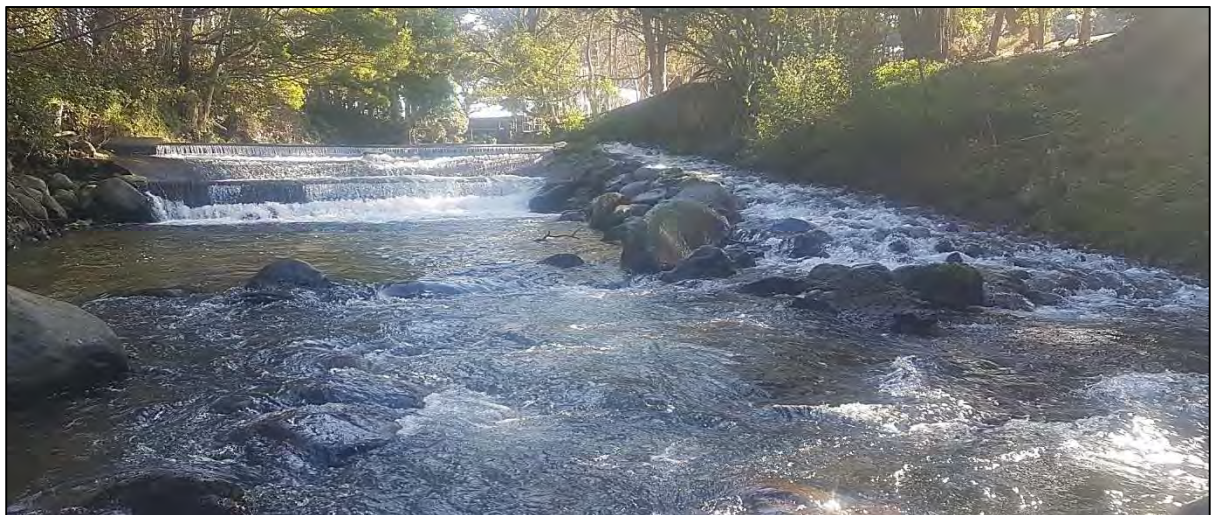
Before any results are interpreted, it is necessary to provide some context. Located downstream of the Kapuni Lactose factory, there is a weir known locally as the Glenn Road weir. This weir is an orphaned structure, but is considered to have some historical significance. It also presents a significant barrier to the passage of most fish, with only the best climbers being able to negotiate it. It is considered highly unlikely that swimming species, such as common smelt, inanga and torrentfish, could negotiate this weir, and as such they are not expected to be in the Kaupokonui River near the lactose factory.

Figure 1 Kaupokonui Stream, Kapuni Lactose weir and fish pass
