Taranaki By-Products Ltd
Monitoring Programme
Annual Report
2016-2017

Technical Report 2017-13

Taranaki Regional Council
Private Bag 713
STRATFORD
March 2018

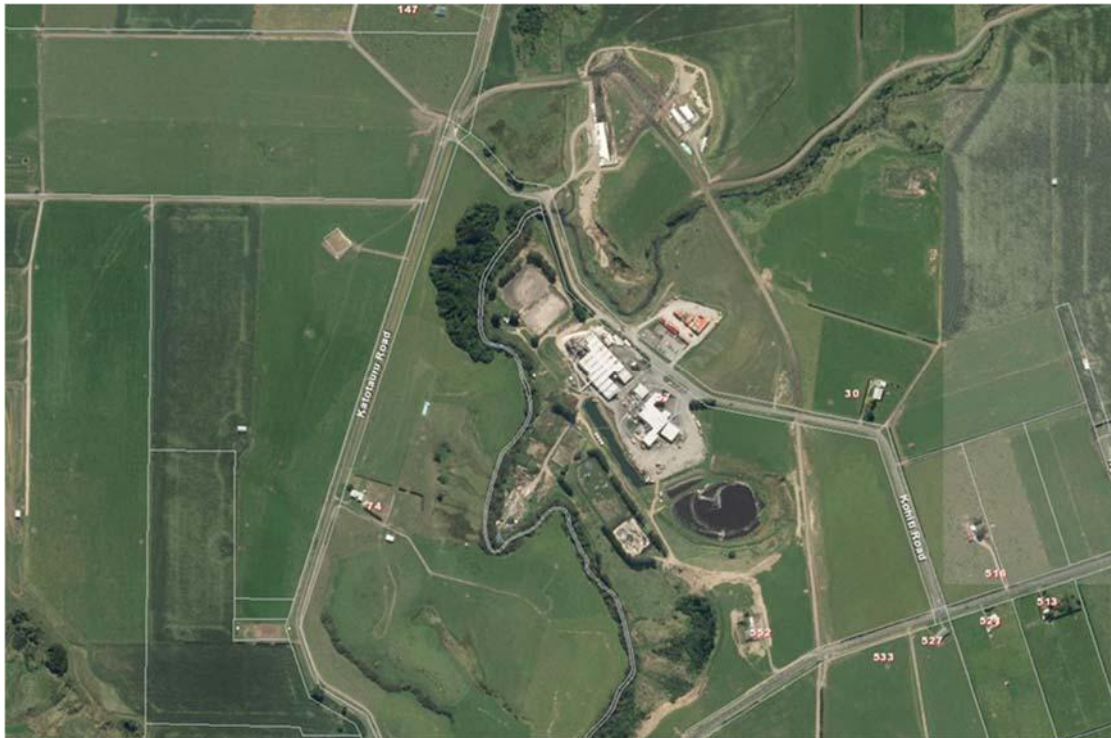
Photo 1 Taranaki By-Products and Taranaki Bio-Extracts aerial view

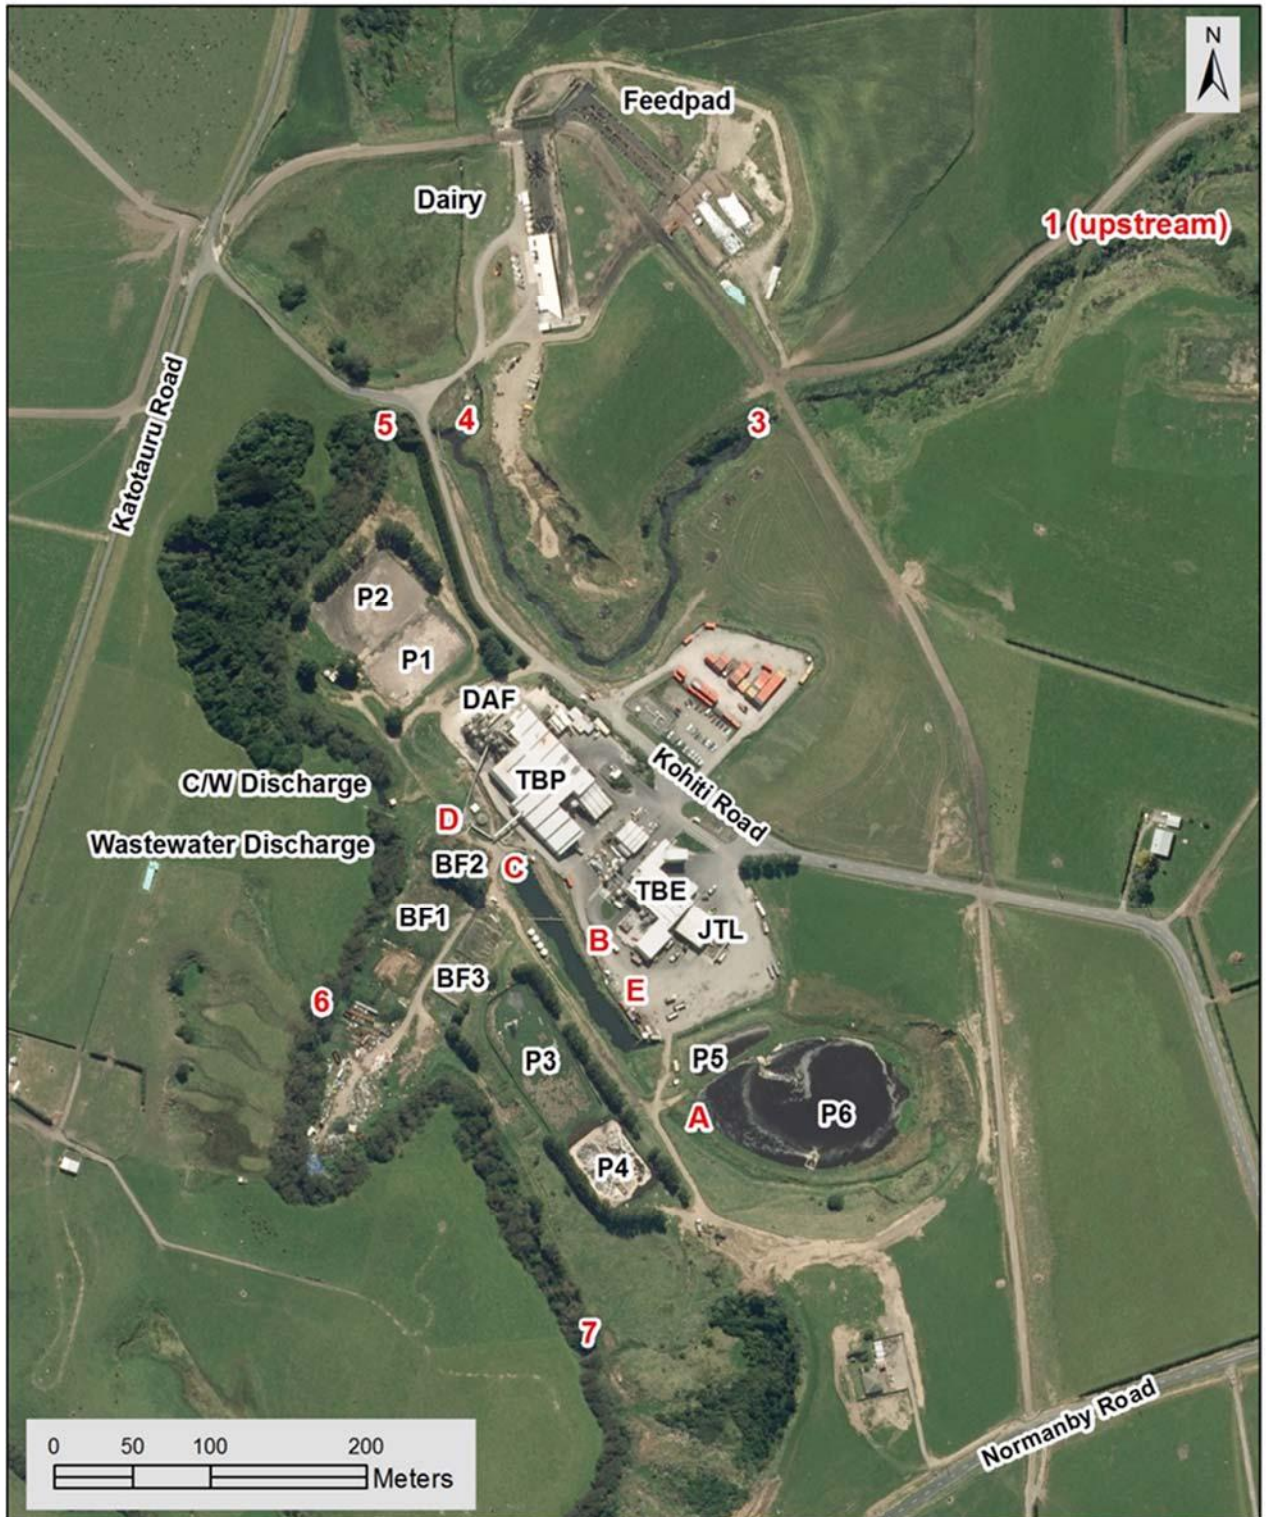
Figure 1 Point source sample location and labelling

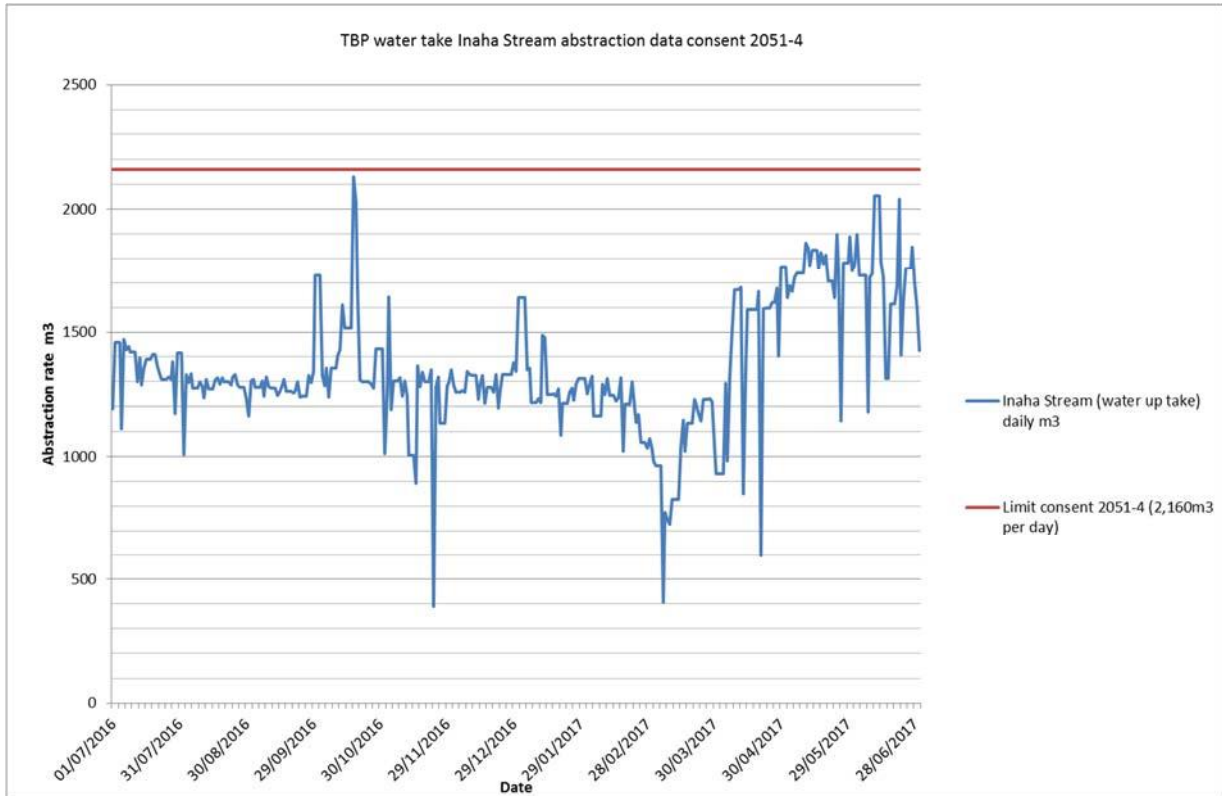
taken, and thereafter supply, by 31 July each year, the record of the preceding 1 July to 30 June period. TBP installed a flow measurement and recording system as required. Verification of the accuracy of the system was carried out by an approved certifier.

Figure 4 Consent 2051-4 surface water abstraction data, Inaha Stream 2016-2017 monitoring year

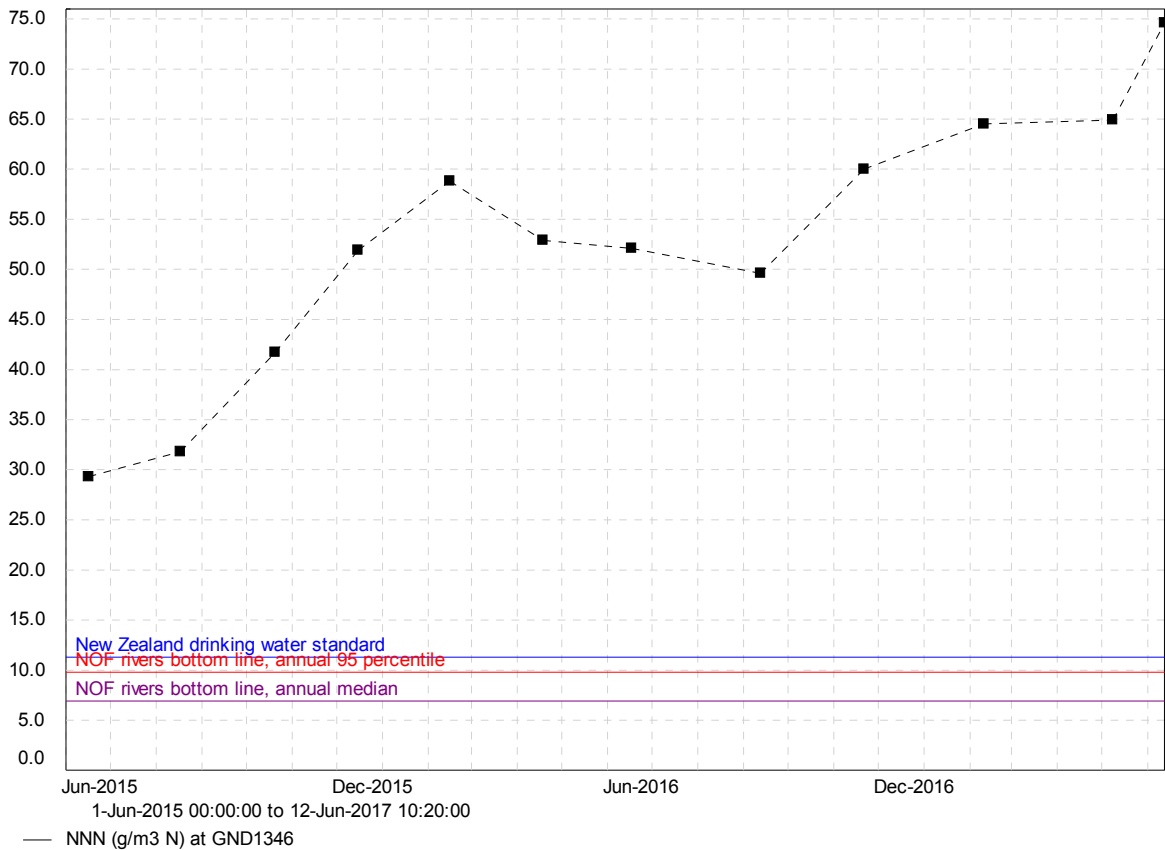
Figure 14 NNN concentrations GND1346 since June 2015

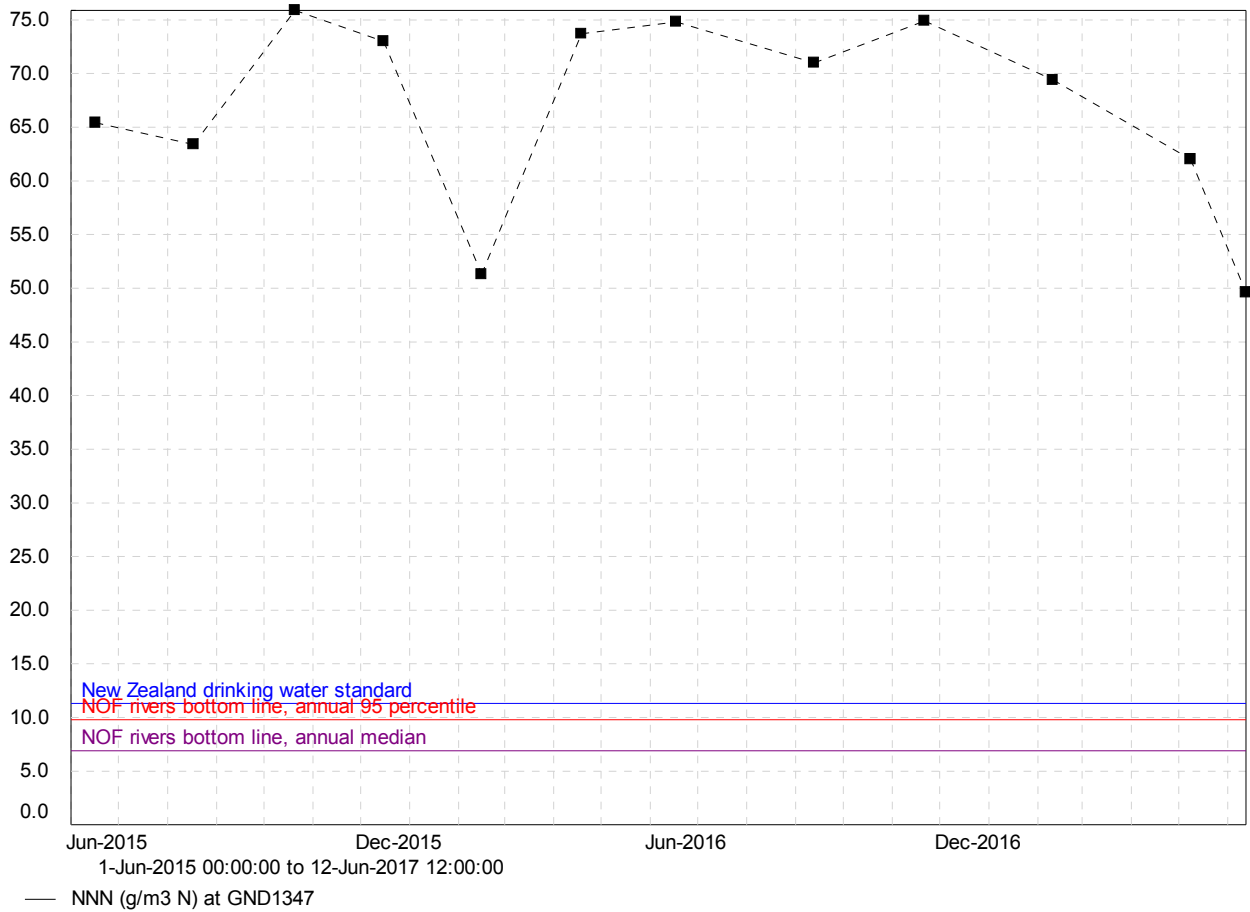
Figure 15 NNN concentration in GND1347 since June 2015

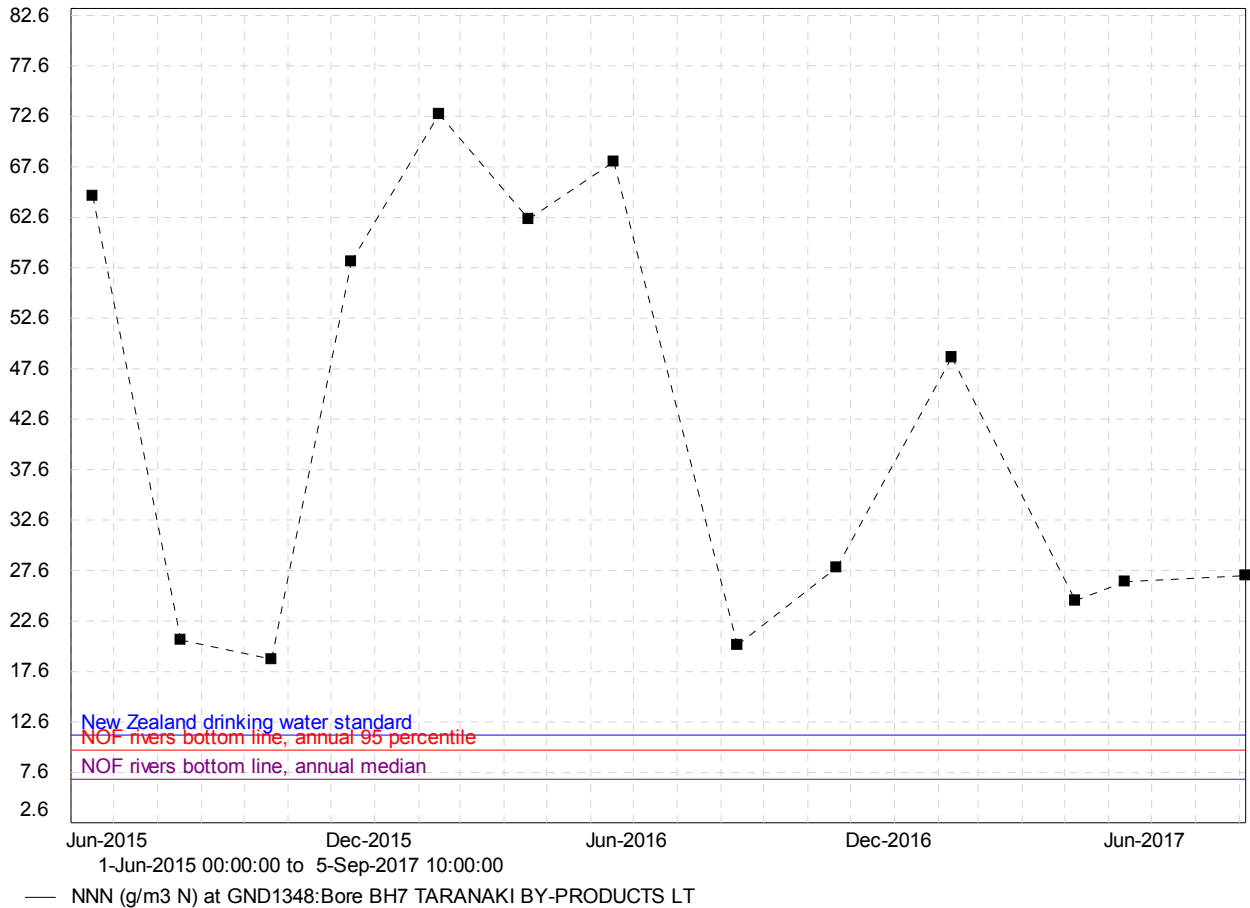
Figure 16 NNN concentrations GND 1348 since June 2015

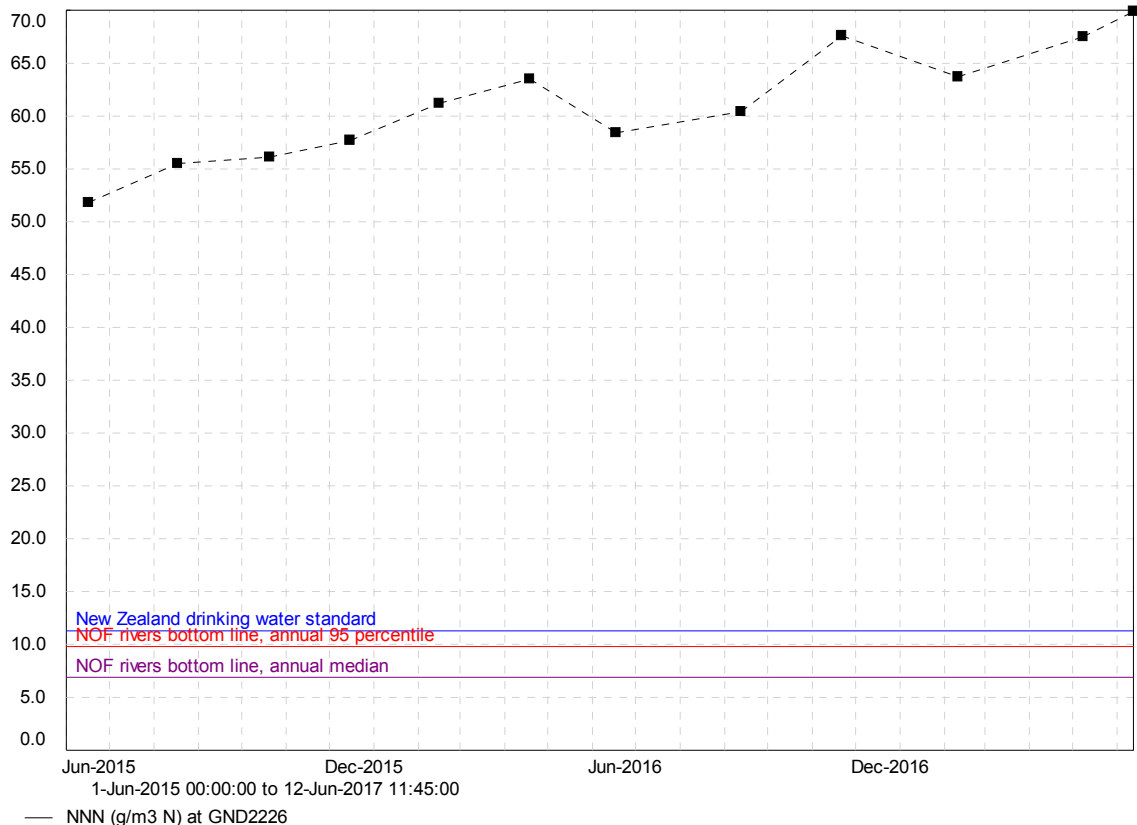
Figure 19 NNN concentrations in GND2226 since June 2015

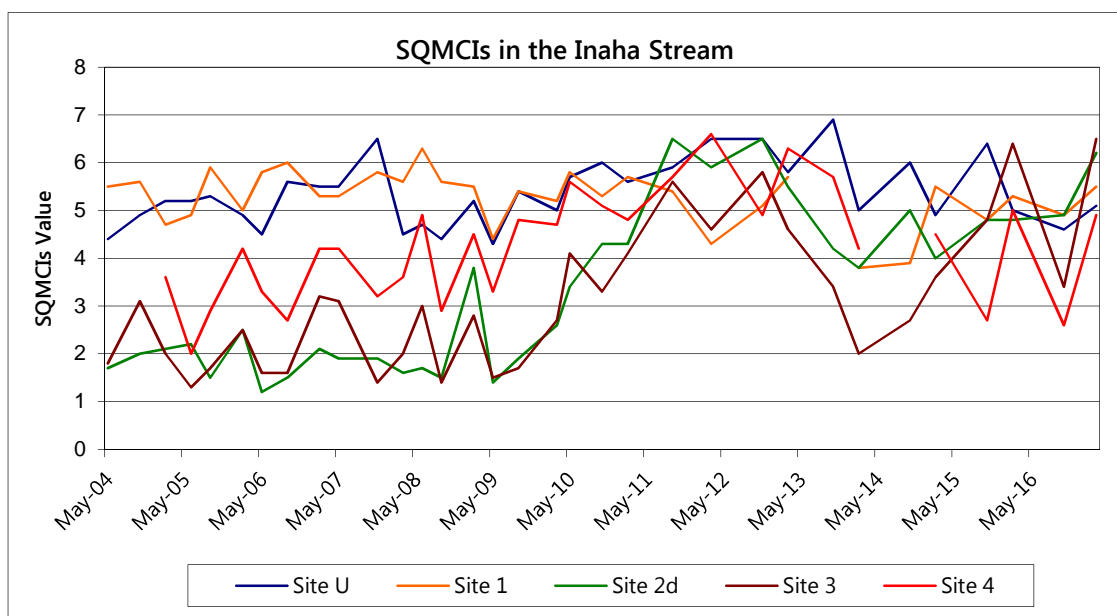
Figure 11) but since 2012 large fluctuations in macroinvertebrate indices have occurred. The best result for this type of survey is that MCI scores and SQMCI₅ scores in the Inaha Stream are not significantly different to each other within each survey. Occasionally differences in habitat between sites can result in different scores, although this can often be explained when the community assemblage is assessed. The SQMCI₅ is more sensitive to changes in habitat, and this is evident in Figure 10. Figure 10 shows SQMCI₅ scores were similar between sites, with the exception being sites 2d and 3, which recorded SQMCI₅ scores substantially higher than the remaining Inaha Stream sites.

Figure 10 SQMCI₅ values for the Inaha Stream sampled in relation to Taranaki By-Products discharges since May 2004.

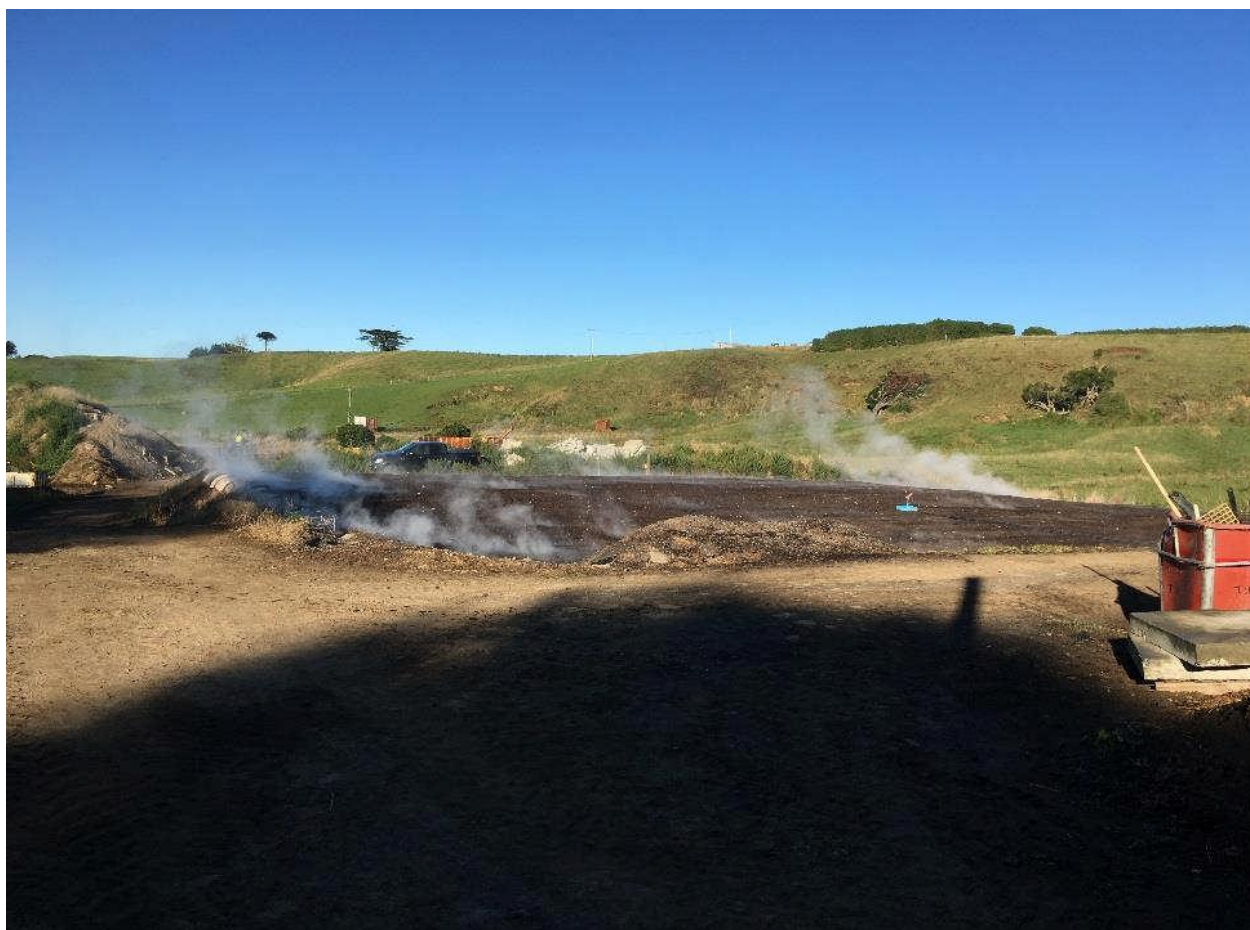
The bark within the TBL biofilter is in a relatively new condition. However, we recommend measures are undertaken to reduce the extent of air channelling that is currently occurring. The exact measures required are not obvious (this requires further investigation), but we recommend investigating air leaks around the Novaflow pipe lateral connections to the main concrete manifold. Furthermore, additional bark can be used to better cover the manifold and fill in the gaps between the bed and the western earth wall.

Figure 1: Photographs of the TBL concentrated source biofilter viewed from the northeast corner.

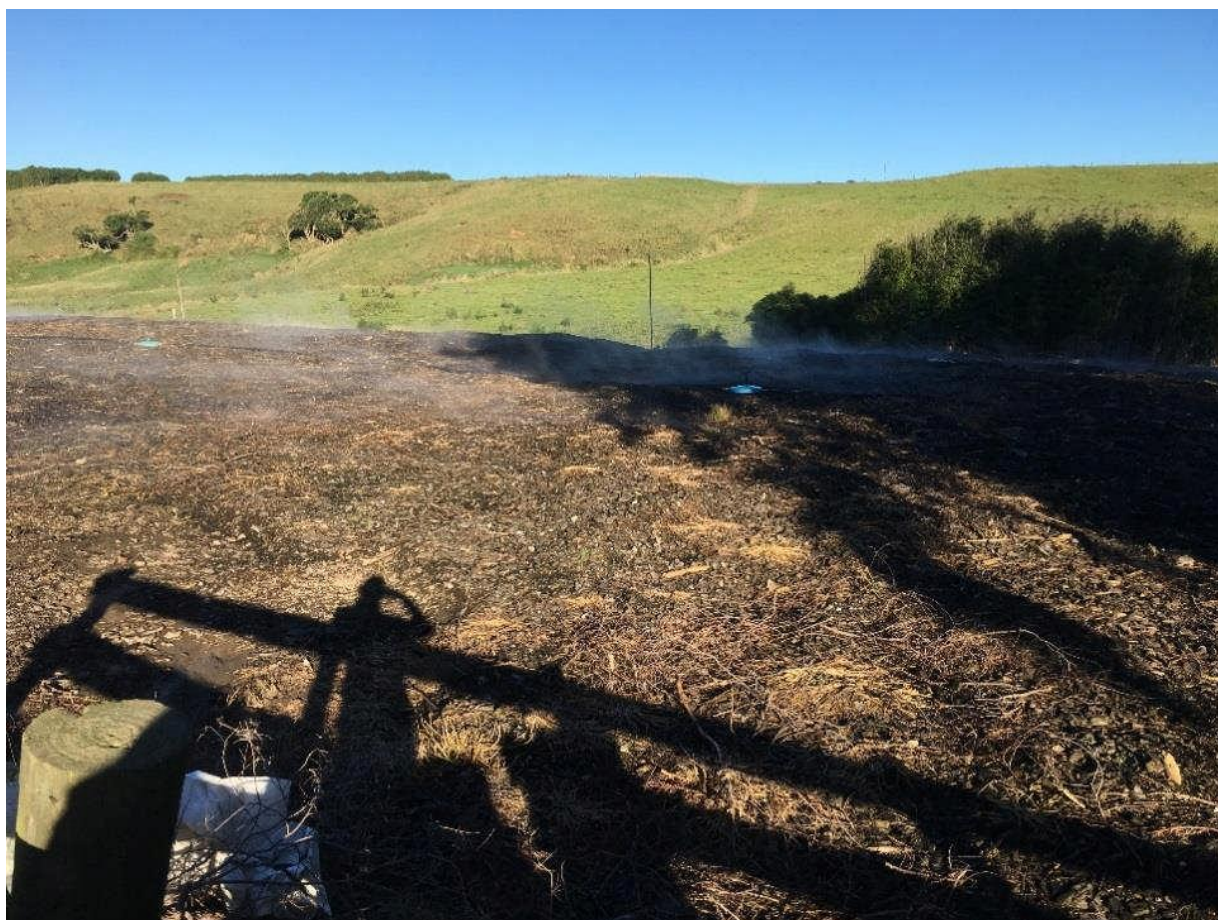
This media is due for replacement and therefore size distribution testing of this is recommended to help confirm what fraction of existing media is retained and remixed with new bark. When replacing these two beds (one at a time) it will be an opportune time to check and clean out the manifold and air distribution system as necessary, strengthen sections of timber wall and re-seal any leaking joints within the internal liner. Figure 3 shows a photograph of the concrete inlet chambers that connect to the two inlet air manifolds to each of the biofilter beds.

Figure 2: Photograph of the Factory Air #1 Biofilter viewed from its northeast corner.

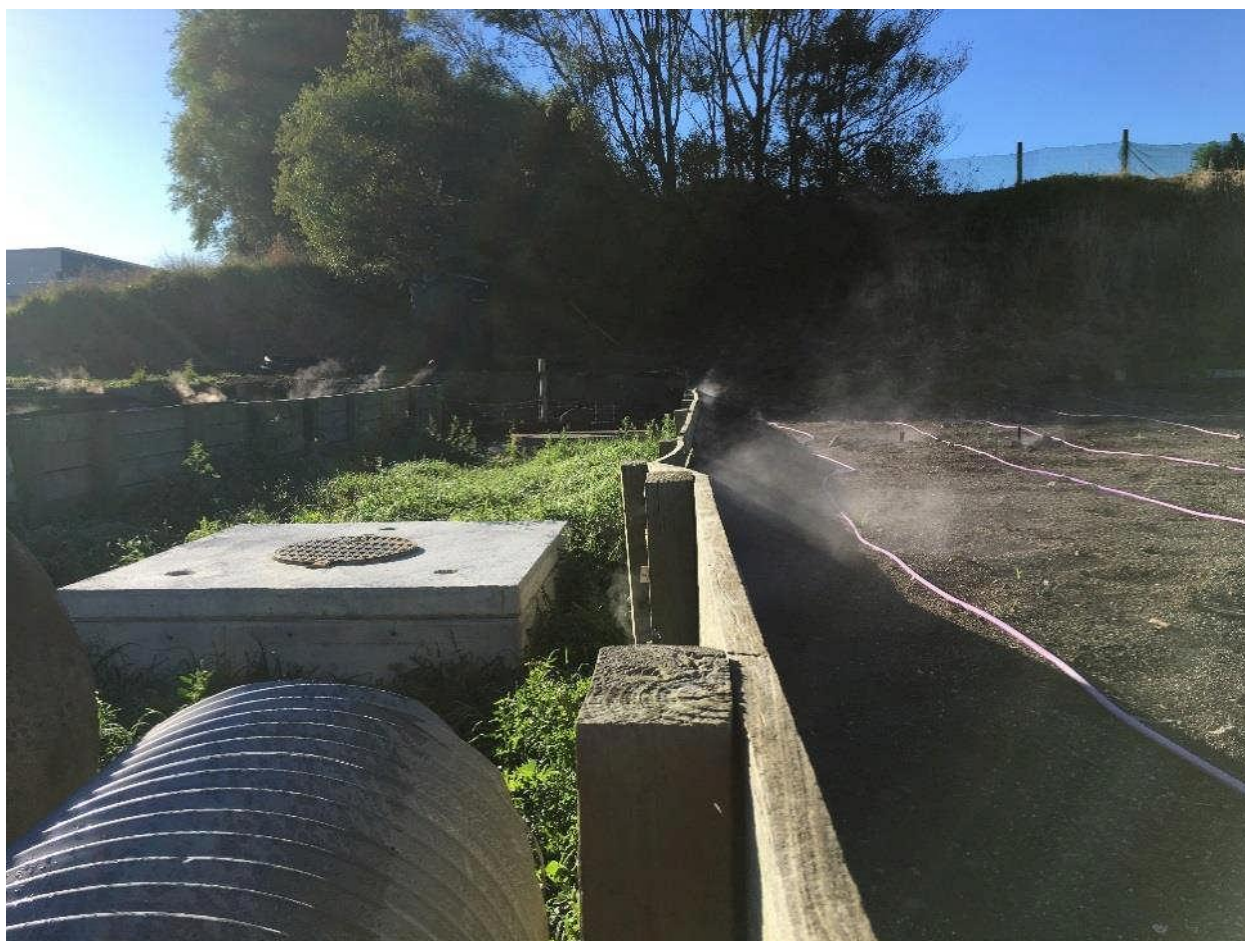
Figure 3: TBE concentrated sources biofilter inlet chambers and timber wall of the second bed.
