Fonterra Kapuni
Air and Water
Monitoring Programme
Annual Report
2017-2018

Technical Report 2018–96

Taranaki Regional Council
Private Bag 713
STRATFORD
March 2019

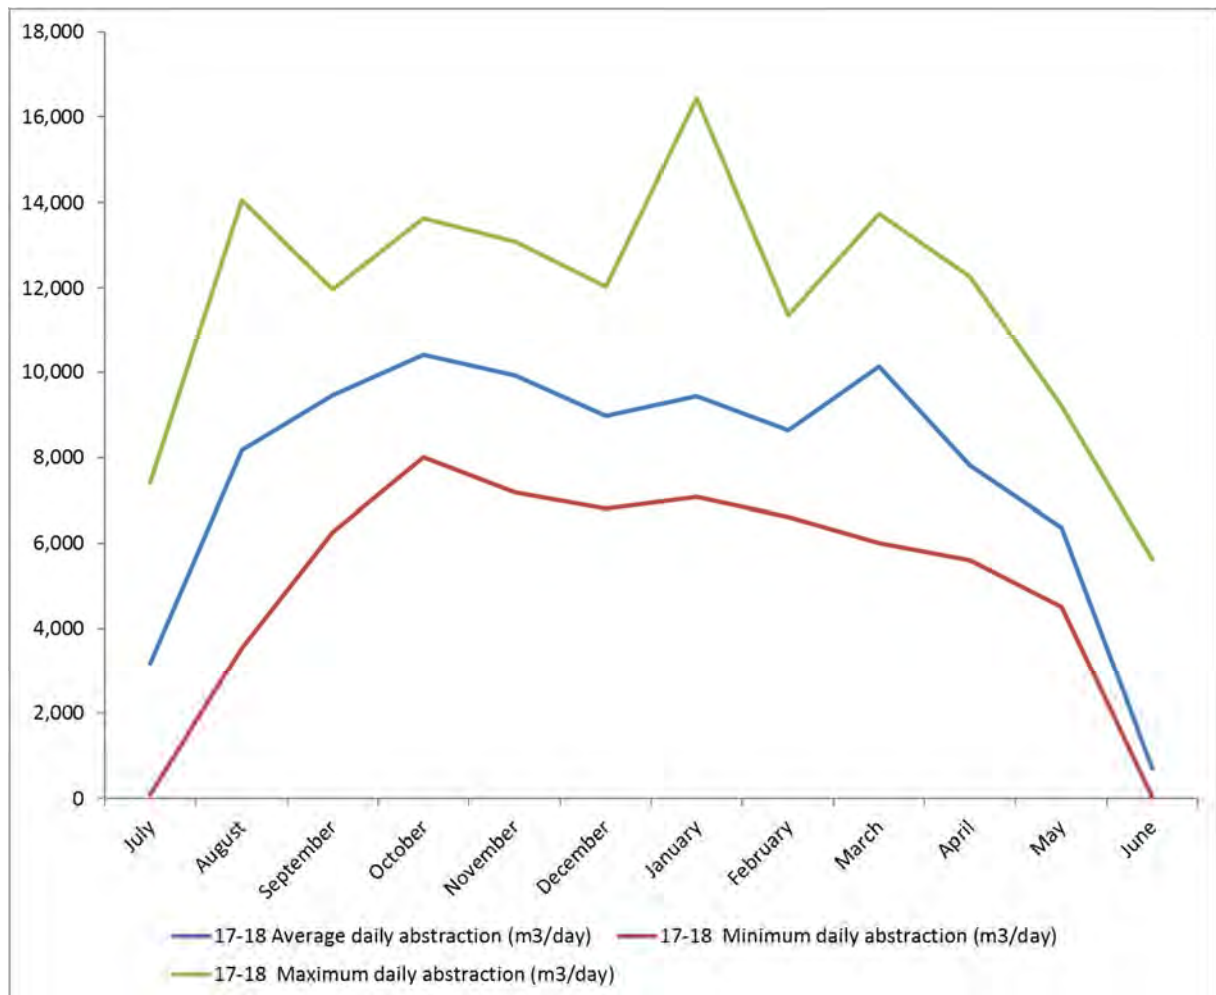
Figure 3 Monthly summary of water abstraction volumes from the Kaipokonui Stream from the Company's monthly reports

The daily stream abstraction data summaries in Table 3 and Figure 3 illustrate that the Company continued to take a significant volume of water from the stream during the 2017-2018 monitoring period.

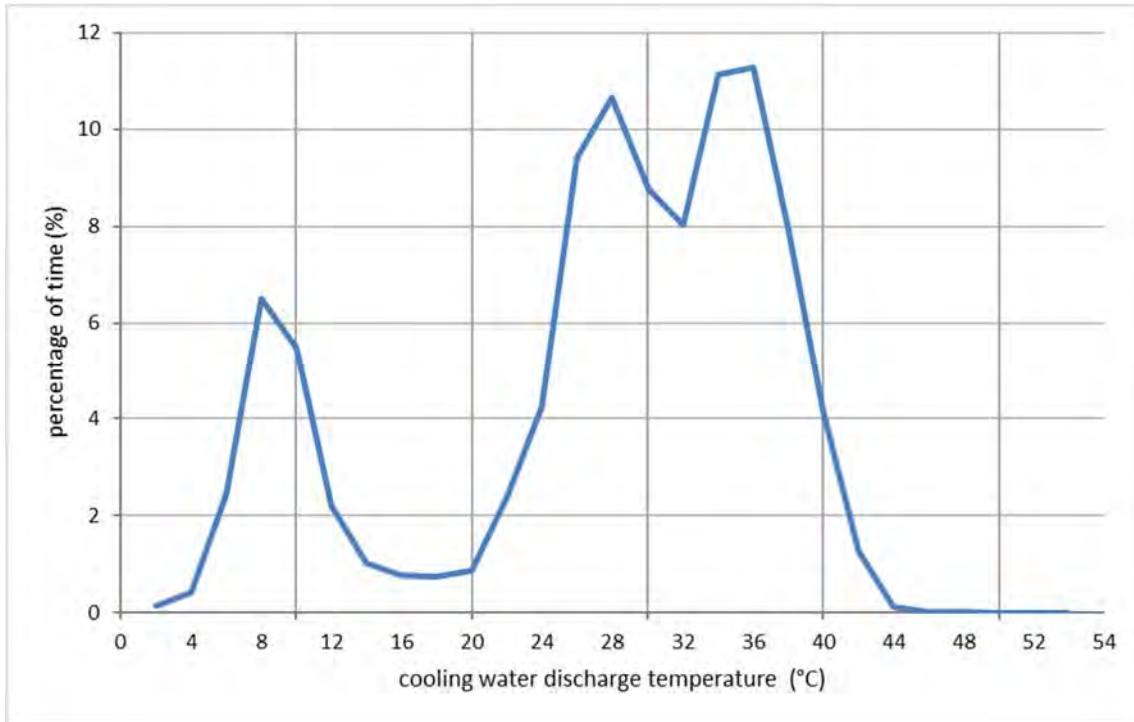
Figure 11 Cooling water tower discharge temperature probability density during the period under review from 1 July - 30 June

Further analysis and comparison of cooling water tower and operational performance is illustrated in Figure 11 and Figure 12. Cumulatively during the year under review the cooling water discharge is at or above 40°C for 6% of the time, generally occurring between November and March.

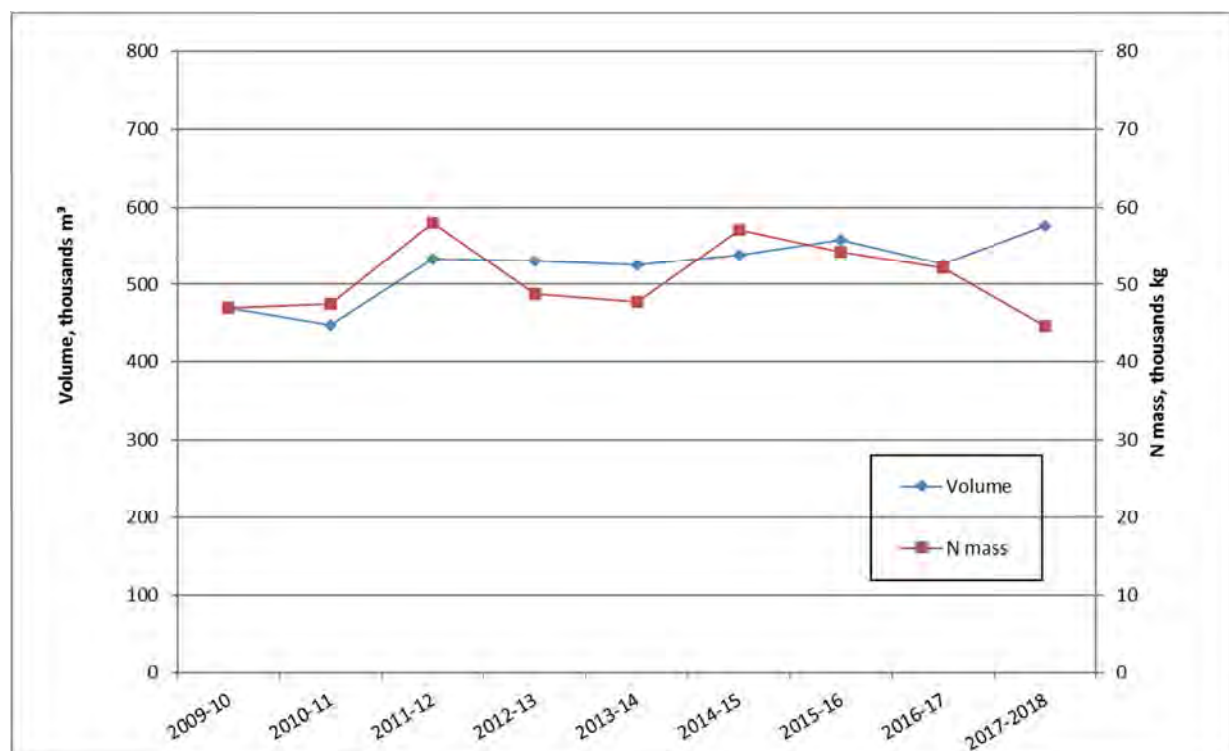
The annual volume of factory wastewater produced since 2009-2010, together with the annual mass of factory nitrogen irrigated, is presented in Figure 16. With respect to the mass discharge rate of wastewater components, factory wastewater volume has generally changed little since 2011-2012. Therefore, historically, the estimated mass discharge rate of the wastewater components has increased or reduced by about the same proportion as their respective concentrations. However, for the year under review it appears that there was a new maximum wastewater discharge volume, with a new minimum mass discharge rate of

nitrogen. It is noted thought that there were a reduced number of determinations of the wastewater nitrogen concentration, particularly when compared to the 2015-2016 year (approximately 10% reduction).

Figure 16 Annual volume of factory wastewater and estimated factory nitrogen mass irrigated, 2009 - 2017

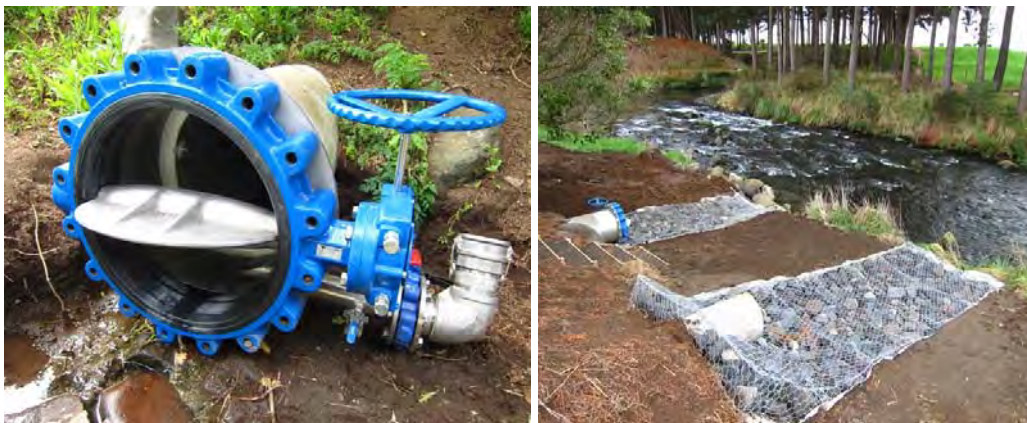
Photo 1 Valve on northern storm drain, and Reno mattresses laid out below storm drains to Kaupokonui Stream

The stormwater outfalls, from the IGL plant installed upstream of the old rail bridge and the detention pond downstream of the cooling water sprayers, did not cause concern during the monitoring period, due to either very low discharge rates or limited contamination of the discharge.

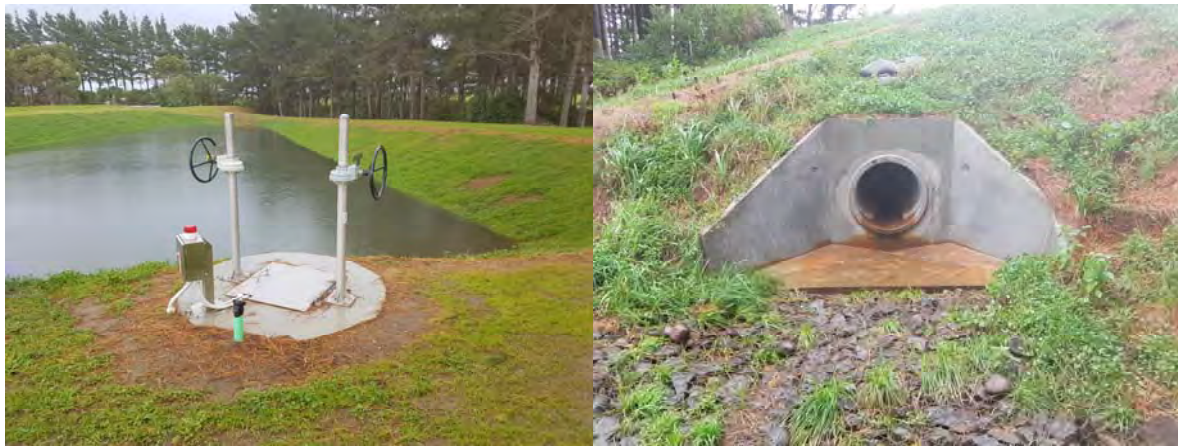
Photo 2 Northern stormwater pond, stop valves and outfall to the Kaipokonui Stream

During the October inspection it was noted that that IGL plant and factory extension stormwater pipes had been combined and the discharge location moved. The stormwater discharged via the new outfall without any treatment as the stormwater pond was yet to be completed, however a shut off valve had been installed and was functional at the time of this inspection (Photo 2). The last samples that the Council obtained from the old stormwater outlets pictured above were on 21 September 2017, with samples from the new outfall collected at the inspections in October 2017 and January, March and May 2018, all of which were relatively low flow discharges. The first discharge the new pond was logged by the Company as being 8 March 2018. At the inspection on 15 March 2018 it was found that a recent storm had caused slips on the newly seeded pond walls and that work was being undertaken at the time of inspection to repair the damage. The stormwater pond outlet was open and only a minor, clear discharge was occurring.

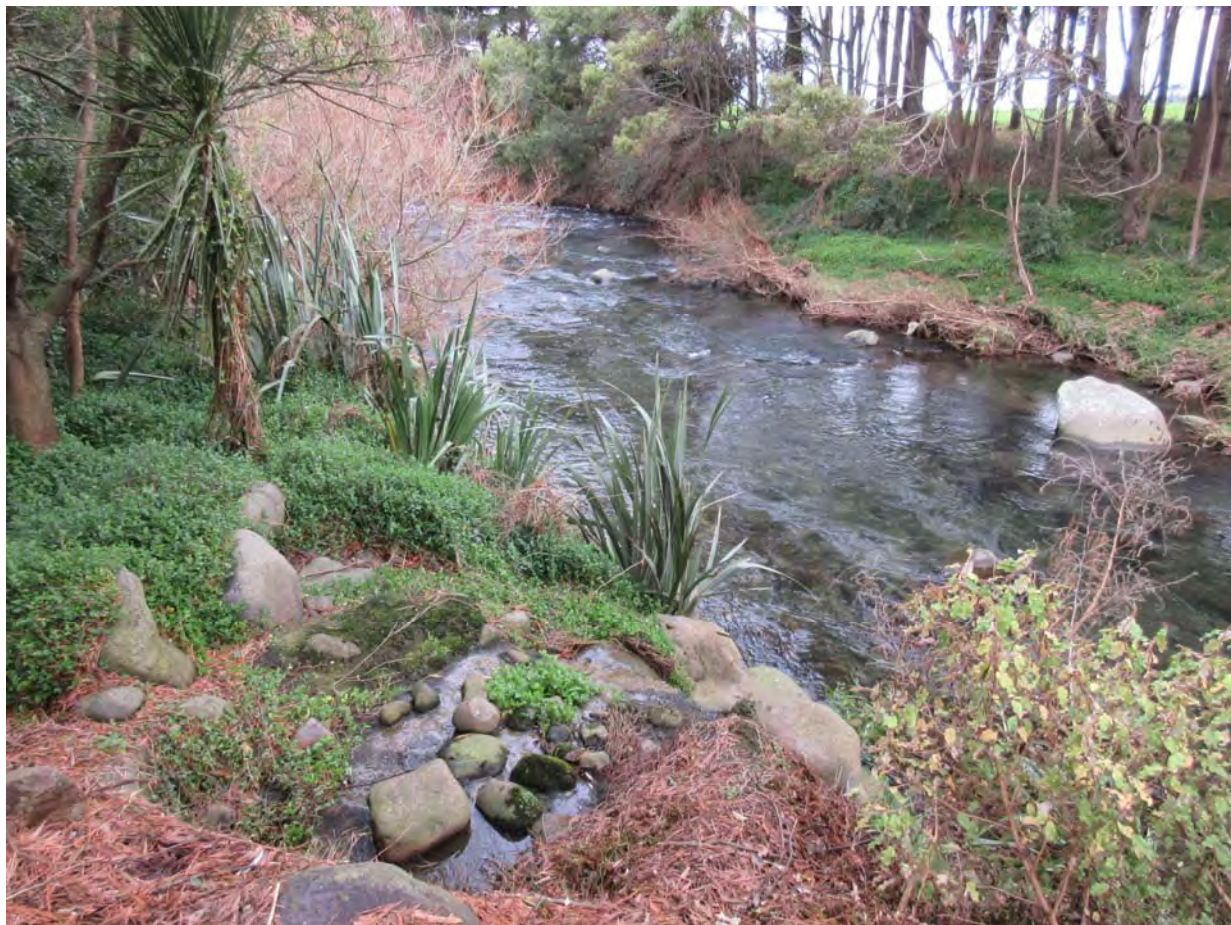
Photo 4 Outfall from stormwater pond to Kaipokonui Stream

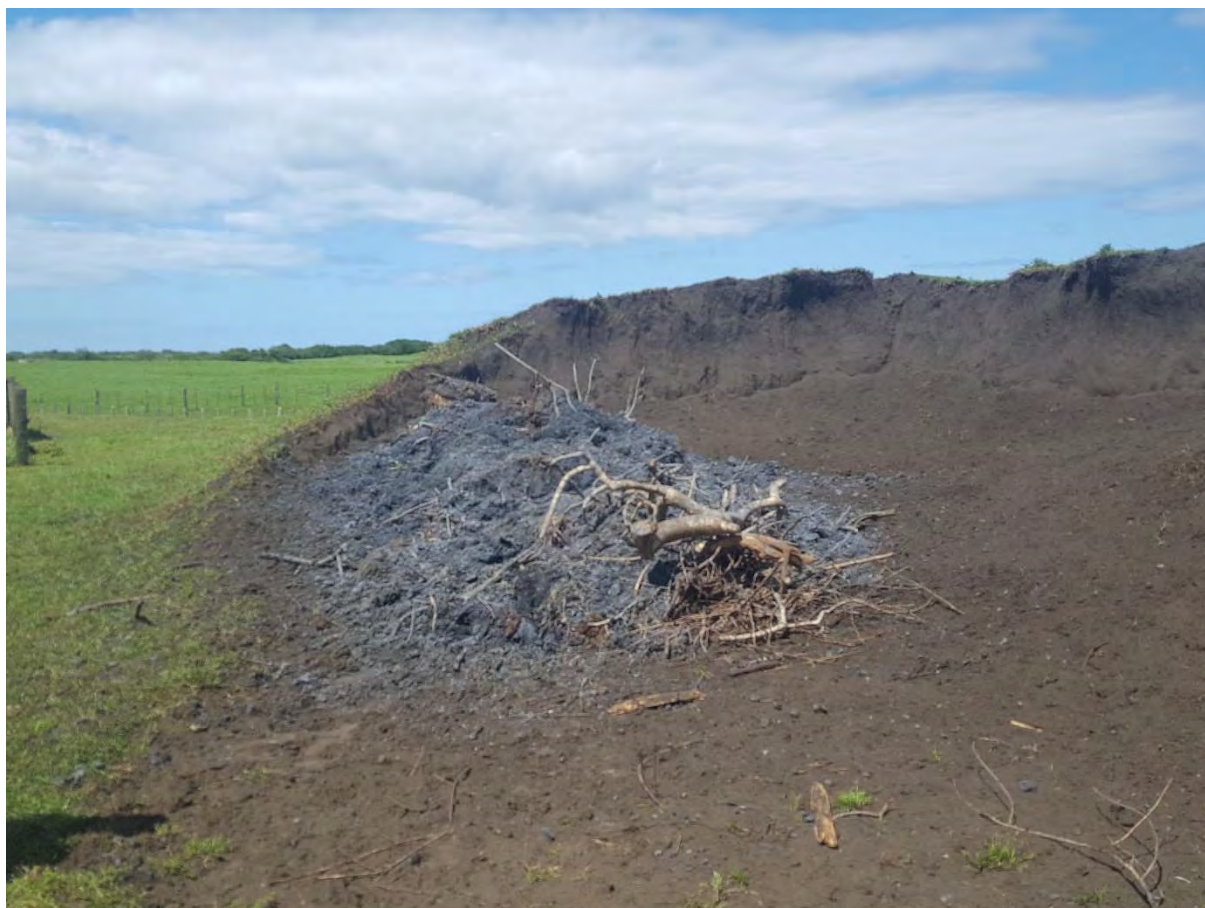
Photo 5 Example of the Company's lactose manufacturing processing wastes disposed of at the Malandra Downs site

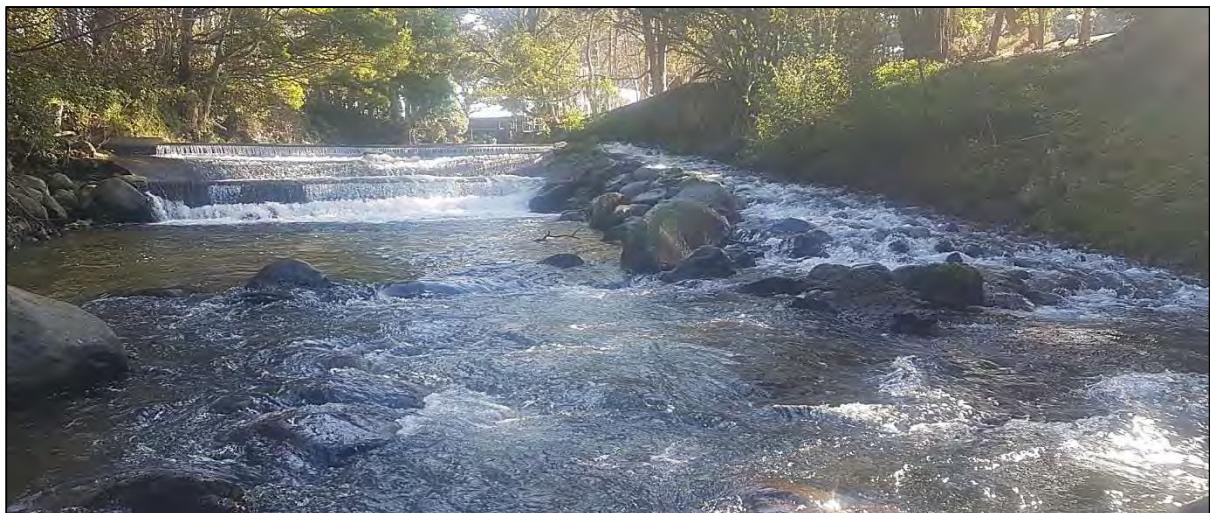
Before any results are interpreted, it is necessary to provide some context. Located downstream of the Kapuni Lactose factory, there is a weir known locally as the Glenn Road weir. This weir is an orphaned structure, but is considered to have some historical significance. It also presents a significant barrier to the passage of most fish, with only the best climbers being able to negotiate it. It is considered highly unlikely that swimming species, such as common smelt, inanga and torrentfish, could negotiate this weir, and as such they are not expected to be in the Kaupokonui River near the lactose factory.

Figure 1 Kaupokonui Stream, Kapuni Lactose weir and fish pass

The fish pass installed by the Company under the guidance of the Council in March 2004, contained an adequate level of water during all inspections. Trout were observed around the weir during the October, November and December 2017 inspections.
