Remediation NZ Ltd Uruti
Waitara and Pennington Road
Monitoring Programme
Annual Report
2017-2018

Technical Report 2018-79

Taranaki Regional Council
Private Bag 713
STRATFORD
March 2019

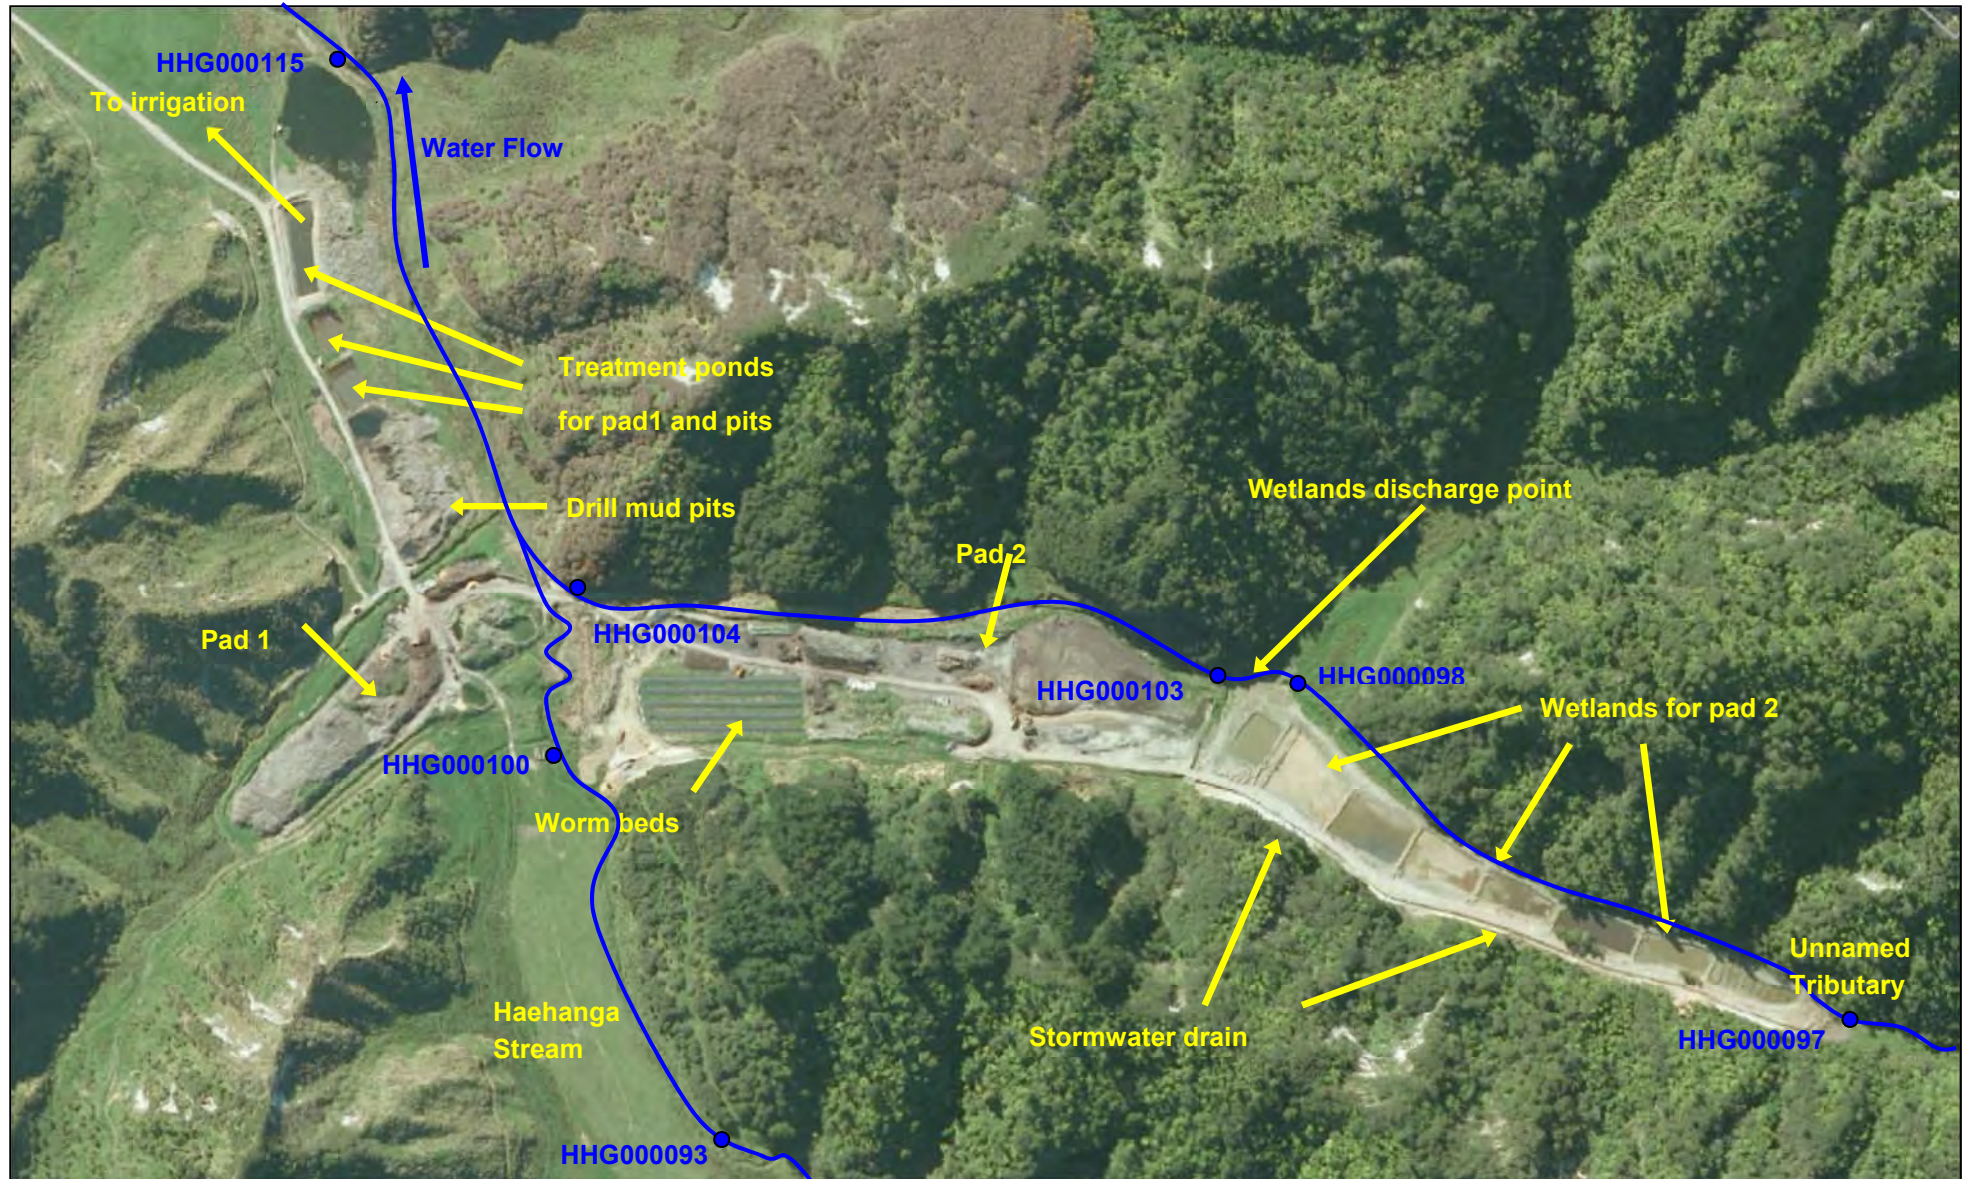
Figure 1 Location of biomonitoring sites in the Haehanga Stream catchment

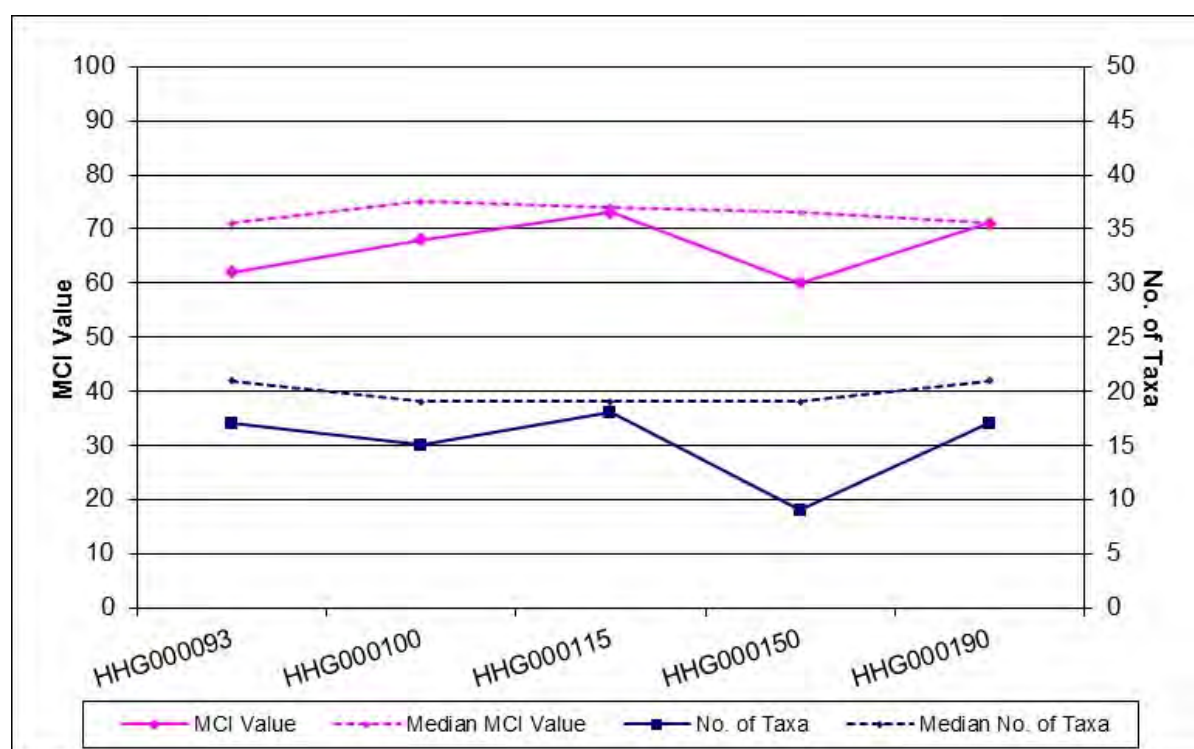
Figure 2 Number of taxa and MCI scores recorded at the Haehanga Stream sites during the current survey, compared with the respective medians for these sites.

The current survey results for the Haehanga mainstem are also presented in Figure 2 and Figure 3, with these figures providing a catchment perspective.

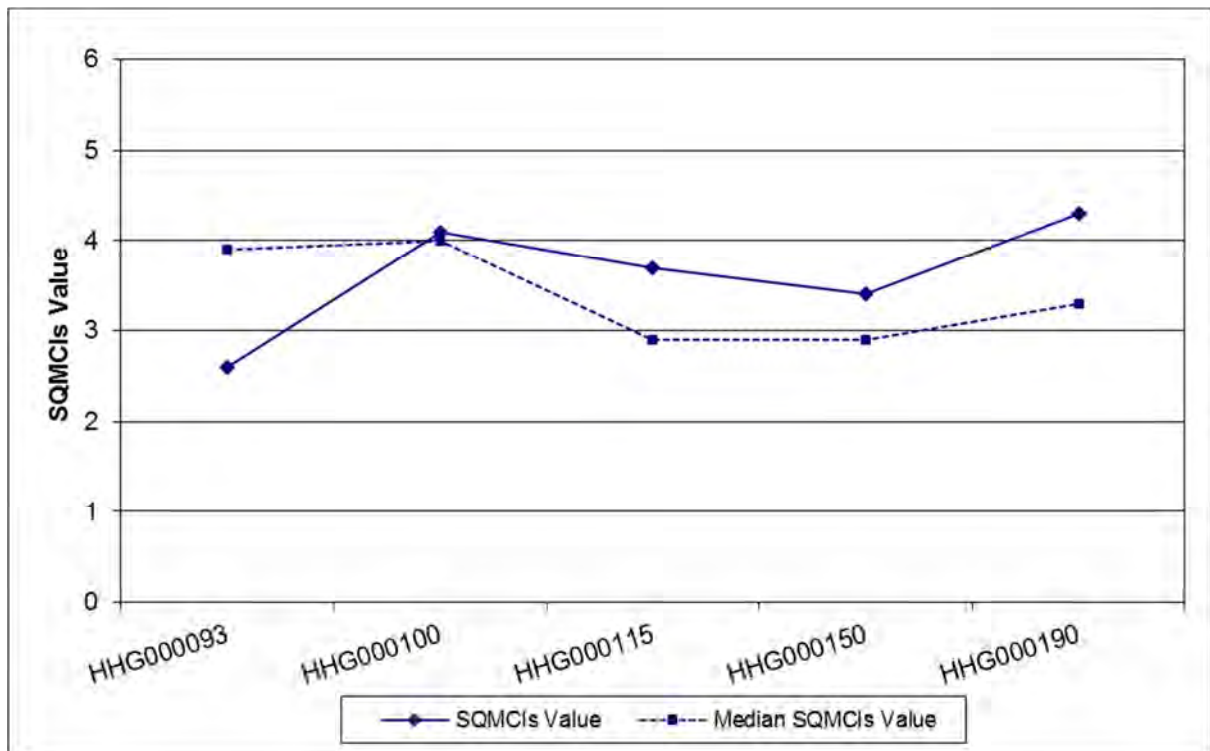
Figure 3 SQMCI_s scores recorded at the Haehanga Stream sites during the current survey, compared with the respective medians for these sites.

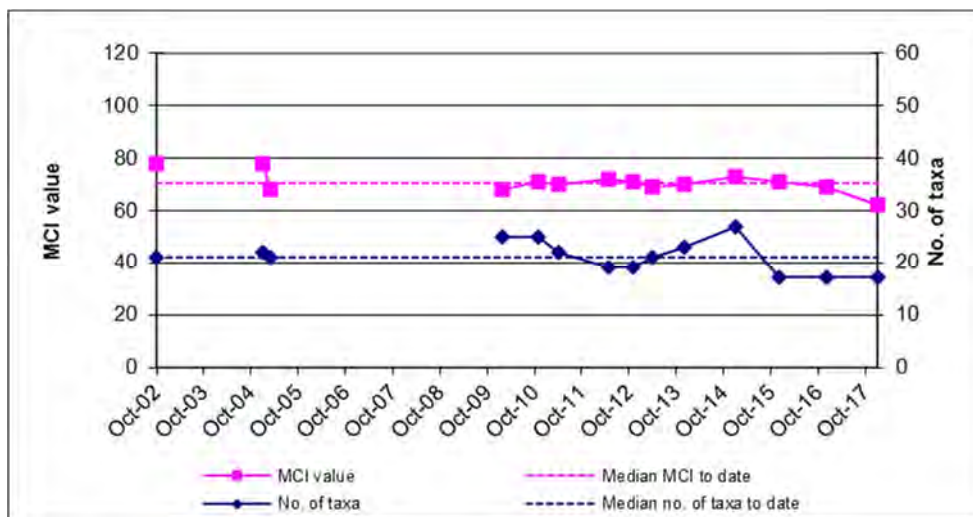
A relatively low taxa richness was recorded at this site (17), which was four taxa less than the median, and the lowest richness recorded at this site to date, equal to that recorded in the two previous surveys (Figure 4). The low taxa richness recorded in the current survey may be related to the low flows that preceded this survey, coupled with the extensive macrophyte beds. These conditions can lead to warm water temperatures and low dissolved oxygen levels, which can lead to a reduction in taxa richness, with only the more resilient species remaining.

Figure 4 Taxa numbers and MCI recorded to date at site 1

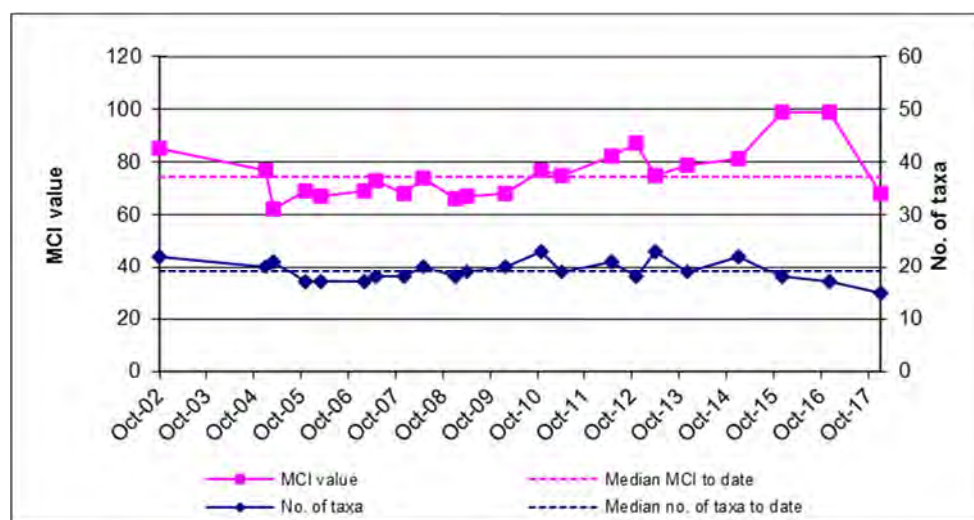
At site 2 in the Haehanga Stream, upstream of all composting areas, 15 macroinvertebrate taxa were recorded. This was two taxa fewer than that recorded in the previous survey and four taxa less than the median for this site (Table 2). The community was dominated by four 'tolerant' taxa, (snails (*Physa* and *Potamopyrgus*) ostracod seed shrimp and damselfly larvae (*Xanthocnemis*)), and two very abundant 'moderately sensitive' taxa, (*Paracalliope* amphipods and *Tripletides* caddisfly) (Table 3).

The MCI value of 68 units reflected a low proportion of sensitive taxa in the community at this site (33%). This score is more than thirty units less than that recorded in the previous survey, but not significantly different to the median score for this site, and is within the range of previous results (Stark 1998) (Table 2, Figure 3). The SQMCI₅ value at this site (4.1) was similar to the median value, and similar to that recorded in the previous survey, and reflecting the overall numerical dominance of the 'extremely abundant' *Potamopyrgus* snails.

Figure 5 Taxa numbers and MCI recorded to date at site 2

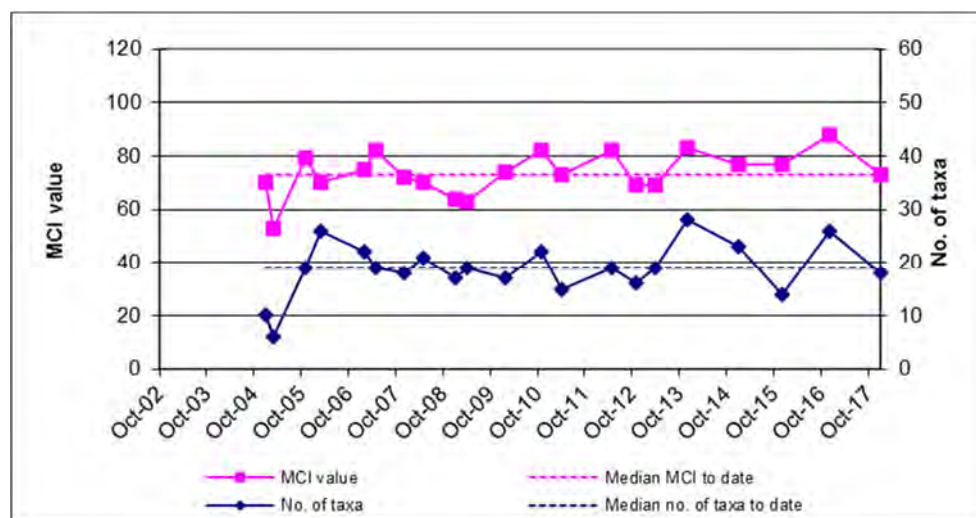
At site 5 in the Haehanga Stream, 25 m downstream of all wastewater ponds, 18 taxa were recorded, one taxon less the median of the twenty previous surveys, but eight taxa fewer than that recorded in the previous survey (Table 2, Figure 3). This reduced richness may be a reflection of the change in sampling technique from the previous survey, which employed the streambed kick methodology. Five 'tolerant' taxa (snails (*Physa* and *Potamopyrgus*), ostracod seed shrimps, damselfly larvae (*Xanthocnemis*) and orthoclad midge larvae) and four 'moderately sensitive' taxa (*Paracalliope* amphipods, backswimmer (*Anisops*), caddisfly larvae (*Triplectides*) and tanypod midge larvae) (Table 3). The numerical dominance of 'extremely abundant' 'tolerant' *Potamopyrgus* snails resulted in the SQMCI_s score of 3.7 units, a statistically insignificant 0.8 unit higher than the median for this site, and similar to that recorded at site 2. The MCI score (73) was very similar to the median score for this site, but fifteen units less than that recorded in the previous survey, which recorded the highest MCI score for this site to date. It was however, five units higher than that recorded at site 2 upstream in the current survey, despite an equivalent proportion of 'sensitive' taxa in the community (33%) (Table 2).

Figure 6 Number of taxa and MCI scores recorded to date at Site 5

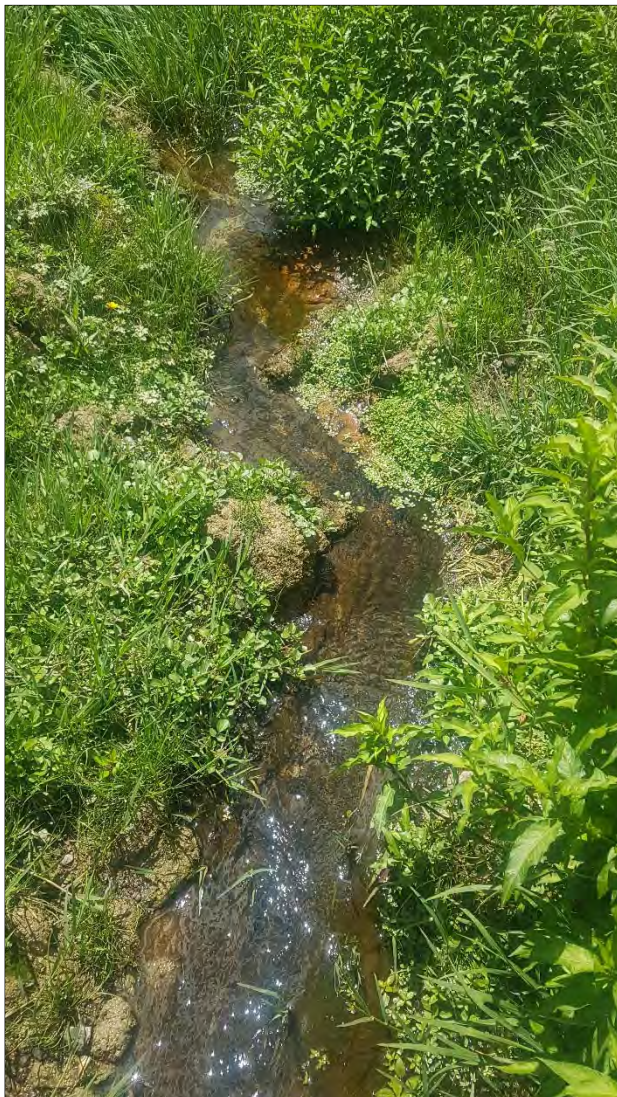
The community consisted mainly of 'tolerant' taxa (67%), resulting in an MCI score of 60 units. This score is significantly lower than the median for this site, 28 units lower than that recorded in the previous survey, and equal to the previous minimum score recorded at this site (Table 2, Figure 2). Although this indicates that the community during the current survey was in well below average health, it does not necessarily indicate that this can be attributed to the monitored activities. The current result is indicative of 'poor' water quality (TRC, 2017).

Photo 1 Haehanga Stream at site 6, 16 January 2018

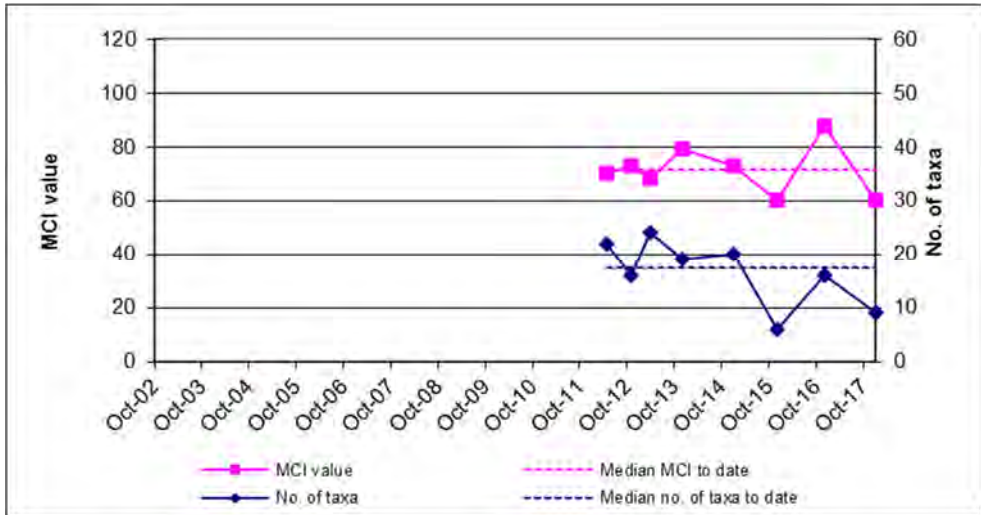
Overall, the results indicate that the community at this site was in average to below average health. Although the MCI score was equal to that recorded in the 2015 survey which coincided with the discovery of a number of dead eels immediately downstream of this site, the SQMCI_s score was significantly higher. This indicates that the lower than average MCI score is related to the low flows and high algal biomass observed at the time.

Figure 7 Number of taxa and MCI scores recorded to date at Site 6

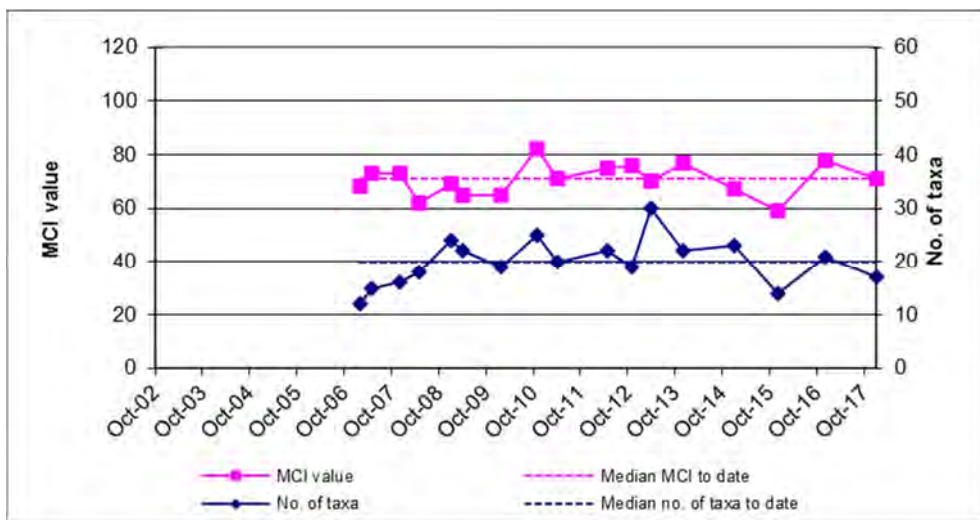
This site exhibited below-average tax richness (17), four taxa fewer than the median, and seven more than the previous survey undertaken at this site. The 'poor' MCI score of 71 was due to the community comprising 65% 'tolerant' taxa, of which three were abundant (snail (*Potamopyrgus*), ostracod seed shrimp and orthoclad midge larvae) and one was very abundant (damselfly larvae (*Xanthocnemis*)). Two 'moderately sensitive' taxa were also recorded in abundance (water fleas (Cladocera) and backswimmers (*Anisops*)), suggesting moderate preceding water quality.

The MCI score of 71 was seven units less than that recorded in the previous survey, a statistically insignificant result (Stark, 1998), but equal to the median score for this site (Table 2, Figure 8). The numerical dominance of the two abundant 'moderately sensitive' taxa resulted in a SQMCI_s of 4.3 units, 1.0 unit higher than the median for this site and 0.8 unit higher than that recorded in the previous survey. This result was equal to the previous maximum SQMCI_s recorded at this site.

Figure 8 Number of taxa and MCI scores recorded to date at Site 7

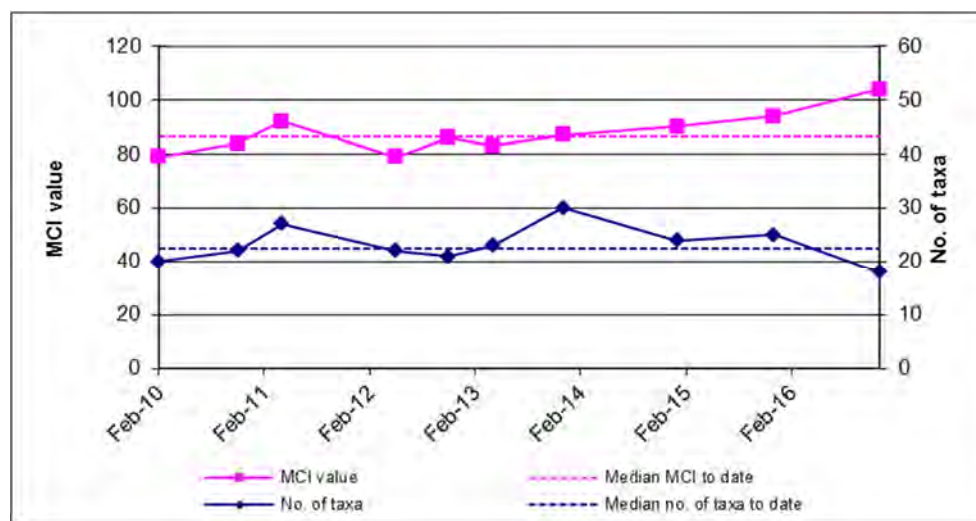
Site T2 was not sampled in the current survey due to low flows and insufficient habitat. Figure 9 presents the data collected at this site to date.

Figure 9 Taxa numbers and MCI recorded to date at site T2

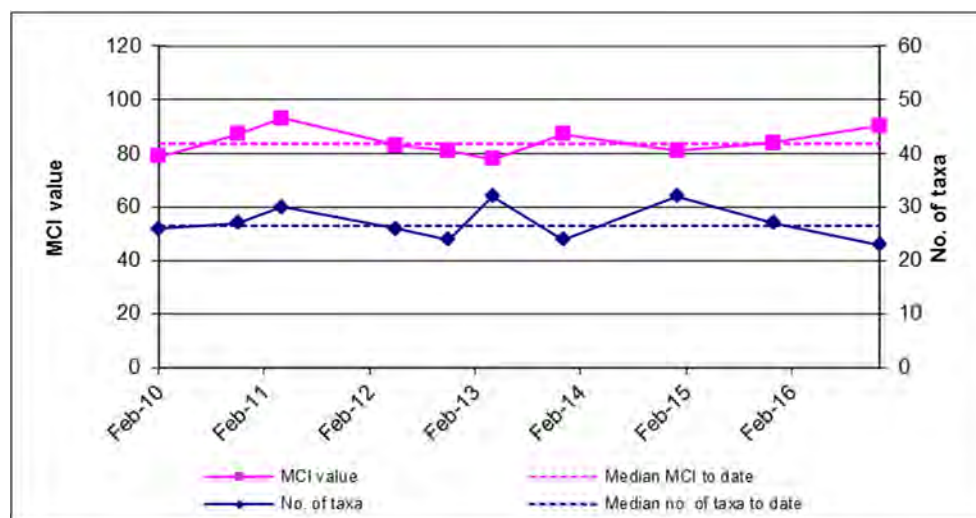
Some previous water quality results indicate that unionised ammonia concentrations in the unnamed tributary have at times been toxic enough to reduce the abundance of, or eliminate entirely, some of the sensitive species usually found in this stream. Results of sampling undertaken in the year prior to this survey show that two of the five samples contained concentrations of unionised ammonia above the toxicity threshold of 0.025 g/m³. This shows management of the unionised ammonia concentrations has

Figure 10 Taxa numbers and MCI recorded to date at site T3

deteriorated since the previous monitoring survey. Should unionised ammonia concentrations continue to exceed the toxicity threshold on occasion, an additional macroinvertebrate survey at this time might be warranted. At the very least, the water quality monitoring will need to continue to assist with the interpretation of macroinvertebrate results.

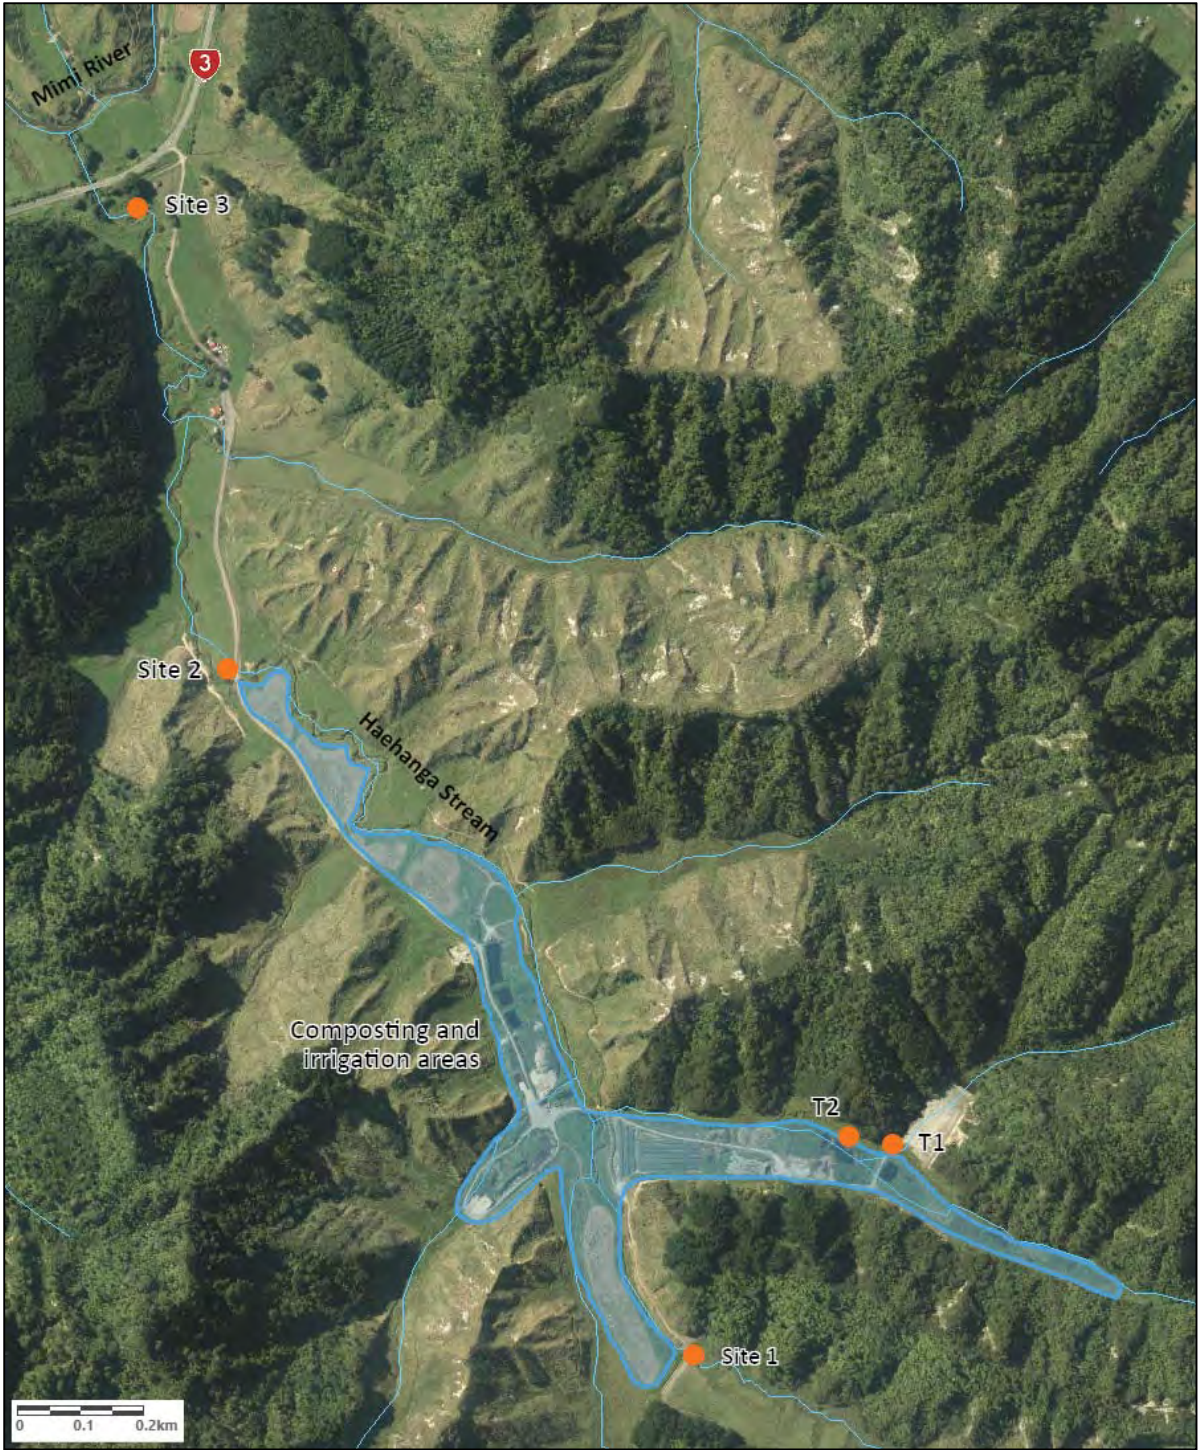
Figure 1 Location of the three Haehanga Stream and two unnamed tributary sampling sites in relation to composting and wastewater irrigation areas.

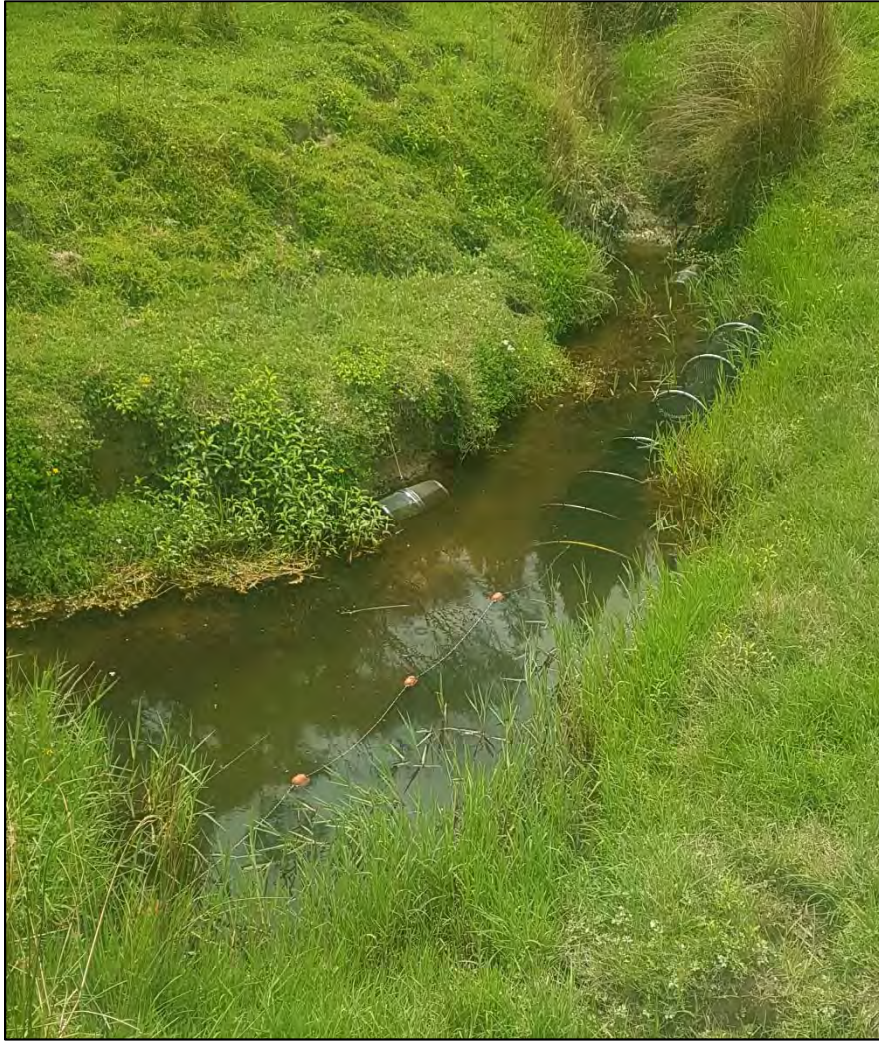
Photo 1 A fyke net and gee minnow trap, set at site 1, Haehanga Stream. 16 January 2018

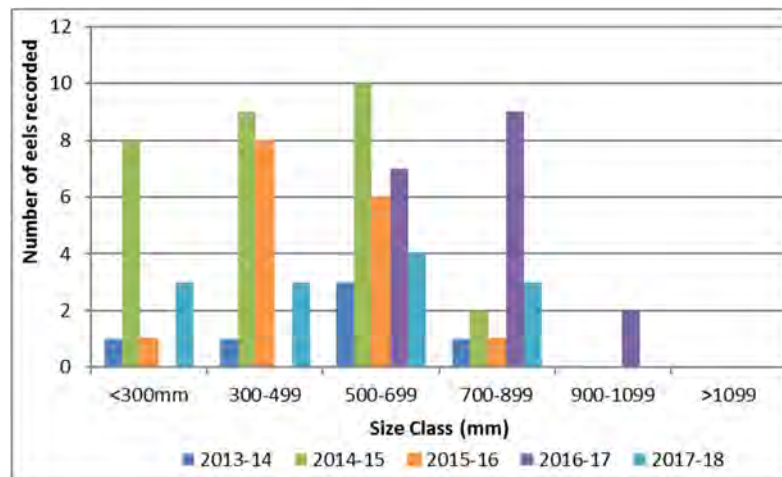
Thirteen eels were captured, of which two were longfin eels, none of which were particularly large, with the largest being 570mm and 0.46kg. This is a reduction from the number of eels recorded in the previous survey, which recorded eighteen eels. Unlike in the more recent surveys, there was little difference in size class distribution, similar to that recorded in the 2013-2014 survey, which was also undertaken in low flows (Figure 2). There were more smaller eels recorded at this site than in the previous survey, which is likely

Figure 2 Size class distribution of all eels recorded at site 2 over the four surveys completed to date

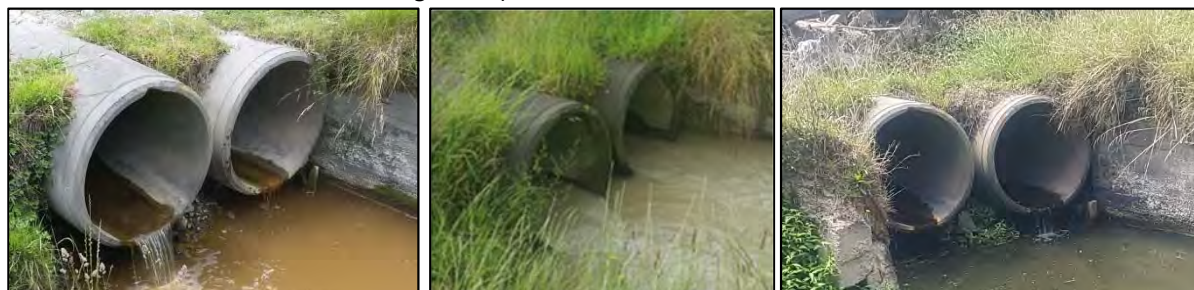
survey. While this was an appropriate approach, as it lifted the water level and resolved the perched nature of the culverts, the material used was too fine and had already begun scouring away. During the current survey, it was apparent that the material had indeed washed away, and the culverts were again perched. Remedial works are therefore once again required.

Photo 2 The access culvert immediately upstream of site 2, December 2015 (left), December 2016 (middle) and January 2018 (right).

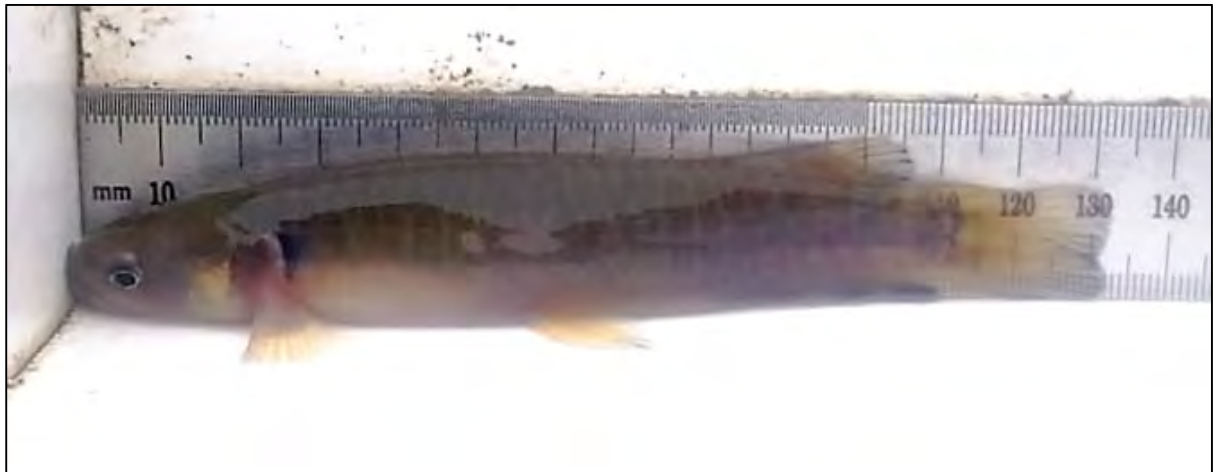
Photo 3 Banded kokopu (*Galaxias fasciatus*) captured in the unnamed tributary upstream of the wetland discharge, December 2016.

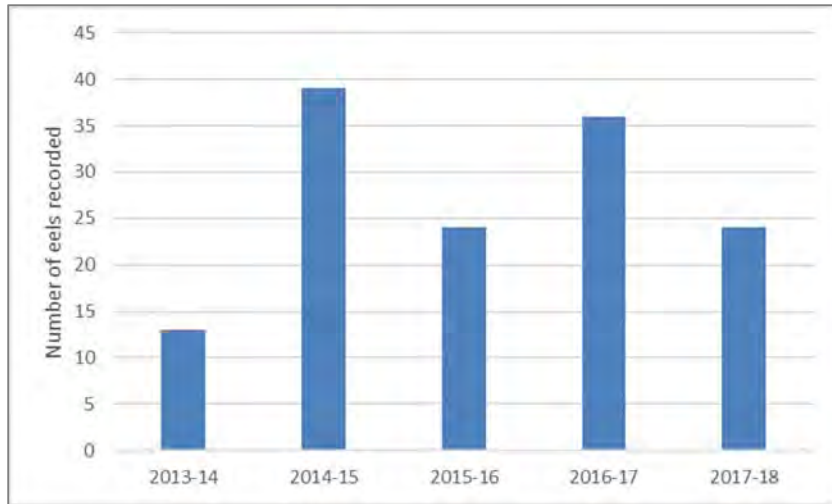
This difference in the number of eels and the size class distribution can be attributed to the reduced flow conditions during the current survey. This lower flow meant that the bait scent was not carried as far downstream, with fish attracted from a smaller area than during higher flows. This will have contributed to the reduced number of large eels in the nets, reducing the likelihood of predation in the nets. This allowed for an increased survival of smaller eels.

Figure 3 The total number of eels recorded per survey

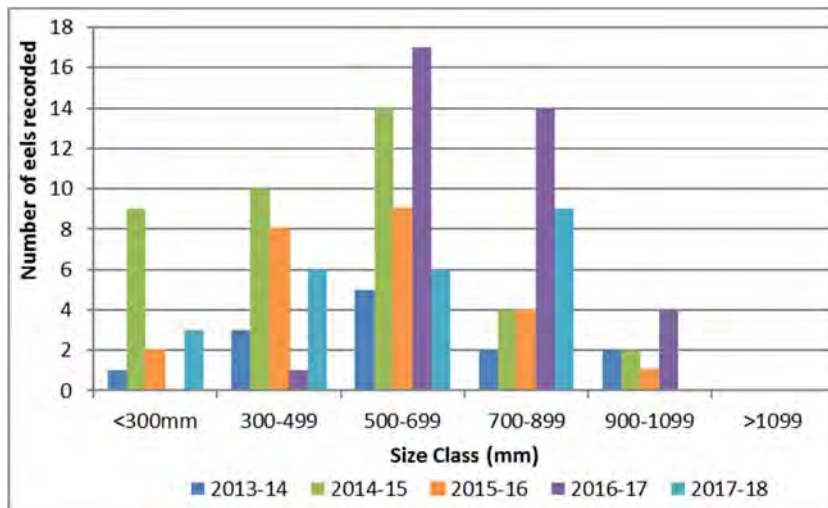
Figure 4 The size class distribution of all eels captured at all sites over the three surveys undertaken to date.

The presence of large eels (coupled with the higher numbers recorded in the previous survey) is a positive result, as it suggests some recovery from the impacts of commercial eeling, which is understood to have occurred just prior to the 2013-14 survey. However, this recovery will not yet be complete. The community will take some time to recover from the impacts of commercial eeling, as commercial eeling methods (fyke netting) are so efficient that 75% of the eels in a fished area can be caught in a single night. As a result, it can take a decade or more for the eel's population at such a site to recover (PCE, 2013). It should be noted that the sampling methodology is less likely to record eels smaller than 150mm, compared with larger eels.

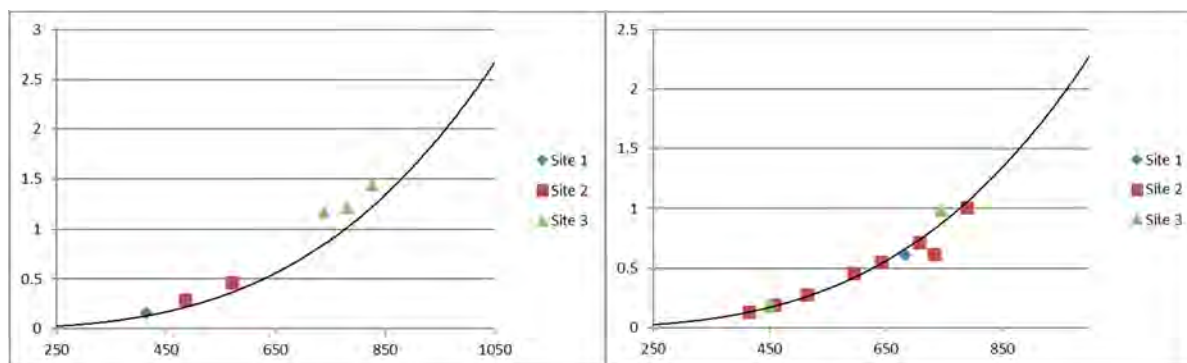
In addition to length and weight measurements, each fish was inspected for obvious physical damage or abnormalities. No such features were noted.

Figure 5 Longfin eel condition (left) and shortfin eel condition (right) in the Haehanga Stream, 14/15 December 2016. Weight (Kg) is on the y-axis, length (mm) on the x-axis. The trend line is the predicted weight, using equations from Jellyman *et al* 2013.

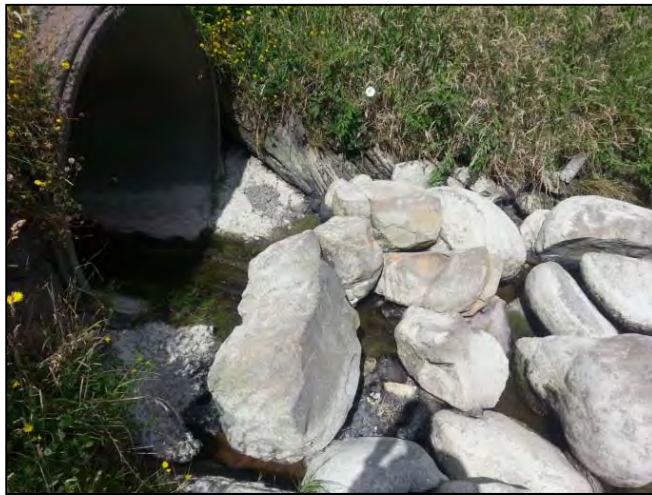
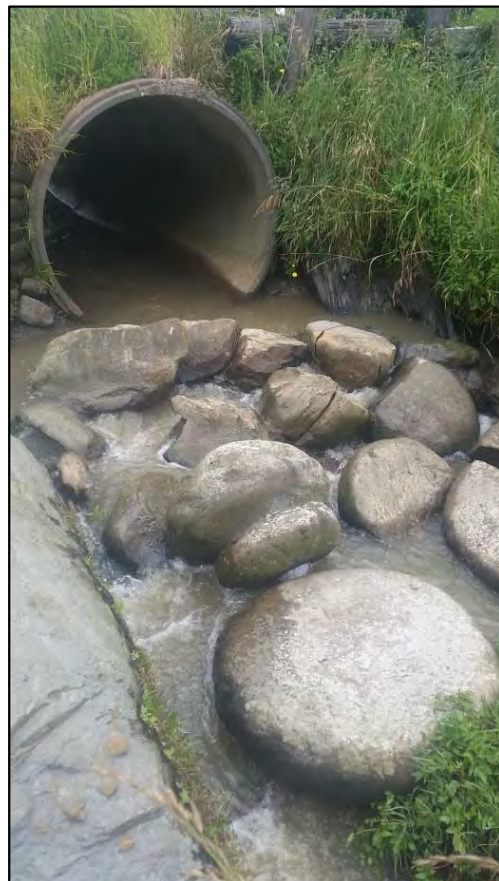
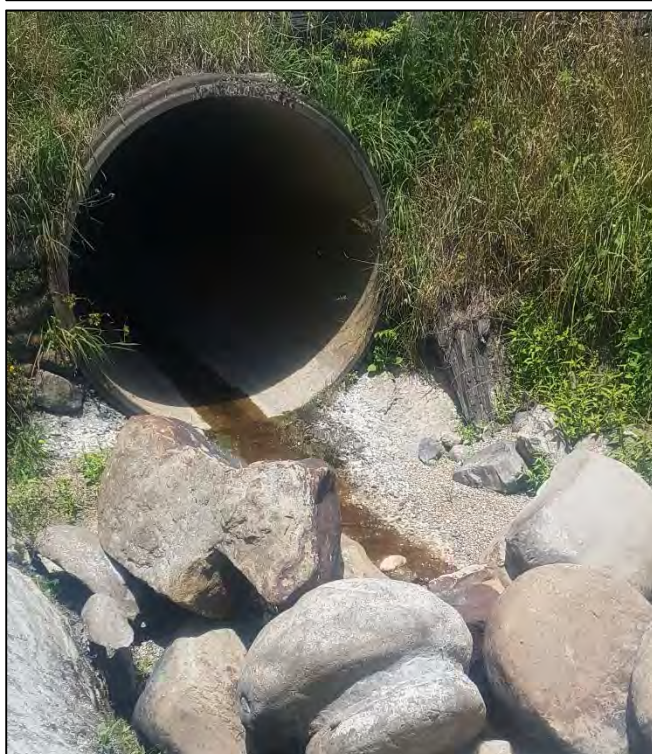
Photo 4 Culvert 1
 Top left: December 2015
 Top right: December 2016
 Bottom left: January 2018

Photo 5 Culvert 2
