New Plymouth District Council
New Plymouth Wastewater Treatment Plant
Marine Outfall and Sludge Lagoon
Monitoring Programme Biennial Report
2012-2014

Technical Report 2014-122

July 2015

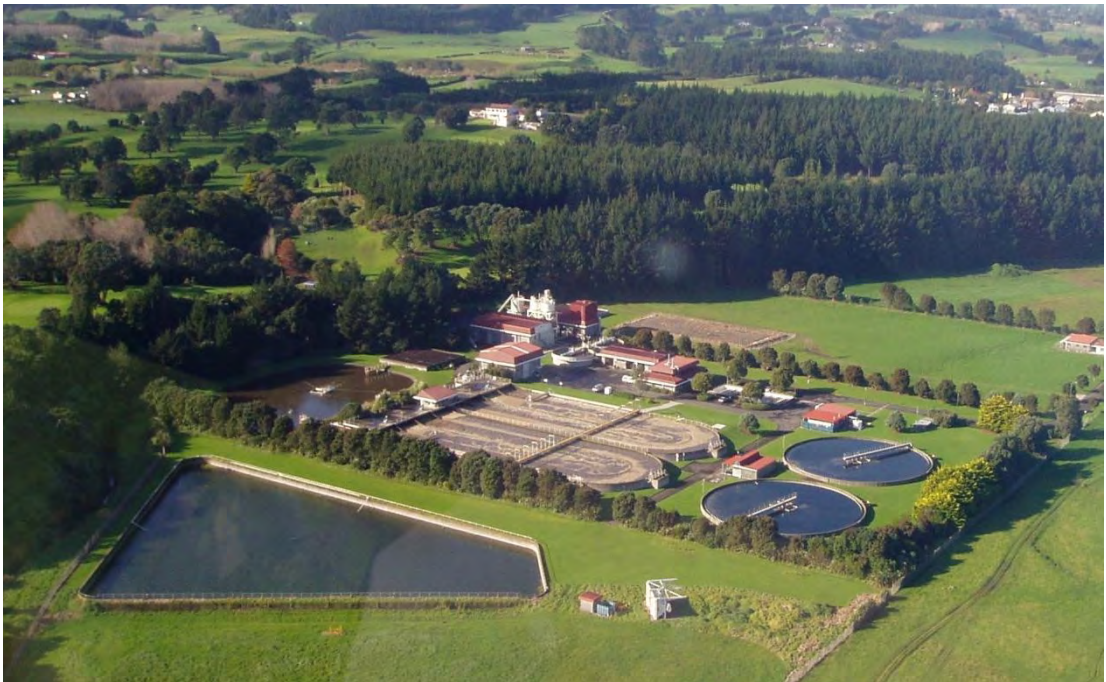
The NPWWTP (Photograph 1) treats the municipal wastewater from the New Plymouth urban area, Bell Block, Oakura and Inglewood, by a process of extended aeration activated sludge. There is also a substantial industrial load, equivalent to approximately 25% of the total biochemical oxygen demand (BOD) load, treated by the plant. The plant was commissioned in 1984, and has had its capacity expanded several times since.

Photograph 1 The New Plymouth Wastewater Treatment Plant

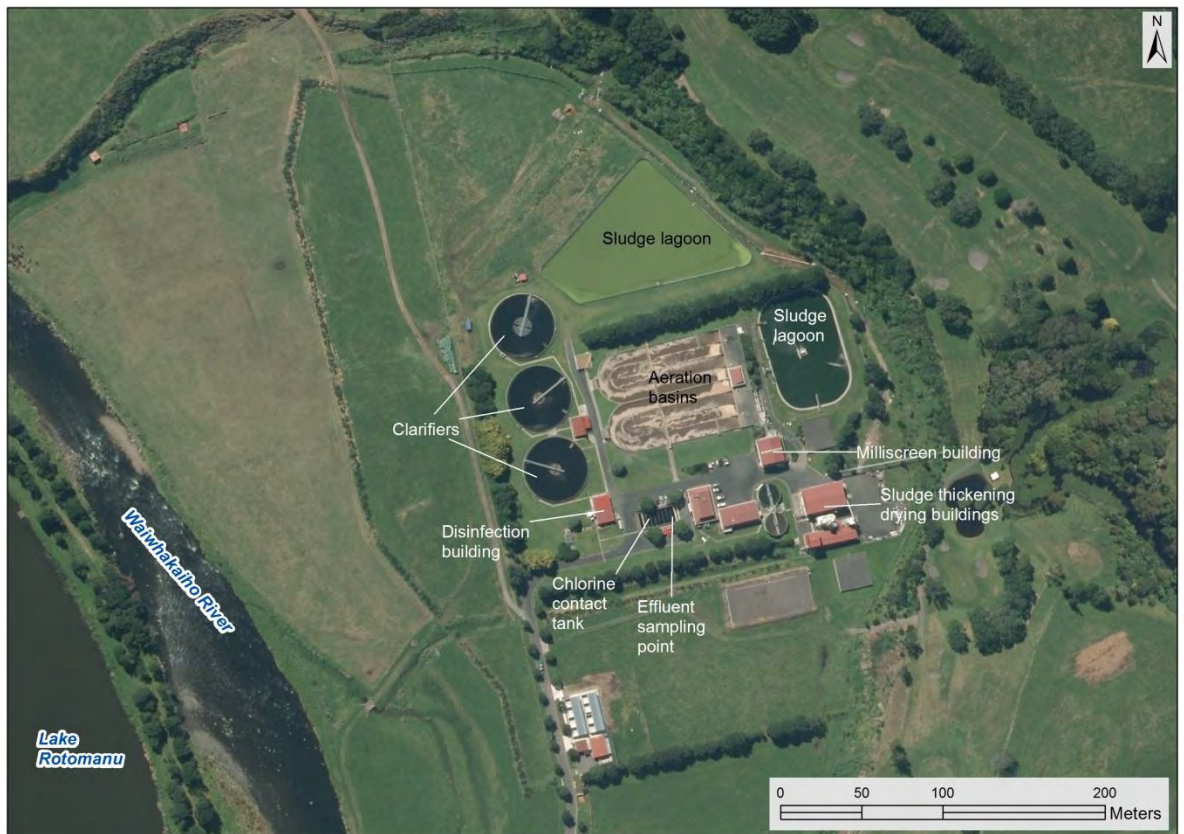
The activated sludge remaining in the clarifiers is returned to the aeration basins to maintain biological levels, while the surplus is diverted to the thermal drying facility (TDF) for sterilisation and disposal by alternative use (soil conditioner).

Figure 1 Layout of the New Plymouth Wastewater Treatment Plant

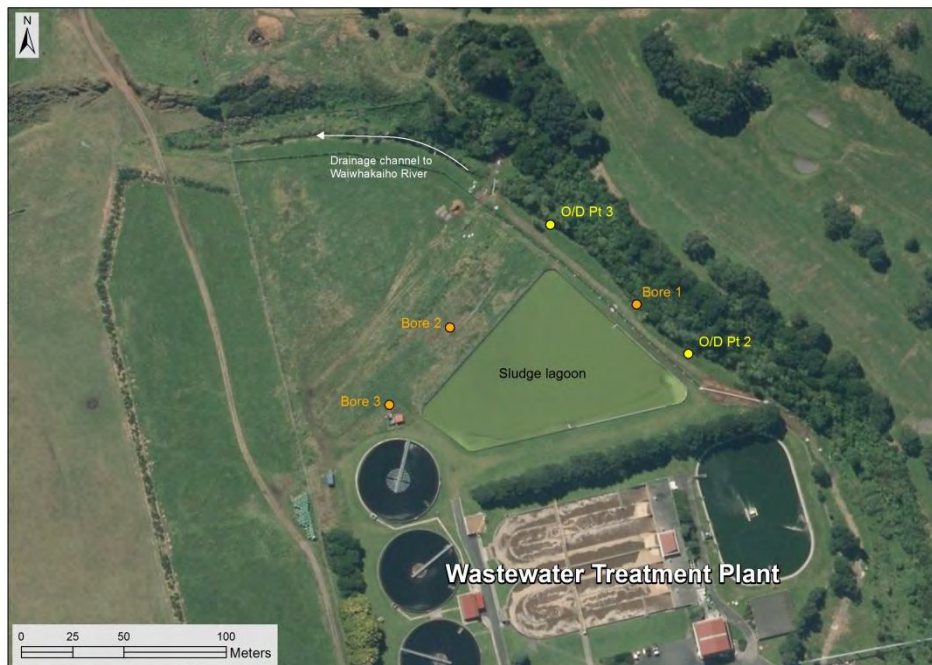
Levels of COD increased from Bore 1, to Bore 2 to Bore 3 with levels in all three wells above the historical median. These elevated COD levels indicate that seepage from the lagoon was occurring. The construction of the lagoon was so that the sludge would be forced by hydraulic pressure into the fine river silts and ash which underline the lagoon, thus blinding and sealing the bottom of the lagoon. This has in the most part been achieved, although minimal leakage still occurs as indicated by the monitoring results of groundwater and surface waters in the vicinity of the lagoon.

Figure 2 Sludge lagoon showing location of NPDC's groundwater bore and drain sampling sites

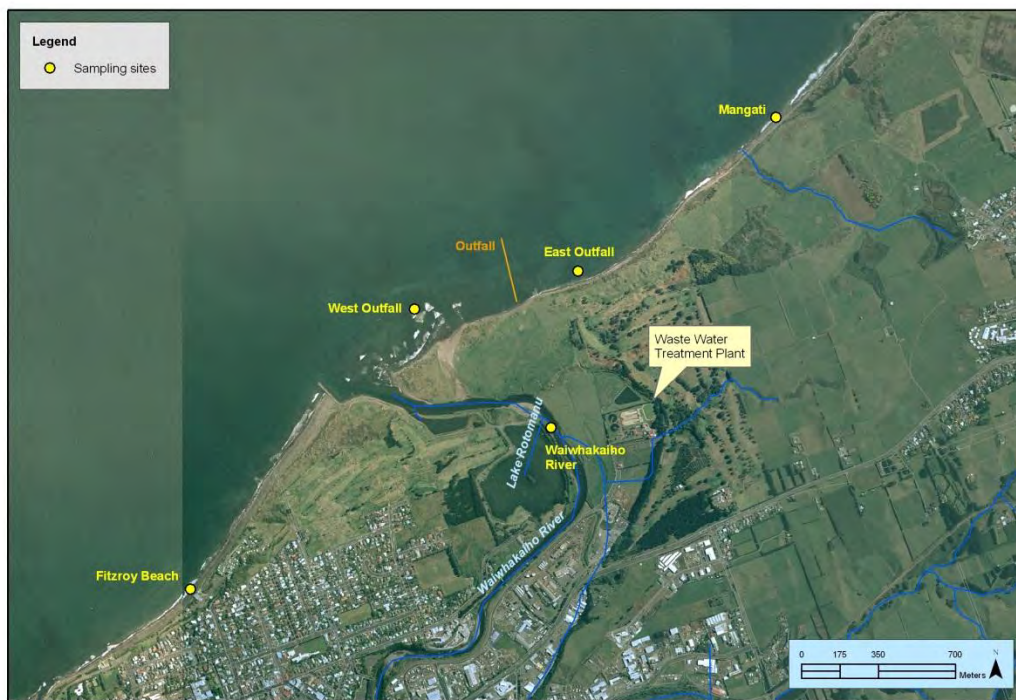
Bacteriological water quality was monitored at four coastal sites in the vicinity of the marine outfall (Figure 4) during the summer months of 2012-2013 to assess whether the discharge from the marine outfall was having any adverse effects on coastal bathing water quality. A site on the Waiwhakaiho River was also monitored in order to determine any influence of the river on coastal water quality. Thirteen samples were collected at each site during dry weather conditions and analysed for enterococci, faecal coliforms, *E. coli* and conductivity.

Figure 4 Location of monitoring sites in relation to the NPWWTP

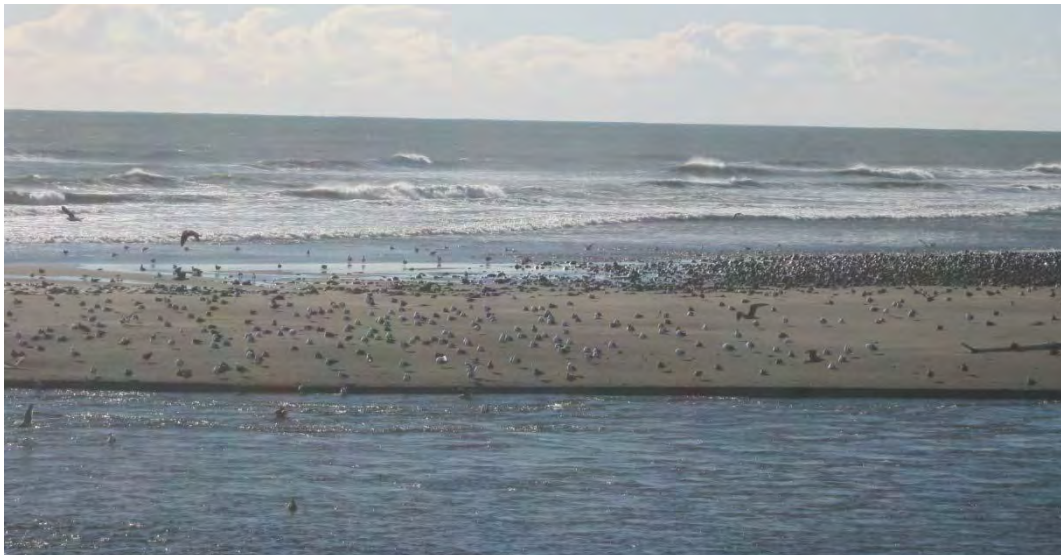
Photograph 2 Gulls at the mouth of the Waiwhakaiho River

Gulls are believed to be the main source of faecal contamination at this site, with bird faeces entering the site from both the Waiwhakaiho River and the Waiwhakaiho Reef (Photograph 2). High numbers of gulls have been observed and results from faecal source tracking support these observations.

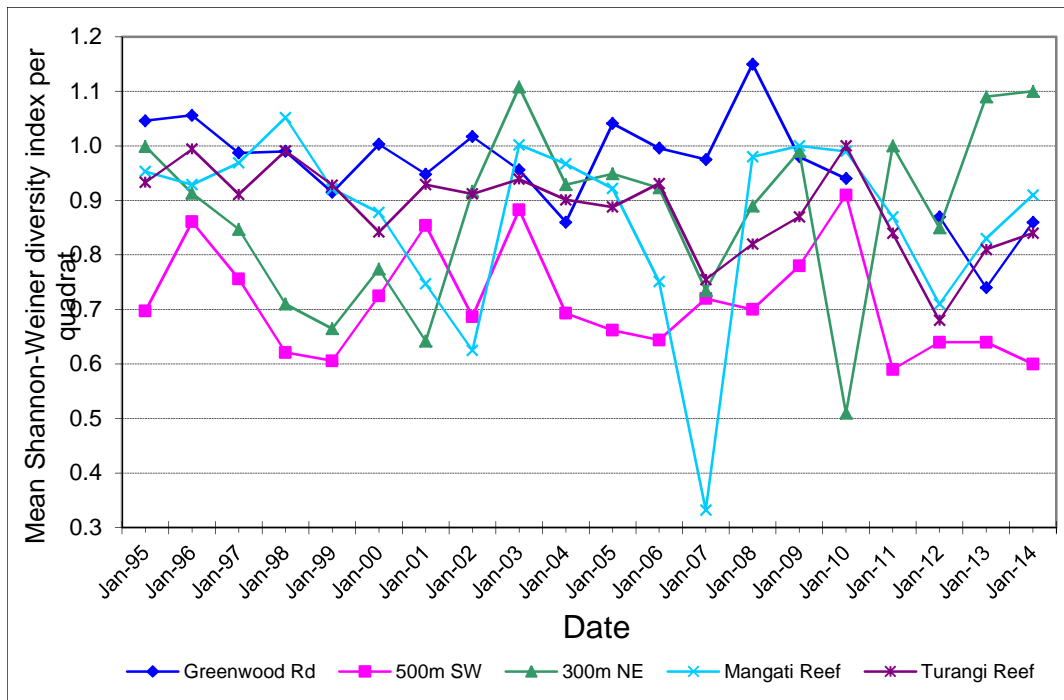
Figure 6 Mean Shannon-Weiner index per quadrat from 1995 to 2014

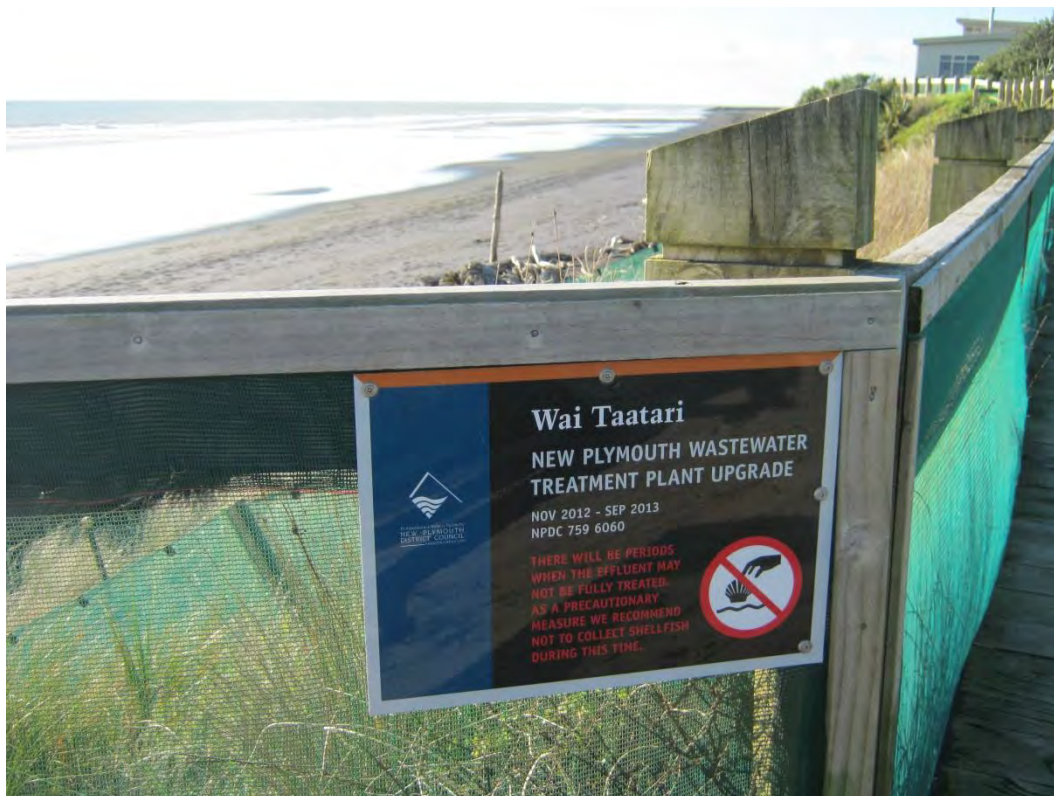
Photograph 5 NPWWTP Upgrade sign at Fitzroy

Condition 9 of consent 0882-4 required signs to be erected at Fitzroy Beach and Bell Block Beach during periods the aeration basins were offline (December 2012 to December 2013) advising the public of potential health risks associated with partially treated sewage. Results from the QMRA were used to assess the potential magnitude of health risks during the bypass period. It was decided that while health risks from contact recreation were likely to be acceptably low (individual illness risk at Fitzroy Beach <0.5%), the risks from consuming raw shellfish were notably higher (individual illness risk at Fitzroy Beach >5%). Taking these results into consideration, the signs included a recommendation not to collect shellfish (Photograph 5). In order to check water quality for contact recreation, three coastal sites (named Fitzroy Beach, Bell Block and 300 m NE) were monitored on a weekly basis under all weather conditions during the bypass period. A site in the Waiwhakaiho River was also monitored in order to determine any potential contamination of the coastal site from the river (noting that this river site would not have been affected by discharges from the NPWWTP). Any decisions regarding contact recreation signage were made by the Taranaki District Health Board based on the monitoring results in relation to the MfE *Guidelines for Recreational Water Quality* (refer to Appendix VI for an explanation of MfE guidelines).

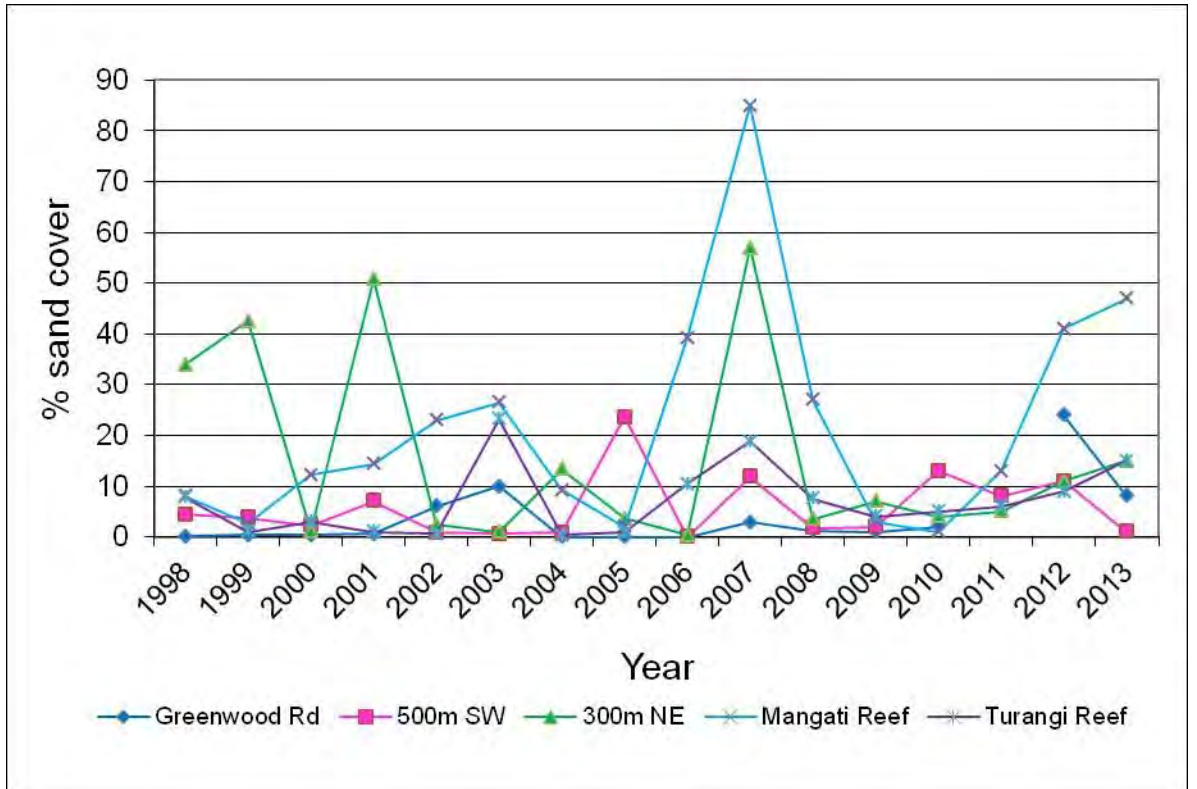
Relative to other sites, Mangati Reef had a high cover of sand (47%). This site has a history of being susceptible to sand accumulation (Refer to Figure 4 and Photograph 3 bottom right hand insert). Previous studies on intertidal reefs in Taranaki have demonstrated that at 30% cover, sand begins to negatively influence hard shore communities.

Figure 4 Percentage sand cover at the five reef sites from 1998 to 2013

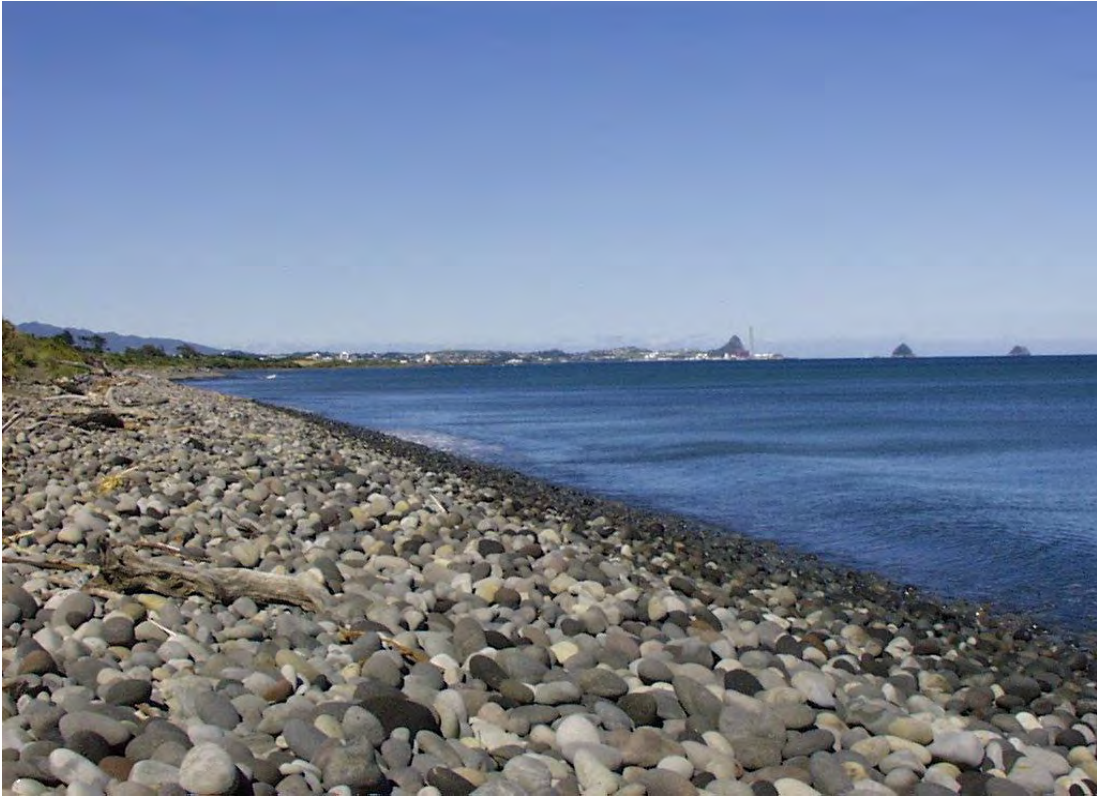
Photograph 1 The Mangati site, looking SW towards the outfall

Water quality was generally good during the 2012-2013 summer period; maximum, mean and minimum were all low, similar to previous monitoring periods.

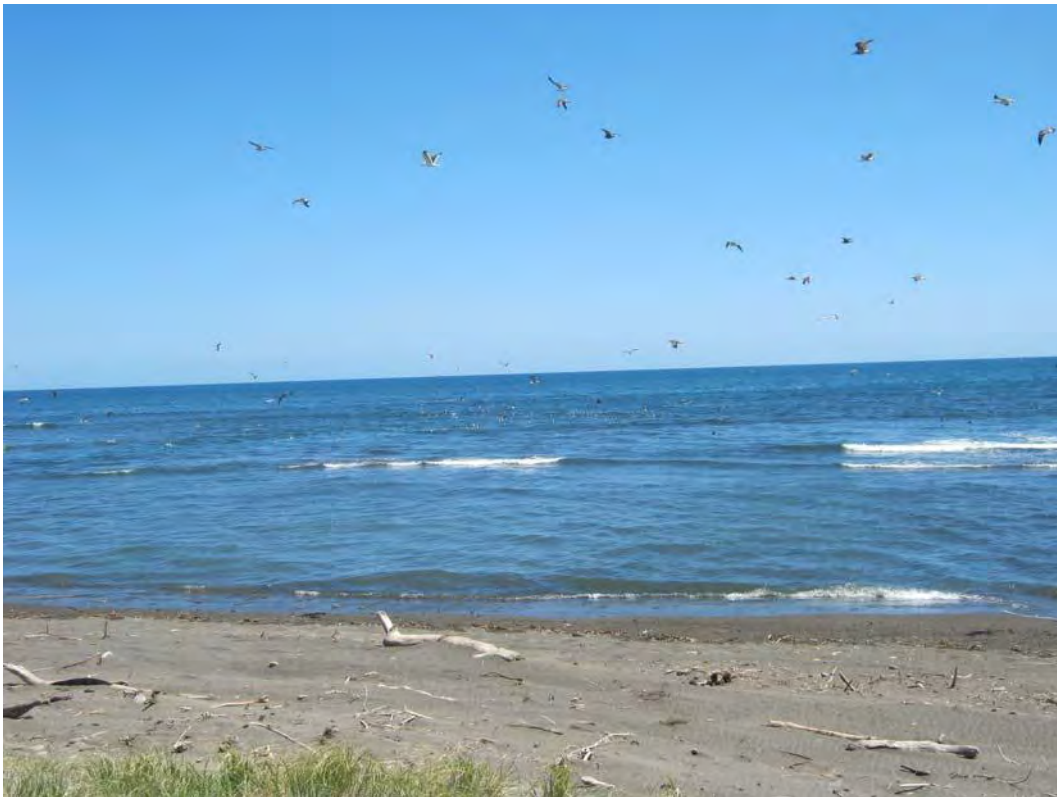
**Photograph 3** Gulls at site 500m SW (west of the outfall)

Faecal indicator bacteria medians and maxima were high, indicating poor water quality at this site. Faecal indicator bacteria counts from the 300m NE site were lower than at the 500m SW site. This would not be expected if discharge from the outfall was the main source of faecal contamination, taking into consideration the predominant north easterly flow.

High bacterial counts in the Waiwhakaiho River can influence the 500m SW site. This is partially supported by the data given the highest enterococci counts at the 500m SW site coincided with those from the Waiwhakaiho River (Tables 11 and 19). However, conductivity data indicates that only minor freshwater influence occurred at the 500m SW site during the 2012-2013 summer season (Table 11). Gulls have been observed in high numbers on the cobbles and sand banks of the Waiwhakaiho Reef (Photograph 3), at the Waiwhakaiho River mouth and immediately upstream of the Waiwhakaiho River site (Photograph 4). Results from faecal source tracking indicate that gulls are likely to be the primary source of faecal contamination at these sites.

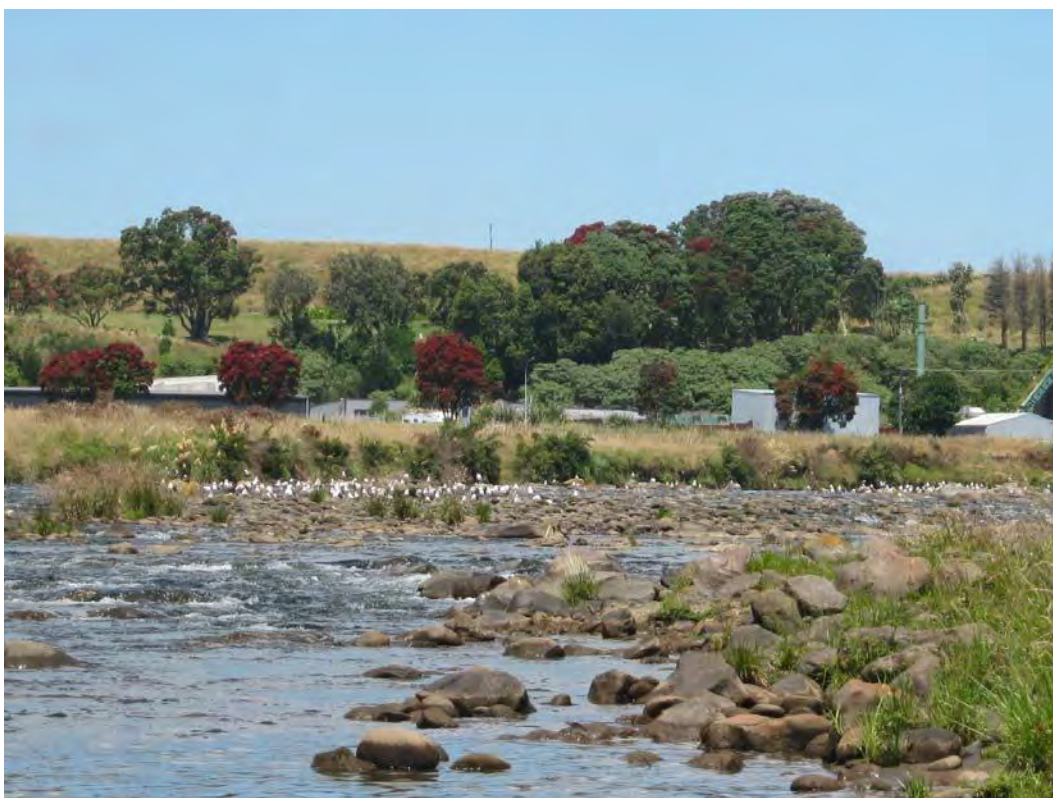
**Photograph 4** Gulls upstream of the Waiwhakaiho River site

Minima, maxima and medians for all faecal indicator bacteria were very high, indicating poor water quality at this site. Faecal source tracking results indicate that gulls are the main source of contamination (Photograph 4). Faecal contamination at this site can affect nearby coastal sites surrounding the river mouth- in particular the 500m SW site.
