South Taranaki District Council  
Eltham Wastewater Treatment Plant  
Monitoring Programme  
Annual Report 2014-2015

Technical Report 2015-21

October 2015

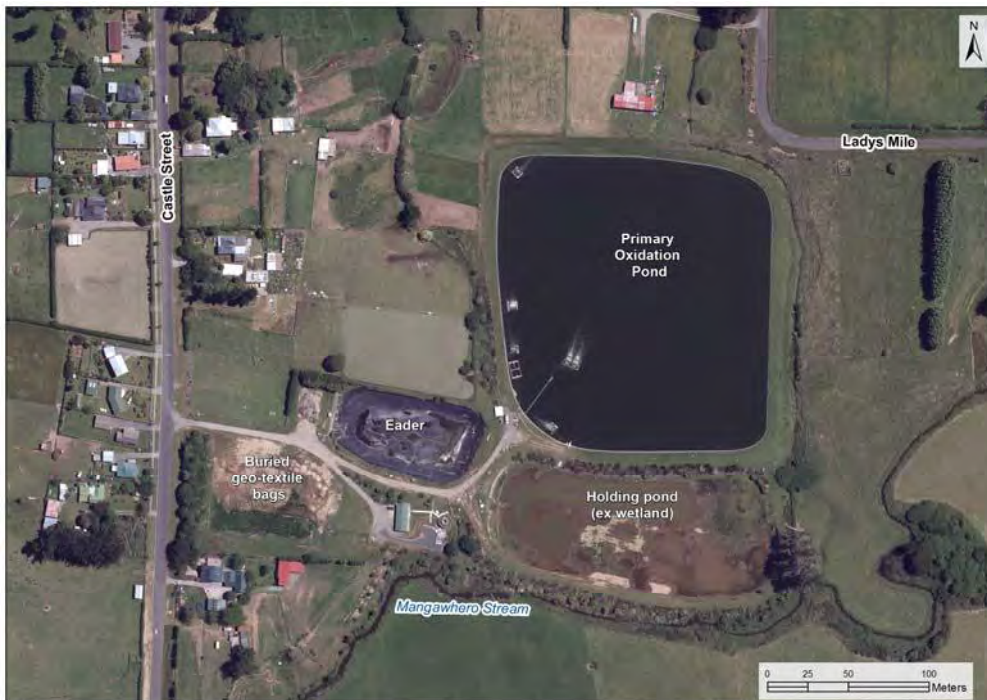
**Figure 2** Aerial view of the Eltham WWTP showing the sludge geo-textile bags disposal area (lower LH corner) near the plant entrance [Note: the wetland (lower, centre) was converted to a holding pond in early 2011]

The primary pond was de-sludged during the 2006-2007 monitoring year with the de-watered sludge contained in geo-textile bags in an excavated, banded area adjacent to the EADER (Figure 2). De-waterings and stormwater from this area continued to be returned to the primary pond through the clarifier during 2007 to 2010 and no odour problems were associated with this operation. However, STDC water treatment plant sludge was placed over the geotextile bags during 2008-2009 without consultation, resulting in neighbours' concerns with respect to future sludge disposal at this site. The original intention had been to dispose of the Eltham WWTP pond sludge to the Patea landfill which, however, was subsequently closed. A consent to discharge sludge from the WWTP and STDC water treatment plants ((7571), Appendix I) to land at the Eltham WWTP site was granted in December, 2009.

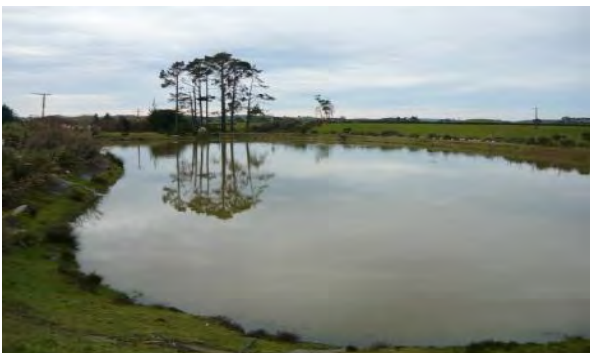
Some use was made of the overflow retention pond in mid July 2011 due to surcharging of the Hawera town

**Photo 1** Overflow retention pond, 21 July 2011
