South Taranaki District Council
Waverley, Kaponga, Manaia and Patea
Municipal Wastewater Treatment Plant Systems
Monitoring Programmes
Annual Report
2014-2015

Technical Report 2015-09

September 2015

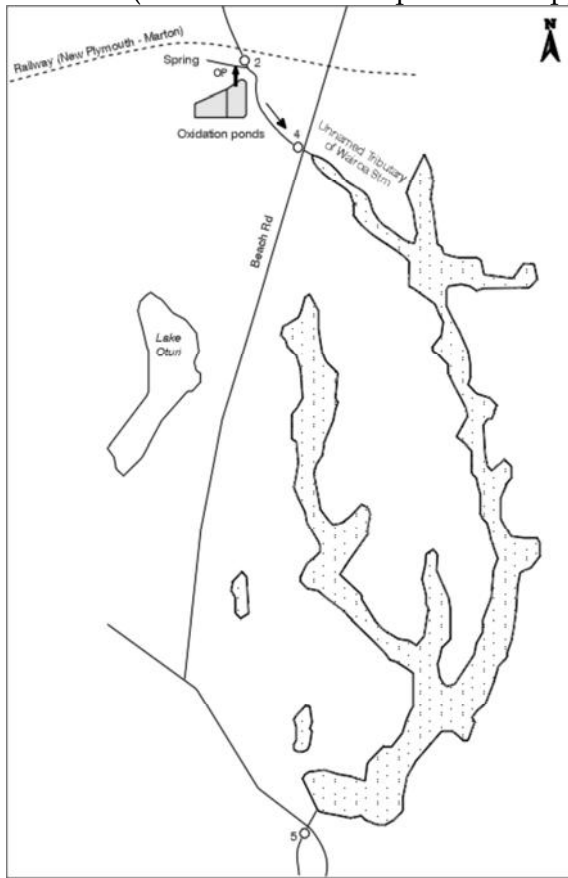
Figure 1 Sampling sites in an unnamed tributary of the Wairoa Stream in relation to Waverley oxidation ponds

Site 2 is located upstream and site 4 downstream of the oxidation pond discharge.

Site 5 has been established to provide an indication of the overall impact of the discharge on the Wairoa Stream in its mid reaches after seepage through the extensive wetlands (i.e. the 9 hectare Ihupuku Swamp) which characterises this drainage system.

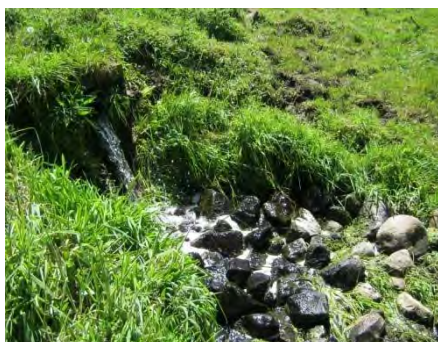
At the time of the monitoring inspections when the wetlands effluent was discharging, minimal discolouration in the small receiving stream was recorded.

Photo 1 The small discharge channel from the wetland's prior to the 'Manaia Creek'

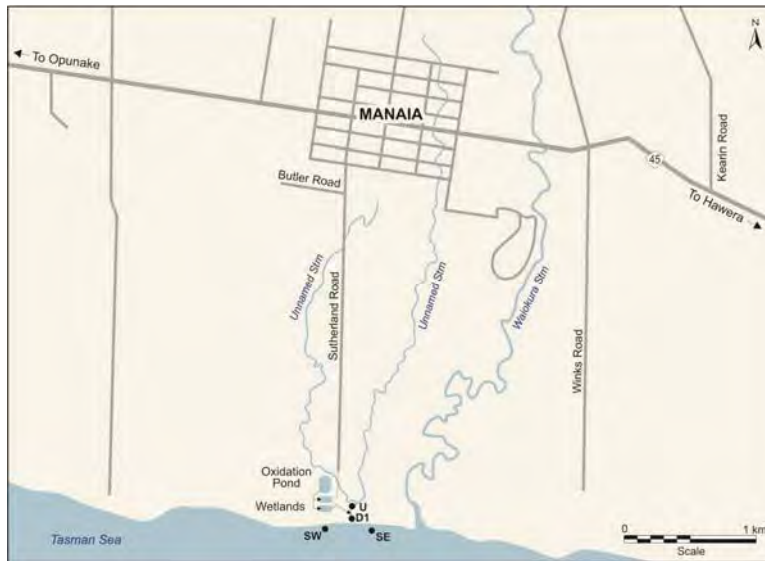
**Figure 5** Location of Manaia oxidation pond-wetlands system and sampling sites

Sampling site locations in relation to the pond system are illustrated in Figures 5 and 6.

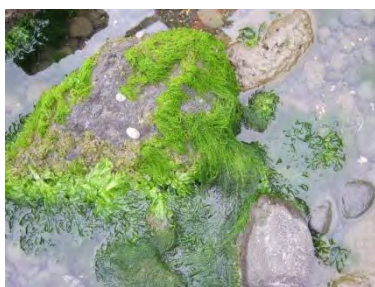
Photo 2 *Enteromorpha intestinalis* and *Ulva lactuca* present in pools at the top of the shore

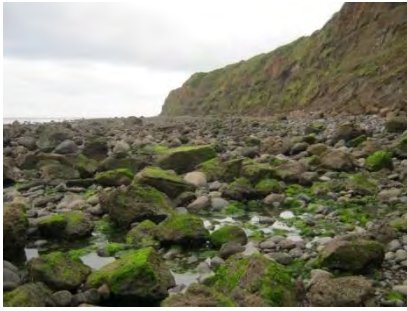
Dense cover of the green macroalgal species *Enteromorpha intestinalis* and *Ulva lactuca* stretched along the high tide mark ~40 m either side of the stream (Photos 2 and 3). These algal species are typical of freshwater influence and thrive under nutrient rich conditions. At the top of the intertidal region within the vicinity of the stream, the gastropods *Austrolittorina*

Photo 3 Green algae evident along the high water mark

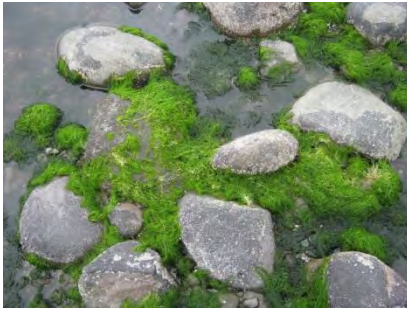
Photo 4 Dense cover of *Enteromorpha intestinalis* in the 'Manaia Creek' at mid shore

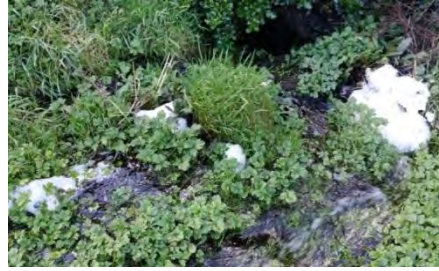
At the time of the inspection the effluent from the oxidation pond-wetland system was discharging at a high rate. The discharge had a brown tinge, a distinctive sewage odour

and was foaming in the channel (Photo 6). No sewage fungus was present on the bed of the Manaia Creek receiving waters. The area surrounding the discharge channel had been fenced since the previous inspection (Photo 7). Rocks had been placed in the

Photo 6 The small discharge channel from the oxidation ponds prior to the Manaia Creek

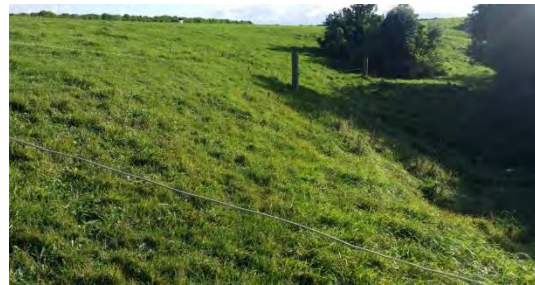
Photo 10 Fencing around the discharge channel from the oxidation ponds

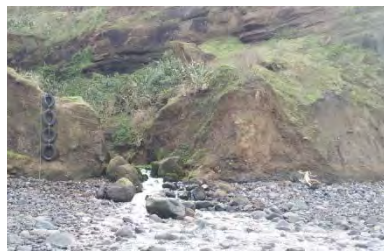
Photo 10 Manaia Creek flowing over the intertidal reef at Manaia

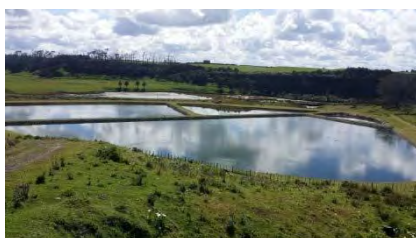
Photo 144 General view of three cell system November 2014

Aerobic conditions were recorded on all occasions with dissolved oxygen levels within the range expected for this type of biological treatment system. During the current monitoring period much less variability than usual (78 to 103% saturation) was recorded for dissolved oxygen. This variation in saturation was far narrower than ranges recorded in most previous monitoring years when supersaturation has often been coincident with a high algal component in the pond. No incidents of super-saturated concentrations were recorded although fully saturated conditions were found in autumn. The pond cells operated at normal levels during the year after completion of the upgrade of the wastewater treatment system some six years earlier (Photo 14).

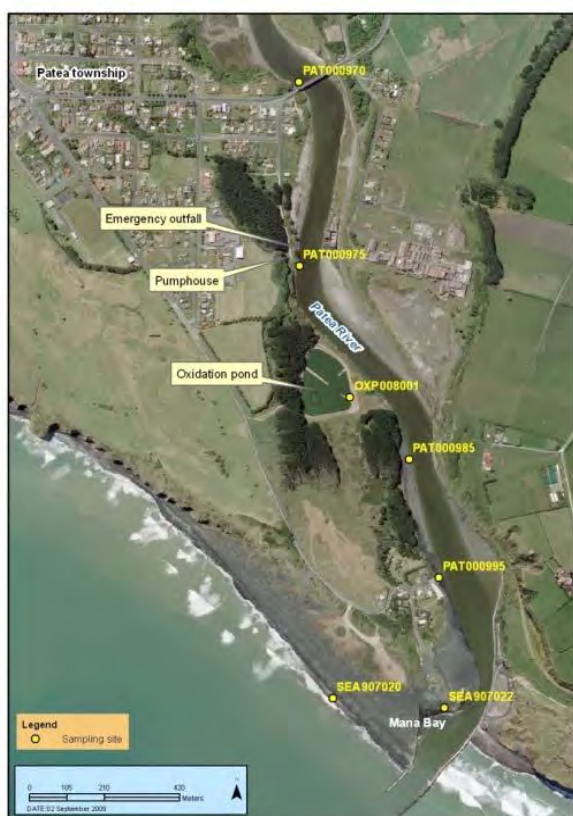
Figure 7 Aerial location map of sampling sites in relation to the Patea upgraded three cell oxidation pond system

Site 2 was added to the programme as a consequence of raw sewage overflow discharges during the 1995-96 monitoring period (see section 5.1) and has been retained as a necessary component of receiving water surveys in relation to the renewed consents.

Two sites were included in the consent monitoring programme (see Table 30 and Figure 7), one in the lower river at the Motor Camp boat ramp (PAT000995) and the other in the nearby coastal waters at Mana Bay (SEA907022). Another site at Patea Beach (SEA 907020) is included at three-yearly intervals in the Council's recreational monitoring programme and was last surveyed over the 2012-2013 period (TRC, 2013b). Sampling at these sites during the Council's defined recreational monitoring period occurred between mid November 2014 and late March 2015 (TRC, 2015), and although concentrated on high tide conditions (13 samples), also included low tidal conditions at these sites on 8 other occasions at the site in the lower river and 7 occasions at Mana Bay. The results are summarised in Tables 32, and 33 and illustrated in Figures 8 and 9.

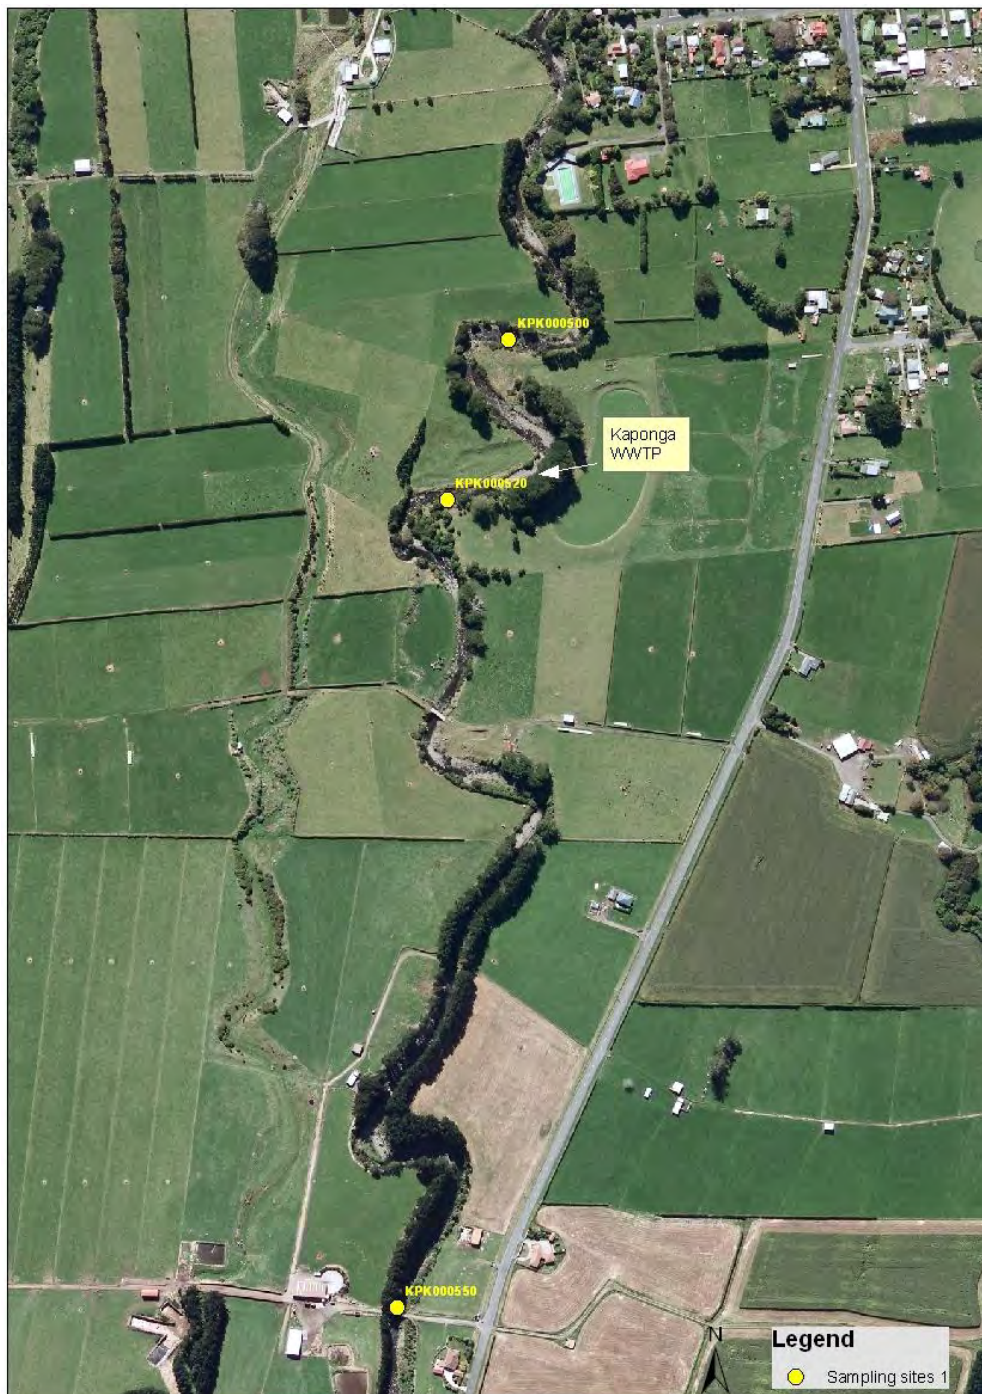
Figure 1 Biomonitoring sites in the Kaipokonui River in relation to Kaponga oxidation ponds system

The standard ‘400 ml kick sampling’ technique was used to collect streambed (benthic) macroinvertebrates from three established sampling sites in the Kaupokonui River in the vicinity of the Kaponga oxidation ponds’ system (illustrated in Figure 1), on 19 February 2015.
