Urenui and Onaero Motor Camps
Monitoring Programme
Annual Report
2014-2015

Technical Report 2015-16

September 2015

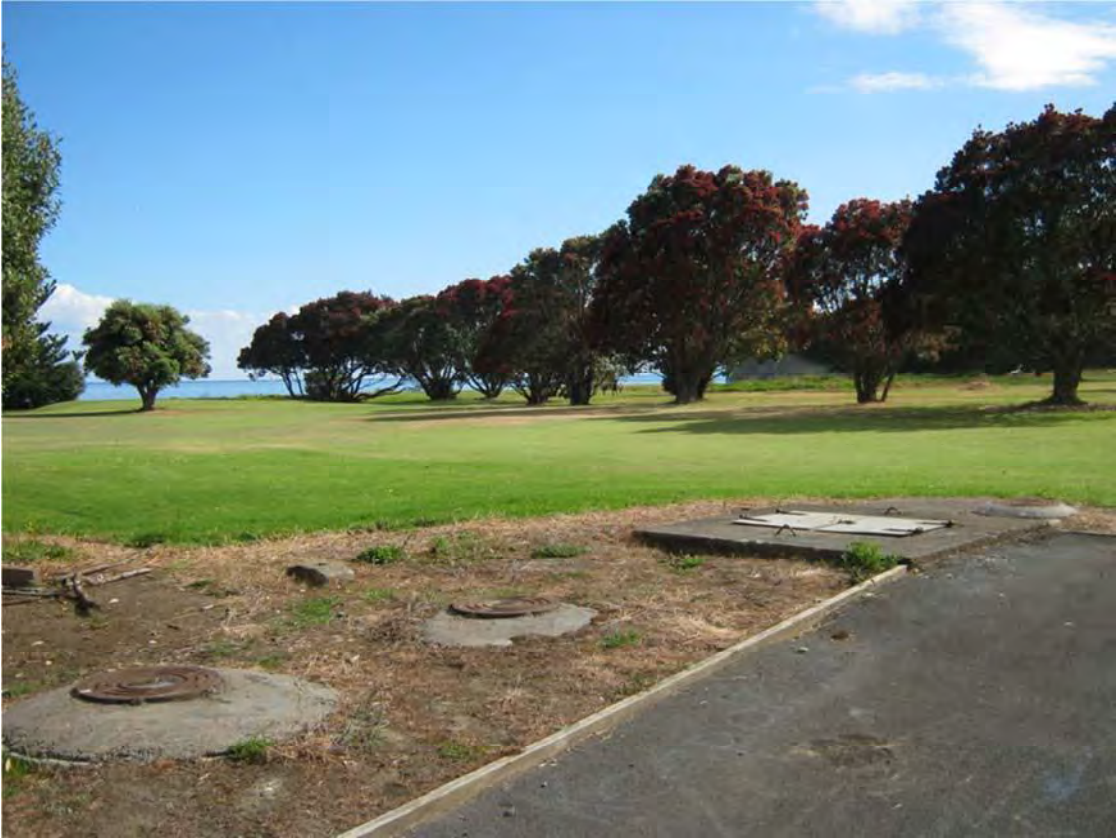
Photo 3 Urenui pump station (8 January 2015)

The camp manager reported that there had been no issues with the sewage disposal system since the previous inspection. There was a slight sewage odour present around the pump station at the time of inspection. The camp was busy with approximately 400 people camping on site and another 200 people staying in baches. Water samples were taken during the inspection for bacteriological analysis.

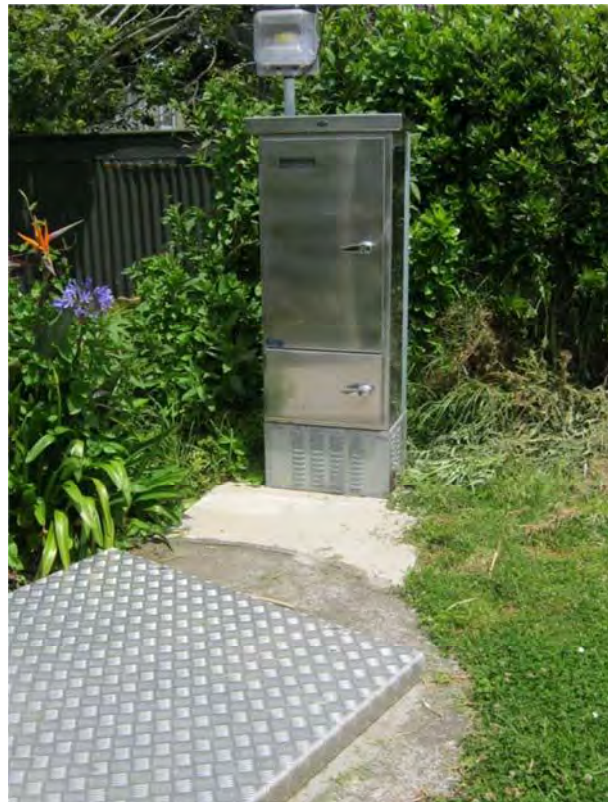
Photo 4 Onaero pump station (16 December 2014)

The camp manager reported that there had been no issues with the sewage disposal system since the previous inspection. There were no sewage odours or visual issues around the pump station at the time of the inspection. The camp was relatively quiet with 12 sites occupied.

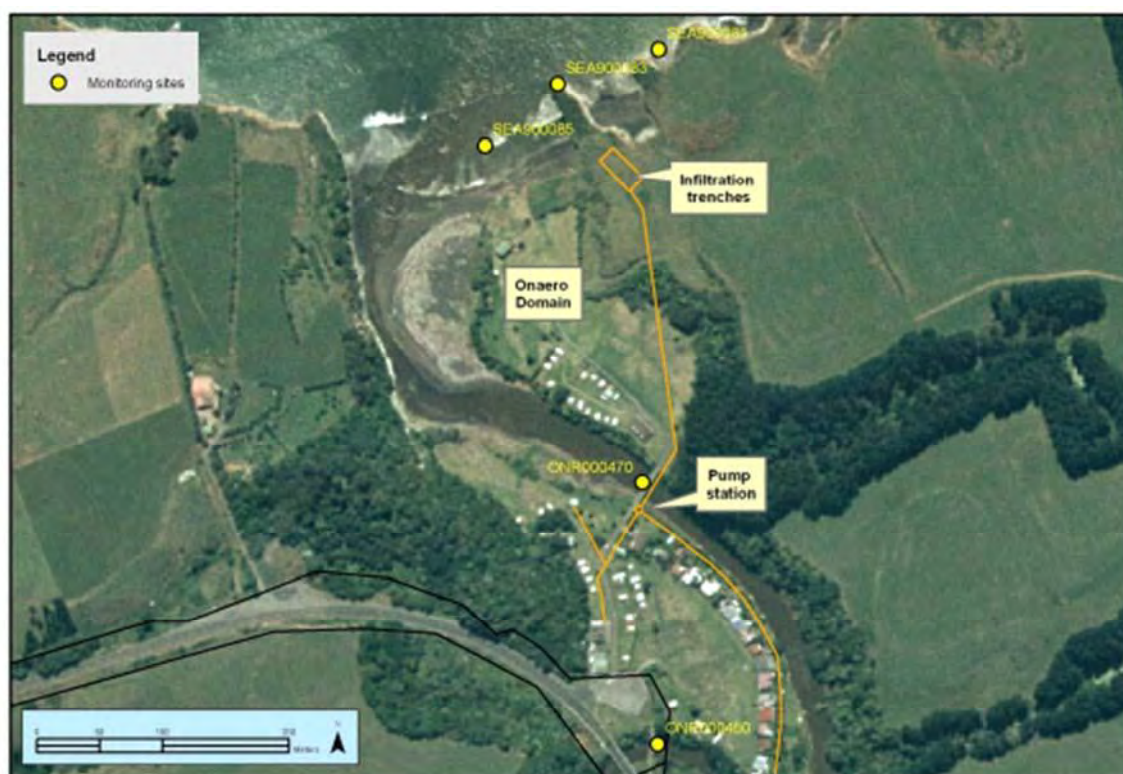
Figure 2 Location of sewage disposal system and sampling sites, Onaero Bay Motor Camp

The location of each of the five sites is shown in Figure 2 and a description of each site is provided in Table 5.

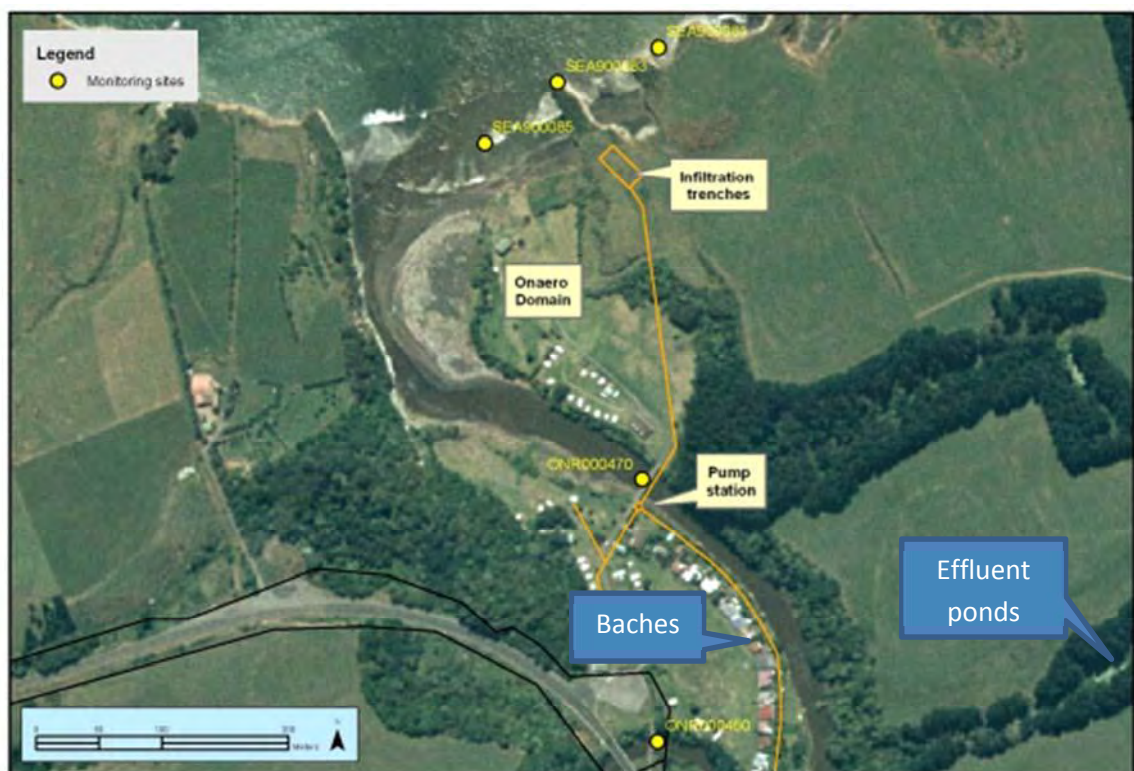
Figure 1 Important features surrounding the Onaero River, including the sewerage system plan and TRC monitoring sites

Samples collected on 8 January 2015 returned elevated counts of *E.coli* at the two river sites (Figure 1, Table 1). These results raised concern as there had been no rain in the three days preceding this sampling date (wet weather can increase agricultural runoff and lead to elevated FIB counts). Furthermore, the *E.coli* count was higher at

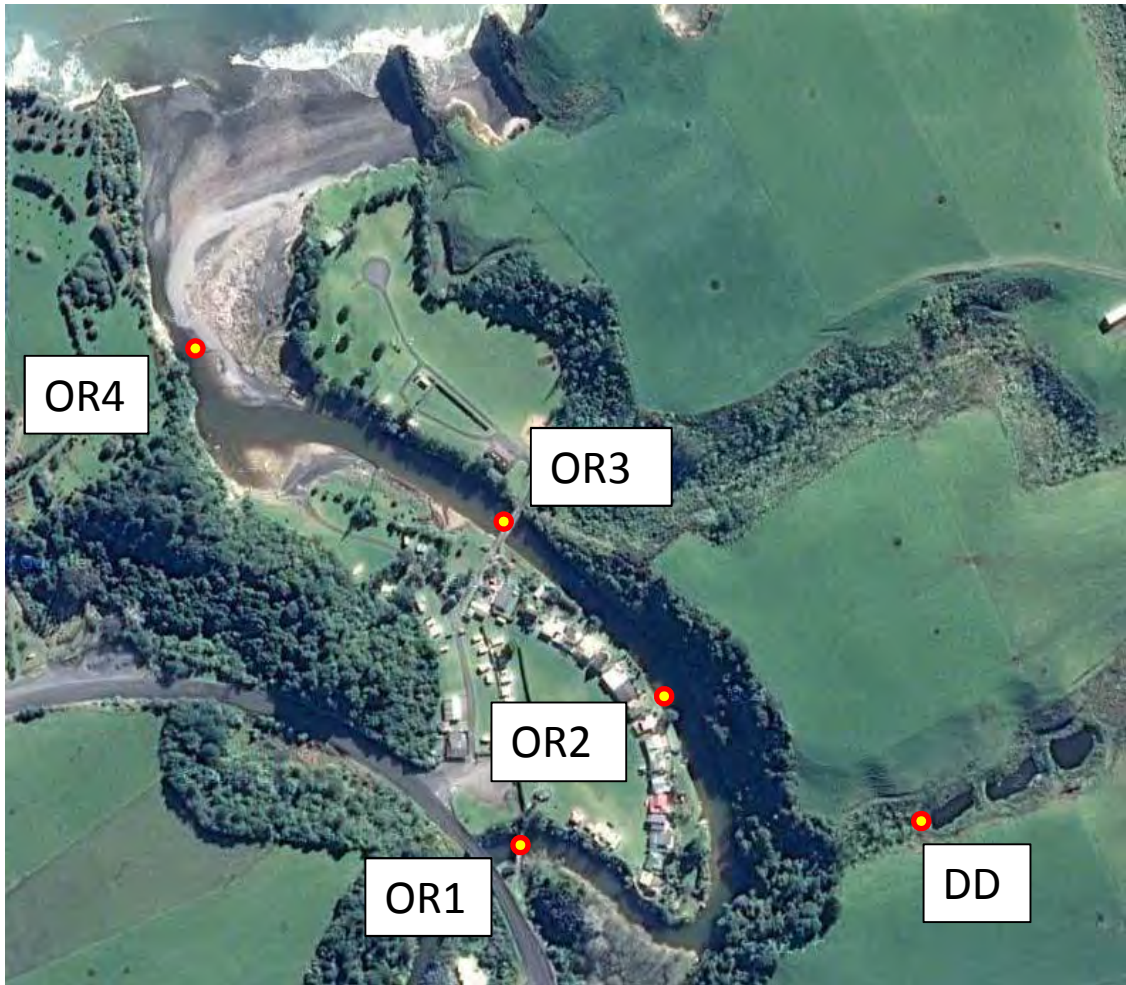
Figure 2 Sampling sites for 1 April 2015 investigation.

Five water samples were collected and analysed for temperature, conductivity, faecal indicator bacteria (FIB), and turbidity. A need to isolate each potential FIB source justified the location of the five water samples (Figure 2, Table 2). Sample locations included four sites on the Onaero River (OR1 - 4) and one dairy pond discharge (DD).

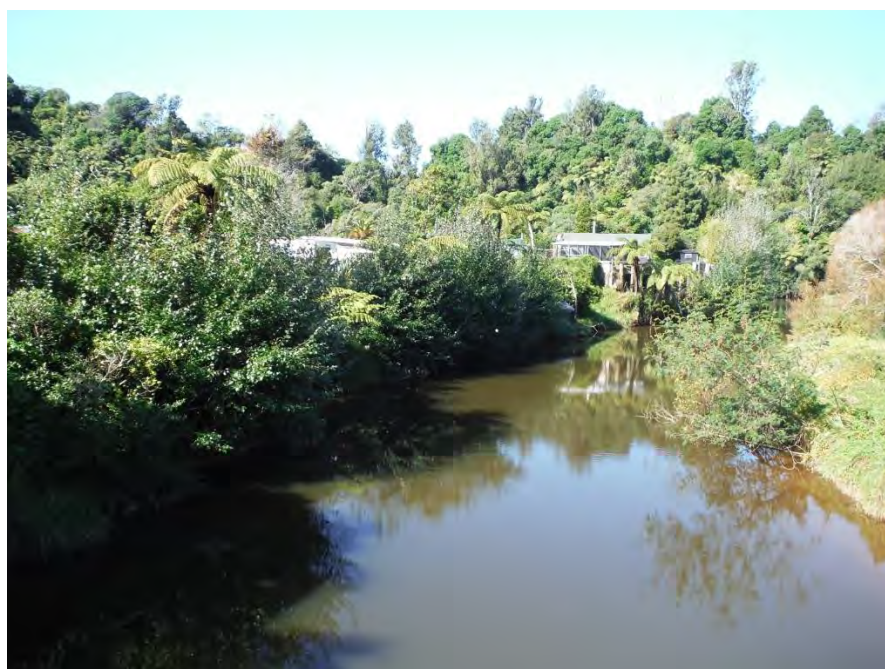
Photo 1 Onaero river downstream from SH3 bridge

The uniform nature of the riverine bacteria counts meant that it was not possible to isolate any immediate sources of faecal contamination. The uniform counts were likely due to the natural, seasonal development of a sand bar at the river mouth; an observation made whilst collecting the final sample (Photo 2). The sand bar was restricting drainage into the sea, causing the river to pool. It was observed that the surface water flow was significantly reduced and appeared stagnant at some points along the river (Photo 1). Also, the river level was relatively high considering that it was approximately low tide at the time of sampling.

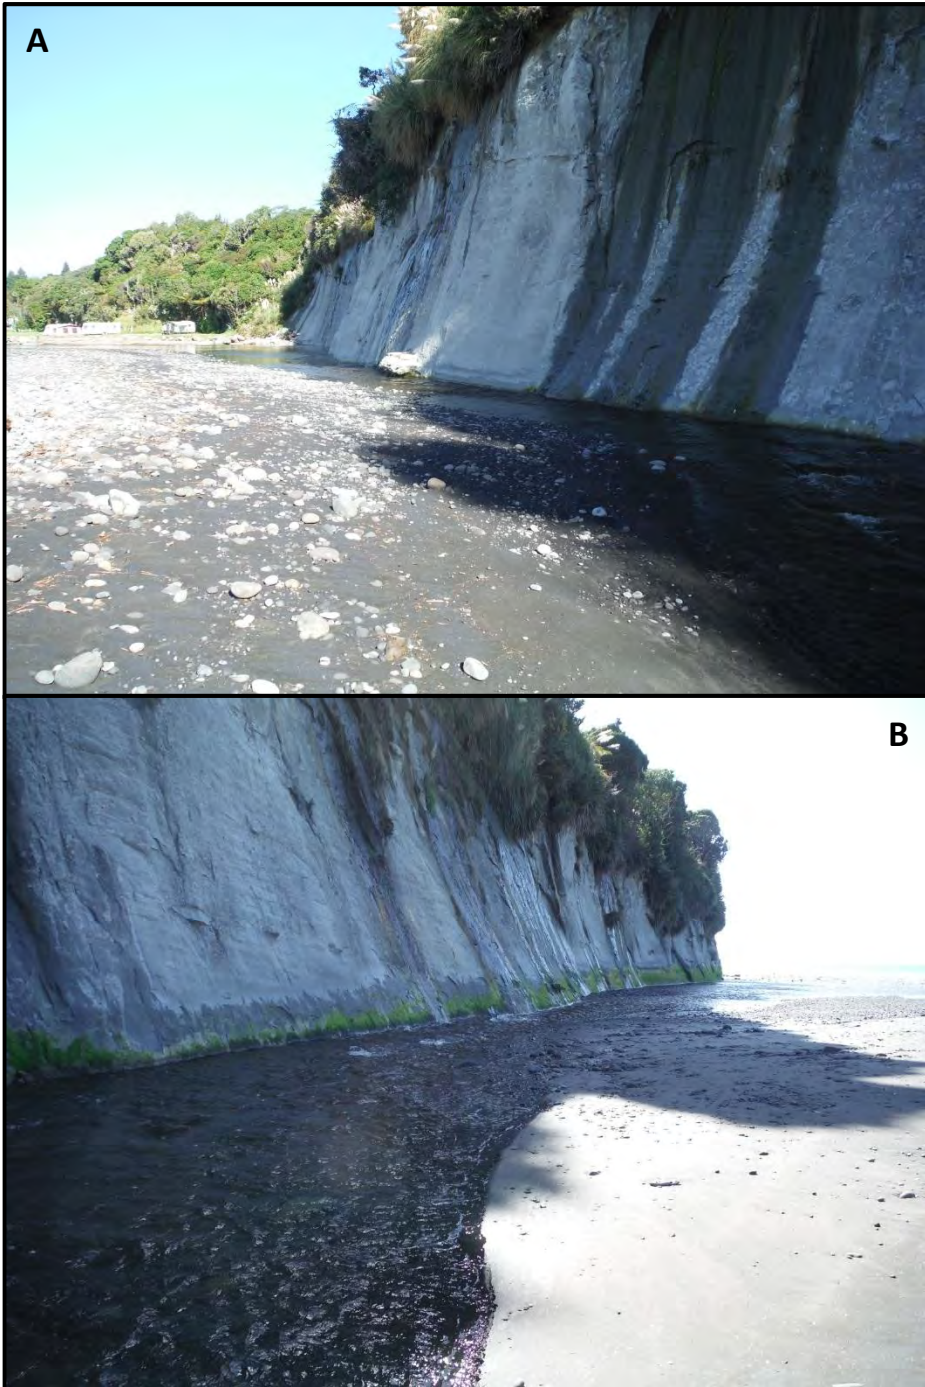
Photo 2 A) Sand bar restricting flow of the Onaero River (southward facing) B) Sand bar restricting flow of the Onaero River (northward facing)

In instances where pooling occurs, there is potential for contaminants within the river to accumulate near the point of the restricted flow. Here, the accumulation of FIB has resulted in elevated counts of *E.coli*. Given that this river drains from developed agricultural land it is likely that much of the catchment has contributed to these high counts. This further limits any inferences that can be made concerning faecal contamination of the Onaero River from sources near the motor camp.

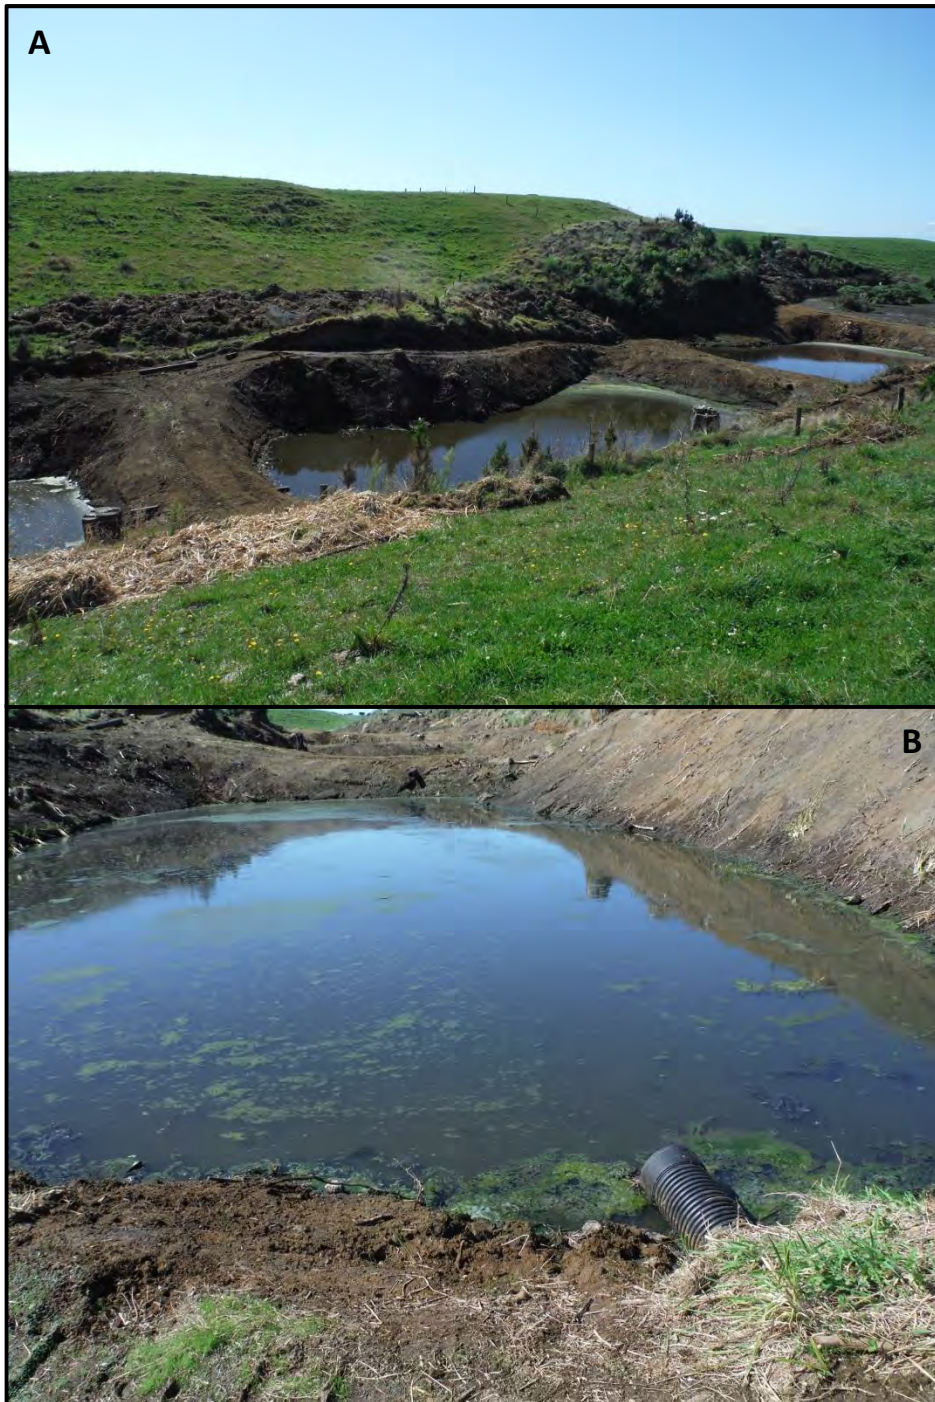
Photo 3 **A)** Three pond dairy effluent system **B)** Final pond with discharge pipe

It should be noted that the effluent discharge that was sampled was likely to be misrepresentative of a typical discharge. After collecting the sample, onsite correspondence with a share-milker revealed that the effluent ponds had been recently cleaned out (Photo 3). This was reflected by the unusually low FIB counts detected in the sample. As the effluent discharge forms the headwaters of the tributary, it seems intuitive that the potential for dilution before reaching the Onaero River is limited. The tributary itself was not thoroughly inspected as it was overgrown with dense scrub and bush (Photo 4).

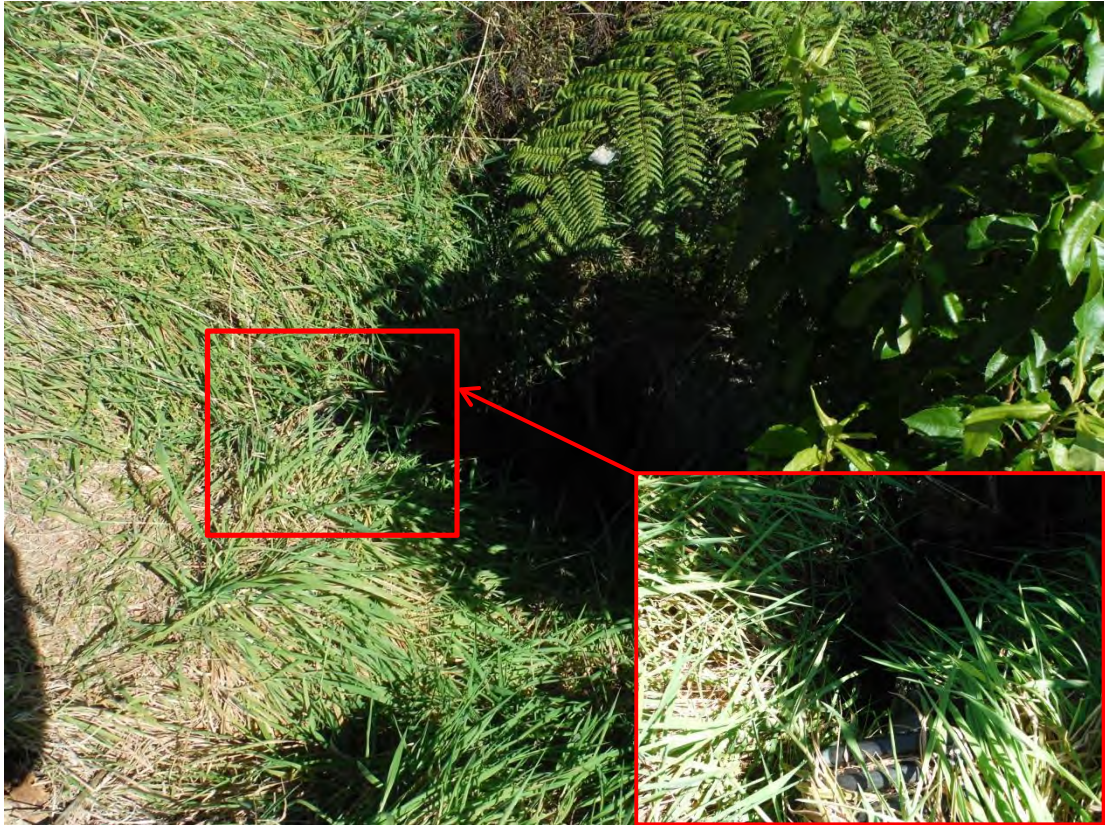
Photo 4 Discharge pipe (inset) and receiving tributary

The outcome of this investigation is inconclusive, however further monitoring is advised. In particular, it would be useful to employ the same sampling scheme at some point over the 2015-2016 monitoring period. Relevant factors to consider when setting a sampling time frame include the formation of the sand bar. A downstream flow is essential to isolate contaminant sources, therefore it would be suitable to sample before this sand bar has established. Also, the dairy calendar should be considered. The effluent discharge needs to be sampled in the midst of the milking season in order to sample a typical discharge. Lastly, sampling should occur during the months of the bathing season, as the presence of faecal contaminants in the Onaero River creates a health risk. It would be useful to employ faecal source tracking as an additional tool. The use of this tool is particularly relevant in this circumstance as human sewage, agricultural effluent and wildfowl are being considered as possible sources of contamination.
