New Plymouth District Council
New Plymouth Wastewater Treatment Plant
Marine Outfall and Sludge Lagoon
Monitoring Programme
Annual Report
2016-2017

Technical Report 2017-80

Taranaki Regional Council
Private Bag 713
STRATFORD
March 2018

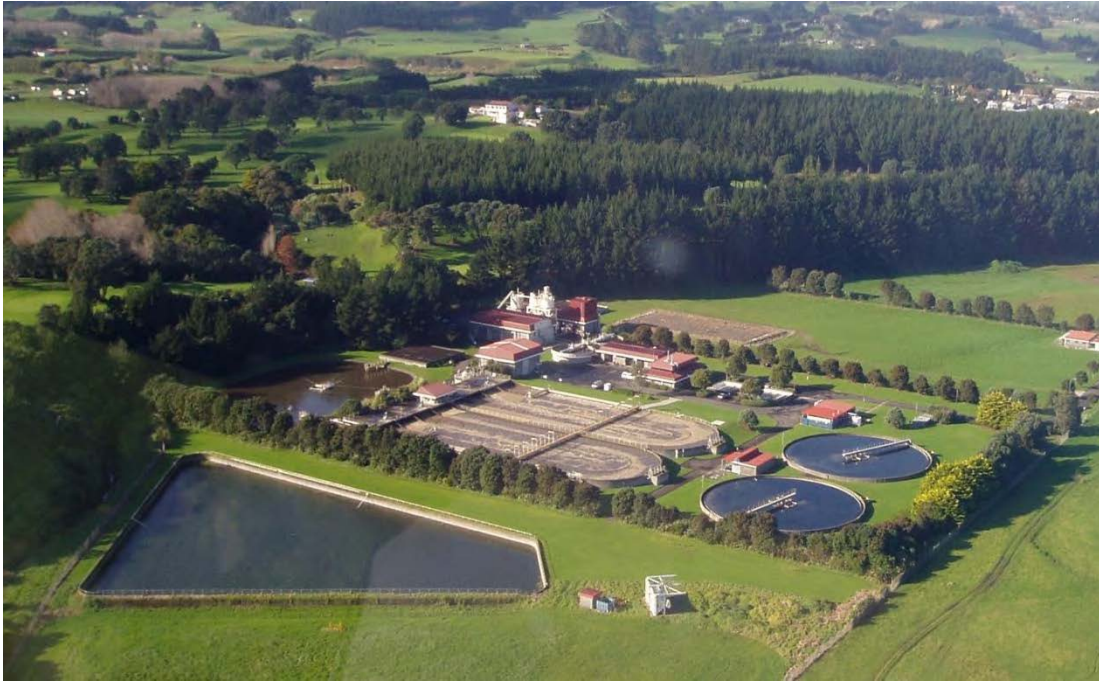
Photo 1 The New Plymouth Wastewater Treatment Plant

The NPWWTP (Photograph 1) treats the municipal wastewater from the New Plymouth urban area, Bell Block, Oakura and Inglewood by a process of extended aeration activated sludge. There is also a substantial industrial load, equivalent to approximately 25% of the total biochemical oxygen demand (BOD) load, treated by the plant. The plant was commissioned in 1984, and has had its capacity expanded several times since.

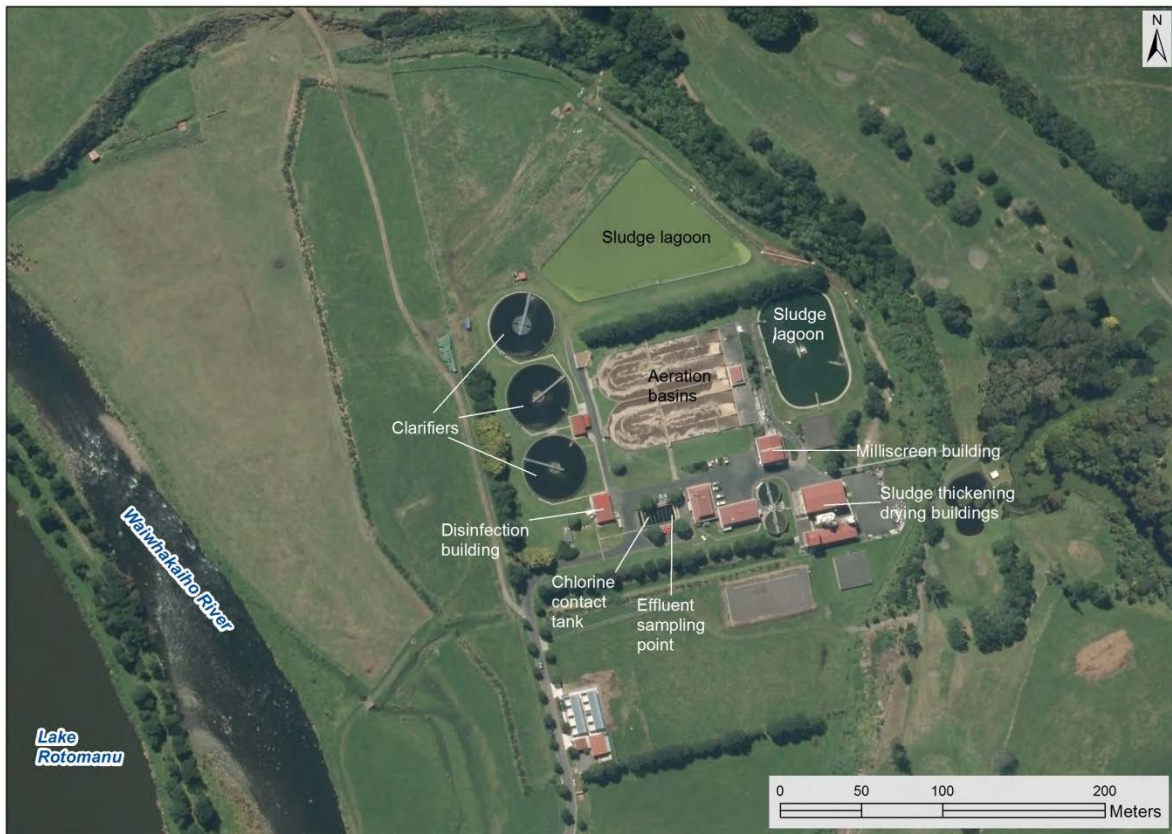
Figure 1 Layout of the New Plymouth Wastewater Treatment Plant

The activated sludge remaining in the clarifiers is returned to the aeration basins to maintain biological levels, while the surplus is diverted to the thermal drying facility (TDF) for sterilisation and disposal by alternative use (soil conditioner).

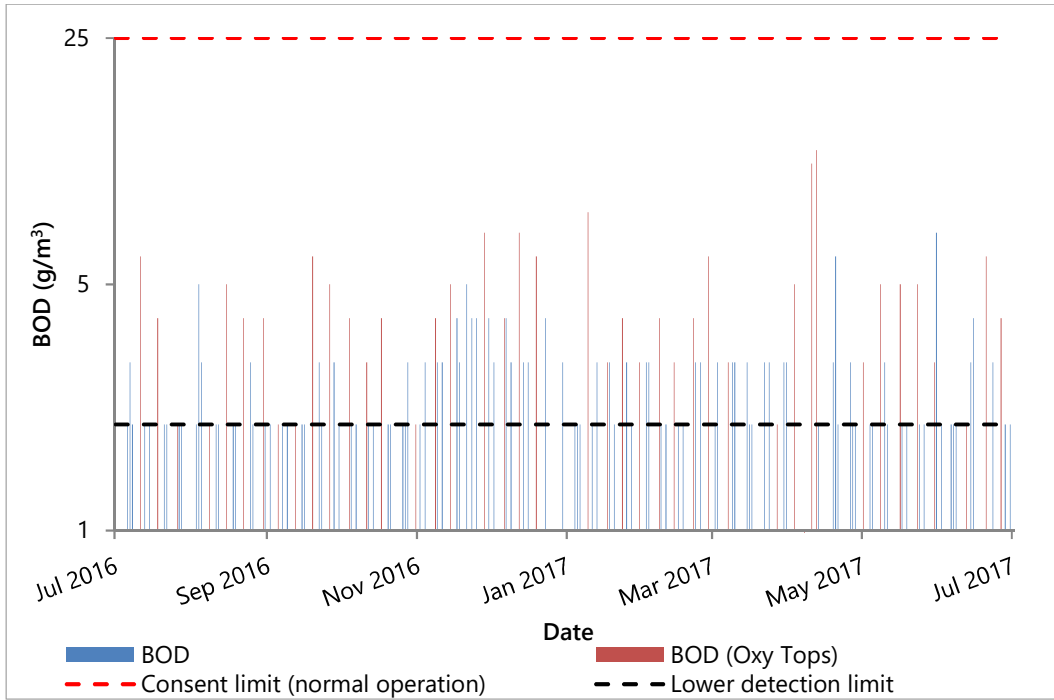
Figure 2 Biochemical oxygen demand results from two different test methods in 24-hour effluent composite samples, presented on a logarithmic scale.

As stated in Special Condition 4, neither BOD nor suspended solids shall exceed a concentration of 25 g/m³ in more than 5% of samples of the final effluent. Results from the effluent composite samples analysed for BOD and suspended solids during the year under review are presented in Figures 2 and 3.

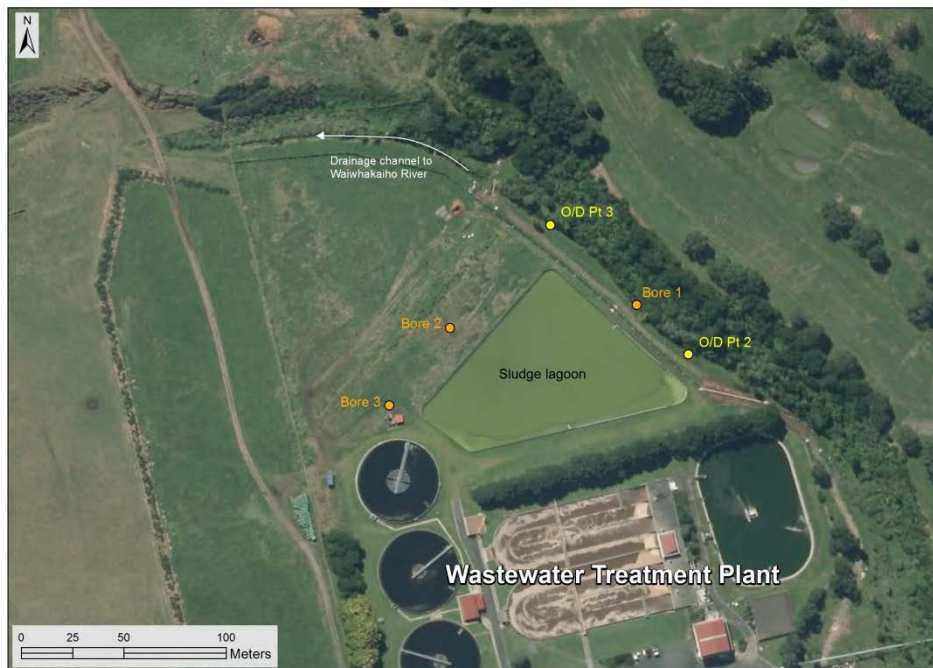
Figure 5 Sludge lagoon showing location of NPDC's groundwater bore and drain sampling sites

The results of sludge lagoon groundwater and surface water monitoring, undertaken monthly by NPDC, are summarised in Figures 6 to 13, along with a summary of previous results from 1990 to 2016. The results from routine monitoring during 2016-2017 are presented in Appendix IV. The locations of the sampling sites in relation to the lagoon are shown in Figure 5. Additional monitoring that was undertaken as part of a 12 month groundwater investigation will be presented in the 2017-2018 annual report.

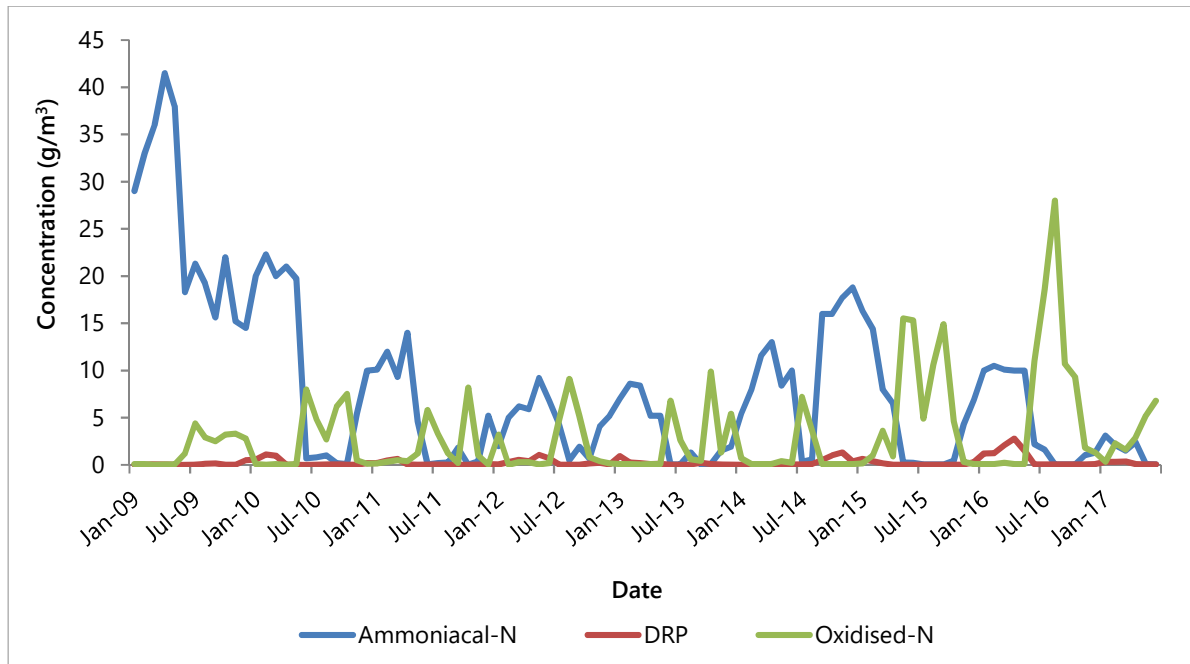
Figure 12 Concentrations of ammoniacal-N, DRP and oxidised-N in monthly groundwater samples taken from Bore 1 (2009-2017)

Seasonal cycles in concentrations of groundwater contaminants have become particularly apparent in recent years. This trend is most distinct with concentrations of ammoniacal-N, oxidised-N, and DRP at Bore 1, which are presented in Figure 12. The maximum concentrations of these three contaminants are also considerably higher at this Bore compared to Bores 2 and 3. At Bore 1, concentrations of ammoniacal-N are highest in the summer and subside in the winter. Conversely, oxidised-N concentrations are greatest in the winter, and subside during the summer. DRP mirrors the trend of ammoniacal-N, albeit at much lower concentrations. These trends were evident again in 2016-2017, although the summer flux in ammoniacal-N was lower in the 2016-2017 year than in recent years, with a maximum of 3.1 g/m³ recorded in January 2017, compared with a maximum of 10.5 g/m³ in the previous monitoring year. On the other hand, the maximum value recorded for oxidised-N in the current monitoring year (28.0 g/m³, July 2016) was considerably higher than in recent years. These differences are likely due to the higher than average rainfall experienced over the past year, which has most likely increased the concentration of dissolved oxygen in groundwater above that typically found during both winter and summer months.

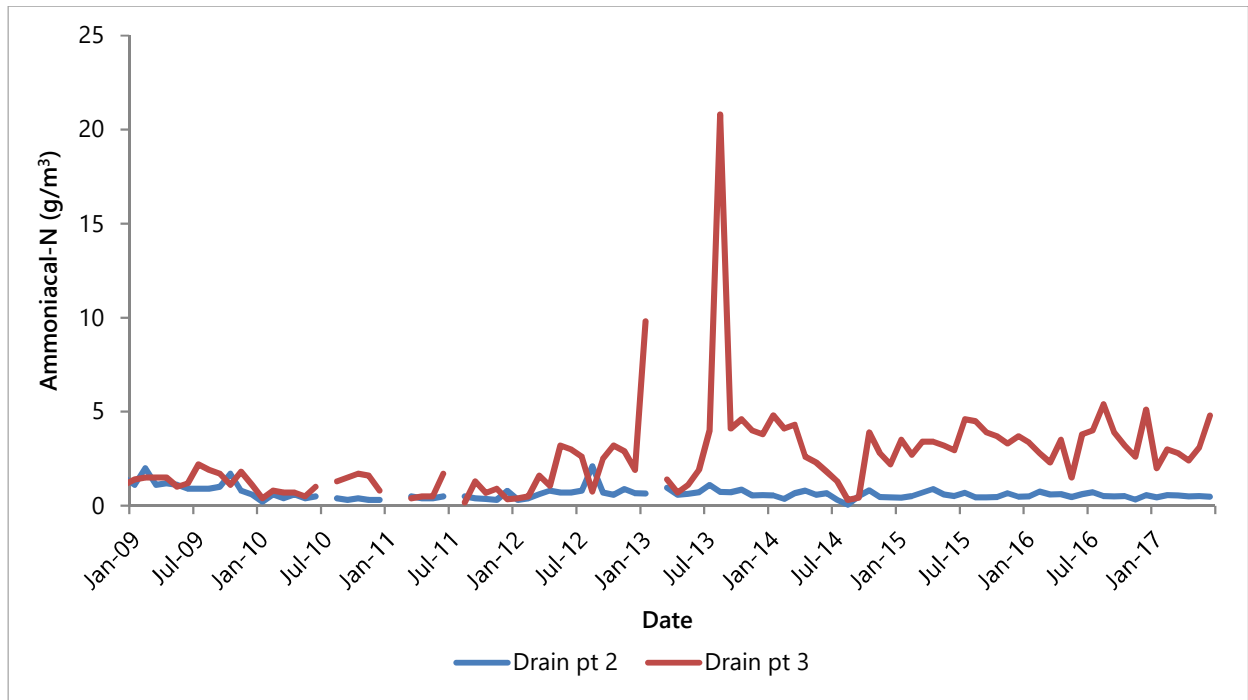
Figure 13 Concentrations of ammoniacal-N in the monthly drain samples collected upstream and downstream of the sludge lagoon (2009-2017)

No seasonal cycle is apparent in the concentrations of ammoniacal-N at the two open drain sites. Whilst the concentration of ammoniacal-N has remained consistently low at the upstream site in recent years, the downstream site has shown a slight increase, potentially due to leaking of the system or increasing permeability of the pond (Figure 13).

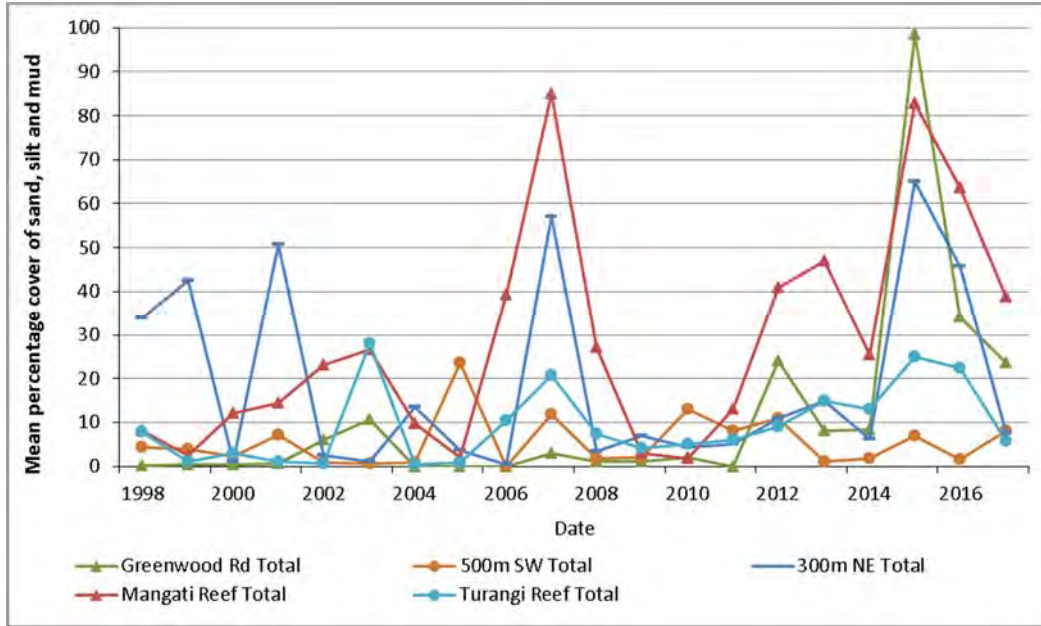
Figure 17 Mean percentage cover of sand, silt and mud at the five reef sites from 1998 to 2017

environmental factors, in particular sand cover, substrate type and substrate mobility, appeared to be the dominant drivers of species diversity at the sites surveyed.

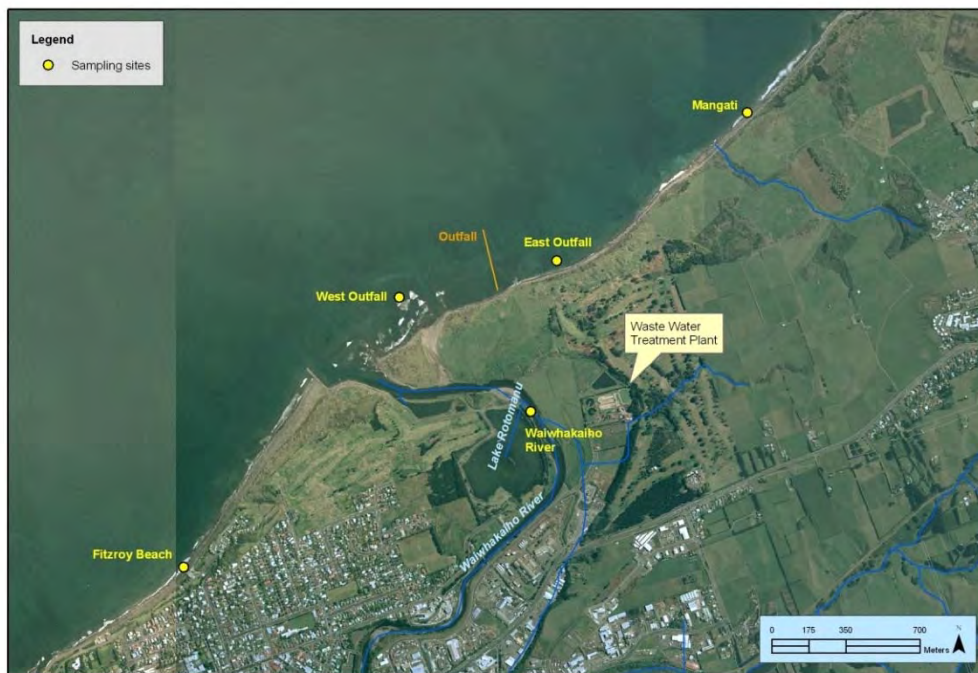
Figure 18 Locations of monitoring sites in relation to the NPWWTP

Bacteriological water quality was monitored at four coastal sites in the vicinity of the marine outfall (Figure 18) during the summer months of 2016-2017 to assess whether the discharge from the marine outfall was having any adverse effects on coastal bathing water quality. A site on the Waiwhakaiho River was also monitored in order to determine any influence of the river on coastal water quality. Thirteen samples were collected at each site during dry weather conditions and analysed for enterococci, faecal coliforms, *E. coli* and conductivity.

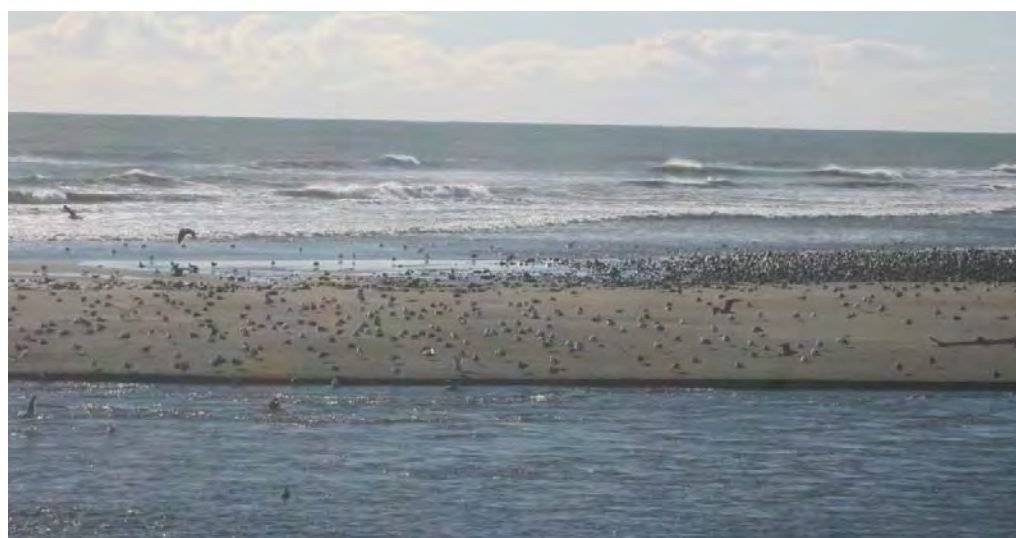
Photo 2 Gulls at the mouth of the Waiwhakaiho River

Enterococci counts have typically been higher at the 500 m SW site, relative to the other three coastal sites, since monitoring began in 1996 (Figure 2). This trend was not found in the current monitoring year, with relatively low FIB counts recorded at all four coastal sites). Previous faecal source tracking investigations have indicated that gulls are likely to be the main source of faecal contamination at the 500 m SW and Waiwhakaio River sites, with these findings supported by frequent observations of high numbers of gulls at the Waiwhakaiho River and the Waiwhakaiho Reef (Photo 2).

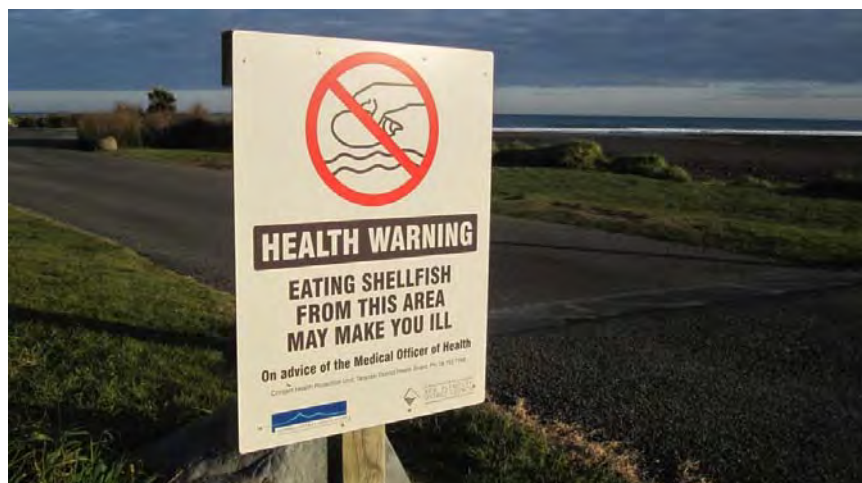
Photo 3 Shellfish health warning sign at the Waiwhakaiho River mouth

Following the completion of the upgrade, norovirus levels in mussel flesh dropped back to low or below detection levels (on 15 June 2014; Table 7). Results from this monitoring period found that norovirus levels in mussels collected from both sites were low or below detection limits (25 May 2017). However, due to the highly infectious nature of norovirus, with only low concentrations posing a high risk of illness, shellfish warning signs remain in place at the Waiwhakaiho area and Bell Block (Photograph 3).

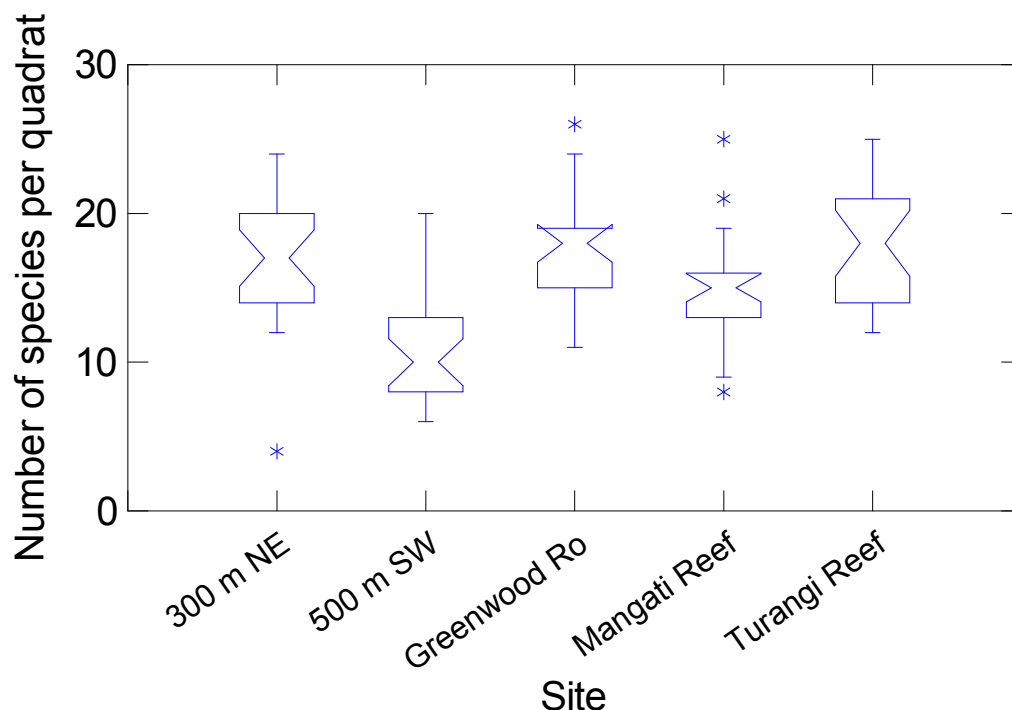
Figure 2 Box and whisker plot of total number of species per quadrat

Figure 2 shows the total number of species per quadrat at each site as a box and whisker plot. The notched area of the box represents the median plus and minus the 95% confidence interval. This form of graphical representation allows a quick comparison to be made between sites. Generally, if the notched areas of the boxes do not overlap you would expect to obtain a significantly different result with ANOVA.

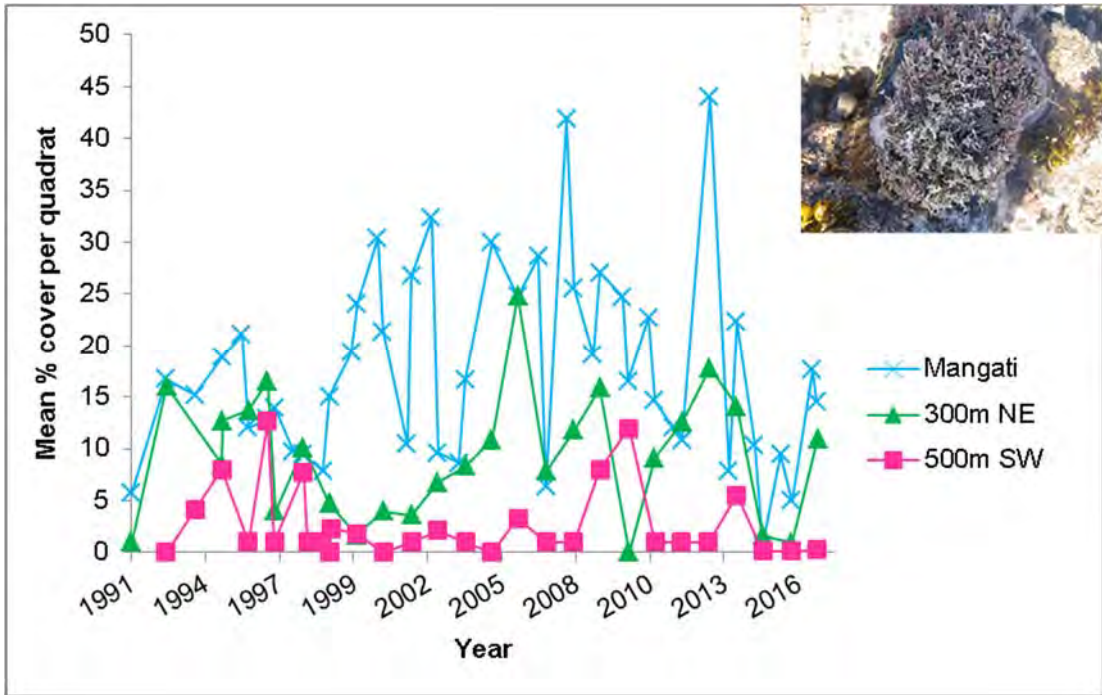
Figure 7 Percentage cover of coralline turf *Corallina officinalis* at the three potential impact sites from 1991 to 2017

Historically, Mangati Reef has supported the growth of coralline turf algae more so than the other two impact sites (Figure 7). Although this reef has been periodically inundated with sand, the sheltered conditions have proved more favourable for coralline algae growth. In turn, the relatively high percentage cover of coralline turf can provide an ideal habitat for juvenile cat's-eyes *Turbo smaragdus* (Figure 8), which are known to feed on the small epiphytes present on the calcified surface of the coralline algae (Morton, 2004). However, in 2015, the extent of sand inundation at the Mangati Reef resulted in extremely low coralline turf cover and *T.smaragdus* densities at the site. A similar result, albeit at a smaller scale, was observed at the 300 m NE site (Figures 4 and 7). There has been a notable increase in turf cover observed at the Mangati Reef and 300 m NE sites over last three surveys. As the sand cover decreases at these sites it would be expected that the coralline turf cover, and subsequently *T.smaragdus* abundance, would continue to increase.

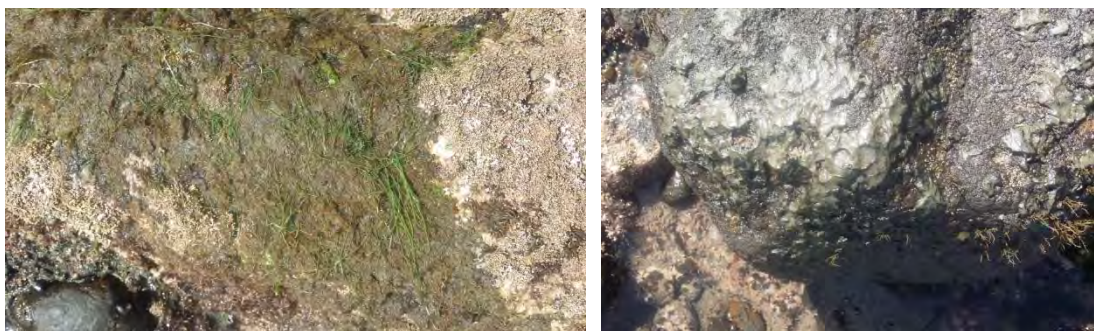
Photo 6 Elevated cover of *Chaetomorpha* and brown mats at the Greenwood Road site (13 January 2017)
