South Taranaki District Council  
Kaponga, Manaia, Patea, and Waverley WWTPs  
Monitoring Programme  
Annual Report  
2016-2017

Technical Report 2017-78

Taranaki Regional Council  
Private Bag 713  
STRATFORD  
January 2018

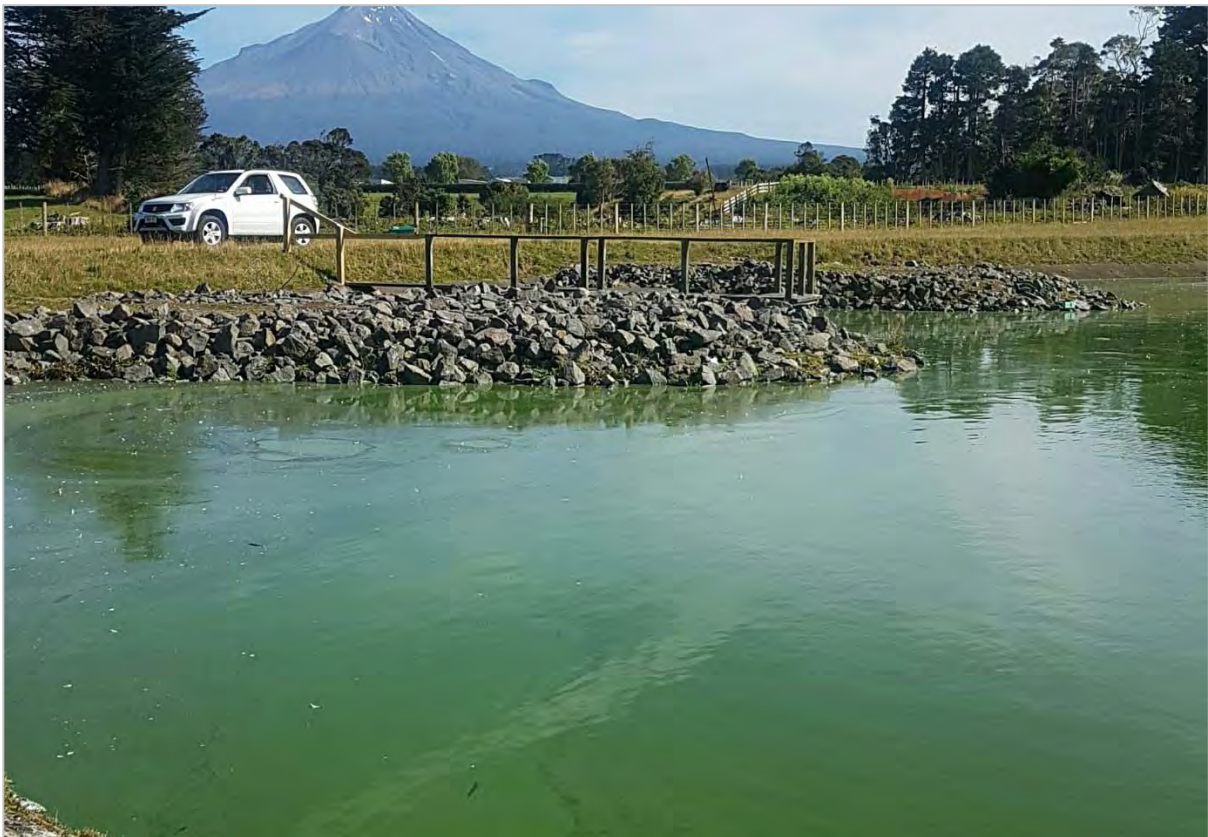
Photo 1 Kaponga WWTP, February 2017

The Kaponga WWTP is a single oxidation pond system (constructed in 1971) that has been separated into two sections by a wooden dividing barrier. The pond is gravity fed mainly domestic wastes from a population of about 370 people although it was designed for a population of 650. A sludge survey performed by consultants for the consent holder (MWH, 2005) found that there had been a slow rate of sludge accumulation and at such a rate, it was estimated that the system would not require desludging for another 17 years. Sludge surveys will be repeated at five-yearly intervals (STDC, 2015). Issues of stormwater infiltration, improved mixing within the ponds' system, and reduction of the microfloral component of the treated wastewater discharge, were identified in consideration of upgrading the treatment system during the consent renewal process in the 2007-2008 period (CH2M Beca Ltd, 2006). Upgrades to the system were completed by late May 2008. Infiltration remedial work has a lesser priority for the Kaponga system than elsewhere in South Taranaki although 121 m of pipeline was re-lined during the 2014-2015 period (STDC, 2015).

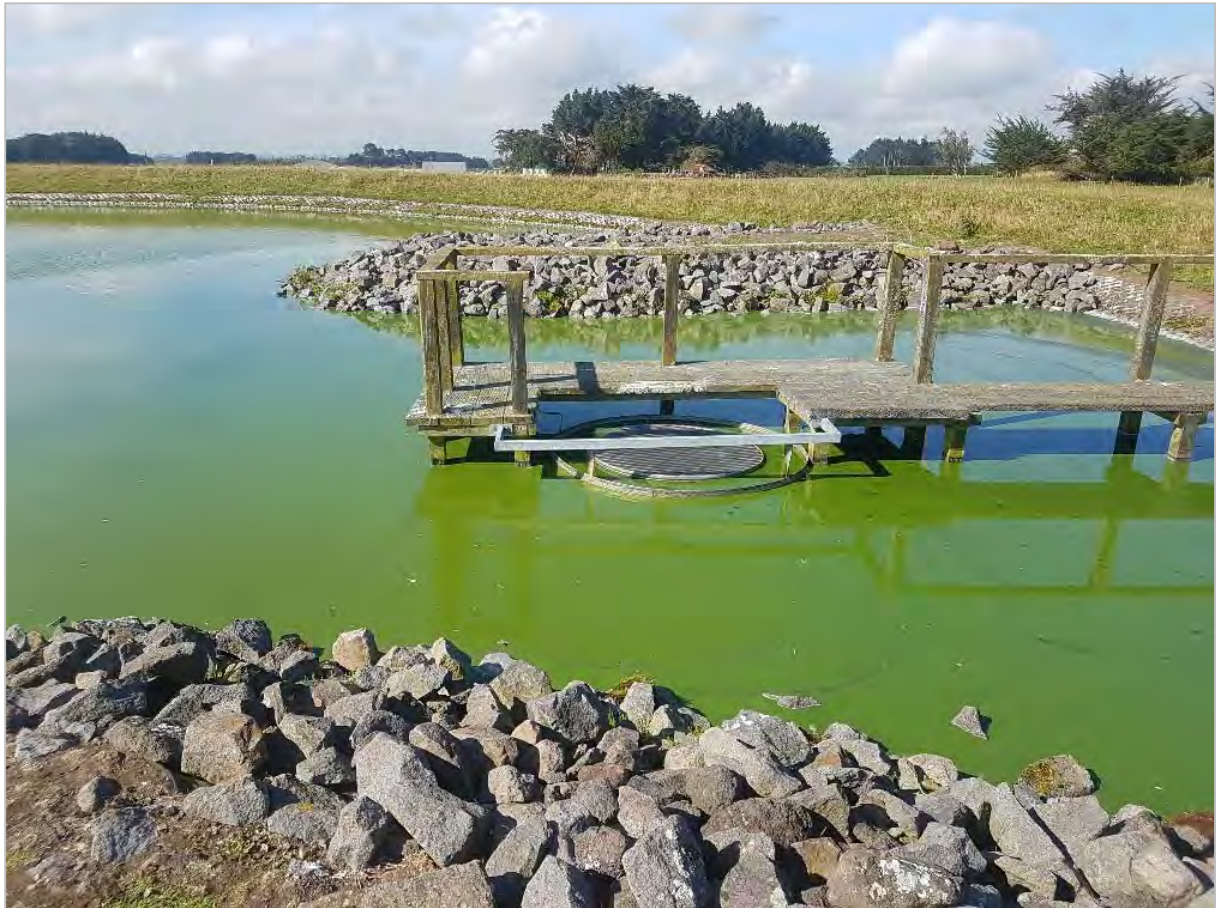
Photo 2 Algal bloom on the surface of the pond caused by high microfloral levels.

Despite the wide range of concentrations of chlorophyll-a in the primary pond, the majority of samples showed high concentrations, indicative of a significant phytoplanktonic component. The lowest measured DO level (3.1 g/m<sup>3</sup>) was associated with the lowest algal concentrations in the pond, which is indicative of the organic wastes' loadings on this system. The highest levels, recorded during the summer survey, were related to a thick green layer noted on the surface of the pond at the time of the visit (Photo 2).

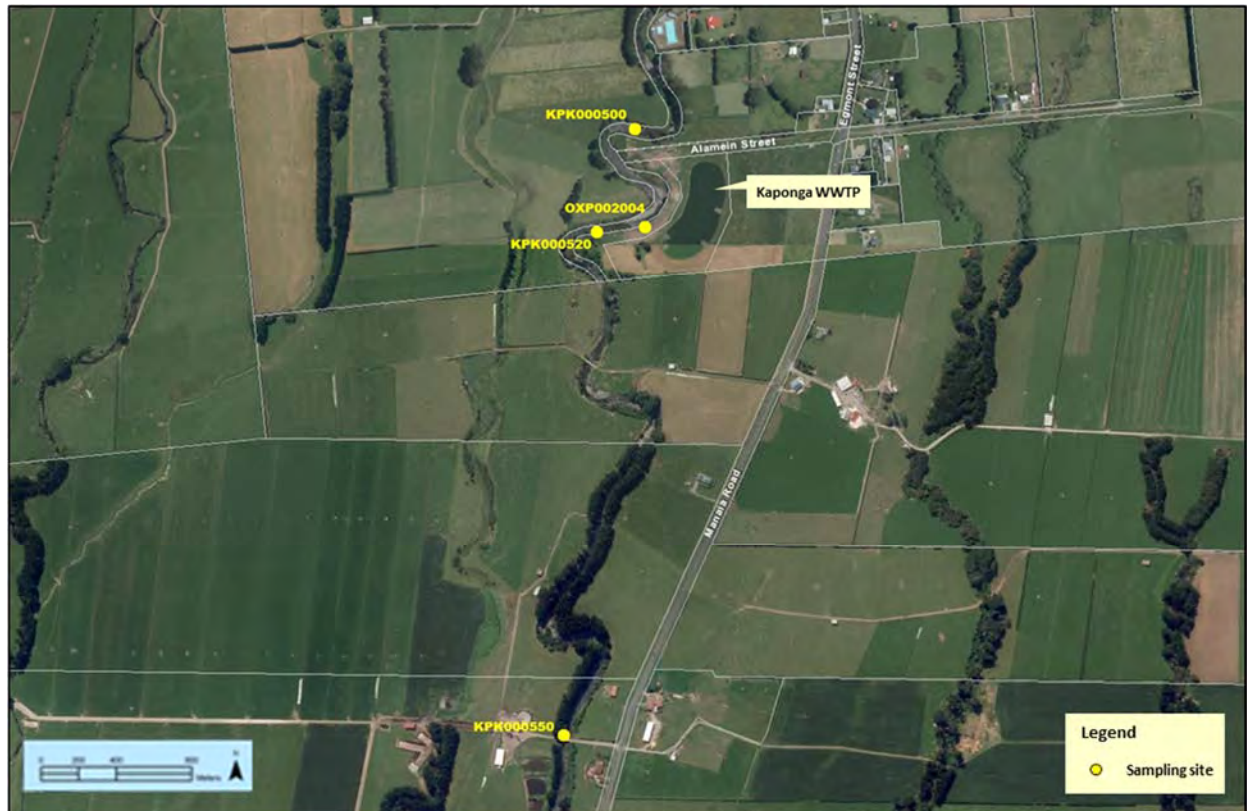
Figure 1 Aerial location map of sampling sites in relation to Kaponga WWTP

summer 2017 (Section 2.1.3.2). The locations of sampling sites are listed in Table 4 and displayed in Figure 1 below.

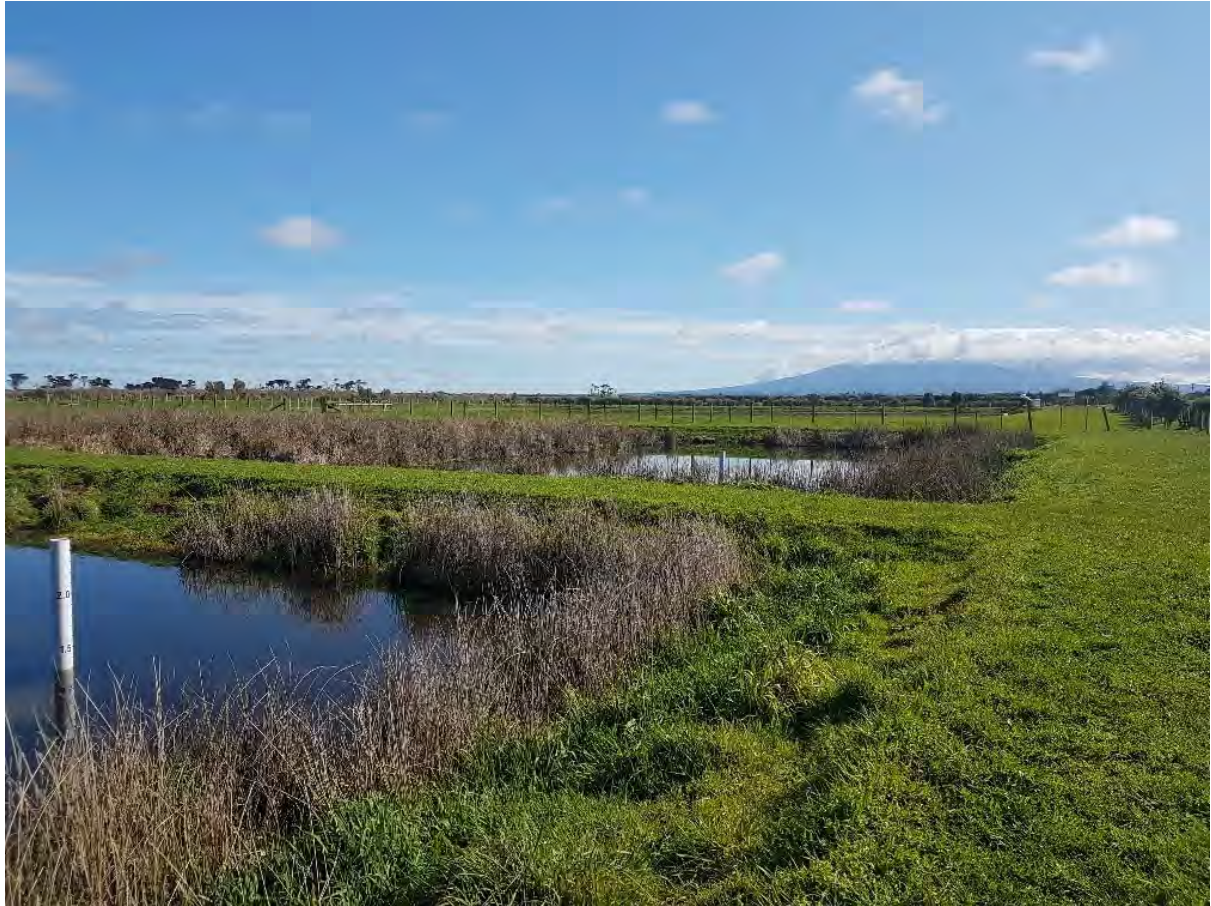
Photo 3 Manaia WWTP showing view of wetlands

The Manaia WWTP is a single treatment oxidation pond (constructed in 1984), followed by twin wetlands (in parallel) receiving mainly domestic sewage together with trade wastes from the bakery industry. These trade wastes are currently un-regulated but with the proposed introduction of a planned trade waste by-law, restrictions and standards are intended to be imposed by the consent holder (STDC, 2013).

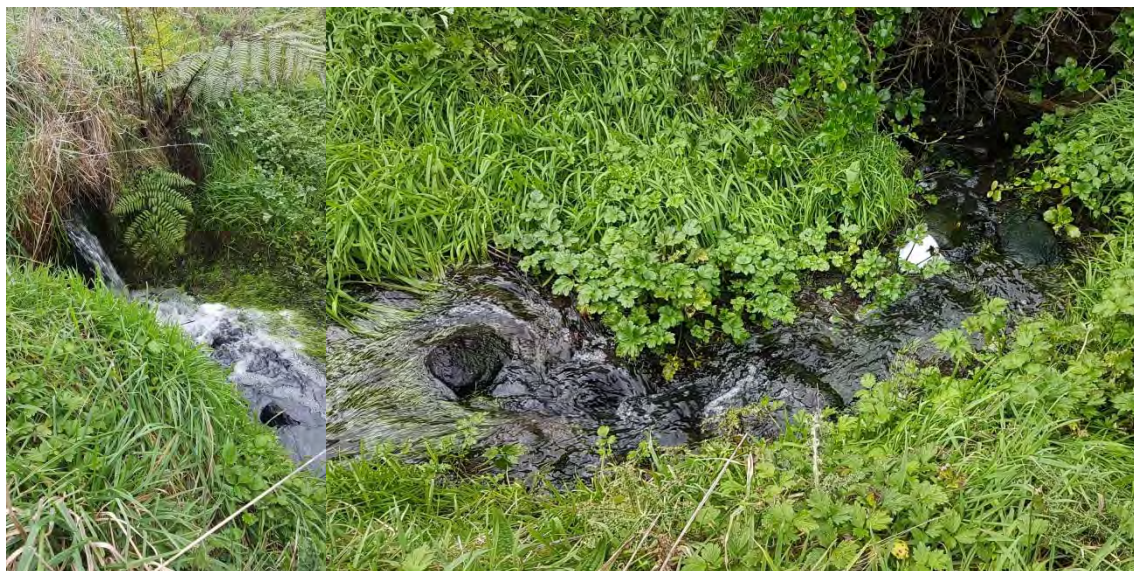
Photo 4 The small discharge channel from the oxidation ponds prior to the Manaia Creek

At the time of the inspection the effluent from the oxidation pond-wetland system was discharging at a high rate (Photo 4). The discharge was clear and had a faint but detectable sewage odour. Small patches of foam were visible. No sewage fungus was present after or before the Manaia Creek stream confluence.

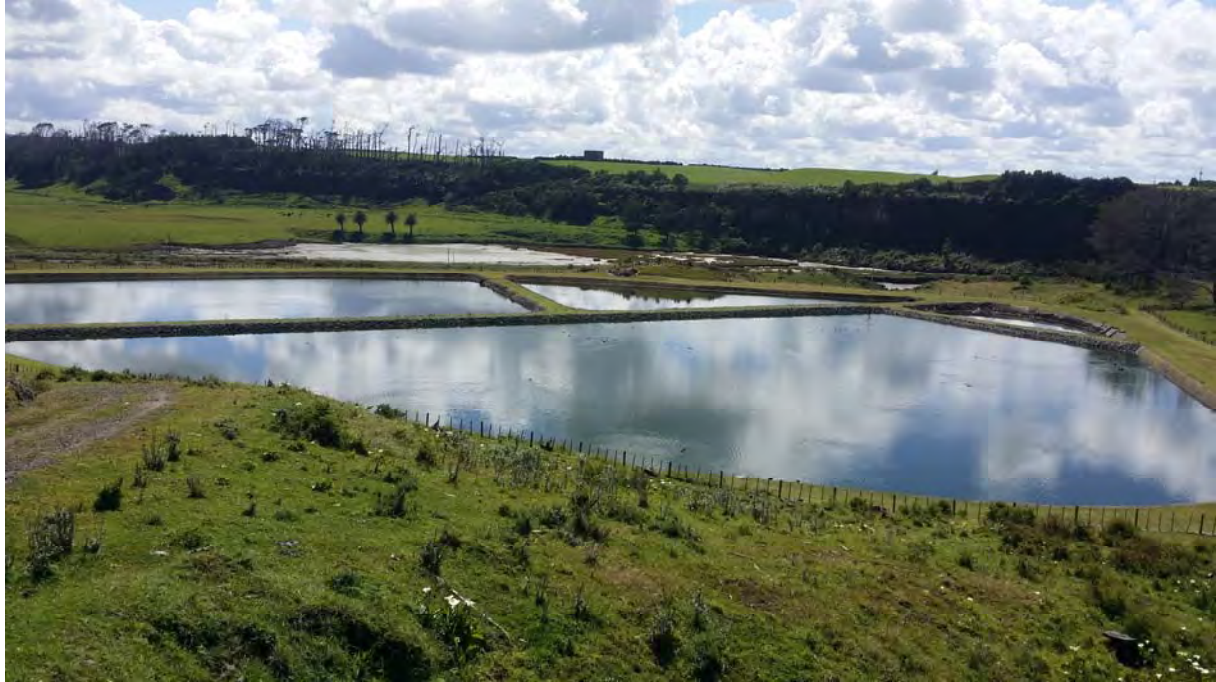
Photo 5 View of Patea WWTP

The Patea WWTP (constructed in 1973 for a population of 2,400) was originally comprised of a single large oxidation pond which was upgraded to a three cell system in 2008 (Photo 5). There are currently no significant industrial wastes being discharged into this pond. The population serviced by the system was 1,098 in 2013. The nearby York Street pumping station has provision for river overflow via a separate outfall in the event of emergencies.

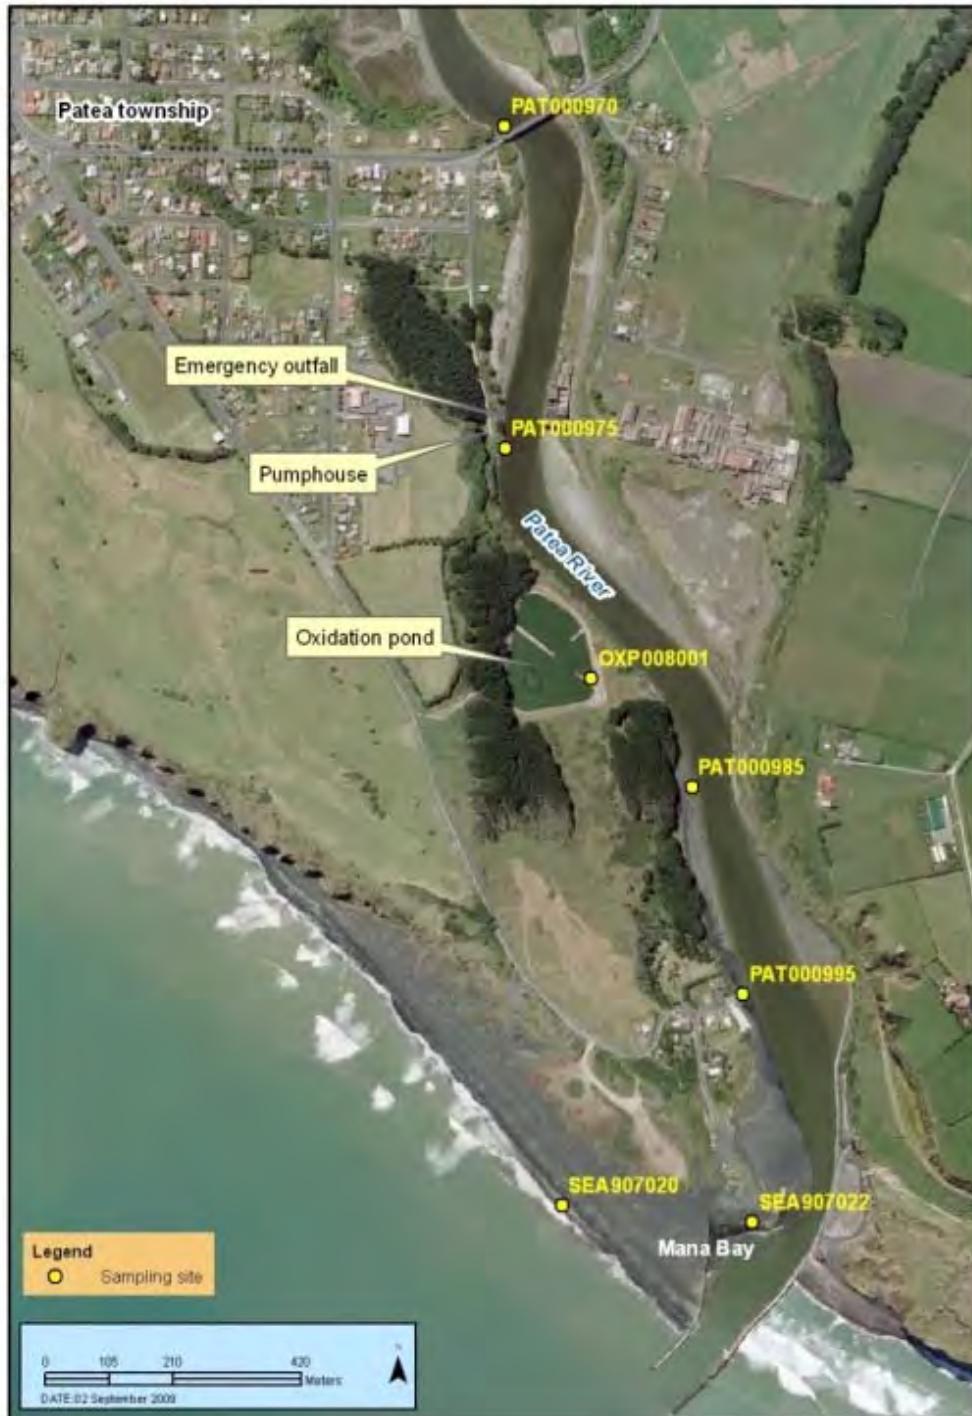
Figure 3 Map showing sampling sites in relation to Patea WWTP

Monitoring of the impacts on receiving waters is measured using both chemical analyses of the lower Patea River, and contact recreational bacteriological quality surveys of the coastal marine area at the Patea Boat Ramp and the Tasman Sea at Mana Bay (Figure 3). Chemical sampling was carried out on two occasions during the 2016-2017 period (Section 4.4.1). Contact recreational bacteriological water quality monitoring at the Patea Boat Ramp and Mana Bay was carried out by the Council on 24 and 13 separate occasions respectively between early November 2016 and mid April 2017 (TRC, 2017). The sampling sites are detailed in Table 20.

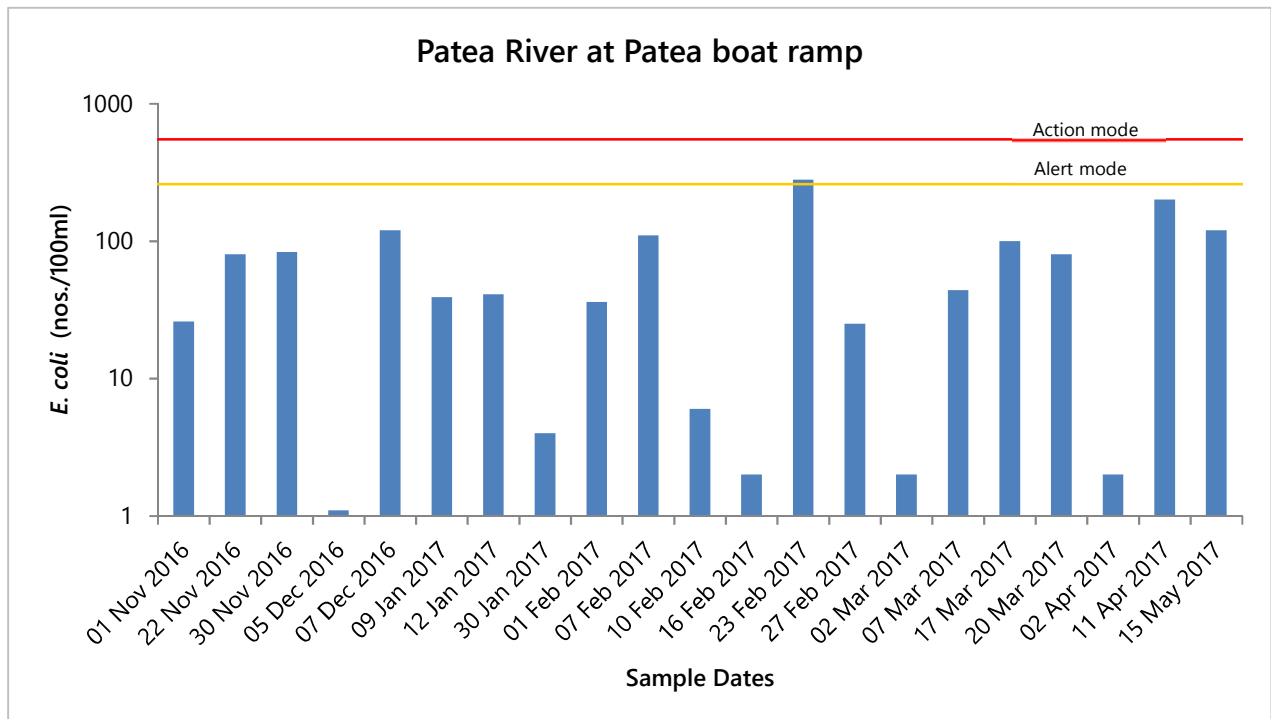
Figure 4 E. coli numbers for lower Patea River at the boat ramp

Bacteriological water quality was typical of the lower reaches of a large ringplain-eastern hill country catchment, with moderate numbers under river (freshwater) dominated conditions and fewer when influenced by saline penetration of the coastal seawater. Numbers of E. coli exceeded the 'Alert' limit on one occasion, but did not exceed the 'Action' limit for all 21 sampling occasions. These data were indicative of good bacteriological water quality conditions coincident with an improved effluent quality discharged upstream from the upgraded wastewater treatment system. Some bathing activity was noted during the 2016-2017 period at this site which was used mainly for boating access and occasionally for fishing and walking. The Council had undertaken microbial source tracking (MST) using DNA marker techniques over the 2011-2012 period at this site and at the upstream site at SH3 bridge on two occasions (high and low tides) (see TRC, 2012). Faecal coliform bacteria were found to have been sourced predominantly from cattle on both occasions at the two sites while gulls contributed to populations at the boat ramp site under both tidal conditions. A faint trace of human source derivation was found (downstream of the Patea WWTP treated discharge) at the boat ramp site only under low tidal flow conditions.

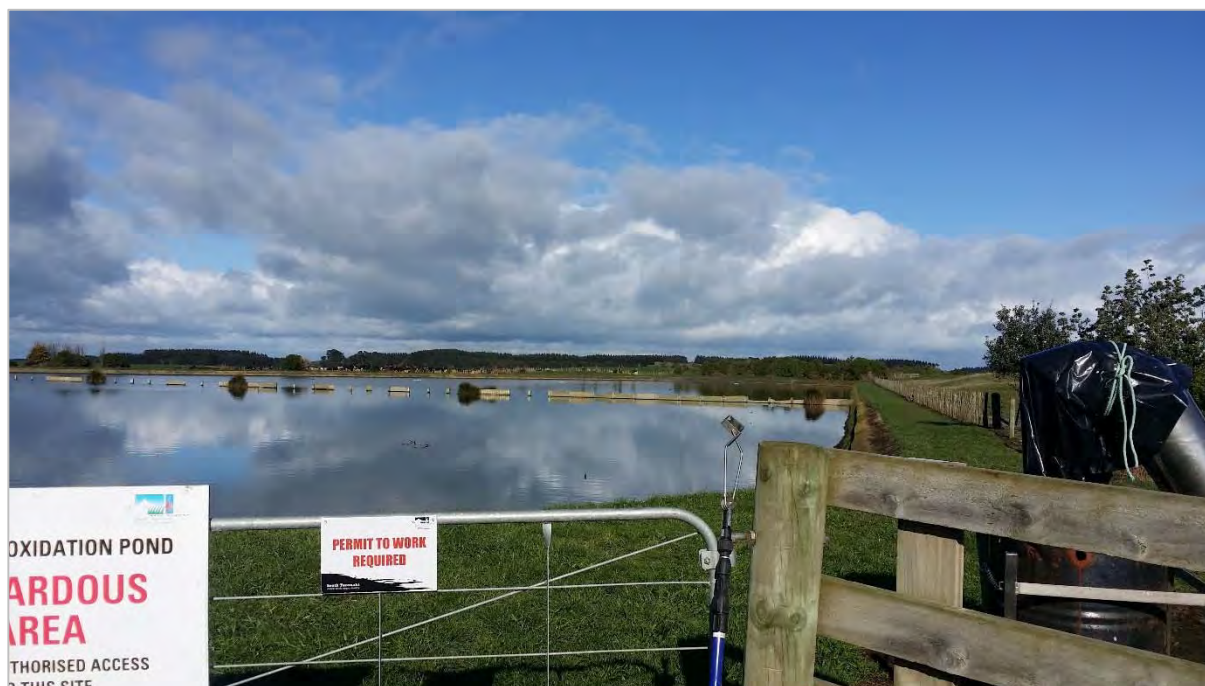
Photo 7 Waverley WWTP, August 2016

The WWTP system was reconfigured during the 2008-2009 period with the existing outfall abandoned, the secondary pond converted to a primary pond with a new inlet design, repairs made to the dividing wall, and the primary pond converted to a secondary pond with a repositioned outlet connected into the original outfall to the Wairoa Stream (Photo 7). 'Sludge-bugs' were introduced into the system for the purpose of microbial sludge digestion in September 2013 and this was completed by December 2014 with more than 5000 cubic metres of sludge removed (STDC, 2015). Inlet flow monitoring was added in 2010. Mechanical screening of the incoming wastes was installed at the inlet during the latter half of the 2012-2013 period, which has associated telemetry alarming.

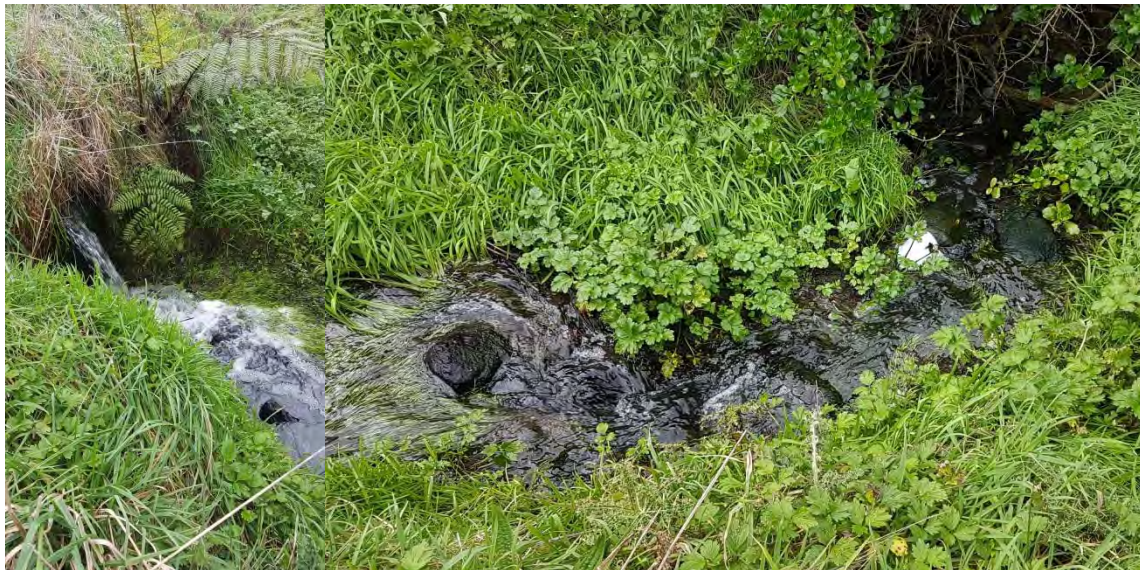
**Photograph 1** The small discharge channel from the oxidation ponds prior to the Manaia Creek

At the time of the inspection the effluent from the oxidation pond-wetland system was discharging at a high rate (Photograph 1). The discharge was clear and had a faint but detectable sewage odour. Small patches of foam were visible. No sewage fungus was present after or before the Manaia Creek stream confluence. The discharge channel below the pipe was fenced (Photograph 2). Rocks had been placed in the channel in order to reduce the risk of sewage fungus growth. The Manaia Creek (Unnamed Stream 27, Consent 1204-4) was in high flow during the inspection (Photograph 3).

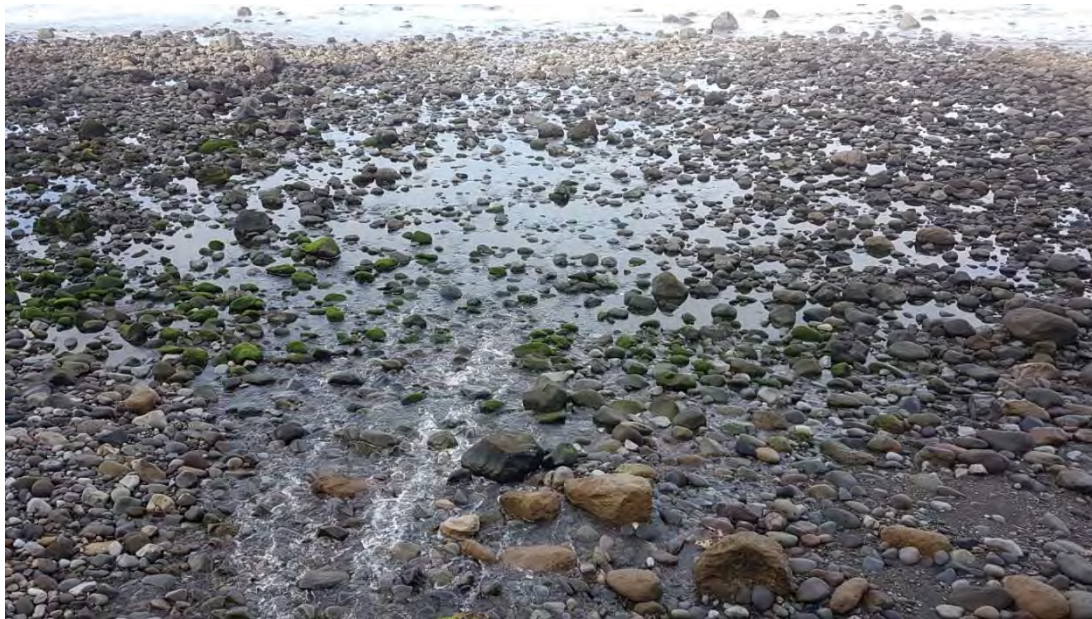
**Photograph 6** The Manaia Creek flowing over the intertidal reef at Manaia

The stream was approximately 10 m wide at the coast. The stream appeared clear with small patches of foam (Photograph 6). There was no detectable odour from the top of the access point.

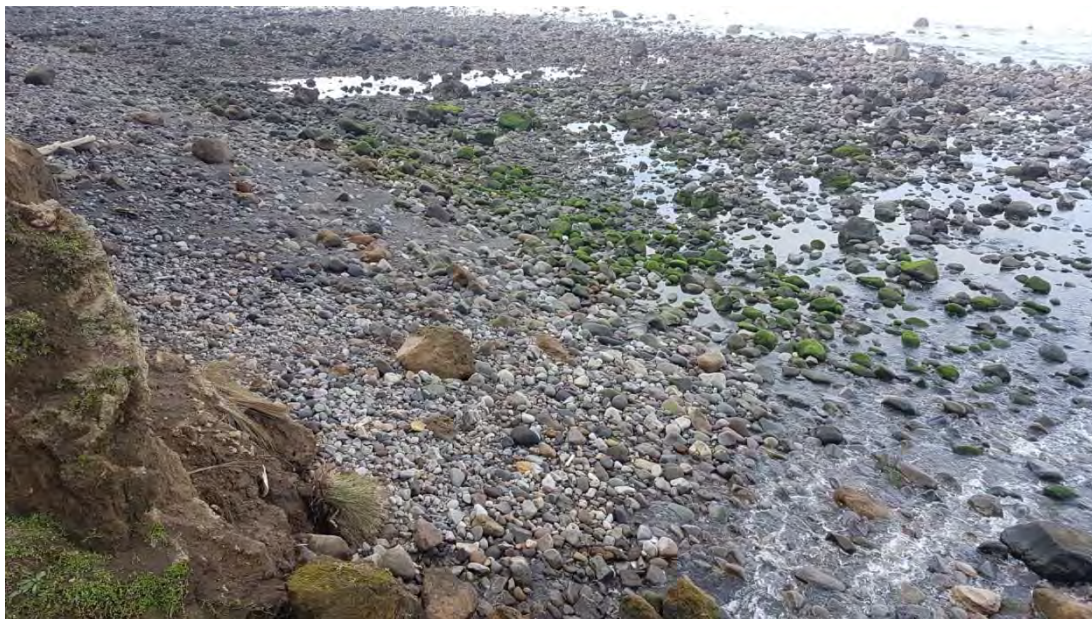
**Photograph 7** Green algae evident along the high water mark

Green macroalgal species (*Ulva* spp.) stretched along the high tide mark ~20m either side of the stream. These algal species are typical of freshwater influence and thrive under nutrient rich conditions.

In summary, the stream appeared to have a significant effect on intertidal algae nearby to the stream, most likely a result of freshwater influence. *Ulva* spp. was evident along the length of the stream, with dense cover higher up on the shore. Prolific growth of this species is typical of nutrient enrichment, however, this species was not abundant beyond the 50 m mixing zone extending either side of the stream.
