## **ANNEX 4**

### **Sensitive Site and Coastal Information**

In order to give priority to the ecological sites in the region that have values worth particular protection, it is wise to know the potential threats from oil spill risk in the region. This Annex identifies the risk potential and the significant ecological sites for protection both within the Port/city confines and along the region's coastline.

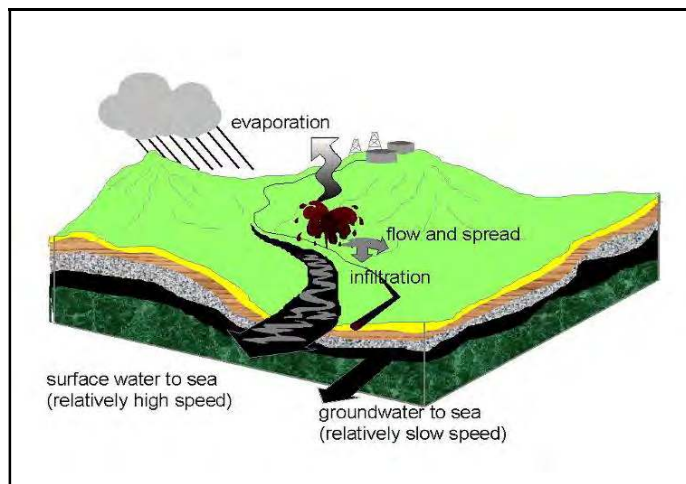
Fate of hydrocarbons onshore

- Impermeable surface
  - Evaporation will commence immediately.
  - Oil will flow and spread freely.
- Permeable Surface
  - Oil, particularly low viscosity oils such as condensate and diesel, will rapidly soak into permeable soil. However once the oil is in the soil it will move slowly.
  - Oil infiltrates horizontally and vertically and may eventually reach ground water.
- Surface Water
  - If oil finds its way to surface water it will spread quickly, and once in a stream or river will flow downstream at the same speed as the current.

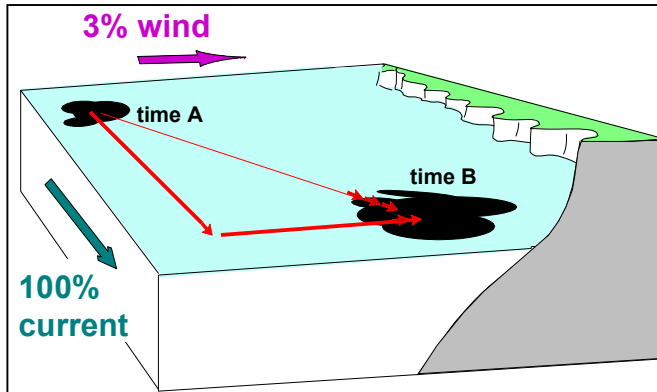
Physical movement of surface oil

Drifting is lateral transport of the oil due to the driving force of winds and currents, and is the primary concern for response. Oil typically moves at 3% of the wind speed and 100% of the current speed.

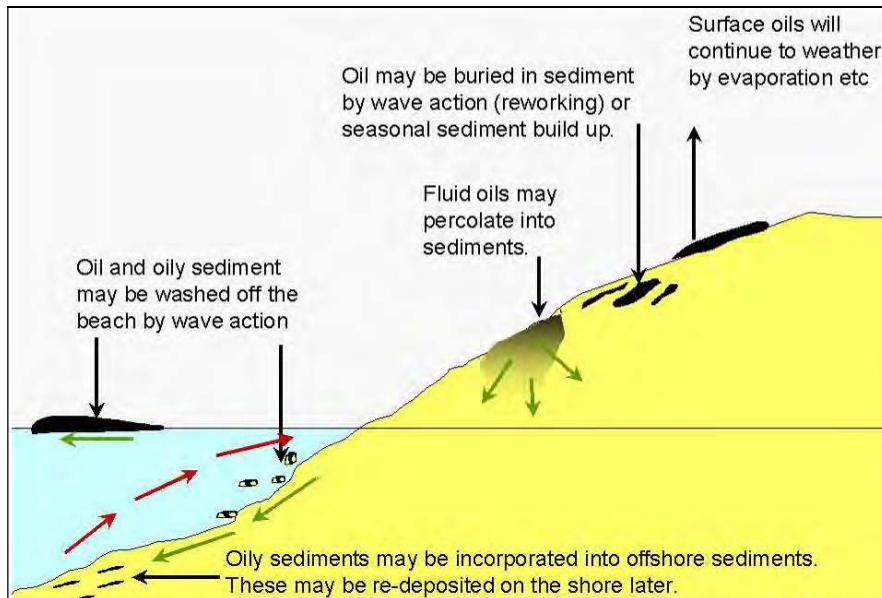
## Behaviour of oil on shorelines

Oil can penetrate deeper into coarse open sediments, but is less likely to adhere to firm fine sands. Light toxic oils can penetrate deep into coarse sandy sediments and can cause high mortality of invertebrates. Heavier oils such as ship bunker fuel may not penetrate so easily, but if they do become incorporated with sediments they can form thick asphalt pavements with very long residence times.

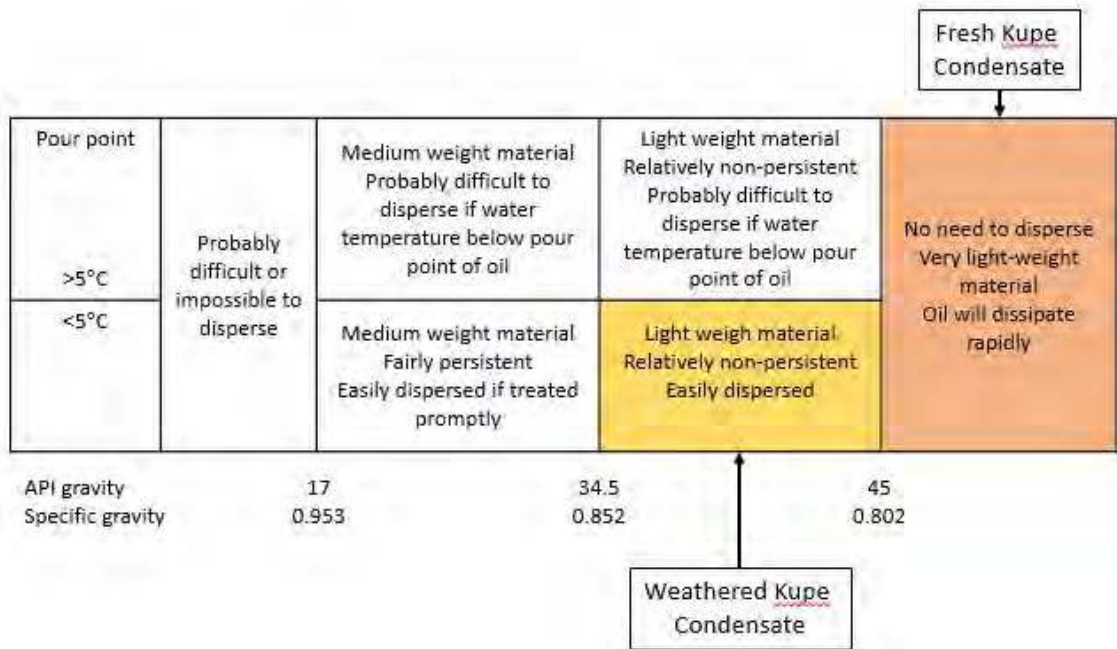
The figure below shows that most recent assay results place unweathered Kupe Condensate within the cell highlighted orange (no need to disperse). Weathered Kupe Condensate is expected to fall within the yellow cell (relatively non-persistent and easy to disperse).

The weathering study conducted on recent Kupe Condensate samples identified that 56% of the spilled condensate would evaporate within 12 hours of release, and 85% would evaporate within 48 hours. The use of chemical dispersants is not recommended as it would transfer condensate components which would otherwise be rapidly lost to evaporation, to the water column instead.

Kupe Condensate would be amenable to chemical dispersion. However, stochastic modelling of a worst feasible case spill from a loss of well control showed that surface slicks would potentially exceed 10 grams per square metre (g/m<sup>2</sup>) (the minimum slick thickness potentially suitable for dispersant application) only within 1 – 2 km of the release point (RPS, 2018).
