Taranaki Regional Estuaries Ecological Vulnerability Assessment

For Taranaki Regional Council

July 2019

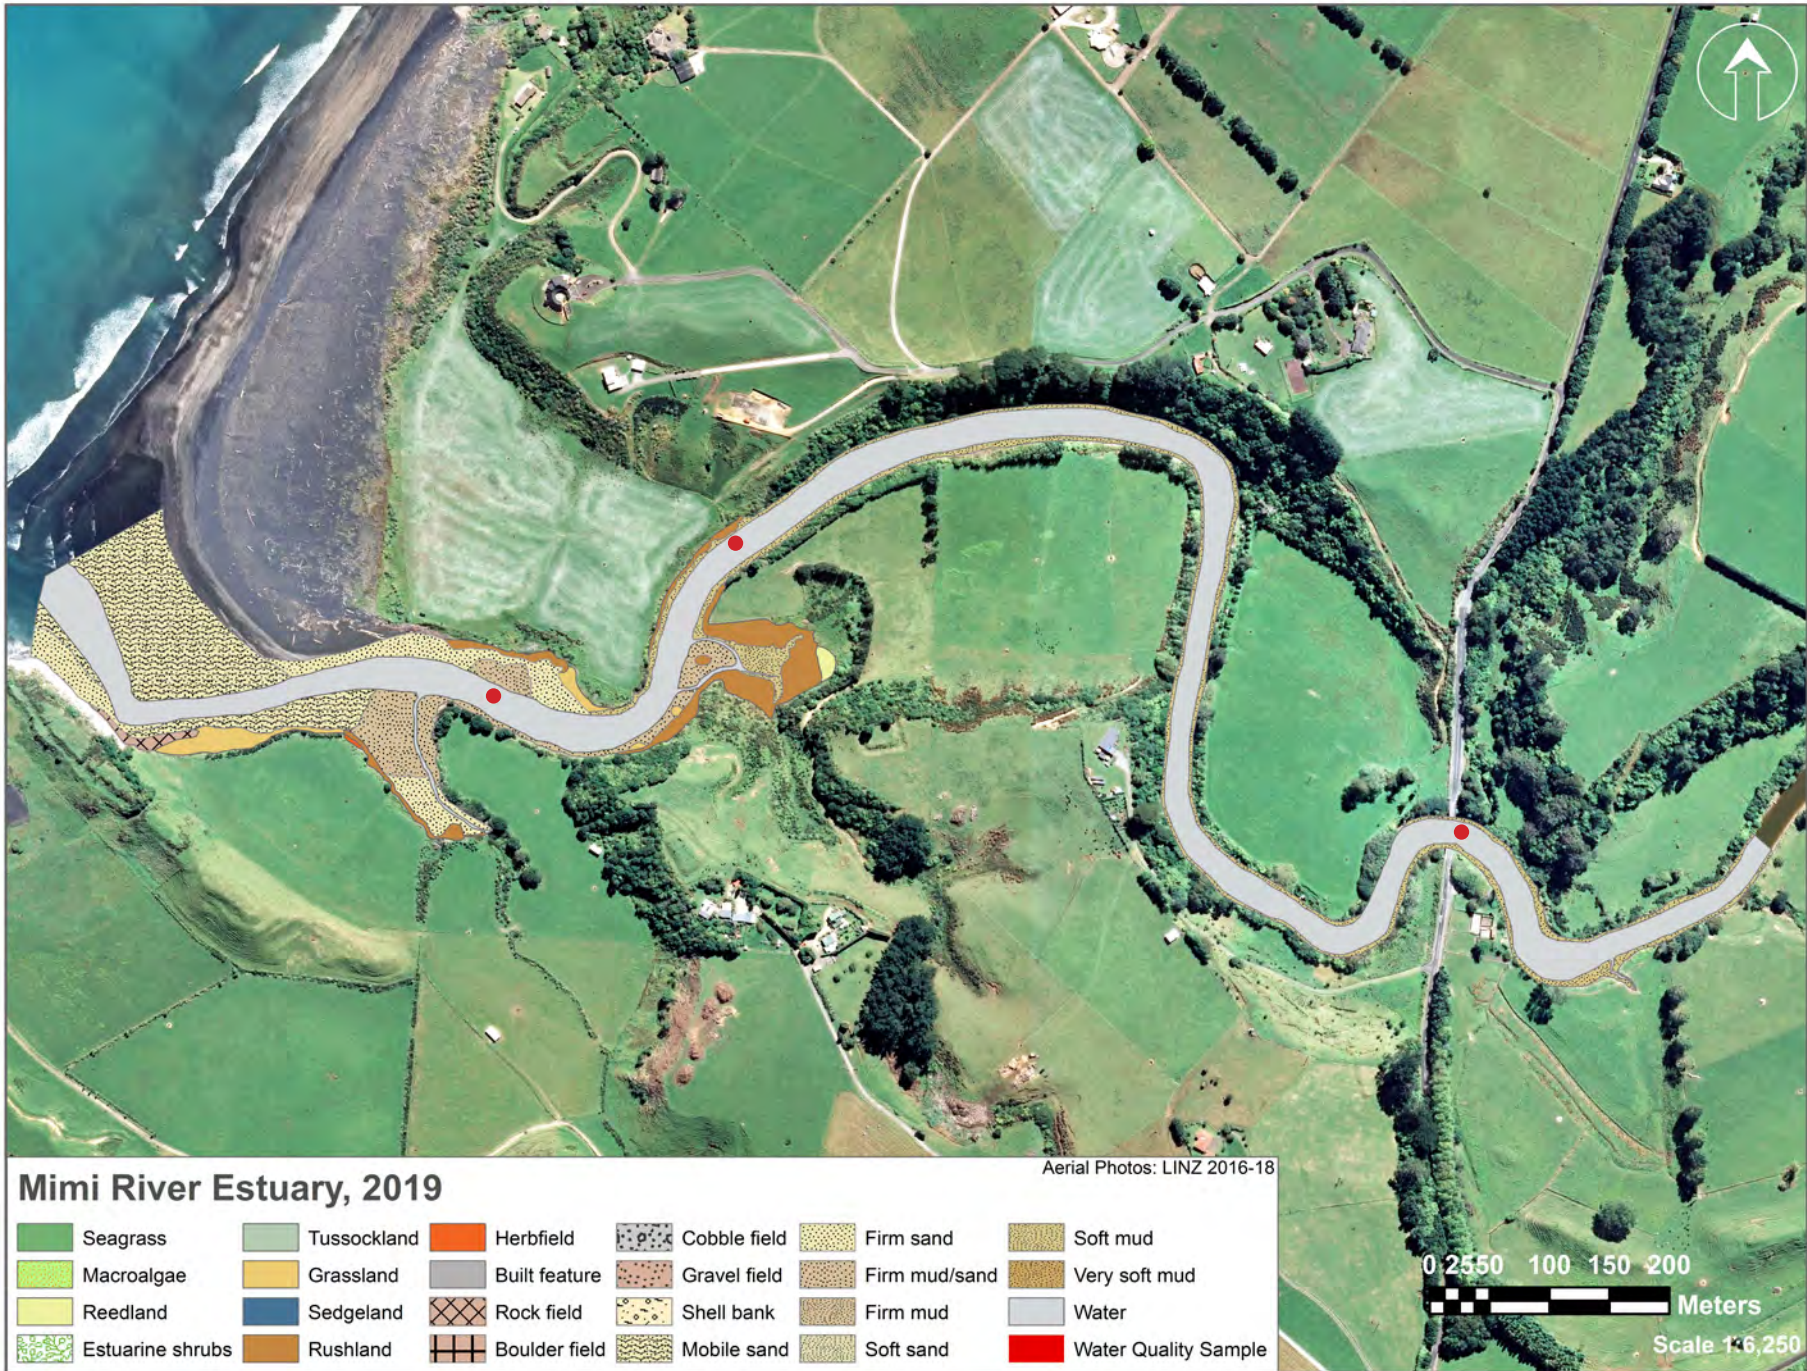
Figure 5. Distribution of intertidal substrata, macrophyte and saltmarsh, and water quality sampling locations, Mimi River Estuary, 2019. Water quality sampling involved assessment of conditions in both surface (0.2 m) and bottom (0.5 m from bottom) waters at each site.

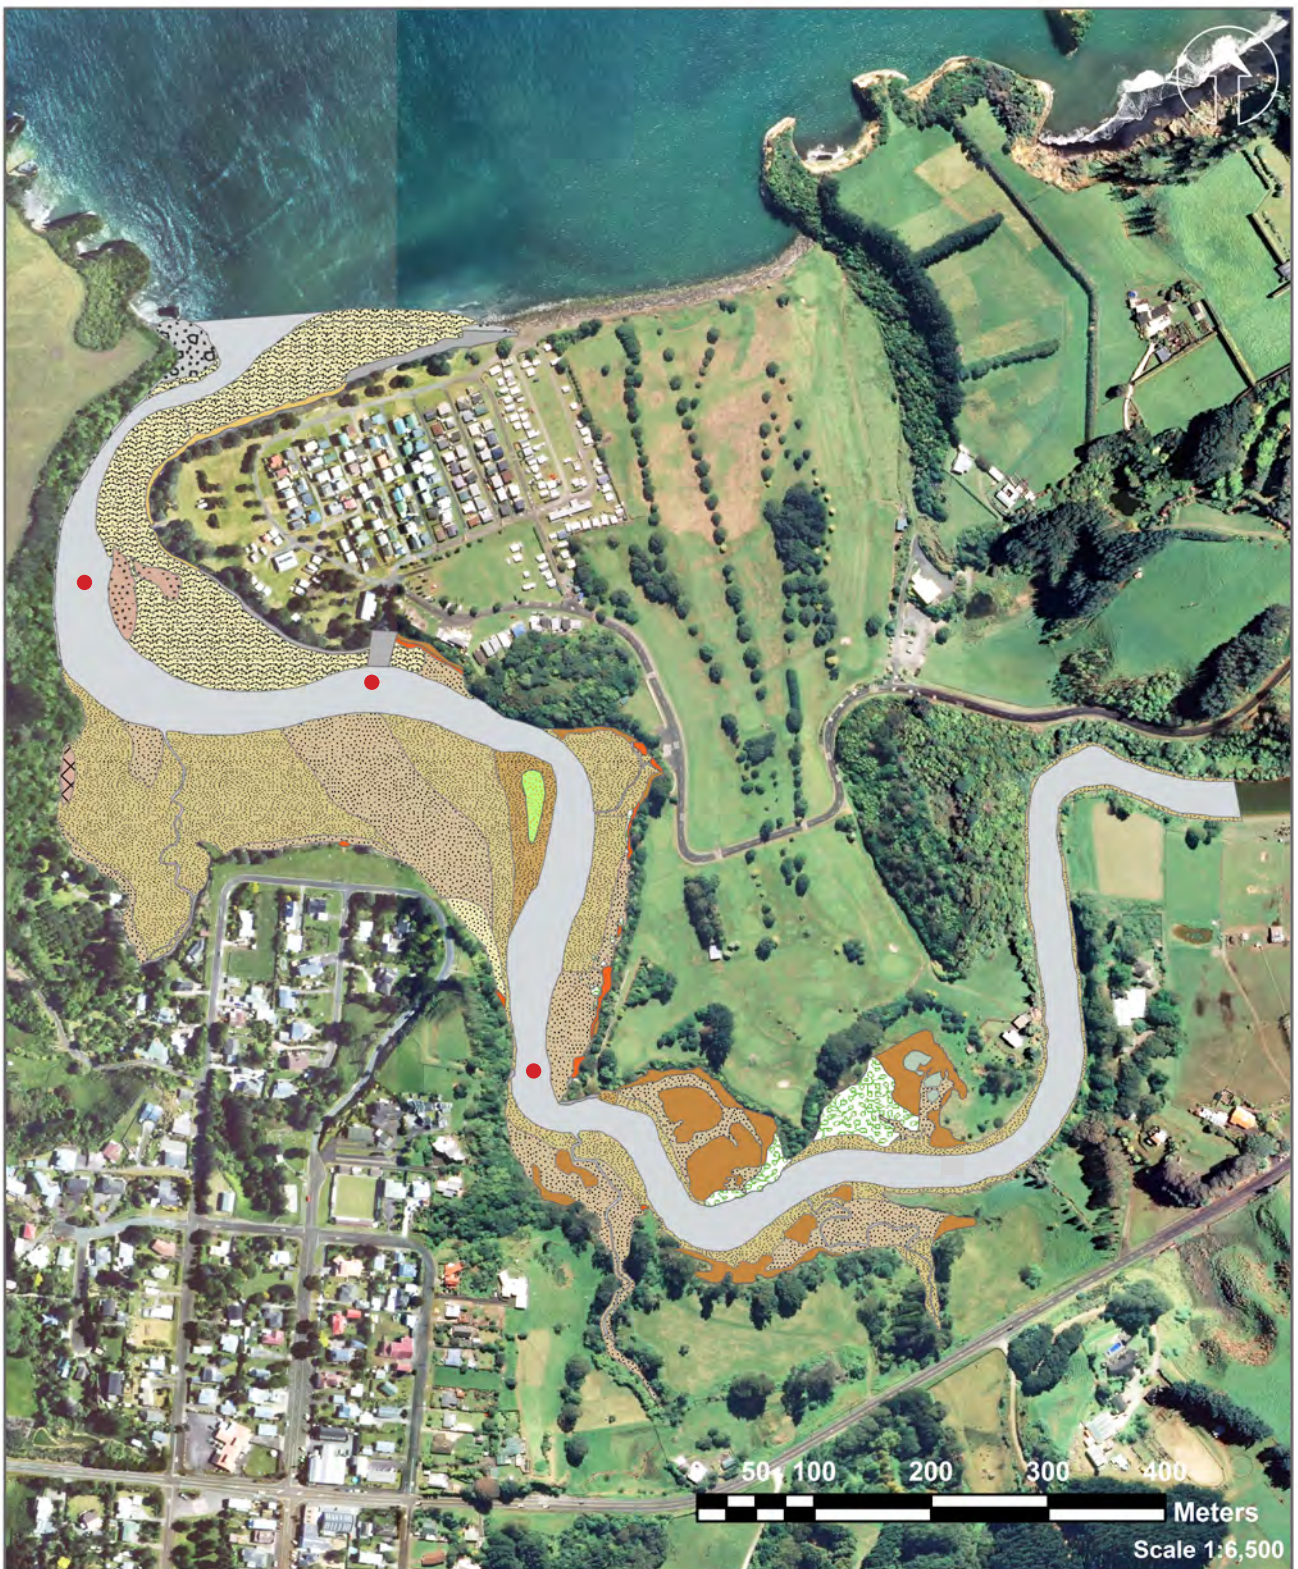
Figure 6. Distribution of intertidal substrata, macrophyte and saltmarsh, and water quality sites, Urenui Estuary, 2019. Water quality sampling involved assessment of conditions in both surface (0.2 m) and bottom (0.5 m from bottom) waters at each site.

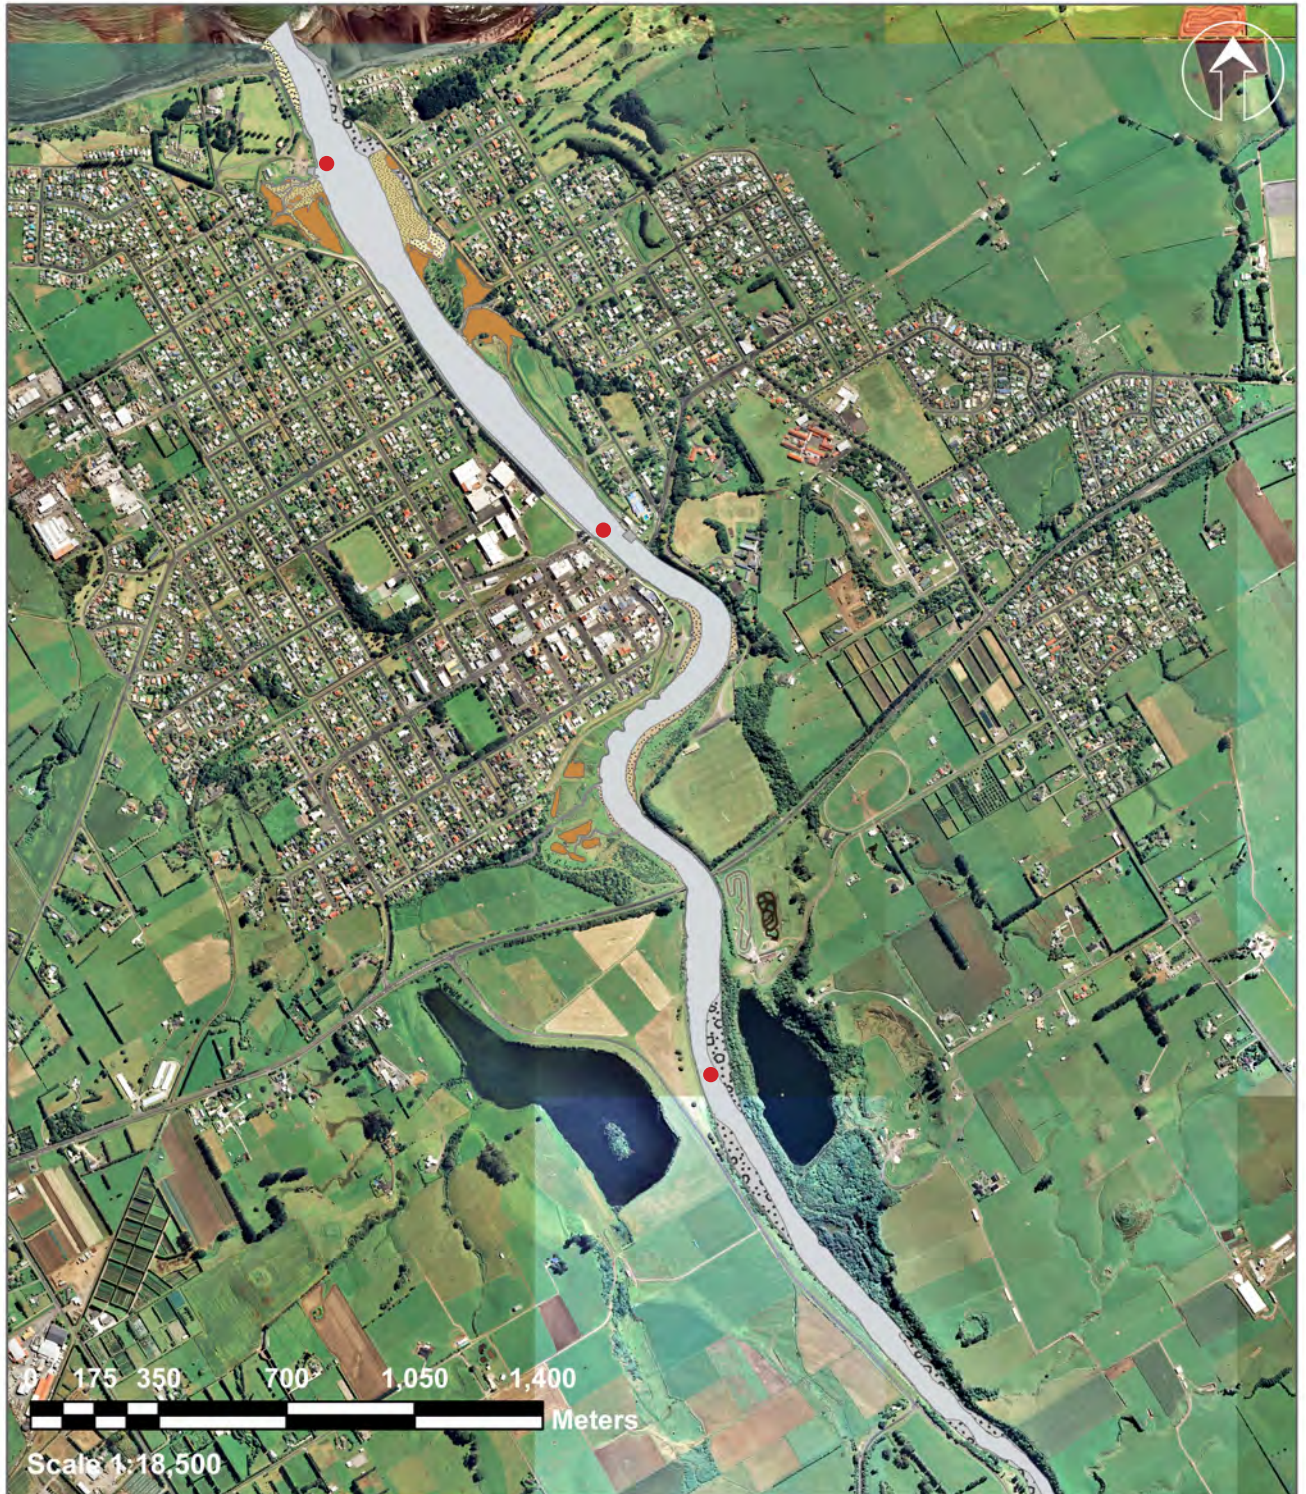
Waitara River Estuary, 2019 Aerial Photos: LINZ 2016-18

Sedimentation (muddiness) status: The estuary is rated as moderate-highly vulnerable to muddiness issues based on the fact that, although the estimated current suspended sediment load (CSSL) is <5 times the estimated natural state SS load (NSSL) and excess sediments are likely to be flushed to the sea during high flows, the catchment is naturally erosion prone (Suspended Sediment Yield map of sediment delivery to rivers and stream [NIWA]) and the synoptic survey showed that the estuary is impacted by muddy sediments in the less well flushed mid-lower (intertidal and subtidal) reaches. Ecologically, the overall high proportion of muds in 2019, possibly a result of recent flood activity, fits the NZ ETI Band D (very high) condition rating.

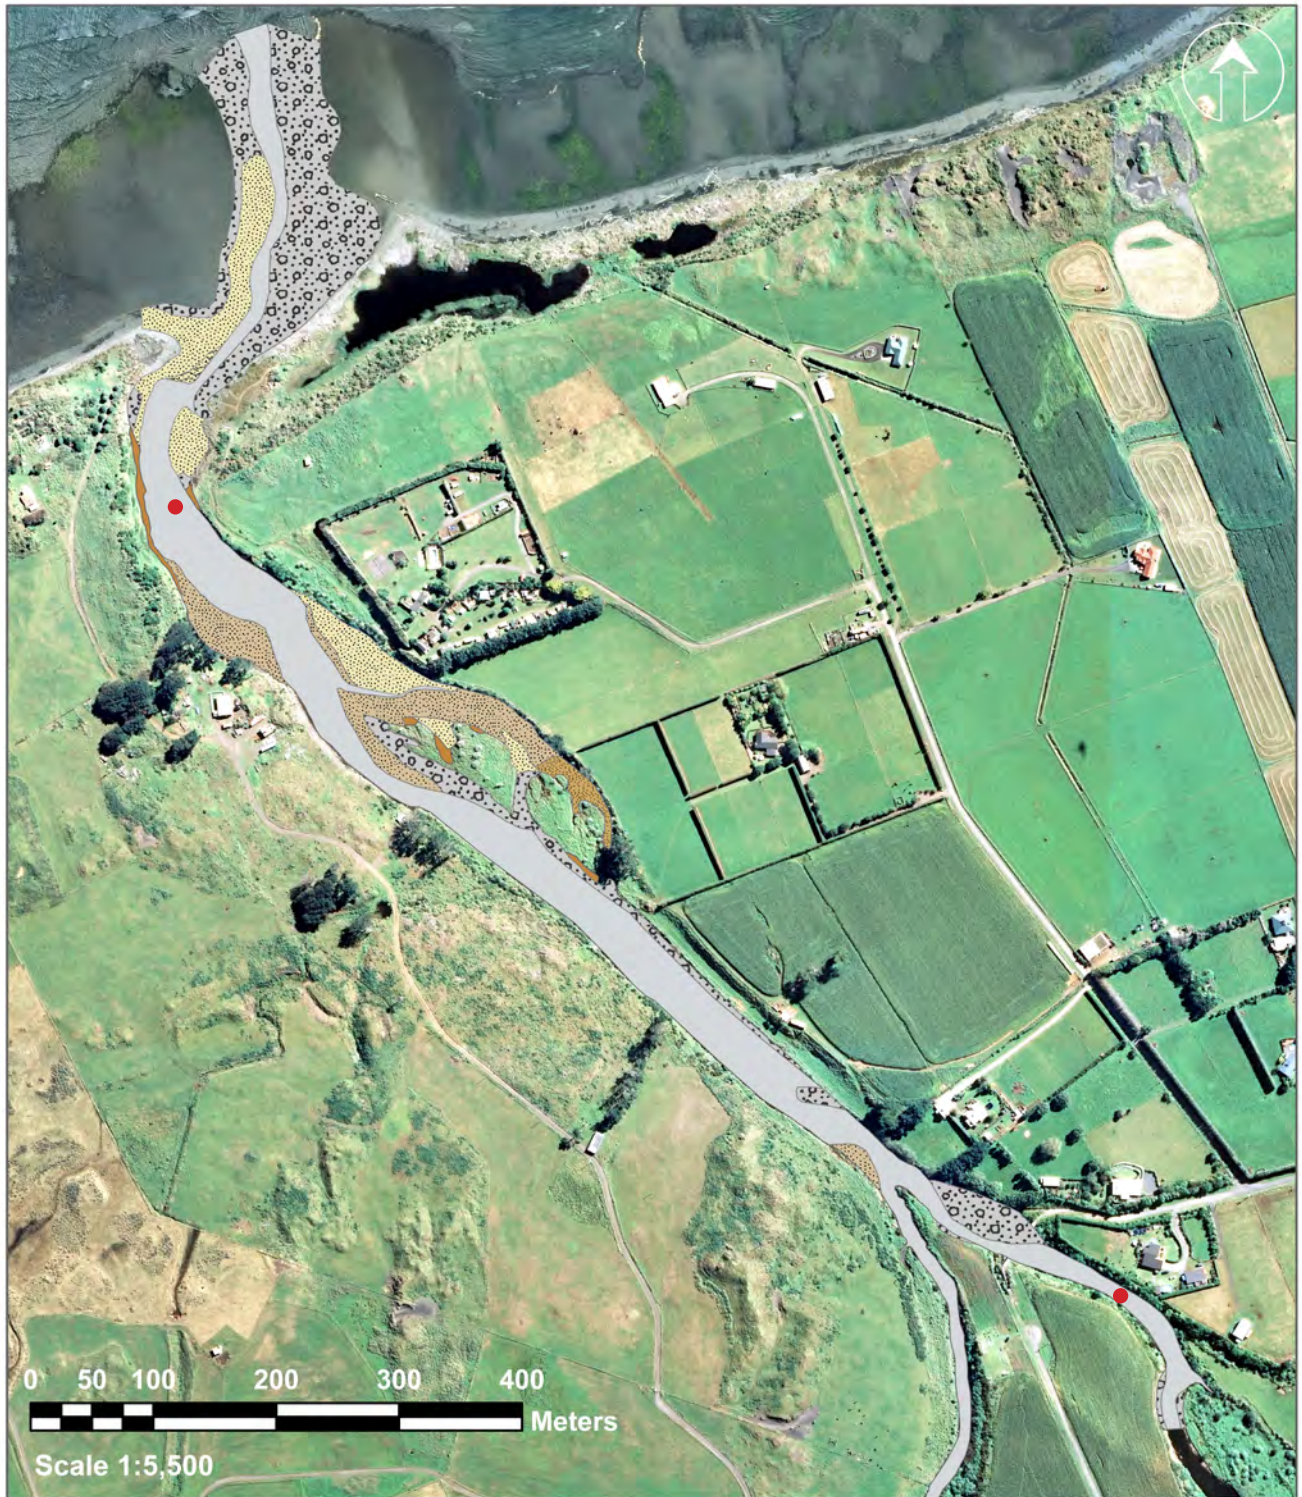
Waiongana River Estuary, 2019

Sedimentation (muddiness) status: The estuary has moderate vulnerability to muddiness issues based on the facts that the current suspended sediment load (CSSL) is <5 times the estimated natural state SS load (NSSL), the estuary is dominated by sands, but the mouth may be occasionally restricted. Ecologically, the overall moderate mud content fits the NZ ETI Band B (moderate muddiness) condition rating.

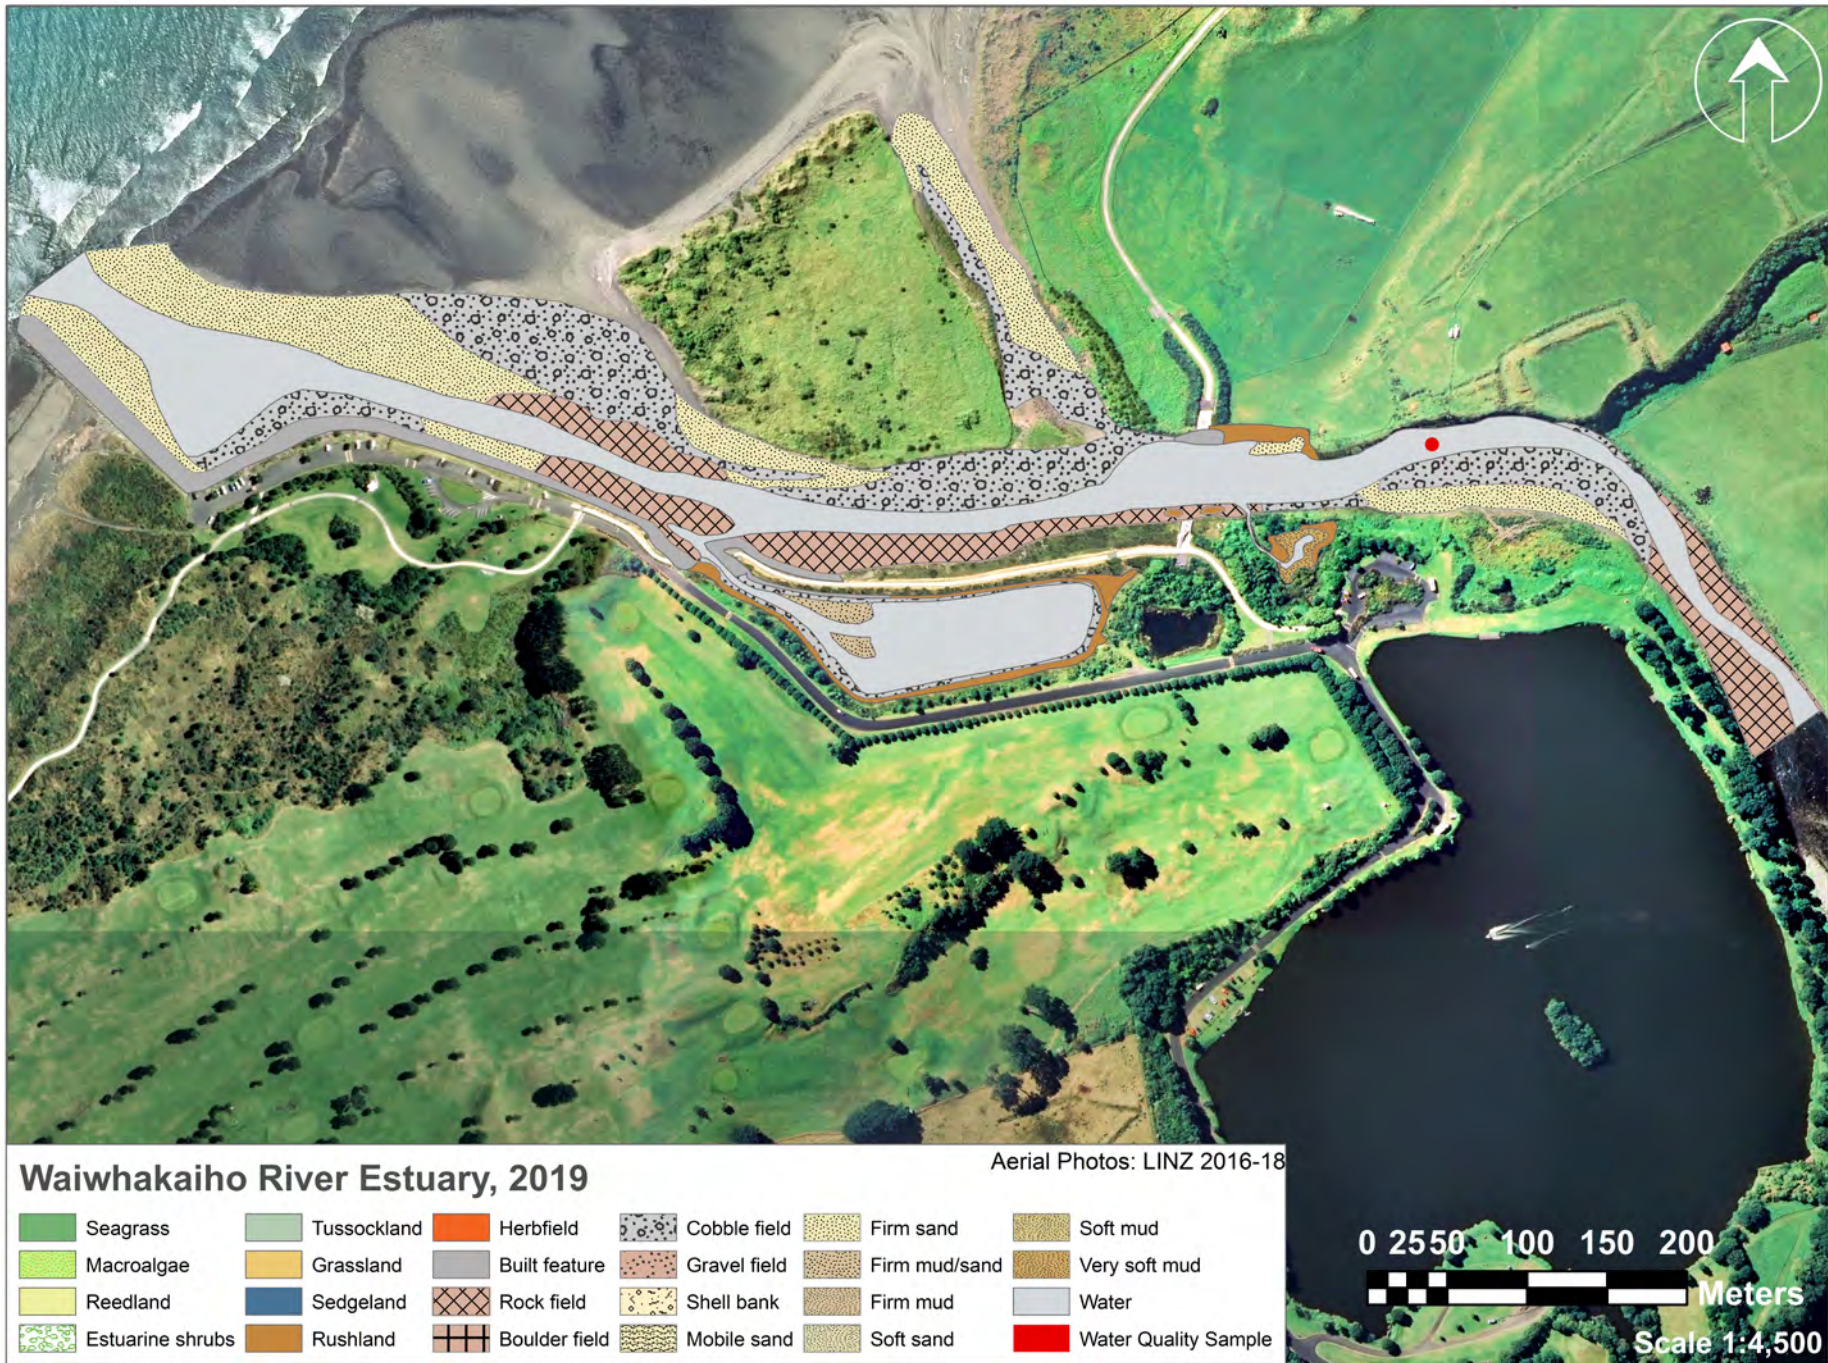
Figure 10. Distribution of intertidal substrata, macrophyte and saltmarsh, and water quality sampling locations, Waiwhakaiho River Estuary, 2019. Water quality sampling involved assessment of conditions in both surface (0.2m) and bottom (0.5m from bottom) waters at each site.

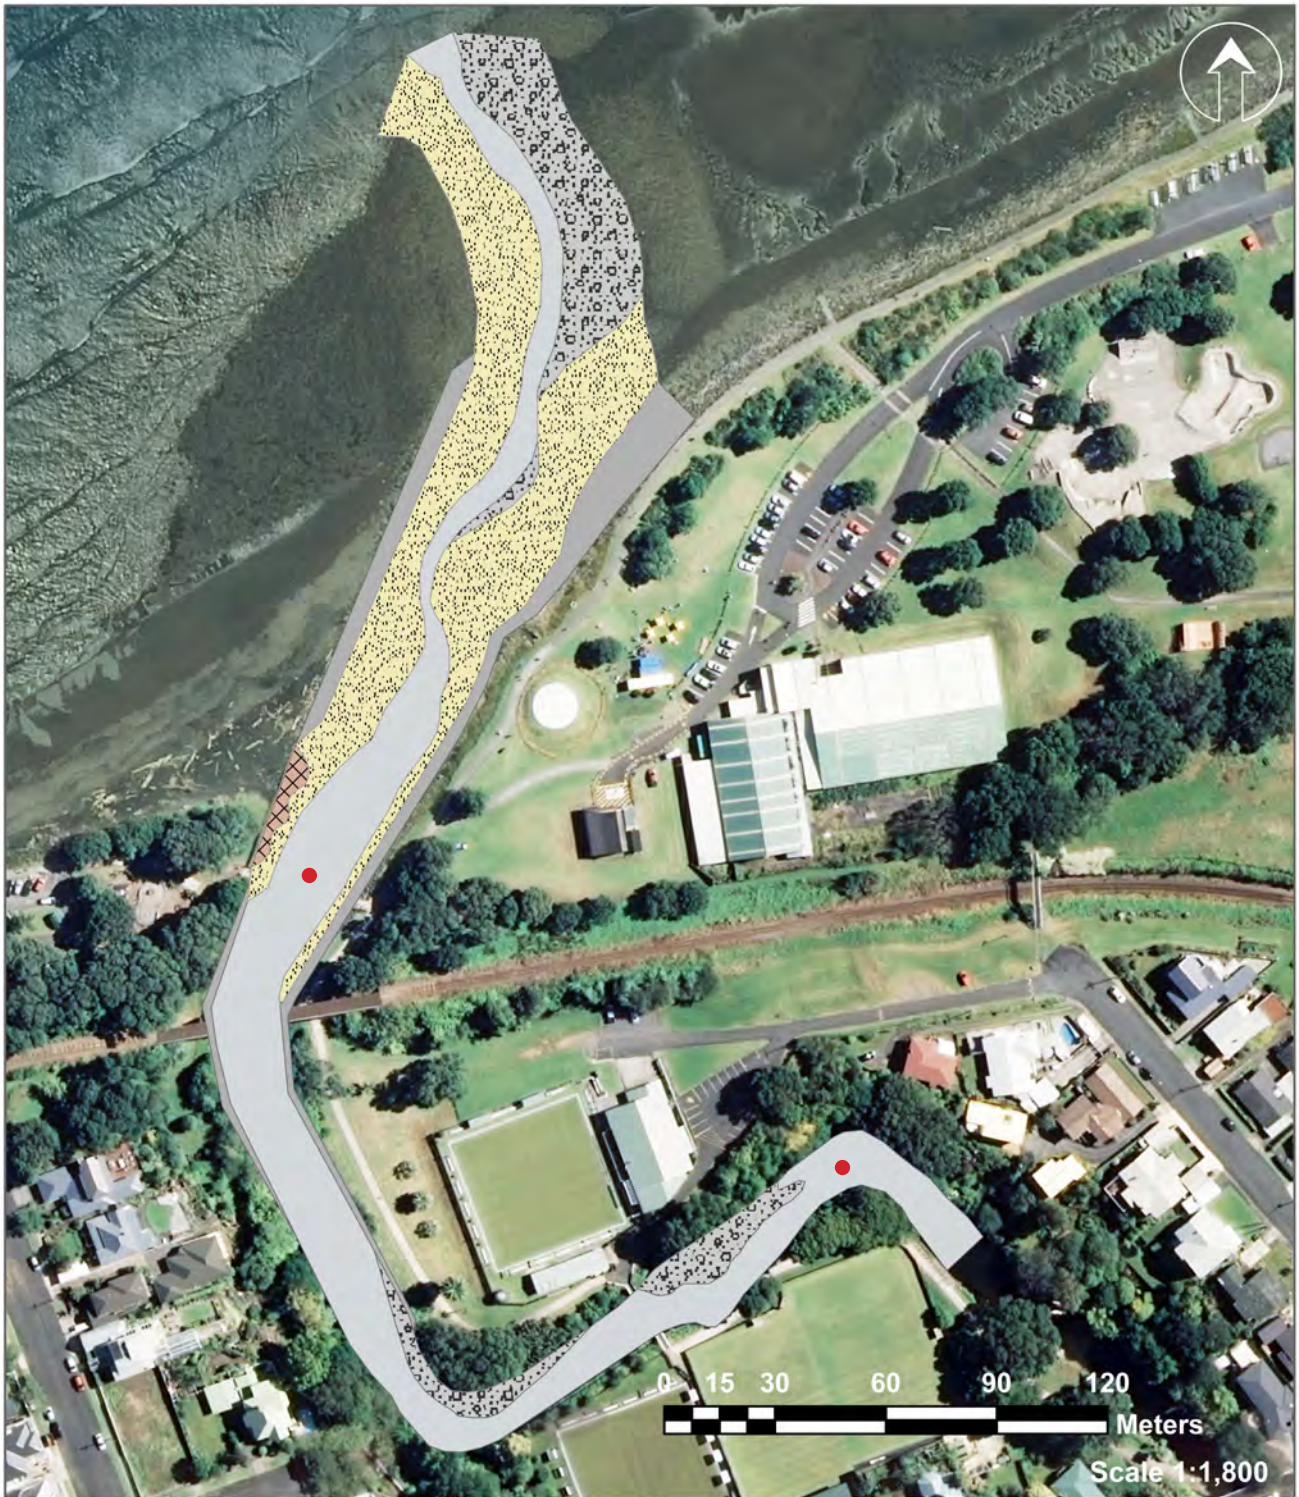
Te Henui River Estuary, 2019

Sedimentation (muddiness) status: The estuary has moderate vulnerability to muddiness issues based on the facts that the current suspended sediment load (CSSL) is <5 times the estimated natural state SS load (NSSL), the estuary is dominated by intertidal sands, but with some subtidal muds, and the mouth may be occasionally restricted. Ecologically, the overall moderate mud content fits the NZ ETI Band B (moderate muddiness) condition rating.

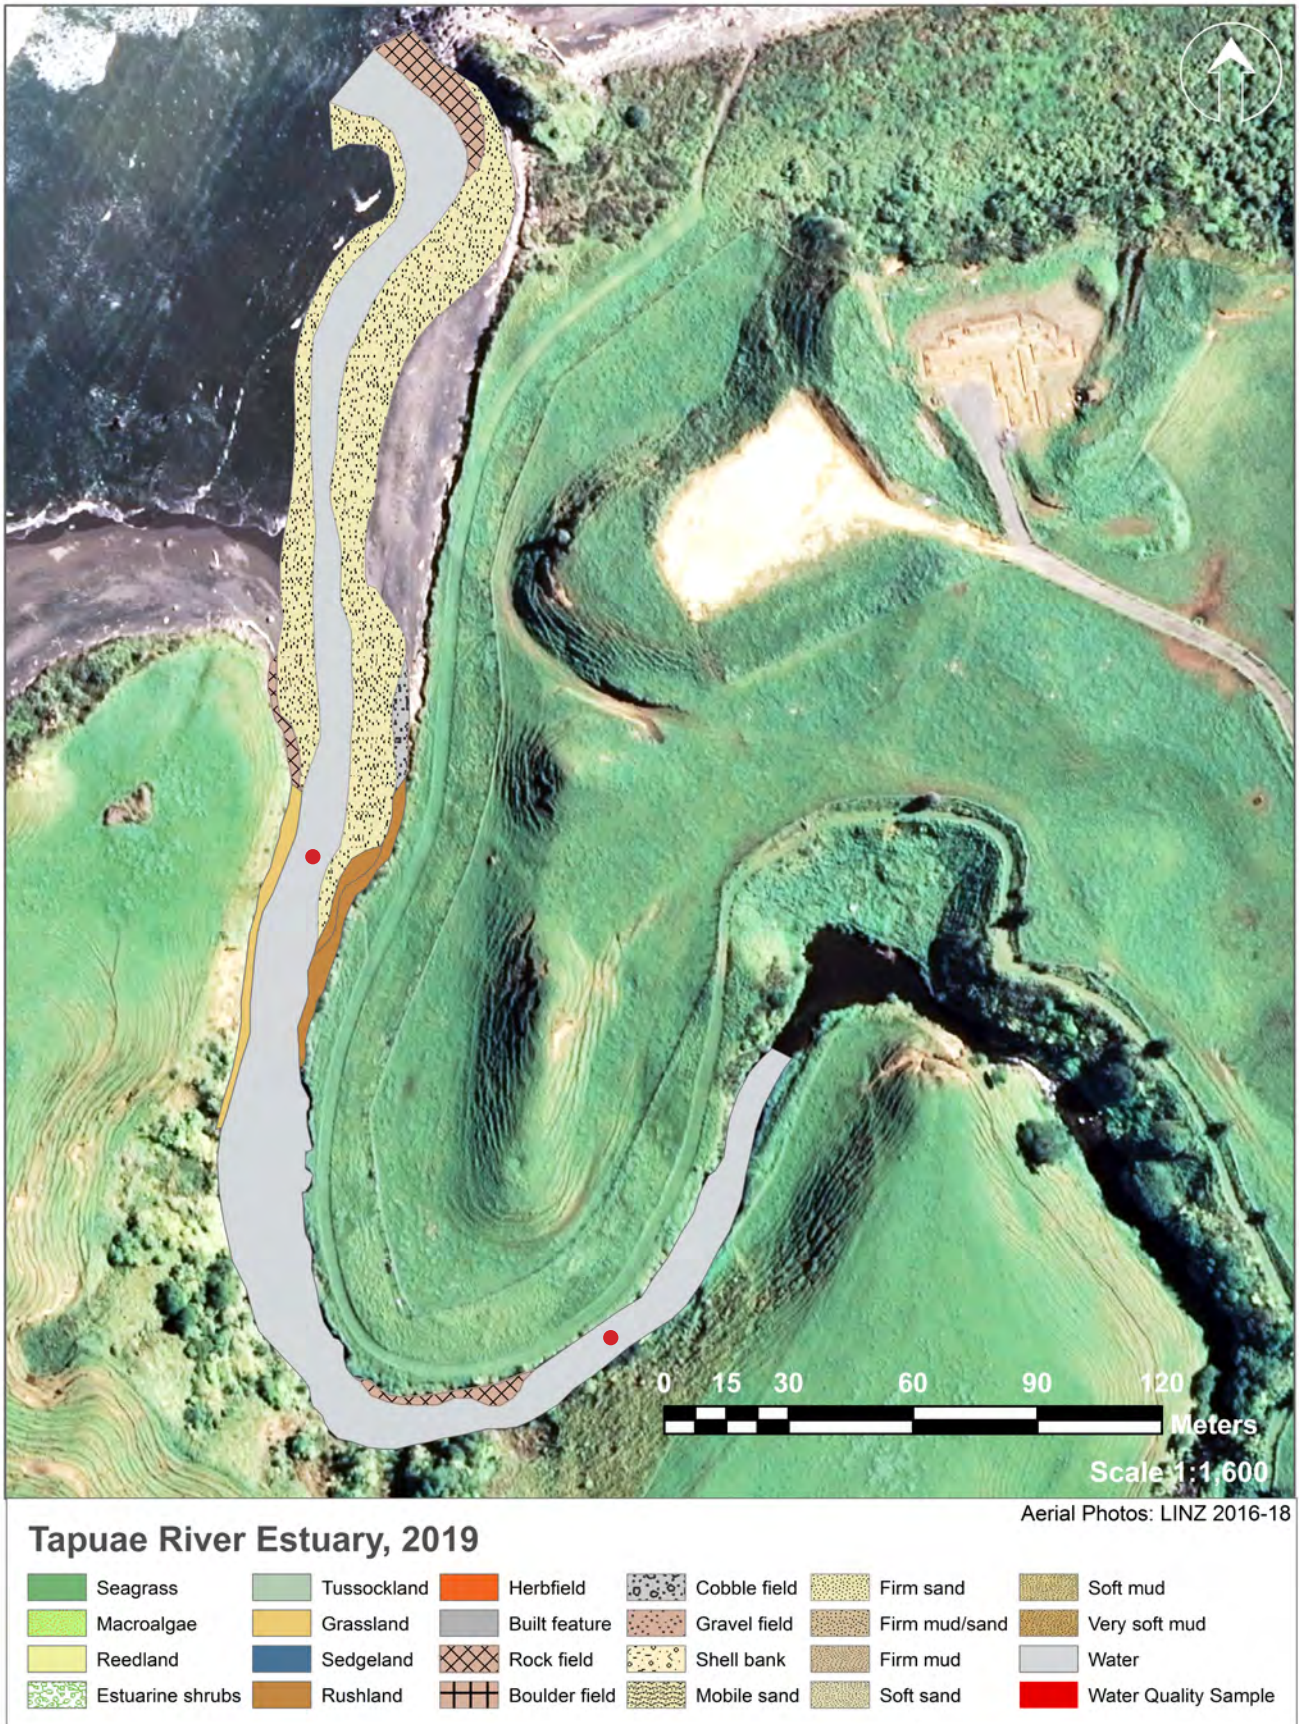
Figure 12. Distribution of intertidal substrata, macrophyte and saltmarsh, and water quality sites, Tapuae Estuary, 2019. Water quality sampling involved assessment of conditions in both surface (0.2 m) and bottom (0.5 m from bottom) waters at each site.

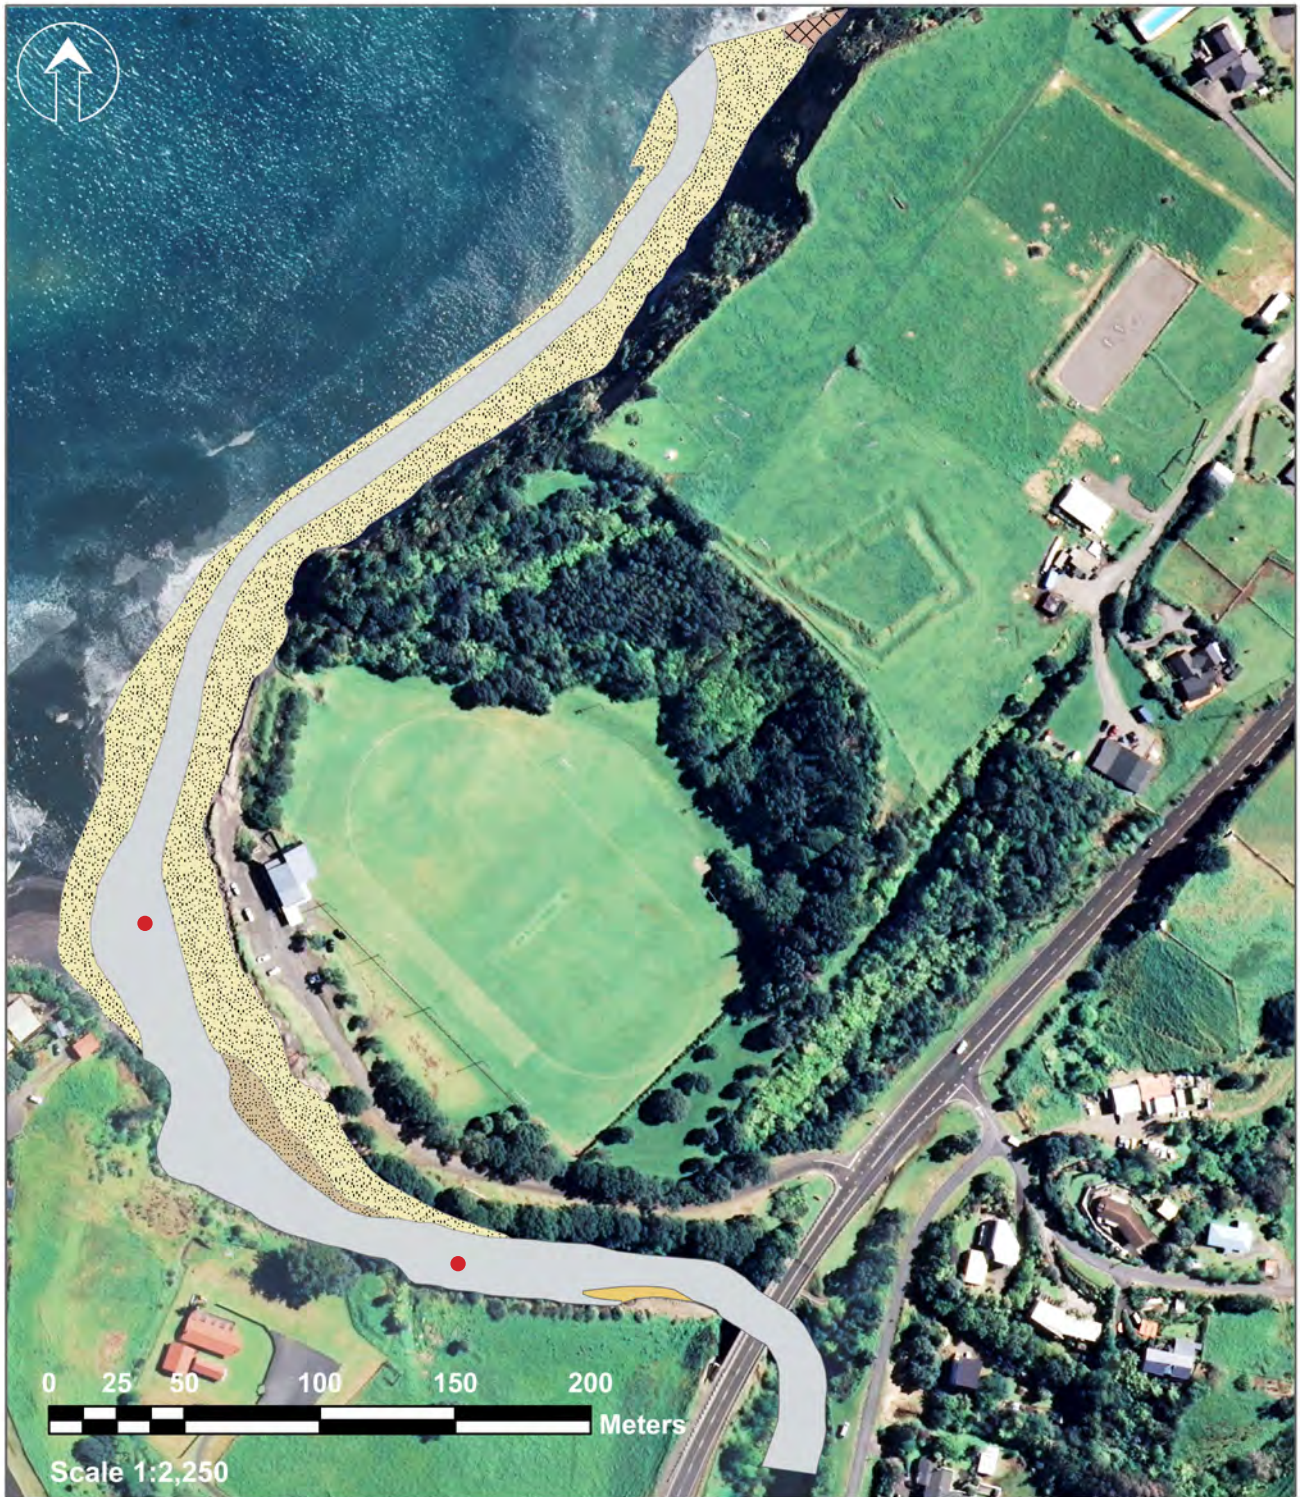
Oakura River Estuary, 2019

Sedimentation (muddiness) status: The estuary has moderate vulnerability to muddiness issues based on the facts that the current suspended sediment load (CSSL) is <5 times the estimated natural state SS load (NSSL), the estuary is dominated by sands, but the mouth may be occasionally restricted. Ecologically, the overall moderate mud extent fits the NZ ETI Band B (moderate muddiness) condition rating.

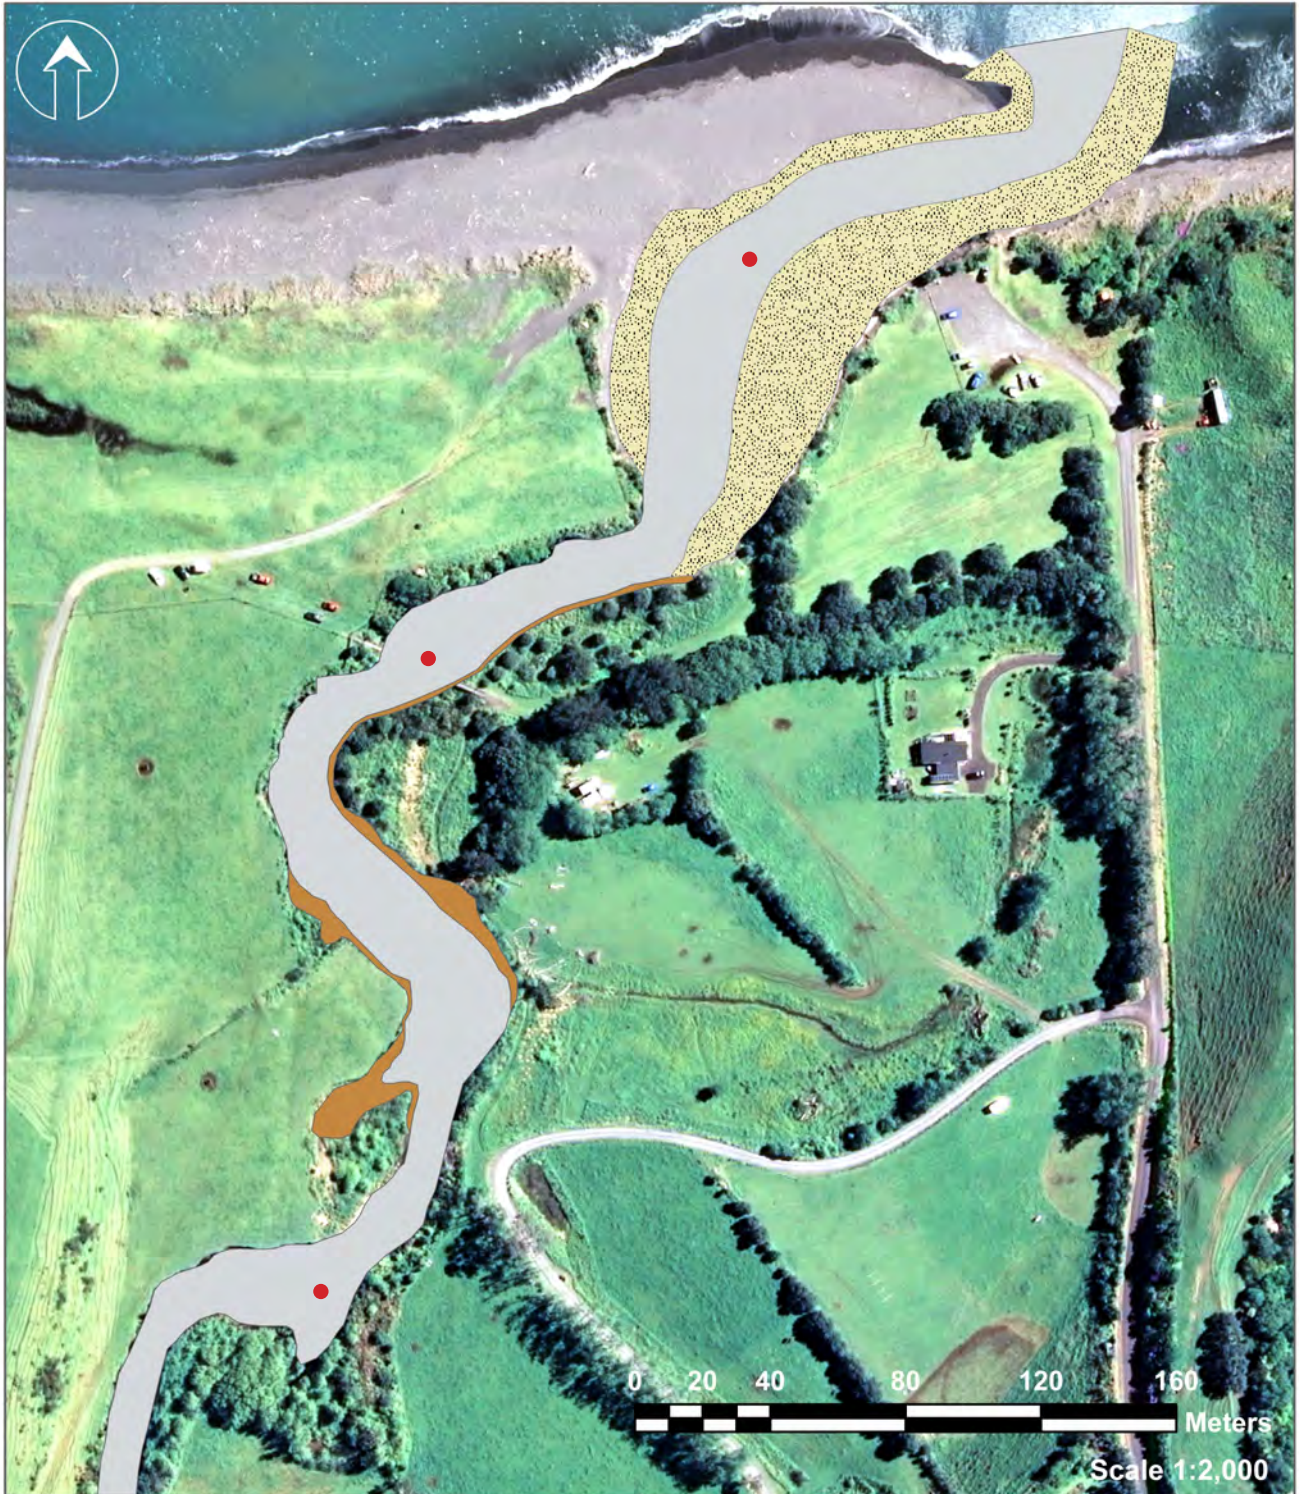
Timaru River Estuary, 2019

Sedimentation (muddiness) status: The estuary has moderate vulnerability to muddiness issues based on the facts that the current suspended sediment load (CSSL) is <5 times the estimated natural state SS load (NSSL), the estuary is dominated by intertidal sands and subtidal muds, but the mouth may be occasionally restricted. Ecologically, the overall moderate mud content fits the NZ ETI Band B (moderate muddiness) condition rating.

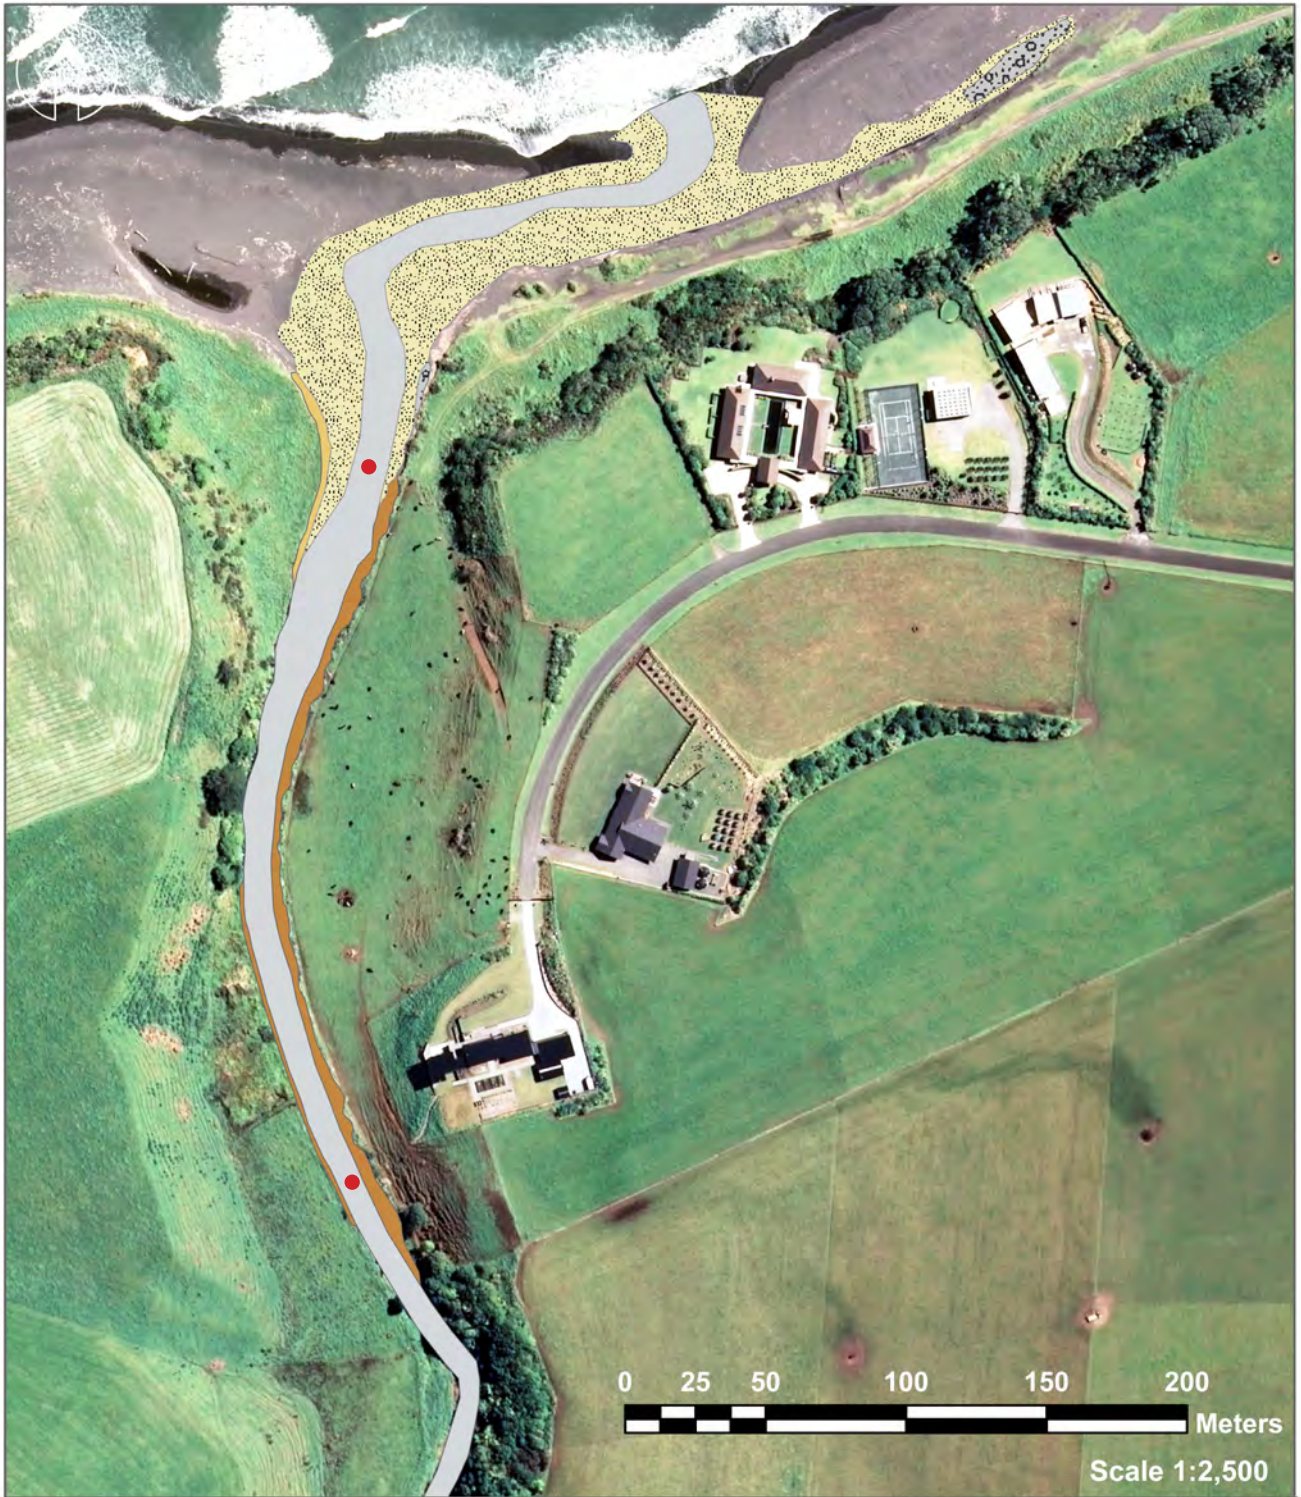
Katikara River Estuary, 2019

Sedimentation (muddiness) status: The estuary has very minimal vulnerability to muddiness issues based on the facts that the current suspended sediment load (CSSL) is <5 times the estimated natural state SS load (NSSL), the intertidal estuary is dominated by sands, but with some subtidal muds, and the mouth may be occasionally restricted. Ecologically, the overall moderate mud content fits the NZ ETI Band B (moderate muddiness) condition rating.
