Taranaki Regional Estuaries Ecological Vulnerability Assessment

For Taranaki Regional Council

July 2019

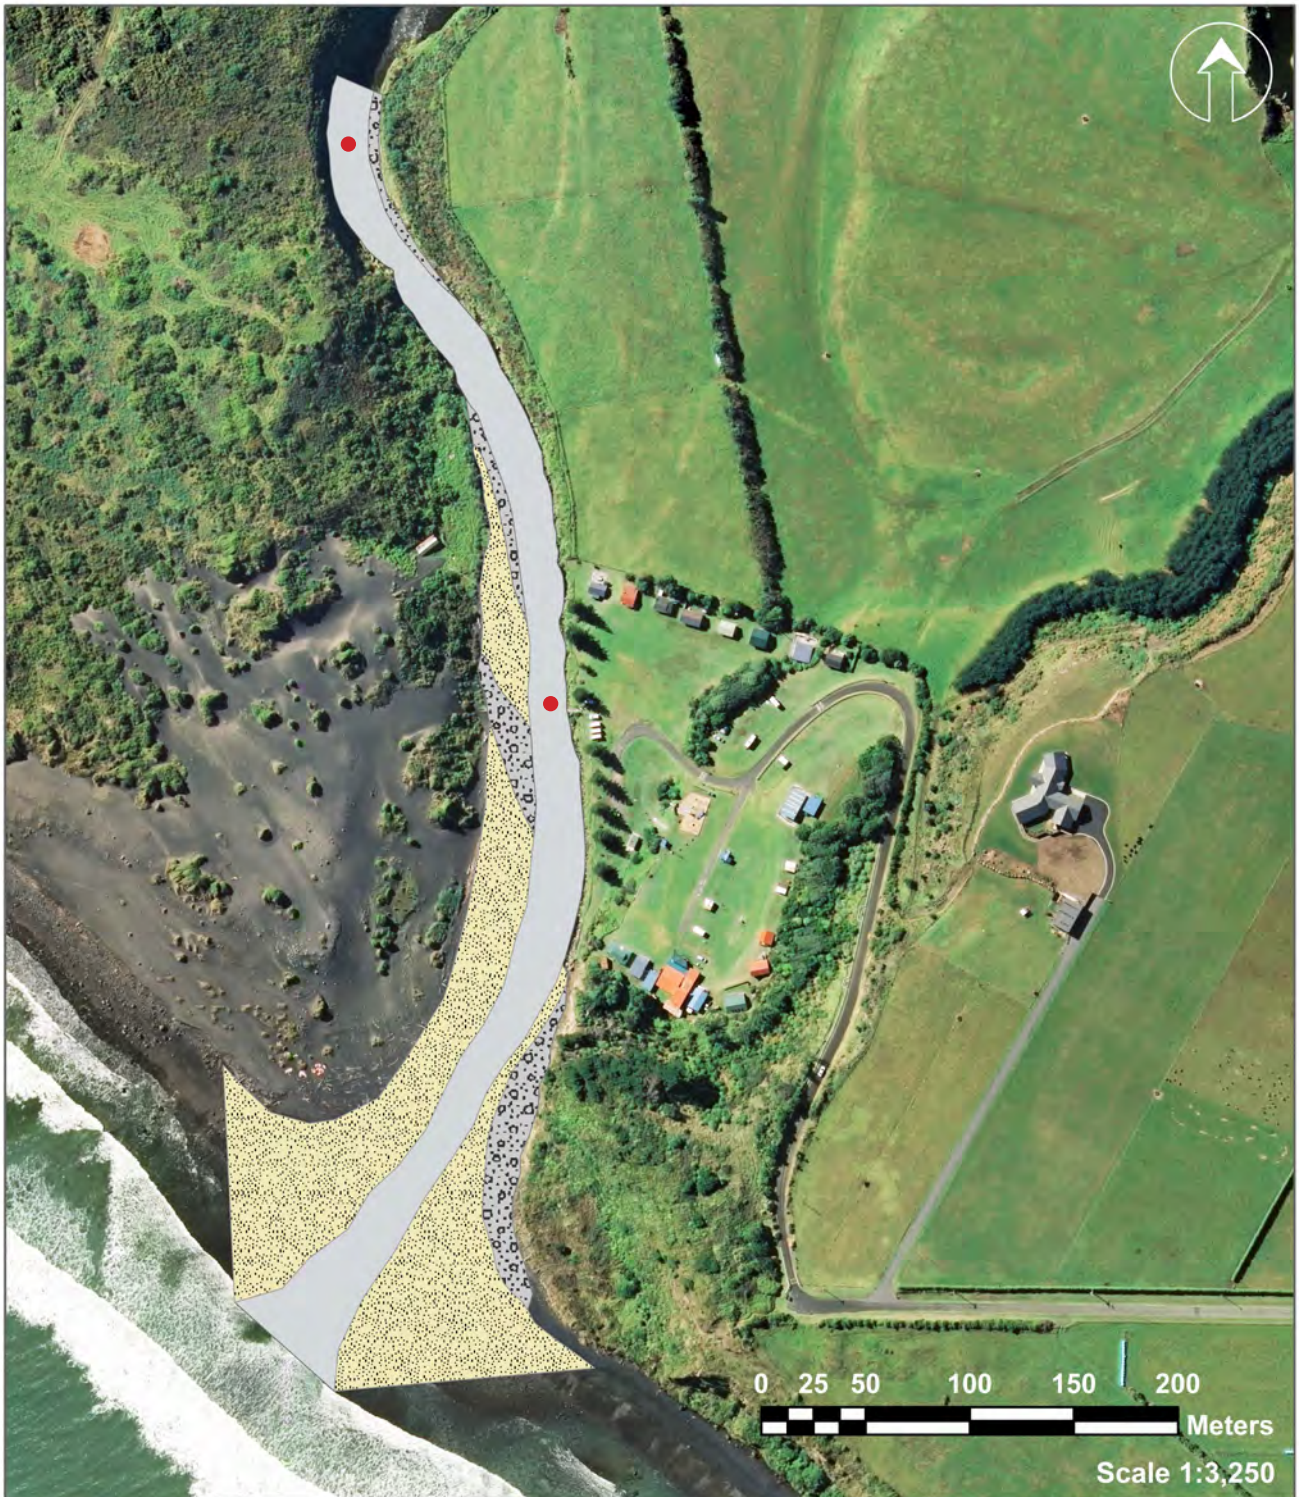
Kaipokonui River Estuary, 2019

Sedimentation (muddiness) status: The estuary has moderate vulnerability to muddiness issues based on the facts that the current suspended sediment load (CSSL) is <5 times the estimated natural state SS load (NSSL), the estuary is dominated by cobble/sand, but the mouth may be occasionally restricted. Ecologically, the overall moderate mud extent fits the NZ ETI Band B (moderate muddiness) condition rating.

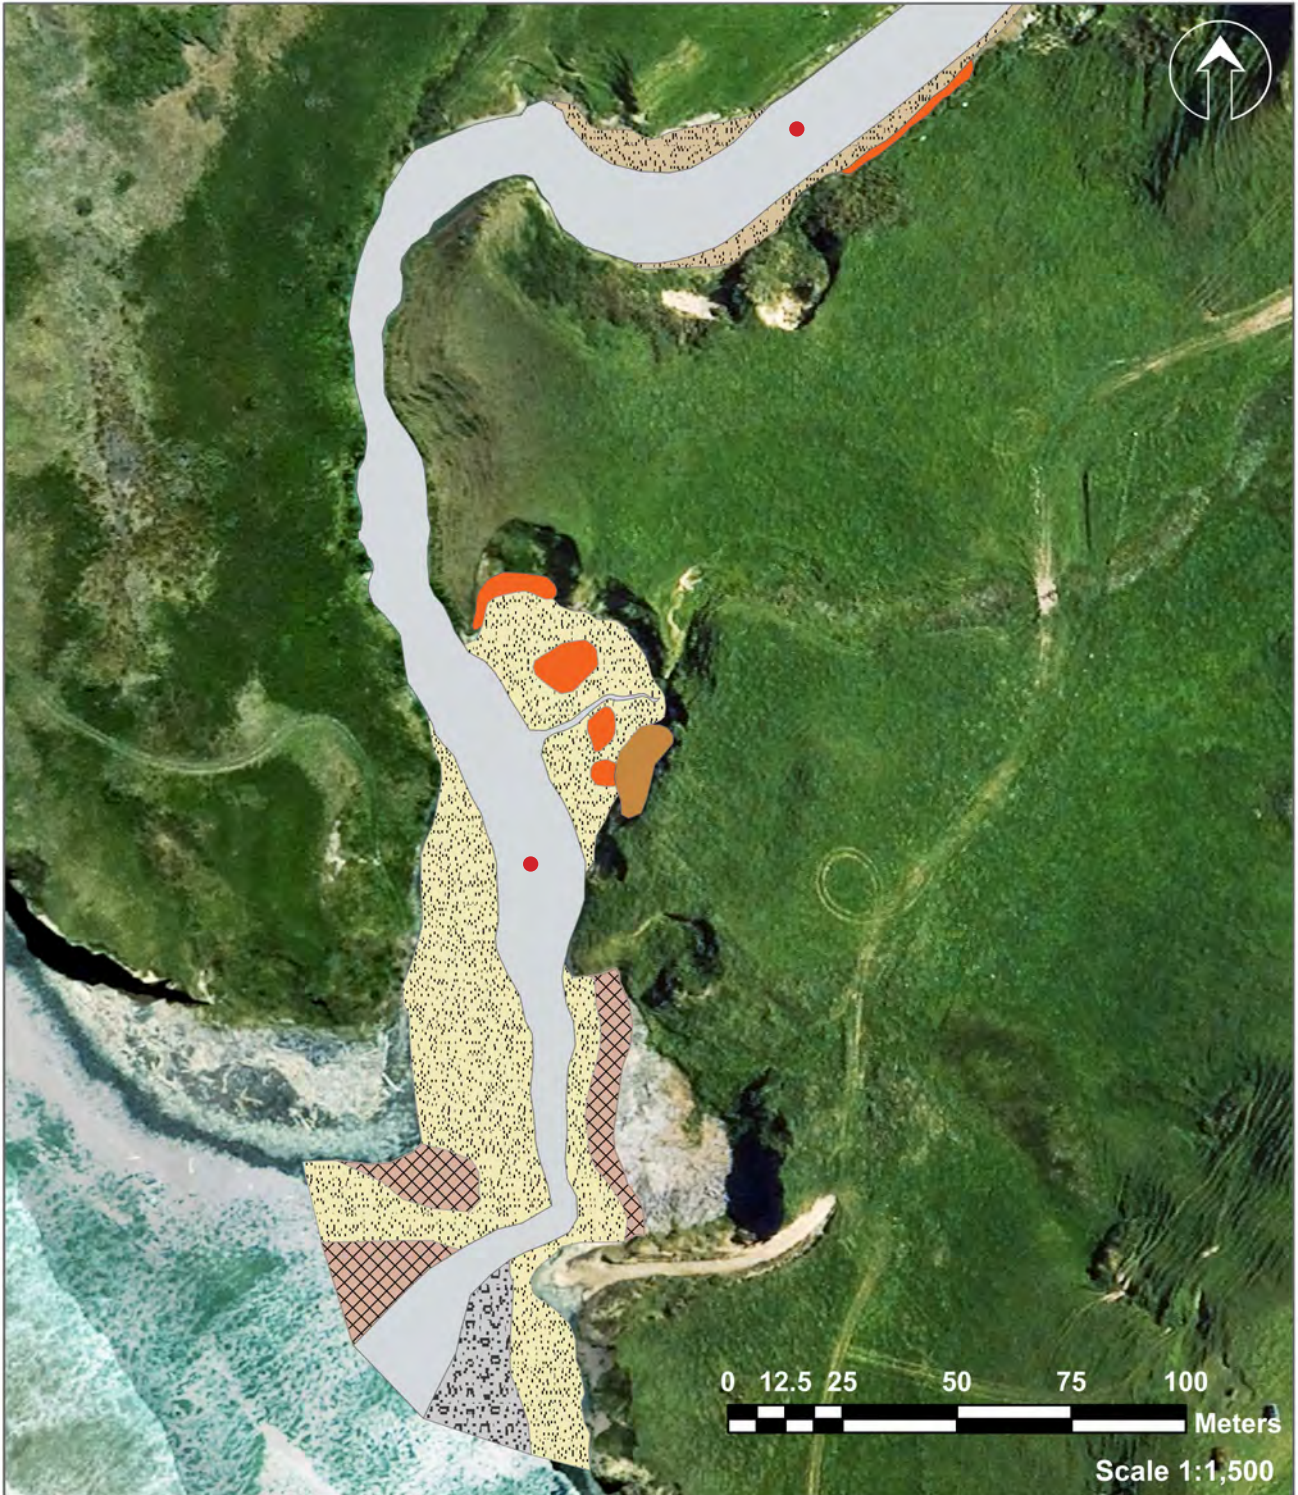
Tangahoe River Estuary, 2019

Sedimentation (muddiness) status: The estuary has moderate vulnerability to muddiness issues based on the facts that the current suspended sediment load (CSSL) is <5 times the estimated natural state SS load (NSSL), the estuary is dominated by sands, but with some subtidal muds, and the mouth may be occasionally restricted. Ecologically, the overall moderate mud extent fits the NZ ETI Band A (moderate muddiness) condition rating.

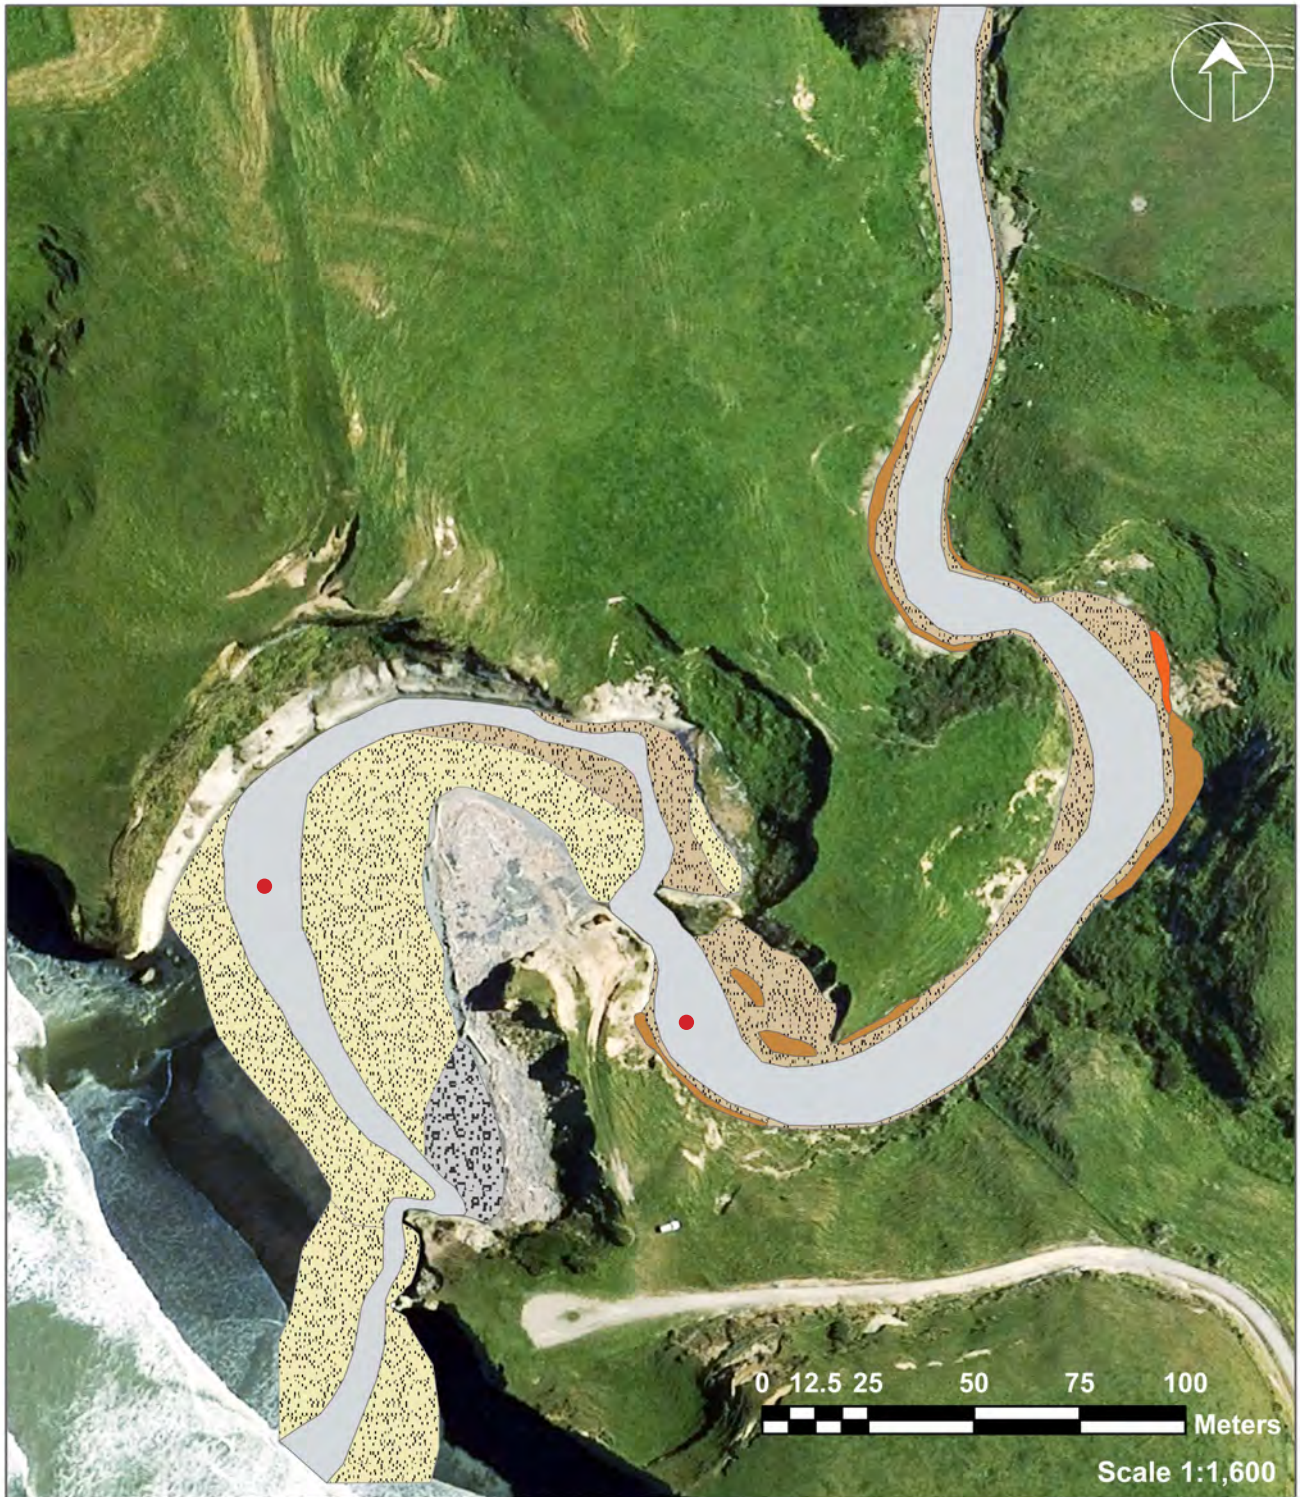
Manawapou River Estuary, 2019

Sedimentation (muddiness) status: The estuary has moderate vulnerability to muddiness issues based on the facts that the current suspended sediment load (CSSL) is <5 times the estimated natural state SS load (NSSL), the estuary is dominated by sands, but the mouth may be occasionally restricted. Ecologically, the overall moderate mud extent fits the NZ ETI Band B (moderate muddiness) condition rating.

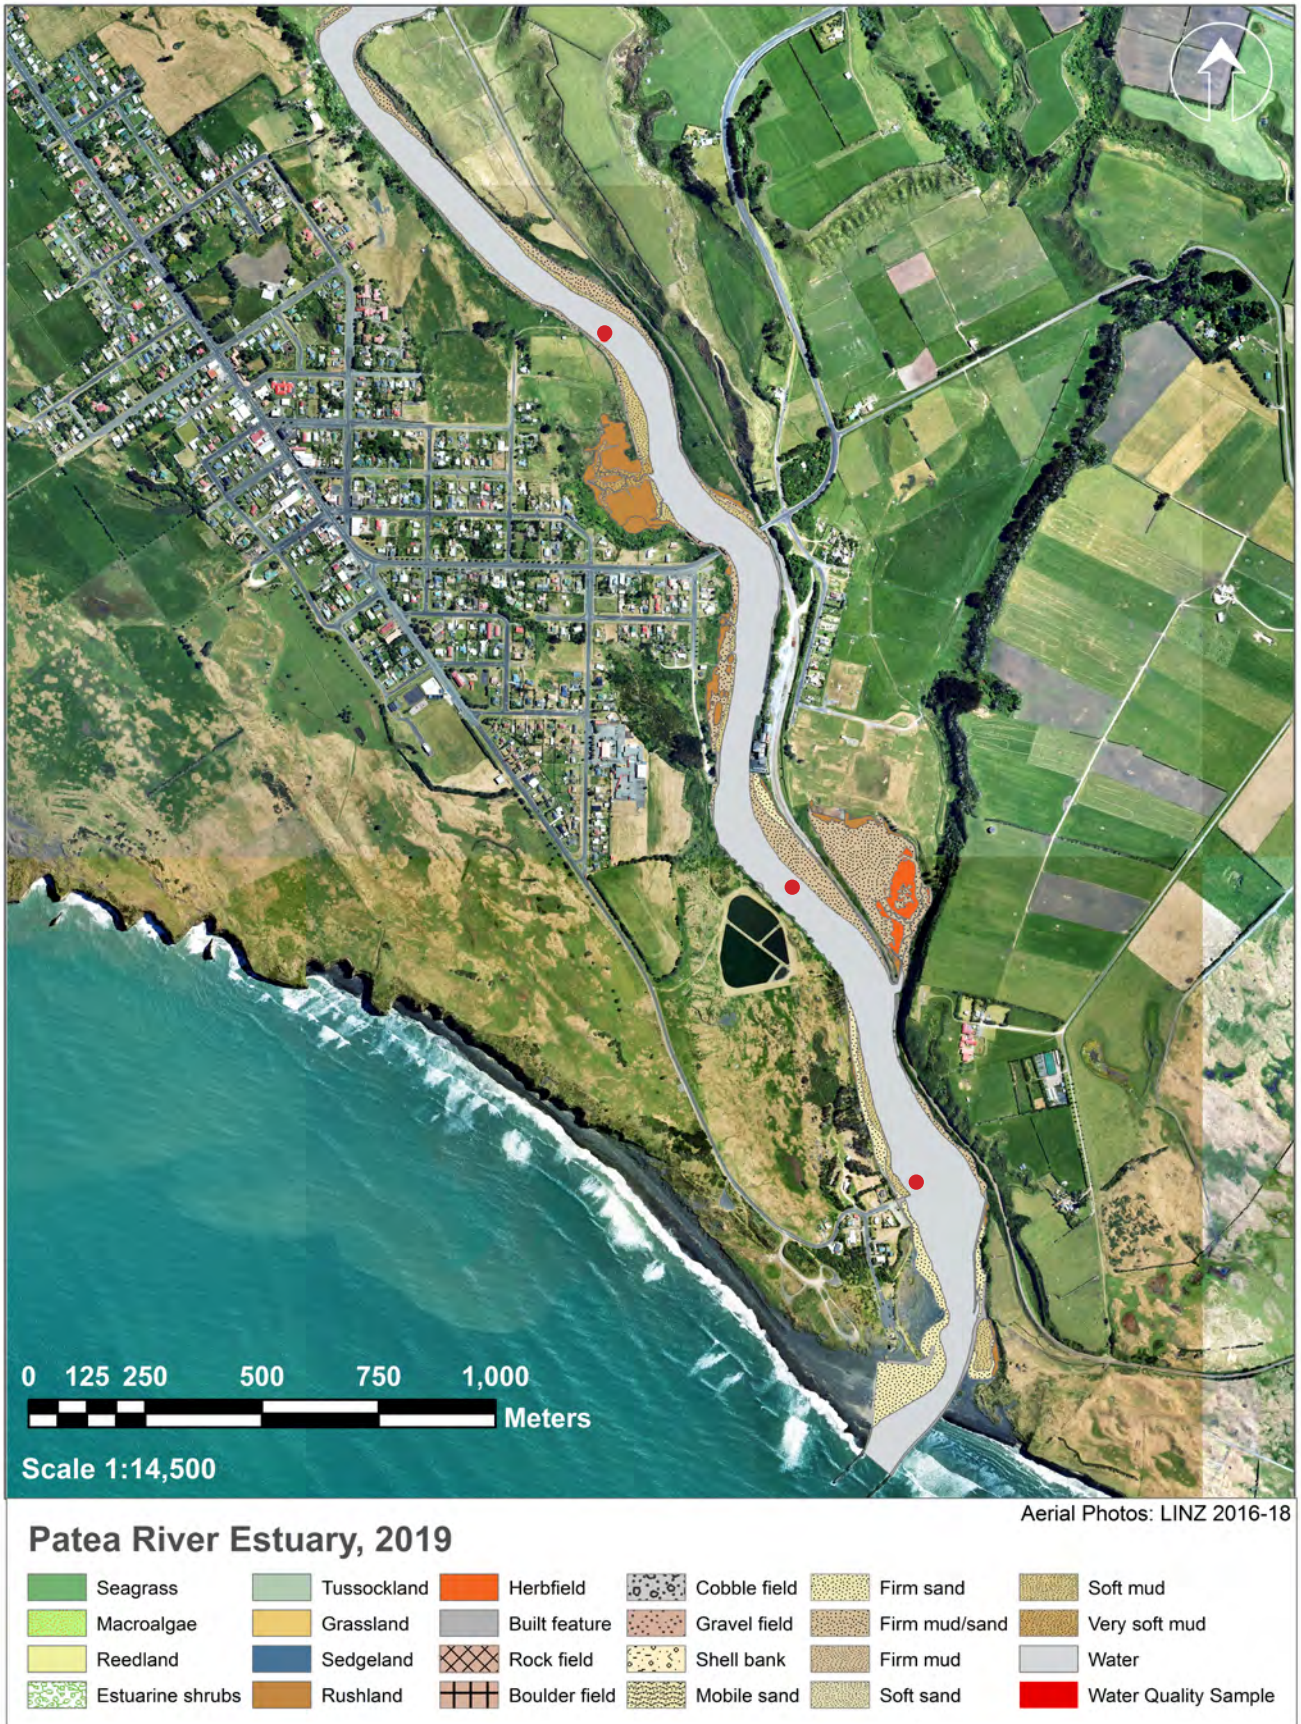
Figure 20. Distribution of intertidal substrata, macrophyte and saltmarsh, and water quality sites, Patea Estuary, 2019. Water quality sampling involved assessment of conditions in both surface (0.2 m) and bottom (0.5 m from bottom) waters at each site.

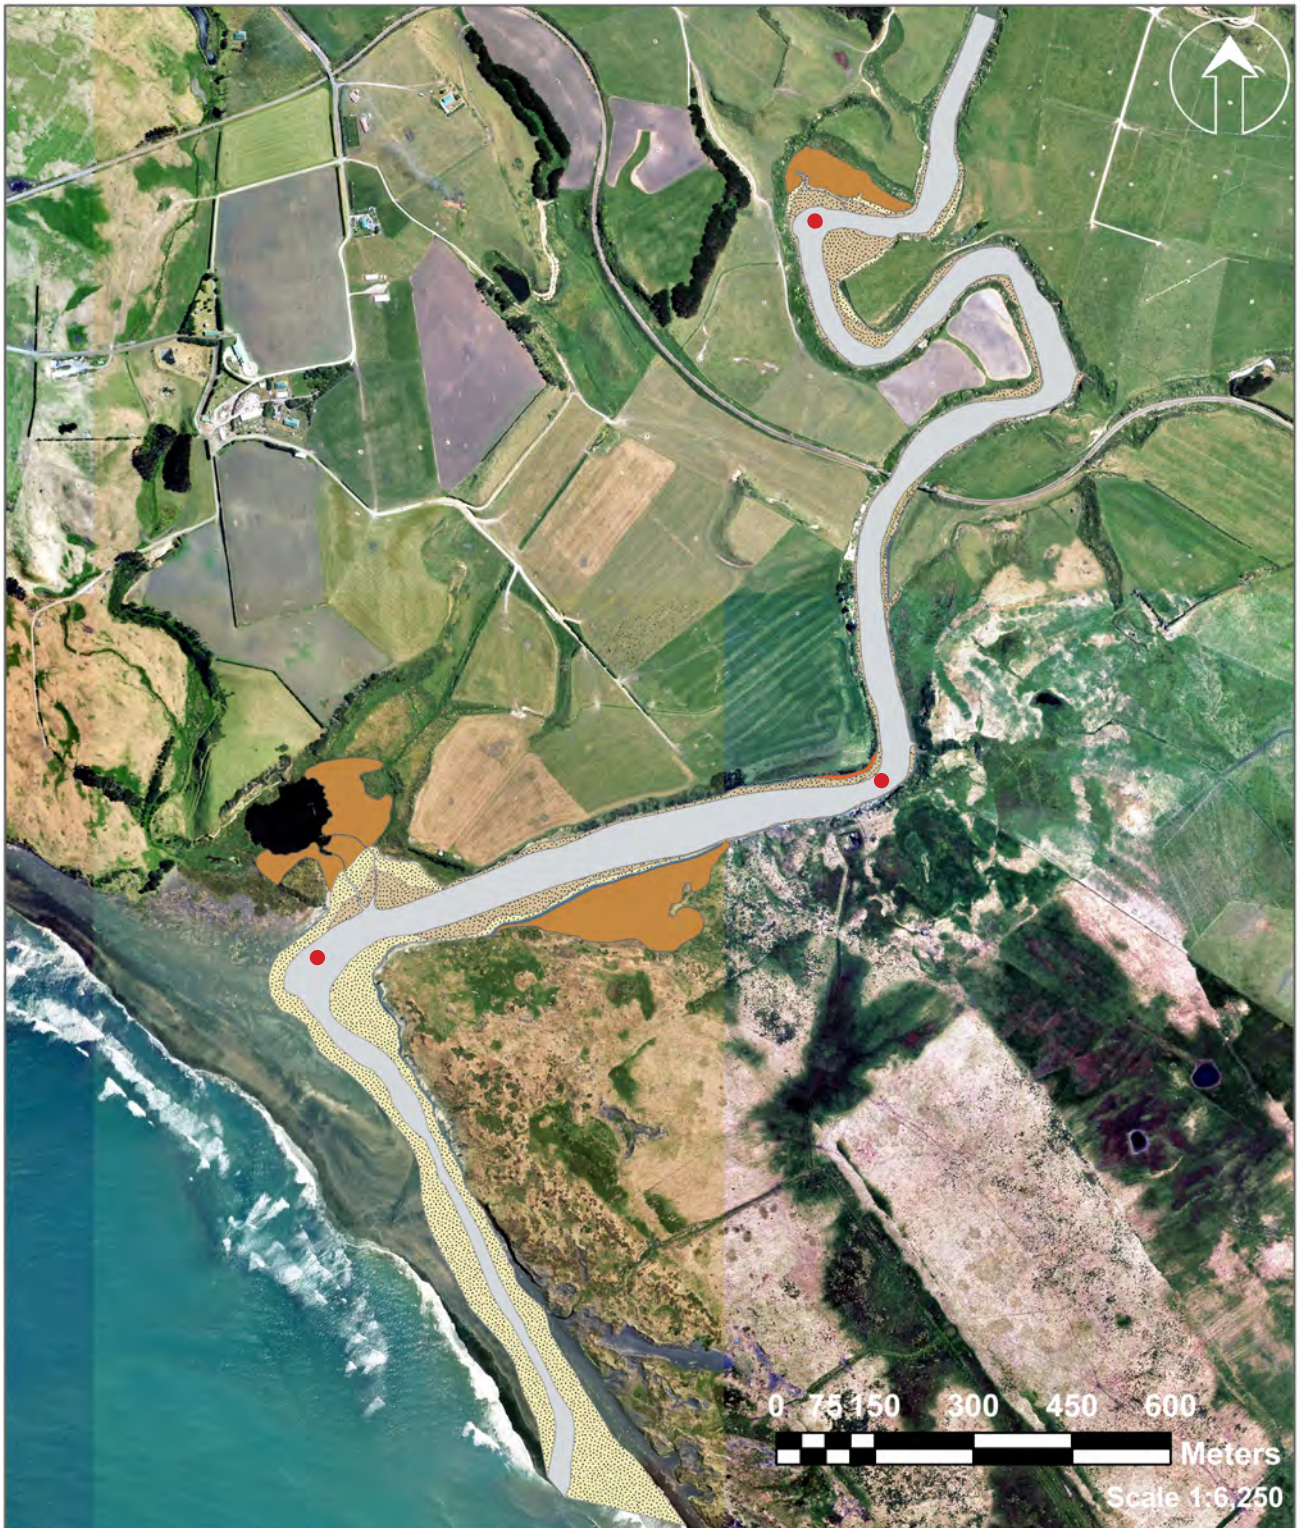
Figure 21. Distribution of intertidal substrata, macrophyte and saltmarsh, and water quality sites, Whenuakura Estuary, 2019. Water quality sampling involved assessment of conditions in both surface (0.2 m) and bottom (0.5 m from bottom) waters at each site.
