# Taranaki June 2015 Flood Event

Taranaki Regional Council  
Private Bag 713  
STRATFORD

June 2016

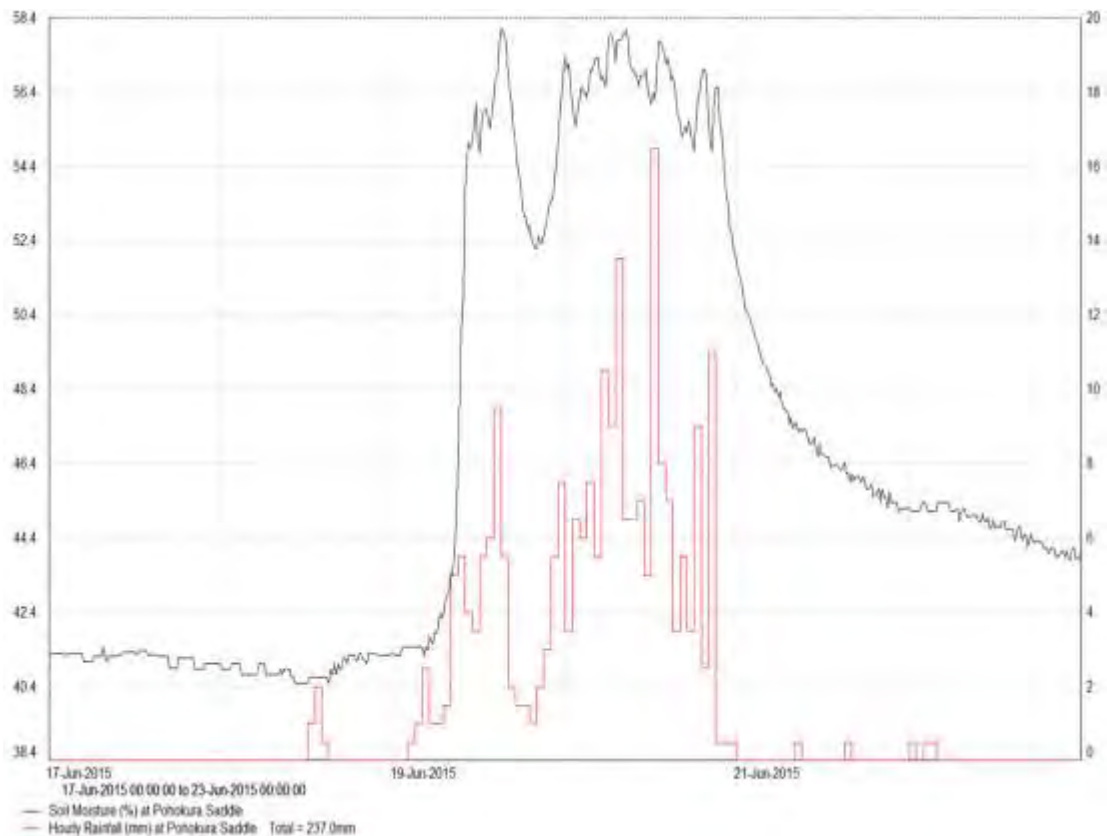
The above graph shows a snap shot of the Rainfall vs the Soil Moisture at Pohokura. Soil moisture scale is on the left axis. (The maximum level that the soil moisture scale can reach is 60%).

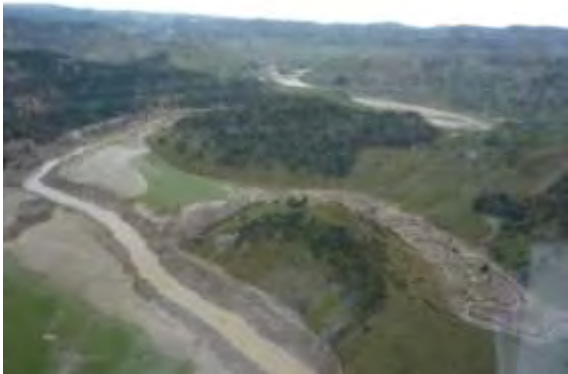
Photo 1: Waitotara River / Werewereonga Stream showing effects of Lake Mangawhio culvert failure

Lake Mangawhio is a small (8.3ha) lake north of Waitotara township, at the head of a tributary of the Weraweraonga Stream, which drains into the Waitotara River. The lake is administered by the Department of Conservation and the access road was upgraded by South Taranaki District Council around 2006, when they replaced the bridge crossing the outlet stream with a culvert. During the June storm the outlet eroded and the culvert 'blew out' with a loss of approximately 500,000 m<sup>3</sup> of water. GNS was not able to ascertain how far any sediment extended or what downstream impact the water drainage has had. GNS reported that the landowner is concerned about further erosion and loss of lake water.

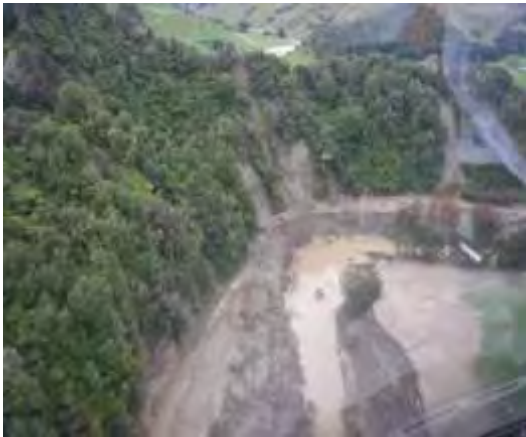
Photo 4: Road closure & silt on Waitotara Valley Rd

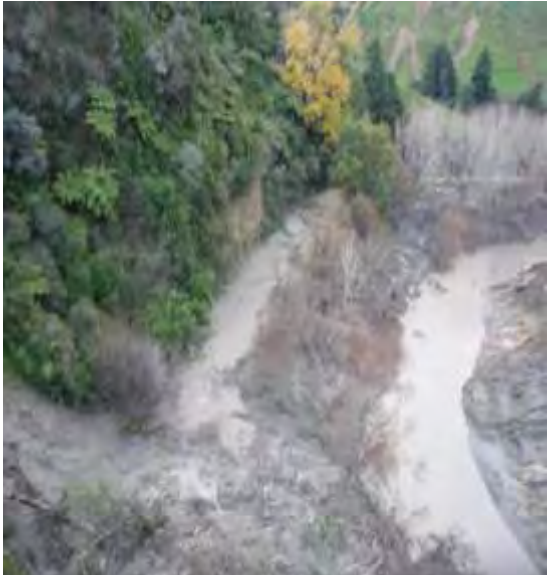
Photo 2: Road closure slips on Waitotara Valley Road

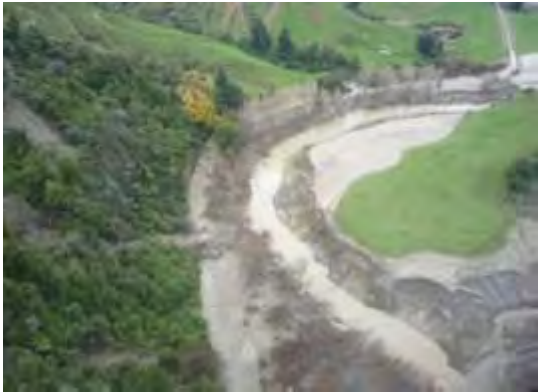
Photo 5: Road closure & silt on Waitotara Valley Rd

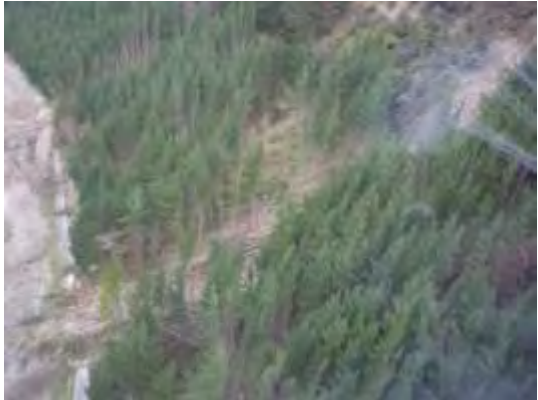
Photo 6: Debris avalanche on Waitotara Valley Rd

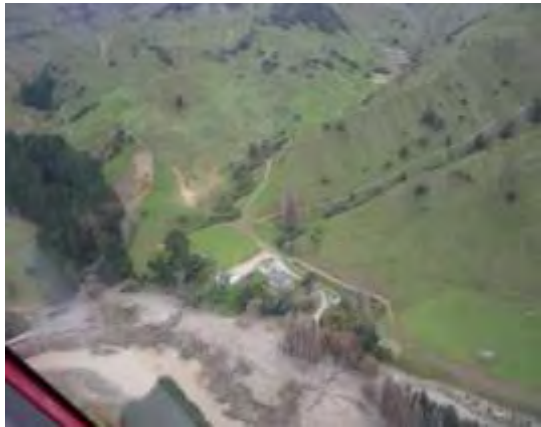
Photo 7: Frewin property damage, Waitotara Valley Rd

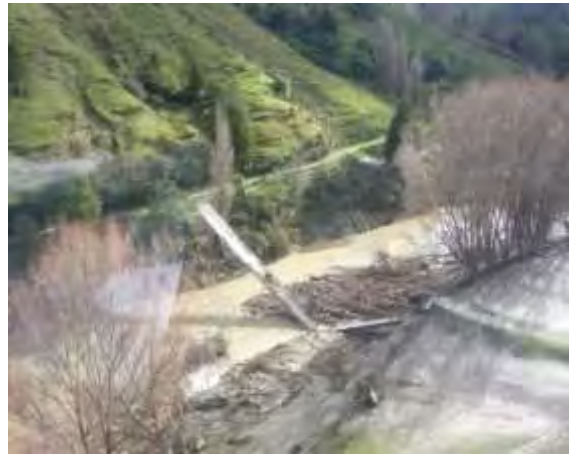
Photo 10: Damaged bridge on Puao property, Waitotara Valley Rd

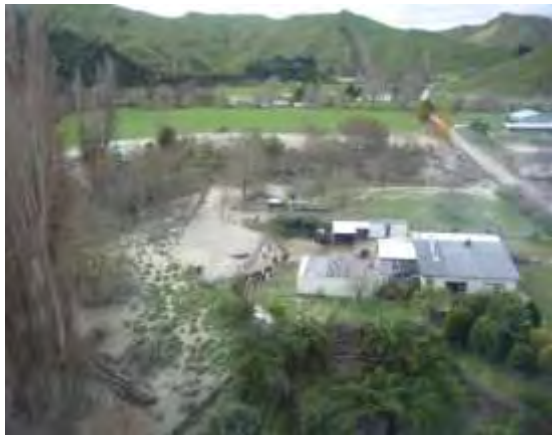
Photo 8: Flooded White property, Waitotara Valley Rd

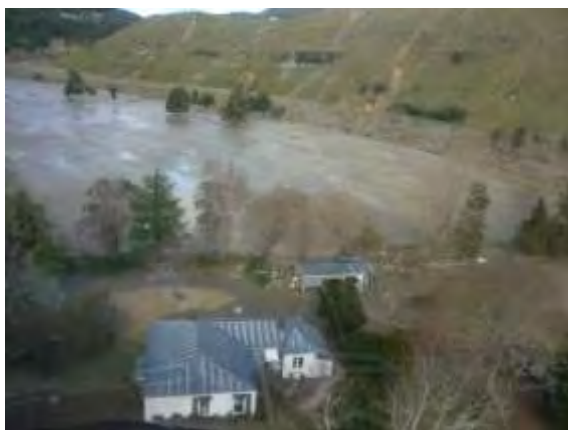
Photo 9: Puao property damage, Waitotara Valley Road

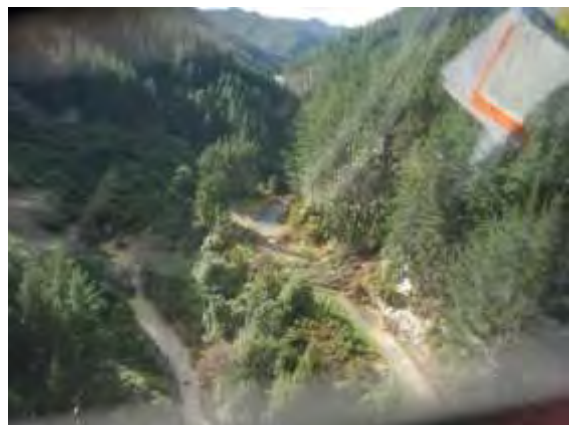
Photo 12: Tangahoe Road closure

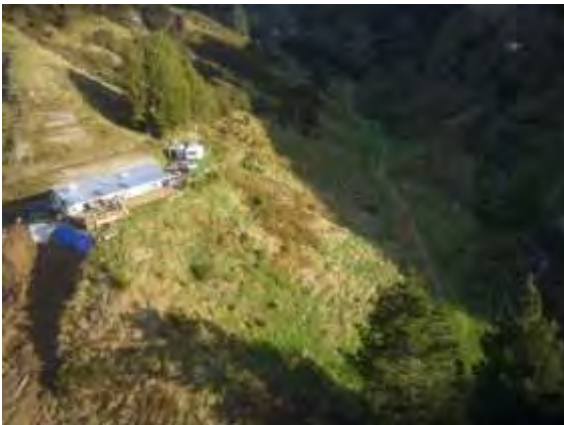
Photo 14: Okoki Rd, slip threatening Crawford property

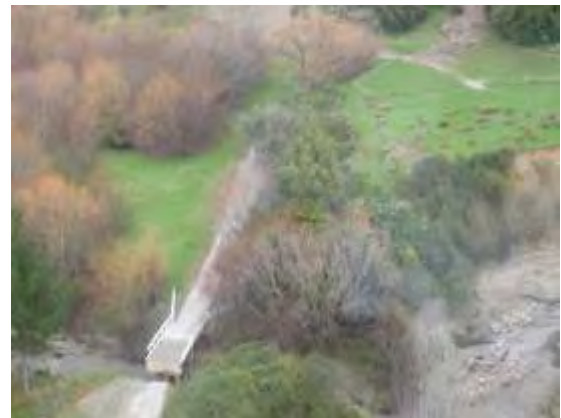
Photo 17: Makakaho Rd, damaged bridge

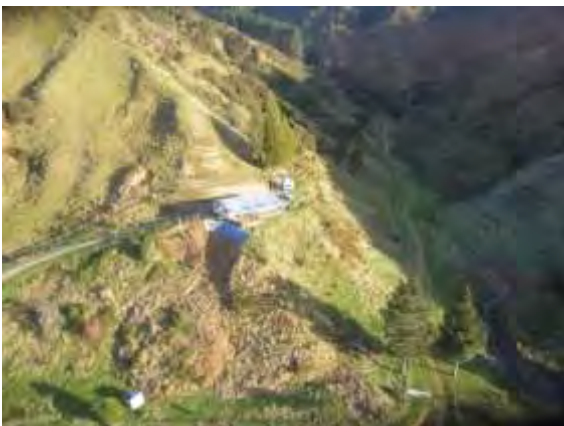
Photo 15: Slip, Crawford property

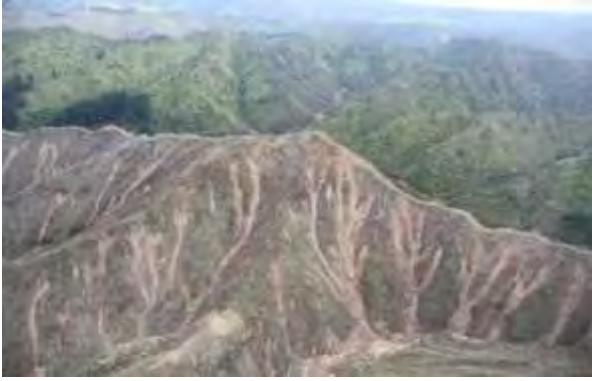
Photo 19: Erosion on harvested forestry block

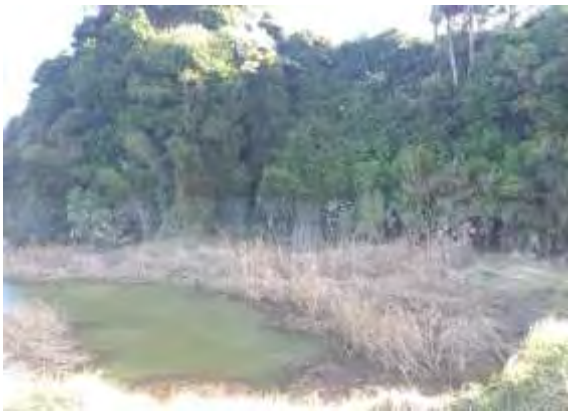
Photo 20: Waitara River bank damage below SH3

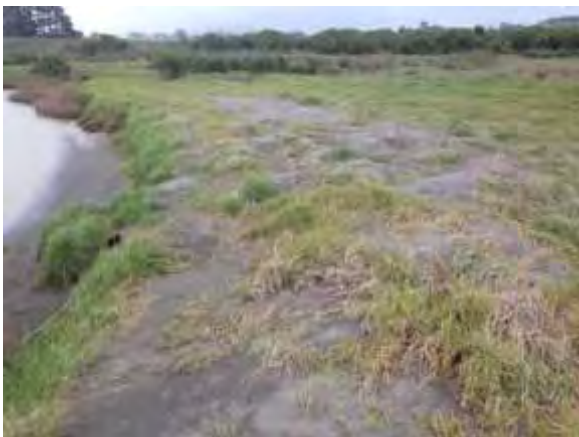
Photo 21: Waitara River embayments after flood

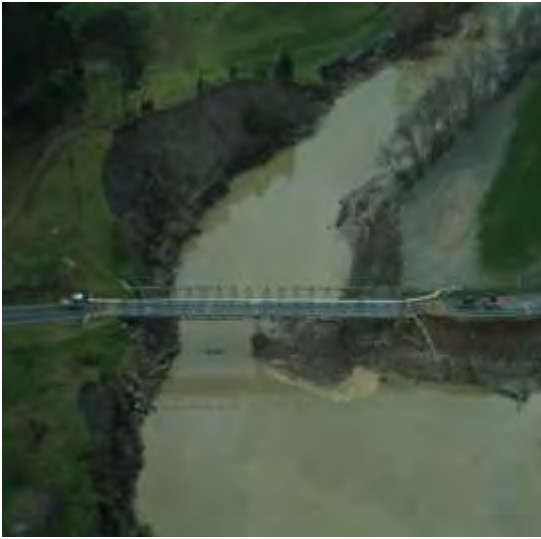
Photo 25: Damage to Limestone Bridge, Waiinu Beach Road , Waitotara

The alignment of the channel at the Limestone Bridge was badly affected and although the bridge has been repaired and the riverbank stabilized, the South Taranaki District Council has investigated a new access route to Beach Road and the Wai-inu Beach settlement.

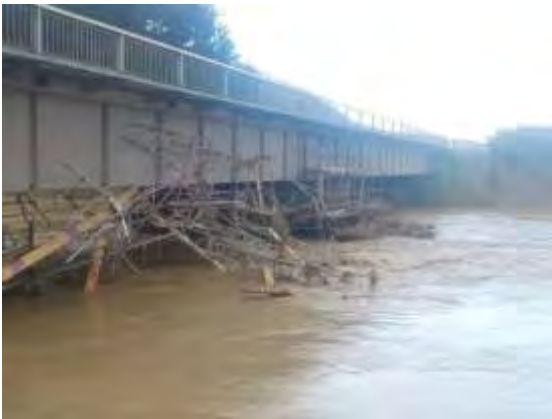
Photo 26: Damage to scaffolding on Waitotara SH3 Bridge Waitotara

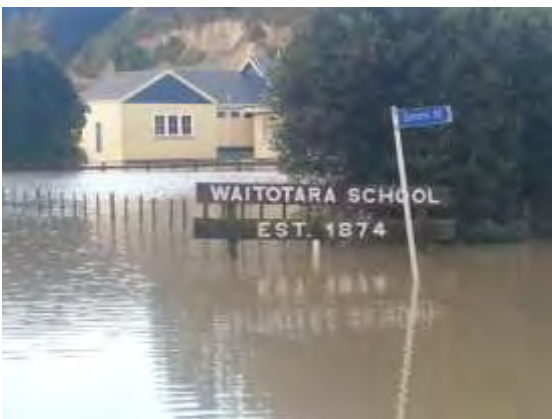
Photo 27: Flooding around Waitotara School

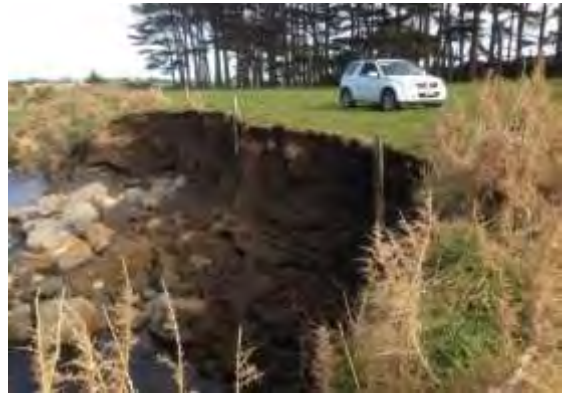
Photo 35: Flood damage

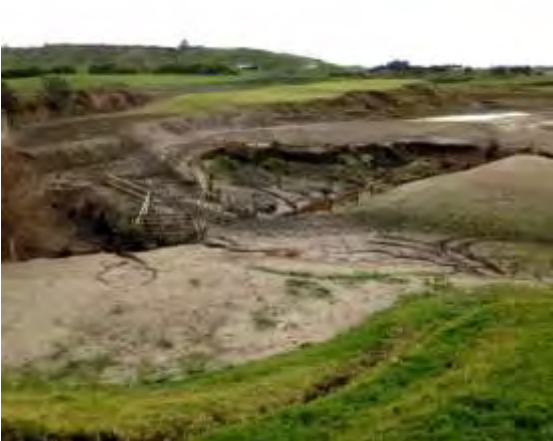
Photo 33: Flood damage at the McColls

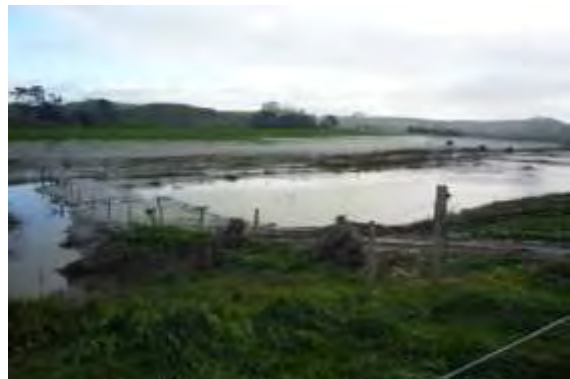
Photo 36: D Wilson property silt deposition - Regionally Significant Wetland Lwr Waitotara Valley
