# STDC Coastal Structures

Monitoring Programme

Annual Report

Technical Report 2021-52

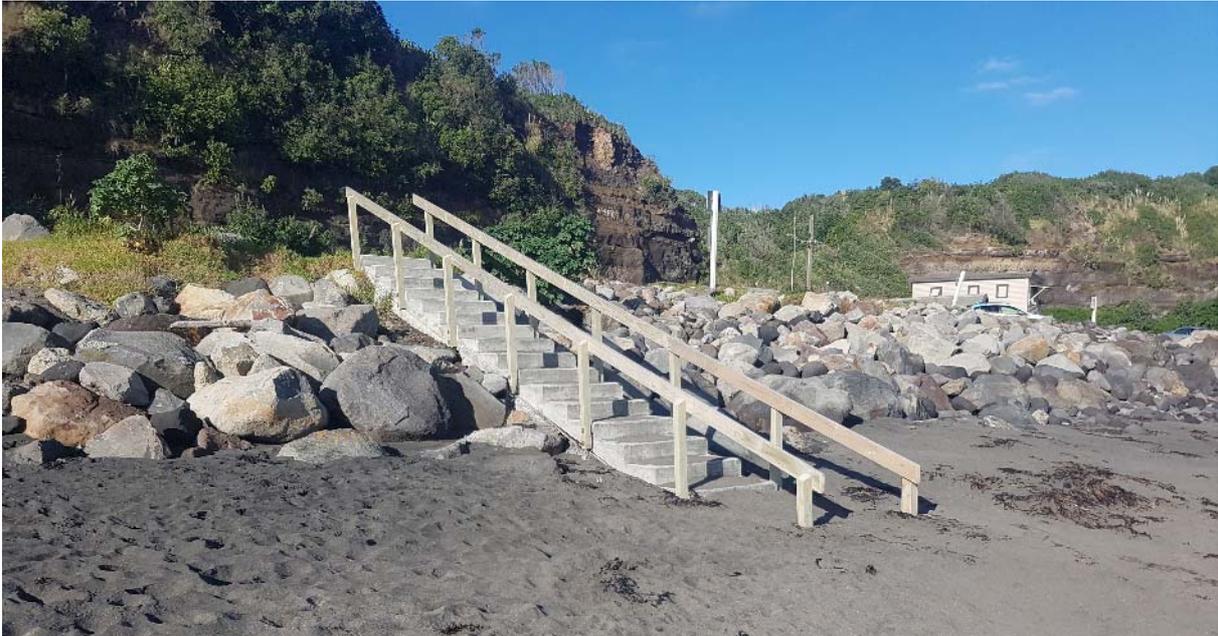
Photo 2 Middleton Bay seawall and staircase (9 June 2021)

Due to Middleton Bay being a pocket sand beach, and the location of the revetment being well forward towards the surf zone, there is a high potential for adverse effects to the soft shoreline at the north-western end and in front of the structure. Within a year of the structure being constructed, there was erosion of the foredune at the north-western end of the revetment, which may have been as a result of 'end effects' from the structure (Tonkin & Taylor, 2001).

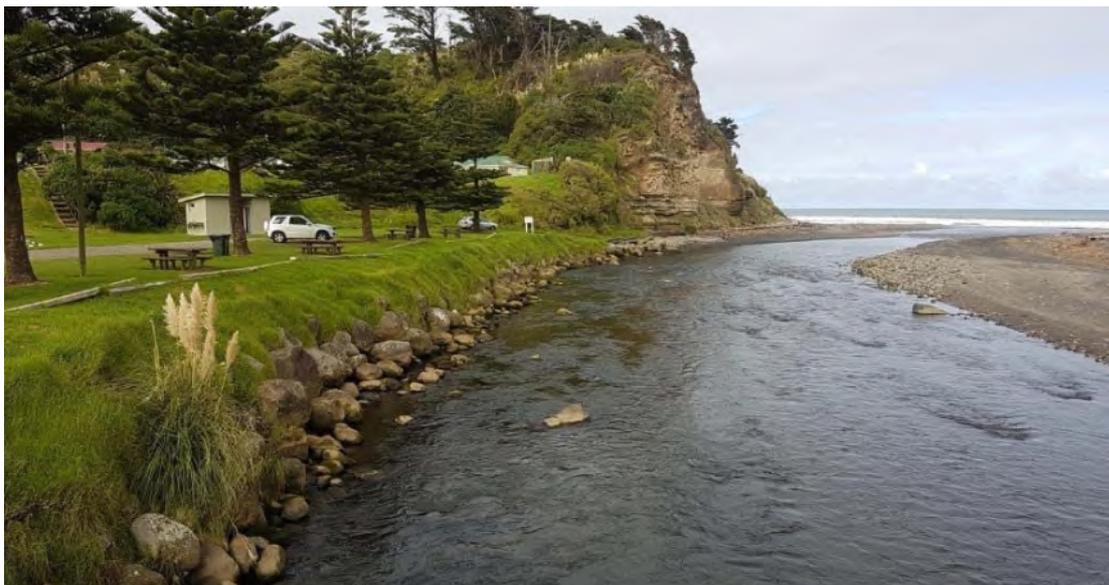
Photo 3 Looking downstream along rock protection works in the Kaupokonui Stream (April 2017)

Following receipt of a complaint regarding works in the Kaupokonui Stream in 2002, investigation by Council officers discovered that substantial boulder rock rip rap had been placed on the true left bank of the Kaupokonui Stream (Photo 3).

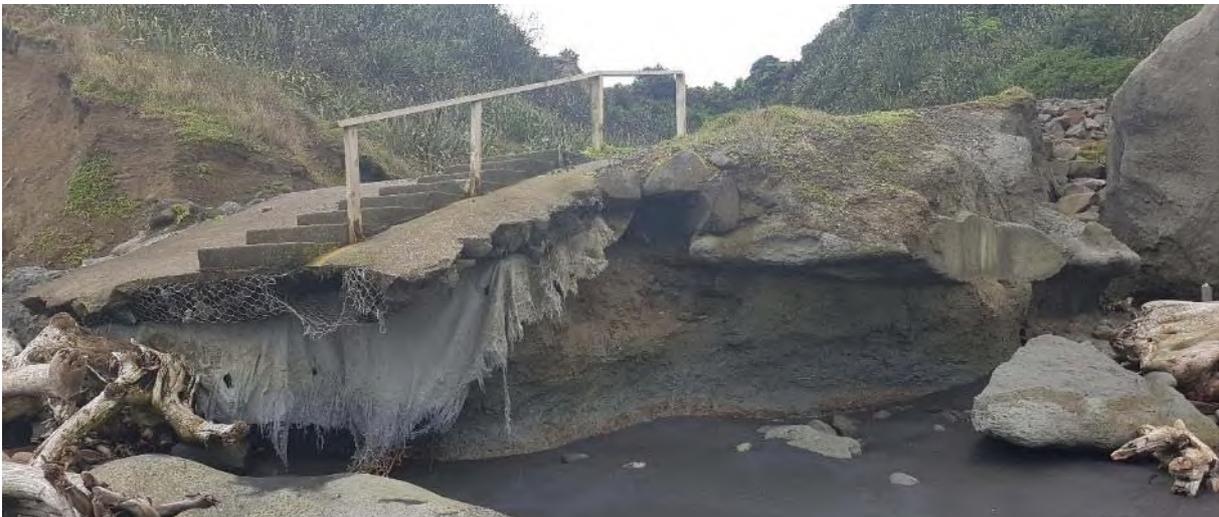
Photo 4 Remnants of Denby Road beach access structure consented under 6736 (April 2019)

Ongoing shoreline erosion caused this structure to gradually deteriorate to the point where it was no longer providing safe access to Waihi Beach, and was deemed non-compliant with coastal permit **6736**. In December 2019, the remaining parts of this access structure were removed and the scarp was fenced off. An alternative track is currently providing beach access.

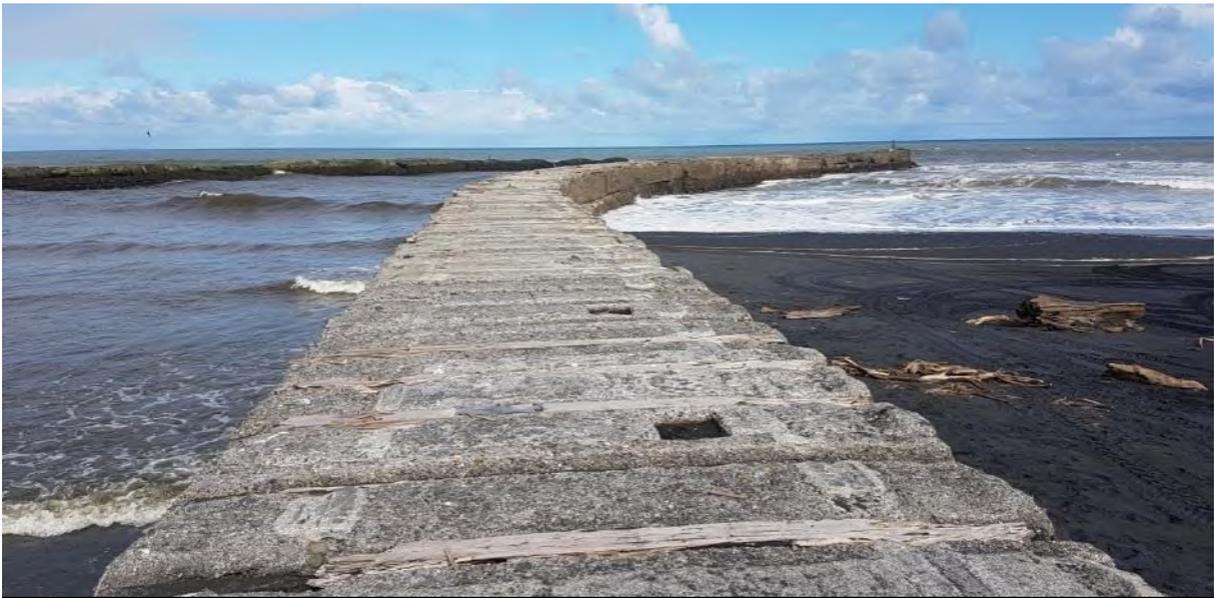
Photo 5 Patea groynes (April 2017)

Significant levels of erosion occurred along this coastline during the past 50 years which led to the river moles becoming seriously degraded. Studies undertaken by consultants (Duffill Watts & King, 2006) showed that with the condition of the moles and rate of shoreline change, the river moles could decay, threatening the overall stability of the river entrance. If the stability of the river entrance changed, this could result in the passage between the river and sea becoming no longer navigable. From the studies undertaken by Duffill, Watts & King (2006), it was found that without some intervention process the Patea River would break through behind the southeast mole within 20 to 25 years and prevent navigable access to the sea. It was proposed that the most effective method to maintain a navigable river entrance for small seagoing craft was to reconstruct the southeast seawall. Consent **6839** was granted by the Council authorising the works, which aimed to constrain the river channel to its existing alignment and prevent it from breaking through behind the left mole (Photo 5).

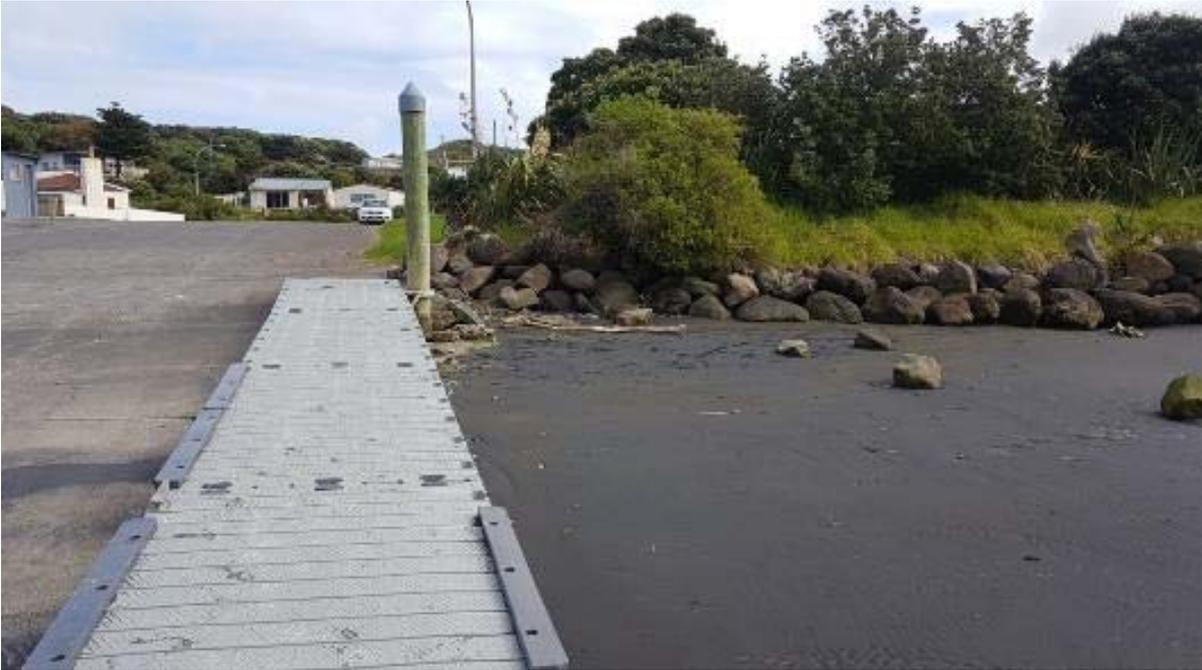
Photo 6 Patea boat ramp (April 2017)

The launching ramp was an undular concrete pad which extended from the end of the formed roadway of Turi Street, down to approximately the low tide level of the river. Upon granting of coastal permit **4566**, the STDC strengthened the existing boat launching ramp by placing a concrete strengthening overlay over the existing ramp. The overlay is 7 m wide and extends a further 3 m down into the river than the previous ramp, improving the launching facility.

The overlay was contoured so it is more consistent with natural beach profiles than the previous ramp and is therefore expected to have less effect on riverbed/beach processes than the previous ramp. In association with expanding and strengthening the ramp, the STDC reinstated and rock protected the eroding riverbank both immediately upstream and downstream of the ramp. The bank protection was wrapped smoothly into the existing bank and aligned in a manner which is compatible with wave refraction/diffraction patterns and which will not adversely affect natural river processes.

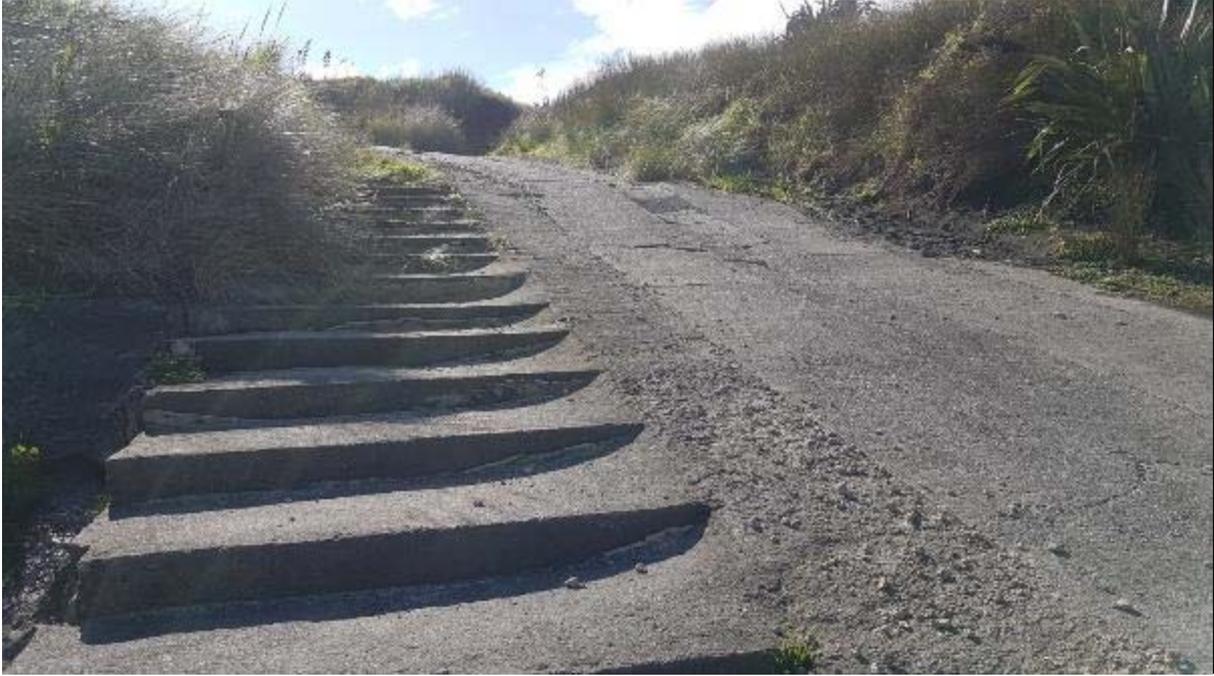
Photo 7 Access to Waverley Beach (April 2017)

The structure covered by consent **4579** consists of a concrete public access ramp way, 20 m in length and 3 m in width with an associated 2 m wide by 16 m long concrete step-way down the western edge of the ramp (Photo 7). The ramp extends down to the beach sands from the upper ground level of the mudstone coastal bluffs, providing access to Caves Beach, again reducing pedestrian damage of the fragile sand dunes.

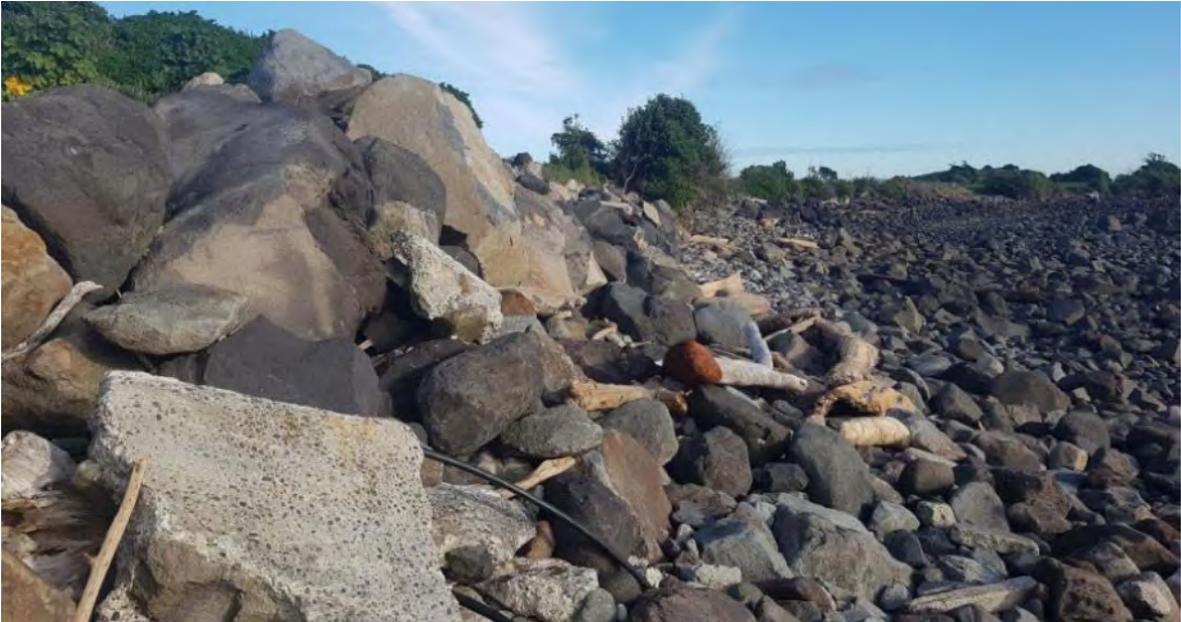
5512-2: Bayly Road seawall			
<b>Council inspection date:</b>	9 June 2021	<b>STDC inspection date:</b>	8 April 2021
<b>Council inspection summary:</b> Previous inspections had identified a number of areas where the seawall had slumped and allowed erosion to occur behind the structure. The erosion was most significant at the intersection of Bayly and Coast Roads. These issues had been repaired prior to this inspection, with additional rock added to all of the affected areas. The slope of repaired section in front of Bayly and Coast Roads was found to be quite steep, with one or two boulders appearing partially perched. STDC have been directed to assess whether additional work is required to reduce the risk of them falling, or if they are, in fact, safe and secure. STDC also carried out an inspection of this structure during the year under review (however, the perched boulder issue was not identified at the time). Their report was provided to Council on 30 June 2021.

<b>Survey based monitoring summary:</b> This structure has not been identified as requiring additional, survey based monitoring.			
<b>Overall compliance assessment:</b> Compliant (pending the outcome of STDC's assessment, mentioned above).			
<b>Photos and figures:</b> Steep repaired section of Bayly Road seawall (9 June 2021).

Date	Details	Compliant (Y/N)	Enforcement Action Taken?	Outcome
09/06/21	A small, potentially unsafe, section of the Bayly Road seawall (5512-2) identified due to boulder size and repair slope.	N	No.	STDC were directed to undertake a qualified engineering assessment of the seawall, which has resulted in a plan for upcoming maintenance repairs.
09/06/21	Lattice wall at eastern end of Opunake Beach (4578-2) has deteriorated significantly, presenting potential safety hazards.	N	No.	STDC have secured funding to replace the lattice wall with a new structure. As an interim measure to mitigate any safety hazards, STDC have installed temporary fencing to isolate beach users from the damaged wall.

Additional rock was placed along the Bayly Road seawall to increase the profile of the wall where slumping had occurred in order to prevent further erosion of the scarp. Near the intersection of Bayly and Coast Roads, these repair works had considerably steepened the profile of the wall. STDC subsequently obtained an engineer's assessment which determined that further maintenance was required. This maintenance is scheduled to be undertaken.

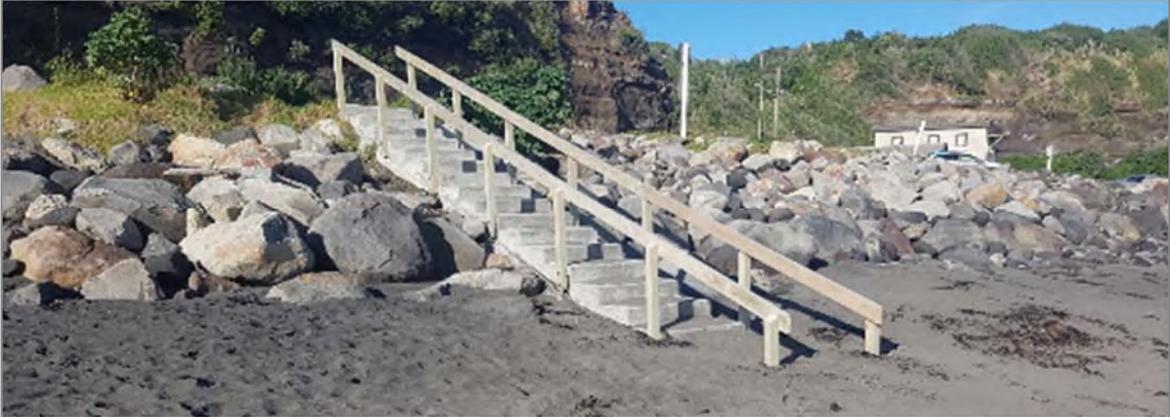
5504-1: Middleton Bay seawall			
<b>Council inspection date:</b>	9 June 2021	<b>STDC inspection date:</b>	8 April 2021
<b>Council inspection summary:</b> No obvious end effects or scouring associated with the structure. Structure appeared to be maintained in satisfactory condition. The adjacent scarp was still yet to be planted as was committed to in the consent renewal application. STDC are now in the process of sourcing plants. STDC also carried out an inspection of this structure during the year under review. Their report was provided to Council on 30 June 2021.			
<b>Survey based monitoring summary:</b> Surveying in Middleton Bay is being carried out to identify impacts on coastal processes potentially caused by the seawall. STDC engaged a surveying contractor to carry out beach profile monitoring during the year. Five beach profile transects were surveyed in Middleton Bay in November 2020. In November 2019, a drone survey was undertaken for the entire Bay, and three of the five beach profile transects were also surveyed on the ground. This information was provided to Council on 30 June 2021. Survey results are yet to be reviewed by a suitably qualified professional; data review requirements, and the ongoing monitoring regime, are currently being finalised in an associated monitoring plan.

<b>Overall compliance assessment:</b> Compliant (based on the information available as summarised above).			
<b>Photos and figures:</b> Middleton Bay seawall and beach access (9 June 2021).

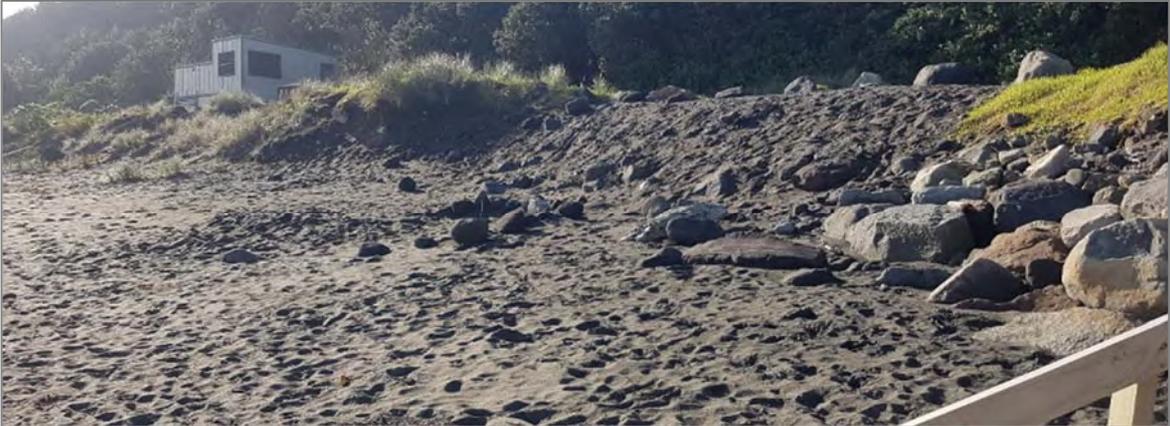
Bare scarp adjacent to seawall (9 June 2021).

The dunes adjacent to the Middleton Bay seawall have been subjected to ongoing scour and erosion. It is unclear whether this erosion is attributed to end effects from the seawall structure, natural processes or a combination of the two factors. However, it was apparent that improvised pedestrian beach access had worsened the issue. The repair works and beach access installation at the northern end of the seawall appear to be helping to protect this section of the dunes.

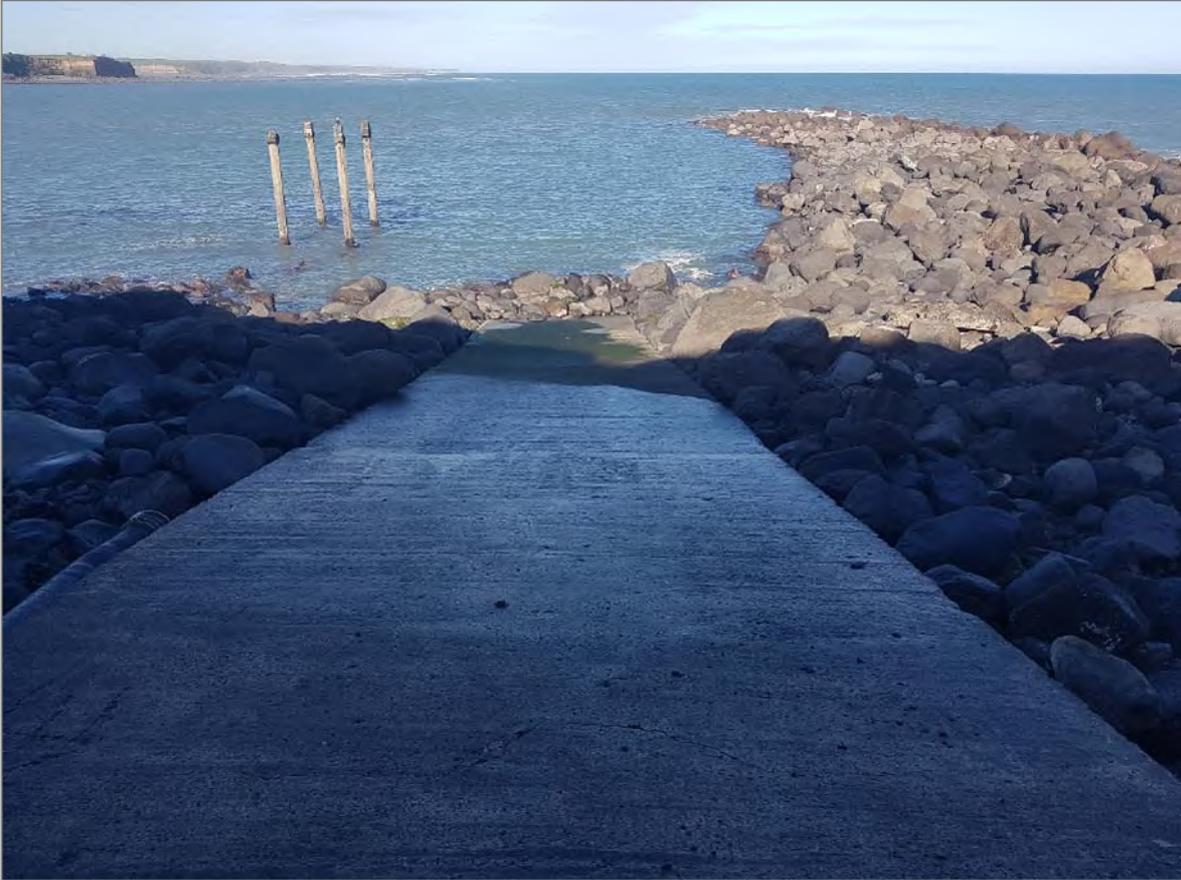
6791-1: Opunake Bay boat ramp and breakwater			
<b>Council inspection date:</b>	9 June 2021	<b>STDC inspection date:</b>	No inspection
<b>Council inspection summary:</b> No obvious changes from previous year. Rocks and boulders scattered across bottom of ramp. STDC did not carry out an inspection of these structures during the year under review.			
<b>Survey based monitoring summary:</b> Surveying in Opunake Bay is being carried out to identify impacts on coastal processes potentially caused by the rock breakwater (consent 6791-1) and beach protection structures (consent 4578-2). STDC engaged a surveying contractor to carry out beach profile monitoring during the year. Five beach profile transects were surveyed in Opunake Bay in November 2020. In November 2019, a drone survey was undertaken for the entire Bay, and three of the five beach profile transects were also surveyed on the ground. This information was provided to Council on 30 June 2021. Survey results are yet to be reviewed by a suitably qualified professional; data review requirements, and the ongoing monitoring regime, are currently being finalised in an associated monitoring plan.

<b>Overall compliance assessment:</b> Compliant (based on the information available as summarised above).			
<b>Photos and figures:</b> Opunake Bay boat ramp and rock groyne (9 June 2021).

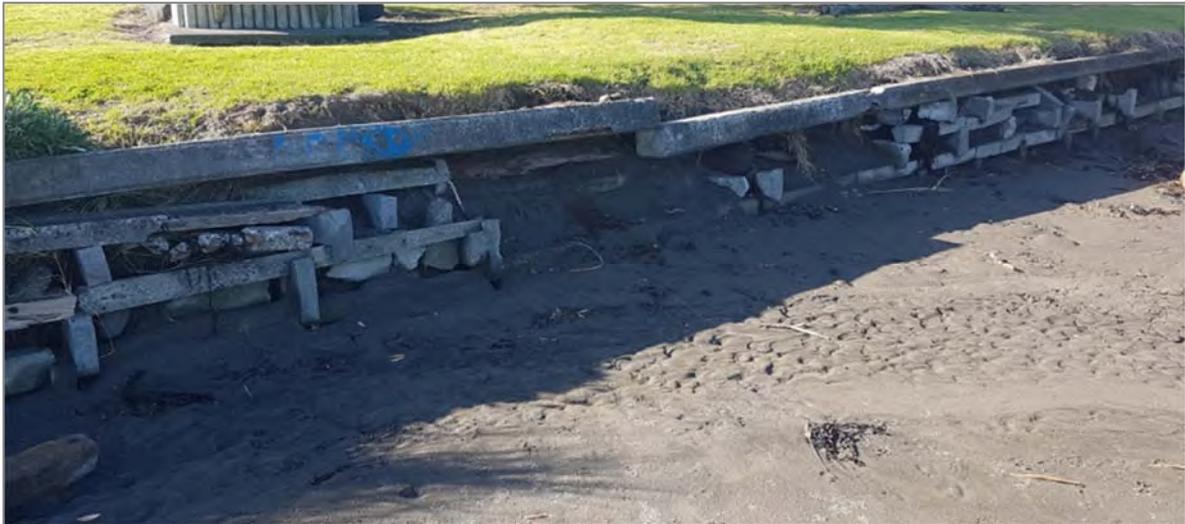
4578-2: Opunake Beach protection structures and access ways			
<b>Council inspection date:</b>	9 June 2021	<b>STDC inspection date:</b>	8 April 2021
<b>Council inspection summary:</b>			
<p>No obvious end effects or scouring associated with these structures. However, at the eastern end of the beach, the lattice wall structure had deteriorated significantly since the previous inspection. Parts of the wall were found strewn across the beach, leaving some of the concrete pylons unsupported (see photos below). This issue was also identified by STDC during their inspection rounds, and have subsequently secured funding to build a replacement structure. The Council made STDC aware that the structure was considered non-compliant with consent conditions in its current state, and that steps needed to be taken to mitigate the safety hazards that it posed. STDC's inspection report was provided to Council on 30 June 2021.</p>

<b>Photos and figures:</b>			
A section of the non-compliant lattice wall structure (9 June 2021).

The lattice wall at the eastern end of Opunake Beach was found to be in a state of disrepair and has been deemed non-compliant. STDC have secured funding to replace the lattice wall with a new structure. As an interim measure to mitigate any safety hazards, STDC has installed temporary fencing to isolate the wall from beach users.

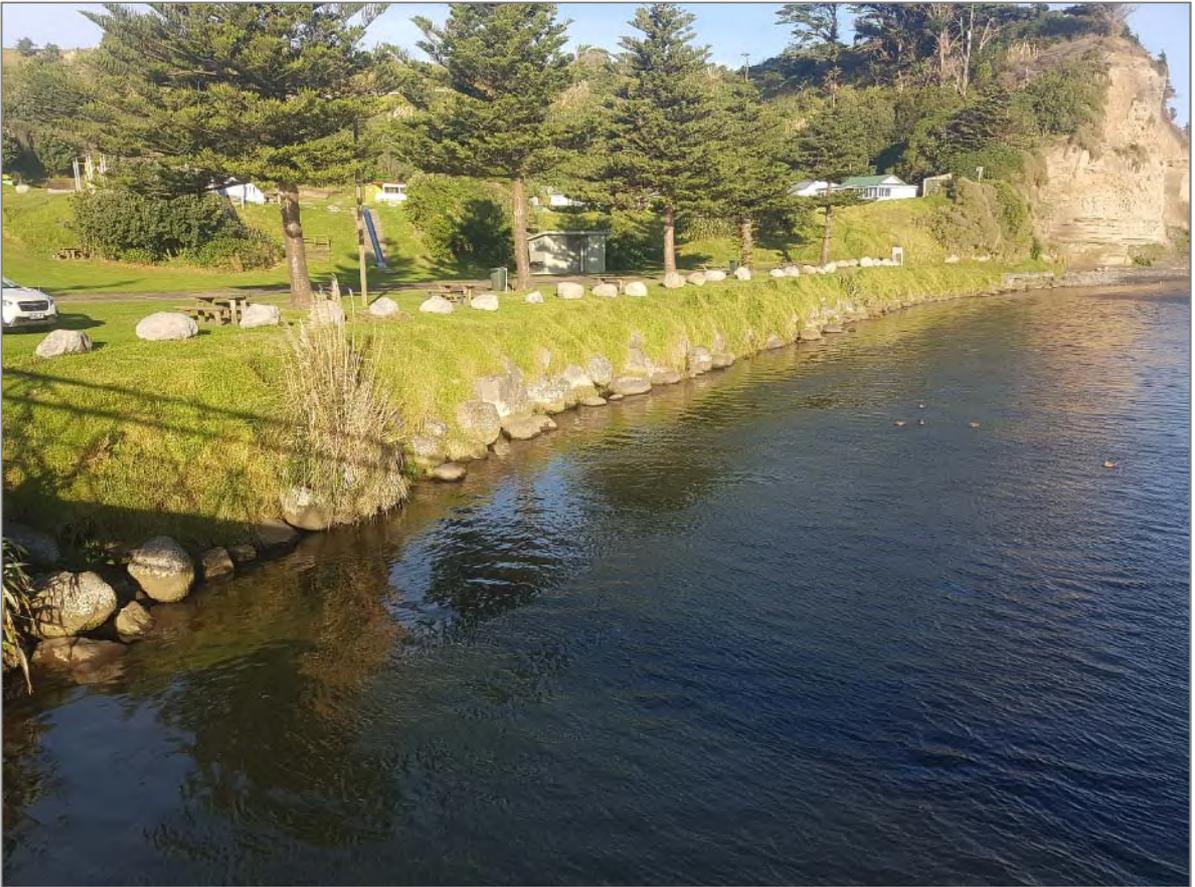
5983-2: Kaupokonui boulder rip rap			
<b>Council inspection date:</b>	8 June 2021	<b>STDC inspection date:</b>	8 April 2021
<b>Council inspection summary:</b> No obvious changes from the previous year. STDC also carried out an inspection of this structure during the year under review. Their report was provided to Council on 30 June 2021.			
<b>Survey based monitoring summary:</b> This structure has not been identified as requiring additional, survey based monitoring.			
<b>Overall compliance assessment:</b> Compliant (based on the information available, as summarised above).			
<b>Photos and figures:</b> Kaupokonui boulder rip rap (9 June 2021).

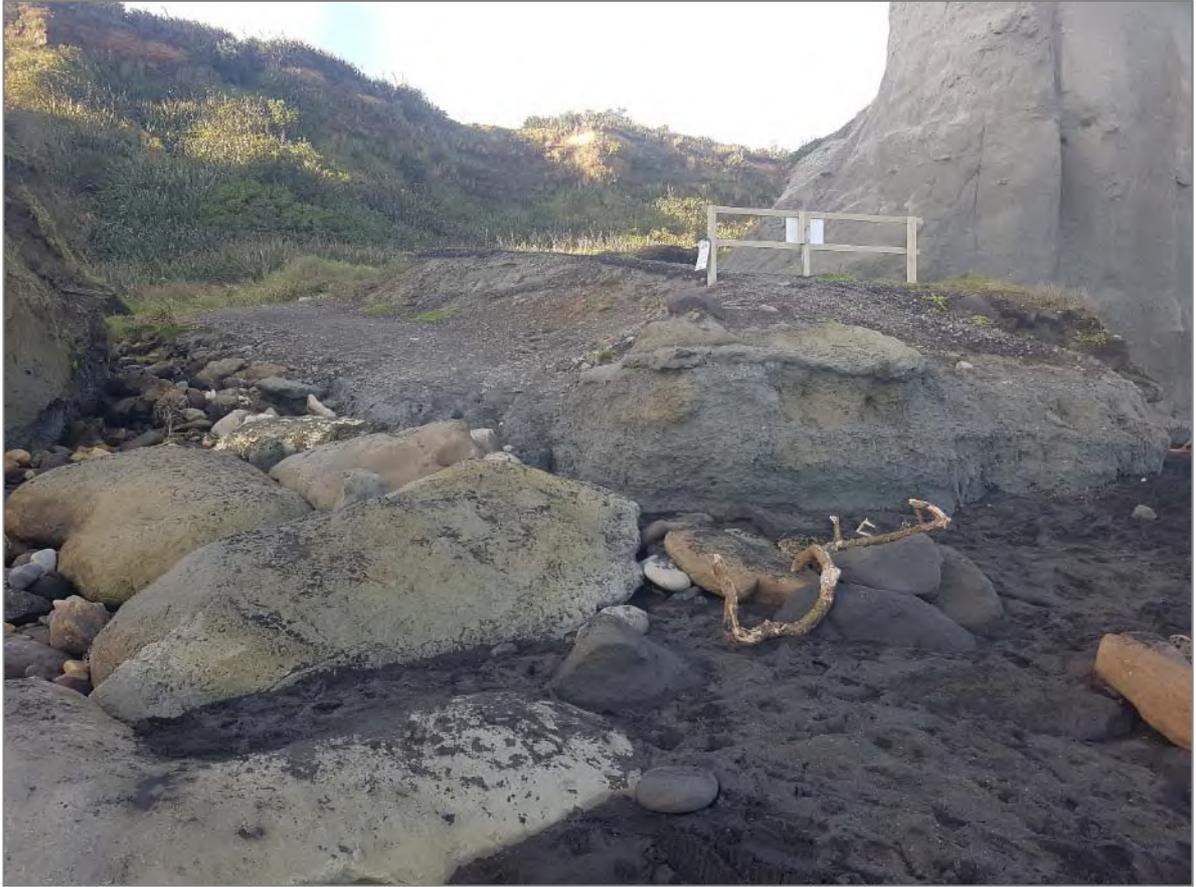
6736-1: Denby Road gabion mattress and access ramp			
<b>Council inspection date:</b>	8 June 2021	<b>STDC inspection date:</b>	8 April 2021
<b>Council inspection summary:</b> No obvious changes from previous year; structure remnants were removed in December 2019. Council inspections will be no longer be undertaken for this structure. STDC also carried out an inspection of this site during the year under review. Their report was provided to Council on 30 June 2021.			
<b>Survey based monitoring summary:</b> This site has not been identified as requiring additional, survey based monitoring.			
<b>Overall compliance assessment:</b> Structure has been removed. Compliance assessment no longer applicable.			
<b>Photos and figures:</b> Current beach access at Denby Road (Waihi Beach) (8 June 2021).

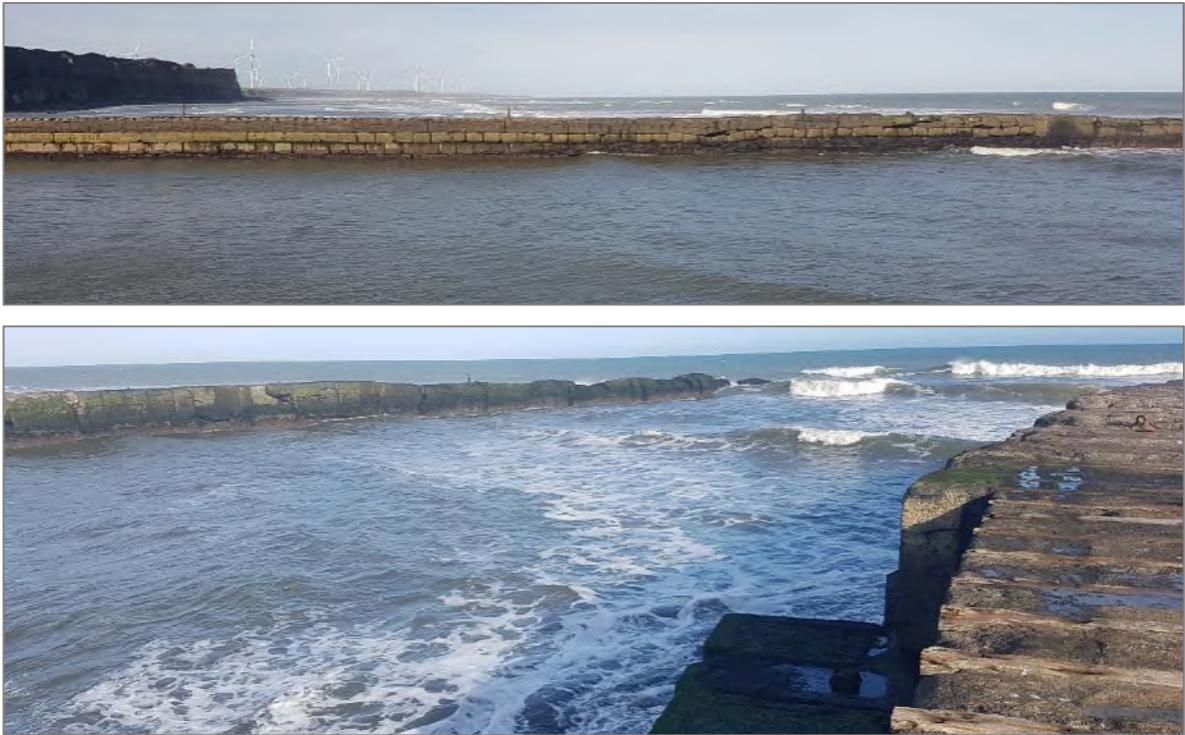
4573-2: Patea River mouth structures; 6839-1: Patea River training wall reinstatement			
<b>Council inspection date:</b>	8 June 2021	<b>STDC inspection date:</b>	8 April 2021
<b>Council inspection summary:</b>			
<p>No issues were identified with the Mana Bay seawall, half tide wall or the wave guide wall. Degradation of the moles was evident through slumping of the structures above the sea surface (particularly the south mole). STDC also carried out an inspection of this site during the year under review. Their report was provided to Council on 30 June 2021. STDC are currently investigating options for remediation of the mole structures. To help inform these repairs, a hydrographic survey is set to be carried out in the 2021-2022 summer period, when conditions are suitable.</p>			
<b>Survey based monitoring summary:</b>			
<p>Surveying the Patea River mouth and adjacent coast is being carried out to identify impacts on coastal processes potentially caused by the river mouth structures (consents 4573-2 and 6839-1). Surveying is set to commence in Spring 2021. Details around survey methods, data review and reporting are being finalised in an associated Monitoring Plan.</p>

<b>Overall compliance assessment:</b>			
<p>Compliant (based on the information available, as summarised above). Further degradation of the mole structures may lead to non-compliance; particularly if the structures present increased navigational hazards.</p>			
<b>Photos and figures:</b>			
Southern mole at Patea River mouth (8 June 2021).

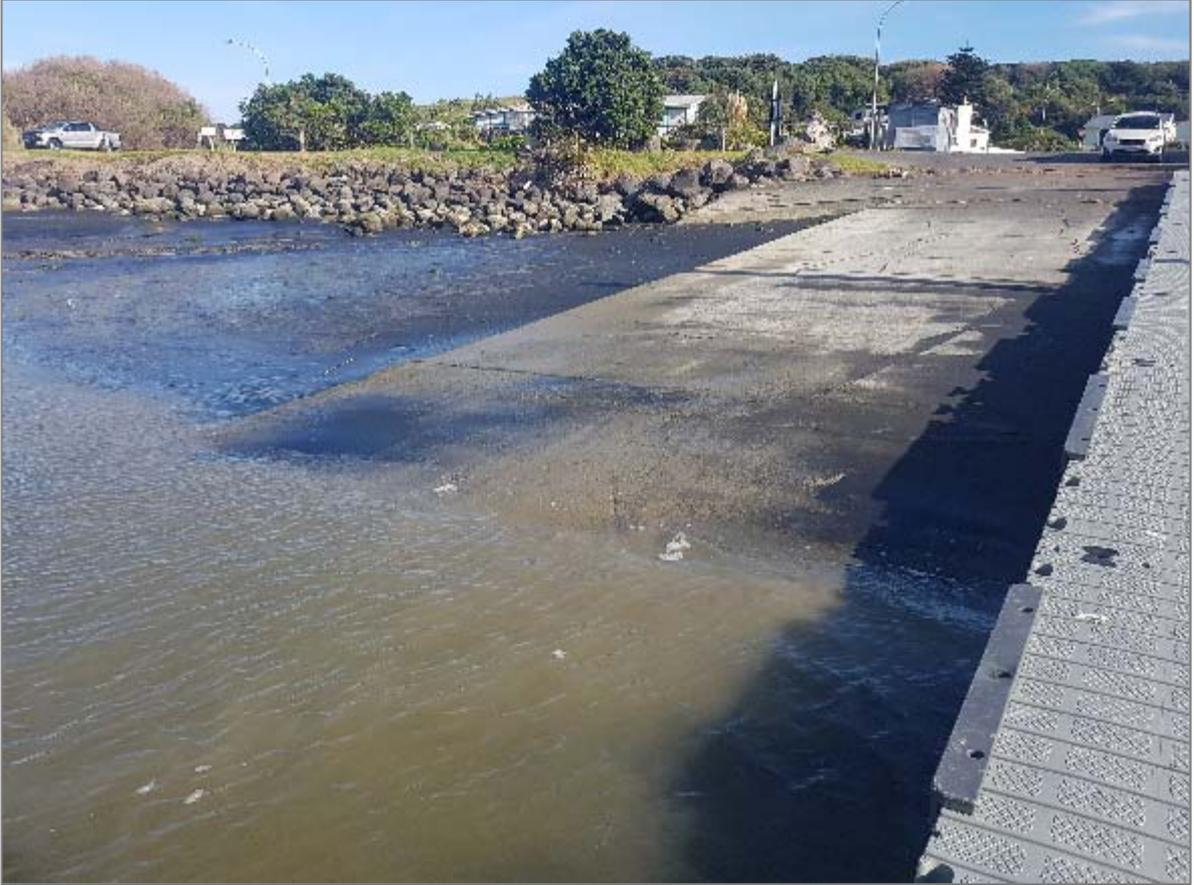
4566-2: Patea River boat ramp, jetty and rock wall			
<b>Council inspection date:</b>	8 June 2021	<b>STDC inspection date:</b>	14 January 2021
<b>Council inspection summary:</b> No obvious changes from the previous year. STDC also carried out an inspection of this structure during the year under review. Their report was provided to Council on 30 June 2021.			
<b>Survey based monitoring summary:</b> Surveying the Patea River channel is being carried out to identify erosional effects potentially caused by the rock walls either side of the boat ramp. Surveying is set to commence in Spring 2021. Details around survey methods, data review and reporting are being finalised in an associated Monitoring Plan.			
<b>Overall compliance assessment:</b> Compliant (based on the information available, as summarised above).			
<b>Photos and figures:</b> Patea boat ramp, jetty and downstream rock wall (8 June 2021).

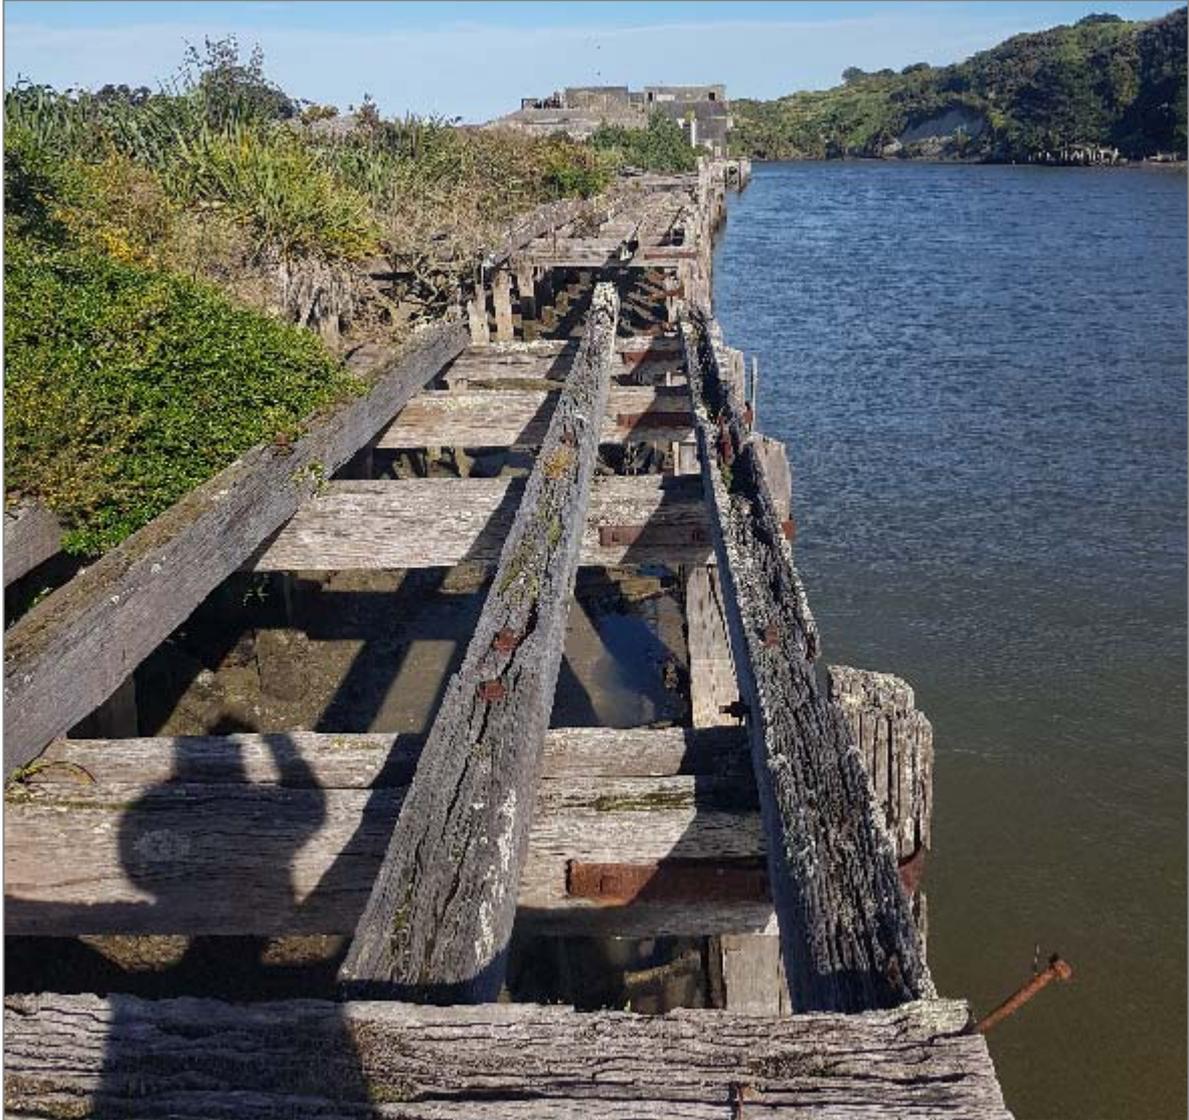
4575-2: Patea wharf and boulder rip rap			
<b>Council inspection date:</b>	8 June 2021	<b>STDC inspection date:</b>	8 April 2021
<b>Council inspection summary:</b> No obvious changes from the previous year. The structure was no posing any increased navigational hazards at the time of the inspection. STDC also carried out an inspection of this structure during the year under review. Their report was provided to Council on 30 June 2021.			
<b>Survey based monitoring summary:</b> This structure has not been identified as requiring additional, survey based monitoring.			
<b>Overall compliance assessment:</b> Compliant (based on the information available, as summarised above).			
<b>Photos and figures:</b> Patea wharf, facing downstream (8 June 2021).

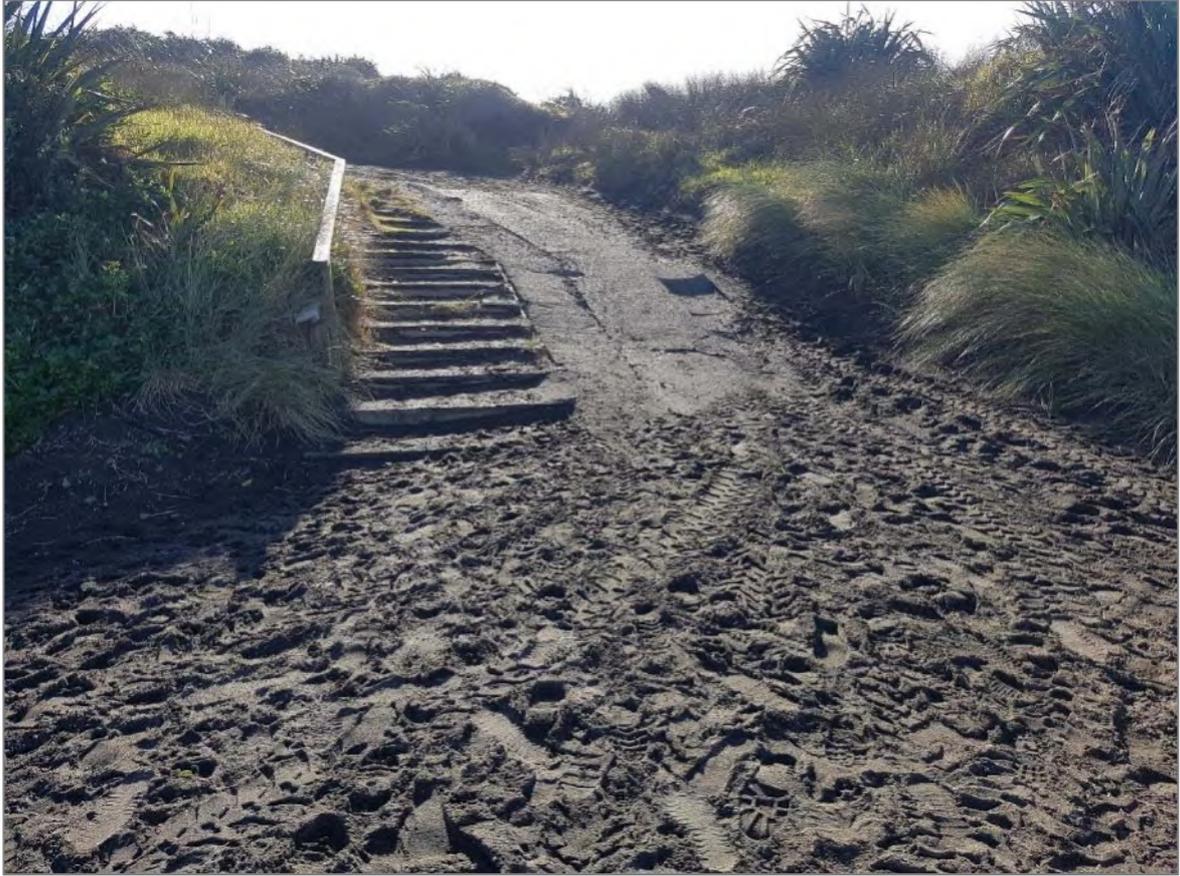
4579-2: Caves Beach access ramp			
<b>Council inspection date:</b>	8 June 2021	<b>STDC inspection date:</b>	8 April 2021
<b>Council inspection summary:</b> No obvious changes from the previous year. Structure is in a fairly degraded state but still appears to be providing safe access to the beach. STDC also carried out an inspection of this structure during the year under review. Their report was provided to Council on 30 June 2021.			
<b>Survey based monitoring summary:</b> This structure has not been identified as requiring additional, survey based monitoring.			
<b>Overall compliance assessment:</b> Compliant (based on the information available, as summarised above).			
<b>Photos and figures:</b> Caves Beach access ramp (8 June 2021).
