Todd Energy Aquatic Centre

Monitoring Programme

Annual Report

Technical Report 2022-62

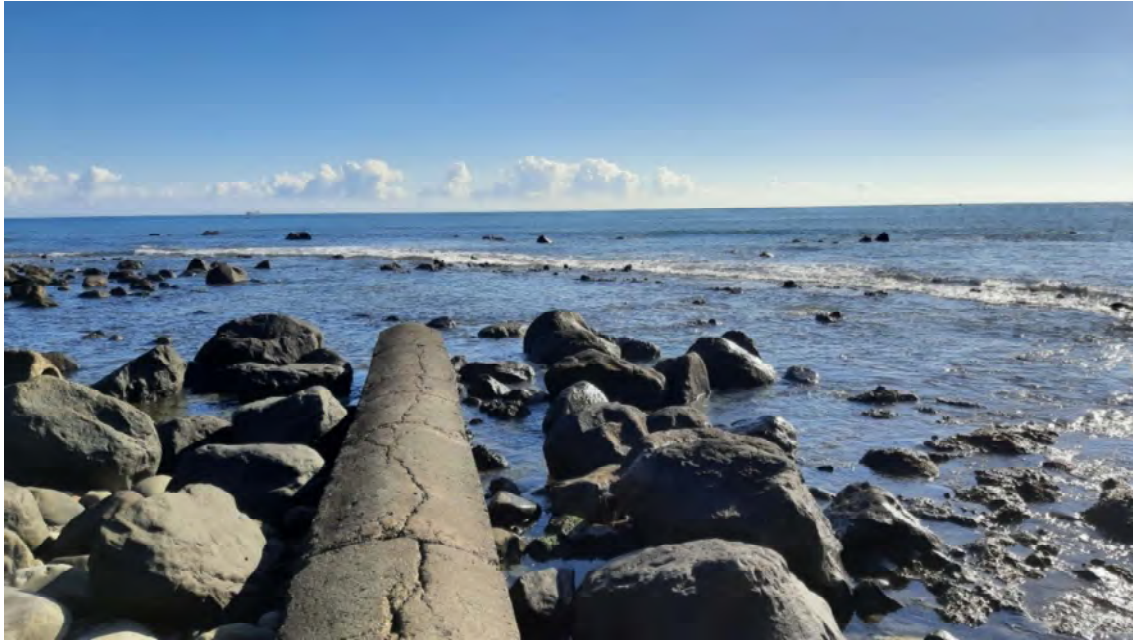
Photo 1 The ocean outfall, situated along the intertidal zone of Kawaroa Reef (5 May 2022)

The ocean outfall was also inspected during the site visit and found to be compliant with consent conditions. Although the structural integrity of the ocean outfall has declined in recent years, the inspection indicated little change since a 2.4 m length of the structure dislodged in the 2016-2017 year.

Environmental performance for consent 4588-3.0 was rated “good” due to the condition of the ocean outfall structure. Although the integrity of the structure has not changed from the previous monitoring period and continues to function effectively as an outlet structure, its condition has deteriorated significantly since installation. Pre-existing cracks along the surface and the previous dislodgment of the end section of the structure warrant careful monitoring.

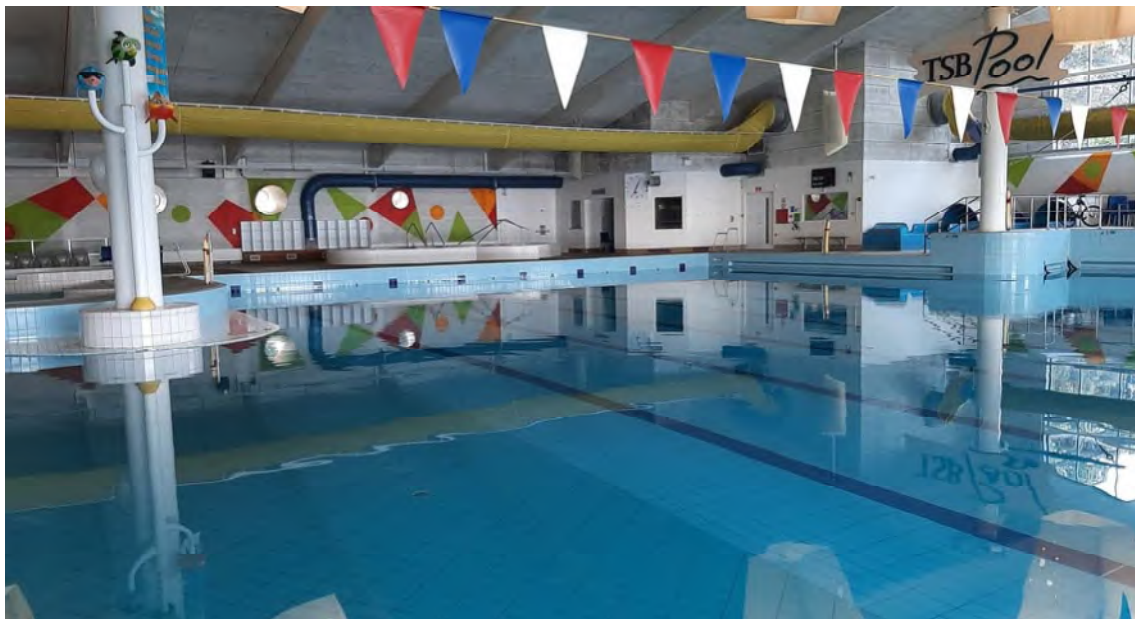
On the morning of 1 February 2022, the Council visited the Aquatic Centre to sample the indoor pool prior to it being emptied for the replacement of its filtration system. Samples were collected at 0810 NZDT and the pool water was clear with no odour at that time (Photo 2). The concentration of total chlorine remaining in the pool water was below the required consent limit (0.5 g/m^3). Aquatic Centre staff advised that the first batch of pool water was to be during their consent window (two hours either side of high tide) that same day (high tide 1048 NZDT, 3.6m). A sample of the receiving waters was taken at 0902 NZDT shortly after the discharge commenced. The coastal waters were turbid and discoloured at the time of discharge.

Photo 2 Todd Energy Aquatic Centre indoor pool ready for discharge (1 February 2022)

The indoor pool sample contained concentrations of suspended solids and oil and grease below laboratory detection limits (Table 2). Concentrations of oil and grease in the shoreline sample were below the laboratory detection and applicable consent limits (2339-4), however the concentration of chlorine in the shoreline sample was at the upper limit of the consent (0.1 g/m^3). The pH was within the typical range for seawater, and the sample contained elevated concentrations of suspended solids most likely attributed to the turbulent conditions of the high energy inshore waters along the coast. The sea did not appear discoloured or otherwise adversely affected by the discharge at the time the samples were taken.

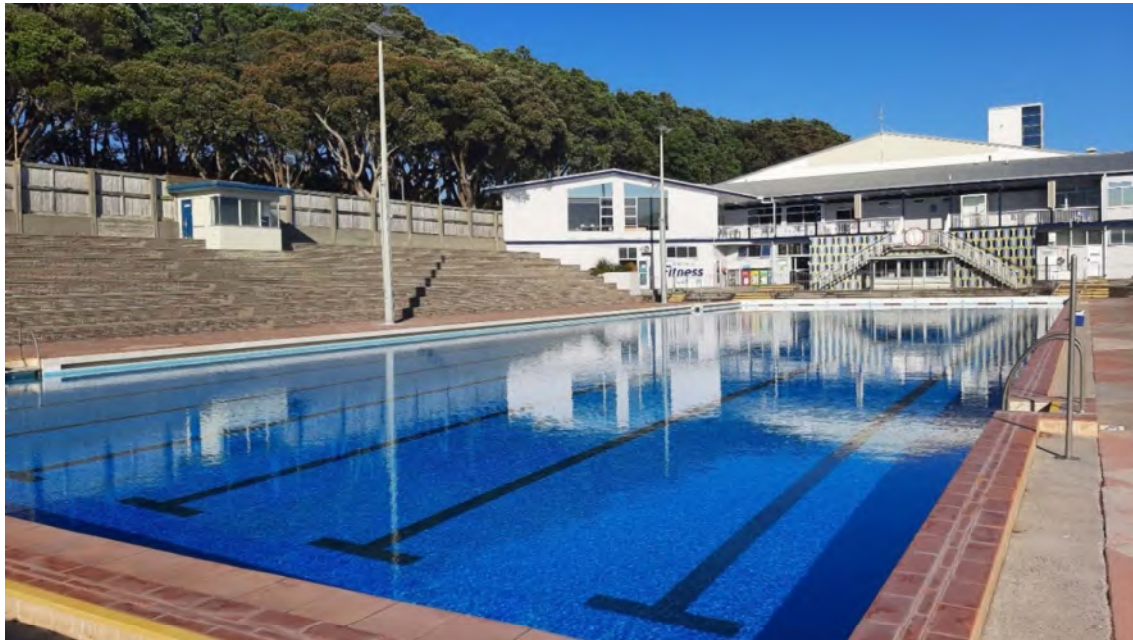
On the morning of 5 May 2022, the Council visited the Aquatic Centre to sample the outdoor pool prior to them being emptied at the end of the summer season. Samples were collected from the main outdoor pool at 0944 NZST and the pool water was clear with no odour at that time (Photo 3). The concentration of total chlorine remaining in the pool water was below the required consent limit (0.5 g/m³). Aquatic Centre staff advised that the first batch of pool water was to be released during their consent window that same day (high tide 1219 NZST, 3.0m). The discharge commenced at 1023 NZST, and a sample of the receiving waters was taken at 1040 NZST.

Photo 3 Todd Energy Aquatic Centre outdoor pool ready for discharge (5 May 2022)

The concentrations of chlorine, suspended solids and oil and grease in the outdoor pool sample were all below laboratory detection limits (Table 3), and all parameters were below their applicable consent limits in both the pool and shoreline samples. The pH was within the typical range for seawater, and the shoreline sample contained low concentrations of suspended solids most likely attributed to the calm conditions of the inshore waters along the coast.

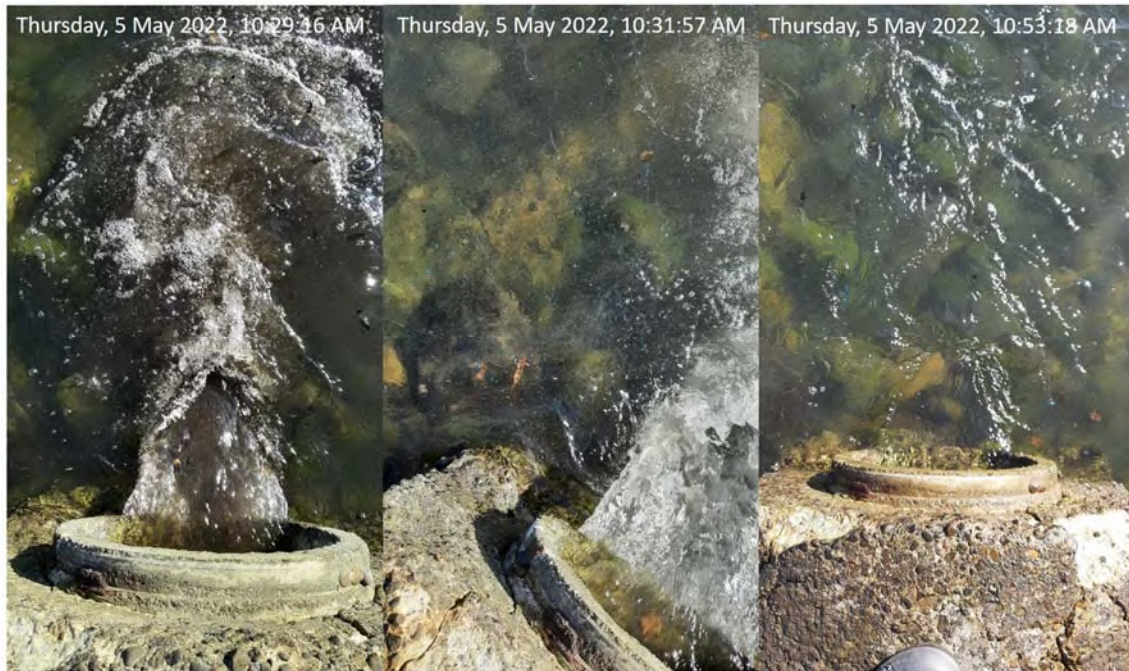
As the discharge onto the reef began, the Inspecting Officer noticed that the discharge was loaded with leafy debris and blue paint chips. It was later found that there was no muslin cloth in place to prevent suspended materials from discharging onto the reef (see Section 2.4). Small paint chips were still discharging when the Inspecting Officer left the reef at 1055 NZST due to the incoming tide, but the Aquatic Centre reported that the flow was temporarily stopped, and a muslin cloth was put onto the main and tots pools discharge valves before starting flow again.

Date	Details	Compliant (Y/N)	Enforcement Action Taken?	Outcome
5 May 2022	Unauthorised discharge of suspended materials (paint chips) onto the reef following the emptying of the outdoor pools	N	N	No lasting adverse effects on local intertidal communities were observed. A review of consent 2339-4.0 was requested in June 2022, resulting in an additional condition being added to the consent which ensures the Aquatic Centre shall prepare and maintain an operation, maintenance and discharge management plan that documents the procedures used on site.

Photo 4 Outdoor pool water discharging from the ocean outfall, showing leafy debris and blue paint chips discharging onto the reef (5 May 2022)

in recent years with regards to the discharge from the ocean outfall and requirements of consent 2339-4.0. An additional condition was added to the reviewed consent which ensures the Aquatic Centre shall prepare and maintain an operation, maintenance and discharge management plan that documents the procedures within the site at Tisch Avenue, New Plymouth (Appendix I; consent 2339-4.1, Special Condition 10).

Reviewed consent 2339-4.1 was granted on 22 August 2022 and included an amendment to condition 2, and the addition of a new condition which ensures the Aquatic Centre shall prepare and maintain an operation, maintenance and discharge management plan that documents the procedures within the site at Tisch Avenue, New Plymouth (Appendix I; consent 2339-4.1).

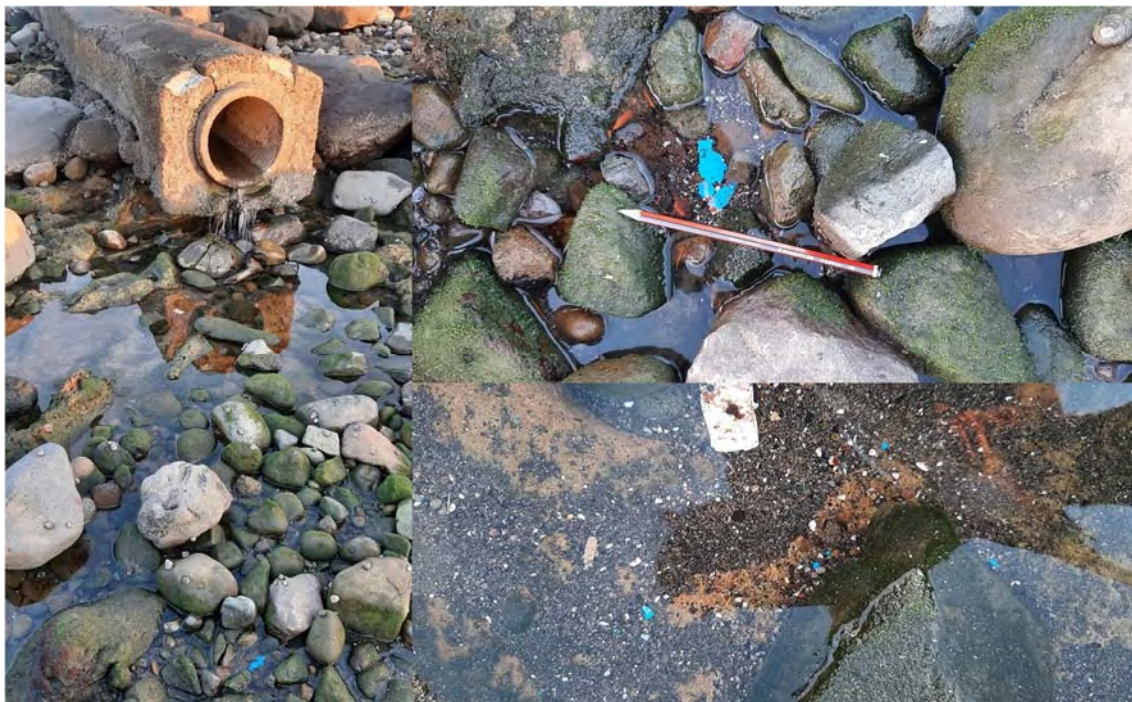
The following ecological reef inspection showed no adverse effects on local intertidal communities observed beyond the 5m mixing zone as a result of the outdoor pool discharge on this occasion (see section 2.3). While some paint chips did remain on the reef after the completion of the discharge, these would have dispersed during subsequent tidal cycles. No adverse effects on local intertidal communities were observed beyond the 5m mixing zone as a result of the outdoor pool discharge on this occasion.

Photo 5 Examples of blue paint chips remaining on the reef in the vicinity of the outfall following the discharge of the Aquatic Centre outdoor pools (6 May 2022)
