Fonterra Kapuni
Monitoring Programme
Annual Report
2020-2021

Technical Report 2021-08

Fonterra Limited (the Company) operates a lactose manufacturing factory plant located on Manaia Road at Kapuni, in the Kaupokonui catchment. The plant processes milk and whey permeate from dairy product manufacture around the North Island. There is also an inhalation grade lactose (IGL) plant on the site operated by another entity, with stormwater discharges from the areas around this activity combined with those of the lactose plant under consents held by the Company. Wastewater from the factory site is disposed of by irrigation onto land on two nearby farms. This report for the period July 2020 to June 2021 describes the monitoring programme implemented by the Taranaki Regional Council (the Council) to assess the Company's environmental performance during the period under review. The report also details the results of the monitoring undertaken and assesses the environmental effects of the Company's activities.

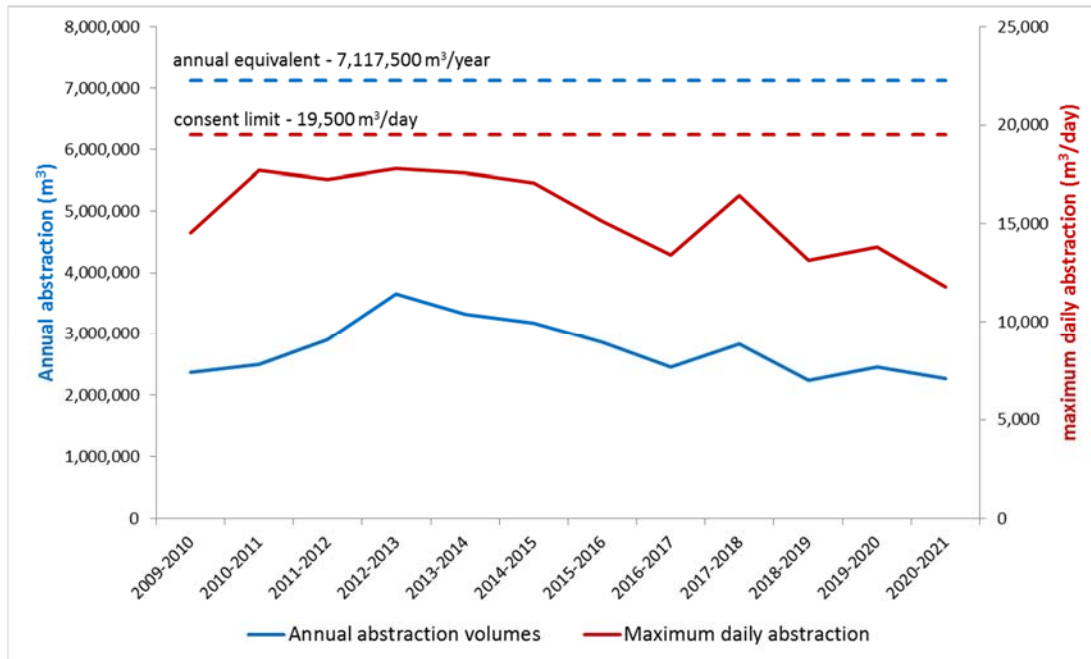
Figure 4 Daily and annual stream abstraction volumes July 2009 to June 2021

The changes in the river abstraction volumes since the 2009-2010 year are illustrated in Figure 4, which shows a general trend of decreasing water abstraction at the site since the 2012-2013 year. It is noted that the graph below is based on the data provided in the Company's monthly reports for the 2009-2020 years and the electronic data provided by the Company for the 2020-2021 year.

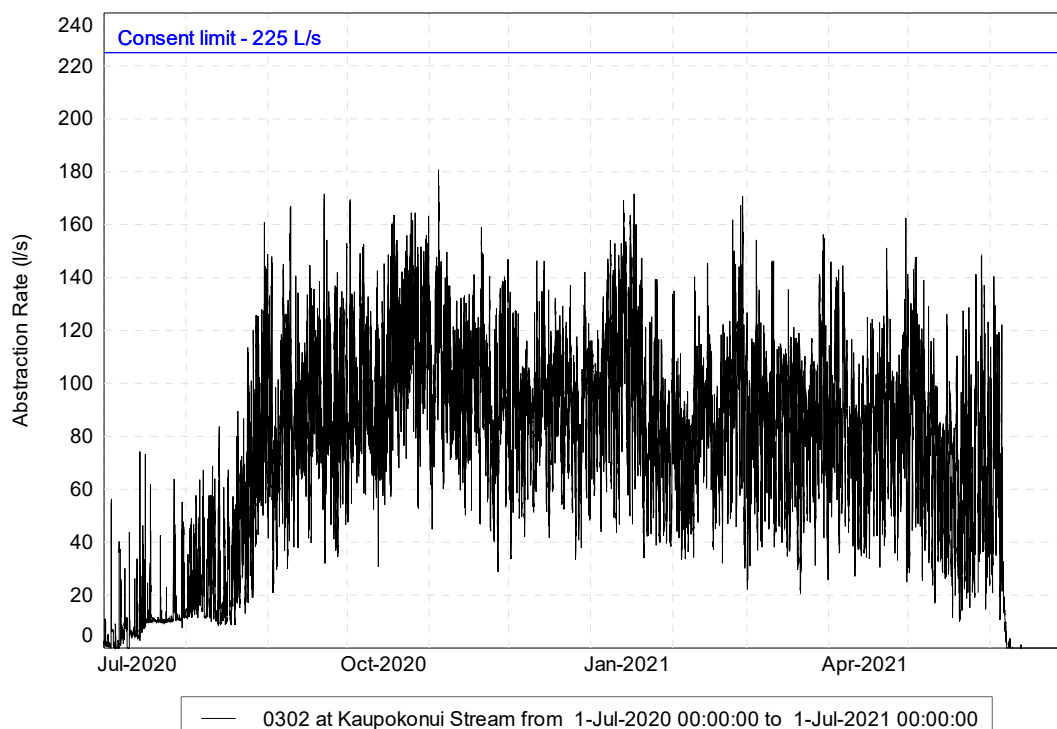
Figure 5 Abstraction rate from the Kaupokonui Stream (consent 0302-3)

The Company's abstraction of water from the Kaupokonui Stream was undertaken in a satisfactory manner and the abstraction rates complied with consent conditions as illustrated in Table 3 and Figure 5. The abstraction rate remained at or below 145 L/s for 99% of the year, with only 1 day, 1 hour and 30 minutes of missing record.

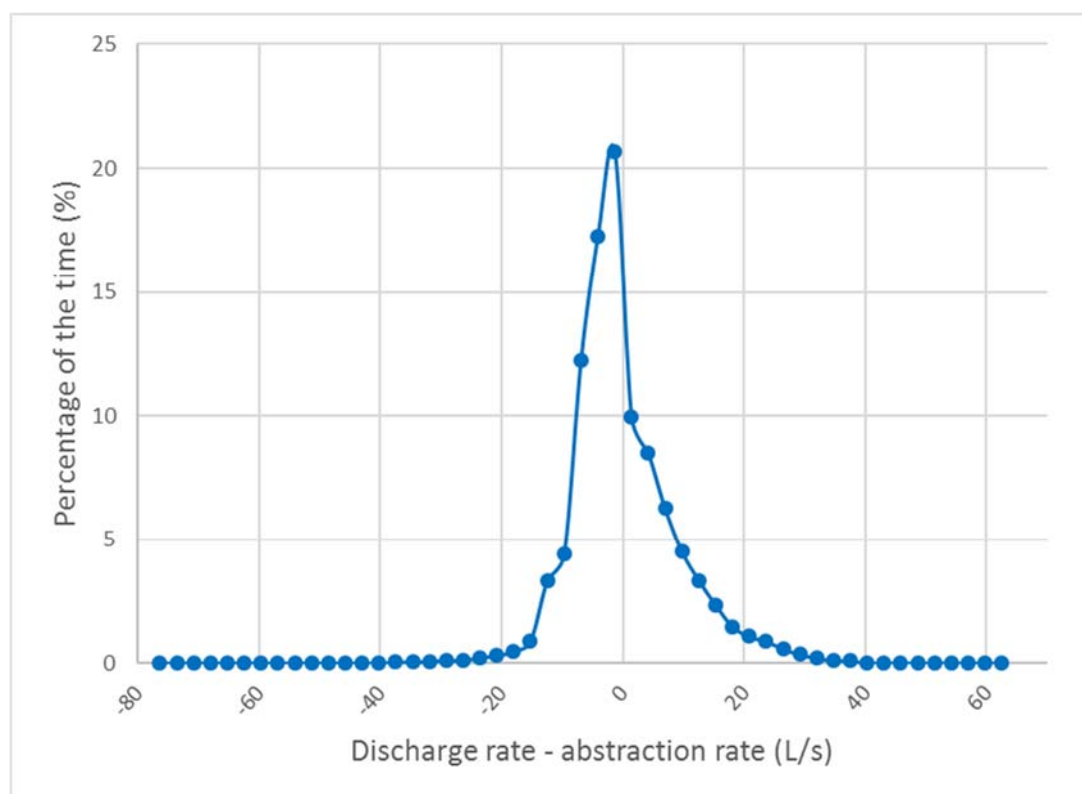
Figure 9 Probability density for the difference between the rate of flow from the cooling tower and the abstraction rate

During the year under review, it was found that the maximum 15 minute average for water usage was 76 L/s and the maximum additional return was 63 L/s.

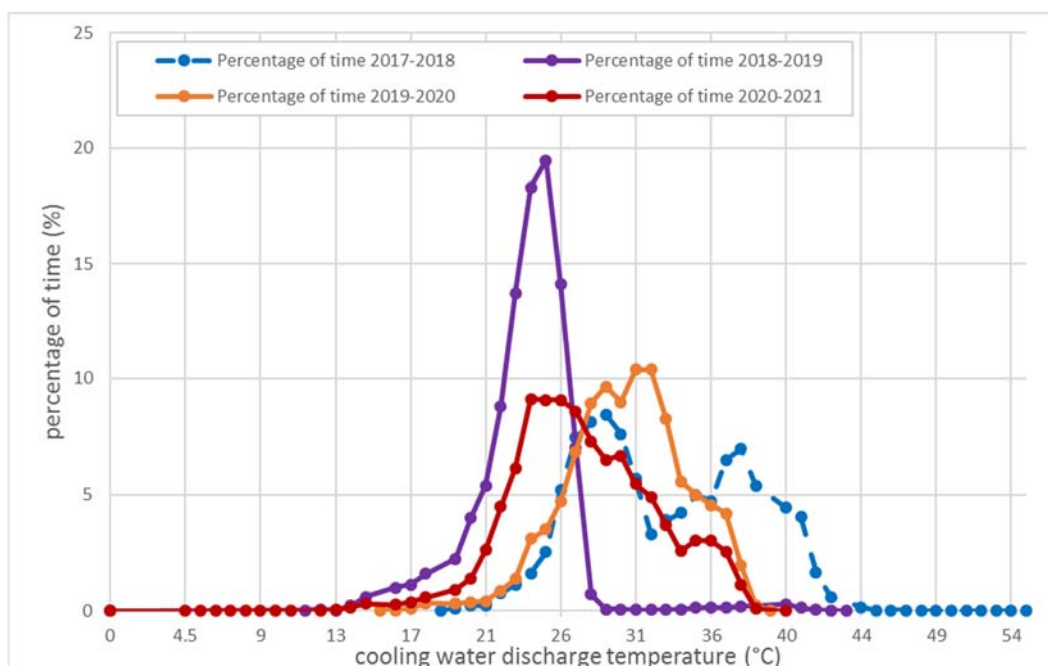
Figure 14 Cooling tower discharge temperature probability density during the 2017 to 2021 years, 1 December-31 March

During the period 1 December to 30 March, the time of year when typically the stream flow is low and the water temperature is higher, the cooling water temperature was at or above 33°C for 16% of the time, and above 35°C for 11% of the time. This in comparison to only 1.3% of the time above both 33 and 35°C respectively during this period for the 2018-2019 year and 48% and 39% of the time respectively for this period in the 2017-2018 year. Whilst there was a significant reduction in the heat load on the receiving environment as a result of the initial improvements in operational management of the cooling tower in the 2018-2019 year, the reduction in heat load had been lessened by the further operational changes that were adopted in the 2019-2021 years, as illustrated in Figure 14.

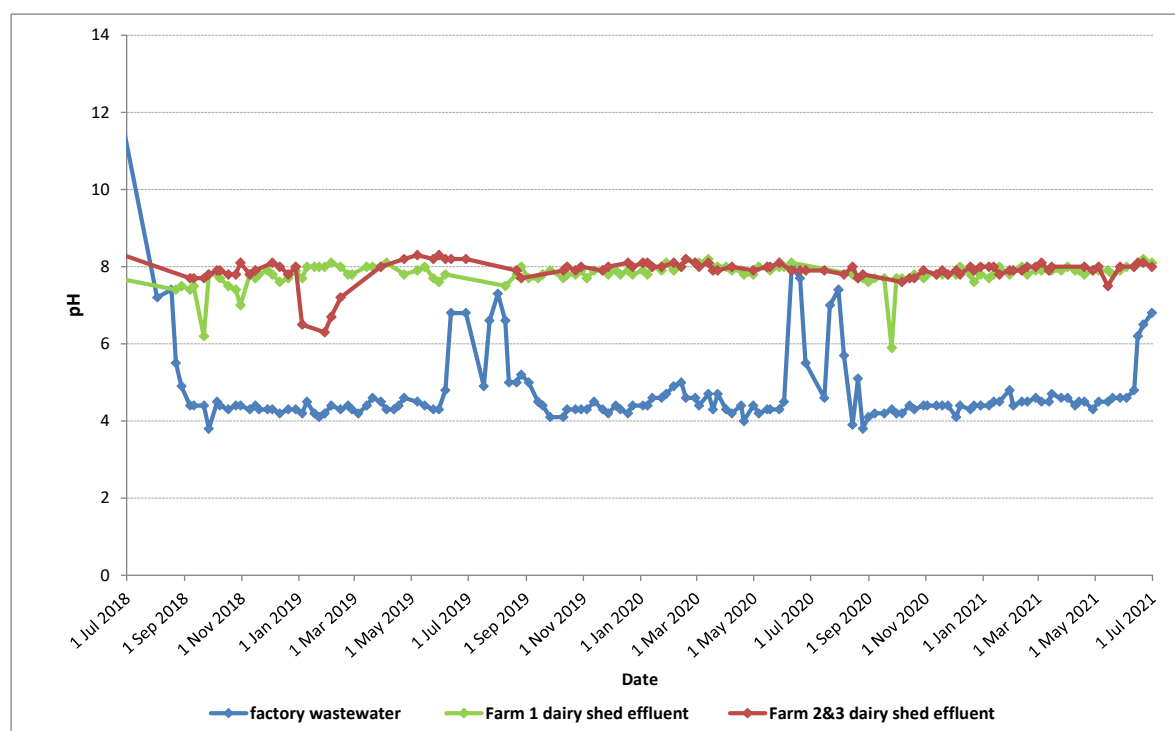
Figure 25 pH of the factory wastewater and dairy shed effluents during the year under review, with previous two years for comparison

The DSE has generally been found to have much lower organic (BOD compared to BOD and COD, Figure 24) and higher mineral strength than factory wastewater (for example potassium, Figure 30), and is slightly alkaline (Figure 25). During the 2018-2019 year it was found that the organic strength of the DSE from Farm 3 exceeded that of the factory wastewater through February and March due to a breakdown of the separator which allowed more solids through to the DSE irrigation pond. This trend has not repeated in the 2019-2021 years (Figure 24). In the 2018-2019 year it was found that the Farm 3 DSE had an oxygen demand, total nitrogen (Figure 26), calcium (Figure 29), potassium (Figure 30) and phosphorus concentrations (Figure 31) that were between two and three times higher than in the previous year. The elevated concentrations occurred during the period January to April. Again this has not reoccurred during the year under review. In the 2019-2021 years the effluent from Farm 1 has had higher median component concentrations than that of Farms 2 and 3, which is in contrast to the 2018-2019 year. The change is a result of both a substantial increase in the median strength of the Farm 1 effluent and a substantial reduction in the median strength of the Farm 3 effluent when compared to the 2018-2019 year. The reduction in the strength of the Farm 3 effluent is likely to be as a result of the separator functioning correctly since the

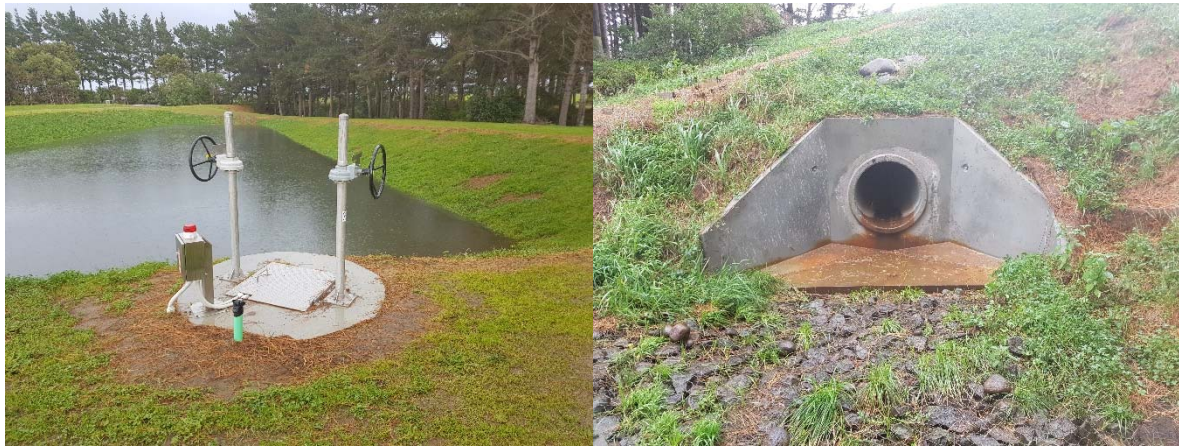
Photo 1 Northern stormwater pond, stop valves and outfall to the Kaupokonui Stream

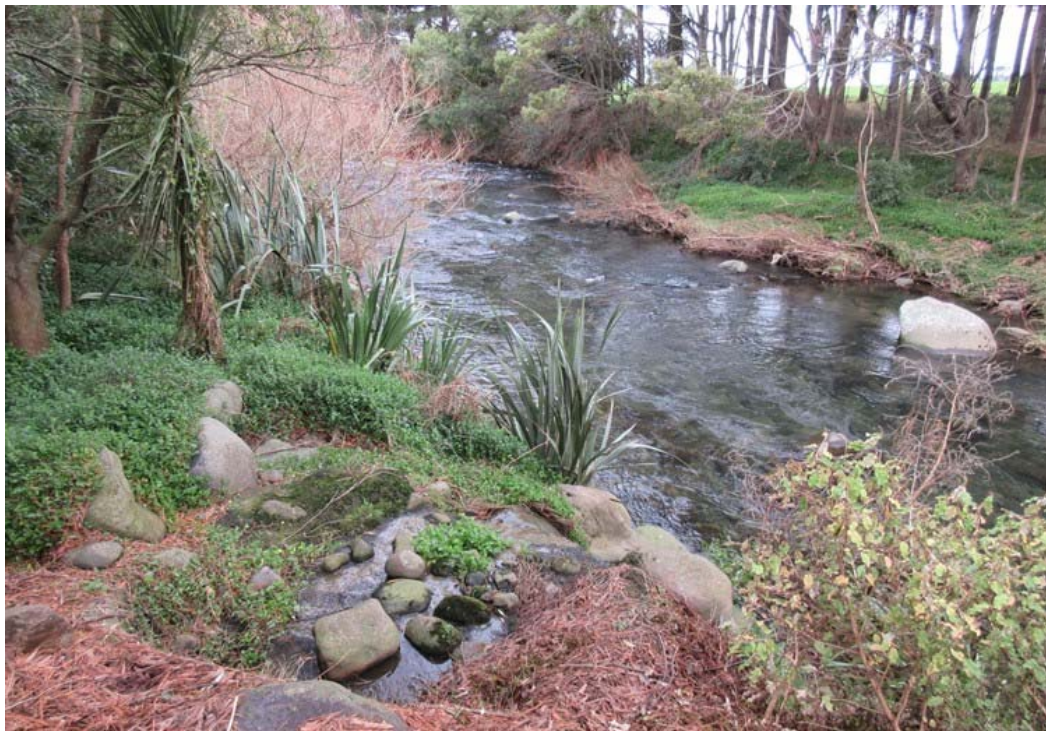
Photo 3 Outfall from the southern stormwater pond to Kaupokonui Stream (STW002078)

A sample was collected from the outlet of the stormwater pond (Site STW002078, Table 21 and Photo 3) on only one occasion during the year under review. This was sampled at a separate site visit as the pond was found to be at a low level and not discharging at the time of the monthly inspections. Sampling showed that the BOD continues to be slightly elevated in the stormwater from this area of the site and that the suspended solids concentration exceeded the limit on the consent.

At the inspection undertaken on 25 June 2021 it was confirmed that the southern pond was only discharging from the upper discharge and the lower discharge had been removed from service whilst ongoing investigation continued into the quality of the stormwater in the pond.
