# **NPDC Colson Road Landfill**

Monitoring Programme
Annual Report
2022-2023

Technical Report 2023-01

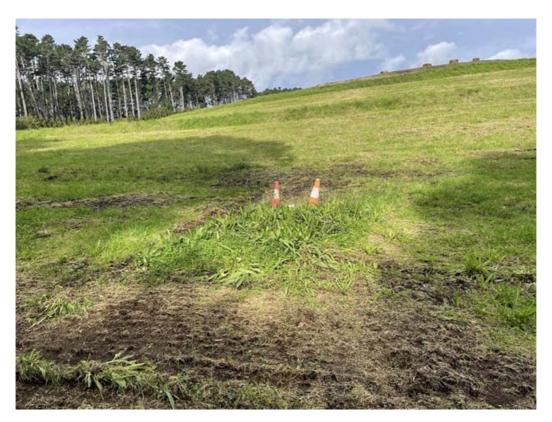
Contouring, preparation work and the application and stabilisation of areas of the final cap has continued during the year under review (Photo 1 and Photo 2). A site closure plan (CP) has been prepared for NPDC that has been reviewed and accepted by Council, which NPDC is continuing to follow. This is discussed further in Section 2.1.3.

Photo 1 Stabilised northern toe of Stage 3, May 2023

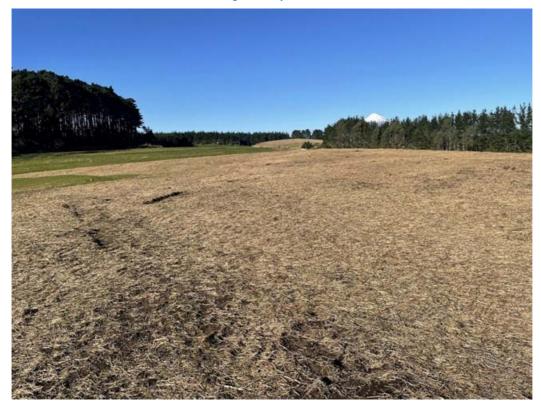
Photo 2 Top of Stage 3 cap looking south, June 2023

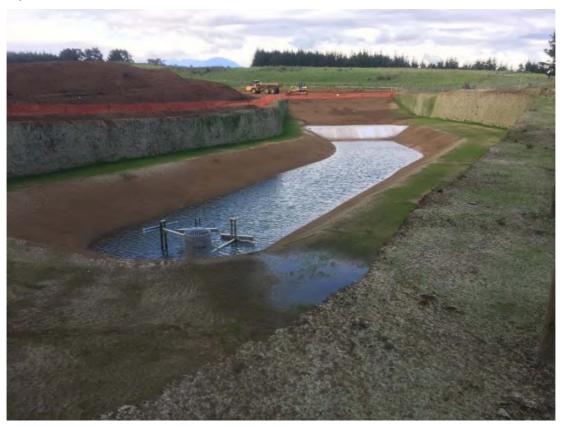
To enable sufficient cover material to be accessed from within the property boundary, works have been undertaken in the south-eastern area of the site, which was the former composting area. These works included installing drainage around the composting area previously occupied by Return2Earth and Revital. Sediment discharges from the borrow area are treated by a separate sediment pond (Photo 3), with the

Photo 3 Borrow area sediment pond, November 2020

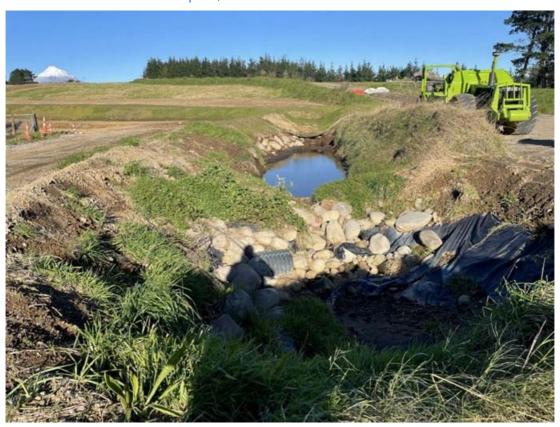
catchment area to this pond having been expanded to enable treatment of the stormwater from the Stage 2 cap remediation works (Photo 4).

Photo 4 Amended drainage and access during capping works for Stage 2 remediation, June 2023

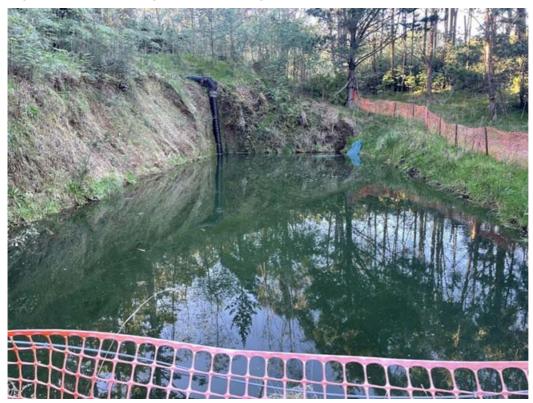
The sediment treatment system for Stage 3 was upgraded during the 2020-2021 year. This was undertaken following an analysis of the erosion and sediment control measures in place at the site and associated recommendations. These upgrades included the addition of a pretreatment pond (Photo 5) prior to the large silt pond and floating decants in the large silt pond (Photo 6).

Photo 5 Pretreatment pond for large silt pond, June 2023

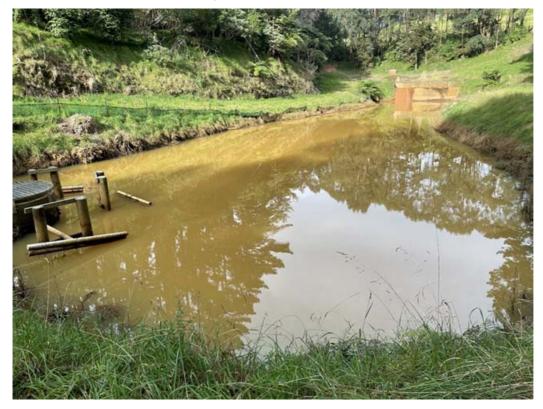
Photo 6 Floating decant system in the large silt pond, May 2023

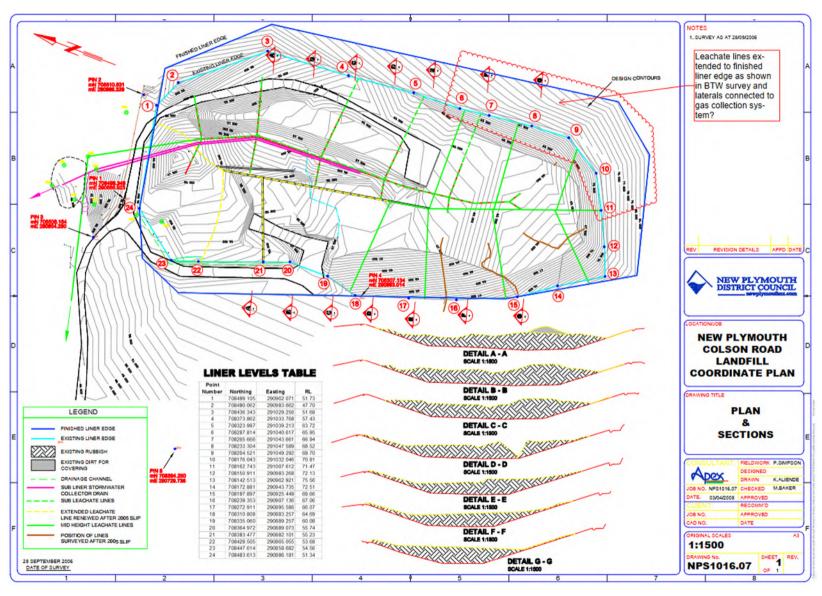
Figure 2 Location of Stage 3 leachate and under liner groundwater collection lines

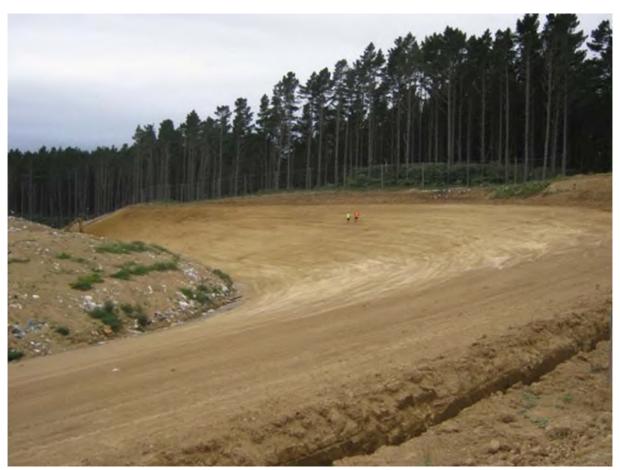
During the 2013-2014 year, the lining of Stage 3 was completed so that the liner covered Stage 3's entire footprint (Photo 7). From this point on, there was an increase in the amount of potentially contaminated stormwater generated due to the increase in the lined and filled area, and this was therefore directed to the leachate collection system for discharge via the New Plymouth wastewater treatment plant. From this point in time, the volumes of leachate/contaminated stormwater generated exceeded the instantaneous capacity of the pipe to the waste water treatment plant on occasion. Therefore the flow from Stage 3 to the leachate system is controlled via a shut off valve to minimise the potential for overflows to the Puremu Stream, when required. Under these circumstances excess leachate/contaminated stormwater is stored within Stage 3 of the landfill.

Photo 7 Stage 3 extension works, February 2011

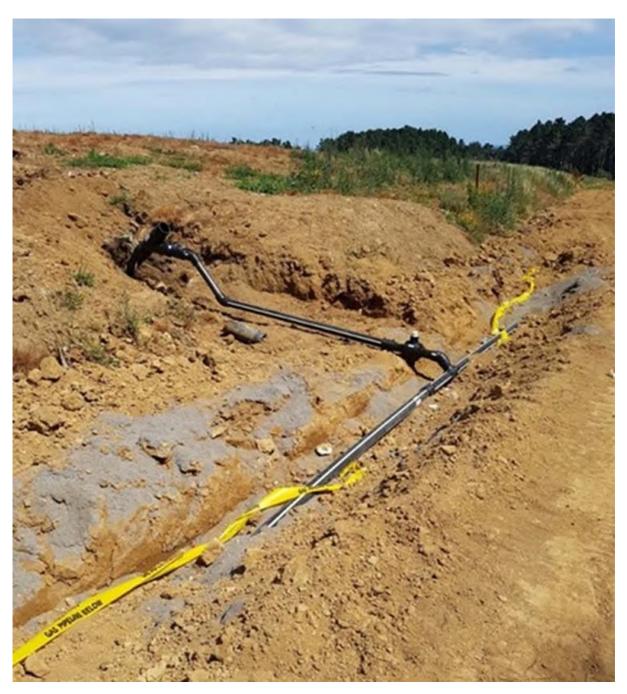
Photo 8 Leachate pipes feeding into the gas collection system

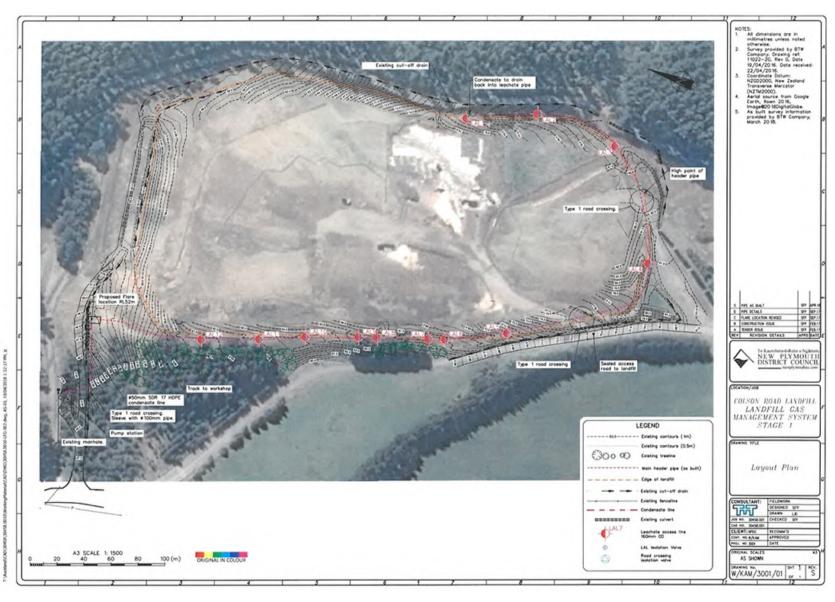
Figure 3 As built drawing of the stage 1 landfill gas collection system

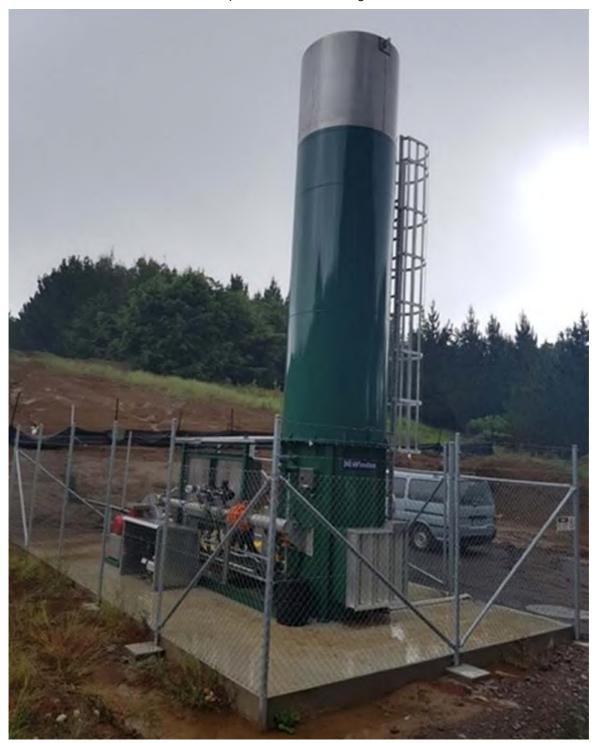
During 2017-2018 a fully enclosed gas flare was installed at the site. It is noted that although the landfill is no longer accepting waste, the landfill could continue to produce potentially odorous gas for up to 30 years post closure.

Photo 9 The fully enclosed flare

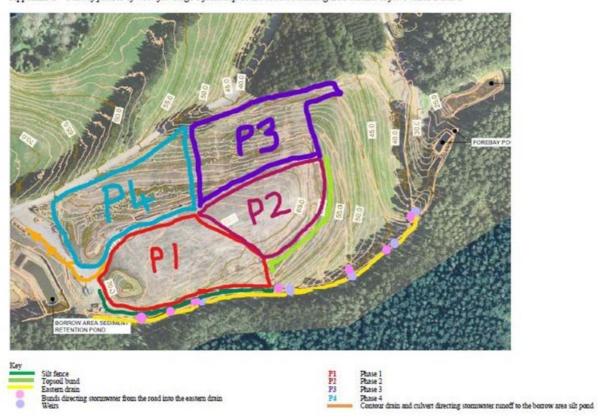
Figure 7 Plan of phases of work for Stage 3 final cap construction.

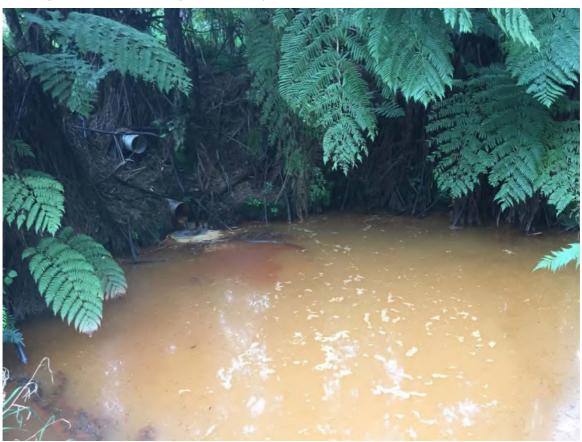
Photo 10 Western small silt pond, 13 September 2021

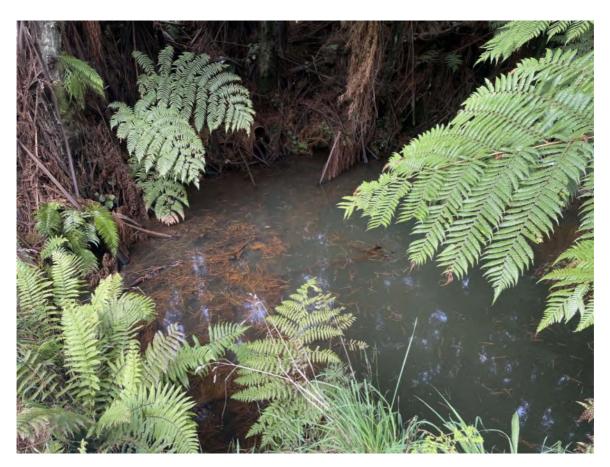
Photo 11 Western small silt pond, 27 March 2023

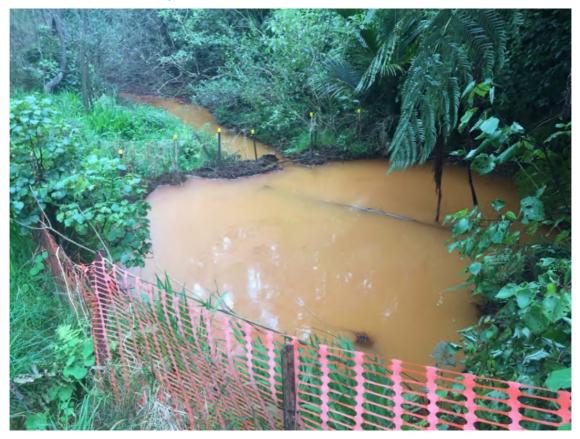
Photo 12 Eastern small silt pond and tributary, 13 September 2021

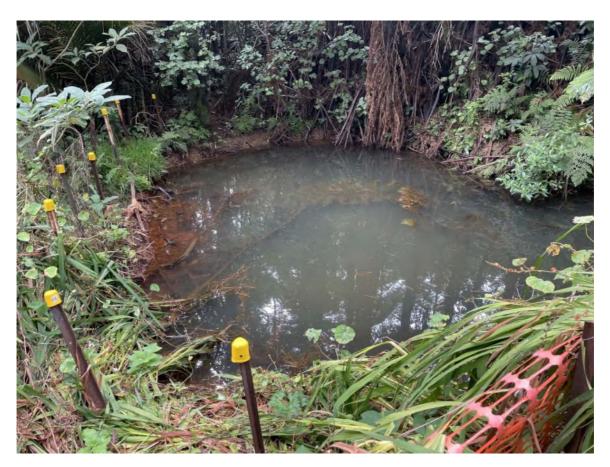
Photo 13 Eastern small silt pond and tributary, 27 March 2023

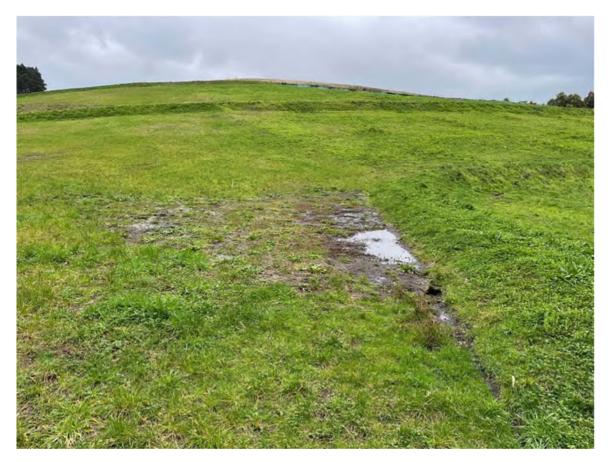
At the inspection on 16 July 2022 it was found that the majority of the site had been seeded following the previous construction season, with hay mulch applied and grass growth starting to establish. It was noted however that there were still some bare patches on the northern end of Stage 3. The inspecting officer was informed that stabilisation of this area was planned, but so far the weather had prevented this from being carried out. There was very good grass growth over the northern face. There was clear water in the northern bunds but no flowing water. There was a very small area of ponding on the bottom north eastern corner (Photo 14). The contractor advised that this area would be built up during the next construction season, when the cap was dry enough for machinery to access the area. This was found to have been done at the time of the October inspection.

Photo 14 Small area of ponding, 19 July 2022

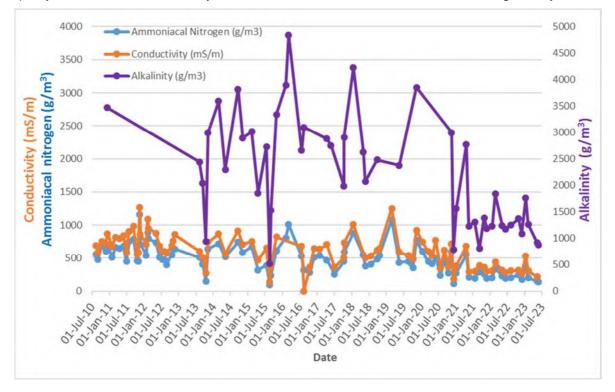
The results gathered by NPDC during the year under review reflect typical leachate quality. It appears that there may be a trend of decreasing leachate strength in recent years (Figure 8). However, it is noted that the concentration variations within each parameter are also likely to reflect seasonal variations in leachate quality and the dilution afforded by the contaminated stormwater that is diverted through this system.

Figure 8 Combined site leachate discharge alkalinity, conductivity and ammoniacal nitrogen, July 2010 to date

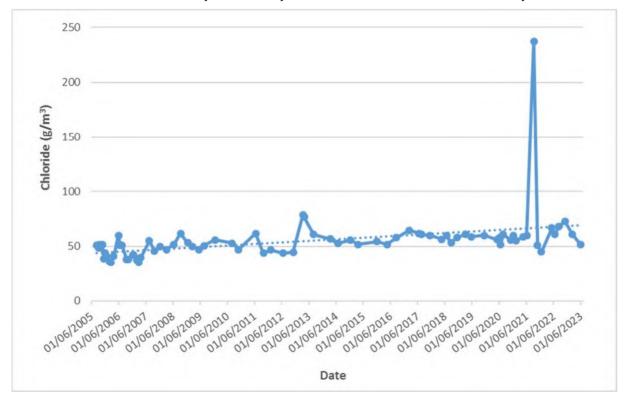
The chloride results (as shown in Figure 10) indicate that although there was a trend of increasing chloride concentration in the 2005 to 2017 years, this may have stabilised somewhat in more recent years.

Figure 10 Full time series data for the chloride concentration of the under liner drainage

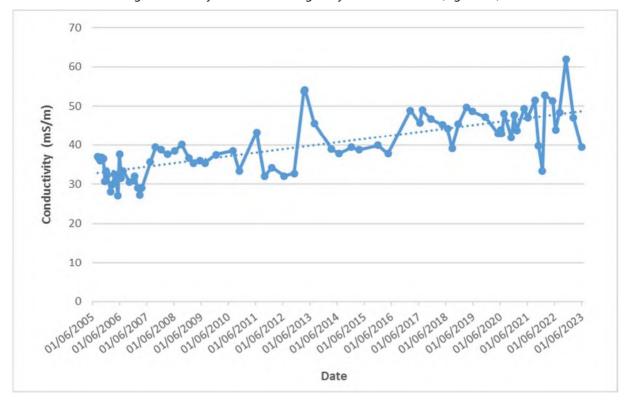
The trend of increasing conductivity continued during the year under review (Figure 11).

Figure 11 Full time series data for the conductivity of the under liner drainage

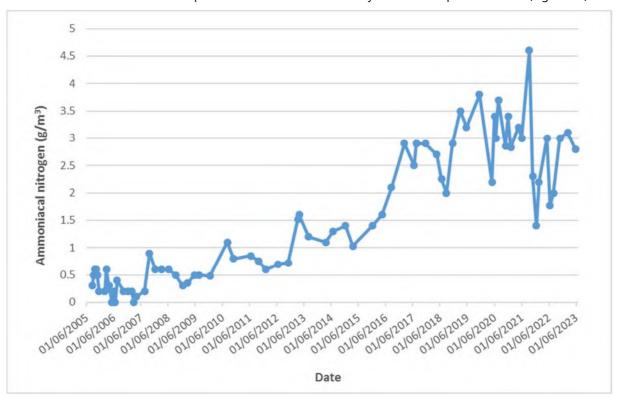
The ammoniacal nitrogen concentration of the under liner groundwater drainage was generally somewhat lower than it had been in the samples collected between February 2019 and September 2021 (Figure 12).

Figure 12 Full time series data for the ammoniacal nitrogen concentration of the under liner drainage

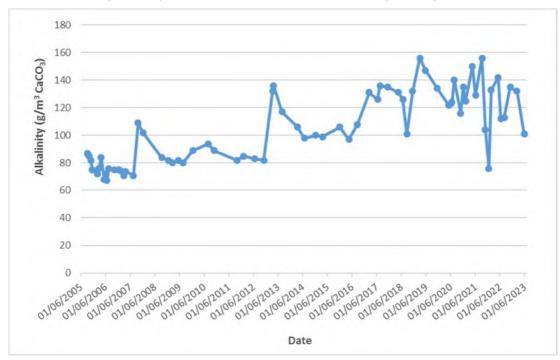
The alkalinity of the under liner groundwater drainage may have stabilised in recent years following the trend of increasing alkalinity that was apparent in the 2005 to 2021 years (Figure 13).

Figure 13 Full time series data for the alkalinity of the under liner drainage

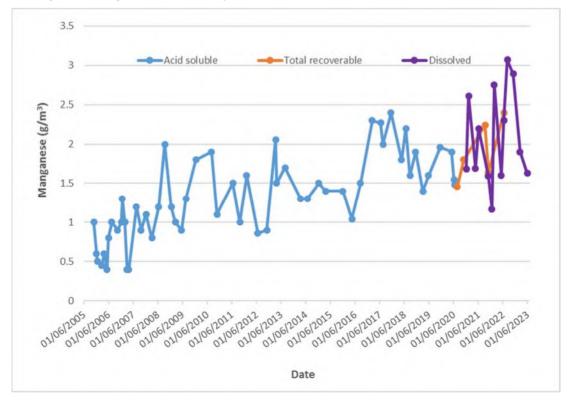
When looking the potential continuation in the trend for manganese concentration that may have occurred in more recent years, the change from determining the total manganese concentration to determining the dissolved manganese concentration has made this more difficult to evaluate. It is clear, however, that there have again been significant (potentially) seasonal variations.

Figure 14 Full time series data for the manganese concentration of the under liner drainage

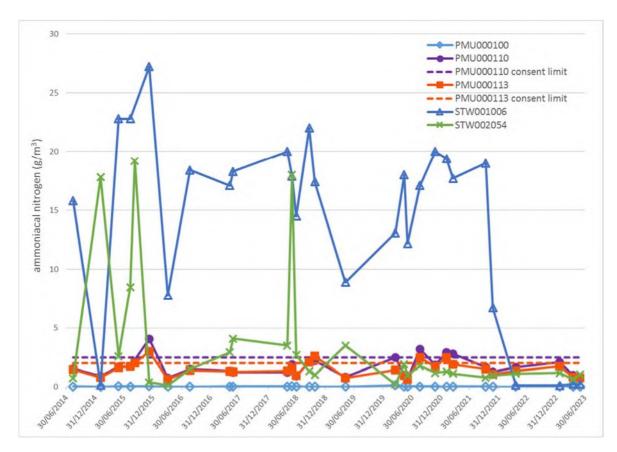
An investigation was undertaken by NPDC following a non-compliance with the ammoniacal nitrogen concentration in the 2020-2021 year. This investigation identified that it was likely that leachate and/or contaminated groundwater from under Stage 1B was discharging to the STW001006 pond, via underground stormwater pipes. In October 2021, the clean stormwater was diverted away from the underground pipes, and the leachate/contaminated stormwater was diverted away from the stormwater pond to the leachate system. Figure 16 shows the significant reduction in the ammoniacal nitrogen concentration of the stormwater pond discharge samples collected following these diversions. The start date of June 2014 has been chosen for use in the following graphs due to the increased number of stormwater results for comparison with the receiving environment monitoring.

Figure 16 Ammoniacal nitrogen concentration in the Puremu Stream and stormwater discharge samples, June 2014 to date (includes wet weather samples)

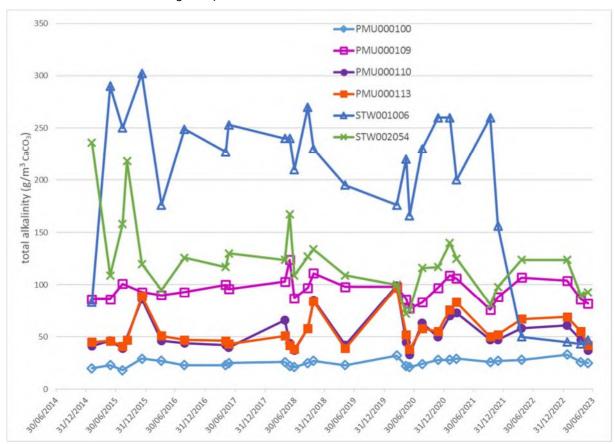
A reduction in the total alkalinity (Figure 17) and conductivity (Figure 18) of the discharge from the small eastern silt ponds has also occurred following the diversion below Stage 1B. Historically, the influence of both the small western and large silt ponds had been notable at PMU000113.

Figure 17 Total alkalinity in the Puremu Stream and stormwater discharge samples, June 2014 to date (includes wet weather samples)

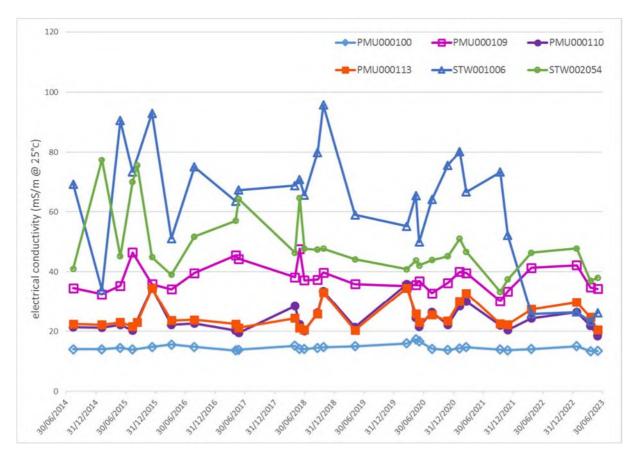
Figure 18 Conductivity in the Puremu Stream and stormwater discharge samples, June 2014 to date (includes wet weather samples)

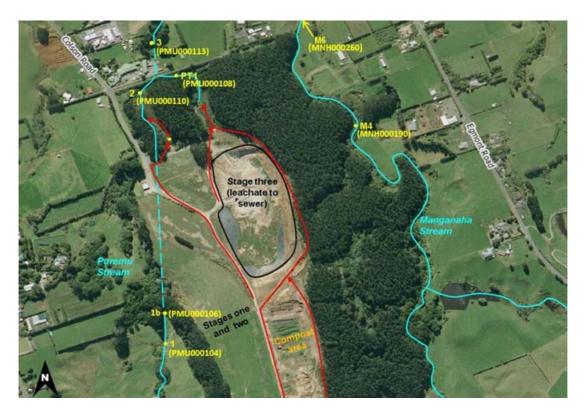
Figure 19 Biomonitoring sites related to the Colson Road landfill, New Plymouth. The red lines on the aerial photograph indicate the direction of stormwater runoff from the landfill site

The sites sampled are described in Table 12 and their locations are shown in Figure 19. During the year under review, the surveys were undertaken on 20 October 2022 and 16 February 2023.

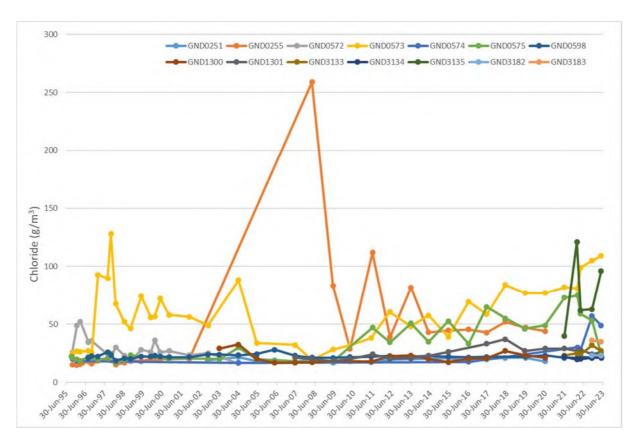
In bores GND0573 (down gradient of Stages 1 and 2) and GND0575 (down gradient of Stage 3) there had been an emerging trend of increasing chloride concentrations and conductivity in the groundwater at these locations. It was thought that this may be indicative of some minor leachate contamination. These trends have continued in GND0573, but not in GND0575. In the case of chloride at GND0575, there has been successive reductions in this parameter in the samples collected during the last three sampling surveys.

Figure 20 Chloride concentrations in the Colson Road groundwater bores

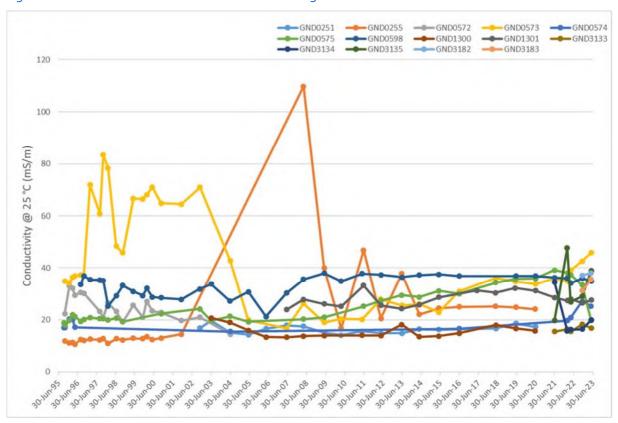
Figure 21 Conductivity in the Colson Road groundwater bores

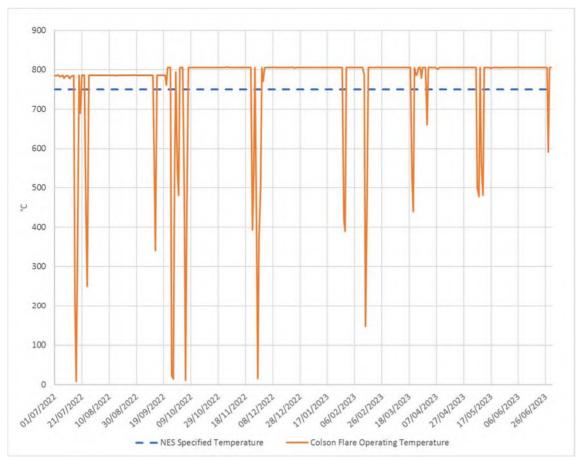
The full year's data was provided in the form of daily average temperature, gas flow, and methane concentration in the feed gas collected by the monitoring system that is integrated into the flare system (Figure 23 and Figure 25).

Figure 23 Colson Road landfill flare temperature for the year under review

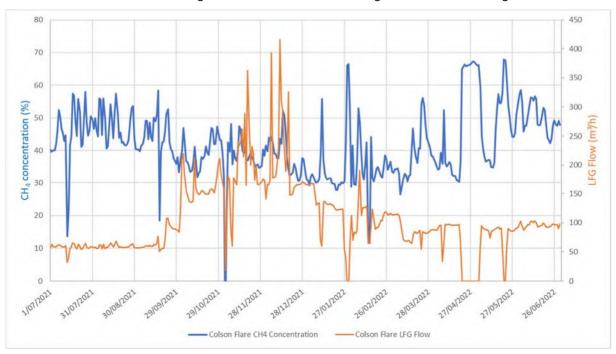
In terms of the changes in the landfill gas quality, whilst it is expected that the landfill gas generation will decrease in time, this may not occur for several years. The reduction in methane concentration that occurred at Colson Road coincided with a significant increase in the landfill gas flow to the flare (Figure 25).

Figure 25 Flare feed gas flow rate and methane concentration during the 2021-2022 year

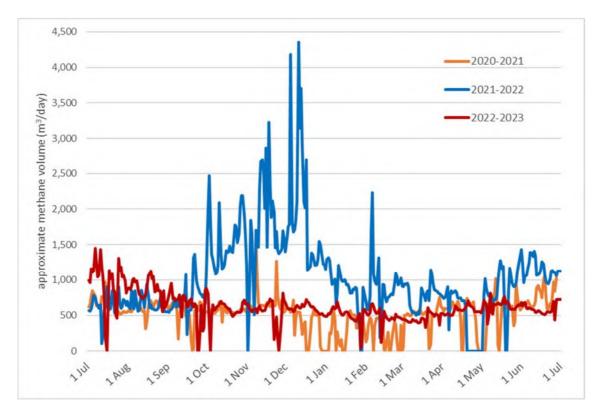
This holistic view of the flare monitoring data confirms that whilst the methane concentration of the feedstock gas was significantly lower in the 2021-2022 year, due to the increased gas flow rate to the flare, a greater volume of methane was extracted and treated by the flare during that year. This indicates that it was likely that, during the 2021-2022 year, there was an ingress of air into the system that was diluting the landfill gas. During the year under review, there was a reduction in both the landfill gas volume and the methane volume when compared to the previous year. The annual volumes were however higher than in the 2020-2021 year, indicating that the ingress of air into the system was avoided during the year under review. Although there has been no significant decrease in landfill gas generation since site closure, peak production may have occurred in the 2021-2022 year.

Figure 27 Approximate daily methane volumes flared in the 2020-2021 to 2022-2023 years

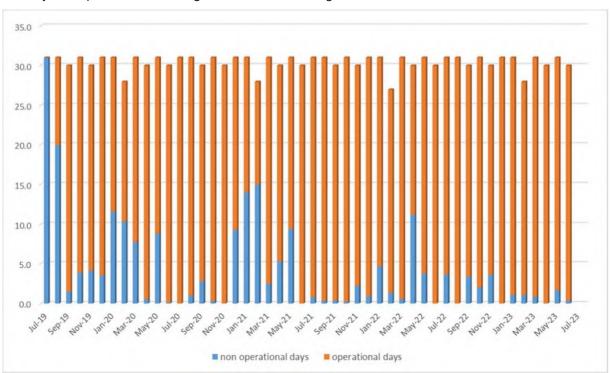
A flare fault log was provided for the year under review. This showed that there was a total of 18 non-operational days in the 2022-2023 year (15 shutdowns in total). This is 4.9% of the year (compared to 7.4% in the 2021-2022 year). The length of the outages varied and were affected by the response being possible only during normal working hours. The shortest outage was just under 5 hours and was to provide for the annual service of the flare system. The longest outage was 2 days and 10 hours days. A summary of the monthly non-operational hours is given in Table 17 and Figure 28.

Figure 28 Monthly operational/non-operational days for the Colson Road landfill gas flare for the 2019 to date

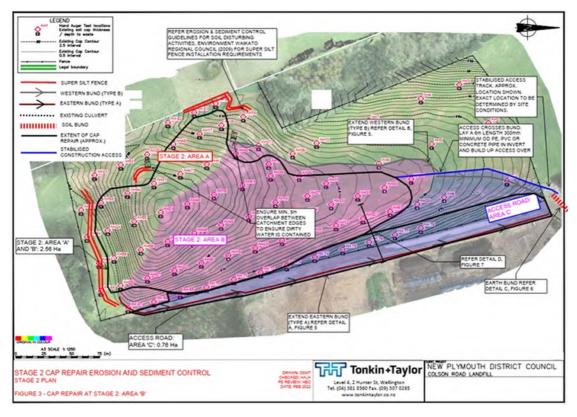
the access road. This was added to the area for planned mitigation works which is identified as Access Road area C in Figure 29. This resulted in a further extension to the timeframe on the abatement notice. During the 2021-2022 year, Stage 2: Area A was completed. The remaining area was completed during the year under review and the abatement notice was found to have been complied with at inspection on 28 April 2023.

Figure 29 Phasing of Stage 2 cap repair

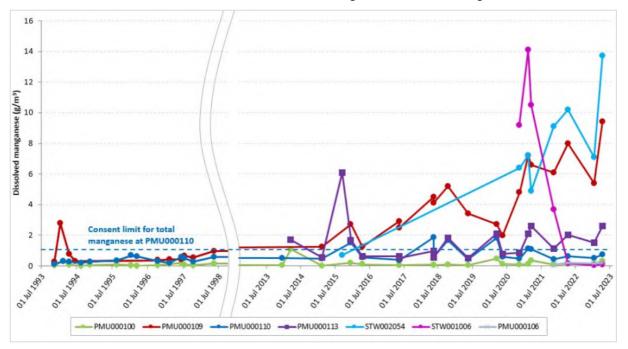
In the 2015 to 2021 years, the total manganese concentration at the compliance point for Consent 2370-3 was exceeded in five out of 12 samples. In contrast, no exceedances occurred during the year under review. The historical results for the more bioavailable dissolved manganese are shown in Figure 30.

Figure 30 Dissolved manganese concentrations in the wetland polishing area and Puremu Stream
