# South Taranaki District Council Closed Landfills (Eltham, Hāwera, Kaponga, Manaia, Pātea, Ōpunake and Otakeho)

Monitoring Programme

Annual Report

Technical Report 2023-47

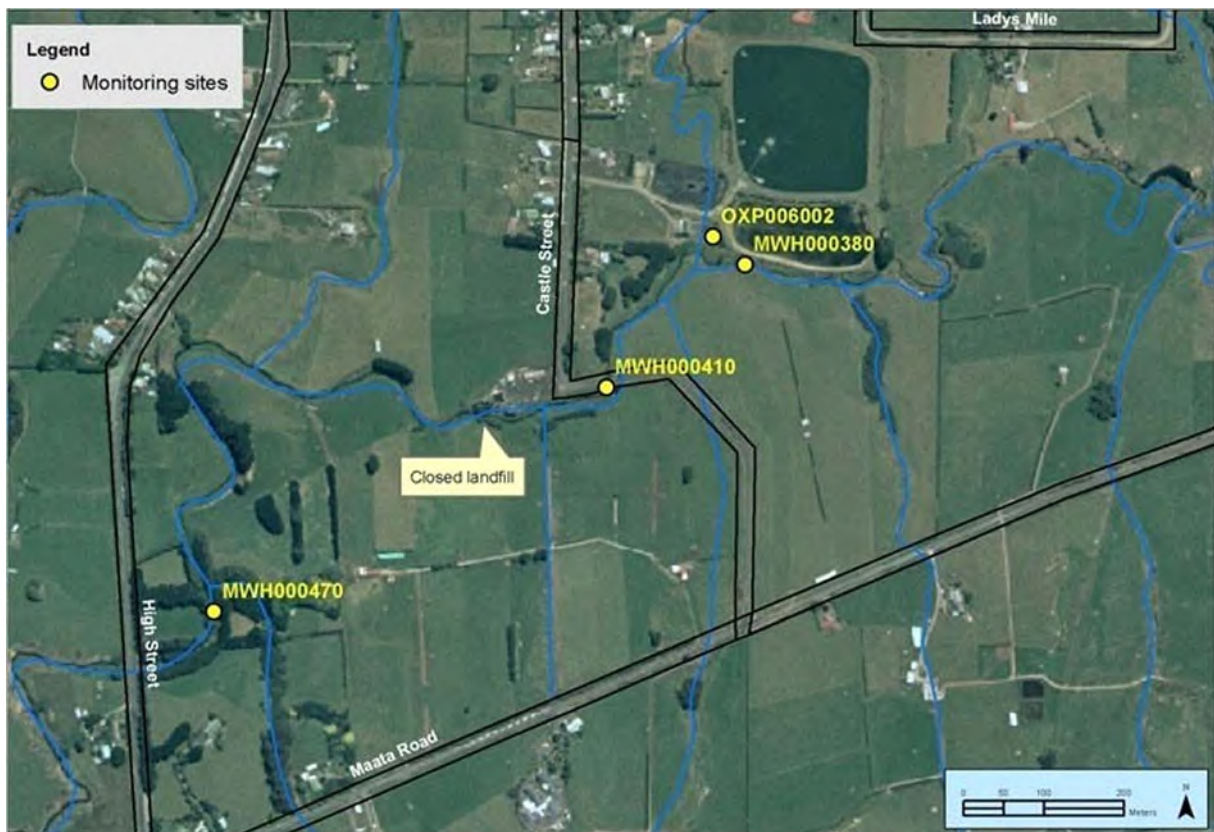
Figure 2 Eltham landfill and sampling sites (not currently monitored)

Inspections of the closed landfill were undertaken on 30 November 2022, 27 February 2023 and 22 May 2023. There was good pasture growth over the landfill cap and no slumping or leachate discharge was observed. No adverse environmental effects from the closed landfill were noted.

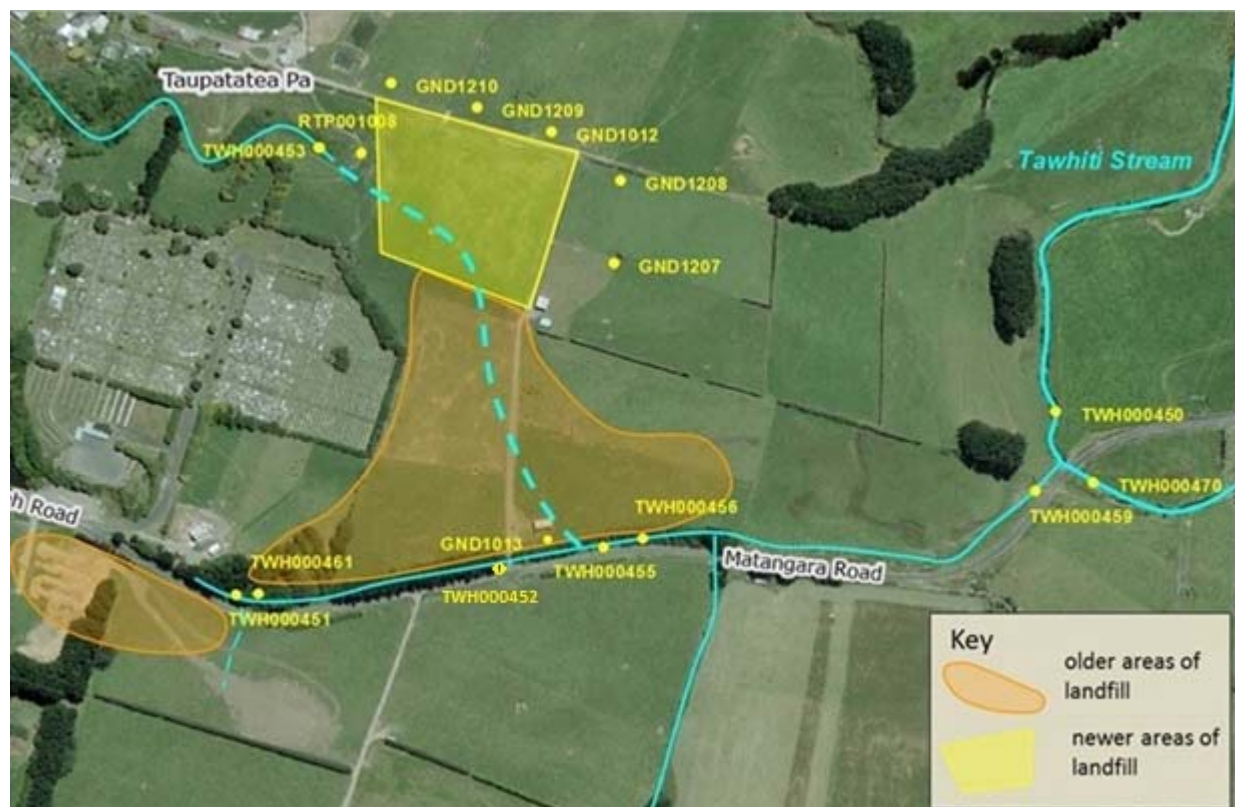
Figure 3 Aerial view of Hāwera landfill and sampling sites

The cap was intact and well-grassed, with no sign of ponding. No slumping, cracking or erosion was noted. The batters were tidy and well-maintained. The leachate system was tidy and operational with no sign of spill or overflows. No odours were detected in the vicinity of the cap. Methane was not detected during inspection. The site was fully fenced and secure with permanent fencing, however there was evidence of cows in the paddock upstream of the leachate system, with cow pats and pugging near the upstream sampling site (TWH000453). No odour or dust issues were noted. Surface water samples were also collected during this visit. The inspecting officer was notified that monitoring bore GND1208 was recently knocked over by farming equipment and is in need of repair.

The roadside tributary continues to show moderate levels of contamination, mostly in the form of BOD, iron and ammoniacal nitrogen. Historically, the uppermost monitoring site in the roadside tributary has been found to contain similar levels of contaminants to the landfill tributary at the culvert outlet, which is unsurprising given the extent of historical filling in the area as shown in Figure 3.

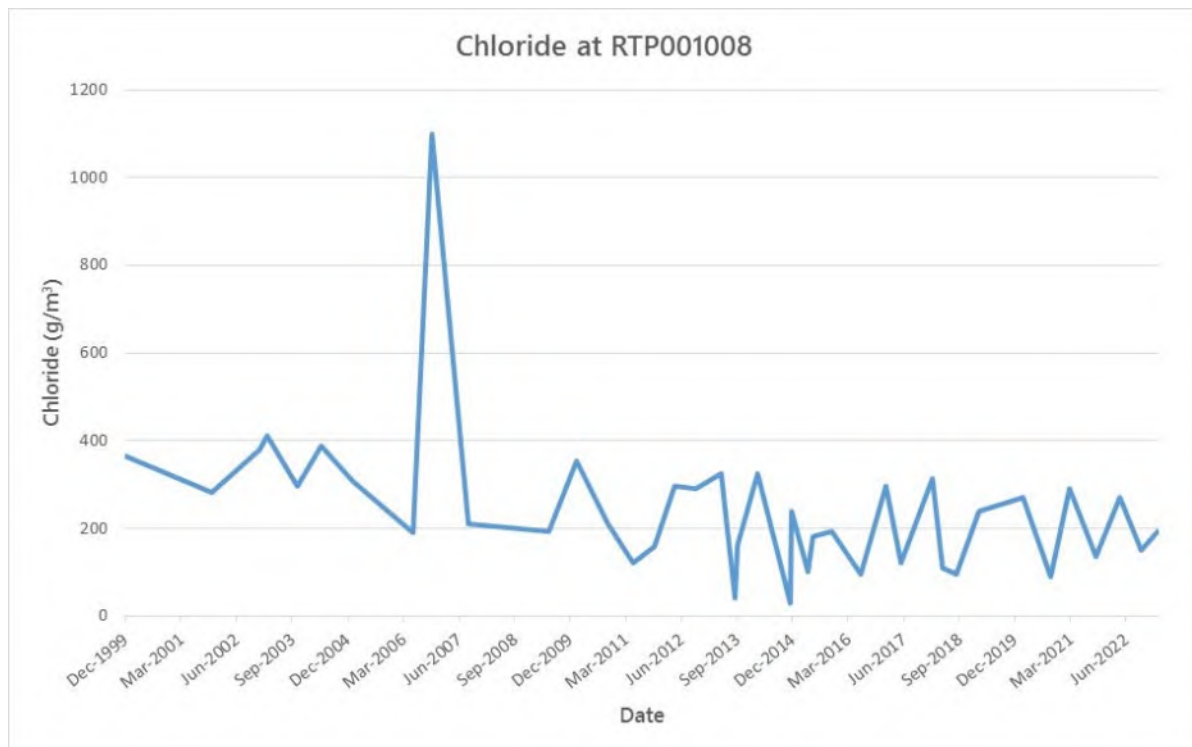
Figure 4 Hāwera landfill leachate chloride concentration 1999-2023

Results indicate that waste in the landfill, now 25 years old, continues to degrade and release contaminants. The alkalinity, chloride, chemical oxygen demand (COD) and ammoniacal nitrogen concentrations are typical values for landfill leachate. As expected, these contaminants have gradually trended down over time (Figure 4, Figure 5, and Figure 6) and are now levelling out, although concentrations continue to fluctuate. All of the results obtained during the year under review were below the maximum values previously recorded, and below the historical medians.

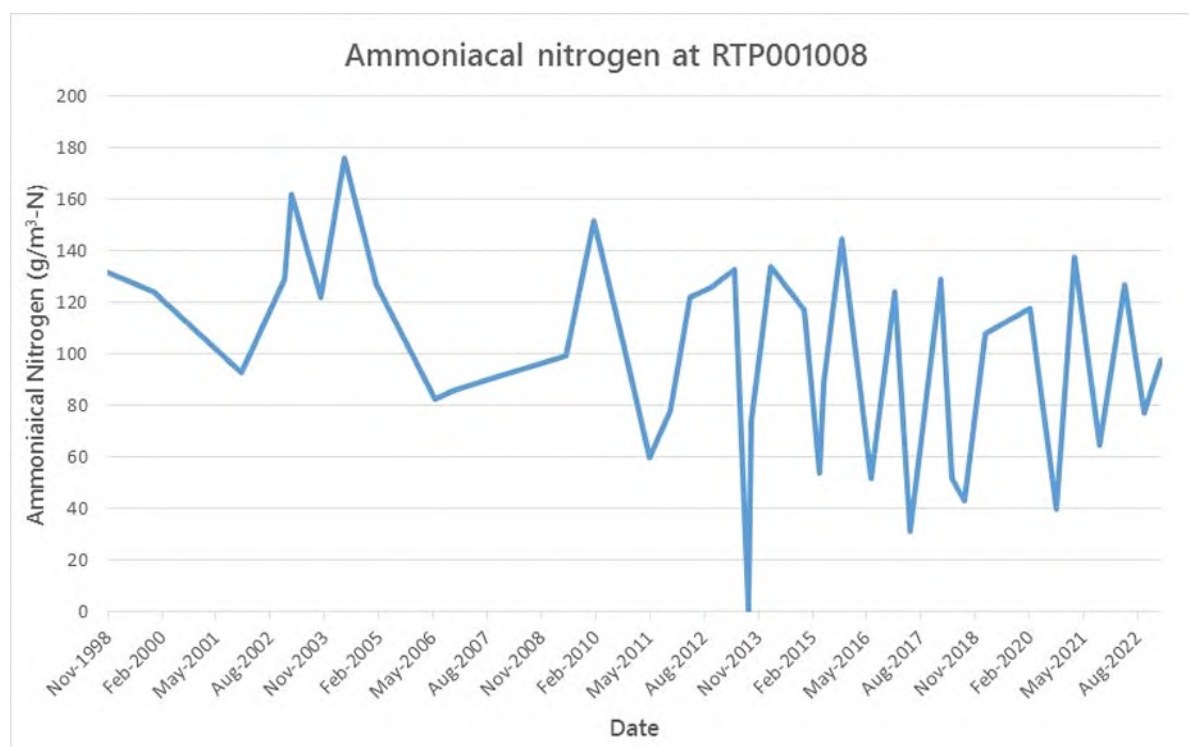
Figure 6 Hāwera landfill leachate ammoniacal nitrogen, 1998-2023

As most of this leachate is pumped to the Hāwera wastewater treatment plant, the majority of the contaminants found in these samples have no direct effect on surface waters near the site. However, they do give an indication of the contaminant concentrations present in the subsurface flows that have the potential to enter groundwater at this site, due to the lack of an engineered liner. It is noted that most of the contaminants show a distinct seasonal variation.

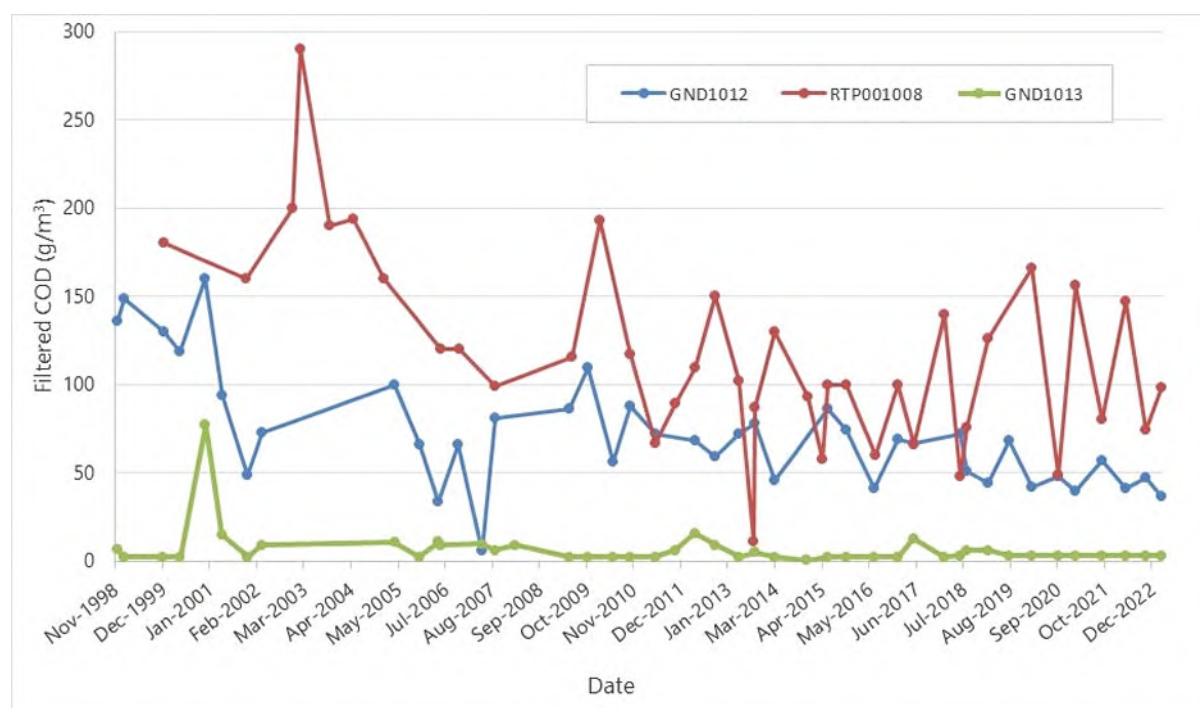
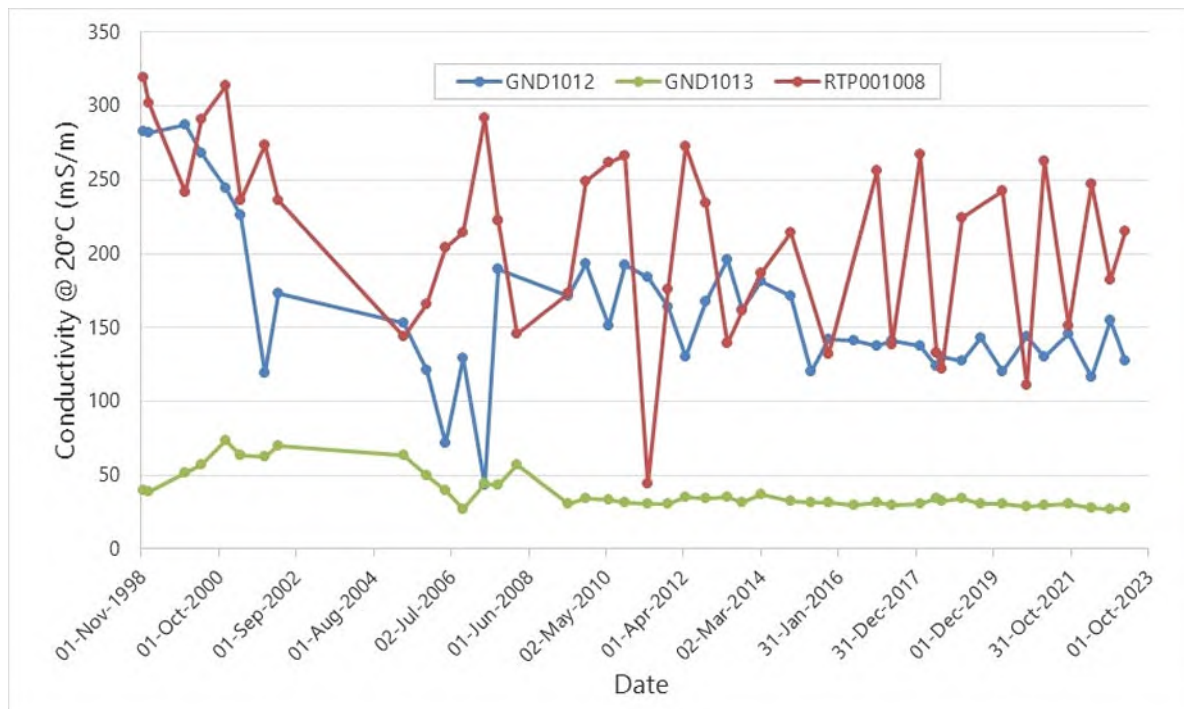
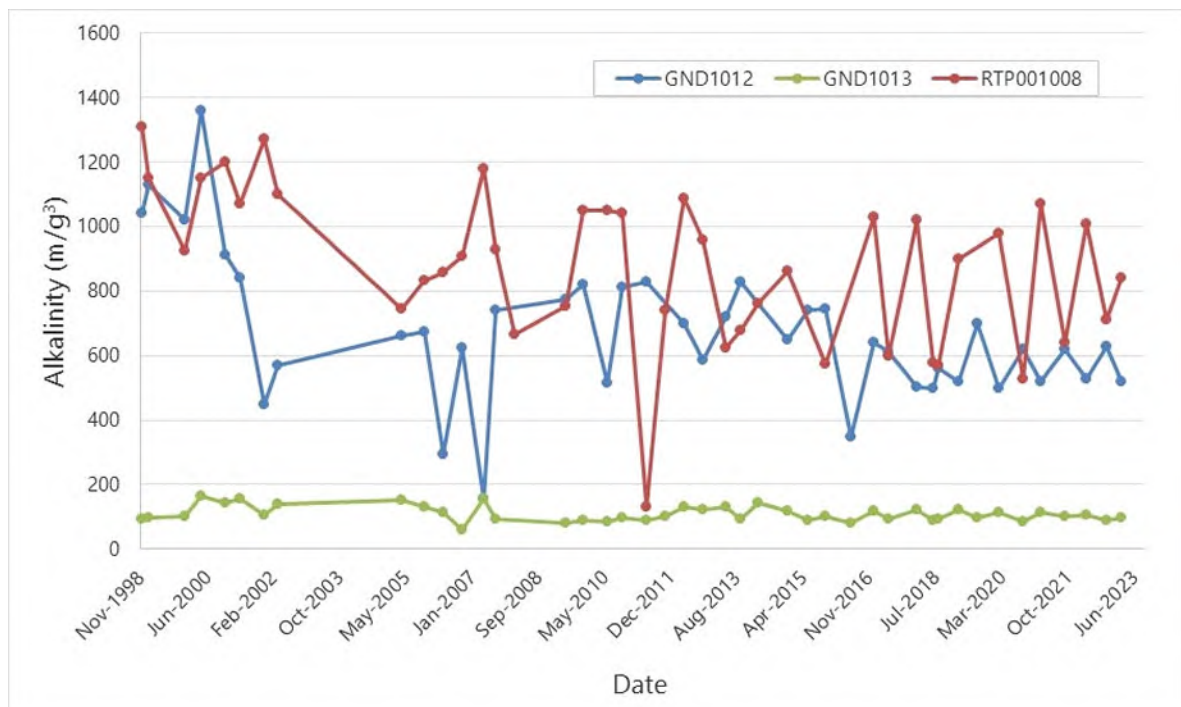
As with previous monitoring periods, bore GND1012 exhibits elevated levels of landfill contamination indicators, such parameters as chlorides, alkalinity, iron, and ammoniacal nitrogen. This bore is immediately adjacent to, the landfill footprint. Concentration levels of contaminants are generally lower than those in the leachate. Over the years there has been an overall downward trend in contaminant levels in GND1012, which in recent years have stabilised, although there are still fluctuations. It is noted that bore GND1013 is further away from the most recently landfilled areas and as a result has far lower levels of the majority of these landfill indicators and continues to be stable in all parameters (Figure 7, Figure 8 and Figure 9).

Figure 7 Comparison of filtered chemical oxygen demand between GND1012, GND1013 and RTP001008

Figure 8 Comparison of conductivity\* between GND1012, GND1013 and RTP001008

Figure 9 Comparison of alkalinity between GND1012, GND1013 and RTP001008

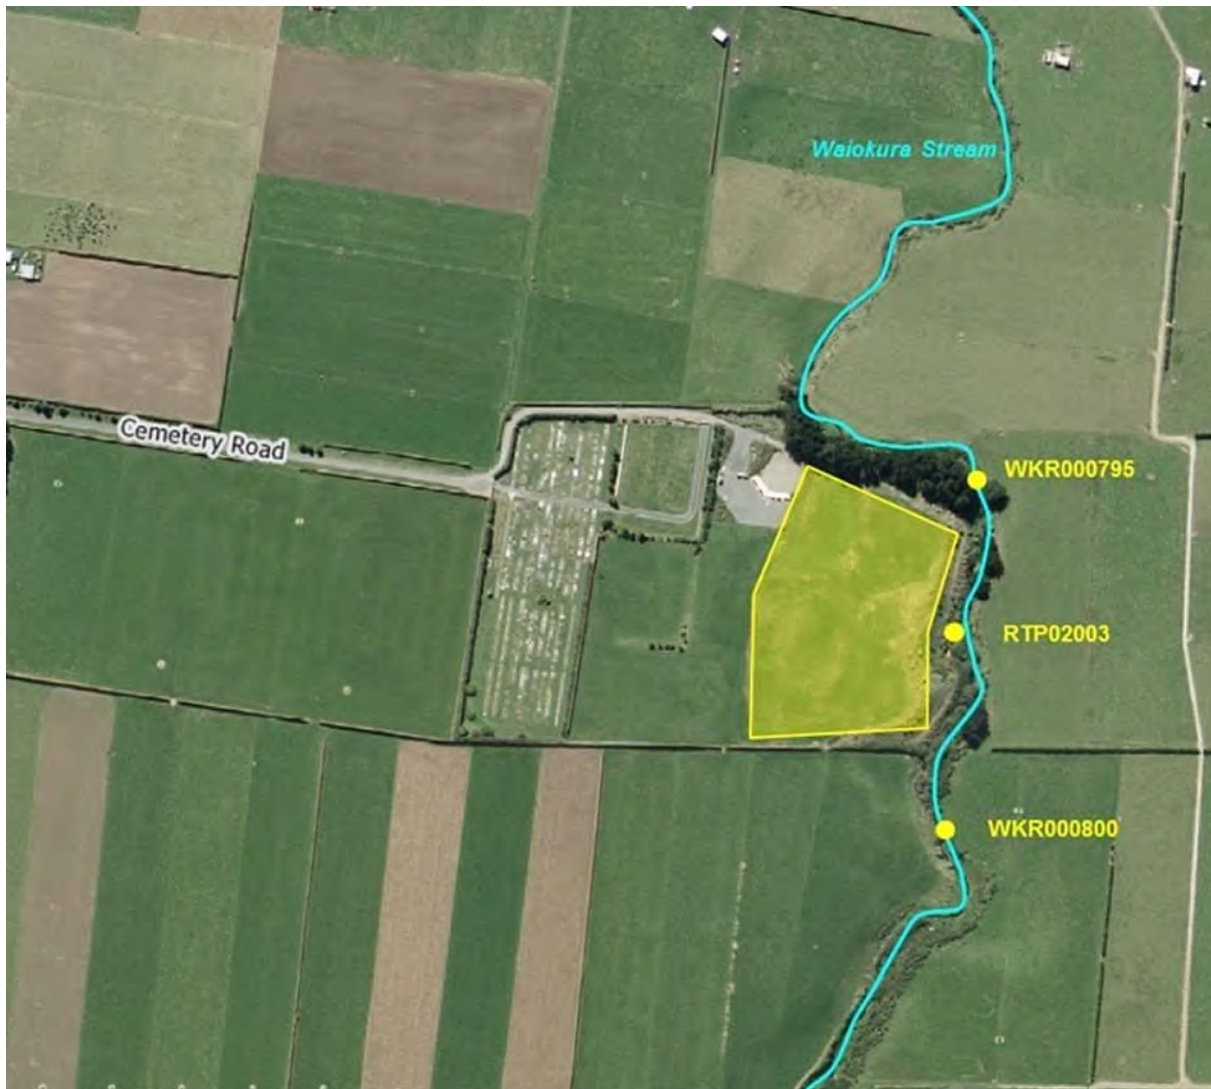
Figure 11 Aerial view of Manaia landfill showing sampling sites and landfill footprint

Leachate from the site is directed into a small settling pond via contouring and a collection drain at the base of the site. An effluent drain is directed from the pond to the Waiokura Stream. Stormwater is directed away from the active disposal areas into the collection drain. A silt trap is installed at the north eastern corner of the site for surface water runoff.

The cap appeared to be in good condition, with no signs of slips, slumps or cracks. There was evidence of recent grazing on the cap, however there was good grass cover remaining. The stormwater/leachate drains were not discharging at the time of inspection. The leachate pond was three quarters full and did not appear to be actively discharging to the Waiokura stream. Leachate pond was green in colour. No visual environmental effects downstream of the discharge point. Temporary fencing erected to section off stream from surrounding pine tree belt. Refuse station was in adequate condition. Surface water and discharge samples were collected. Compliant at the time of inspection.

The cap was well grassed and showed some signs of being recently grazed. No slumps, cracks or slips present in the cap. The leachate pond was not discharging to the stream, it was slightly turbid and yellow in colour. Leachate drains appear in good condition. There was a new drain dug from the refuse station to a new pond near the main entrance which discharges directly to stream via overland flow through an open drain. Refuse station was tidy and maintained well. Fencing requires some maintenance around the boundary to the stream. Surface water and discharge samples were collected. All compliant at the time of inspection.

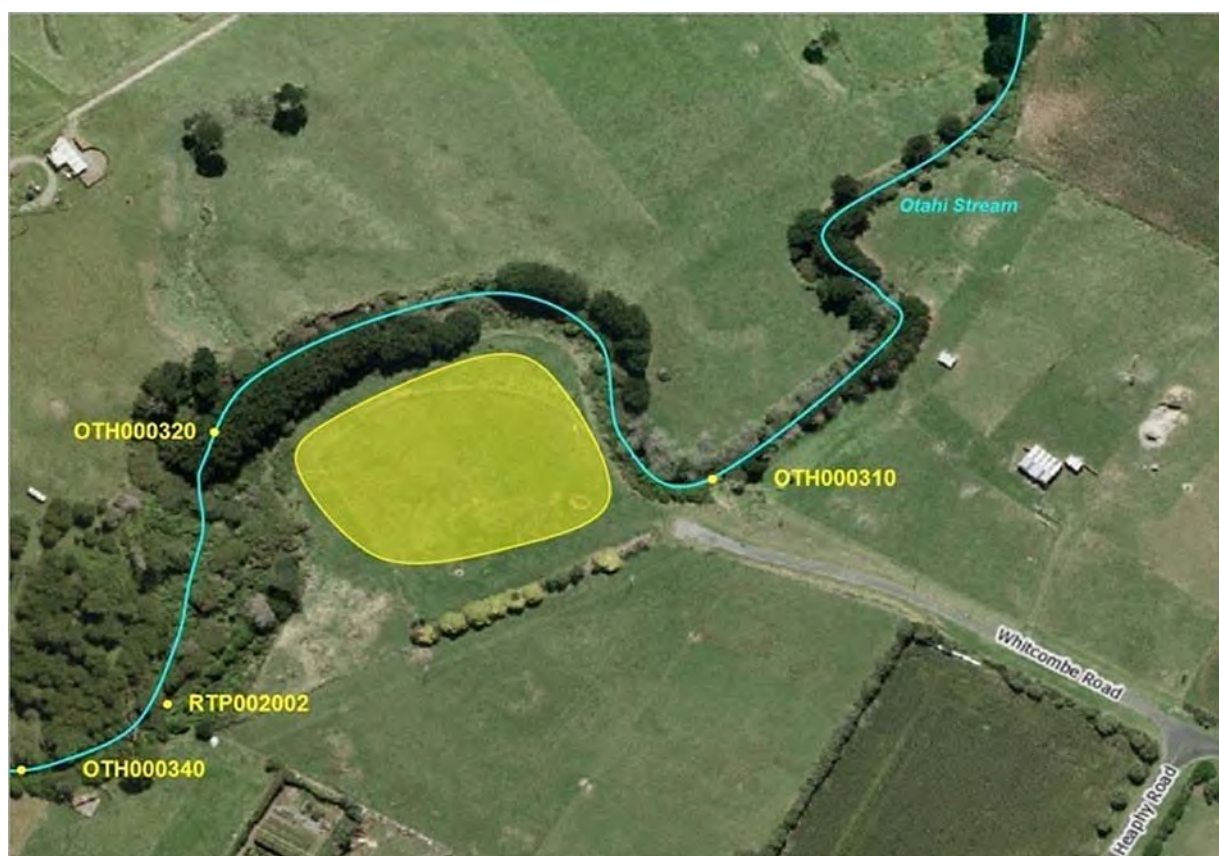
Figure 12 Aerial view of Ōpunake landfill footprint and sampling sites

Leachate from the site is directed to a settling pond via contouring and a collection drain. The effluent drain then leads to the Otahi Stream, passing through a small wetland enabling further breakdown of the leachate and natural assimilation of organic compounds.

Samples were collected from the leachate drain, and the Otahi Stream at sites above, below and adjacent to the landfill (Figure 12) on 4 November 2022. The results are presented in Table 12.

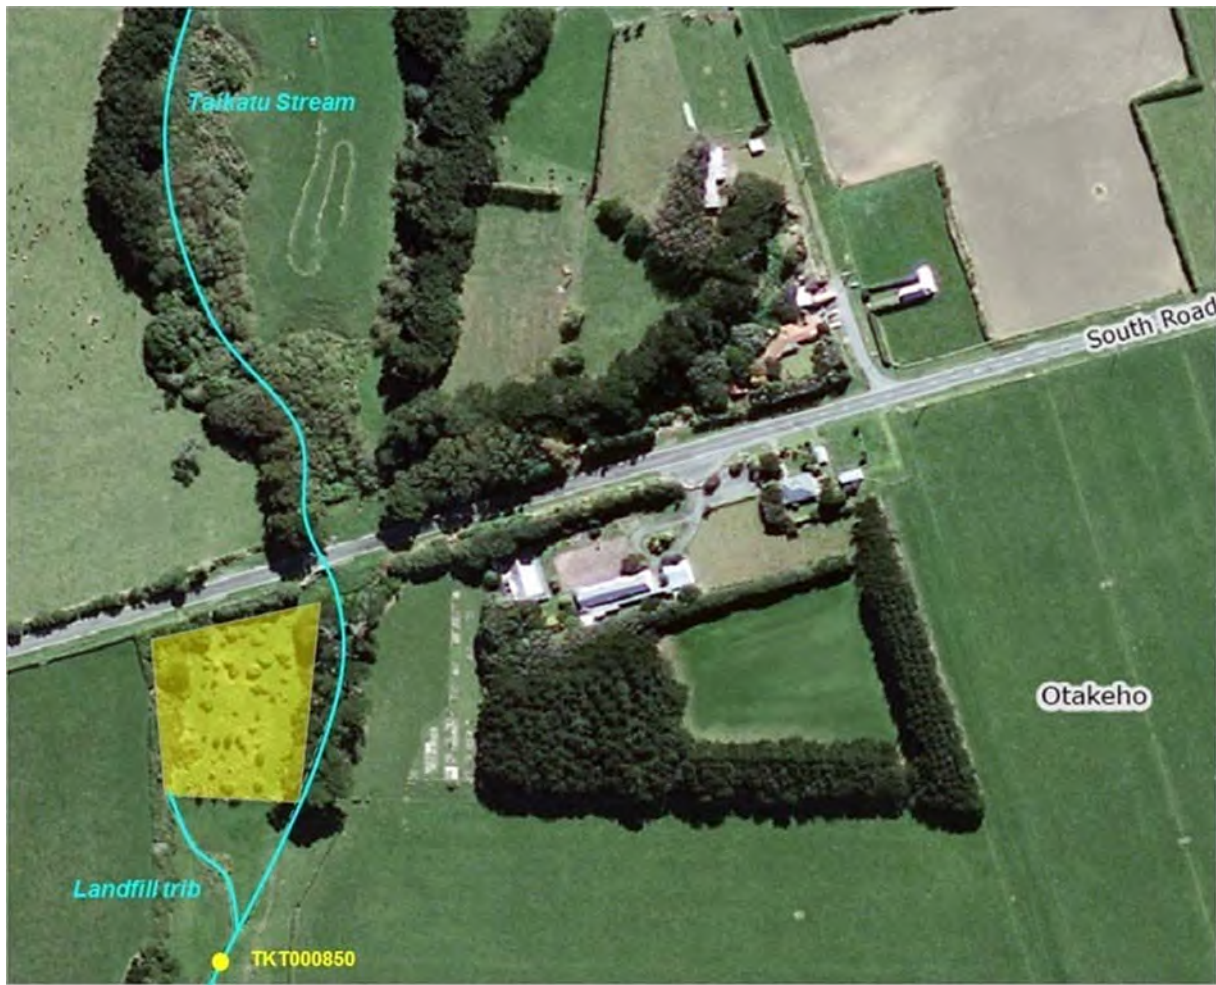
Figure 13 Aerial image of Otakeho landfill and monitoring site in the Taikatu Stream

The Otakeho landfill (Figure 13) was a small uncontrolled landfill that STDC closed in 1991. STDC at the time also applied for a consent to discharge leachate and stormwater into the Taikatu Stream.
